MORA Cycle 6

Final Report

Road Inventory and Condition Assessment of Paved Routes Mount Rainier National Park

Report Date: May 2016

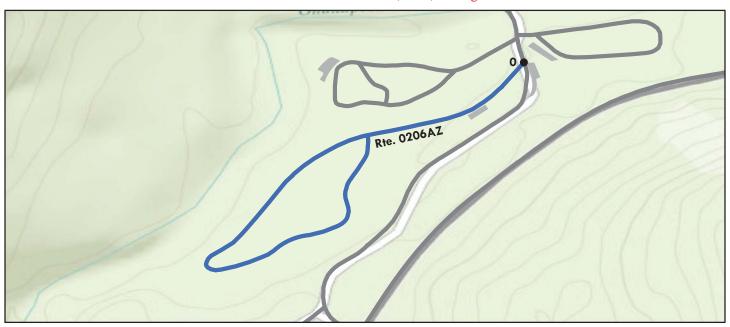
ROUTE 0206AZ: OHANA CAMPGROUND LOOPA

Subcomponent of Route MORA-0206ZZ Data Collection Vehicle (DCV) Rating

Route (Condition Legend – Pav	ement Condi	ition Rating (PC	CR)		
Poor (0 - 60			(85 - 94)	Excellent (95		Not Rat	ed
		See Appendix for def					
Inspection Date:	8/8/2015	Beginning Section MP	0		I	I	
Paved Length (Mile	es): 0.48	Section Length (MI)	0.48				
Surface Type:	ASPHALT	Route Summary					
Roadway Condition	n Information						
Pavement Conditio	on Rating (PCR)	97	97				
Surface Condition R	tating (SCR)	97	97				
Roughness Conditio	n Index (RCI)	N/A	N/A				
Distress Index Valu	es						
Structural Crack In	dex	100	100				
Alligator Crack Inc	lex	100	100				
Longitudinal Crack	Index	100	100				
Transverse Crackin	ig Index	100	100				
Patching Index		100	100				
Rutting Index		97	97				
International Rough	hness Index (IRI)	N/A	N/A				
Lane & Width Info	rmation						
Number of Lanes		1	1				
Paved Width (ft)		13.3	13.3				
Lane Width (ft)		10.8	10.8

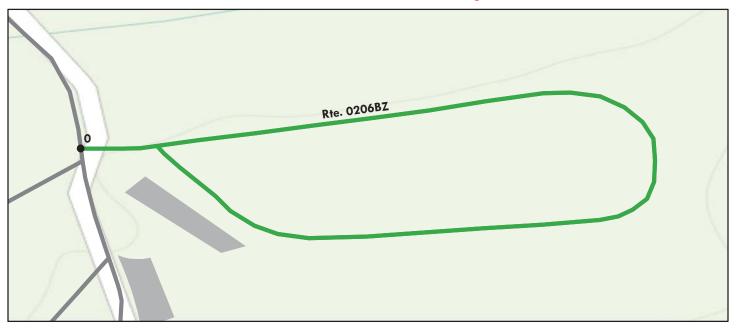
ROUTE 0206BZ: OHANA CAMPGROUND LOOP B

Subcomponent of Route MORA-0206ZZ Data Collection Vehicle (DCV) Rating

Route (Condition Legend – Pav	ement Condi	ition Rating (PCR)		
Poor (0 - 60	_		(85 - 94)	Excellent (9		Not Ra	ted
		See Appendix for def	,				
Inspection Date:	8/8/2015	Beginning Section MP	0				
Paved Length (Mile	es): 0.21	Section Length (MI)	0.21				
Surface Type:	ASPHALT	Route Summary					
Roadway Condition	Information						
Pavement Condition	n Rating (PCR)	91	91				
Surface Condition R	ating (SCR)	91	91				
Roughness Condition	n Index (RCI)	N/A	N/A				
Distress Index Value	es						
Structural Crack Inc	dex	99	99				
Alligator Crack Ind	lex	100	100				
Longitudinal Crack	Index	99	99				
Transverse Crackin	g Index	100	100				
Patching Index		98	98				
Rutting Index		91	91				
International Rough	nness Index (IRI)	N/A	N/A				
Lane & Width Info	rmation						
Number of Lanes		1	1				
Paved Width (ft)		16.6	16.6				
Lane Width (ft)		16.6	16.6

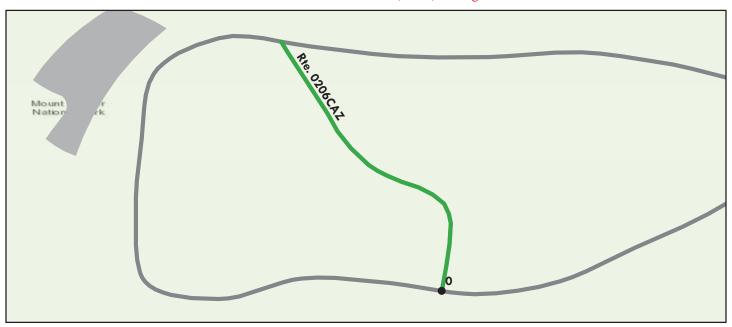
ROUTE 0206CAZ: OHANA CAMPGROUND LOOP C BISECTOR

Subcomponent of Route MORA-0206ZZ Data Collection Vehicle (DCV) Rating

Route (Condition Legend – Pav	ement Condi	ition Rating (P	PCR)		
Poor (0 - 60			(85 - 94)	Excellent (9		Not Ra	ted
		See Appendix for def	1				
Inspection Date:	8/8/2015	Beginning Section MP	0				
Paved Length (Mile	es): 0.04	Section Length (MI)	0.04				
Surface Type:	ASPHALT	Route Summary					
Roadway Condition	n Information						
Pavement Conditio	on Rating (PCR)	93	93				
Surface Condition R	Rating (SCR)	93	93				
Roughness Conditio	on Index (RCI)	N/A	N/A				
Distress Index Valu	es						
Structural Crack In	dex	100	100				
Alligator Crack Inc	lex	100	100				
Longitudinal Crack	Index	100	100				
Transverse Crackin	ng Index	100	100				
Patching Index		100	100				
Rutting Index		93	93				
International Rough	hness Index (IRI)	N/A	N/A				
Lane & Width Info	rmation						
Number of Lanes		1	1				
Paved Width (ft)		11.3	11.3				
Lane Width (ft)		11.3	11.3

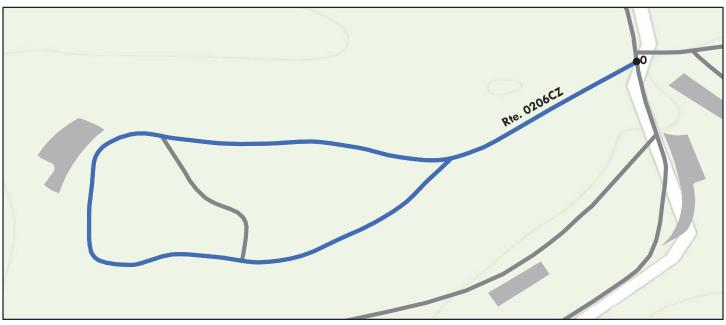
ROUTE 0206CZ: OHANA CAMPGROUND LOOP C

Subcomponent of Route MORA-0206ZZ Data Collection Vehicle (DCV) Rating

Route (Condition Legend – Pav	ement Condi	ition Rating (PCR)		
Poor (0 - 60)			(85 - 94)	Excellent (9	-	Not Rat	ed
		See Appendix for def	finitions and f	ormulas			
Inspection Date:	8/8/2015	Beginning Section MP	0				
Paved Length (Miles): 0.25	Section Length (MI)	0.25				
Surface Type:	ASPHALT	Route Summary					
Roadway Condition	Information						
Pavement Condition	Rating (PCR)	97	97				
Surface Condition Rat	ting (SCR)	97	97				
Roughness Condition	Index (RCI)	N/A	N/A				
Distress Index Values	S						
Structural Crack Inde	ex	100	100				
Alligator Crack Inde	X	100	100				
Longitudinal Crack 1	Index	100	100				
Transverse Cracking	Index	100	100				
Patching Index		100	100				
Rutting Index		97	97				
International Roughr	ness Index (IRI)	N/A	N/A				
Lane & Width Inform	mation						
Number of Lanes		1	1				
Paved Width (ft)		13.9	13.9				
Lane Width (ft)		11.1	11.1

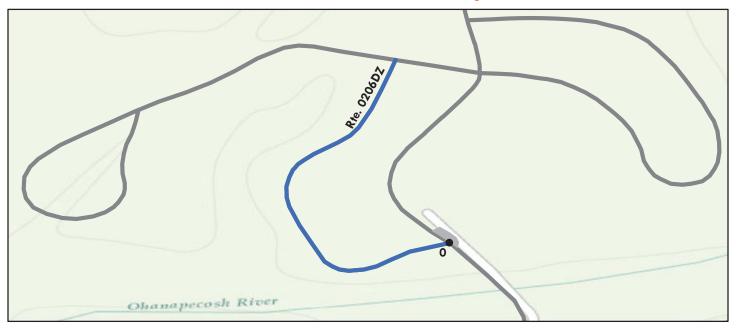
ROUTE 0206DZ: OHANA CAMPGROUND LOOP D

Data Collection Vehicle (DCV) Rating

Route (Condition Legend – Pav	ement Condi	ition Rating (PCR)		
Poor (0 - 60			(85 - 94)	Excellent (9		Not Ra	ted
		See Appendix for def	initions and f	ormulas			
Inspection Date:	8/8/2015	Beginning Section MP	0				
Paved Length (Miles): 0.15		Section Length (MI)	0.15				
Surface Type:	ASPHALT	Route Summary					
Roadway Condition	n Information						
Pavement Condition	on Rating (PCR)	96	96				
Surface Condition R	Rating (SCR)	96	96				
Roughness Condition	on Index (RCI)	N/A	N/A				
Distress Index Valu	es						
Structural Crack In	ıdex	100	100				
Alligator Crack Inc	dex	100	100				
Longitudinal Crack	Index	100	100				
Transverse Crackin	ng Index	100	100				
Patching Index		100	100				
Rutting Index		96	96				
International Roug	hness Index (IRI)	N/A	N/A				
Lane & Width Info	rmation						
Number of Lanes		1	1				
Paved Width (ft)		12.2	12.2				
Lane Width (ft)		12.2	12.2

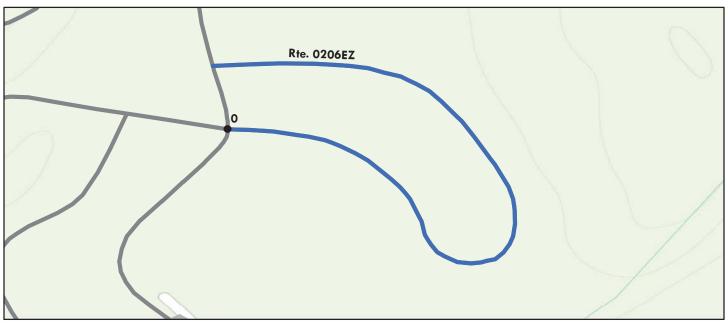
ROUTE 0206EZ: OHANA CAMPGROUND LOOP E

Data Collection Vehicle (DCV) Rating

Route (Condition Legend – Pav	ement Condi	ition Rating (I	PCR)		
Poor (0 - 60			(85 - 94)	Excellent (9		Not Ra	ted
		See Appendix for def	1				
Inspection Date:	8/8/2015	Beginning Section MP	0				
Paved Length (Miles): 0.23		Section Length (MI)	0.23				
Surface Type:	ASPHALT	Route Summary					
Roadway Condition	n Information						
Pavement Conditio	n Rating (PCR)	98	98				
Surface Condition R	ating (SCR)	98	98				
Roughness Condition	n Index (RCI)	N/A	N/A				
Distress Index Value	es						
Structural Crack In-	dex	100	100				
Alligator Crack Ind	lex	100	100				
Longitudinal Crack	Index	100	100				
Transverse Crackin	g Index	100	100				
Patching Index		100	100				
Rutting Index		98	98				
International Rough	hness Index (IRI)	N/A	N/A				
Lane & Width Info	rmation						·
Number of Lanes		1	1				
Paved Width (ft)		11.8	11.8				
Lane Width (ft)		11.8	11.8	1

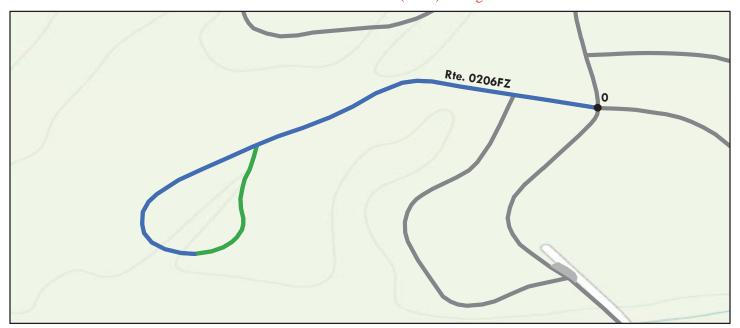
ROUTE 0206FZ: OHANA CAMPGROUND LOOP F

Subcomponent of Route MORA-0206ZZ Data Collection Vehicle (DCV) Rating

Route (Condition Legend – Pav	ement Condi	ition Rating (P	PCR)		
Poor (0 - 60			(85 - 94)	Excellent (9:		Not Rat	ted
		See Appendix for def	,				
Inspection Date:	8/8/2015	Beginning Section MP	0				
Paved Length (Miles): 0.25		Section Length (MI)	0.25				
Surface Type:	ASPHALT	Route Summary					
Roadway Condition	n Information						
Pavement Conditio	n Rating (PCR)	94	94				
Surface Condition R	tating (SCR)	94	94				
Roughness Condition	n Index (RCI)	N/A	N/A				
Distress Index Value	es						
Structural Crack In-	dex	100	100				
Alligator Crack Ind	lex	100	100				
Longitudinal Crack	Index	100	100				
Transverse Crackin	ig Index	100	100				
Patching Index		100	100				
Rutting Index		94	94				
International Rough	hness Index (IRI)	N/A	N/A				
Lane & Width Info	rmation						
Number of Lanes		1	1				
Paved Width (ft)		14.6	14.6				
Lane Width (ft)		10.5	10.5

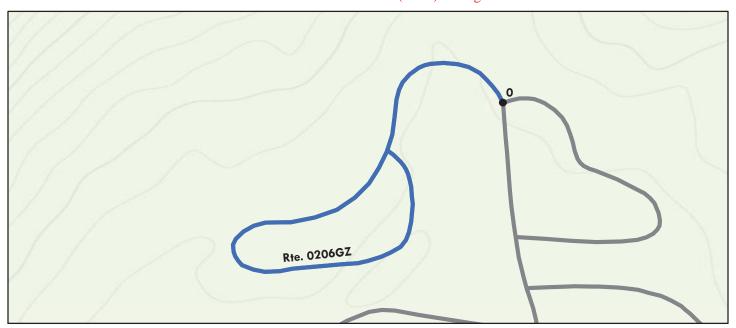
ROUTE 0206GZ: OHANA CAMPGROUND LOOP G

Subcomponent of Route MORA-0206ZZ Data Collection Vehicle (DCV) Rating

Route (Condition Legend – Pav	ement Condi	ition Rating (PCR)		
Poor (0 - 60	_		(85 - 94)	Excellent (9		Not Ra	ted
		See Appendix for def	1		,		
Inspection Date:	8/8/2015	Beginning Section MP	0				
Paved Length (Mile	es): 0.31	Section Length (MI)	0.31				
Surface Type:	ASPHALT	Route Summary					
Roadway Condition	Information						
Pavement Conditio	n Rating (PCR)	97	97				
Surface Condition R	ating (SCR)	97	97				
Roughness Condition	n Index (RCI)	N/A	N/A				
Distress Index Value	es						
Structural Crack In-	dex	100	100				
Alligator Crack Ind	lex	100	100				
Longitudinal Crack	Index	100	100				
Transverse Crackin	g Index	100	100				
Patching Index		100	100				
Rutting Index		97	97				
International Rough	nness Index (IRI)	N/A	N/A				
Lane & Width Info	rmation						
Number of Lanes		1	1				
Paved Width (ft)		15.3	15.3				
Lane Width (ft)		12	12

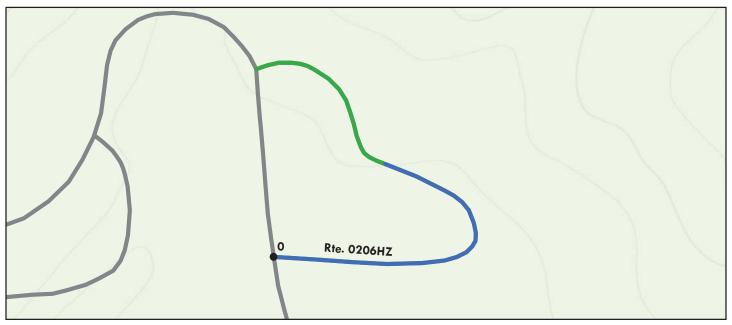
ROUTE 0206HZ: OHANA CAMPGROUND LOOP H

Subcomponent of Route MORA-0206ZZ Data Collection Vehicle (DCV) Rating

Route (Condition Legend – Pav	ement Condi	tion Rating (I	PCR)		
Poor (0 - 60	_		(85 - 94)	Excellent (9		Not Ra	ted
		See Appendix for def	1				
Inspection Date:	8/8/2015	Beginning Section MP	0				
Paved Length (Mile	es): 0.16	Section Length (MI)	0.16				
Surface Type:	ASPHALT	Route Summary					
Roadway Condition	Information						
Pavement Condition	n Rating (PCR)	96	96				
Surface Condition R	ating (SCR)	96	96				
Roughness Condition	n Index (RCI)	N/A	N/A				
Distress Index Value	es						
Structural Crack Inc	dex	100	100				
Alligator Crack Ind	lex	100	100				
Longitudinal Crack	Index	100	100				
Transverse Crackin	g Index	100	100				
Patching Index		100	100				
Rutting Index		96	96				
International Rough	nness Index (IRI)	N/A	N/A				
Lane & Width Info	rmation						
Number of Lanes		1	1				
Paved Width (ft)		11	11				
Lane Width (ft)		11	11

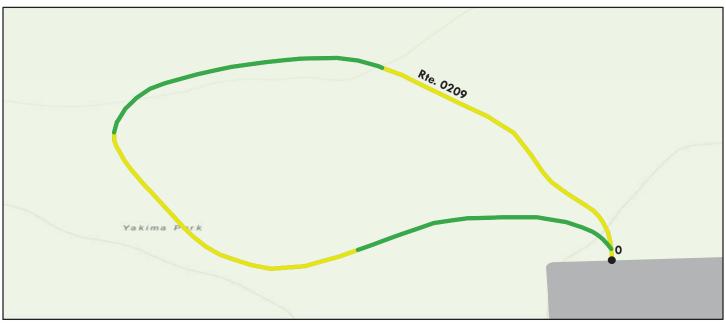
ROUTE 0209: SUNRISE PICNIC AREA ROAD

Data Collection Vehicle (DCV) Rating

Route (Condition Legend – Pav	ement Condi	tion Rating (PCR)		
Poor (0 - 60			(85 - 94)	Excellent (9		Not Ra	ted
		See Appendix for def	1				
Inspection Date:	8/8/2015	Beginning Section MP	0				
Paved Length (Mile	es): 0.38	Section Length (MI)	0.38				
Surface Type:	ASPHALT	Route Summary					
Roadway Condition	Information						
Pavement Condition	n Rating (PCR)	84	84				
Surface Condition R	ating (SCR)	84	84				
Roughness Condition	n Index (RCI)	N/A	N/A				
Distress Index Value	es						
Structural Crack Inc	dex	90	90				
Alligator Crack Ind	lex	98	98				
Longitudinal Crack	Index	92	92				
Transverse Crackin	g Index	99	99				
Patching Index		95	95				
Rutting Index		84	84				
International Rough	nness Index (IRI)	N/A	N/A				
Lane & Width Info	rmation						
Number of Lanes		2	2				
Paved Width (ft)		15.7	15.7				
Lane Width (ft)		7.9	7.9

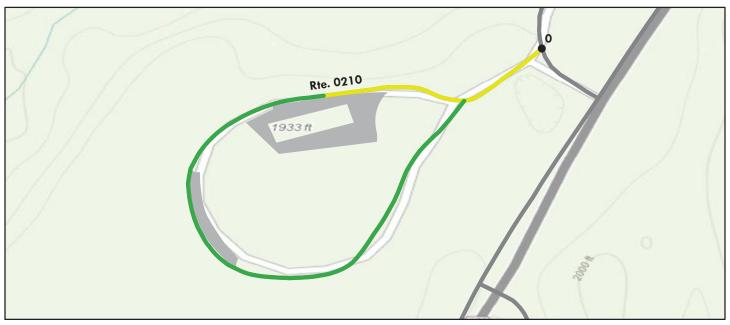
ROUTE 0210: OHANA RANGER STATION ENTRANCE ROAD

Data Collection Vehicle (DCV) Rating

Route (Condition Legend – Pav	ement Condi	ition Rating (1	PCR)		
Poor (0 - 60	_		(85 - 94)	Excellent (9		Not Ra	ted
		See Appendix for def	,				
Inspection Date:	8/8/2015	Beginning Section MP	0				
Paved Length (Miles): 0.38		Section Length (MI)	0.38				
Surface Type:	ASPHALT	Route Summary					
Roadway Condition	Information						
Pavement Condition	n Rating (PCR)	85	85				
Surface Condition Ra	ating (SCR)	85	85				
Roughness Condition	n Index (RCI)	N/A	N/A				
Distress Index Value	es						
Structural Crack Inc	dex	96	96				
Alligator Crack Ind	ex	100	100				
Longitudinal Crack	Index	96	96				
Transverse Cracking	g Index	97	97				
Patching Index		85	85				
Rutting Index		96	96				
International Rough	nness Index (IRI)	N/A	N/A				
Lane & Width Infor	rmation						
Number of Lanes		2	2				
Paved Width (ft)		17.6	17.6				
Lane Width (ft)		8.8	8.8

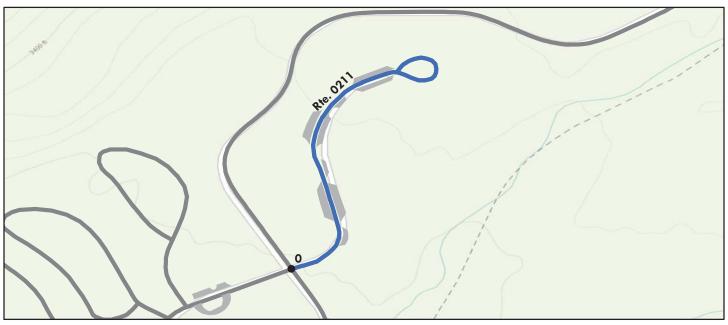
ROUTE 0211: COUGAR ROCK PICNIC AREA ROAD

Data Collection Vehicle (DCV) Rating

Route (Condition Legend – Pav	ement Condi	tion Rating (PCR)		
Poor (0 - 60	_		(85 - 94)	Excellent (9		Not Ra	ted
		See Appendix for def	1				
Inspection Date:	8/9/2015	Beginning Section MP	0				
Paved Length (Miles): 0.29		Section Length (MI)	0.29				
Surface Type:	ASPHALT	Route Summary					
Roadway Condition	Information						
Pavement Condition	n Rating (PCR)	96	96				
Surface Condition R	ating (SCR)	96	96				
Roughness Condition	n Index (RCI)	N/A	N/A				
Distress Index Value	es						
Structural Crack Inc	dex	100	100				
Alligator Crack Ind	lex	100	100				
Longitudinal Crack	Index	100	100				
Transverse Crackin	g Index	100	100				
Patching Index		100	100				
Rutting Index		96	96				
International Rough	nness Index (IRI)	N/A	N/A				
Lane & Width Info	rmation						
Number of Lanes		2	2				
Paved Width (ft)		17.8	17.8				
Lane Width (ft)		10	10

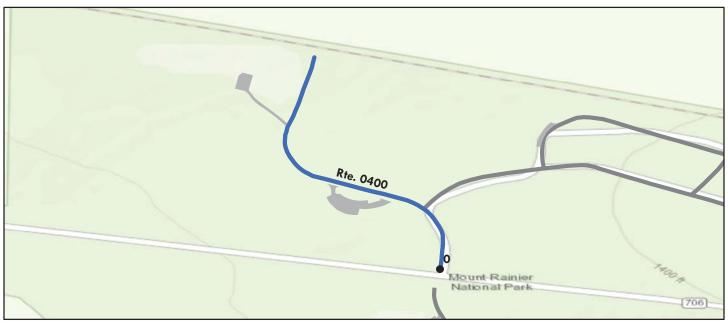
ROUTE 0400: TAHOMA WOODS ADMIN ENTRANCE ROAD

Data Collection Vehicle (DCV) Rating

Route (Condition Legend – Pav	ement Condi	ition Rating (PCR)		
Poor (0 - 60)	_		(85 - 94)	Excellent (9		Not Ra	ted
		See Appendix for def	1				
Inspection Date:	8/7/2015	Beginning Section MP	0				
Paved Length (Miles): 0.32		Section Length (MI)	0.32				
Surface Type:	ASPHALT	Route Summary					
Roadway Condition	Information						
Pavement Condition	Rating (PCR)	98	98				
Surface Condition Ra	ating (SCR)	98	98				
Roughness Condition	Index (RCI)	N/A	N/A				
Distress Index Value	es						
Structural Crack Ind	lex	100	100				
Alligator Crack Inde	ex	100	100				
Longitudinal Crack	Index	100	100				
Transverse Cracking	g Index	100	100				
Patching Index		100	100				
Rutting Index		98	98				
International Rough	ness Index (IRI)	N/A	N/A				
Lane & Width Infor	mation						
Number of Lanes		2	2				
Paved Width (ft)		17.3	17.3				
Lane Width (ft)		11.7	11.7

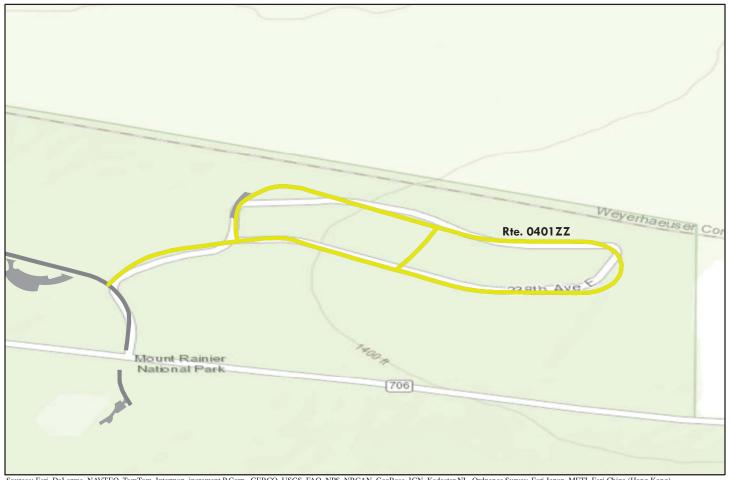
ROUTE 0401ZZ: TAHOMA WOODS RESIDENTIAL ROADS

Summary Route

Note: The weighted average summary PCR value is calculated from only the sections of road where the PCR was collected. The overall PCR for the summary route may not reflect individual subcomponent ratings.

route may not reflect indiv	iduai subcomponent rat	ings.						
	Route C	ondition Leg	end – Pav	ement Condi	tion Rating (PCR)		
Poor (0 - 60)	Poor (0 - 60) Fair (6		1- 84) Good (Excellent (95 - 100)		Not Ra	ted
		See Appen	dix for def	initions and f	ormulas			
Inspection Date:	8/7/2015							
Paved Length (Miles)): 0.81							
Surface Type:	ASPHALT	Route Sumn	nary					
Roadway Condition I	Information							
Pavement Condition	Rating (PCR)	74						
Lane & Width Inform	nation							
Number of Lanes		2						
Paved Width (ft)		20.4	4					
Lane Width (ft)		10.2	2

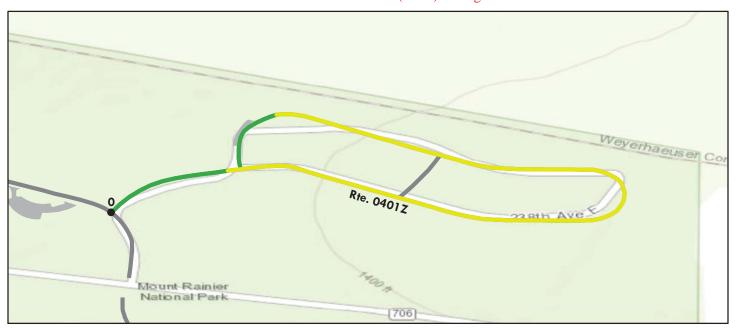
ROUTE 0401Z: TAHOMA WOODS RESIDENTIAL ROAD

Subcomponent of Route MORA-0401ZZ

Data Collection Vehicle (DCV) Rating

Route (Condition Legend – Pav	ement Condi	tion Rating (PCR)			
Poor (0 - 60			(85 - 94)	Excellent (9		- 100) Not Rated		
		See Appendix for def	finitions and f	ormulas				
Inspection Date:	8/7/2015	Beginning Section MP	0					
Paved Length (Mile	es): 0.77	Section Length (MI)	0.77					
Surface Type:	ASPHALT	Route Summary						
Roadway Condition	n Information							
Pavement Condition	on Rating (PCR)	73	73					
Surface Condition R	Rating (SCR)	91	91					
Roughness Condition	on Index (RCI)	46	46					
Distress Index Valu	es							
Structural Crack In	ıdex	98	98					
Alligator Crack Inc	dex	100	100					
Longitudinal Crack	Index	98	98					
Transverse Crackin	ng Index	95	95					
Patching Index		100	100					
Rutting Index		91	91					
International Roug	hness Index (IRI)	307	307					
Lane & Width Info	rmation							
Number of Lanes		2	2					
Paved Width (ft)		20.5	20.5					
Lane Width (ft)		10.2	10.2

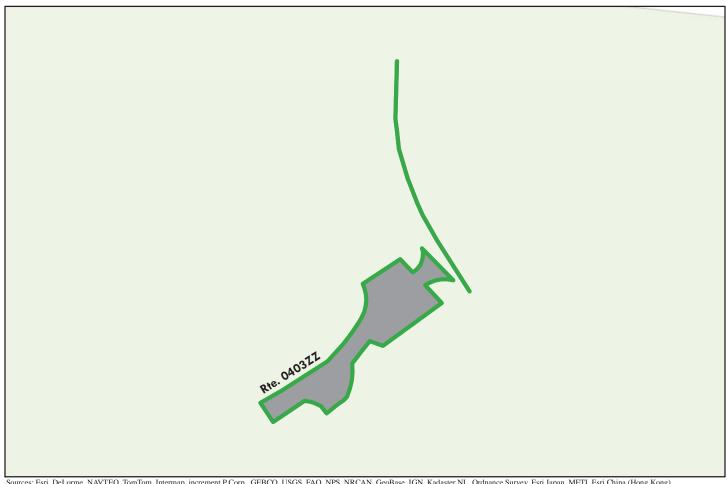
ROUTE 0403ZZ: TAHOMA WOODS WASTE WATER SERVICE ROADS

Summary Route

Note: The weighted average summary PCR value is calculated from only the sections of road where the PCR was collected. The overall PCR for the summary route may not reflect individual subcomponent ratings.

oute may not reflect individual subcomponent ratings.										
	Route C	Condition Leg	end – Pav	ement Condi	tion Rating (PCR)				
Poor (0 - 60)	Poor (0 - 60) Fair (61		Good	(85 - 94)	Excellent (95 - 100)		Not Ra	ted		
	_	See Appen	dix for def	initions and f	ormulas					
Inspection Date:	8/7/2015									
Paved Length (Miles)): 0.04									
Surface Type:	ASPHALT	Route Summ	ary							
Roadway Condition	Information									
Pavement Condition	Rating (PCR)	92								
Lane & Width Inform	nation									
Number of Lanes		1								
Paved Width (ft)		14.7	1							
Lane Width (ft)		7.4

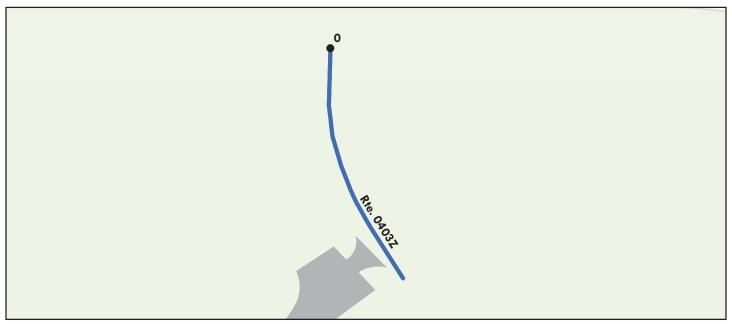
ROUTE 0403Z: TAHOMA WOODS WASTE WATER SERVICE ROAD

Subcomponent of Route MORA-0403ZZ

Data Collection Vehicle (DCV) Rating

Route (Condition Legend – Pav	ement Condi	tion Rating (PCR)		
Poor (0 - 60			(85 - 94)	Excellent ((95 - 100) Not Rated		
		See Appendix for def	finitions and f	ormulas			
Inspection Date:	8/7/2015	Beginning Section MP	0				
Paved Length (Mile	es): 0.04	Section Length (MI)	0.04				
Surface Type:	ASPHALT	Route Summary					
Roadway Condition	n Information						
Pavement Condition	on Rating (PCR)	95	95				
Surface Condition R	Rating (SCR)	95	95				
Roughness Condition	on Index (RCI)	N/A	N/A				
Distress Index Valu	ies						
Structural Crack In	ndex	100	100				
Alligator Crack Inc	dex	100	100				
Longitudinal Crack	x Index	100	100				
Transverse Crackir	ng Index	100	100				
Patching Index		100	100				
Rutting Index		95	95				
International Roug	hness Index (IRI)	N/A	N/A				
Lane & Width Info	rmation						
Number of Lanes		2	2				
Paved Width (ft)		14.7	14.7				
Lane Width (ft)		7.4	7.4

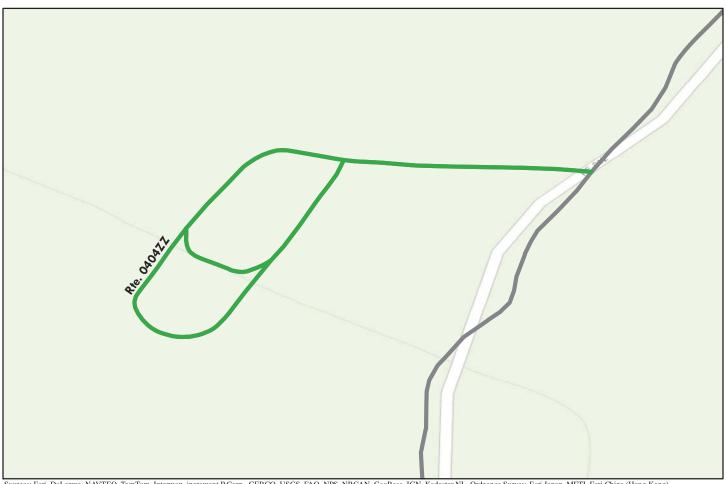
ROUTE 0404ZZ: ROAD SERVICE (LONGMIRE WATER TREATMENT)

Summary Route

Note: The weighted average summary PCR value is calculated from only the sections of road where the PCR was collected. The overall PCR for the summary route may not reflect individual subcomponent ratings

route may not reflect individual subcomponent ratings.										
	Route C	Condition Leg	end – Pav	ement Condi	tion Rating (PCR)				
Poor (0 - 60)	Poor (0 - 60) Fair (61		Good	(85 - 94)	Excellent (95 - 100)		Not Ra	ted		
		See Appen	dix for def	initions and f	ormulas					
Inspection Date:	8/9/2015									
Paved Length (Miles)	0.3									
Surface Type:	ASPHALT	Route Summ	ary							
Roadway Condition I	Information									
Pavement Condition	Rating (PCR)	91								
Lane & Width Inform	nation									
Number of Lanes		1								
Paved Width (ft)		9.9								
Lane Width (ft)		9.9

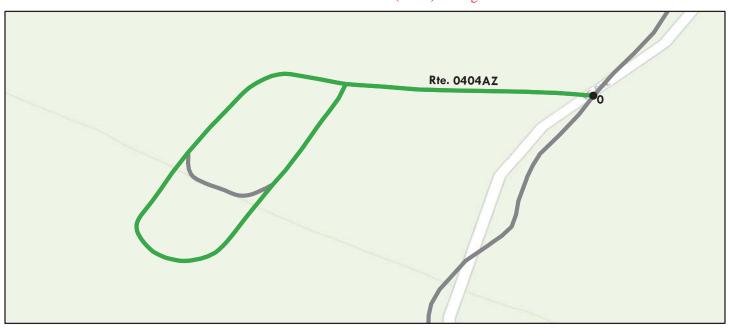
ROUTE 0404AZ: LONGMIRE WATER TREATMENT ROAD

Subcomponent of Route MORA-0404ZZ Data Collection Vehicle (DCV) Rating

Route (Condition Legend – Pav	ement Condi	tion Rating (PCR)		
Poor (0 - 60			(85 - 94)	Excellent (Not Rated	
		See Appendix for def	finitions and f	ormulas			
Inspection Date:	8/9/2015	Beginning Section MP	0				
Paved Length (Mile	es): 0.26	Section Length (MI)	0.26				
Surface Type:	ASPHALT	Route Summary					
Roadway Condition	n Information						
Pavement Condition	on Rating (PCR)	91	91				
Surface Condition R	Rating (SCR)	91	91				
Roughness Condition	on Index (RCI)	N/A	N/A				
Distress Index Valu	es						
Structural Crack In	ıdex	94	94				
Alligator Crack Inc	dex	100	100				
Longitudinal Crack	Index	94	94				
Transverse Crackir	ng Index	92	92				
Patching Index		97	97				
Rutting Index		91	91				
International Roug	hness Index (IRI)	N/A	N/A				
Lane & Width Info	rmation						
Number of Lanes		1	1				
Paved Width (ft)		9.6	9.6				
Lane Width (ft)		9.6	9.6

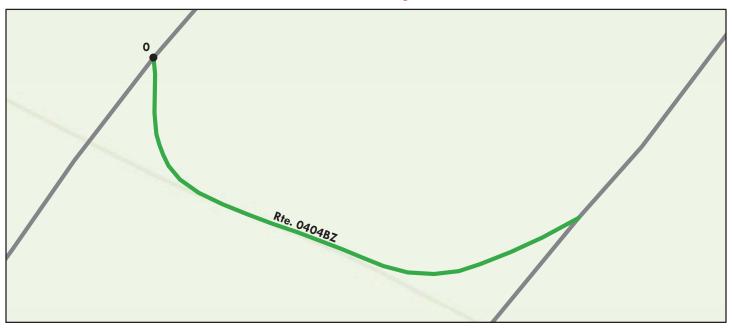
ROUTE 0404BZ: LONGMIRE WATER TREATMENT CUT THROUGH

Subcomponent of Route MORA-0404ZZ Manual Rating

Route (Condition Legend – Pav	ement Condi	tion Rating (PCR)			
Poor (0 - 60	_		(85 - 94)	Excellent (Not Rated		
		See Appendix for def	finitions and f	ormulas				
Inspection Date:	8/9/2015	Beginning Section MP	0.00					
Paved Length (Mile	es): 0.04	Section Length (MI)	0.04					
Surface Type:	ASPHALT	Route Summary						
Roadway Condition	n Information							
Pavement Condition	on Rating (PCR)	90	90					
Surface Condition R	Rating (SCR)	90	90					
Roughness Condition	on Index (RCI)	N/A	N/A					
Distress Index Valu	es							
Structural Crack In	ıdex	N/A	N/A					
Alligator Crack Inc	dex	97	97					
Longitudinal Crack	Index	90	90					
Transverse Crackin	ng Index	90	90					
Patching Index		97	97					
Rutting Index		97	97					
International Roug	hness Index (IRI)	N/A	N/A					
Lane & Width Info	rmation							
Number of Lanes		1	1					
Paved Width (ft)		12	12					
Lane Width (ft)		12	12

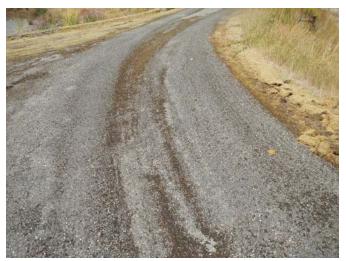
MORA_0404BZ_1767.JPG

ROUTE 0404BZ: LONGMIRE WATER TREATMENT CUT THROUGH

Condition Photos

Condition photos are shown only for manually rated roads. Use the PathView program to see images of DCV rated roads.

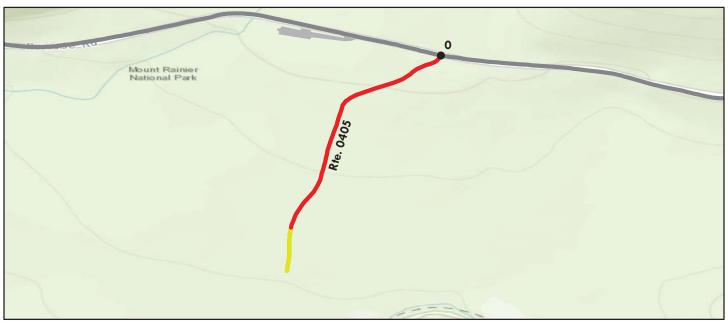
ROUTE 0405: KAUTZ HELIBASE ACCESS ROAD

Data Collection Vehicle (DCV) Rating

Route (Condition Legend – Pav	ement Condi	tion Rating (PCR)		
Poor (0 - 60	_		(85 - 94)	Excellent (9		Not Ra	ted
		See Appendix for def	1		,		
Inspection Date:	8/9/2015	Beginning Section MP	0				
Paved Length (Miles): 0.36		Section Length (MI)	0.36				
Surface Type:	ASPHALT	Route Summary					
Roadway Condition	Information						
Pavement Condition	n Rating (PCR)	44	44				
Surface Condition R	ating (SCR)	44	44				
Roughness Condition	n Index (RCI)	N/A	N/A				
Distress Index Value	es						
Structural Crack Inc	dex	44	44				
Alligator Crack Ind	lex	78	78				
Longitudinal Crack	Index	66	66				
Transverse Crackin	g Index	98	98				
Patching Index		94	94				
Rutting Index		88	88				
International Rough	nness Index (IRI)	N/A	N/A				
Lane & Width Info	rmation						
Number of Lanes		2	2				
Paved Width (ft)		16.2	16.2				
Lane Width (ft)		8.1	8.1

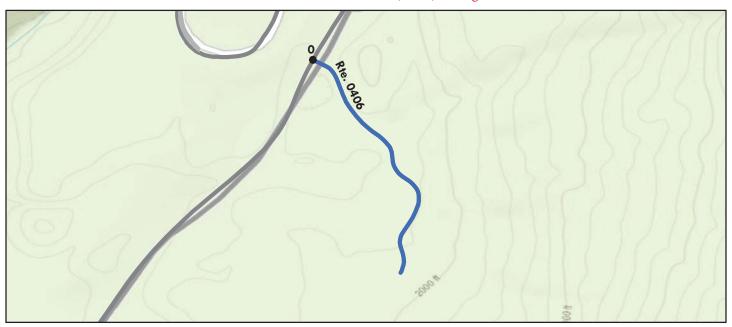
ROUTE 0406: ROAD SERVICE (OHANA WASTE WATER TREATMENT)

Route (Condition Legend – Pav	ement Condi	ition Rating (P	PCR)		
Poor (0 - 60			(85 - 94)	Excellent (9:		Not Rat	ted
		See Appendix for def	, , , , , , , , , , , , , , , , , , , ,				
Inspection Date:	8/8/2015	Beginning Section MP	0				
Paved Length (Miles): 0.29		Section Length (MI)	0.29				
Surface Type:	ASPHALT	Route Summary					
Roadway Condition	n Information						
Pavement Conditio	on Rating (PCR)	98	98				
Surface Condition R	tating (SCR)	98	98				
Roughness Conditio	n Index (RCI)	N/A	N/A				
Distress Index Valu	es						
Structural Crack In	dex	100	100				
Alligator Crack Inc	lex	100	100				
Longitudinal Crack	Index	100	100				
Transverse Crackin	ig Index	100	100				
Patching Index		100	100				
Rutting Index		98	98				
International Rough	hness Index (IRI)	N/A	N/A				
Lane & Width Info	rmation						
Number of Lanes		1	1				
Paved Width (ft)		10.2	10.2				
Lane Width (ft)		10.2	10.2	1

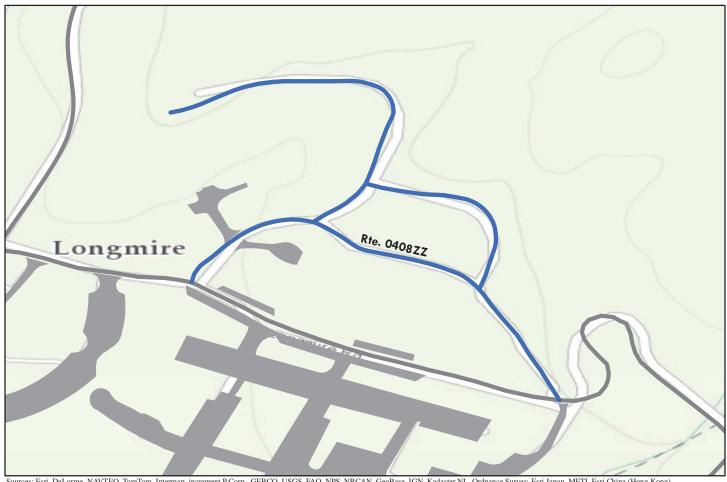
ROUTE 0408ZZ: ROAD RESIDENTIAL (LONGMIRE)

Summary Route

Note: The weighted average summary PCR value is calculated from only the sections of road where the PCR was collected. The overall PCR for the summary route may not reflect individual subcomponent ratings.

toute may not renect mulvidual subcomponent ratings.											
	Route Condition Legend – Pavement Condition Rating (PCR)										
Poor (0 - 60)	Poor (0 - 60) Fair (61		1- 84) Good (Excellent (95 - 100)		Not Ra	ted			
		See Appen	dix for def	initions and f	ormulas			_			
Inspection Date:	8/9/2015										
Paved Length (Miles)	: 0.41										
Surface Type:	ASPHALT	Route Summ	ary		•						
Roadway Condition I	nformation										
Pavement Condition	Rating (PCR)	97									
Lane & Width Inform	nation										
Number of Lanes		1									
Paved Width (ft)		15.1									
Lane Width (ft)		10.9

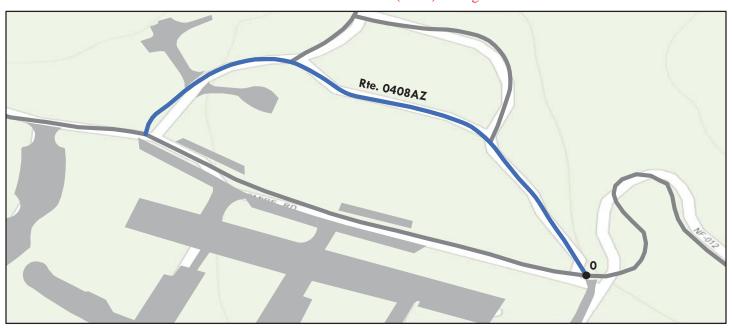
ROUTE 0408AZ: LONGMIRE RESIDENTIAL ROAD A

Subcomponent of Route MORA-0408ZZ Data Collection Vehicle (DCV) Rating

Route (Condition Legend – Pav	ement Condi	ition Rating (PCR)		
Poor (0 - 60)	_		(85 - 94)	Excellent (9		Not Ra	ted
		See Appendix for def	,				
Inspection Date:	8/9/2015	Beginning Section MP	0				
Paved Length (Miles): 0.18		Section Length (MI)	0.18				
Surface Type:	ASPHALT	Route Summary					
Roadway Condition	Information						
Pavement Condition	Rating (PCR)	96	96				
Surface Condition Ra	ting (SCR)	96	96				
Roughness Condition	Index (RCI)	N/A	N/A				
Distress Index Values	s						
Structural Crack Inde	ex	100	100				
Alligator Crack Inde	X	100	100				
Longitudinal Crack 1	Index	100	100				
Transverse Cracking	Index	100	100				
Patching Index		100	100				
Rutting Index		96	96				
International Roughi	ness Index (IRI)	N/A	N/A				
Lane & Width Inform	mation						
Number of Lanes		1	1				
Paved Width (ft)		14.9	14.9				
Lane Width (ft)		14.9	14.9

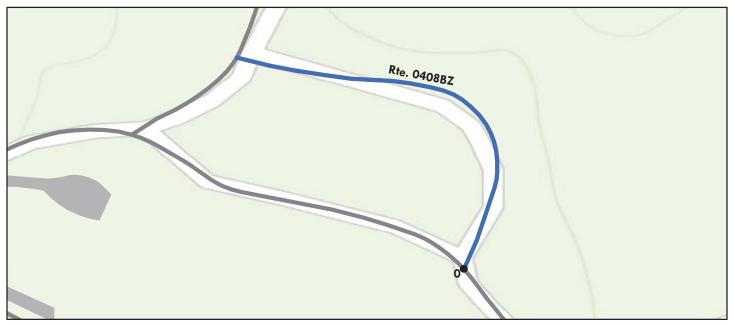
ROUTE 0408BZ: LONGMIRE RESIDENTIAL ROAD B

Subcomponent of Route MORA-0408ZZ Data Collection Vehicle (DCV) Rating

Route (Condition Legend – Pav	ement Condi	ition Rating (PCR)		
Poor (0 - 60			(85 - 94)	Excellent (9		Not Ra	ted
,		See Appendix for def	1		· ·		
Inspection Date:	8/9/2015	Beginning Section MP	0				
Paved Length (Miles	s): 0.08	Section Length (MI)	0.08				
Surface Type:	ASPHALT	Route Summary					
Roadway Condition	Information						
Pavement Condition	n Rating (PCR)	98	98				
Surface Condition Ra	ating (SCR)	98	98				
Roughness Condition	n Index (RCI)	N/A	N/A				
Distress Index Value	es						
Structural Crack Inc	lex	100	100				
Alligator Crack Inde	ex	100	100				
Longitudinal Crack	Index	100	100				
Transverse Cracking	g Index	100	100				
Patching Index		100	100				
Rutting Index		98	98				
International Rough	ness Index (IRI)	N/A	N/A				
Lane & Width Infor	mation						
Number of Lanes		2	2				
Paved Width (ft)		14.3	14.3				
Lane Width (ft)		7.2	7.2

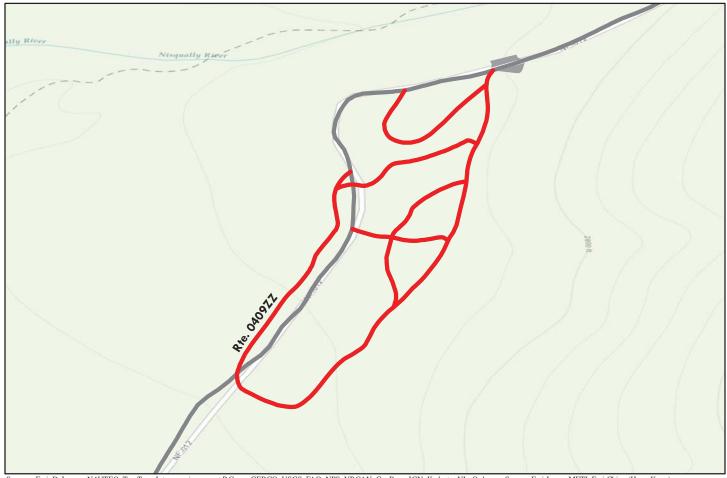
ROUTE 0409ZZ: ROAD CAMPGROUND LOOPS (LONGMIRE)

Summary Route

Note: The weighted average summary PCR value is calculated from only the sections of road where the PCR was collected. The overall PCR for the summary route may not reflect individual subcomponent ratings

Toute may not reflect murv	oute may not reflect individual subcomponent ratings.								
	Route Condition Legend – Pavement Condition Rating (PCR)								
Poor (0 - 60) Fair (6		1- 84)	Good	(85 - 94)	Excellent (95 - 100)	Not Ra	ted	
		See Appen	dix for def	initions and f	ormulas				
Inspection Date:	8/9/2015								
Paved Length (Miles)): 0.94								
Surface Type:	ASPHALT	Route Summ	ary						
Roadway Condition I	Information								
Pavement Condition	Rating (PCR)	58							
Lane & Width Inform	nation								
Number of Lanes		1							
Paved Width (ft)	8.8								
Lane Width (ft)		8.8

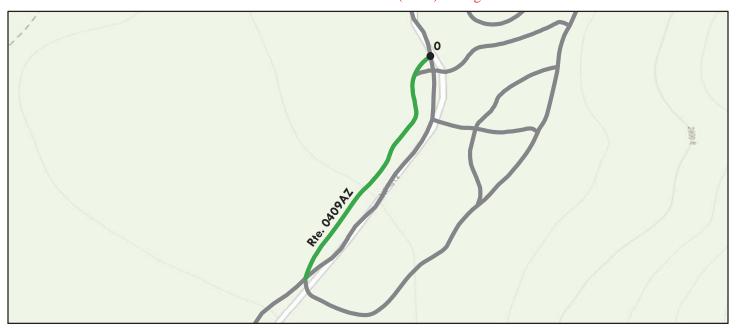
ROUTE 0409AZ: LONGMIRE CAMPGROUND LOOP A

Subcomponent of Route MORA-0409ZZ Data Collection Vehicle (DCV) Rating

Route (Condition Legend – Pav	ement Condi	tion Rating (PCR)		
Poor (0 - 60			(85 - 94)	Excellent (9		Not Ra	ted
		See Appendix for def	1		*		
Inspection Date:	8/9/2015	Beginning Section MP	0				
Paved Length (Mile	es): 0.2	Section Length (MI)	0.2				
Surface Type:	ASPHALT	Route Summary					
Roadway Condition	n Information						
Pavement Conditio	on Rating (PCR)	85	85				
Surface Condition R	tating (SCR)	85	85				
Roughness Condition	n Index (RCI)	N/A	N/A				
Distress Index Value	es						
Structural Crack In-	dex	100	100				
Alligator Crack Ind	lex	100	100				
Longitudinal Crack	Index	100	100				
Transverse Crackin	ig Index	100	100				
Patching Index		100	100				
Rutting Index		85	85				
International Rough	hness Index (IRI)	N/A	N/A				
Lane & Width Info	rmation						
Number of Lanes		1	1				
Paved Width (ft)		8.7	8.7				
Lane Width (ft)		8.7	8.7

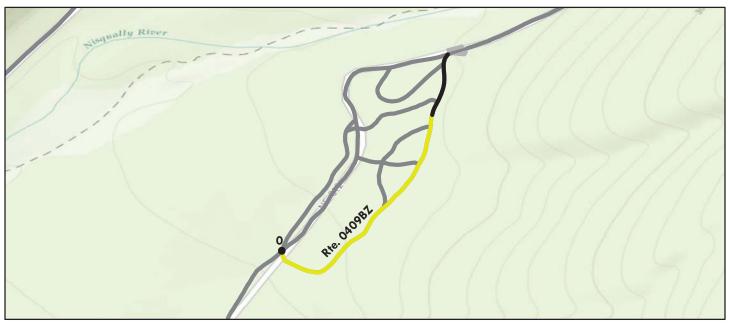
ROUTE 0409BZ: LONGMIRE CAMPGROUND LOOP B

Subcomponent of Route MORA-0409ZZ Data Collection Vehicle (DCV) Rating

Route	Condition Legend – Pav	ement Condi	ition Rating (PCR)	
Poor (0 - 60) Fair	(61- 84) Good	(85 - 94)	Excellent (95 - 100)	Not Rated
	See Appendix for det	finitions and f	ormulas	
Inspection Date: 8/9/2015	Beginning Section MP	0		
Paved Length (Miles): 0.32	Section Length (MI)	0.39		
Surface Type: ASPHALT	Route Summary			-
Roadway Condition Information				
Pavement Condition Rating (PCR)	82	82		
Surface Condition Rating (SCR)	82	82		
Roughness Condition Index (RCI)	N/A	N/A		
Distress Index Values				
Structural Crack Index	99	99		
Alligator Crack Index	99	99		
Longitudinal Crack Index	100	100		
Transverse Cracking Index	100	100		
Patching Index	100	100		
Rutting Index	82	82		
International Roughness Index (IRI)	N/A	N/A		
Lane & Width Information				
Number of Lanes	1	1		
Paved Width (ft)	8	8		
Lane Width (ft)	8	8

This road did not a receive condition rating from MP 0.32 to 0.39 because this section is unpaved.

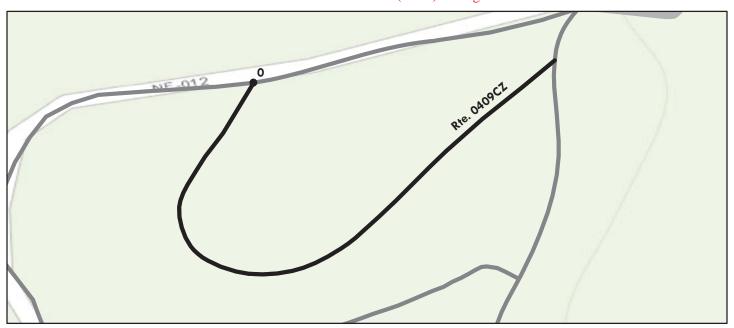
ROUTE 0409CZ: LONGMIRE CAMPGROUND LOOP C

Subcomponent of Route MORA-0409ZZ Data Collection Vehicle (DCV) Rating

Route (Condition Legend – Pav	ement Condi	ition Rating (PCR)	
Poor (0 - 60) Fair (6	1- 84) Good ((85 - 94)	Excellent (95 - 100)	Not Rated
	See Appendix for def	initions and f	ormulas	
Inspection Date: 8/9/2015	Beginning Section MP	0		
Paved Length (Miles): 0.12	Section Length (MI)	0.12		
Surface Type: ASPHALT	Route Summary			•
Roadway Condition Information				
Pavement Condition Rating (PCR)	N/A	N/A		
Surface Condition Rating (SCR)	N/A	N/A		
Roughness Condition Index (RCI)	N/A	N/A		
Distress Index Values				
Structural Crack Index	N/A	N/A		
Alligator Crack Index	N/A	N/A		
Longitudinal Crack Index	N/A	N/A		
Transverse Cracking Index	N/A	N/A		
Patching Index	N/A	N/A		
Rutting Index	N/A	N/A		
International Roughness Index (IRI)	N/A	N/A		
Lane & Width Information				
Number of Lanes	1	1		
Paved Width (ft)	7.9	7.9		
Lane Width (ft)	7.9	7.9

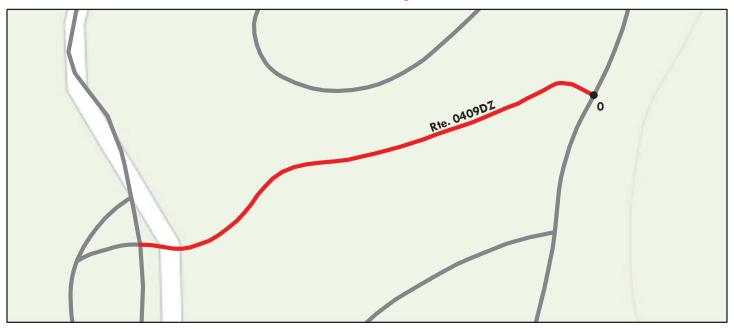
ROUTE 0409DZ: LONGMIRE CAMPGROUND LOOP D

Subcomponent of Route MORA-0409ZZ Manual Rating

Route (Condition Legend – Pav	ement Condi	ition Rating (PCR)			
Poor (0 - 60) Fair (6	1- 84) Good ((85 - 94)	Excellent (95 - 100) Not Rated			
	See Appendix for def	initions and f	ormulas			
Inspection Date: 8/9/2015	Beginning Section MP	0.00				
Paved Length (Miles): 0.09	Section Length (MI)	0.09				
Surface Type: ASPHALT	Route Summary					
Roadway Condition Information						
Pavement Condition Rating (PCR)	0	0				
Surface Condition Rating (SCR)	0	0				
Roughness Condition Index (RCI)	N/A	N/A				
Distress Index Values						
Structural Crack Index	N/A	N/A				
Alligator Crack Index	N/A	N/A				
Longitudinal Crack Index	N/A	N/A				
Transverse Cracking Index	N/A	N/A				
Patching Index	N/A	N/A				
Rutting Index	N/A	N/A				
International Roughness Index (IRI)	N/A	N/A				
Lane & Width Information						
Number of Lanes	1	1				
Paved Width (ft)	10	10				
Lane Width (ft)	10	10

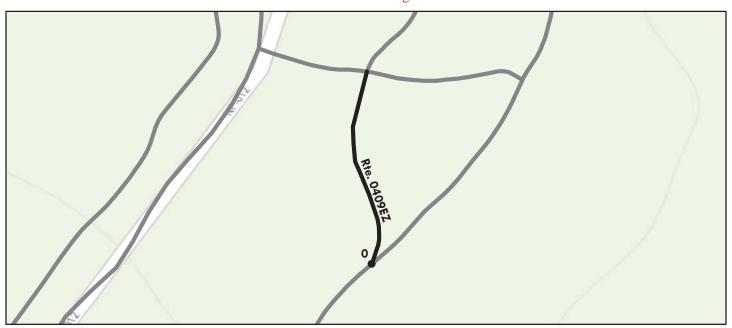
ROUTE 0409EZ: LONGMIRE CAMPGROUND LOOP E

Subcomponent of Route MORA-0409ZZ Manual Rating

Route	Condition Legend – Pav	ement Condi	ition Rating (PCR)	
Poor (0 - 60) Fair (Good ((85 - 94)	Excellent (95 - 100)	Not Rated
	See Appendix for def	initions and f	ormulas	
Inspection Date: 8/9/2015	Beginning Section MP	0.00		
Paved Length (Miles): 0.06	Section Length (MI)	0.06		
Surface Type: ASPHALT	Route Summary			•
Roadway Condition Information				
Pavement Condition Rating (PCR)	N/A	N/A		
Surface Condition Rating (SCR)	N/A	N/A		
Roughness Condition Index (RCI)	N/A	N/A		
Distress Index Values				
Structural Crack Index	N/A	N/A		
Alligator Crack Index	N/A	N/A		
Longitudinal Crack Index	N/A	N/A		
Transverse Cracking Index	N/A	N/A		
Patching Index	N/A	N/A		
Rutting Index	N/A	N/A		
International Roughness Index (IRI)	N/A	N/A		
Lane & Width Information				
Number of Lanes	1	1		
Paved Width (ft)	10	10		
Lane Width (ft)	10	10

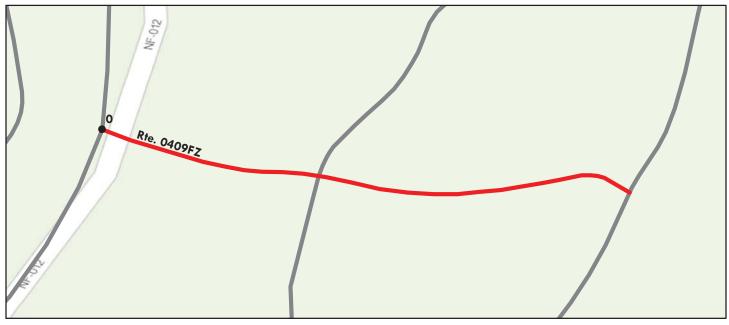
ROUTE 0409FZ: LONGMIRE CAMPGROUND LOOP F

Subcomponent of Route MORA-0409ZZ Manual Rating

Route (Condition Legend – Pav	ement Condi	tion Rating (PCR)			
Poor (0 - 60) Fair (6	1- 84) Good ((85 - 94)	Excellent (95 - 100) Not Rated			
	See Appendix for def	initions and f	ormulas			
Inspection Date: 8/9/2015	Beginning Section MP	0.00				
Paved Length (Miles): 0.06	Section Length (MI)	0.06				
Surface Type: ASPHALT	Route Summary					
Roadway Condition Information						
Pavement Condition Rating (PCR)	0	0				
Surface Condition Rating (SCR)	0	0				
Roughness Condition Index (RCI)	N/A	N/A				
Distress Index Values						
Structural Crack Index	N/A	N/A				
Alligator Crack Index	N/A	N/A				
Longitudinal Crack Index	N/A	N/A				
Transverse Cracking Index	N/A	N/A				
Patching Index	N/A	N/A				
Rutting Index	N/A	N/A				
International Roughness Index (IRI)	N/A	N/A				
Lane & Width Information						
Number of Lanes	1	1				
Paved Width (ft)	10	10				
Lane Width (ft)	10	10

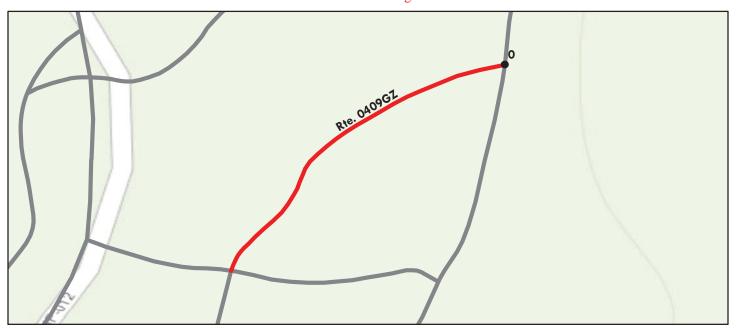
ROUTE 0409GZ: LONGMIRE CAMPGROUND LOOP G

Subcomponent of Route MORA-0409ZZ Manual Rating

Route (Condition Legend – Pav	ement Condi	tion Rating (PCR)		
Poor (0 - 60			(85 - 94)	Excellent (Not Rat	ted
		See Appendix for def	initions and f	ormulas			
Inspection Date:	8/9/2015	Beginning Section MP	0.00				
Paved Length (Mile	es): 0.07	Section Length (MI)	0.07				
Surface Type:	ASPHALT	Route Summary					
Roadway Condition	n Information						
Pavement Condition	on Rating (PCR)	30	30				
Surface Condition R	Rating (SCR)	30	30				
Roughness Condition	on Index (RCI)	N/A	N/A				
Distress Index Valu	es						
Structural Crack In	dex	N/A	N/A				
Alligator Crack Inc	lex	30	30				
Longitudinal Crack	Index	30	30				
Transverse Crackir	ng Index	53	53				
Patching Index		30	30				
Rutting Index		53	53				
International Roug	hness Index (IRI)	N/A	N/A				
Lane & Width Info	rmation						
Number of Lanes		1	1				
Paved Width (ft)		10	10				
Lane Width (ft)		10	10

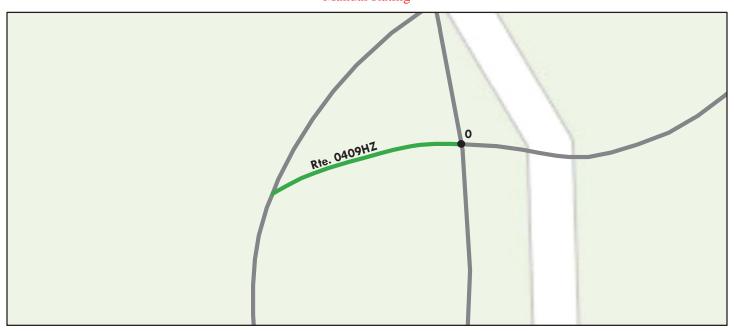
ROUTE 0409HZ: LONGMIRE CAMPGROUND LOOP H

Route (Condition Legend – Pav	ement Condi	tion Rating (PCR)		
Poor (0 - 60			(85 - 94)	Excellent (ted	
		See Appendix for def	initions and f	ormulas			
Inspection Date:	8/9/2015	Beginning Section MP	0.00				
Paved Length (Mile	es): 0.01	Section Length (MI)	0.01				
Surface Type:	ASPHALT	Route Summary					
Roadway Condition	n Information						
Pavement Condition	on Rating (PCR)	90	90				
Surface Condition R	Rating (SCR)	90	90				
Roughness Condition	on Index (RCI)	N/A	N/A				
Distress Index Valu	es						
Structural Crack In	dex	N/A	N/A				
Alligator Crack Inc	lex	90	90				
Longitudinal Crack	Index	97	97				
Transverse Crackir	ng Index	97	97				
Patching Index		97	97				
Rutting Index		90	90				
International Roug	hness Index (IRI)	N/A	N/A				
Lane & Width Info	rmation						
Number of Lanes		1	1				
Paved Width (ft)		10	10				
Lane Width (ft)		10	10

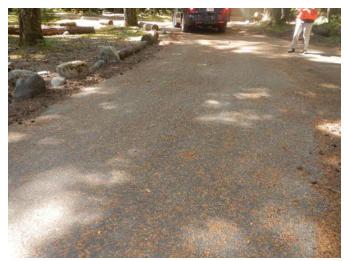
MORA_0409HZ_1745.JPG

Condition photos are shown only for manually rated roads. Use the PathView program to see images of DCV rated roads.

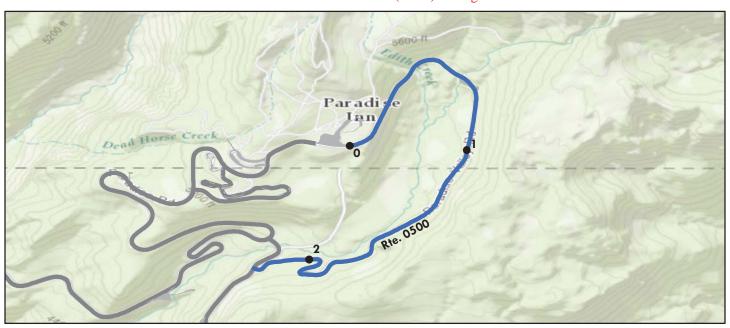
ROUTE 0500: VALLEY ROAD

Route (Condition Legend – Pav	ement Condi	tion Rating (PCR)		
Poor (0 - 60)	Fair (6		(85 - 94)	Excellent (Not Rat	ted
		See Appendix for de			<u> </u>		
Inspection Date:	8/7/2015	Beginning Section MP	0	1	2		
Paved Length (Miles):	2.2	Section Length (MI)	1	1	0.2		
Surface Type:	ASPHALT	Route Summary			!		
Roadway Condition In	formation						
Pavement Condition R	ating (PCR)	99	99	100	100		
Surface Condition Ratin	Surface Condition Rating (SCR)		99	100	100		
Roughness Condition In	dex (RCI)	N/A	N/A	N/A	N/A		
Distress Index Values							
Structural Crack Index		100	100	100	100		
Alligator Crack Index		100	100	100	100		
Longitudinal Crack Inc	dex	100	100	100	100		
Transverse Cracking Ir	ndex	100	100	100	100		
Patching Index		100	100	100	100		
Rutting Index		99	99	100	100		
International Roughnes	ss Index (IRI)	N/A	N/A	N/A	N/A		
Lane & Width Informa	ation						
Number of Lanes		1	1	1	1		
Paved Width (ft)		21.6	22.5	21	19.8

Lane Width (ft)		16.1	17	15.1	17.6

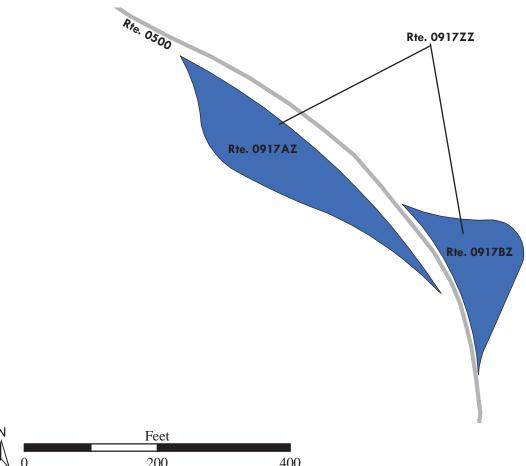
ROUTE 0917ZZ: FOURTH CROSSING PARKING COMPLEX

Inspection Date	FMSS Number	User Access	Surface Type		
8/7/2015	20258	PUBLIC	ASPHALT		
Area (Sq. Ft.)	Lane Miles (11' Widths)	Condition Rating / PCR			
31,406	0.541	SUMMARY / 97			
	Route Condition Legend – Pavement Condition Rating (PCR)				
Poor (0 - 60)	Fair (61- 84) Good ((85 - 94) Excellent (95 - 10	0) Not Rated		
See Appendix for definitions and formulas

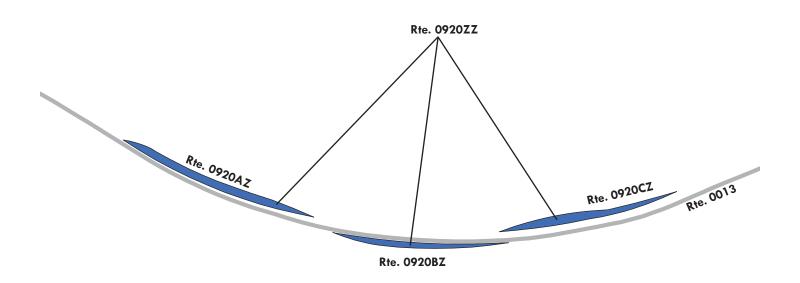
ROUTE 0920ZZ: REFLECTION LAKES PARKING COMPLEX

Inspection Date	FMSS Number	User Access	Surface Type	
8/7/2015	20262	PUBLIC	ASPHALT	
Area (Sq. Ft.)	Lane Miles (11' Widths)	Condition R	ating / PCR	
22,566	0.388	SUMMA	RY / 97	
Route Condition Legend – Pavement Condition Rating (PCR)				
Poor (0 - 60)	Fair (61- 84) Good ((85 - 94) Excellent (95 - 10	0) Not Rated	
See Appendix for definitions and formulas

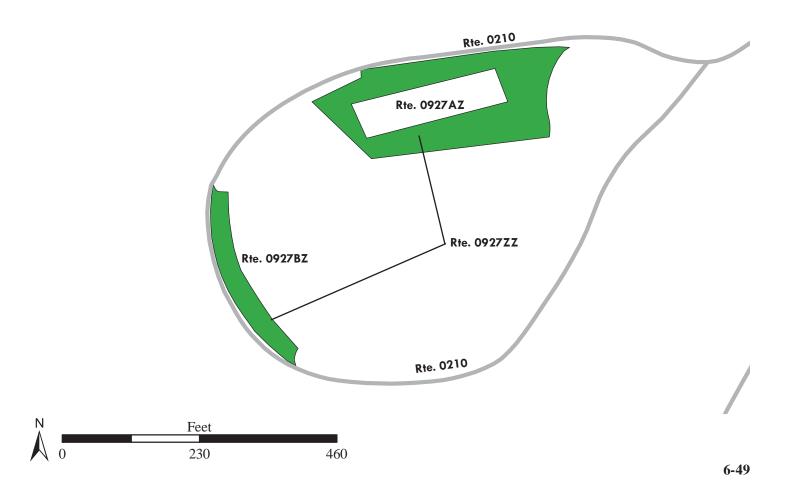
ROUTE 0927ZZ: OHANA RANGER STATION / RESIDENCE AREA PARKING COMPLEX

Inspection Date	FMSS Number	User Access	Surface Type	
8/8/2015	20269	PUBLIC	ASPHALT	
Area (Sq. Ft.)	Lane Miles (11' Widths)	Condition R	ating / PCR	
33,768	0.582	SUMMA	RY / 90	
Route Condition Legend – Pavement Condition Rating (PCR)				
Poor (0 - 60)	Fair (61- 84) Good ((85 - 94) Excellent (95 - 10	0) Not Rated	
See Appendix for definitions and formulas

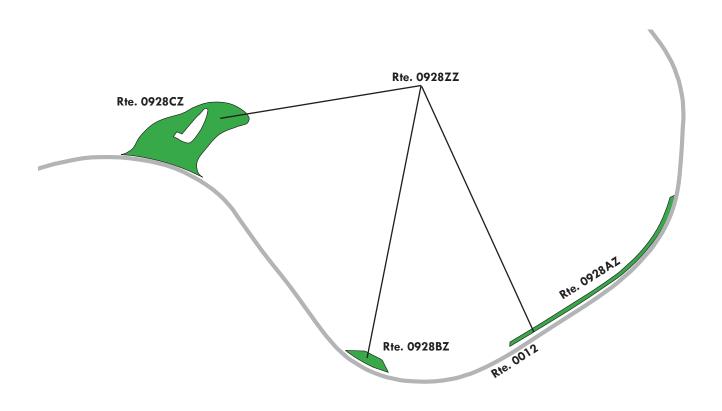
ROUTE 0928ZZ: TIPSOO LAKE PARKING COMPLEX

Inspection Date	FMSS Number	User Access	Surface Type
8/8/2015	20271	PUBLIC	ASPHALT
Area (Sq. Ft.)	Lane Miles (11' Widths)	Condition Rating / PCR	
56,100	0.965	SUMMARY / 90	
Route Condition Legend – Pavement Condition Rating (PCR)			
Poor (0 - 60)	Fair (61- 84) Good ((85 - 94) Excellent (95 - 10	0) Not Rated
See Appendix for definitions and formulas

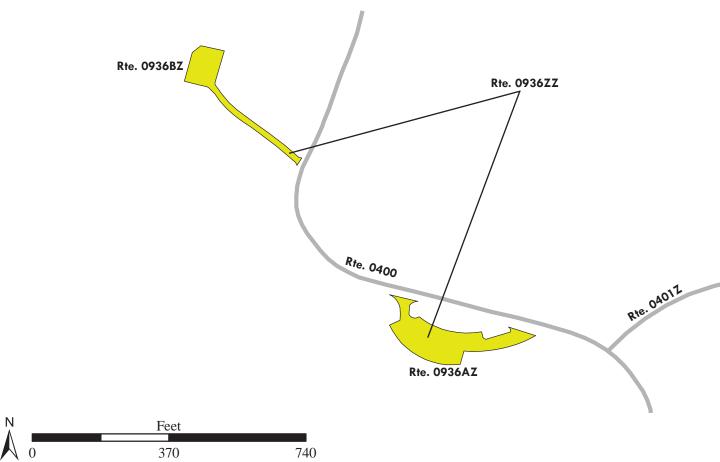
Inspection Date	FMSS Number	User Access	Surface Type		
8/7/2015	40227	PUBLIC	ASPHALT		
Area (Sq. Ft.)	Lane Miles (11' Widths)	Condition Rating / PCR			
26,675	0.459	SUMMARY / 81			
Route Condition Legend – Pavement Condition Rating (PCR)					
Poor (0 - 60)	Fair (61- 84) Good ((85 - 94) Excellent (95 - 10	0) Not Rated		
	See Appendix for definitions and formulas

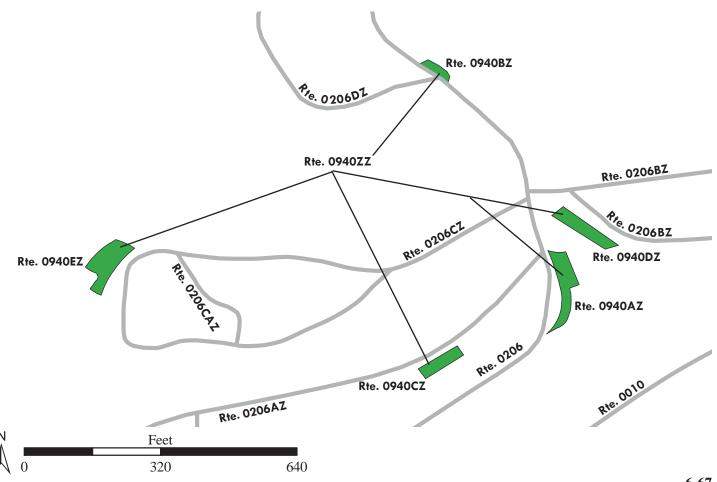
Inspection Date	FMSS Number	User Access	Surface Type		
8/8/2015	104356	PUBLIC	ASPHALT		
Area (Sq. Ft.)	Lane Miles (11' Widths)	Condition Rating / PCR			
14,246	0.246	SUMMA	RY / 89		
	Route Condition Legend – Pavement Condition Rating (PCR)				
Poor (0 - 60)	Fair (61- 84) Good ((85 - 94) Excellent (95 - 10	0) Not Rated		
See Appendix for definitions and formulas

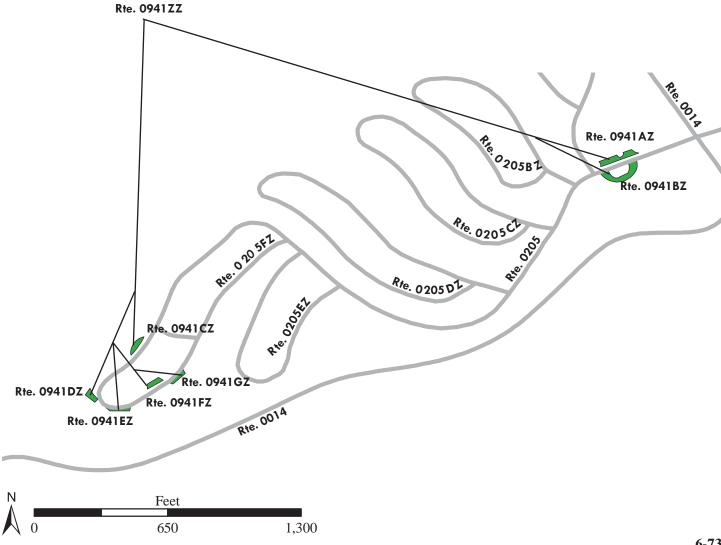
ROUTE 0941ZZ: COUGAR ROCK CAMPGROUND PARKING AREAS

Inspection Date	FMSS Number	User Access	Surface Type	
8/8/2015	104386	PUBLIC	ASPHALT	
Area (Sq. Ft.)	Lane Miles (11' Widths)	Condition R	ating / PCR	
13,901	0.238	SUMMA	RY / 88	
Route Condition Legend – Pavement Condition Rating (PCR)				
Poor (0 - 60)	Fair (61- 84) Good ((85 - 94) Excellent (95 - 10	0) Not Rated	
See Appendix for definitions and formulas

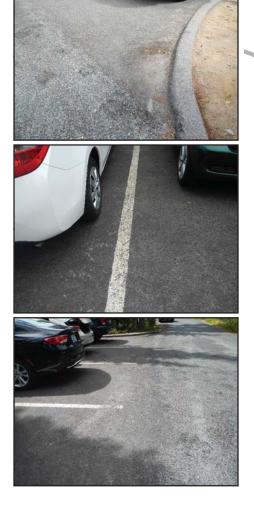
ROUTE 0943GZ: PARADISE PICNIC AREA PARKING G

ADJACENT TO ROUTE 0202AZ (PARADISE PICNIC AREA ROAD)

Inspection Date	FMSS Number	User Access	Surface Type		
8/8/2015	108256	PUBLIC	ASPHALT		
Area (Sq. Ft.)	Lane Miles (11' Widths)	Curb Reveal (Inches)	Curb Recommendation		
1,424	0.025	5	LIGHT REPAIR		
Curb	Curb Type		Curb & Gutter Type		
ASPI	ASPHALT		NO CURB AND GUTTER		
Pavement Recommendation		Condition R	ating / PCR		
PREVENTIVE N	PREVENTIVE MAINTENANCE		GOOD / 90		
	Route Condition Legend – Pavement Condition Rating (PCR)				
Poor (0 - 60)	Fair (61- 84) Good ((85 - 94) Excellent (95 - 10	0) Not Rated		
See Appendix for definitions and formulas

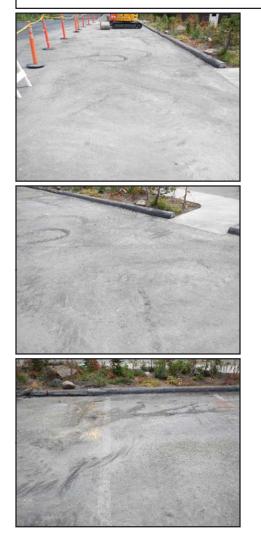
ROUTE 0943HZ: PARADISE PICNIC AREA PARKING H

Inspection Date	FMSS Number	User Access	Surface Type	
8/8/2015	108256	PUBLIC	ASPHALT	
Area (Sq. Ft.)	Lane Miles (11' Widths)	Curb Reveal (Inches)	Curb Recommendation	
1,321	0.023	5	DO NOTHING	
Curb	Curb Type		Curb & Gutter Type	
ASPI	ASPHALT		ND GUTTER	
Pavement Rec	Pavement Recommendation		Rating / PCR	
PREVENTIVE N	PREVENTIVE MAINTENANCE		O / 90	
Route Condition Legend – Payement Condition Rating (PCR)
