MORA Cycle 6

Final Report

Road Inventory and Condition Assessment of Paved Routes Mount Rainier National Park

Report Date: May 2016

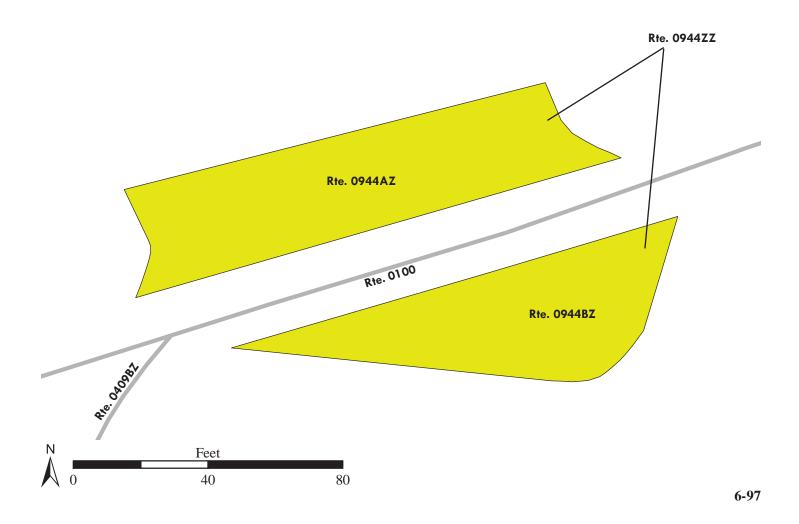
ROUTE 0944AZ: LONGMIRE COMMUNITY BUILDING PARKING A

ADJACENT TO ROUTE 0100 (LONGMIRE SOUTH BACK GATE ROAD) AT MP 0.56

Inspection Date	FMSS Number	User Access	Surface Type	
8/9/2015	108261	PUBLIC	ASPHALT	
Area (Sq. Ft.)	Lane Miles (11' Widths)	Curb Reveal (Inches)	Curb Recommendation	
2,712	0.047	NOT APPLICABLE	NOT APPLICABLE	
Curb Type		Curb & Gutter Type		
NO CURB		NO CURB AND GUTTER		
Pavement Recommendation		Condition Rating / PCR		
LIGHT 3R TR	LIGHT 3R TREATMENTS		FAIR / 73	
Route Condition Legend – Pavement Condition Rating (PCR)				
Poor (0 - 60)	Fair (61- 84) Good ((85 - 94) Excellent (95 - 10	0) Not Rated

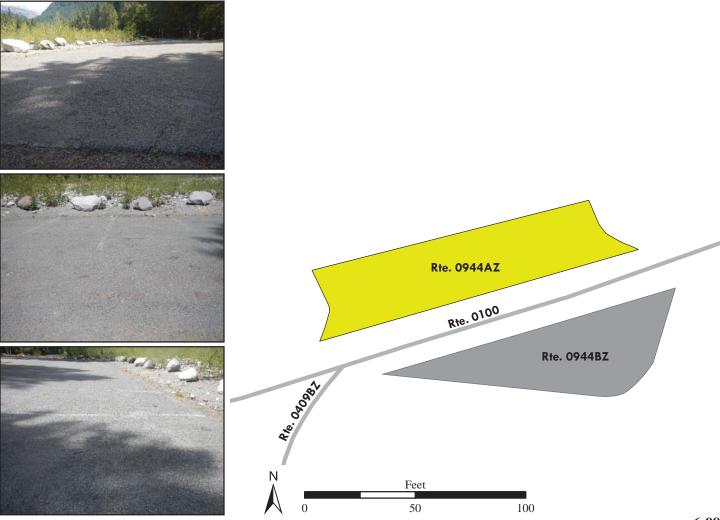
ROUTE 0944BZ: LONGMIRE COMMUNITY BUILDING PARKING B

Inspection Date	FMSS Number	User Access	Surface Type
8/9/2015	108261	PUBLIC	ASPHALT
Area (Sq. Ft.)	Lane Miles (11' Widths)	Curb Reveal (Inches)	Curb Recommendation
2,054	0.035	NOT APPLICABLE	NOT APPLICABLE
Curb Type		Curb & Gutter Type	
NO CURB		NO CURB AND GUTTER	
Pavement Recommendation Condition Rating / PCR		ating / PCR	
LIGHT 3R TREATMENTS		FAIR / 73	
Route Condition Legend – Pavement Condition Rating (PCR)			
Poor (0 - 60)	Fair (61- 84) Good ((85 - 94) Excellent (95 - 10	0) Not Rated

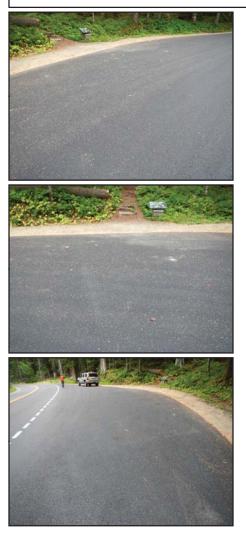
ROUTE 0946ZZ: WHITE RIVER DAY USE PARKING AREAS

Inspection Date	FMSS Number	User Access	Surface Type	
8/8/2015	240196	PUBLIC	ASPHALT	
Area (Sq. Ft.)	Lane Miles (11' Widths)	Condition R	ating / PCR	
21,157	0.364	SUMMA	RY / 54	
Route Condition Legend – Pavement Condition Rating (PCR)				
Poor (0 - 60)	Fair (61- 84) Good	(85 - 94) Excellent (95 - 10	0) Not Rated	
See Appendix for definitions and formulas

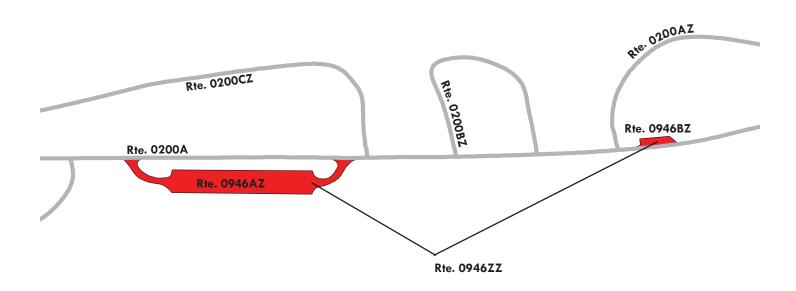
ROUTE 0946AZ: WHITE RIVER DAY USE PARKING

TO ROUTE 0200A (WHITE RIVER CAMPGROUND ENTRANCE ROAD)

Inspection Date	FMSS Number	User Access	Surface Type	
8/8/2015	240196	PUBLIC	ASPHALT	
Area (Sq. Ft.)	Lane Miles (11' Widths)	Curb Reveal (Inches)	Curb Recommendation	
19,885	0.342	NOT APPLICABLE	NOT APPLICABLE	
Curb Type		Curb & Gutter Type		
NO CURB		NO CURB AND GUTTER		
Pavement Recommendation		Condition Rating / PCR		
HEAVY 3R TREATMENTS		POOR / 53		
	Route Condition Legend – Pavement Condition Rating (PCR)			
Poor (0 - 60)			0) Not Rated	
	See Appendix for definitions and formulas

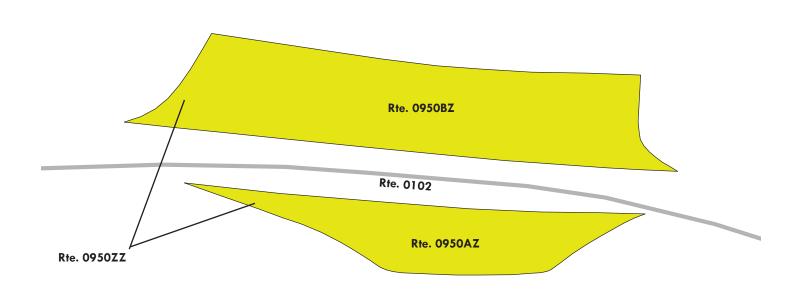
ROUTE 0950AZ: CARBON RIVER ENTRANCE PARKING A

Inspection Date	FMSS Number	User Access	Surface Type	
8/9/2015	247117	PUBLIC	ASPHALT	
Area (Sq. Ft.)	Lane Miles (11' Widths)	Curb Reveal (Inches)	Curb Recommendation	
751	0.013	NOT APPLICABLE	NOT APPLICABLE	
Curb	Туре	Curb & Gutter Type		
NO C	CURB	NO CURB A	ND GUTTER	
Pavement Rec	commendation	Condition R	ating / PCR	
PREVENTIVE N	MAINTENANCE	GOOI	0 / 90	
	D + C 11-1 T 1 D	(DOD)
