ROMO Cycle 6

Final Report

Road Inventory and Condition Assessment of Paved Routes Rocky Mountain National Park

**Federal Highway Administration
Eastern Federal Lands Highway Division
Road Inventory Program (RIP)**

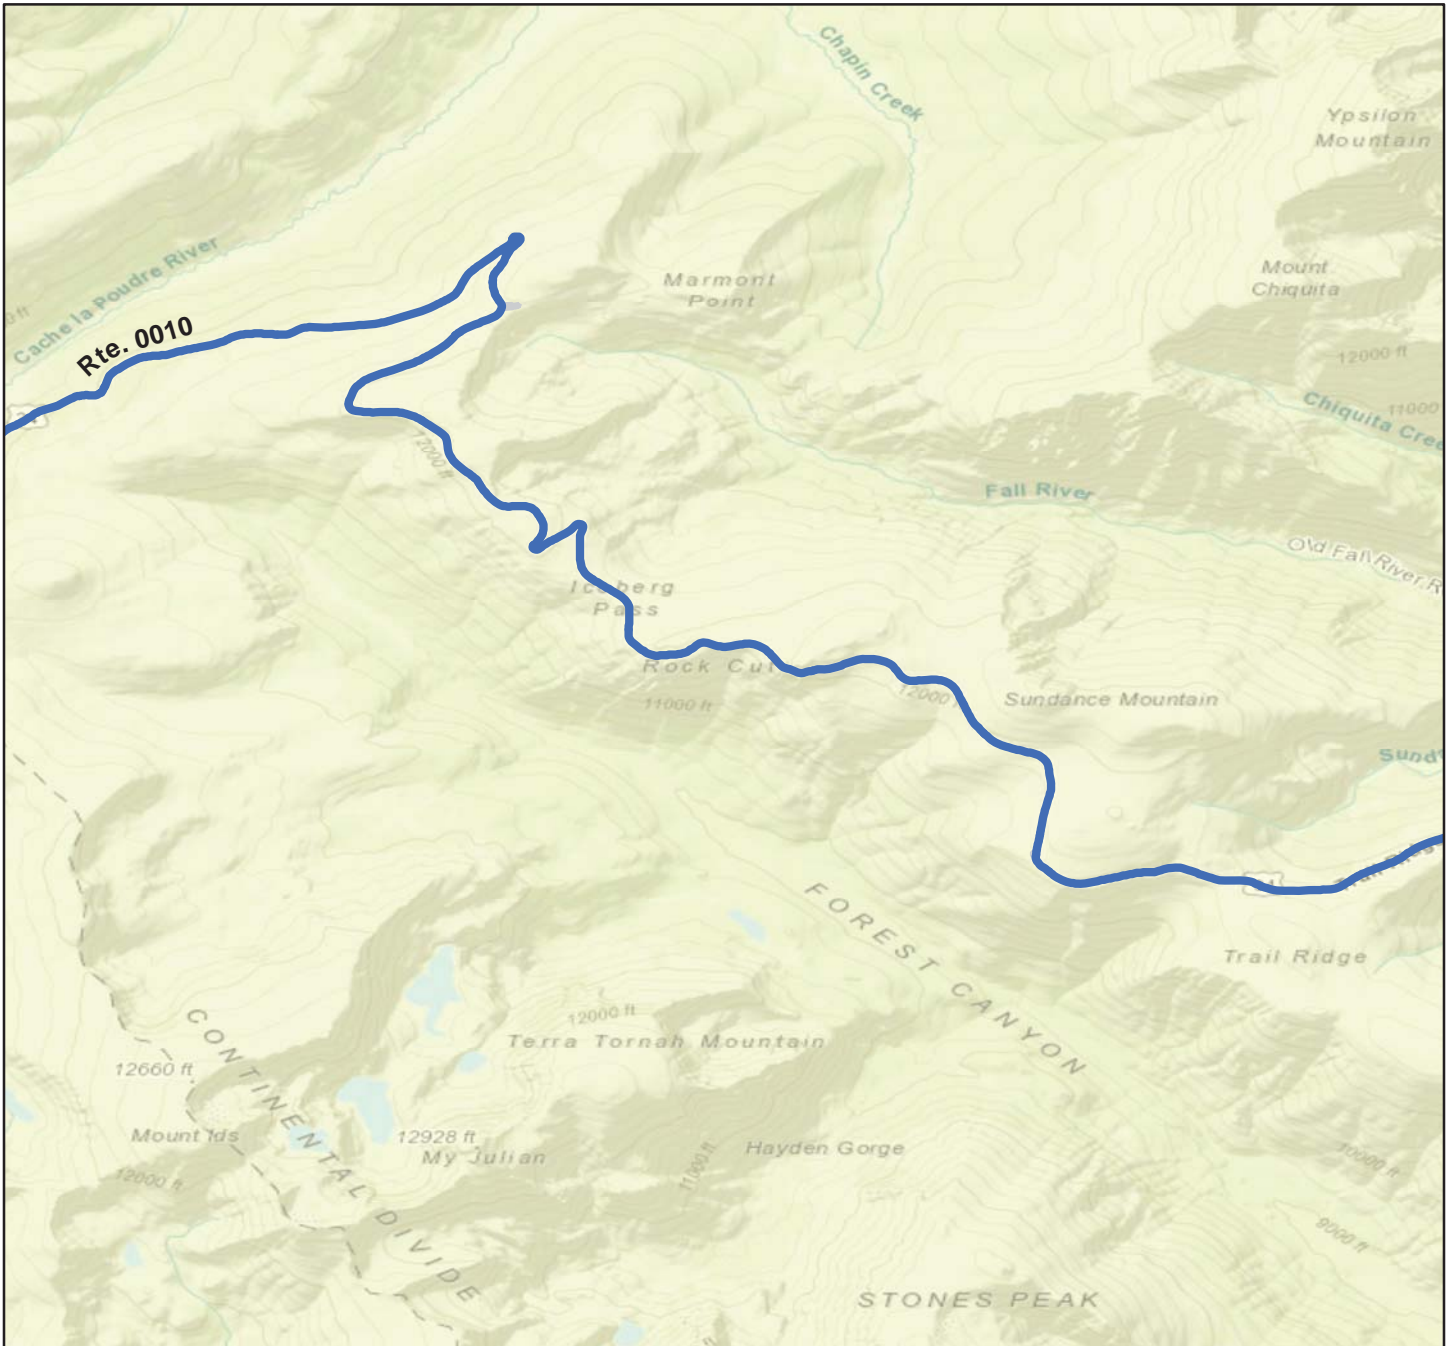
Area Map 3

ROUTE CONDITION MAP

PCR - MILE BY MILE

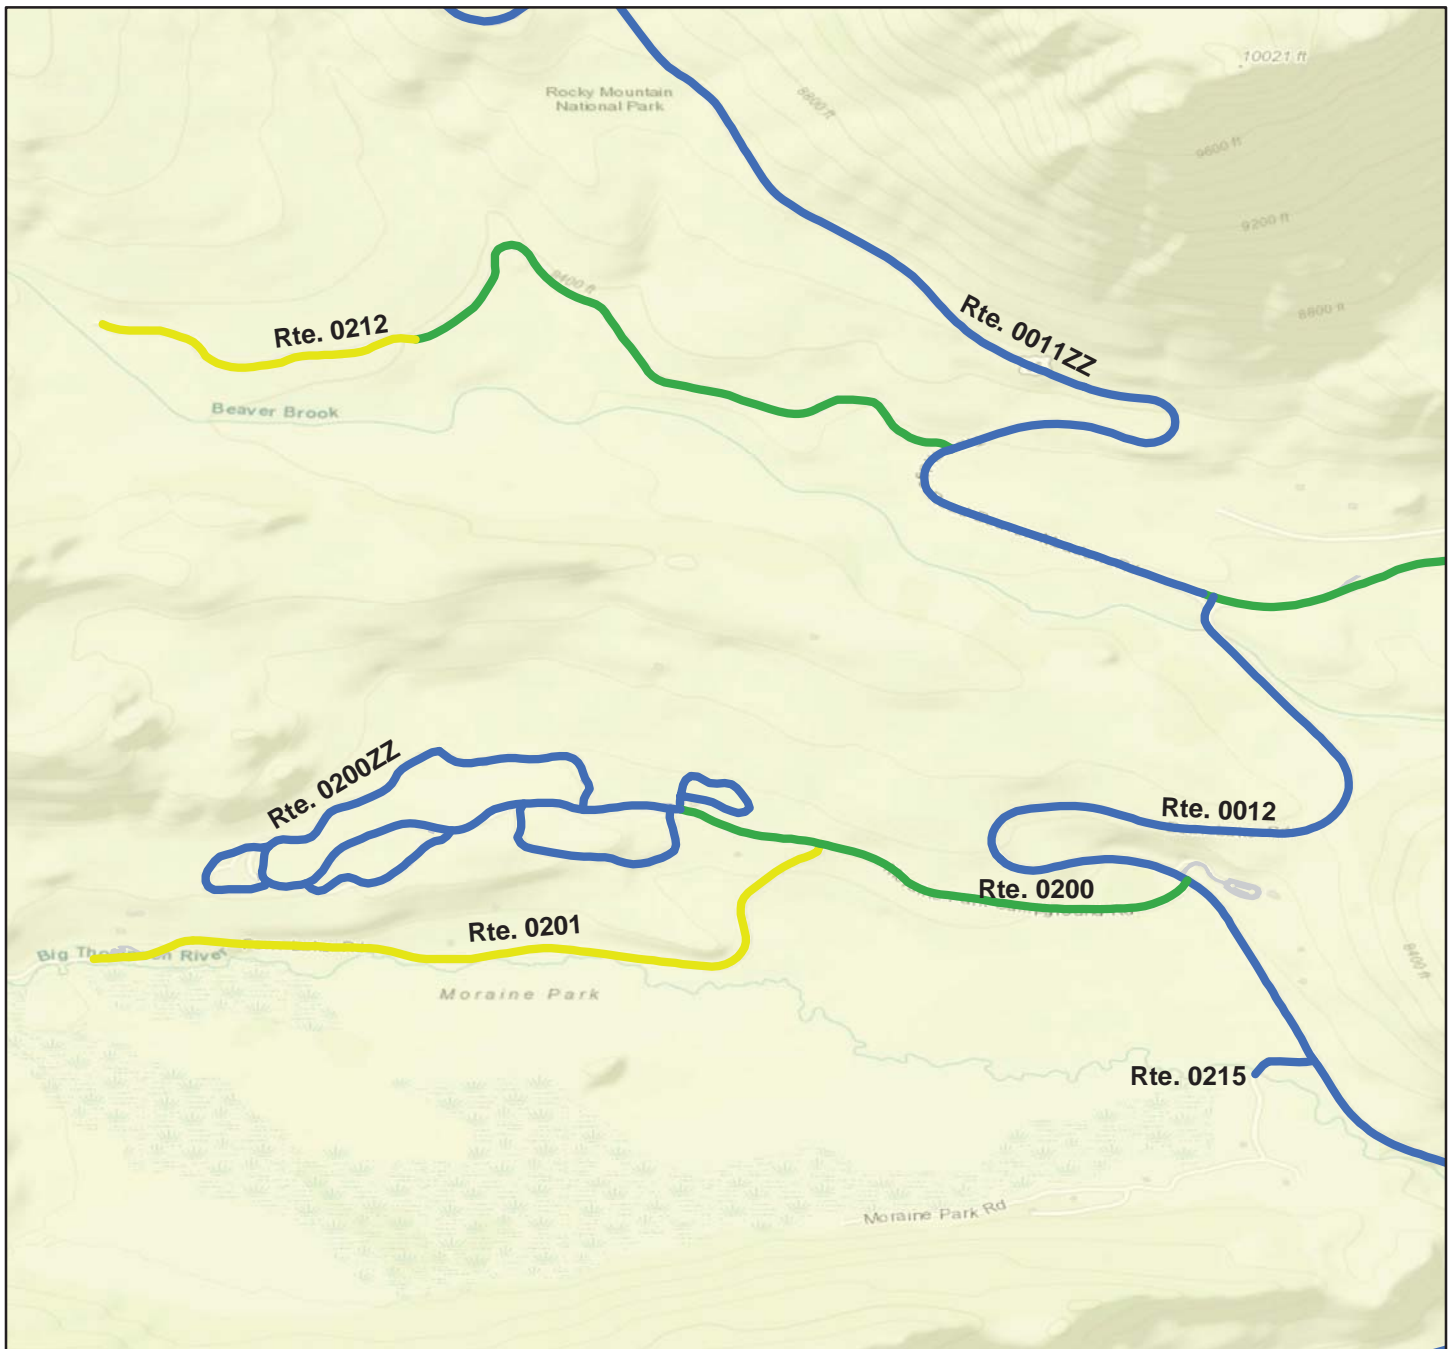
Area Map 4B

ROUTE CONDITION MAP

PCR - MILE BY MILE

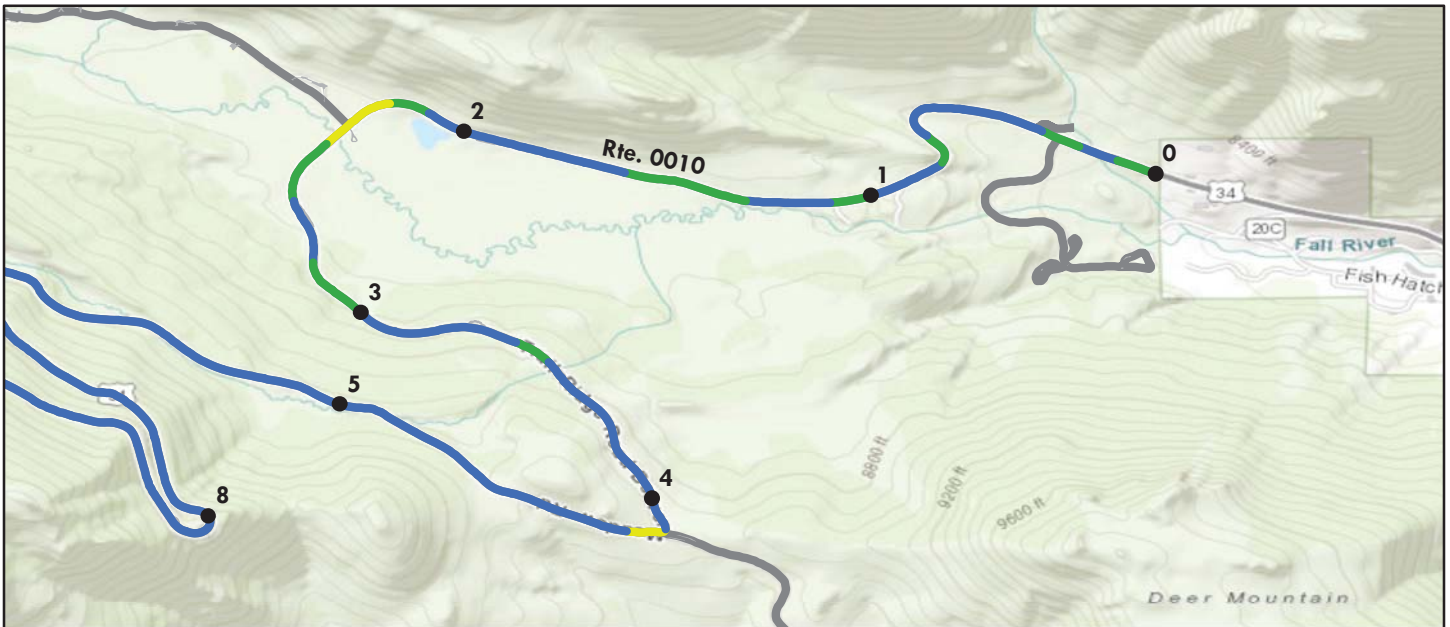
ROUTE 0010: TRAIL RIDGE ROAD

Data Collection Vehicle (DCV) Rating

Colors on map represent condition scores at 0.10-mile intervals. See Appendix for definitions and formulas.

Inspection Date:	6/21/2017	Beginning Section MP	0	1	2	3	4
	Paved Length (Miles):	42.73	Section Length (MI)	1	1	1	1
Surface Type:	ASPHALT	Route Summary					
Roadway Condition Information							
Pavement Condition Rating (PCR)	99	96	97	93	98	99	
Surface Condition Rating (SCR)	98	97	95	95	96	99	
Roughness Condition Index (RCI)	100	95	100	89	100	100	
Distress Index Values							
Structural Crack Index	99	98	98	96	99	99	
Alligator Crack Index	100	100	100	100	100	100	
Longitudinal Crack Index	99	98	98	96	99	99	
Transverse Cracking Index	99	97	99	98	99	99	
Patching Index	100	99	100	100	100	100	
Rutting Index	98	97	95	95	96	100	
International Roughness Index (IRI)	97	126	112	143	98	93	
Lane & Width Information							
Number of Lanes	2	2	2	2	2	2	
Paved Width (ft)	29.1	31.4	25.2	27.6	25.2	30	
Lane Width (ft)	12.2	12.2	11.9	11.8	11.3	11.9

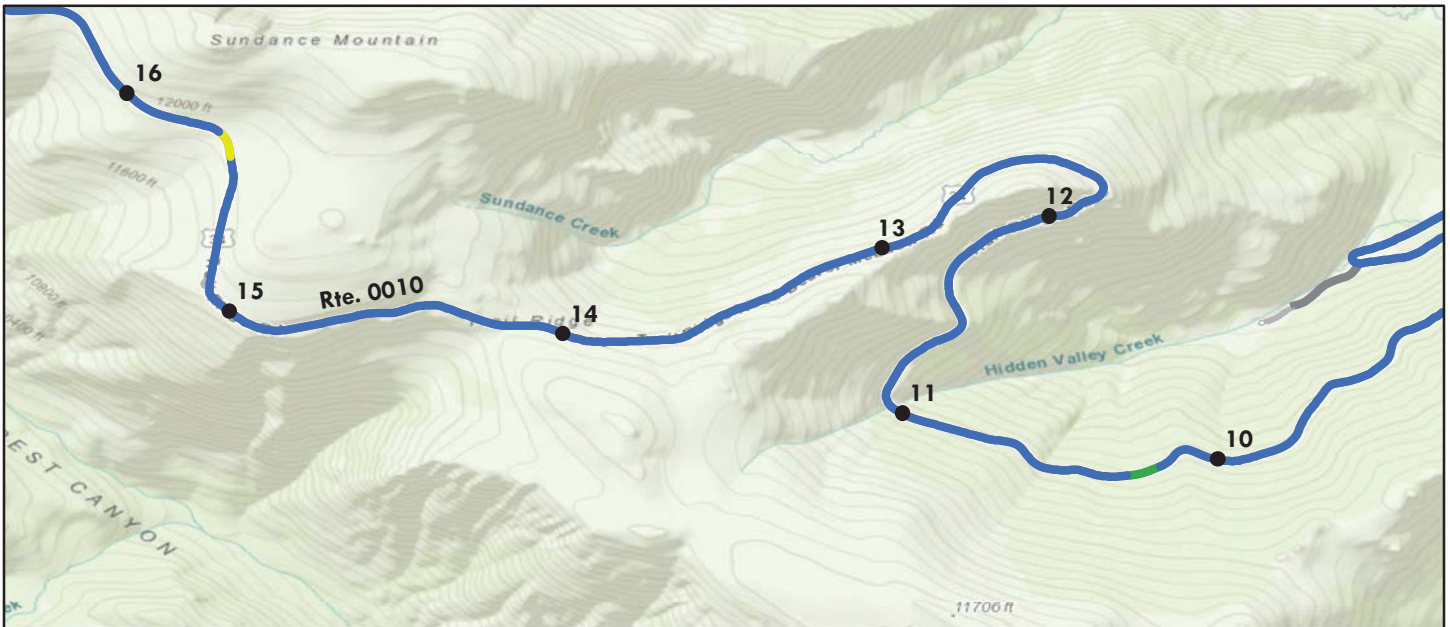
ROUTE 0010: TRAIL RIDGE ROAD

Data Collection Vehicle (DCV) Rating

Inspection Date:	6/21/2017	Beginning Section MP	10	11	12	13	14
Paved Length (Miles):	42.73	Section Length (MI)	1	1	1	1	1
Surface Type:	ASPHALT	Route Summary					
Roadway Condition Information							
Pavement Condition Rating (PCR)	99	99	100	99	99	99	
Surface Condition Rating (SCR)	98	99	100	98	99	99	
Roughness Condition Index (RCI)	100	100	100	100	100	100	
Distress Index Values							
Structural Crack Index	99	100	100	100	100	100	
Alligator Crack Index	100	100	100	100	100	100	
Longitudinal Crack Index	99	100	100	100	100	100	
Transverse Cracking Index	99	100	100	100	100	100	
Patching Index	100	100	100	100	100	100	
Rutting Index	98	99	100	98	99	99	
International Roughness Index (IRI)	97	109	87	97	81	106	
Lane & Width Information							
Number of Lanes	2	2	2	2	2	2	
Paved Width (ft)	29.1	27.5	27.5	27.3	27.7	28.7	
Lane Width (ft)	12.2	11.6	11.4	11.5	12.3	12

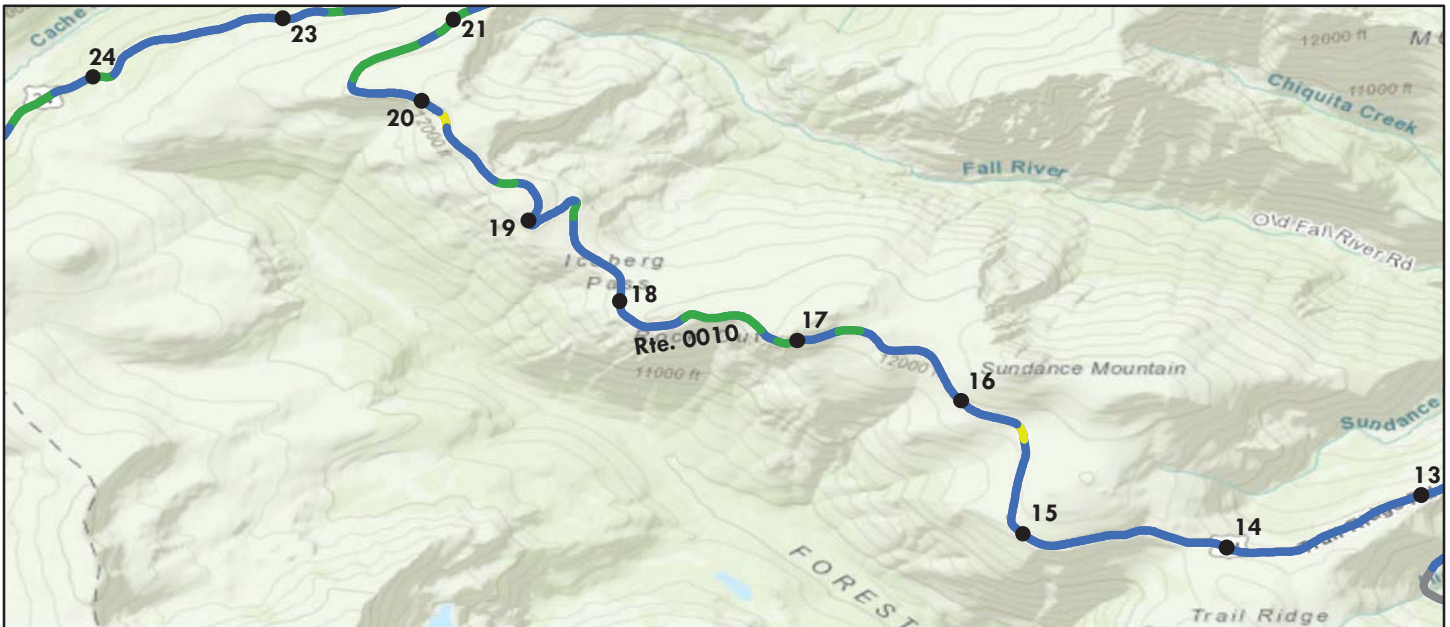
ROUTE 0010: TRAIL RIDGE ROAD

Data Collection Vehicle (DCV) Rating

Inspection Date:	6/21/2017	Beginning Section MP	15	16	17	18	19
Paved Length (Miles):	42.73	Section Length (MI)	1	1	1	1	1
Surface Type:	ASPHALT	Route Summary					
Roadway Condition Information							
Pavement Condition Rating (PCR)	99	99	99	95	99	97	
Surface Condition Rating (SCR)	98	99	99	98	98	97	
Roughness Condition Index (RCI)	100	100	100	90	100	96	
Distress Index Values							
Structural Crack Index	99	100	100	100	100	100	
Alligator Crack Index	100	100	100	100	100	100	
Longitudinal Crack Index	99	100	100	100	100	100	
Transverse Cracking Index	99	100	100	100	98	100	
Patching Index	100	100	100	100	100	100	
Rutting Index	98	99	99	98	98	97	
International Roughness Index (IRI)	97	112	115	139	111	126	
Lane & Width Information							
Number of Lanes	2	2	2	2	2	2	
Paved Width (ft)	29.1	28.5	30.1	28.8	30.3	28.8	
Lane Width (ft)	12.2	12.1	12.2	12.2	12.4	12.2

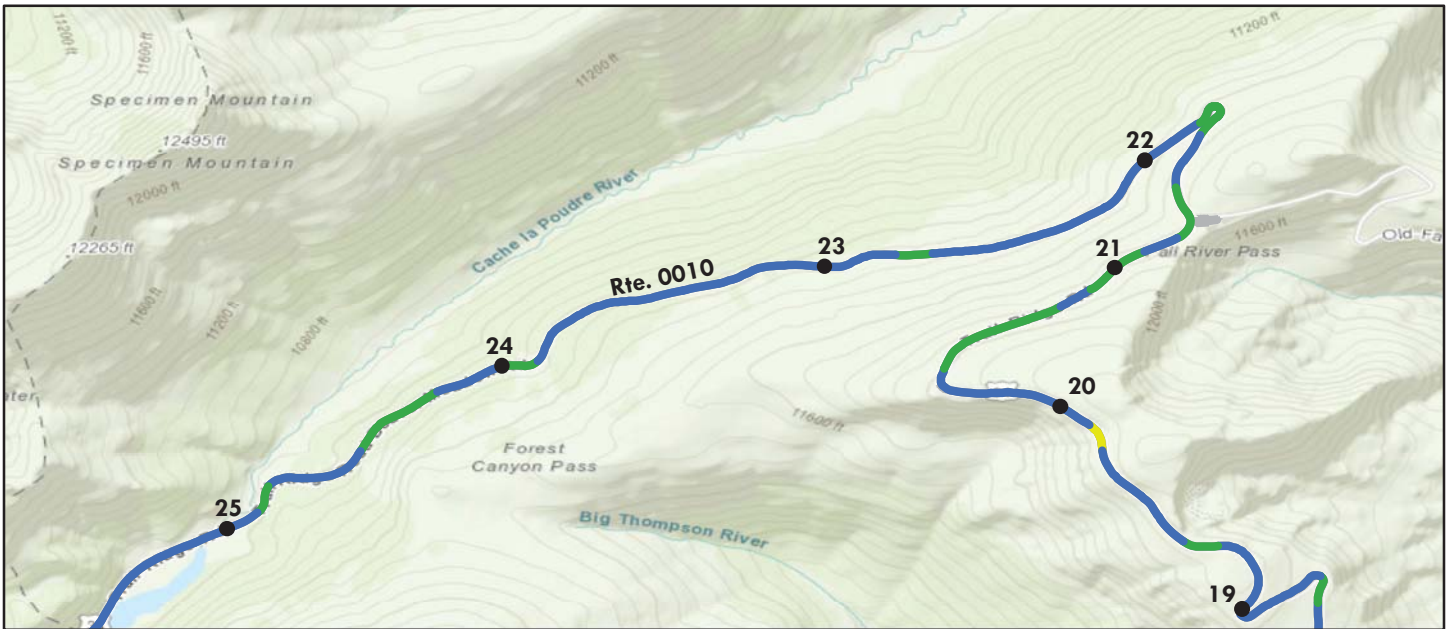
ROUTE 0010: TRAIL RIDGE ROAD

Data Collection Vehicle (DCV) Rating

Inspection Date:	6/21/2017	Beginning Section MP	20	21	22	23	24
Paved Length (Miles):	42.73	Section Length (MI)	1	1	1	1	1
Surface Type:	ASPHALT	Route Summary					
Roadway Condition Information							
Pavement Condition Rating (PCR)	99	97	96	98	99	96	
Surface Condition Rating (SCR)	98	98	96	97	99	94	
Roughness Condition Index (RCI)	100	95	96	100	100	100	
Distress Index Values							
Structural Crack Index	99	100	100	100	100	100	
Alligator Crack Index	100	100	100	100	100	100	
Longitudinal Crack Index	99	100	100	100	100	100	
Transverse Cracking Index	99	100	100	100	100	100	
Patching Index	100	100	100	100	100	100	
Rutting Index	98	98	96	97	99	94	
International Roughness Index (IRI)	97	126	124	97	100	101	
Lane & Width Information							
Number of Lanes	2	2	2	2	2	2	
Paved Width (ft)	29.1	27.5	28.2	25.8	27.2	27	
Lane Width (ft)	12.2	11.9	12.4	12.8	12.7	12.5

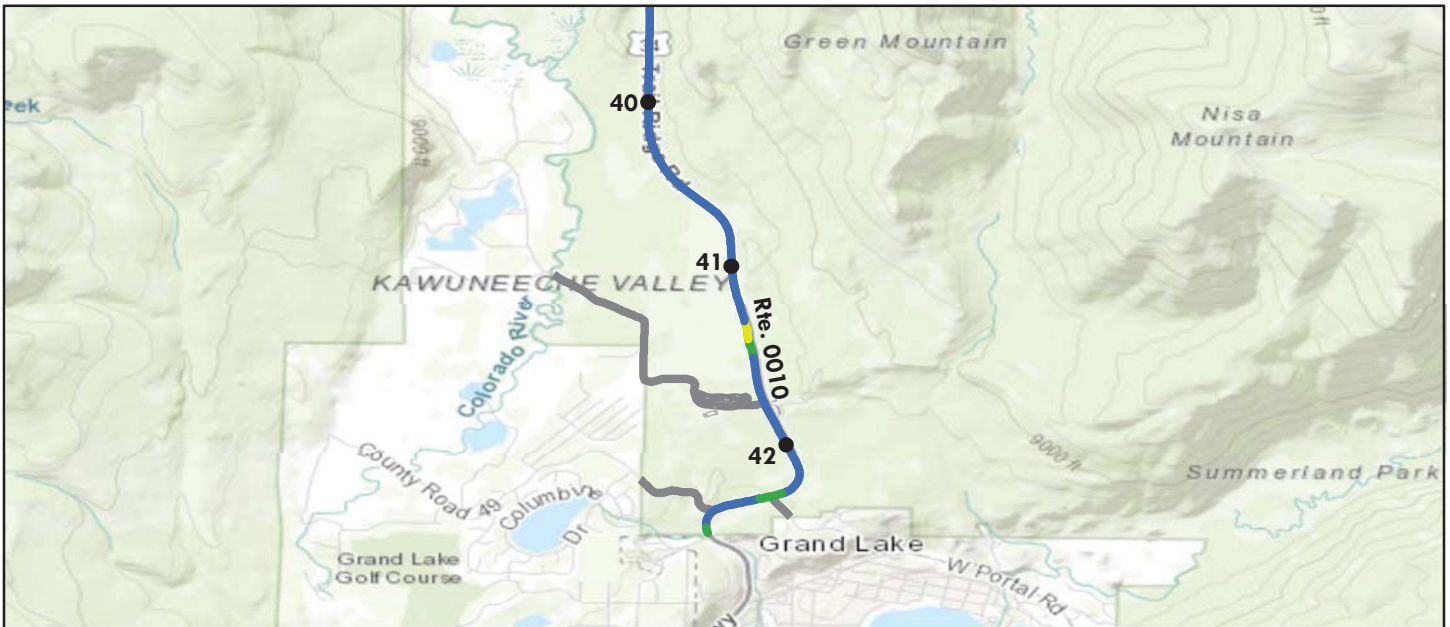
ROUTE 0010: TRAIL RIDGE ROAD

Data Collection Vehicle (DCV) Rating

Beginning Section MP	40	41	42		
Inspection Date:	6/21/2017	Section Length (MI)	1	1	0.73		
Paved Length (Miles):	42.73	Route Summary					
Surface Type:	ASPHALT						
Roadway Condition Information							
	Pavement Condition Rating (PCR)	99	99	99	99		
	Surface Condition Rating (SCR)	98	99	99	98		
	Roughness Condition Index (RCI)	100	100	100	100		
Distress Index Values							
	Structural Crack Index	99	99	99	99		
	Alligator Crack Index	100	100	100	100		
	Longitudinal Crack Index	99	99	99	99		
	Transverse Cracking Index	99	99	99	98		
	Patching Index	100	100	100	100		
	Rutting Index	98	100	100	99		
	International Roughness Index (IRI)	97	56	98	96		
Lane & Width Information							
	Number of Lanes	2	2	2	2		
	Paved Width (ft)	29.1	30.6	34.5	36.7		
	Lane Width (ft)	12.2	12.7	14.2	13.4

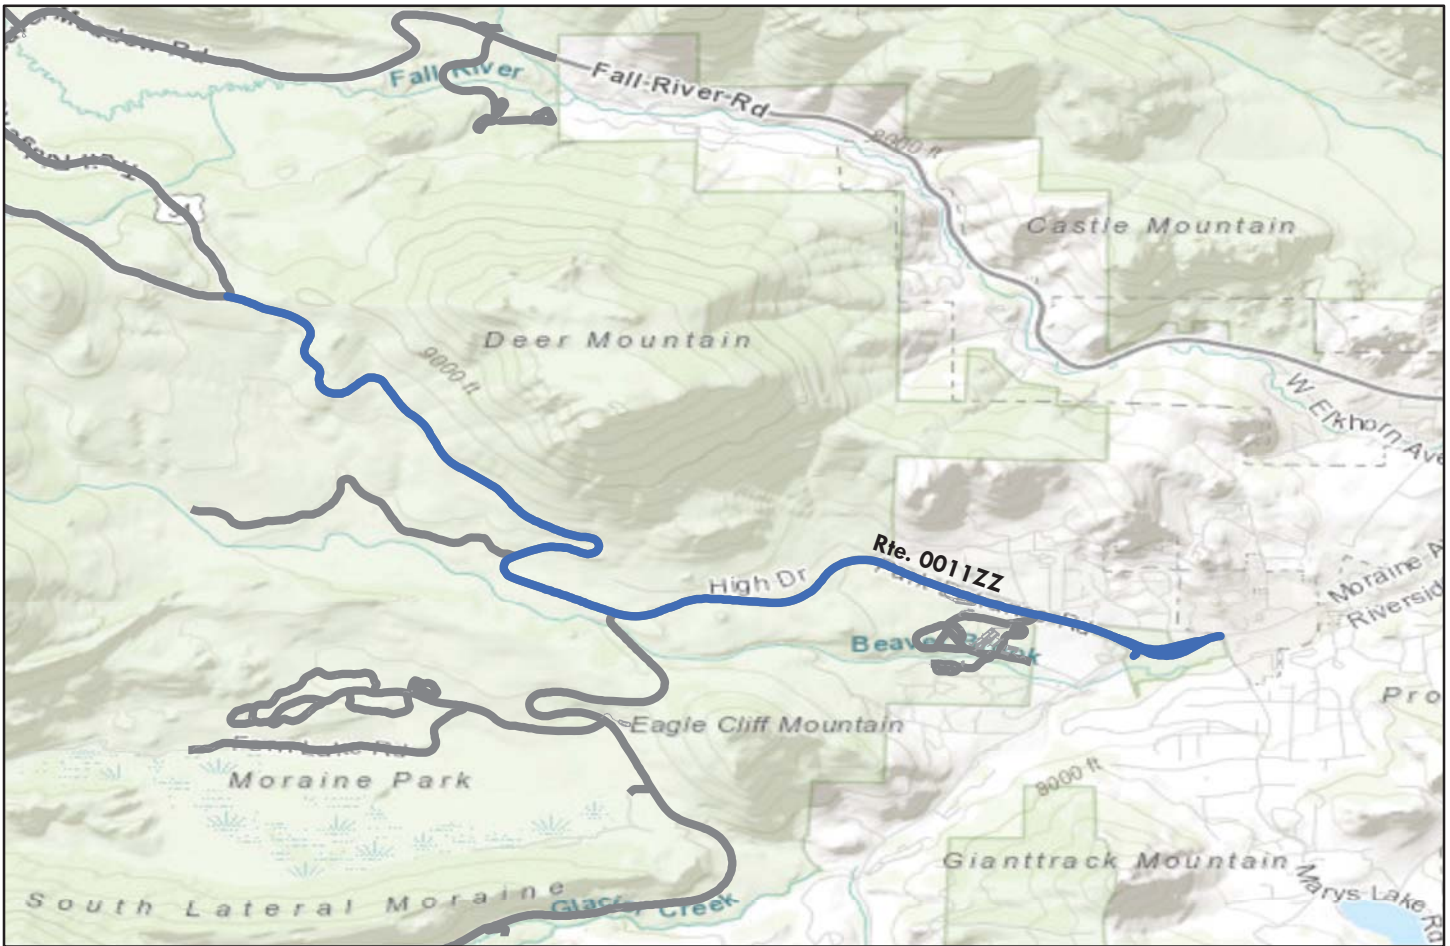
ROUTE 0011ZZ: BEAVER MEADOWS ROADS AND U.S. HIGHWAY 36 (MORaine AVENUE)

Summary Route

Note: The weighted average summary PCR value is calculated from only the sections of road where the PCR was collected. The overall PCR for the summary route may not reflect individual subcomponent ratings.

Inspection Date:	6/22/2017					
Paved Length (Miles):	5.66					
Surface Type:	ASPHALT					
Roadway Condition Information						
Pavement Condition Rating (PCR)	95					
Lane & Width Information						
Number of Lanes	1					
Paved Width (ft)	21.8					
Lane Width (ft)	9.4

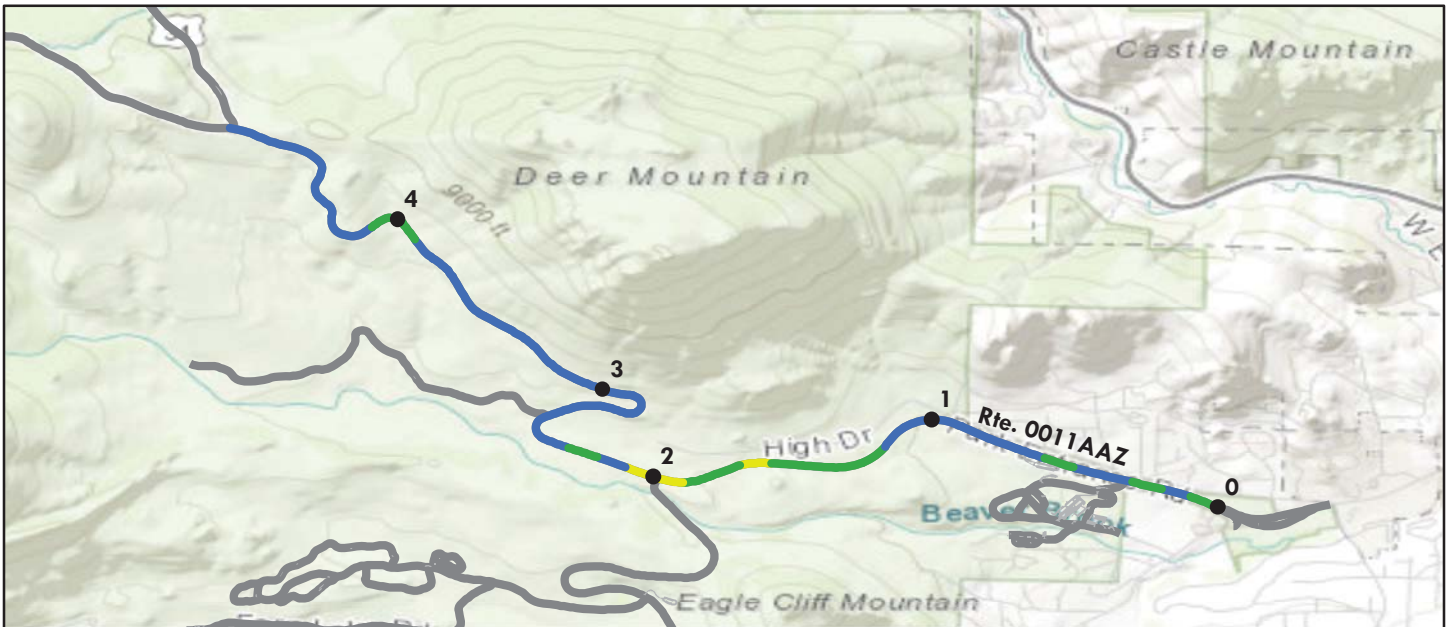
Subcomponent of Route ROMO-0011ZZ

Data Collection Vehicle (DCV) Rating

Inspection Date:	6/22/2017	Beginning Section MP	0	1	2	3	4
	Paved Length (Miles):	4.87	Section Length (MI)	1	1	1	1
Surface Type:	ASPHALT	Route Summary					
Roadway Condition Information							
Pavement Condition Rating (PCR)	97	97	92	96	98	99	
Surface Condition Rating (SCR)	95	95	91	95	96	98	
Roughness Condition Index (RCI)	99	100	93	98	100	100	
Distress Index Values							
Structural Crack Index	99	99	97	99	100	100	
Alligator Crack Index	100	100	100	100	100	100	
Longitudinal Crack Index	99	99	97	99	100	100	
Transverse Cracking Index	97	98	97	96	97	98	
Patching Index	100	100	100	100	100	100	
Rutting Index	95	95	91	95	96	98	
International Roughness Index (IRI)	116	113	132	120	108	110	
Lane & Width Information							
Number of Lanes	2	2	2	2	2	2	
Paved Width (ft)	21.2	24.3	19.4	20.7	19.7	19.7	
Lane Width (ft)	9.1	9.1	9.3	9.2	9	8.8

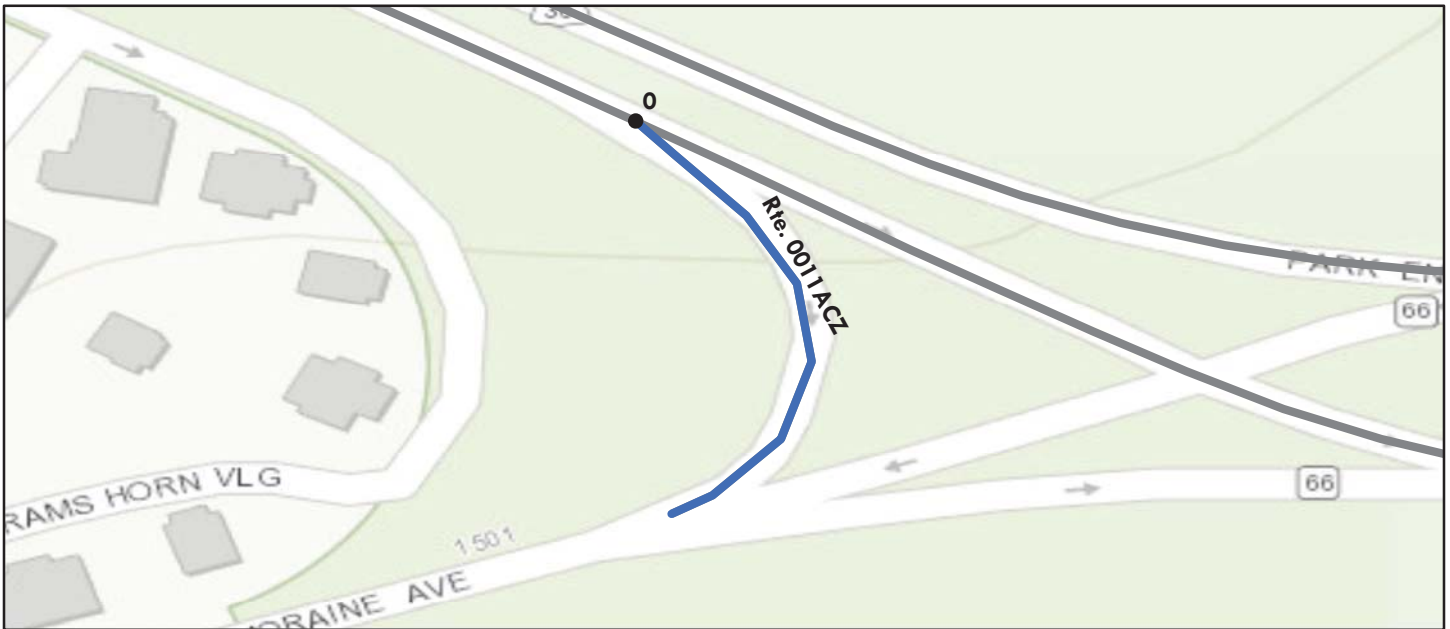
ROUTE 0011ACZ: BEAVER MEADOWS ROAD RAMP

Subcomponent of Route ROMO-0011ZZ
Data Collection Vehicle (DCV) Rating

Inspection Date: 6/22/2017	Beginning Section MP	0				
Paved Length (Miles): 0.05	Section Length (MI)	0.05				
Surface Type: ASPHALT	Route Summary					
Roadway Condition Information						
Pavement Condition Rating (PCR)	97	97				
Surface Condition Rating (SCR)	97	97				
Roughness Condition Index (RCI)	N/A	N/A				
Distress Index Values						
Structural Crack Index	100	100				
Alligator Crack Index	100	100				
Longitudinal Crack Index	100	100				
Transverse Cracking Index	98	98				
Patching Index	100	100				
Rutting Index	97	97				
International Roughness Index (IRI)	N/A	N/A				
Lane & Width Information						
Number of Lanes	1	1				
Paved Width (ft)	19.5	19.5				
Lane Width (ft)	19.5	19.5

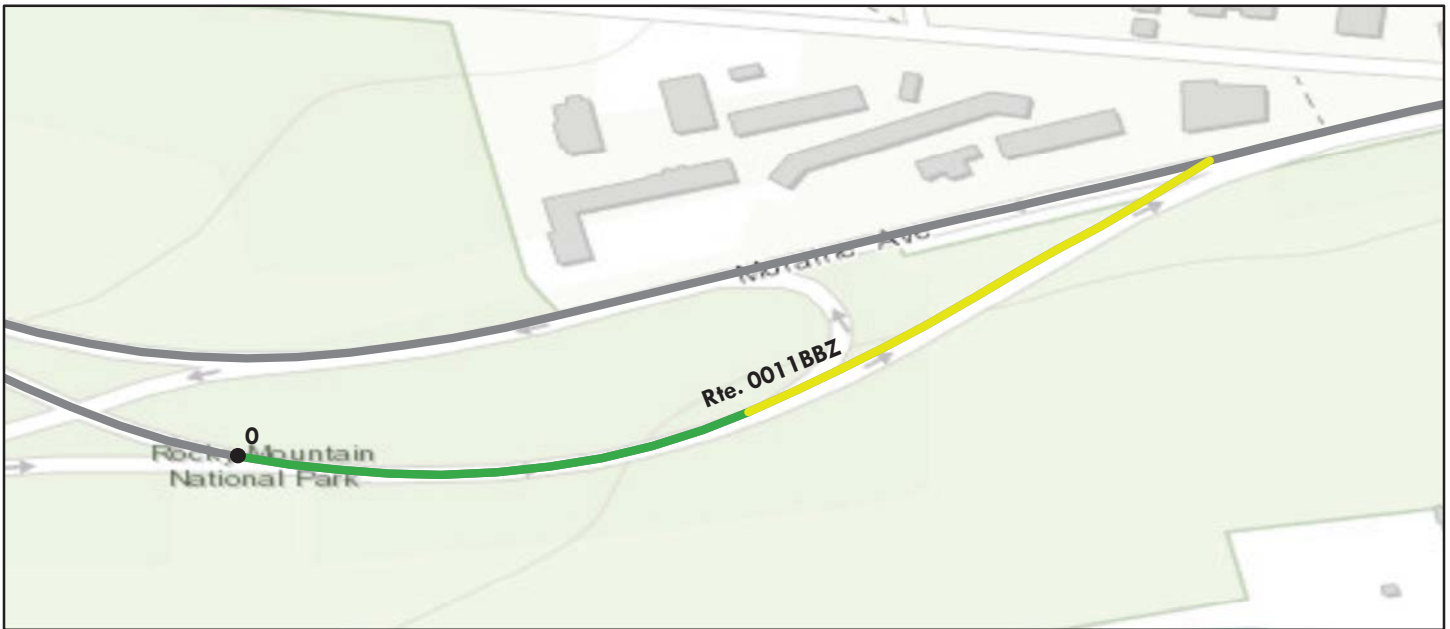
ROUTE 0011BBZ: U.S. HIGHWAY 36 (MORAINE AVENUE) RAMP

Subcomponent of Route ROMO-0011ZZ
Data Collection Vehicle (DCV) Rating

Route Condition Legend – Pavement Condition Rating (PCR)						
Poor (0 - 60)	Fair (61- 84)	Good (85 - 94)	Excellent (95 - 100)	Not Rated		
Colors on map represent condition scores at 0.10-mile intervals. See Appendix for definitions and formulas.						
Inspection Date: 6/22/2017	Beginning Section MP	0				
Paved Length (Miles): 0.2	Section Length (MI)	0.2				
Surface Type: ASPHALT	Route Summary					
Roadway Condition Information						
Pavement Condition Rating (PCR)	77	77				
Surface Condition Rating (SCR)	77	77				
Roughness Condition Index (RCI)	N/A	N/A				
Distress Index Values						
Structural Crack Index	77	77				
Alligator Crack Index	100	100				
Longitudinal Crack Index	77	77				
Transverse Cracking Index	85	85				
Patching Index	100	100				
Rutting Index	93	93				
International Roughness Index (IRI)	N/A	N/A				
Lane & Width Information						
Number of Lanes	2	2				
Paved Width (ft)	24.8	24.8				
Lane Width (ft)	9.8	9.8

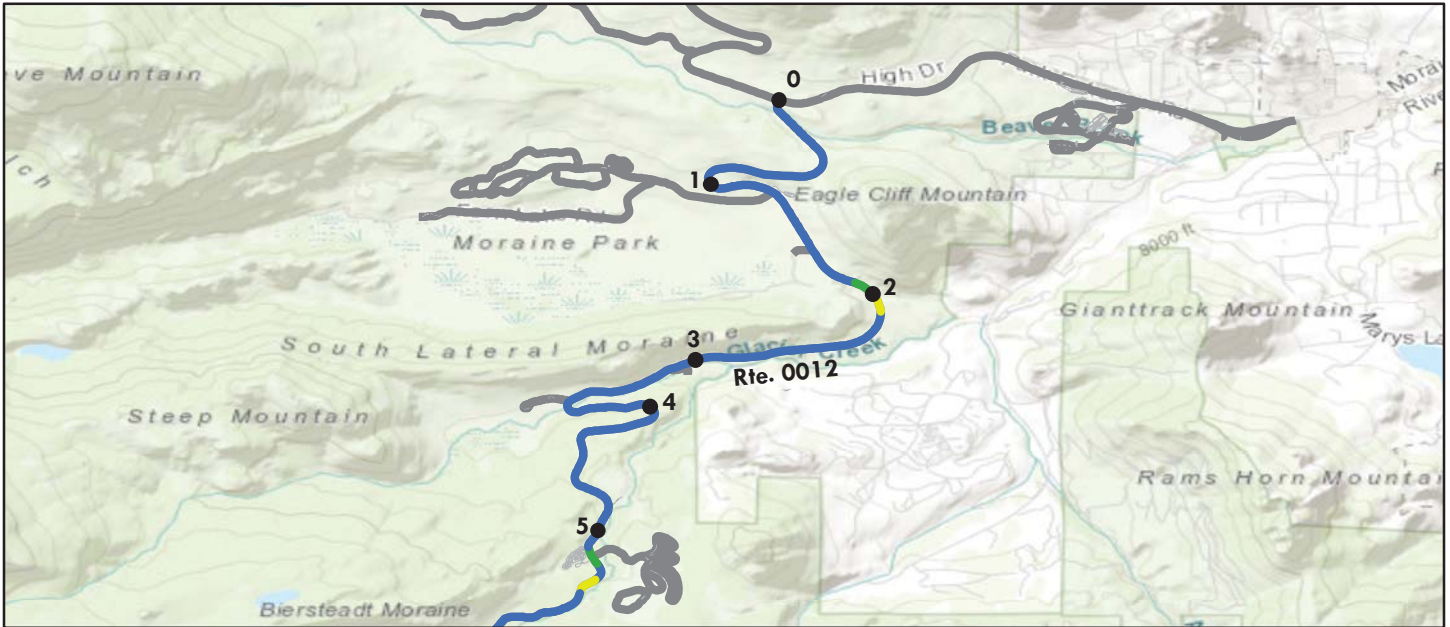
ROUTE 0012: BEAR LAKE ROAD

Data Collection Vehicle (DCV) Rating

Inspection Date: 6/22/2017	Beginning Section MP	0	1	2	3	4
Paved Length (Miles): 9.34	Section Length (MI)	1	1	1	1	1
Surface Type: ASPHALT	Route Summary					
Roadway Condition Information						
Pavement Condition Rating (PCR)	99	100	100	100	100	100
Surface Condition Rating (SCR)	99	100	100	100	100	100
Roughness Condition Index (RCI)	100	100	100	100	100	100
Distress Index Values						
Structural Crack Index	99	100	100	100	100	100
Alligator Crack Index	100	100	100	100	100	100
Longitudinal Crack Index	99	100	100	100	100	100
Transverse Cracking Index	100	100	100	100	100	100
Patching Index	100	100	100	100	100	100
Rutting Index	99	100	100	100	100	100
International Roughness Index (IRI)	104	86	99	90	89	80
Lane & Width Information						
Number of Lanes	2	2	2	2	2	2
Paved Width (ft)	21.8	21.6	22.4	22.7	23.3	24.2
Lane Width (ft)	8.9	9.7	9.6	9.3	9	9.4

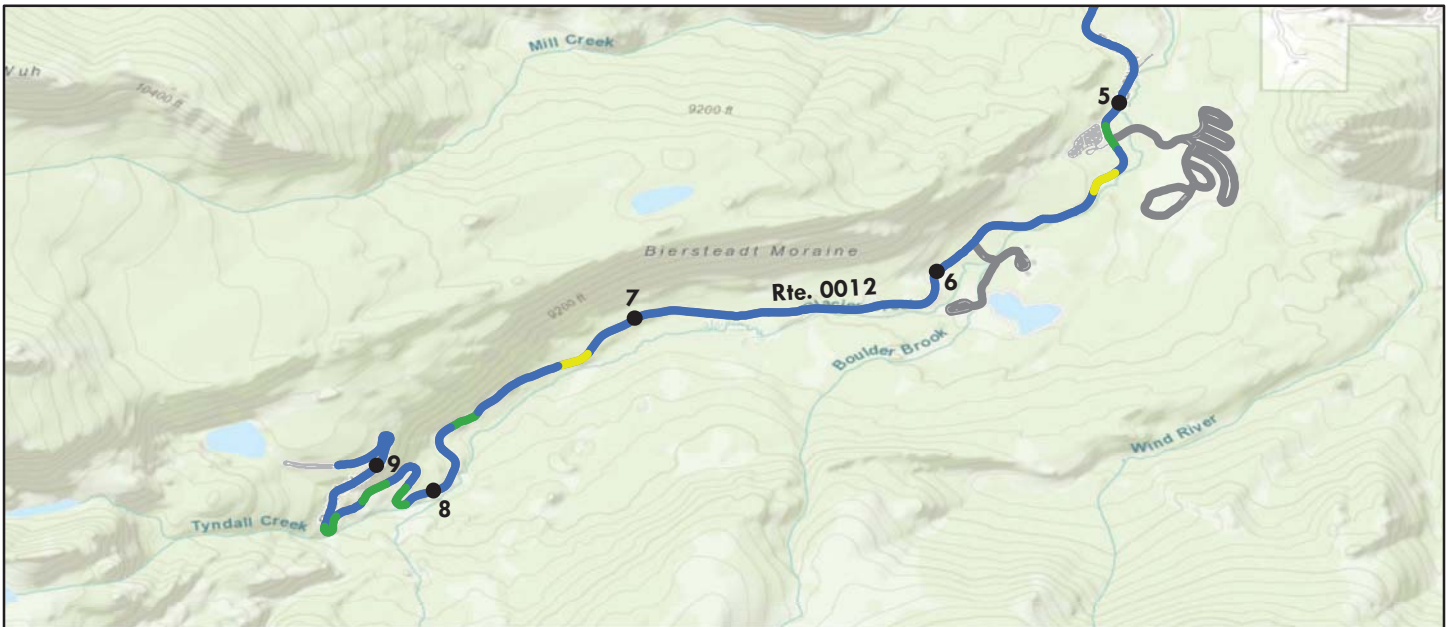
ROUTE 0012: BEAR LAKE ROAD

Data Collection Vehicle (DCV) Rating

Inspection Date:	6/22/2017	Beginning Section MP	5	6	7	8	9
Paved Length (Miles):	9.34	Section Length (MI)	1	1	1	1	0.34
Surface Type:	ASPHALT	Route Summary					
Roadway Condition Information							
Pavement Condition Rating (PCR)	99	96	99	98	97	99	
Surface Condition Rating (SCR)	99	96	99	98	99	99	
Roughness Condition Index (RCI)	100	95	100	98	94	100	
Distress Index Values							
Structural Crack Index	99	99	100	98	100	99	
Alligator Crack Index	100	100	100	100	100	100	
Longitudinal Crack Index	99	99	100	98	100	99	
Transverse Cracking Index	100	100	100	100	99	100	
Patching Index	100	100	100	100	100	100	
Rutting Index	99	96	99	99	100	100	
International Roughness Index (IRI)	104	128	111	120	130	113	
Lane & Width Information							
Number of Lanes	2	2	2	2	2	2	
Paved Width (ft)	21.8	20.4	19.1	20.6	22	21.1	
Lane Width (ft)	8.9	8.3	8.2	8.2	8.7	8.8

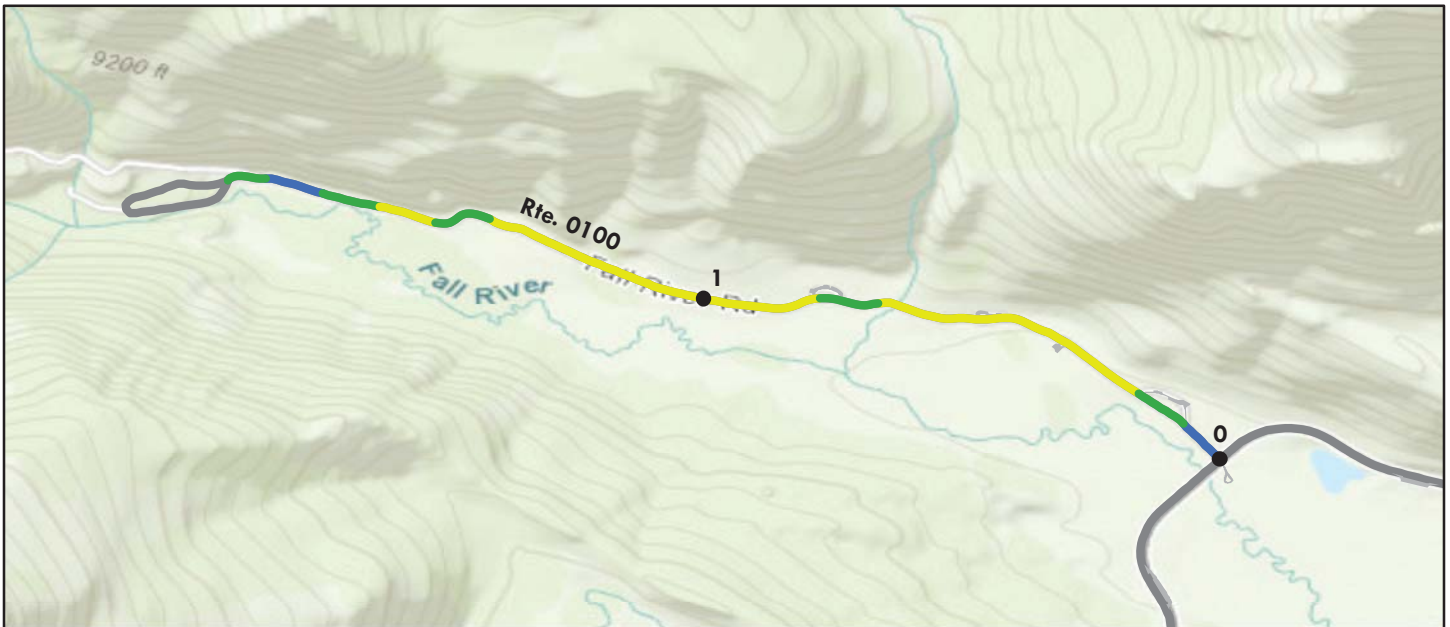
ROUTE 0100: ENDOVALLEY ROAD

Data Collection Vehicle (DCV) Rating

Inspection Date:	6/22/2017	Beginning Section MP	0	1			
Paved Length (Miles):	1.87	Section Length (MI)	1	0.87			
Surface Type:	ASPHALT	Route Summary					
Roadway Condition Information							
Pavement Condition Rating (PCR)	80	81	79				
Surface Condition Rating (SCR)	94	95	93				
Roughness Condition Index (RCI)	60	61	59				
Distress Index Values							
Structural Crack Index	100	100	99				
Alligator Crack Index	100	100	100				
Longitudinal Crack Index	100	100	99				
Transverse Cracking Index	97	97	98				
Patching Index	100	100	100				
Rutting Index	94	95	93				
International Roughness Index (IRI)	239	236	245				
Lane & Width Information							
Number of Lanes	2	2	2				
Paved Width (ft)	20.9	21.1	20.7				
Lane Width (ft)	10.3	10.8	9.7

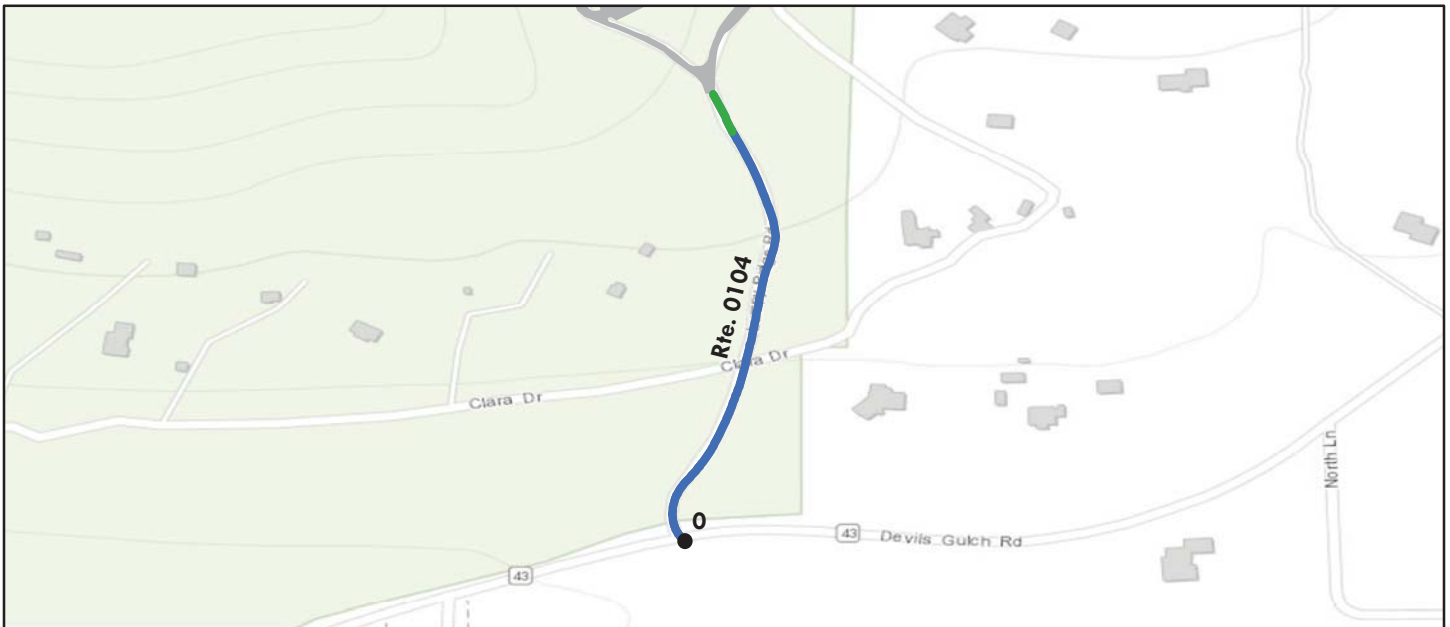
ROUTE 0104: LUMPY RIDGE ACCESS ROAD

Data Collection Vehicle (DCV) Rating

Inspection Date: 6/22/2017	Beginning Section MP	0				
Paved Length (Miles): 0.22	Section Length (MI)	0.22				
Surface Type: ASPHALT	Route Summary					
Roadway Condition Information						
Pavement Condition Rating (PCR)	97	97				
Surface Condition Rating (SCR)	97	97				
Roughness Condition Index (RCI)	N/A	N/A				
Distress Index Values						
Structural Crack Index	100	100				
Alligator Crack Index	100	100				
Longitudinal Crack Index	100	100				
Transverse Cracking Index	100	100				
Patching Index	100	100				
Rutting Index	97	97				
International Roughness Index (IRI)	N/A	N/A				
Lane & Width Information						
Number of Lanes	2	2				
Paved Width (ft)	20.8	20.8				
Lane Width (ft)	10.4	10.4

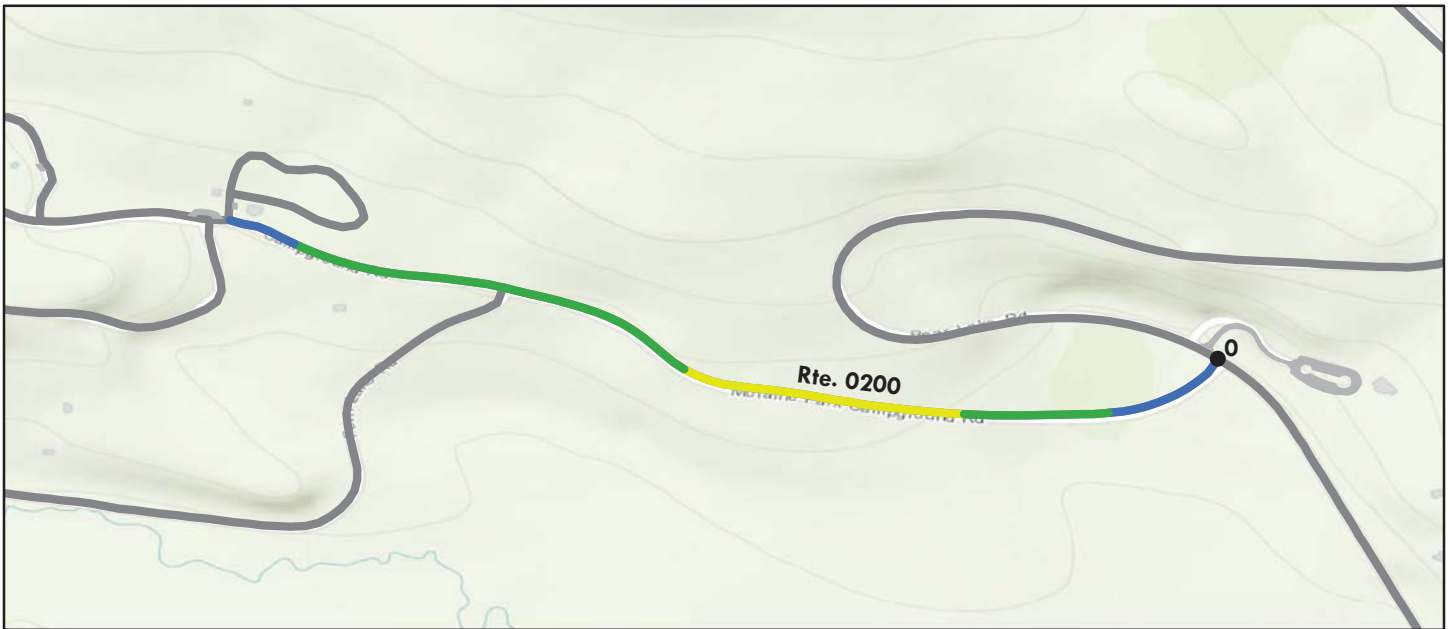
ROUTE 0200: MORAINE PARK CAMPGROUND ROAD

Data Collection Vehicle (DCV) Rating

Route Condition Legend – Pavement Condition Rating (PCR)						
Poor (0 - 60)	Fair (61- 84)	Good (85 - 94)	Excellent (95 - 100)	Not Rated		
Colors on map represent condition scores at 0.10-mile intervals. See Appendix for definitions and formulas.						
Inspection Date: 6/22/2017	Beginning Section MP	0				
Paved Length (Miles): 0.75	Section Length (MI)	0.75				
Surface Type: ASPHALT	Route Summary					
Roadway Condition Information						
Pavement Condition Rating (PCR)	90	90				
Surface Condition Rating (SCR)	90	90				
Roughness Condition Index (RCI)	N/A	N/A				
Distress Index Values						
Structural Crack Index	94	94				
Alligator Crack Index	100	100				
Longitudinal Crack Index	94	94				
Transverse Cracking Index	96	96				
Patching Index	99	99				
Rutting Index	90	90				
International Roughness Index (IRI)	N/A	N/A				
Lane & Width Information						
Number of Lanes	2	2				
Paved Width (ft)	23	23				
Lane Width (ft)	11.9	11.9

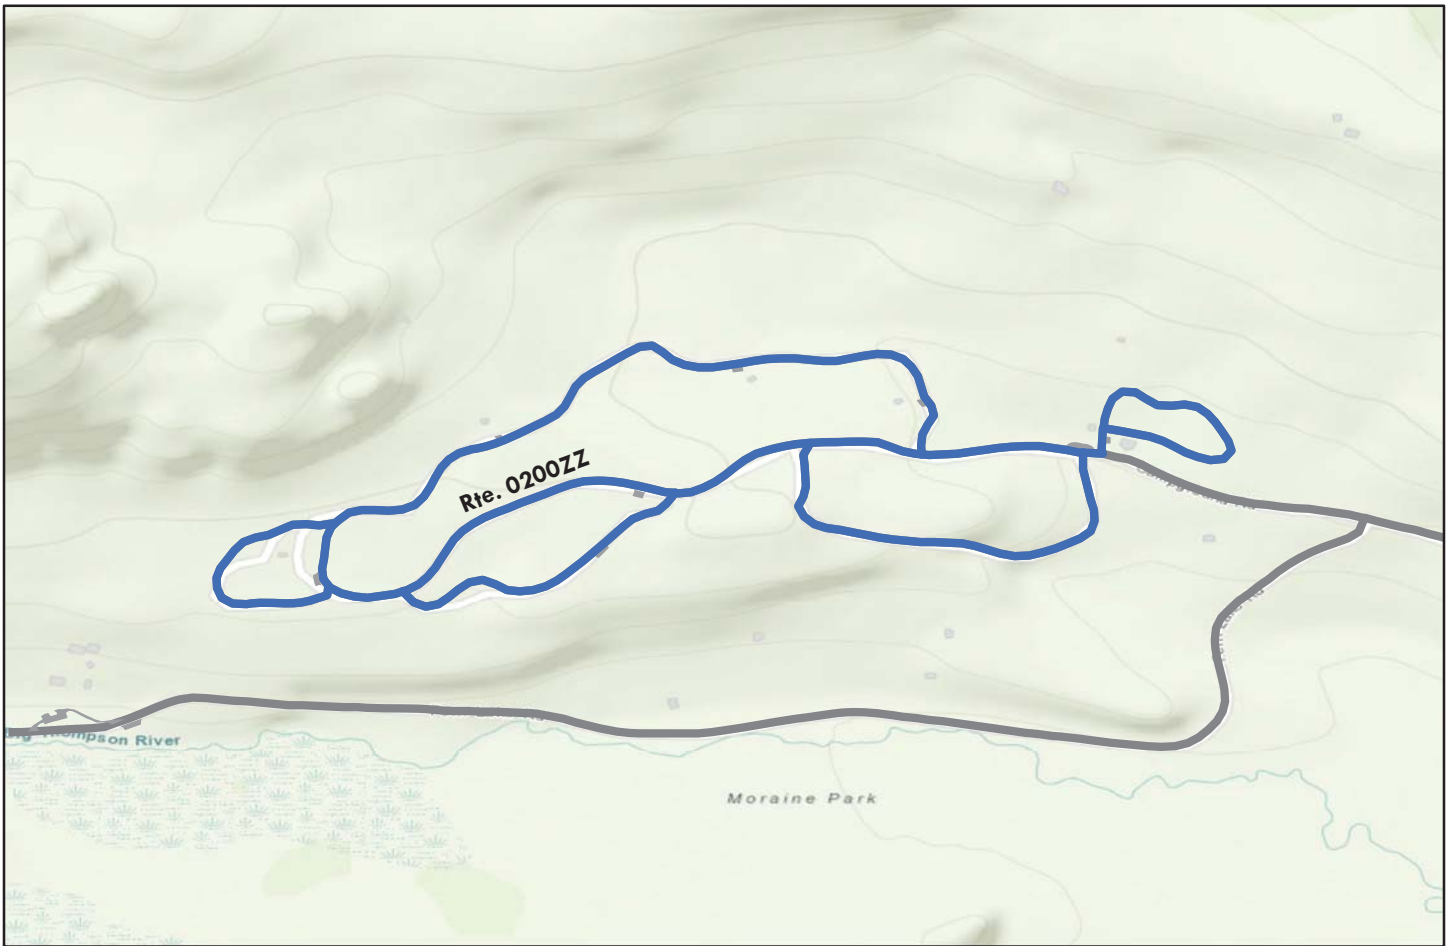
ROUTE 0200ZZ: MORAINE PARK CAMPGROUND LOOPS

Summary Route

Note: The weighted average summary PCR value is calculated from only the sections of road where the PCR was collected. The overall PCR for the summary route may not reflect individual subcomponent ratings.

Route Condition Legend – Pavement Condition Rating (PCR)						
Poor (0 - 60)	Fair (61- 84)	Good (85 - 94)	Excellent (95 - 100)	Not Rated		
See Appendix for definitions and formulas						
Inspection Date: 6/22/2017						
Paved Length (Miles): 2.4						
Surface Type: ASPHALT	Route Summary					
Roadway Condition Information						
Pavement Condition Rating (PCR)	97					
Lane & Width Information						
Number of Lanes	1					
Paved Width (ft)	17.5					
Lane Width (ft)	12.1
