ROMO Cycle 6

Final Report

Road Inventory and Condition Assessment of Paved Routes Rocky Mountain National Park

**Federal Highway Administration
Eastern Federal Lands Highway Division
Road Inventory Program (RIP)**

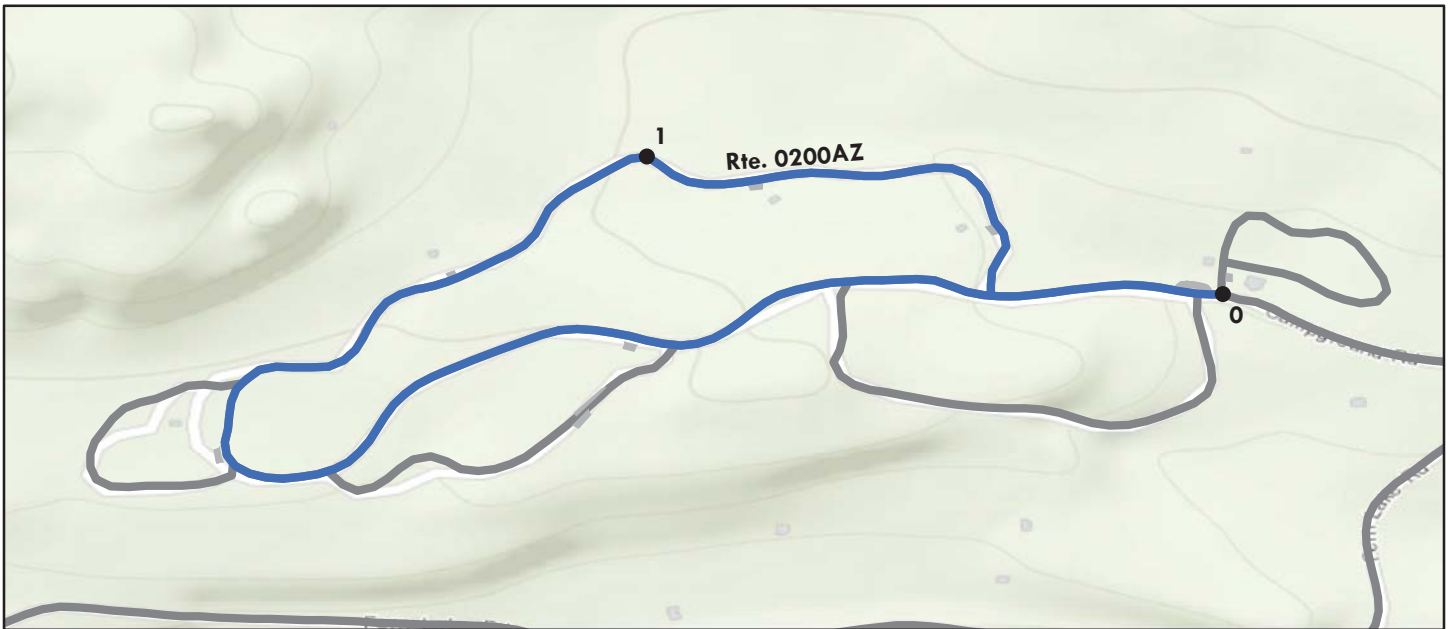
ROUTE 0200AZ: MORaine PARK CAMPGROUND LOOP A

Subcomponent of Route ROMO-0200ZZ
Data Collection Vehicle (DCV) Rating

Route Condition Legend – Pavement Condition Rating (PCR)						
Poor (0 - 60)	Fair (61- 84)	Good (85 - 94)	Excellent (95 - 100)	Not Rated		
Colors on map represent condition scores at 0.10-mile intervals. See Appendix for definitions and formulas.						
Inspection Date: 6/22/2017	Beginning Section MP	0	1			
Paved Length (Miles): 1.29	Section Length (MI)	1	0.29			
Surface Type: ASPHALT	Route Summary					
Roadway Condition Information						
Pavement Condition Rating (PCR)	97	97	96			
Surface Condition Rating (SCR)	97	97	96			
Roughness Condition Index (RCI)	N/A	N/A	N/A			
Distress Index Values						
Structural Crack Index	100	100	100			
Alligator Crack Index	100	100	100			
Longitudinal Crack Index	100	100	100			
Transverse Cracking Index	100	100	100			
Patching Index	100	100	100			
Rutting Index	97	97	96			
International Roughness Index (IRI)	N/A	N/A	N/A			
Lane & Width Information						
Number of Lanes	2	2	2

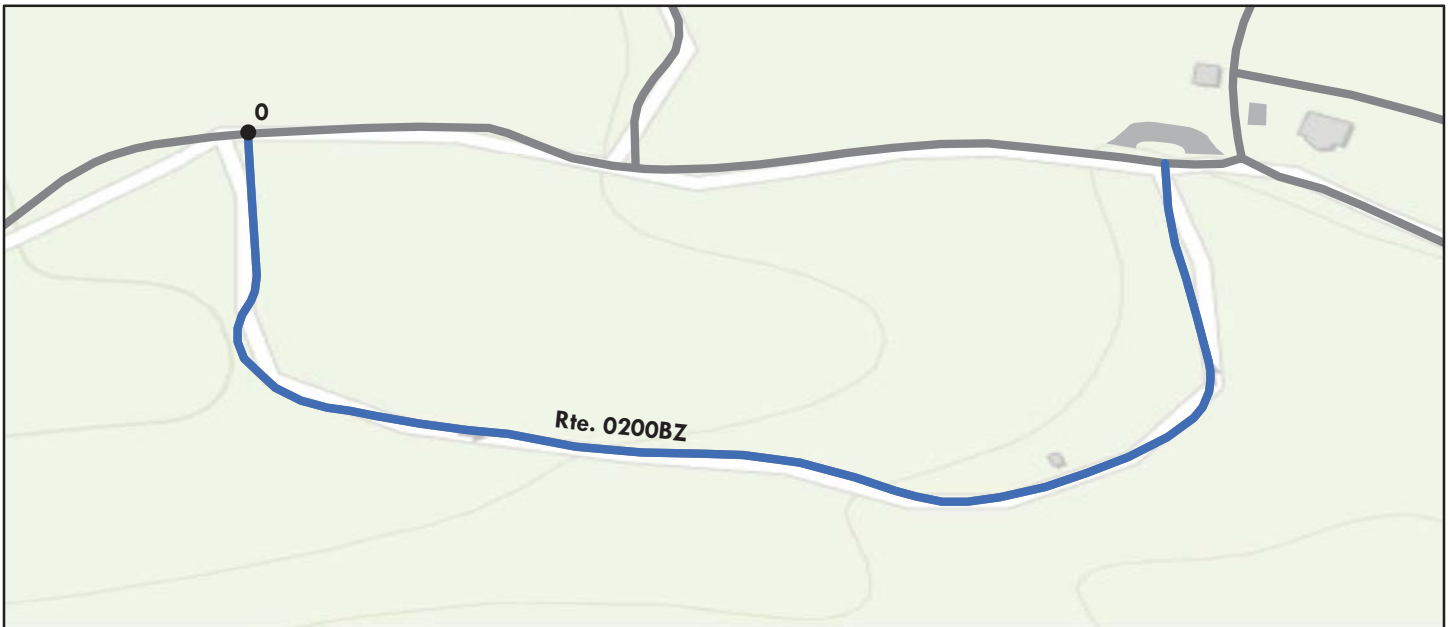
ROUTE 0200BZ: MORAINE PARK CAMPGROUND LOOP B

Subcomponent of Route ROMO-0200ZZ
Data Collection Vehicle (DCV) Rating

Route Condition Legend – Pavement Condition Rating (PCR)						
Poor (0 - 60)	Fair (61- 84)	Good (85 - 94)	Excellent (95 - 100)	Not Rated		
Colors on map represent condition scores at 0.10-mile intervals. See Appendix for definitions and formulas.						
Inspection Date: 6/22/2017	Beginning Section MP	0				
Paved Length (Miles): 0.36	Section Length (MI)	0.36				
Surface Type: ASPHALT	Route Summary					
Roadway Condition Information						
Pavement Condition Rating (PCR)	99	99				
Surface Condition Rating (SCR)	99	99				
Roughness Condition Index (RCI)	N/A	N/A				
Distress Index Values						
Structural Crack Index	100	100				
Alligator Crack Index	100	100				
Longitudinal Crack Index	100	100				
Transverse Cracking Index	100	100				
Patching Index	100	100				
Rutting Index	99	99				
International Roughness Index (IRI)	N/A	N/A				
Lane & Width Information						
Number of Lanes	1	1				
Paved Width (ft)	12.1	12.1

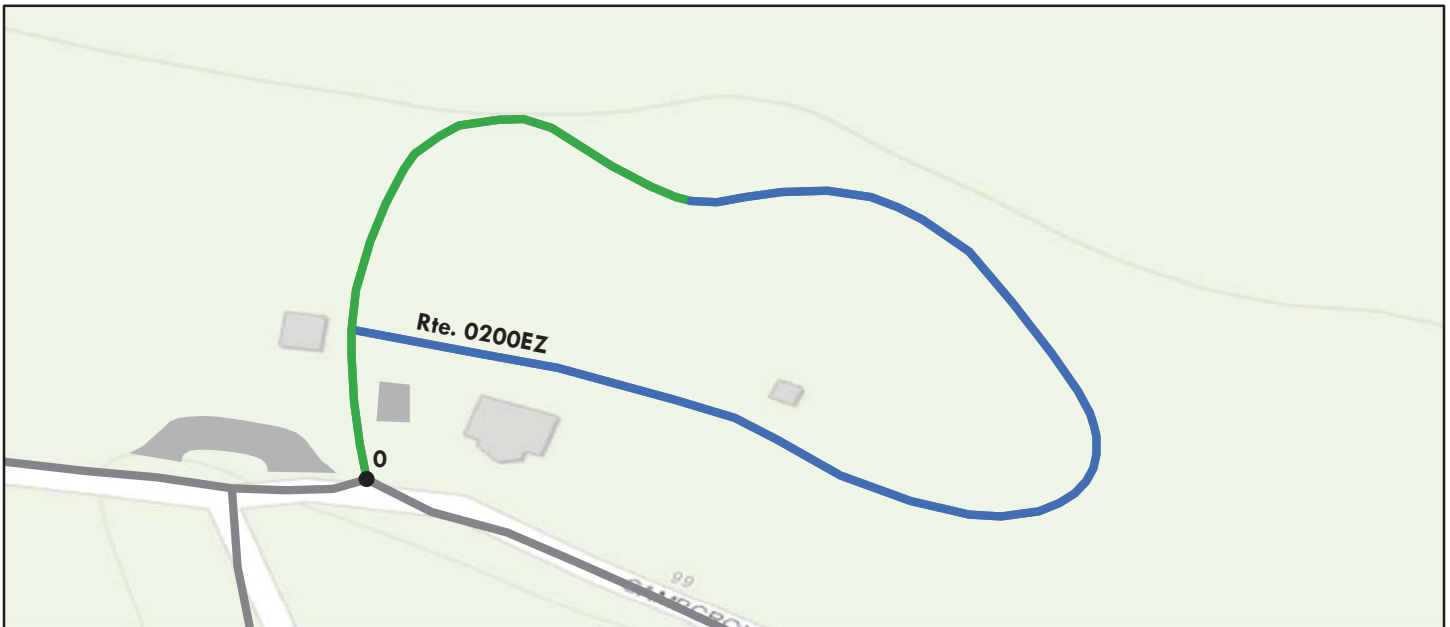
ROUTE 0200EZ: MORAINE PARK CAMPGROUND LOOP E

Subcomponent of Route ROMO-0200ZZ
Data Collection Vehicle (DCV) Rating

Route Condition Legend – Pavement Condition Rating (PCR)						
Poor (0 - 60)	Fair (61- 84)	Good (85 - 94)	Excellent (95 - 100)	Not Rated		
Colors on map represent condition scores at 0.10-mile intervals. See Appendix for definitions and formulas.						
Inspection Date: 6/22/2017	Beginning Section MP	0				
Paved Length (Miles): 0.28	Section Length (MI)	0.28				
Surface Type: ASPHALT	Route Summary					
Roadway Condition Information						
Pavement Condition Rating (PCR)	97	97				
Surface Condition Rating (SCR)	97	97				
Roughness Condition Index (RCI)	N/A	N/A				
Distress Index Values						
Structural Crack Index	100	100				
Alligator Crack Index	100	100				
Longitudinal Crack Index	100	100				
Transverse Cracking Index	100	100				
Patching Index	100	100				
Rutting Index	97	97				
International Roughness Index (IRI)	N/A	N/A				
Lane & Width Information						
Number of Lanes	1	1				
Paved Width (ft)	15.1	15.1

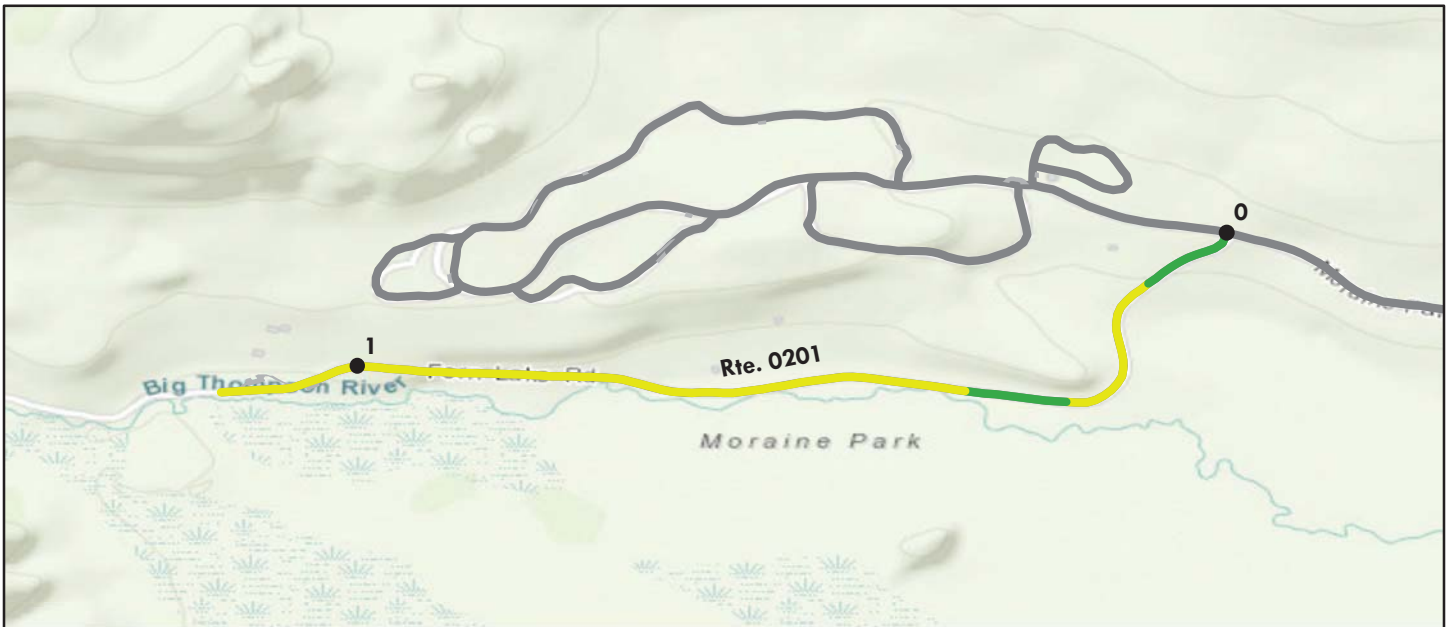
ROUTE 0201: CUB LAKE / STABLES ROAD

Data Collection Vehicle (DCV) Rating

Inspection Date: 6/22/2017		Beginning Section MP	0	1			
Paved Length (Miles): 1.14		Section Length (MI)	1	0.14			
Surface Type: ASPHALT		Route Summary					
Roadway Condition Information							
Pavement Condition Rating (PCR)	79	81	69				
Surface Condition Rating (SCR)	93	93	94				
Roughness Condition Index (RCI)	57	62	31				
Distress Index Values							
Structural Crack Index	96	95	96				
Alligator Crack Index	100	100	99				
Longitudinal Crack Index	96	95	97				
Transverse Cracking Index	96	97	96				
Patching Index	100	100	99				
Rutting Index	93	93	94				
International Roughness Index (IRI)	253	231	400				
Lane & Width Information							
Number of Lanes	2	2	2				
Paved Width (ft)	21.8	22	21.1				
Lane Width (ft)	10.8	10.9	9.9

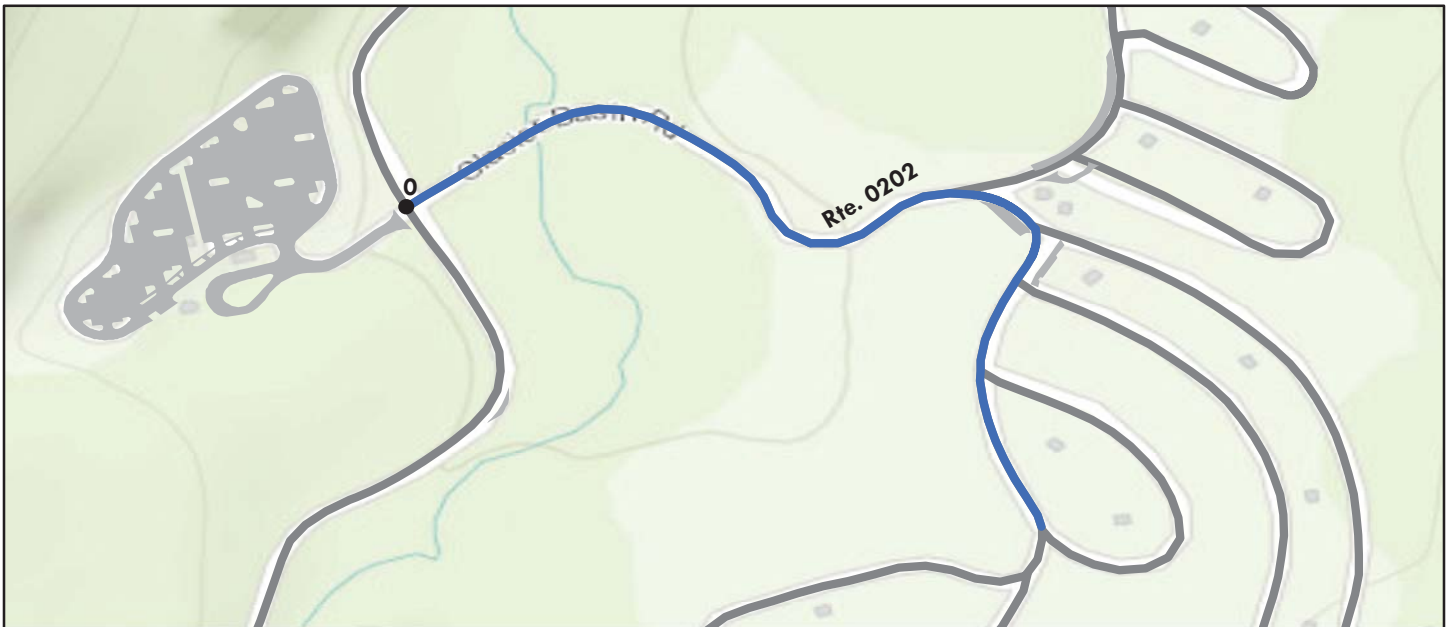
ROUTE 0202: GLACIER BASIN CAMPGROUND ROAD

Data Collection Vehicle (DCV) Rating

Route Condition Legend – Pavement Condition Rating (PCR)						
Poor (0 - 60)	Fair (61- 84)	Good (85 - 94)	Excellent (95 - 100)	Not Rated		
Colors on map represent condition scores at 0.10-mile intervals. See Appendix for definitions and formulas.						
Inspection Date: 6/22/2017	Beginning Section MP	0				
Paved Length (Miles): 0.46	Section Length (MI)	0.46				
Surface Type: ASPHALT	Route Summary					
Roadway Condition Information						
Pavement Condition Rating (PCR)	99	99				
Surface Condition Rating (SCR)	99	99				
Roughness Condition Index (RCI)	N/A	N/A				
Distress Index Values						
Structural Crack Index	100	100				
Alligator Crack Index	100	100				
Longitudinal Crack Index	100	100				
Transverse Cracking Index	100	100				
Patching Index	100	100				
Rutting Index	99	99				
International Roughness Index (IRI)	N/A	N/A				
Lane & Width Information						
Number of Lanes	2	2				
Paved Width (ft)	20.8	20.8

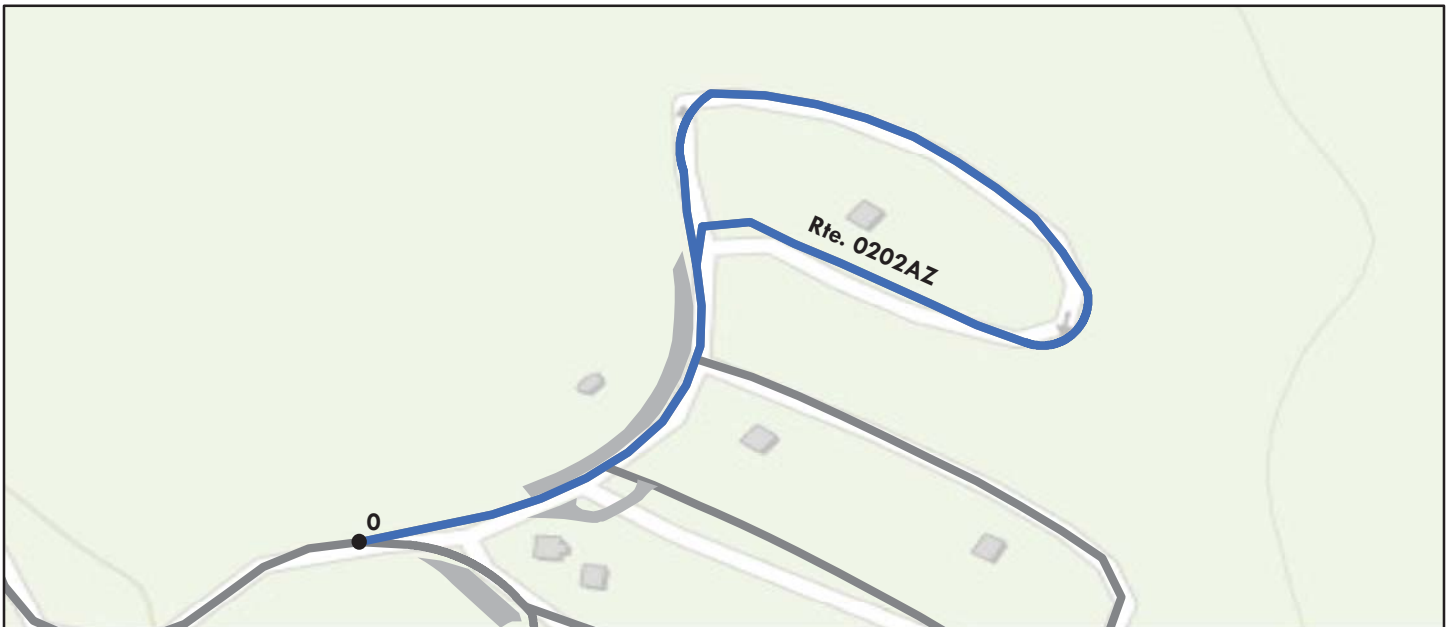
ROUTE 0202AZ: GLACIER BASIN CAMPGROUND LOOP A

Subcomponent of Route ROMO-0202ZZ
Data Collection Vehicle (DCV) Rating

Route Condition Legend – Pavement Condition Rating (PCR)						
Poor (0 - 60)	Fair (61- 84)	Good (85 - 94)	Excellent (95 - 100)	Not Rated		
Colors on map represent condition scores at 0.10-mile intervals. See Appendix for definitions and formulas.						
Inspection Date: 6/22/2017	Beginning Section MP	0				
Paved Length (Miles): 0.32	Section Length (MI)	0.32				
Surface Type: ASPHALT	Route Summary					
Roadway Condition Information						
Pavement Condition Rating (PCR)	99	99				
Surface Condition Rating (SCR)	99	99				
Roughness Condition Index (RCI)	N/A	N/A				
Distress Index Values						
Structural Crack Index	100	100				
Alligator Crack Index	100	100				
Longitudinal Crack Index	100	100				
Transverse Cracking Index	99	99				
Patching Index	100	100				
Rutting Index	99	99				
International Roughness Index (IRI)	N/A	N/A				
Lane & Width Information						
Number of Lanes	1	1				
Paved Width (ft)	14.3	14.3

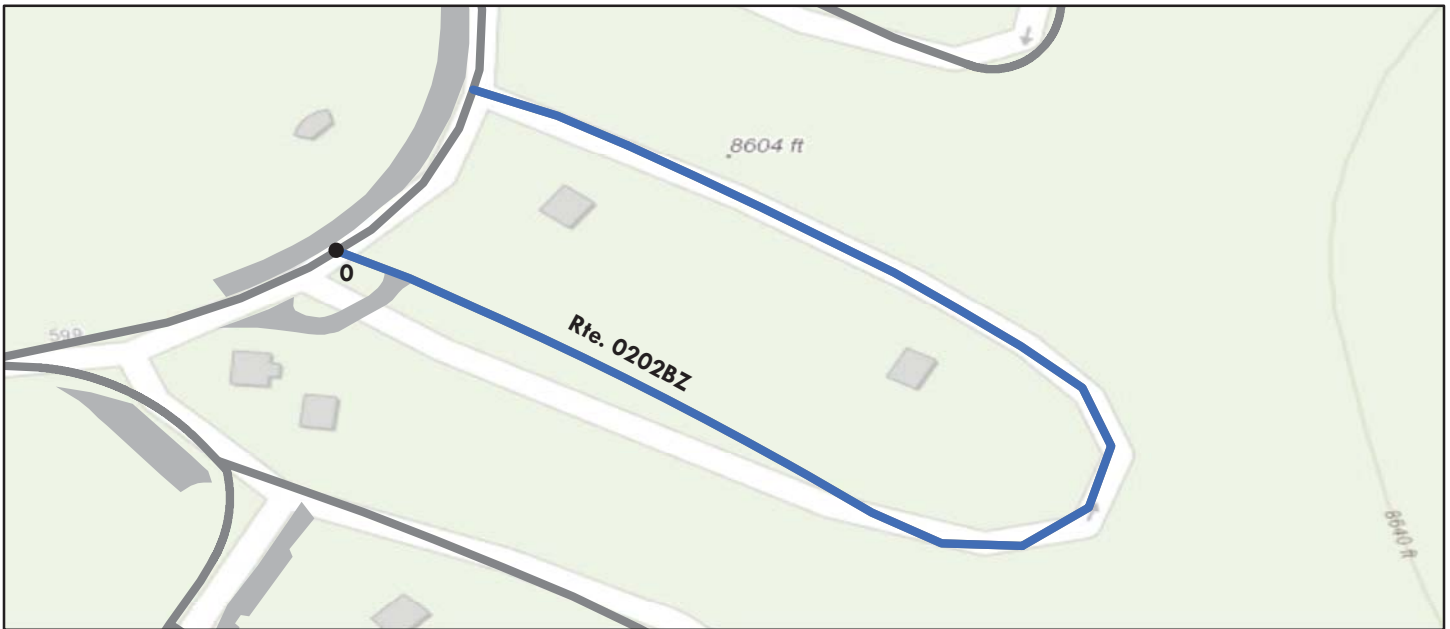
ROUTE 0202BZ: GLACIER BASIN CAMPGROUND LOOP B

Subcomponent of Route ROMO-0202ZZ
 Data Collection Vehicle (DCV) Rating

Route Condition Legend – Pavement Condition Rating (PCR)						
Poor (0 - 60)	Fair (61- 84)	Good (85 - 94)	Excellent (95 - 100)	Not Rated		
Colors on map represent condition scores at 0.10-mile intervals. See Appendix for definitions and formulas.						
Inspection Date: 6/22/2017	Beginning Section MP	0				
Paved Length (Miles): 0.22	Section Length (MI)	0.22				
Surface Type: ASPHALT	Route Summary					
Roadway Condition Information						
Pavement Condition Rating (PCR)	99	99				
Surface Condition Rating (SCR)	99	99				
Roughness Condition Index (RCI)	N/A	N/A				
Distress Index Values						
Structural Crack Index	100	100				
Alligator Crack Index	100	100				
Longitudinal Crack Index	100	100				
Transverse Cracking Index	100	100				
Patching Index	100	100				
Rutting Index	99	99				
International Roughness Index (IRI)	N/A	N/A				
Lane & Width Information						
Number of Lanes	1	1				
Paved Width (ft)	12.6	12.6

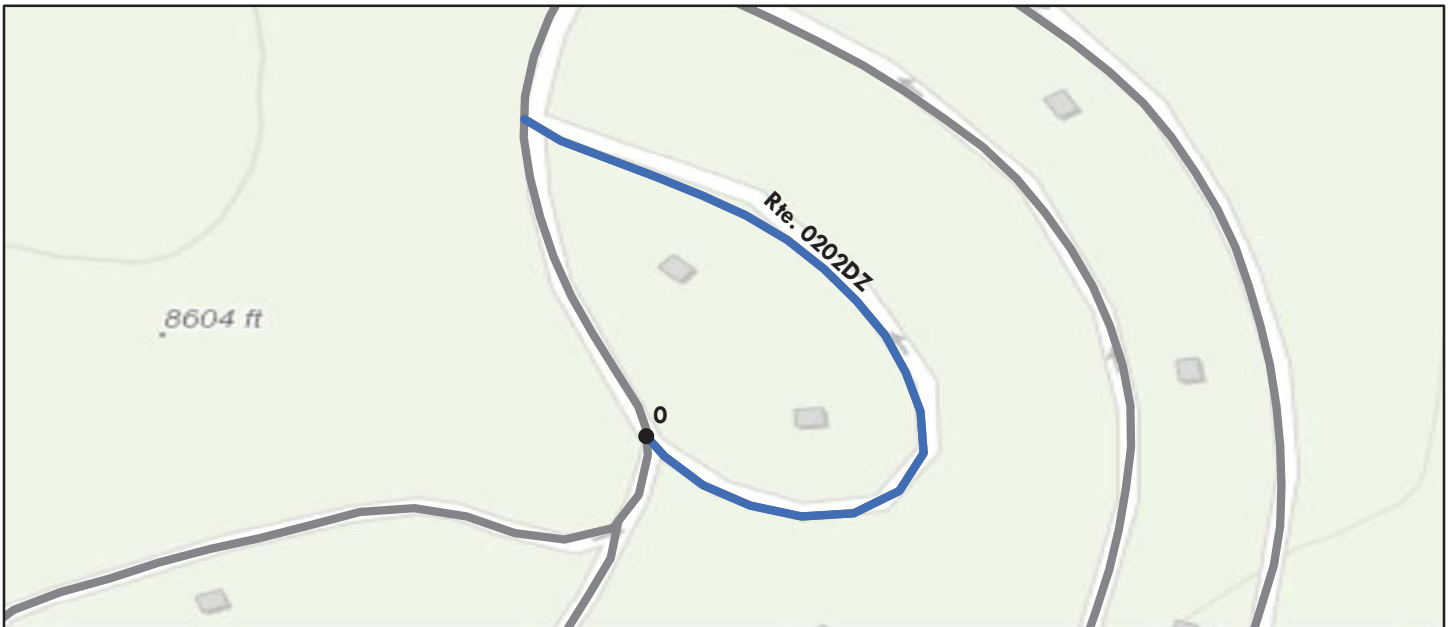
ROUTE 0202DZ: GLACIER BASIN CAMPGROUND LOOP D

Subcomponent of Route ROMO-0202ZZ
Data Collection Vehicle (DCV) Rating

Route Condition Legend – Pavement Condition Rating (PCR)						
Poor (0 - 60)	Fair (61- 84)	Good (85 - 94)	Excellent (95 - 100)	Not Rated		
Colors on map represent condition scores at 0.10-mile intervals. See Appendix for definitions and formulas.						
Inspection Date: 6/22/2017	Beginning Section MP	0				
Paved Length (Miles): 0.19	Section Length (MI)	0.19				
Surface Type: ASPHALT	Route Summary					
Roadway Condition Information						
Pavement Condition Rating (PCR)	97	97				
Surface Condition Rating (SCR)	97	97				
Roughness Condition Index (RCI)	N/A	N/A				
Distress Index Values						
Structural Crack Index	100	100				
Alligator Crack Index	100	100				
Longitudinal Crack Index	100	100				
Transverse Cracking Index	99	99				
Patching Index	100	100				
Rutting Index	97	97				
International Roughness Index (IRI)	N/A	N/A				
Lane & Width Information						
Number of Lanes	1	1				
Paved Width (ft)	14.4	14.4

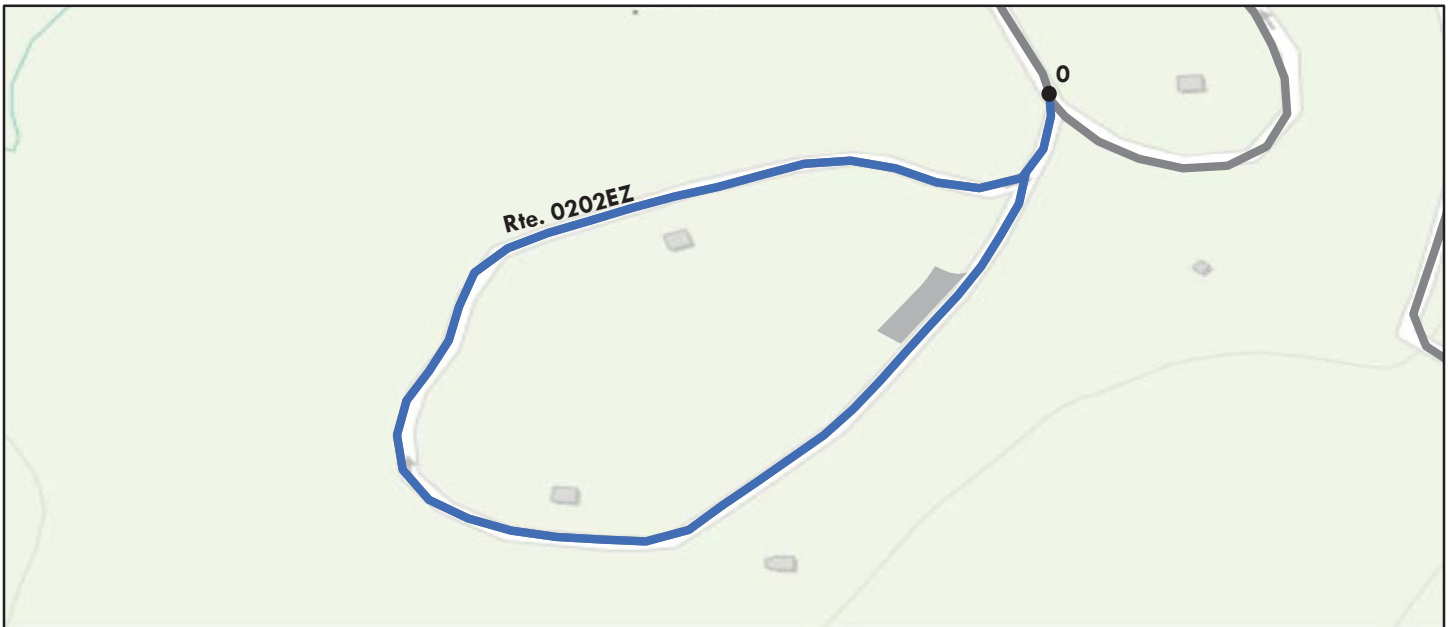
Subcomponent of Route ROMO-0202ZZ

Data Collection Vehicle (DCV) Rating

Inspection Date: 6/22/2017	Beginning Section MP	0				
Paved Length (Miles): 0.41	Section Length (MI)	0.41				
Surface Type: ASPHALT	Route Summary					
Roadway Condition Information						
Pavement Condition Rating (PCR)	99	99				
Surface Condition Rating (SCR)	99	99				
Roughness Condition Index (RCI)	N/A	N/A				
Distress Index Values						
Structural Crack Index	100	100				
Alligator Crack Index	100	100				
Longitudinal Crack Index	100	100				
Transverse Cracking Index	100	100				
Patching Index	100	100				
Rutting Index	99	99				
International Roughness Index (IRI)	N/A	N/A				
Lane & Width Information						
Number of Lanes	1	1				
Paved Width (ft)	12.2	12.2				
Lane Width (ft)	11.4	11.4

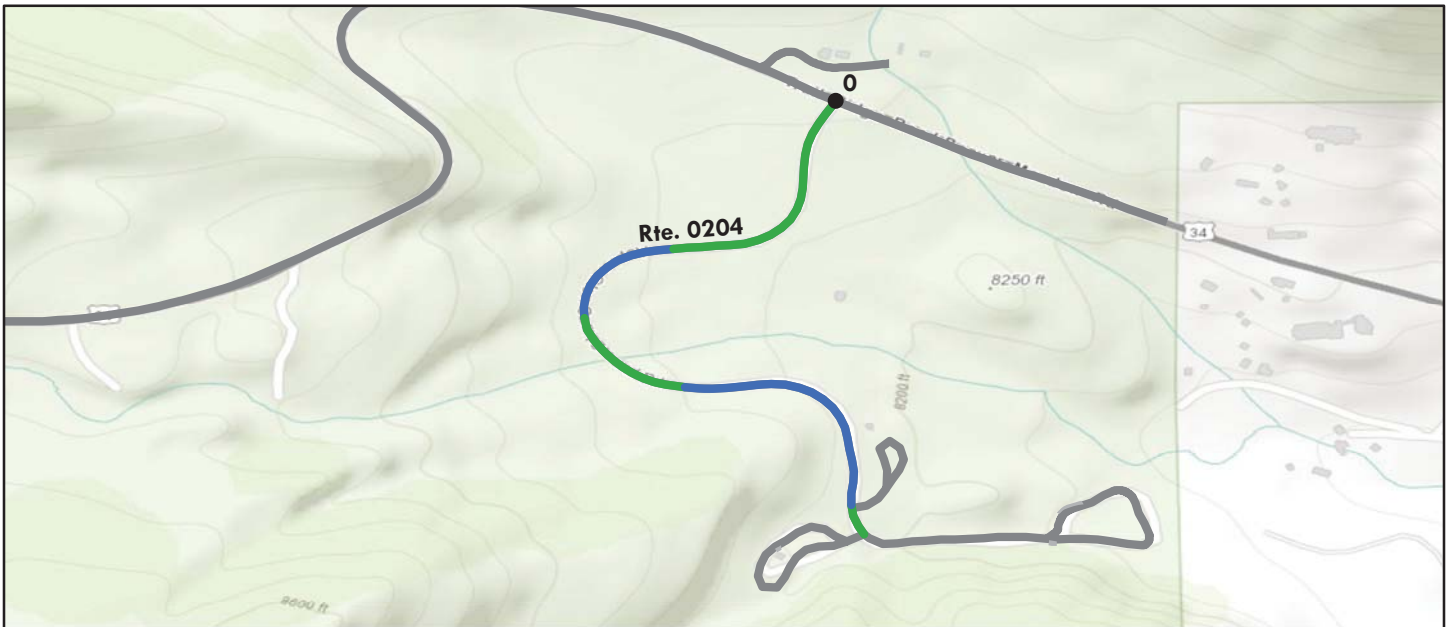
ROUTE 0204: ASPENGLÉN CAMPGROUND ROAD COMPLEX

Data Collection Vehicle (DCV) Rating

Route Condition Legend – Pavement Condition Rating (PCR)						
Poor (0 - 60)	Fair (61- 84)	Good (85 - 94)	Excellent (95 - 100)	Not Rated		
Colors on map represent condition scores at 0.10-mile intervals. See Appendix for definitions and formulas.						
Inspection Date: 6/21/2017	Beginning Section MP	0				
Paved Length (Miles): 0.64	Section Length (MI)	0.64				
Surface Type: ASPHALT	Route Summary					
Roadway Condition Information						
Pavement Condition Rating (PCR)	94	94				
Surface Condition Rating (SCR)	94	94				
Roughness Condition Index (RCI)	N/A	N/A				
Distress Index Values						
Structural Crack Index	99	99				
Alligator Crack Index	100	100				
Longitudinal Crack Index	99	99				
Transverse Cracking Index	98	98				
Patching Index	100	100				
Rutting Index	94	94				
International Roughness Index (IRI)	N/A	N/A				
Lane & Width Information						
Number of Lanes	2	2				
Paved Width (ft)	21.3	21.3				
Lane Width (ft)	10.5	10.5

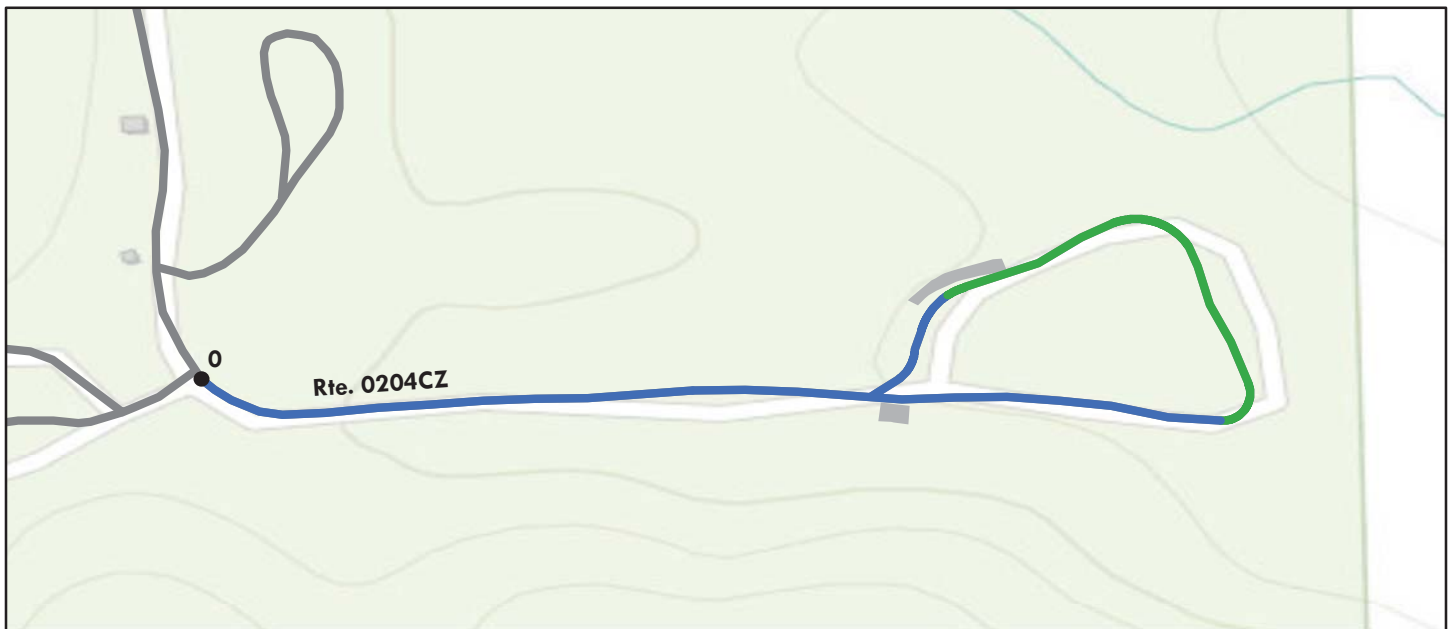
ROUTE 0204CZ: ASPENGLLEN CAMPGROUND LOOP C

Subcomponent of Route ROMO-0204ZZ
Data Collection Vehicle (DCV) Rating

Route Condition Legend – Pavement Condition Rating (PCR)						
Poor (0 - 60)	Fair (61- 84)	Good (85 - 94)	Excellent (95 - 100)	Not Rated		
Colors on map represent condition scores at 0.10-mile intervals. See Appendix for definitions and formulas.						
Inspection Date: 6/21/2017	Beginning Section MP	0				
Paved Length (Miles): 0.33	Section Length (MI)	0.33				
Surface Type: ASPHALT	Route Summary					
Roadway Condition Information						
Pavement Condition Rating (PCR)	96	96				
Surface Condition Rating (SCR)	96	96				
Roughness Condition Index (RCI)	N/A	N/A				
Distress Index Values						
Structural Crack Index	100	100				
Alligator Crack Index	100	100				
Longitudinal Crack Index	100	100				
Transverse Cracking Index	99	99				
Patching Index	100	100				
Rutting Index	96	96				
International Roughness Index (IRI)	N/A	N/A				
Lane & Width Information						
Number of Lanes	1	1				
Paved Width (ft)	16.2	16.2

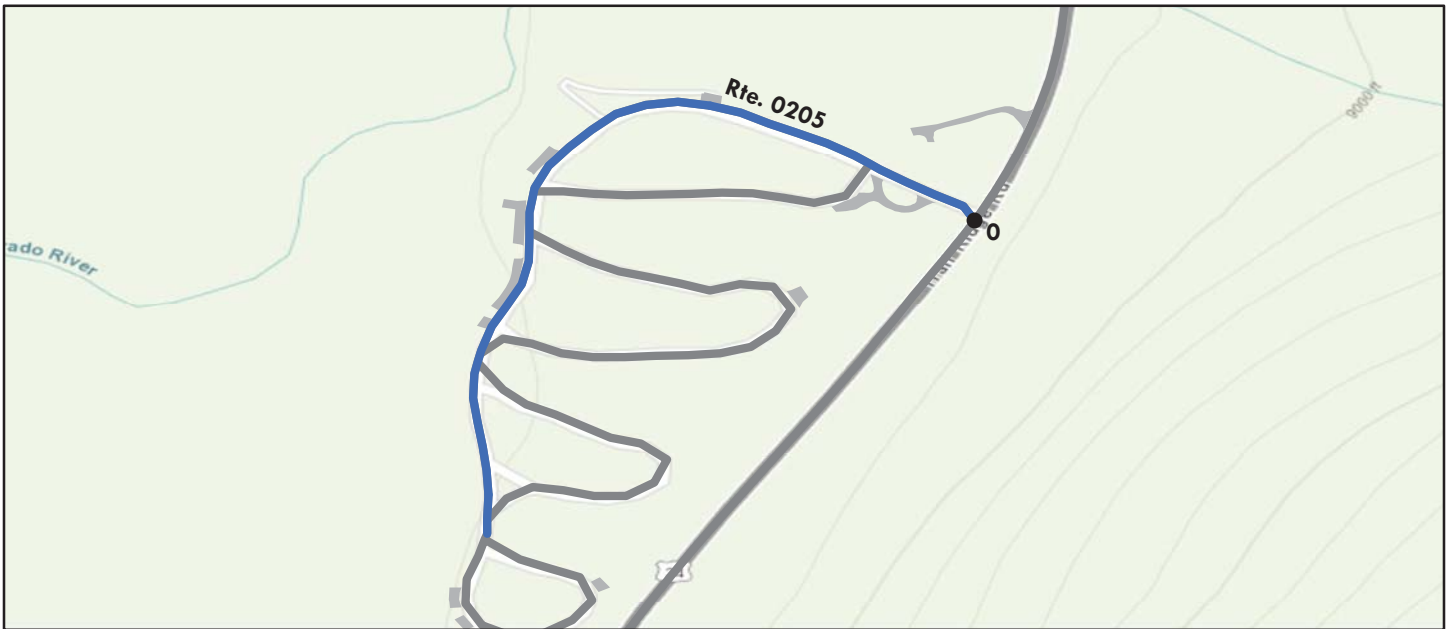
ROUTE 0205: TIMBER CREEK CAMPGROUND ENTRANCE ROAD

Data Collection Vehicle (DCV) Rating

Route Condition Legend – Pavement Condition Rating (PCR)						
Poor (0 - 60)	Fair (61- 84)	Good (85 - 94)	Excellent (95 - 100)	Not Rated		
Colors on map represent condition scores at 0.10-mile intervals. See Appendix for definitions and formulas.						
Inspection Date: 6/21/2017	Beginning Section MP	0				
Paved Length (Miles): 0.32	Section Length (MI)	0.32				
Surface Type: ASPHALT	Route Summary					
Roadway Condition Information						
Pavement Condition Rating (PCR)	96	96				
Surface Condition Rating (SCR)	96	96				
Roughness Condition Index (RCI)	N/A	N/A				
Distress Index Values						
Structural Crack Index	100	100				
Alligator Crack Index	100	100				
Longitudinal Crack Index	100	100				
Transverse Cracking Index	100	100				
Patching Index	100	100				
Rutting Index	96	96				
International Roughness Index (IRI)	N/A	N/A				
Lane & Width Information						
Number of Lanes	2	2				
Paved Width (ft)	19.7	19.7

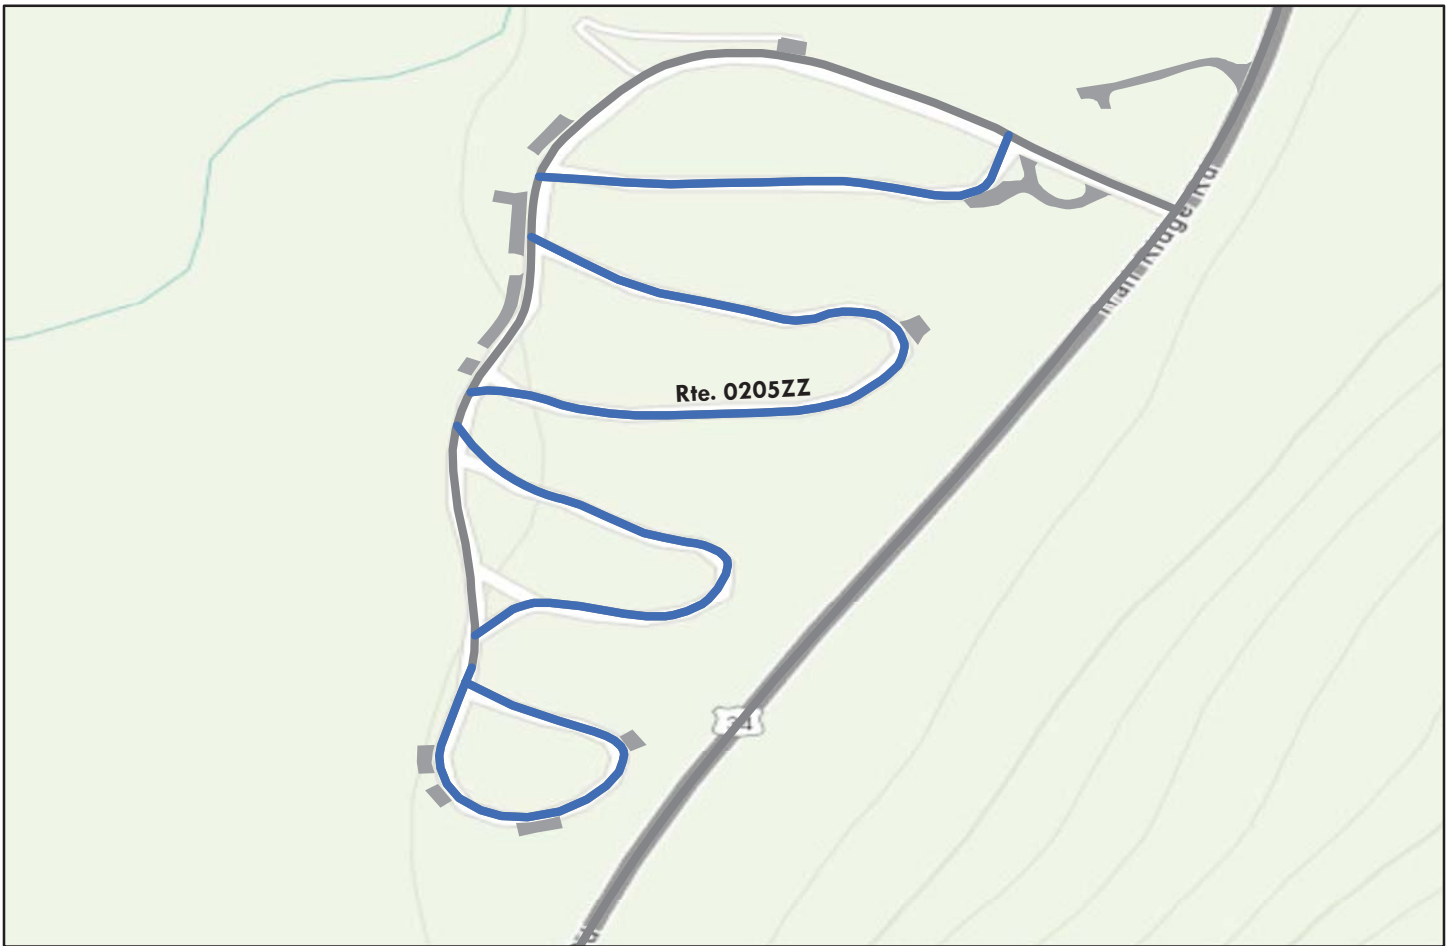
ROUTE 0205ZZ: TIMBER CREEK CAMPGROUND ROADS

Summary Route

Note: The weighted average summary PCR value is calculated from only the sections of road where the PCR was collected. The overall PCR for the summary route may not reflect individual subcomponent ratings.

Route Condition Legend – Pavement Condition Rating (PCR)						
Poor (0 - 60)	Fair (61- 84)	Good (85 - 94)	Excellent (95 - 100)	Not Rated		
See Appendix for definitions and formulas						
Inspection Date: 6/21/2017						
Paved Length (Miles): 0.57						
Surface Type: ASPHALT	Route Summary					
Roadway Condition Information						
Pavement Condition Rating (PCR)	95					
Lane & Width Information						
Number of Lanes	2					
Paved Width (ft)	11.3					
Lane Width (ft)	11.3

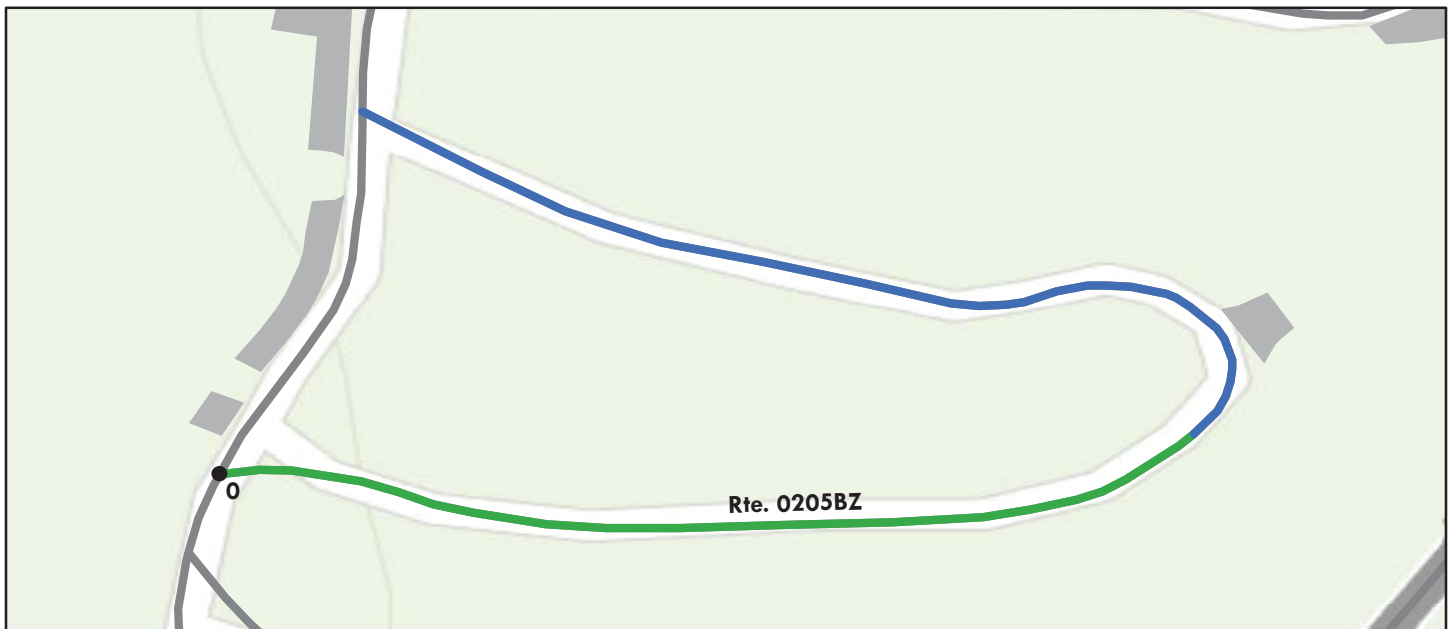
Subcomponent of Route ROMO-0205ZZ

Data Collection Vehicle (DCV) Rating

Inspection Date: 6/21/2017	Beginning Section MP	0				
Paved Length (Miles): 0.2	Section Length (MI)	0.2				
Surface Type: ASPHALT	Route Summary					
Roadway Condition Information						
Pavement Condition Rating (PCR)	94	94				
Surface Condition Rating (SCR)	94	94				
Roughness Condition Index (RCI)	N/A	N/A				
Distress Index Values						
Structural Crack Index	100	100				
Alligator Crack Index	100	100				
Longitudinal Crack Index	100	100				
Transverse Cracking Index	100	100				
Patching Index	100	100				
Rutting Index	94	94				
International Roughness Index (IRI)	N/A	N/A				
Lane & Width Information						
Number of Lanes	1	1				
Paved Width (ft)	10.9	10.9				
Lane Width (ft)	10.9	10.9

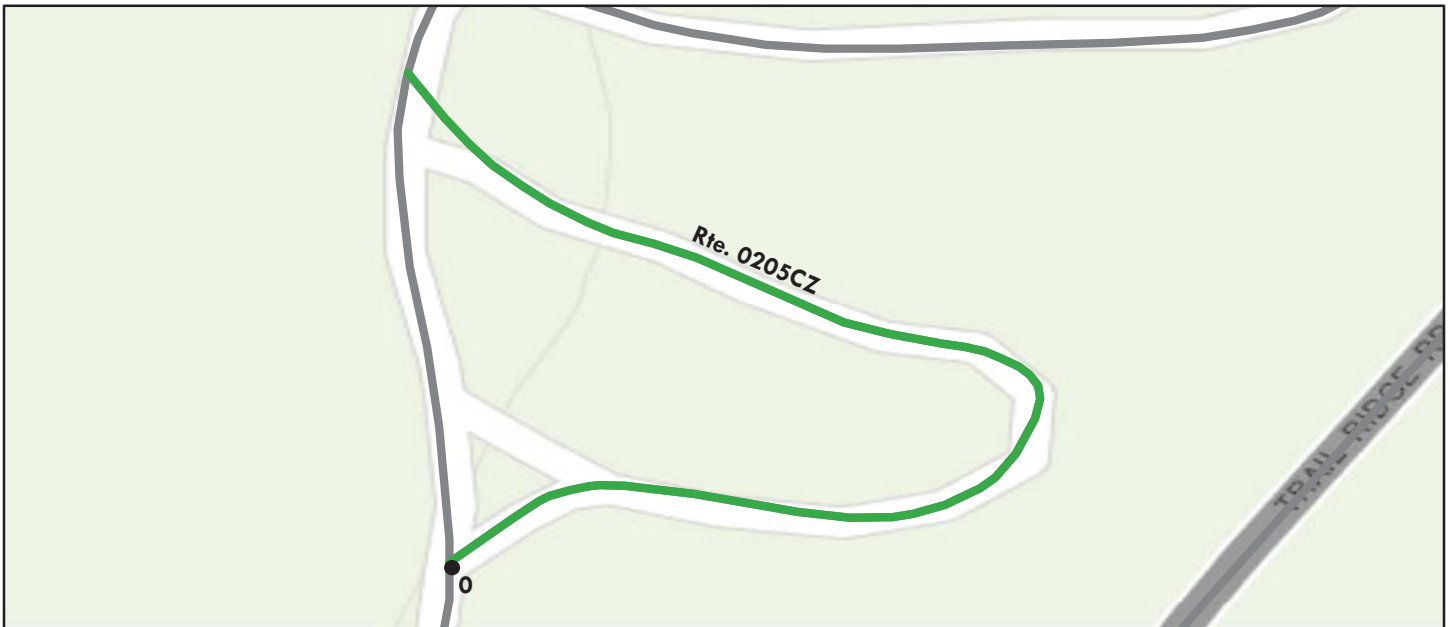
ROUTE 0205CZ: TIMBER CREEK CAMPGROUND COLUMBINE LOOP

Subcomponent of Route ROMO-0205ZZ
Data Collection Vehicle (DCV) Rating

Inspection Date: 6/21/2017	Beginning Section MP	0				
Paved Length (Miles): 0.14	Section Length (MI)	0.14				
Surface Type: ASPHALT	Route Summary					
Roadway Condition Information						
Pavement Condition Rating (PCR)	94	94				
Surface Condition Rating (SCR)	94	94				
Roughness Condition Index (RCI)	N/A	N/A				
Distress Index Values						
Structural Crack Index	100	100				
Alligator Crack Index	100	100				
Longitudinal Crack Index	100	100				
Transverse Cracking Index	100	100				
Patching Index	100	100				
Rutting Index	94	94				
International Roughness Index (IRI)	N/A	N/A				
Lane & Width Information						
Number of Lanes	1	1				
Paved Width (ft)	12.7	12.7				
Lane Width (ft)	12.6	12.6

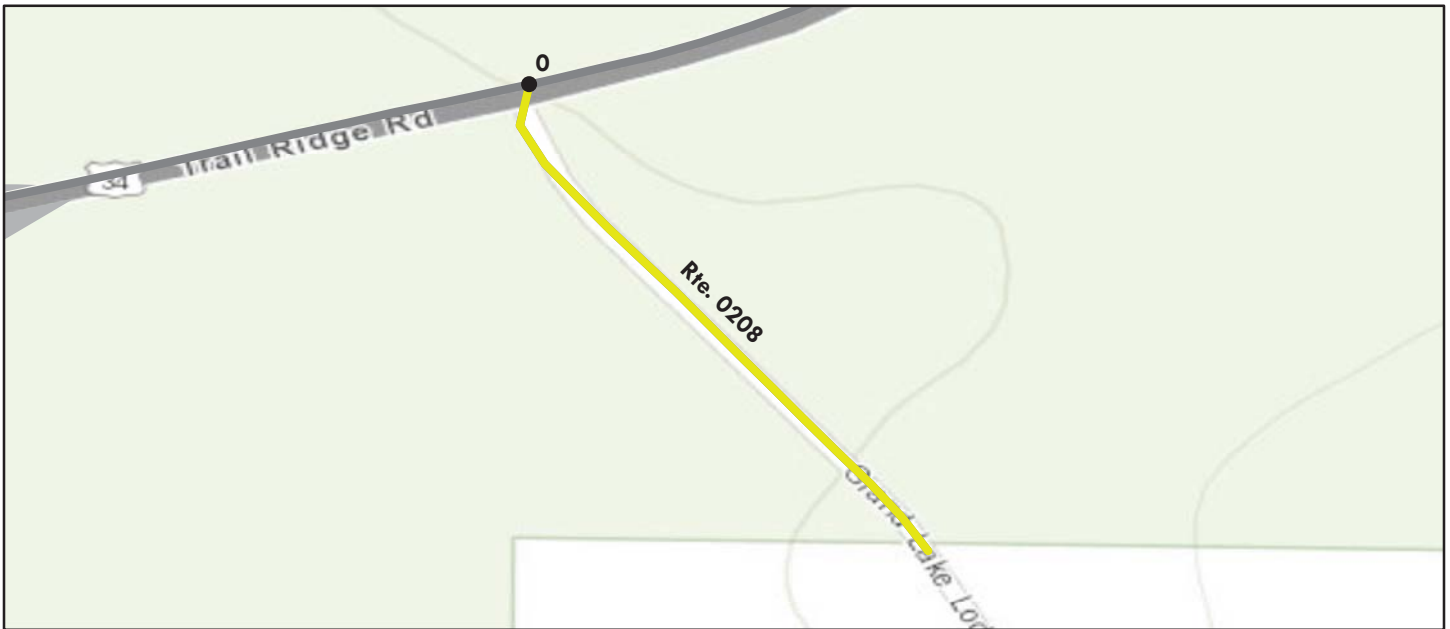
ROUTE 0208: GRAND LAKE LODGE ROAD

Data Collection Vehicle (DCV) Rating

Inspection Date: 6/21/2017	Beginning Section MP	0				
Paved Length (Miles): 0.14	Section Length (MI)	0.14				
Surface Type: ASPHALT	Route Summary					
Roadway Condition Information						
Pavement Condition Rating (PCR)	86	86				
Surface Condition Rating (SCR)	86	86				
Roughness Condition Index (RCI)	N/A	N/A				
Distress Index Values						
Structural Crack Index	86	86				
Alligator Crack Index	100	100				
Longitudinal Crack Index	86	86				
Transverse Cracking Index	87	87				
Patching Index	100	100				
Rutting Index	97	97				
International Roughness Index (IRI)	N/A	N/A				
Lane & Width Information						
Number of Lanes	2	2				
Paved Width (ft)	20.4	20.4				
Lane Width (ft)	9.9	9.9

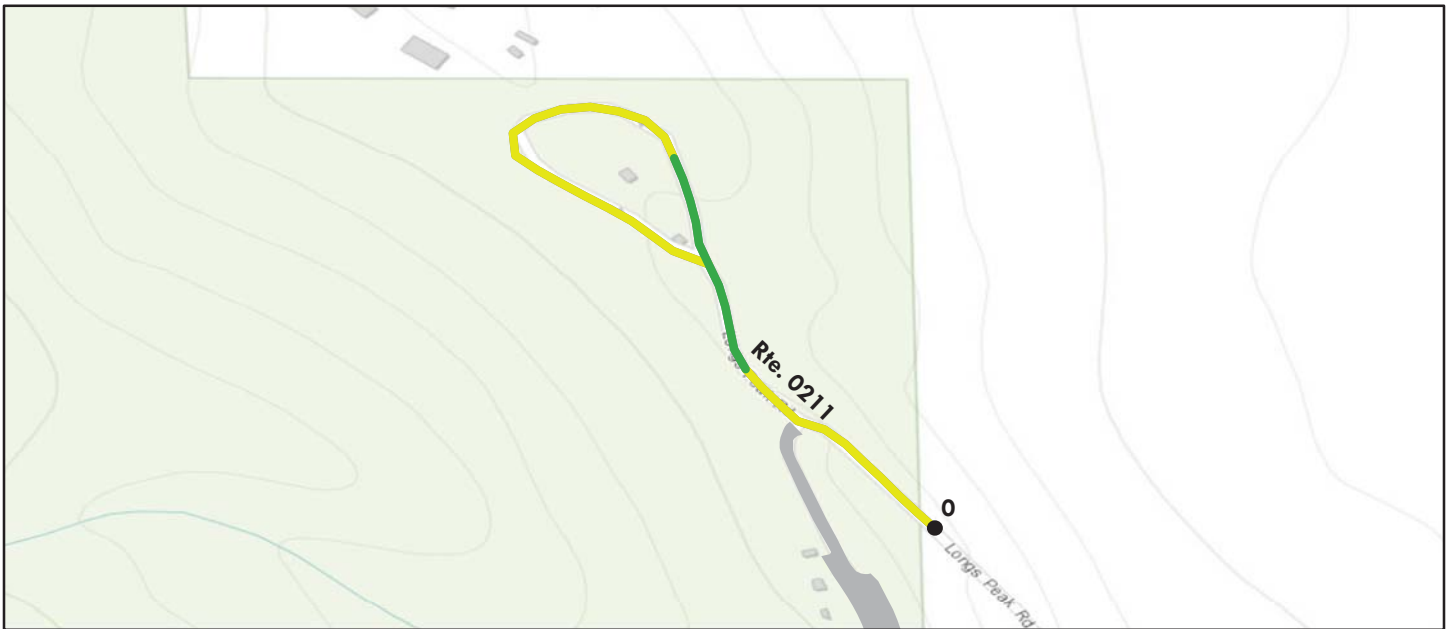
ROUTE 0211: LONGS PEAK CAMPGROUND ROAD

Data Collection Vehicle (DCV) Rating

Route Condition Legend – Pavement Condition Rating (PCR)						
Poor (0 - 60)	Fair (61- 84)	Good (85 - 94)	Excellent (95 - 100)	Not Rated		
Colors on map represent condition scores at 0.10-mile intervals. See Appendix for definitions and formulas.						
Inspection Date: 6/22/2017	Beginning Section MP	0				
Paved Length (Miles): 0.36	Section Length (MI)	0.36				
Surface Type: ASPHALT	Route Summary					
Roadway Condition Information						
Pavement Condition Rating (PCR)	82	82				
Surface Condition Rating (SCR)	82	82				
Roughness Condition Index (RCI)	N/A	N/A				
Distress Index Values						
Structural Crack Index	82	82				
Alligator Crack Index	100	100				
Longitudinal Crack Index	82	82				
Transverse Cracking Index	89	89				
Patching Index	100	100				
Rutting Index	94	94				
International Roughness Index (IRI)	N/A	N/A				
Lane & Width Information						
Number of Lanes	2	2				
Paved Width (ft)	17.7	17.7				
Lane Width (ft)	12.4	12.4

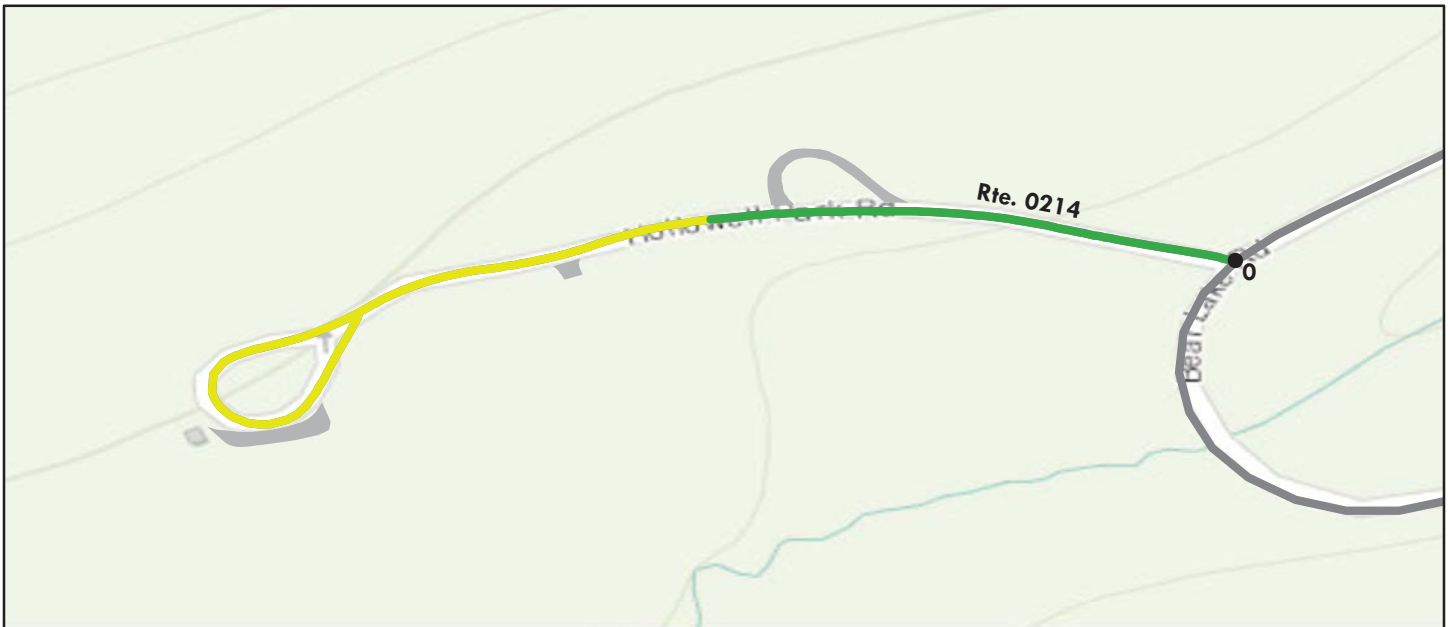
ROUTE 0214: HALLOWELL PARK ROAD

Data Collection Vehicle (DCV) Rating

Inspection Date: 6/22/2017	Beginning Section MP	0				
Paved Length (Miles): 0.26	Section Length (MI)	0.26				
Surface Type: ASPHALT	Route Summary					
Roadway Condition Information						
Pavement Condition Rating (PCR)	87	87				
Surface Condition Rating (SCR)	87	87				
Roughness Condition Index (RCI)	N/A	N/A				
Distress Index Values						
Structural Crack Index	93	93				
Alligator Crack Index	100	100				
Longitudinal Crack Index	93	93				
Transverse Cracking Index	87	87				
Patching Index	100	100				
Rutting Index	92	92				
International Roughness Index (IRI)	N/A	N/A				
Lane & Width Information						
Number of Lanes	2	2				
Paved Width (ft)	16.7	16.7				
Lane Width (ft)	9.6	9.6

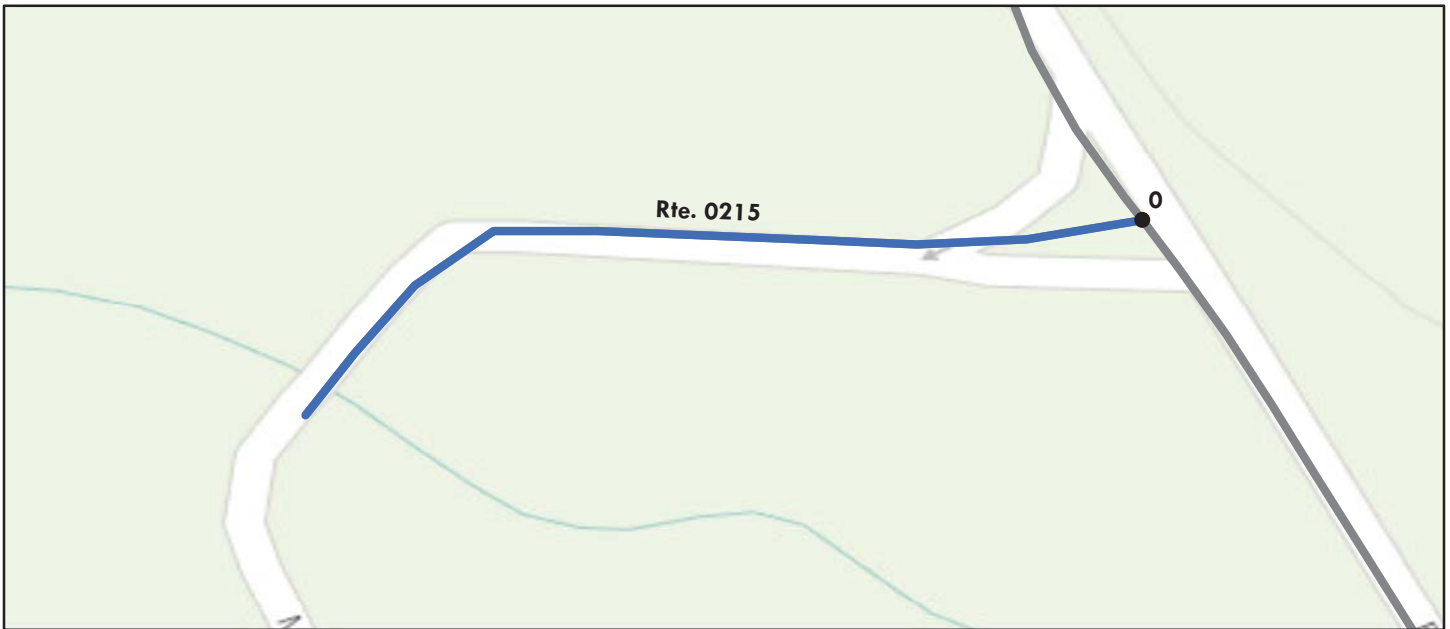
ROUTE 0215: CABINS ROAD / KALEY COTTAGES

Data Collection Vehicle (DCV) Rating

Route Condition Legend – Pavement Condition Rating (PCR)						
Poor (0 - 60)	Fair (61- 84)	Good (85 - 94)	Excellent (95 - 100)	Not Rated		
Colors on map represent condition scores at 0.10-mile intervals. See Appendix for definitions and formulas.						
Inspection Date: 6/22/2017	Beginning Section MP	0				
Paved Length (Miles): 0.09	Section Length (MI)	0.09				
Surface Type: ASPHALT	Route Summary					
Roadway Condition Information						
Pavement Condition Rating (PCR)	98	98				
Surface Condition Rating (SCR)	98	98				
Roughness Condition Index (RCI)	N/A	N/A				
Distress Index Values						
Structural Crack Index	100	100				
Alligator Crack Index	100	100				
Longitudinal Crack Index	100	100				
Transverse Cracking Index	100	100				
Patching Index	100	100				
Rutting Index	98	98				
International Roughness Index (IRI)	N/A	N/A				
Lane & Width Information						
Number of Lanes	2	2				
Paved Width (ft)	21	21				
Lane Width (ft)	9.1	9.1
