ROMO Cycle 6

Final Report

Road Inventory and Condition Assessment of Paved Routes Rocky Mountain National Park

**Federal Highway Administration
Eastern Federal Lands Highway Division
Road Inventory Program (RIP)**

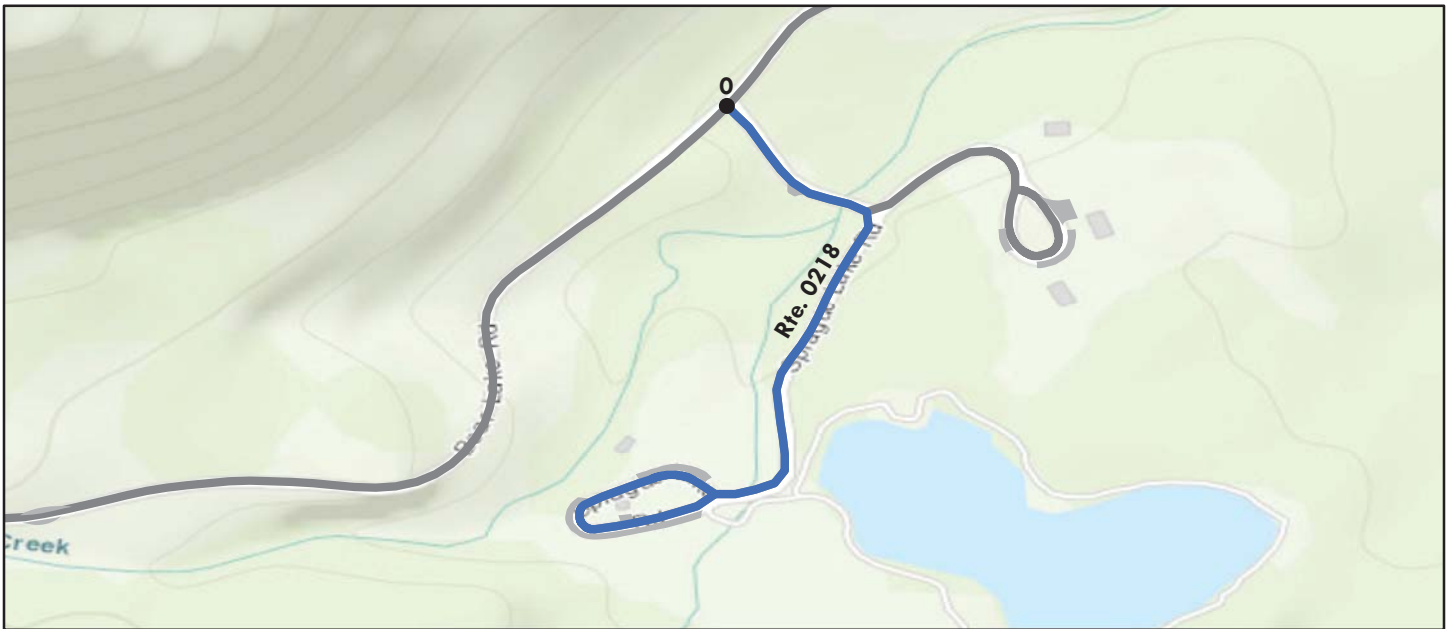
ROUTE 0218: SPRAGUE LAKE PICNIC AREA ROAD

Data Collection Vehicle (DCV) Rating

Route Condition Legend – Pavement Condition Rating (PCR)						
Poor (0 - 60)	Fair (61- 84)	Good (85 - 94)	Excellent (95 - 100)	Not Rated		
Colors on map represent condition scores at 0.10-mile intervals. See Appendix for definitions and formulas.						
Inspection Date: 6/22/2017	Beginning Section MP	0				
Paved Length (Miles): 0.46	Section Length (MI)	0.46				
Surface Type: ASPHALT	Route Summary					
Roadway Condition Information						
Pavement Condition Rating (PCR)	98	98				
Surface Condition Rating (SCR)	98	98				
Roughness Condition Index (RCI)	N/A	N/A				
Distress Index Values						
Structural Crack Index	100	100				
Alligator Crack Index	100	100				
Longitudinal Crack Index	100	100				
Transverse Cracking Index	99	99				
Patching Index	100	100				
Rutting Index	98	98				
International Roughness Index (IRI)	N/A	N/A				
Lane & Width Information						
Number of Lanes	2	2				
Paved Width (ft)	19.6	19.6

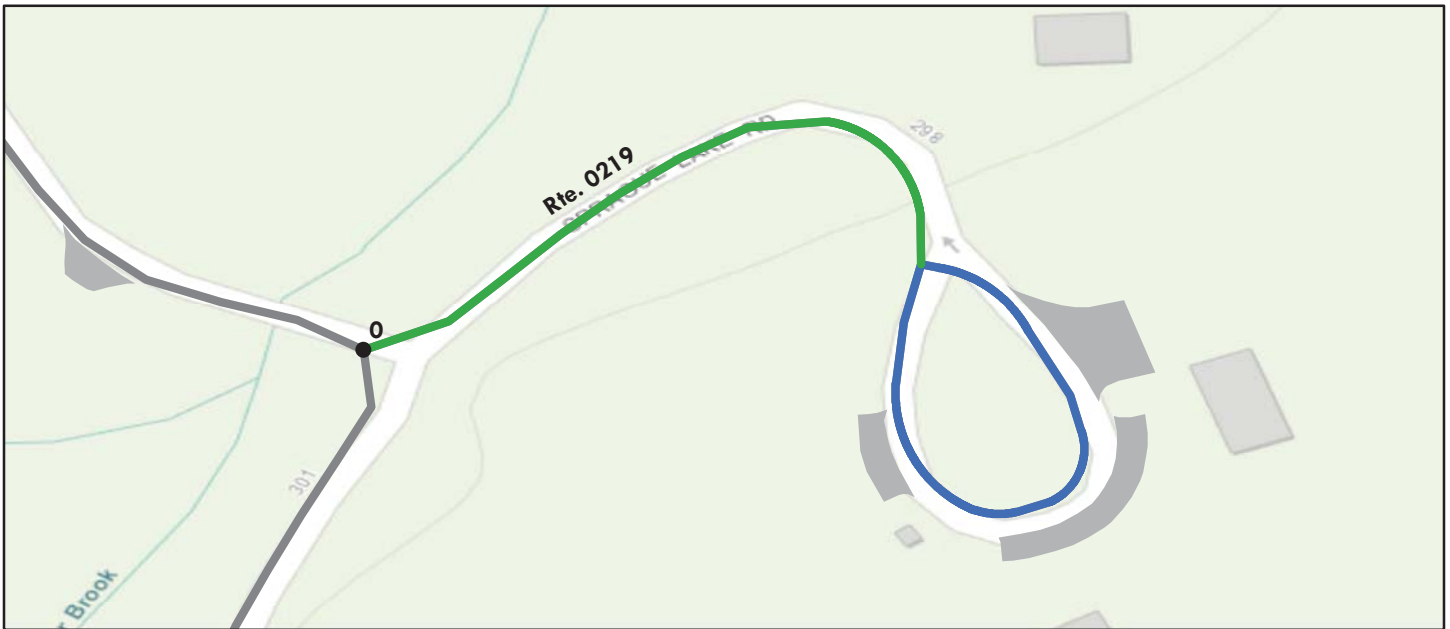
ROUTE 0219: GLACIER CREEK RIDING STABLE ROAD

Data Collection Vehicle (DCV) Rating

Route Condition Legend – Pavement Condition Rating (PCR)						
Poor (0 - 60)	Fair (61- 84)	Good (85 - 94)	Excellent (95 - 100)	Not Rated		
Colors on map represent condition scores at 0.10-mile intervals. See Appendix for definitions and formulas.						
Inspection Date: 6/22/2017	Beginning Section MP	0				
Paved Length (Miles): 0.19	Section Length (MI)	0.19				
Surface Type: ASPHALT	Route Summary					
Roadway Condition Information						
Pavement Condition Rating (PCR)	95	95				
Surface Condition Rating (SCR)	95	95				
Roughness Condition Index (RCI)	N/A	N/A				
Distress Index Values						
Structural Crack Index	100	100				
Alligator Crack Index	100	100				
Longitudinal Crack Index	100	100				
Transverse Cracking Index	100	100				
Patching Index	100	100				
Rutting Index	95	95				
International Roughness Index (IRI)	N/A	N/A				
Lane & Width Information						
Number of Lanes	2	2				
Paved Width (ft)	25.8	25.8

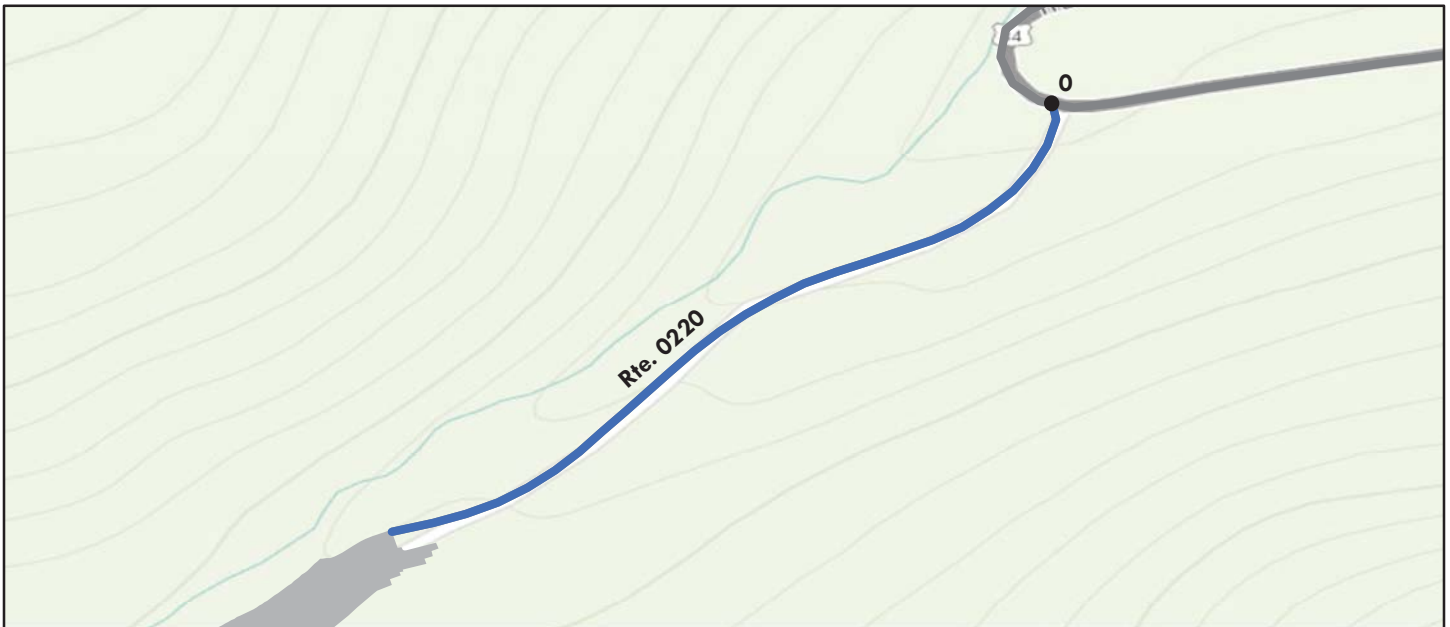
ROUTE 0220: HIDDEN VALLEY ACCESS ROAD

Data Collection Vehicle (DCV) Rating

Inspection Date: 6/22/2017	Beginning Section MP	0				
Paved Length (Miles): 0.26	Section Length (MI)	0.26				
Surface Type: ASPHALT	Route Summary					
Roadway Condition Information						
Pavement Condition Rating (PCR)	97	97				
Surface Condition Rating (SCR)	97	97				
Roughness Condition Index (RCI)	N/A	N/A				
Distress Index Values						
Structural Crack Index	100	100				
Alligator Crack Index	100	100				
Longitudinal Crack Index	100	100				
Transverse Cracking Index	99	99				
Patching Index	100	100				
Rutting Index	97	97				
International Roughness Index (IRI)	N/A	N/A				
Lane & Width Information						
Number of Lanes	2	2				
Paved Width (ft)	24.1	24.1				
Lane Width (ft)	11.7	11.7

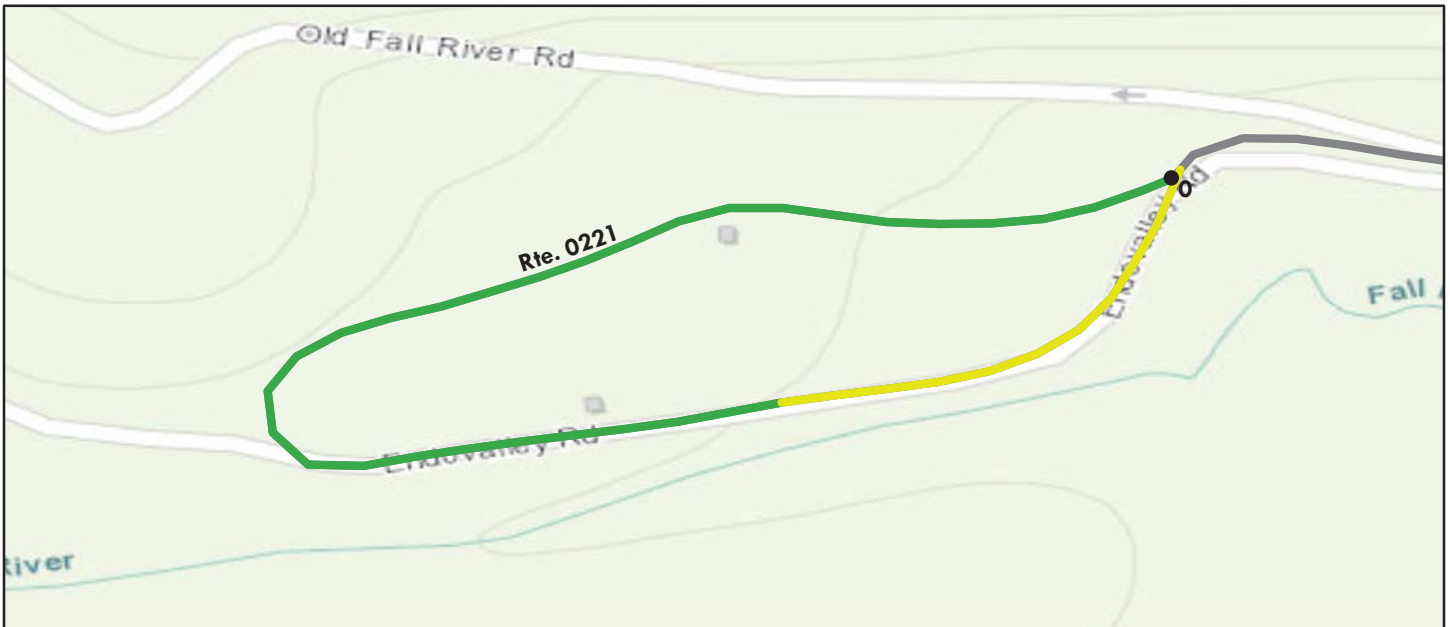
ROUTE 0221: ENDOVALLEY PICNIC AREA ROAD

Data Collection Vehicle (DCV) Rating

Inspection Date: 6/22/2017	Beginning Section MP	0				
Paved Length (Miles): 0.4	Section Length (MI)	0.4				
Surface Type: ASPHALT	Route Summary					
Roadway Condition Information						
Pavement Condition Rating (PCR)	87	87				
Surface Condition Rating (SCR)	87	87				
Roughness Condition Index (RCI)	N/A	N/A				
Distress Index Values						
Structural Crack Index	100	100				
Alligator Crack Index	100	100				
Longitudinal Crack Index	100	100				
Transverse Cracking Index	100	100				
Patching Index	100	100				
Rutting Index	87	87				
International Roughness Index (IRI)	N/A	N/A				
Lane & Width Information						
Number of Lanes	1	1				
Paved Width (ft)	12.6	12.6				
Lane Width (ft)	12.6	12.6

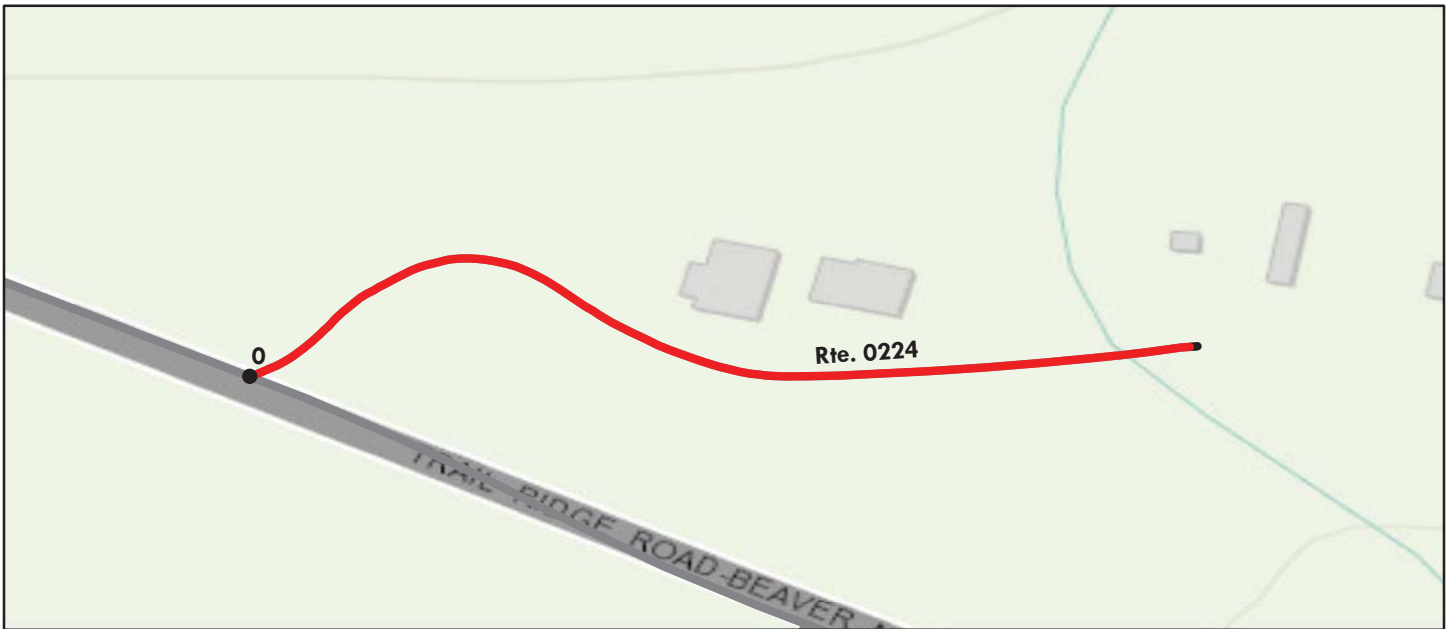
ROUTE 0224: BIGHORN RANGER STATION ACCESS ROAD

Data Collection Vehicle (DCV) Rating

Route Condition Legend – Pavement Condition Rating (PCR)						
Poor (0 - 60)	Fair (61- 84)	Good (85 - 94)	Excellent (95 - 100)	Not Rated		
Colors on map represent condition scores at 0.10-mile intervals. See Appendix for definitions and formulas.						
Inspection Date: 6/21/2017	Beginning Section MP	0				
Paved Length (Miles): 0.1	Section Length (MI)	0.1				
Surface Type: ASPHALT	Route Summary					
Roadway Condition Information						
Pavement Condition Rating (PCR)	46	46				
Surface Condition Rating (SCR)	46	46				
Roughness Condition Index (RCI)	N/A	N/A				
Distress Index Values						
Structural Crack Index	46	46				
Alligator Crack Index	92	92				
Longitudinal Crack Index	54	54				
Transverse Cracking Index	68	68				
Patching Index	97	97				
Rutting Index	94	94				
International Roughness Index (IRI)	N/A	N/A				
Lane & Width Information						
Number of Lanes	1	1				
Paved Width (ft)	16.1	16.1				
Lane Width (ft)	16.1	16.1

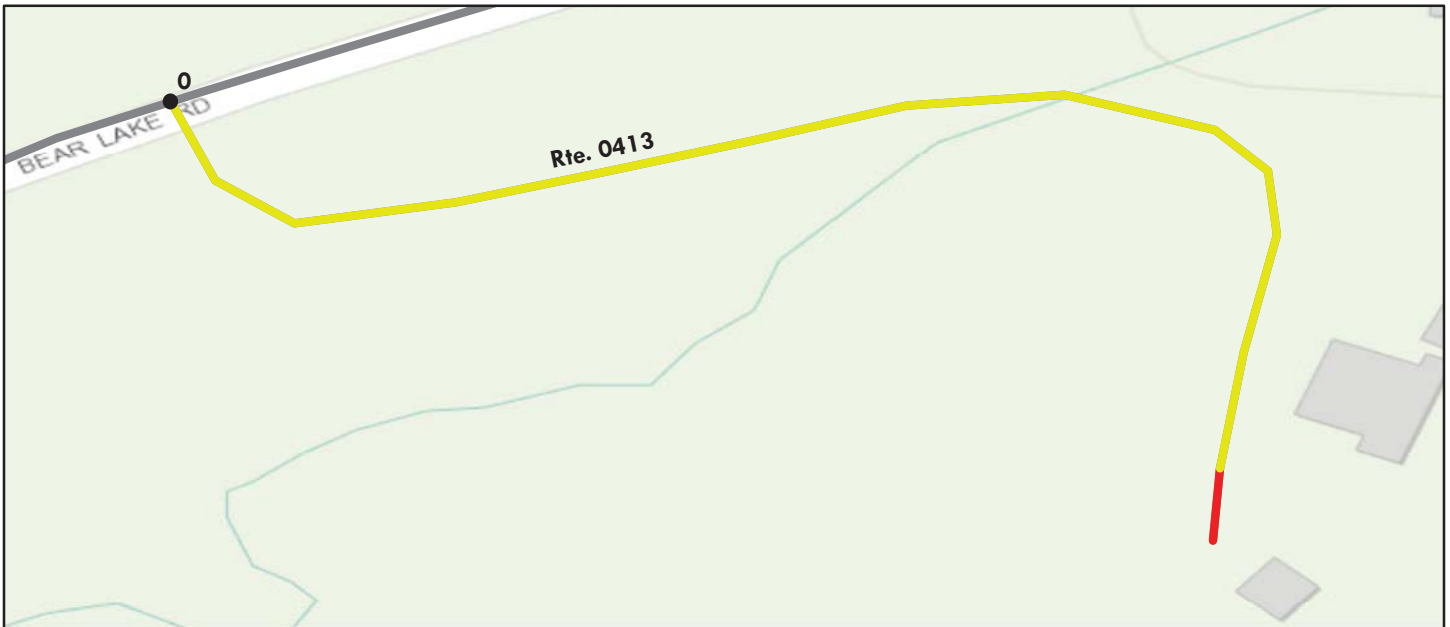
ROUTE 0413: MILL CREEK RESIDENCE ROAD

Data Collection Vehicle (DCV) Rating

Inspection Date: 6/22/2017	Beginning Section MP	0				
Paved Length (Miles): 0.11	Section Length (MI)	0.11				
Surface Type: ASPHALT	Route Summary					
Roadway Condition Information						
Pavement Condition Rating (PCR)	74	74				
Surface Condition Rating (SCR)	74	74				
Roughness Condition Index (RCI)	N/A	N/A				
Distress Index Values						
Structural Crack Index	85	85				
Alligator Crack Index	98	98				
Longitudinal Crack Index	87	87				
Transverse Cracking Index	74	74				
Patching Index	100	100				
Rutting Index	97	97				
International Roughness Index (IRI)	N/A	N/A				
Lane & Width Information						
Number of Lanes	2	2				
Paved Width (ft)	15	15				
Lane Width (ft)	7.5	7.5

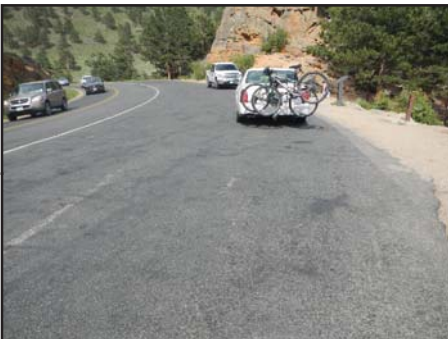
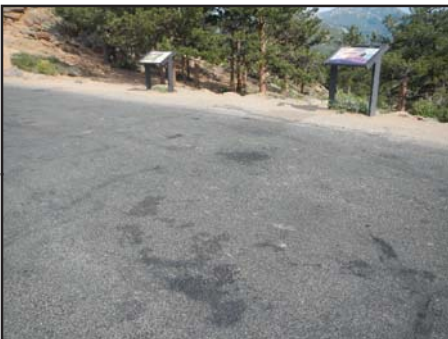
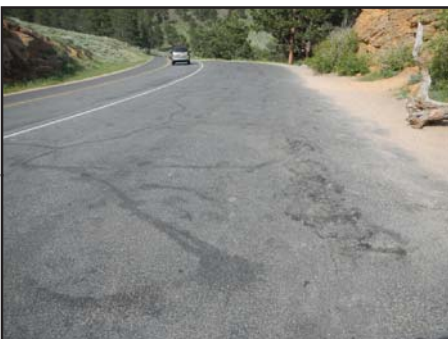
Inspection Date	FMISS Number	User Access	Surface Type
6/21/2017	37567	PUBLIC	ASPHALT
Area (Sq. Ft.)	Lane Miles (11' Widths)	Curb Reveal (Inches)	Curb Recommendation
6,876	0.118	NOT APPLICABLE	NOT APPLICABLE
Curb Type		Curb & Gutter Type	
NO CURB		NO CURB AND GUTTER	
Pavement Recommendation		Condition Rating / PCR	
PREVENTIVE MAINTENANCE		GOOD / 90

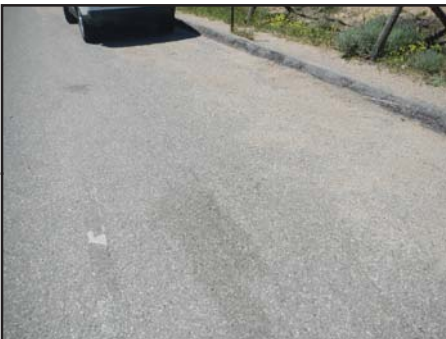
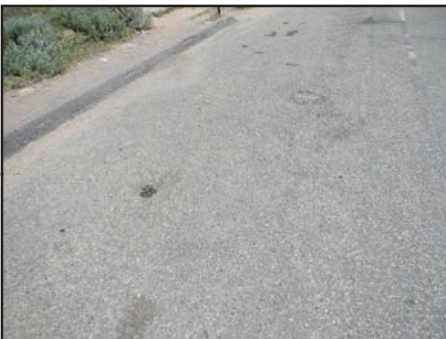
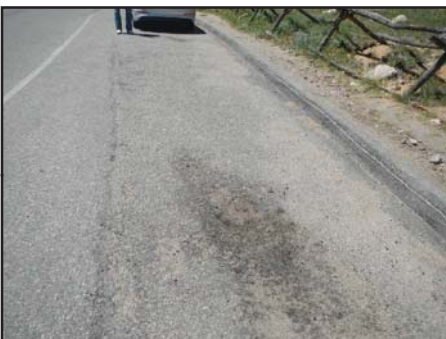
ROUTE 0901BZ: S DEER MOUNTAIN TRAIL PARKING

Inspection Date	FMSS Number	User Access	Surface Type
6/21/2017	37567	PUBLIC	ASPHALT
Area (Sq. Ft.)	Lane Miles (11' Widths)	Curb Reveal (Inches)	Curb Recommendation
2,934	0.051	6	DO NOTHING
Curb Type		Curb & Gutter Type	
ASPHALT		NO CURB AND GUTTER	
Pavement Recommendation		Condition Rating / PCR	
LIGHT 3R TREATMENTS		FAIR / 73

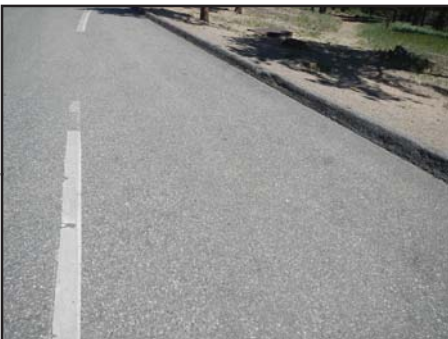
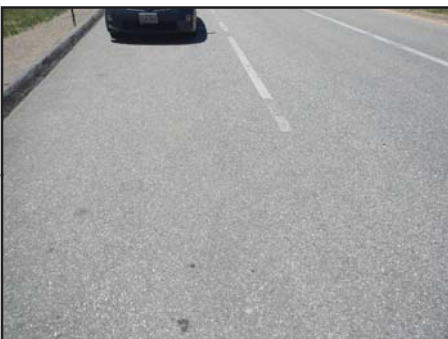
ROUTE 0901CZ: UTE TRAIL PARKING

Inspection Date	FMSS Number	User Access	Surface Type
6/21/2017	37567	PUBLIC	ASPHALT
Area (Sq. Ft.)	Lane Miles (11' Widths)	Curb Reveal (Inches)	Curb Recommendation
2,376	0.041	6	DO NOTHING
Curb Type		Curb & Gutter Type	
ASPHALT		NO CURB AND GUTTER	
Pavement Recommendation		Condition Rating / PCR	
PREVENTIVE MAINTENANCE		GOOD / 90

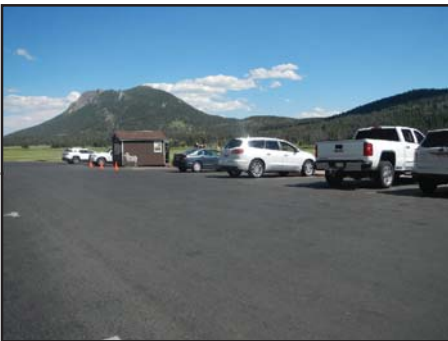
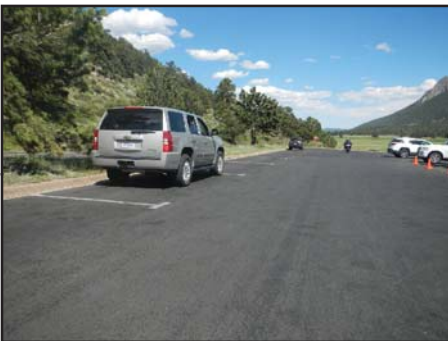
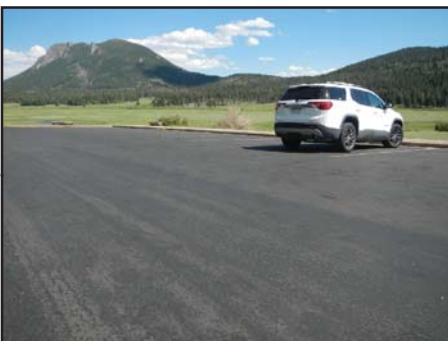
ROUTE 0904: SHEEP LAKES PARKING AREA

Inspection Date	FMSS Number	User Access	Surface Type
6/21/2017	37580	PUBLIC	ASPHALT
Area (Sq. Ft.)	Lane Miles (11' Widths)	Curb Reveal (Inches)	Curb Recommendation
15,914	0.274	NOT APPLICABLE	DO NOTHING
Curb Type		Curb & Gutter Type	
NO CURB		CONCRETE	
Pavement Recommendation		Condition Rating / PCR	
DO NOTHING		EXCELLENT / 97

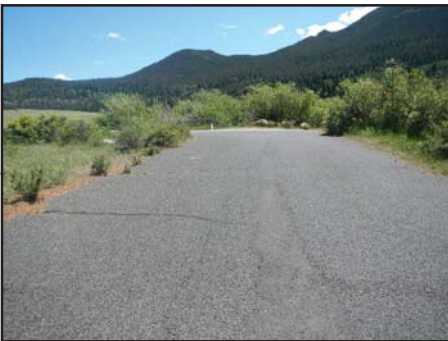
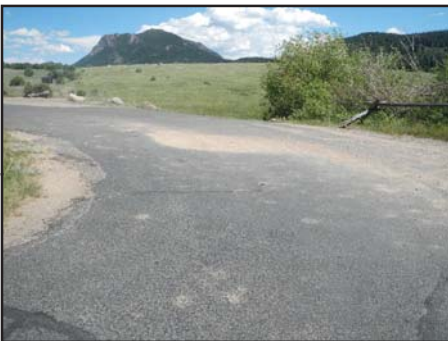
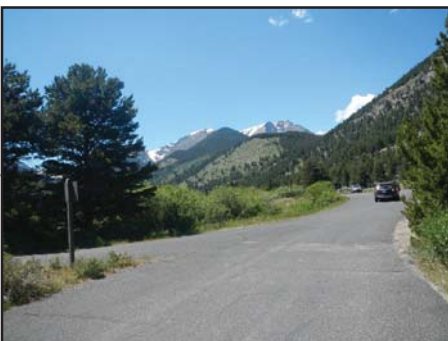
ROUTE 0905: ENDOVALLEY CUL DE SAC

Inspection Date	FMSS Number	User Access	Surface Type
6/21/2017	37582	PUBLIC	ASPHALT
Area (Sq. Ft.)	Lane Miles (11' Widths)	Curb Reveal (Inches)	Curb Recommendation
8,647	0.149	NOT APPLICABLE	NOT APPLICABLE
Curb Type		Curb & Gutter Type	
NO CURB		NO CURB AND GUTTER	
Pavement Recommendation		Condition Rating / PCR	
LIGHT 3R TREATMENTS		FAIR / 73

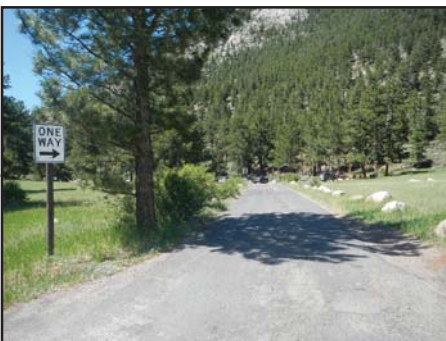
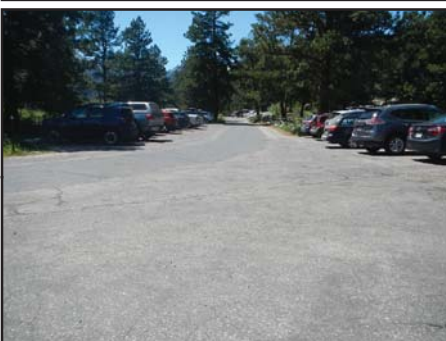
ROUTE 0906: LAWN LAKE TRAILHEAD PARKING

Inspection Date	FMSS Number	User Access	Surface Type
6/21/2017	37583	PUBLIC	ASPHALT
Area (Sq. Ft.)	Lane Miles (11' Widths)	Curb Reveal (Inches)	Curb Recommendation
17,864	0.308	NOT APPLICABLE	NOT APPLICABLE
Curb Type		Curb & Gutter Type	
NO CURB		NO CURB AND GUTTER	
Pavement Recommendation		Condition Rating / PCR	
HEAVY 3R TREATMENTS		POOR / 53

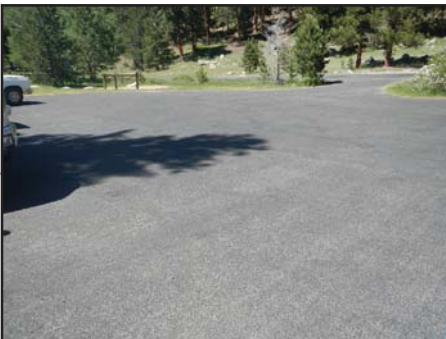
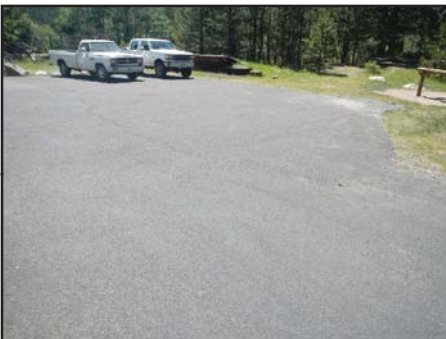
ROUTE 0907Z: STOCK RAMP PARKING

Inspection Date	FMSS Number	User Access	Surface Type
6/21/2017	37590	PUBLIC	ASPHALT
Area (Sq. Ft.)	Lane Miles (11' Widths)	Curb Reveal (Inches)	Curb Recommendation
7,175	0.124	NOT APPLICABLE	NOT APPLICABLE
Curb Type		Curb & Gutter Type	
NO CURB		NO CURB AND GUTTER	
Pavement Recommendation		Condition Rating / PCR	
PREVENTIVE MAINTENANCE		GOOD / 90

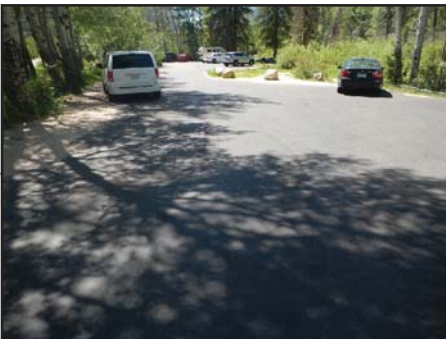
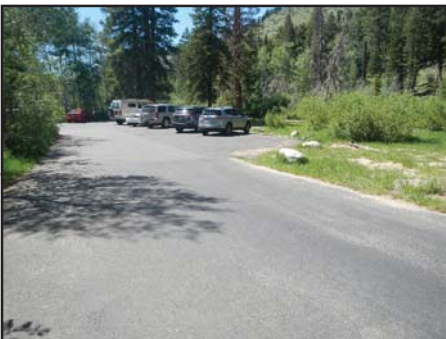
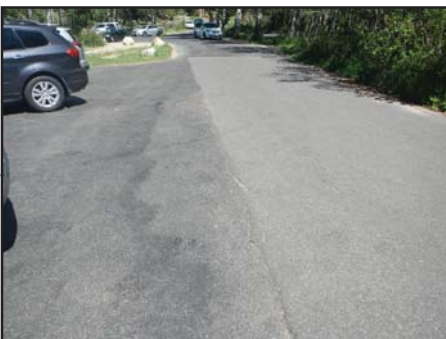
ROUTE 0908Z: EAST ALLUVIAL FAN PARKING

Inspection Date	FMSS Number	User Access	Surface Type
6/21/2017	37590	PUBLIC	ASPHALT
Area (Sq. Ft.)	Lane Miles (11' Widths)	Curb Reveal (Inches)	Curb Recommendation
10,015	0.172	NOT APPLICABLE	NOT APPLICABLE
Curb Type		Curb & Gutter Type	
NO CURB		NO CURB AND GUTTER	
Pavement Recommendation		Condition Rating / PCR	
PREVENTIVE MAINTENANCE		GOOD / 90

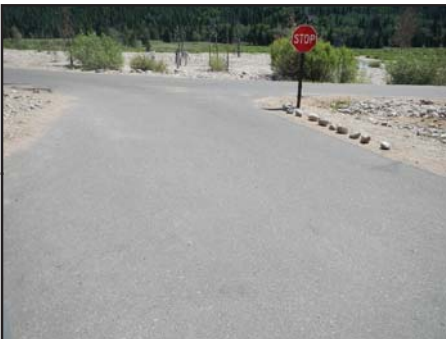
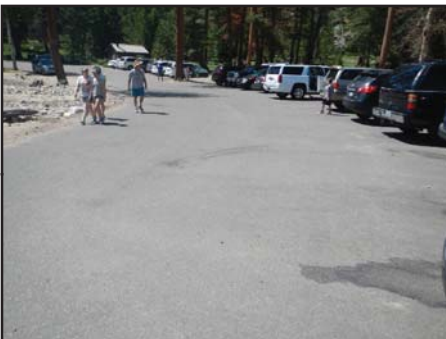
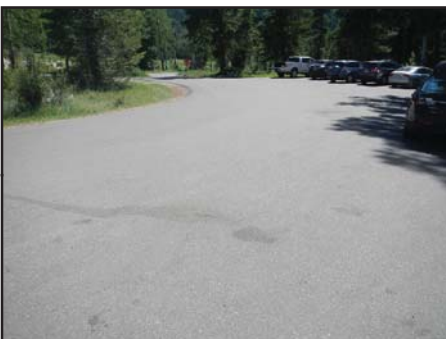
ROUTE 0909Z: WEST ALLUVIAL FAN PARKING

Inspection Date	FMSS Number	User Access	Surface Type
6/21/2017	37590	PUBLIC	ASPHALT
Area (Sq. Ft.)	Lane Miles (11' Widths)	Curb Reveal (Inches)	Curb Recommendation
17,041	0.293	NOT APPLICABLE	NOT APPLICABLE
Curb Type		Curb & Gutter Type	
NO CURB		NO CURB AND GUTTER	
Pavement Recommendation		Condition Rating / PCR	
PREVENTIVE MAINTENANCE		GOOD / 90

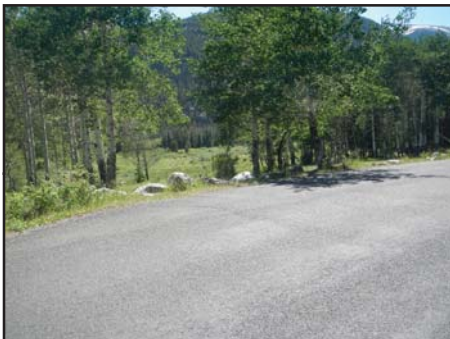
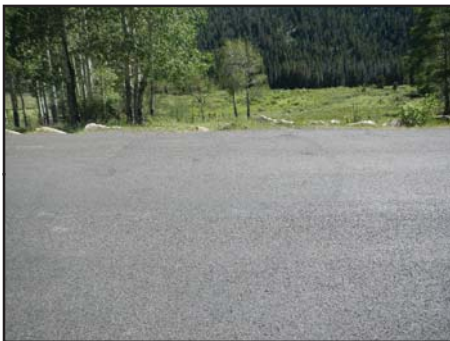
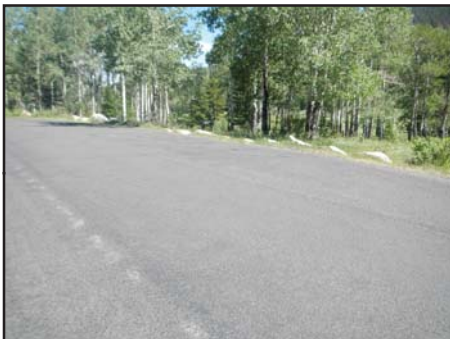
ROUTE 0980BZ: ASPEN SCARS PARKING AREA B

Inspection Date	FMSS Number	User Access	Surface Type
6/21/2017	37590	PUBLIC	ASPHALT
Area (Sq. Ft.)	Lane Miles (11' Widths)	Curb Reveal (Inches)	Curb Recommendation
814	0.014	NOT APPLICABLE	NOT APPLICABLE
Curb Type		Curb & Gutter Type	
NO CURB		NO CURB AND GUTTER	
Pavement Recommendation		Condition Rating / PCR	
PREVENTIVE MAINTENANCE		GOOD / 90

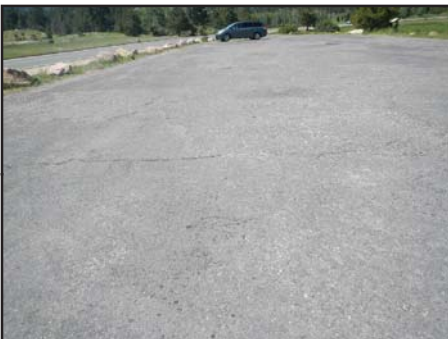
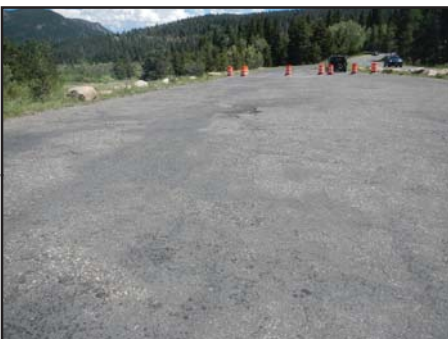
ROUTE 0910: WEST HORSESHOE PARK PARKING AREA

Inspection Date	FMSS Number	User Access	Surface Type
6/21/2017	37596	PUBLIC	ASPHALT
Area (Sq. Ft.)	Lane Miles (11' Widths)	Curb Reveal (Inches)	Curb Recommendation
20,147	0.347	NOT APPLICABLE	NOT APPLICABLE
Curb Type		Curb & Gutter Type	
NO CURB		NO CURB AND GUTTER	
Pavement Recommendation		Condition Rating / PCR	
LIGHT 3R TREATMENTS		FAIR / 73

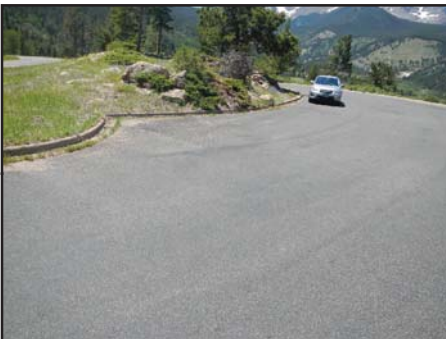
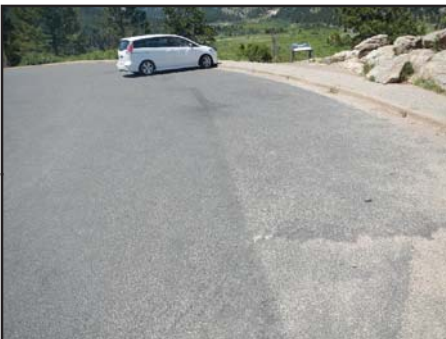
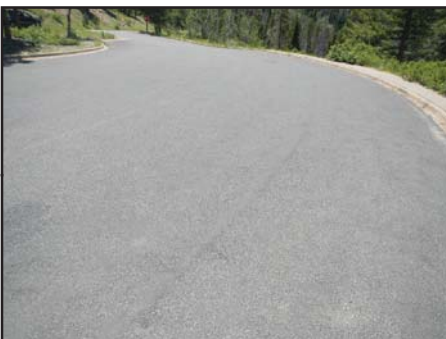
ROUTE 0911: HORSESHOE PARK OVERLOOK

Inspection Date	FMSS Number	User Access	Surface Type
6/21/2017	37597	PUBLIC	ASPHALT
Area (Sq. Ft.)	Lane Miles (11' Widths)	Curb Reveal (Inches)	Curb Recommendation
12,289	0.212	NOT APPLICABLE	DO NOTHING
Curb Type		Curb & Gutter Type	
NO CURB		CONCRETE	
Pavement Recommendation		Condition Rating / PCR	
PREVENTIVE MAINTENANCE		GOOD / 90

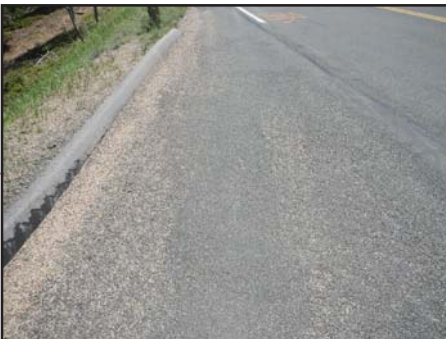
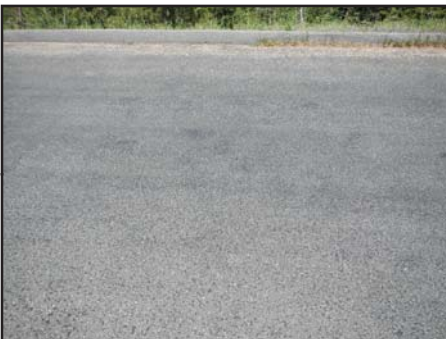
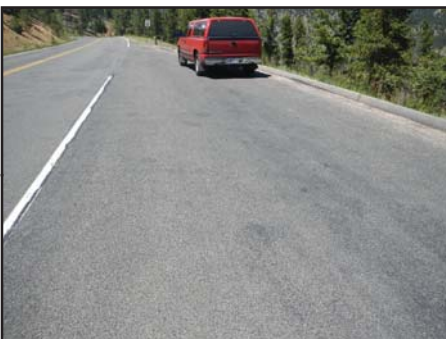
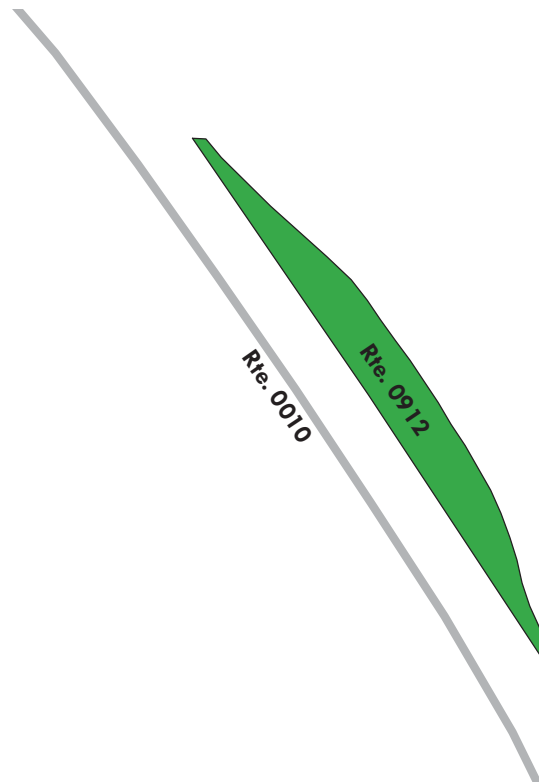
ROUTE 0912: THE WOOD PECKER ARMY PARKING AREA

Inspection Date	FMSS Number	User Access	Surface Type
6/21/2017	37599	PUBLIC	ASPHALT
Area (Sq. Ft.)	Lane Miles (11' Widths)	Curb Reveal (Inches)	Curb Recommendation
3,110	0.054	6	DO NOTHING
Curb Type		Curb & Gutter Type	
ASPHALT		NO CURB AND GUTTER	
Pavement Recommendation		Condition Rating / PCR	
PREVENTIVE MAINTENANCE		GOOD / 90

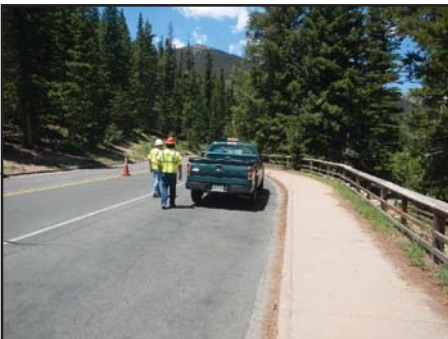
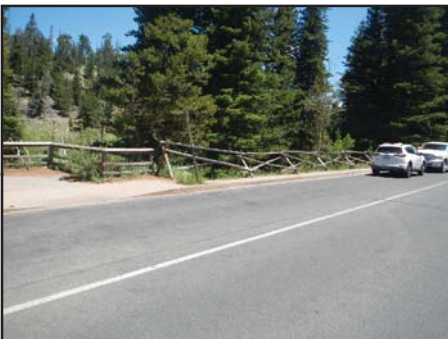
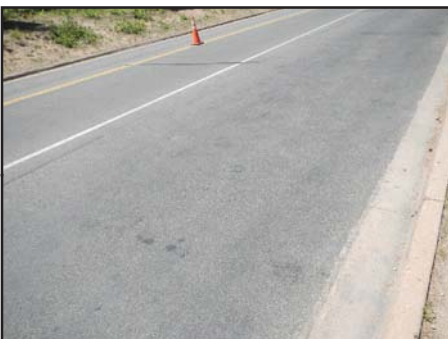
ROUTE 0913: BEAVER PONDS EAST PARKING AREA

Inspection Date	FMSS Number	User Access	Surface Type
6/21/2017	37650	PUBLIC	ASPHALT
Area (Sq. Ft.)	Lane Miles (11' Widths)	Curb Reveal (Inches)	Curb Recommendation
2,769	0.048	NOT APPLICABLE	DO NOTHING
Curb Type		Curb & Gutter Type	
NO CURB		CONCRETE	
Pavement Recommendation		Condition Rating / PCR	
PREVENTIVE MAINTENANCE		GOOD / 90

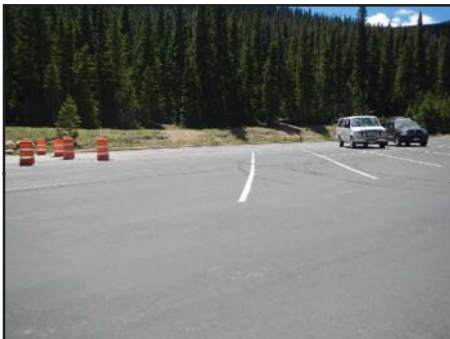
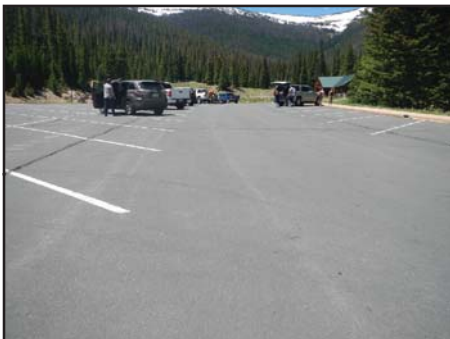
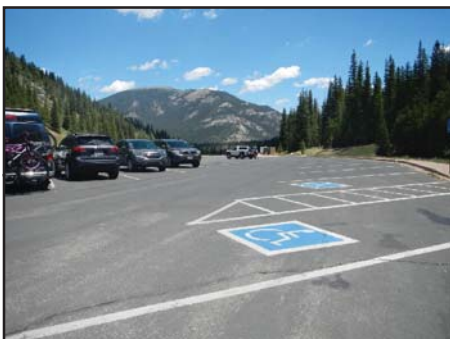
ROUTE 0914: HIDDEN VALLEY PARKING AREA

Inspection Date	FMSS Number	User Access	Surface Type
6/21/2017	37653	PUBLIC	ASPHALT
Area (Sq. Ft.)	Lane Miles (11' Widths)	Curb Reveal (Inches)	Curb Recommendation
56,762	0.977	NOT APPLICABLE	DO NOTHING
Curb Type		Curb & Gutter Type	
NO CURB		CONCRETE	
Pavement Recommendation		Condition Rating / PCR	
PREVENTIVE MAINTENANCE		GOOD / 90

Note: Parking area consists of multiple surface types: 1 part Asphalt at 55,134 square feet; 1 part Concrete at 1,628 square feet.

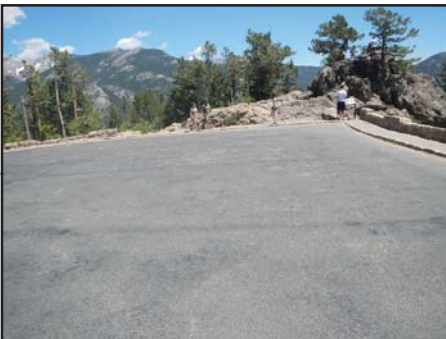
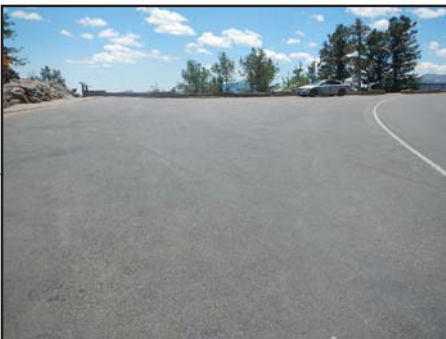
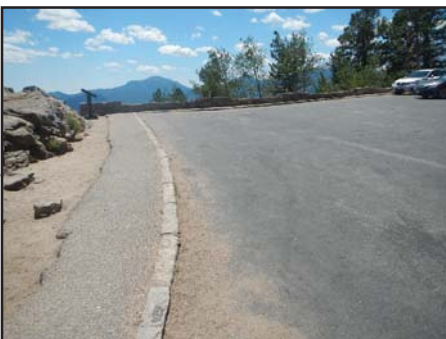
ROUTE 0915Z: LOWER MANY PARKS CURVE PARKING AREA

Inspection Date	FMSS Number	User Access	Surface Type
6/21/2017	37654	PUBLIC	ASPHALT
Area (Sq. Ft.)	Lane Miles (11' Widths)	Curb Reveal (Inches)	Curb Recommendation
5,770	0.099	3	DO NOTHING
Curb Type		Curb & Gutter Type	
STONE		NO CURB AND GUTTER	
Pavement Recommendation		Condition Rating / PCR	
PREVENTIVE MAINTENANCE		GOOD / 90

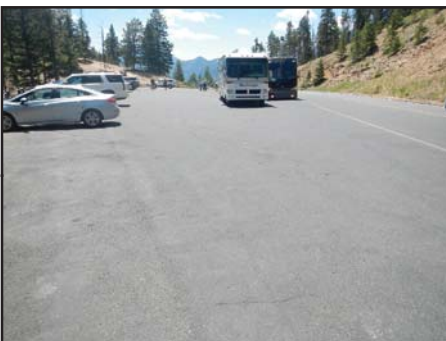
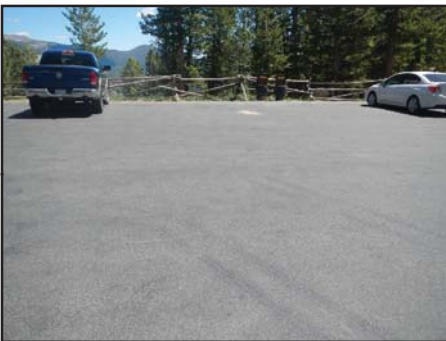
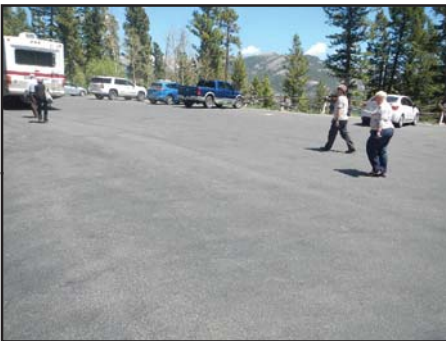
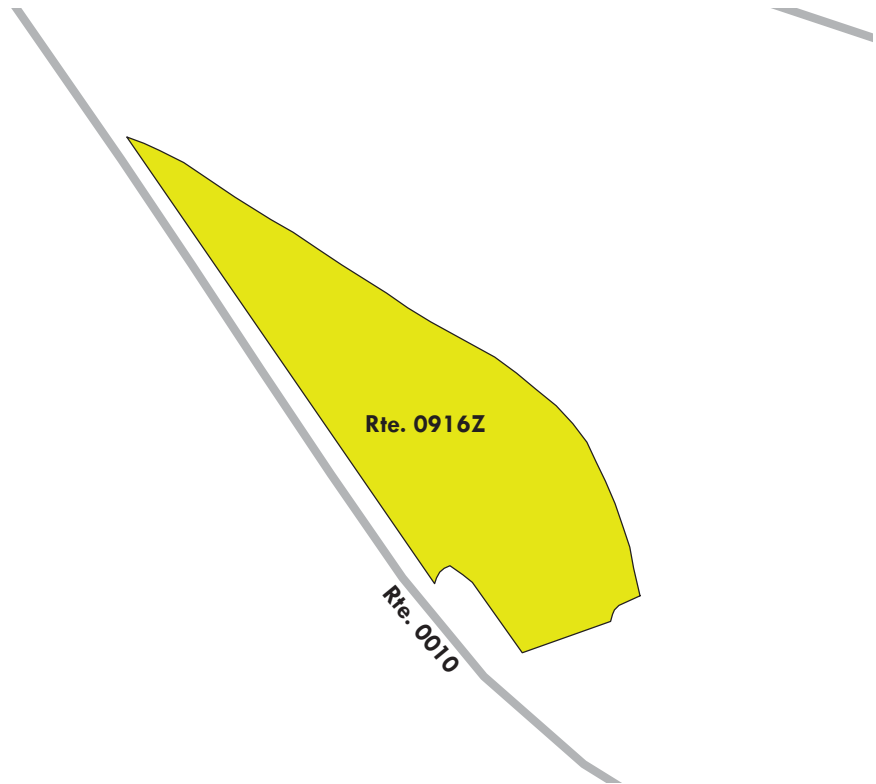
ROUTE 0916Z: UPPER MANY PARKS CURVE PARKING AREA

Inspection Date	FMSS Number	User Access	Surface Type
6/21/2017	37654	PUBLIC	ASPHALT
Area (Sq. Ft.)	Lane Miles (11' Widths)	Curb Reveal (Inches)	Curb Recommendation
12,625	0.217	NOT APPLICABLE	NOT APPLICABLE
Curb Type		Curb & Gutter Type	
NO CURB		NO CURB AND GUTTER	
Pavement Recommendation		Condition Rating / PCR	
LIGHT 3R TREATMENTS		FAIR / 73

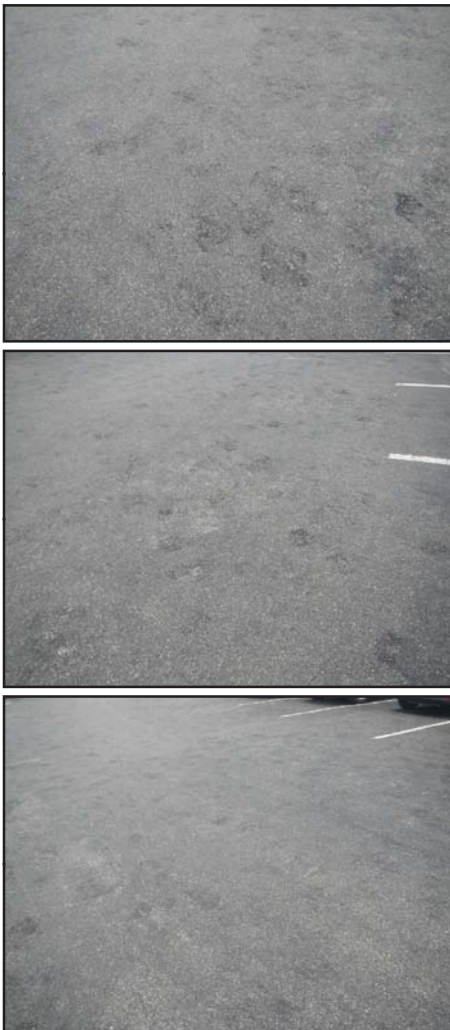
ROUTE 0918: FOREST CANYON OVERLOOK PARKING

Inspection Date	FMSS Number	User Access	Surface Type
6/22/2017	37657	PUBLIC	ASPHALT
Area (Sq. Ft.)	Lane Miles (11' Widths)	Curb Reveal (Inches)	Curb Recommendation
18,617	0.321	NOT APPLICABLE	NOT APPLICABLE
Curb Type		Curb & Gutter Type	
NO CURB		NO CURB AND GUTTER	
Pavement Recommendation		Condition Rating / PCR	
PREVENTIVE MAINTENANCE		GOOD / 90

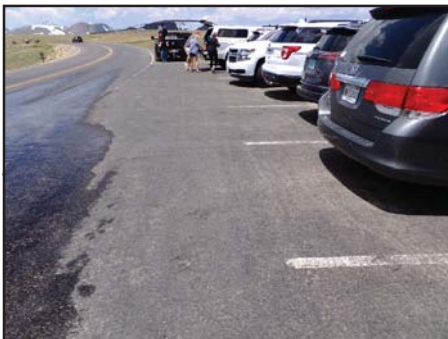
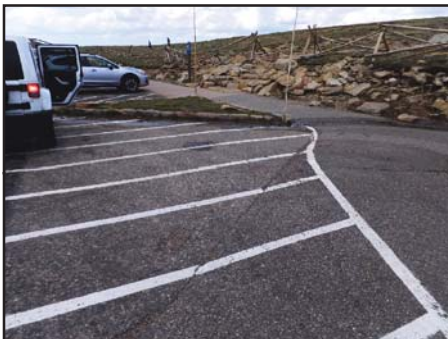
ROUTE 0920AZ: ROCK CUT PARKING AREA A

Inspection Date	FMSS Number	User Access	Surface Type
6/22/2017	37659	PUBLIC	ASPHALT
Area (Sq. Ft.)	Lane Miles (11' Widths)	Curb Reveal (Inches)	Curb Recommendation
10,608	0.183	4	DO NOTHING
Curb Type		Curb & Gutter Type	
CONCRETE AND STONE		NO CURB AND GUTTER	
Pavement Recommendation		Condition Rating / PCR	
LIGHT 3R TREATMENTS		FAIR / 73

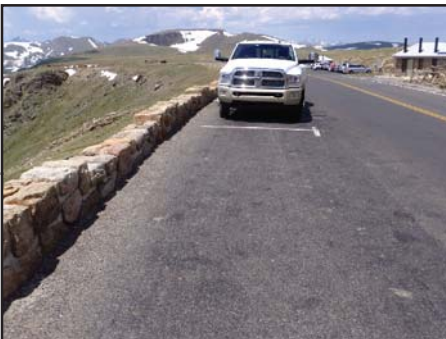
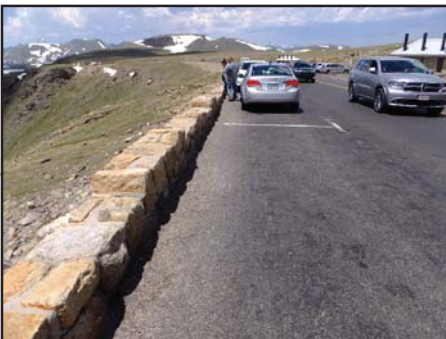
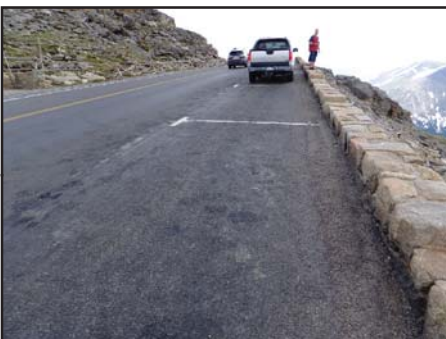
ROUTE 0920BZ: ROCK CUT PARKING AREA B

Inspection Date	FMSS Number	User Access	Surface Type
6/22/2017	37659	PUBLIC	ASPHALT
Area (Sq. Ft.)	Lane Miles (11' Widths)	Curb Reveal (Inches)	Curb Recommendation
5,836	0.1	NOT APPLICABLE	NOT APPLICABLE
Curb Type		Curb & Gutter Type	
NO CURB		NO CURB AND GUTTER	
Pavement Recommendation		Condition Rating / PCR	
LIGHT 3R TREATMENTS		FAIR / 73

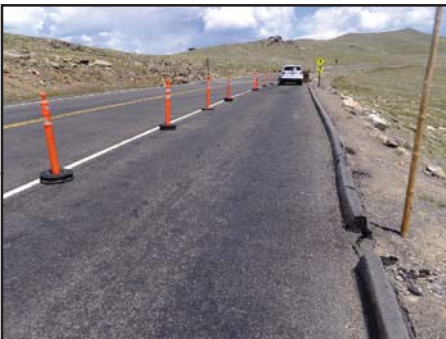
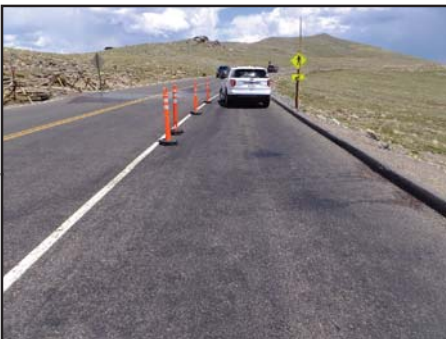
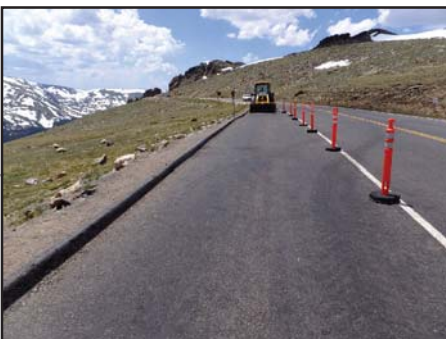
ROUTE 1017Z: TOLL MEMORIAL PARKING EAST OF ROCK CUT

Inspection Date	FMSS Number	User Access	Surface Type
6/22/2017	37659	PUBLIC	ASPHALT
Area (Sq. Ft.)	Lane Miles (11' Widths)	Curb Reveal (Inches)	Curb Recommendation
2,787	0.048	5	DO NOTHING
Curb Type		Curb & Gutter Type	
ASPHALT		NO CURB AND GUTTER	
Pavement Recommendation		Condition Rating / PCR	
LIGHT 3R TREATMENTS		FAIR / 73

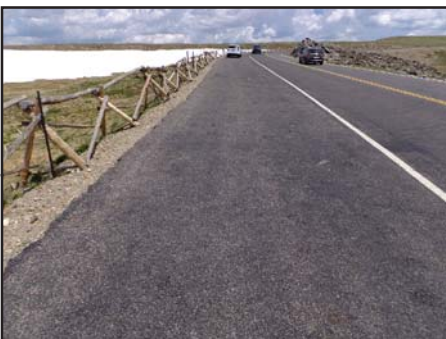
ROUTE 0921: ICEBERG PASS PARKING AREA

Inspection Date	FMSS Number	User Access	Surface Type
6/22/2017	37660	PUBLIC	ASPHALT
Area (Sq. Ft.)	Lane Miles (11' Widths)	Curb Reveal (Inches)	Curb Recommendation
4,680	0.081	NOT APPLICABLE	NOT APPLICABLE
Curb Type		Curb & Gutter Type	
NO CURB		NO CURB AND GUTTER	
Pavement Recommendation		Condition Rating / PCR	
PREVENTIVE MAINTENANCE		GOOD / 90

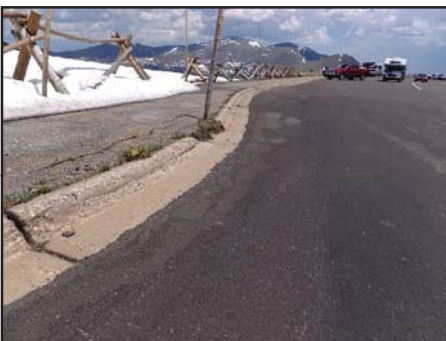
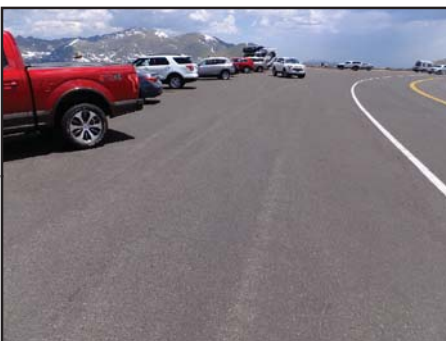
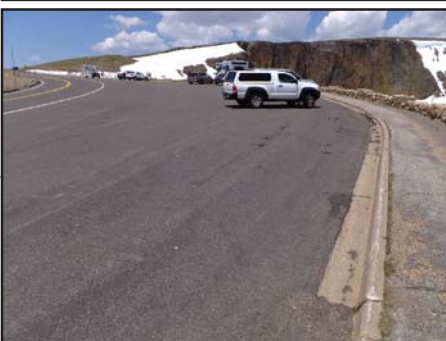
ROUTE 0922: LAVA CLIFFS OVERLOOK PARKING

Inspection Date	FMSS Number	User Access	Surface Type
6/22/2017	37663	PUBLIC	ASPHALT
Area (Sq. Ft.)	Lane Miles (11' Widths)	Curb Reveal (Inches)	Curb Recommendation
17,571	0.303	NOT APPLICABLE	LIGHT REPAIR
Curb Type		Curb & Gutter Type	
NO CURB		CONCRETE	
Pavement Recommendation		Condition Rating / PCR	
PREVENTIVE MAINTENANCE		GOOD / 90

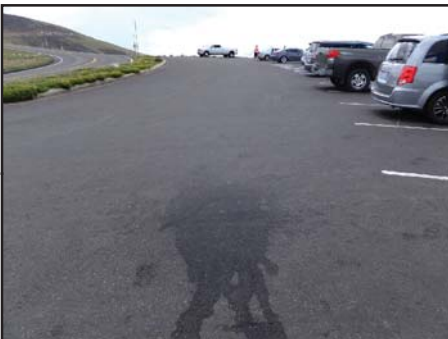
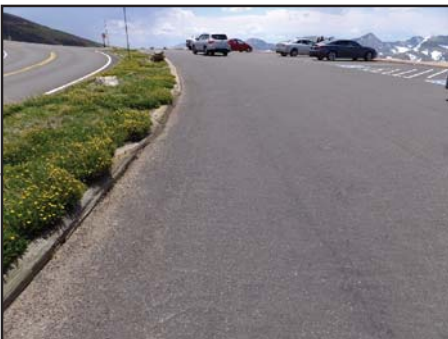
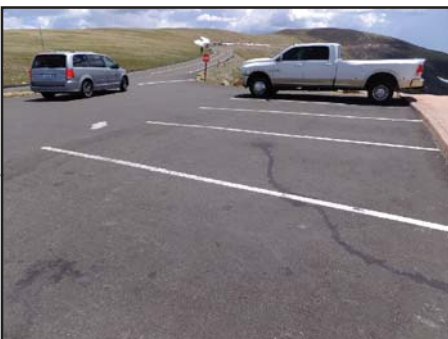
ROUTE 0923: GORE RANGE OVERLOOK PARKING

Inspection Date	FMSS Number	User Access	Surface Type
6/22/2017	37664	PUBLIC	ASPHALT
Area (Sq. Ft.)	Lane Miles (11' Widths)	Curb Reveal (Inches)	Curb Recommendation
11,409	0.196	4	DO NOTHING
Curb Type		Curb & Gutter Type	
CONCRETE AND WOOD		NO CURB AND GUTTER	
Pavement Recommendation		Condition Rating / PCR	
PREVENTIVE MAINTENANCE		GOOD / 90

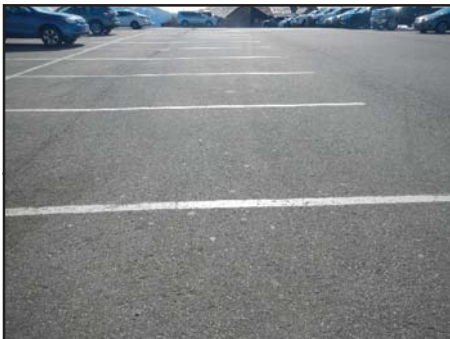
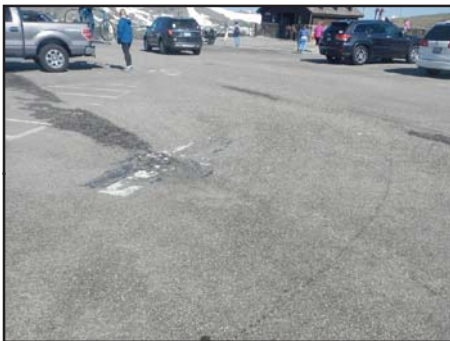
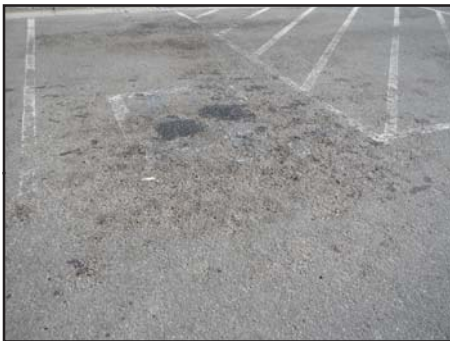
ROUTE 0924: ALPINE VISITORS CENTER PARKING

Inspection Date	FMSS Number	User Access	Surface Type
6/22/2017	37666	PUBLIC	ASPHALT
Area (Sq. Ft.)	Lane Miles (11' Widths)	Curb Reveal (Inches)	Curb Recommendation
79,762	1.373	NOT APPLICABLE	LIGHT REPAIR
Curb Type		Curb & Gutter Type	
NO CURB		CONCRETE	
Pavement Recommendation		Condition Rating / PCR	
PREVENTIVE MAINTENANCE		GOOD / 90

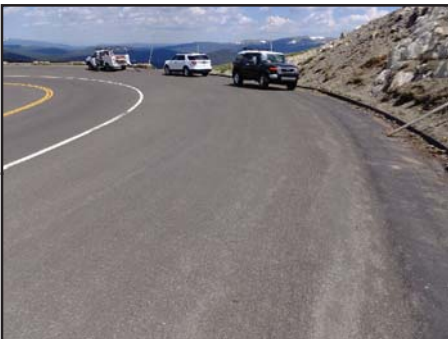
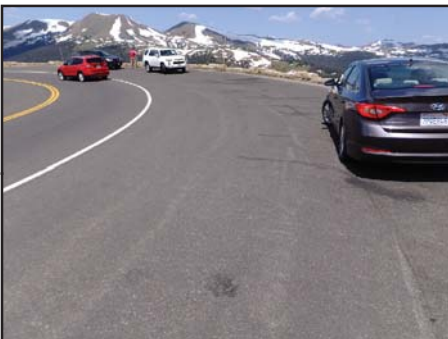
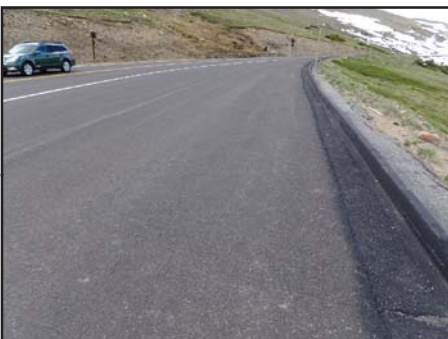
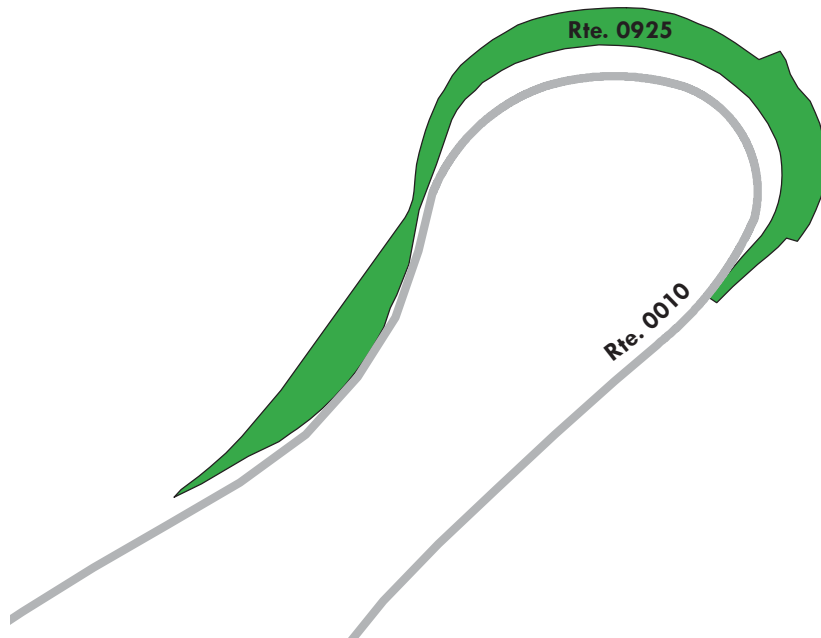
ROUTE 0925: MEDICINE BOW CURVE PARKING AREA

Inspection Date	FMSS Number	User Access	Surface Type
6/22/2017	37667	PUBLIC	ASPHALT
Area (Sq. Ft.)	Lane Miles (11' Widths)	Curb Reveal (Inches)	Curb Recommendation
14,843	0.256	5	DO NOTHING
Curb Type		Curb & Gutter Type	
ASPHALT		NO CURB AND GUTTER	
Pavement Recommendation		Condition Rating / PCR	
PREVENTIVE MAINTENANCE		GOOD / 90
