ROMO Cycle 6

Final Report

Road Inventory and Condition Assessment of Paved Routes Rocky Mountain National Park

**Federal Highway Administration
Eastern Federal Lands Highway Division
Road Inventory Program (RIP)**

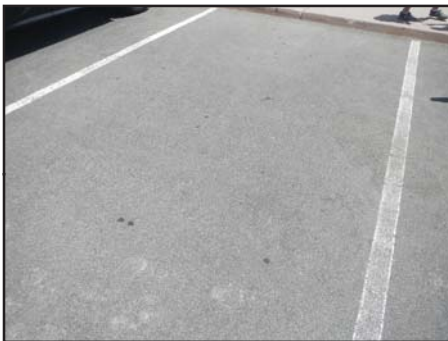
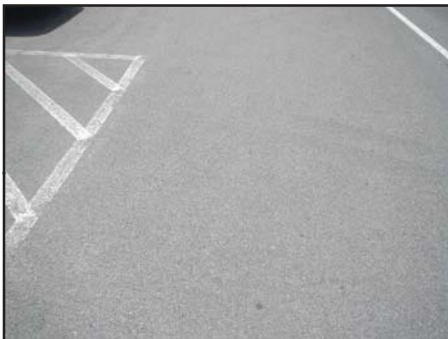
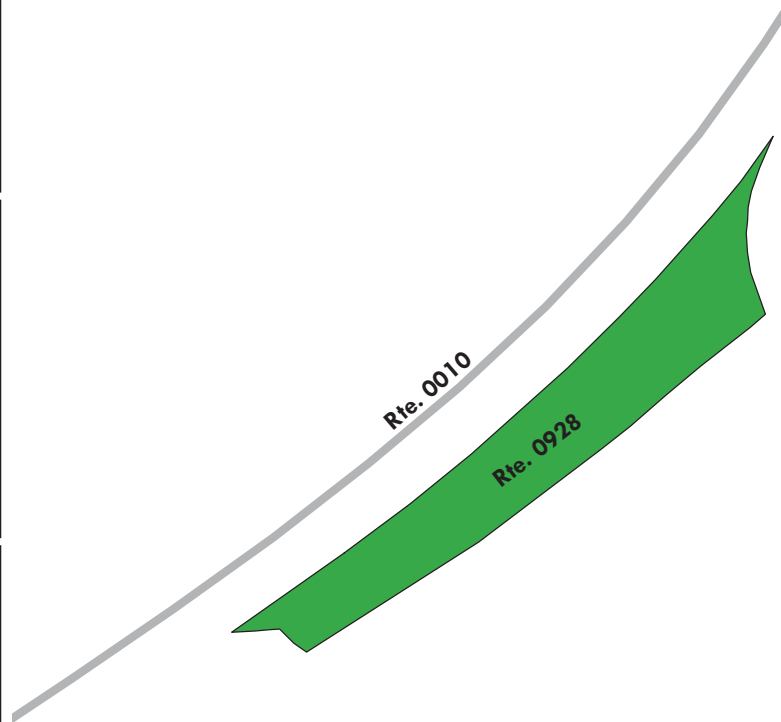
ROUTE 0928: MILNER PASS PARKING AREA

Inspection Date	FMSS Number	User Access	Surface Type
6/22/2017	14860	PUBLIC	ASPHALT
Area (Sq. Ft.)	Lane Miles (11' Widths)	Curb Reveal (Inches)	Curb Recommendation
9,544	0.164	NOT APPLICABLE	NOT APPLICABLE
Curb Type		Curb & Gutter Type	
NO CURB		NO CURB AND GUTTER	
Pavement Recommendation		Condition Rating / PCR	
PREVENTIVE MAINTENANCE		GOOD / 90

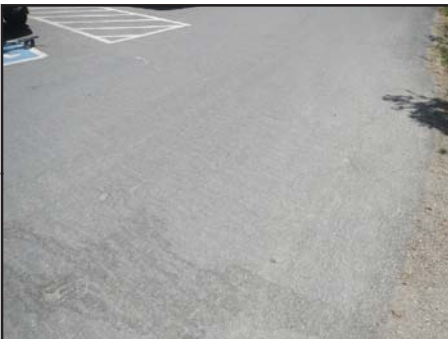
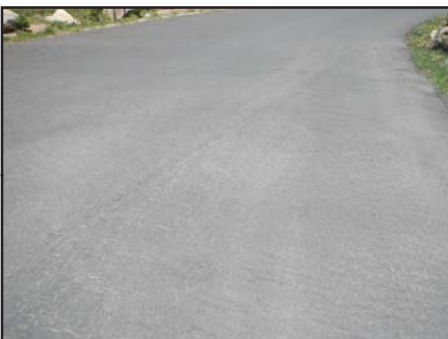
ROUTE 0929: LAKE IRENE PARKING AREA

Inspection Date	FMSS Number	User Access	Surface Type
6/22/2017	14854	PUBLIC	ASPHALT
Area (Sq. Ft.)	Lane Miles (11' Widths)	Curb Reveal (Inches)	Curb Recommendation
15,375	0.265	NOT APPLICABLE	NOT APPLICABLE
Curb Type		Curb & Gutter Type	
NO CURB		NO CURB AND GUTTER	
Pavement Recommendation		Condition Rating / PCR	
PREVENTIVE MAINTENANCE		GOOD / 90

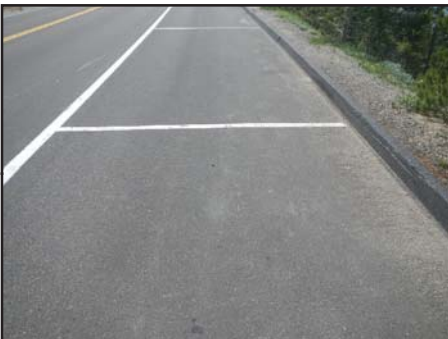
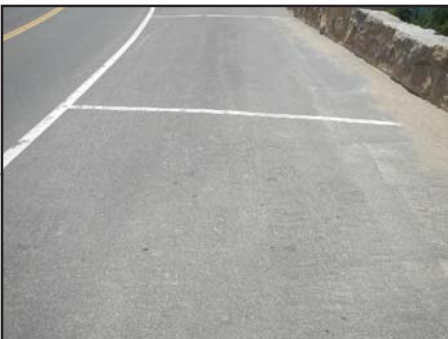
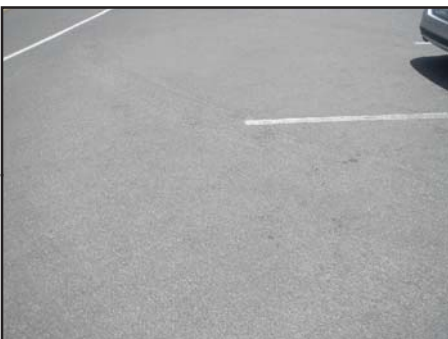
ROUTE 0930: FARVIEW CURVE OVERLOOK PARKING

Inspection Date	FMSS Number	User Access	Surface Type
6/22/2017	14848	PUBLIC	ASPHALT
Area (Sq. Ft.)	Lane Miles (11' Widths)	Curb Reveal (Inches)	Curb Recommendation
11,460	0.197	6	DO NOTHING
Curb Type		Curb & Gutter Type	
ASPHALT		NO CURB AND GUTTER	
Pavement Recommendation		Condition Rating / PCR	
PREVENTIVE MAINTENANCE		GOOD / 90

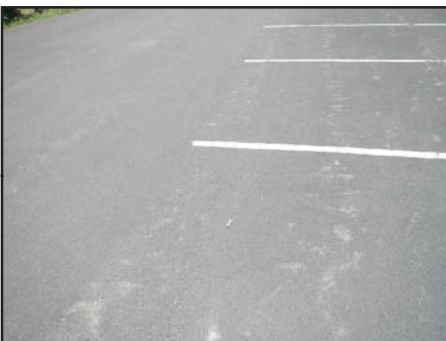
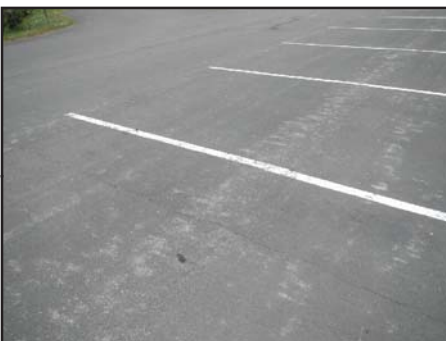
ROUTE 0931: COLORADO RIVER TRAILHEAD PARKING

Inspection Date	FMSS Number	User Access	Surface Type
6/22/2017	37675	PUBLIC	ASPHALT
Area (Sq. Ft.)	Lane Miles (11' Widths)	Curb Reveal (Inches)	Curb Recommendation
53,869	0.927	NOT APPLICABLE	NOT APPLICABLE
Curb Type		Curb & Gutter Type	
NO CURB		NO CURB AND GUTTER	
Pavement Recommendation		Condition Rating / PCR	
PREVENTIVE MAINTENANCE		GOOD / 90

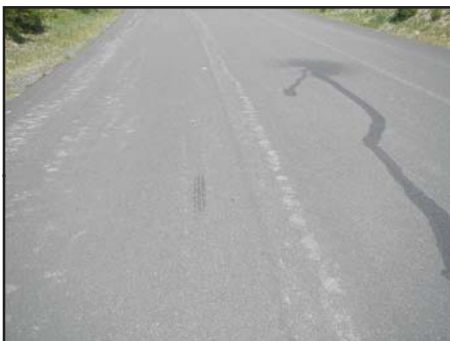
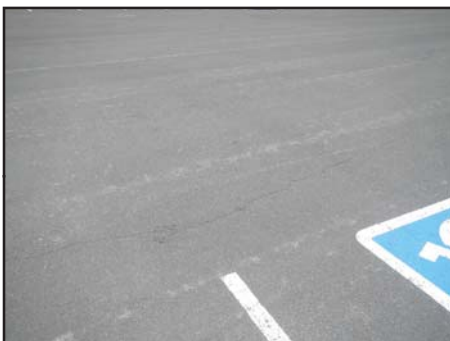
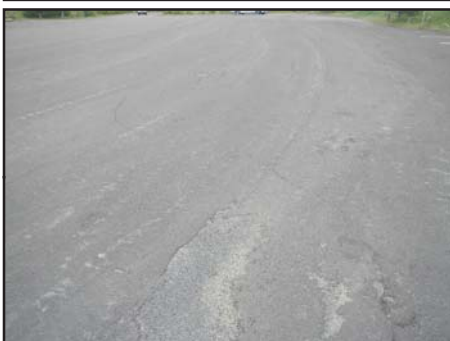
ROUTE 0932: TIMBER LAKE TRAILHEAD PARKING

Inspection Date	FMSS Number	User Access	Surface Type
6/22/2017	14839	PUBLIC	ASPHALT
Area (Sq. Ft.)	Lane Miles (11' Widths)	Curb Reveal (Inches)	Curb Recommendation
47,727	0.822	NOT APPLICABLE	NOT APPLICABLE
Curb Type		Curb & Gutter Type	
NO CURB		NO CURB AND GUTTER	
Pavement Recommendation		Condition Rating / PCR	
PREVENTIVE MAINTENANCE		GOOD / 90

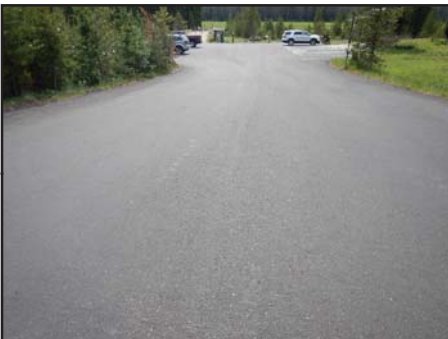
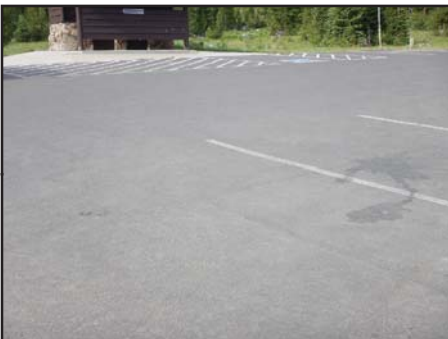
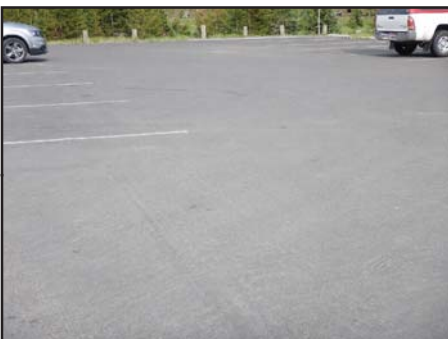
ROUTE 0933: BOWEN / BAKER PARKING AREA

Inspection Date	FMSS Number	User Access	Surface Type
6/21/2017	14782	PUBLIC	ASPHALT
Area (Sq. Ft.)	Lane Miles (11' Widths)	Curb Reveal (Inches)	Curb Recommendation
15,092	0.26	NOT APPLICABLE	NOT APPLICABLE
Curb Type		Curb & Gutter Type	
NO CURB		NO CURB AND GUTTER	
Pavement Recommendation		Condition Rating / PCR	
PREVENTIVE MAINTENANCE		GOOD / 90

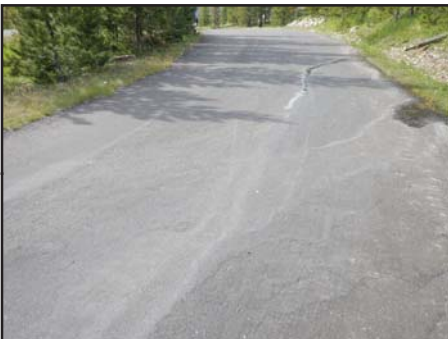
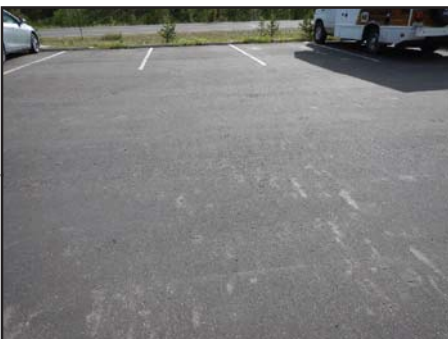
ROUTE 0935: ONAHU CREEK TRAILHEAD PARKING

Inspection Date	FMSS Number	User Access	Surface Type
6/21/2017	14774	PUBLIC	ASPHALT
Area (Sq. Ft.)	Lane Miles (11' Widths)	Curb Reveal (Inches)	Curb Recommendation
10,746	0.185	NOT APPLICABLE	NOT APPLICABLE
Curb Type		Curb & Gutter Type	
NO CURB		NO CURB AND GUTTER	
Pavement Recommendation		Condition Rating / PCR	
PREVENTIVE MAINTENANCE		GOOD / 90

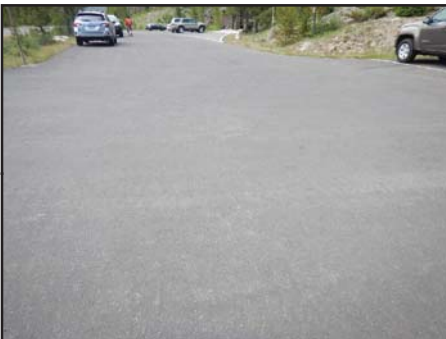
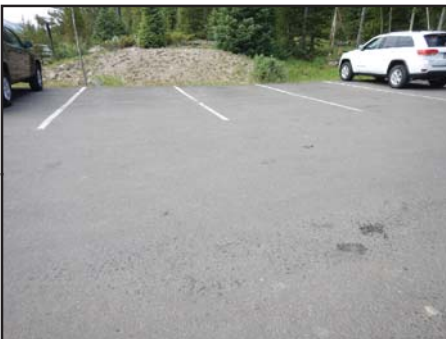
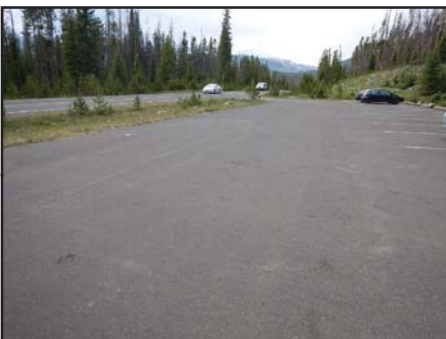
ROUTE 0936: GREEN MOUNTAIN TRAILHEAD PARKING

Inspection Date	FMSS Number	User Access	Surface Type
6/21/2017	14771	PUBLIC	ASPHALT
Area (Sq. Ft.)	Lane Miles (11' Widths)	Curb Reveal (Inches)	Curb Recommendation
18,858	0.325	NOT APPLICABLE	NOT APPLICABLE
Curb Type		Curb & Gutter Type	
NO CURB		NO CURB AND GUTTER	
Pavement Recommendation		Condition Rating / PCR	
PREVENTIVE MAINTENANCE		GOOD / 90

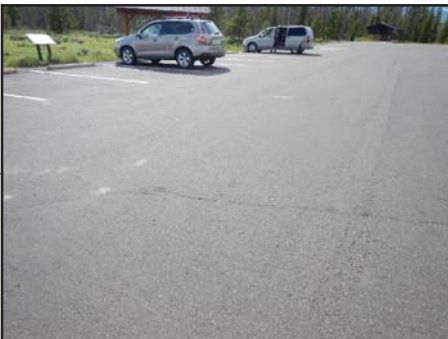
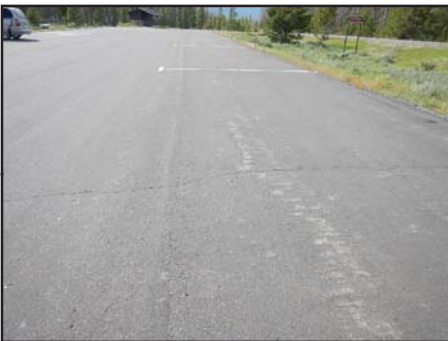
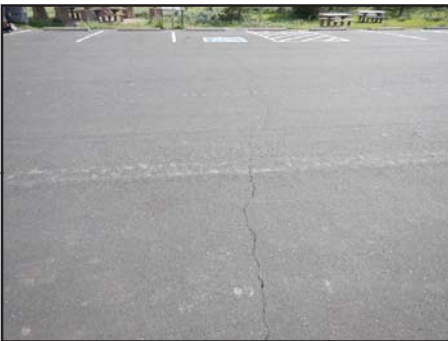
ROUTE 0937: HARBISON PICNIC AREA PARKING

Inspection Date	FMSS Number	User Access	Surface Type
6/21/2017	37679	PUBLIC	ASPHALT
Area (Sq. Ft.)	Lane Miles (11' Widths)	Curb Reveal (Inches)	Curb Recommendation
20,966	0.361	NOT APPLICABLE	NOT APPLICABLE
Curb Type		Curb & Gutter Type	
NO CURB		NO CURB AND GUTTER	
Pavement Recommendation		Condition Rating / PCR	
PREVENTIVE MAINTENANCE		GOOD / 90

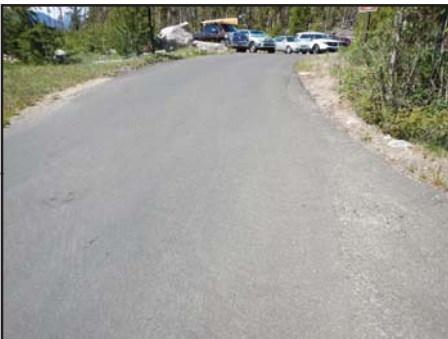
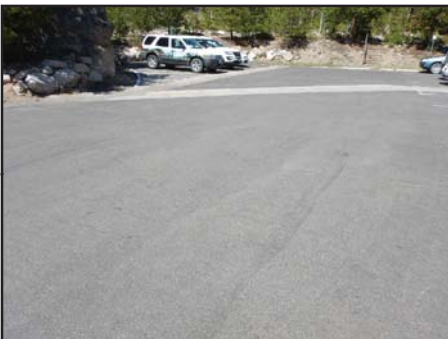
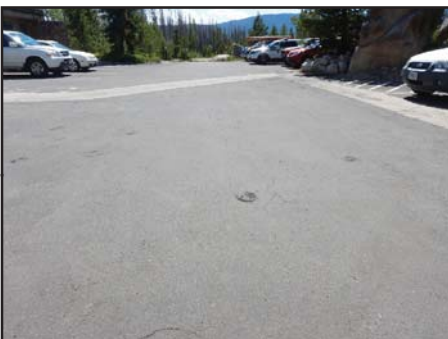
ROUTE 0939: KAWUNEECHE VISITOR CENTER PARKING

Inspection Date	FMSS Number	User Access	Surface Type
6/21/2017	37681	PUBLIC	ASPHALT
Area (Sq. Ft.)	Lane Miles (11' Widths)	Curb Reveal (Inches)	Curb Recommendation
27,071	0.466	NOT APPLICABLE	LIGHT REPAIR
Curb Type		Curb & Gutter Type	
NO CURB		CONCRETE	
Pavement Recommendation		Condition Rating / PCR	
PREVENTIVE MAINTENANCE		GOOD / 90

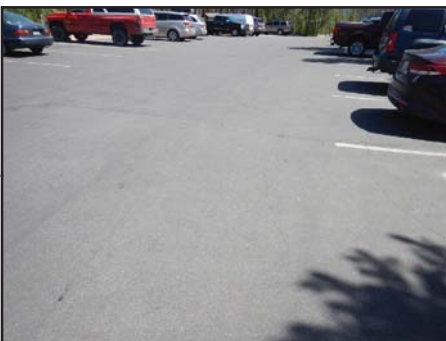
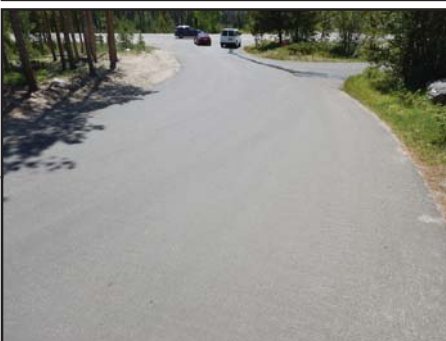
ROUTE 0940: MAINTENANCE YARD PARKING AREA CRD

Inspection Date	FMSS Number	User Access	Surface Type
6/21/2017	14739	NONPUBLIC	ASPHALT
Area (Sq. Ft.)	Lane Miles (11' Widths)	Curb Reveal (Inches)	Curb Recommendation
42,477	0.731	NOT APPLICABLE	NOT APPLICABLE
Curb Type		Curb & Gutter Type	
NO CURB		NO CURB AND GUTTER	
Pavement Recommendation		Condition Rating / PCR	
PREVENTIVE MAINTENANCE		GOOD / 90

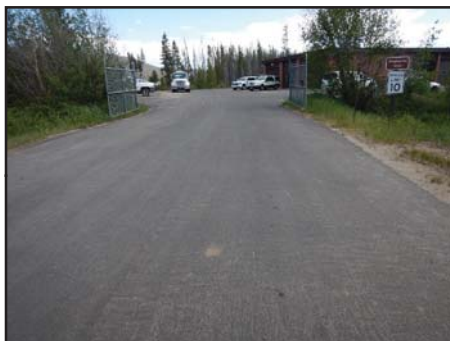
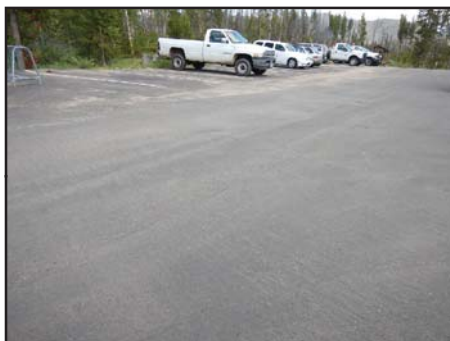
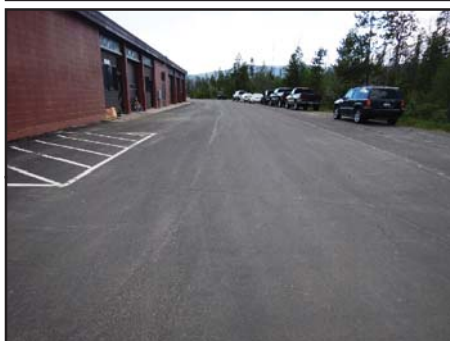
ROUTE 0941: MORaine PARK VISITOR CENTER

Note: Parking area consists of multiple surface types: 1 part Asphalt at 41,261 square feet; 1 part Concrete at 1,216 square feet.

Inspection Date	FMSS Number	User Access	Surface Type
6/21/2017	37684	PUBLIC	ASPHALT
Area (Sq. Ft.)	Lane Miles (11' Widths)	Curb Reveal (Inches)	Curb Recommendation
36,232	0.624	8	LIGHT REPAIR
Curb Type		Curb & Gutter Type	
WOOD		NO CURB AND GUTTER	
Pavement Recommendation		Condition Rating / PCR	
PREVENTIVE MAINTENANCE		GOOD / 90

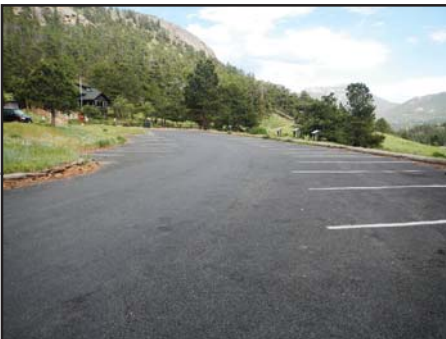
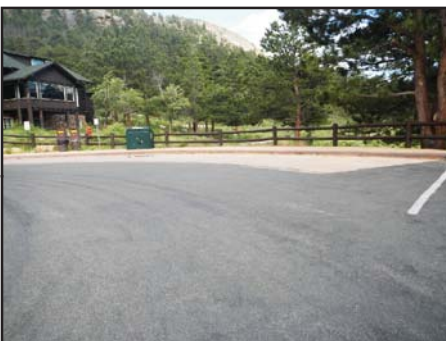
ROUTE 0942: MORAINE PARK STABLE PARKING

Note: Parking area consists of multiple surface types: 1 part Asphalt at 35,010 square feet; 1 part Concrete at 1,222 square feet.

Inspection Date	FMSS Number	User Access	Surface Type
6/28/2017	37688	PUBLIC	ASPHALT
Area (Sq. Ft.)	Lane Miles (11' Widths)	Curb Reveal (Inches)	Curb Recommendation
8,370	0.144	NOT APPLICABLE	NOT APPLICABLE
Curb Type		Curb & Gutter Type	
NO CURB		NO CURB AND GUTTER	
Pavement Recommendation		Condition Rating / PCR	
RECONSTRUCTION		POOR / 0

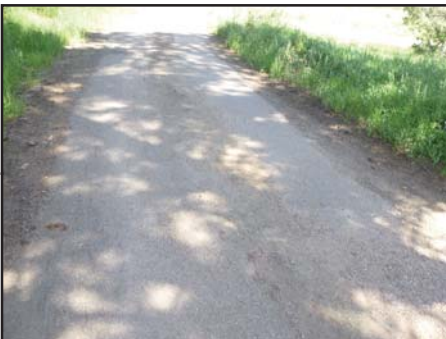
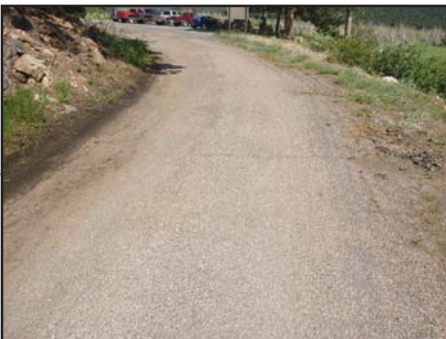
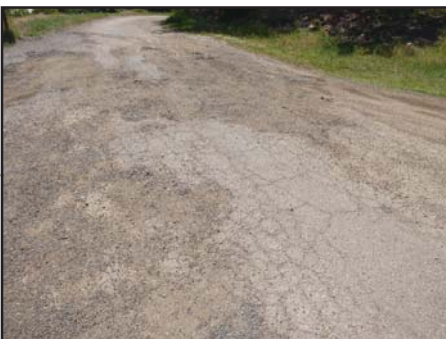
ROUTE 0943: YMCA PICNIC AREA PARKING

Inspection Date	FMSS Number	User Access	Surface Type
6/28/2017	37690	PUBLIC	ASPHALT
Area (Sq. Ft.)	Lane Miles (11' Widths)	Curb Reveal (Inches)	Curb Recommendation
5,900	0.102	NOT APPLICABLE	DO NOTHING
Curb Type		Curb & Gutter Type	
NO CURB		CONCRETE	
Pavement Recommendation		Condition Rating / PCR	
PREVENTIVE MAINTENANCE		GOOD / 90

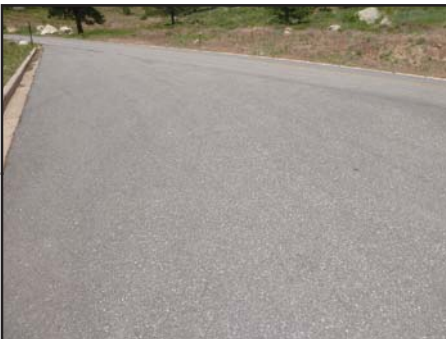
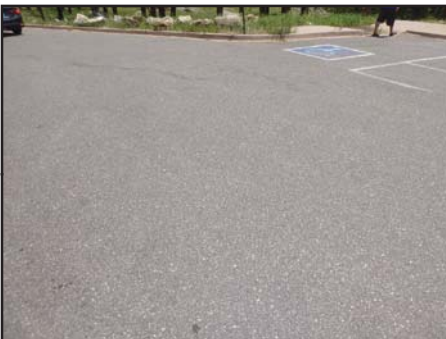
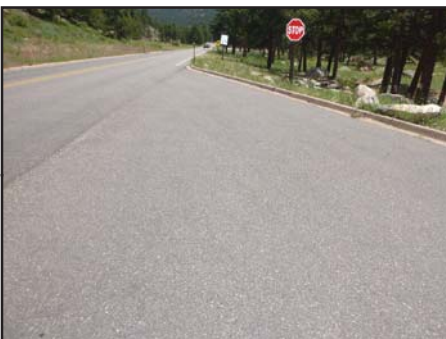
ROUTE 0944: PARK AND RIDE PARKING

Inspection Date	FMSS Number	User Access	Surface Type
6/22/2017	37691	PUBLIC	ASPHALT
Area (Sq. Ft.)	Lane Miles (11' Widths)	Curb Reveal (Inches)	Curb Recommendation
180,400	3.106	NOT APPLICABLE	LIGHT REPAIR
Curb Type		Curb & Gutter Type	
NO CURB		CONCRETE	
Pavement Recommendation		Condition Rating / PCR	
HEAVY 3R TREATMENTS		POOR / 53

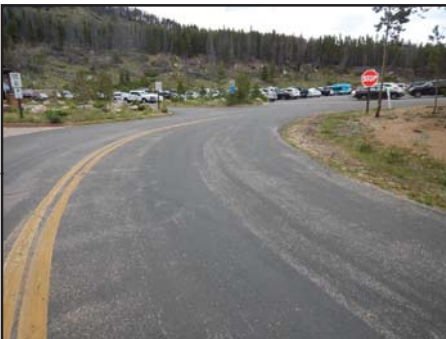
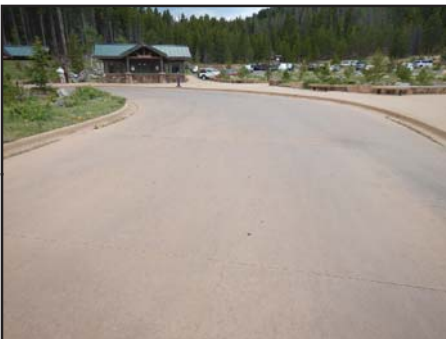
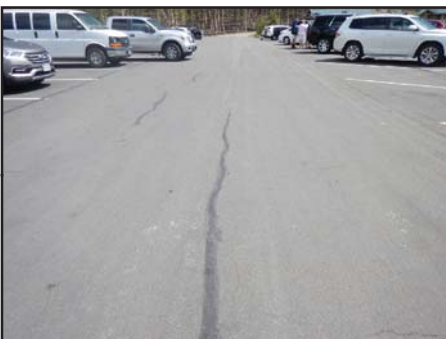
ROUTE 0945ZZ: SPRAGUE LAKE PARKING AREAS

Note: Parking area consists of multiple surface types: 1 part Asphalt at 169,019 square feet; 1 part Concrete at 11,381 square feet.

Inspection Date	FMSS Number	User Access	Surface Type
6/22/2017	37693	PUBLIC	ASPHALT
Area (Sq. Ft.)	Lane Miles (11' Widths)	Condition Rating / PCR	
15,001	0.259	SUMMARY / 90

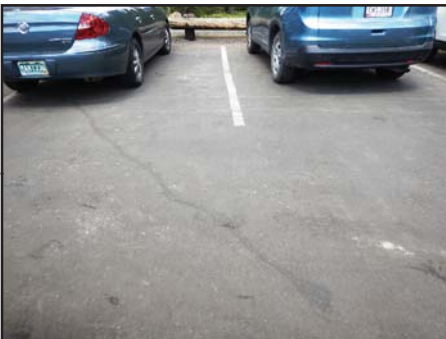
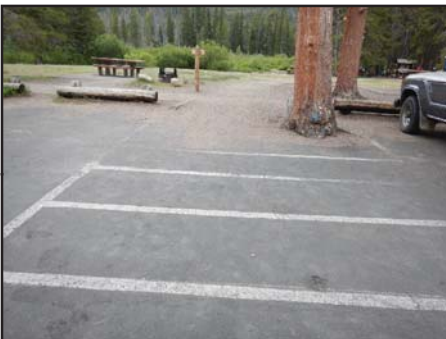
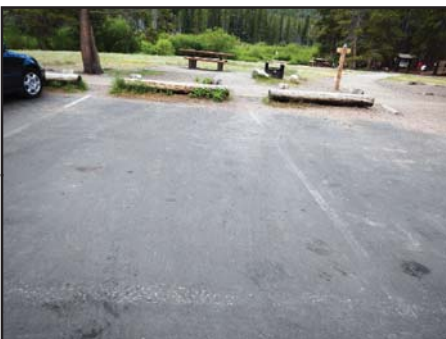
ROUTE 0945CZ: SPRAGUE LAKE COMFORT STATION PARKING

Inspection Date	FMSS Number	User Access	Surface Type
6/22/2017	37693	PUBLIC	ASPHALT
Area (Sq. Ft.)	Lane Miles (11' Widths)	Curb Reveal (Inches)	Curb Recommendation
786	0.014	1	DO NOTHING
Curb Type		Curb & Gutter Type	
WOOD		NO CURB AND GUTTER	
Pavement Recommendation		Condition Rating / PCR	
PREVENTIVE MAINTENANCE		GOOD / 90

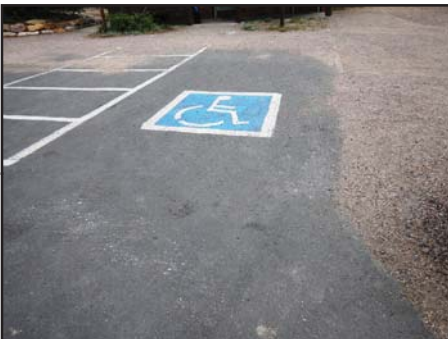
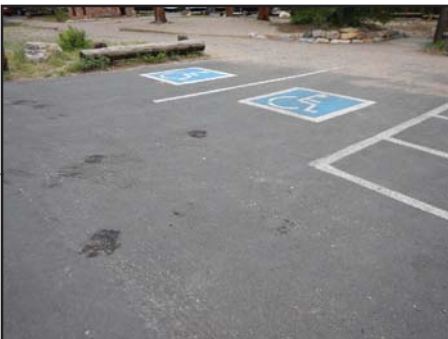
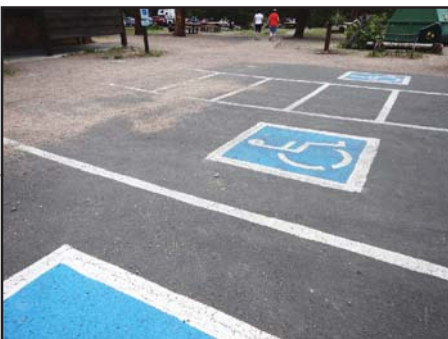
ROUTE 0945DZ: SPRAGUE LAKE PICNIC PARKING AREA

Inspection Date	FMSS Number	User Access	Surface Type
6/22/2017	37693	PUBLIC	ASPHALT
Area (Sq. Ft.)	Lane Miles (11' Widths)	Curb Reveal (Inches)	Curb Recommendation
1,083	0.019	NOT APPLICABLE	NOT APPLICABLE
Curb Type		Curb & Gutter Type	
NO CURB		NO CURB AND GUTTER	
Pavement Recommendation		Condition Rating / PCR	
PREVENTIVE MAINTENANCE		GOOD / 90

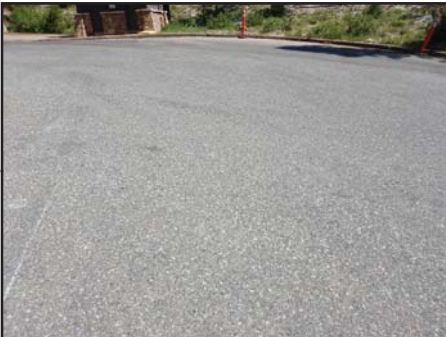
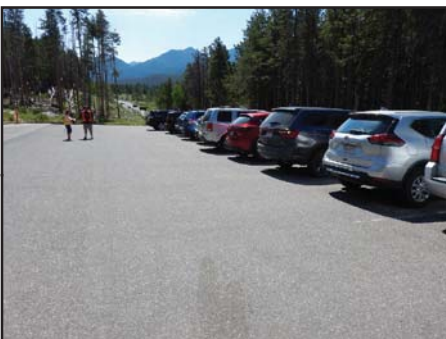
ROUTE 0946: BIERSTADT LAKE BUS STOP

Inspection Date	FMSS Number	User Access	Surface Type
6/22/2017	87501	PUBLIC	ASPHALT
Area (Sq. Ft.)	Lane Miles (11' Widths)	Curb Reveal (Inches)	Curb Recommendation
9,625	0.166	NOT APPLICABLE	LIGHT REPAIR
Curb Type		Curb & Gutter Type	
NO CURB		CONCRETE	
Pavement Recommendation		Condition Rating / PCR	
PREVENTIVE MAINTENANCE		GOOD / 90

Note: Parking area consists of multiple surface types: 1 part Asphalt at 8,400 square feet; 1 part Concrete at 1,225 square feet.

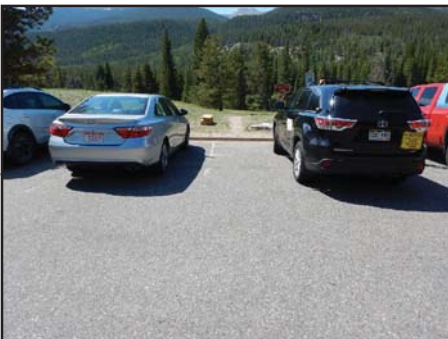
ROUTE 0948: BIERSTADT LAKE / STORM PASS TRAILHEAD PARKING

Inspection Date	FMSS Number	User Access	Surface Type
6/22/2017	37697	PUBLIC	ASPHALT
Area (Sq. Ft.)	Lane Miles (11' Widths)	Curb Reveal (Inches)	Curb Recommendation
2,588	0.045	NOT APPLICABLE	DO NOTHING
Curb Type		Curb & Gutter Type	
NO CURB		CONCRETE	
Pavement Recommendation		Condition Rating / PCR	
PREVENTIVE MAINTENANCE		GOOD / 90

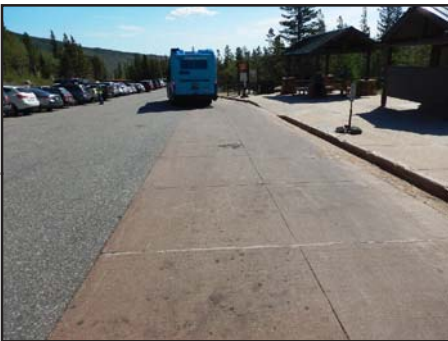
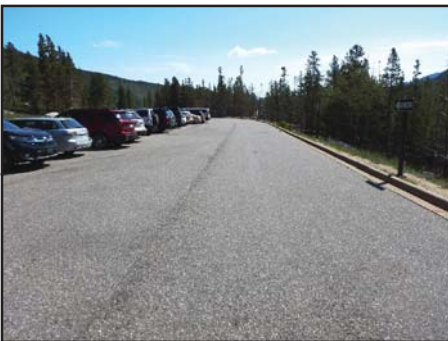
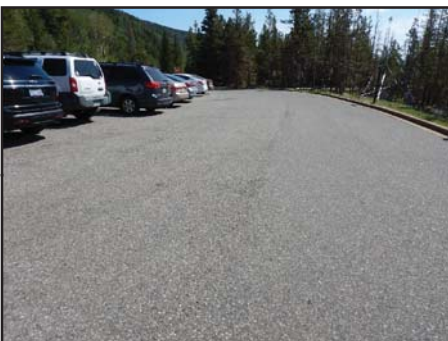
ROUTE 0950: GLACIER GORGE PARKING

Inspection Date	FMSS Number	User Access	Surface Type
6/22/2017	37699	PUBLIC	ASPHALT
Area (Sq. Ft.)	Lane Miles (11' Widths)	Curb Reveal (Inches)	Curb Recommendation
22,973	0.396	NOT APPLICABLE	DO NOTHING
Curb Type		Curb & Gutter Type	
NO CURB		CONCRETE	
Pavement Recommendation		Condition Rating / PCR	
PREVENTIVE MAINTENANCE		GOOD / 90

Note: Parking area consists of multiple surface types: 1 part Asphalt at 21,571 square feet; 1 part Concrete at 1,402 square feet.

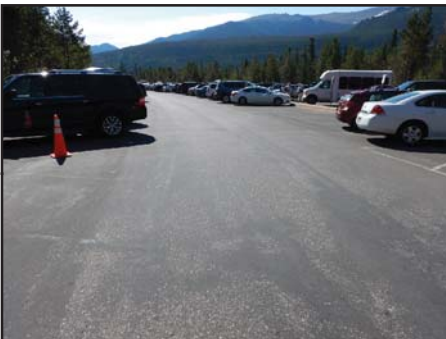
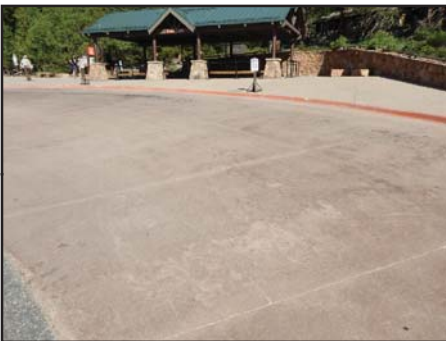
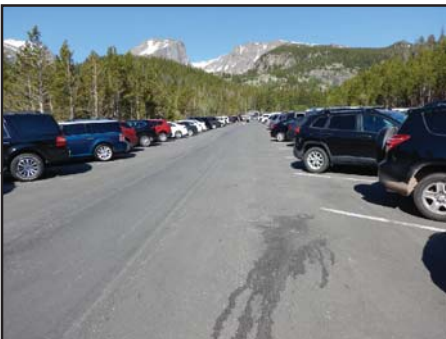
ROUTE 0951: BEAR LAKE PARKING AREA

Inspection Date	FMSS Number	User Access	Surface Type
6/22/2017	37700	PUBLIC	ASPHALT
Area (Sq. Ft.)	Lane Miles (11' Widths)	Curb Reveal (Inches)	Curb Recommendation
82,252	1.416	NOT APPLICABLE	LIGHT REPAIR
Curb Type		Curb & Gutter Type	
NO CURB		CONCRETE	
Pavement Recommendation		Condition Rating / PCR	
LIGHT 3R TREATMENTS		FAIR / 73

Note: Parking area consists of multiple surface types: 1 part Asphalt at 76,956 square feet; 1 part Concrete at 5,296 square feet.

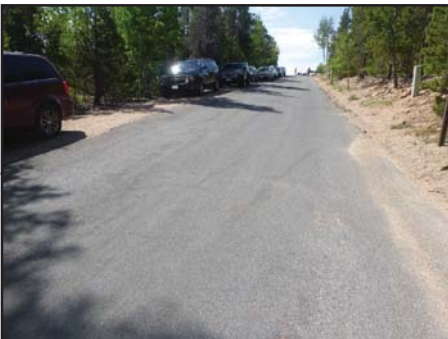
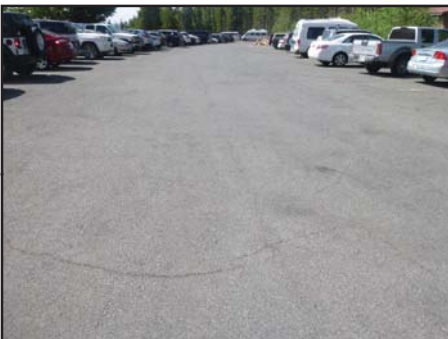
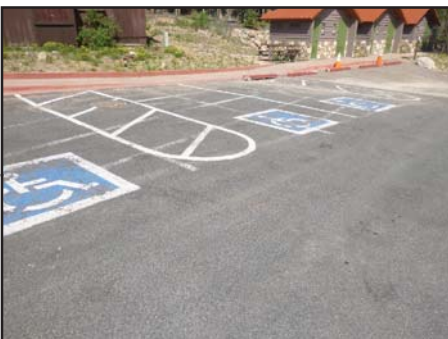
ROUTE 0952: LONGS PEAK TRAILHEAD PARKING

Inspection Date	FMSS Number	User Access	Surface Type
6/28/2017	37701	PUBLIC	ASPHALT
Area (Sq. Ft.)	Lane Miles (11' Widths)	Curb Reveal (Inches)	Curb Recommendation
32,510	0.56	NOT APPLICABLE	DO NOTHING
Curb Type		Curb & Gutter Type	
NO CURB		CONCRETE	
Pavement Recommendation		Condition Rating / PCR	
LIGHT 3R TREATMENTS		FAIR / 73

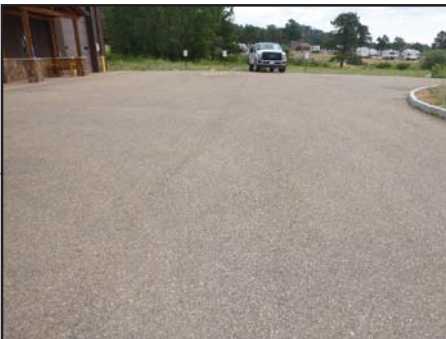
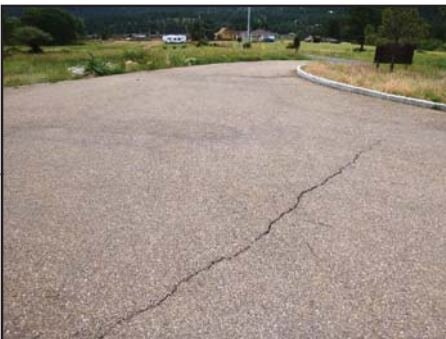
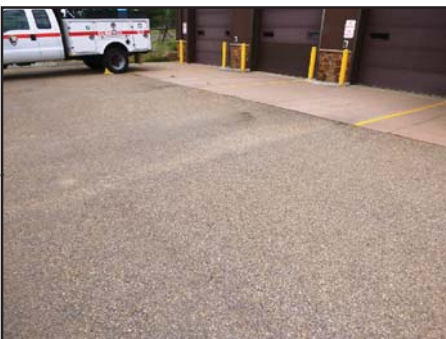
ROUTE 0953AZ: EMERGENCY OPERATIONS BUILDING PARKING AREA

Inspection Date	FMSS Number	User Access	Surface Type
6/28/2017	37705	NONPUBLIC	ASPHALT
Area (Sq. Ft.)	Lane Miles (11' Widths)	Curb Reveal (Inches)	Curb Recommendation
6,357	0.109	5	DO NOTHING
Curb Type		Curb & Gutter Type	
STONE		NO CURB AND GUTTER	
Pavement Recommendation		Condition Rating / PCR	
PREVENTIVE MAINTENANCE		GOOD / 90

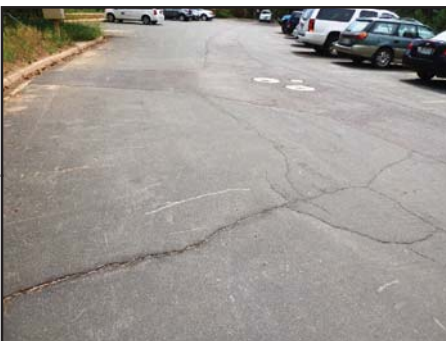
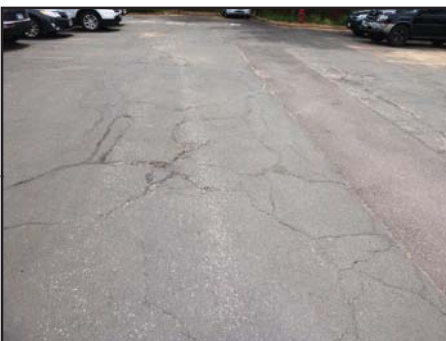
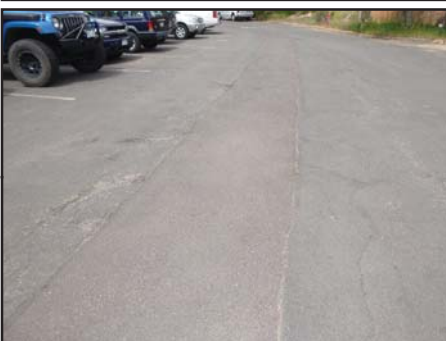
ROUTE 0953Z: VISITOR CENTER EMPLOYEE PARKING AREA HQ

Inspection Date	FMSS Number	User Access	Surface Type
7/11/2017	37705	NONPUBLIC	ASPHALT
Area (Sq. Ft.)	Lane Miles (11' Widths)	Curb Reveal (Inches)	Curb Recommendation
18,855	0.325	NOT APPLICABLE	LIGHT REPAIR
Curb Type		Curb & Gutter Type	
NO CURB		CONCRETE	
Pavement Recommendation		Condition Rating / PCR	
PREVENTIVE MAINTENANCE		GOOD / 90

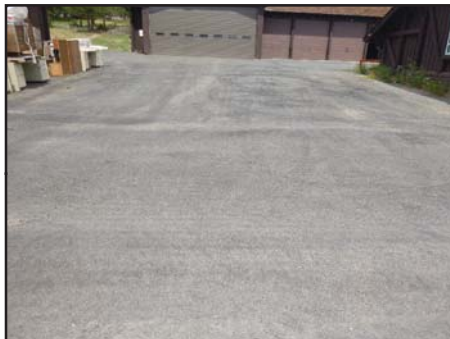
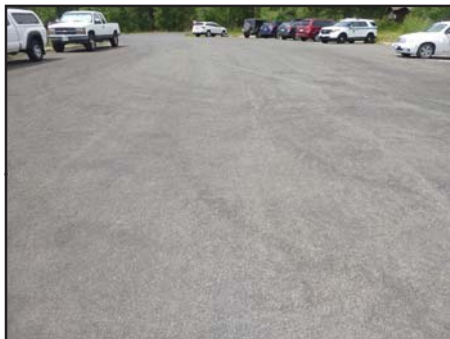
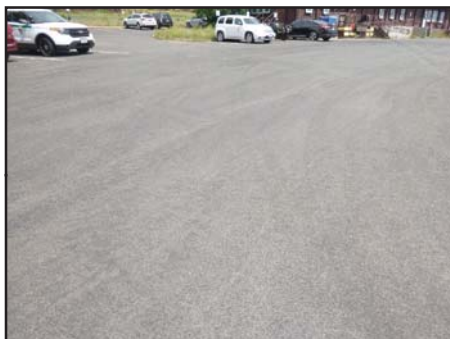
ROUTE 0954Z: UTILITY ROAD MAINTENANCE PARKING

Inspection Date	FMSS Number	User Access	Surface Type
7/11/2017	37705	NONPUBLIC	ASPHALT
Area (Sq. Ft.)	Lane Miles (11' Widths)	Curb Reveal (Inches)	Curb Recommendation
147,794	2.545	7	LIGHT REPAIR
Curb Type		Curb & Gutter Type	
CONCRETE		NO CURB AND GUTTER	
Pavement Recommendation		Condition Rating / PCR	
PREVENTIVE MAINTENANCE		GOOD / 90

Note: Parking area consists of multiple surface types: 1 part Asphalt at 141,506 square feet; 2 parts Concrete at 6,288 square feet.

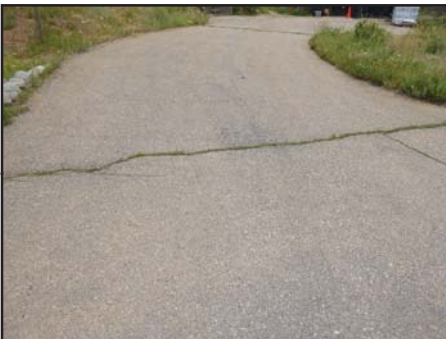
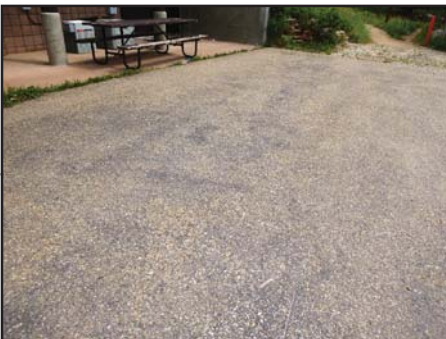
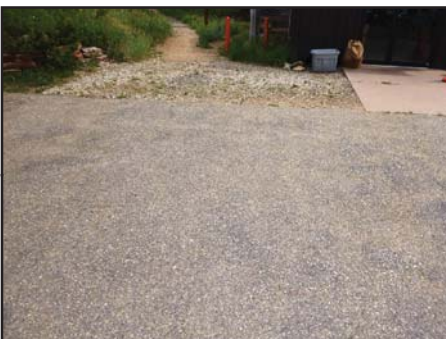
ROUTE 0955Z: GREENHOUSE PARKING

Inspection Date	FMSS Number	User Access	Surface Type
7/11/2017	37705	NONPUBLIC	ASPHALT
Area (Sq. Ft.)	Lane Miles (11' Widths)	Curb Reveal (Inches)	Curb Recommendation
3,087	0.053	NOT APPLICABLE	NOT APPLICABLE
Curb Type		Curb & Gutter Type	
NO CURB		NO CURB AND GUTTER	
Pavement Recommendation		Condition Rating / PCR	
PREVENTIVE MAINTENANCE		GOOD / 90

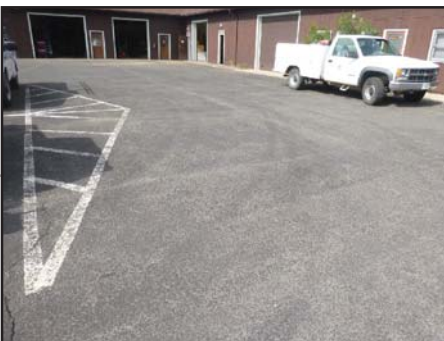
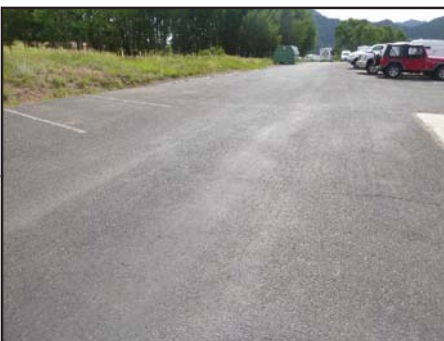
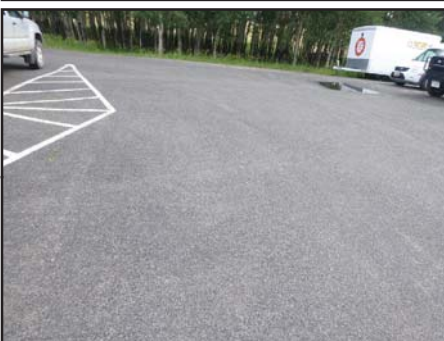
Inspection Date	FMSS Number	User Access	Surface Type
7/11/2017	37705	NONPUBLIC	ASPHALT
Area (Sq. Ft.)	Lane Miles (11' Widths)	Curb Reveal (Inches)	Curb Recommendation
48,743	0.839	7	DO NOTHING
Curb Type		Curb & Gutter Type	
CONCRETE		NO CURB AND GUTTER	
Pavement Recommendation		Condition Rating / PCR	
LIGHT 3R TREATMENTS		FAIR / 73

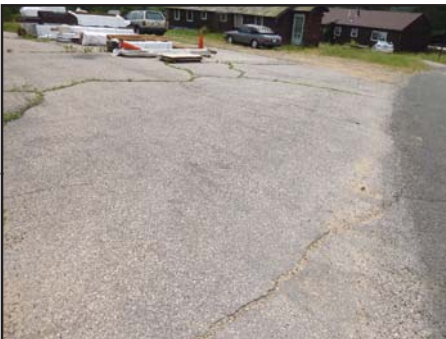
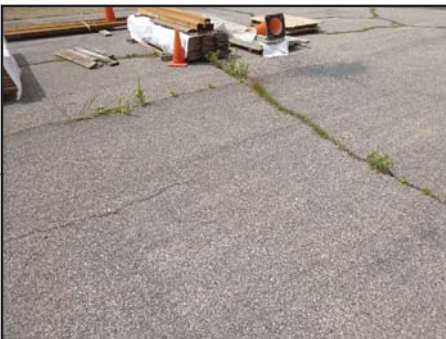
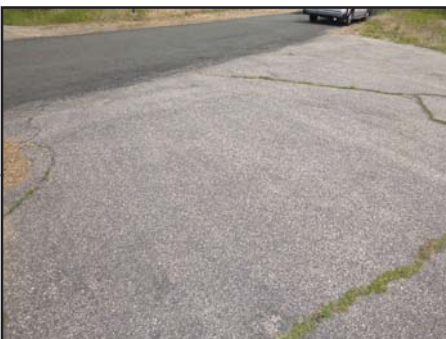
ROUTE 0963Z: PTARMIGAN LANE PARKING

Inspection Date	FMSS Number	User Access	Surface Type
7/11/2017	37705	NONPUBLIC	ASPHALT
Area (Sq. Ft.)	Lane Miles (11' Widths)	Curb Reveal (Inches)	Curb Recommendation
2,877	0.05	NOT APPLICABLE	NOT APPLICABLE
Curb Type		Curb & Gutter Type	
NO CURB		NO CURB AND GUTTER	
Pavement Recommendation		Condition Rating / PCR	
HEAVY 3R TREATMENTS		POOR / 53

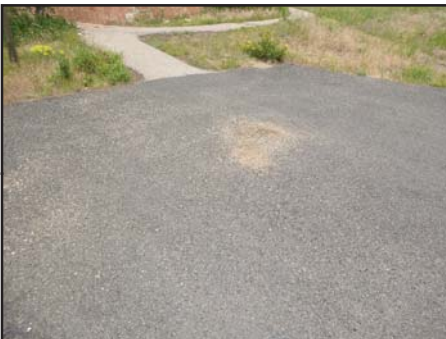
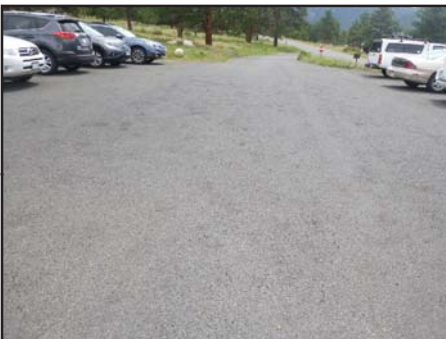
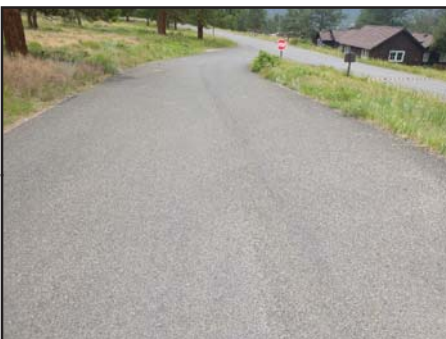
ROUTE 1004Z: BCO PARKING AREA

Inspection Date	FMSS Number	User Access	Surface Type
7/11/2017	37705	NONPUBLIC	ASPHALT
Area (Sq. Ft.)	Lane Miles (11' Widths)	Curb Reveal (Inches)	Curb Recommendation
7,308	0.126	NOT APPLICABLE	NOT APPLICABLE
Curb Type		Curb & Gutter Type	
NO CURB		NO CURB AND GUTTER	
Pavement Recommendation		Condition Rating / PCR	
PREVENTIVE MAINTENANCE		GOOD / 90

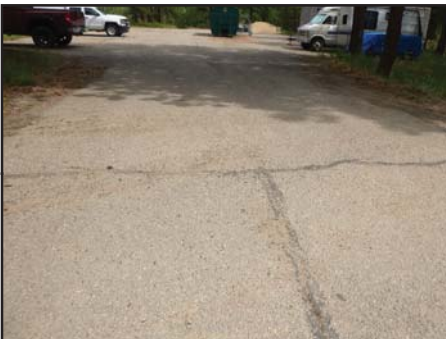
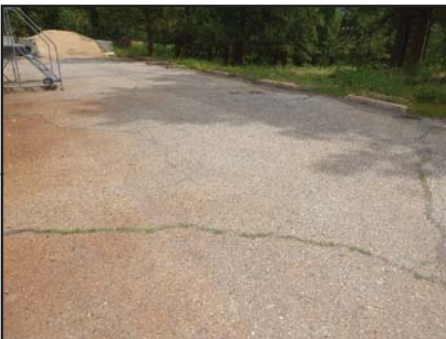
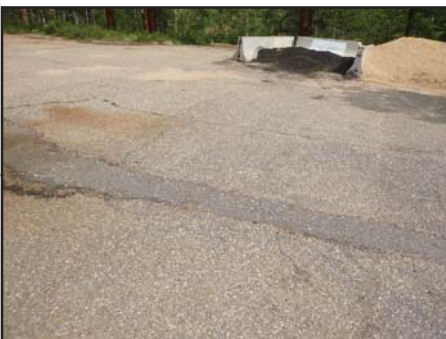
ROUTE 0958Z: BLISTER RUST PARKING

Inspection Date	FMSS Number	User Access	Surface Type
7/11/2017	37707	PUBLIC	ASPHALT
Area (Sq. Ft.)	Lane Miles (11' Widths)	Curb Reveal (Inches)	Curb Recommendation
9,107	0.157	NOT APPLICABLE	NOT APPLICABLE
Curb Type		Curb & Gutter Type	
NO CURB		NO CURB AND GUTTER	
Pavement Recommendation		Condition Rating / PCR	
HEAVY 3R TREATMENTS		POOR / 53

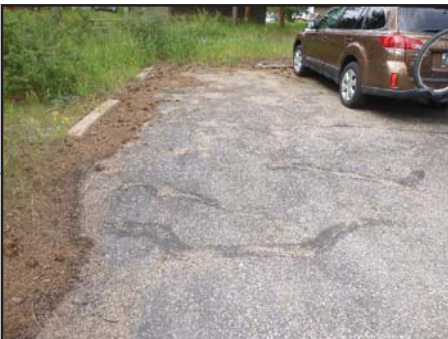
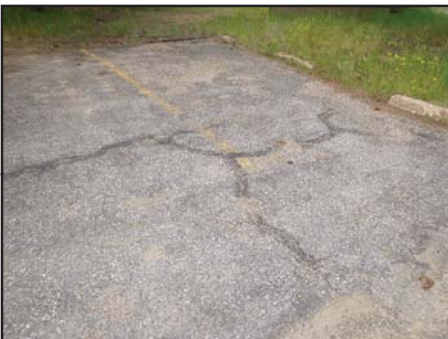
ROUTE 0965AZ: SUNDANCE CIRCLE PARKING A

Inspection Date	FMSS Number	User Access	Surface Type
7/11/2017	37707	PUBLIC	ASPHALT
Area (Sq. Ft.)	Lane Miles (11' Widths)	Curb Reveal (Inches)	Curb Recommendation
1,150	0.02	NOT APPLICABLE	NOT APPLICABLE
Curb Type		Curb & Gutter Type	
NO CURB		NO CURB AND GUTTER	
Pavement Recommendation		Condition Rating / PCR	
HEAVY 3R TREATMENTS		POOR / 53

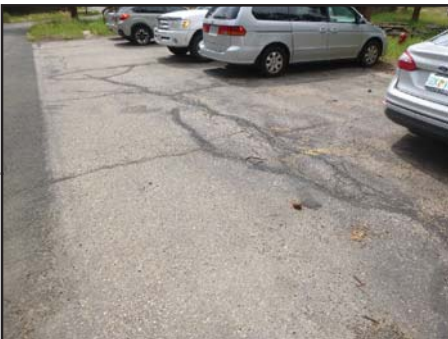
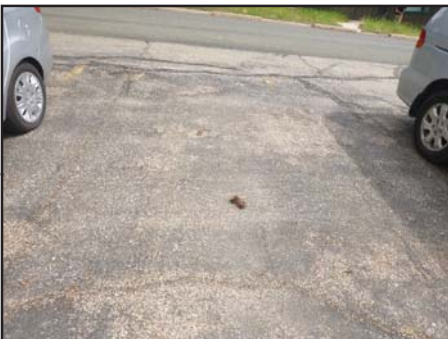
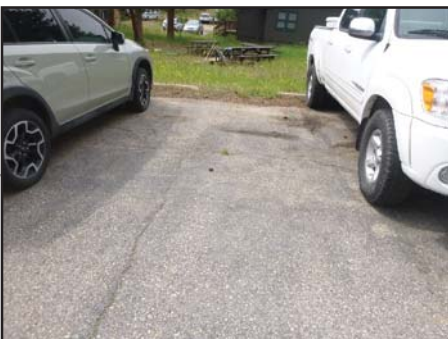
ROUTE 0965BZ: SUNDANCE CIRCLE PARKING B

Inspection Date	FMSS Number	User Access	Surface Type
7/11/2017	37707	PUBLIC	ASPHALT
Area (Sq. Ft.)	Lane Miles (11' Widths)	Curb Reveal (Inches)	Curb Recommendation
1,655	0.028	NOT APPLICABLE	NOT APPLICABLE
Curb Type		Curb & Gutter Type	
NO CURB		NO CURB AND GUTTER	
Pavement Recommendation		Condition Rating / PCR	
HEAVY 3R TREATMENTS		POOR / 53

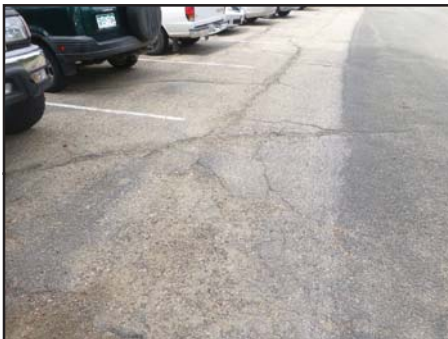
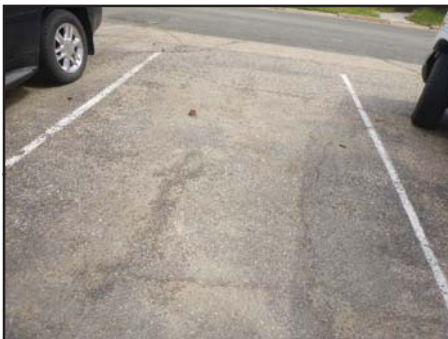
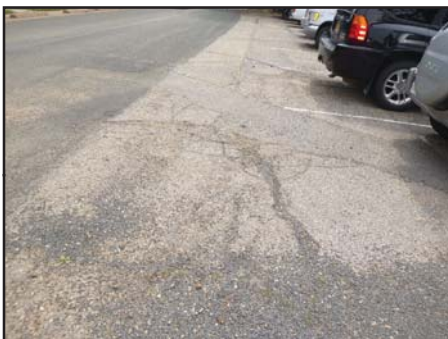
ROUTE 0965CZ: SUNDANCE CIRCLE PARKING C

Inspection Date	FMSS Number	User Access	Surface Type
7/11/2017	37707	PUBLIC	ASPHALT
Area (Sq. Ft.)	Lane Miles (11' Widths)	Curb Reveal (Inches)	Curb Recommendation
1,801	0.031	NOT APPLICABLE	NOT APPLICABLE
Curb Type		Curb & Gutter Type	
NO CURB		NO CURB AND GUTTER	
Pavement Recommendation		Condition Rating / PCR	
HEAVY 3R TREATMENTS		POOR / 53

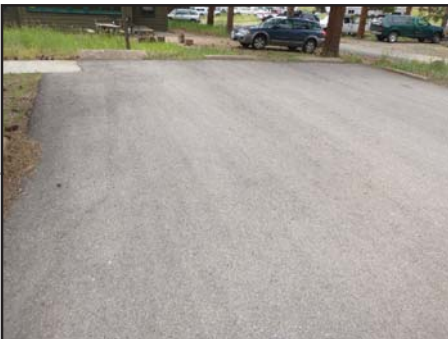
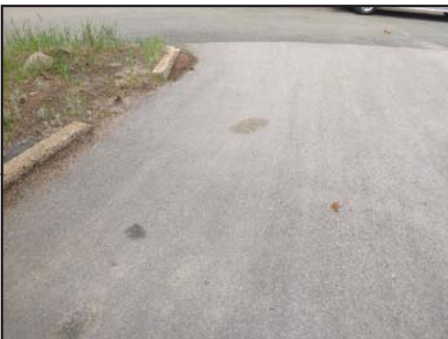
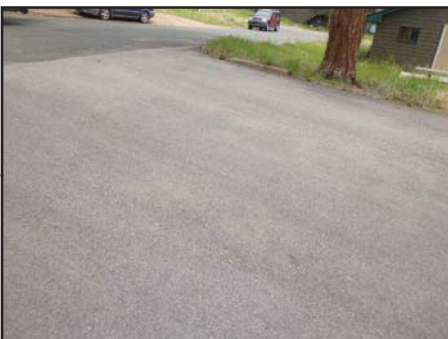
ROUTE 0965DZ: SUNDANCE CIRCLE PARKING D

Inspection Date	FMSS Number	User Access	Surface Type
7/11/2017	37707	PUBLIC	ASPHALT
Area (Sq. Ft.)	Lane Miles (11' Widths)	Curb Reveal (Inches)	Curb Recommendation
811	0.014	NOT APPLICABLE	NOT APPLICABLE
Curb Type		Curb & Gutter Type	
NO CURB		NO CURB AND GUTTER	
Pavement Recommendation		Condition Rating / PCR	
PREVENTIVE MAINTENANCE		GOOD / 90

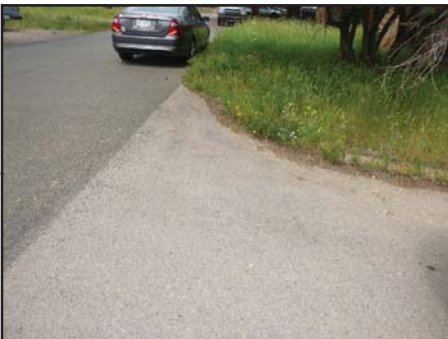
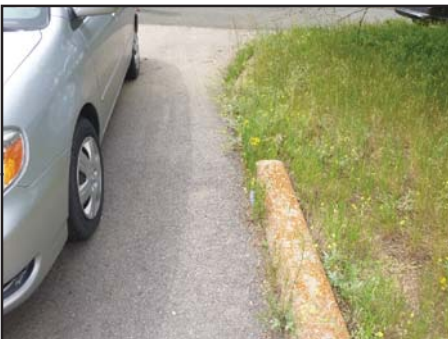
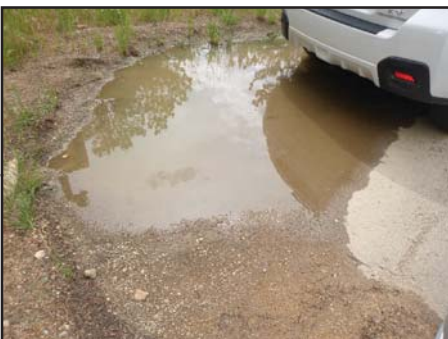
ROUTE 0965EZ: SUNDANCE CIRCLE PARKING E

Inspection Date	FMSS Number	User Access	Surface Type
7/11/2017	37707	PUBLIC	ASPHALT
Area (Sq. Ft.)	Lane Miles (11' Widths)	Curb Reveal (Inches)	Curb Recommendation
614	0.011	NOT APPLICABLE	NOT APPLICABLE
Curb Type		Curb & Gutter Type	
NO CURB		NO CURB AND GUTTER	
Pavement Recommendation		Condition Rating / PCR	
HEAVY 3R TREATMENTS		POOR / 53

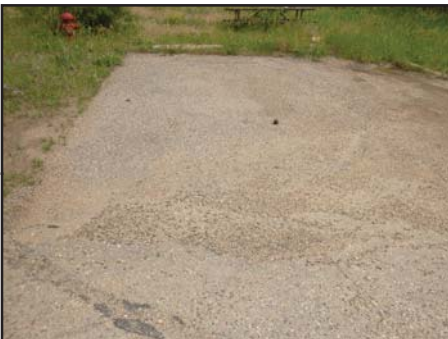
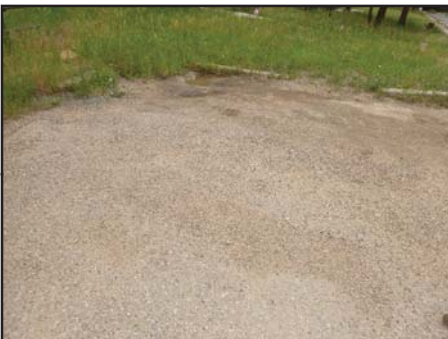
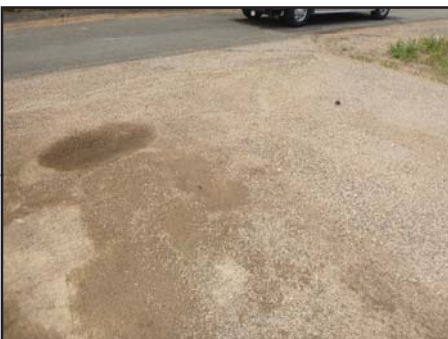
Inspection Date	FMSS Number	User Access	Surface Type
7/11/2017	37707	PUBLIC	ASPHALT
Area (Sq. Ft.)	Lane Miles (11' Widths)	Curb Reveal (Inches)	Curb Recommendation
534	0.009	NOT APPLICABLE	NOT APPLICABLE
Curb Type		Curb & Gutter Type	
NO CURB		NO CURB AND GUTTER	
Pavement Recommendation		Condition Rating / PCR	
PREVENTIVE MAINTENANCE		GOOD / 90

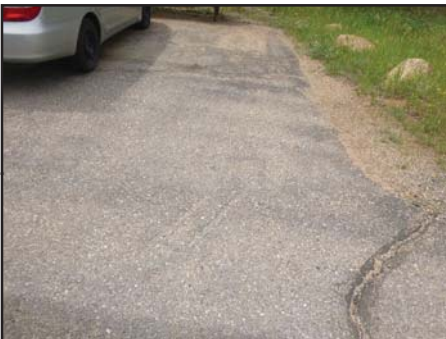
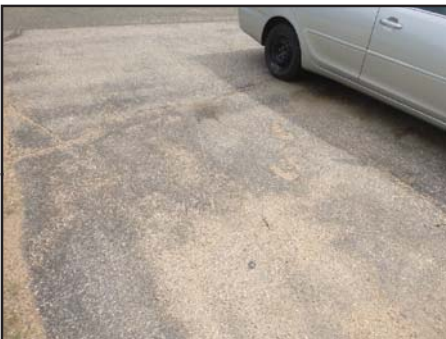
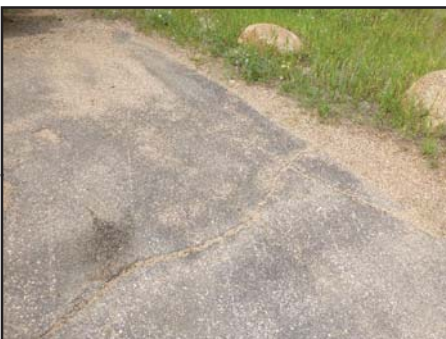
ROUTE 1006Z: 495 BONEYARD RESIDENCE PARKING

Inspection Date	FMSS Number	User Access	Surface Type
7/11/2017	37707	PUBLIC	ASPHALT
Area (Sq. Ft.)	Lane Miles (11' Widths)	Curb Reveal (Inches)	Curb Recommendation
442	0.008	NOT APPLICABLE	NOT APPLICABLE
Curb Type		Curb & Gutter Type	
NO CURB		NO CURB AND GUTTER	
Pavement Recommendation		Condition Rating / PCR	
PREVENTIVE MAINTENANCE		GOOD / 90

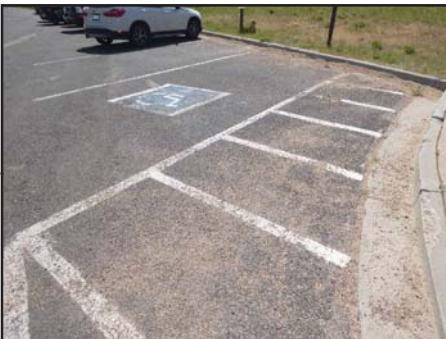
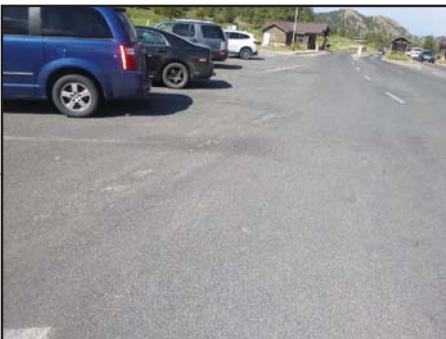
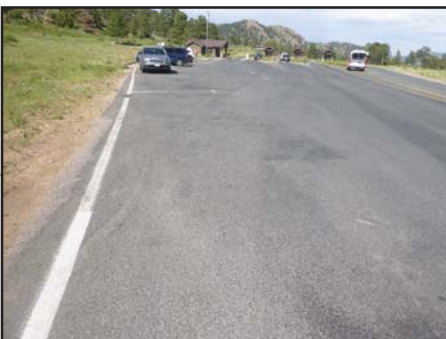
ROUTE 0961: BEAVER MEADOWS ENTRANCE FEE STATION PARKING

Inspection Date	FMSS Number	User Access	Surface Type
6/28/2017	91166	PUBLIC	ASPHALT
Area (Sq. Ft.)	Lane Miles (11' Widths)	Curb Reveal (Inches)	Curb Recommendation
3,203	0.055	NOT APPLICABLE	MODERATE REPAIR
Curb Type		Curb & Gutter Type	
NO CURB		CONCRETE	
Pavement Recommendation		Condition Rating / PCR	
LIGHT 3R TREATMENTS		FAIR / 73

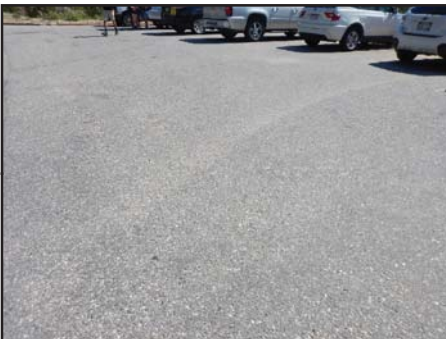
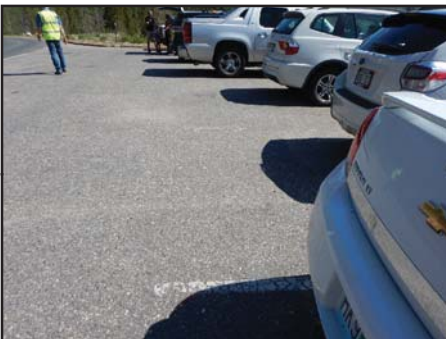
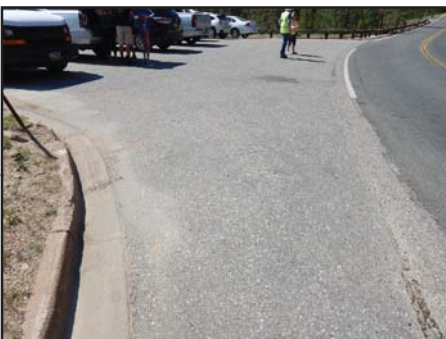
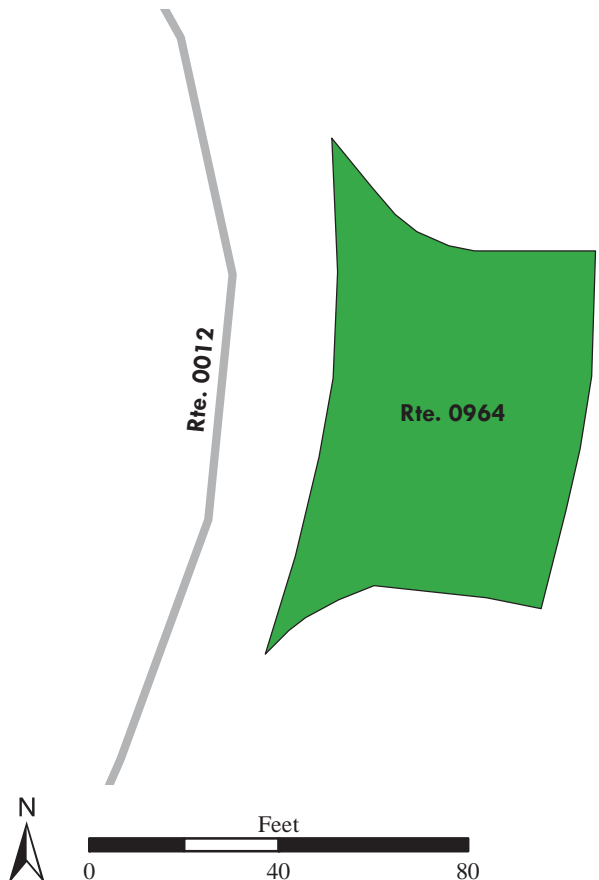
ROUTE 0964: PROSPECT CANYON PARKING

Inspection Date	FMSS Number	User Access	Surface Type
6/22/2017	91464	PUBLIC	ASPHALT
Area (Sq. Ft.)	Lane Miles (11' Widths)	Curb Reveal (Inches)	Curb Recommendation
3,270	0.056	NOT APPLICABLE	LIGHT REPAIR
Curb Type		Curb & Gutter Type	
NO CURB		CONCRETE	
Pavement Recommendation		Condition Rating / PCR	
PREVENTIVE MAINTENANCE		GOOD / 90

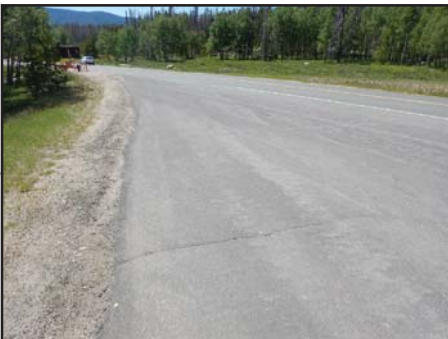
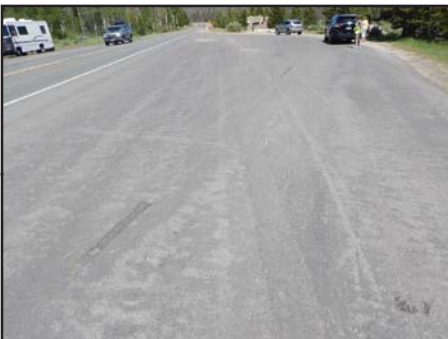
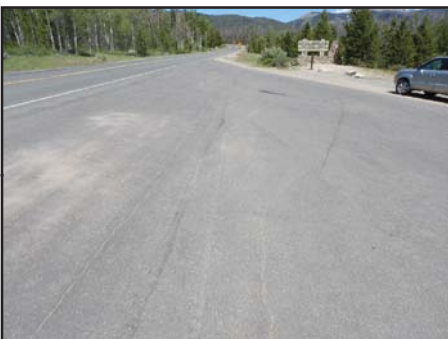
ROUTE 0967A: WEST ENTRANCE SIGN PARKING A

Inspection Date	FMSS Number	User Access	Surface Type
6/21/2017	105229	PUBLIC	ASPHALT
Area (Sq. Ft.)	Lane Miles (11' Widths)	Curb Reveal (Inches)	Curb Recommendation
8,549	0.147	NOT APPLICABLE	NOT APPLICABLE
Curb Type		Curb & Gutter Type	
NO CURB		NO CURB AND GUTTER	
Pavement Recommendation		Condition Rating / PCR	
PREVENTIVE MAINTENANCE		GOOD / 90
