ROMO Cycle 6

Final Report

Road Inventory and Condition Assessment of Paved Routes Rocky Mountain National Park

**Federal Highway Administration
Eastern Federal Lands Highway Division
Road Inventory Program (RIP)**

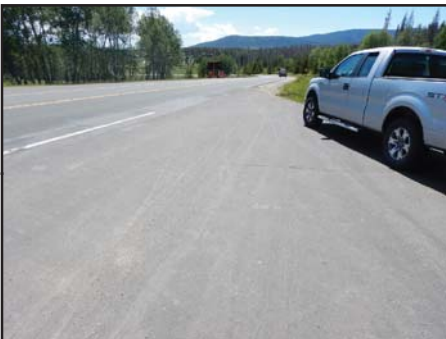
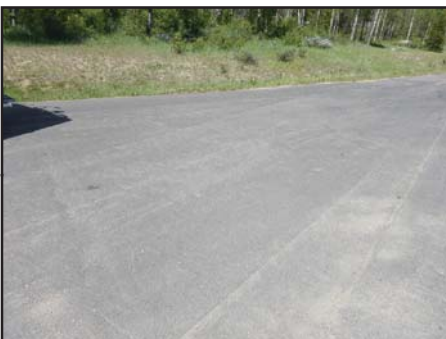
ROUTE 0967B: WEST ENTRANCE SIGN PARKING B

Inspection Date	FMSS Number	User Access	Surface Type
6/21/2017	105223	PUBLIC	ASPHALT
Area (Sq. Ft.)	Lane Miles (11' Widths)	Curb Reveal (Inches)	Curb Recommendation
4,499	0.077	NOT APPLICABLE	NOT APPLICABLE
Curb Type		Curb & Gutter Type	
NO CURB		NO CURB AND GUTTER	
Pavement Recommendation		Condition Rating / PCR	
PREVENTIVE MAINTENANCE		GOOD / 90

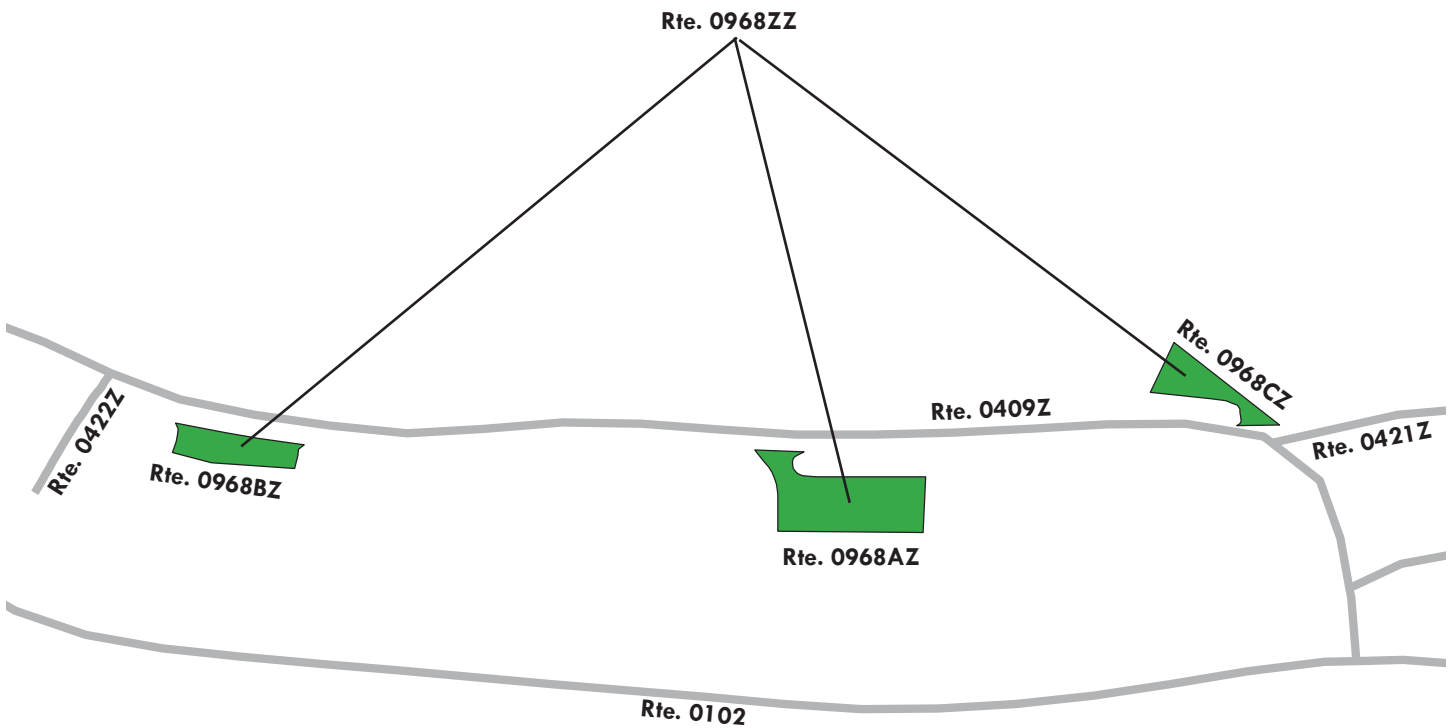
ROUTE 0968ZZ: GRAND LAKE HOUSING PARKING AREAS

Inspection Date	FMSS Number	User Access	Surface Type
6/21/2017	105239	NONPUBLIC	ASPHALT
Area (Sq. Ft.)	Lane Miles (11' Widths)	Condition Rating / PCR	
9,322	0.16	SUMMARY / 90

The condition shown on this page reflects the overall route condition and may not reflect individual subcomponent ratings.

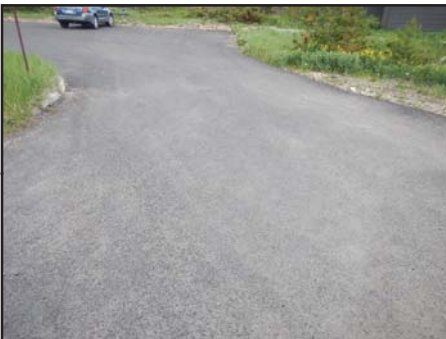
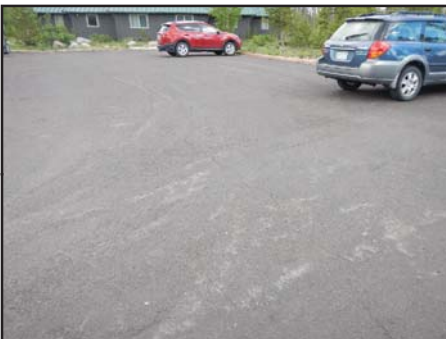
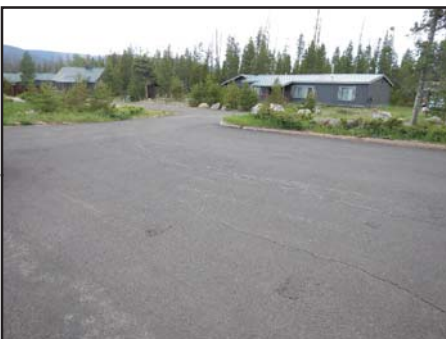
ROUTE 0968AZ: 464 / 465 RESIDENCE PARKING

Inspection Date	FMSS Number	User Access	Surface Type
6/21/2017	105239	NONPUBLIC	ASPHALT
Area (Sq. Ft.)	Lane Miles (11' Widths)	Curb Reveal (Inches)	Curb Recommendation
5,300	0.091	4	MODERATE REPAIR
Curb Type		Curb & Gutter Type	
CONCRETE		NO CURB AND GUTTER	
Pavement Recommendation		Condition Rating / PCR	
PREVENTIVE MAINTENANCE		GOOD / 90

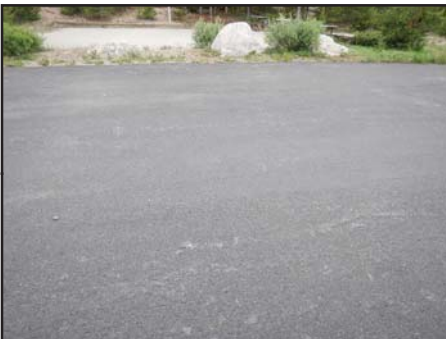
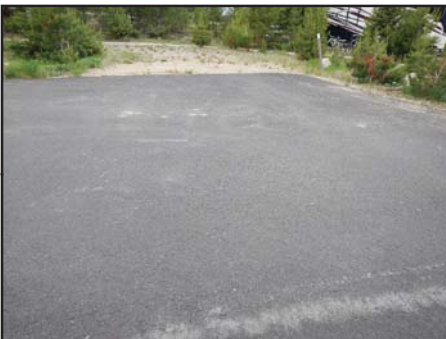
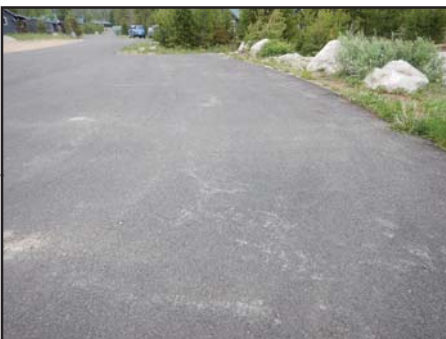
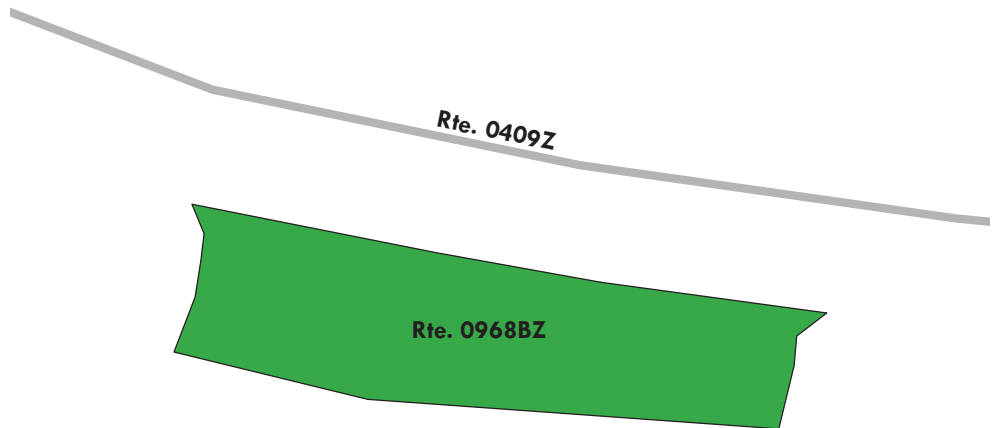
ROUTE 0968BZ: 467 RESIDENCE PARKING

Inspection Date	FMSS Number	User Access	Surface Type
6/21/2017	105239	NONPUBLIC	ASPHALT
Area (Sq. Ft.)	Lane Miles (11' Widths)	Curb Reveal (Inches)	Curb Recommendation
2,106	0.036	NOT APPLICABLE	NOT APPLICABLE
Curb Type		Curb & Gutter Type	
NO CURB		NO CURB AND GUTTER	
Pavement Recommendation		Condition Rating / PCR	
PREVENTIVE MAINTENANCE		GOOD / 90

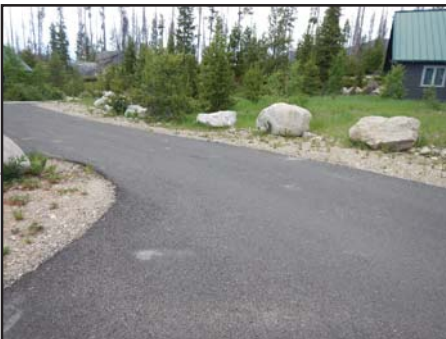
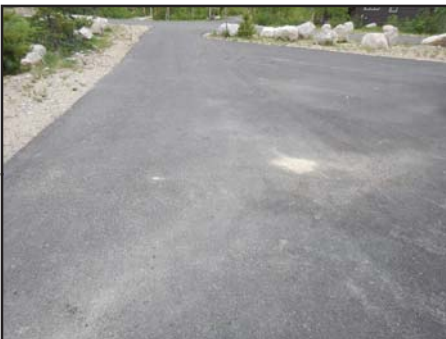
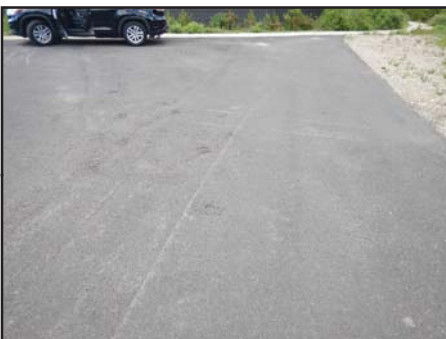
ROUTE 0968CZ: RESIDENCE PARKING

Inspection Date	FMSS Number	User Access	Surface Type
6/21/2017	105239	NONPUBLIC	ASPHALT
Area (Sq. Ft.)	Lane Miles (11' Widths)	Curb Reveal (Inches)	Curb Recommendation
1,916	0.033	NOT APPLICABLE	NOT APPLICABLE
Curb Type		Curb & Gutter Type	
NO CURB		NO CURB AND GUTTER	
Pavement Recommendation		Condition Rating / PCR	
PREVENTIVE MAINTENANCE		GOOD / 90

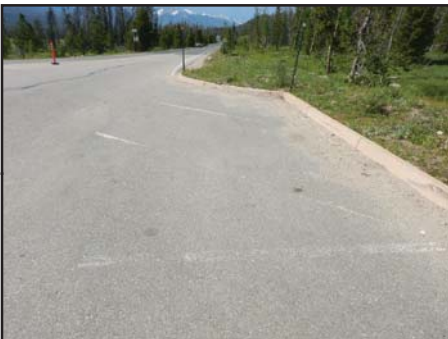
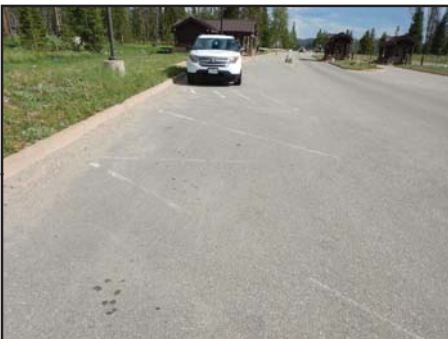
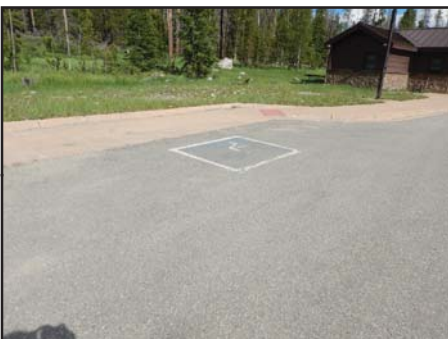
ROUTE 0958Z: BLISTER RUST PARKING

Inspection Date	FMSS Number	User Access	Surface Type
6/21/2017	105236	PUBLIC	ASPHALT
Area (Sq. Ft.)	Lane Miles (11' Widths)	Curb Reveal (Inches)	Curb Recommendation
1,396	0.024	NOT APPLICABLE	LIGHT REPAIR
Curb Type		Curb & Gutter Type	
NO CURB		CONCRETE	
Pavement Recommendation		Condition Rating / PCR	
PREVENTIVE MAINTENANCE		GOOD / 90

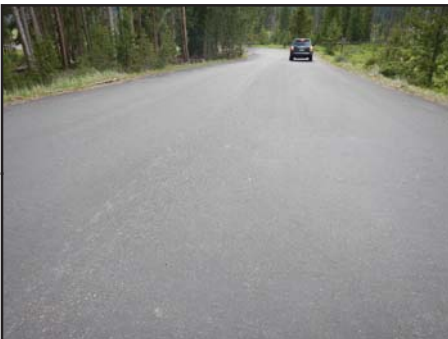
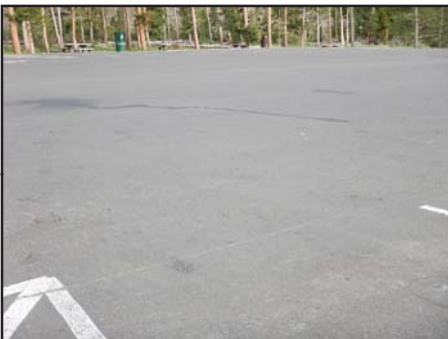
ROUTE 0971: HOLZWARTH HISTORIC PARKING AREA

Inspection Date	FMSS Number	User Access	Surface Type
6/21/2017	14788	PUBLIC	ASPHALT
Area (Sq. Ft.)	Lane Miles (11' Widths)	Curb Reveal (Inches)	Curb Recommendation
31,116	0.536	NOT APPLICABLE	NOT APPLICABLE
Curb Type		Curb & Gutter Type	
NO CURB		NO CURB AND GUTTER	
Pavement Recommendation		Condition Rating / PCR	
PREVENTIVE MAINTENANCE		GOOD / 90

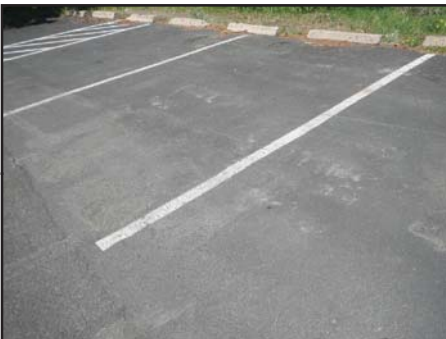
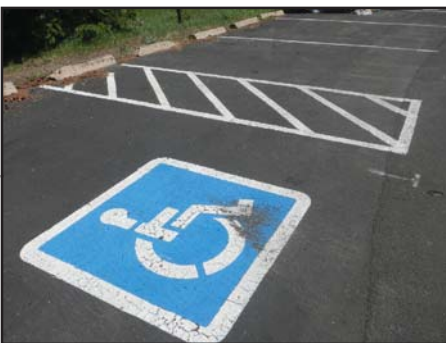
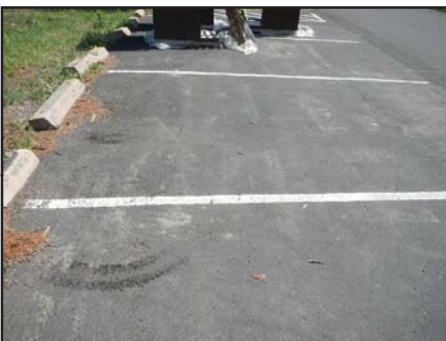
ROUTE 0972AZ: TCCG CAMPFIRE PROGRAM PARKING A

Inspection Date	FMSS Number	User Access	Surface Type
6/22/2017	104620	PUBLIC	ASPHALT
Area (Sq. Ft.)	Lane Miles (11' Widths)	Curb Reveal (Inches)	Curb Recommendation
1,156	0.02	NOT APPLICABLE	NOT APPLICABLE
Curb Type		Curb & Gutter Type	
NO CURB		NO CURB AND GUTTER	
Pavement Recommendation		Condition Rating / PCR	
PREVENTIVE MAINTENANCE		GOOD / 90

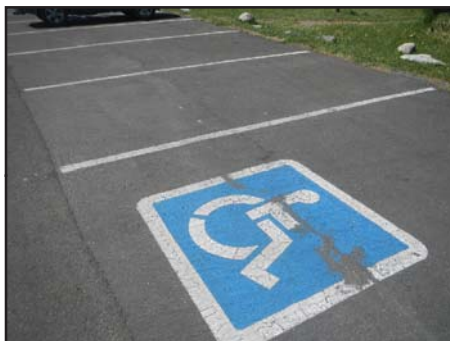
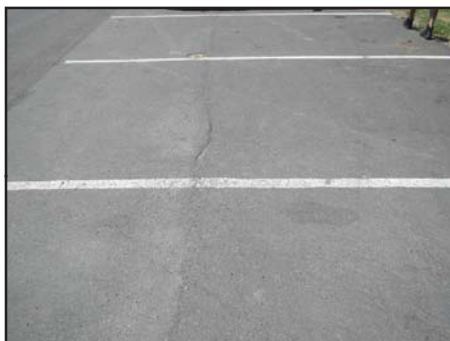
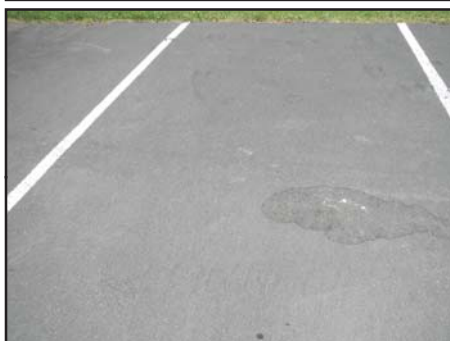
ROUTE 0972BZ: TCCG CAMPFIRE PROGRAM PARKING B

Inspection Date	FMSS Number	User Access	Surface Type
6/22/2017	104620	PUBLIC	ASPHALT
Area (Sq. Ft.)	Lane Miles (11' Widths)	Curb Reveal (Inches)	Curb Recommendation
2,029	0.035	NOT APPLICABLE	NOT APPLICABLE
Curb Type		Curb & Gutter Type	
NO CURB		NO CURB AND GUTTER	
Pavement Recommendation		Condition Rating / PCR	
PREVENTIVE MAINTENANCE		GOOD / 90

Note: Parking area consists of multiple surface types: 1 part Asphalt at 1,600 square feet; 1 part Concrete at 429 square feet.

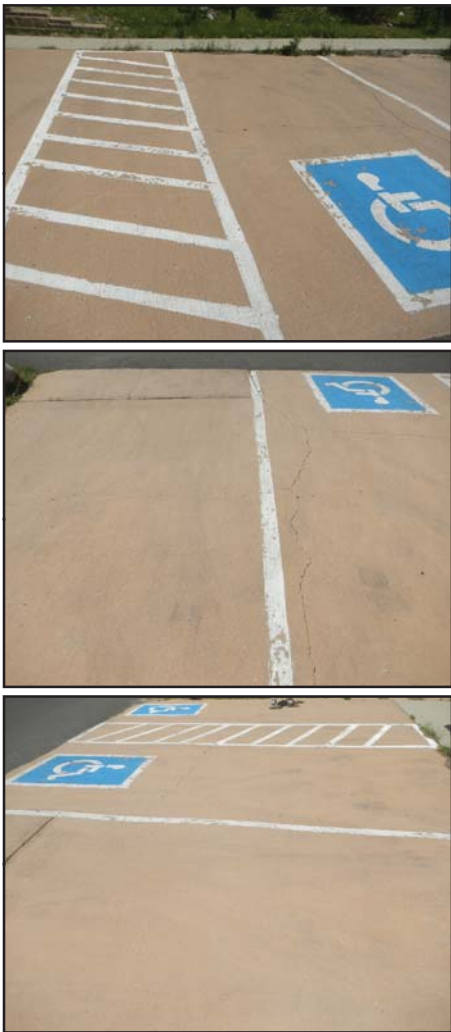
ROUTE 0972CZ: TCCG CAMPFIRE PROGRAM HANDICAP PARKING

Inspection Date	FMSS Number	User Access	Surface Type
6/22/2017	104620	PUBLIC	CONCRETE
Area (Sq. Ft.)	Lane Miles (11' Widths)	Curb Reveal (Inches)	Curb Recommendation
712	0.012	NOT APPLICABLE	NOT APPLICABLE
Curb Type		Curb & Gutter Type	
NO CURB		NO CURB AND GUTTER	
Pavement Recommendation		Condition Rating / PCR	
PREVENTIVE MAINTENANCE		GOOD / 90

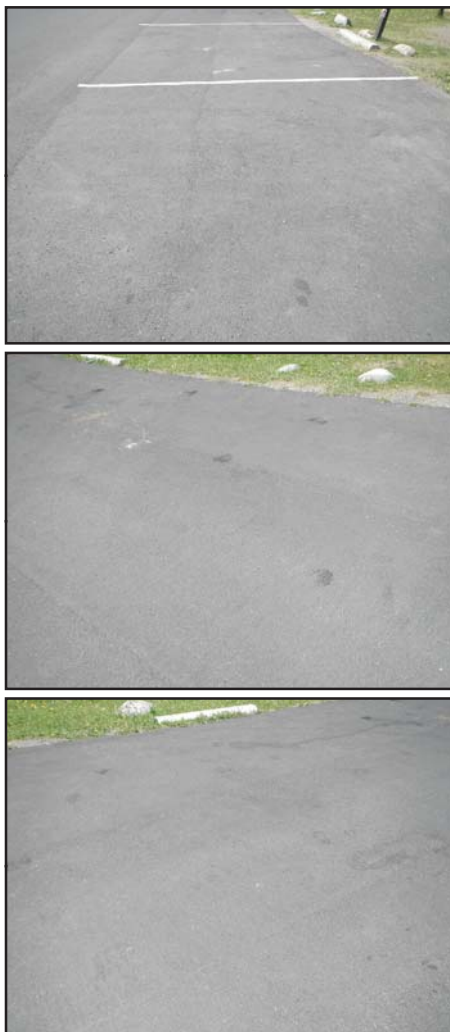
ROUTE 0972DZ: TCCG CAMPFIRE PROGRAM PARKING D

Inspection Date	FMSS Number	User Access	Surface Type
6/22/2017	104620	PUBLIC	ASPHALT
Area (Sq. Ft.)	Lane Miles (11' Widths)	Curb Reveal (Inches)	Curb Recommendation
1,804	0.031	NOT APPLICABLE	NOT APPLICABLE
Curb Type		Curb & Gutter Type	
NO CURB		NO CURB AND GUTTER	
Pavement Recommendation		Condition Rating / PCR	
PREVENTIVE MAINTENANCE		GOOD / 90

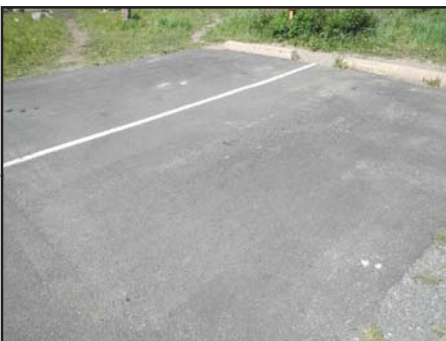
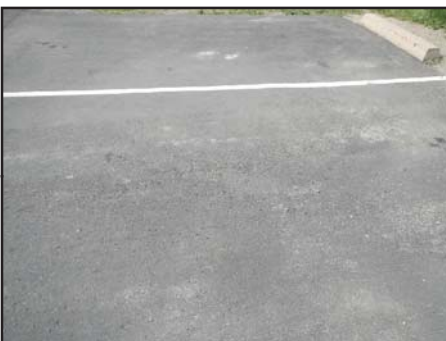
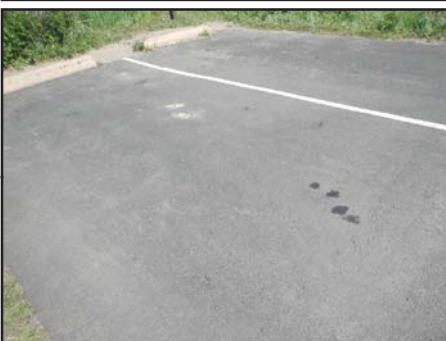
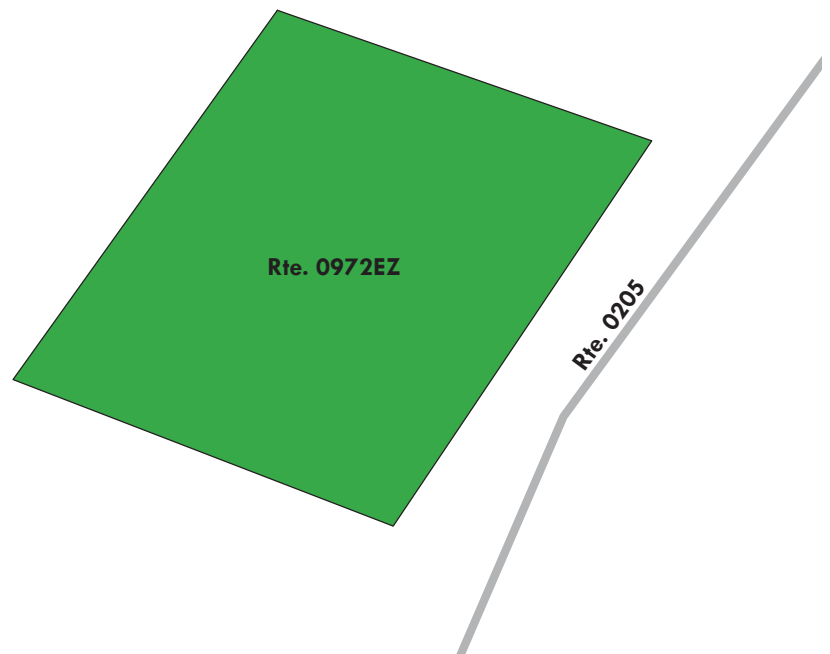
ROUTE 0972EZ: TCCG CAMPFIRE PROGRAM PARKING E

Inspection Date	FMSS Number	User Access	Surface Type
6/22/2017	104620	PUBLIC	ASPHALT
Area (Sq. Ft.)	Lane Miles (11' Widths)	Curb Reveal (Inches)	Curb Recommendation
430	0.007	NOT APPLICABLE	NOT APPLICABLE
Curb Type		Curb & Gutter Type	
NO CURB		NO CURB AND GUTTER	
Pavement Recommendation		Condition Rating / PCR	
PREVENTIVE MAINTENANCE		GOOD / 90

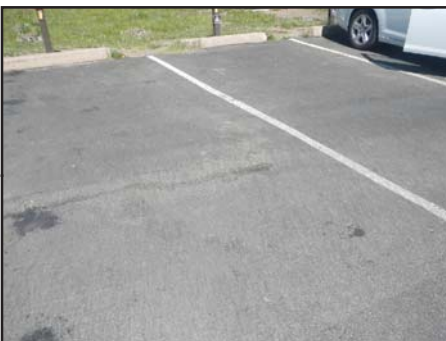
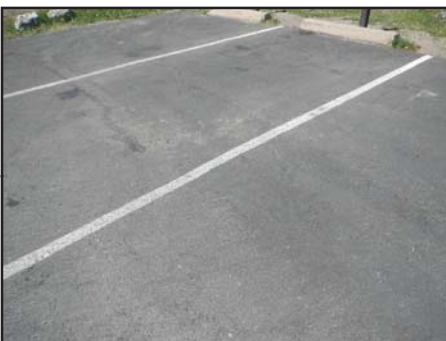
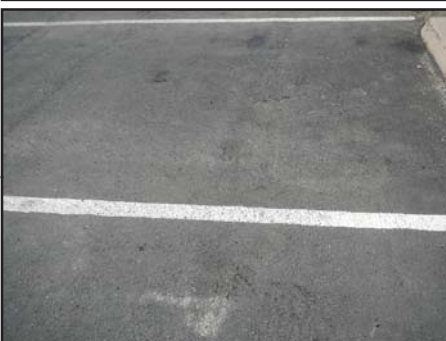
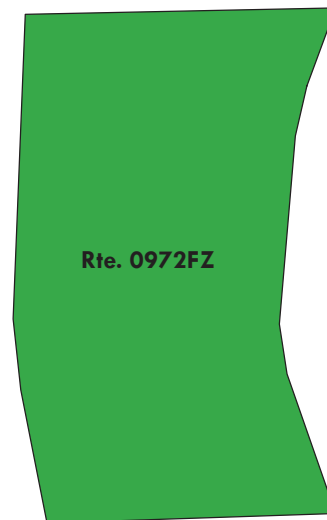
ROUTE 0972FZ: TCCG CAMPFIRE PROGRAM PARKING F

Inspection Date	FMSS Number	User Access	Surface Type
6/22/2017	104620	PUBLIC	ASPHALT
Area (Sq. Ft.)	Lane Miles (11' Widths)	Curb Reveal (Inches)	Curb Recommendation
778	0.013	NOT APPLICABLE	NOT APPLICABLE
Curb Type		Curb & Gutter Type	
NO CURB		NO CURB AND GUTTER	
Pavement Recommendation		Condition Rating / PCR	
PREVENTIVE MAINTENANCE		GOOD / 90

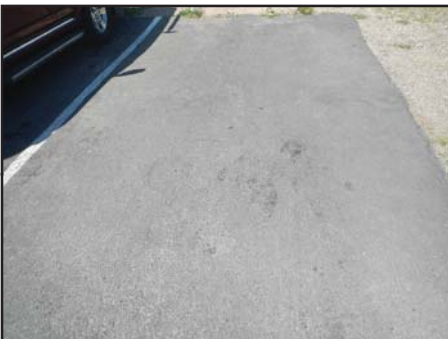
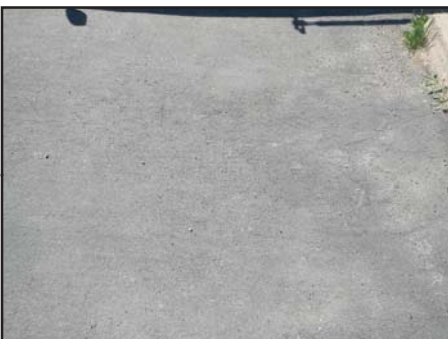
ROUTE 0972GZ: TCCG CAMPFIRE PROGRAM PARKING G

Inspection Date	FMSS Number	User Access	Surface Type
6/22/2017	104620	PUBLIC	ASPHALT
Area (Sq. Ft.)	Lane Miles (11' Widths)	Curb Reveal (Inches)	Curb Recommendation
527	0.009	NOT APPLICABLE	NOT APPLICABLE
Curb Type		Curb & Gutter Type	
NO CURB		NO CURB AND GUTTER	
Pavement Recommendation		Condition Rating / PCR	
PREVENTIVE MAINTENANCE		GOOD / 90

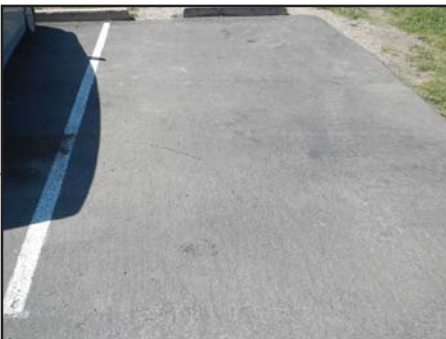
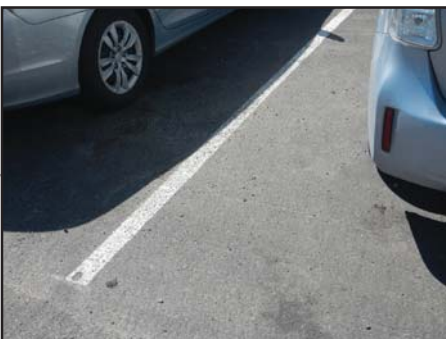
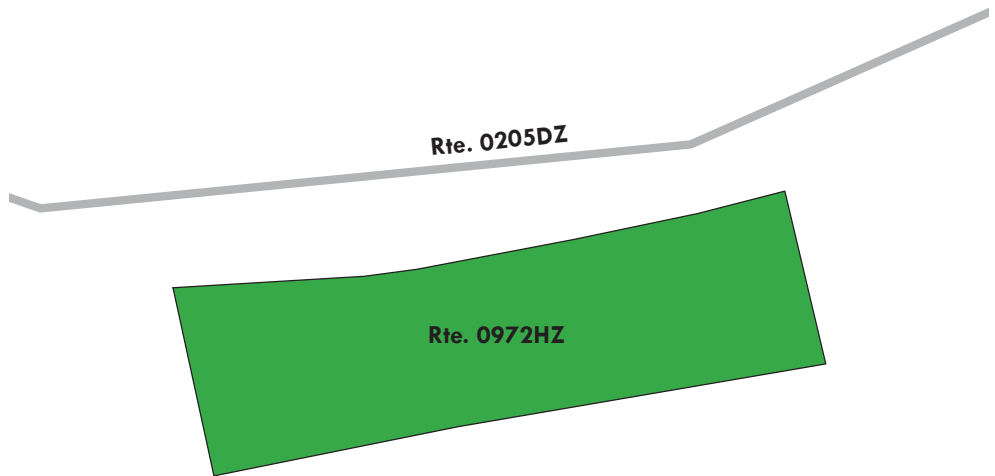
ROUTE 0972HZ: TCCG CAMPFIRE PROGRAM PARKING H

Inspection Date	FMSS Number	User Access	Surface Type
6/22/2017	104620	PUBLIC	ASPHALT
Area (Sq. Ft.)	Lane Miles (11' Widths)	Curb Reveal (Inches)	Curb Recommendation
944	0.016	NOT APPLICABLE	NOT APPLICABLE
Curb Type		Curb & Gutter Type	
NO CURB		NO CURB AND GUTTER	
Pavement Recommendation		Condition Rating / PCR	
PREVENTIVE MAINTENANCE		GOOD / 90

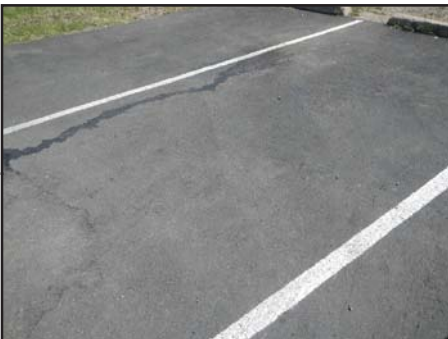
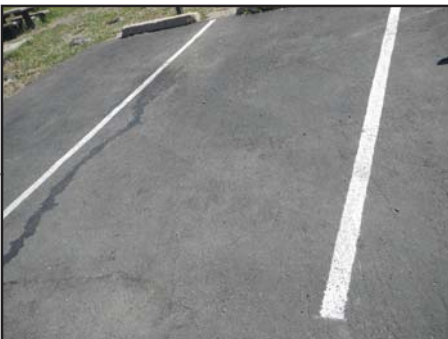
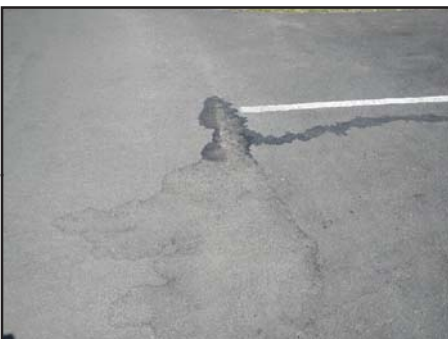
ROUTE 0972JZ: TCCG CAMPFIRE PROGRAM PARKING J

Inspection Date	FMSS Number	User Access	Surface Type
6/22/2017	104620	PUBLIC	ASPHALT
Area (Sq. Ft.)	Lane Miles (11' Widths)	Curb Reveal (Inches)	Curb Recommendation
798	0.014	NOT APPLICABLE	NOT APPLICABLE
Curb Type		Curb & Gutter Type	
NO CURB		NO CURB AND GUTTER	
Pavement Recommendation		Condition Rating / PCR	
PREVENTIVE MAINTENANCE		GOOD / 90

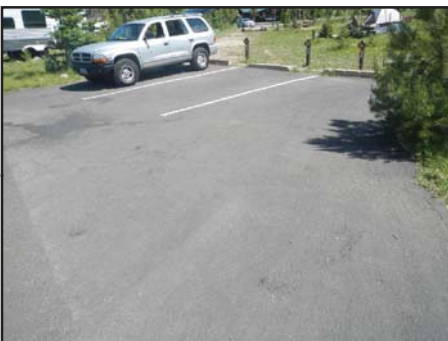
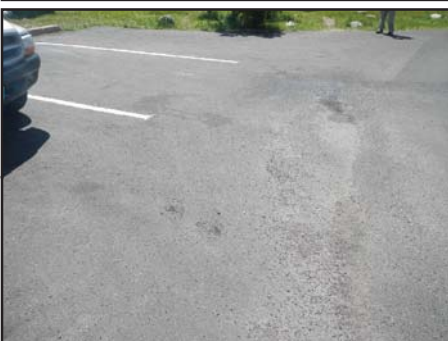
ROUTE 0973Z: TIMBER CREEK CAMPGROUND DUMP STATION

Inspection Date	FMSS Number	User Access	Surface Type
6/22/2017	104620	PUBLIC	ASPHALT
Area (Sq. Ft.)	Lane Miles (11' Widths)	Curb Reveal (Inches)	Curb Recommendation
3,800	0.065	NOT APPLICABLE	NOT APPLICABLE
Curb Type		Curb & Gutter Type	
NO CURB		NO CURB AND GUTTER	
Pavement Recommendation		Condition Rating / PCR	
PREVENTIVE MAINTENANCE		GOOD / 90

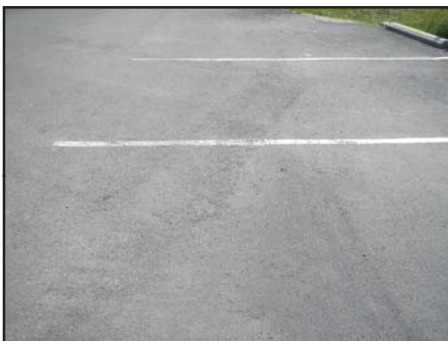
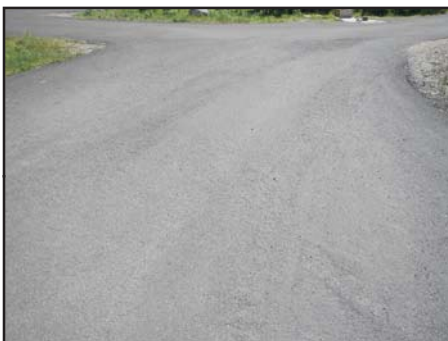
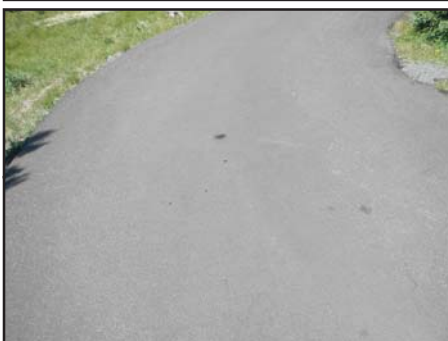
ROUTE 0974Z: TIMBER CREEK CAMPGROUND EMPLOYEE PARKING

Inspection Date	FMSS Number	User Access	Surface Type
6/22/2017	104620	PUBLIC	ASPHALT
Area (Sq. Ft.)	Lane Miles (11' Widths)	Curb Reveal (Inches)	Curb Recommendation
3,447	0.059	NOT APPLICABLE	NOT APPLICABLE
Curb Type		Curb & Gutter Type	
NO CURB		NO CURB AND GUTTER	
Pavement Recommendation		Condition Rating / PCR	
PREVENTIVE MAINTENANCE		GOOD / 90

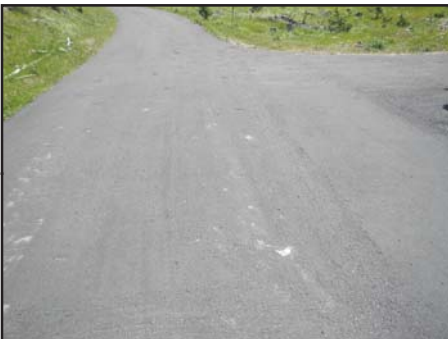
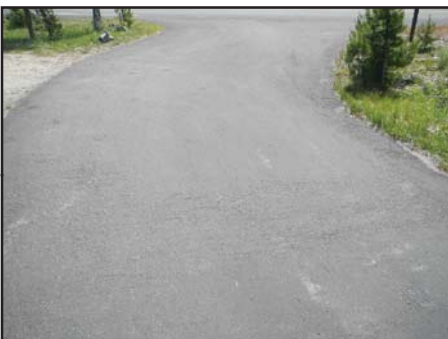
ROUTE 0976: BEAVER PONDS ROADSIDE PARKING CRD

Inspection Date	FMSS Number	User Access	Surface Type
6/22/2017	91466	PUBLIC	ASPHALT
Area (Sq. Ft.)	Lane Miles (11' Widths)	Curb Reveal (Inches)	Curb Recommendation
3,627	0.062	NOT APPLICABLE	NOT APPLICABLE
Curb Type		Curb & Gutter Type	
NO CURB		NO CURB AND GUTTER	
Pavement Recommendation		Condition Rating / PCR	
PREVENTIVE MAINTENANCE		GOOD / 90

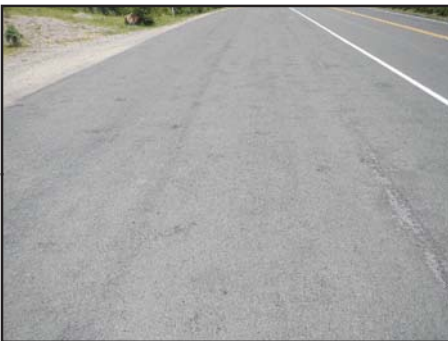
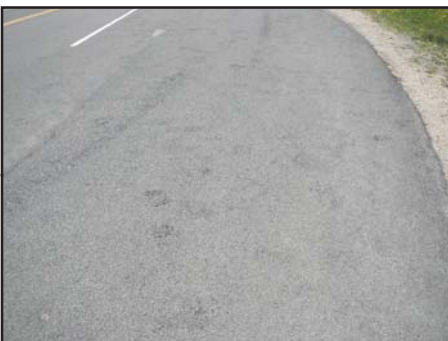
ROUTE 0977: HIGH COUNTRY THOROUGHFARE PARKING

Inspection Date	FMSS Number	User Access	Surface Type
6/22/2017	105365	PUBLIC	ASPHALT
Area (Sq. Ft.)	Lane Miles (11' Widths)	Curb Reveal (Inches)	Curb Recommendation
2,334	0.04	4	DO NOTHING
Curb Type		Curb & Gutter Type	
CONCRETE		NO CURB AND GUTTER	
Pavement Recommendation		Condition Rating / PCR	
PREVENTIVE MAINTENANCE		GOOD / 90

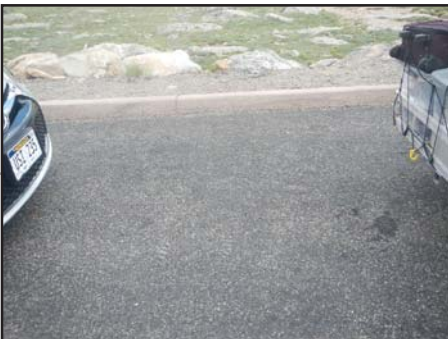
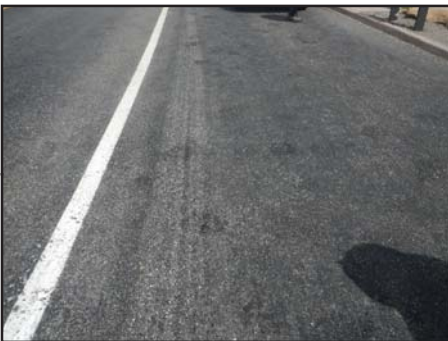
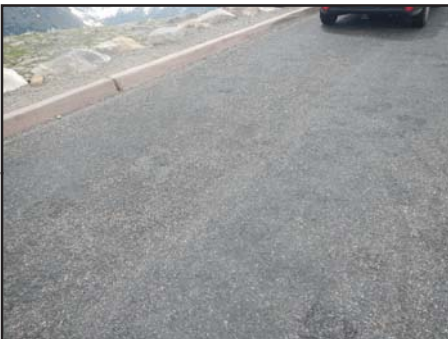
ROUTE 0981ZZ: ASPENGLLEN CAMPGROUND PARKING AREAS

Inspection Date	FMSS Number	User Access	Surface Type
6/21/2017	105246	PUBLIC	ASPHALT
Area (Sq. Ft.)	Lane Miles (11' Widths)	Condition Rating / PCR	
2,666	0.046	SUMMARY / 61

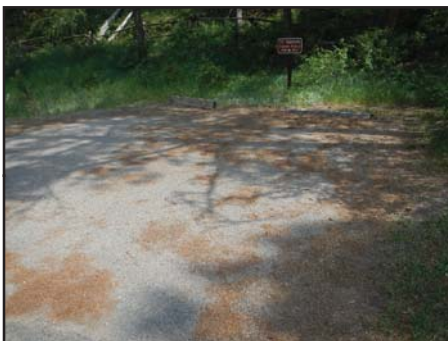
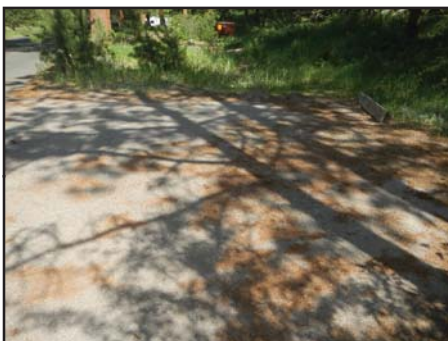
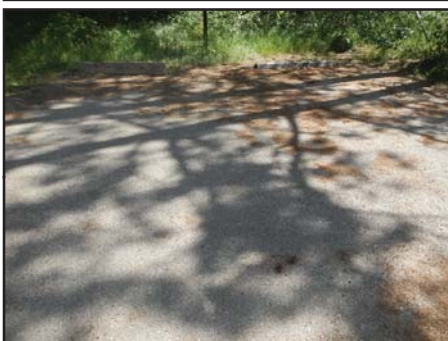
ROUTE 0982Z: ASPENGLLEN AMPHITHEATER PARKING

Inspection Date	FMSS Number	User Access	Surface Type
6/21/2017	105246	PUBLIC	ASPHALT
Area (Sq. Ft.)	Lane Miles (11' Widths)	Curb Reveal (Inches)	Curb Recommendation
1,527	0.026	NOT APPLICABLE	NOT APPLICABLE
Curb Type		Curb & Gutter Type	
NO CURB		NO CURB AND GUTTER	
Pavement Recommendation		Condition Rating / PCR	
LIGHT 3R TREATMENTS		FAIR / 73

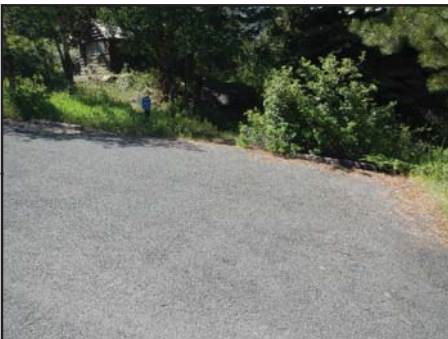
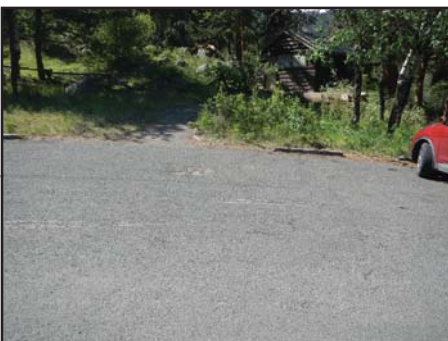
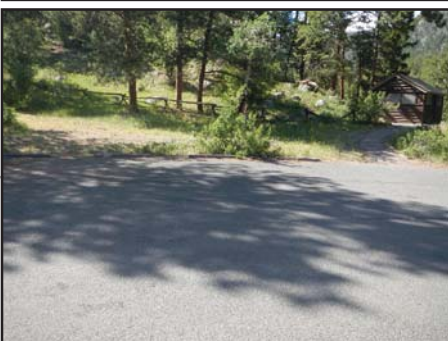
ROUTE 0983Z: ASPENGLLEN LOOP B COMFORT STATION PARKING

Inspection Date	FMSS Number	User Access	Surface Type
6/21/2017	105246	PUBLIC	ASPHALT
Area (Sq. Ft.)	Lane Miles (11' Widths)	Curb Reveal (Inches)	Curb Recommendation
439	0.008	NOT APPLICABLE	NOT APPLICABLE
Curb Type		Curb & Gutter Type	
NO CURB		NO CURB AND GUTTER	
Pavement Recommendation		Condition Rating / PCR	
RECONSTRUCTION		POOR / 0

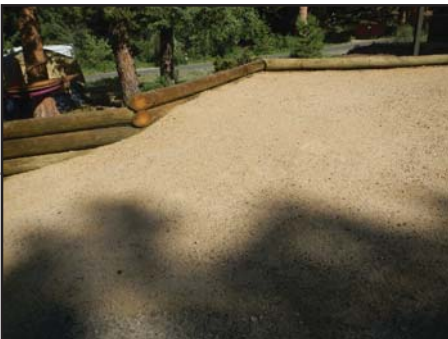
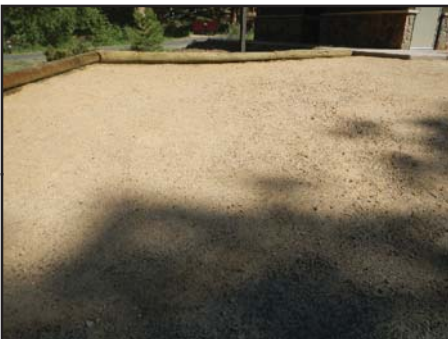
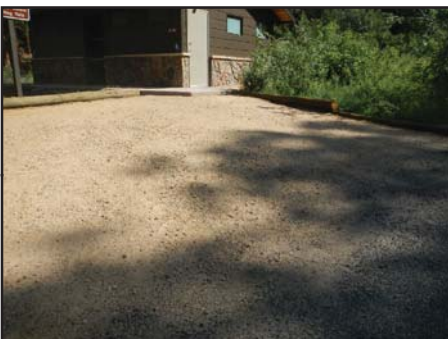
ROUTE 0984ZZ: GLACIER BASIN CAMPGROUND PARKING AREAS

Inspection Date	FMSS Number	User Access	Surface Type
6/22/2017	105265	PUBLIC	ASPHALT
Area (Sq. Ft.)	Lane Miles (11' Widths)	Condition Rating / PCR	
16,940	0.291	SUMMARY / 92

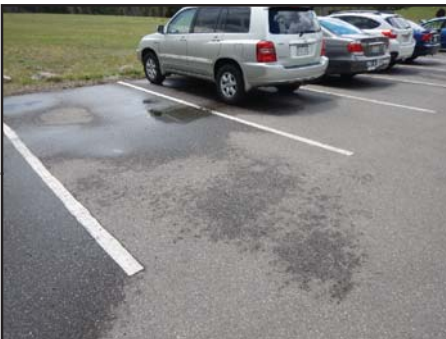
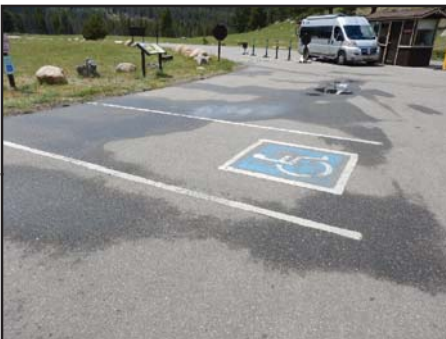
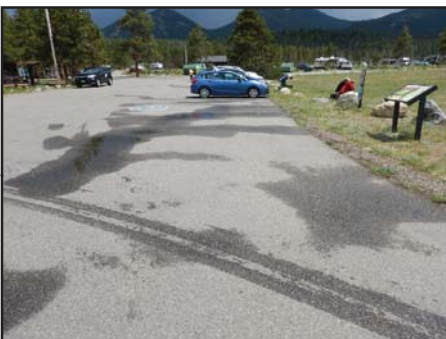
ROUTE 0985Z: GLACIER BASIN GROUP SITE PARKING

Inspection Date	FMSS Number	User Access	Surface Type
6/22/2017	105265	PUBLIC	ASPHALT
Area (Sq. Ft.)	Lane Miles (11' Widths)	Curb Reveal (Inches)	Curb Recommendation
4,014	0.069	NOT APPLICABLE	NOT APPLICABLE
Curb Type		Curb & Gutter Type	
NO CURB		NO CURB AND GUTTER	
Pavement Recommendation		Condition Rating / PCR	
DO NOTHING		EXCELLENT / 97

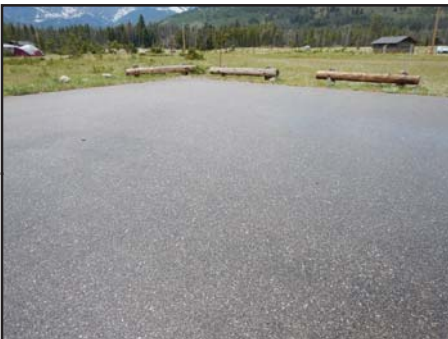
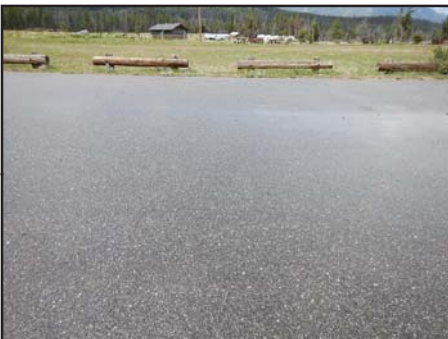
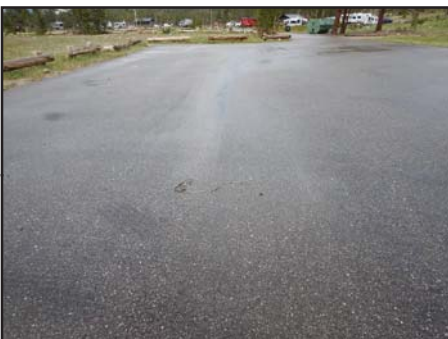
ROUTE 0988Z: GLACIER BASIN CAMPGROUND BUS LOOP

Inspection Date	FMSS Number	User Access	Surface Type
6/22/2017	105265	PUBLIC	CONCRETE
Area (Sq. Ft.)	Lane Miles (11' Widths)	Curb Reveal (Inches)	Curb Recommendation
1,978	0.034	NOT APPLICABLE	NOT APPLICABLE
Curb Type		Curb & Gutter Type	
NO CURB		NO CURB AND GUTTER	
Pavement Recommendation		Condition Rating / PCR	
PREVENTIVE MAINTENANCE		GOOD / 90

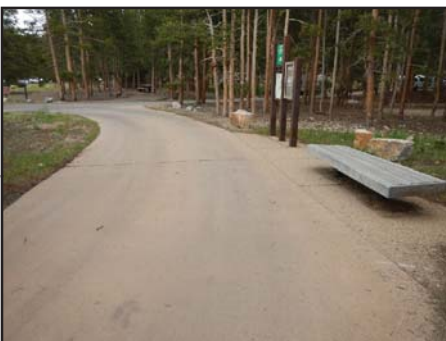
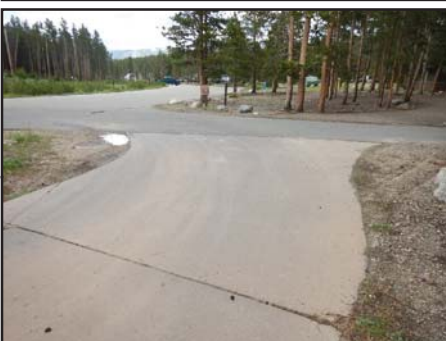
ROUTE 1013Z: GLACIER BASIN CAMPGROUND DUMP STATION

Inspection Date	FMSS Number	User Access	Surface Type
6/22/2017	105265	PUBLIC	ASPHALT
Area (Sq. Ft.)	Lane Miles (11' Widths)	Curb Reveal (Inches)	Curb Recommendation
1,915	0.033	NOT APPLICABLE	NOT APPLICABLE
Curb Type		Curb & Gutter Type	
NO CURB		NO CURB AND GUTTER	
Pavement Recommendation		Condition Rating / PCR	
PREVENTIVE MAINTENANCE		GOOD / 90

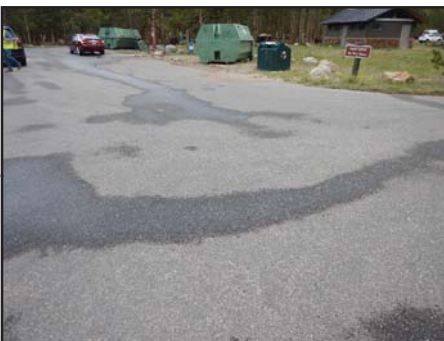
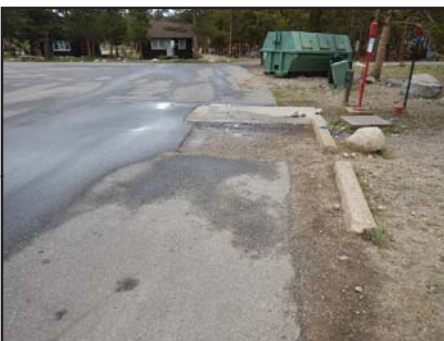
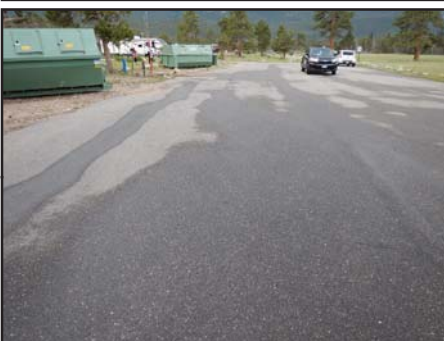
ROUTE 1039Z: GLACIER BASIN AMPHITHEATER PARKING

Inspection Date	FMSS Number	User Access	Surface Type
6/22/2017	105265	PUBLIC	ASPHALT
Area (Sq. Ft.)	Lane Miles (11' Widths)	Curb Reveal (Inches)	Curb Recommendation
6,394	0.11	NOT APPLICABLE	NOT APPLICABLE
Curb Type		Curb & Gutter Type	
NO CURB		NO CURB AND GUTTER	
Pavement Recommendation		Condition Rating / PCR	
PREVENTIVE MAINTENANCE		GOOD / 90

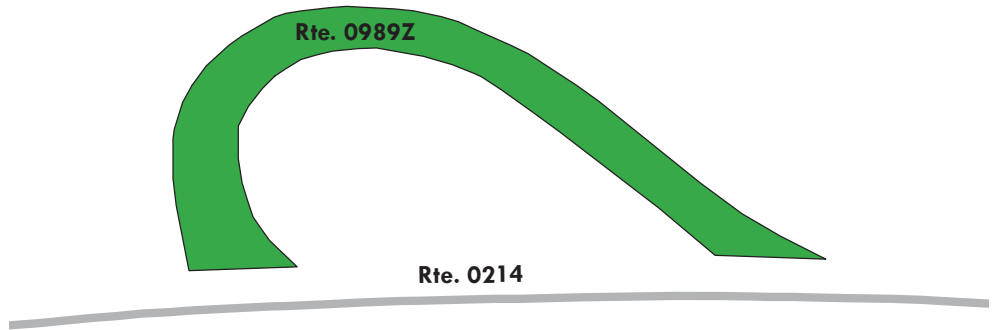
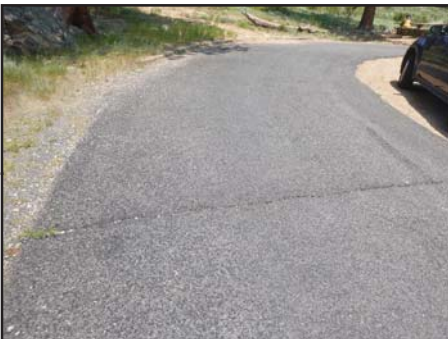
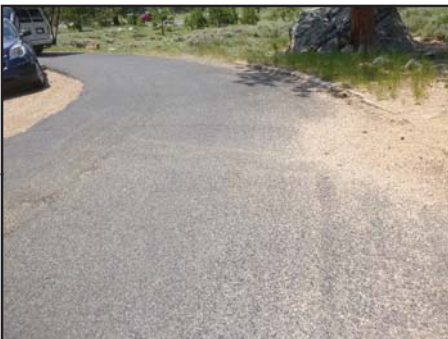
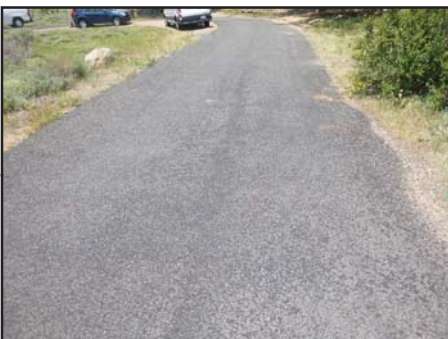
ROUTE 0989Z: HALLOWELL PARK ROAD PARKING #1

Inspection Date	FMSS Number	User Access	Surface Type
6/28/2017	91468	PUBLIC	ASPHALT
Area (Sq. Ft.)	Lane Miles (11' Widths)	Curb Reveal (Inches)	Curb Recommendation
2,576	0.044	NOT APPLICABLE	NOT APPLICABLE
Curb Type		Curb & Gutter Type	
NO CURB		NO CURB AND GUTTER	
Pavement Recommendation		Condition Rating / PCR	
PREVENTIVE MAINTENANCE		GOOD / 90

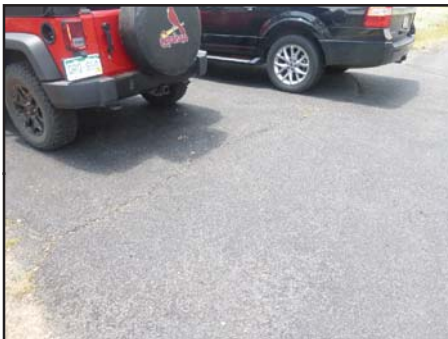
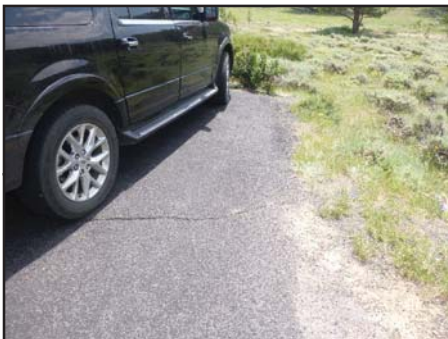
ROUTE 0990Z: HALLOWELL PARK ROAD PARKING #2

Inspection Date	FMSS Number	User Access	Surface Type
6/28/2017	91468	PUBLIC	ASPHALT
Area (Sq. Ft.)	Lane Miles (11' Widths)	Curb Reveal (Inches)	Curb Recommendation
450	0.008	NOT APPLICABLE	NOT APPLICABLE
Curb Type		Curb & Gutter Type	
NO CURB		NO CURB AND GUTTER	
Pavement Recommendation		Condition Rating / PCR	
PREVENTIVE MAINTENANCE		GOOD / 90

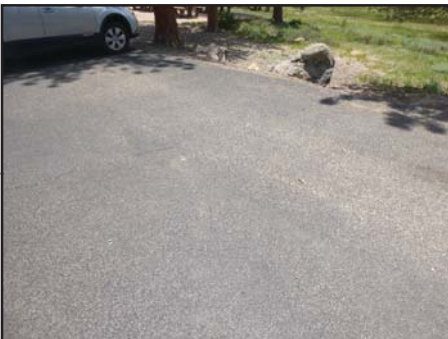
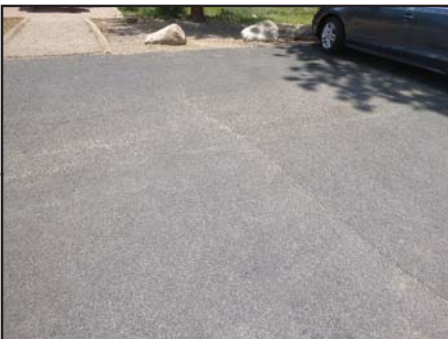
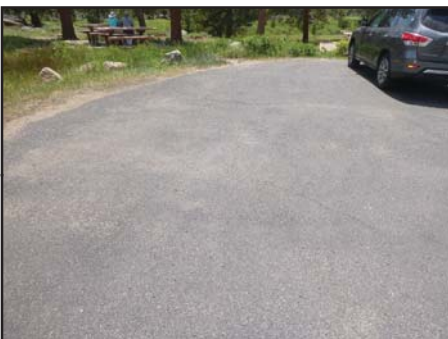
ROUTE 0991Z: HALLOWELL PARK ROAD PARKING #3

Inspection Date	FMSS Number	User Access	Surface Type
6/28/2017	91468	PUBLIC	ASPHALT
Area (Sq. Ft.)	Lane Miles (11' Widths)	Curb Reveal (Inches)	Curb Recommendation
2,344	0.04	NOT APPLICABLE	NOT APPLICABLE
Curb Type		Curb & Gutter Type	
NO CURB		NO CURB AND GUTTER	
Pavement Recommendation		Condition Rating / PCR	
PREVENTIVE MAINTENANCE		GOOD / 90

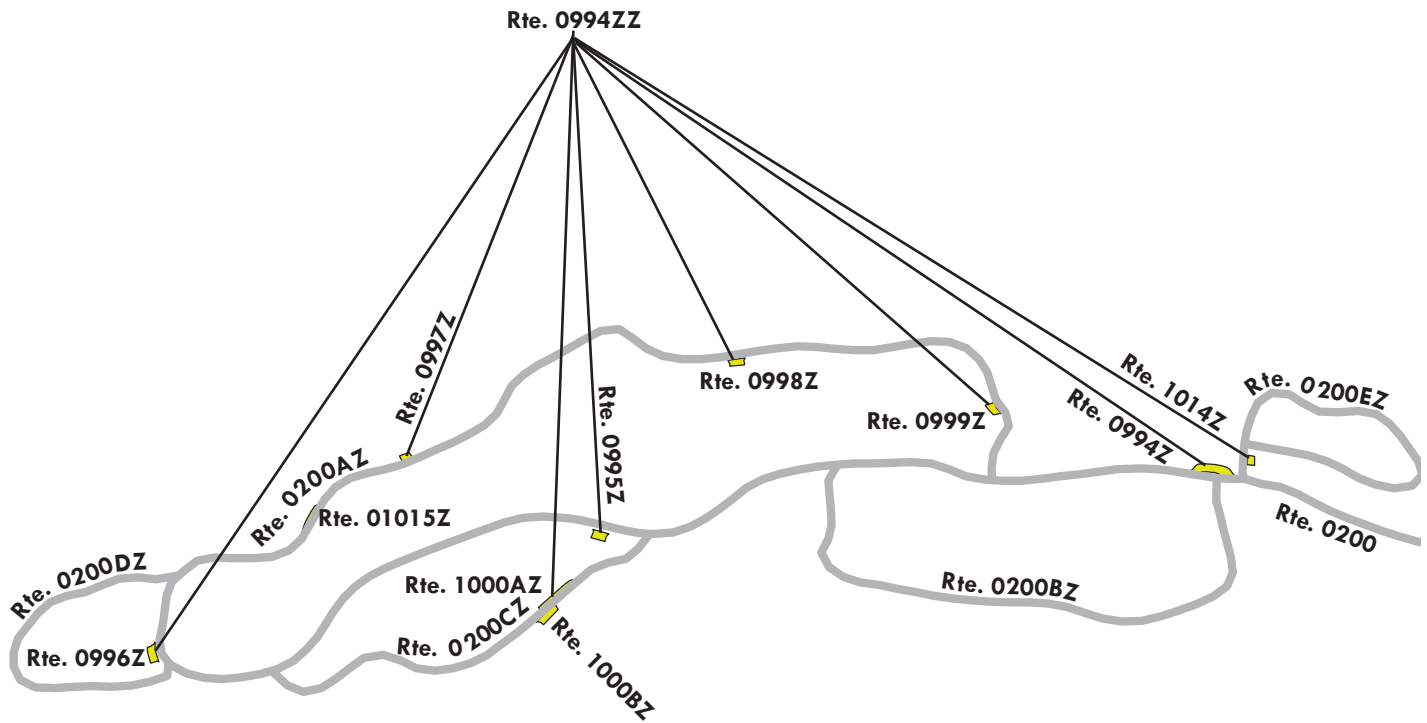
ROUTE 0994ZZ: MORAINE PARK CAMPGROUND PARKING AREAS

Inspection Date	FMSS Number	User Access	Surface Type
6/28/2017	105264	PUBLIC	ASPHALT
Area (Sq. Ft.)	Lane Miles (11' Widths)	Condition Rating / PCR	
13,721	0.237	SUMMARY / 79

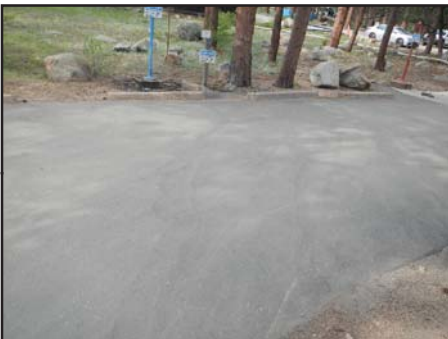
ROUTE 0994Z: MORaine PARK CAMPGROUND DUMP STATION

Inspection Date	FMSS Number	User Access	Surface Type
6/21/2017	105264	PUBLIC	ASPHALT
Area (Sq. Ft.)	Lane Miles (11' Widths)	Curb Reveal (Inches)	Curb Recommendation
3,476	0.06	NOT APPLICABLE	NOT APPLICABLE
Curb Type		Curb & Gutter Type	
NO CURB		NO CURB AND GUTTER	
Pavement Recommendation		Condition Rating / PCR	
PREVENTIVE MAINTENANCE		GOOD / 90

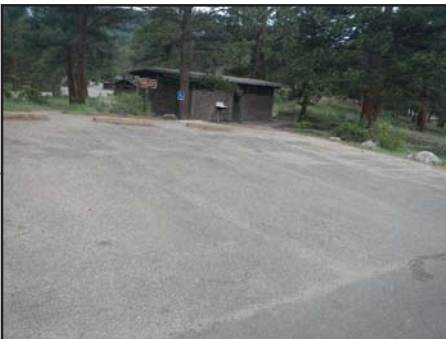
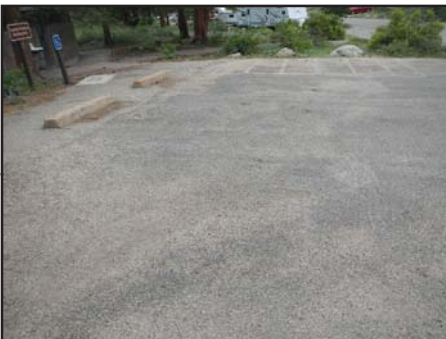
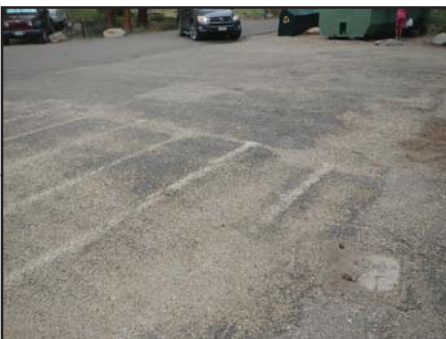
ROUTE 0996Z: MORaine PARK LOOP A COMFORT STATION PARKING 2

Inspection Date	FMSS Number	User Access	Surface Type
6/21/2017	105264	PUBLIC	ASPHALT
Area (Sq. Ft.)	Lane Miles (11' Widths)	Curb Reveal (Inches)	Curb Recommendation
1,311	0.023	NOT APPLICABLE	NOT APPLICABLE
Curb Type		Curb & Gutter Type	
NO CURB		NO CURB AND GUTTER	
Pavement Recommendation		Condition Rating / PCR	
RECONSTRUCTION		POOR / 0

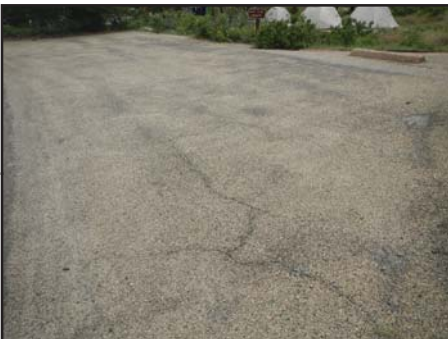
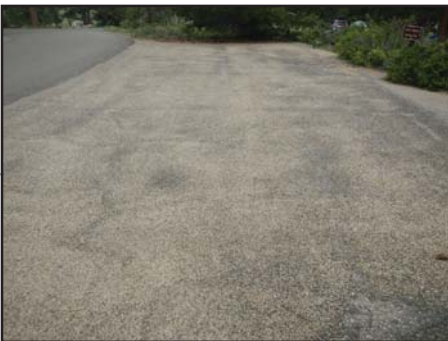
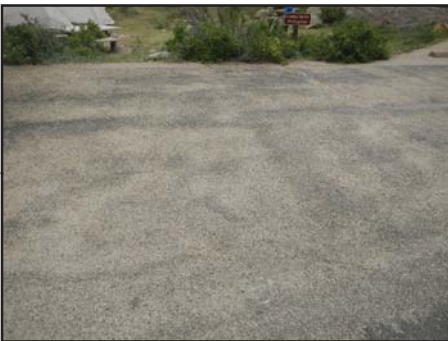
ROUTE 0997Z: MORAINES PARK LOOP A COMFORT STATION PARKING 3

Inspection Date	FMSS Number	User Access	Surface Type
6/21/2017	105264	PUBLIC	ASPHALT
Area (Sq. Ft.)	Lane Miles (11' Widths)	Curb Reveal (Inches)	Curb Recommendation
704	0.012	NOT APPLICABLE	NOT APPLICABLE
Curb Type		Curb & Gutter Type	
NO CURB		NO CURB AND GUTTER	
Pavement Recommendation		Condition Rating / PCR	
PREVENTIVE MAINTENANCE		GOOD / 90

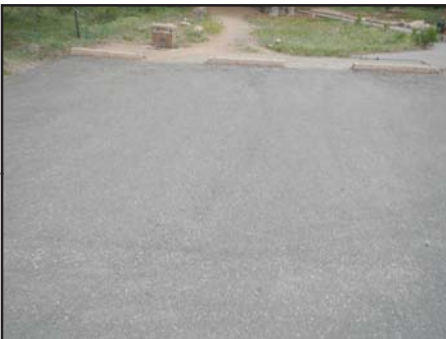
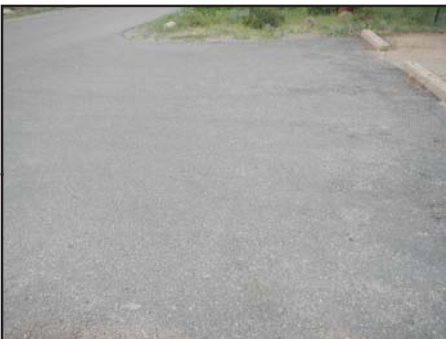
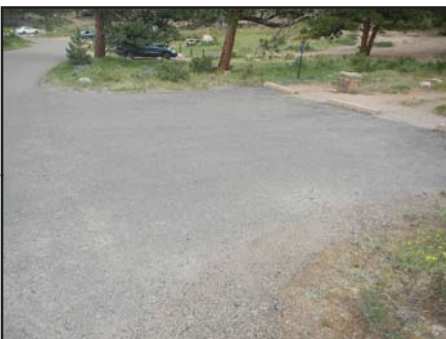
ROUTE 0998Z: MORaine PARK LOOP A COMFORT STATION PARKING 4

Inspection Date	FMSS Number	User Access	Surface Type
6/21/2017	105264	PUBLIC	ASPHALT
Area (Sq. Ft.)	Lane Miles (11' Widths)	Curb Reveal (Inches)	Curb Recommendation
969	0.017	NOT APPLICABLE	NOT APPLICABLE
Curb Type		Curb & Gutter Type	
NO CURB		NO CURB AND GUTTER	
Pavement Recommendation		Condition Rating / PCR	
LIGHT 3R TREATMENTS		FAIR / 73

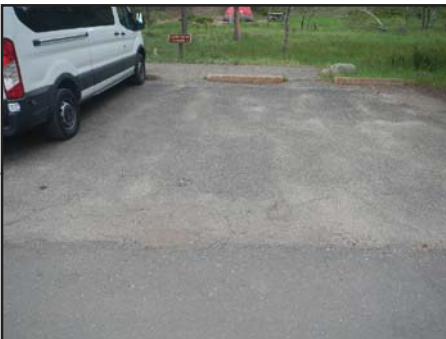
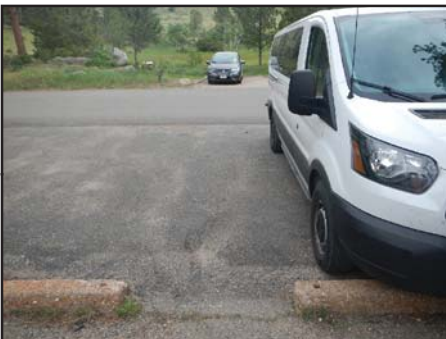
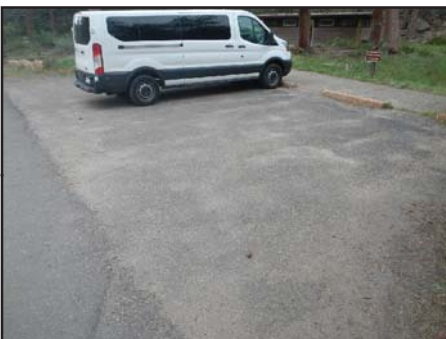
ROUTE 0999Z: MORaine PARK LOOP A COMFORT STATION PARKING 5

Inspection Date	FMSS Number	User Access	Surface Type
6/21/2017	105264	PUBLIC	ASPHALT
Area (Sq. Ft.)	Lane Miles (11' Widths)	Curb Reveal (Inches)	Curb Recommendation
943	0.016	NOT APPLICABLE	NOT APPLICABLE
Curb Type		Curb & Gutter Type	
NO CURB		NO CURB AND GUTTER	
Pavement Recommendation		Condition Rating / PCR	
PREVENTIVE MAINTENANCE		GOOD / 90
