ROMO Cycle 6

Final Report

Road Inventory and Condition Assessment of Paved Routes Rocky Mountain National Park

**Federal Highway Administration
Eastern Federal Lands Highway Division
Road Inventory Program (RIP)**

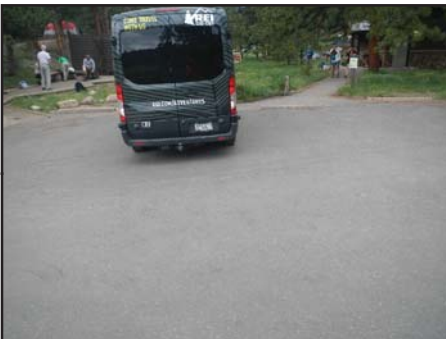
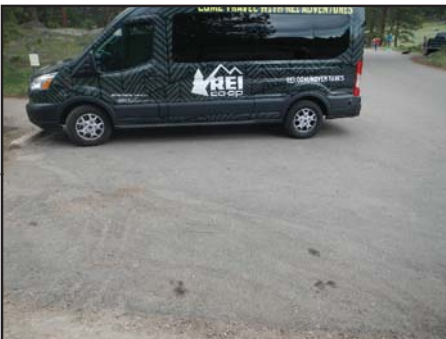
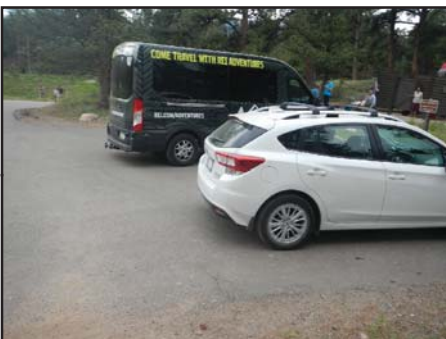
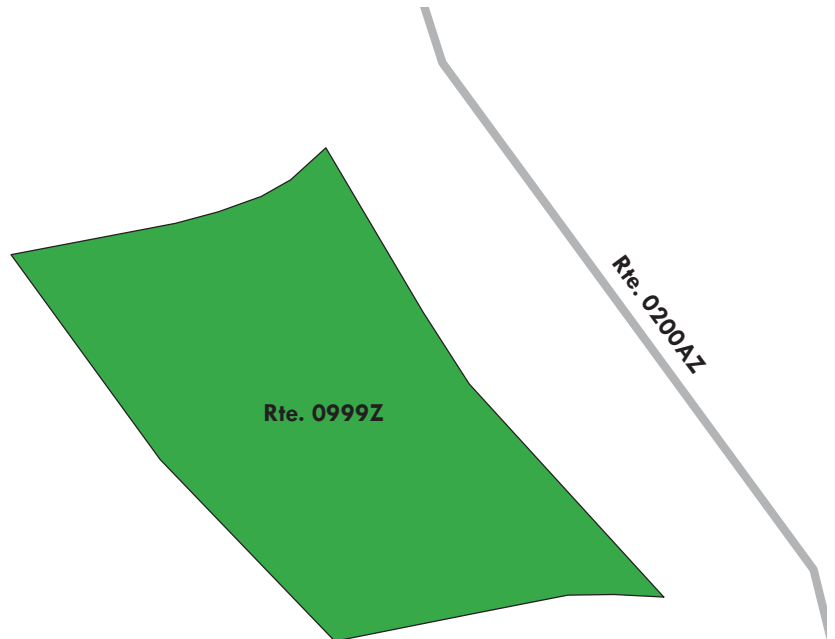
ROUTE 1000AZ: MORaine PARK LOOP C AMPHITHEATER PARKING A

Inspection Date	FMSS Number	User Access	Surface Type
6/28/2017	105264	PUBLIC	ASPHALT
Area (Sq. Ft.)	Lane Miles (11' Widths)	Curb Reveal (Inches)	Curb Recommendation
1,967	0.034	NOT APPLICABLE	NOT APPLICABLE
Curb Type		Curb & Gutter Type	
NO CURB		NO CURB AND GUTTER	
Pavement Recommendation		Condition Rating / PCR	
PREVENTIVE MAINTENANCE		GOOD / 90

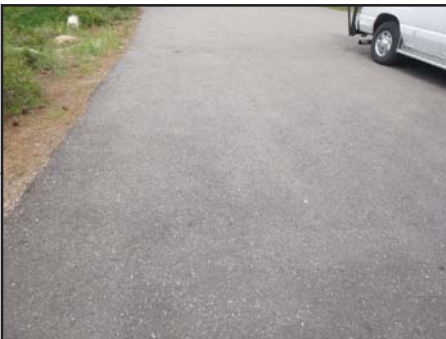
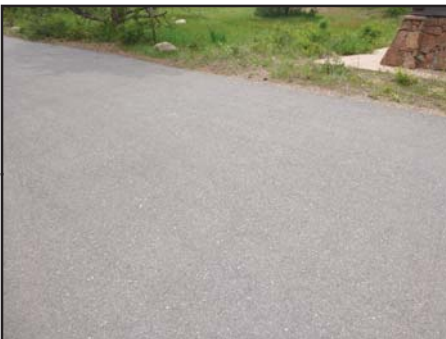
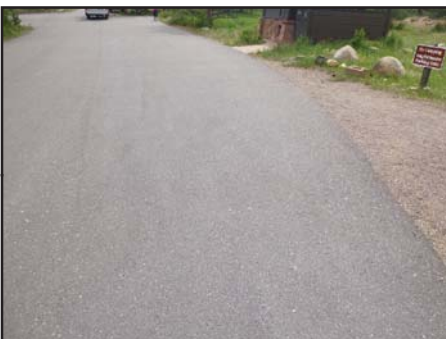
ROUTE 1000BZ: MORaine PARK LOOP C AMPHITHEATER PARKING B

Inspection Date	FMSS Number	User Access	Surface Type
6/28/2017	105264	PUBLIC	ASPHALT
Area (Sq. Ft.)	Lane Miles (11' Widths)	Curb Reveal (Inches)	Curb Recommendation
1,562	0.027	NOT APPLICABLE	NOT APPLICABLE
Curb Type		Curb & Gutter Type	
NO CURB		NO CURB AND GUTTER	
Pavement Recommendation		Condition Rating / PCR	
PREVENTIVE MAINTENANCE		GOOD / 90

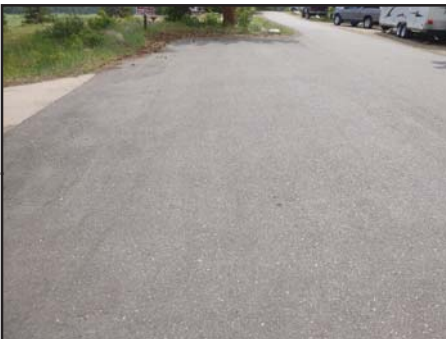
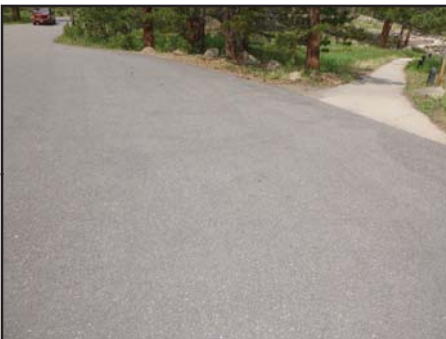
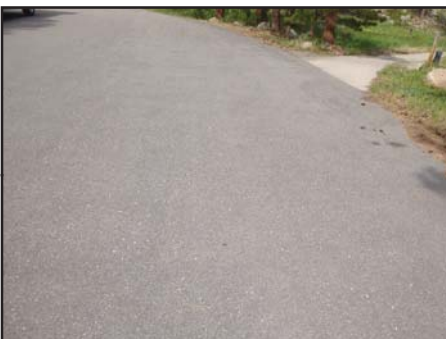
ROUTE 1014Z: MORaine PARK CAMPGROUND EMPLOYEE PARKING

Inspection Date	FMSS Number	User Access	Surface Type
6/21/2017	105264	PUBLIC	ASPHALT
Area (Sq. Ft.)	Lane Miles (11' Widths)	Curb Reveal (Inches)	Curb Recommendation
698	0.012	NOT APPLICABLE	NOT APPLICABLE
Curb Type		Curb & Gutter Type	
NO CURB		NO CURB AND GUTTER	
Pavement Recommendation		Condition Rating / PCR	
PREVENTIVE MAINTENANCE		GOOD / 90

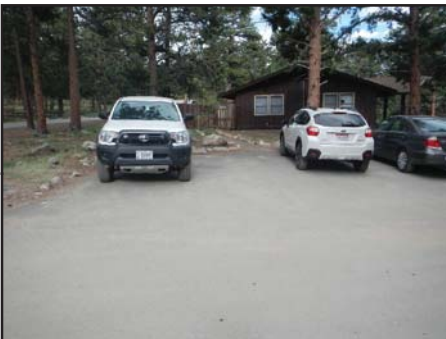
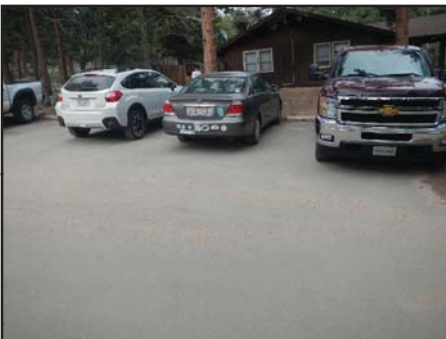
ROUTE 1015Z: MORaine PARK LOOP A COMFORT STATION PARKING 2B

Inspection Date	FMSS Number	User Access	Surface Type
6/21/2017	105264	PUBLIC	ASPHALT
Area (Sq. Ft.)	Lane Miles (11' Widths)	Curb Reveal (Inches)	Curb Recommendation
901	0.016	NOT APPLICABLE	NOT APPLICABLE
Curb Type		Curb & Gutter Type	
NO CURB		NO CURB AND GUTTER	
Pavement Recommendation		Condition Rating / PCR	
PREVENTIVE MAINTENANCE		GOOD / 90

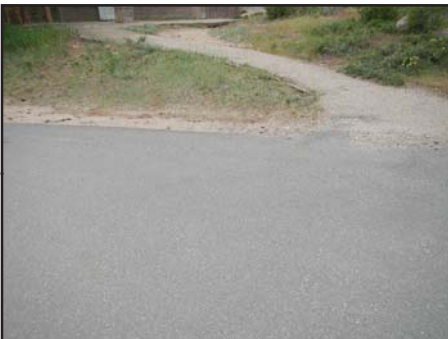
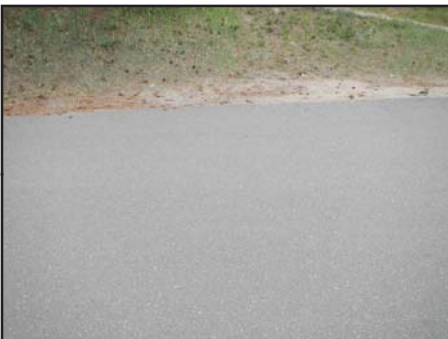
ROUTE 1008A: PARKING AREA A

Inspection Date	FMSS Number	User Access	Surface Type
6/22/2017	105359	PUBLIC	ASPHALT
Area (Sq. Ft.)	Lane Miles (11' Widths)	Curb Reveal (Inches)	Curb Recommendation
1,476	0.025	NOT APPLICABLE	DO NOTHING
Curb Type		Curb & Gutter Type	
NO CURB		CONCRETE	
Pavement Recommendation		Condition Rating / PCR	
PREVENTIVE MAINTENANCE		GOOD / 90

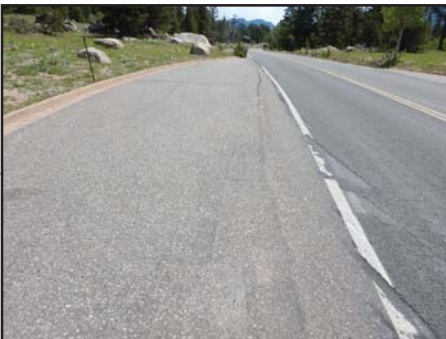
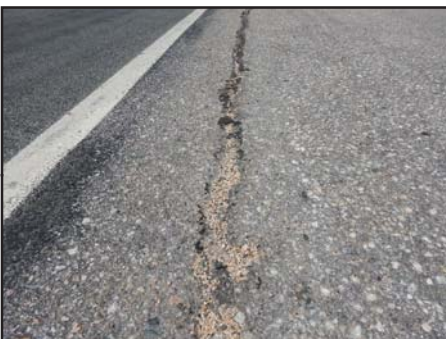
ROUTE 1008B: PARKING AREA B

Inspection Date	FMSS Number	User Access	Surface Type
6/22/2017	105360	PUBLIC	ASPHALT
Area (Sq. Ft.)	Lane Miles (11' Widths)	Curb Reveal (Inches)	Curb Recommendation
902	0.016	NOT APPLICABLE	DO NOTHING
Curb Type		Curb & Gutter Type	
NO CURB		CONCRETE	
Pavement Recommendation		Condition Rating / PCR	
PREVENTIVE MAINTENANCE		GOOD / 90

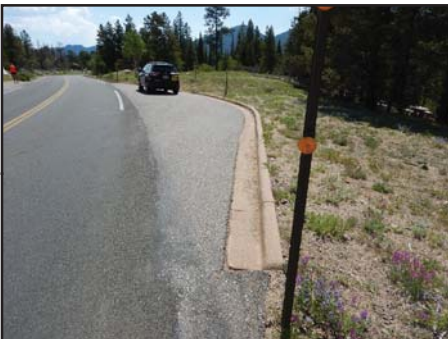
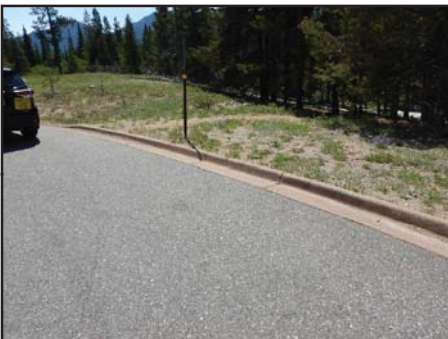
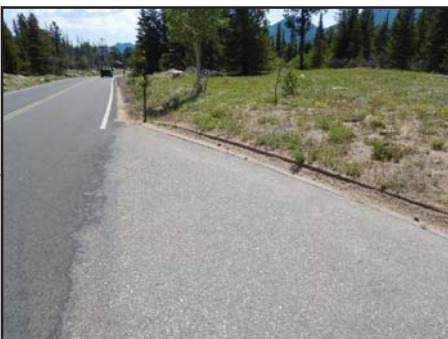
ROUTE 1009: PARKING AREA #3

Inspection Date	FMSS Number	User Access	Surface Type
6/22/2017	105361	PUBLIC	ASPHALT
Area (Sq. Ft.)	Lane Miles (11' Widths)	Curb Reveal (Inches)	Curb Recommendation
1,518	0.026	NOT APPLICABLE	DO NOTHING
Curb Type		Curb & Gutter Type	
NO CURB		CONCRETE	
Pavement Recommendation		Condition Rating / PCR	
PREVENTIVE MAINTENANCE		GOOD / 90

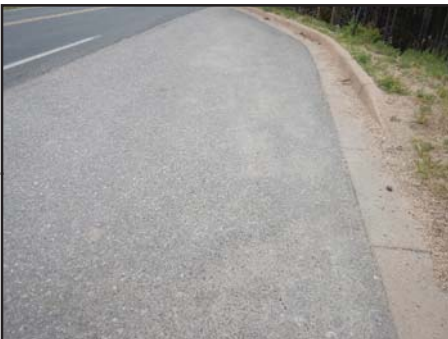
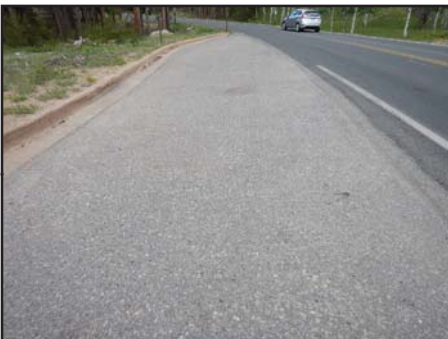
ROUTE 1010: PARKING AREA #2

Inspection Date	FMSS Number	User Access	Surface Type
6/22/2017	105362	PUBLIC	ASPHALT
Area (Sq. Ft.)	Lane Miles (11' Widths)	Curb Reveal (Inches)	Curb Recommendation
1,293	0.022	NOT APPLICABLE	DO NOTHING
Curb Type		Curb & Gutter Type	
NO CURB		CONCRETE	
Pavement Recommendation		Condition Rating / PCR	
PREVENTIVE MAINTENANCE		GOOD / 90

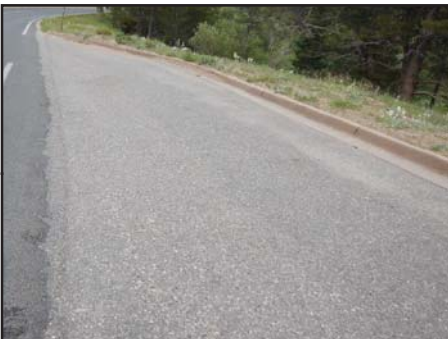
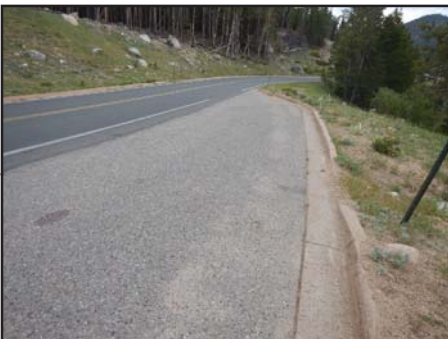
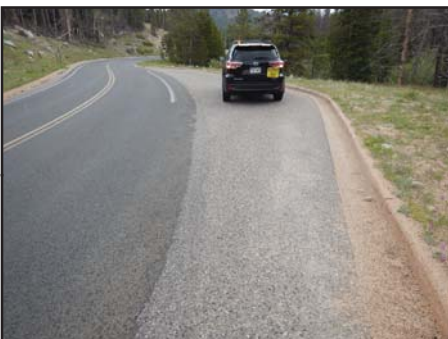
ROUTE 1011: PARKING AREA #1

Inspection Date	FMSS Number	User Access	Surface Type
6/22/2017	105363	PUBLIC	ASPHALT
Area (Sq. Ft.)	Lane Miles (11' Widths)	Curb Reveal (Inches)	Curb Recommendation
776	0.013	NOT APPLICABLE	DO NOTHING
Curb Type		Curb & Gutter Type	
NO CURB		CONCRETE	
Pavement Recommendation		Condition Rating / PCR	
PREVENTIVE MAINTENANCE		GOOD / 90

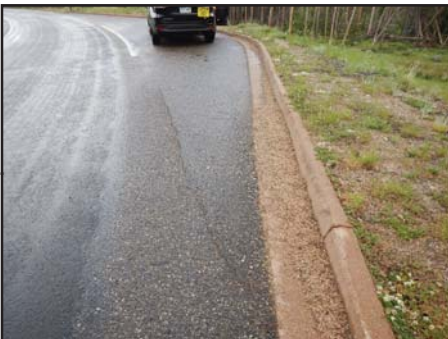
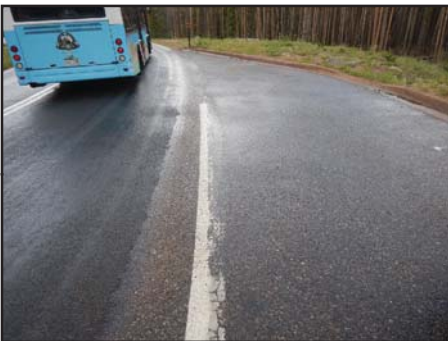
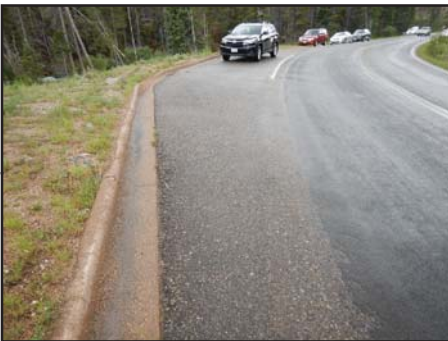
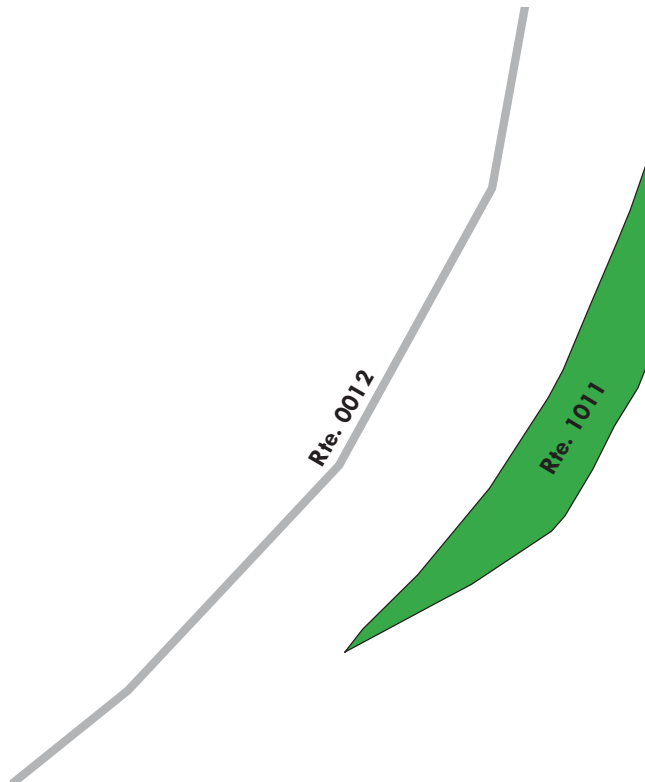
ROUTE 1012ZZ: GLACIER CREEK STABLES PARKING AREAS

Inspection Date	FMSS Number	User Access	Surface Type
6/22/2017	105364	PUBLIC	ASPHALT
Area (Sq. Ft.)	Lane Miles (11' Widths)	Condition Rating / PCR	
8,701	0.151	SUMMARY / 90

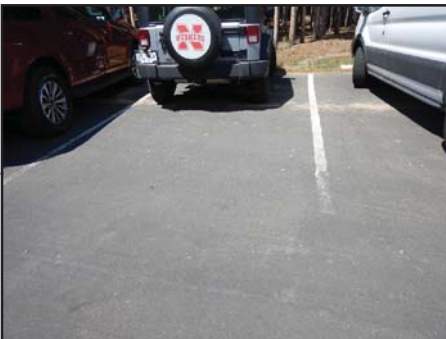
ROUTE 1012BZ: GLACIER CREEK RIDING STABLE PARKING AREA B

Inspection Date	FMSS Number	User Access	Surface Type
6/22/2017	105364	PUBLIC	ASPHALT
Area (Sq. Ft.)	Lane Miles (11' Widths)	Curb Reveal (Inches)	Curb Recommendation
3,341	0.058	NOT APPLICABLE	NOT APPLICABLE
Curb Type		Curb & Gutter Type	
NO CURB		NO CURB AND GUTTER	
Pavement Recommendation		Condition Rating / PCR	
PREVENTIVE MAINTENANCE		GOOD / 90

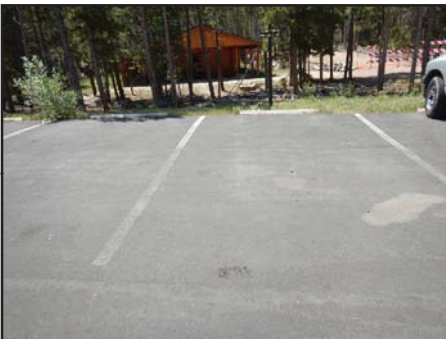
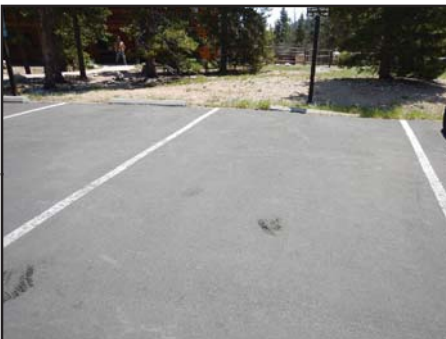
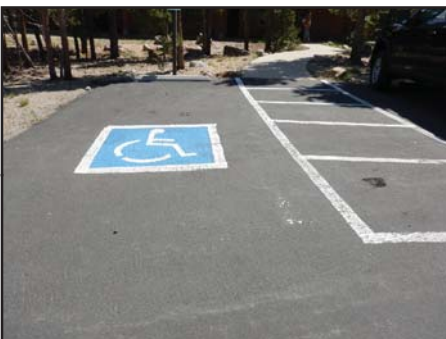
ROUTE 1012CZ: GLACIER CREEK RIDING STABLE PARKING AREA C

Inspection Date	FMSS Number	User Access	Surface Type
6/22/2017	105364	PUBLIC	ASPHALT
Area (Sq. Ft.)	Lane Miles (11' Widths)	Curb Reveal (Inches)	Curb Recommendation
3,873	0.067	NOT APPLICABLE	NOT APPLICABLE
Curb Type		Curb & Gutter Type	
NO CURB		NO CURB AND GUTTER	
Pavement Recommendation		Condition Rating / PCR	
PREVENTIVE MAINTENANCE		GOOD / 90

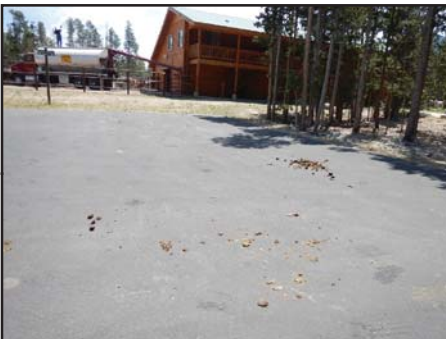
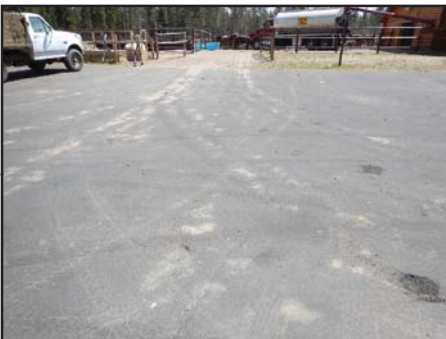
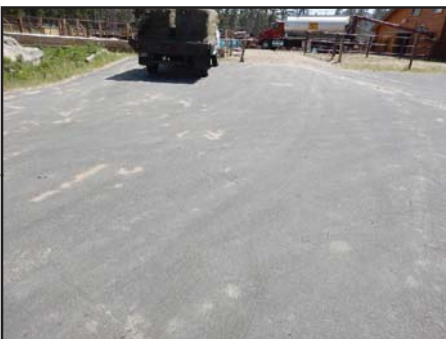
ROUTE 1016: MORaine PARK PARKING AREA

Inspection Date	FMSS Number	User Access	Surface Type
6/28/2017	105340	PUBLIC	ASPHALT
Area (Sq. Ft.)	Lane Miles (11' Widths)	Curb Reveal (Inches)	Curb Recommendation
1,780	0.031	NOT APPLICABLE	NOT APPLICABLE
Curb Type		Curb & Gutter Type	
NO CURB		NO CURB AND GUTTER	
Pavement Recommendation		Condition Rating / PCR	
RECONSTRUCTION		POOR / 0

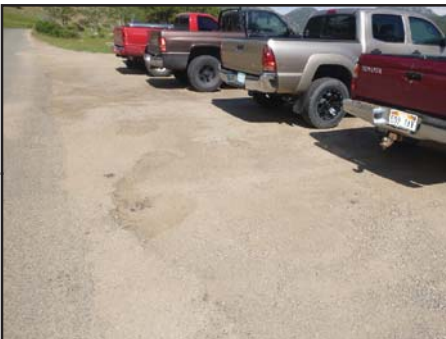
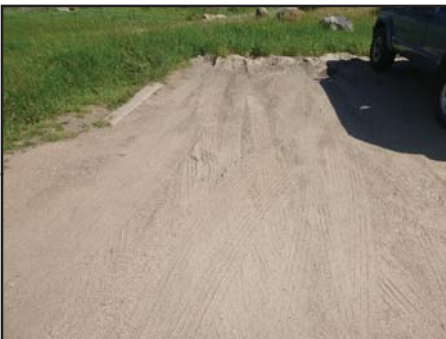
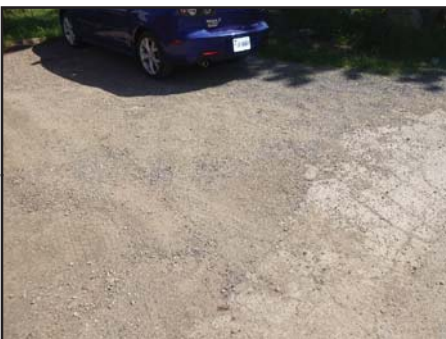
ROUTE 1022: SANDBEACH LAKE TRAILHEAD PARKING AREA

Inspection Date	FMSS Number	User Access	Surface Type
6/28/2017	109844	PUBLIC	ASPHALT
Area (Sq. Ft.)	Lane Miles (11' Widths)	Curb Reveal (Inches)	Curb Recommendation
17,232	0.297	NOT APPLICABLE	NOT APPLICABLE
Curb Type		Curb & Gutter Type	
NO CURB		NO CURB AND GUTTER	
Pavement Recommendation		Condition Rating / PCR	
PREVENTIVE MAINTENANCE		GOOD / 90

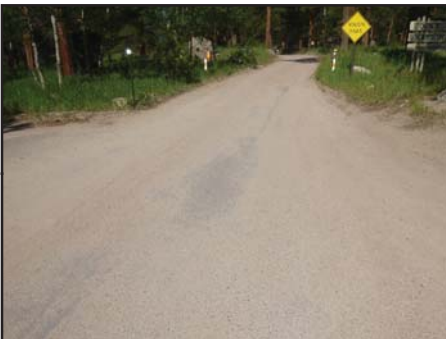
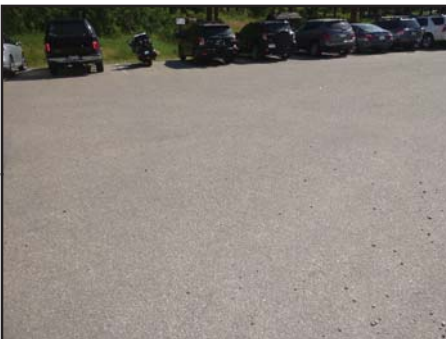
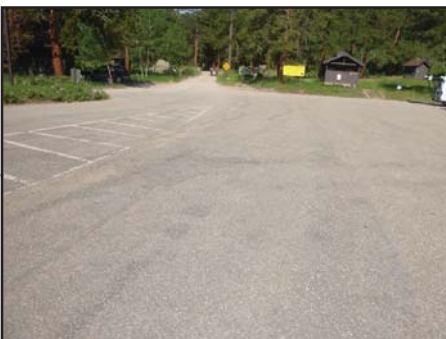
ROUTE 1027: LILY LAKE TRAILHEAD PARKING

Inspection Date	FMSS Number	User Access	Surface Type
6/28/2017	105347	PUBLIC	ASPHALT
Area (Sq. Ft.)	Lane Miles (11' Widths)	Curb Reveal (Inches)	Curb Recommendation
9,991	0.172	NOT APPLICABLE	NOT APPLICABLE
Curb Type		Curb & Gutter Type	
NO CURB		NO CURB AND GUTTER	
Pavement Recommendation		Condition Rating / PCR	
PREVENTIVE MAINTENANCE		GOOD / 90

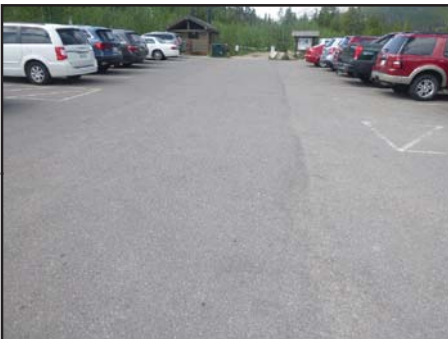
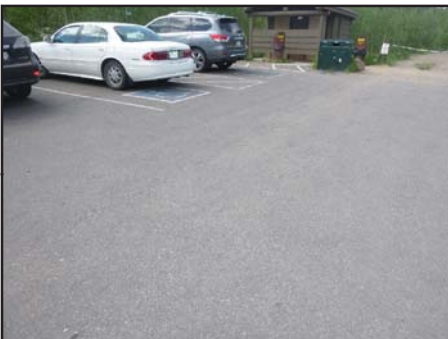
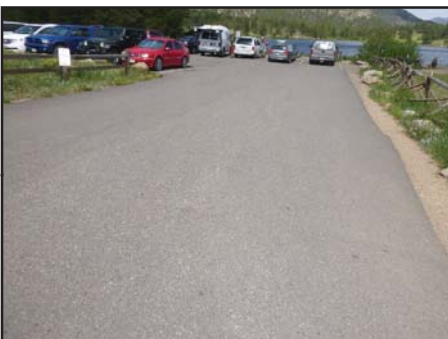
ROUTE 1031: UPPER BEAVER MEADOWS EMERGENCY PARKING

Inspection Date	FMSS Number	User Access	Surface Type
6/21/2017	105352	NONPUBLIC	ASPHALT
Area (Sq. Ft.)	Lane Miles (11' Widths)	Curb Reveal (Inches)	Curb Recommendation
712	0.012	NOT APPLICABLE	NOT APPLICABLE
Curb Type		Curb & Gutter Type	
NO CURB		NO CURB AND GUTTER	
Pavement Recommendation		Condition Rating / PCR	
PREVENTIVE MAINTENANCE		GOOD / 90

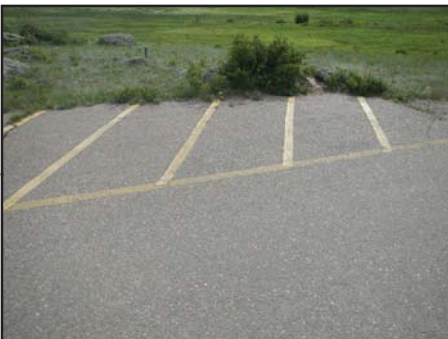
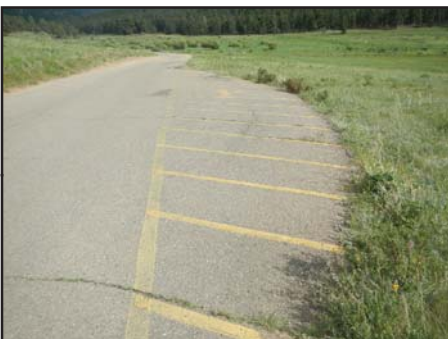
ROUTE 1038: LUMPY RIDGE PARKING AREA

Inspection Date	FMSS Number	User Access	Surface Type
6/28/2017	83613	PUBLIC	ASPHALT
Area (Sq. Ft.)	Lane Miles (11' Widths)	Curb Reveal (Inches)	Curb Recommendation
39,661	0.683	NOT APPLICABLE	DO NOTHING
Curb Type		Curb & Gutter Type	
NO CURB		CONCRETE	
Pavement Recommendation		Condition Rating / PCR	
PREVENTIVE MAINTENANCE		GOOD / 90

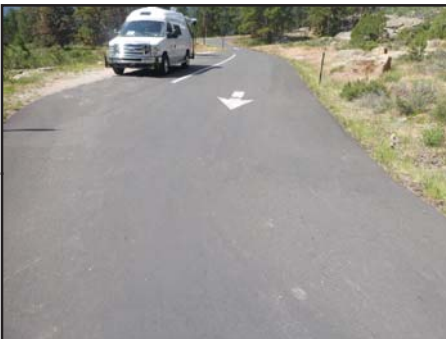
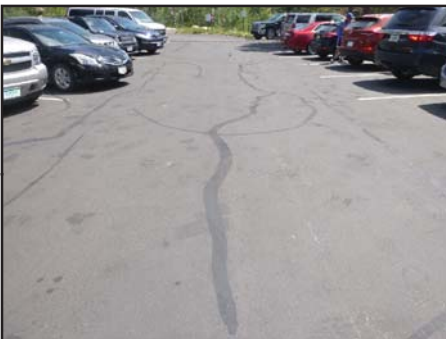
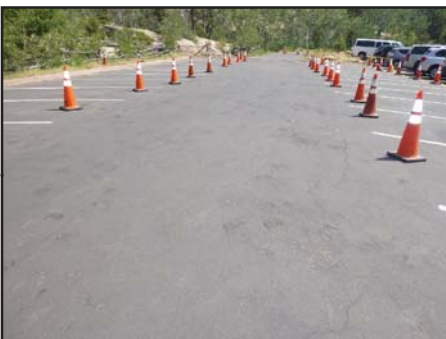
ROUTE 1040: GLACIER CREEK FISHING ACCESS PARKING AREA

Inspection Date	FMSS Number	User Access	Surface Type
6/28/2017	249229	PUBLIC	ASPHALT
Area (Sq. Ft.)	Lane Miles (11' Widths)	Curb Reveal (Inches)	Curb Recommendation
13,436	0.231	NOT APPLICABLE	DO NOTHING
Curb Type		Curb & Gutter Type	
NO CURB		CONCRETE	
Pavement Recommendation		Condition Rating / PCR	
PREVENTIVE MAINTENANCE		GOOD / 90
