Road Inventory and Condition Assessment of Paved Routes Sequoia National Park

**Federal Lands Highway
Road Inventory Program**

Federal Highway Administration
Eastern Federal Lands Highway Division
Road Inventory Program (RIP)

Report Date: January 2016

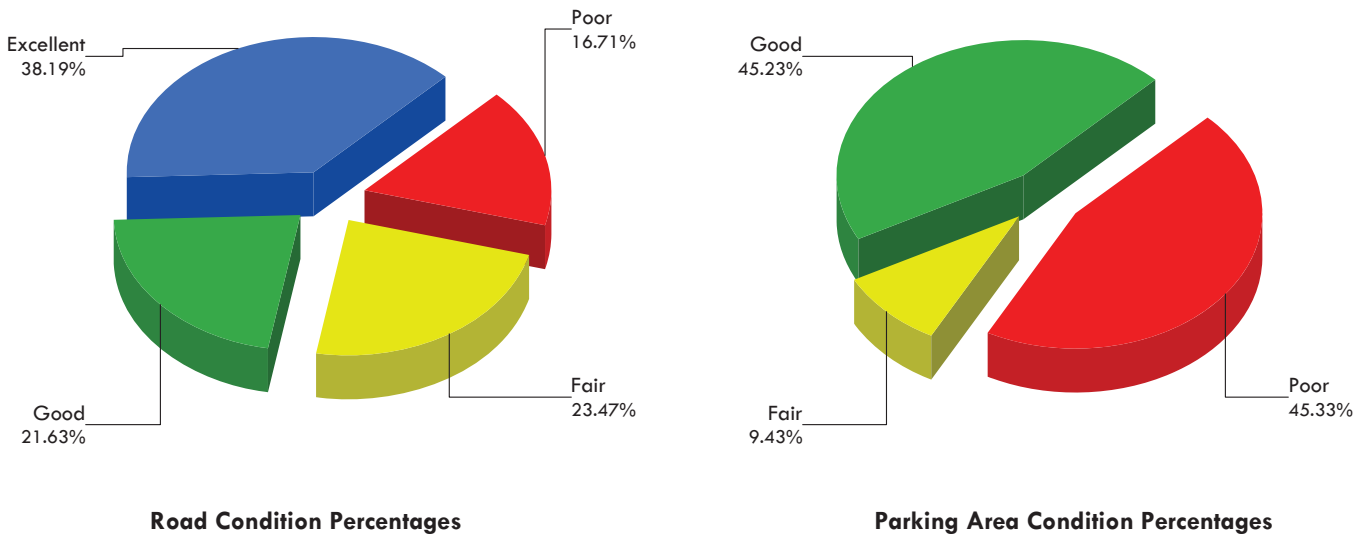
Figure 1: Pavement Condition Rating Breakdown for Paved Roads and Parking Areas

Parkwide Condition Percentages

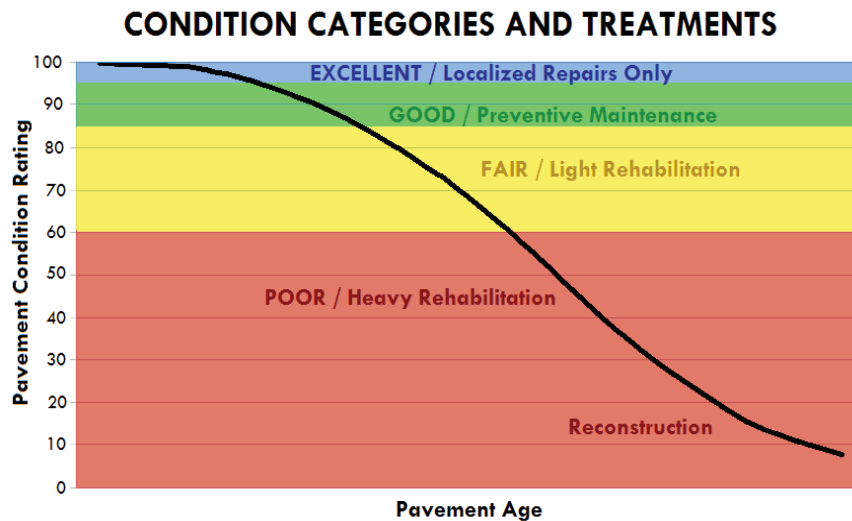
The Road Inventory Program aims to provide assistance in translating the excellent / good / fair / poor rating categories into pavement needs categories. The PCR can be used to indicate the place in the Pavement Life Cycle and the type of treatments that should be considered now and into the future.

- Excellent / New: PCR of 95-100
 - o Pavements in this range will require only spot repairs
- Good: PCR of 85-94
 - o Pavements in this range will likely be candidates for Preventive Maintenance. Examples include Chip and Slurry Seals, Micro Surfacing and Thin Overlays.
- Fair: PCR of 61-84
 - o Pavements in this range will likely be candidates of Light Rehabilitation (L3R). Examples include singlelift overlays up to 2.5 inches in total thickness, milling and overlays.
- Poor: PCR of 0-60
 - o Pavements in this range will likely be candidates of Heavy Rehabilitation or Reconstruction (H3R or 4R). Examples include Pulverization, Multiple Lift Overlays, and Reconstruction.

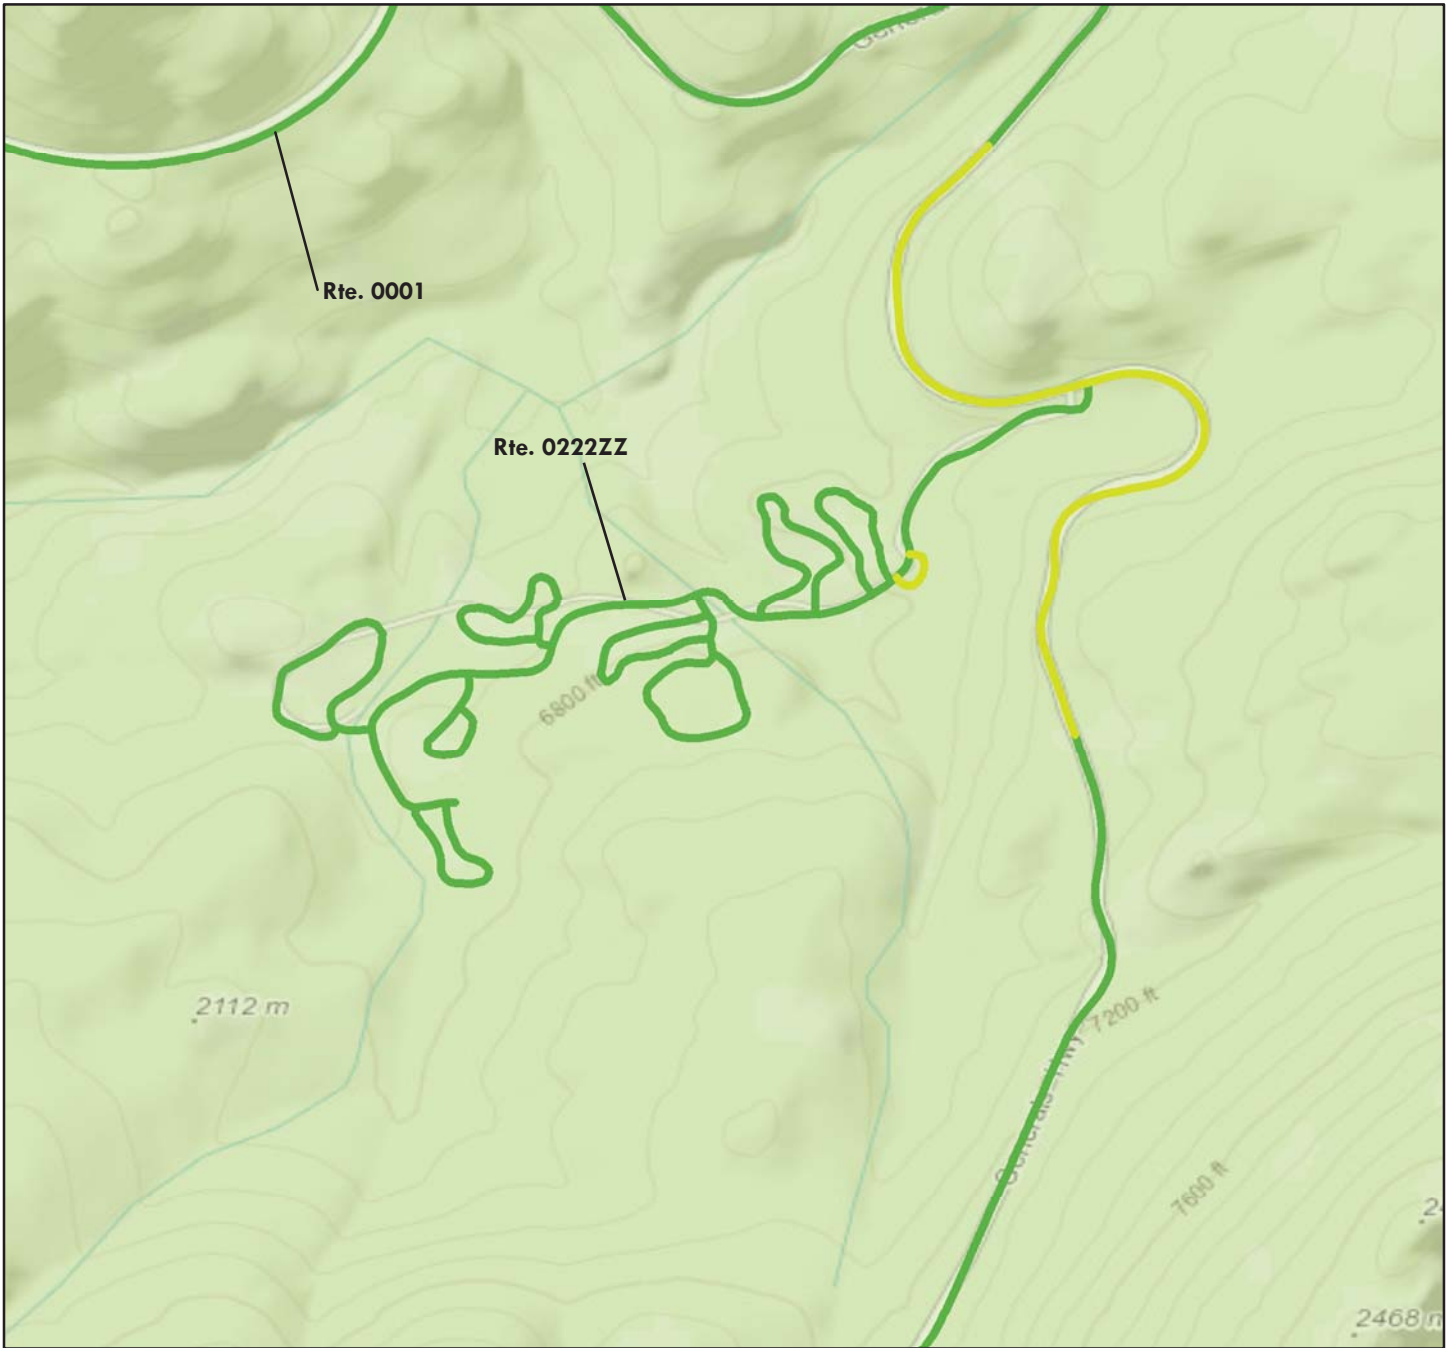
Map 1A

ROUTE CONDITION MAP

PCR - MILE BY MILE

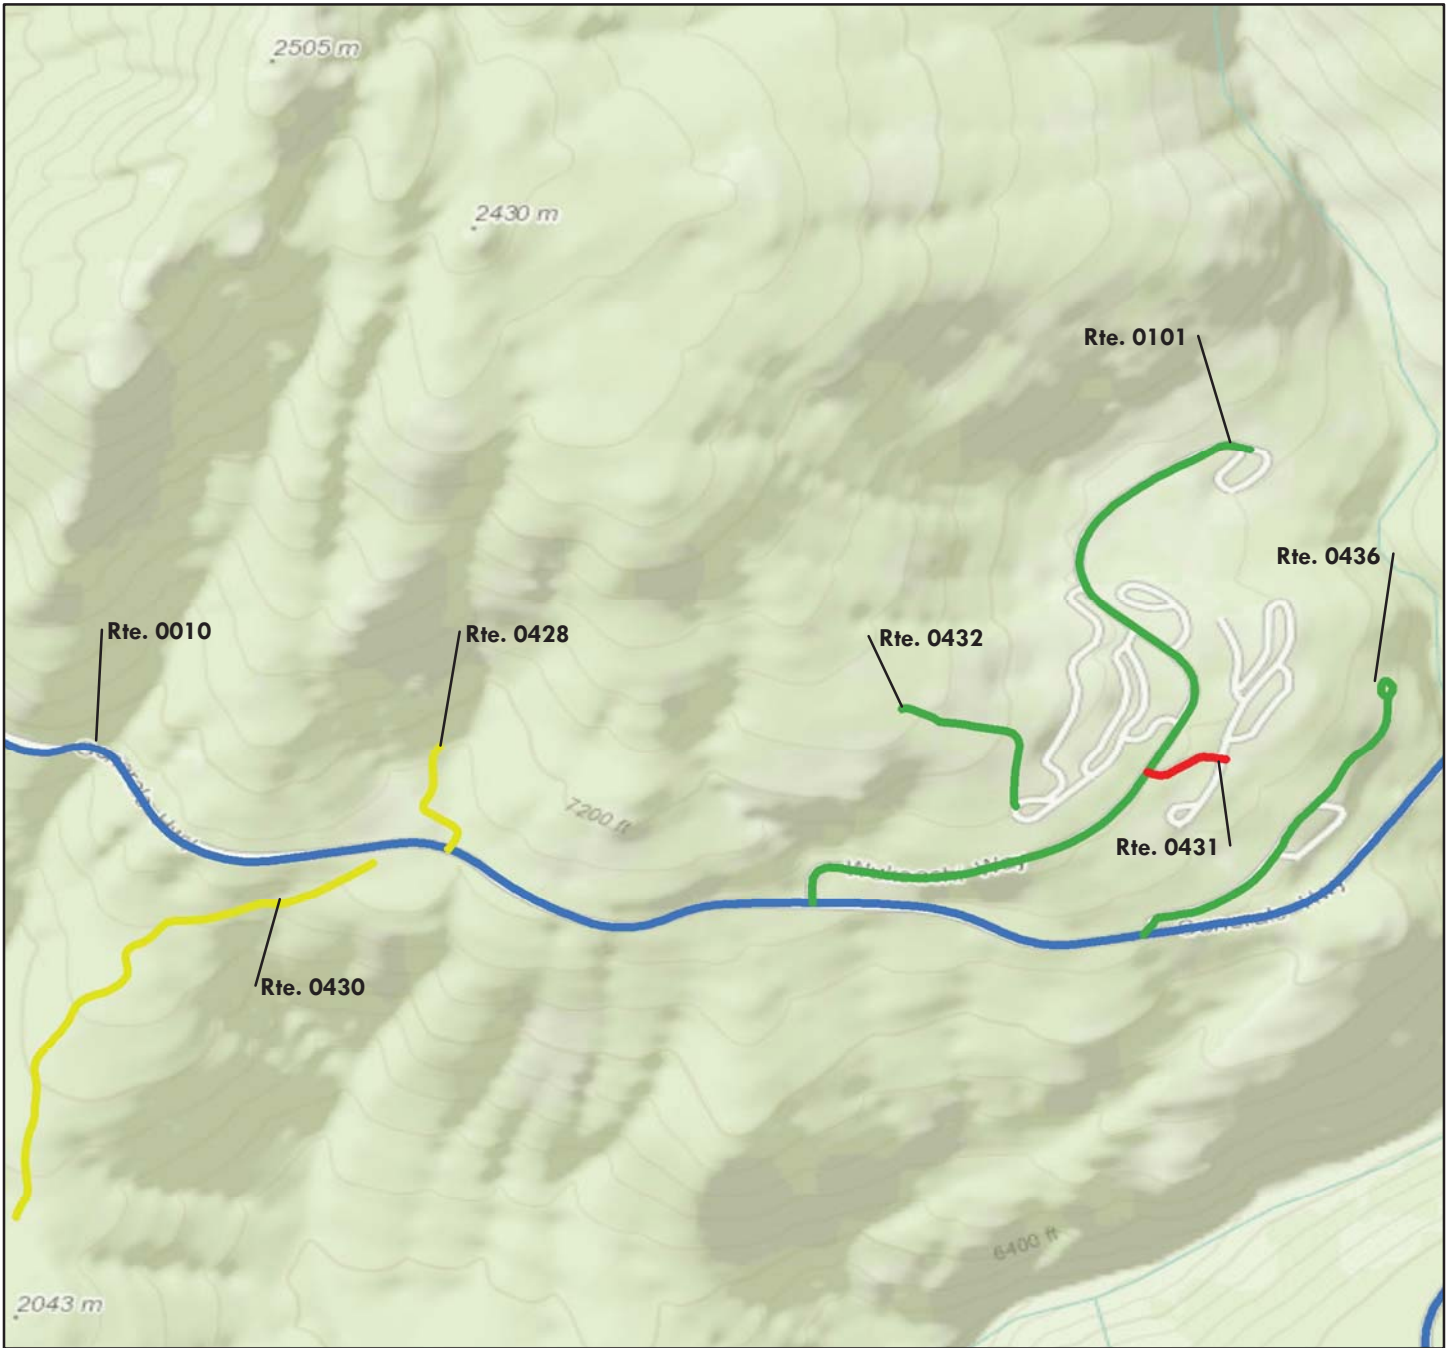
Map 1B

ROUTE CONDITION MAP

PCR - MILE BY MILE

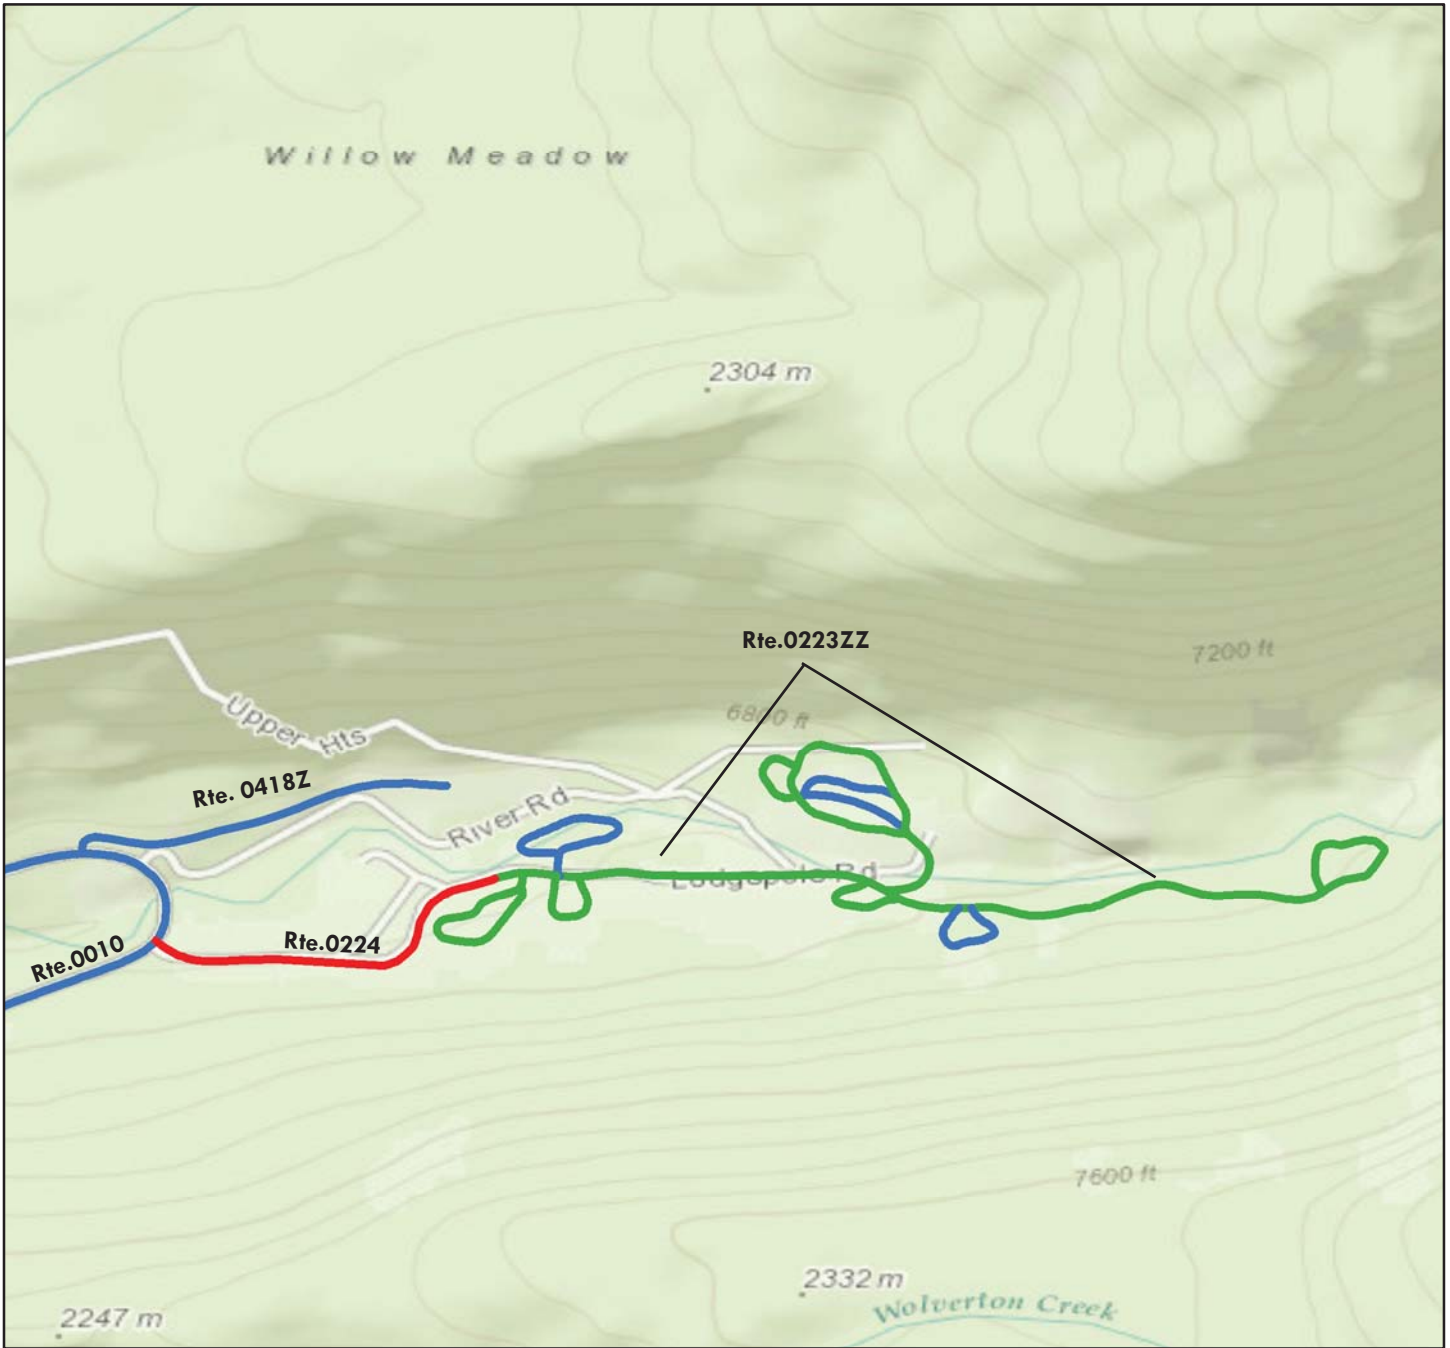
Map 1C

ROUTE CONDITION MAP

PCR - MILE BY MILE

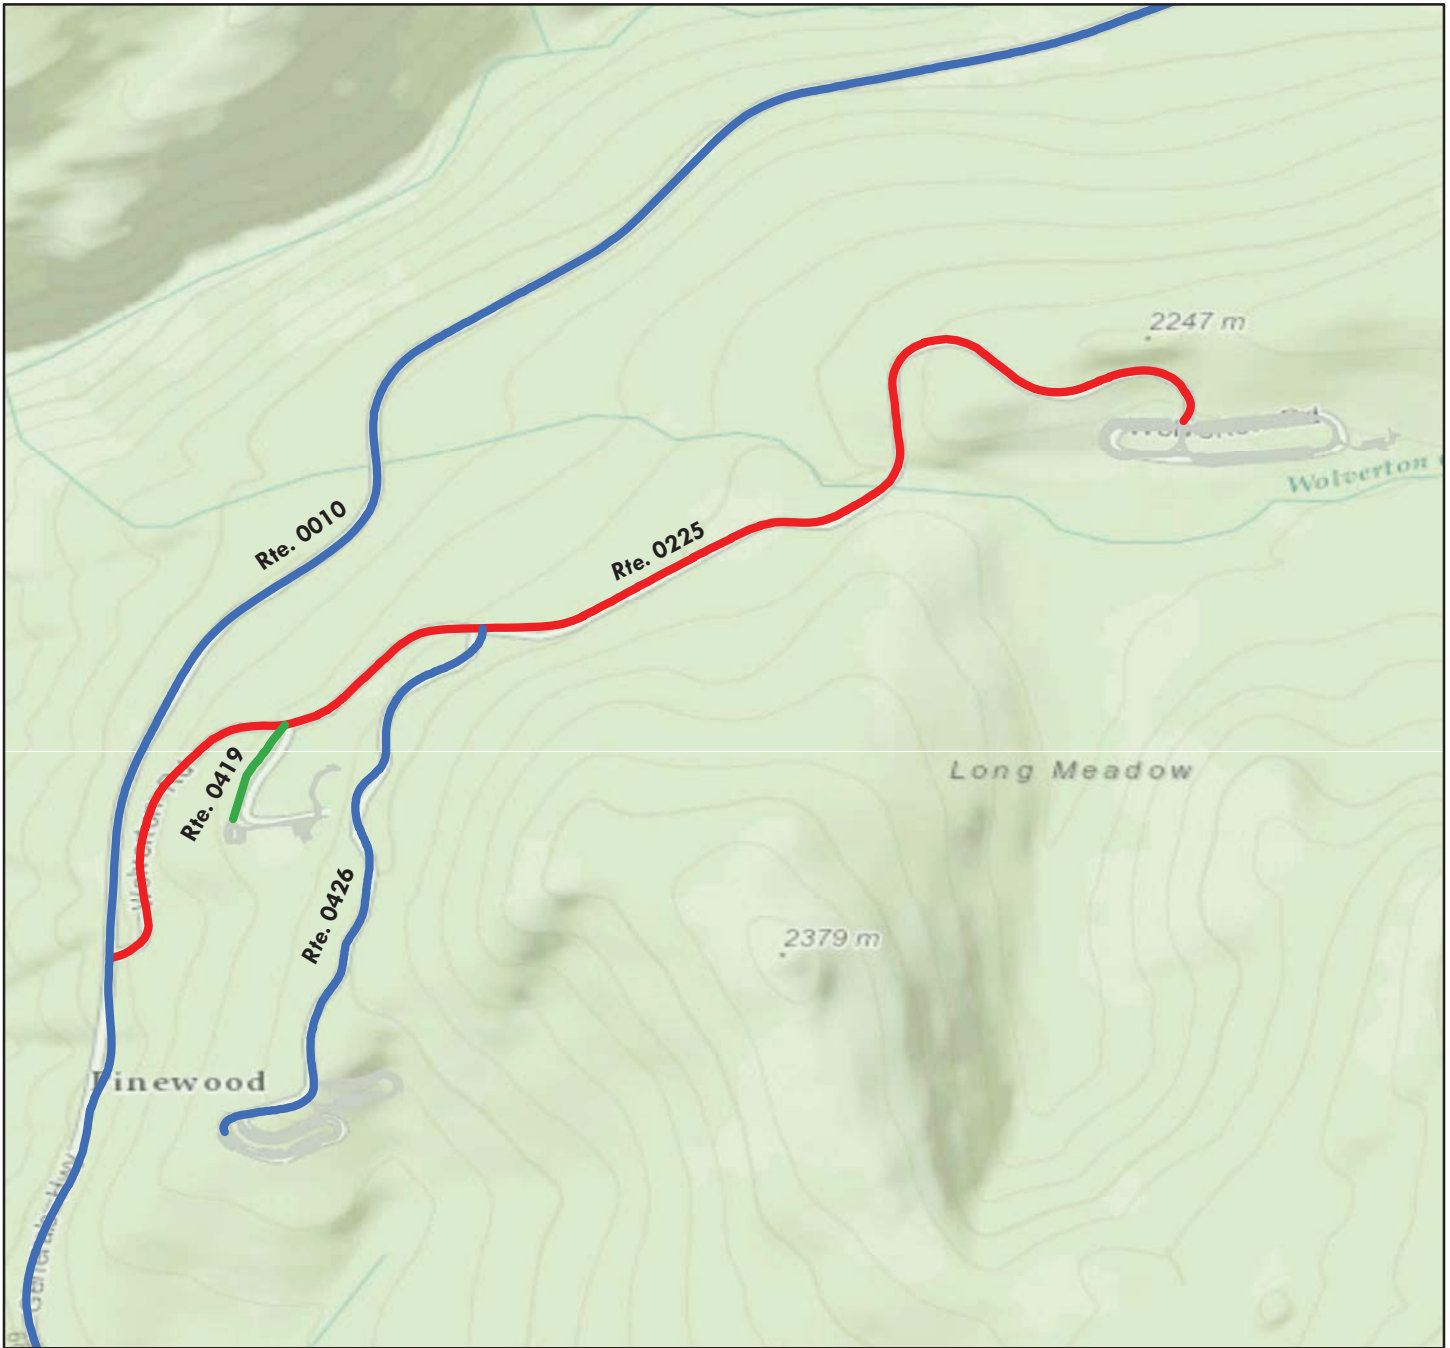
Area Map 1D

ROUTE CONDITION MAP

PCR - MILE BY MILE

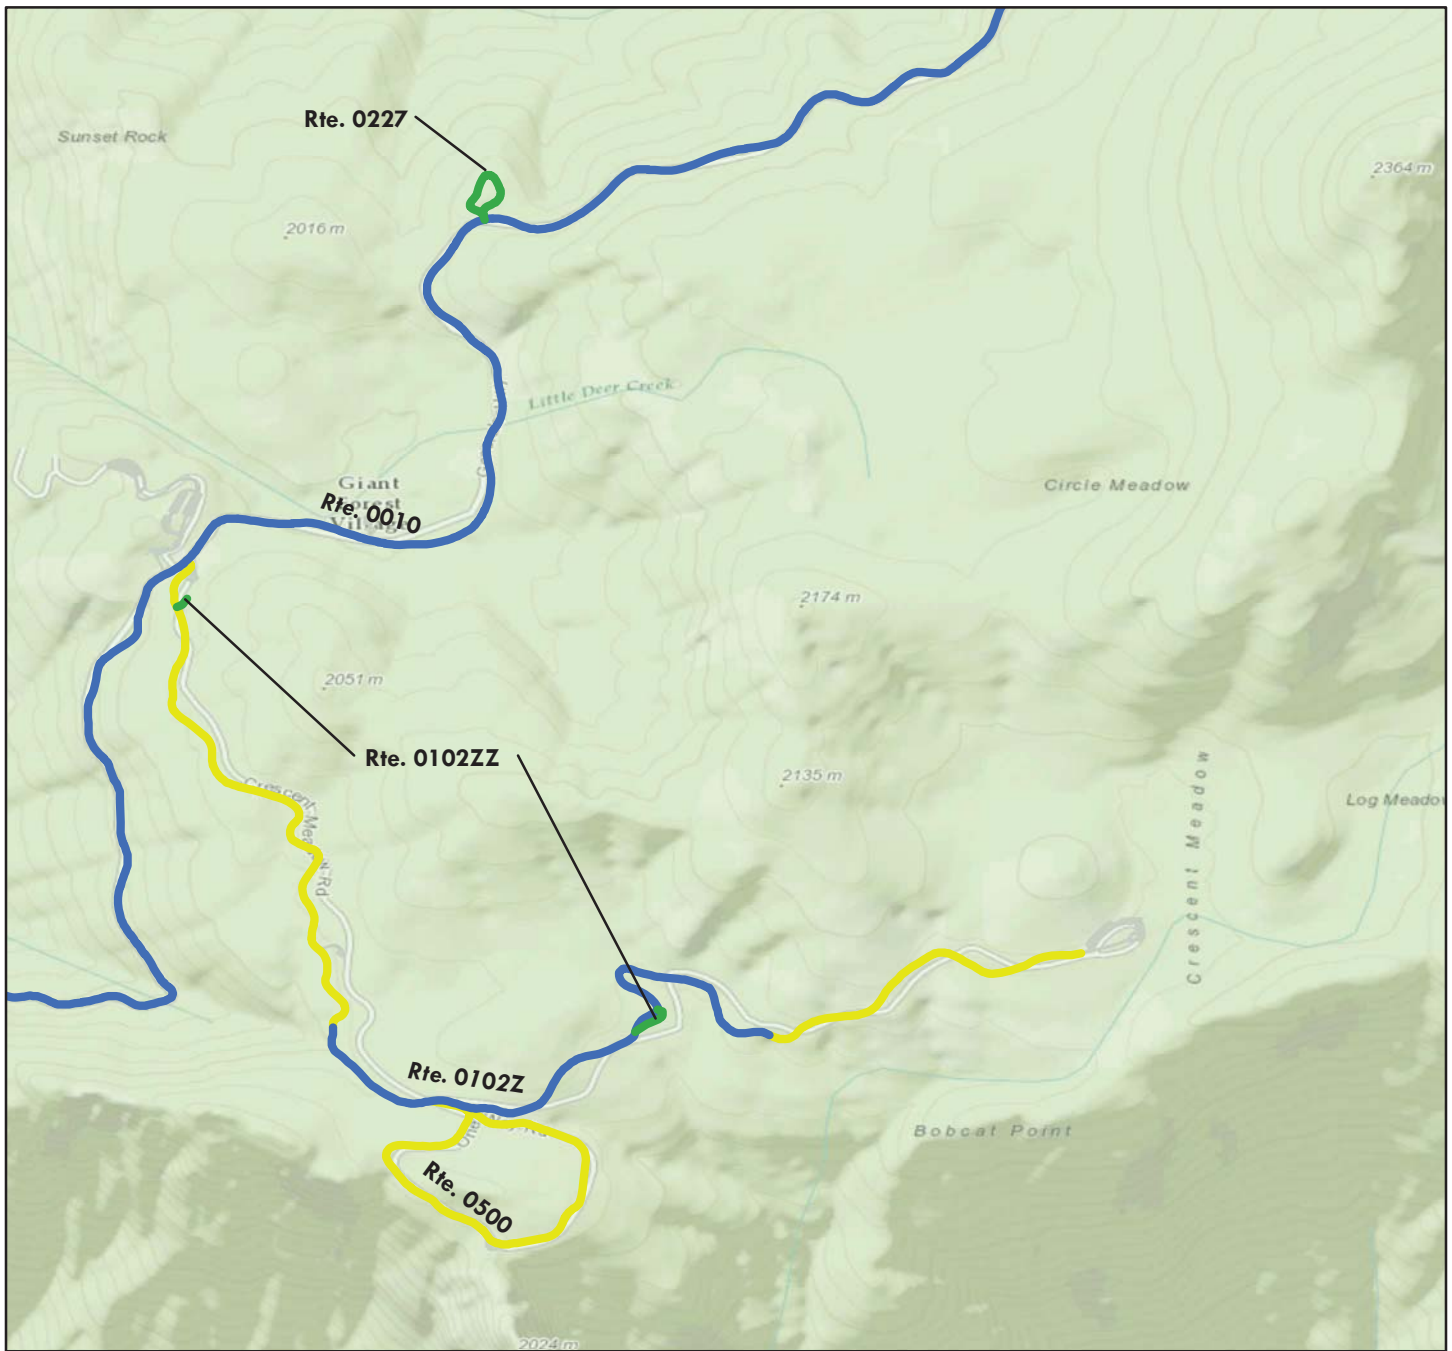
Area Map 1E

ROUTE CONDITION MAP

PCR - MILE BY MILE

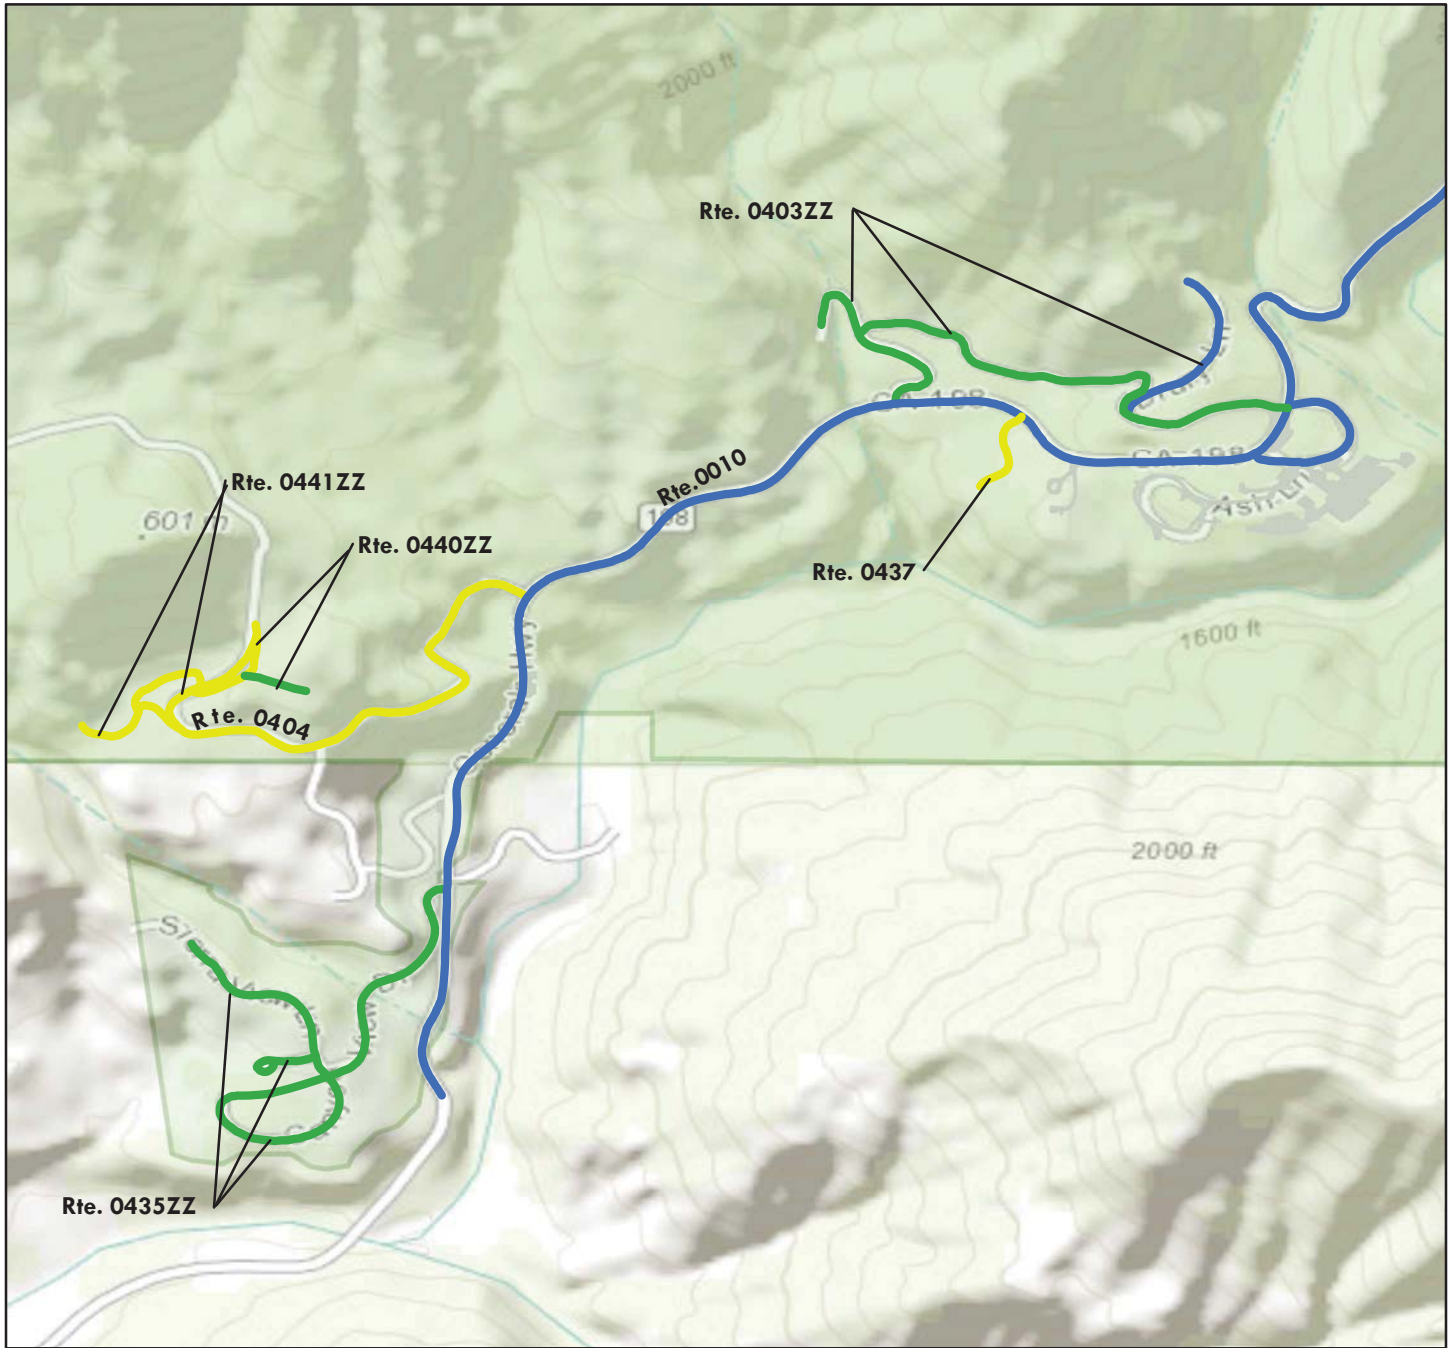
Area Map 2A

ROUTE CONDITION MAP

PCR - MILE BY MILE

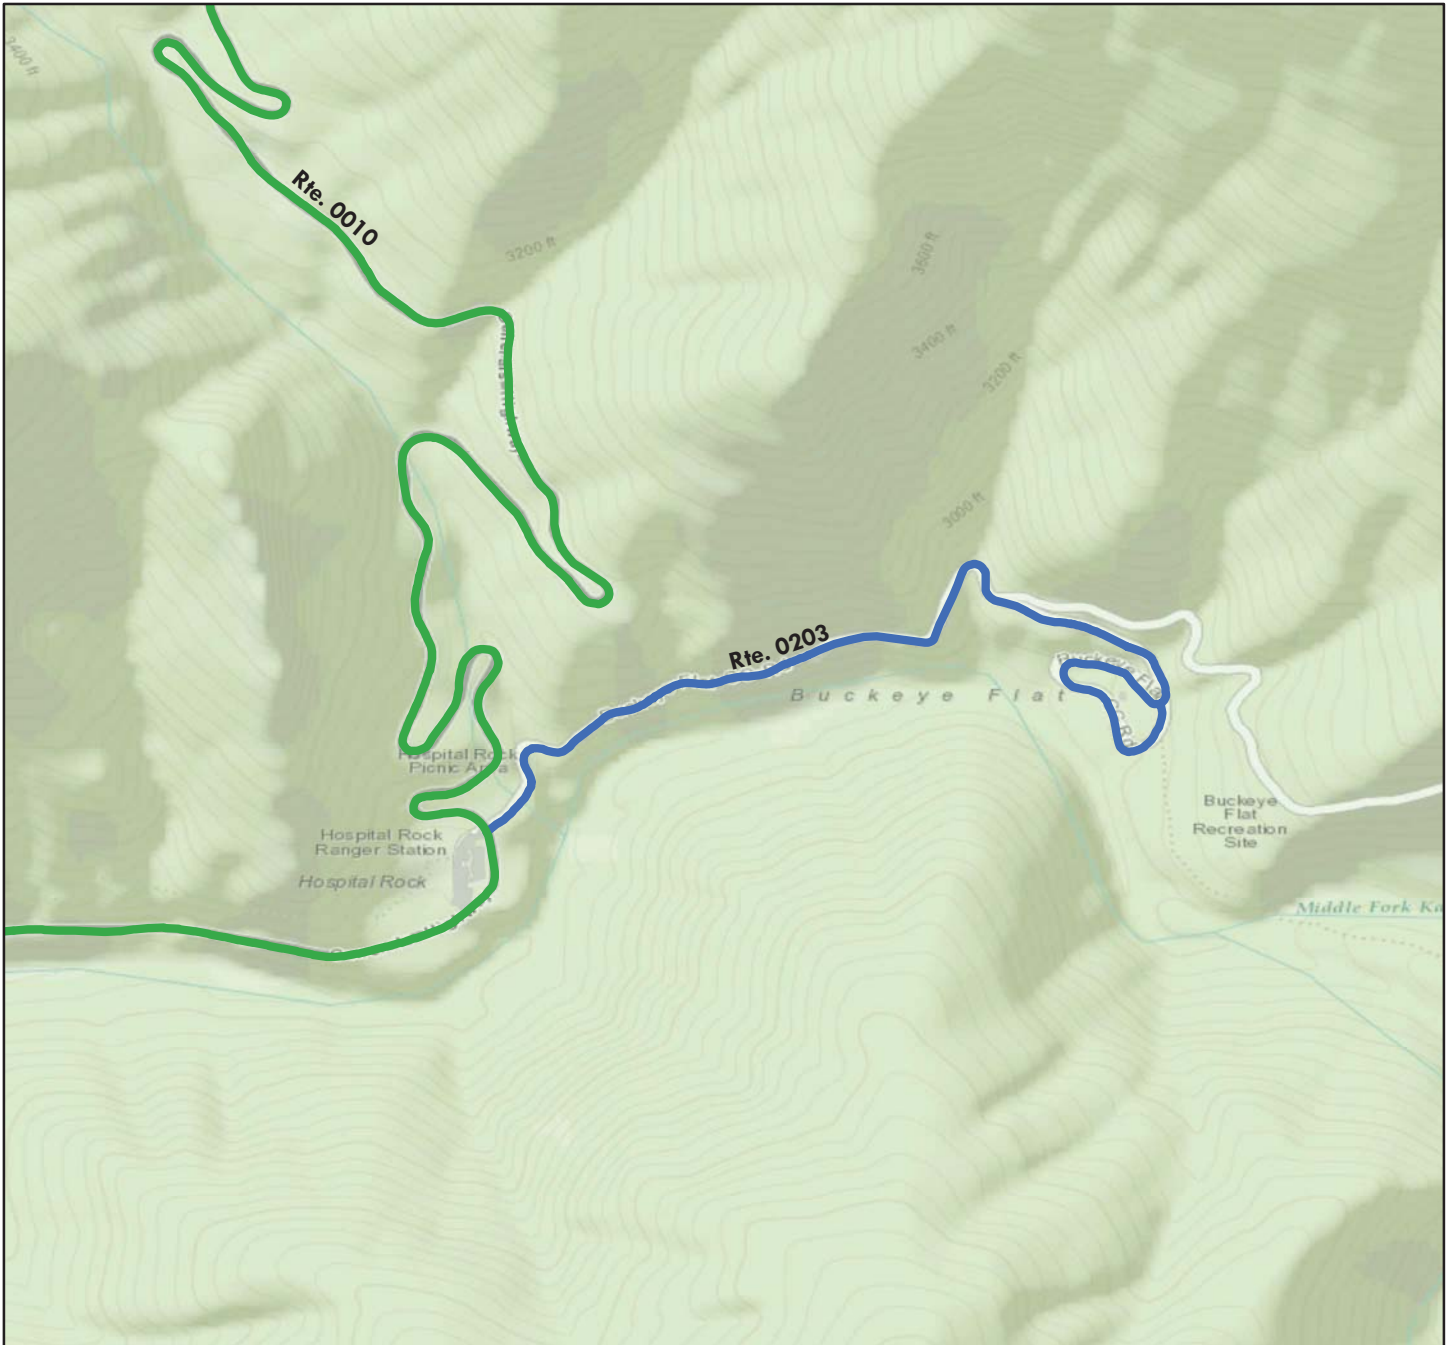
Area Map 2C

ROUTE CONDITION MAP

PCR - MILE BY MILE

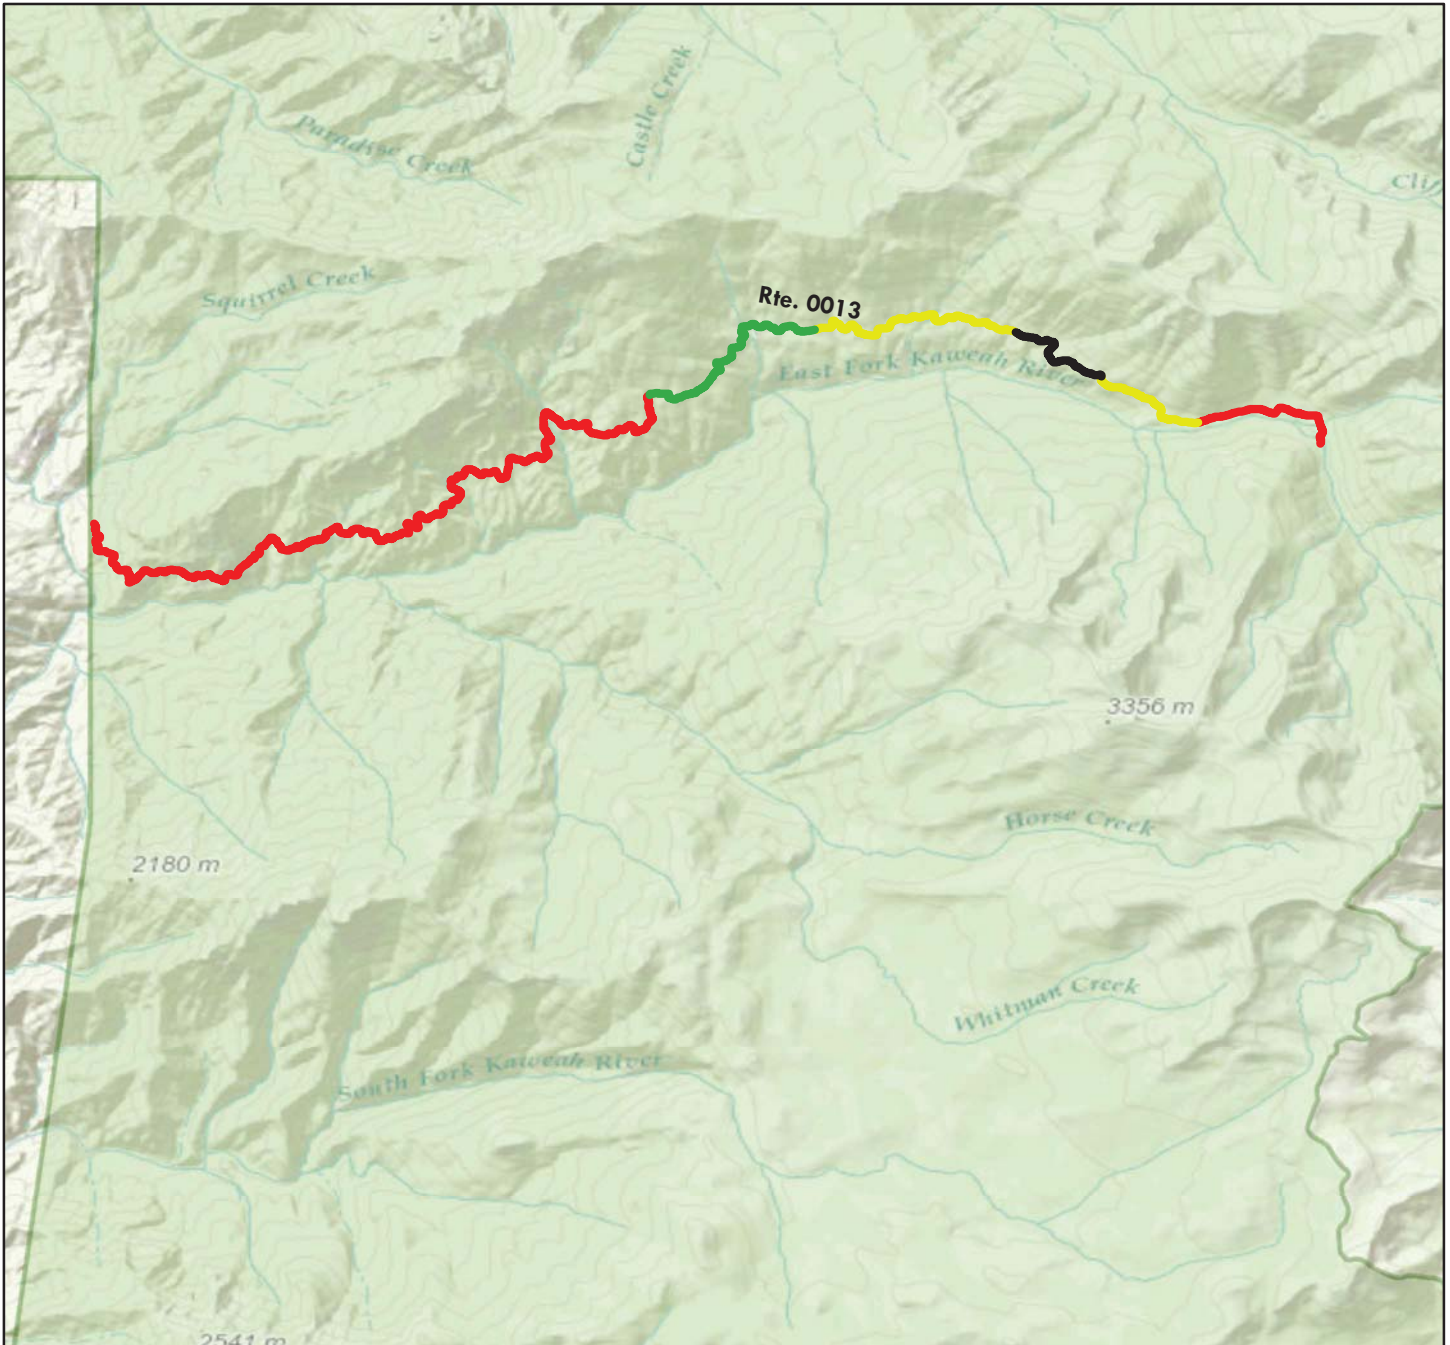
Area Map 3

ROUTE CONDITION MAP

PCR - MILE BY MILE

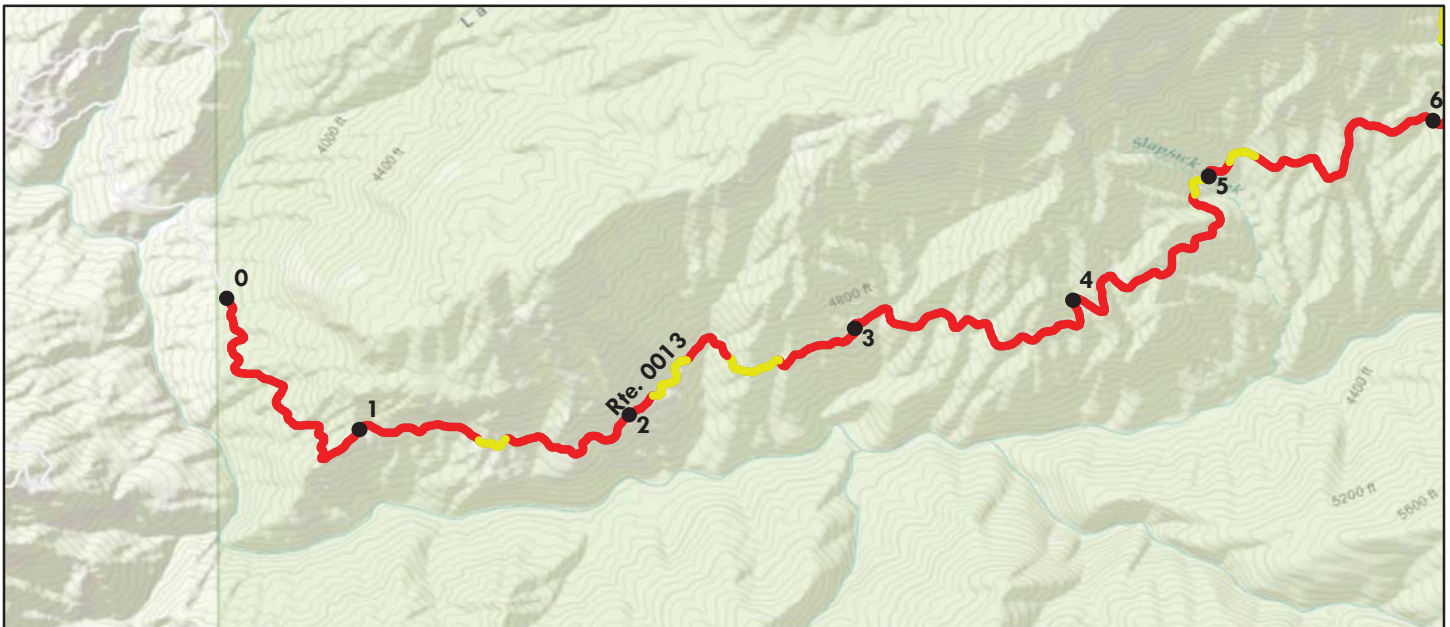
ROUTE 0013: MINERAL KING ROAD

Data Collection Vehicle (DCV) Rating

Route Condition Legend – Pavement Condition Rating (PCR)						
Poor (0 - 60)	Fair (61- 84)	Good (85 - 94)	Excellent (95 - 100)	Not Rated		
See Appendix for definitions and formulas						
Inspection Date: 5/27/2015	Beginning Section MP	0	1	2	3	4
Paved Length (Miles): 13.91	Section Length (MI)	1	1	1	1	1
Surface Type: ASPHALT	Route Summary					
Roadway Condition Information						
Pavement Condition Rating (PCR)	46	0	41	49	22	26
Surface Condition Rating (SCR)	46	0	41	49	22	26
Roughness Condition Index (RCI)	N/A	N/A	N/A	N/A	N/A	N/A
Distress Index Values						
Structural Crack Index	46	0	41	49	22	26
Alligator Crack Index	93	92	99	98	92	90
Longitudinal Crack Index	53	0	42	51	30	36
Transverse Cracking Index	74	5	59	63	53	70
Patching Index	98	95	97	98	98	98
Rutting Index	83	85	84	80	79	81
International Roughness Index (IRI)	N/A	N/A	N/A	N/A	N/A	N/A
Lane & Width Information						
Number of Lanes	1	1	1	1	1	1
Paved Width (ft)	14.4	16.2	15.2	14.7	14.6	15.5

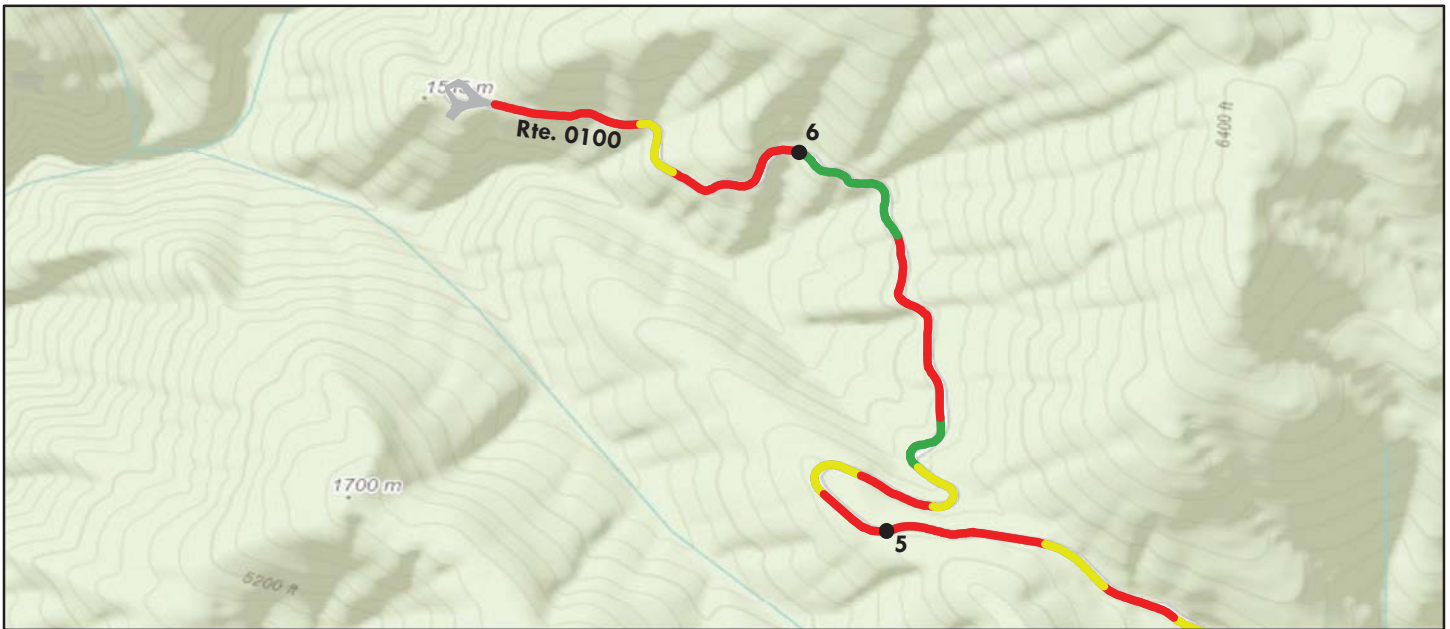
ROUTE 0100: CRYSTAL CAVE ROAD

Data Collection Vehicle (DCV) Rating

Route Condition Legend – Pavement Condition Rating (PCR)						
Poor (0 - 60)	Fair (61- 84)	Good (85 - 94)	Excellent (95 - 100)	Not Rated		
See Appendix for definitions and formulas						
Inspection Date: 5/27/2015	Beginning Section MP	5	6			
Paved Length (Miles): 6.48	Section Length (MI)	1	0.48			
Surface Type: ASPHALT	Route Summary					
Roadway Condition Information						
Pavement Condition Rating (PCR)	62	59	55			
Surface Condition Rating (SCR)	83	81	73			
Roughness Condition Index (RCI)	30	26	27			
Distress Index Values						
Structural Crack Index	83	81	73			
Alligator Crack Index	98	96	99			
Longitudinal Crack Index	85	85	74			
Transverse Cracking Index	96	96	92			
Patching Index	100	100	100			
Rutting Index	90	88	87			
International Roughness Index (IRI)	412	442	437			
Lane & Width Information						
Number of Lanes	2	2	2			
Paved Width (ft)	18.8	18.7	19.5			
Lane Width (ft)	9.4	9.3	9.7

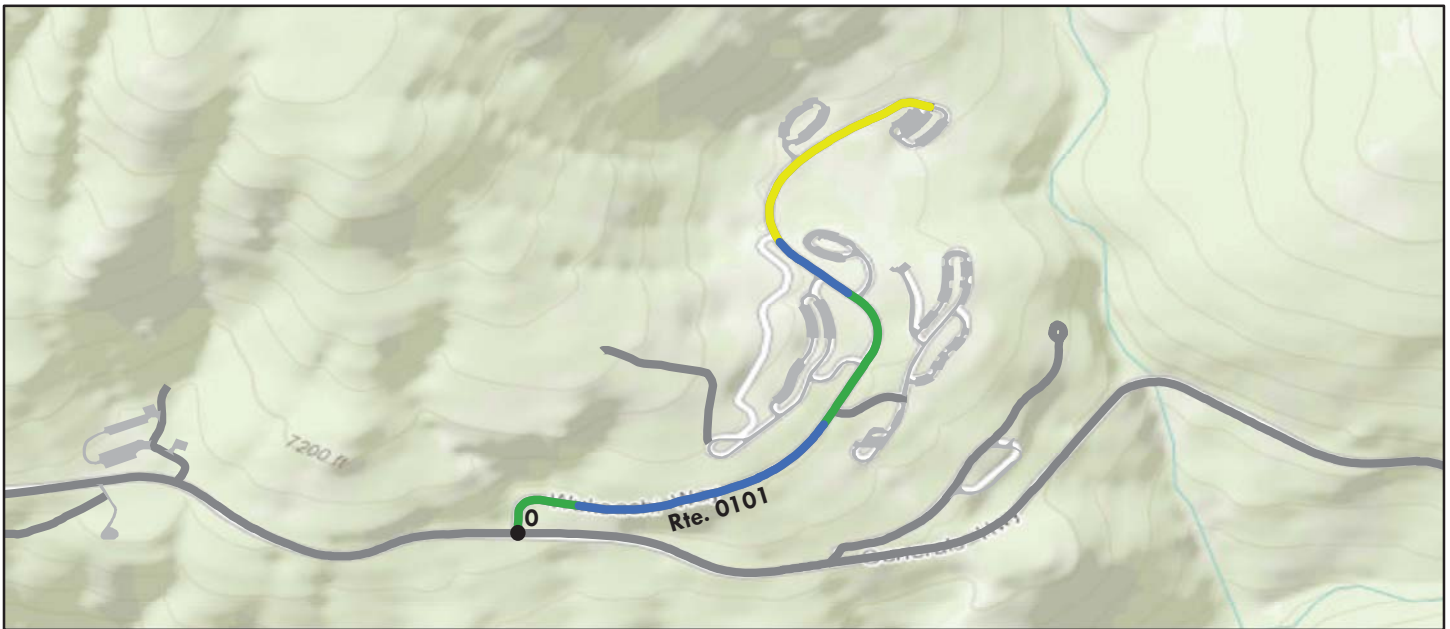
ROUTE 0101: WUKSACHI ROAD

Data Collection Vehicle (DCV) Rating

Route Condition Legend – Pavement Condition Rating (PCR)						
Poor (0 - 60)	Fair (61- 84)	Good (85 - 94)	Excellent (95 - 100)	Not Rated		
See Appendix for definitions and formulas						
Inspection Date: 5/26/2015	Beginning Section MP	0				
Paved Length (Miles): 1	Section Length (MI)	1				
Surface Type: ASPHALT	Route Summary					
Roadway Condition Information						
Pavement Condition Rating (PCR)	88	88				
Surface Condition Rating (SCR)	97	97				
Roughness Condition Index (RCI)	75	75				
Distress Index Values						
Structural Crack Index	100	100				
Alligator Crack Index	100	100				
Longitudinal Crack Index	100	100				
Transverse Cracking Index	97	97				
Patching Index	100	100				
Rutting Index	99	99				
International Roughness Index (IRI)	184	184				
Lane & Width Information						
Number of Lanes	2	2				
Paved Width (ft)	23.5	23.5				
Lane Width (ft)	11	11

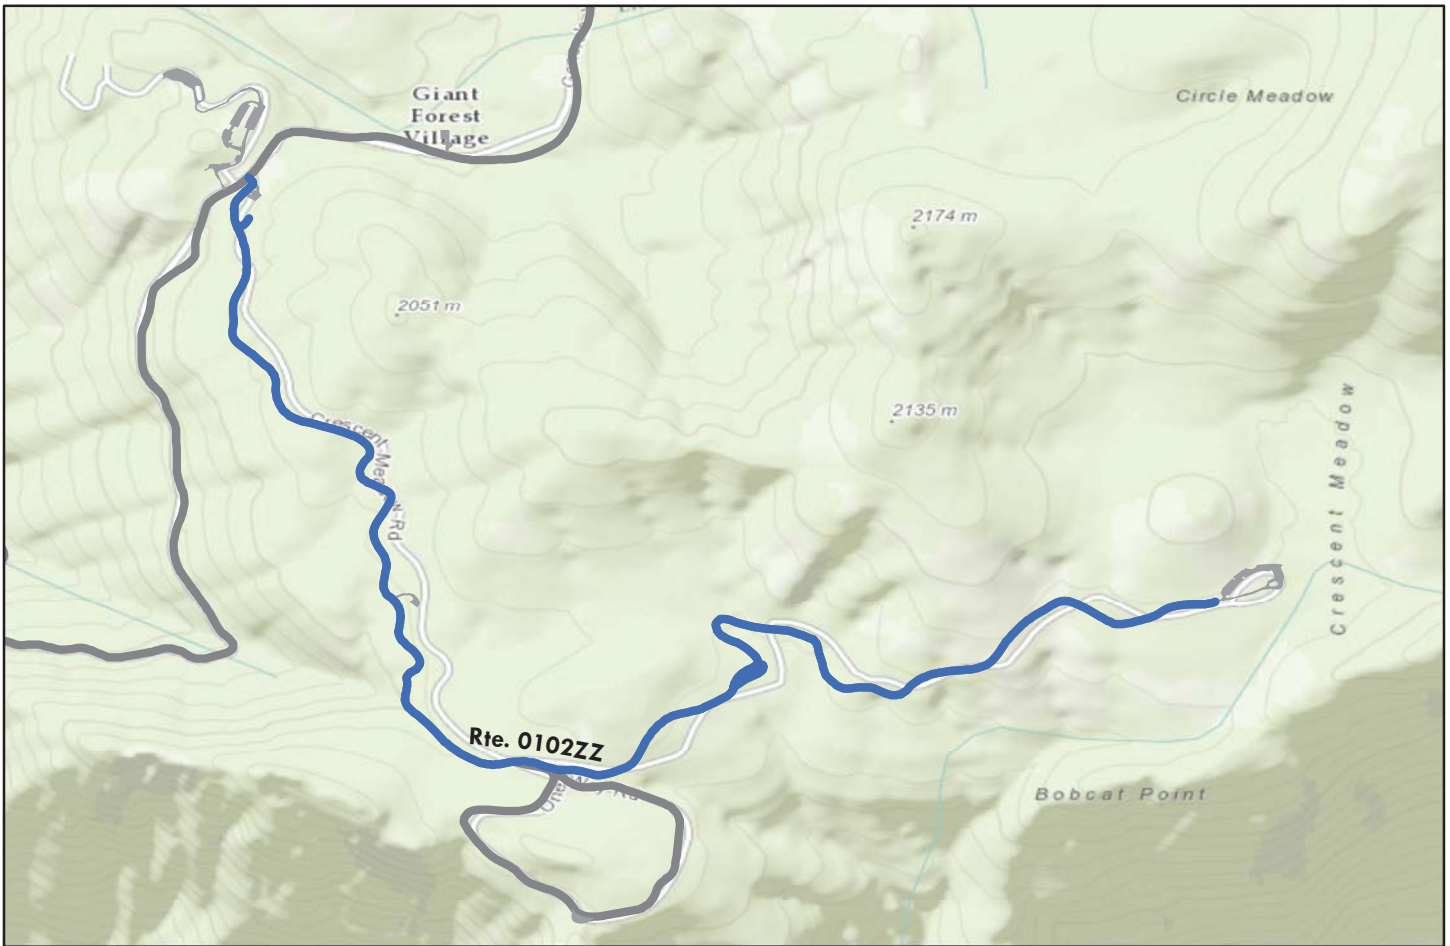
ROUTE 0102ZZ: CRESCENT MEADOW ROADS

Summary Route

Note: The weighted average summary PCR value is calculated from only the sections of road where the PCR was collected. The overall PCR for the summary route may not reflect individual subcomponent ratings.

Inspection Date:	5/26/2015					
Paved Length (Miles):	2.62					
Surface Type:	ASPHALT	Route Summary				
Roadway Condition Information						
Pavement Condition Rating (PCR)	99					
Lane & Width Information						
Number of Lanes	2					
Paved Width (ft)	15					
Lane Width (ft)	7.4
