Road Inventory and Condition Assessment of Paved Routes Sequoia National Park

**Federal Lands Highway
Road Inventory Program**

Federal Highway Administration
Eastern Federal Lands Highway Division
Road Inventory Program (RIP)

Report Date: January 2016

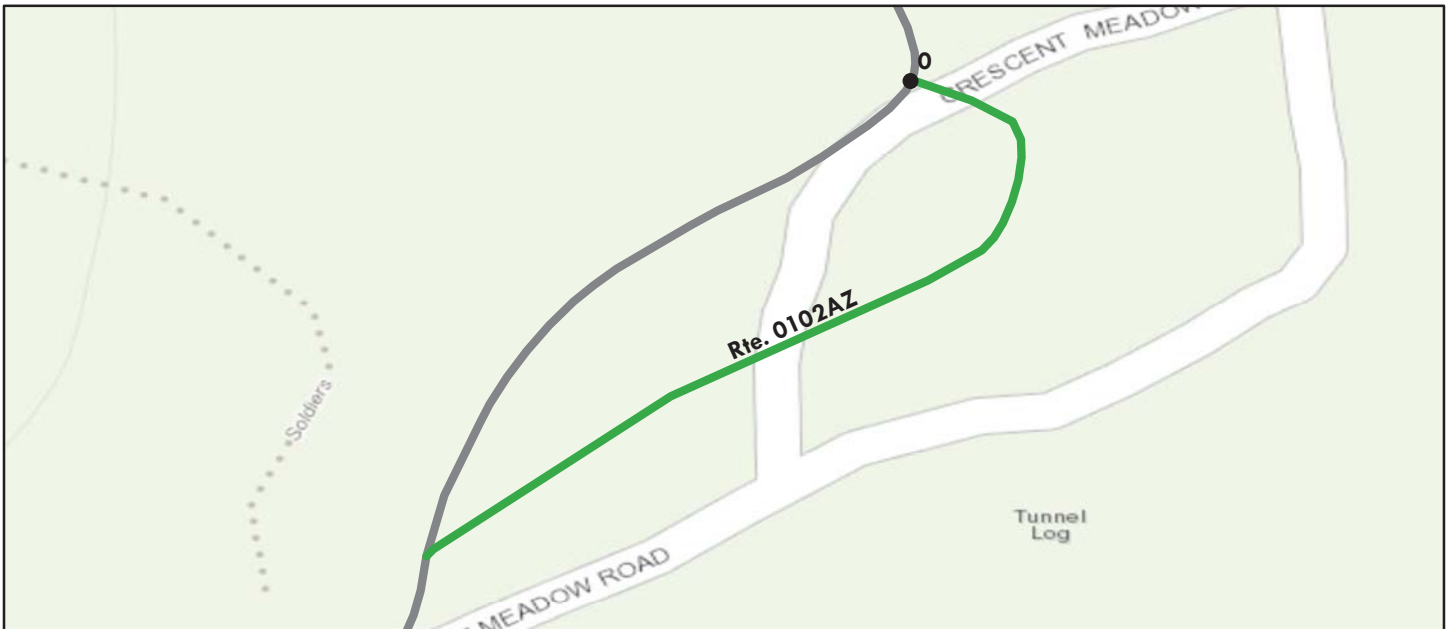
Subcomponent of Route SEQU-0102ZZ

Manual Rating

Route Condition Legend – Pavement Condition Rating (PCR)						
Poor (0 - 60)	Fair (61- 84)	Good (85 - 94)	Excellent (95 - 100)	Not Rated		
See Appendix for definitions and formulas						
Inspection Date: 9/25/2014	Beginning Section MP	0.00				
Paved Length (Miles): 0.06	Section Length (MI)	0.06				
Surface Type: ASPHALT	Route Summary					
Roadway Condition Information						
Pavement Condition Rating (PCR)	90	90				
Surface Condition Rating (SCR)	90	90				
Roughness Condition Index (RCI)	N/A	N/A				
Distress Index Values						
Structural Crack Index	N/A	N/A				
Alligator Crack Index	97	97				
Longitudinal Crack Index	90	90				
Transverse Cracking Index	97	97				
Patching Index	97	97				
Rutting Index	97	97				
International Roughness Index (IRI)	N/A	N/A				
Lane & Width Information						
Number of Lanes	2	2				
Paved Width (ft)	16	16				
Lane Width (ft)	8	8

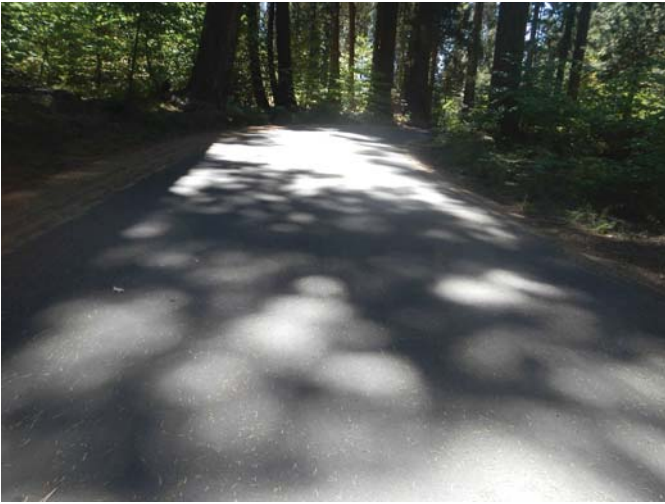
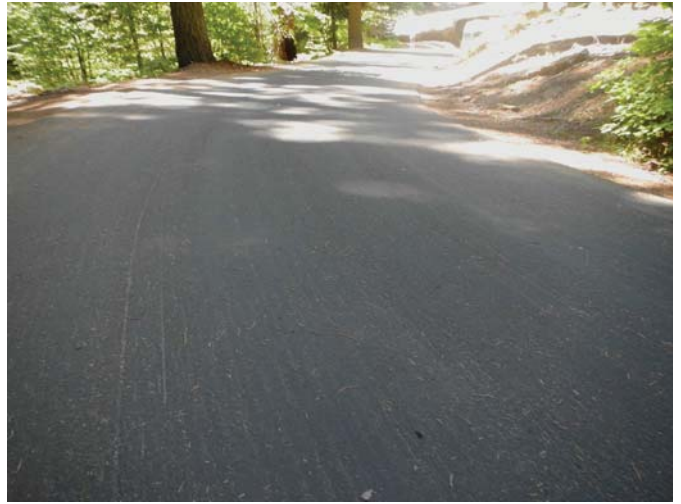
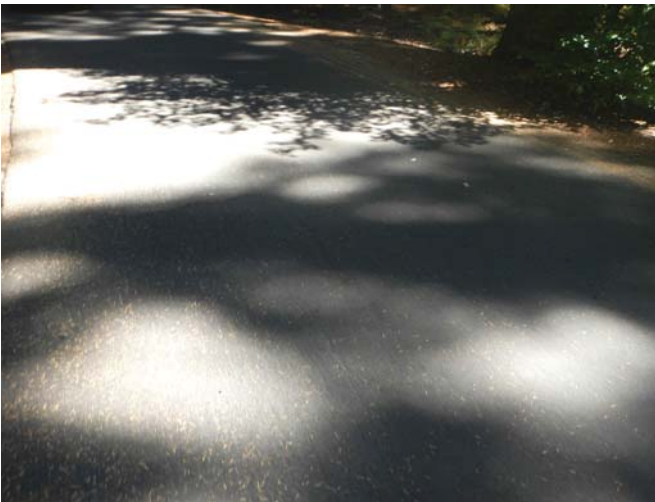
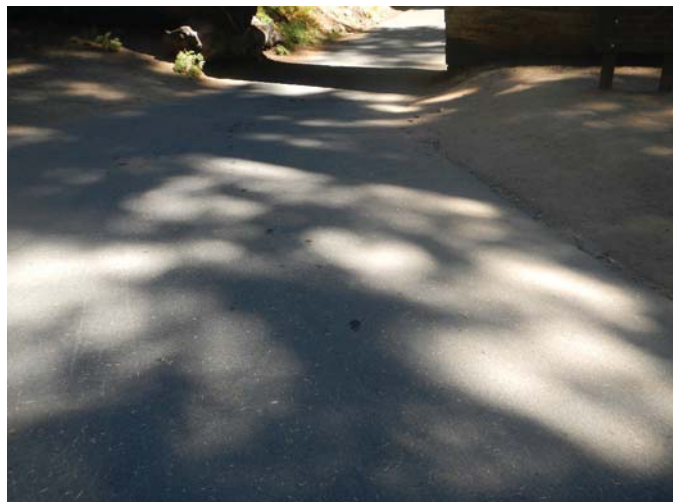
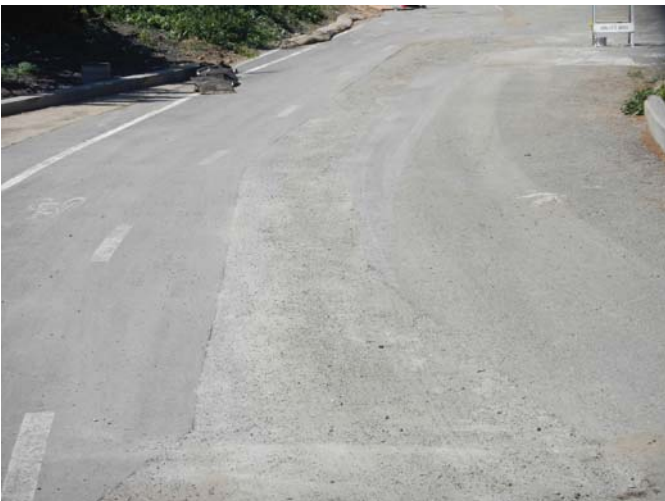
Condition Photos

Condition photos are shown only for manually rated roads. Use the PathView program to see images of DCV rated roads.

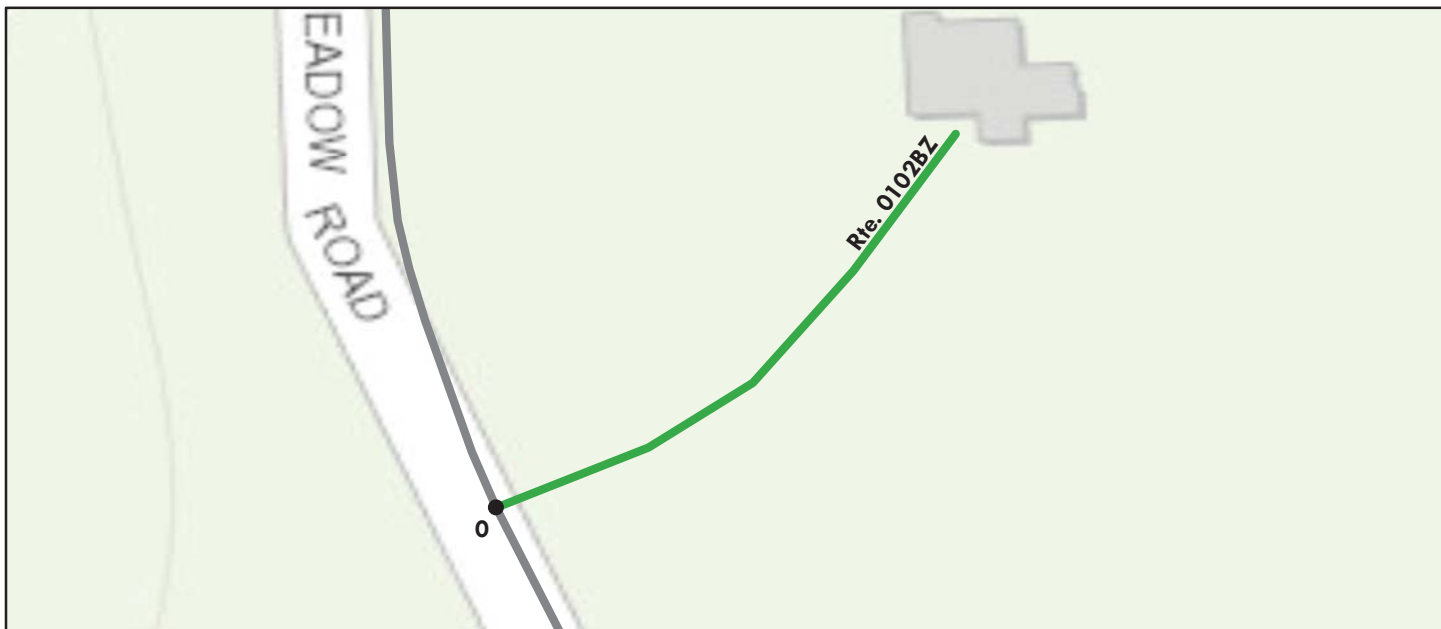
Subcomponent of Route SEQU-0102ZZ

Manual Rating

Inspection Date: 9/25/2014	Beginning Section MP	0.00				
Paved Length (Miles): 0.02	Section Length (MI)	0.02				
Surface Type: ASPHALT	Route Summary					
Roadway Condition Information						
Pavement Condition Rating (PCR)	90	90				
Surface Condition Rating (SCR)	90	90				
Roughness Condition Index (RCI)	N/A	N/A				
Distress Index Values						
Structural Crack Index	N/A	N/A				
Alligator Crack Index	97	97				
Longitudinal Crack Index	90	90				
Transverse Cracking Index	90	90				
Patching Index	97	97				
Rutting Index	97	97				
International Roughness Index (IRI)	N/A	N/A				
Lane & Width Information						
Number of Lanes	2	2				
Paved Width (ft)	21	21				
Lane Width (ft)	10.5	10.5

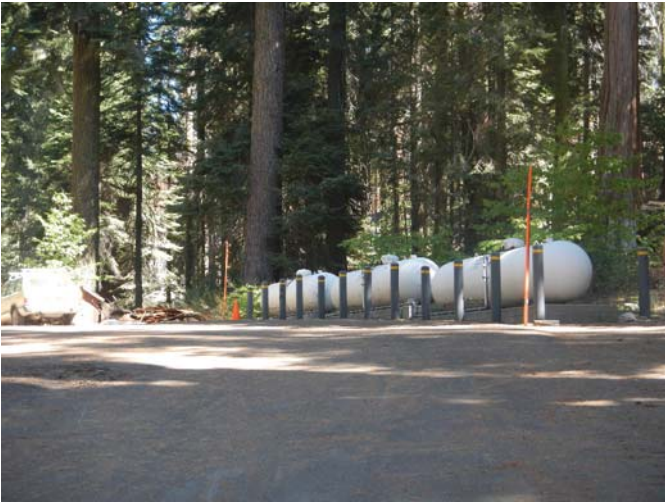
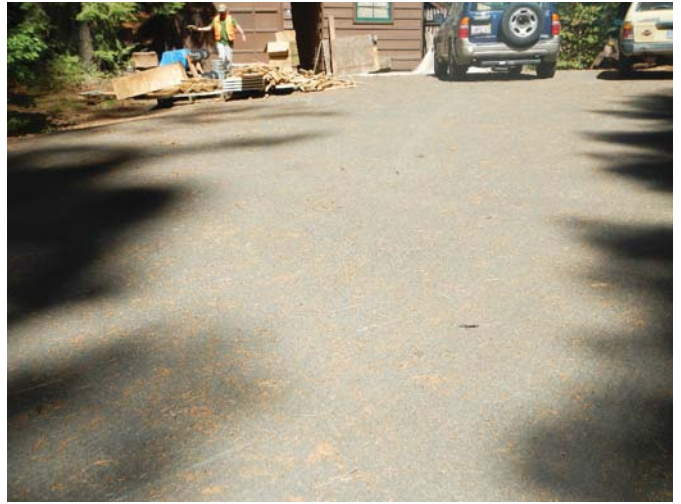
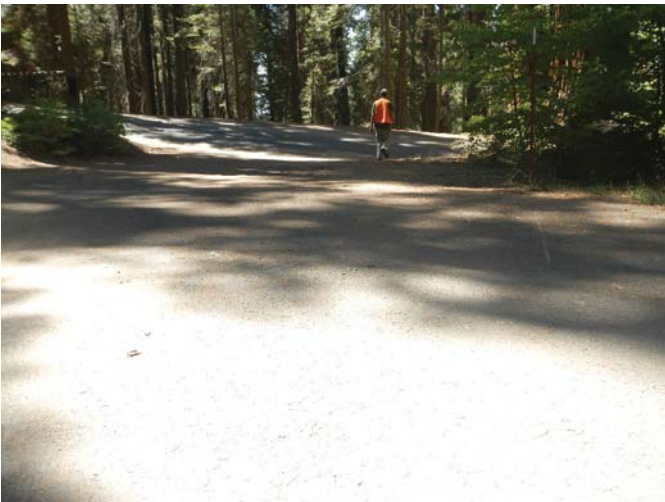
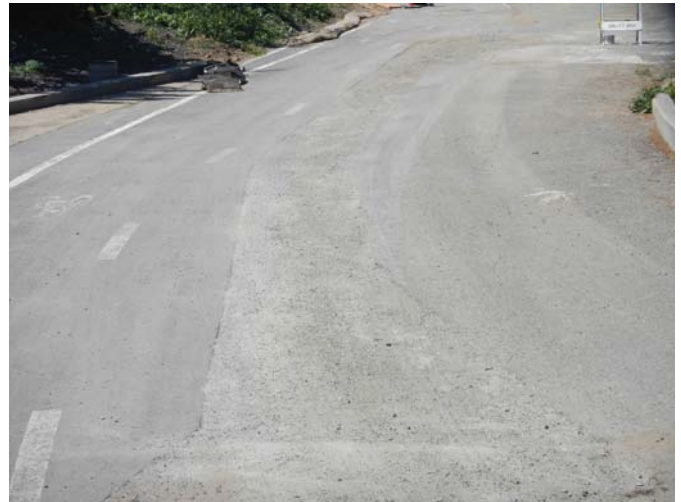
Condition Photos

Condition photos are shown only for manually rated roads. Use the PathView program to see images of DCV rated roads.

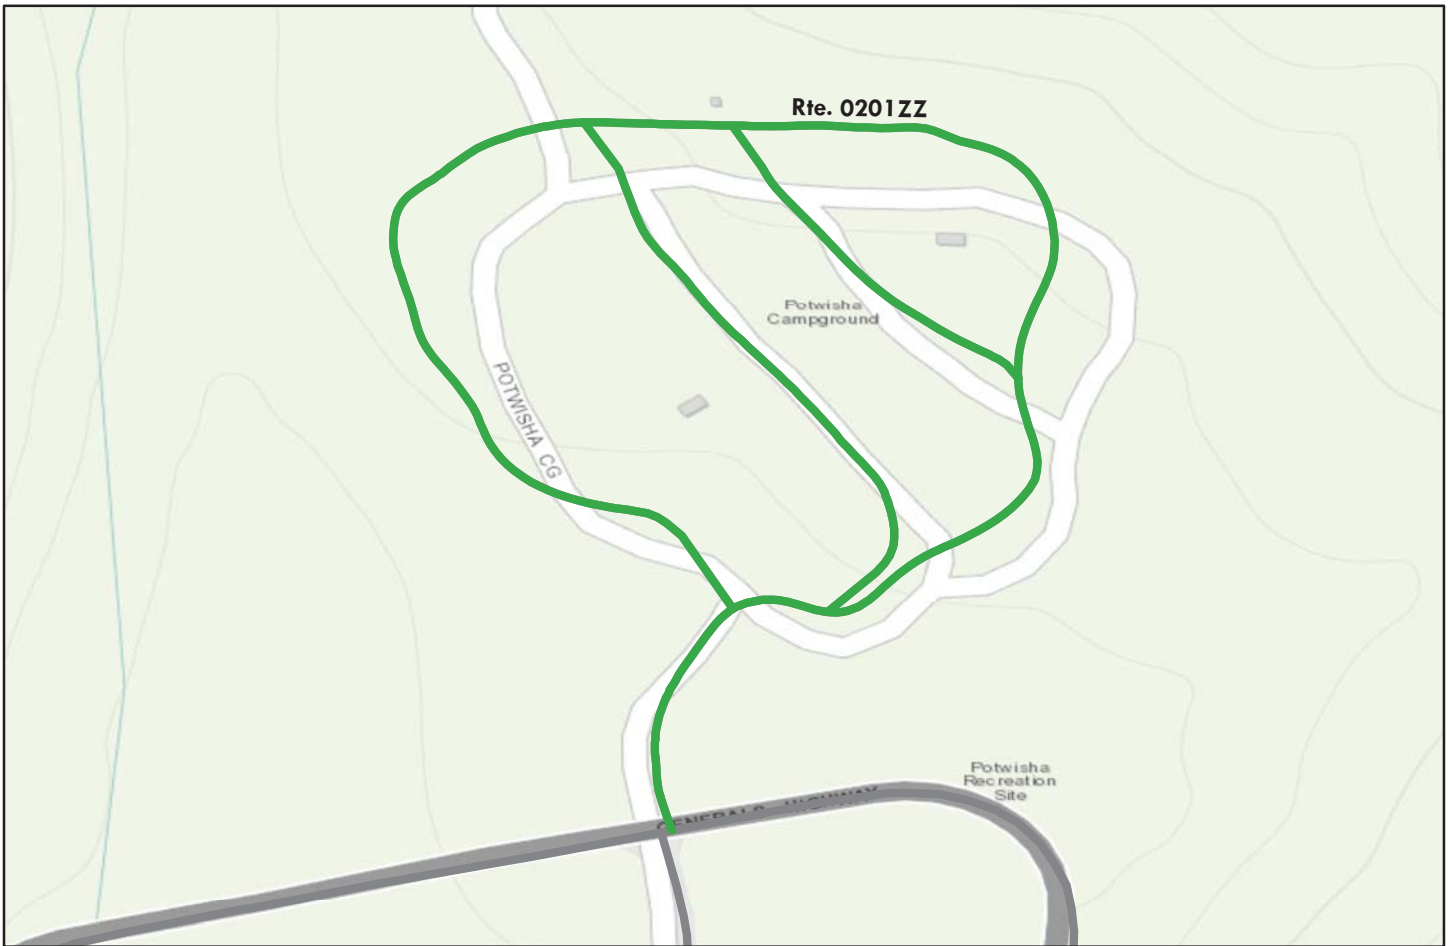
ROUTE 0201ZZ: POTWISHA CAMPGROUND ROADS

Note: The weighted average summary PCR value is calculated from only the sections of road where the PCR was collected. The overall PCR for the summary route may not reflect individual subcomponent ratings.

Route Condition Legend – Pavement Condition Rating (PCR)						
Poor (0 - 60)	Fair (61- 84)	Good (85 - 94)	Excellent (95 - 100)	Not Rated		
See Appendix for definitions and formulas						
Inspection Date:	5/26/2015					
Paved Length (Miles):	0.56					
Surface Type:	ASPHALT	Route Summary				
Roadway Condition Information						
Pavement Condition Rating (PCR)	94					
Lane & Width Information						
Number of Lanes	1					
Paved Width (ft)	14.5					
Lane Width (ft)	12.2

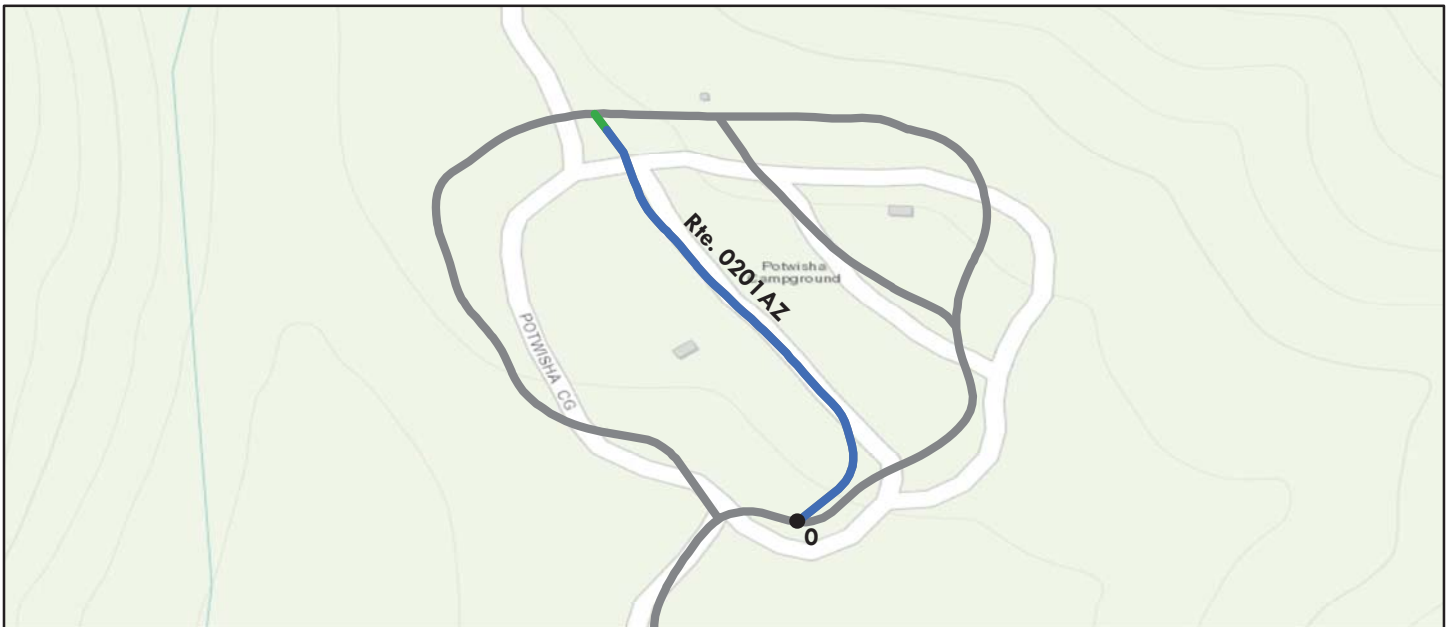
ROUTE 0201AZ: POTWISHA CAMPGROUND ROAD A

Subcomponent of Route SEQU-0201ZZ
Data Collection Vehicle (DCV) Rating

Route Condition Legend – Pavement Condition Rating (PCR)						
Poor (0 - 60)	Fair (61- 84)	Good (85 - 94)	Excellent (95 - 100)	Not Rated		
See Appendix for definitions and formulas						
Inspection Date: 5/26/2015	Beginning Section MP	0				
Paved Length (Miles): 0.1	Section Length (MI)	0.1				
Surface Type: ASPHALT	Route Summary					
Roadway Condition Information						
Pavement Condition Rating (PCR)	95	95				
Surface Condition Rating (SCR)	95	95				
Roughness Condition Index (RCI)	N/A	N/A				
Distress Index Values						
Structural Crack Index	97	97				
Alligator Crack Index	100	100				
Longitudinal Crack Index	97	97				
Transverse Cracking Index	99	99				
Patching Index	100	100				
Rutting Index	95	95				
International Roughness Index (IRI)	N/A	N/A				
Lane & Width Information						
Number of Lanes	1	1				
Paved Width (ft)	13.5	13.5				
Lane Width (ft)	13.5	13.5

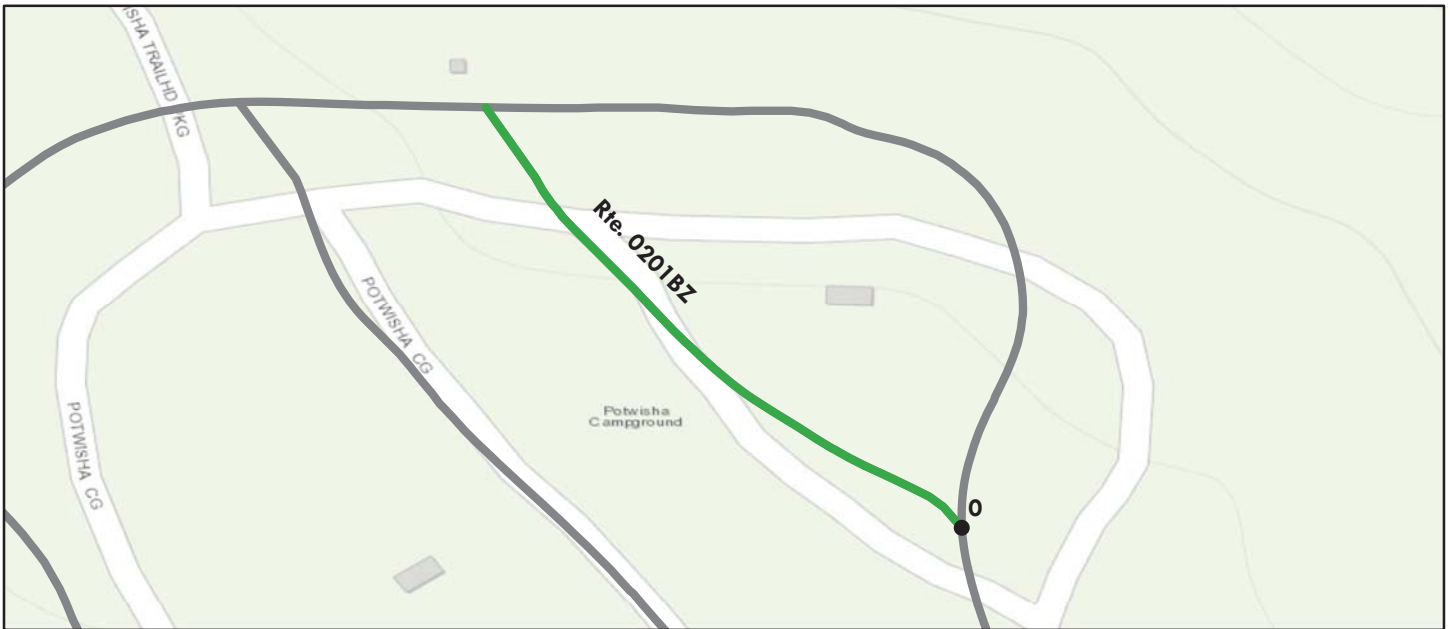
ROUTE 0201BZ: POTWISHA CAMPGROUND ROAD B

Subcomponent of Route SEQU-0201ZZ
Data Collection Vehicle (DCV) Rating

Route Condition Legend – Pavement Condition Rating (PCR)						
Poor (0 - 60)	Fair (61- 84)	Good (85 - 94)	Excellent (95 - 100)	Not Rated		
See Appendix for definitions and formulas						
Inspection Date: 5/26/2015	Beginning Section MP	0				
Paved Length (Miles): 0.07	Section Length (MI)	0.07				
Surface Type: ASPHALT	Route Summary					
Roadway Condition Information						
Pavement Condition Rating (PCR)	92	92				
Surface Condition Rating (SCR)	92	92				
Roughness Condition Index (RCI)	N/A	N/A				
Distress Index Values						
Structural Crack Index	100	100				
Alligator Crack Index	100	100				
Longitudinal Crack Index	100	100				
Transverse Cracking Index	100	100				
Patching Index	100	100				
Rutting Index	92	92				
International Roughness Index (IRI)	N/A	N/A				
Lane & Width Information						
Number of Lanes	1	1				
Paved Width (ft)	11	11				
Lane Width (ft)	11	11

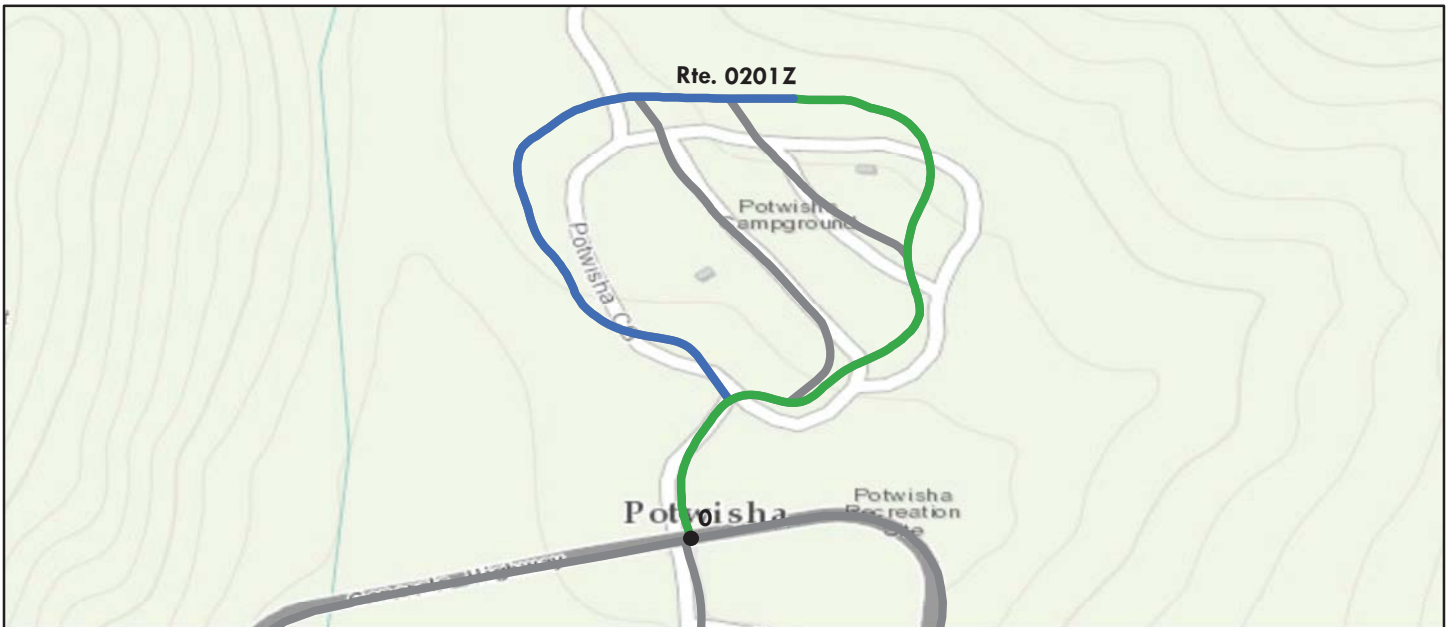
ROUTE 0201Z: POTWISHA CAMPGROUND ROAD

Subcomponent of Route SEQU-0201ZZ
Data Collection Vehicle (DCV) Rating

Inspection Date: 5/26/2015	Beginning Section MP	0				
Paved Length (Miles): 0.38	Section Length (MI)	0.38				
Surface Type: ASPHALT	Route Summary					
Roadway Condition Information						
Pavement Condition Rating (PCR)	94	94				
Surface Condition Rating (SCR)	94	94				
Roughness Condition Index (RCI)	N/A	N/A				
Distress Index Values						
Structural Crack Index	99	99				
Alligator Crack Index	100	100				
Longitudinal Crack Index	99	99				
Transverse Cracking Index	98	98				
Patching Index	100	100				
Rutting Index	94	94				
International Roughness Index (IRI)	N/A	N/A				
Lane & Width Information						
Number of Lanes	1	1				
Paved Width (ft)	15.4	15.4				
Lane Width (ft)	12.1	12.1

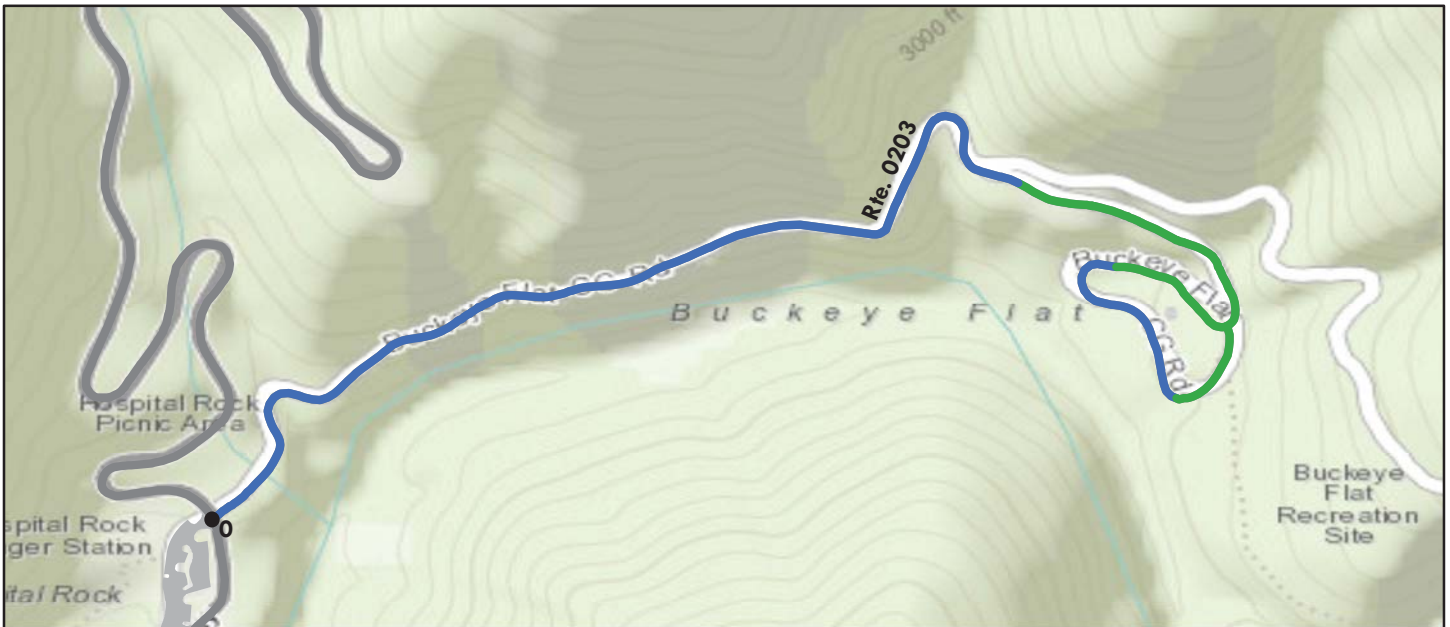
ROUTE 0203: BUCKEYE FLAT ROAD

Data Collection Vehicle (DCV) Rating

Route Condition Legend – Pavement Condition Rating (PCR)						
Poor (0 - 60)	Fair (61- 84)	Good (85 - 94)	Excellent (95 - 100)	Not Rated		
See Appendix for definitions and formulas						
Inspection Date: 5/26/2015	Beginning Section MP	0				
Paved Length (Miles): 0.85	Section Length (MI)	0.85				
Surface Type: ASPHALT	Route Summary					
Roadway Condition Information						
Pavement Condition Rating (PCR)	96	96				
Surface Condition Rating (SCR)	96	96				
Roughness Condition Index (RCI)	N/A	N/A				
Distress Index Values						
Structural Crack Index	99	99				
Alligator Crack Index	100	100				
Longitudinal Crack Index	99	99				
Transverse Cracking Index	99	99				
Patching Index	100	100				
Rutting Index	96	96				
International Roughness Index (IRI)	N/A	N/A				
Lane & Width Information						
Number of Lanes	2	2				
Paved Width (ft)	16.5	16.5				
Lane Width (ft)	8.8	8.8

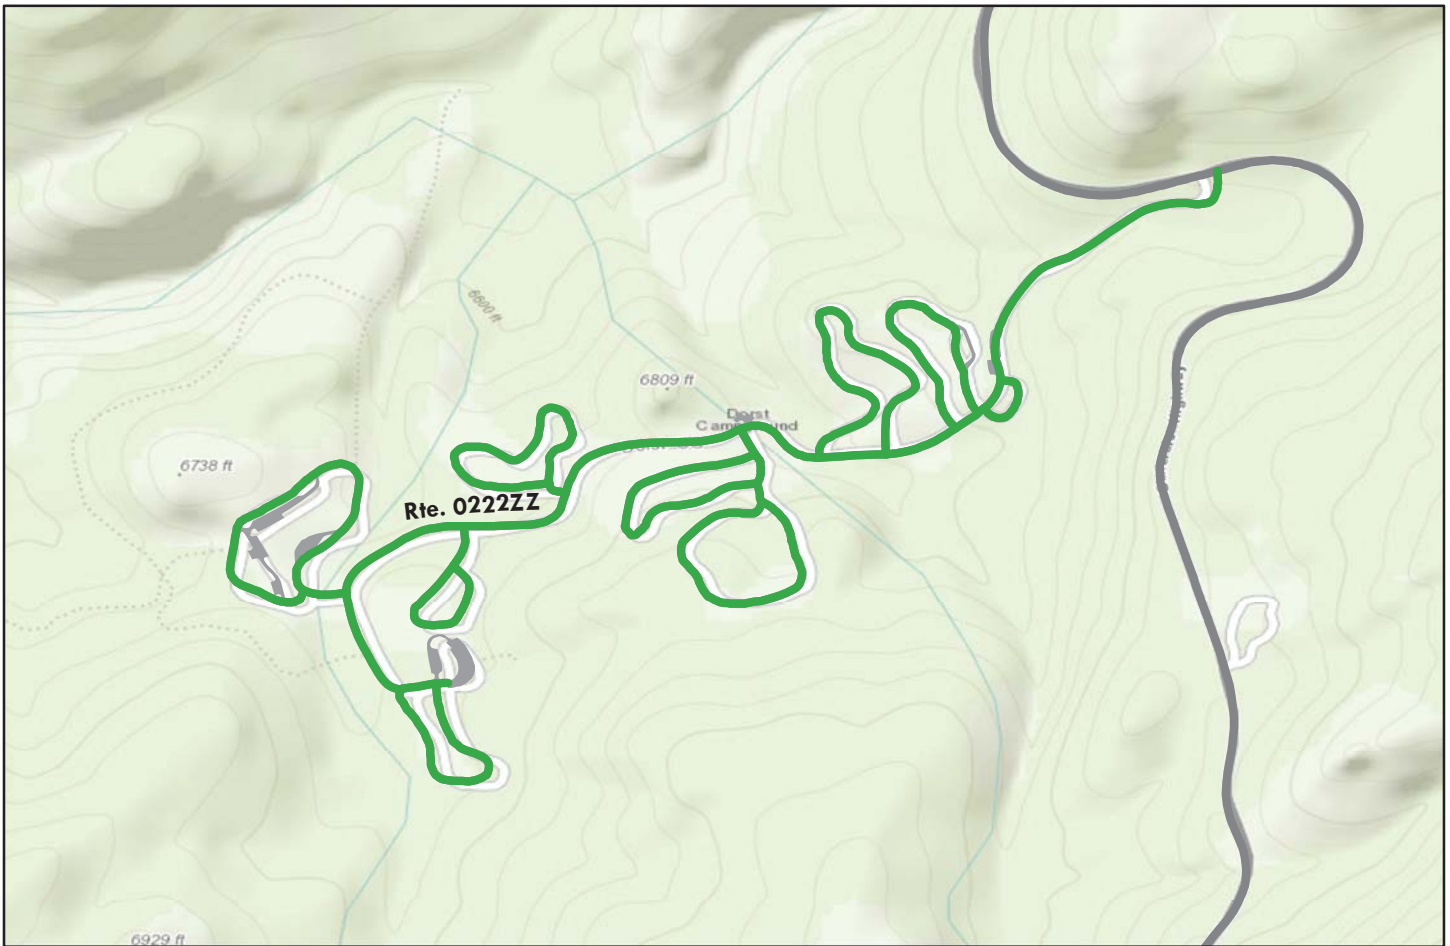
ROUTE 0222ZZ: DORST CAMPGROUND ROADS

Note: The weighted average summary PCR value is calculated from only the sections of road where the PCR was collected. The overall PCR for the summary route may not reflect individual subcomponent ratings.

Route Condition Legend – Pavement Condition Rating (PCR)						
Poor (0 - 60)	Fair (61- 84)	Good (85 - 94)	Excellent (95 - 100)	Not Rated		
See Appendix for definitions and formulas						
Inspection Date:	5/29/2015					
Paved Length (Miles):	3.3					
Surface Type:	ASPHALT					
Roadway Condition Information	Route Summary					
Pavement Condition Rating (PCR)	91					
Lane & Width Information						
Number of Lanes	1					
Paved Width (ft)	14.8					
Lane Width (ft)	11.7

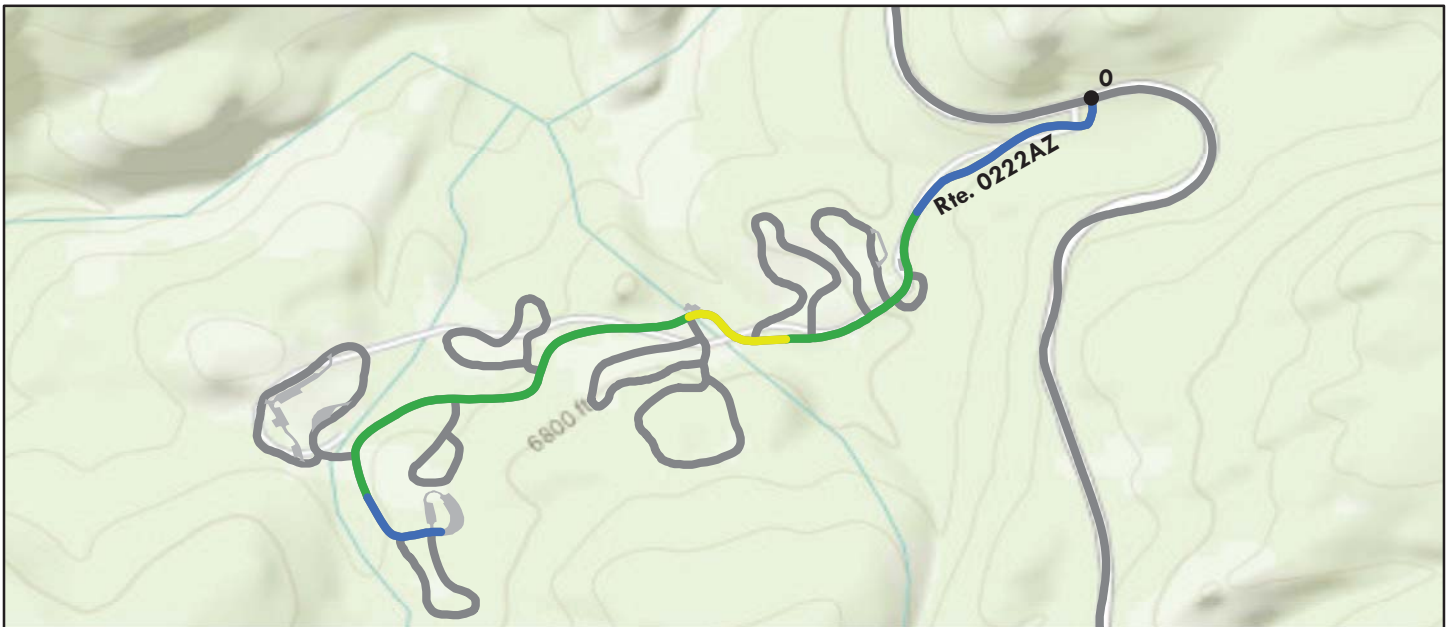
ROUTE 0222AZ: DORST CREEK CAMPGROUND ACCESS ROAD

Subcomponent of Route SEQU-0222ZZ
Data Collection Vehicle (DCV) Rating

Route Condition Legend – Pavement Condition Rating (PCR)						
Poor (0 - 60)	Fair (61- 84)	Good (85 - 94)	Excellent (95 - 100)	Not Rated		
See Appendix for definitions and formulas						
Inspection Date: 5/29/2015	Beginning Section MP	0				
Paved Length (Miles): 0.99	Section Length (MI)	0.99				
Surface Type: ASPHALT	Route Summary					
Roadway Condition Information						
Pavement Condition Rating (PCR)	89	89				
Surface Condition Rating (SCR)	98	98				
Roughness Condition Index (RCI)	76	76				
Distress Index Values						
Structural Crack Index	100	100				
Alligator Crack Index	100	100				
Longitudinal Crack Index	100	100				
Transverse Cracking Index	99	99				
Patching Index	100	100				
Rutting Index	98	98				
International Roughness Index (IRI)	181	181				
Lane & Width Information						
Number of Lanes	2	2				
Paved Width (ft)	17.3	17.3				
Lane Width (ft)	8.6	8.6

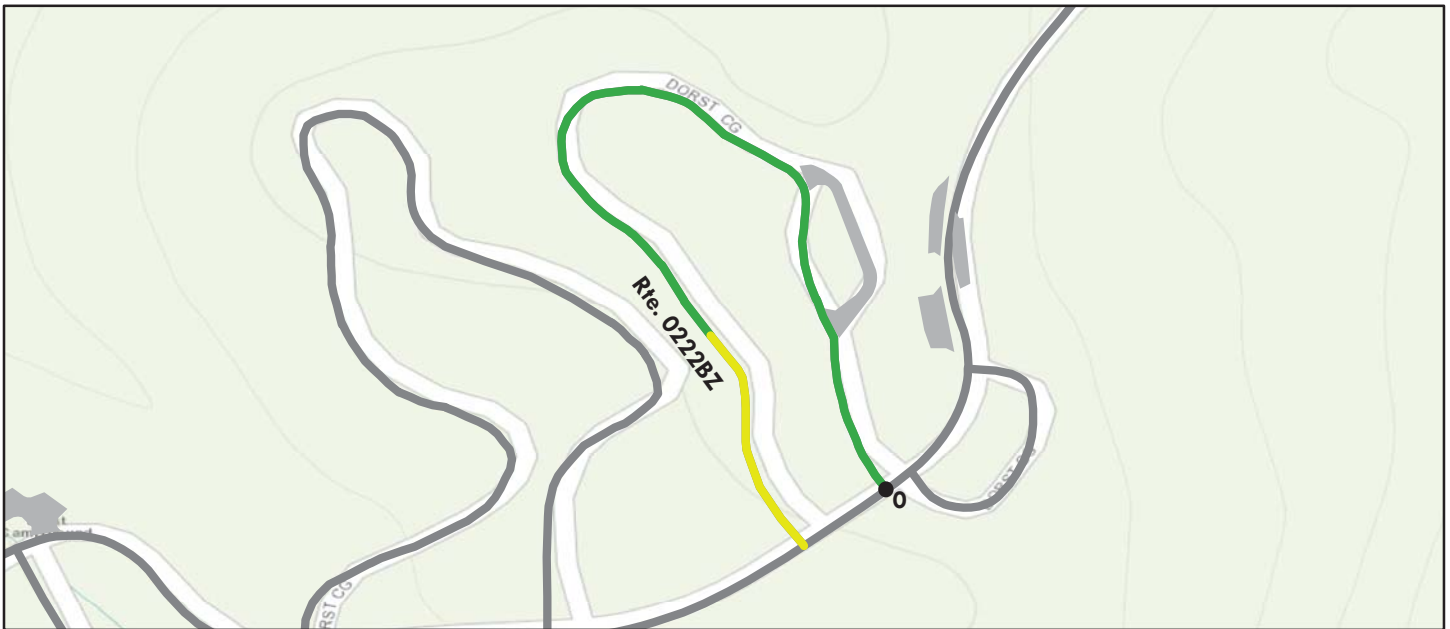
ROUTE 0222BZ: DORST CAMPGROUND ROAD LOOP B (CAMPSITES 1-28)

Subcomponent of Route SEQU-0222ZZ
Data Collection Vehicle (DCV) Rating

Route Condition Legend – Pavement Condition Rating (PCR)						
Poor (0 - 60)	Fair (61- 84)	Good (85 - 94)	Excellent (95 - 100)	Not Rated		
See Appendix for definitions and formulas						
Inspection Date: 5/29/2015	Beginning Section MP	0				
Paved Length (Miles): 0.25	Section Length (MI)	0.25				
Surface Type: ASPHALT	Route Summary					
Roadway Condition Information						
Pavement Condition Rating (PCR)	92	92				
Surface Condition Rating (SCR)	92	92				
Roughness Condition Index (RCI)	N/A	N/A				
Distress Index Values						
Structural Crack Index	100	100				
Alligator Crack Index	100	100				
Longitudinal Crack Index	100	100				
Transverse Cracking Index	98	98				
Patching Index	100	100				
Rutting Index	92	92				
International Roughness Index (IRI)	N/A	N/A				
Lane & Width Information						
Number of Lanes	1	1				
Paved Width (ft)	13.3	13.3				
Lane Width (ft)	13.3	13.3

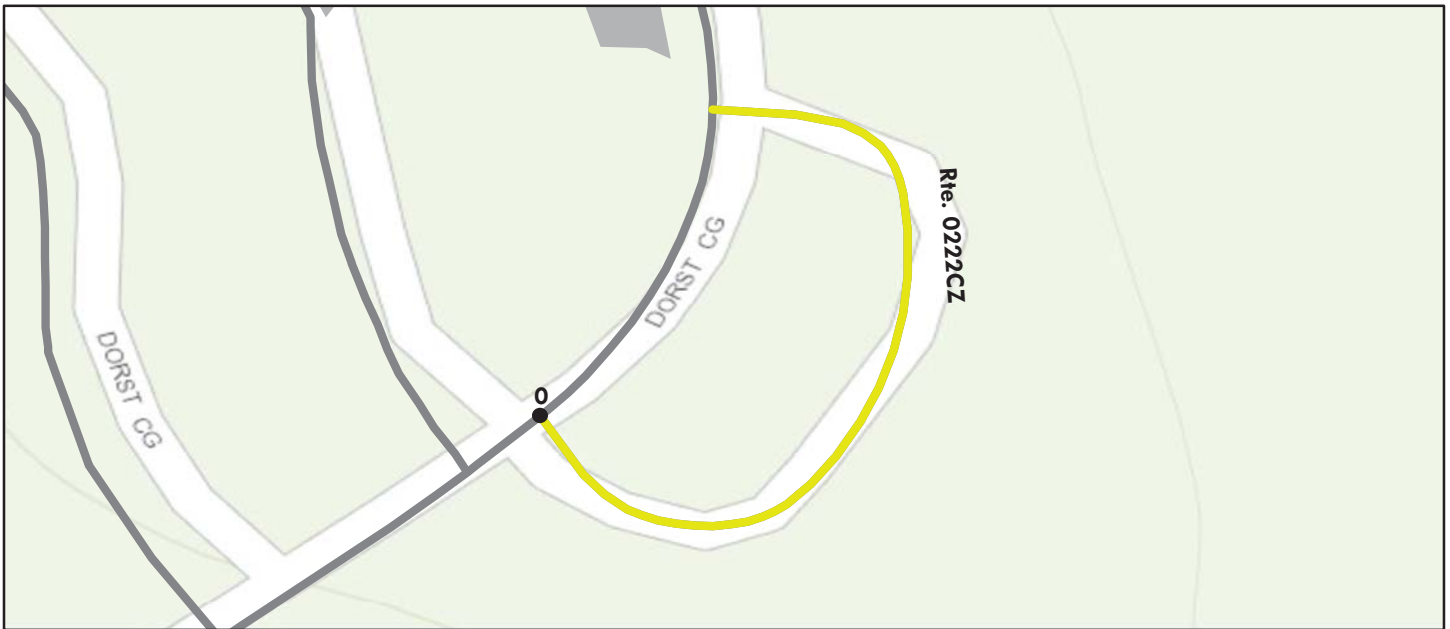
ROUTE 0222CZ: DORST CAMPGROUND ROAD LOOP C

Subcomponent of Route SEQU-0222ZZ
Data Collection Vehicle (DCV) Rating

Route Condition Legend – Pavement Condition Rating (PCR)						
Poor (0 - 60)	Fair (61- 84)	Good (85 - 94)	Excellent (95 - 100)	Not Rated		
See Appendix for definitions and formulas						
Inspection Date: 5/29/2015	Beginning Section MP	0				
Paved Length (Miles): 0.06	Section Length (MI)	0.06				
Surface Type: ASPHALT	Route Summary					
Roadway Condition Information						
Pavement Condition Rating (PCR)	83	83				
Surface Condition Rating (SCR)	83	83				
Roughness Condition Index (RCI)	N/A	N/A				
Distress Index Values						
Structural Crack Index	100	100				
Alligator Crack Index	100	100				
Longitudinal Crack Index	100	100				
Transverse Cracking Index	100	100				
Patching Index	100	100				
Rutting Index	83	83				
International Roughness Index (IRI)	N/A	N/A				
Lane & Width Information						
Number of Lanes	1	1				
Paved Width (ft)	15.8	15.8				
Lane Width (ft)	15.8	15.8

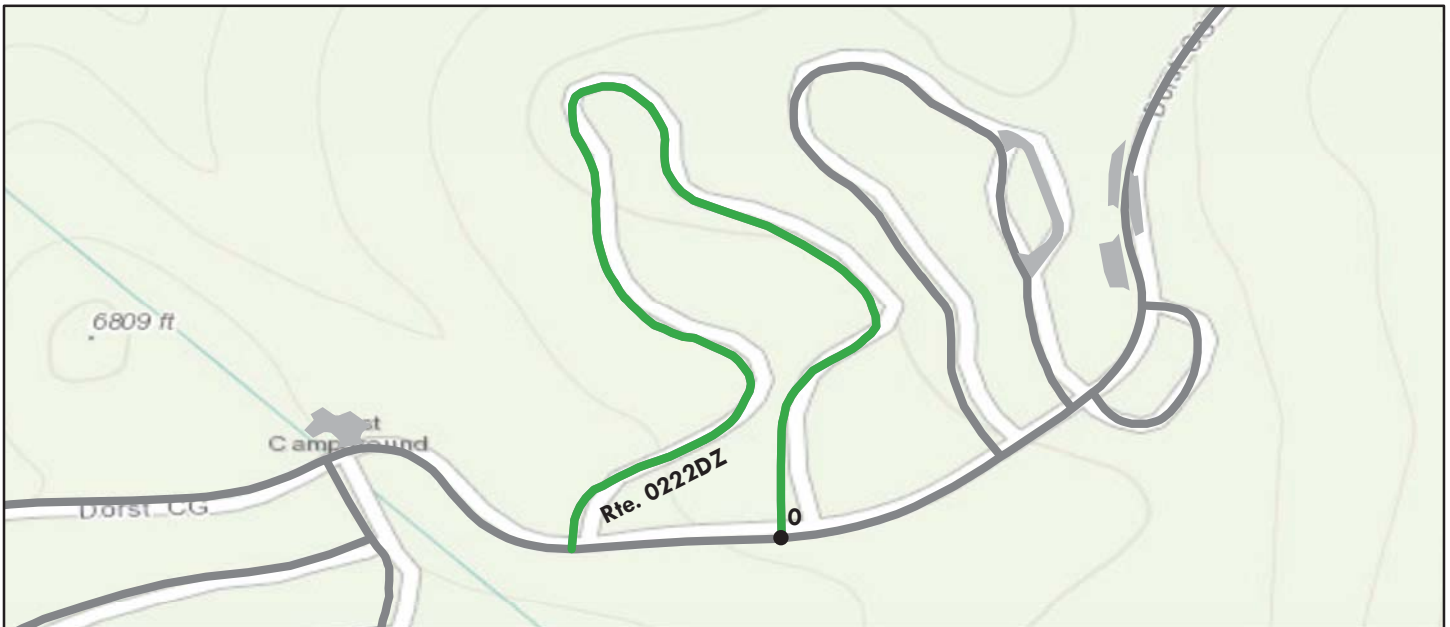
ROUTE 0222DZ: DORST CAMPGROUND ROAD LOOP D (CAMPSITES 29-61)

Subcomponent of Route SEQU-0222ZZ
Data Collection Vehicle (DCV) Rating

Route Condition Legend – Pavement Condition Rating (PCR)						
Poor (0 - 60)	Fair (61- 84)	Good (85 - 94)	Excellent (95 - 100)	Not Rated		
See Appendix for definitions and formulas						
Inspection Date: 5/29/2015	Beginning Section MP	0				
Paved Length (Miles): 0.35	Section Length (MI)	0.35				
Surface Type: ASPHALT	Route Summary					
Roadway Condition Information						
Pavement Condition Rating (PCR)	89	89				
Surface Condition Rating (SCR)	89	89				
Roughness Condition Index (RCI)	N/A	N/A				
Distress Index Values						
Structural Crack Index	100	100				
Alligator Crack Index	100	100				
Longitudinal Crack Index	100	100				
Transverse Cracking Index	95	95				
Patching Index	100	100				
Rutting Index	89	89				
International Roughness Index (IRI)	N/A	N/A				
Lane & Width Information						
Number of Lanes	1	1				
Paved Width (ft)	14.6	14.6				
Lane Width (ft)	14.6	14.6

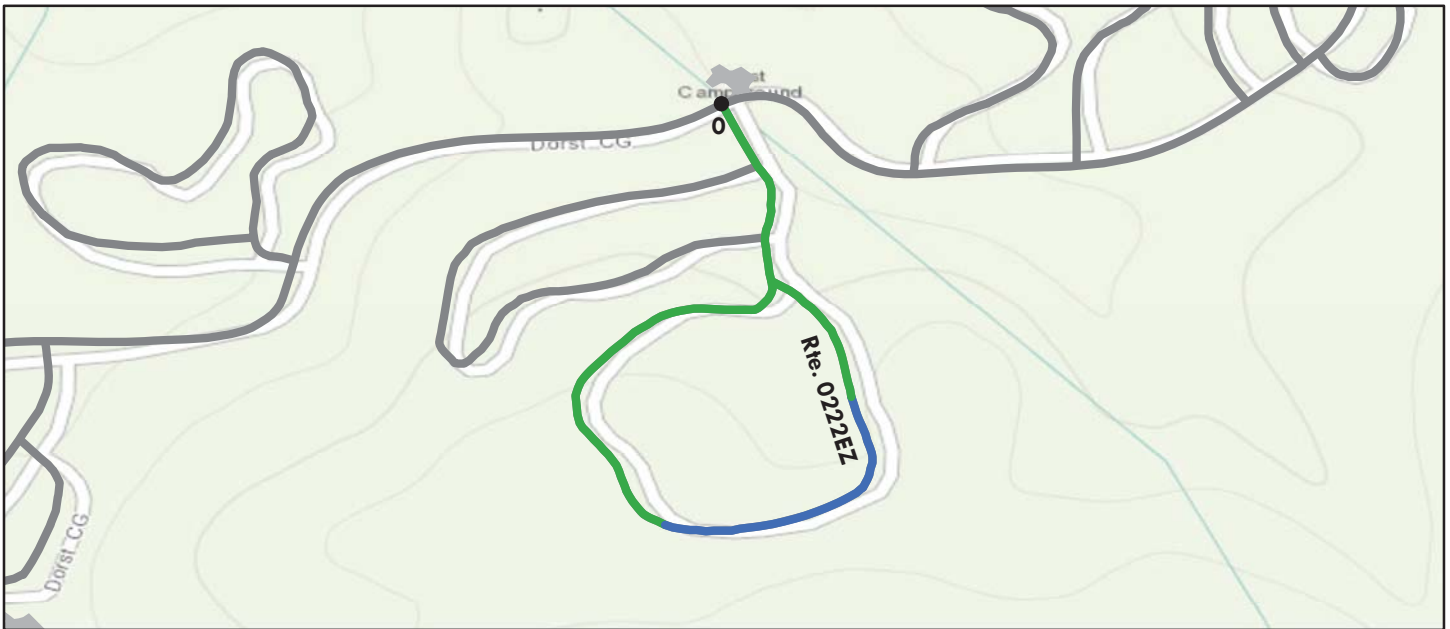
ROUTE 0222EZ: DORST CAMPGROUND ROAD LOOP E (CAMPSITES 99-127)

Subcomponent of Route SEQU-0222ZZ
Data Collection Vehicle (DCV) Rating

Route Condition Legend – Pavement Condition Rating (PCR)						
Poor (0 - 60)	Fair (61- 84)	Good (85 - 94)	Excellent (95 - 100)	Not Rated		
See Appendix for definitions and formulas						
Inspection Date: 5/29/2015	Beginning Section MP	0				
Paved Length (Miles): 0.35	Section Length (MI)	0.35				
Surface Type: ASPHALT	Route Summary					
Roadway Condition Information						
Pavement Condition Rating (PCR)	93	93				
Surface Condition Rating (SCR)	93	93				
Roughness Condition Index (RCI)	N/A	N/A				
Distress Index Values						
Structural Crack Index	100	100				
Alligator Crack Index	100	100				
Longitudinal Crack Index	100	100				
Transverse Cracking Index	100	100				
Patching Index	100	100				
Rutting Index	93	93				
International Roughness Index (IRI)	N/A	N/A				
Lane & Width Information						
Number of Lanes	1	1				
Paved Width (ft)	13.9	13.9				
Lane Width (ft)	11.7	11.7

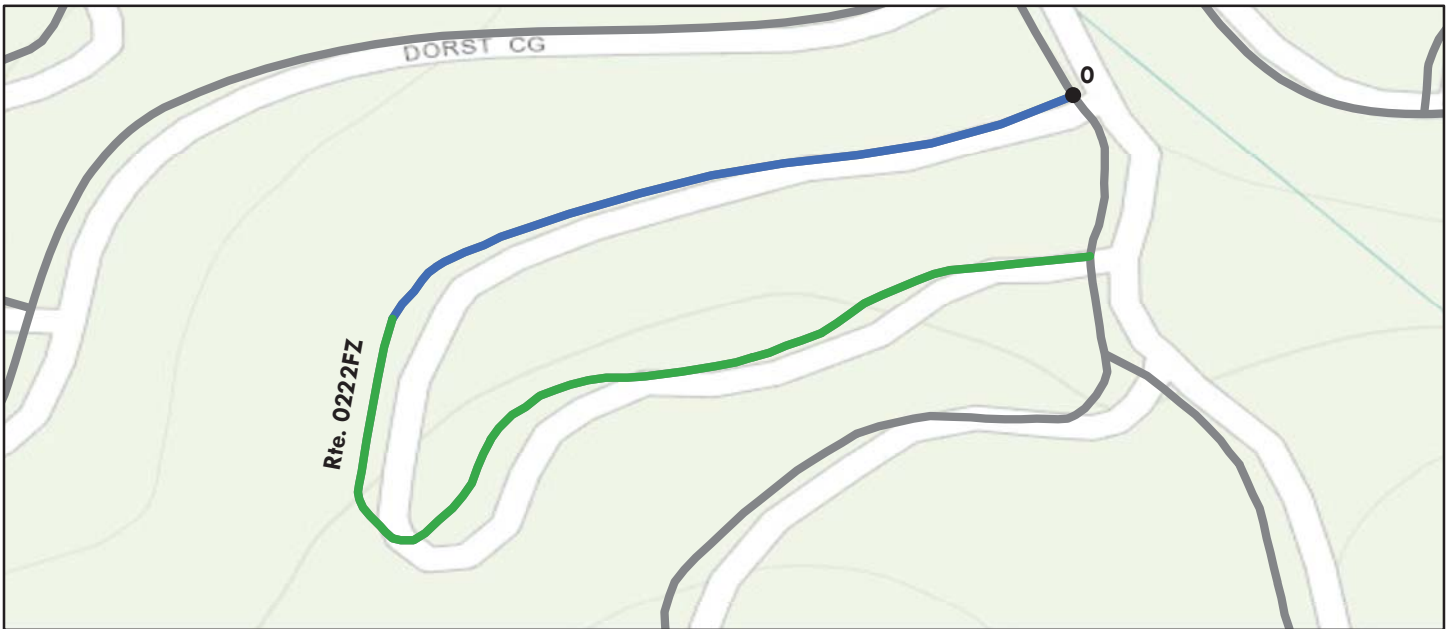
ROUTE 0222FZ: DORST CAMPGROUND ROAD LOOP F (CAMPSITES 74-98)

Subcomponent of Route SEQU-0222ZZ
Data Collection Vehicle (DCV) Rating

Route Condition Legend – Pavement Condition Rating (PCR)						
Poor (0 - 60)	Fair (61 - 84)	Good (85 - 94)	Excellent (95 - 100)	Not Rated		
See Appendix for definitions and formulas						
Inspection Date: 5/29/2015	Beginning Section MP	0				
Paved Length (Miles): 0.25	Section Length (MI)	0.25				
Surface Type: ASPHALT	Route Summary					
Roadway Condition Information						
Pavement Condition Rating (PCR)	94	94				
Surface Condition Rating (SCR)	94	94				
Roughness Condition Index (RCI)	N/A	N/A				
Distress Index Values						
Structural Crack Index	100	100				
Alligator Crack Index	100	100				
Longitudinal Crack Index	100	100				
Transverse Cracking Index	100	100				
Patching Index	100	100				
Rutting Index	94	94				
International Roughness Index (IRI)	N/A	N/A				
Lane & Width Information						
Number of Lanes	1	1				
Paved Width (ft)	12.2	12.2				
Lane Width (ft)	12.2	12.2

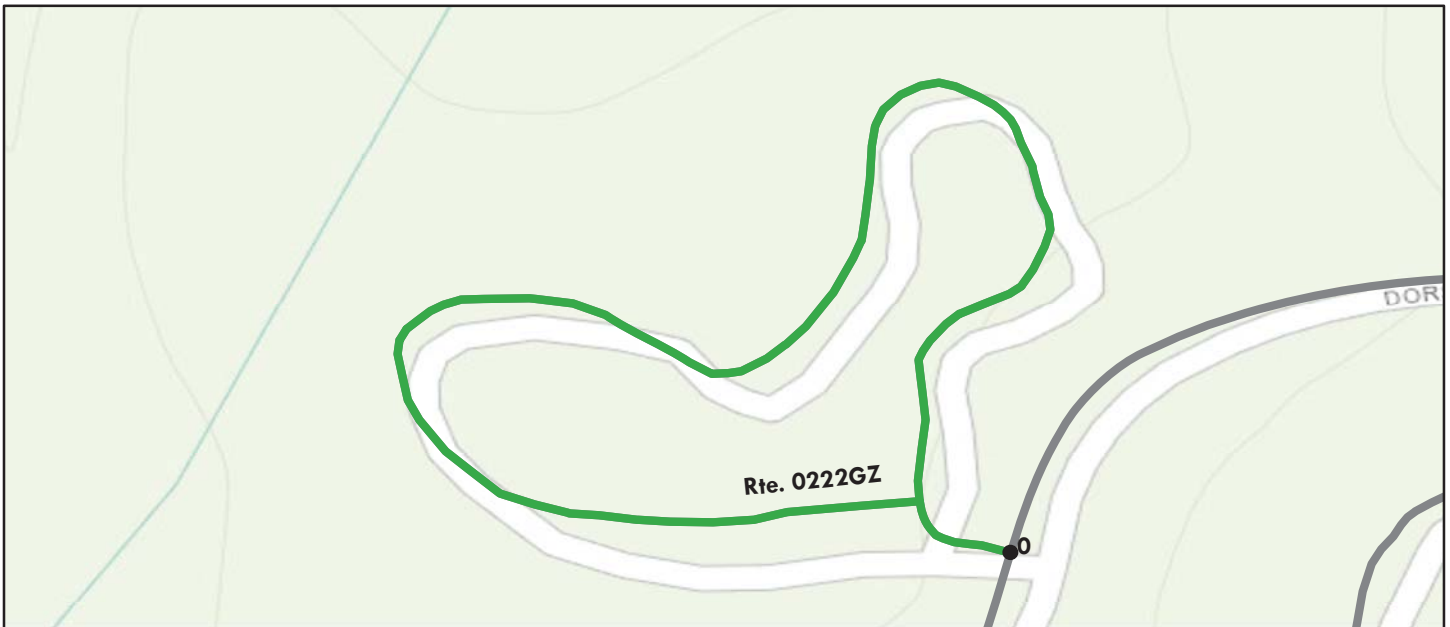
ROUTE 0222GZ: DORST CAMPGROUND ROAD LOOP G (CAMPSITES 128-163)

Subcomponent of Route SEQU-0222ZZ
Data Collection Vehicle (DCV) Rating

Route Condition Legend – Pavement Condition Rating (PCR)						
Poor (0 - 60)	Fair (61- 84)	Good (85 - 94)	Excellent (95 - 100)	Not Rated		
See Appendix for definitions and formulas						
Inspection Date: 5/29/2015	Beginning Section MP	0				
Paved Length (Miles): 0.29	Section Length (MI)	0.29				
Surface Type: ASPHALT	Route Summary					
Roadway Condition Information						
Pavement Condition Rating (PCR)	90	90				
Surface Condition Rating (SCR)	90	90				
Roughness Condition Index (RCI)	N/A	N/A				
Distress Index Values						
Structural Crack Index	100	100				
Alligator Crack Index	100	100				
Longitudinal Crack Index	100	100				
Transverse Cracking Index	100	100				
Patching Index	100	100				
Rutting Index	90	90				
International Roughness Index (IRI)	N/A	N/A				
Lane & Width Information						
Number of Lanes	1	1				
Paved Width (ft)	11.9	11.9				
Lane Width (ft)	11.9	11.9

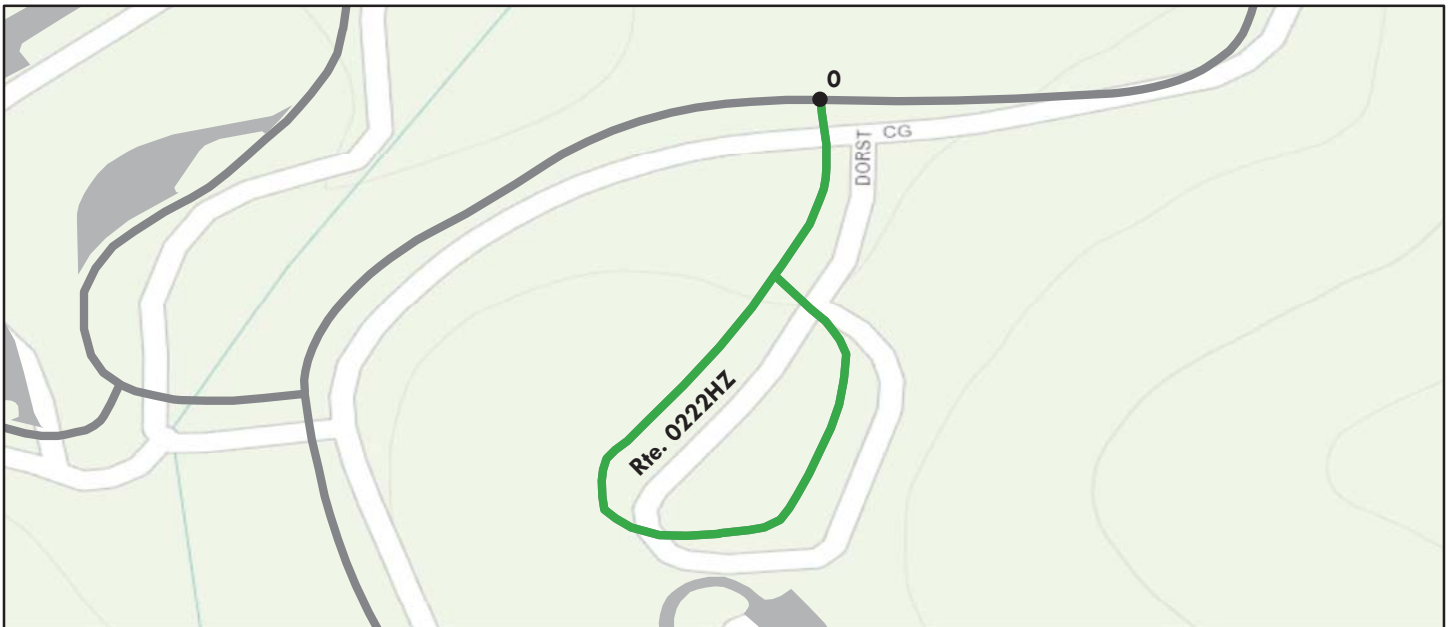
ROUTE 0222HZ: DORST CAMPGROUND ROAD LOOP H (CAMPSITES 164-192)

Subcomponent of Route SEQU-0222ZZ
Data Collection Vehicle (DCV) Rating

Route Condition Legend – Pavement Condition Rating (PCR)						
Poor (0 - 60)	Fair (61- 84)	Good (85 - 94)	Excellent (95 - 100)	Not Rated		
See Appendix for definitions and formulas						
Inspection Date: 5/29/2015	Beginning Section MP	0				
Paved Length (Miles): 0.17	Section Length (MI)	0.17				
Surface Type: ASPHALT	Route Summary					
Roadway Condition Information						
Pavement Condition Rating (PCR)	92	92				
Surface Condition Rating (SCR)	92	92				
Roughness Condition Index (RCI)	N/A	N/A				
Distress Index Values						
Structural Crack Index	100	100				
Alligator Crack Index	100	100				
Longitudinal Crack Index	100	100				
Transverse Cracking Index	100	100				
Patching Index	100	100				
Rutting Index	92	92				
International Roughness Index (IRI)	N/A	N/A				
Lane & Width Information						
Number of Lanes	1	1				
Paved Width (ft)	14.2	14.2				
Lane Width (ft)	11.8	11.8
