Road Inventory and Condition Assessment of Paved Routes Sequoia National Park

**Federal Lands Highway
Road Inventory Program**

Federal Highway Administration
Eastern Federal Lands Highway Division
Road Inventory Program (RIP)

Report Date: January 2016

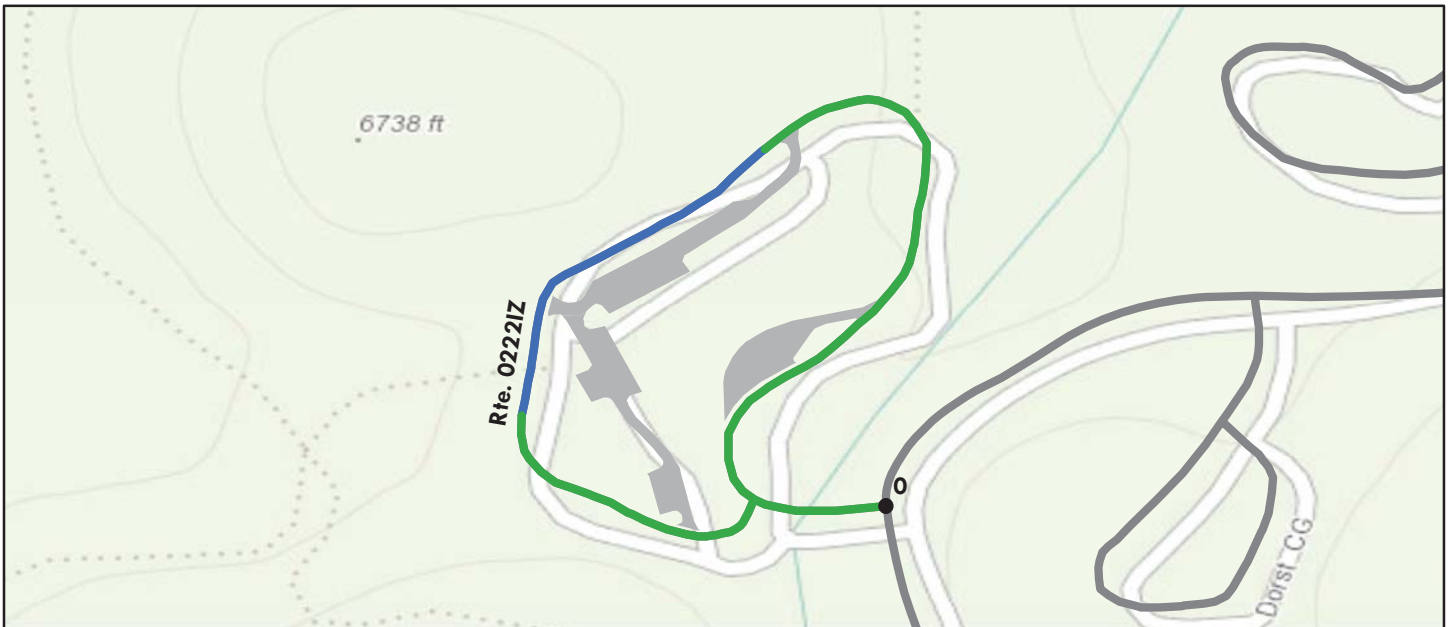
ROUTE 0222IZ: DORST CAMPGROUND ROAD LOOP I (GROUP CAMPSITES)

Subcomponent of Route SEQU-0222ZZ
Data Collection Vehicle (DCV) Rating

Inspection Date: 5/29/2015	Beginning Section MP	0				
Paved Length (Miles): 0.38	Section Length (MI)	0.38				
Surface Type: ASPHALT	Route Summary					
Roadway Condition Information						
Pavement Condition Rating (PCR)	94	94				
Surface Condition Rating (SCR)	94	94				
Roughness Condition Index (RCI)	N/A	N/A				
Distress Index Values						
Structural Crack Index	100	100				
Alligator Crack Index	100	100				
Longitudinal Crack Index	100	100				
Transverse Cracking Index	100	100				
Patching Index	100	100				
Rutting Index	94	94				
International Roughness Index (IRI)	N/A	N/A				
Lane & Width Information						
Number of Lanes	1	1				
Paved Width (ft)	15.5	15.5				
Lane Width (ft)	14.4	14.4

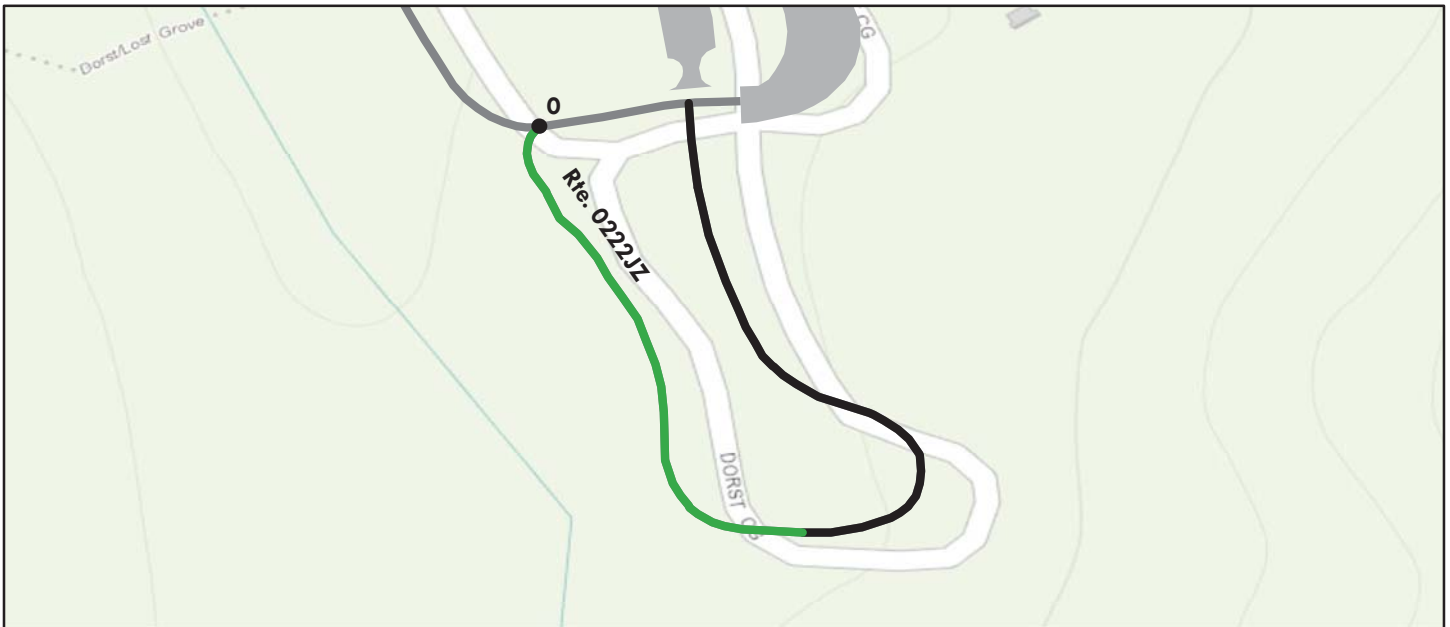
ROUTE 0222JZ: DORST CAMPGROUND ROAD LOOP J (CAMPSITES 193-218)

Subcomponent of Route SEQU-0222ZZ
Data Collection Vehicle (DCV) Rating

Route Condition Legend – Pavement Condition Rating (PCR)						
Poor (0 - 60)	Fair (61- 84)	Good (85 - 94)	Excellent (95 - 100)	Not Rated		
See Appendix for definitions and formulas						
Inspection Date: 5/29/2015	Beginning Section MP	0				
Paved Length (Miles): 0.22	Section Length (MI)	0.22				
Surface Type: ASPHALT	Route Summary					
Roadway Condition Information						
Pavement Condition Rating (PCR)	92	92				
Surface Condition Rating (SCR)	92	92				
Roughness Condition Index (RCI)	N/A	N/A				
Distress Index Values						
Structural Crack Index	100	100				
Alligator Crack Index	100	100				
Longitudinal Crack Index	100	100				
Transverse Cracking Index	100	100				
Patching Index	100	100				
Rutting Index	92	92				
International Roughness Index (IRI)	N/A	N/A				
Lane & Width Information						
Number of Lanes	1	1				
Paved Width (ft)	12.5	12.5				
Lane Width (ft)	12.5	12.5

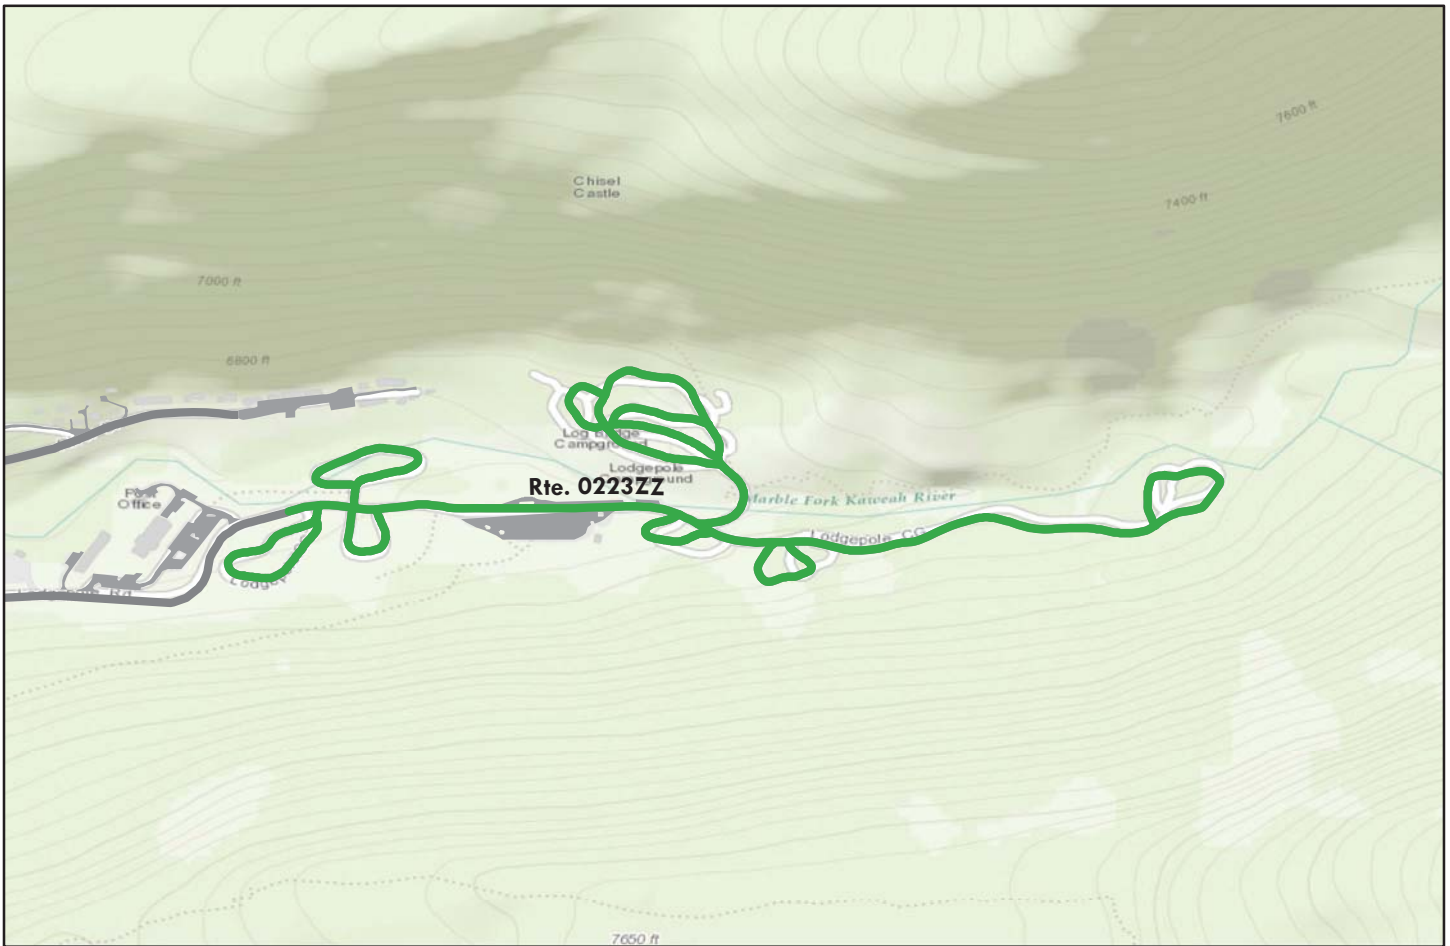
ROUTE 0223ZZ: LODGEPOLE CAMPGROUND LOOPS

Note: The weighted average summary PCR value is calculated from only the sections of road where the PCR was collected. The overall PCR for the summary route may not reflect individual subcomponent ratings.

Route Condition Legend – Pavement Condition Rating (PCR)						
Poor (0 - 60)	Fair (61- 84)	Good (85 - 94)	Excellent (95 - 100)	Not Rated		
See Appendix for definitions and formulas						
Inspection Date: 5/26/2015						
Paved Length (Miles): 2.25						
Surface Type: ASPHALT	Route Summary					
Roadway Condition Information						
Pavement Condition Rating (PCR)	93					
Lane & Width Information						
Number of Lanes	1					
Paved Width (ft)	14.5					
Lane Width (ft)	11.7

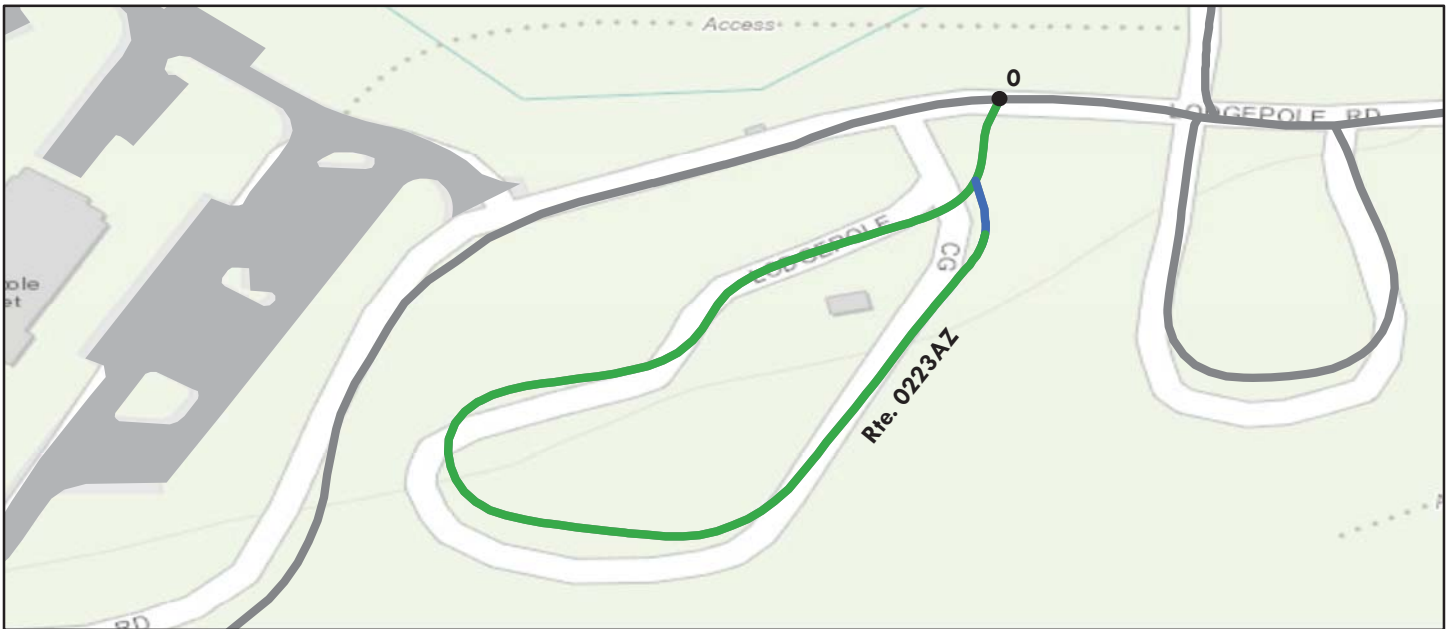
ROUTE 0223AZ: LODGEPOLE CAMPGROUND LOOP A (CAMPSITES 1-24)

Subcomponent of Route SEQU-0223ZZ
Data Collection Vehicle (DCV) Rating

Inspection Date: 5/26/2015	Beginning Section MP	0				
Paved Length (Miles): 0.21	Section Length (MI)	0.21				
Surface Type: ASPHALT	Route Summary					
Roadway Condition Information						
Pavement Condition Rating (PCR)	93	93				
Surface Condition Rating (SCR)	93	93				
Roughness Condition Index (RCI)	N/A	N/A				
Distress Index Values						
Structural Crack Index	95	95				
Alligator Crack Index	100	100				
Longitudinal Crack Index	95	95				
Transverse Cracking Index	93	93				
Patching Index	100	100				
Rutting Index	94	94				
International Roughness Index (IRI)	N/A	N/A				
Lane & Width Information						
Number of Lanes	1	1				
Paved Width (ft)	14.4	14.4				
Lane Width (ft)	14.4	14.4

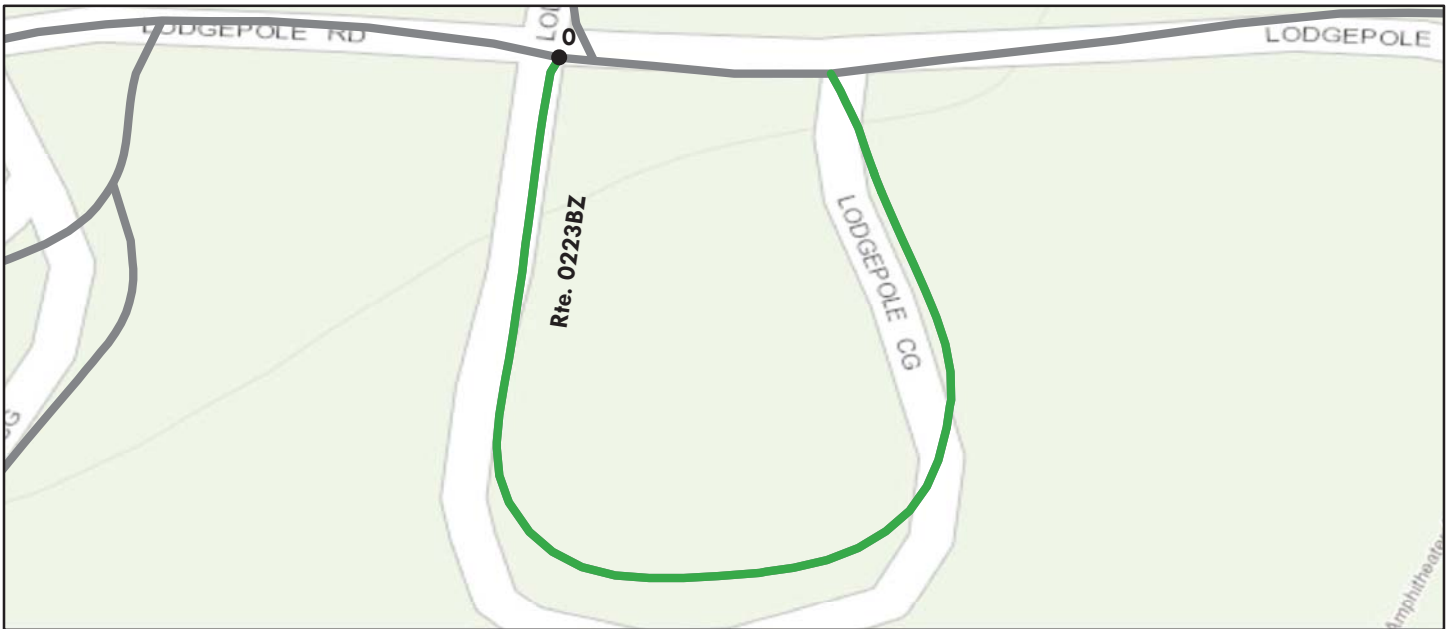
ROUTE 0223BZ: LODGEPOLE CAMPGROUND LOOP B (CAMPSITES 25-35)

Subcomponent of Route SEQU-0223ZZ
Data Collection Vehicle (DCV) Rating

Inspection Date: 5/26/2015	Beginning Section MP	0				
Paved Length (Miles): 0.11	Section Length (MI)	0.11				
Surface Type: ASPHALT	Route Summary					
Roadway Condition Information						
Pavement Condition Rating (PCR)	92	92				
Surface Condition Rating (SCR)	92	92				
Roughness Condition Index (RCI)	N/A	N/A				
Distress Index Values						
Structural Crack Index	96	96				
Alligator Crack Index	100	100				
Longitudinal Crack Index	96	96				
Transverse Cracking Index	92	92				
Patching Index	100	100				
Rutting Index	95	95				
International Roughness Index (IRI)	N/A	N/A				
Lane & Width Information						
Number of Lanes	1	1				
Paved Width (ft)	13.1	13.1				
Lane Width (ft)	13.1	13.1

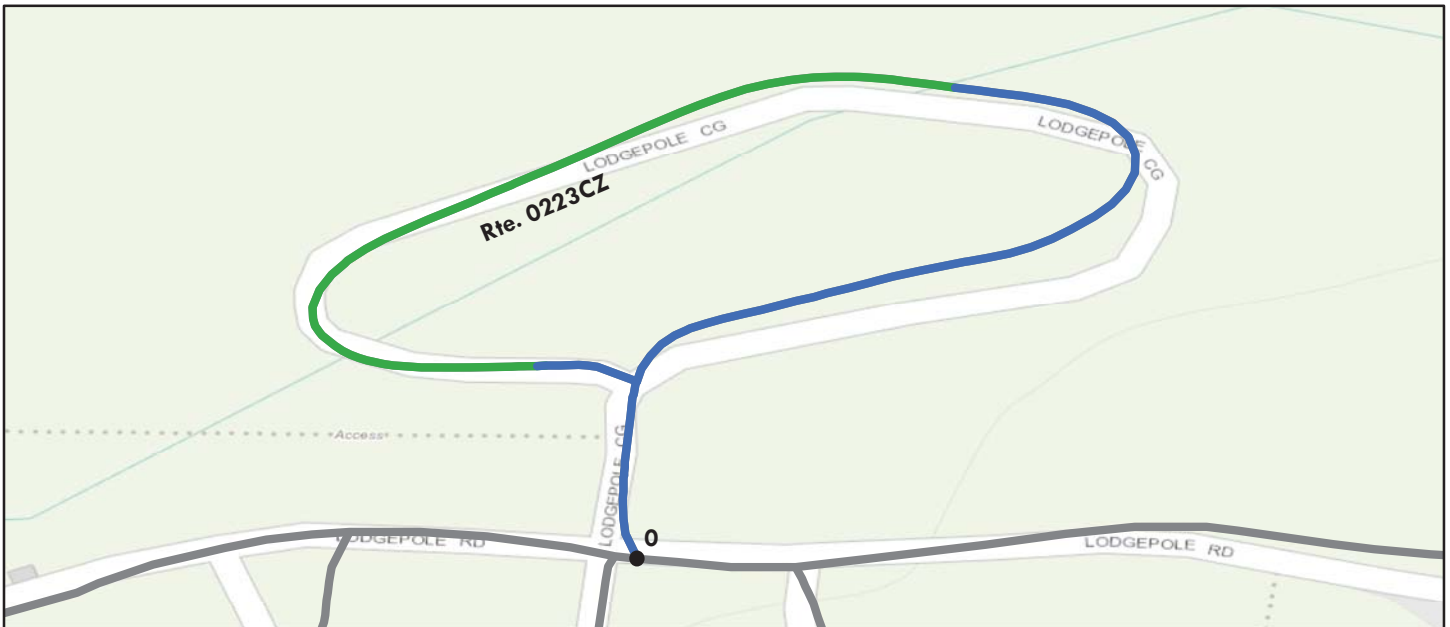
ROUTE 0223CZ: LODGEPOLE CAMPGROUND LOOP C (CAMPSITES 36-60)

Subcomponent of Route SEQU-0223ZZ
Data Collection Vehicle (DCV) Rating

Inspection Date: 5/26/2015	Beginning Section MP	0				
Paved Length (Miles): 0.21	Section Length (MI)	0.21				
Surface Type: ASPHALT	Route Summary					
Roadway Condition Information						
Pavement Condition Rating (PCR)	95	95				
Surface Condition Rating (SCR)	95	95				
Roughness Condition Index (RCI)	N/A	N/A				
Distress Index Values						
Structural Crack Index	100	100				
Alligator Crack Index	100	100				
Longitudinal Crack Index	100	100				
Transverse Cracking Index	99	99				
Patching Index	100	100				
Rutting Index	95	95				
International Roughness Index (IRI)	N/A	N/A				
Lane & Width Information						
Number of Lanes	2	2				
Paved Width (ft)	17.1	17.1				
Lane Width (ft)	11.5	11.5

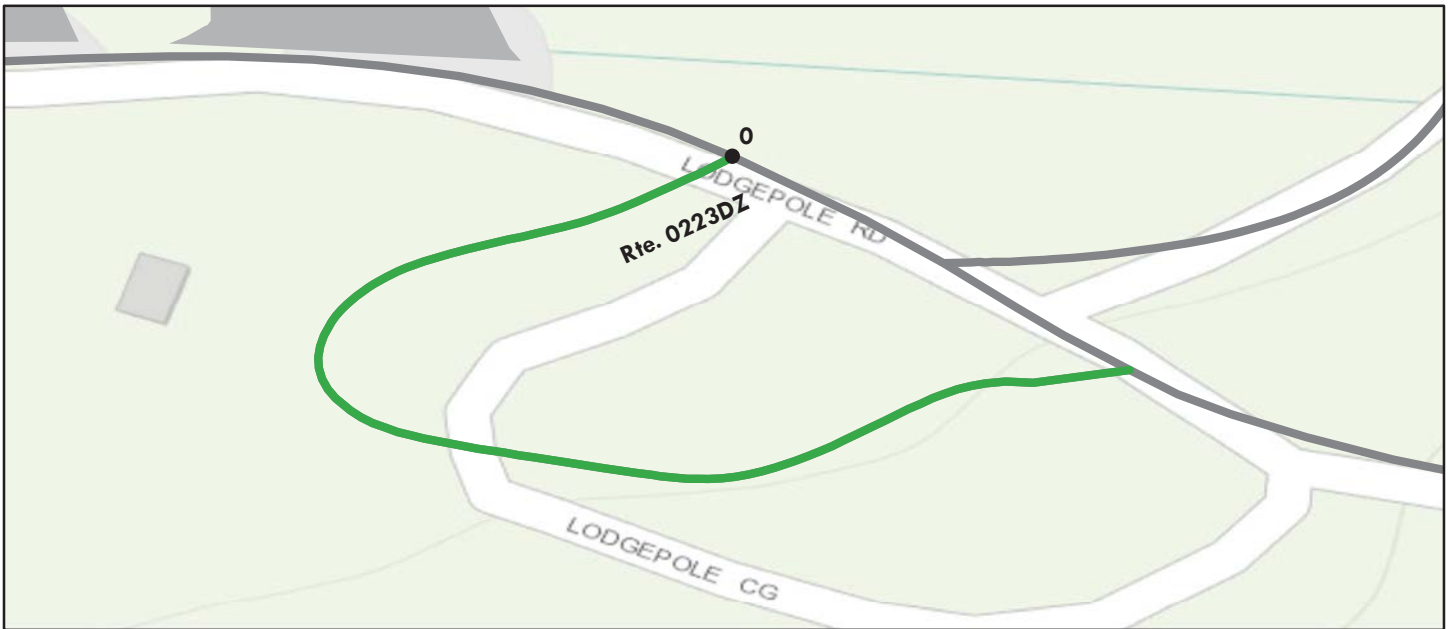
ROUTE 0223DZ: LODGEPOLE CAMPGROUND LOOP D (CAMPSITES 61-68)

Subcomponent of Route SEQU-0223ZZ
Data Collection Vehicle (DCV) Rating

Route Condition Legend – Pavement Condition Rating (PCR)						
Poor (0 - 60)	Fair (61- 84)	Good (85 - 94)	Excellent (95 - 100)	Not Rated		
See Appendix for definitions and formulas						
Inspection Date: 5/26/2015	Beginning Section MP	0				
Paved Length (Miles): 0.09	Section Length (MI)	0.09				
Surface Type: ASPHALT	Route Summary					
Roadway Condition Information						
Pavement Condition Rating (PCR)	92	92				
Surface Condition Rating (SCR)	92	92				
Roughness Condition Index (RCI)	N/A	N/A				
Distress Index Values						
Structural Crack Index	100	100				
Alligator Crack Index	100	100				
Longitudinal Crack Index	100	100				
Transverse Cracking Index	99	99				
Patching Index	100	100				
Rutting Index	92	92				
International Roughness Index (IRI)	N/A	N/A				
Lane & Width Information						
Number of Lanes	1	1				
Paved Width (ft)	14.6	14.6				
Lane Width (ft)	14.6	14.6

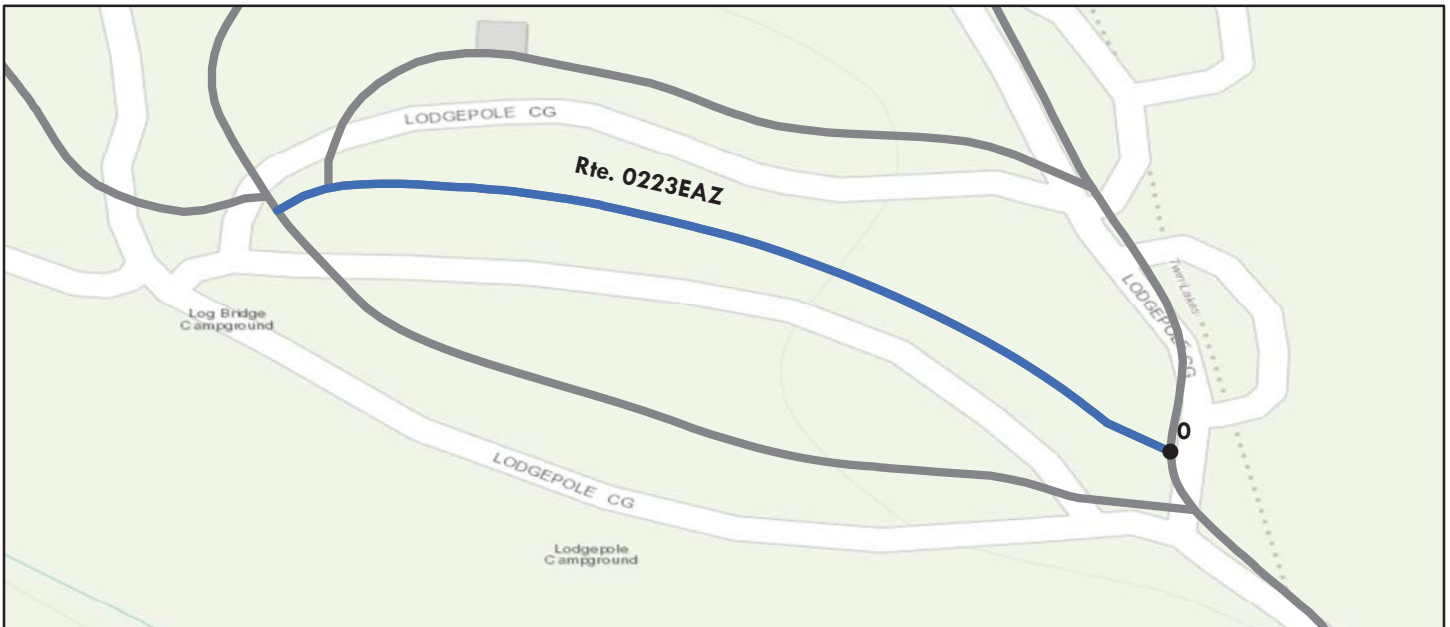
ROUTE 0223EAZ: LODGEPOLE CAMPGROUND LOOPEA

Subcomponent of Route SEQU-0223ZZ
Data Collection Vehicle (DCV) Rating

Route Condition Legend – Pavement Condition Rating (PCR)						
Poor (0 - 60)	Fair (61- 84)	Good (85 - 94)	Excellent (95 - 100)	Not Rated		
See Appendix for definitions and formulas						
Inspection Date: 5/26/2015	Beginning Section MP	0				
Paved Length (Miles): 0.09	Section Length (MI)	0.09				
Surface Type: ASPHALT	Route Summary					
Roadway Condition Information						
Pavement Condition Rating (PCR)	95	95				
Surface Condition Rating (SCR)	95	95				
Roughness Condition Index (RCI)	N/A	N/A				
Distress Index Values						
Structural Crack Index	99	99				
Alligator Crack Index	100	100				
Longitudinal Crack Index	99	99				
Transverse Cracking Index	100	100				
Patching Index	100	100				
Rutting Index	95	95				
International Roughness Index (IRI)	N/A	N/A				
Lane & Width Information						
Number of Lanes	1	1				
Paved Width (ft)	15.1	15.1				
Lane Width (ft)	15.1	15.1

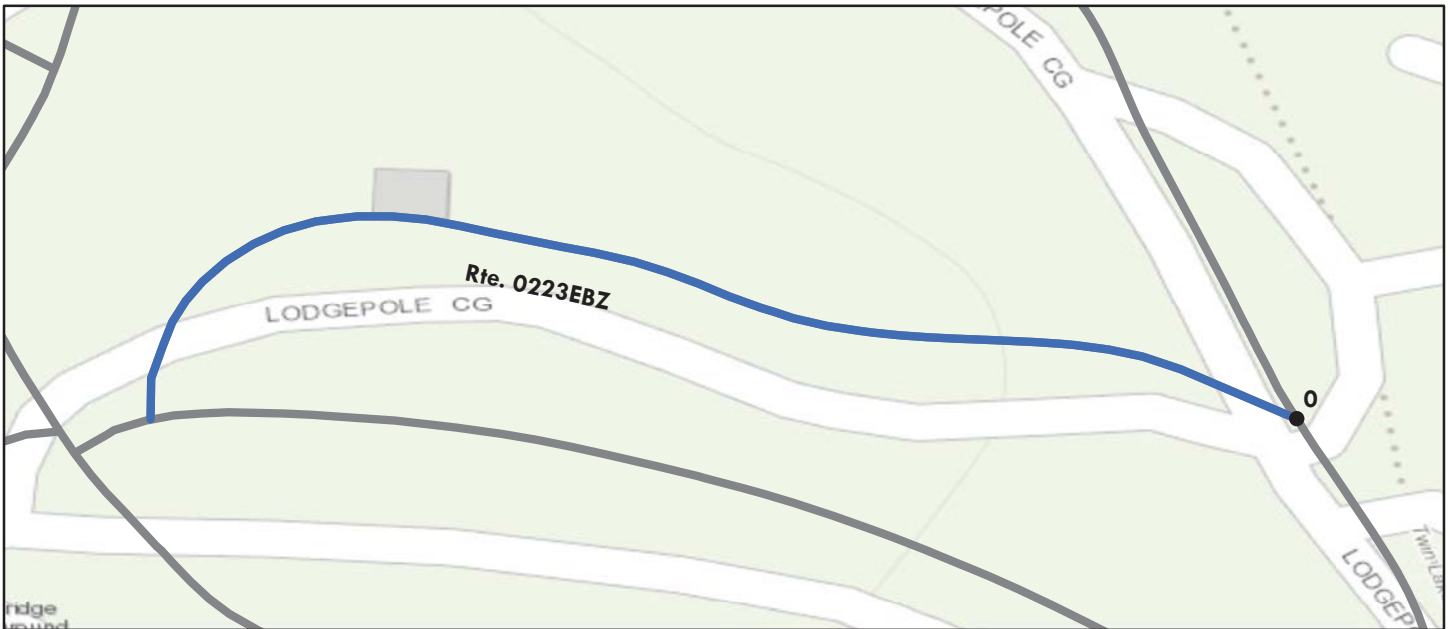
ROUTE 0223EBZ: LODGEPOLE CAMPGROUND LOOP EB

Subcomponent of Route SEQU-0223ZZ
Data Collection Vehicle (DCV) Rating

Route Condition Legend – Pavement Condition Rating (PCR)						
Poor (0 - 60)	Fair (61- 84)	Good (85 - 94)	Excellent (95 - 100)	Not Rated		
See Appendix for definitions and formulas						
Inspection Date: 5/26/2015	Beginning Section MP	0				
Paved Length (Miles): 0.08	Section Length (MI)	0.08				
Surface Type: ASPHALT	Route Summary					
Roadway Condition Information						
Pavement Condition Rating (PCR)	95	95				
Surface Condition Rating (SCR)	95	95				
Roughness Condition Index (RCI)	N/A	N/A				
Distress Index Values						
Structural Crack Index	100	100				
Alligator Crack Index	100	100				
Longitudinal Crack Index	100	100				
Transverse Cracking Index	98	98				
Patching Index	100	100				
Rutting Index	95	95				
International Roughness Index (IRI)	N/A	N/A				
Lane & Width Information						
Number of Lanes	1	1				
Paved Width (ft)	14	14				
Lane Width (ft)	14	14

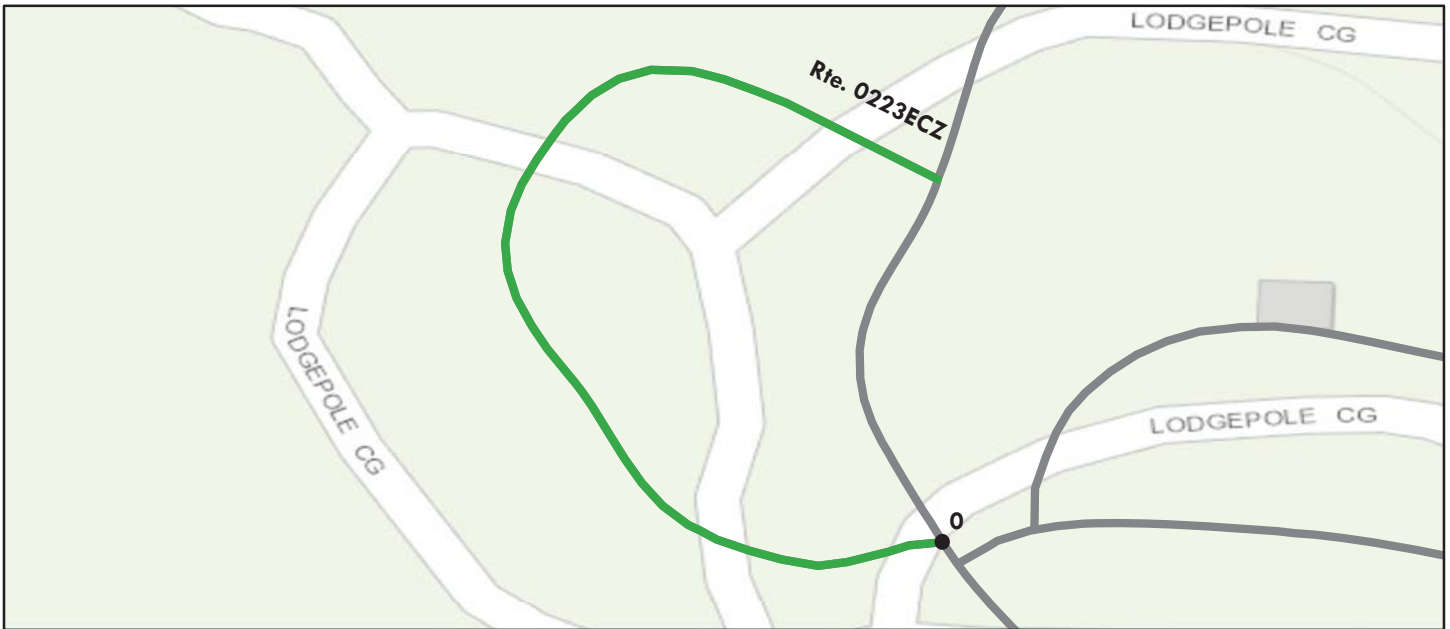
ROUTE 0223ECZ: LODGEPOLE CAMPGROUND LOOPEC

Subcomponent of Route SEQU-0223ZZ
Data Collection Vehicle (DCV) Rating

Route Condition Legend – Pavement Condition Rating (PCR)						
Poor (0 - 60)	Fair (61- 84)	Good (85 - 94)	Excellent (95 - 100)	Not Rated		
See Appendix for definitions and formulas						
Inspection Date: 5/26/2015	Beginning Section MP	0				
Paved Length (Miles): 0.07	Section Length (MI)	0.07				
Surface Type: ASPHALT	Route Summary					
Roadway Condition Information						
Pavement Condition Rating (PCR)	93	93				
Surface Condition Rating (SCR)	93	93				
Roughness Condition Index (RCI)	N/A	N/A				
Distress Index Values						
Structural Crack Index	100	100				
Alligator Crack Index	100	100				
Longitudinal Crack Index	100	100				
Transverse Cracking Index	99	99				
Patching Index	100	100				
Rutting Index	93	93				
International Roughness Index (IRI)	N/A	N/A				
Lane & Width Information						
Number of Lanes	1	1				
Paved Width (ft)	11.5	11.5				
Lane Width (ft)	11.5	11.5

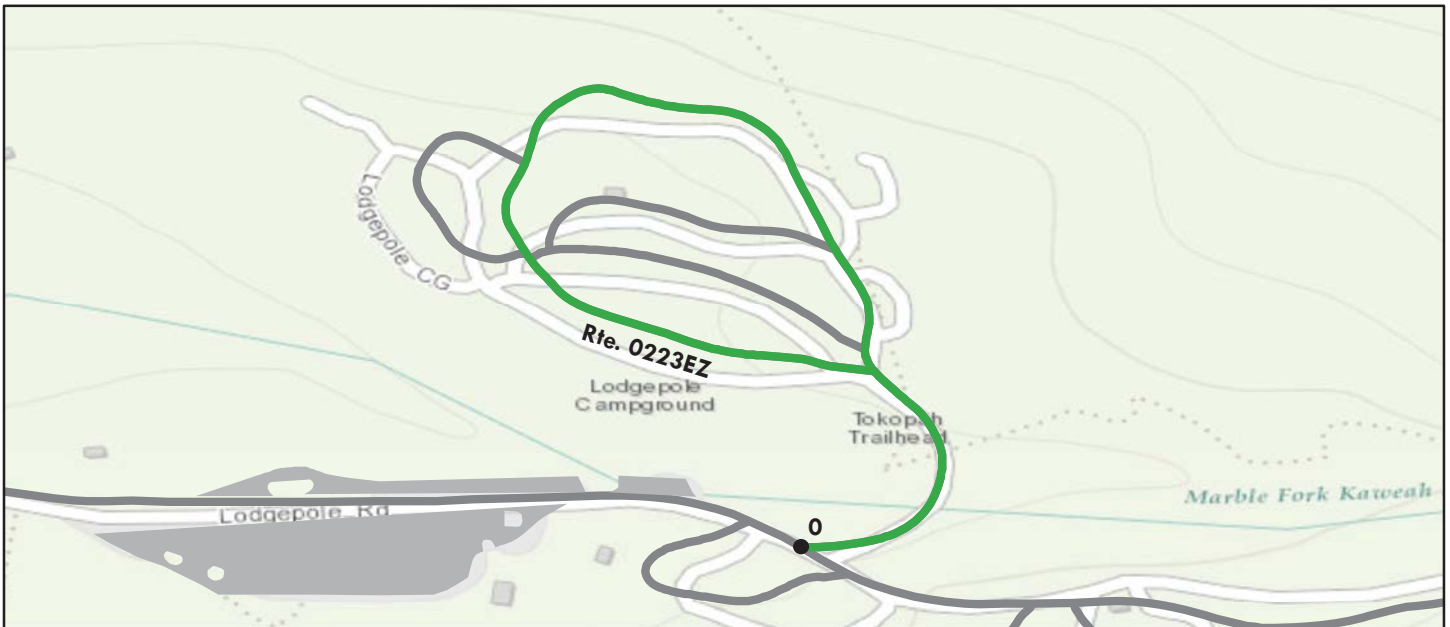
ROUTE 0223EZ: LODGEPOLE CAMPGROUND LOOPE (CAMPSITES 151-214)

Subcomponent of Route SEQU-0223ZZ
Data Collection Vehicle (DCV) Rating

Route Condition Legend – Pavement Condition Rating (PCR)						
Poor (0 - 60)	Fair (61- 84)	Good (85 - 94)	Excellent (95 - 100)	Not Rated		
See Appendix for definitions and formulas						
Inspection Date: 5/26/2015	Beginning Section MP	0				
Paved Length (Miles): 0.38	Section Length (MI)	0.38				
Surface Type: ASPHALT	Route Summary					
Roadway Condition Information						
Pavement Condition Rating (PCR)	90	90				
Surface Condition Rating (SCR)	90	90				
Roughness Condition Index (RCI)	N/A	N/A				
Distress Index Values						
Structural Crack Index	100	100				
Alligator Crack Index	100	100				
Longitudinal Crack Index	100	100				
Transverse Cracking Index	98	98				
Patching Index	100	100				
Rutting Index	90	90				
International Roughness Index (IRI)	N/A	N/A				
Lane & Width Information						
Number of Lanes	1	1				
Paved Width (ft)	15.5	15.5				
Lane Width (ft)	11.6	11.6

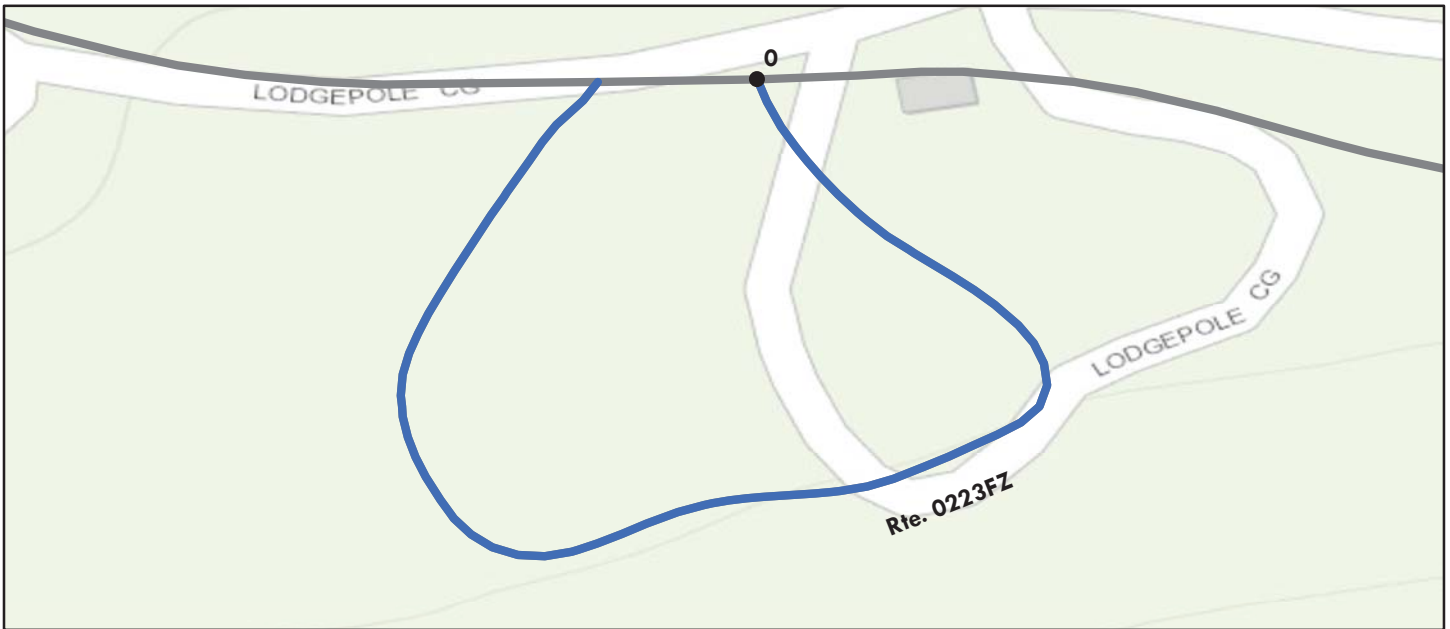
ROUTE 0223FZ: LODGEPOLE CAMPGROUND LOOP F

Subcomponent of Route SEQU-0223ZZ
Data Collection Vehicle (DCV) Rating

Route Condition Legend – Pavement Condition Rating (PCR)						
Poor (0 - 60)	Fair (61- 84)	Good (85 - 94)	Excellent (95 - 100)	Not Rated		
See Appendix for definitions and formulas						
Inspection Date: 5/26/2015	Beginning Section MP	0				
Paved Length (Miles): 0.12	Section Length (MI)	0.12				
Surface Type: ASPHALT	Route Summary					
Roadway Condition Information						
Pavement Condition Rating (PCR)	96	96				
Surface Condition Rating (SCR)	96	96				
Roughness Condition Index (RCI)	N/A	N/A				
Distress Index Values						
Structural Crack Index	100	100				
Alligator Crack Index	100	100				
Longitudinal Crack Index	100	100				
Transverse Cracking Index	100	100				
Patching Index	100	100				
Rutting Index	96	96				
International Roughness Index (IRI)	N/A	N/A				
Lane & Width Information						
Number of Lanes	1	1				
Paved Width (ft)	11.6	11.6				
Lane Width (ft)	11.6	11.6

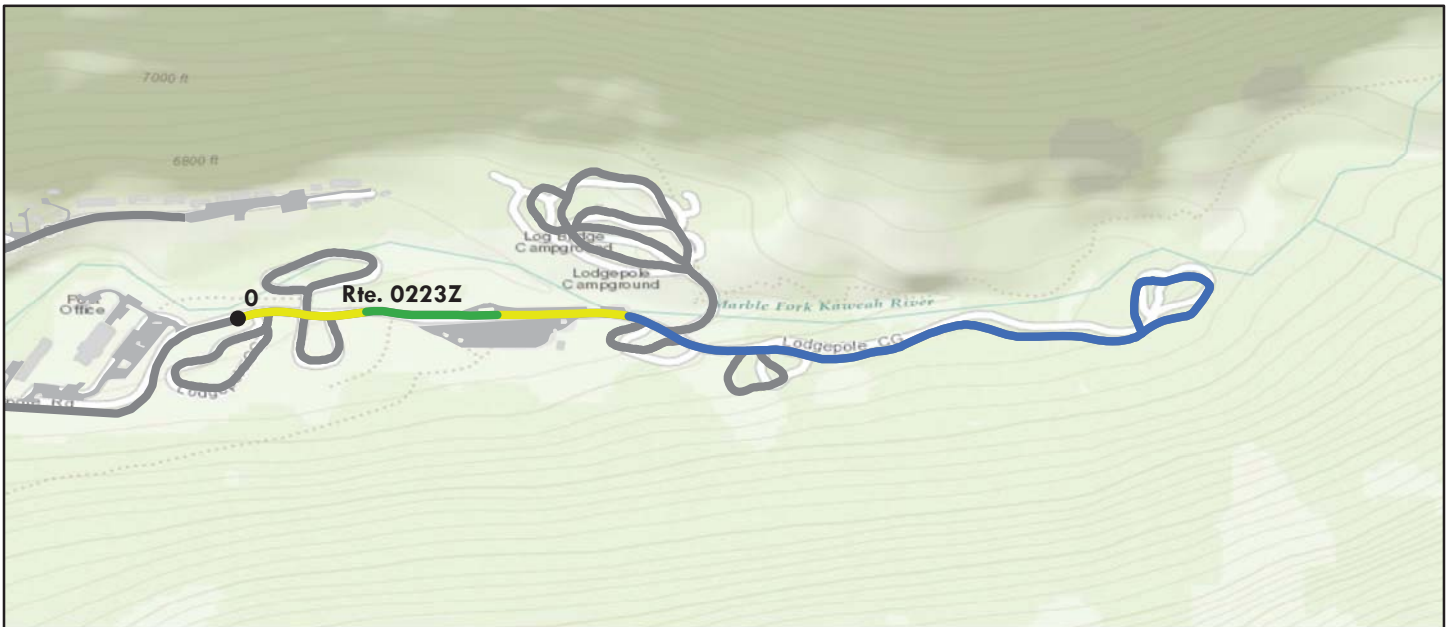
ROUTE 0223Z: LODGEPOLE CAMPGROUND ROAD (UPPER CAMPSITES 69-150)

Subcomponent of Route SEQU-0223ZZ
Data Collection Vehicle (DCV) Rating

Route Condition Legend – Pavement Condition Rating (PCR)						
Poor (0 - 60)	Fair (61- 84)	Good (85 - 94)	Excellent (95 - 100)	Not Rated		
See Appendix for definitions and formulas						
Inspection Date: 5/26/2015	Beginning Section MP	0				
Paved Length (Miles): 0.89	Section Length (MI)	0.89				
Surface Type: ASPHALT	Route Summary					
Roadway Condition Information						
Pavement Condition Rating (PCR)	94	94				
Surface Condition Rating (SCR)	94	94				
Roughness Condition Index (RCI)	N/A	N/A				
Distress Index Values						
Structural Crack Index	97	97				
Alligator Crack Index	100	100				
Longitudinal Crack Index	97	97				
Transverse Cracking Index	94	94				
Patching Index	100	100				
Rutting Index	95	95				
International Roughness Index (IRI)	N/A	N/A				
Lane & Width Information						
Number of Lanes	1	1				
Paved Width (ft)	14.3	14.3				
Lane Width (ft)	10.1	10.1

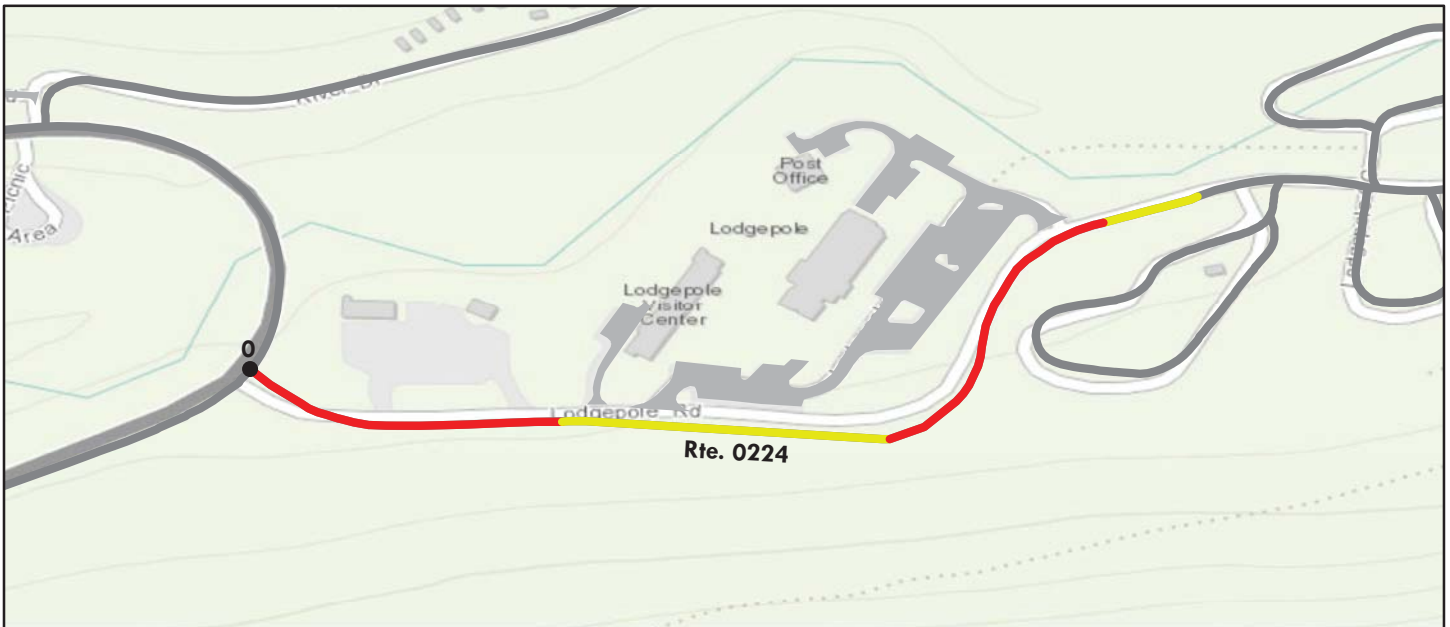
ROUTE 0224: LODGEPOLE VISITOR CENTER ROAD

Data Collection Vehicle (DCV) Rating

Route Condition Legend – Pavement Condition Rating (PCR)						
Poor (0 - 60)	Fair (61- 84)	Good (85 - 94)	Excellent (95 - 100)	Not Rated		
See Appendix for definitions and formulas						
Inspection Date: 5/26/2015	Beginning Section MP	0				
Paved Length (Miles): 0.33	Section Length (MI)	0.33				
Surface Type: ASPHALT	Route Summary					
Roadway Condition Information						
Pavement Condition Rating (PCR)	58	58				
Surface Condition Rating (SCR)	58	58				
Roughness Condition Index (RCI)	N/A	N/A				
Distress Index Values						
Structural Crack Index	75	75				
Alligator Crack Index	99	99				
Longitudinal Crack Index	76	76				
Transverse Cracking Index	58	58				
Patching Index	100	100				
Rutting Index	94	94				
International Roughness Index (IRI)	N/A	N/A				
Lane & Width Information						
Number of Lanes	2	2				
Paved Width (ft)	28.8	28.8				
Lane Width (ft)	12.1	12.1

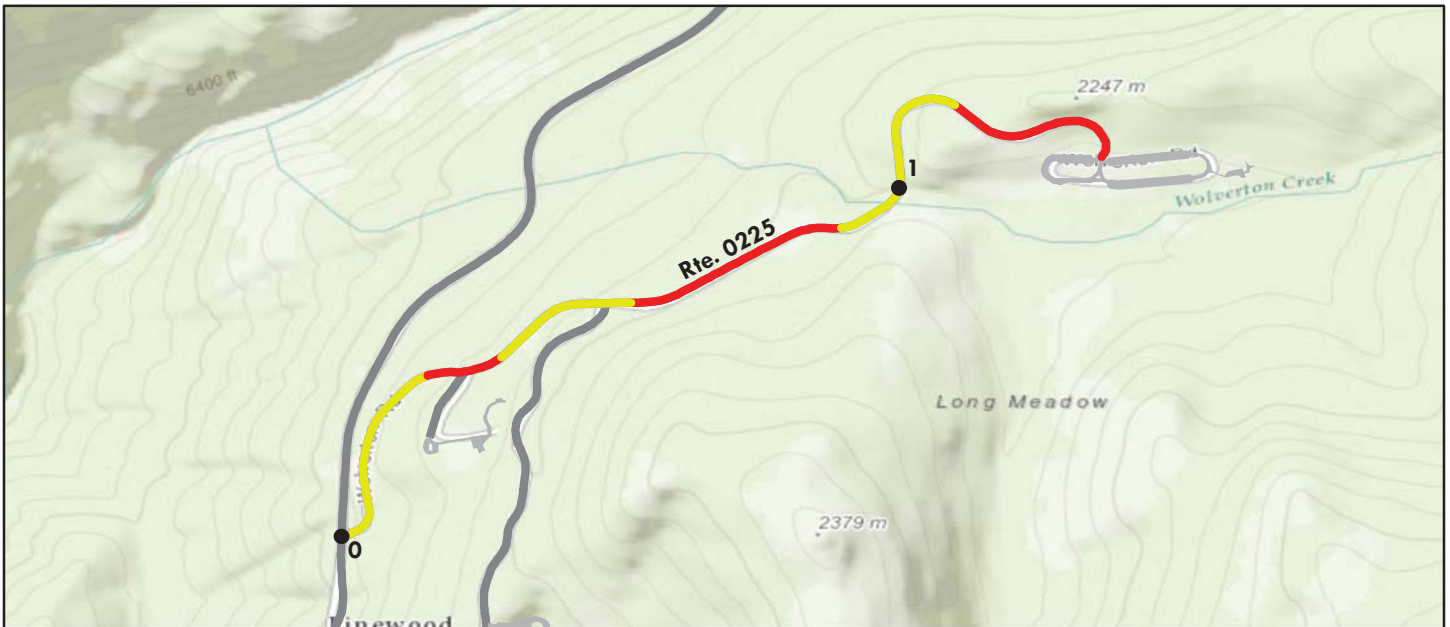
ROUTE 0225: WOLVERTON ROAD

Data Collection Vehicle (DCV) Rating

Route Condition Legend – Pavement Condition Rating (PCR)						
Poor (0 - 60)	Fair (61- 84)	Good (85 - 94)	Excellent (95 - 100)	Not Rated		
See Appendix for definitions and formulas						
Inspection Date: 5/26/2015	Beginning Section MP	0	1			
Paved Length (Miles): 1.45	Section Length (MI)	1	0.45			
Surface Type: ASPHALT	Route Summary					
Roadway Condition Information						
Pavement Condition Rating (PCR)	58	59	52			
Surface Condition Rating (SCR)	58	61	48			
Roughness Condition Index (RCI)	57	57	57			
Distress Index Values						
Structural Crack Index	58	61	48			
Alligator Crack Index	98	96	100			
Longitudinal Crack Index	60	65	48			
Transverse Cracking Index	96	95	97			
Patching Index	93	92	96			
Rutting Index	92	91	92			
International Roughness Index (IRI)	253	253	252			
Lane & Width Information						
Number of Lanes	2	2	2			
Paved Width (ft)	22.1	22.5	21			
Lane Width (ft)	10.4	10.5	10.2

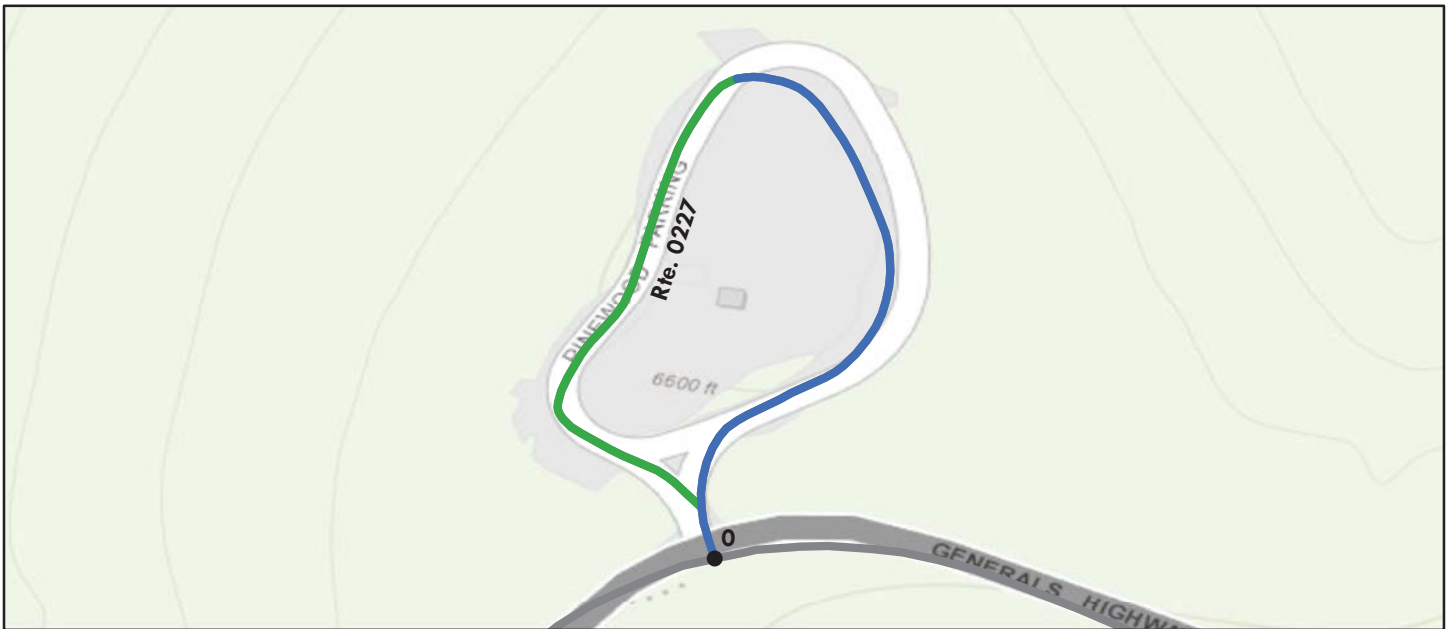
ROUTE 0227: PINWOOD PICNIC AREA ROAD

Data Collection Vehicle (DCV) Rating

Route Condition Legend – Pavement Condition Rating (PCR)						
Poor (0 - 60)	Fair (61- 84)	Good (85 - 94)	Excellent (95 - 100)	Not Rated		
See Appendix for definitions and formulas						
Inspection Date: 5/29/2015	Beginning Section MP	0				
Paved Length (Miles): 0.19	Section Length (MI)	0.19				
Surface Type: ASPHALT	Route Summary					
Roadway Condition Information						
Pavement Condition Rating (PCR)	93	93				
Surface Condition Rating (SCR)	93	93				
Roughness Condition Index (RCI)	N/A	N/A				
Distress Index Values						
Structural Crack Index	98	98				
Alligator Crack Index	100	100				
Longitudinal Crack Index	98	98				
Transverse Cracking Index	94	94				
Patching Index	100	100				
Rutting Index	93	93				
International Roughness Index (IRI)	N/A	N/A				
Lane & Width Information						
Number of Lanes	1	1				
Paved Width (ft)	12.2	12.2				
Lane Width (ft)	12.2	12.2

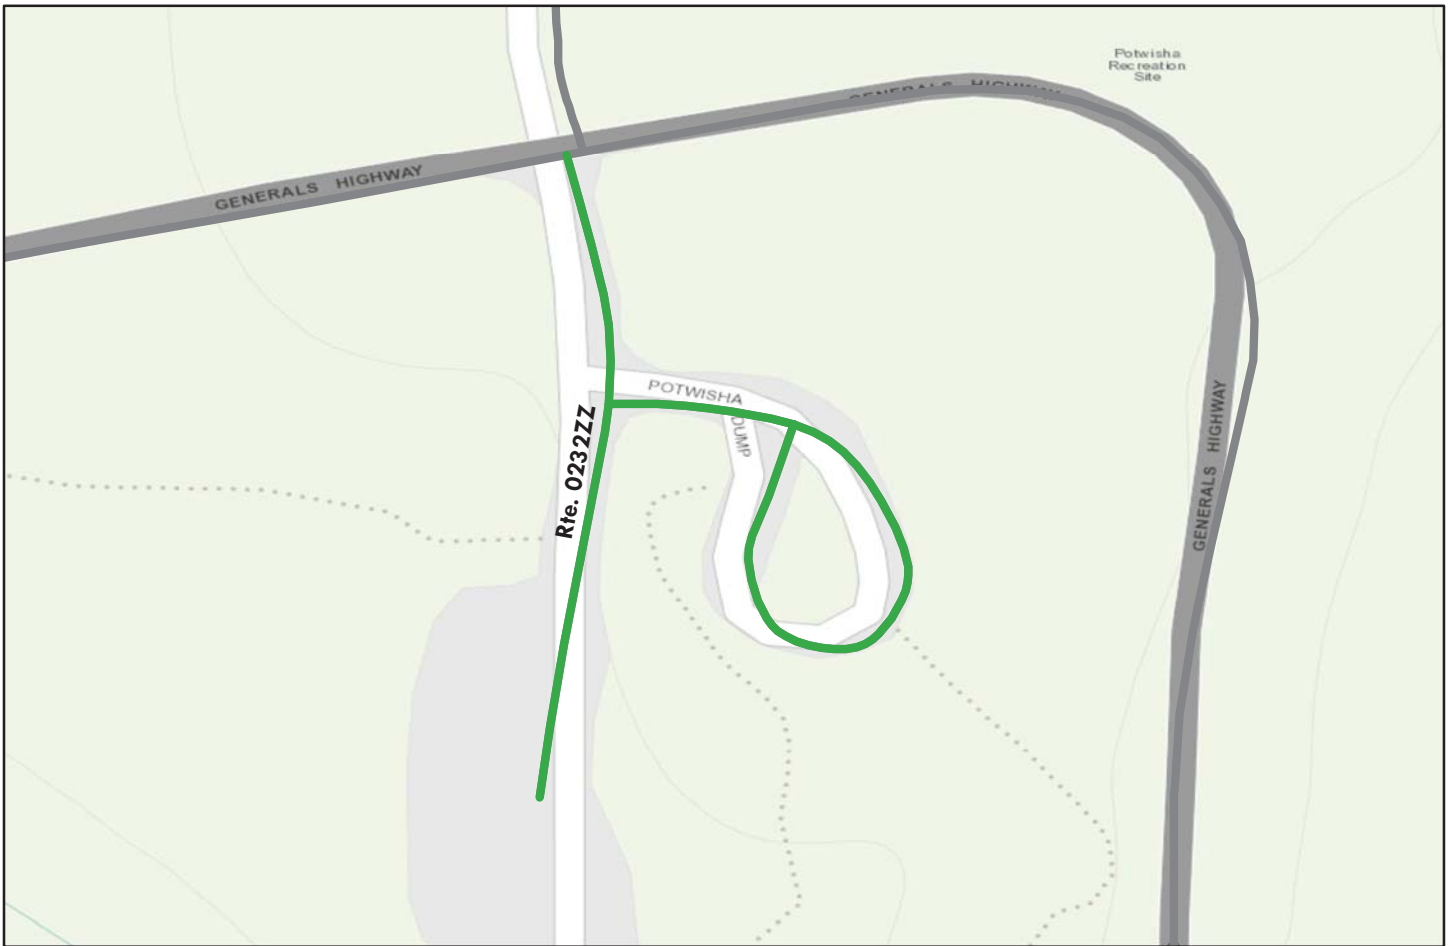
ROUTE 0232ZZ: POTWISHA TRAILER DUMP ROADS

Summary Route

Note: The weighted average summary PCR value is calculated from only the sections of road where the PCR was collected. The overall PCR for the summary route may not reflect individual subcomponent ratings.

Route Condition Legend – Pavement Condition Rating (PCR)						
Poor (0 - 60)	Fair (61- 84)	Good (85 - 94)	Excellent (95 - 100)	Not Rated		
See Appendix for definitions and formulas						
Inspection Date: 5/26/2015						
Paved Length (Miles): 0.16						
Surface Type: ASPHALT	Route Summary					
Roadway Condition Information						
Pavement Condition Rating (PCR)	94					
Lane & Width Information						
Number of Lanes	1					
Paved Width (ft)	18.2					
Lane Width (ft)	9.5

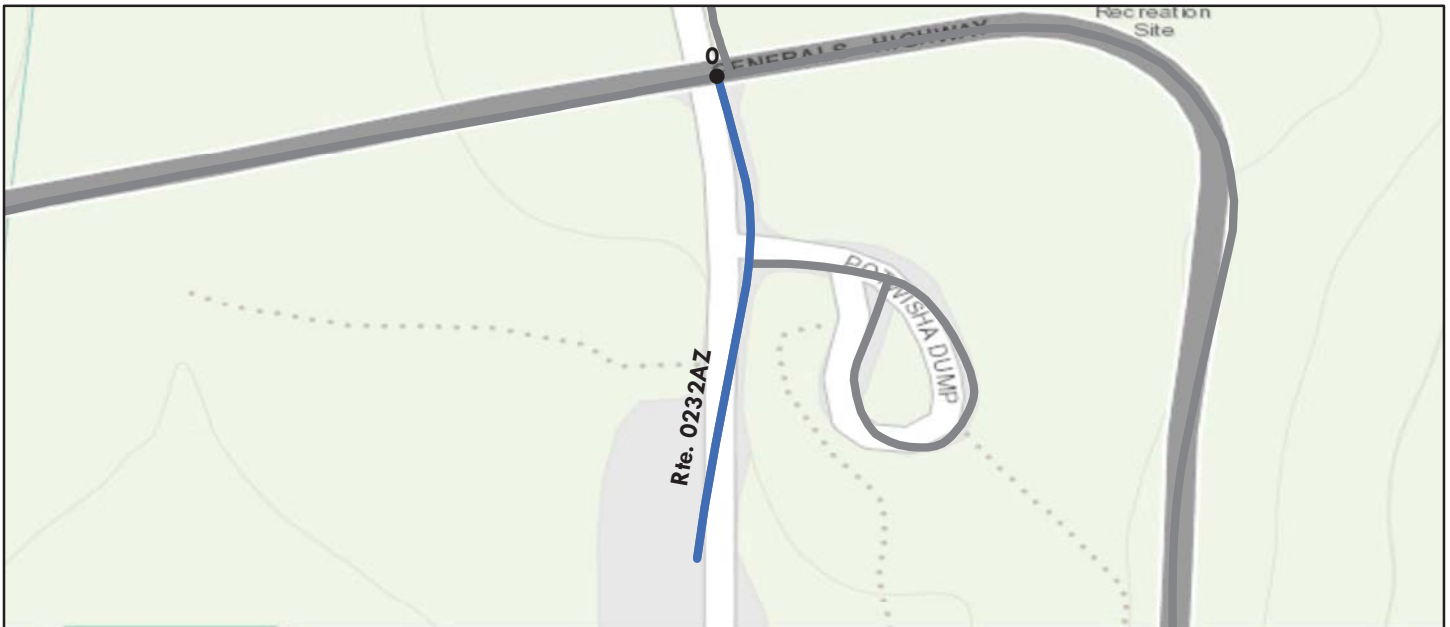
ROUTE 0232AZ: POTWISHA TRAILER DUMP ROAD A

Subcomponent of Route SEQU-0232ZZ
 Data Collection Vehicle (DCV) Rating

Route Condition Legend – Pavement Condition Rating (PCR)						
Poor (0 - 60)	Fair (61- 84)	Good (85 - 94)	Excellent (95 - 100)	Not Rated		
See Appendix for definitions and formulas						
Inspection Date: 5/26/2015	Beginning Section MP	0				
Paved Length (Miles): 0.08	Section Length (MI)	0.08				
Surface Type: ASPHALT	Route Summary					
Roadway Condition Information						
Pavement Condition Rating (PCR)	99	99				
Surface Condition Rating (SCR)	99	99				
Roughness Condition Index (RCI)	N/A	N/A				
Distress Index Values						
Structural Crack Index	100	100				
Alligator Crack Index	100	100				
Longitudinal Crack Index	100	100				
Transverse Cracking Index	99	99				
Patching Index	100	100				
Rutting Index	99	99				
International Roughness Index (IRI)	N/A	N/A				
Lane & Width Information						
Number of Lanes	2	2				
Paved Width (ft)	18.4	18.4				
Lane Width (ft)	7.4	7.4
