Road Inventory and Condition Assessment of Paved Routes Sequoia National Park

**Federal Lands Highway
Road Inventory Program**

Federal Highway Administration
Eastern Federal Lands Highway Division
Road Inventory Program (RIP)

Report Date: January 2016

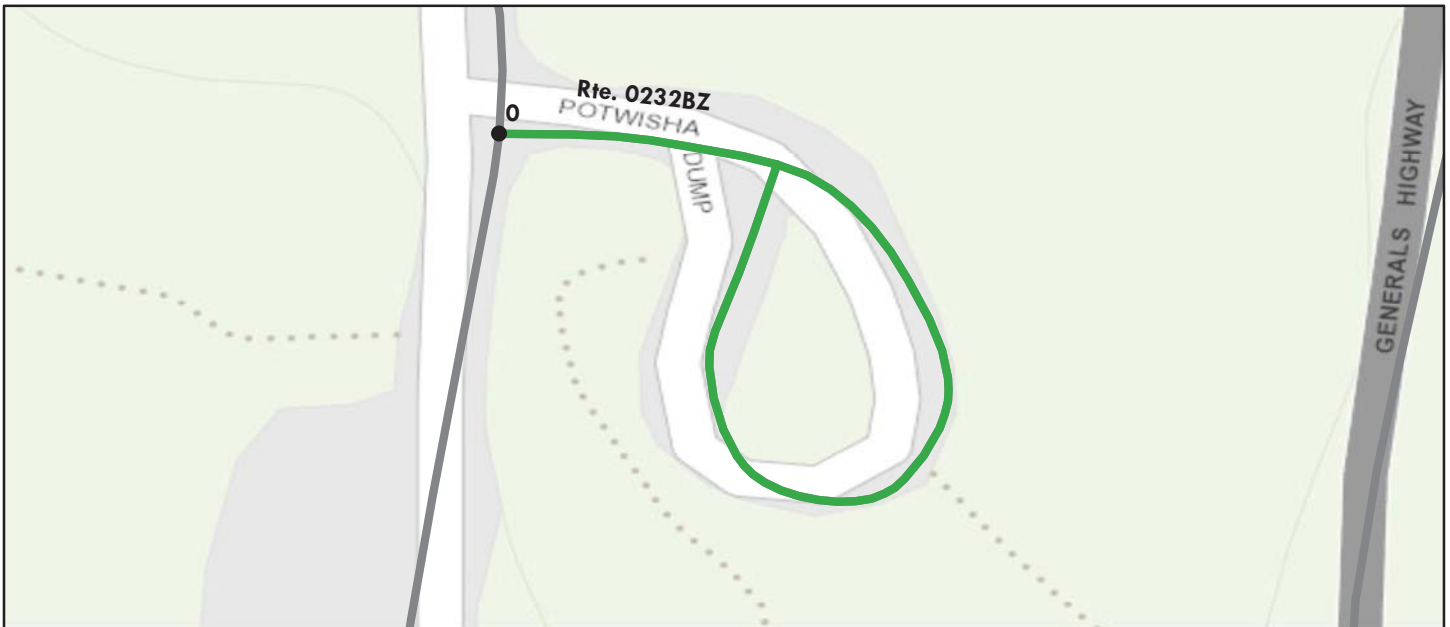
ROUTE 0232BZ: POTWISHA TRAILER DUMP ROAD B

Subcomponent of Route SEQU-0232ZZ
Data Collection Vehicle (DCV) Rating

Route Condition Legend – Pavement Condition Rating (PCR)						
Poor (0 - 60)	Fair (61- 84)	Good (85 - 94)	Excellent (95 - 100)	Not Rated		
See Appendix for definitions and formulas						
Inspection Date: 5/26/2015	Beginning Section MP	0				
Paved Length (Miles): 0.09	Section Length (MI)	0.09				
Surface Type: ASPHALT	Route Summary					
Roadway Condition Information						
Pavement Condition Rating (PCR)	90	90				
Surface Condition Rating (SCR)	90	90				
Roughness Condition Index (RCI)	N/A	N/A				
Distress Index Values						
Structural Crack Index	95	95				
Alligator Crack Index	100	100				
Longitudinal Crack Index	95	95				
Transverse Cracking Index	94	94				
Patching Index	100	100				
Rutting Index	90	90				
International Roughness Index (IRI)	N/A	N/A				
Lane & Width Information						
Number of Lanes	1	1				
Paved Width (ft)	18	18				
Lane Width (ft)	11.5	11.5

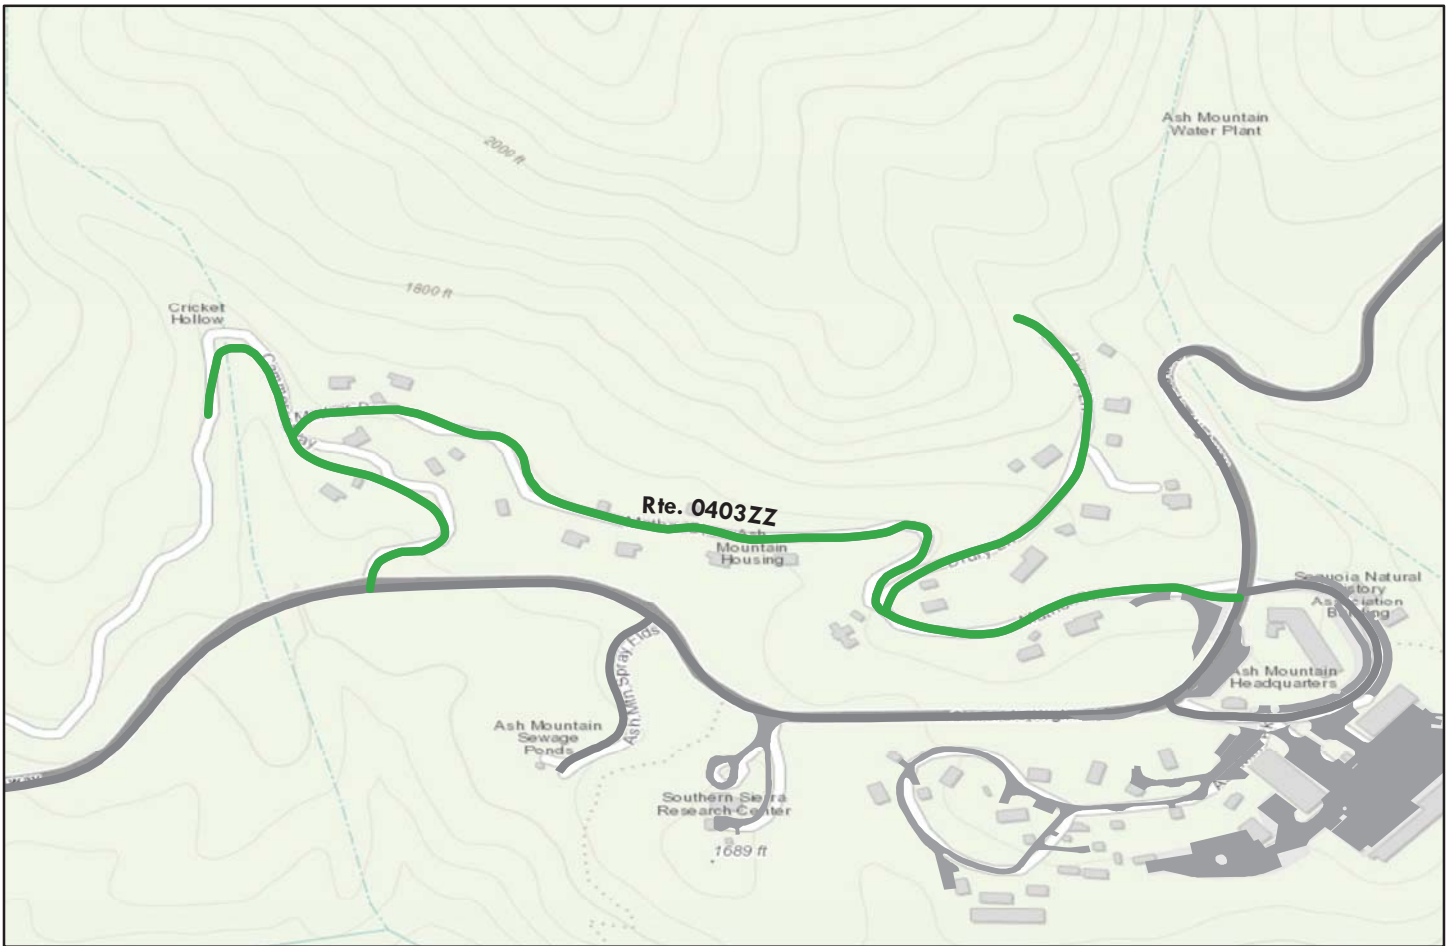
ROUTE 0403ZZ: ASH MOUNTAIN RESIDENCE ROADS

Summary Route

Note: The weighted average summary PCR value is calculated from only the sections of road where the PCR was collected. The overall PCR for the summary route may not reflect individual subcomponent ratings.

Route Condition Legend – Pavement Condition Rating (PCR)						
Poor (0 - 60)	Fair (61- 84)	Good (85 - 94)	Excellent (95 - 100)	Not Rated		
See Appendix for definitions and formulas						
Inspection Date: 5/28/2015						
Paved Length (Miles): 0.79						
Surface Type: ASPHALT	Route Summary					
Roadway Condition Information						
Pavement Condition Rating (PCR)	91					
Lane & Width Information						
Number of Lanes	1					
Paved Width (ft)	13.9					
Lane Width (ft)	11.9

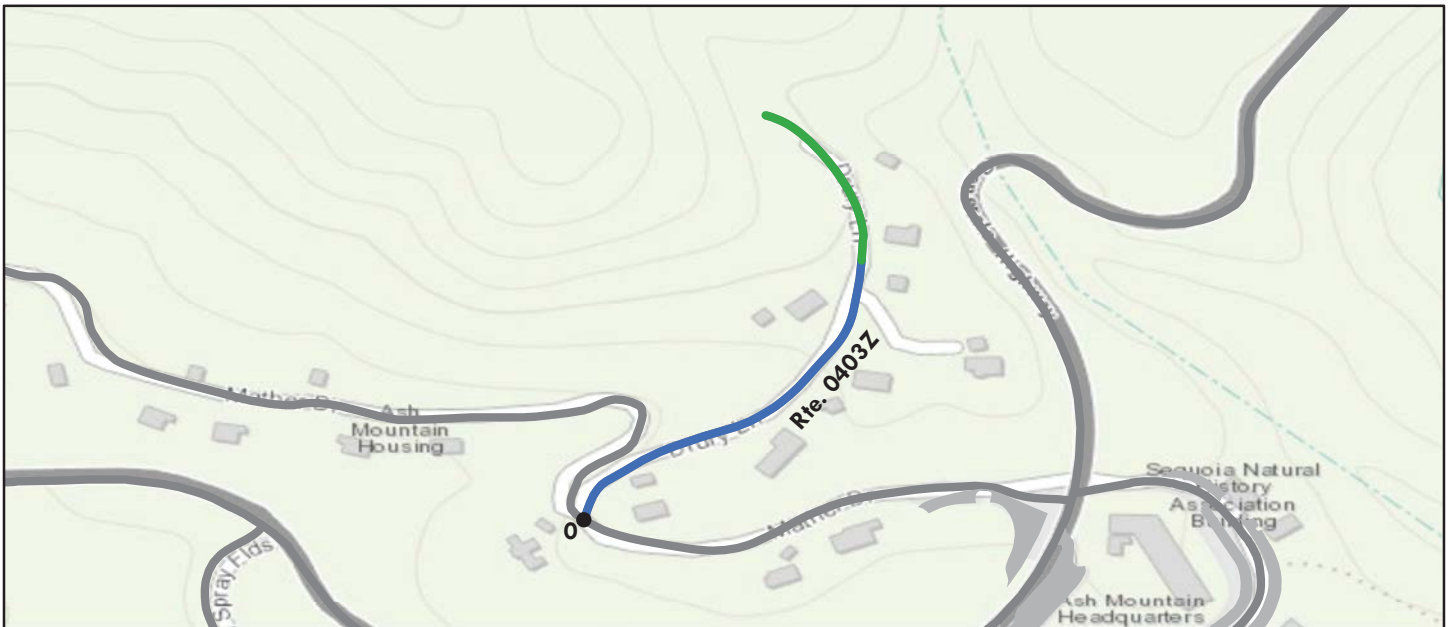
ROUTE 0403Z: ASH MOUNTAIN RESIDENCE ROAD

Subcomponent of Route SEQU-0403ZZ
 Data Collection Vehicle (DCV) Rating

Route Condition Legend – Pavement Condition Rating (PCR)						
Poor (0 - 60)	Fair (61- 84)	Good (85 - 94)	Excellent (95 - 100)	Not Rated		
See Appendix for definitions and formulas						
Inspection Date: 5/26/2015	Beginning Section MP	0				
Paved Length (Miles): 0.16	Section Length (MI)	0.16				
Surface Type: ASPHALT	Route Summary					
Roadway Condition Information						
Pavement Condition Rating (PCR)	95	95				
Surface Condition Rating (SCR)	95	95				
Roughness Condition Index (RCI)	N/A	N/A				
Distress Index Values						
Structural Crack Index	95	95				
Alligator Crack Index	100	100				
Longitudinal Crack Index	95	95				
Transverse Cracking Index	96	96				
Patching Index	100	100				
Rutting Index	95	95				
International Roughness Index (IRI)	N/A	N/A				
Lane & Width Information						
Number of Lanes	1	1				
Paved Width (ft)	13.7	13.7				
Lane Width (ft)	13.7	13.7

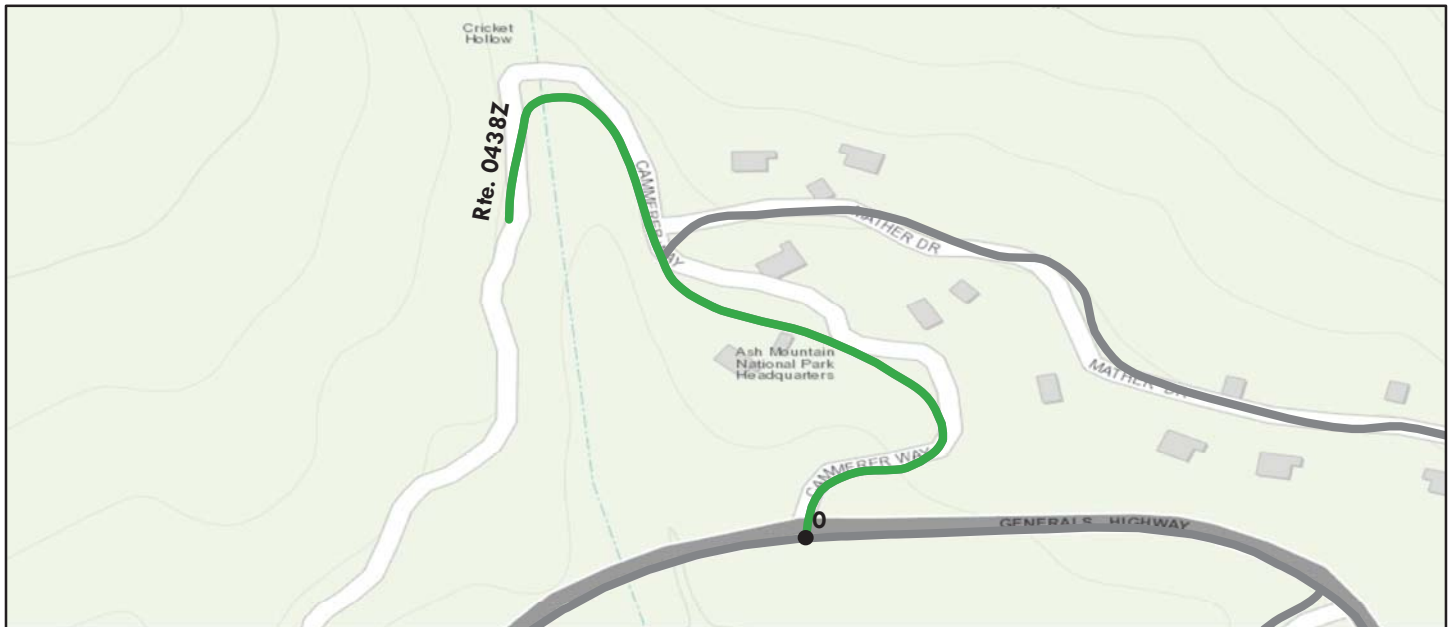
ROUTE 0438Z: CRICKET HOLLOW ROAD

Subcomponent of Route SEQU-0403ZZ
Data Collection Vehicle (DCV) Rating

Route Condition Legend – Pavement Condition Rating (PCR)						
Poor (0 - 60)	Fair (61- 84)	Good (85 - 94)	Excellent (95 - 100)	Not Rated		
See Appendix for definitions and formulas						
Inspection Date: 5/26/2015	Beginning Section MP	0				
Paved Length (Miles): 0.2	Section Length (MI)	0.2				
Surface Type: ASPHALT	Route Summary					
Roadway Condition Information						
Pavement Condition Rating (PCR)	91	91				
Surface Condition Rating (SCR)	91	91				
Roughness Condition Index (RCI)	N/A	N/A				
Distress Index Values						
Structural Crack Index	100	100				
Alligator Crack Index	100	100				
Longitudinal Crack Index	100	100				
Transverse Cracking Index	98	98				
Patching Index	100	100				
Rutting Index	91	91				
International Roughness Index (IRI)	N/A	N/A				
Lane & Width Information						
Number of Lanes	1	1				
Paved Width (ft)	14.6	14.6				
Lane Width (ft)	11.2	11.2

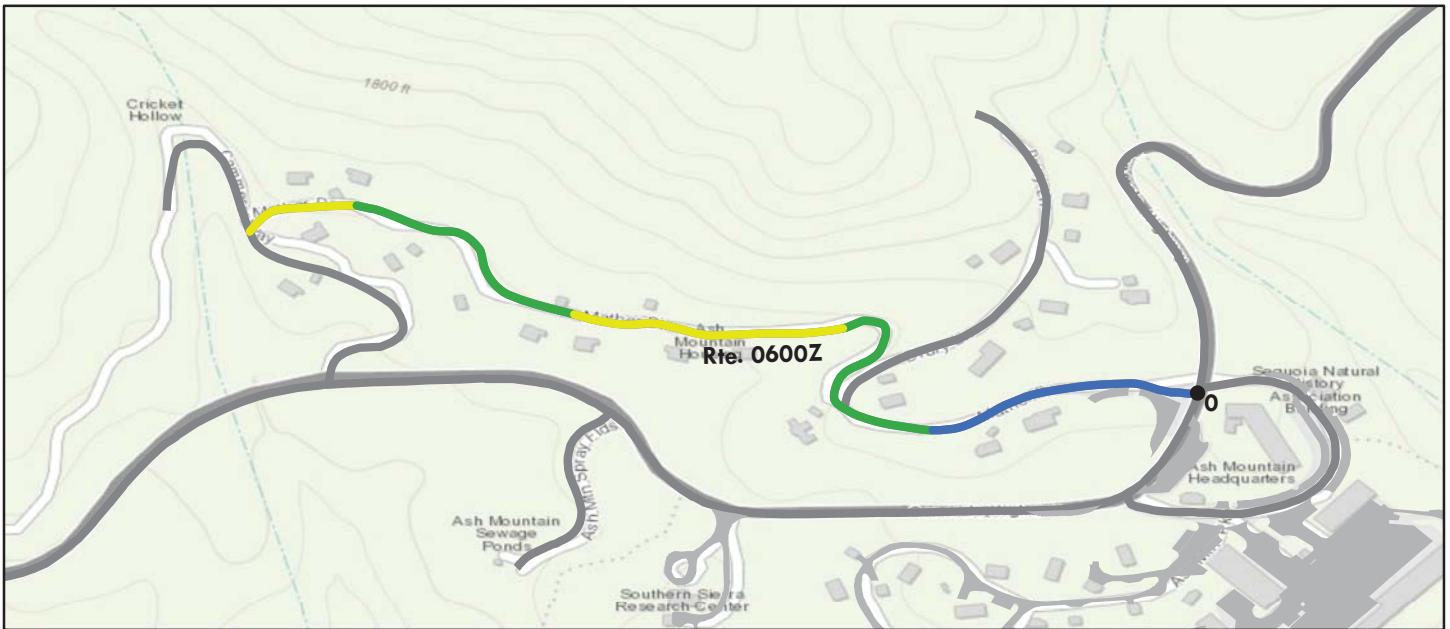
ROUTE 0600Z: ASH MOUNTAIN RESIDENCE STREETS

Subcomponent of Route SEQU-0403ZZ
Data Collection Vehicle (DCV) Rating

Inspection Date: 5/28/2015	Beginning Section MP	0				
Paved Length (Miles): 0.44	Section Length (MI)	0.44				
Surface Type: ASPHALT	Route Summary					
Roadway Condition Information						
Pavement Condition Rating (PCR)	90	90				
Surface Condition Rating (SCR)	90	90				
Roughness Condition Index (RCI)	N/A	N/A				
Distress Index Values						
Structural Crack Index	96	96				
Alligator Crack Index	100	100				
Longitudinal Crack Index	96	96				
Transverse Cracking Index	98	98				
Patching Index	100	100				
Rutting Index	90	90				
International Roughness Index (IRI)	N/A	N/A				
Lane & Width Information						
Number of Lanes	1	1				
Paved Width (ft)	13.6	13.6				
Lane Width (ft)	11.5	11.5

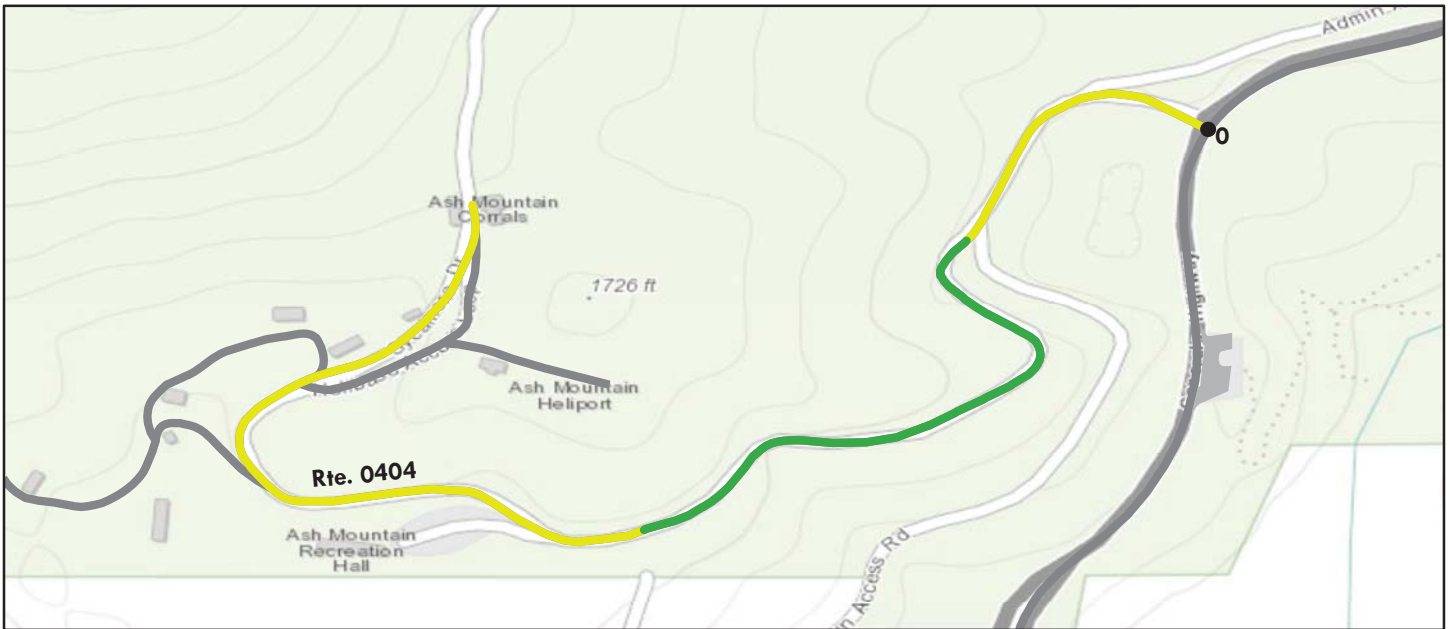
ROUTE 0404: SYCAMORE SERVICE ROAD

Data Collection Vehicle (DCV) Rating

Route Condition Legend – Pavement Condition Rating (PCR)						
Poor (0 - 60)	Fair (61- 84)	Good (85 - 94)	Excellent (95 - 100)	Not Rated		
See Appendix for definitions and formulas						
Inspection Date: 5/26/2015	Beginning Section MP	0				
Paved Length (Miles): 0.56	Section Length (MI)	0.56				
Surface Type: ASPHALT	Route Summary					
Roadway Condition Information						
Pavement Condition Rating (PCR)	84	84				
Surface Condition Rating (SCR)	84	84				
Roughness Condition Index (RCI)	N/A	N/A				
Distress Index Values						
Structural Crack Index	93	93				
Alligator Crack Index	98	98				
Longitudinal Crack Index	95	95				
Transverse Cracking Index	99	99				
Patching Index	99	99				
Rutting Index	84	84				
International Roughness Index (IRI)	N/A	N/A				
Lane & Width Information						
Number of Lanes	2	2				
Paved Width (ft)	18	18				
Lane Width (ft)	10.2	10.2

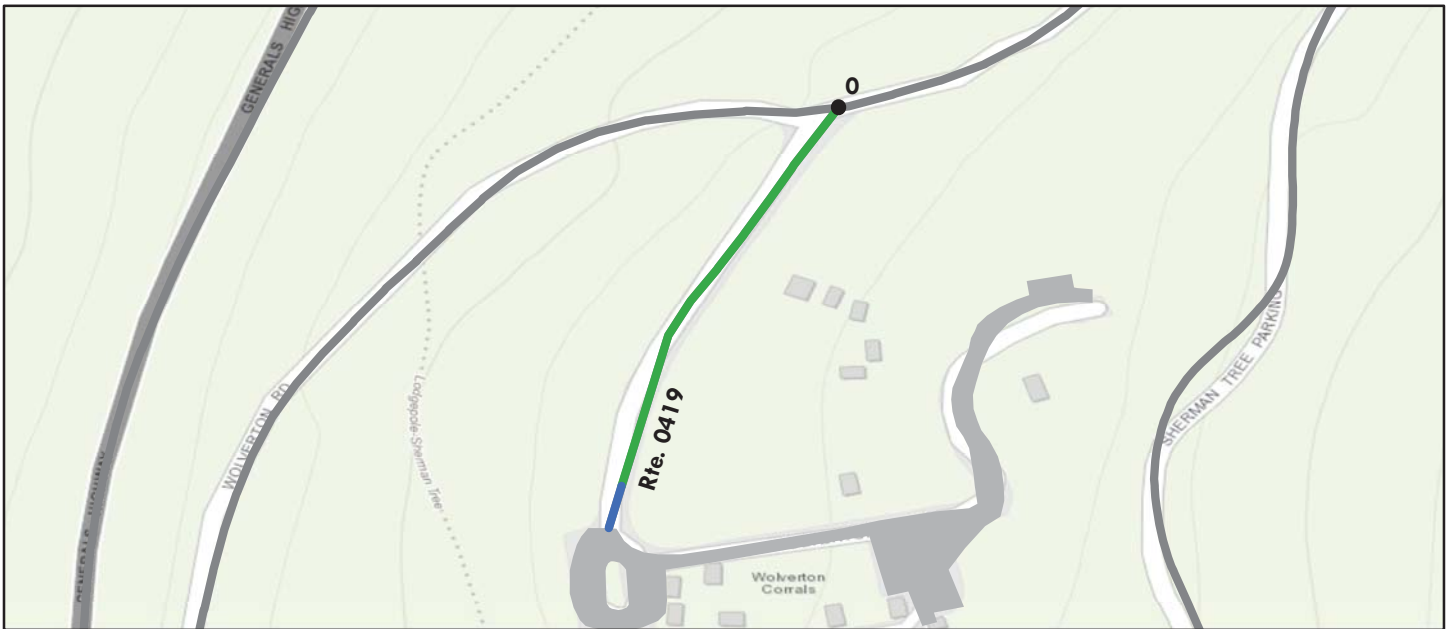
ROUTE 0419: WOLVERTON CORRAL ROAD

Data Collection Vehicle (DCV) Rating

Route Condition Legend – Pavement Condition Rating (PCR)						
Poor (0 - 60)	Fair (61- 84)	Good (85 - 94)	Excellent (95 - 100)	Not Rated		
See Appendix for definitions and formulas						
Inspection Date: 5/26/2015	Beginning Section MP	0				
Paved Length (Miles): 0.11	Section Length (MI)	0.11				
Surface Type: ASPHALT	Route Summary					
Roadway Condition Information						
Pavement Condition Rating (PCR)	93	93				
Surface Condition Rating (SCR)	93	93				
Roughness Condition Index (RCI)	N/A	N/A				
Distress Index Values						
Structural Crack Index	93	93				
Alligator Crack Index	100	100				
Longitudinal Crack Index	93	93				
Transverse Cracking Index	100	100				
Patching Index	100	100				
Rutting Index	95	95				
International Roughness Index (IRI)	N/A	N/A				
Lane & Width Information						
Number of Lanes	2	2				
Paved Width (ft)	18.2	18.2				
Lane Width (ft)	9	9

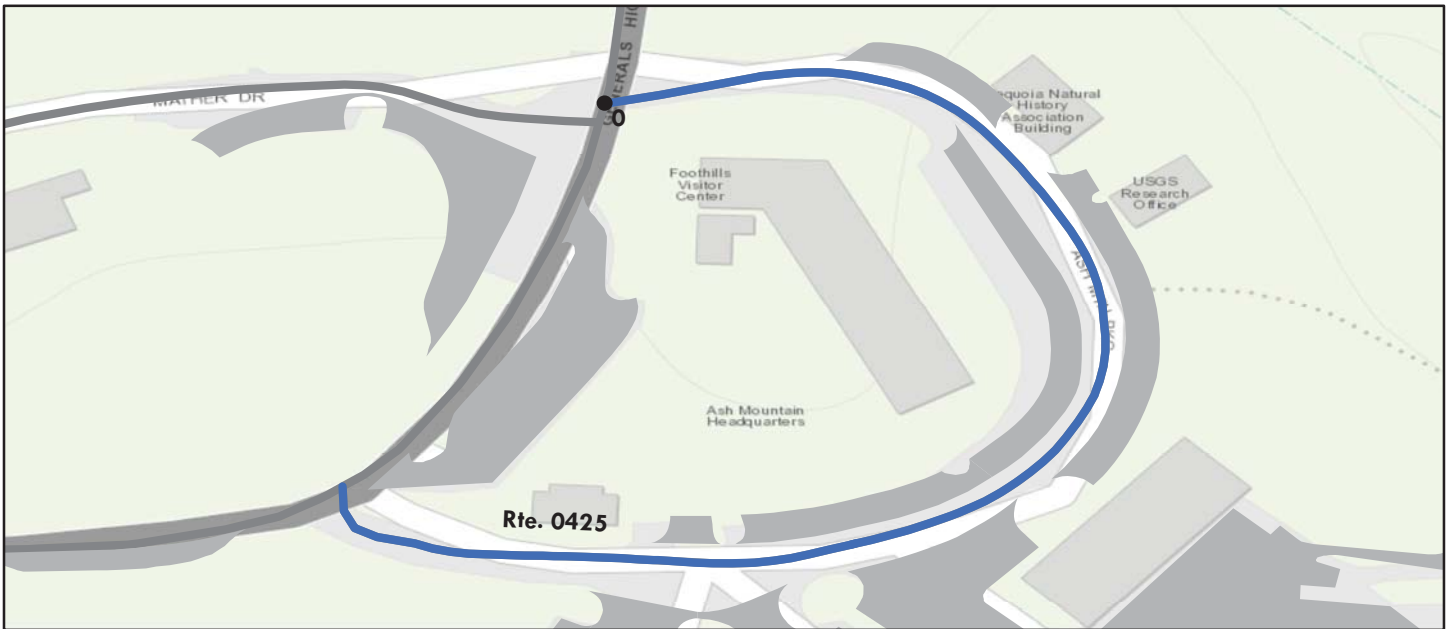
ROUTE 0425: HEADQUARTERS STREET (ASH LINE)

Data Collection Vehicle (DCV) Rating

Route Condition Legend – Pavement Condition Rating (PCR)						
Poor (0 - 60)	Fair (61- 84)	Good (85 - 94)	Excellent (95 - 100)	Not Rated		
See Appendix for definitions and formulas						
Inspection Date: 5/26/2015	Beginning Section MP	0				
Paved Length (Miles): 0.16	Section Length (MI)	0.16				
Surface Type: ASPHALT	Route Summary					
Roadway Condition Information						
Pavement Condition Rating (PCR)	98	98				
Surface Condition Rating (SCR)	98	98				
Roughness Condition Index (RCI)	N/A	N/A				
Distress Index Values						
Structural Crack Index	98	98				
Alligator Crack Index	100	100				
Longitudinal Crack Index	98	98				
Transverse Cracking Index	100	100				
Patching Index	100	100				
Rutting Index	99	99				
International Roughness Index (IRI)	N/A	N/A				
Lane & Width Information						
Number of Lanes	2	2				
Paved Width (ft)	16.8	16.8				
Lane Width (ft)	8.4	8.4

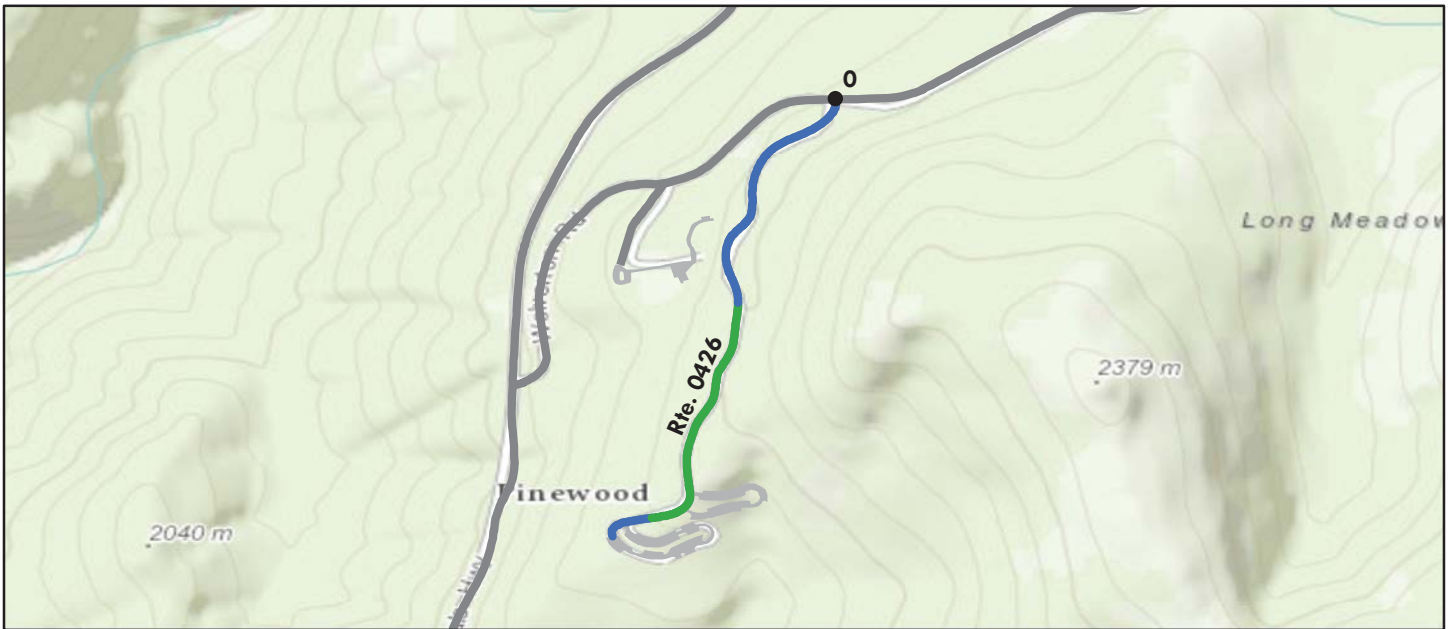
ROUTE 0426: SHERMAN TREE ROAD

Data Collection Vehicle (DCV) Rating

Route Condition Legend – Pavement Condition Rating (PCR)						
Poor (0 - 60)	Fair (61- 84)	Good (85 - 94)	Excellent (95 - 100)	Not Rated		
See Appendix for definitions and formulas						
Inspection Date: 5/26/2015	Beginning Section MP	0				
Paved Length (Miles): 0.66	Section Length (MI)	0.66				
Surface Type: ASPHALT	Route Summary					
Roadway Condition Information						
Pavement Condition Rating (PCR)	96	96				
Surface Condition Rating (SCR)	100	100				
Roughness Condition Index (RCI)	89	89				
Distress Index Values						
Structural Crack Index	100	100				
Alligator Crack Index	100	100				
Longitudinal Crack Index	100	100				
Transverse Cracking Index	100	100				
Patching Index	100	100				
Rutting Index	100	100				
International Roughness Index (IRI)	142	142				
Lane & Width Information						
Number of Lanes	2	2				
Paved Width (ft)	21.7	21.7				
Lane Width (ft)	9.1	9.1

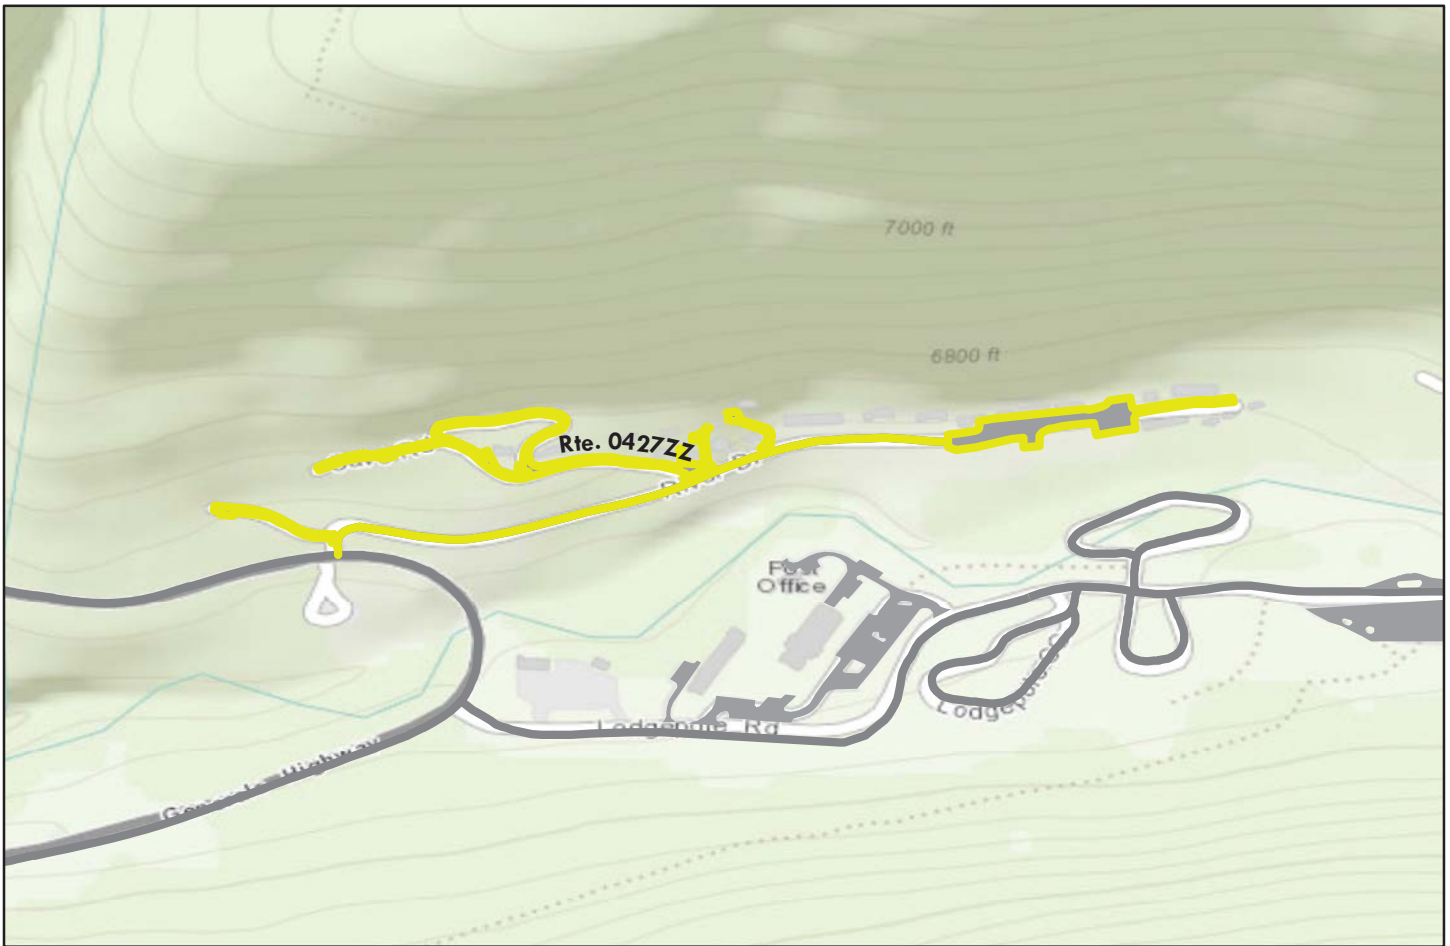
ROUTE 0427ZZ: LODGEPOLE NORTH RESIDENCE ROADS

Summary Route

Note: The weighted average summary PCR value is calculated from only the sections of road where the PCR was collected. The overall PCR for the summary route may not reflect individual subcomponent ratings.

Route Condition Legend – Pavement Condition Rating (PCR)						
Poor (0 - 60)	Fair (61- 84)	Good (85 - 94)	Excellent (95 - 100)	Not Rated		
See Appendix for definitions and formulas						
Inspection Date: 5/26/2015						
Paved Length (Miles): 0.33						
Surface Type: ASPHALT	Route Summary					
Roadway Condition Information						
Pavement Condition Rating (PCR)	73					
Lane & Width Information						
Number of Lanes	1					
Paved Width (ft)	17					
Lane Width (ft)	8.5

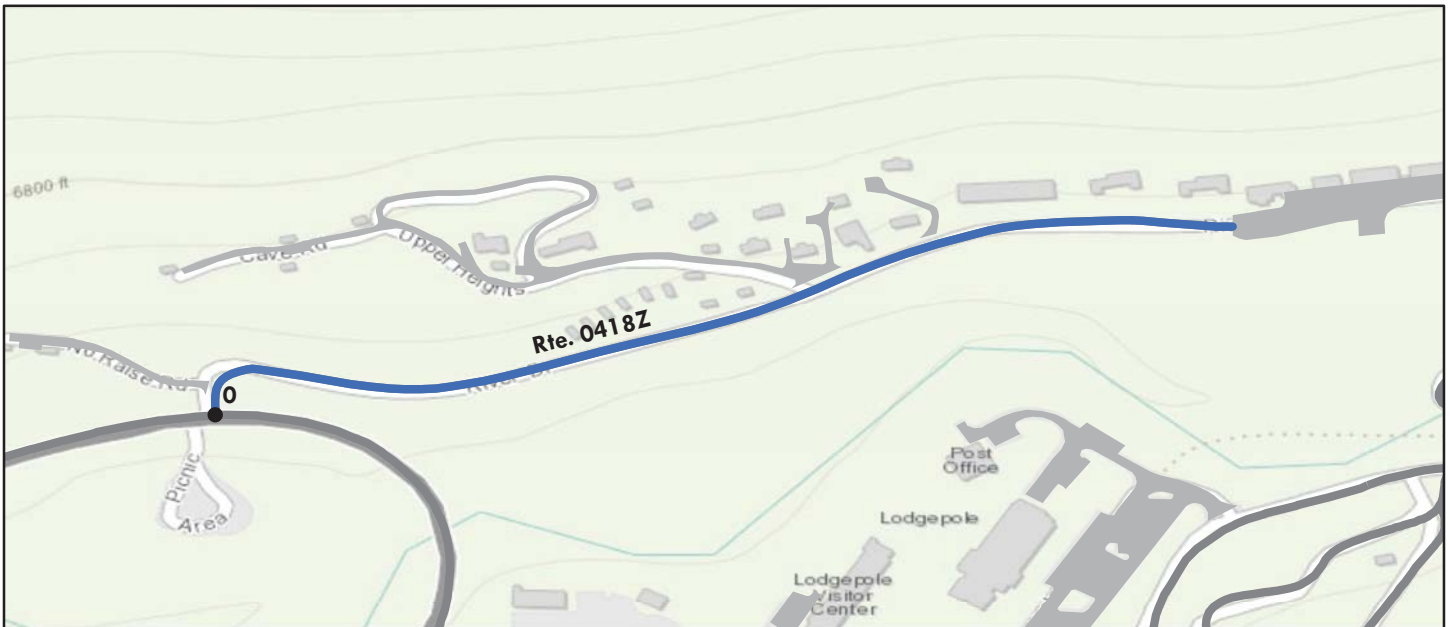
Subcomponent of Route SEQU-0427ZZ

Data Collection Vehicle (DCV) Rating

Inspection Date: 5/26/2015	Beginning Section MP	0				
Paved Length (Miles): 0.33	Section Length (MI)	0.33				
Surface Type: ASPHALT	Route Summary					
Roadway Condition Information						
Pavement Condition Rating (PCR)	99	99				
Surface Condition Rating (SCR)	99	99				
Roughness Condition Index (RCI)	N/A	N/A				
Distress Index Values						
Structural Crack Index	100	100				
Alligator Crack Index	100	100				
Longitudinal Crack Index	100	100				
Transverse Cracking Index	100	100				
Patching Index	100	100				
Rutting Index	99	99				
International Roughness Index (IRI)	N/A	N/A				
Lane & Width Information						
Number of Lanes	2	2				
Paved Width (ft)	17	17				
Lane Width (ft)	8.5	8.5

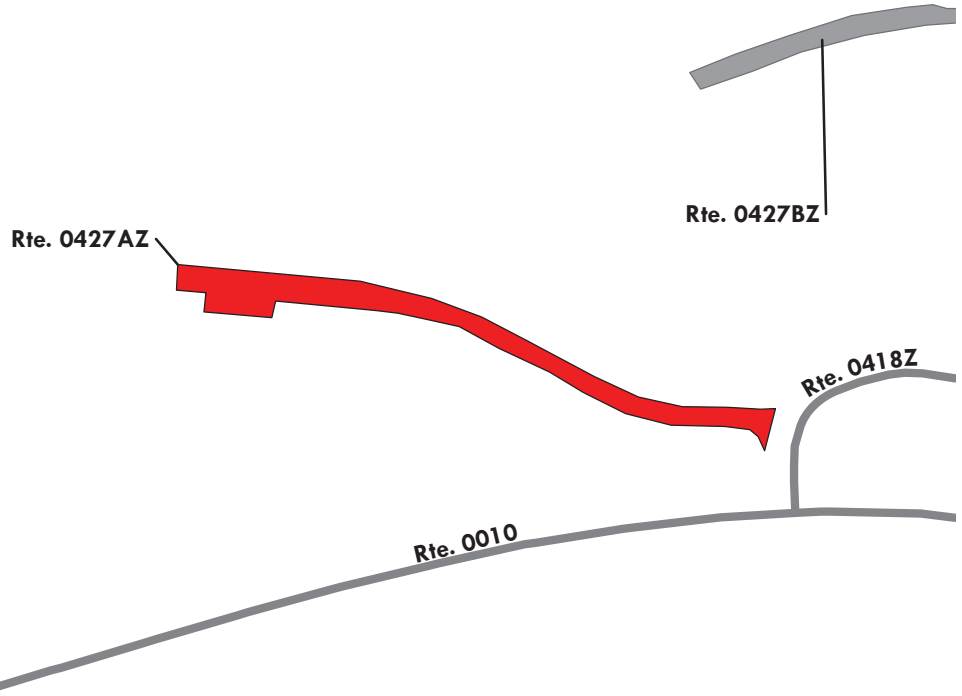
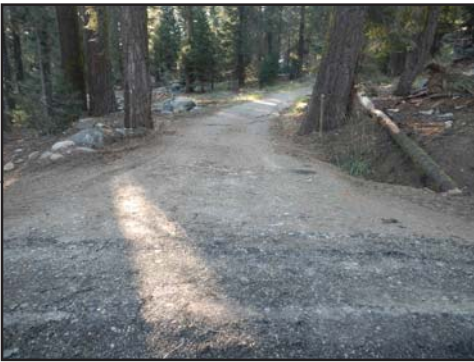
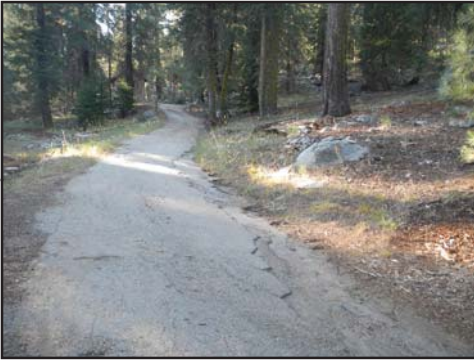
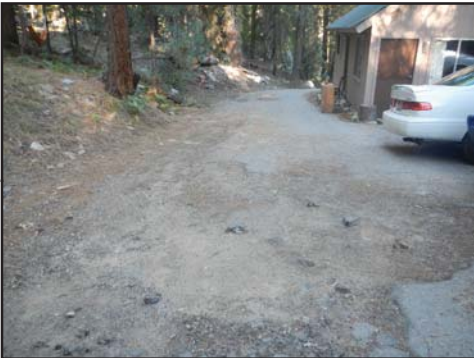
Inspection Date	FMSS Number	User Access	Surface Type
9/25/2014	73881	NONPUBLIC	ASPHALT
Area (Sq. Ft.)	Lane Miles (11' Widths)	Pavement Recommendation	
5,142	0.089	RECONSTRUCTION	
Condition Rating / PCR			
POOR / 30			
Route Condition Legend – Pavement Condition Rating (PCR)			
Poor (0 - 60)	Fair (61- 84)	Good (85 - 94)	Excellent (95 - 100)
Not Rated			
See Appendix for definitions and formulas

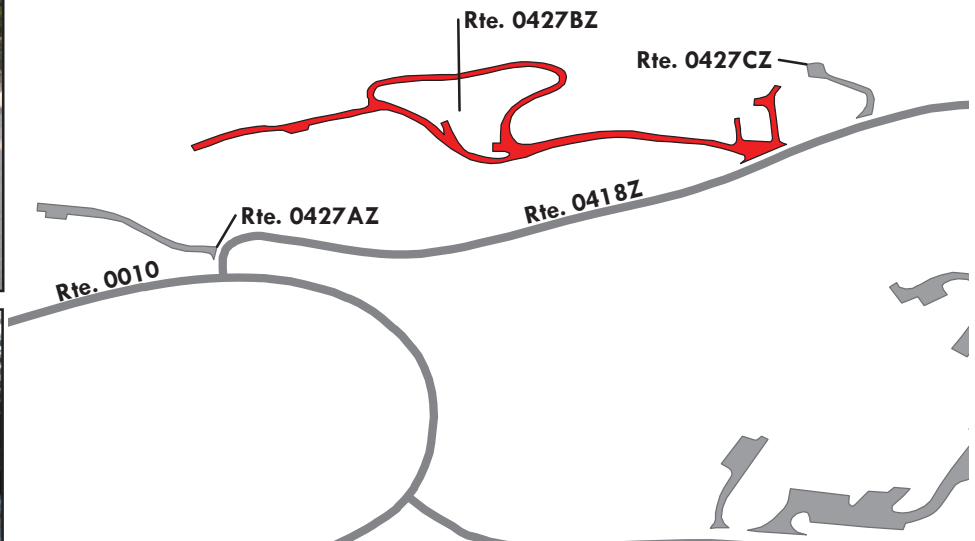
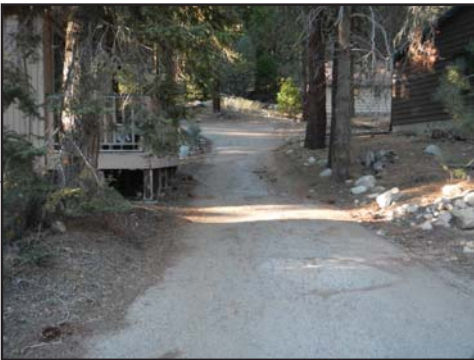
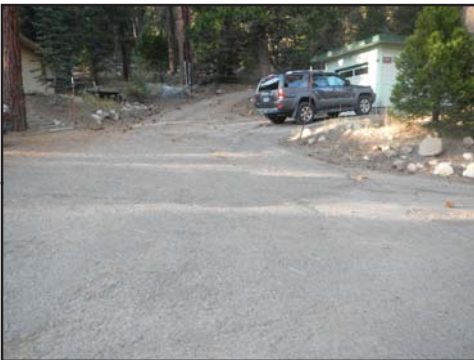
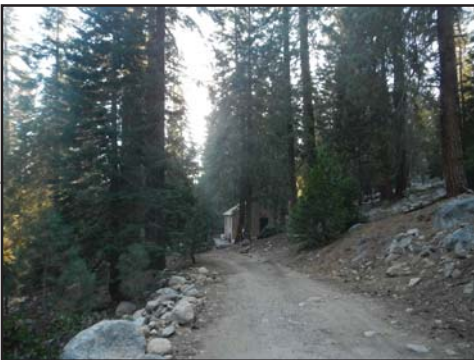
ROUTE 0427BZ: LODGEPOLE NORTH RESIDENCE ROAD B

THROUGH RESIDENTIAL AREA

Inspection Date	FMSS Number	User Access	Surface Type
9/25/2014	73881	NONPUBLIC	ASPHALT
Area (Sq. Ft.)	Lane Miles (11' Widths)	Pavement Recommendation	
26,617	0.458	HEAVY 3R TREATMENTS	
Condition Rating / PCR			
POOR / 53			
Route Condition Legend – Pavement Condition Rating (PCR)			
Poor (0 - 60)	Fair (61- 84)	Good (85 - 94)	Excellent (95 - 100)
Not Rated			
See Appendix for definitions and formulas

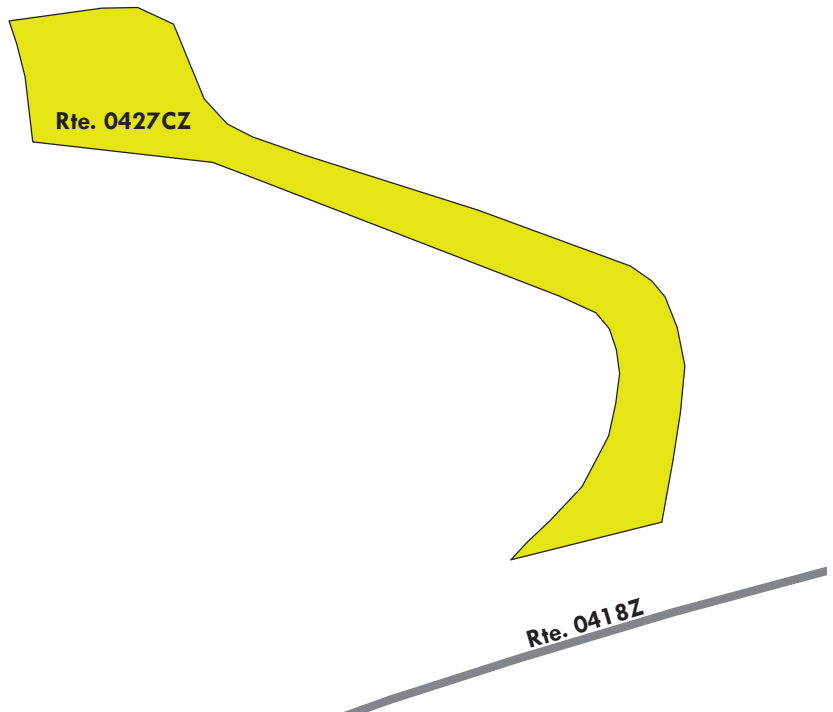
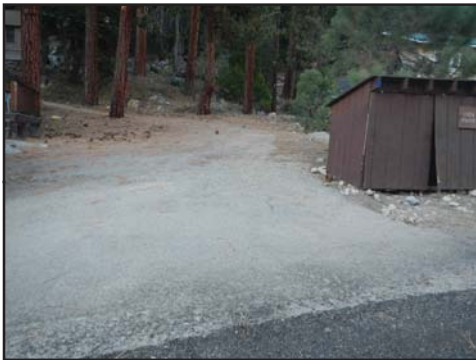
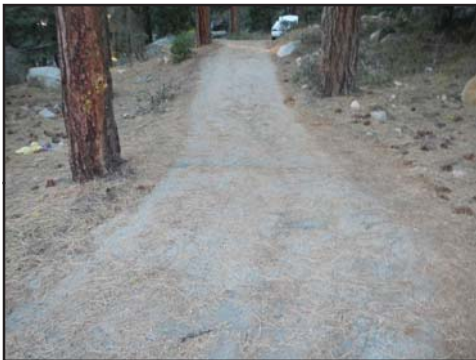
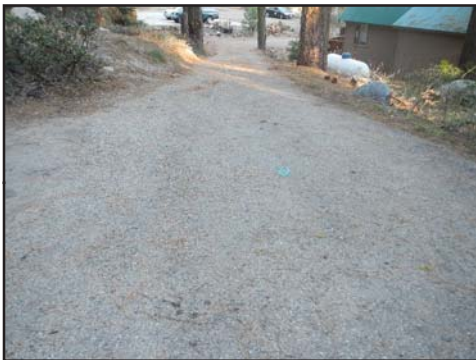
ROUTE 0427CZ: LODGEPOLE NORTH RESIDENCE ROAD C

FROM ROUTE 0418Z (LODGEPOLE NORTH RESIDENCE ACCESS ROAD) AT MP 0.24, LEFT
 TO END

Inspection Date	FMSS Number	User Access	Surface Type
9/25/2014	73881	NONPUBLIC	ASPHALT
Area (Sq. Ft.)	Lane Miles (11' Widths)	Pavement Recommendation	
2,415	0.042	LIGHT 3R TREATMENTS	
Condition Rating / PCR			
FAIR / 73			
Route Condition Legend – Pavement Condition Rating (PCR)			
Poor (0 - 60)	Fair (61- 84)	Good (85 - 94)	Excellent (95 - 100)
			Not Rated
See Appendix for definitions and formulas

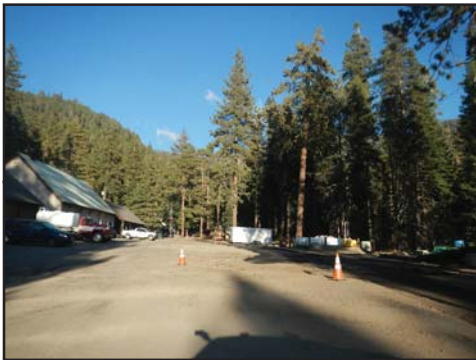
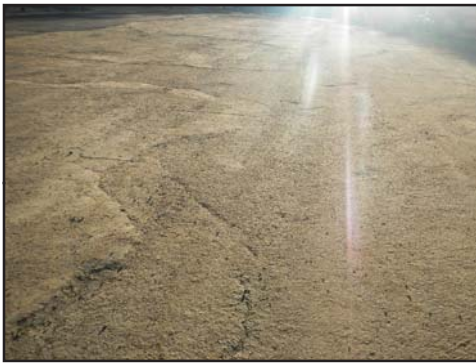
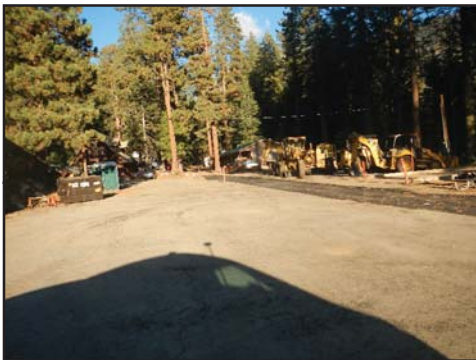
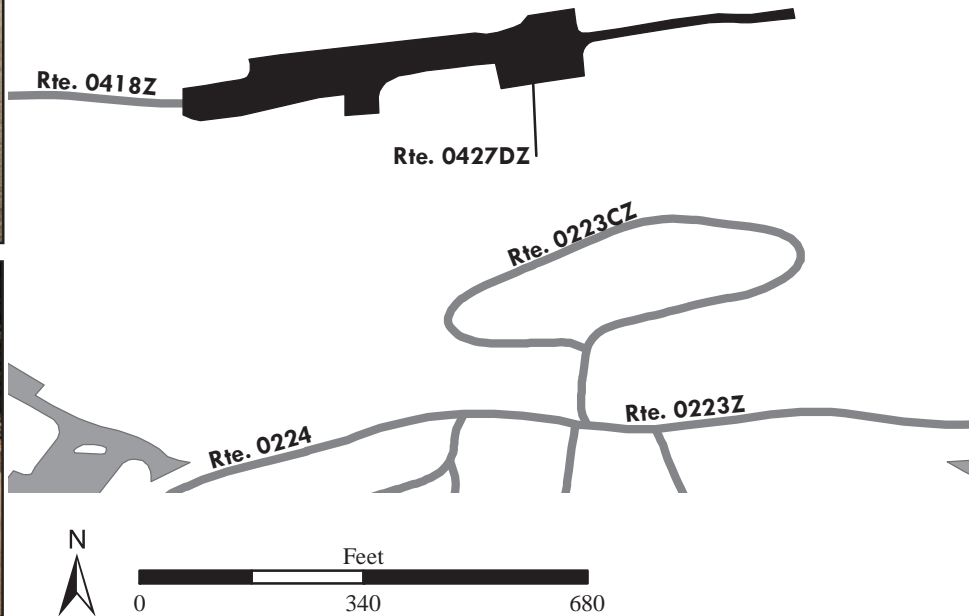
ROUTE 0427DZ: LODGEPOLE NORTH RESIDENCE ROAD D

Inspection Date	FMSS Number	User Access	Surface Type
9/25/2014	73881	NONPUBLIC	ASPHALT
Area (Sq. Ft.)	Lane Miles (11' Widths)	Pavement Recommendation	
38,214	0.658	NOT APPLICABLE	
Condition Rating / PCR			
NOT RATED / N/A			
Route Condition Legend – Pavement Condition Rating (PCR)			
Poor (0 - 60)	Fair (61- 84)	Good (85 - 94)	Excellent (95 - 100)
Not Rated			
See Appendix for definitions and formulas

Parking area was not rated because it was under construction.

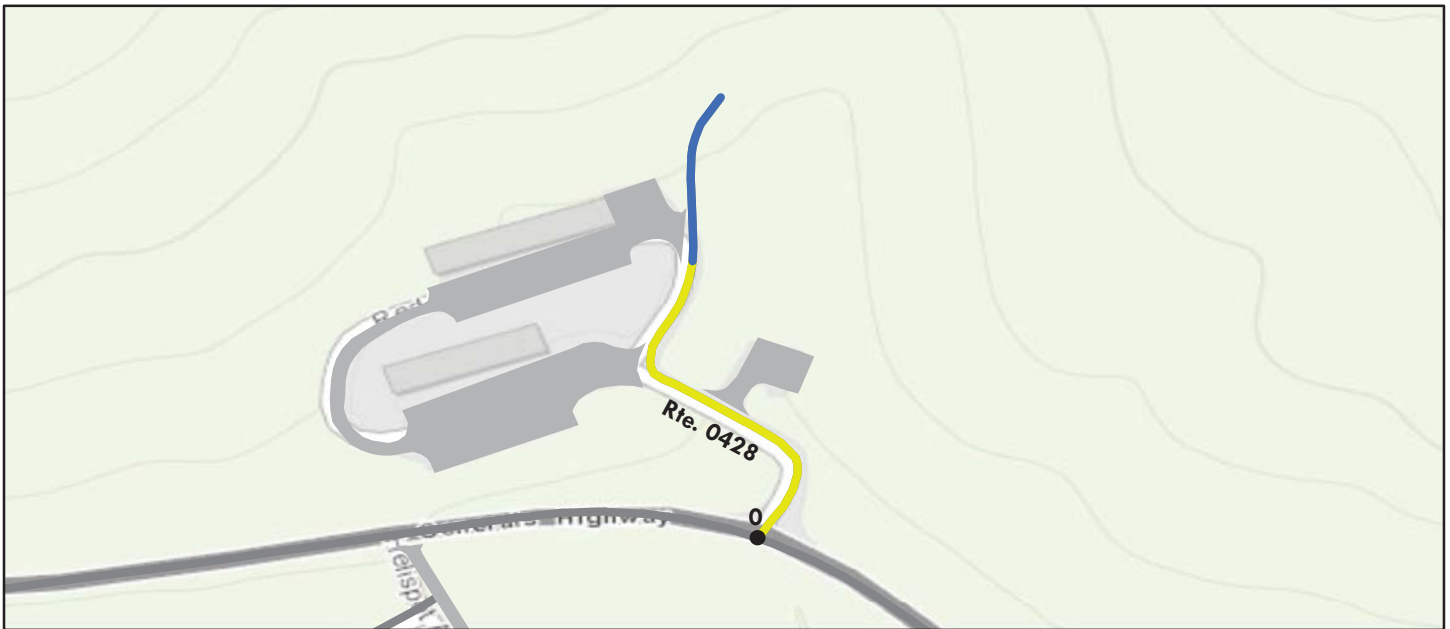
ROUTE 0428: RED FIR ACCESS ROAD

Data Collection Vehicle (DCV) Rating

Route Condition Legend – Pavement Condition Rating (PCR)						
Poor (0 - 60)	Fair (61- 84)	Good (85 - 94)	Excellent (95 - 100)	Not Rated		
See Appendix for definitions and formulas						
Inspection Date: 5/26/2015	Beginning Section MP	0				
Paved Length (Miles): 0.15	Section Length (MI)	0.15				
Surface Type: ASPHALT	Route Summary					
Roadway Condition Information						
Pavement Condition Rating (PCR)	83	83				
Surface Condition Rating (SCR)	83	83				
Roughness Condition Index (RCI)	N/A	N/A				
Distress Index Values						
Structural Crack Index	83	83				
Alligator Crack Index	91	91				
Longitudinal Crack Index	92	92				
Transverse Cracking Index	87	87				
Patching Index	100	100				
Rutting Index	97	97				
International Roughness Index (IRI)	N/A	N/A				
Lane & Width Information						
Number of Lanes	2	2				
Paved Width (ft)	20.7	20.7				
Lane Width (ft)	10.1	10.1

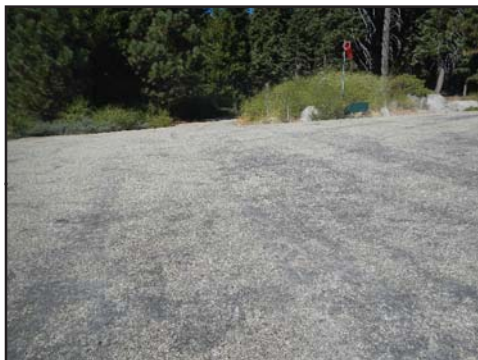
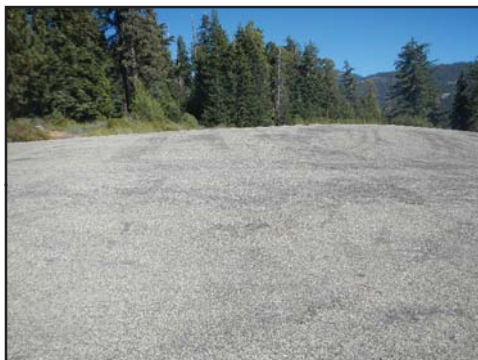
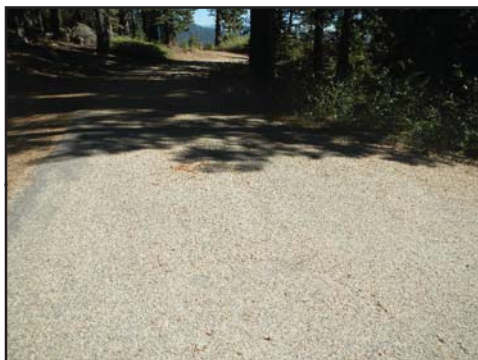
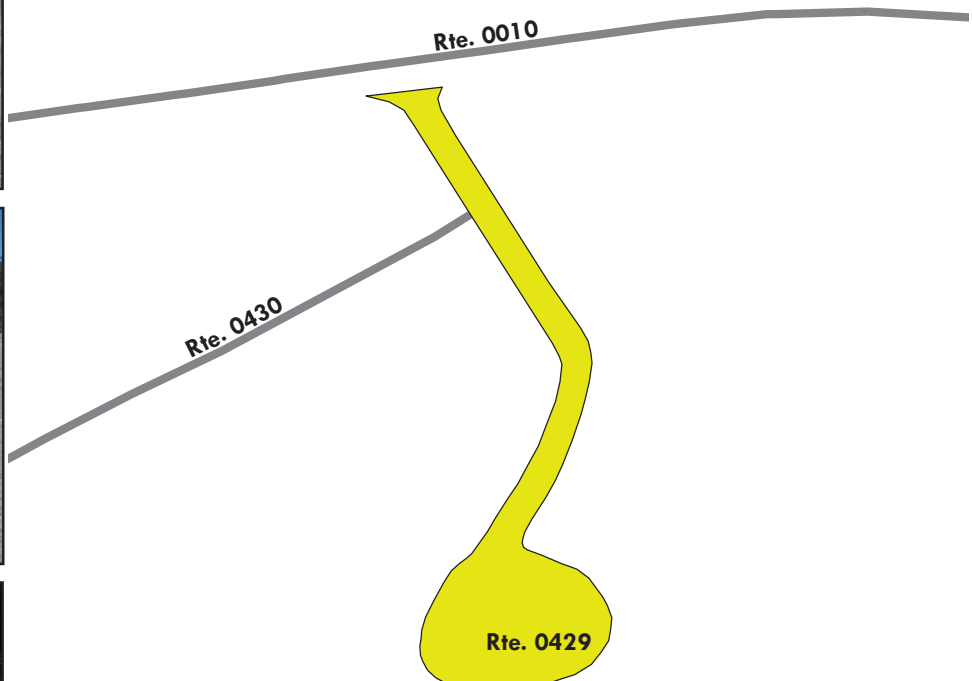
Inspection Date	FMSS Number	User Access	Surface Type
9/24/2014	73894	NONPUBLIC	ASPHALT
Area (Sq. Ft.)	Lane Miles (11' Widths)	Pavement Recommendation	
13,052	0.225	LIGHT 3R TREATMENTS

Shape area consists of multiple surface types. 1 part Asphalt at 12,628 square feet; 1 part Concrete at 424 square feet.

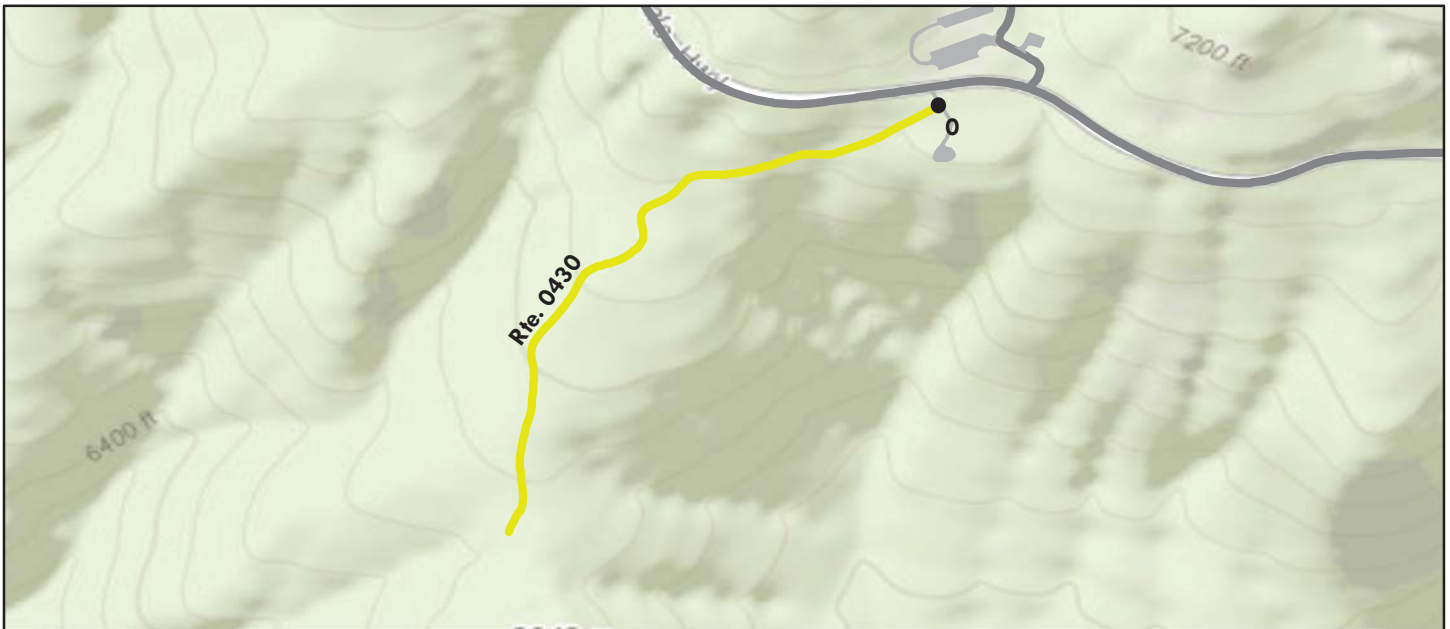
ROUTE 0430: RED FIR SPRAY FIELD ROAD

Manual Rating

Route Condition Legend – Pavement Condition Rating (PCR)						
Poor (0 - 60)	Fair (61- 84)	Good (85 - 94)	Excellent (95 - 100)	Not Rated		
See Appendix for definitions and formulas						
Inspection Date: 9/24/2014	Beginning Section MP	0.00				
Paved Length (Miles): 0.65	Section Length (MI)	0.65				
Surface Type: ASPHALT	Route Summary					
Roadway Condition Information						
Pavement Condition Rating (PCR)	73	73				
Surface Condition Rating (SCR)	73	73				
Roughness Condition Index (RCI)	N/A	N/A				
Distress Index Values						
Structural Crack Index	N/A	N/A				
Alligator Crack Index	90	90				
Longitudinal Crack Index	90	90				
Transverse Cracking Index	90	90				
Patching Index	90	90				
Rutting Index	73	73				
International Roughness Index (IRI)	N/A	N/A				
Lane & Width Information						
Number of Lanes	1	1				
Paved Width (ft)	10	10				
Lane Width (ft)	10	10
