Road Inventory and Condition Assessment of Paved Routes Sequoia National Park

**Federal Lands Highway
Road Inventory Program**

Federal Highway Administration
Eastern Federal Lands Highway Division
Road Inventory Program (RIP)

Report Date: January 2016

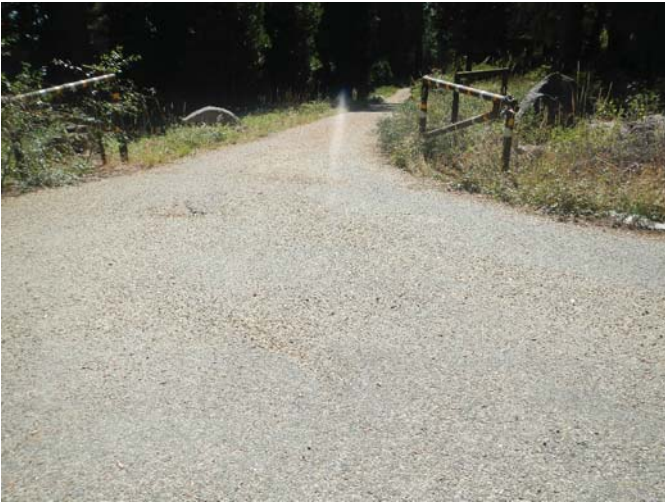
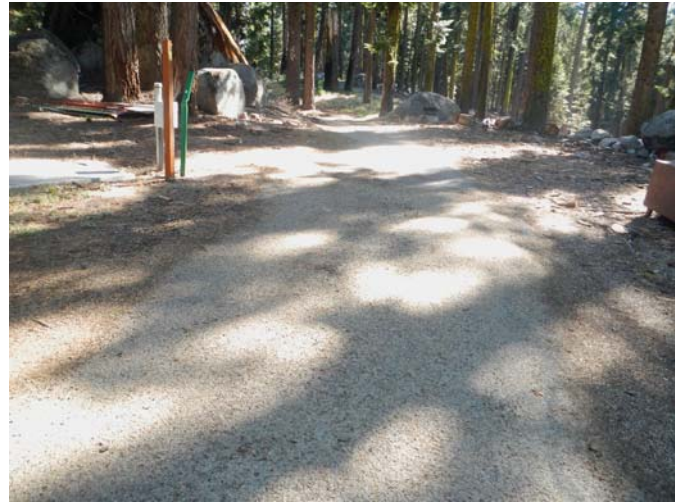
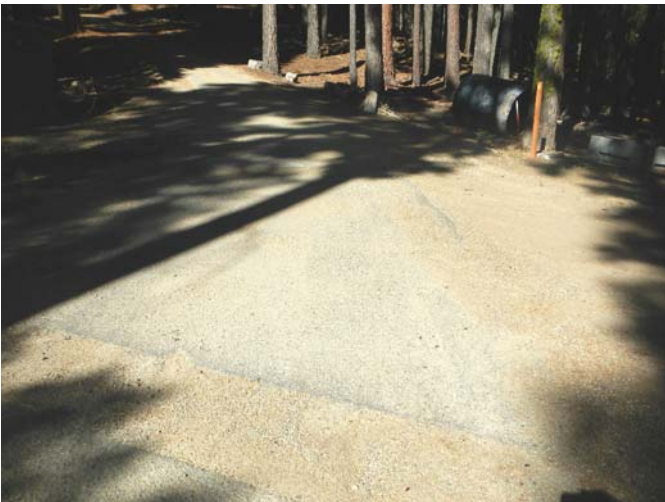
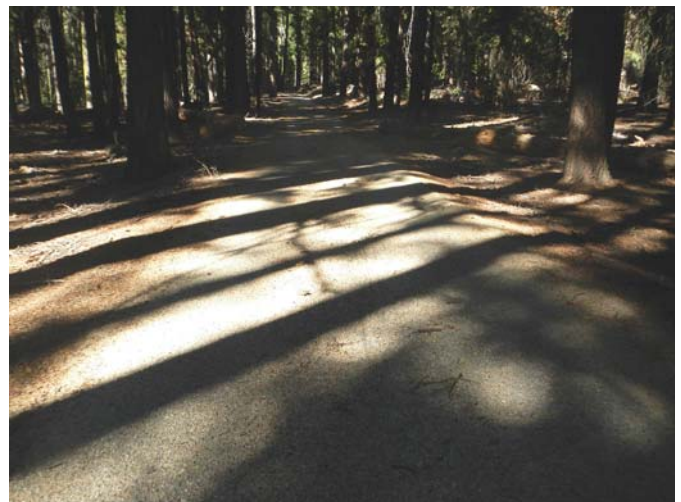
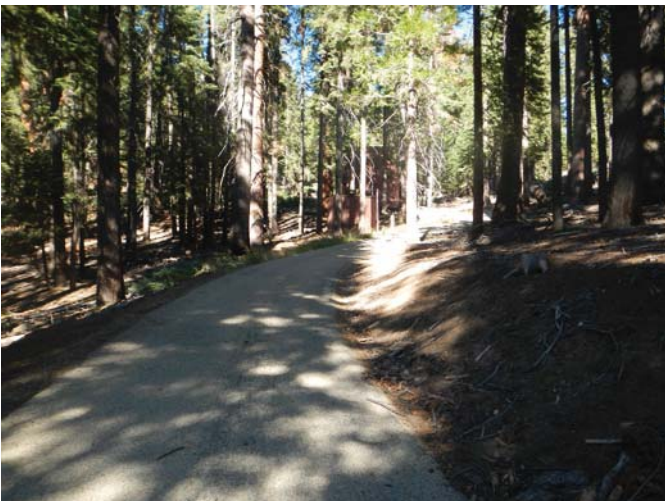
Condition Photos

Condition photos are shown only for manually rated roads. Use the PathView program to see images of DCV rated roads.

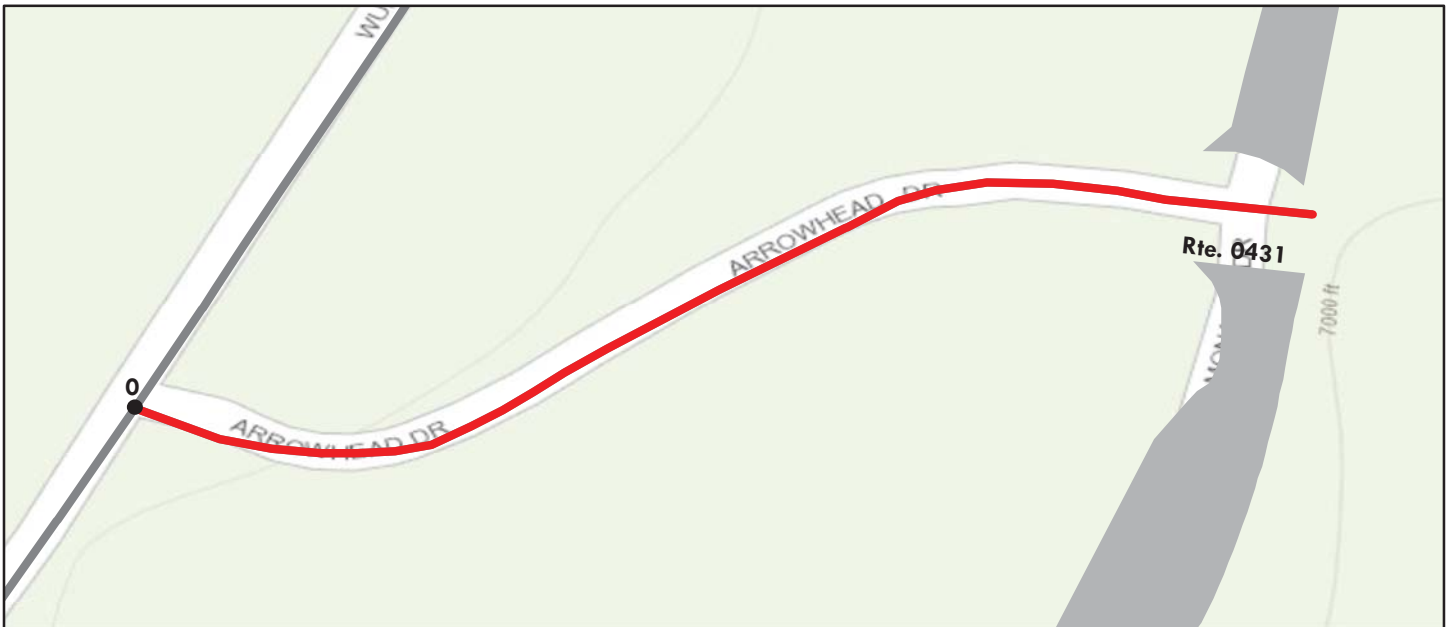
ROUTE 0431: WUKSACHI FIRE STATION ROAD

Data Collection Vehicle (DCV) Rating

Route Condition Legend – Pavement Condition Rating (PCR)						
Poor (0 - 60)	Fair (61- 84)	Good (85 - 94)	Excellent (95 - 100)	Not Rated		
See Appendix for definitions and formulas						
Inspection Date: 5/26/2015	Beginning Section MP	0				
Paved Length (Miles): 0.07	Section Length (MI)	0.07				
Surface Type: ASPHALT	Route Summary					
Roadway Condition Information						
Pavement Condition Rating (PCR)	5	5				
Surface Condition Rating (SCR)	5	5				
Roughness Condition Index (RCI)	N/A	N/A				
Distress Index Values						
Structural Crack Index	5	5				
Alligator Crack Index	83	83				
Longitudinal Crack Index	22	22				
Transverse Cracking Index	46	46				
Patching Index	99	99				
Rutting Index	97	97				
International Roughness Index (IRI)	N/A	N/A				
Lane & Width Information						
Number of Lanes	2	2				
Paved Width (ft)	20.3	20.3				
Lane Width (ft)	9	9

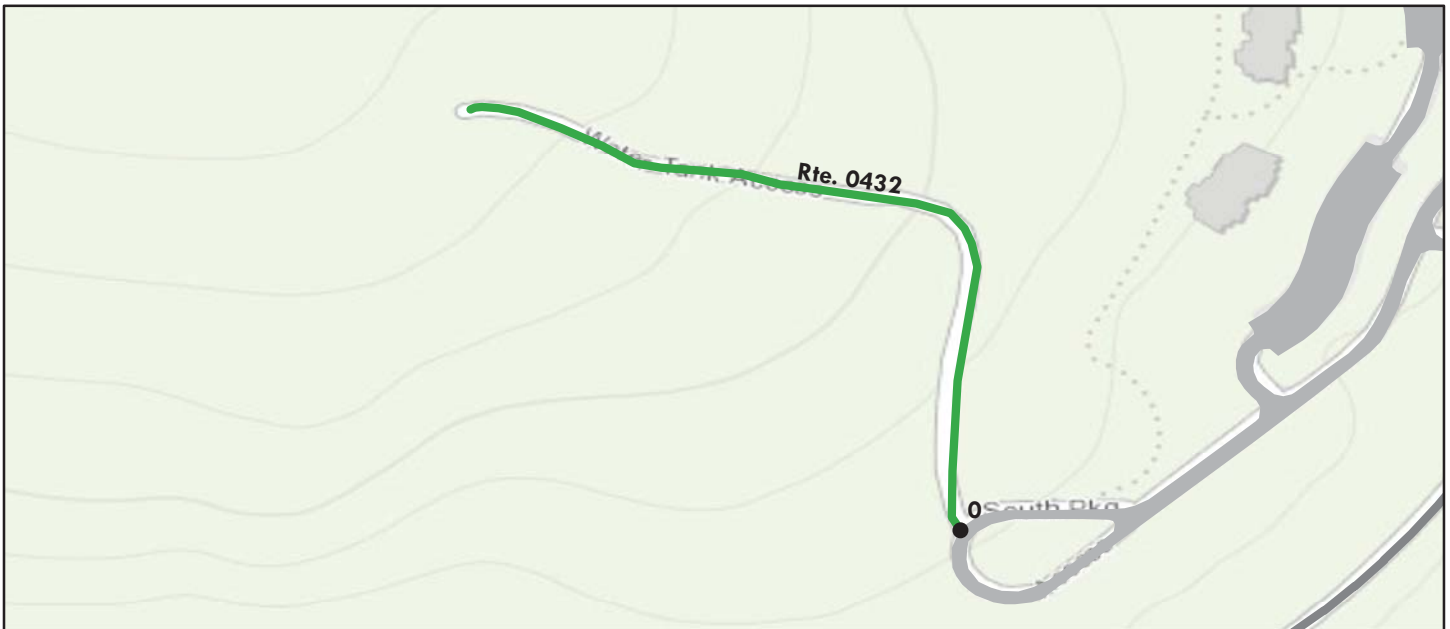
ROUTE 0432: WUKSACHI WATER TOWER ROAD

Manual Rating

Route Condition Legend – Pavement Condition Rating (PCR)						
Poor (0 - 60)	Fair (61- 84)	Good (85 - 94)	Excellent (95 - 100)	Not Rated		
See Appendix for definitions and formulas						
Inspection Date: 9/24/2014	Beginning Section MP	0.00				
Paved Length (Miles): 0.21	Section Length (MI)	0.21				
Surface Type: ASPHALT	Route Summary					
Roadway Condition Information						
Pavement Condition Rating (PCR)	90	90				
Surface Condition Rating (SCR)	90	90				
Roughness Condition Index (RCI)	N/A	N/A				
Distress Index Values						
Structural Crack Index	N/A	N/A				
Alligator Crack Index	90	90				
Longitudinal Crack Index	90	90				
Transverse Cracking Index	90	90				
Patching Index	97	97				
Rutting Index	97	97				
International Roughness Index (IRI)	N/A	N/A				
Lane & Width Information						
Number of Lanes	2	2				
Paved Width (ft)	22	22				
Lane Width (ft)	11	11

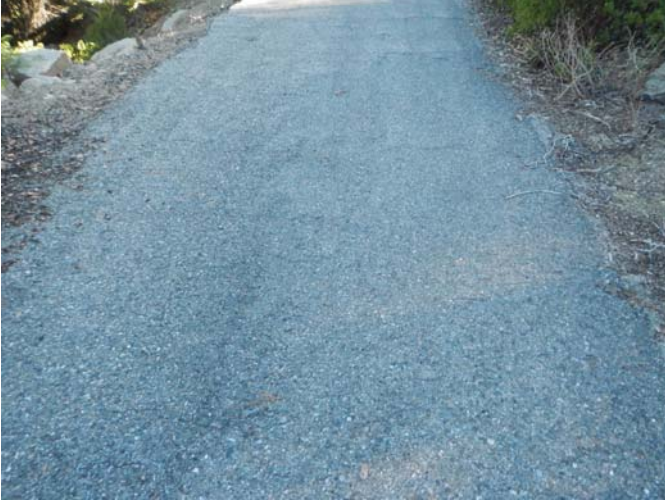
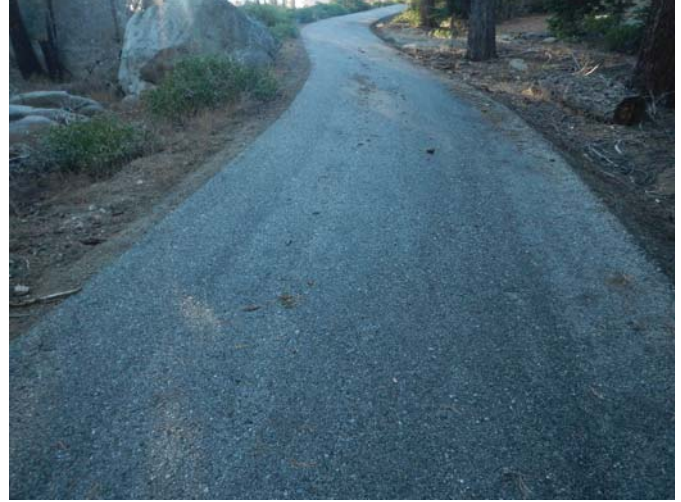
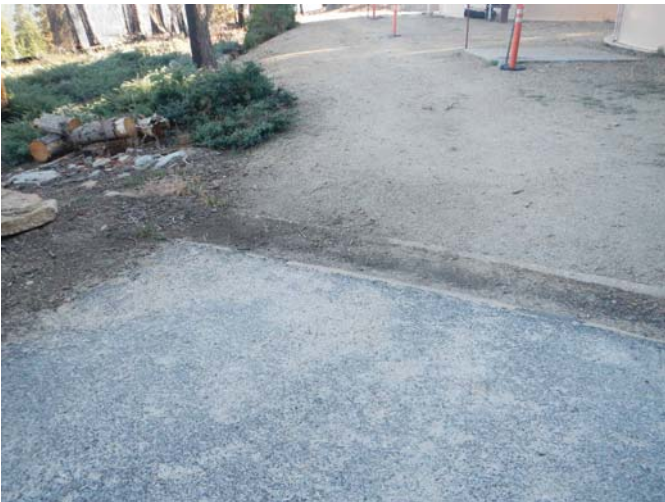
Condition Photos

Condition photos are shown only for manually rated roads. Use the PathView program to see images of DCV rated roads.

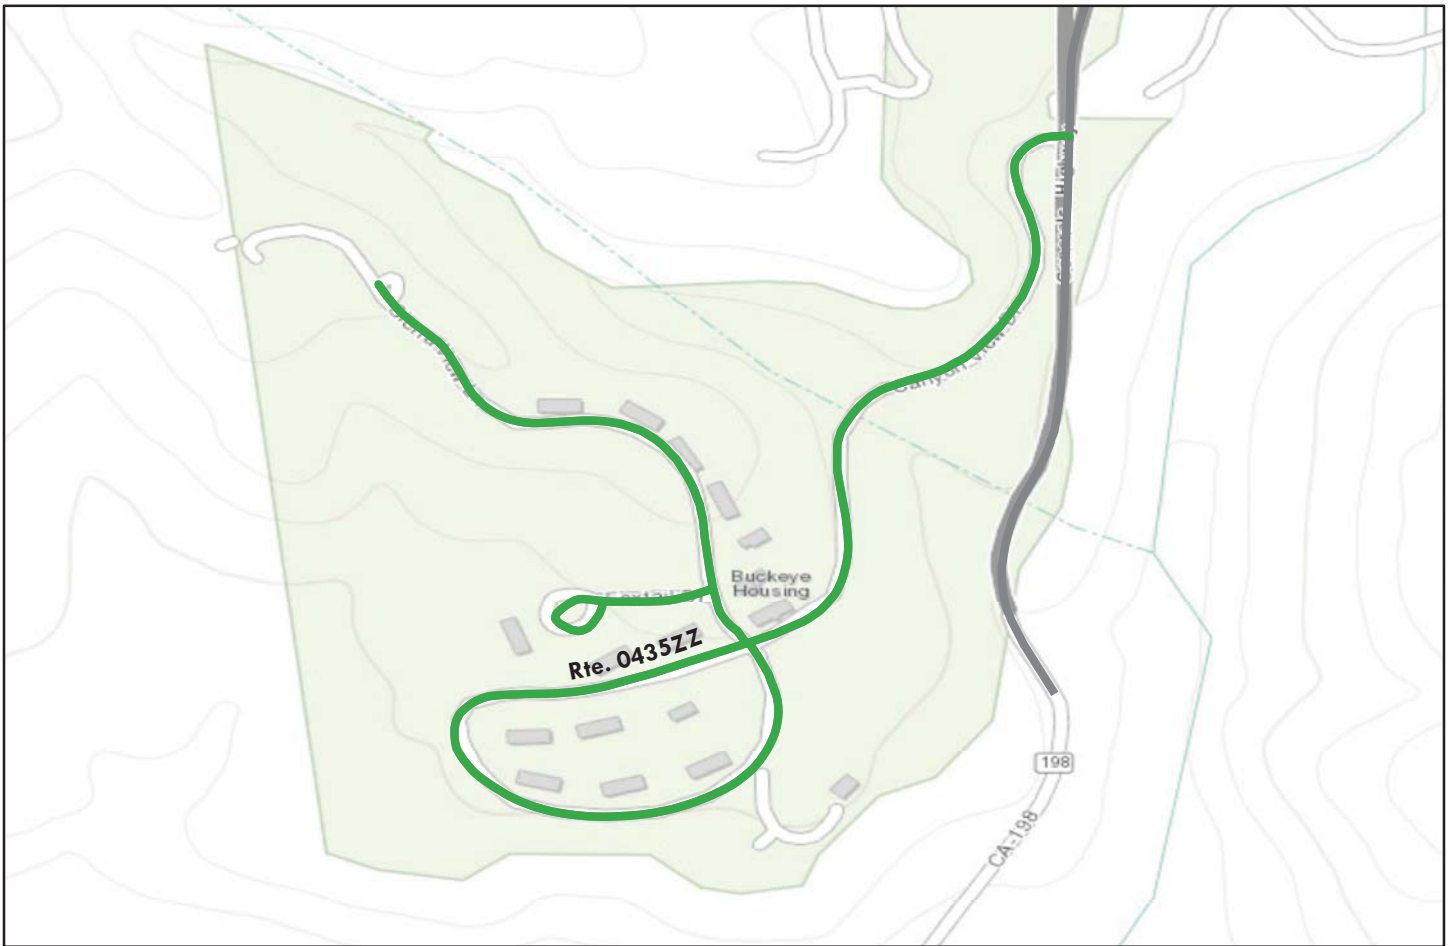
ROUTE 0435ZZ: BUCKEYE RESIDENCE ROADS

Note: The weighted average summary PCR value is calculated from only the sections of road where the PCR was collected. The overall PCR for the summary route may not reflect individual subcomponent ratings.

Route Condition Legend – Pavement Condition Rating (PCR)						
Poor (0 - 60)	Fair (61- 84)	Good (85 - 94)	Excellent (95 - 100)	Not Rated		
See Appendix for definitions and formulas						
Inspection Date: 5/28/2015						
Paved Length (Miles): 0.75						
Surface Type: ASPHALT	Route Summary					
Roadway Condition Information						
Pavement Condition Rating (PCR)	92					
Lane & Width Information						
Number of Lanes	1					
Paved Width (ft)	18.6					
Lane Width (ft)	8.4

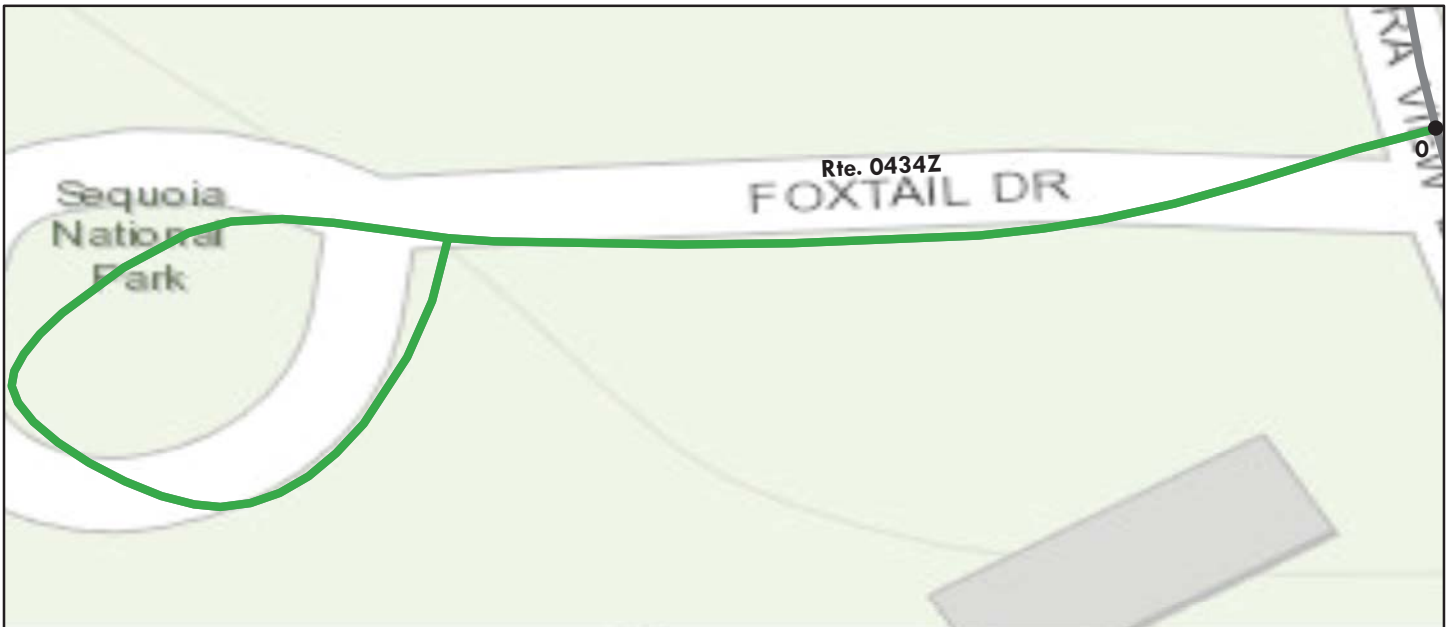
Subcomponent of Route SEQU-0435ZZ

Route Condition Legend – Pavement Condition Rating (PCR)						
Poor (0 - 60)	Fair (61- 84)	Good (85 - 94)	Excellent (95 - 100)	Not Rated		
See Appendix for definitions and formulas						
Inspection Date: 5/28/2015	Beginning Section MP	0				
Paved Length (Miles): 0.07	Section Length (MI)	0.07				
Surface Type: ASPHALT	Route Summary					
Roadway Condition Information						
Pavement Condition Rating (PCR)	92	92				
Surface Condition Rating (SCR)	92	92				
Roughness Condition Index (RCI)	N/A	N/A				
Distress Index Values						
Structural Crack Index	100	100				
Alligator Crack Index	100	100				
Longitudinal Crack Index	100	100				
Transverse Cracking Index	100	100				
Patching Index	100	100				
Rutting Index	92	92				
International Roughness Index (IRI)	N/A	N/A				
Lane & Width Information						
Number of Lanes	2	2				
Paved Width (ft)	19.1	19.1				
Lane Width (ft)	9.5	9.5

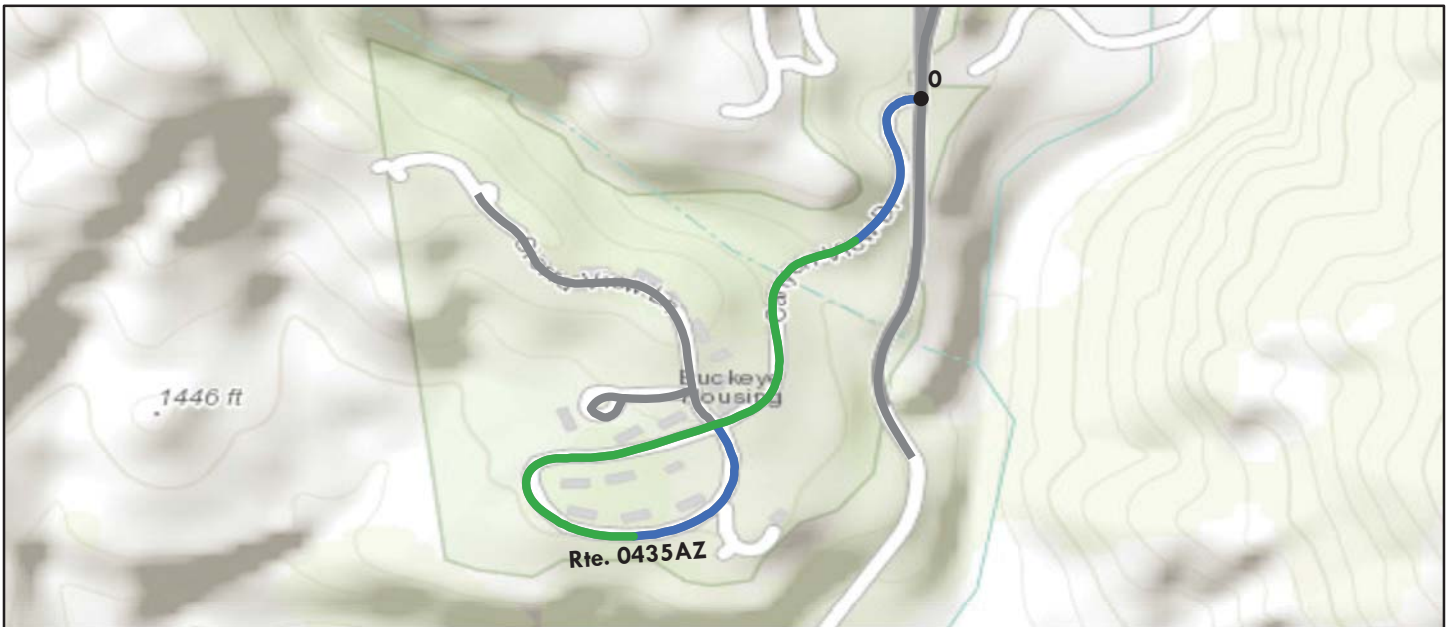
ROUTE 0435AZ: CANYON VIEW DRIVE

Route Condition Legend – Pavement Condition Rating (PCR)						
Poor (0 - 60)	Fair (61- 84)	Good (85 - 94)	Excellent (95 - 100)	Not Rated		
See Appendix for definitions and formulas						
Inspection Date: 5/28/2015	Beginning Section MP	0				
Paved Length (Miles): 0.49	Section Length (MI)	0.49				
Surface Type: ASPHALT	Route Summary					
Roadway Condition Information						
Pavement Condition Rating (PCR)	92	92				
Surface Condition Rating (SCR)	92	92				
Roughness Condition Index (RCI)	N/A	N/A				
Distress Index Values						
Structural Crack Index	99	99				
Alligator Crack Index	100	100				
Longitudinal Crack Index	99	99				
Transverse Cracking Index	99	99				
Patching Index	100	100				
Rutting Index	92	92				
International Roughness Index (IRI)	N/A	N/A				
Lane & Width Information						
Number of Lanes	2	2				
Paved Width (ft)	19.7	19.7				
Lane Width (ft)	8.5	8.5

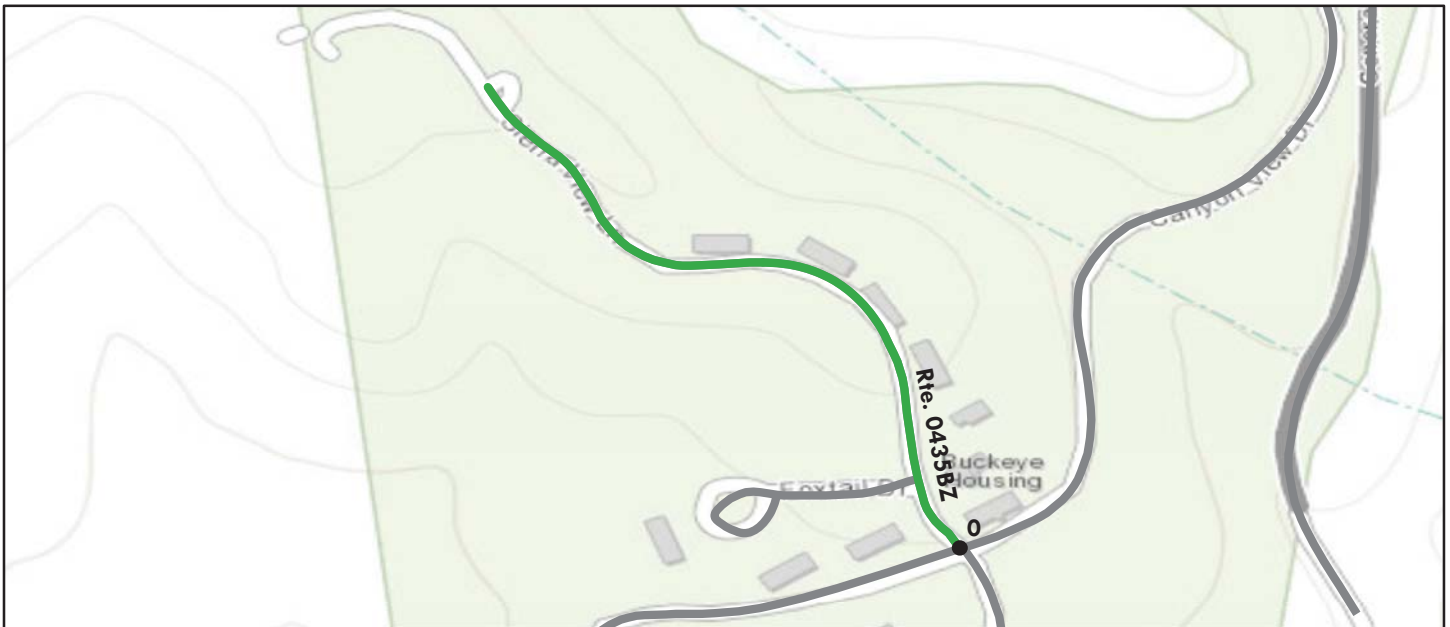
ROUTE 0435BZ: SIERRA VIEW LANE

Route Condition Legend – Pavement Condition Rating (PCR)						
Poor (0 - 60)	Fair (61- 84)	Good (85 - 94)	Excellent (95 - 100)	Not Rated		
See Appendix for definitions and formulas						
Inspection Date: 5/28/2015	Beginning Section MP	0				
Paved Length (Miles): 0.19	Section Length (MI)	0.19				
Surface Type: ASPHALT	Route Summary					
Roadway Condition Information						
Pavement Condition Rating (PCR)	91	91				
Surface Condition Rating (SCR)	91	91				
Roughness Condition Index (RCI)	N/A	N/A				
Distress Index Values						
Structural Crack Index	99	99				
Alligator Crack Index	100	100				
Longitudinal Crack Index	99	99				
Transverse Cracking Index	100	100				
Patching Index	100	100				
Rutting Index	91	91				
International Roughness Index (IRI)	N/A	N/A				
Lane & Width Information						
Number of Lanes	2	2				
Paved Width (ft)	15.7	15.7				
Lane Width (ft)	7.8	7.8

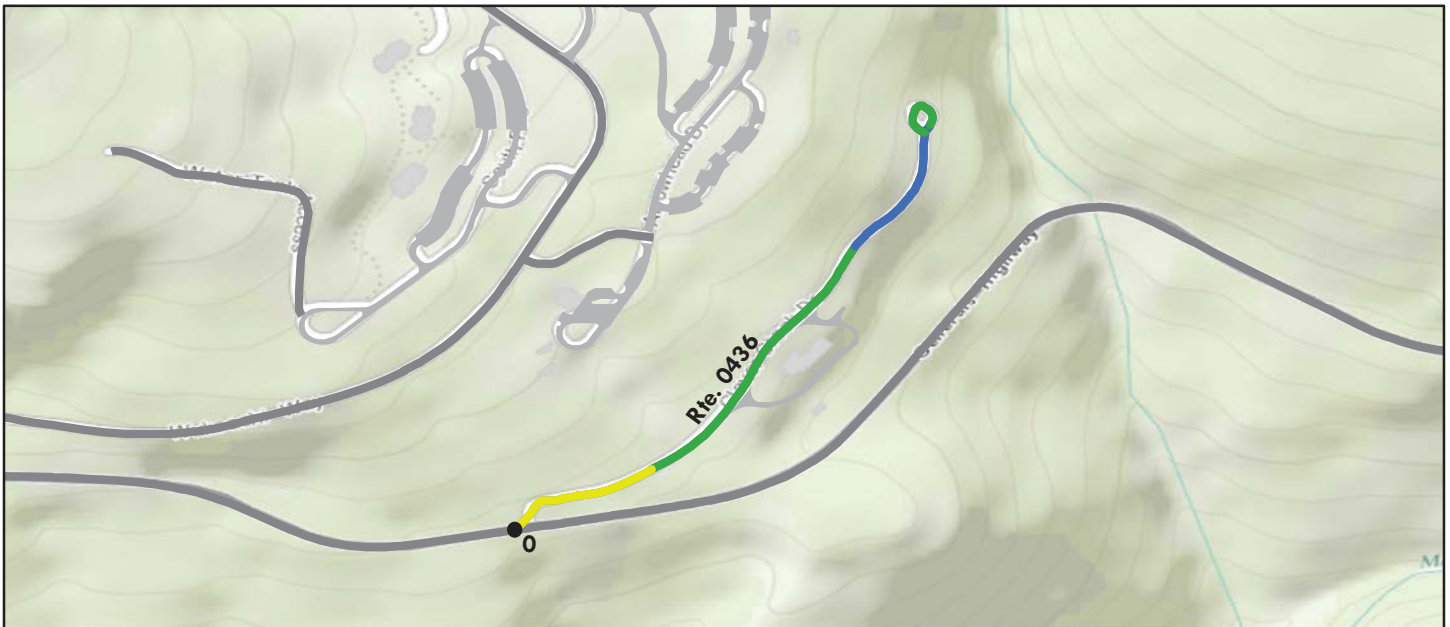
ROUTE 0436: CLOVER CREEK PLANT ACCESS ROAD

Route Condition Legend – Pavement Condition Rating (PCR)						
Poor (0 - 60)	Fair (61- 84)	Good (85 - 94)	Excellent (95 - 100)	Not Rated		
See Appendix for definitions and formulas						
Inspection Date: 5/26/2015	Beginning Section MP	0				
Paved Length (Miles): 0.44	Section Length (MI)	0.44				
Surface Type: ASPHALT	Route Summary					
Roadway Condition Information						
Pavement Condition Rating (PCR)	91	91				
Surface Condition Rating (SCR)	91	91				
Roughness Condition Index (RCI)	N/A	N/A				
Distress Index Values						
Structural Crack Index	98	98				
Alligator Crack Index	100	100				
Longitudinal Crack Index	98	98				
Transverse Cracking Index	91	91				
Patching Index	100	100				
Rutting Index	97	97				
International Roughness Index (IRI)	N/A	N/A				
Lane & Width Information						
Number of Lanes	2	2				
Paved Width (ft)	24.3	24.3				
Lane Width (ft)	11.9	11.9

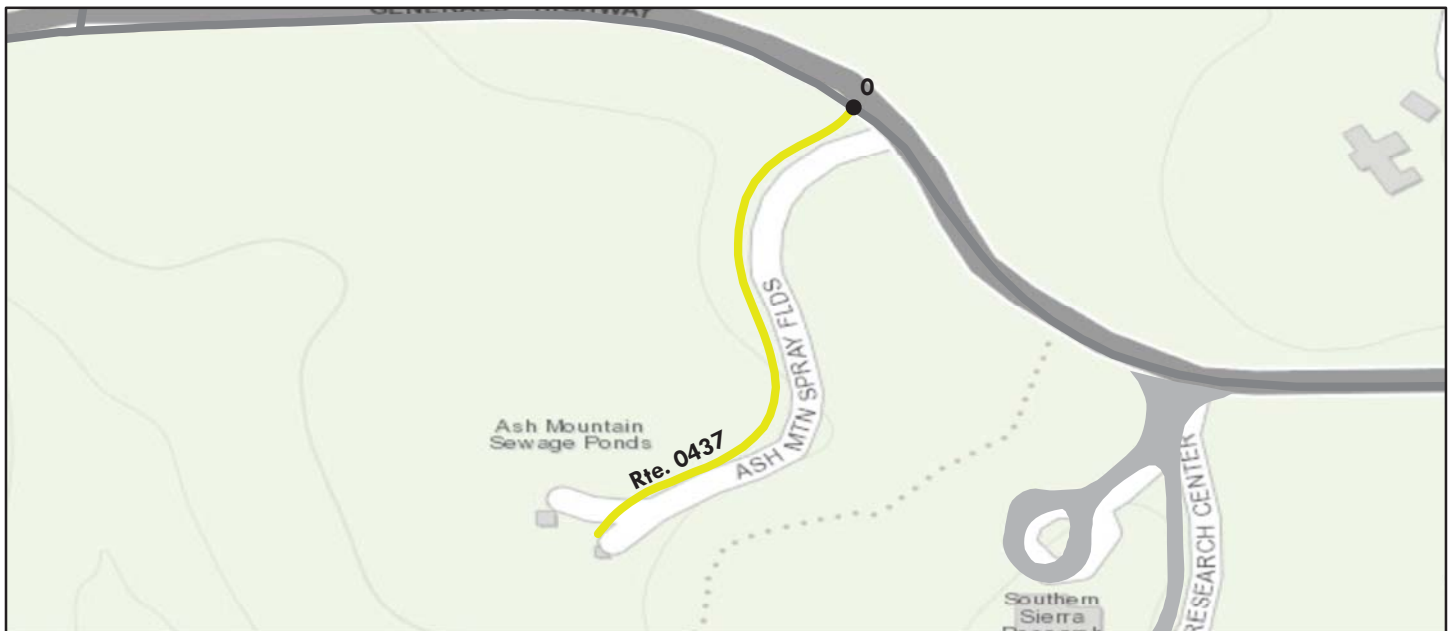
ROUTE 0437: ASH MOUNTAIN SEWER PLANT ROAD

Route Condition Legend – Pavement Condition Rating (PCR)						
Poor (0 - 60)	Fair (61- 84)	Good (85 - 94)	Excellent (95 - 100)	Not Rated		
See Appendix for definitions and formulas						
Inspection Date:	9/24/2014	Beginning Section MP	0.00			
Paved Length (Miles):	0.09	Section Length (MI)	0.09			
Surface Type:	ASPHALT	Route Summary				
Roadway Condition Information						
Pavement Condition Rating (PCR)	73	73				
Surface Condition Rating (SCR)	73	73				
Roughness Condition Index (RCI)	N/A	N/A				
Distress Index Values						
Structural Crack Index	N/A	N/A				
Alligator Crack Index	90	90				
Longitudinal Crack Index	90	90				
Transverse Cracking Index	90	90				
Patching Index	97	97				
Rutting Index	73	73				
International Roughness Index (IRI)	N/A	N/A				
Lane & Width Information						
Number of Lanes	1	1				
Paved Width (ft)	11	11				
Lane Width (ft)	11	11

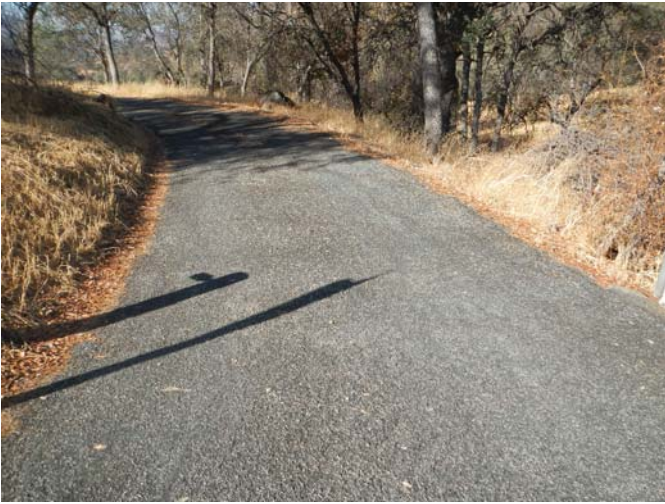
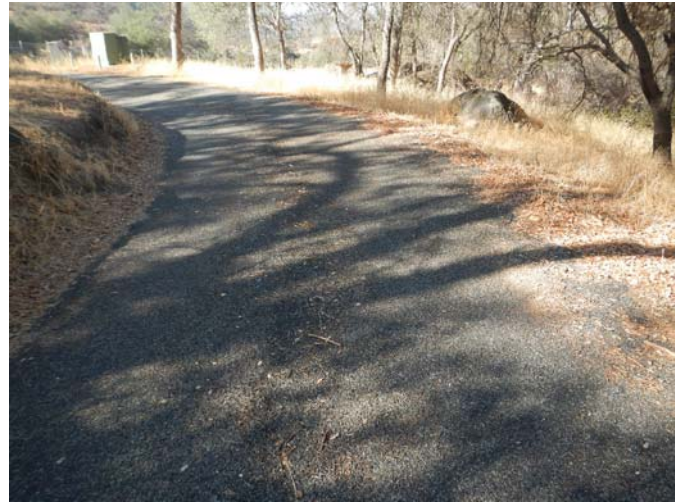
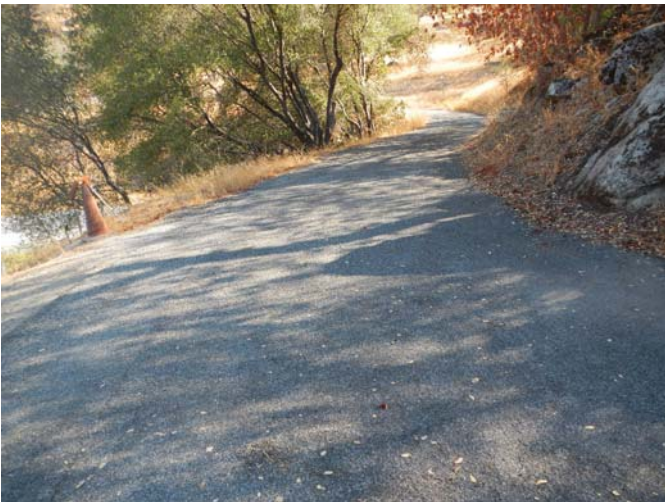
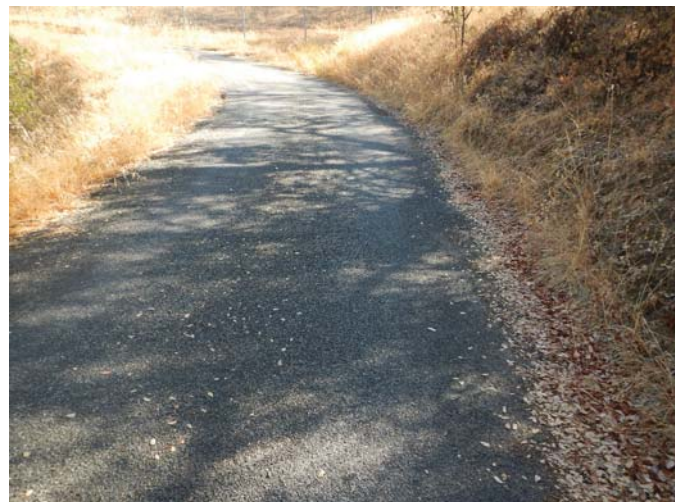
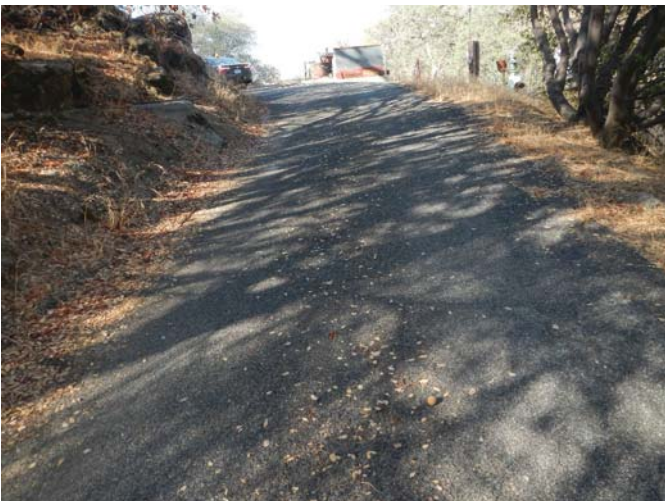
Condition Photos

Condition photos are shown only for manually rated roads. Use the PathView program to see images of DCV rated roads.

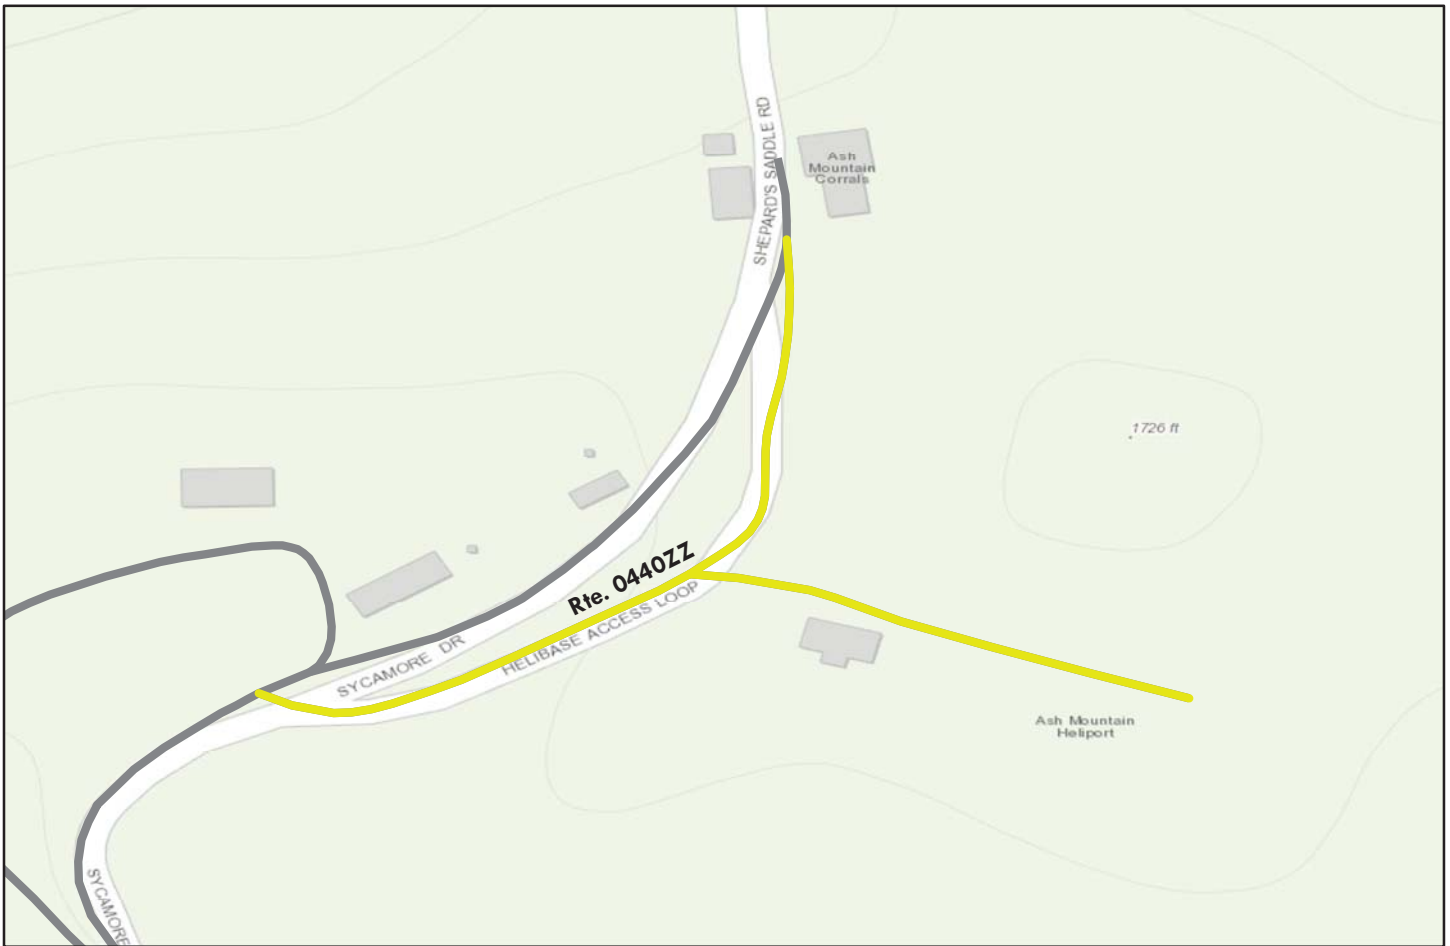
ROUTE 0440ZZ: HELIPORT SPUR ROADS

Note: The weighted average summary PCR value is calculated from only the sections of road where the PCR was collected. The overall PCR for the summary route may not reflect individual subcomponent ratings.

Route Condition Legend – Pavement Condition Rating (PCR)						
Poor (0 - 60)	Fair (61- 84)	Good (85 - 94)	Excellent (95 - 100)	Not Rated		
See Appendix for definitions and formulas						
Inspection Date: 5/26/2015						
Paved Length (Miles): 0.14						
Surface Type: ASPHALT	Route Summary					
Roadway Condition Information						
Pavement Condition Rating (PCR)	84					
Lane & Width Information						
Number of Lanes	1					
Paved Width (ft)	11.5					
Lane Width (ft)	11.5

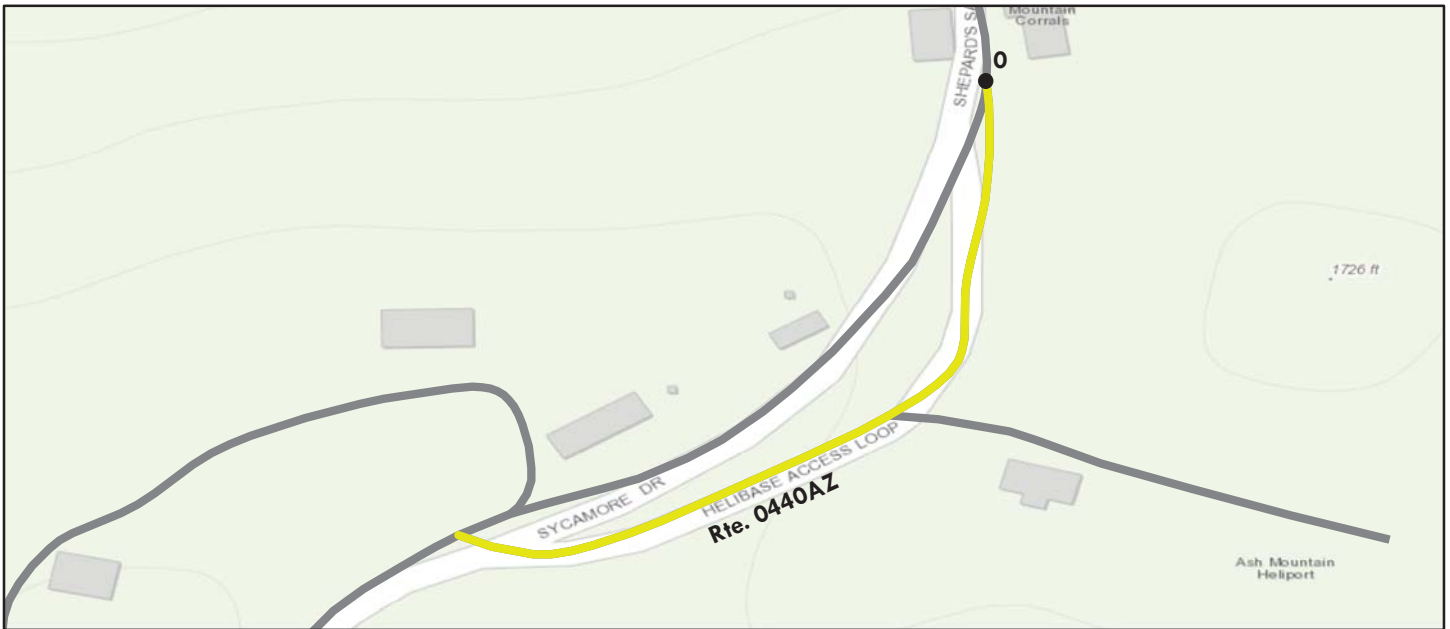
ROUTE 0440AZ: HELIPOINT SPUR ROAD A

Route Condition Legend – Pavement Condition Rating (PCR)						
Poor (0 - 60)	Fair (61- 84)	Good (85 - 94)	Excellent (95 - 100)	Not Rated		
See Appendix for definitions and formulas						
Inspection Date: 5/26/2015	Beginning Section MP	0				
Paved Length (Miles): 0.09	Section Length (MI)	0.09				
Surface Type: ASPHALT	Route Summary					
Roadway Condition Information						
Pavement Condition Rating (PCR)	83	83				
Surface Condition Rating (SCR)	83	83				
Roughness Condition Index (RCI)	N/A	N/A				
Distress Index Values						
Structural Crack Index	99	99				
Alligator Crack Index	100	100				
Longitudinal Crack Index	99	99				
Transverse Cracking Index	98	98				
Patching Index	99	99				
Rutting Index	83	83				
International Roughness Index (IRI)	N/A	N/A				
Lane & Width Information						
Number of Lanes	1	1				
Paved Width (ft)	12.7	12.7				
Lane Width (ft)	12.7	12.7

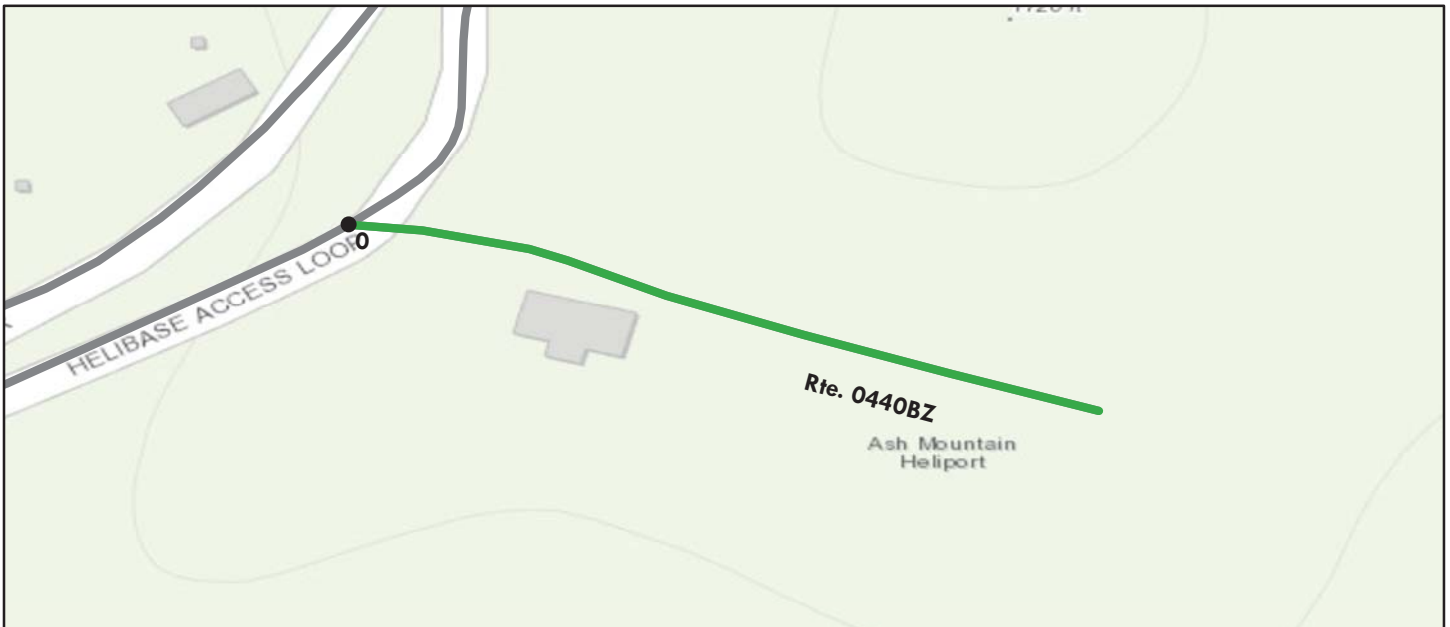
ROUTE 0440BZ: HELIPORT SPUR ROAD B

Route Condition Legend – Pavement Condition Rating (PCR)						
Poor (0 - 60)	Fair (61- 84)	Good (85 - 94)	Excellent (95 - 100)	Not Rated		
See Appendix for definitions and formulas						
Inspection Date: 5/26/2015	Beginning Section MP	0				
Paved Length (Miles): 0.05	Section Length (MI)	0.05				
Surface Type: ASPHALT	Route Summary					
Roadway Condition Information						
Pavement Condition Rating (PCR)	86	86				
Surface Condition Rating (SCR)	86	86				
Roughness Condition Index (RCI)	N/A	N/A				
Distress Index Values						
Structural Crack Index	97	97				
Alligator Crack Index	100	100				
Longitudinal Crack Index	97	97				
Transverse Cracking Index	99	99				
Patching Index	100	100				
Rutting Index	86	86				
International Roughness Index (IRI)	N/A	N/A				
Lane & Width Information						
Number of Lanes	1	1				
Paved Width (ft)	9.5	9.5				
Lane Width (ft)	9.5	9.5

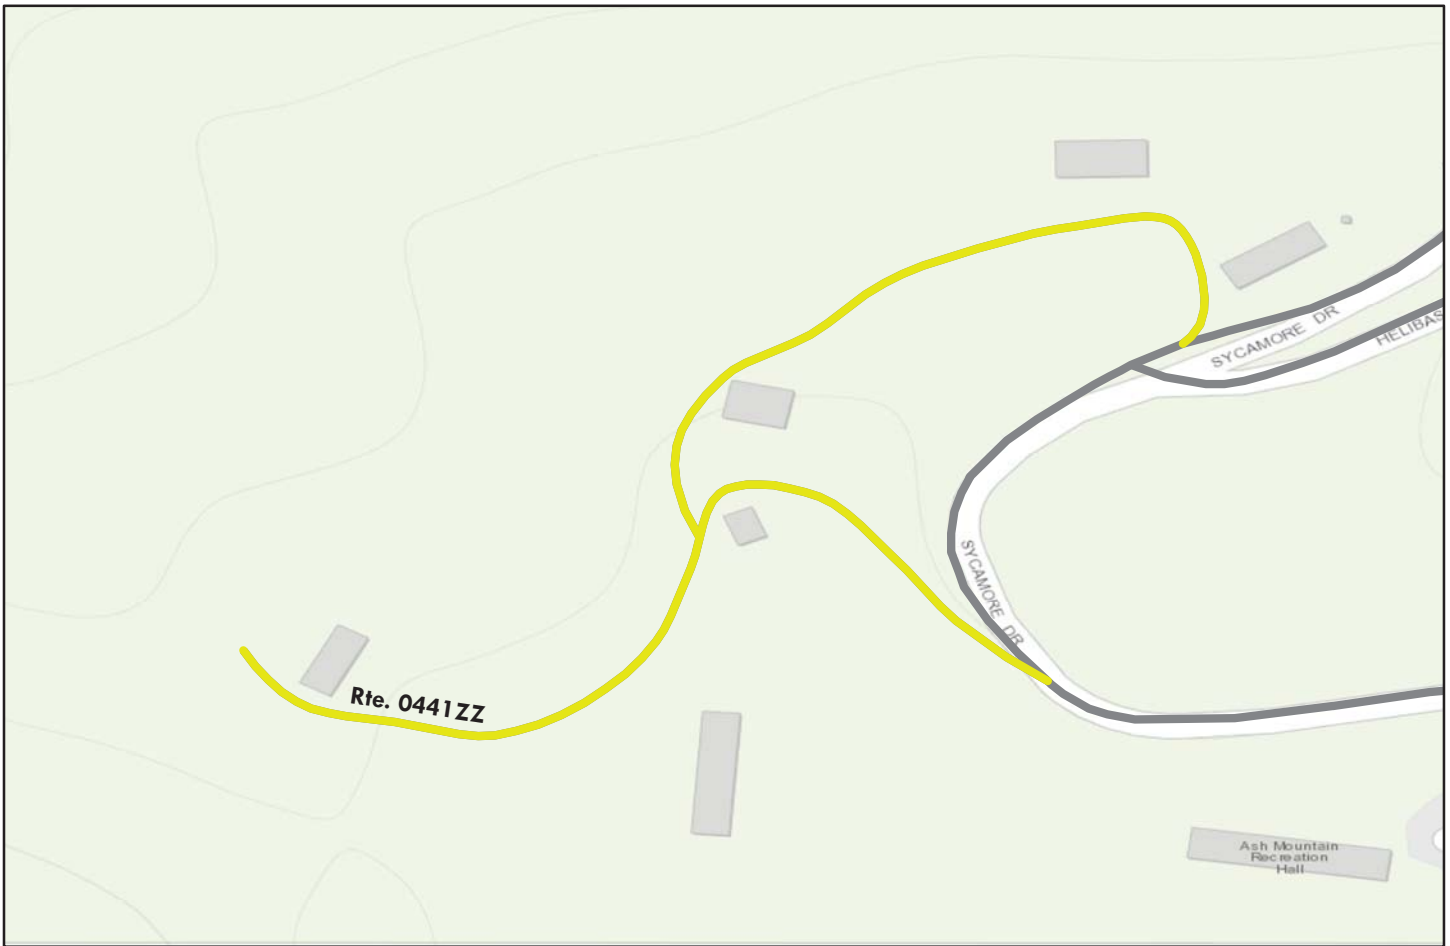
ROUTE 0441ZZ: SYCAMORE LOWER MAINTENANCE ROADS

Note: The weighted average summary PCR value is calculated from only the sections of road where the PCR was collected. The overall PCR for the summary route may not reflect individual subcomponent ratings.

Route Condition Legend – Pavement Condition Rating (PCR)						
Poor (0 - 60)	Fair (61- 84)	Good (85 - 94)	Excellent (95 - 100)	Not Rated		
See Appendix for definitions and formulas						
Inspection Date:	5/26/2015					
Paved Length (Miles):	0.19					
Surface Type:	ASPHALT	Route Summary				
Roadway Condition Information						
Pavement Condition Rating (PCR)	78					
Lane & Width Information						
Number of Lanes	1					
Paved Width (ft)	9.9					
Lane Width (ft)	9.9

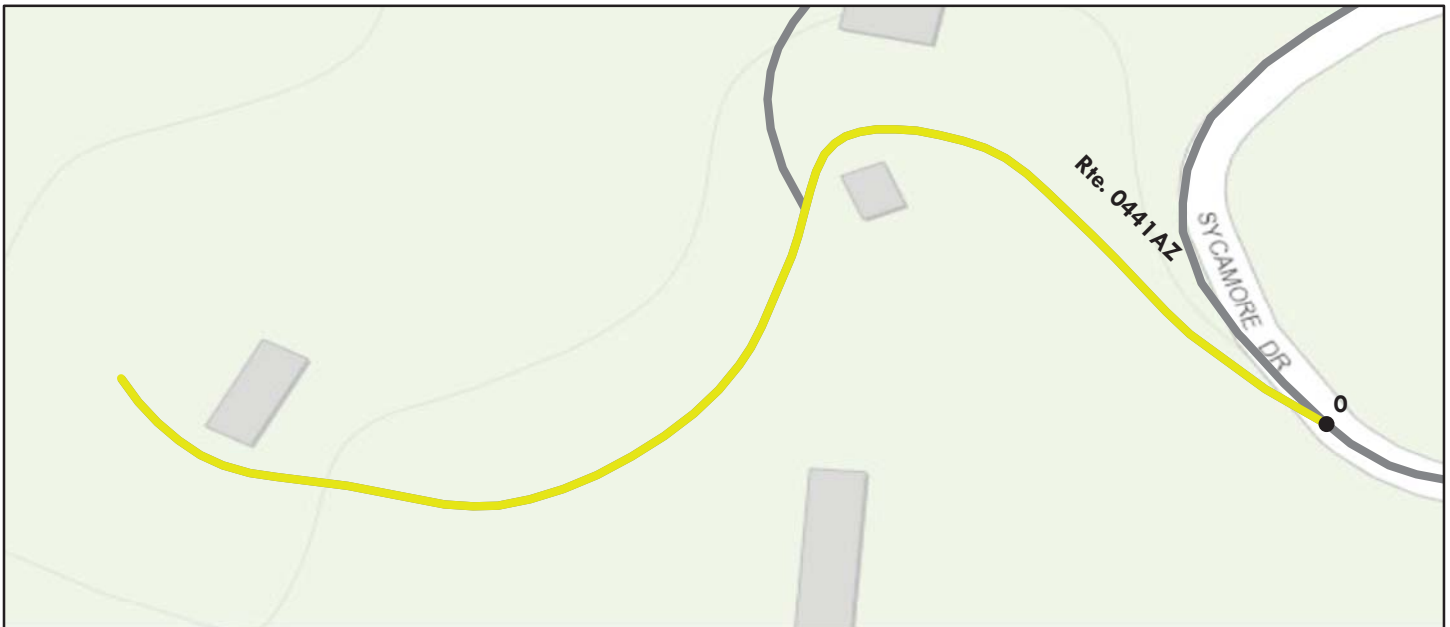
ROUTE 0441AZ: SYCAMORE LOWER MAINTENANCE ROAD A

Route Condition Legend – Pavement Condition Rating (PCR)						
Poor (0 - 60)	Fair (61- 84)	Good (85 - 94)	Excellent (95 - 100)	Not Rated		
See Appendix for definitions and formulas						
Inspection Date: 5/26/2015	Beginning Section MP	0				
Paved Length (Miles): 0.11	Section Length (MI)	0.11				
Surface Type: ASPHALT	Route Summary					
Roadway Condition Information						
Pavement Condition Rating (PCR)	81	81				
Surface Condition Rating (SCR)	81	81				
Roughness Condition Index (RCI)	N/A	N/A				
Distress Index Values						
Structural Crack Index	100	100				
Alligator Crack Index	100	100				
Longitudinal Crack Index	100	100				
Transverse Cracking Index	100	100				
Patching Index	99	99				
Rutting Index	81	81				
International Roughness Index (IRI)	N/A	N/A				
Lane & Width Information						
Number of Lanes	1	1				
Paved Width (ft)	10	10				
Lane Width (ft)	10	10

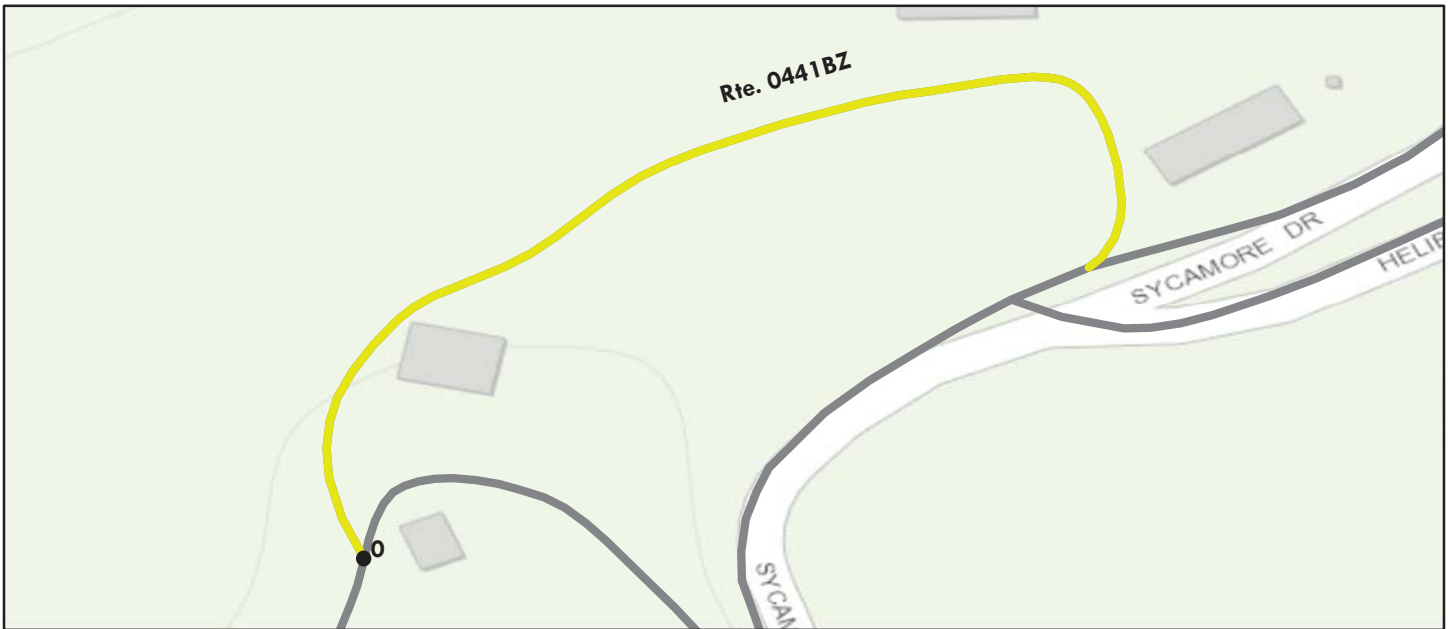
ROUTE 0441BZ: SYCAMORE LOWER MAINTENANCE ROAD B

Inspection Date: 5/26/2015	Beginning Section MP	0				
Paved Length (Miles): 0.09	Section Length (MI)	0.09				
Surface Type: ASPHALT	Route Summary					
Roadway Condition Information						
Pavement Condition Rating (PCR)	74	74				
Surface Condition Rating (SCR)	74	74				
Roughness Condition Index (RCI)	N/A	N/A				
Distress Index Values						
Structural Crack Index	98	98				
Alligator Crack Index	100	100				
Longitudinal Crack Index	98	98				
Transverse Cracking Index	100	100				
Patching Index	100	100				
Rutting Index	74	74				
International Roughness Index (IRI)	N/A	N/A				
Lane & Width Information						
Number of Lanes	1	1				
Paved Width (ft)	9.8	9.8				
Lane Width (ft)	9.8	9.8
