Road Inventory and Condition Assessment of Paved Routes Sequoia National Park

**Federal Lands Highway
Road Inventory Program**

Federal Highway Administration
Eastern Federal Lands Highway Division
Road Inventory Program (RIP)

Report Date: January 2016

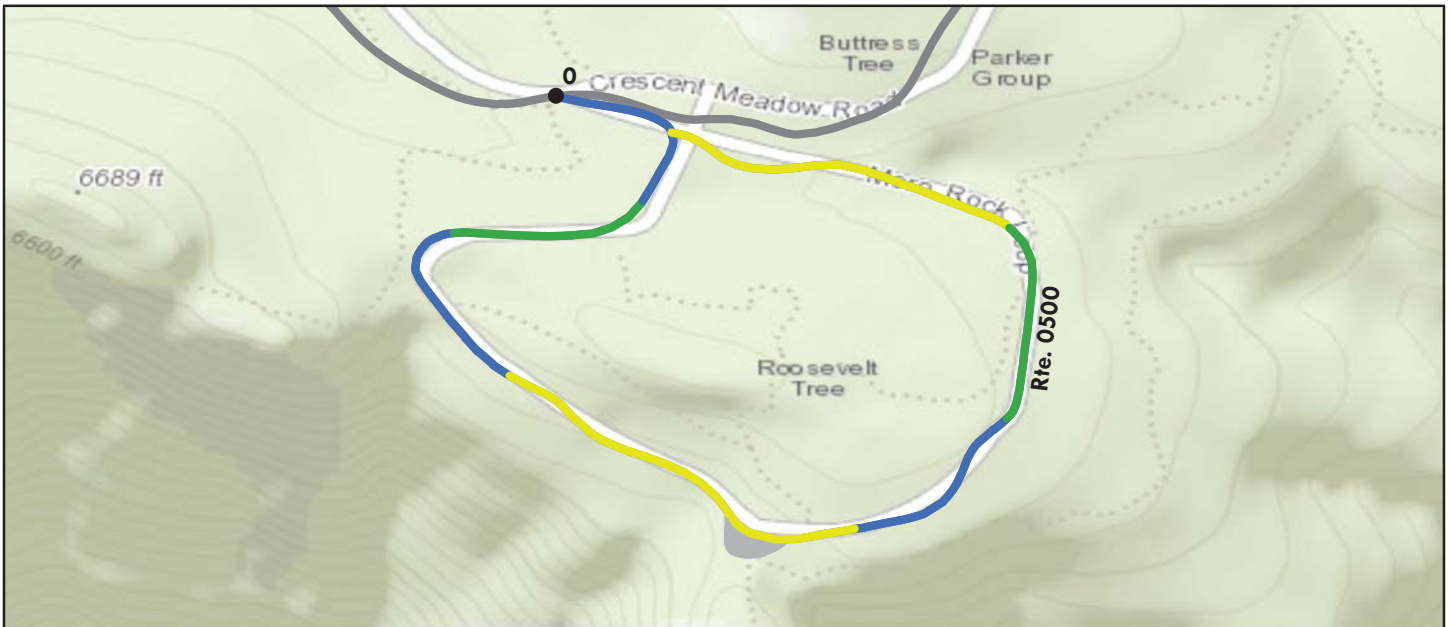
ROUTE 0500: MORO ROCK LOOP ROAD

Route Condition Legend – Pavement Condition Rating (PCR)						
Poor (0 - 60)	Fair (61- 84)	Good (85 - 94)	Excellent (95 - 100)	Not Rated		
See Appendix for definitions and formulas						
Inspection Date: 5/26/2015	Beginning Section MP	0				
Paved Length (Miles): 0.88	Section Length (MI)	0.88				
Surface Type: ASPHALT	Route Summary					
Roadway Condition Information						
Pavement Condition Rating (PCR)	82	82				
Surface Condition Rating (SCR)	95	95				
Roughness Condition Index (RCI)	63	63				
Distress Index Values						
Structural Crack Index	95	95				
Alligator Crack Index	100	100				
Longitudinal Crack Index	95	95				
Transverse Cracking Index	100	100				
Patching Index	100	100				
Rutting Index	97	97				
International Roughness Index (IRI)	226	226				
Lane & Width Information						
Number of Lanes	1	1				
Paved Width (ft)	19	19				
Lane Width (ft)	19	19

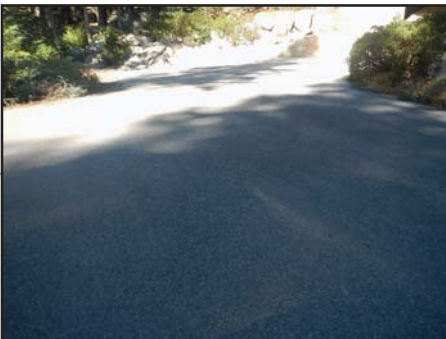
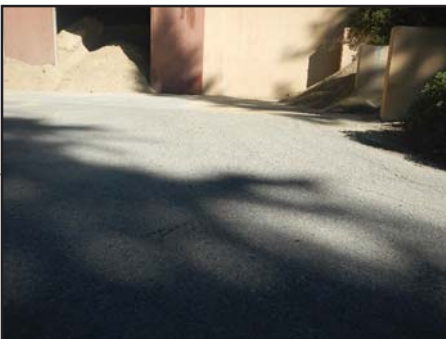
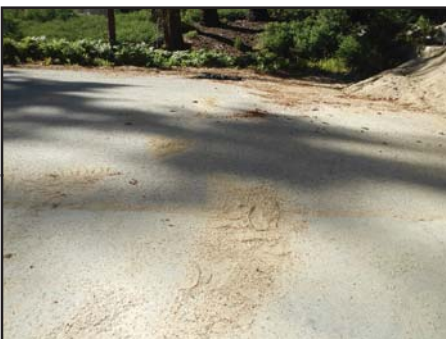
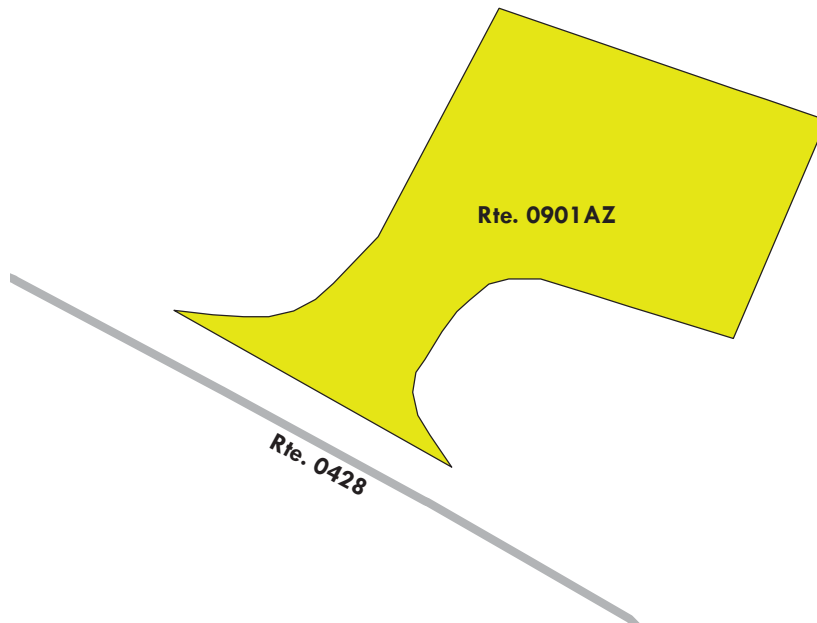
ROUTE 0901AZ: RED FIR MAINTENANCE FACILITY PARKING A

Inspection Date	FMSS Number	User Access	Surface Type
9/24/2014	73927	NONPUBLIC	ASPHALT
Area (Sq. Ft.)	Lane Miles (11' Widths)	Curb Reveal (Inches)	Curb Recommendation
6,262	0.108	NOT APPLICABLE	NOT APPLICABLE
Curb Type		Curb & Gutter Type	
NO CURB		NO CURB AND GUTTER	
Pavement Recommendation		Condition Rating / PCR	
LIGHT 3R TREATMENTS		FAIR / 73

Parking area consists of multiple surface types. 1 part Asphalt at 5,384 square feet; 1 part Concrete at 878 square feet.

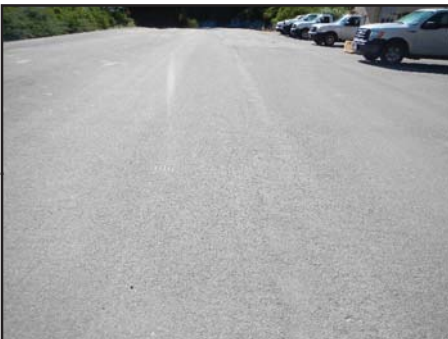
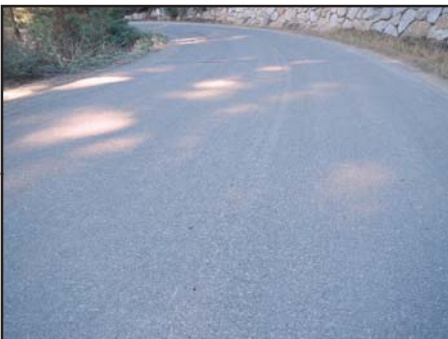
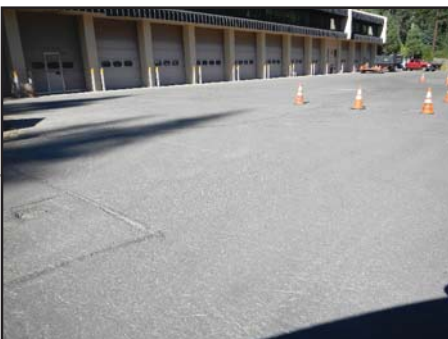
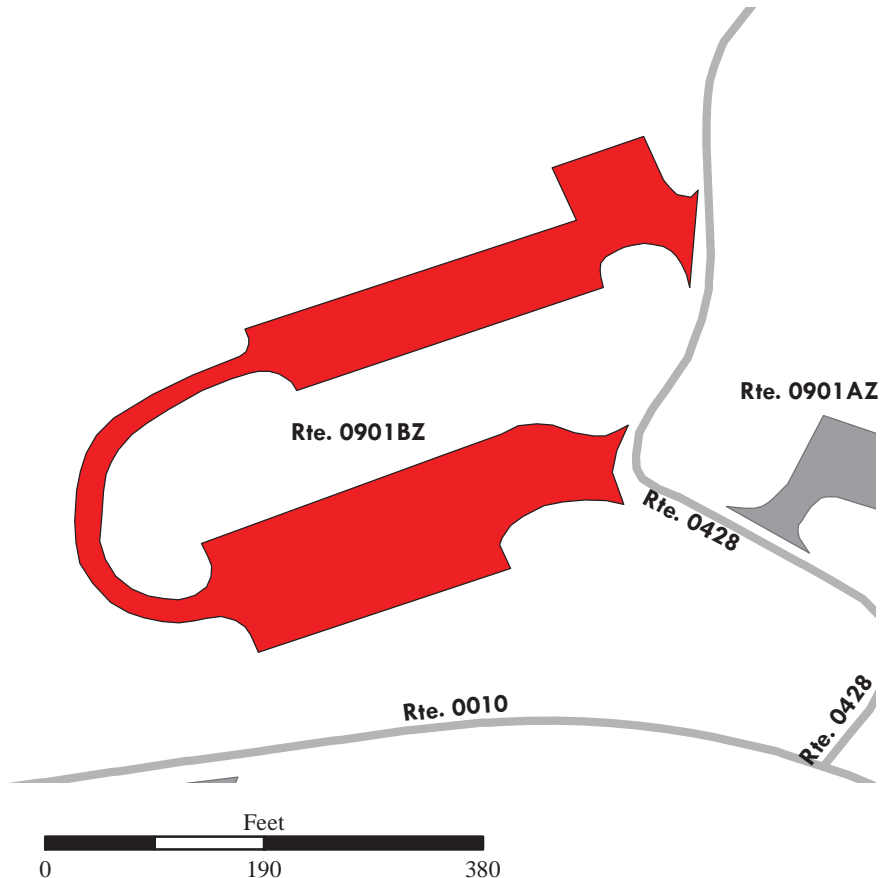
ROUTE 0901BZ: RED FIR MAINTENANCE FACILITY PARKING B

Inspection Date	FMSS Number	User Access	Surface Type
9/24/2014	73927	NONPUBLIC	ASPHALT
Area (Sq. Ft.)	Lane Miles (11' Widths)	Curb Reveal (Inches)	Curb Recommendation
56,246	0.968	NOT APPLICABLE	NOT APPLICABLE
Curb Type		Curb & Gutter Type	
NO CURB		NO CURB AND GUTTER	
Pavement Recommendation		Condition Rating / PCR	
HEAVY 3R TREATMENTS		POOR / 53

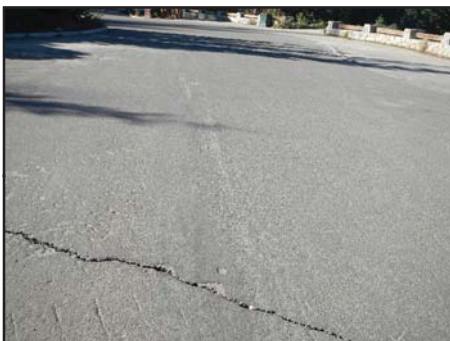
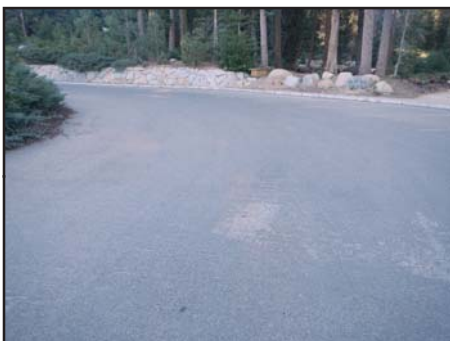
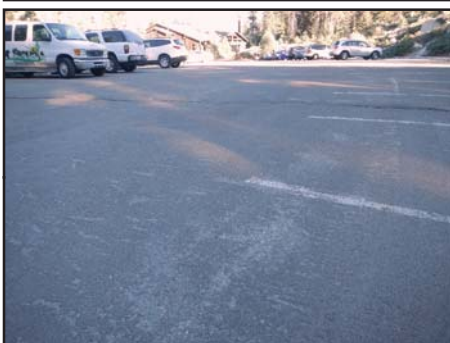
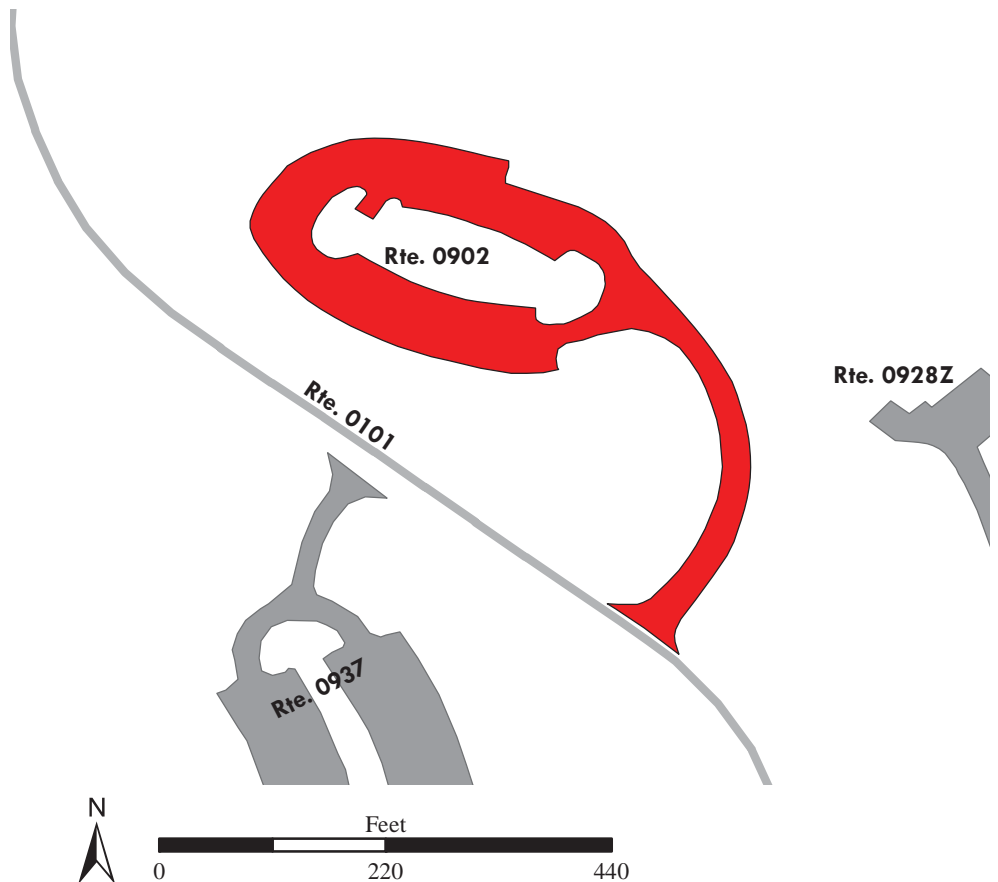
ROUTE 0902: WUKSACHI VILLAGE CENTER ACCESS AND PARKING

Inspection Date	FMSS Number	User Access	Surface Type
9/24/2014	73928	PUBLIC	ASPHALT
Area (Sq. Ft.)	Lane Miles (11' Widths)	Curb Reveal (Inches)	Curb Recommendation
43,000	0.74	5	DO NOTHING
Curb Type		Curb & Gutter Type	
STONE		NO CURB AND GUTTER	
Pavement Recommendation		Condition Rating / PCR	
HEAVY 3R TREATMENTS		POOR / 53

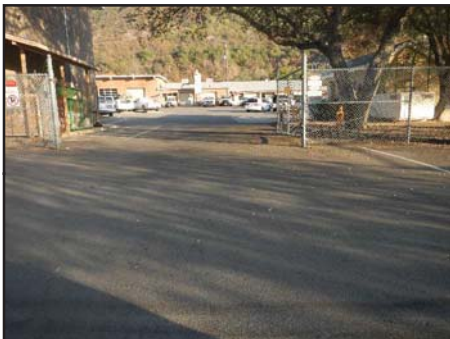
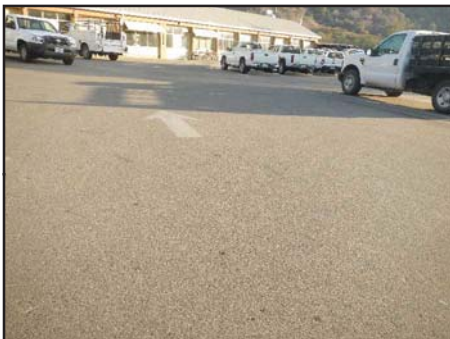
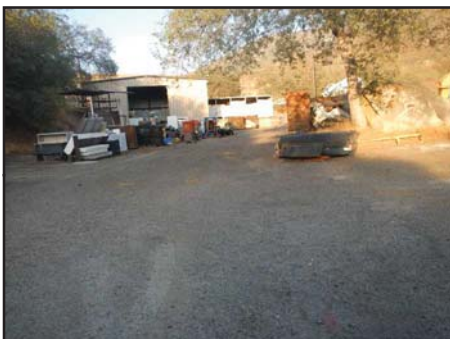
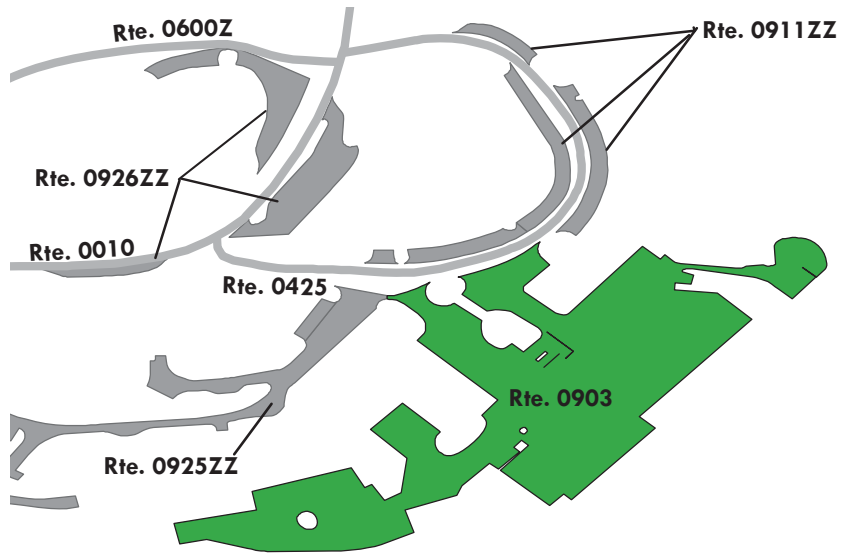
ROUTE 0903: ASH MOUNTAIN MAINTENANCE YARD

Inspection Date	FMSS Number	User Access	Surface Type
9/23/2014	73929	NONPUBLIC	ASPHALT
Area (Sq. Ft.)	Lane Miles (11' Widths)	Curb Reveal (Inches)	Curb Recommendation
95,620	1.646	6	DO NOTHING
Curb Type		Curb & Gutter Type	
CONCRETE AND STONE		CONCRETE	
Pavement Recommendation		Condition Rating / PCR	
PREVENTIVE MAINTENANCE		GOOD / 90

Parking area consists of multiple surface types. 1 part Asphalt at 90,433 square feet; 3 parts Concrete at 5,187 square feet.

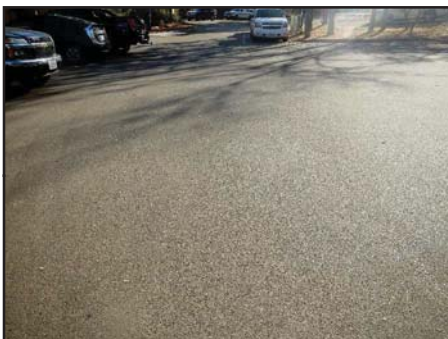
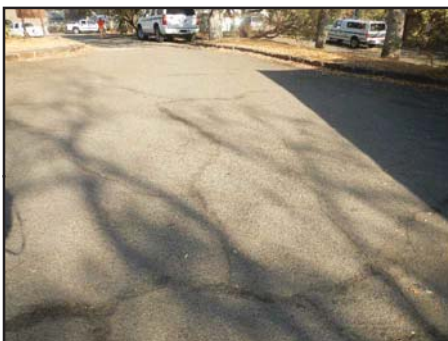
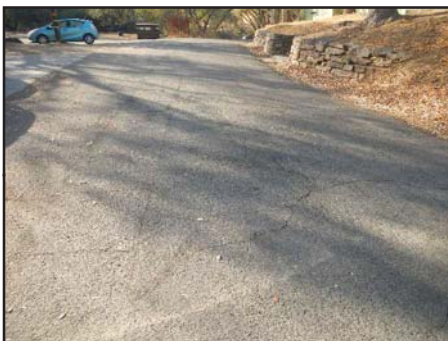
ROUTE 0905: CRYSTAL CAVE PARKING AREA

Inspection Date	FMSS Number	User Access	Surface Type
9/25/2014	73931	PUBLIC	ASPHALT
Area (Sq. Ft.)	Lane Miles (11' Widths)	Curb Reveal (Inches)	Curb Recommendation
42,523	0.732	NOT APPLICABLE	NOT APPLICABLE
Curb Type		Curb & Gutter Type	
NO CURB		NO CURB AND GUTTER	
Pavement Recommendation		Condition Rating / PCR	
LIGHT 3R TREATMENTS		FAIR / 73

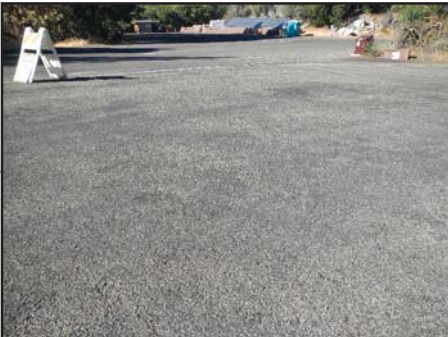
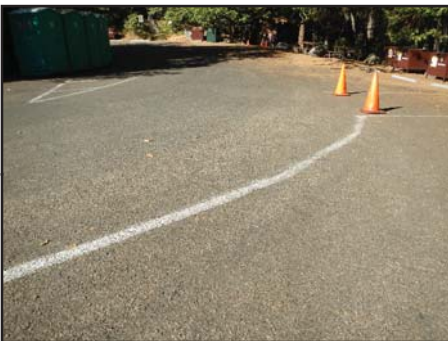
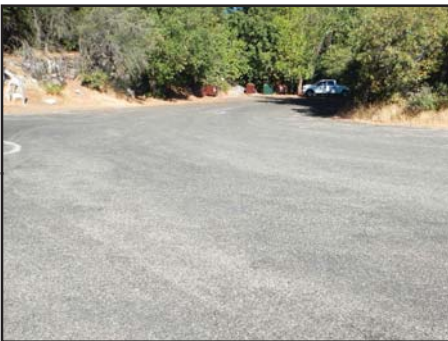
ROUTE 0906: HOSPITAL ROCK PARKING

Inspection Date	FMSS Number	User Access	Surface Type
9/23/2014	73932	PUBLIC	ASPHALT
Area (Sq. Ft.)	Lane Miles (11' Widths)	Curb Reveal (Inches)	Curb Recommendation
21,251	0.366	NOT APPLICABLE	DO NOTHING
Curb Type		Curb & Gutter Type	
NO CURB		CONCRETE	
Pavement Recommendation		Condition Rating / PCR	
PREVENTIVE MAINTENANCE		GOOD / 90

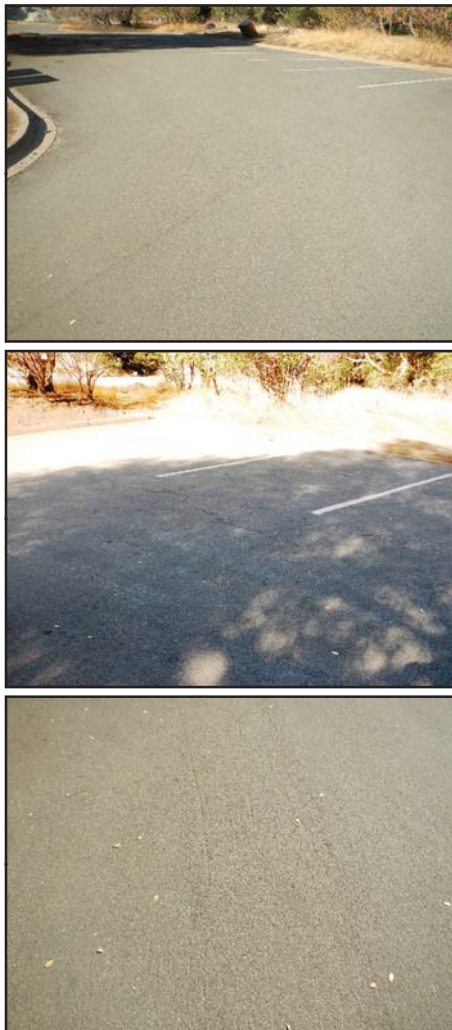
ROUTE 0907: CRESCENT MEADOW PARKING LOOP

Inspection Date	FMSS Number	User Access	Surface Type
9/25/2014	73933	PUBLIC	ASPHALT
Area (Sq. Ft.)	Lane Miles (11' Widths)	Curb Reveal (Inches)	Curb Recommendation
50,113	0.863	NOT APPLICABLE	NOT APPLICABLE
Curb Type		Curb & Gutter Type	
NO CURB		NO CURB AND GUTTER	
Pavement Recommendation		Condition Rating / PCR	
PREVENTIVE MAINTENANCE		GOOD / 90

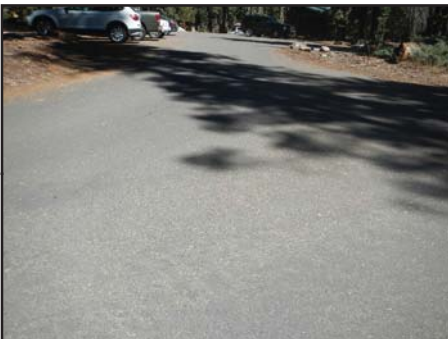
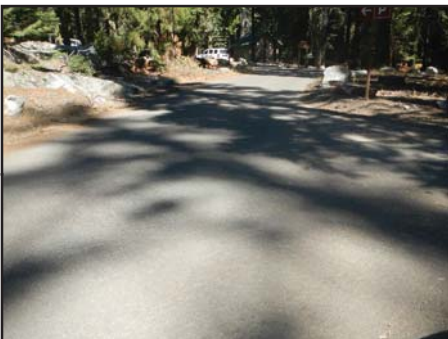
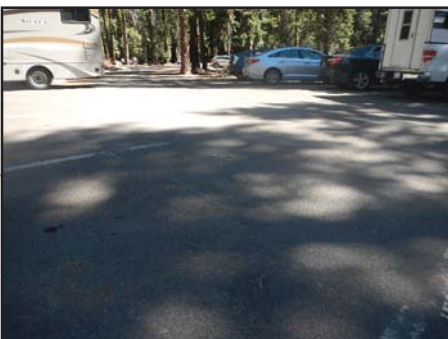
ROUTE 0911ZZ: HEADQUARTERS PARKING AREAS

Inspection Date	FMSS Number	User Access	Surface Type
9/23/2014	73937	PUBLIC	ASPHALT
Area (Sq. Ft.)	Lane Miles (11' Widths)	Condition Rating / PCR	
11,898	0.206	SUMMARY / 90

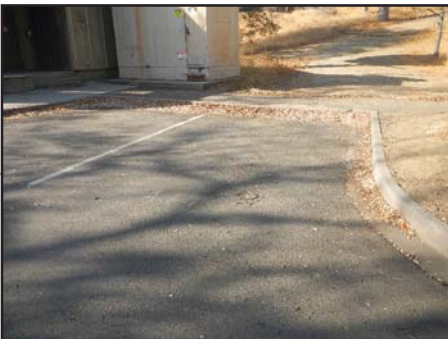
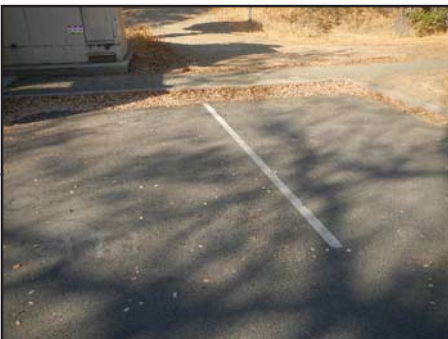
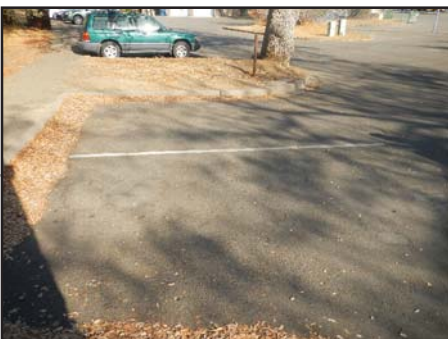
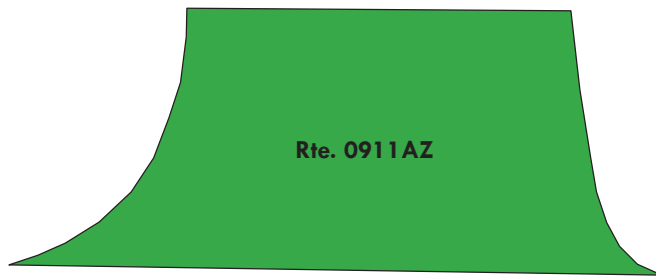
ROUTE 0911BZ: HEADQUARTERS PARKING B

Inspection Date	FMSS Number	User Access	Surface Type
9/23/2014	73937	PUBLIC	ASPHALT
Area (Sq. Ft.)	Lane Miles (11' Widths)	Curb Reveal (Inches)	Curb Recommendation
2,359	0.041	NOT APPLICABLE	DO NOTHING
Curb Type		Curb & Gutter Type	
NO CURB		CONCRETE	
Pavement Recommendation		Condition Rating / PCR	
PREVENTIVE MAINTENANCE		GOOD / 90

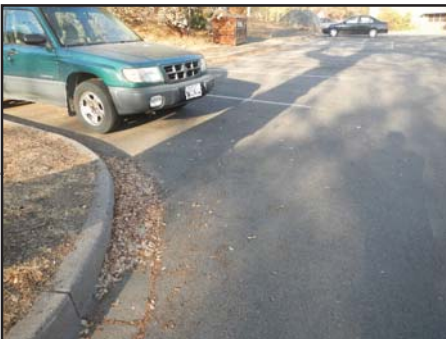
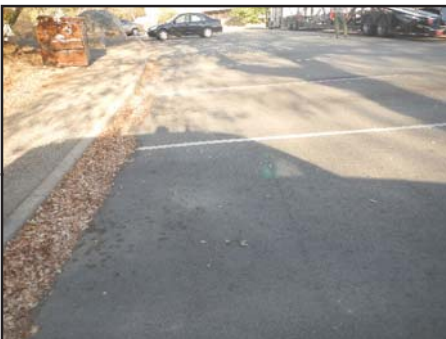
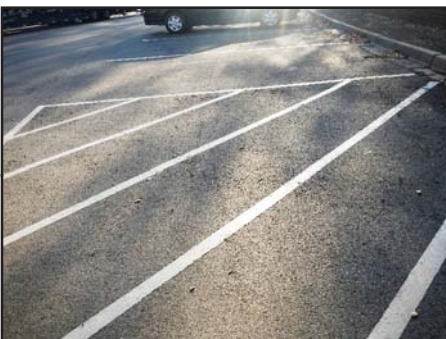
ROUTE 0911CZ: HEADQUARTERS PARKING C

Inspection Date	FMSS Number	User Access	Surface Type
9/23/2014	73937	PUBLIC	ASPHALT
Area (Sq. Ft.)	Lane Miles (11' Widths)	Curb Reveal (Inches)	Curb Recommendation
3,869	0.067	NOT APPLICABLE	DO NOTHING
Curb Type		Curb & Gutter Type	
NO CURB		CONCRETE	
Pavement Recommendation		Condition Rating / PCR	
PREVENTIVE MAINTENANCE		GOOD / 90

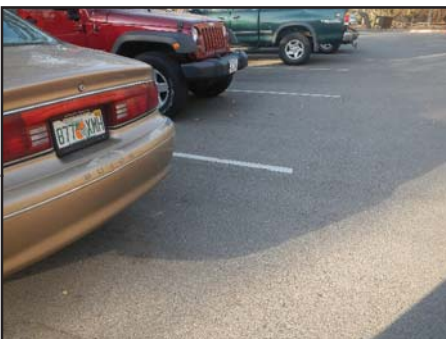
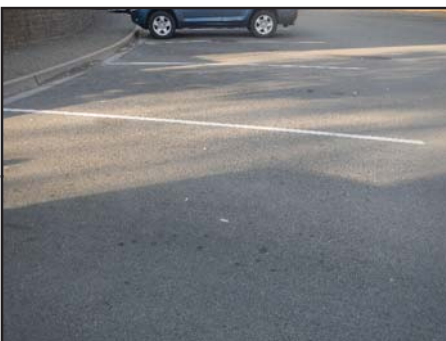
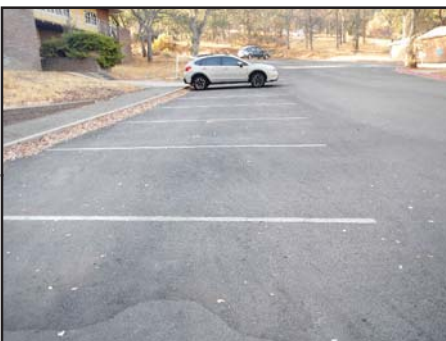
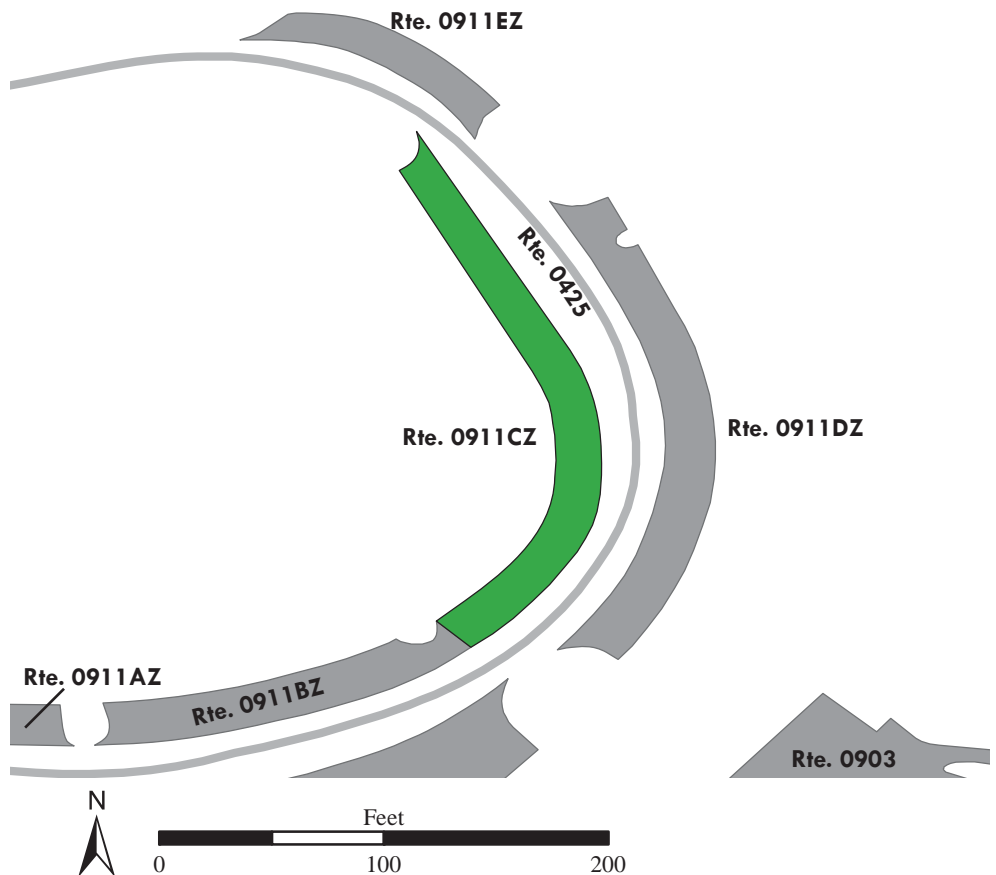
ROUTE 0911DZ: HEADQUARTERS PARKING D

Inspection Date	FMSS Number	User Access	Surface Type
9/23/2014	73937	PUBLIC	ASPHALT
Area (Sq. Ft.)	Lane Miles (11' Widths)	Curb Reveal (Inches)	Curb Recommendation
3,883	0.067	NOT APPLICABLE	DO NOTHING
Curb Type		Curb & Gutter Type	
NO CURB		CONCRETE	
Pavement Recommendation		Condition Rating / PCR	
PREVENTIVE MAINTENANCE		GOOD / 90

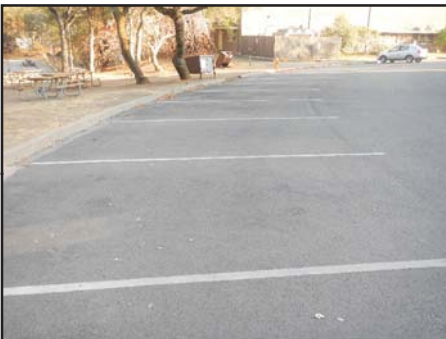
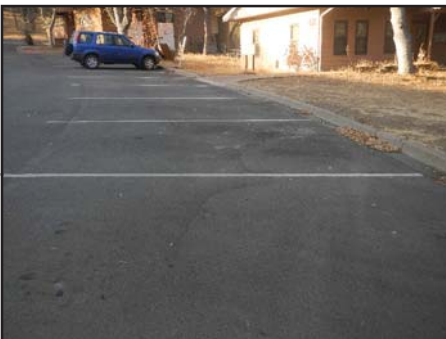
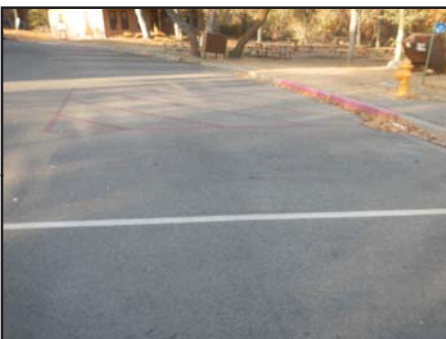
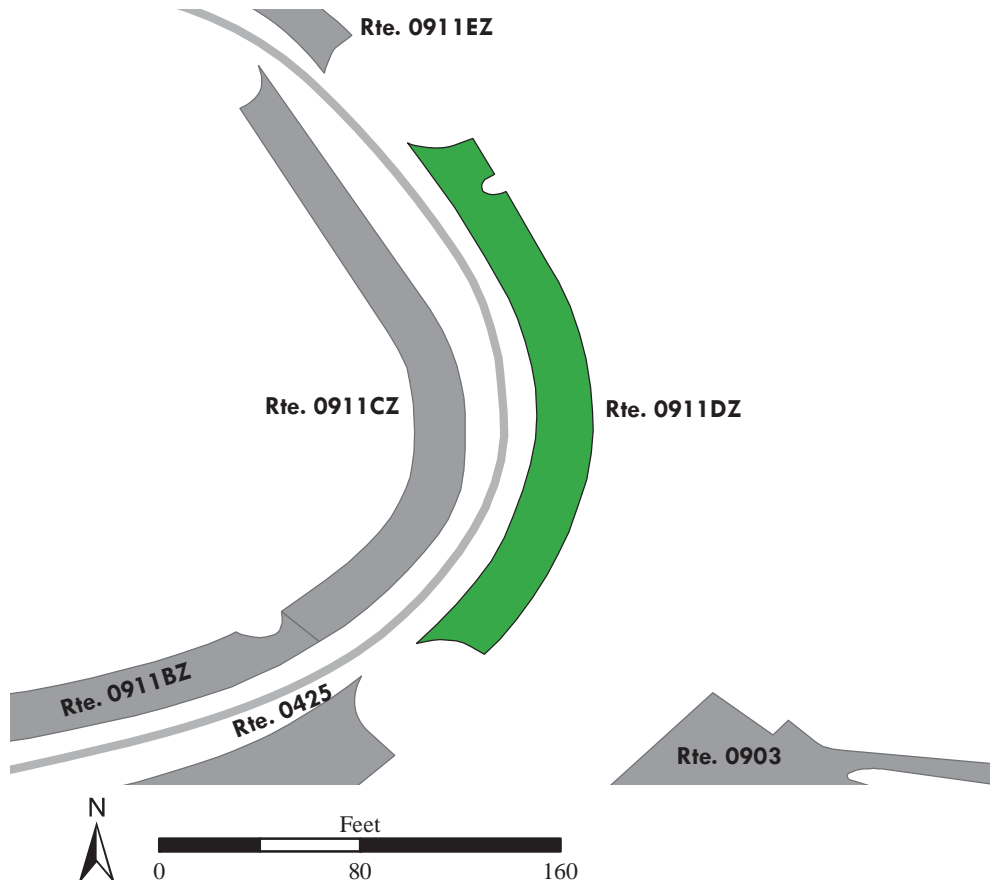
ROUTE 0911EZ: HEADQUARTERS PARKING E

Inspection Date	FMSS Number	User Access	Surface Type
9/23/2014	73937	PUBLIC	ASPHALT
Area (Sq. Ft.)	Lane Miles (11' Widths)	Curb Reveal (Inches)	Curb Recommendation
1,333	0.023	4	LIGHT REPAIR
Curb Type		Curb & Gutter Type	
STONE		NO CURB AND GUTTER	
Pavement Recommendation		Condition Rating / PCR	
PREVENTIVE MAINTENANCE		GOOD / 90

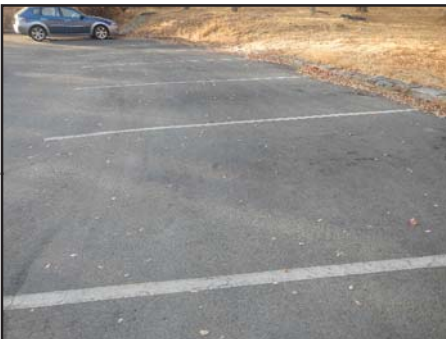
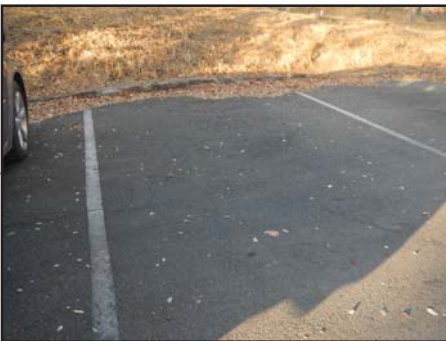
ROUTE 0913: INDIAN HEAD PARKING

Inspection Date	FMSS Number	User Access	Surface Type
9/23/2014	73939	PUBLIC	ASPHALT
Area (Sq. Ft.)	Lane Miles (11' Widths)	Curb Reveal (Inches)	Curb Recommendation
5,344	0.092	5	DO NOTHING
Curb Type		Curb & Gutter Type	
STONE		NO CURB AND GUTTER	
Pavement Recommendation		Condition Rating / PCR	
PREVENTIVE MAINTENANCE		GOOD / 90

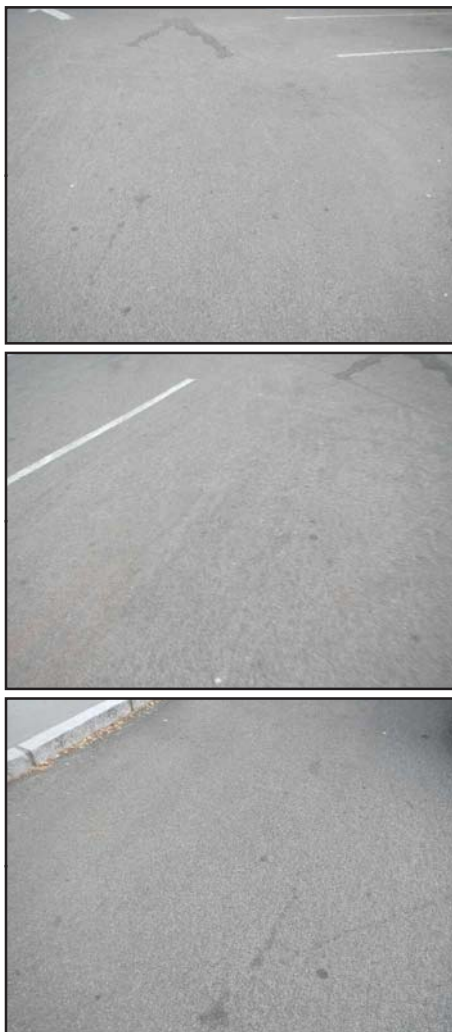
ROUTE 0914: CLOVER CREEK PLANT PARKING

Inspection Date	FMSS Number	User Access	Surface Type
9/24/2014	73940	NONPUBLIC	ASPHALT
Area (Sq. Ft.)	Lane Miles (11' Widths)	Curb Reveal (Inches)	Curb Recommendation
17,488	0.301	5	MODERATE REPAIR
Curb Type		Curb & Gutter Type	
ASPHALT		NO CURB AND GUTTER	
Pavement Recommendation		Condition Rating / PCR	
RECONSTRUCTION		POOR / 30

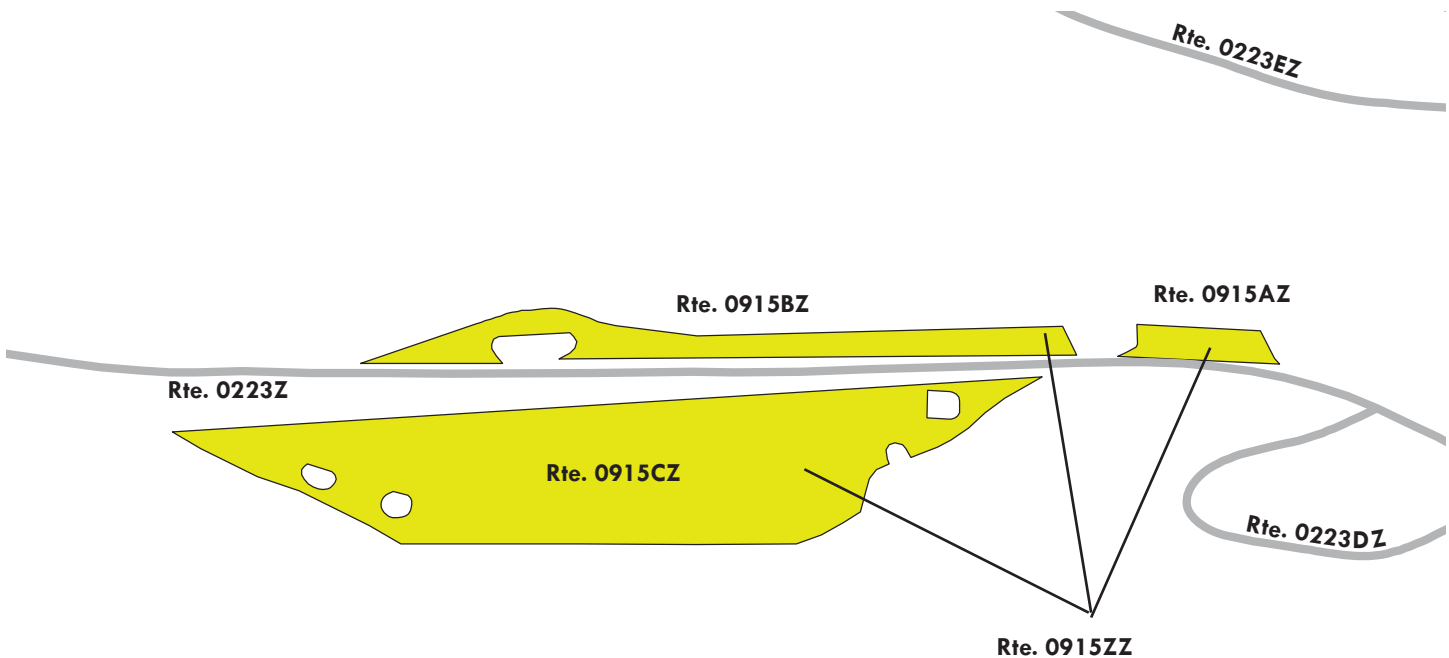
ROUTE 0915ZZ: LODGEPOLE AMPHITHEATER PARKING AREAS

Inspection Date	FMSS Number	User Access	Surface Type
9/25/2014	73941	PUBLIC	ASPHALT
Area (Sq. Ft.)	Lane Miles (11' Widths)	Condition Rating / PCR	
77,395	1.332	SUMMARY / 77

The condition shown on this page reflects the overall route condition and may not reflect individual subcomponent ratings.

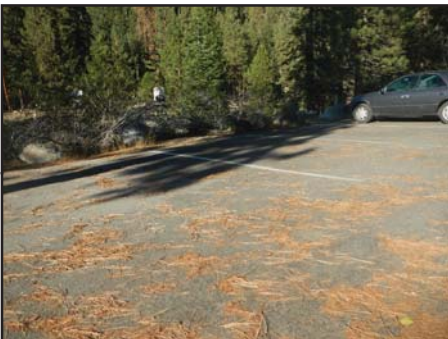
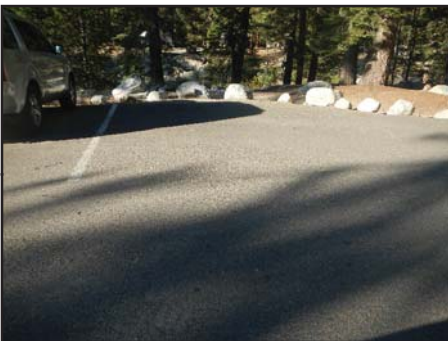
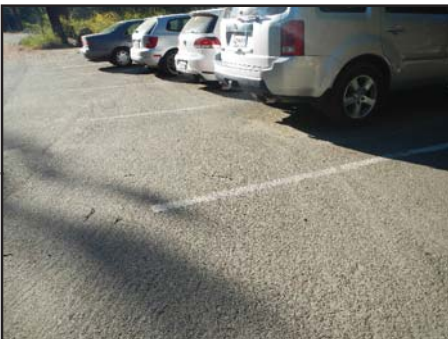
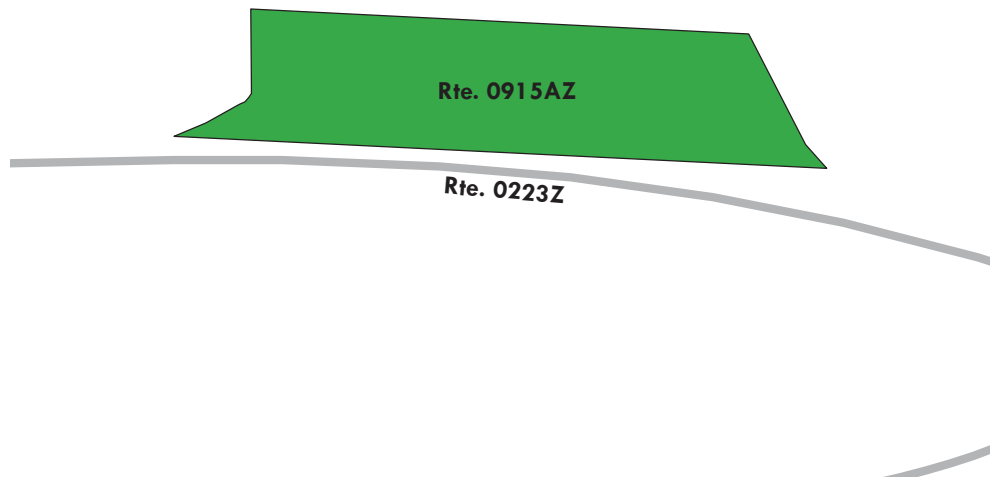
ROUTE 0915AZ: LODGEPOLE AMPHITHEATER PARKING A

Inspection Date	FMSS Number	User Access	Surface Type
9/25/2014	73941	PUBLIC	ASPHALT
Area (Sq. Ft.)	Lane Miles (11' Widths)	Curb Reveal (Inches)	Curb Recommendation
3,133	0.054	NOT APPLICABLE	NOT APPLICABLE
Curb Type		Curb & Gutter Type	
NO CURB		NO CURB AND GUTTER	
Pavement Recommendation		Condition Rating / PCR	
PREVENTIVE MAINTENANCE		GOOD / 90

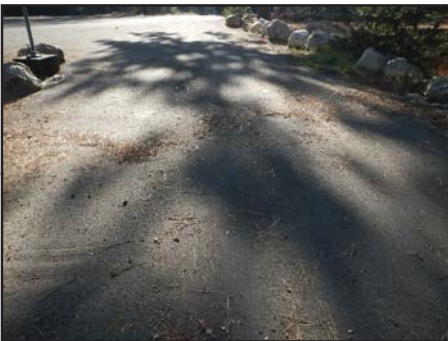
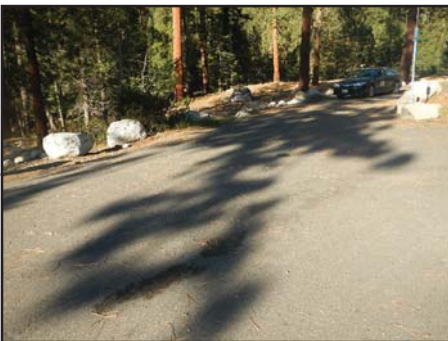
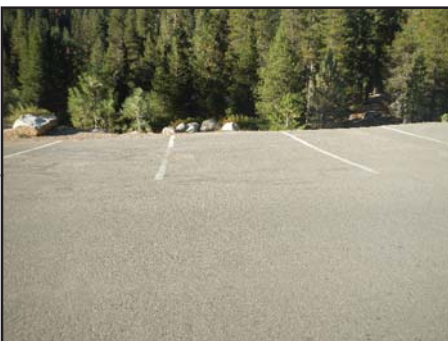
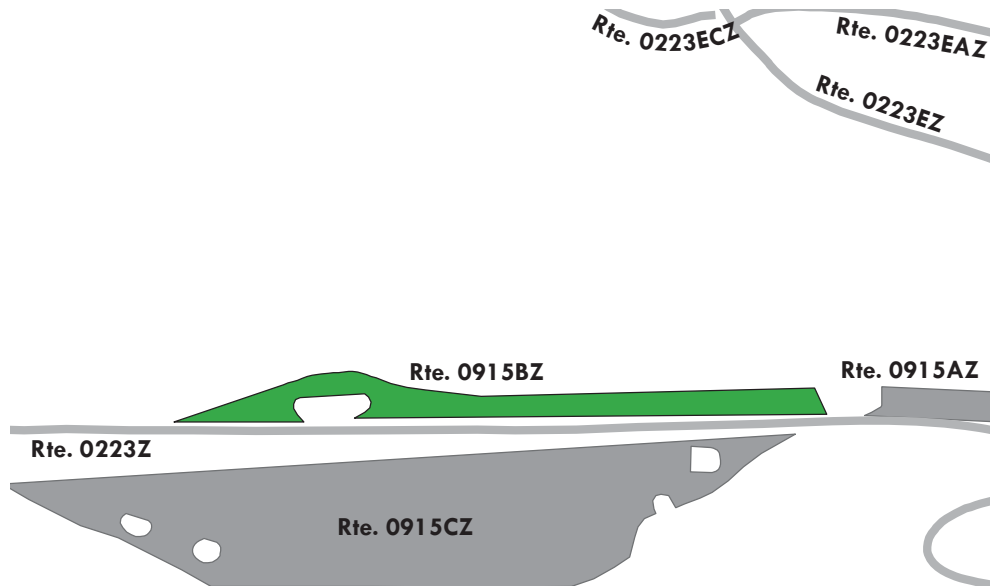
ROUTE 0915BZ: LODGEPOLE AMPHITHEATER PARKING B

Inspection Date	FMSS Number	User Access	Surface Type
9/25/2014	73941	PUBLIC	ASPHALT
Area (Sq. Ft.)	Lane Miles (11' Widths)	Curb Reveal (Inches)	Curb Recommendation
13,205	0.227	NOT APPLICABLE	NOT APPLICABLE
Curb Type		Curb & Gutter Type	
NO CURB		NO CURB AND GUTTER	
Pavement Recommendation		Condition Rating / PCR	
PREVENTIVE MAINTENANCE		GOOD / 90

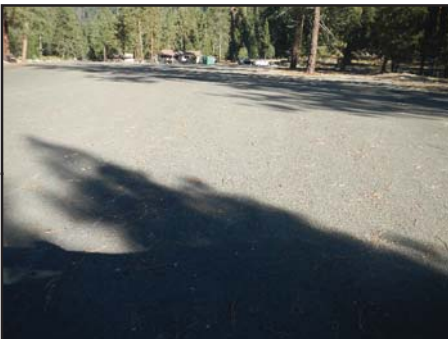
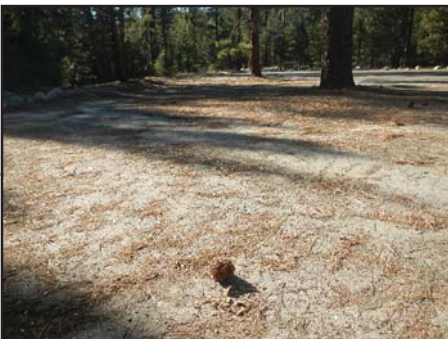
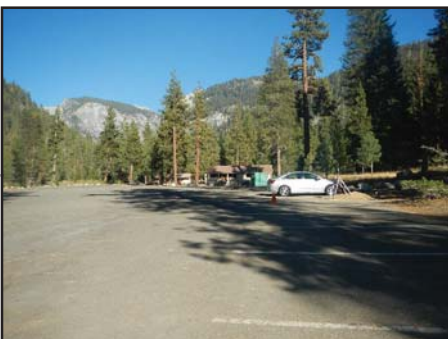
ROUTE 0915CZ: LODGEPOLE AMPHITHEATER PARKING C

Inspection Date	FMSS Number	User Access	Surface Type
9/25/2014	73941	PUBLIC	ASPHALT
Area (Sq. Ft.)	Lane Miles (11' Widths)	Curb Reveal (Inches)	Curb Recommendation
61,057	1.051	NOT APPLICABLE	NOT APPLICABLE
Curb Type		Curb & Gutter Type	
NO CURB		NO CURB AND GUTTER	
Pavement Recommendation		Condition Rating / PCR	
LIGHT 3R TREATMENTS		FAIR / 73

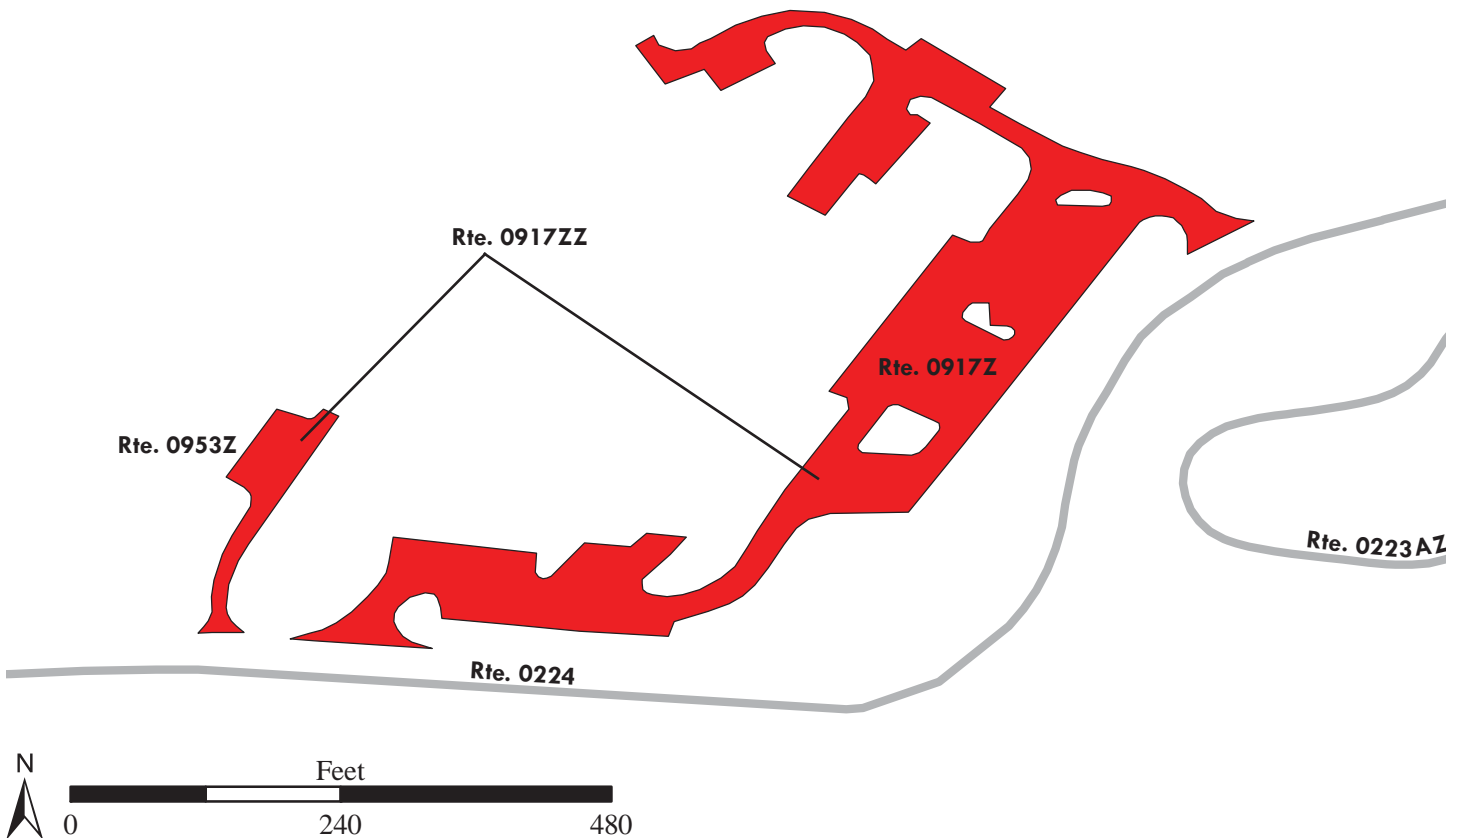
ROUTE 0917ZZ: LODGEPOLE VISITOR CENTER PARKING AREAS

Inspection Date	FMSS Number	User Access	Surface Type
9/25/2014	73943	PUBLIC	ASPHALT
Area (Sq. Ft.)	Lane Miles (11' Widths)	Condition Rating / PCR	
72,081	1.241	SUMMARY / 56

The condition shown on this page reflects the overall route condition and may not reflect individual subcomponent ratings.

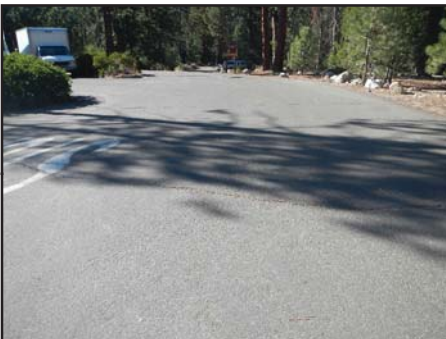
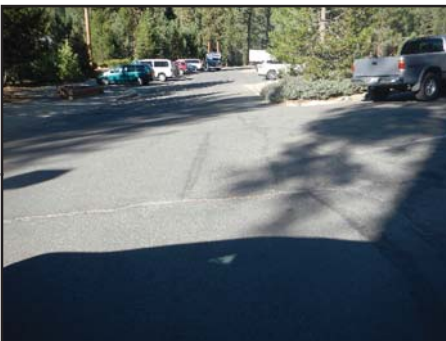
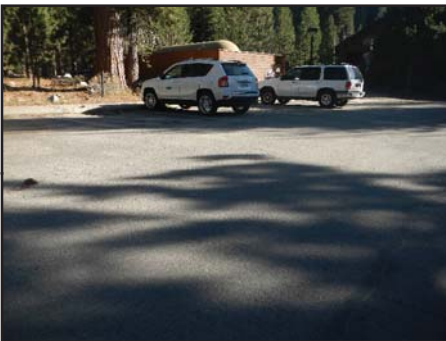
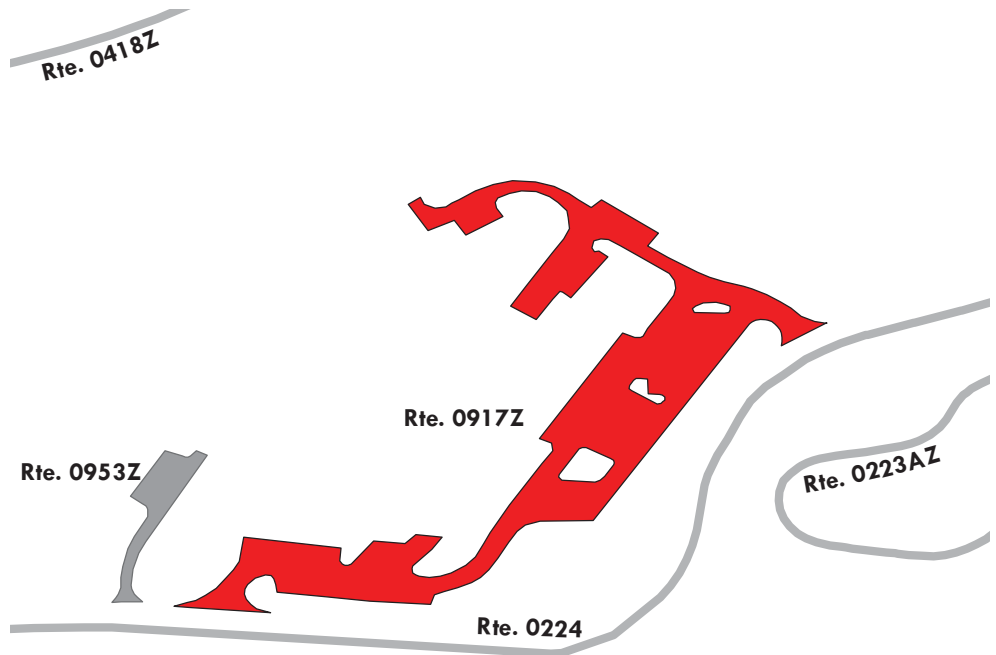
ROUTE 0917Z: LODGEPOLE VISITOR CENTER PARKING

Inspection Date	FMSS Number	User Access	Surface Type
9/25/2014	73943	PUBLIC	ASPHALT
Area (Sq. Ft.)	Lane Miles (11' Widths)	Curb Reveal (Inches)	Curb Recommendation
66,914	1.152	NOT APPLICABLE	MODERATE REPAIR
Curb Type		Curb & Gutter Type	
NO CURB		CONCRETE	
Pavement Recommendation		Condition Rating / PCR	
HEAVY 3R TREATMENTS		POOR / 53

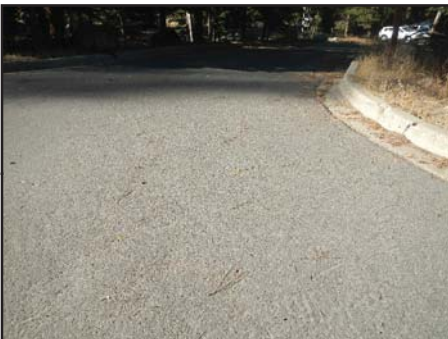
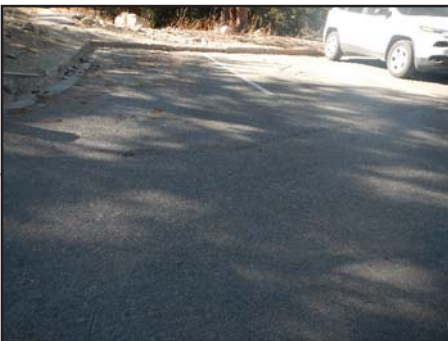
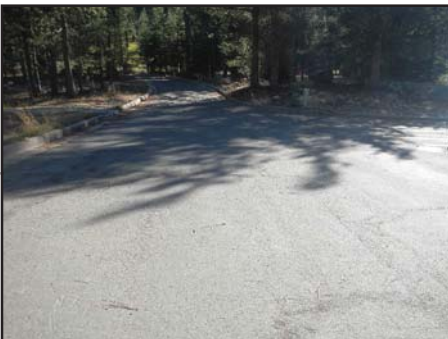
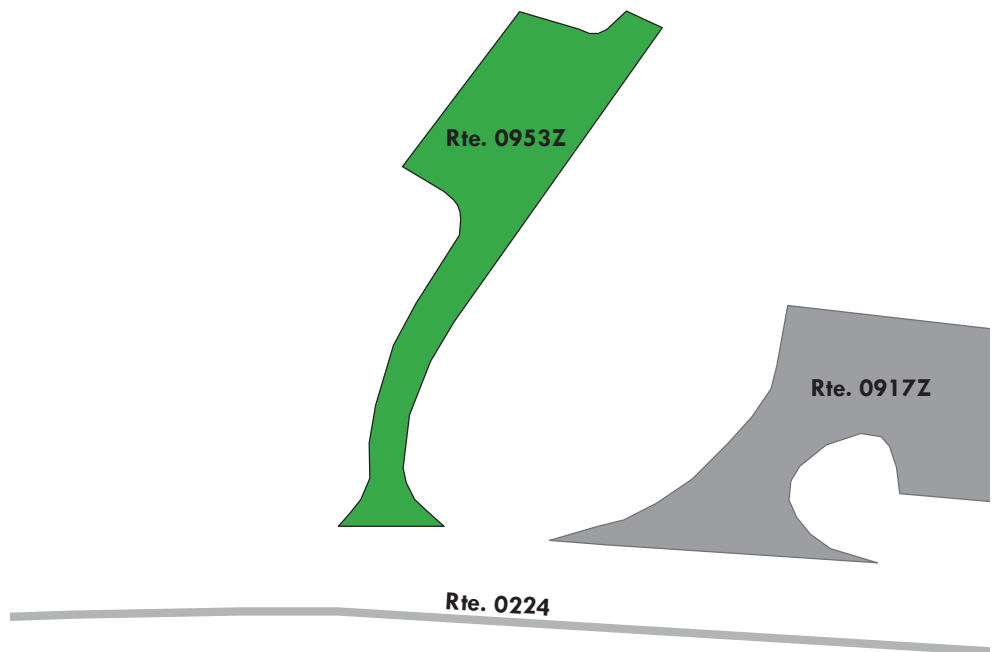
ROUTE 0953Z: LODGEPOLE VISITOR CENTER REAR PARKING

Inspection Date	FMSS Number	User Access	Surface Type
9/25/2014	73943	PUBLIC	ASPHALT
Area (Sq. Ft.)	Lane Miles (11' Widths)	Curb Reveal (Inches)	Curb Recommendation
5,167	0.089	NOT APPLICABLE	DO NOTHING
Curb Type		Curb & Gutter Type	
NO CURB		CONCRETE	
Pavement Recommendation		Condition Rating / PCR	
PREVENTIVE MAINTENANCE		GOOD / 90

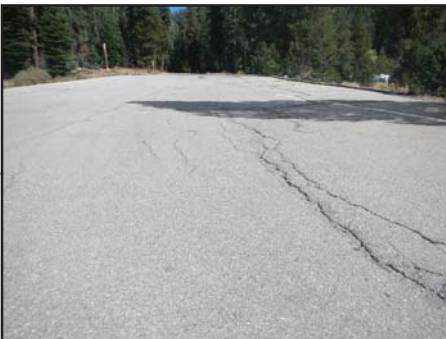
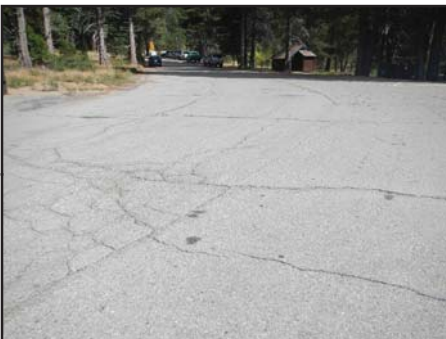
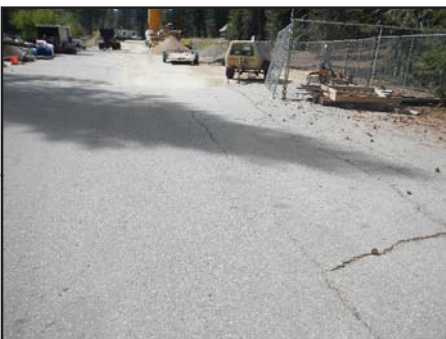
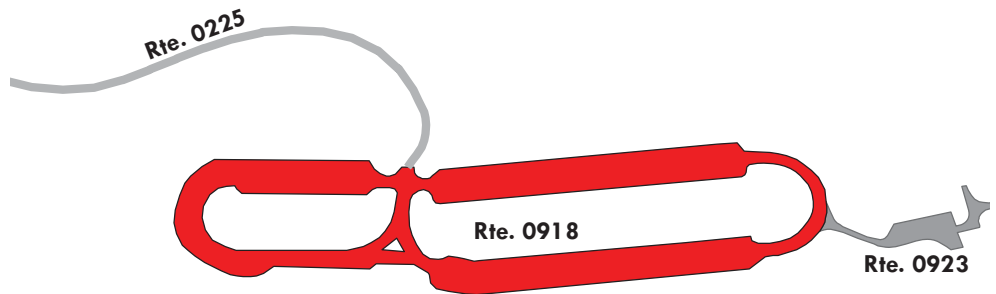
ROUTE 0918: WOLVERTON PARKING AREA

Inspection Date	FMSS Number	User Access	Surface Type
9/25/2014	73944	PUBLIC	ASPHALT
Area (Sq. Ft.)	Lane Miles (11' Widths)	Curb Reveal (Inches)	Curb Recommendation
139,813	2.407	6	LIGHT REPAIR
Curb Type		Curb & Gutter Type	
ASPHALT		NO CURB AND GUTTER	
Pavement Recommendation		Condition Rating / PCR	
HEAVY 3R TREATMENTS		POOR / 53
