Road Inventory and Condition Assessment of Paved Routes Sequoia National Park

**Federal Lands Highway
Road Inventory Program**

Federal Highway Administration
Eastern Federal Lands Highway Division
Road Inventory Program (RIP)

Report Date: January 2016

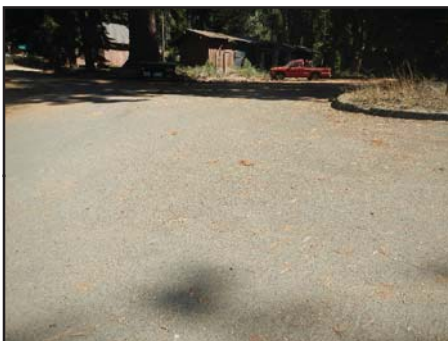
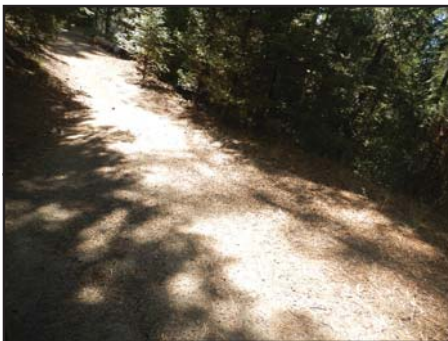
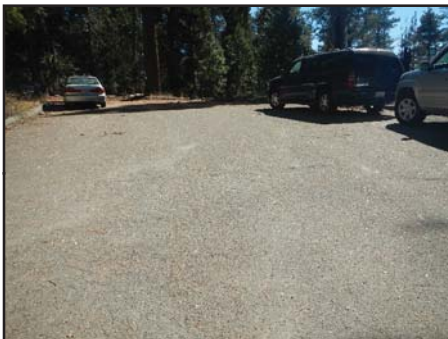
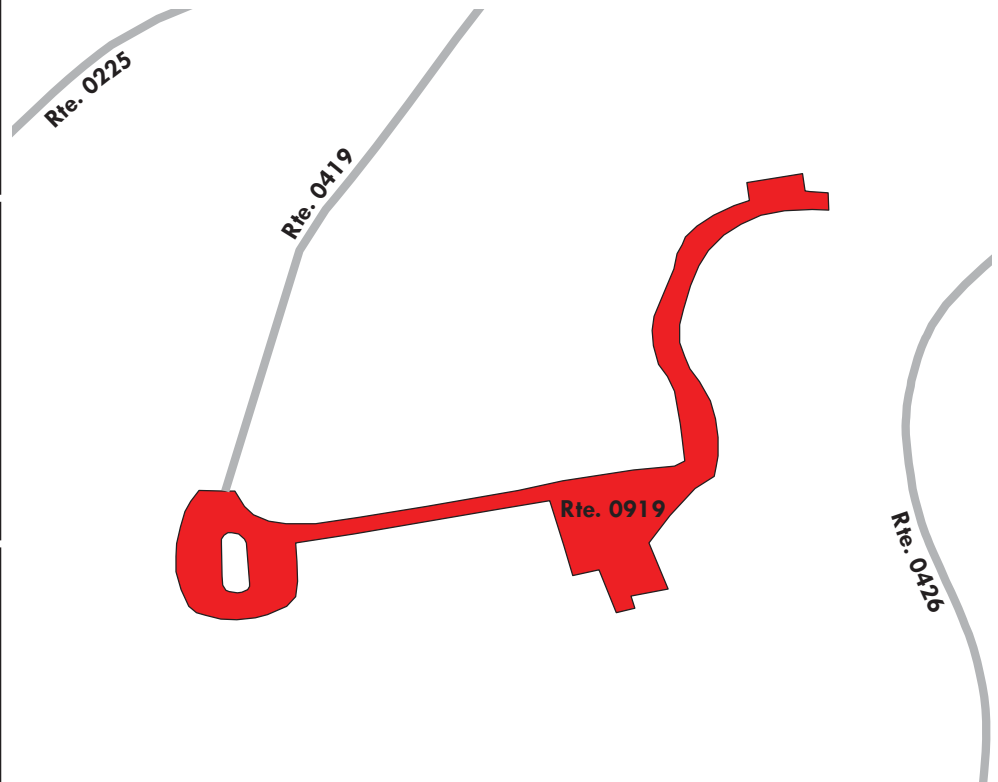
ROUTE 0919: WOLVERTON CORRAL PARKING AREA

Inspection Date	FMSS Number	User Access	Surface Type
9/25/2014	74200	NONPUBLIC	ASPHALT
Area (Sq. Ft.)	Lane Miles (11' Widths)	Curb Reveal (Inches)	Curb Recommendation
33,712	0.58	7	MODERATE REPAIR
Curb Type		Curb & Gutter Type	
ASPHALT		NO CURB AND GUTTER	
Pavement Recommendation		Condition Rating / PCR	
HEAVY 3R TREATMENTS		POOR / 53

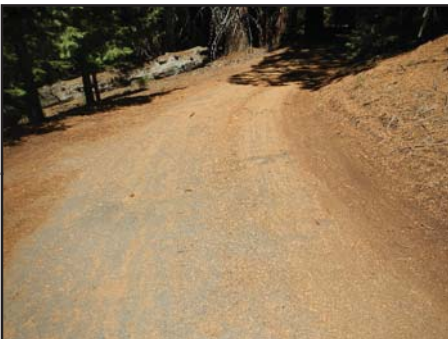
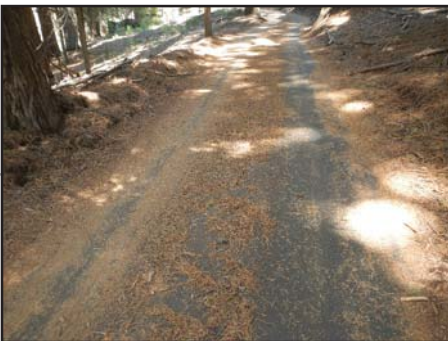
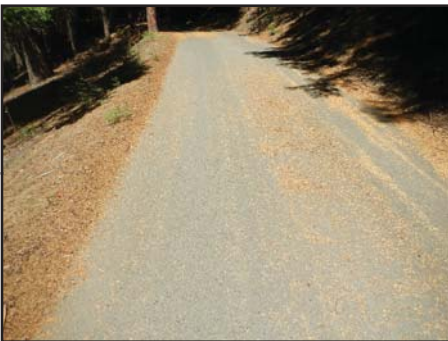
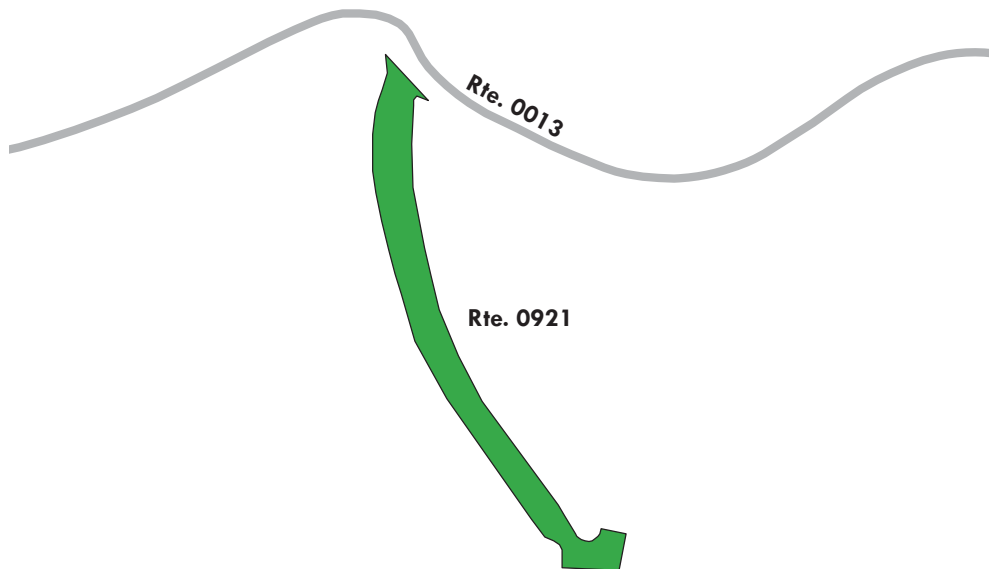
ROUTE 0921: ATWELL MILL MAINTENANCE PARKING

Inspection Date	FMSS Number	User Access	Surface Type
9/23/2014	73946	NONPUBLIC	ASPHALT
Area (Sq. Ft.)	Lane Miles (11' Widths)	Curb Reveal (Inches)	Curb Recommendation
17,560	0.302	NOT APPLICABLE	NOT APPLICABLE
Curb Type		Curb & Gutter Type	
NO CURB		NO CURB AND GUTTER	
Pavement Recommendation		Condition Rating / PCR	
PREVENTIVE MAINTENANCE		GOOD / 90

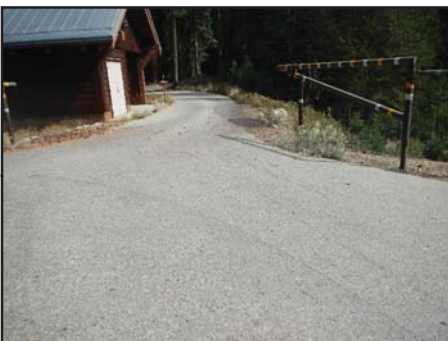
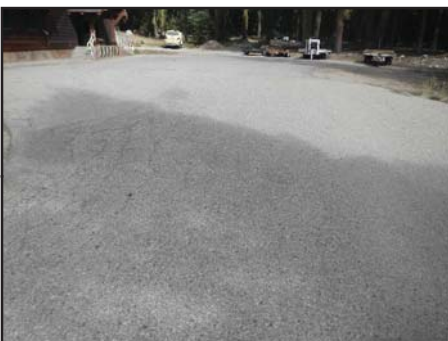
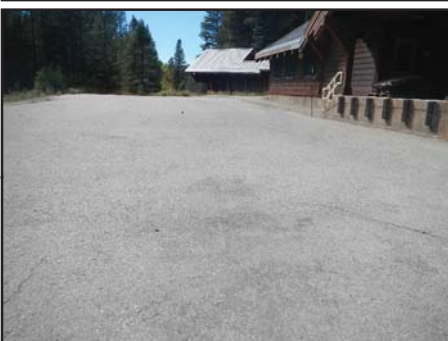
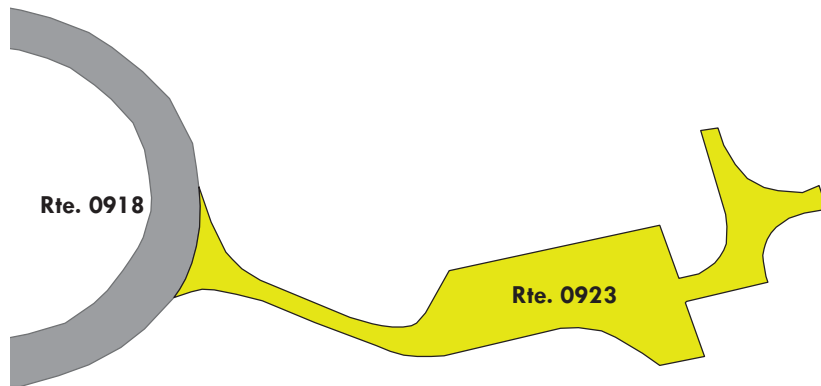
Inspection Date	FMSS Number	User Access	Surface Type
9/25/2014	74152	NONPUBLIC	ASPHALT
Area (Sq. Ft.)	Lane Miles (11' Widths)	Curb Reveal (Inches)	Curb Recommendation
10,554	0.182	NOT APPLICABLE	NOT APPLICABLE
Curb Type		Curb & Gutter Type	
NO CURB		NO CURB AND GUTTER	
Pavement Recommendation		Condition Rating / PCR	
LIGHT 3R TREATMENTS		FAIR / 73

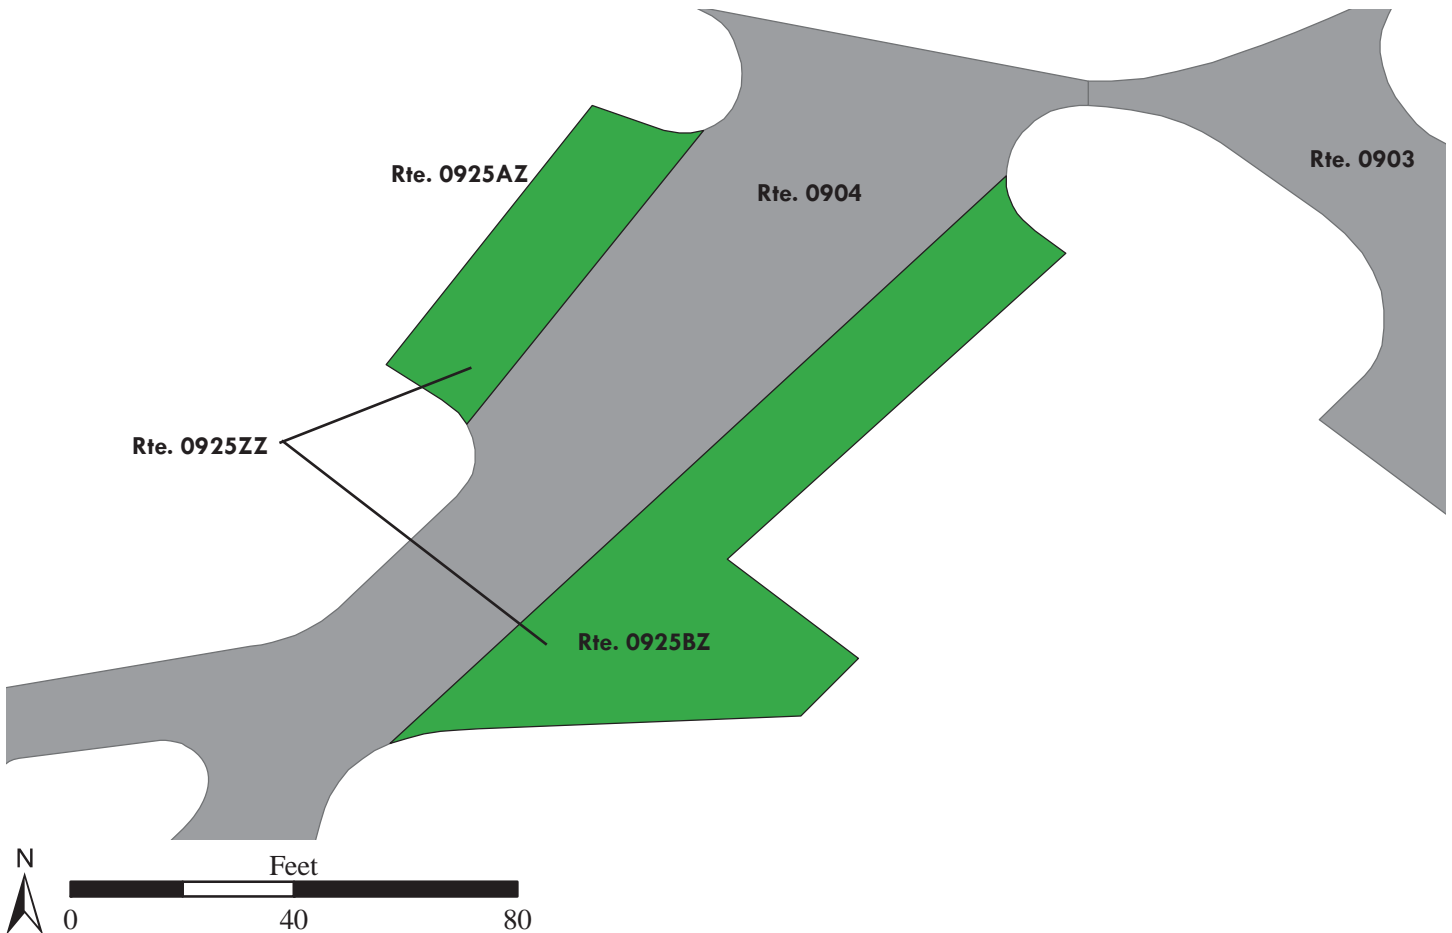
ROUTE 0925ZZ: HEADQUARTERS STATION PARKING AREAS

Inspection Date	FMSS Number	User Access	Surface Type
9/23/2014	74158	NONPUBLIC	ASPHALT
Area (Sq. Ft.)	Lane Miles (11' Widths)	Condition Rating / PCR	
3,434	0.06	SUMMARY / 90

The condition shown on this page reflects the overall route condition and may not reflect individual subcomponent ratings.

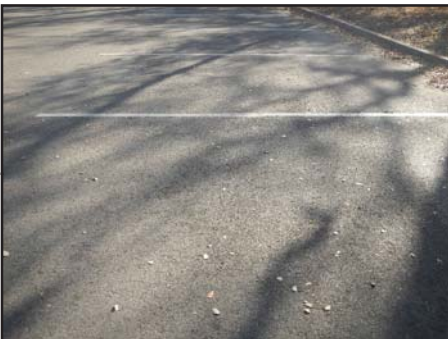
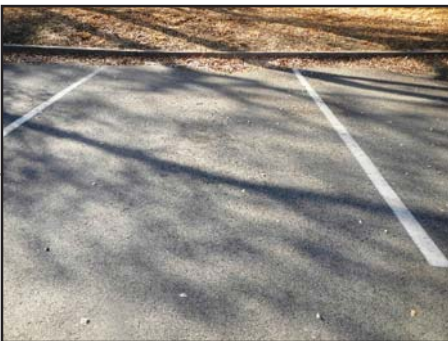
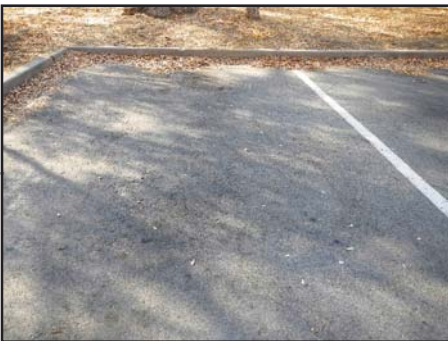
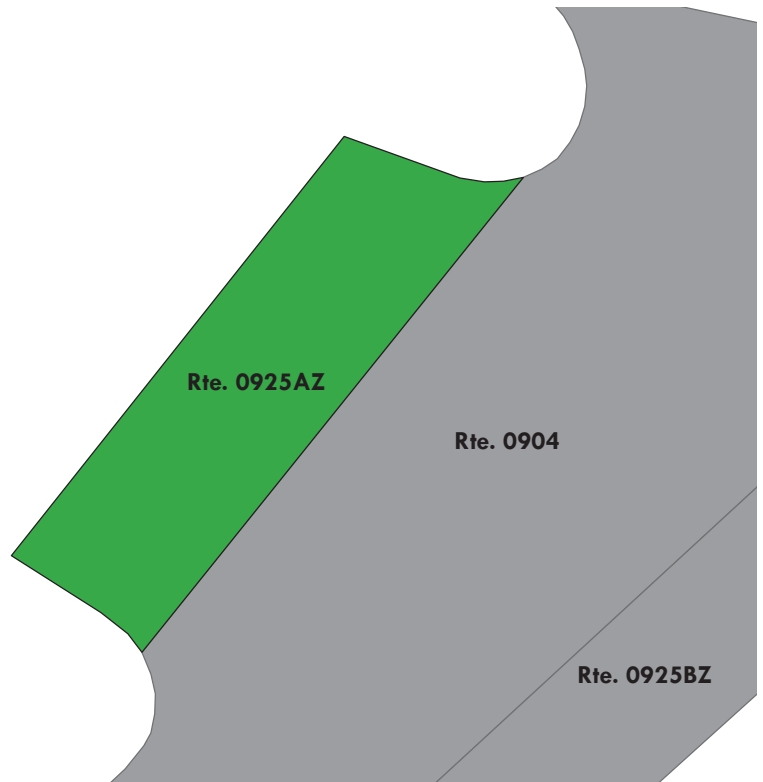
ROUTE 0925AZ: HEADQUARTERS STATION PARKING A

Inspection Date	FMSS Number	User Access	Surface Type
9/23/2014	74158	NONPUBLIC	ASPHALT
Area (Sq. Ft.)	Lane Miles (11' Widths)	Curb Reveal (Inches)	Curb Recommendation
906	0.016	NOT APPLICABLE	DO NOTHING
Curb Type		Curb & Gutter Type	
NO CURB		CONCRETE	
Pavement Recommendation		Condition Rating / PCR	
PREVENTIVE MAINTENANCE		GOOD / 90

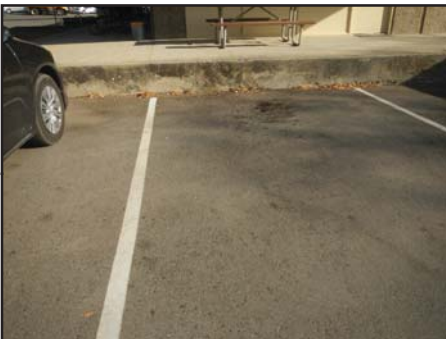
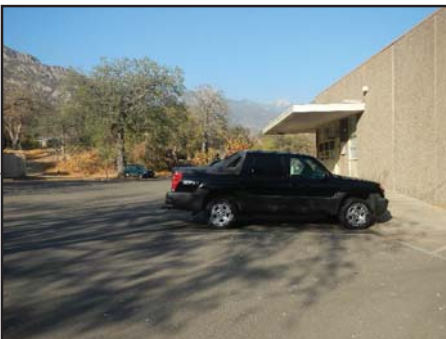
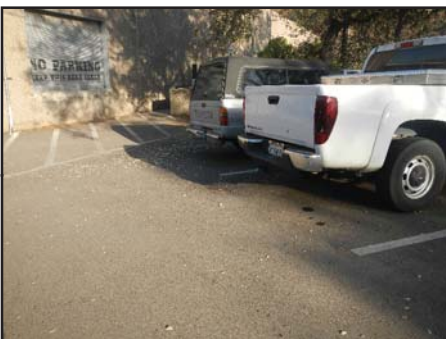
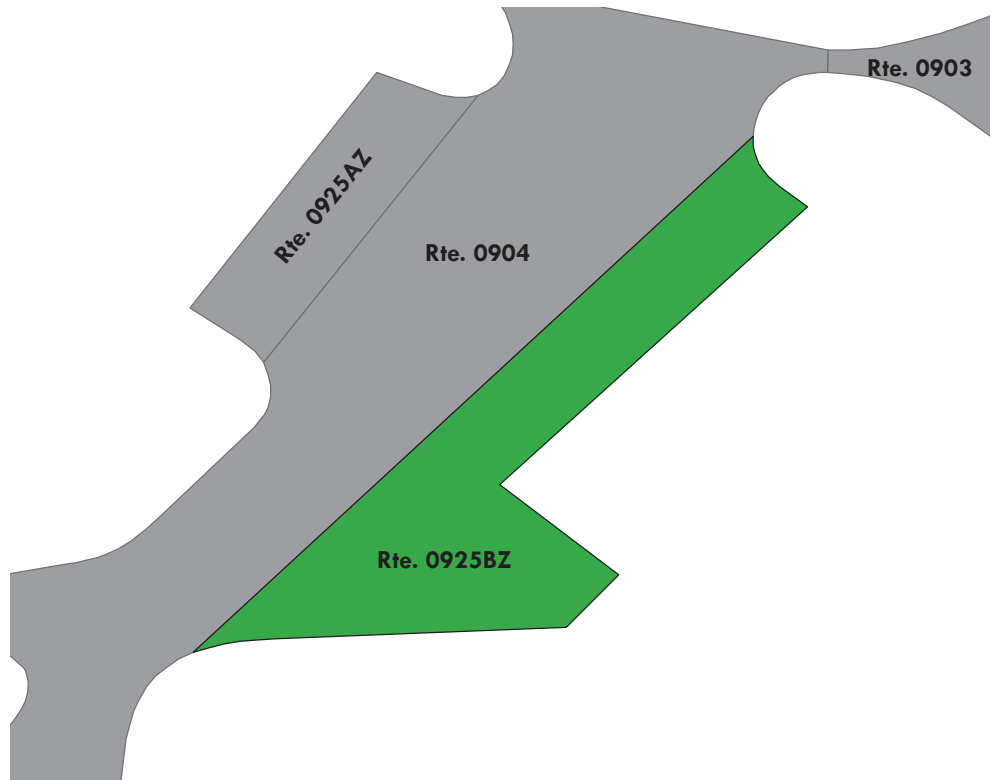
ROUTE 0925BZ: HEADQUARTERS STATION PARKING B

Inspection Date	FMSS Number	User Access	Surface Type
9/23/2014	74158	NONPUBLIC	ASPHALT
Area (Sq. Ft.)	Lane Miles (11' Widths)	Curb Reveal (Inches)	Curb Recommendation
2,528	0.044	NOT APPLICABLE	DO NOTHING
Curb Type		Curb & Gutter Type	
NO CURB		CONCRETE	
Pavement Recommendation		Condition Rating / PCR	
PREVENTIVE MAINTENANCE		GOOD / 90

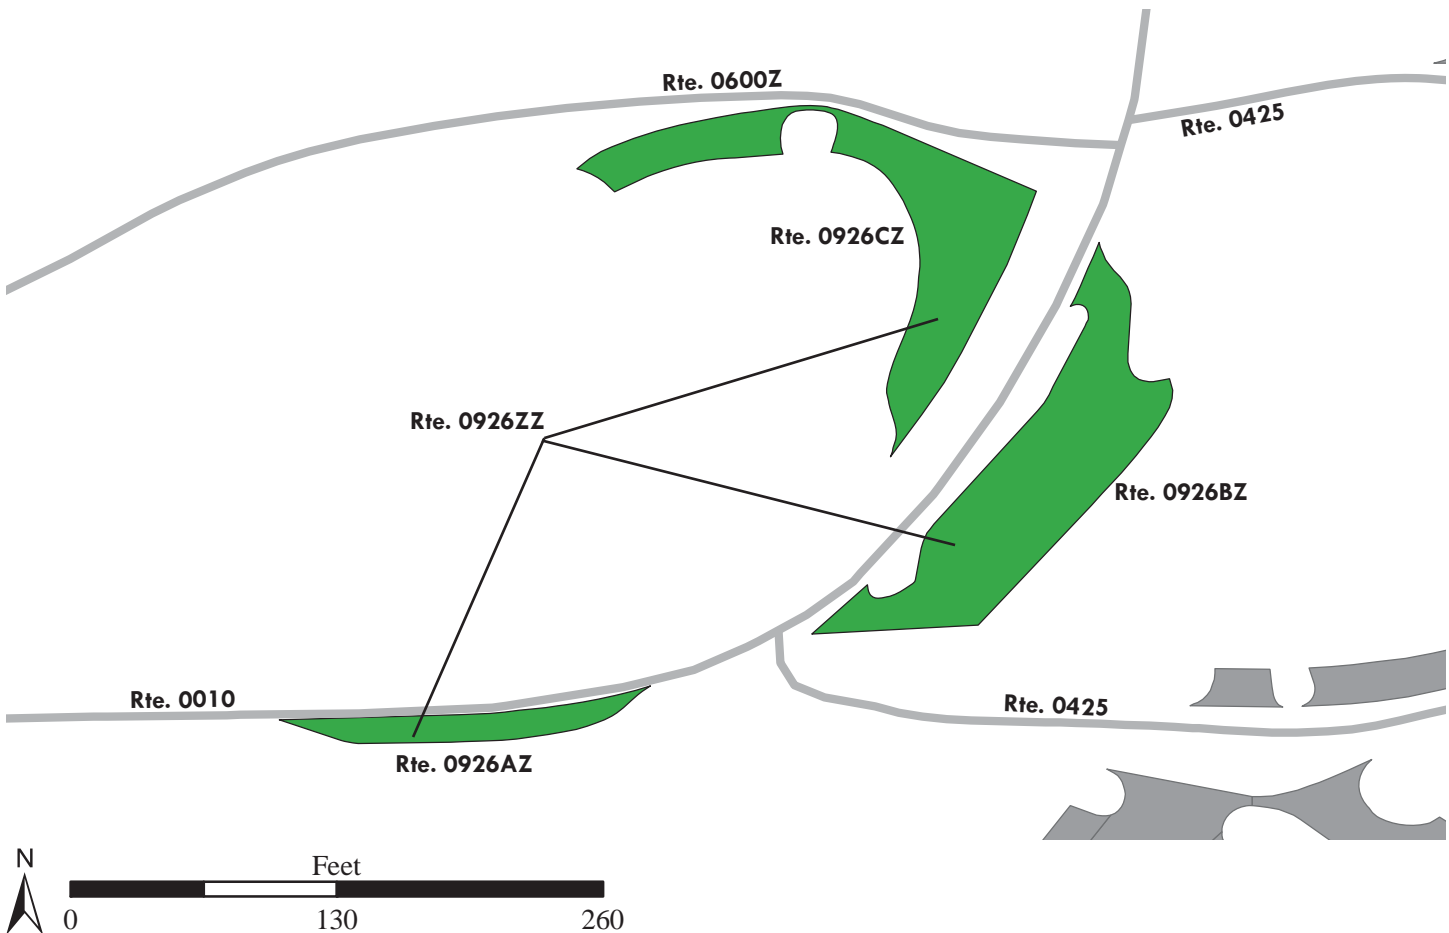
ROUTE 0926ZZ: ASH MOUNTAIN VISITOR CENTER PARKING AREAS

Inspection Date	FMSS Number	User Access	Surface Type
9/23/2014	74163	PUBLIC	ASPHALT
Area (Sq. Ft.)	Lane Miles (11' Widths)	Condition Rating / PCR	
15,571	0.268	SUMMARY / 88

The condition shown on this page reflects the overall route condition and may not reflect individual subcomponent ratings.

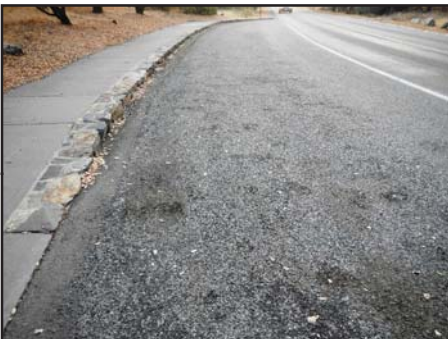
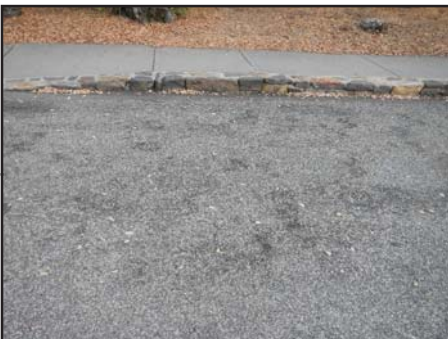
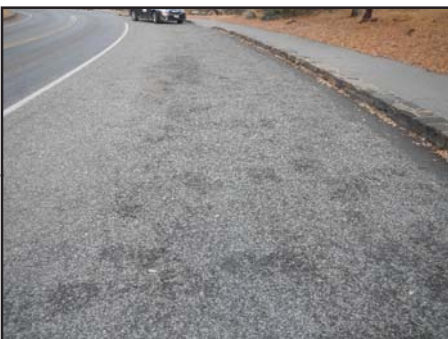
ROUTE 0926AZ: ASH MOUNTAIN VISITOR CENTER PARKING AREA A

Inspection Date	FMSS Number	User Access	Surface Type
9/23/2014	74163	PUBLIC	ASPHALT
Area (Sq. Ft.)	Lane Miles (11' Widths)	Curb Reveal (Inches)	Curb Recommendation
1,577	0.027	6	DO NOTHING
Curb Type		Curb & Gutter Type	
STONE		NO CURB AND GUTTER	
Pavement Recommendation		Condition Rating / PCR	
LIGHT 3R TREATMENTS		FAIR / 73

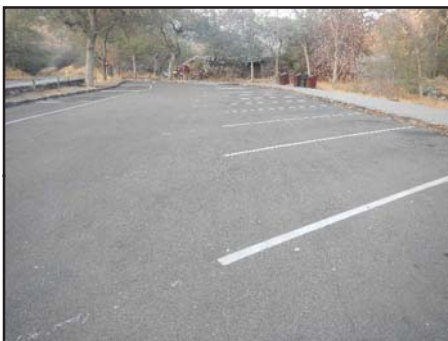
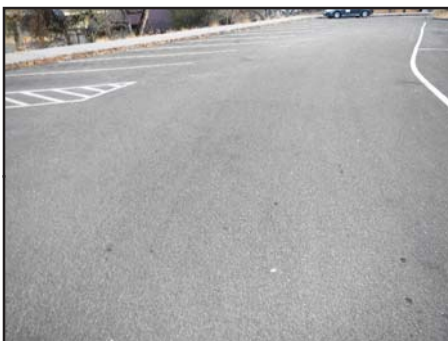
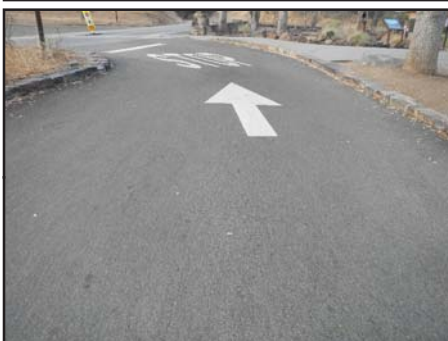
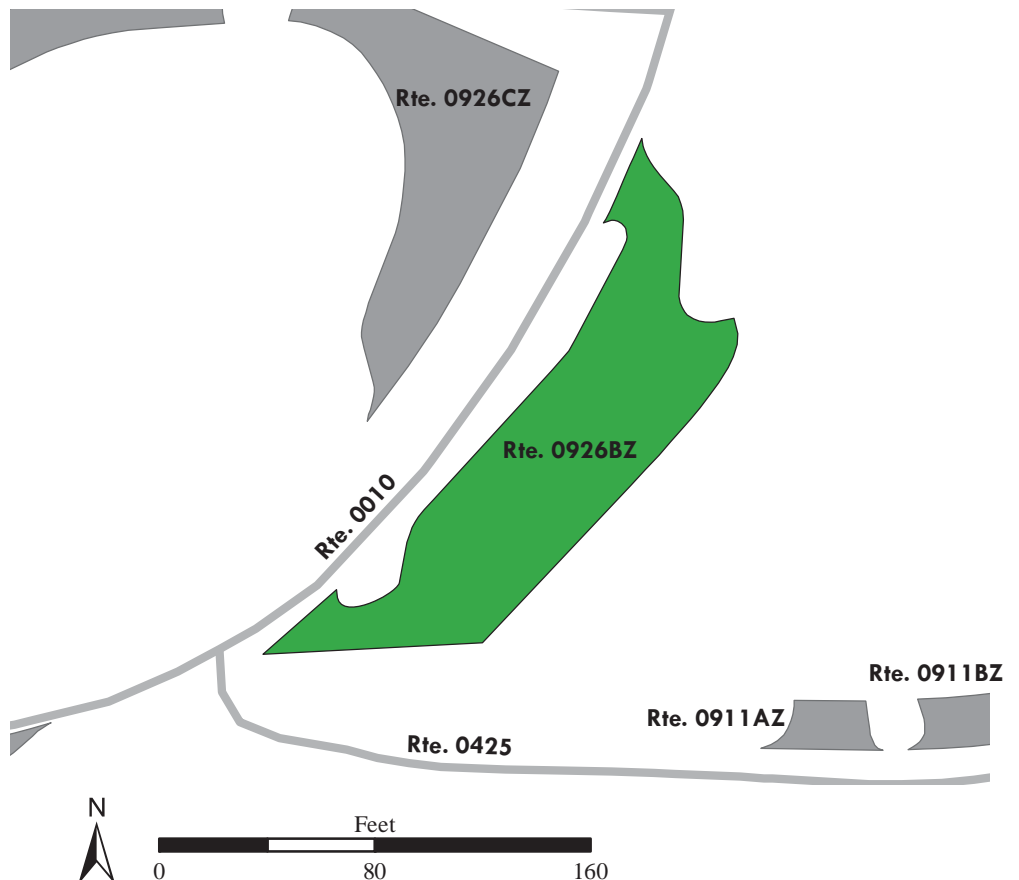
ROUTE 0926BZ: ASH MOUNTAIN VISITOR CENTER PARKING AREA B

Inspection Date	FMSS Number	User Access	Surface Type
9/23/2014	74163	PUBLIC	ASPHALT
Area (Sq. Ft.)	Lane Miles (11' Widths)	Curb Reveal (Inches)	Curb Recommendation
7,569	0.13	5	DO NOTHING
Curb Type		Curb & Gutter Type	
STONE		NO CURB AND GUTTER	
Pavement Recommendation		Condition Rating / PCR	
PREVENTIVE MAINTENANCE		GOOD / 90

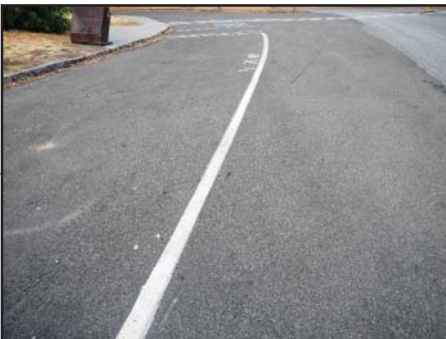
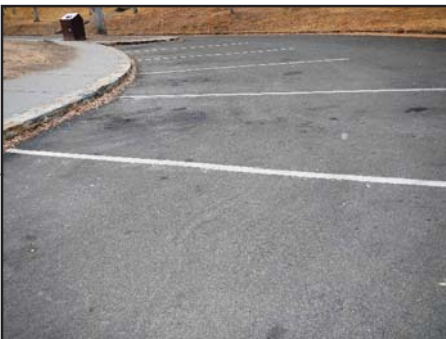
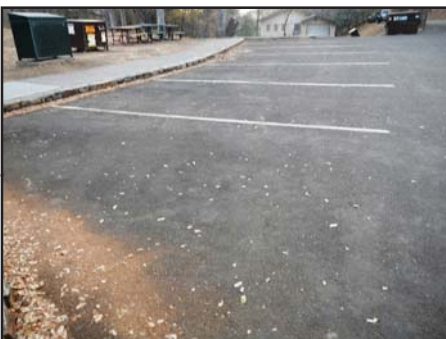
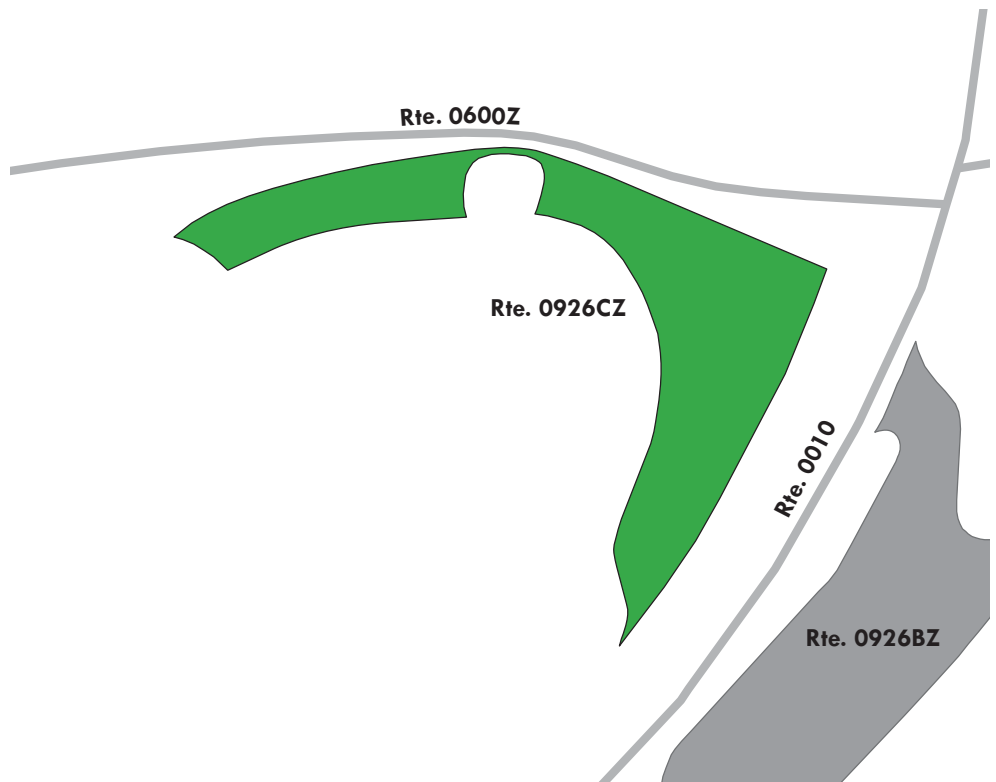
ROUTE 0926CZ: ASH MOUNTAIN VISITOR CENTER PICNIC AND HANDICAPPED PARKING

Inspection Date	FMSS Number	User Access	Surface Type
9/23/2014	74163	PUBLIC	ASPHALT
Area (Sq. Ft.)	Lane Miles (11' Widths)	Curb Reveal (Inches)	Curb Recommendation
6,425	0.111	6	DO NOTHING
Curb Type		Curb & Gutter Type	
STONE		NO CURB AND GUTTER	
Pavement Recommendation		Condition Rating / PCR	
PREVENTIVE MAINTENANCE		GOOD / 90

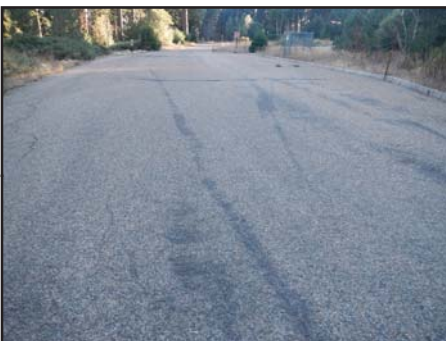
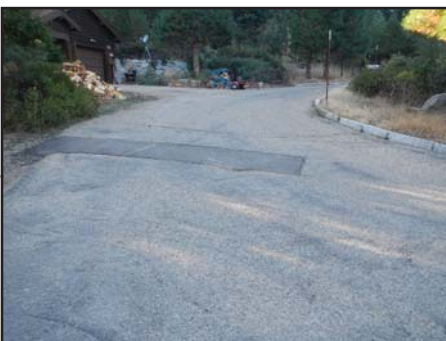
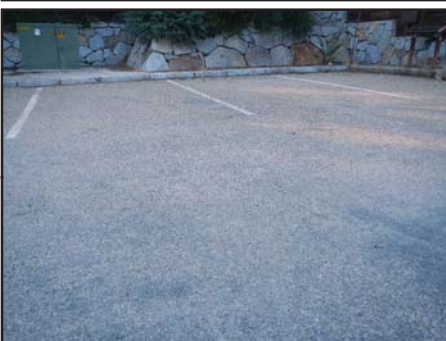
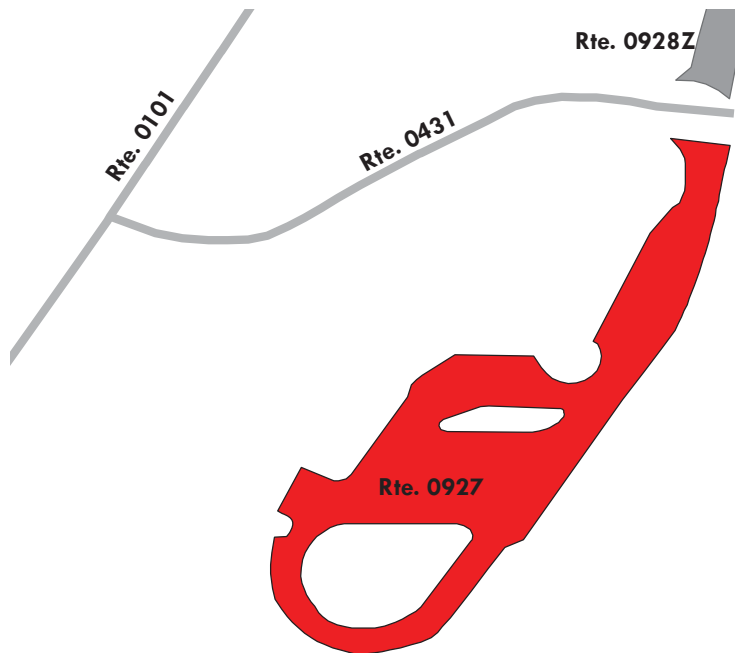
ROUTE 0927: WUKSACHI FIRE/RESIDENCE PARKING

Inspection Date	FMSS Number	User Access	Surface Type
9/24/2014	74166	NONPUBLIC	ASPHALT
Area (Sq. Ft.)	Lane Miles (11' Widths)	Curb Reveal (Inches)	Curb Recommendation
30,951	0.533	6	DO NOTHING
Curb Type		Curb & Gutter Type	
STONE		NO CURB AND GUTTER	
Pavement Recommendation		Condition Rating / PCR	
HEAVY 3R TREATMENTS		POOR / 53

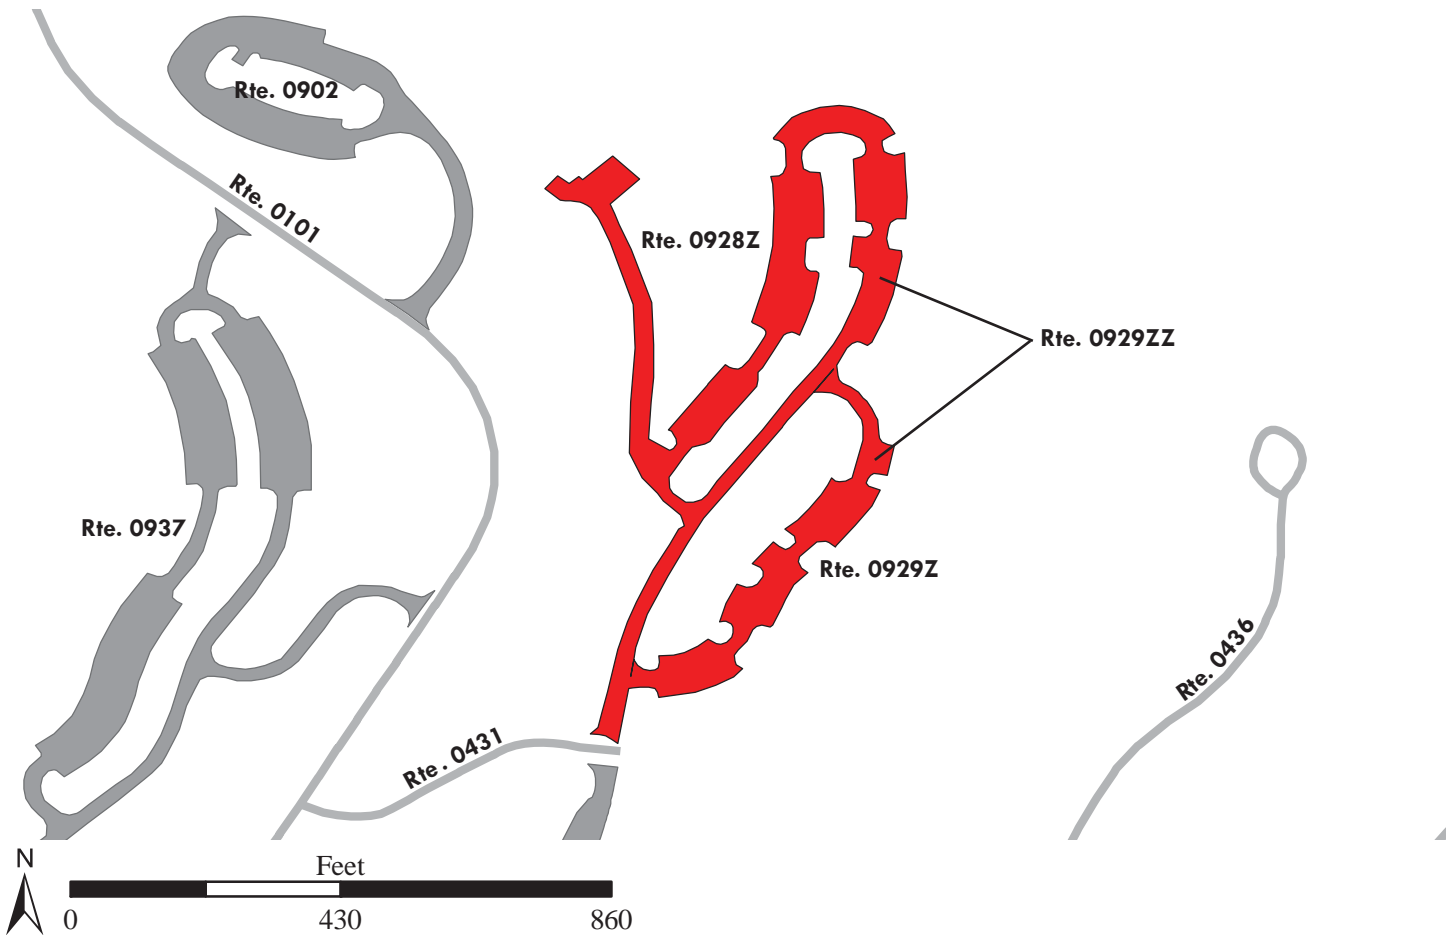
ROUTE 0929ZZ: WUKSACHI CONCESSION HOUSING PARKING AREAS

Inspection Date	FMSS Number	User Access	Surface Type
9/25/2014	74193	PUBLIC	ASPHALT
Area (Sq. Ft.)	Lane Miles (11' Widths)	Condition Rating / PCR	
110,752	1.907	SUMMARY / 53

The condition shown on this page reflects the overall route condition and may not reflect individual subcomponent ratings.

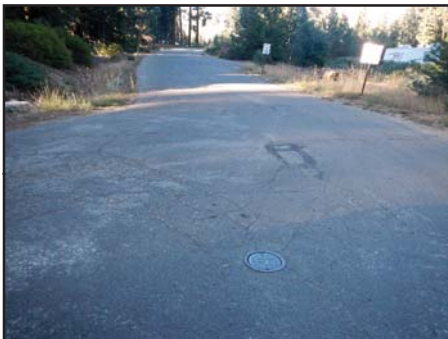
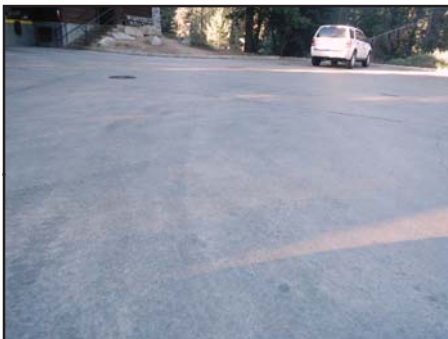
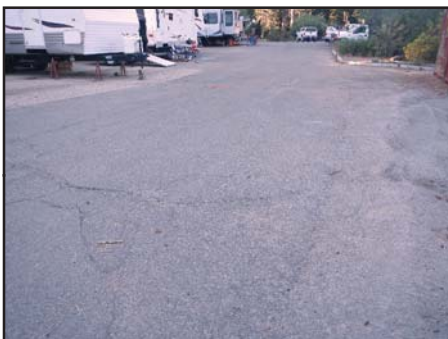
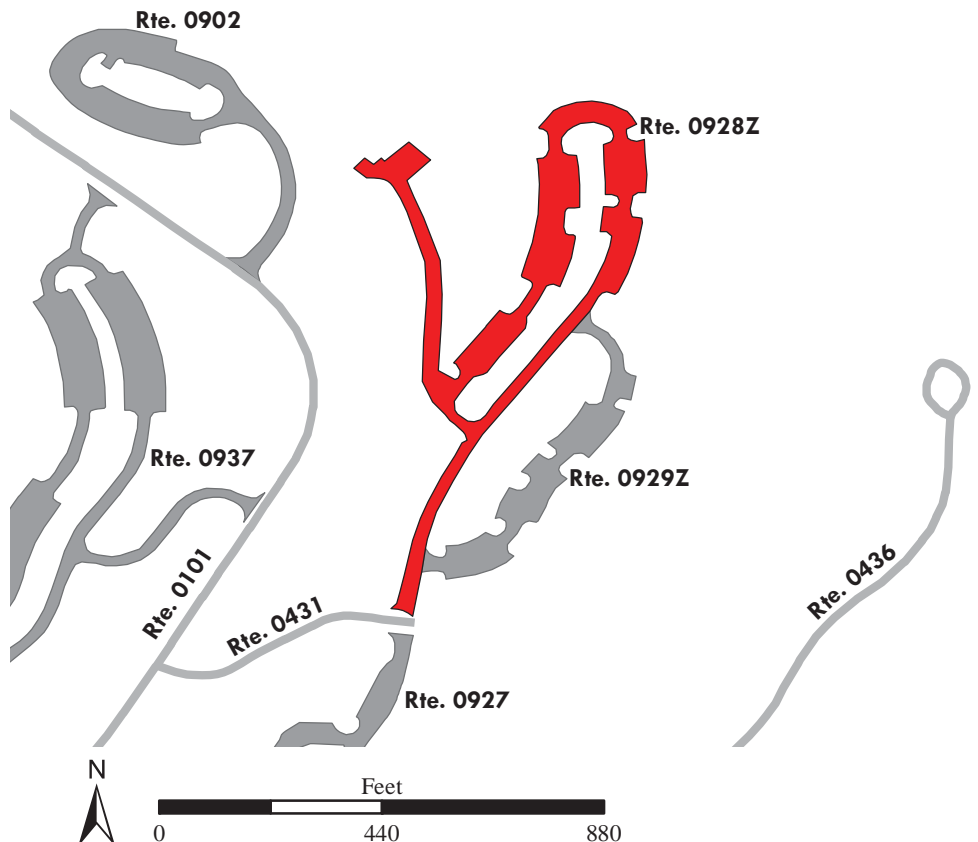
ROUTE 0928Z: WUKSACHI CONCESSION HOUSING PARKING

Inspection Date	FMSS Number	User Access	Surface Type
9/25/2014	74193	PUBLIC	ASPHALT
Area (Sq. Ft.)	Lane Miles (11' Widths)	Curb Reveal (Inches)	Curb Recommendation
81,765	1.408	5	DO NOTHING
Curb Type		Curb & Gutter Type	
CONCRETE AND STONE		NO CURB AND GUTTER	
Pavement Recommendation		Condition Rating / PCR	
HEAVY 3R TREATMENTS		POOR / 53

Parking area consists of multiple surface types. 1 part Asphalt at 76,244 square feet; 1 part Concrete at 5,425 square feet.

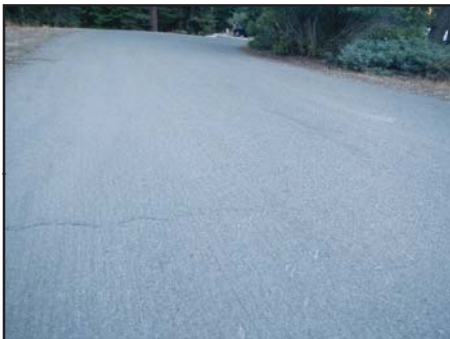
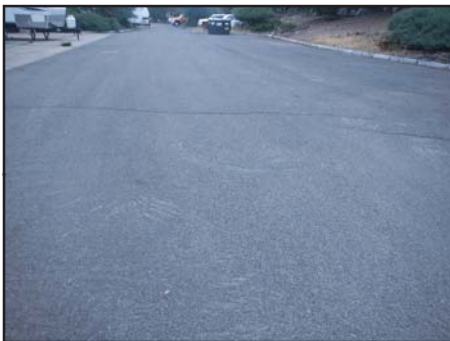
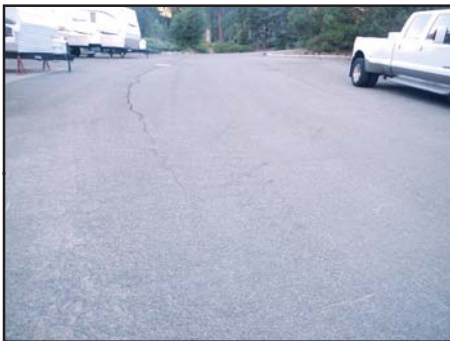
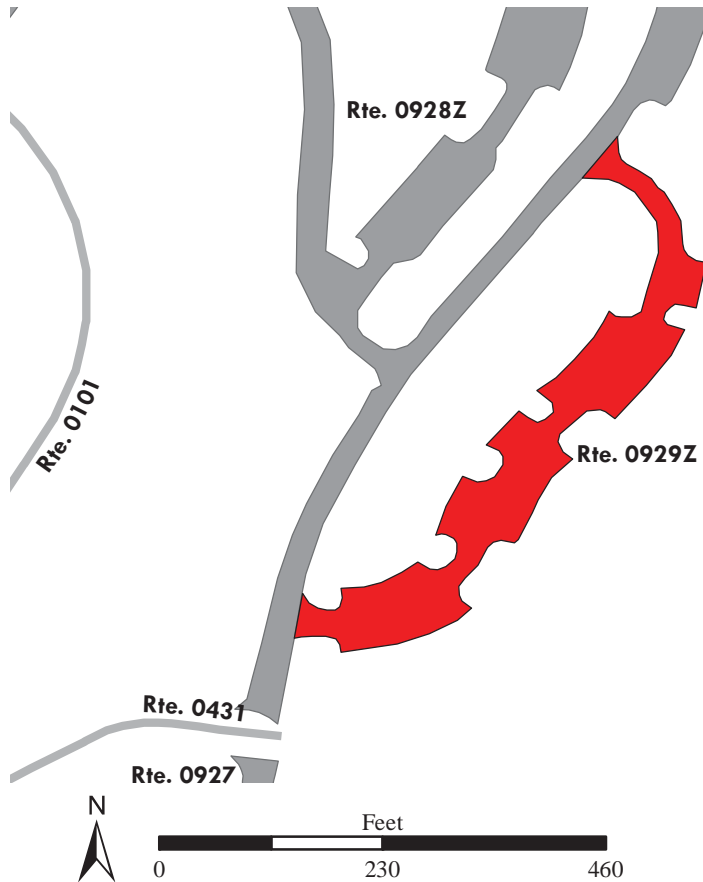
ROUTE 0929Z: WUKSACHI EMPLOYEE TRAILER PARKING

Inspection Date	FMSS Number	User Access	Surface Type
9/24/2014	74193	PUBLIC	ASPHALT
Area (Sq. Ft.)	Lane Miles (11' Widths)	Curb Reveal (Inches)	Curb Recommendation
28,987	0.499	4	LIGHT REPAIR
Curb Type		Curb & Gutter Type	
STONE		NO CURB AND GUTTER	
Pavement Recommendation		Condition Rating / PCR	
HEAVY 3R TREATMENTS		POOR / 53

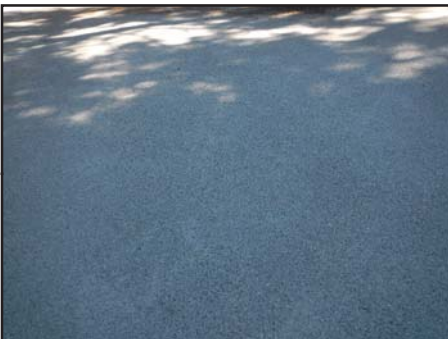
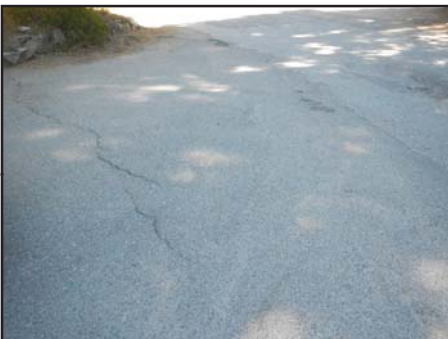
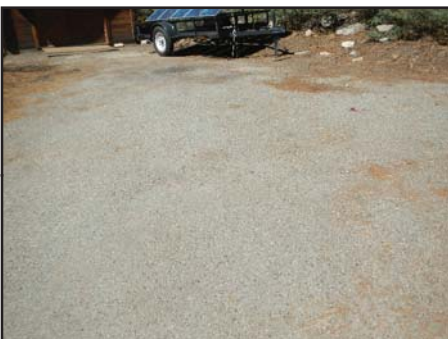
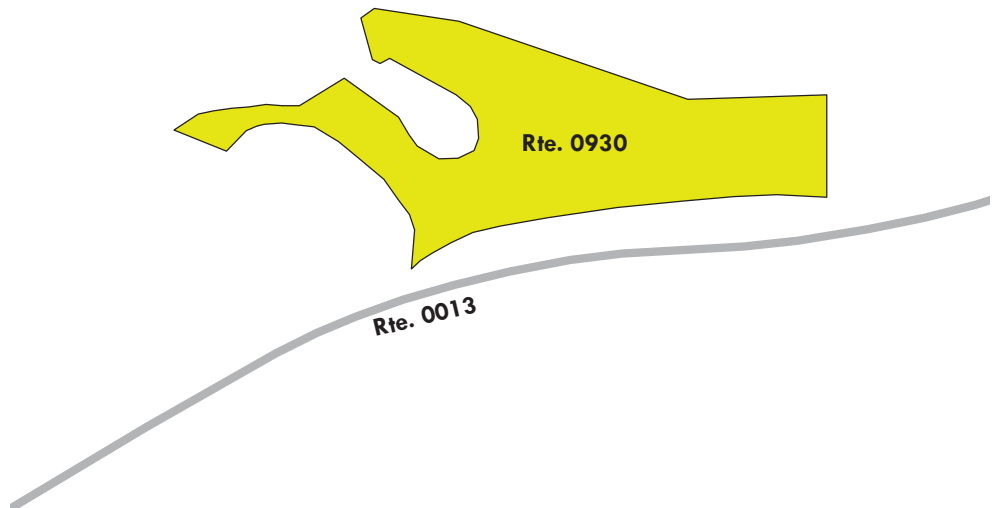
Inspection Date	FMSS Number	User Access	Surface Type
9/23/2014	74196	PUBLIC	ASPHALT
Area (Sq. Ft.)	Lane Miles (11' Widths)	Curb Reveal (Inches)	Curb Recommendation
4,567	0.079	NOT APPLICABLE	NOT APPLICABLE
Curb Type		Curb & Gutter Type	
NO CURB		NO CURB AND GUTTER	
Pavement Recommendation		Condition Rating / PCR	
LIGHT 3R TREATMENTS		FAIR / 73

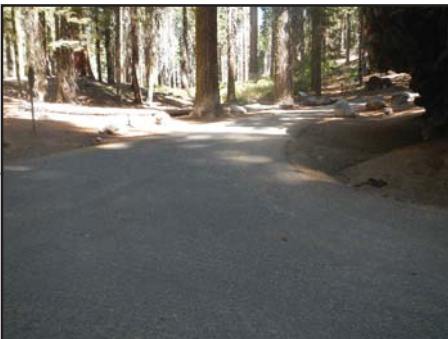
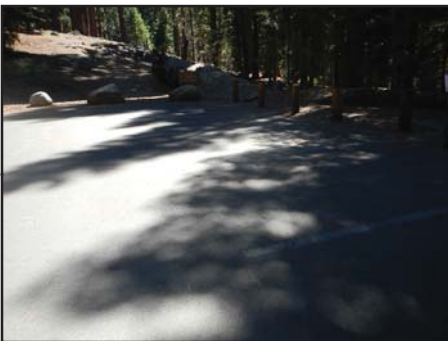
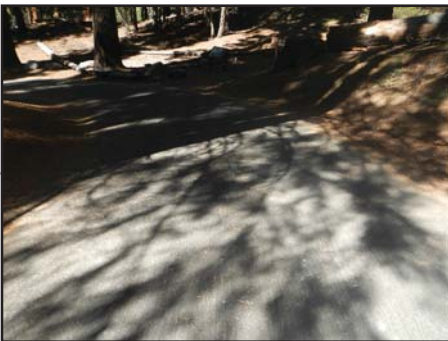
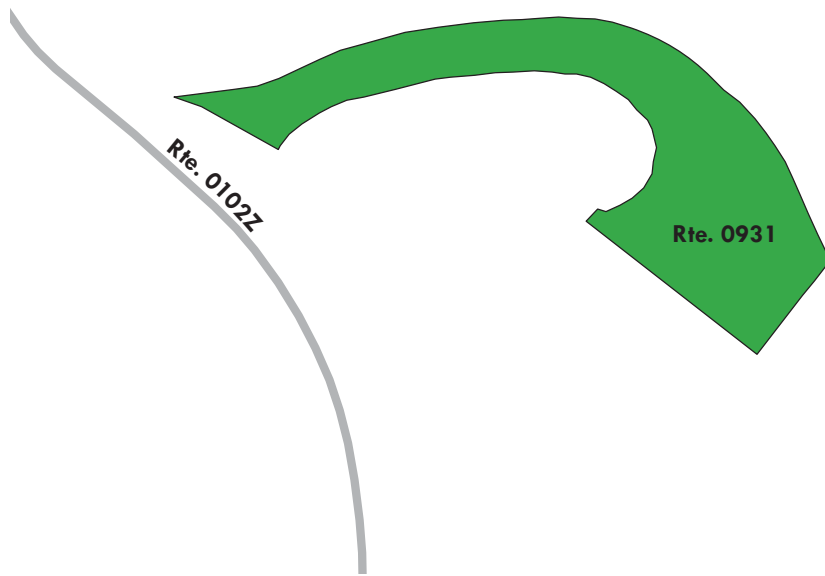
ROUTE 0931: AUTO LOG PARKING AREA

Inspection Date	FMSS Number	User Access	Surface Type
9/25/2014	74198	PUBLIC	ASPHALT
Area (Sq. Ft.)	Lane Miles (11' Widths)	Curb Reveal (Inches)	Curb Recommendation
6,571	0.113	NOT APPLICABLE	NOT APPLICABLE
Curb Type		Curb & Gutter Type	
NO CURB		NO CURB AND GUTTER	
Pavement Recommendation		Condition Rating / PCR	
PREVENTIVE MAINTENANCE		GOOD / 90

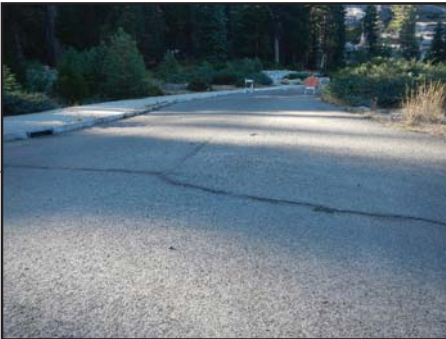
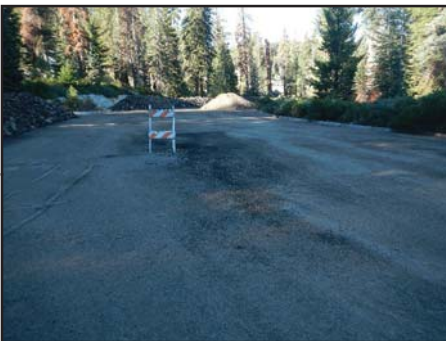
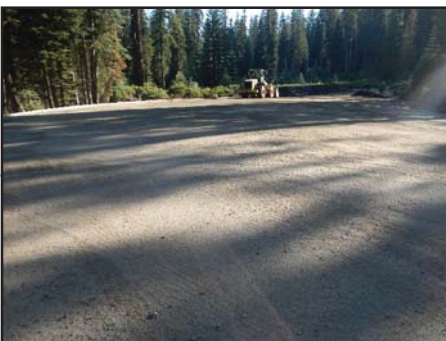
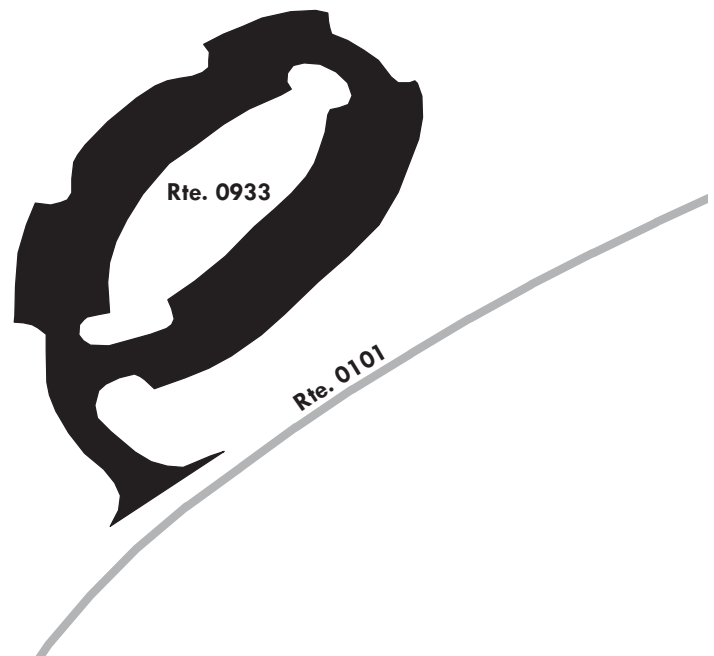
ROUTE 0933: WUKSACHI VILLAGE PARKING, WEST TERRACE

Inspection Date	FMSS Number	User Access	Surface Type
9/24/2014	74201	PUBLIC	ASPHALT
Area (Sq. Ft.)	Lane Miles (11' Widths)	Curb Reveal (Inches)	Curb Recommendation
47,400	0.816	6	DO NOTHING
Curb Type		Curb & Gutter Type	
STONE		NO CURB AND GUTTER	
Pavement Recommendation		Condition Rating / PCR	
NOT APPLICABLE		NOT RATED / -1

Parking area was not rated because it was under construction (being rubblized).

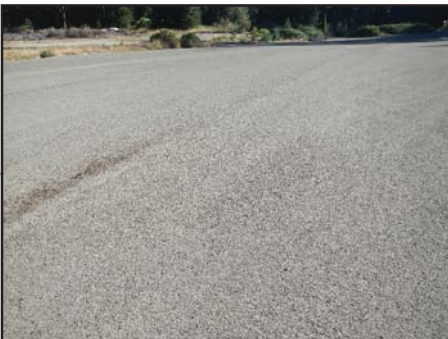
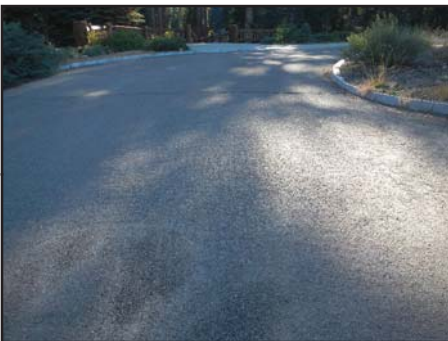
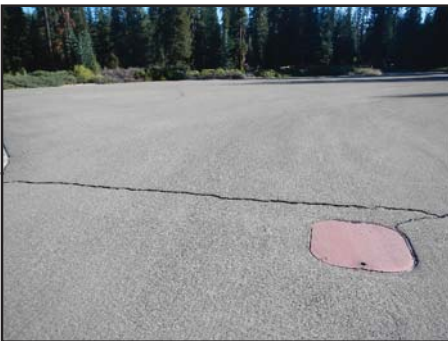
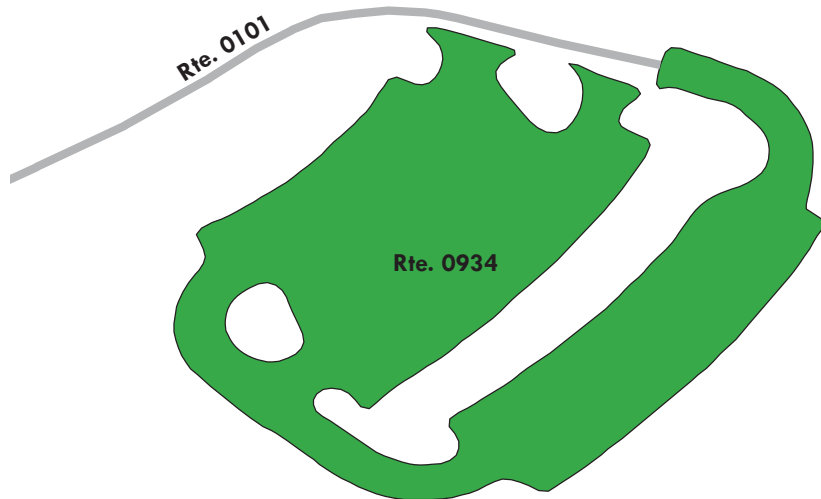
ROUTE 0934: WUKSACHI VILLAGE PARKING, NORTH TERRACE

Inspection Date	FMSS Number	User Access	Surface Type
9/24/2014	74204	PUBLIC	ASPHALT
Area (Sq. Ft.)	Lane Miles (11' Widths)	Curb Reveal (Inches)	Curb Recommendation
51,315	0.884	6	DO NOTHING
Curb Type		Curb & Gutter Type	
STONE		NO CURB AND GUTTER	
Pavement Recommendation		Condition Rating / PCR	
PREVENTIVE MAINTENANCE		GOOD / 90

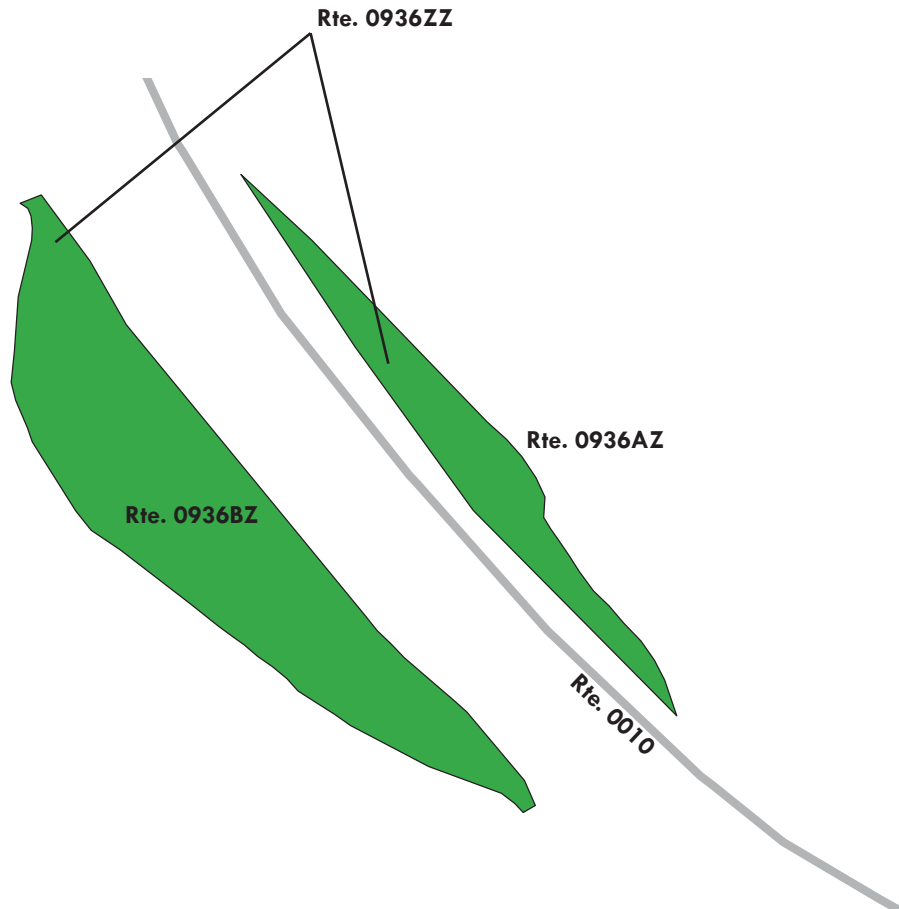
ROUTE 0936ZZ: LOST GROVE PARKING AREAS

Inspection Date	FMSS Number	User Access	Surface Type
9/24/2014	74210	PUBLIC	ASPHALT
Area (Sq. Ft.)	Lane Miles (11' Widths)	Condition Rating / PCR	
6,462	0.111	SUMMARY / 90

The condition shown on this page reflects the overall route condition and may not reflect individual subcomponent ratings.
