Road Inventory and Condition Assessment of Paved Routes Sequoia National Park

**Federal Lands Highway
Road Inventory Program**

Federal Highway Administration
Eastern Federal Lands Highway Division
Road Inventory Program (RIP)

Report Date: January 2016

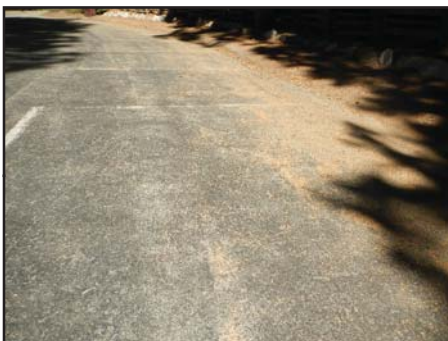
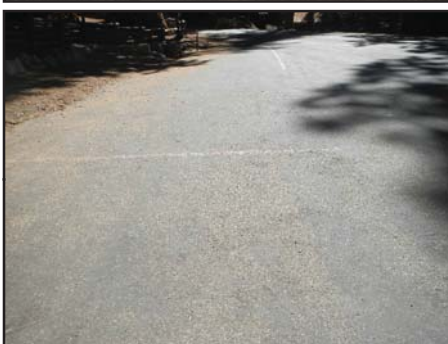
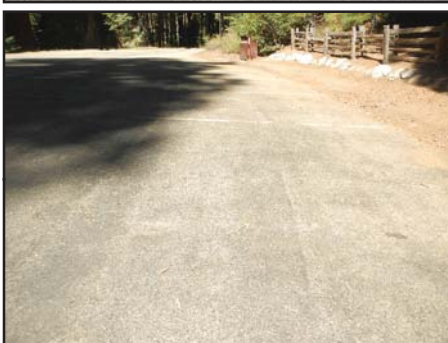
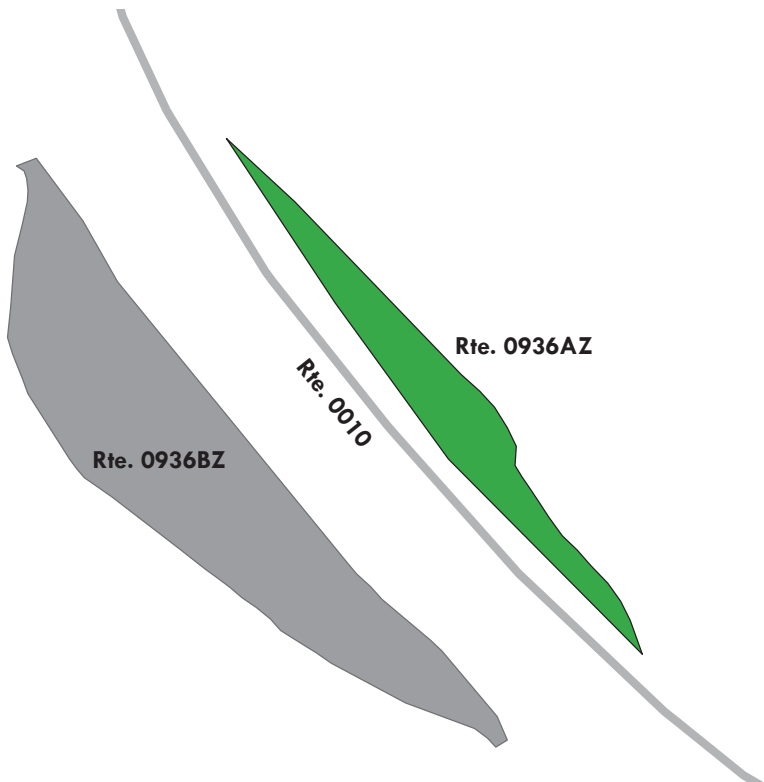
ROUTE 0936AZ: LOST GROVE PARKING AREA A

Inspection Date	FMSS Number	User Access	Surface Type
9/24/2014	74210	PUBLIC	ASPHALT
Area (Sq. Ft.)	Lane Miles (11' Widths)	Curb Reveal (Inches)	Curb Recommendation
1,562	0.027	5	DO NOTHING
Curb Type		Curb & Gutter Type	
ASPHALT		NO CURB AND GUTTER	
Pavement Recommendation		Condition Rating / PCR	
PREVENTIVE MAINTENANCE		GOOD / 90

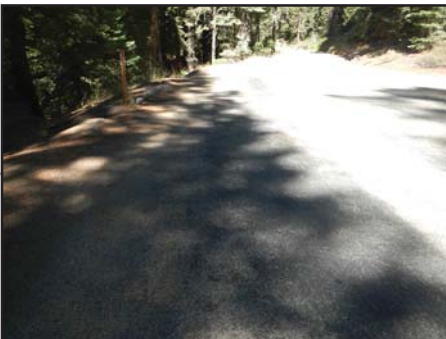
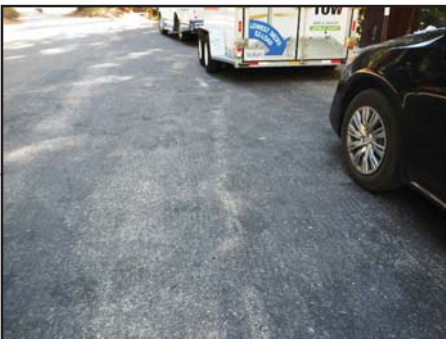
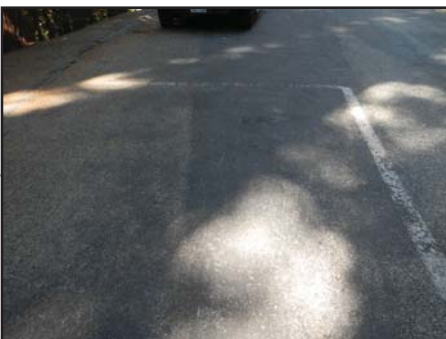
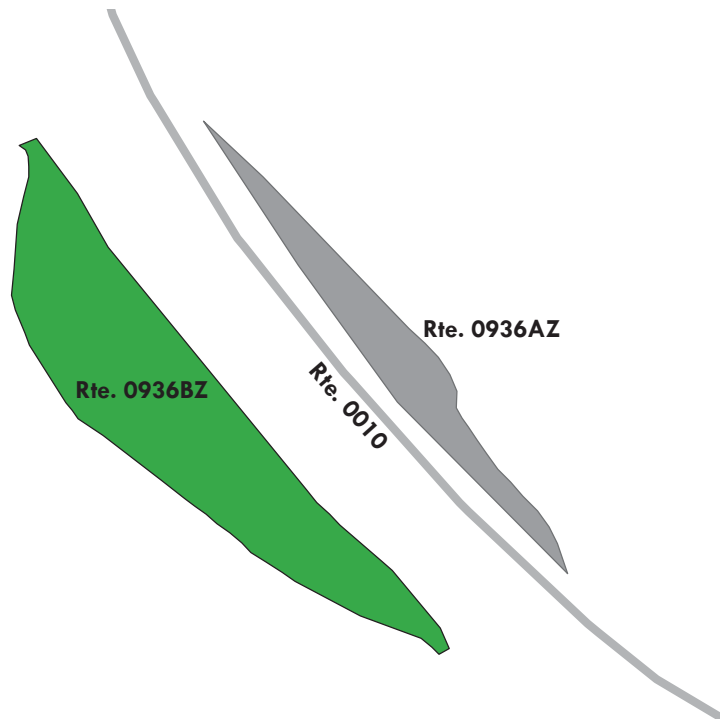
ROUTE 0936BZ: LOST GROVE PARKING AREA B

Inspection Date	FMSS Number	User Access	Surface Type
9/24/2014	74210	PUBLIC	ASPHALT
Area (Sq. Ft.)	Lane Miles (11' Widths)	Curb Reveal (Inches)	Curb Recommendation
4,900	0.084	5	DO NOTHING
Curb Type		Curb & Gutter Type	
ASPHALT		NO CURB AND GUTTER	
Pavement Recommendation		Condition Rating / PCR	
PREVENTIVE MAINTENANCE		GOOD / 90

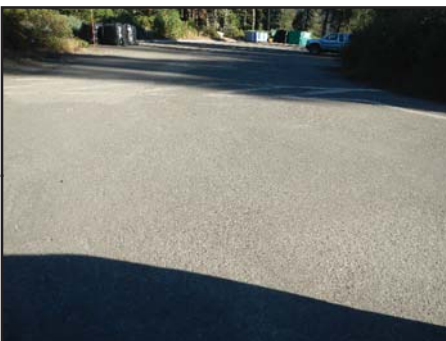
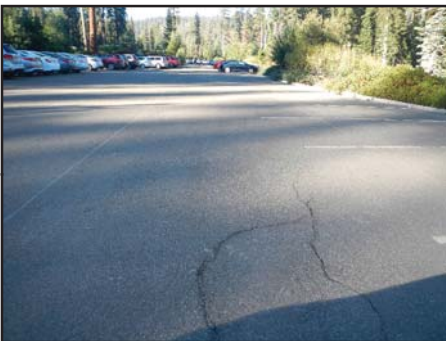
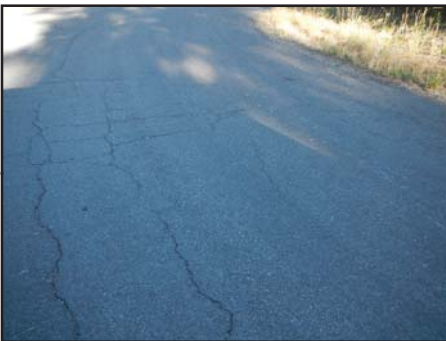
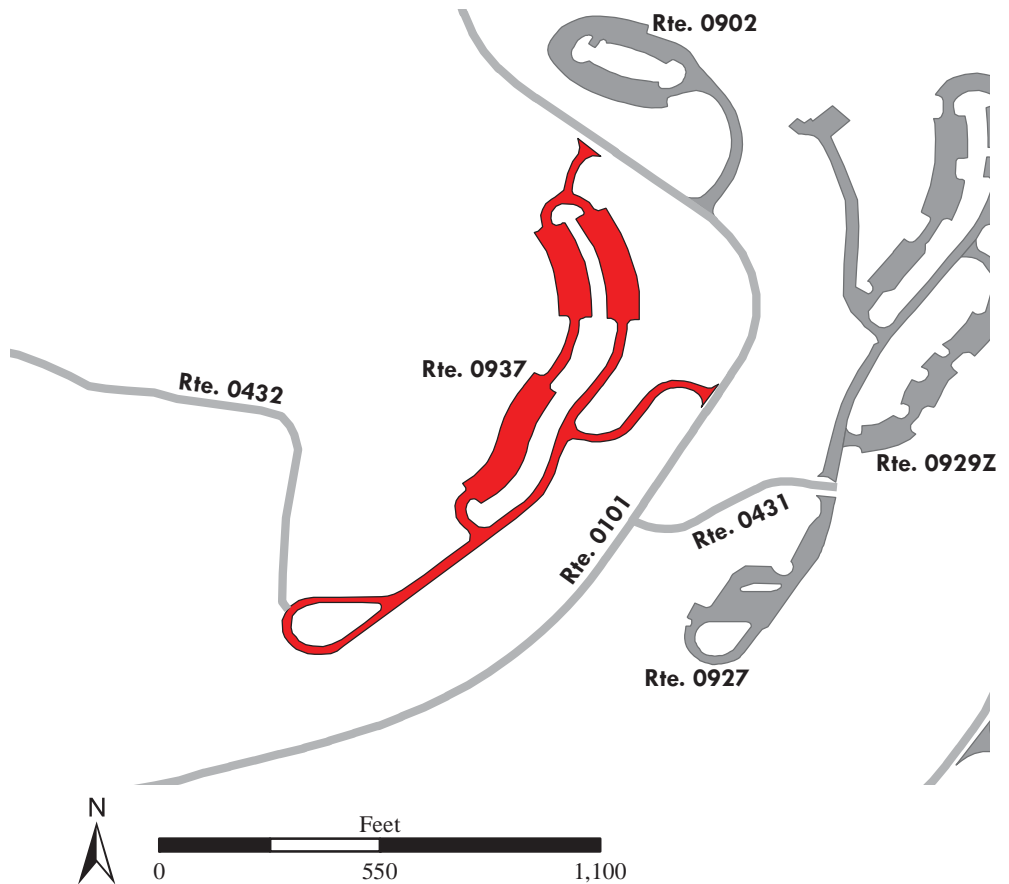
ROUTE 0937: WUKSACHI SOUTH TERRACE PARKING

Inspection Date	FMSS Number	User Access	Surface Type
9/24/2014	74214	PUBLIC	ASPHALT
Area (Sq. Ft.)	Lane Miles (11' Widths)	Curb Reveal (Inches)	Curb Recommendation
100,756	1.735	6	DO NOTHING
Curb Type		Curb & Gutter Type	
STONE		NO CURB AND GUTTER	
Pavement Recommendation		Condition Rating / PCR	
HEAVY 3R TREATMENTS		POOR / 53

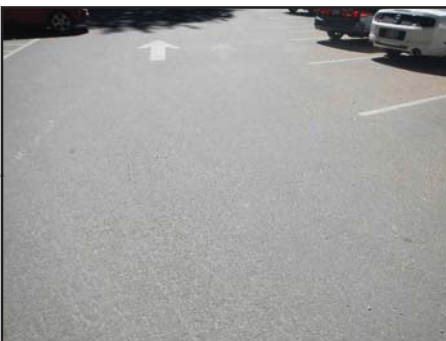
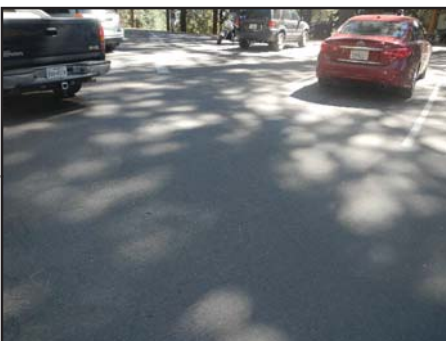
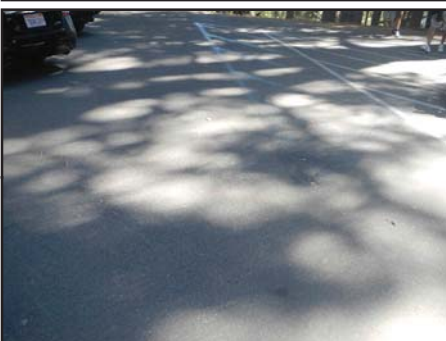
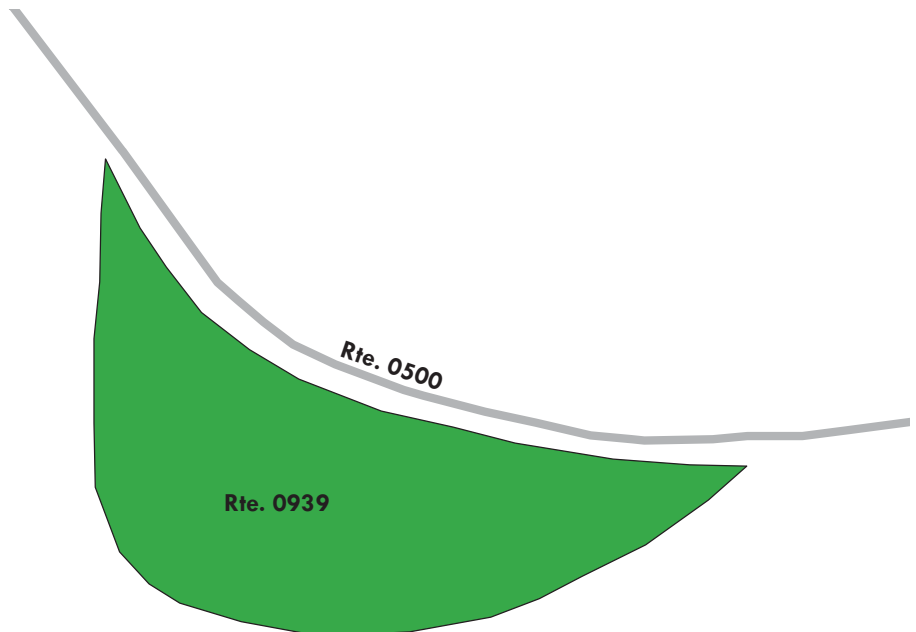
ROUTE 0939: MORO ROCK AREA PARKING

Inspection Date	FMSS Number	User Access	Surface Type
9/25/2014	74217	PUBLIC	ASPHALT
Area (Sq. Ft.)	Lane Miles (11' Widths)	Curb Reveal (Inches)	Curb Recommendation
9,514	0.164	5	DO NOTHING
Curb Type		Curb & Gutter Type	
STONE		NO CURB AND GUTTER	
Pavement Recommendation		Condition Rating / PCR	
PREVENTIVE MAINTENANCE		GOOD / 90

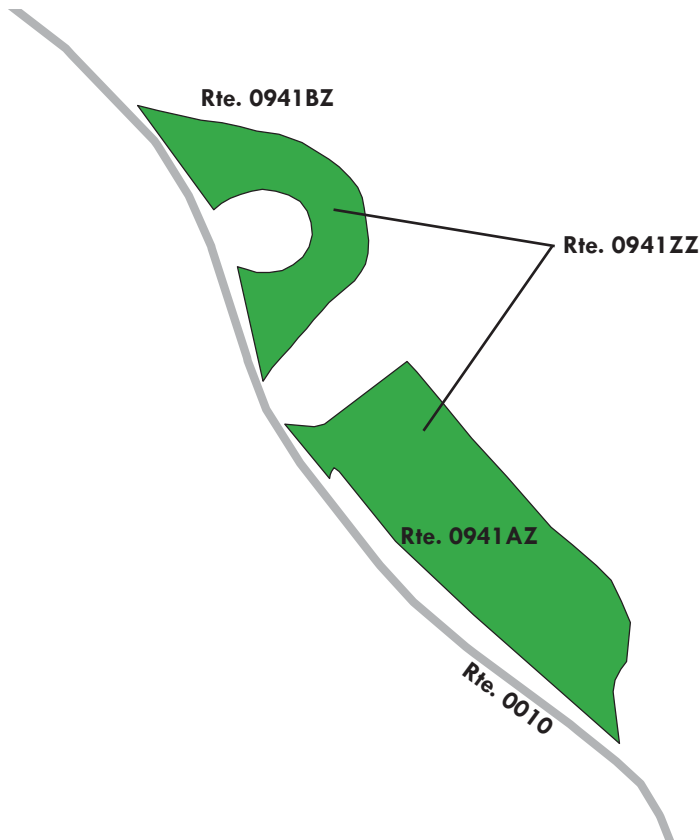
ROUTE 0941ZZ: LOWER GENERAL SHERMAN PARKING AREAS

Inspection Date	FMSS Number	User Access	Surface Type
9/25/2014	104942	PUBLIC	ASPHALT
Area (Sq. Ft.)	Lane Miles (11' Widths)	Condition Rating / PCR	
11,481	0.198	SUMMARY / 90

The condition shown on this page reflects the overall route condition and may not reflect individual subcomponent ratings.

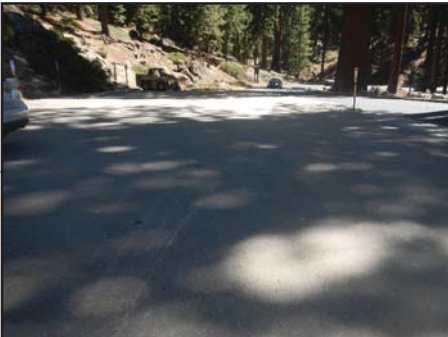
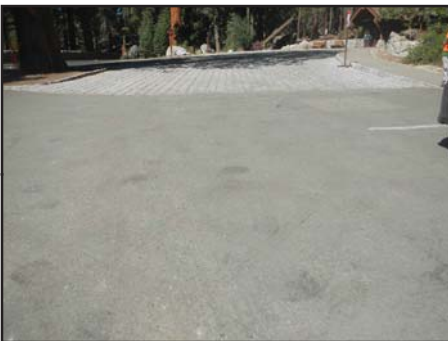
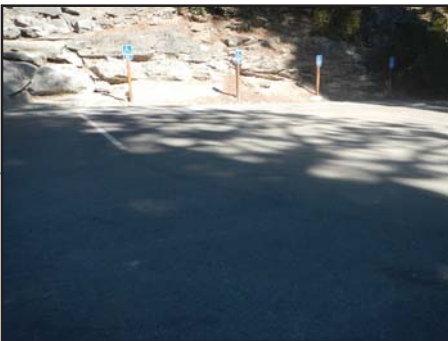
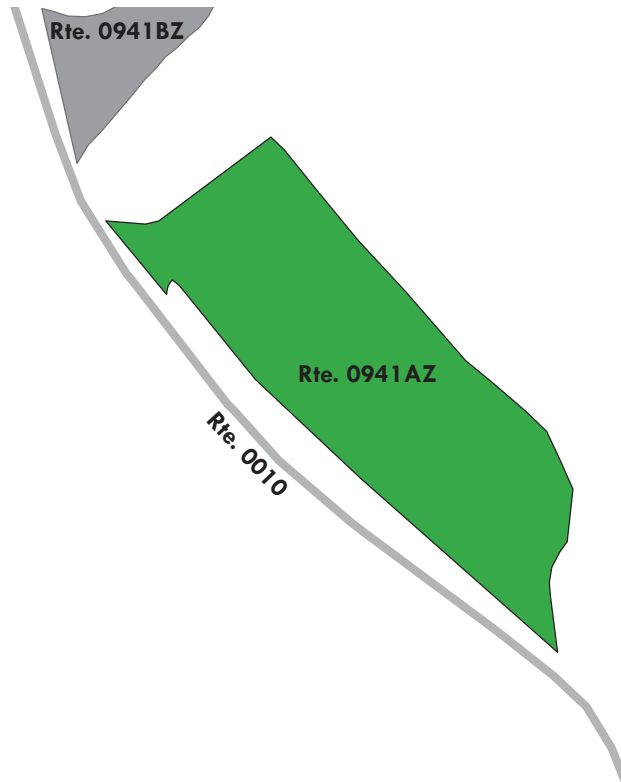
ROUTE 0941AZ: LOWER GENERAL SHERMAN PARKING A

Inspection Date	FMSS Number	User Access	Surface Type
9/25/2014	104942	PUBLIC	ASPHALT
Area (Sq. Ft.)	Lane Miles (11' Widths)	Curb Reveal (Inches)	Curb Recommendation
7,776	0.134	6	DO NOTHING
Curb Type		Curb & Gutter Type	
STONE		NO CURB AND GUTTER	
Pavement Recommendation		Condition Rating / PCR	
PREVENTIVE MAINTENANCE		GOOD / 90

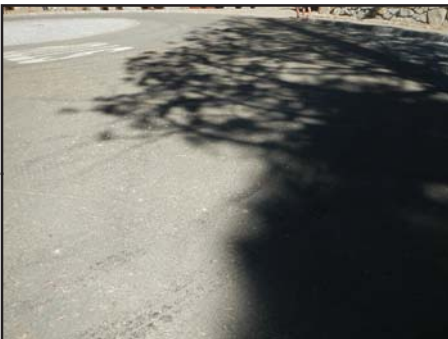
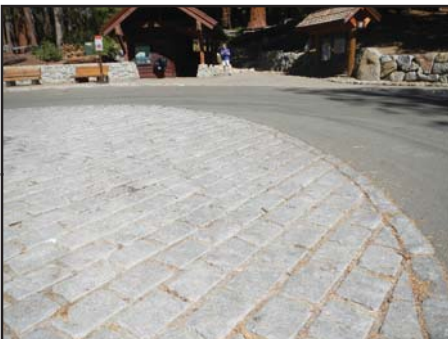
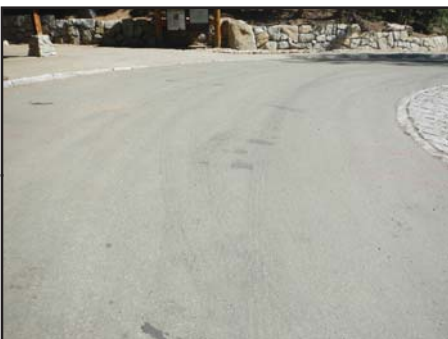
ROUTE 0942: BIG TREE HANDICAP PARKING

Inspection Date	FMSS Number	User Access	Surface Type
9/25/2014	73872	PUBLIC	ASPHALT
Area (Sq. Ft.)	Lane Miles (11' Widths)	Curb Reveal (Inches)	Curb Recommendation
9,162	0.158	NOT APPLICABLE	NOT APPLICABLE
Curb Type		Curb & Gutter Type	
NO CURB		NO CURB AND GUTTER	
Pavement Recommendation		Condition Rating / PCR	
PREVENTIVE MAINTENANCE		GOOD / 90

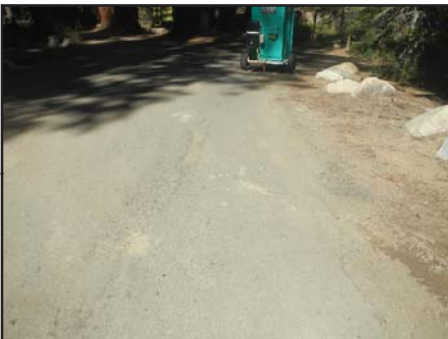
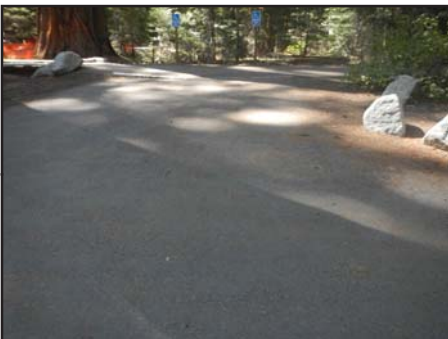
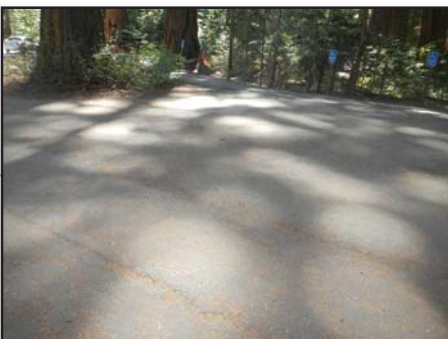
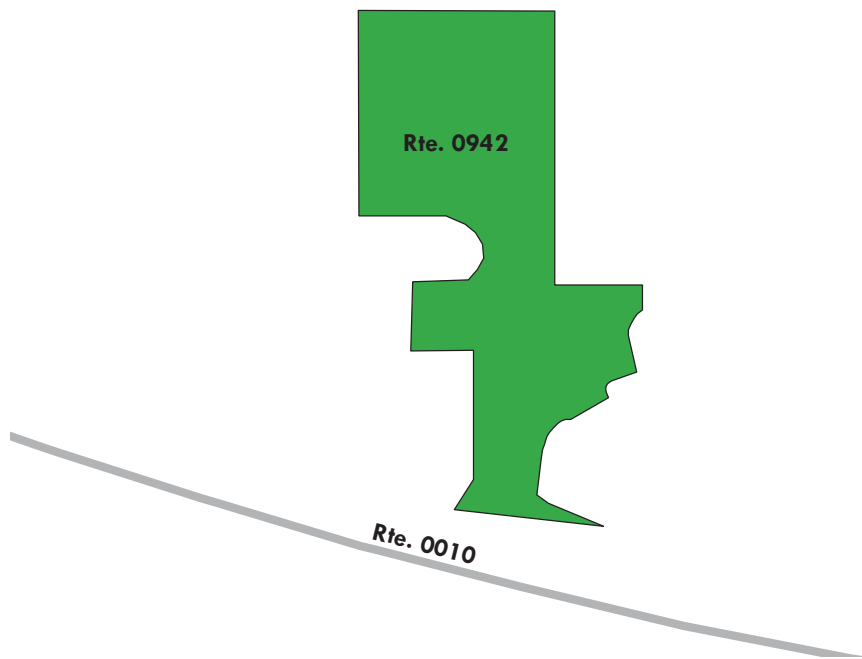
ROUTE 0943: MUSEUM HANDICAP PARKING

Inspection Date	FMSS Number	User Access	Surface Type
9/25/2014	113026	PUBLIC	ASPHALT
Area (Sq. Ft.)	Lane Miles (11' Widths)	Curb Reveal (Inches)	Curb Recommendation
8,354	0.144	4	DO NOTHING
Curb Type		Curb & Gutter Type	
STONE		NO CURB AND GUTTER	
Pavement Recommendation		Condition Rating / PCR	
PREVENTIVE MAINTENANCE		GOOD / 90

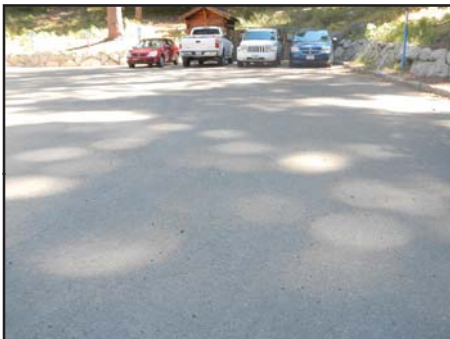
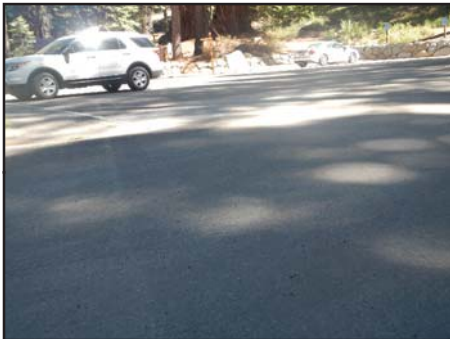
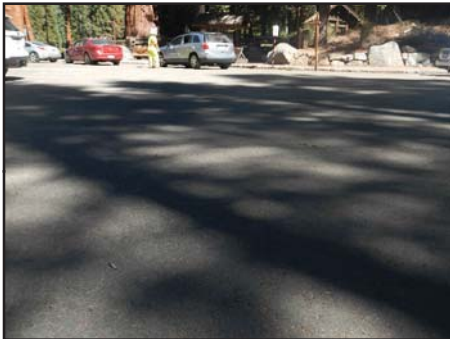
ROUTE 0944: UPPER MUSEUM PARKING & BEETLE RESEARCH ROAD

Inspection Date	FMSS Number	User Access	Surface Type
9/25/2014	113027	PUBLIC	ASPHALT
Area (Sq. Ft.)	Lane Miles (11' Widths)	Curb Reveal (Inches)	Curb Recommendation
106,064	1.826	5	DO NOTHING
Curb Type		Curb & Gutter Type	
ASPHALT AND STONE		NO CURB AND GUTTER	
Pavement Recommendation		Condition Rating / PCR	
PREVENTIVE MAINTENANCE		GOOD / 90

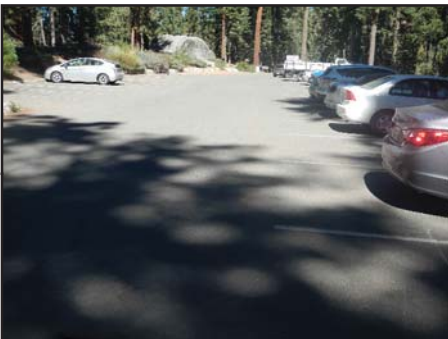
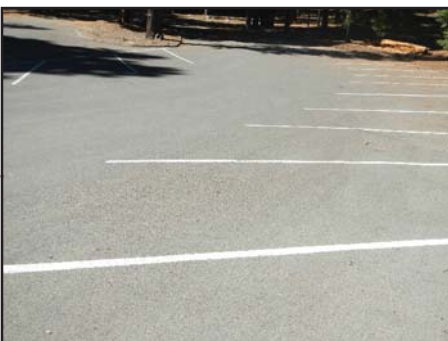
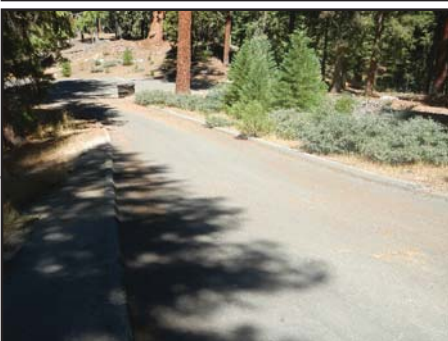
ROUTE 0947: AMPHITHEATRE POINT PARKING

Inspection Date	FMSS Number	User Access	Surface Type
9/25/2014	104914	PUBLIC	ASPHALT
Area (Sq. Ft.)	Lane Miles (11' Widths)	Curb Reveal (Inches)	Curb Recommendation
4,817	0.083	7	DO NOTHING
Curb Type		Curb & Gutter Type	
CONCRETE		NO CURB AND GUTTER	
Pavement Recommendation		Condition Rating / PCR	
LIGHT 3R TREATMENTS		FAIR / 73

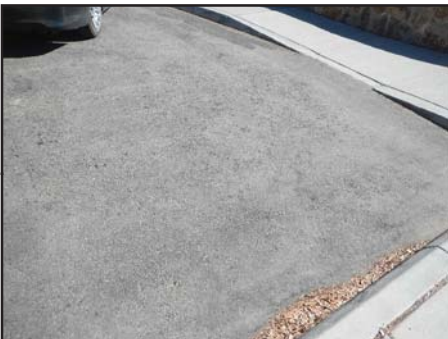
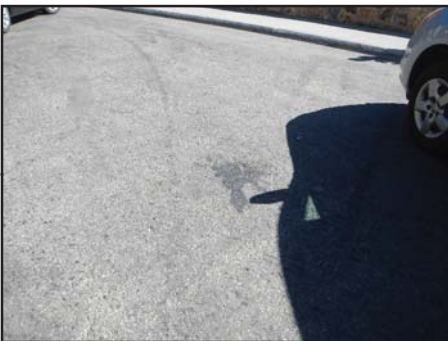
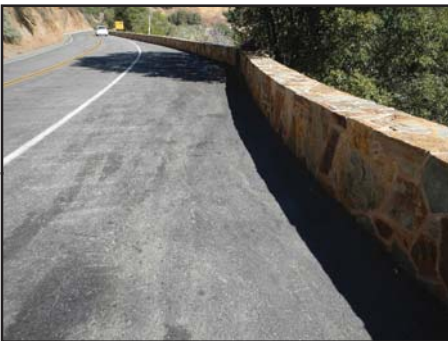
ROUTE 0949ZZ: TUNNEL ROCK PARKING AREAS

Inspection Date	FMSS Number	User Access	Surface Type
9/23/2014	104919	PUBLIC	ASPHALT
Area (Sq. Ft.)	Lane Miles (11' Widths)	Condition Rating / PCR	
3,525	0.06	SUMMARY / 90

The condition shown on this page reflects the overall route condition and may not reflect individual subcomponent ratings.

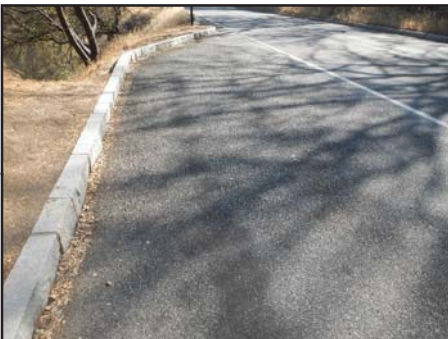
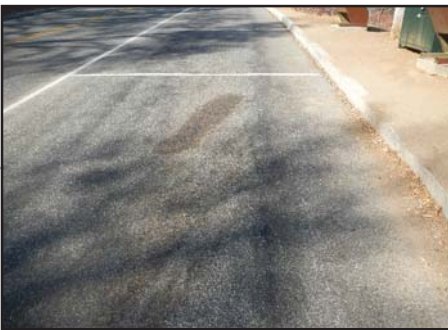
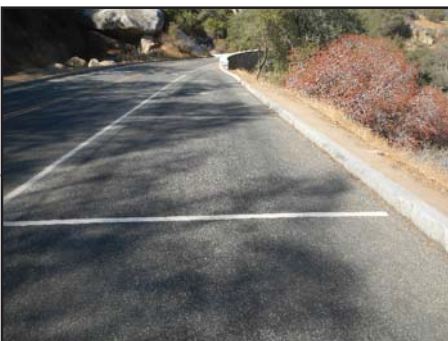
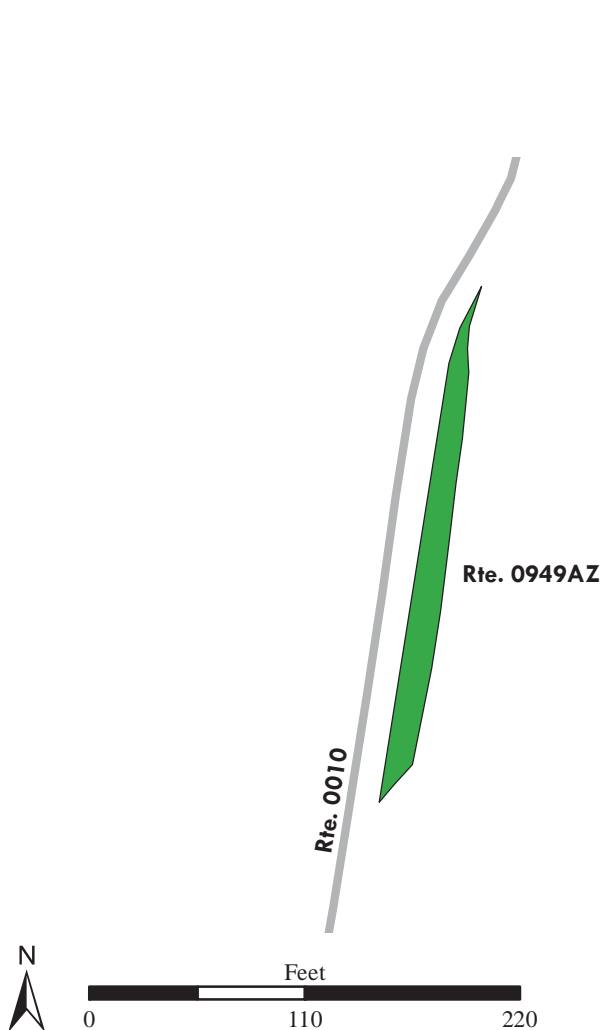
ROUTE 0949AZ: TUNNEL ROCK PARKING

Inspection Date	FMSS Number	User Access	Surface Type
9/23/2014	104919	PUBLIC	ASPHALT
Area (Sq. Ft.)	Lane Miles (11' Widths)	Curb Reveal (Inches)	Curb Recommendation
2,582	0.044	7	DO NOTHING
Curb Type		Curb & Gutter Type	
STONE		NO CURB AND GUTTER	
Pavement Recommendation		Condition Rating / PCR	
PREVENTIVE MAINTENANCE		GOOD / 90

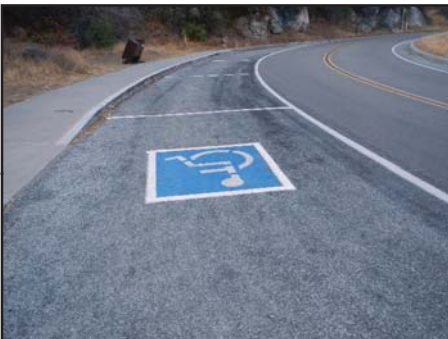
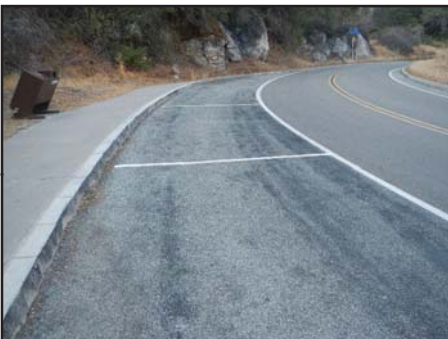
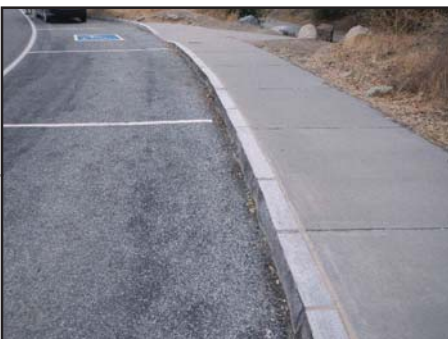
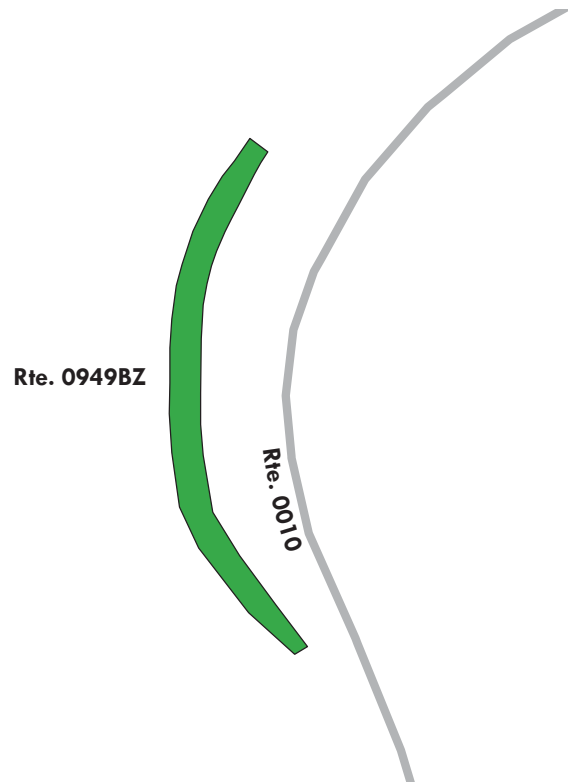
ROUTE 0949BZ: TUNNEL ROCK PARKING HANDICAPPED

Inspection Date	FMSS Number	User Access	Surface Type
9/23/2014	104919	PUBLIC	ASPHALT
Area (Sq. Ft.)	Lane Miles (11' Widths)	Curb Reveal (Inches)	Curb Recommendation
943	0.016	7	DO NOTHING
Curb Type		Curb & Gutter Type	
STONE		NO CURB AND GUTTER	
Pavement Recommendation		Condition Rating / PCR	
PREVENTIVE MAINTENANCE		GOOD / 90

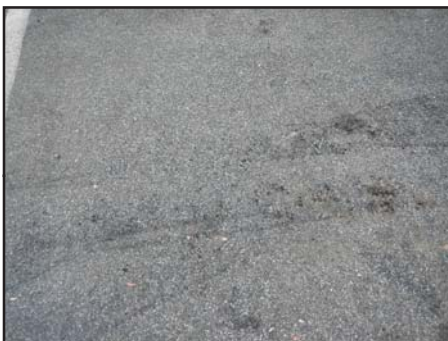
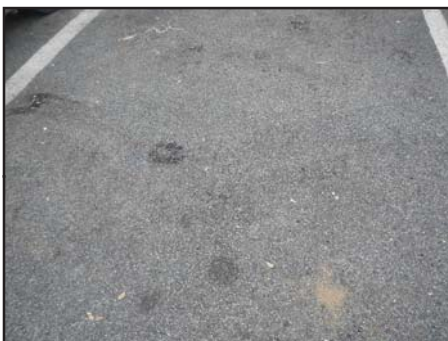
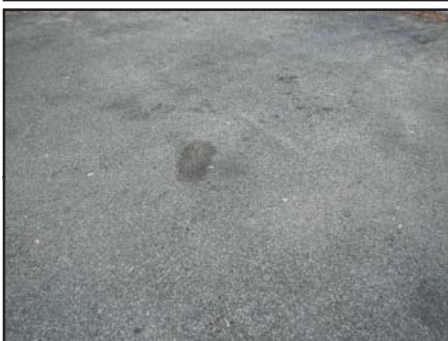
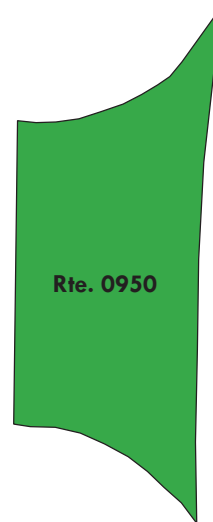
ROUTE 0950: SOUTH ENTRANCE STATION PARKING

Inspection Date	FMSS Number	User Access	Surface Type
9/23/2014	104934	PUBLIC	ASPHALT
Area (Sq. Ft.)	Lane Miles (11' Widths)	Curb Reveal (Inches)	Curb Recommendation
1,868	0.032	5	DO NOTHING
Curb Type		Curb & Gutter Type	
STONE		NO CURB AND GUTTER	
Pavement Recommendation		Condition Rating / PCR	
PREVENTIVE MAINTENANCE		GOOD / 90

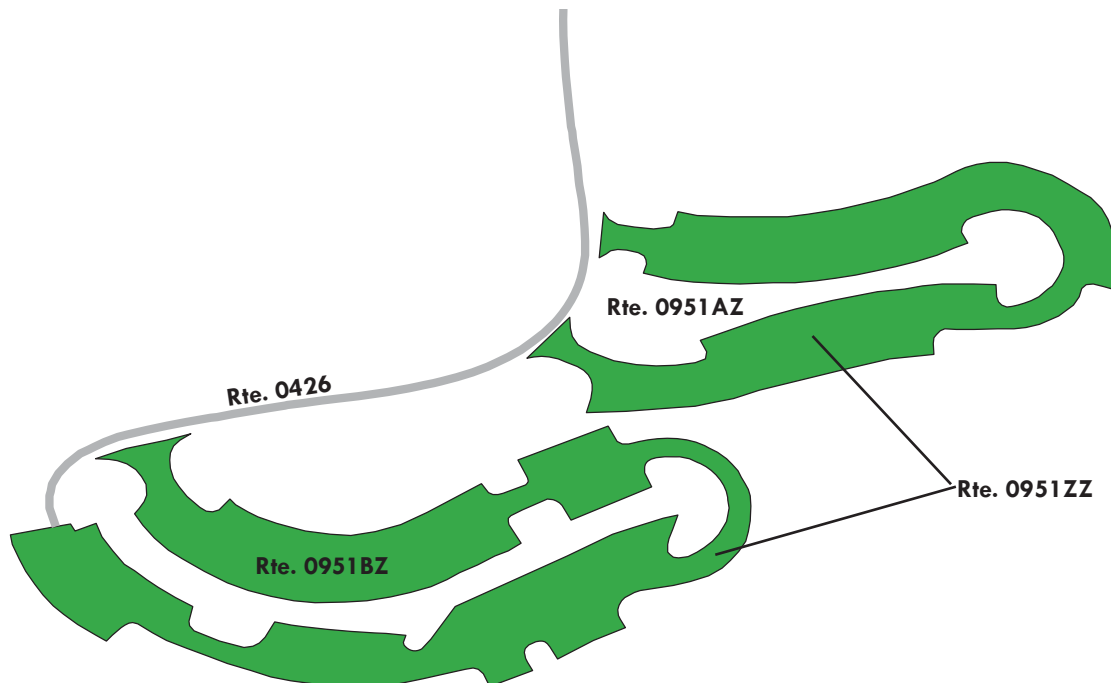
ROUTE 0951ZZ: UPPER GENERAL SHERMAN TREE PARKING AREAS

Inspection Date	FMSS Number	User Access	Surface Type
9/25/2014	73926	PUBLIC	ASPHALT
Area (Sq. Ft.)	Lane Miles (11' Widths)	Condition Rating / PCR	
110,354	1.9	SUMMARY / 90	
Route Condition Legend – Pavement Condition Rating (PCR)			
Poor (0 - 60)	Fair (61- 84)	Good (85 - 94)	Excellent (95 - 100)
See Appendix for definitions and formulas

The condition shown on this page reflects the overall route condition and may not reflect individual subcomponent ratings.

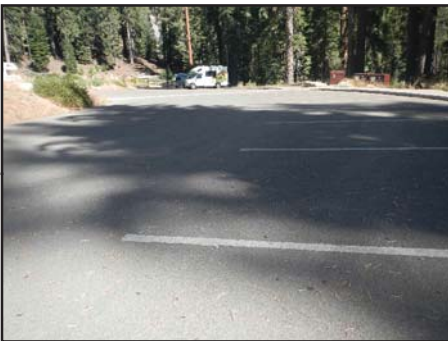
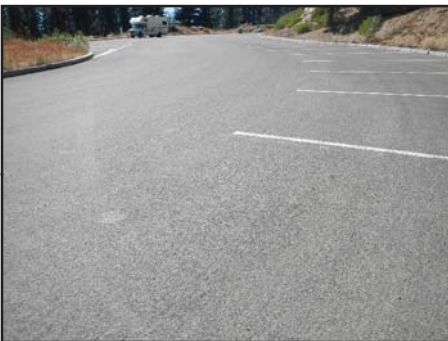
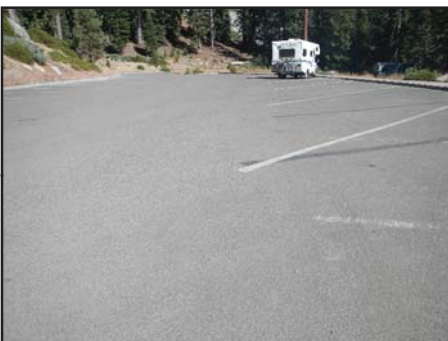
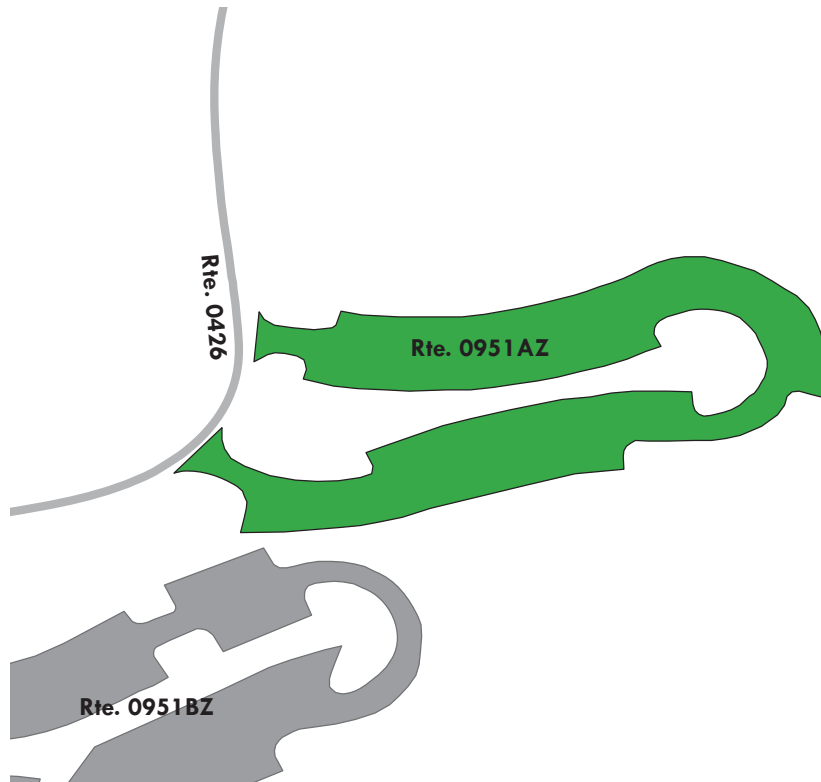
ROUTE 0951AZ: UPPER GENERAL SHERMAN TREE RV PARKING

Inspection Date	FMSS Number	User Access	Surface Type
9/25/2014	73926	PUBLIC	ASPHALT
Area (Sq. Ft.)	Lane Miles (11' Widths)	Curb Reveal (Inches)	Curb Recommendation
46,652	0.803	6	DO NOTHING
Curb Type		Curb & Gutter Type	
STONE		NO CURB AND GUTTER	
Pavement Recommendation		Condition Rating / PCR	
PREVENTIVE MAINTENANCE		GOOD / 90

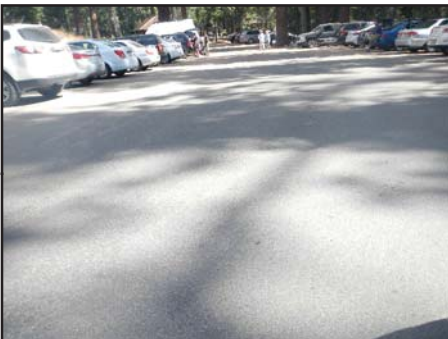
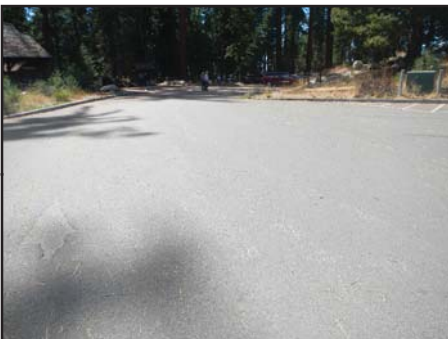
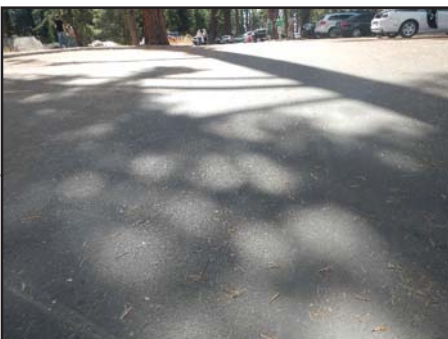
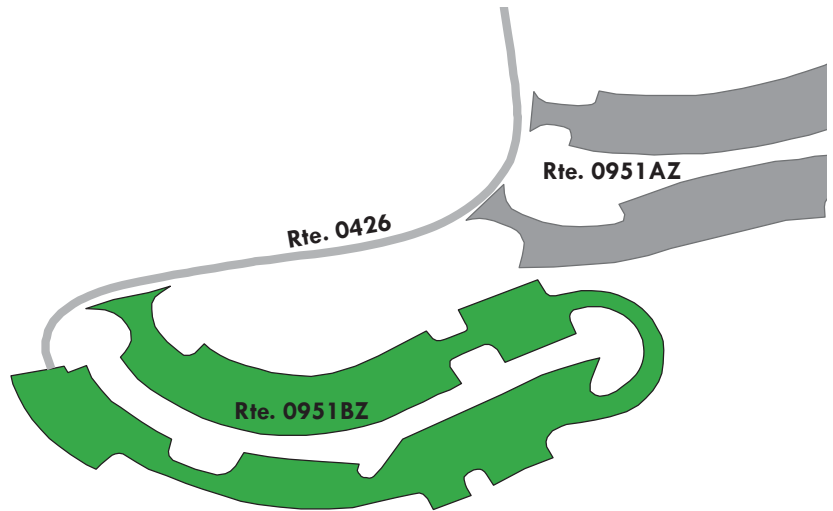
Inspection Date	FMSS Number	User Access	Surface Type
9/25/2014	73926	PUBLIC	ASPHALT
Area (Sq. Ft.)	Lane Miles (11' Widths)	Curb Reveal (Inches)	Curb Recommendation
63,702	1.097	5	LIGHT REPAIR
Curb Type		Curb & Gutter Type	
STONE		NO CURB AND GUTTER	
Pavement Recommendation		Condition Rating / PCR	
PREVENTIVE MAINTENANCE		GOOD / 90

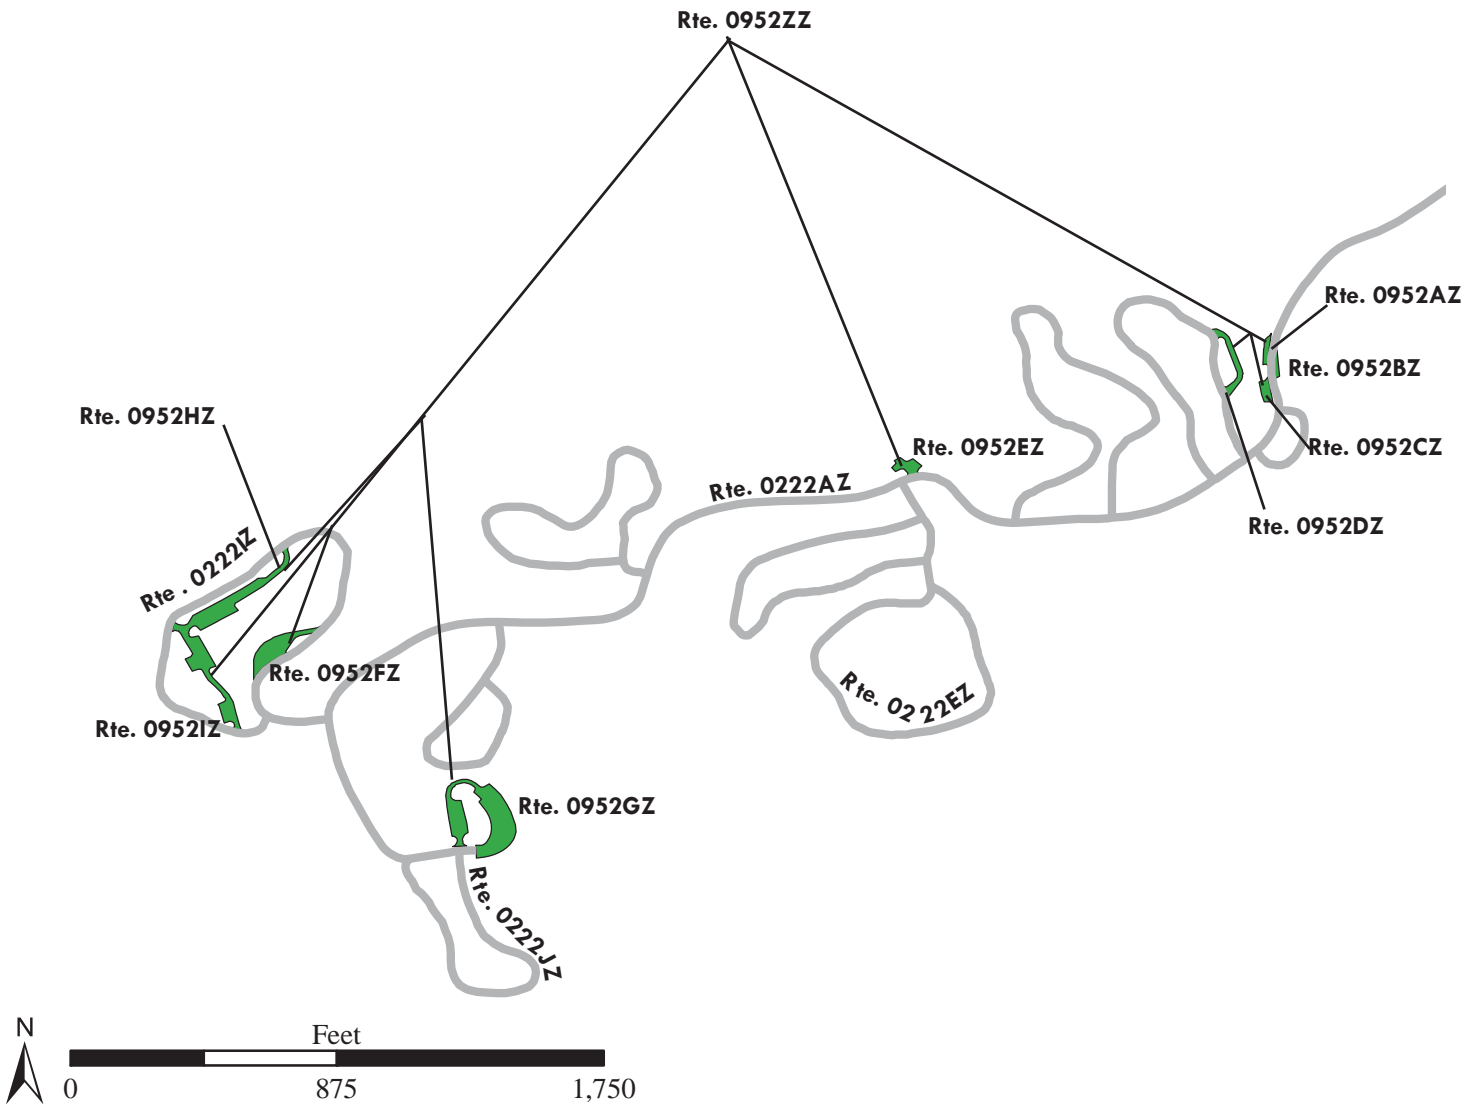
ROUTE 0952ZZ: DORST CAMPGROUND PARKING AREAS

Inspection Date	FMSS Number	User Access	Surface Type
9/24/2014	N/A	PUBLIC	ASPHALT
Area (Sq. Ft.)	Lane Miles (11' Widths)	Condition Rating / PCR	
64,627	1.112	SUMMARY / 90

The condition shown on this page reflects the overall route condition and may not reflect individual subcomponent ratings.

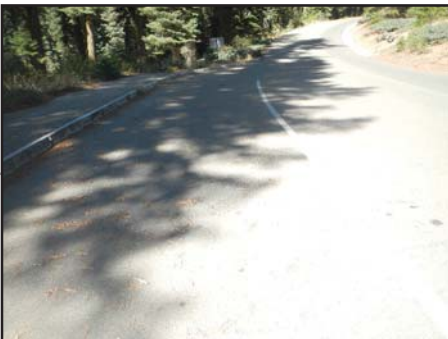
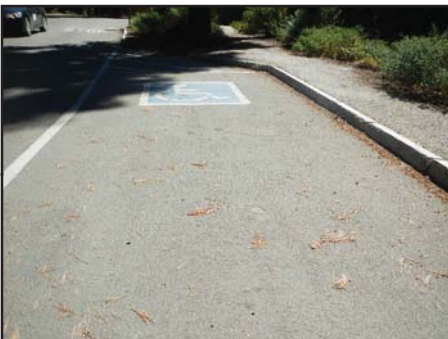
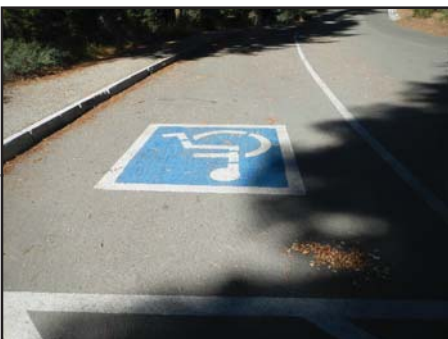
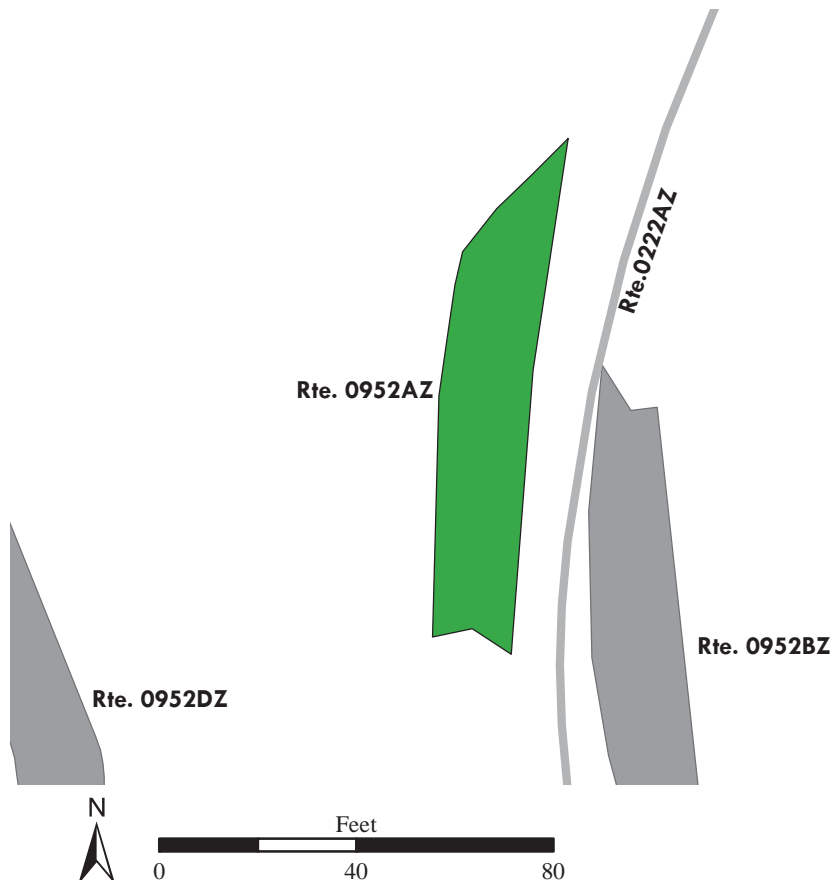
ROUTE 0952AZ: DORST CAMPGROUND PARKING A

Inspection Date	FMSS Number	User Access	Surface Type
9/24/2014	N/A	PUBLIC	ASPHALT
Area (Sq. Ft.)	Lane Miles (11' Widths)	Curb Reveal (Inches)	Curb Recommendation
1,297	0.022	6	DO NOTHING
Curb Type		Curb & Gutter Type	
STONE		NO CURB AND GUTTER	
Pavement Recommendation		Condition Rating / PCR	
PREVENTIVE MAINTENANCE		GOOD / 90

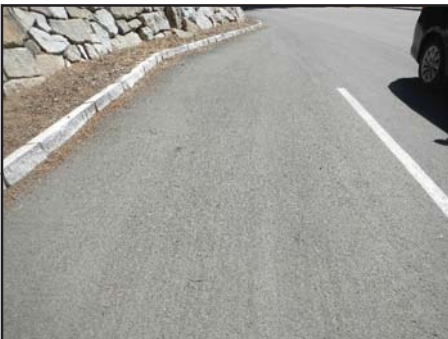
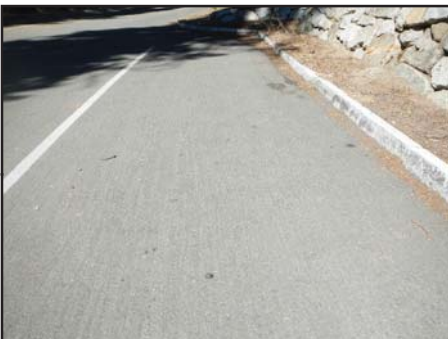
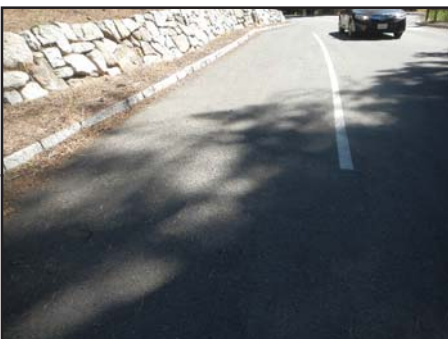
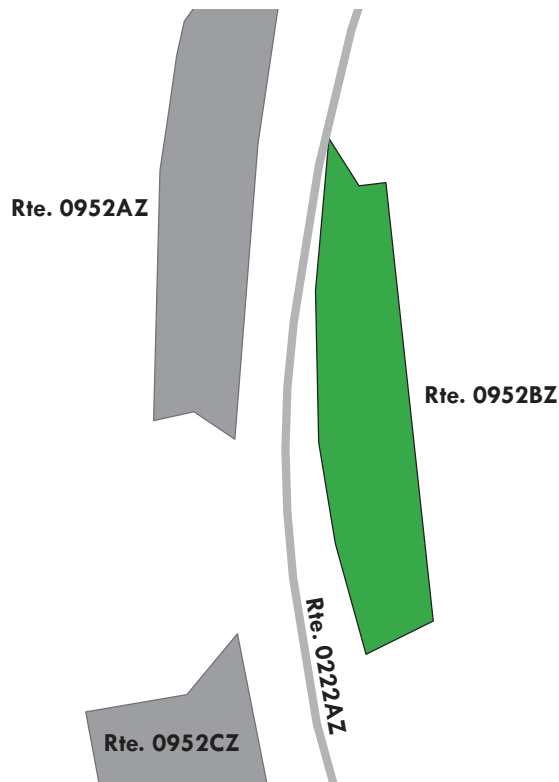
ROUTE 0952BZ: DORST CAMPGROUND PARKING B

Inspection Date	FMSS Number	User Access	Surface Type
9/24/2014	N/A	PUBLIC	ASPHALT
Area (Sq. Ft.)	Lane Miles (11' Widths)	Curb Reveal (Inches)	Curb Recommendation
1,201	0.021	4	DO NOTHING
Curb Type		Curb & Gutter Type	
STONE		NO CURB AND GUTTER	
Pavement Recommendation		Condition Rating / PCR	
PREVENTIVE MAINTENANCE		GOOD / 90

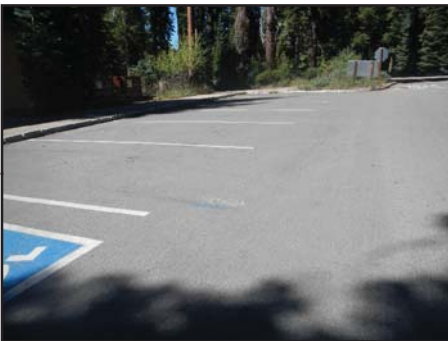
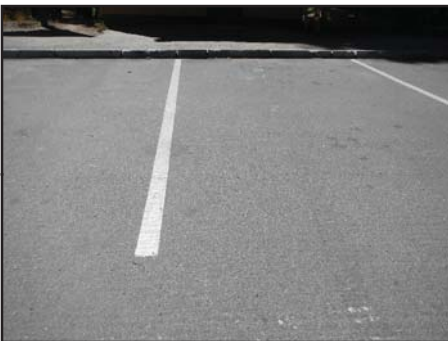
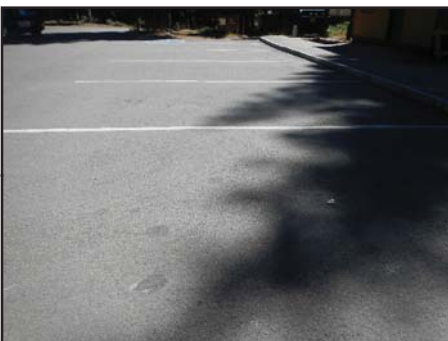
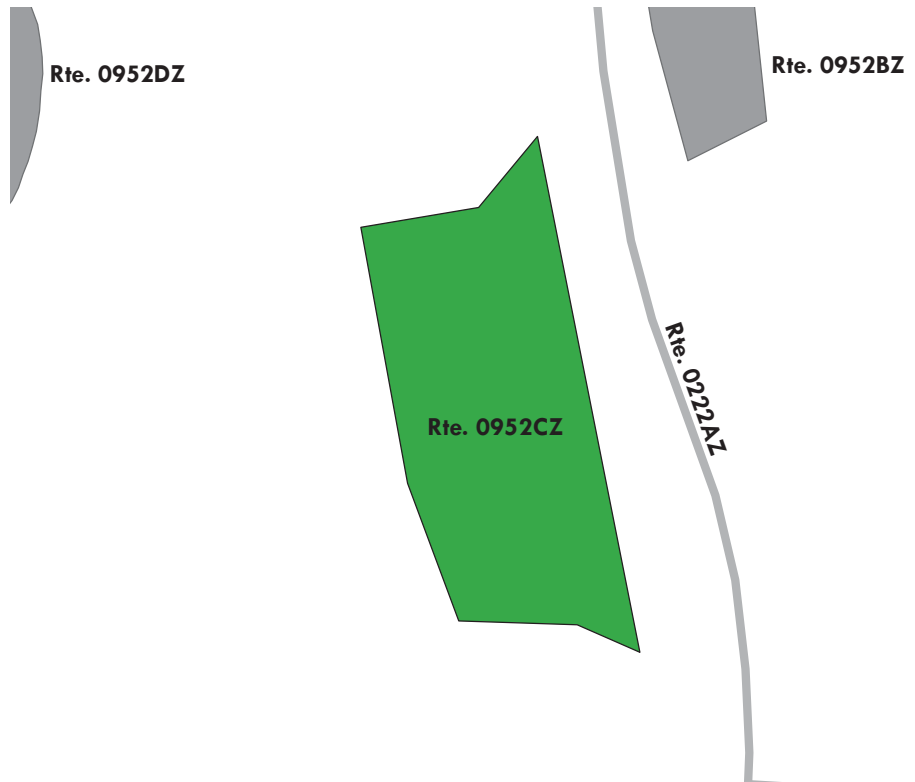
ROUTE 0952CZ: DORST CAMPGROUND PARKING C

Inspection Date	FMSS Number	User Access	Surface Type
9/24/2014	N/A	PUBLIC	ASPHALT
Area (Sq. Ft.)	Lane Miles (11' Widths)	Curb Reveal (Inches)	Curb Recommendation
1,867	0.032	4	DO NOTHING
Curb Type		Curb & Gutter Type	
STONE		NO CURB AND GUTTER	
Pavement Recommendation		Condition Rating / PCR	
PREVENTIVE MAINTENANCE		GOOD / 90

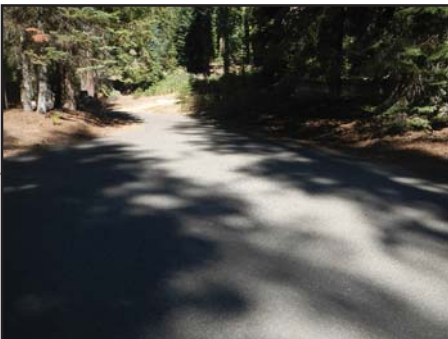
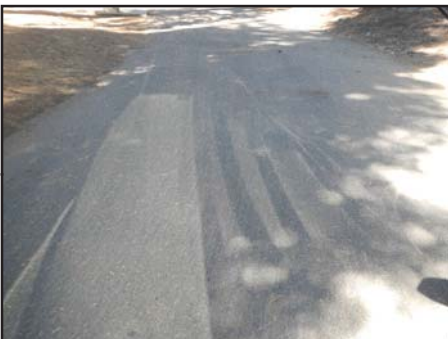
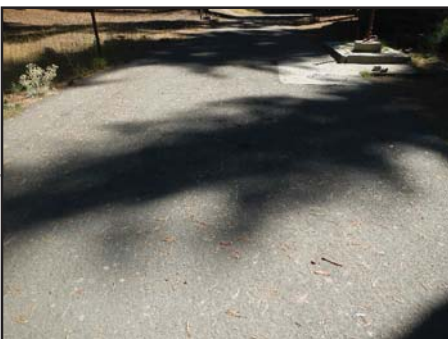
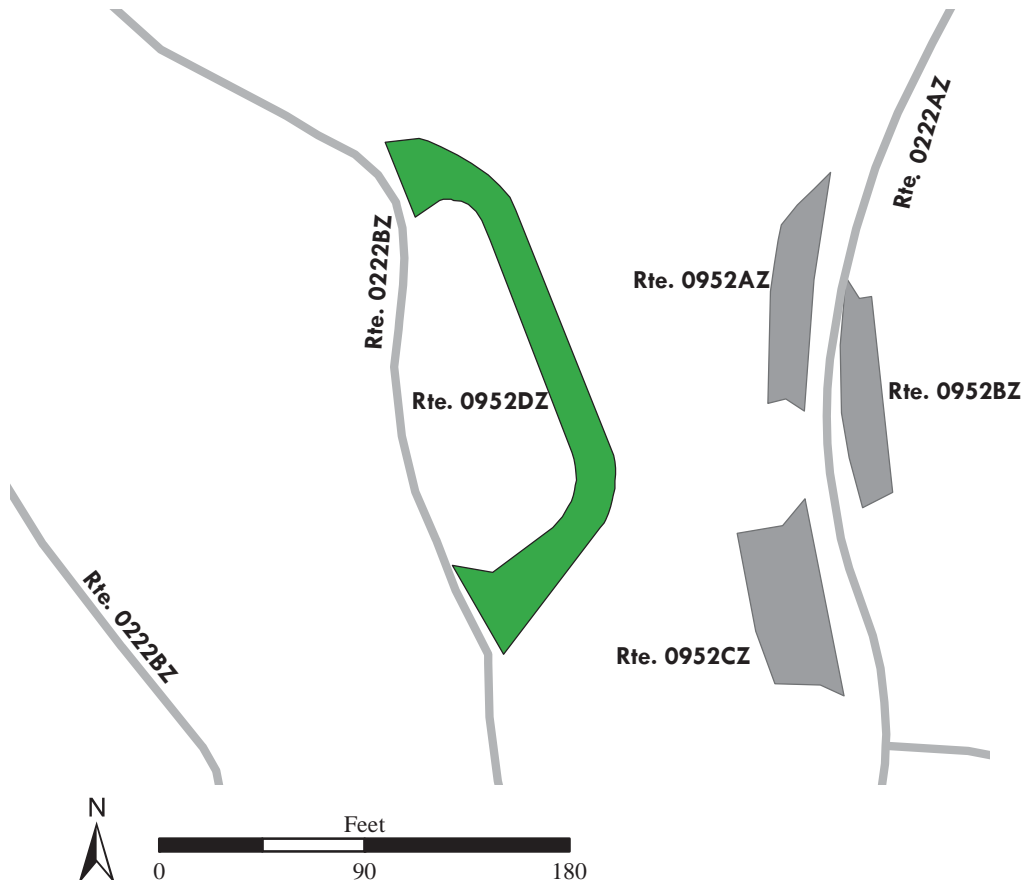
ROUTE 0952DZ: DORST CAMPGROUND DUMP STATION

Inspection Date	FMSS Number	User Access	Surface Type
9/24/2014	N/A	PUBLIC	ASPHALT
Area (Sq. Ft.)	Lane Miles (11' Widths)	Curb Reveal (Inches)	Curb Recommendation
3,936	0.068	NOT APPLICABLE	NOT APPLICABLE
Curb Type		Curb & Gutter Type	
NO CURB		NO CURB AND GUTTER	
Pavement Recommendation		Condition Rating / PCR	
PREVENTIVE MAINTENANCE		GOOD / 90
