Road Inventory and Condition Assessment of Paved Routes Sequoia National Park

**Federal Lands Highway
Road Inventory Program**

Federal Highway Administration
Eastern Federal Lands Highway Division
Road Inventory Program (RIP)

Report Date: January 2016

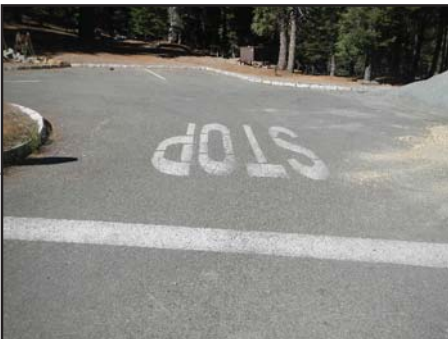
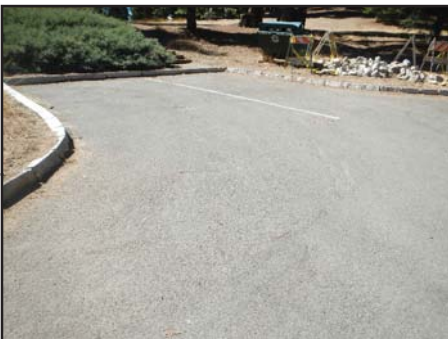
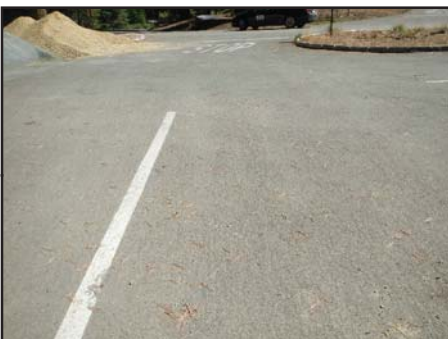
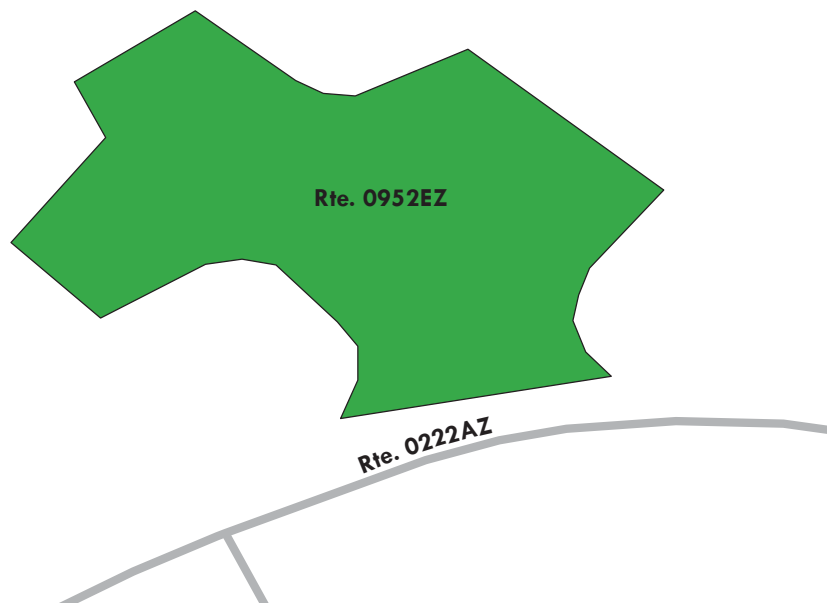
ROUTE 0952EZ: DORST CAMPGROUND PARKING E

Inspection Date	FMSS Number	User Access	Surface Type
9/24/2014	N/A	PUBLIC	ASPHALT
Area (Sq. Ft.)	Lane Miles (11' Widths)	Curb Reveal (Inches)	Curb Recommendation
2,727	0.047	4	DO NOTHING
Curb Type		Curb & Gutter Type	
STONE		NO CURB AND GUTTER	
Pavement Recommendation		Condition Rating / PCR	
PREVENTIVE MAINTENANCE		GOOD / 90

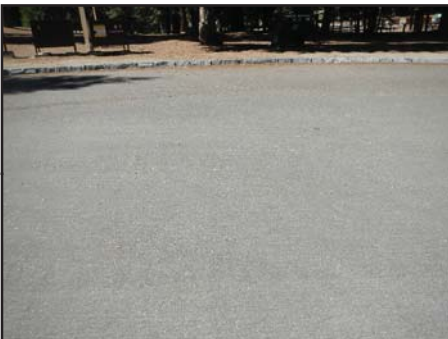
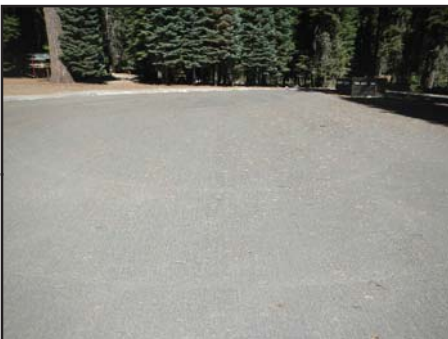
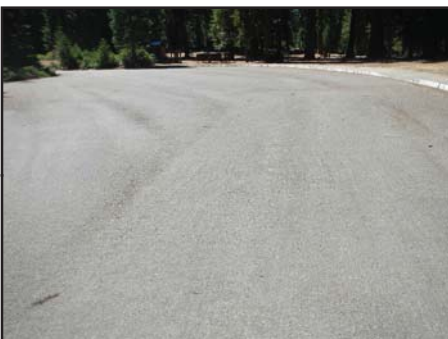
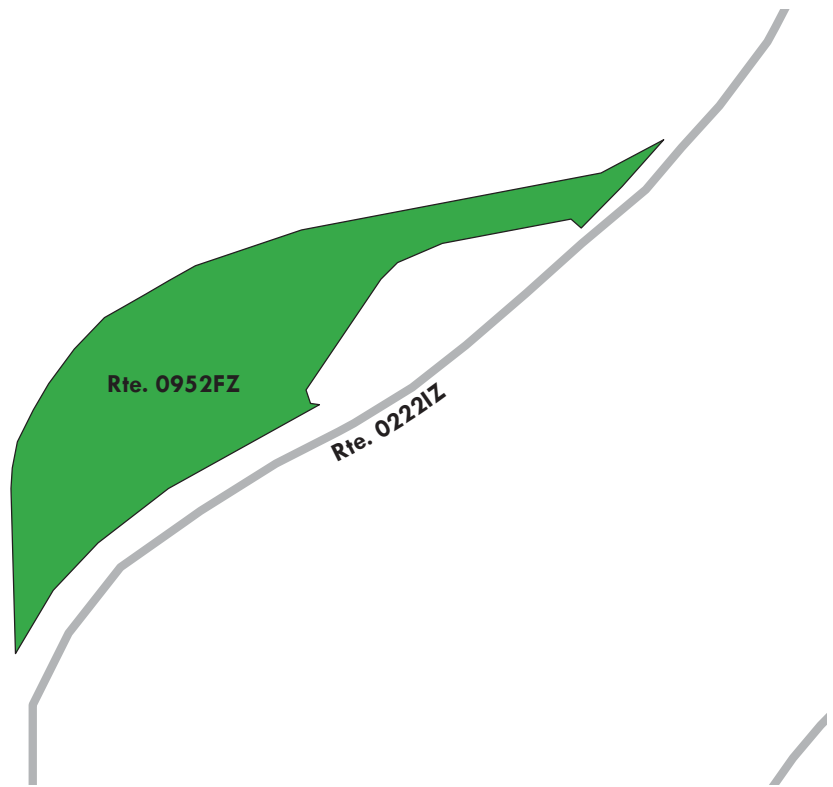
ROUTE 0952FZ: DORST CAMPGROUND PARKING F

Inspection Date	FMSS Number	User Access	Surface Type
9/24/2014	N/A	PUBLIC	ASPHALT
Area (Sq. Ft.)	Lane Miles (11' Widths)	Curb Reveal (Inches)	Curb Recommendation
8,265	0.142	7	DO NOTHING
Curb Type		Curb & Gutter Type	
STONE		NO CURB AND GUTTER	
Pavement Recommendation		Condition Rating / PCR	
PREVENTIVE MAINTENANCE		GOOD / 90

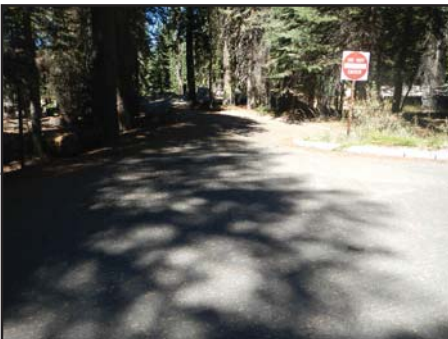
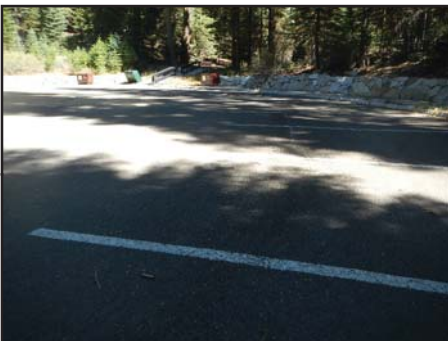
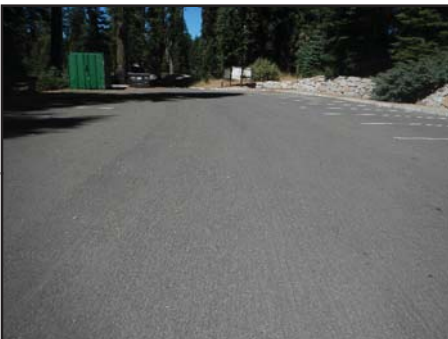
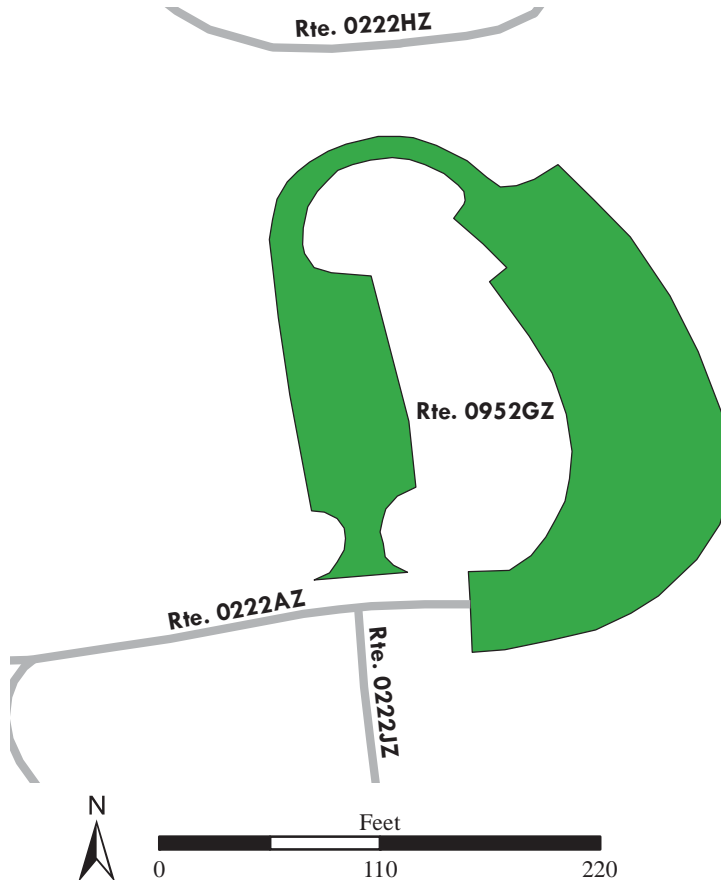
ROUTE 0952GZ: DORST CAMPGROUND AMPHITHEATER PARKING

Inspection Date	FMSS Number	User Access	Surface Type
9/24/2014	N/A	PUBLIC	ASPHALT
Area (Sq. Ft.)	Lane Miles (11' Widths)	Curb Reveal (Inches)	Curb Recommendation
21,860	0.376	4	DO NOTHING
Curb Type		Curb & Gutter Type	
STONE		NO CURB AND GUTTER	
Pavement Recommendation		Condition Rating / PCR	
PREVENTIVE MAINTENANCE		GOOD / 90

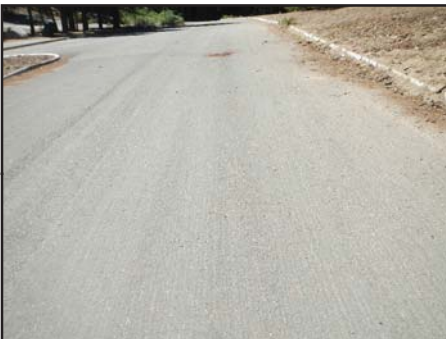
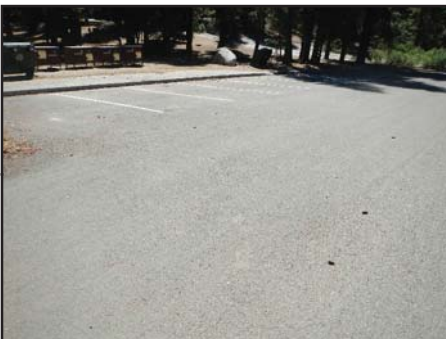
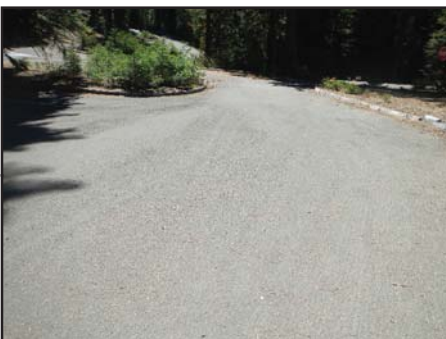
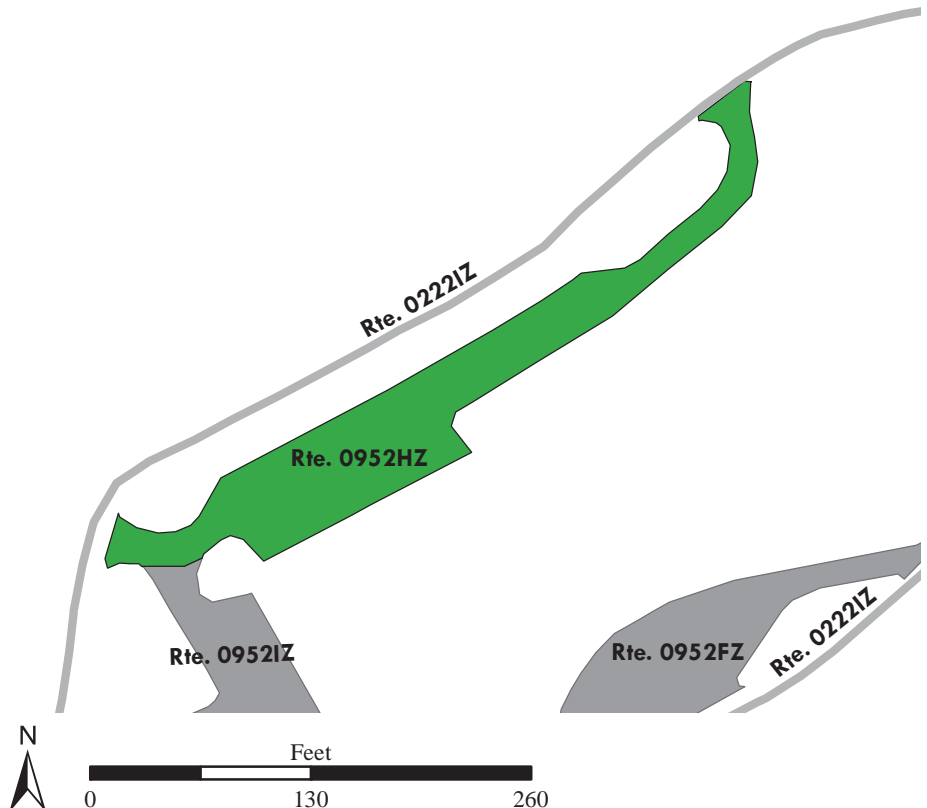
ROUTE 0952HZ: DORST CAMPGROUND GROUP PARKING H

Inspection Date	FMSS Number	User Access	Surface Type
9/24/2014	N/A	PUBLIC	ASPHALT
Area (Sq. Ft.)	Lane Miles (11' Widths)	Curb Reveal (Inches)	Curb Recommendation
12,737	0.219	6	DO NOTHING
Curb Type		Curb & Gutter Type	
STONE		NO CURB AND GUTTER	
Pavement Recommendation		Condition Rating / PCR	
PREVENTIVE MAINTENANCE		GOOD / 90

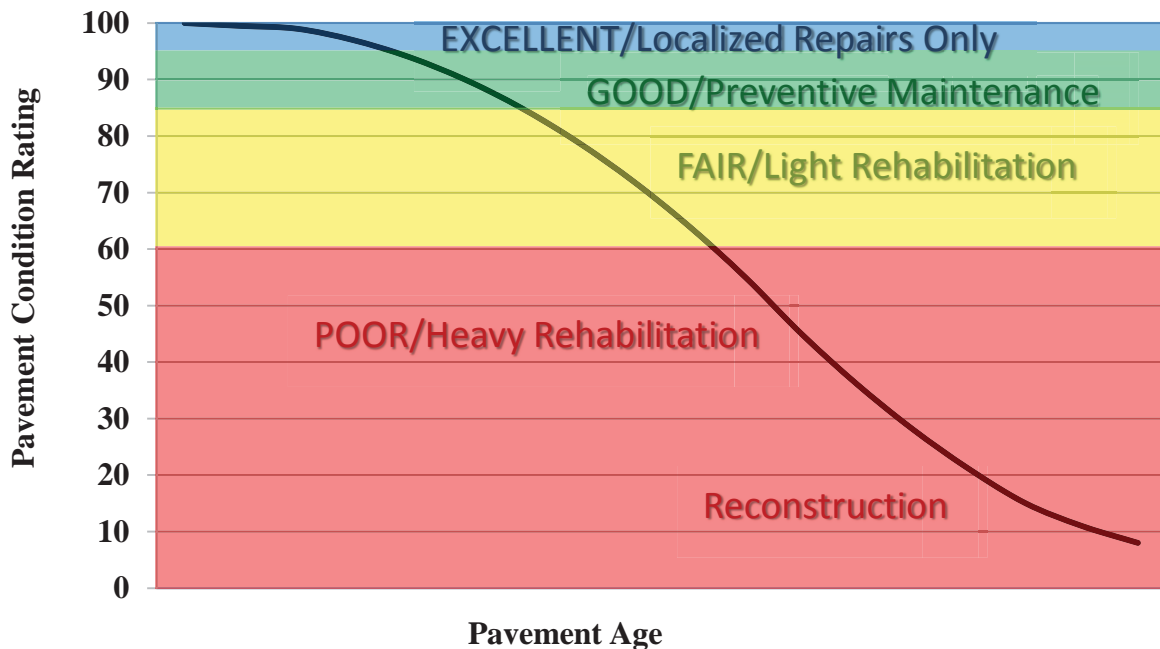
Condition Categories and Treatments

Description of Pavement Treatment Types

1. **Preventive Maintenance** is a planned strategy of cost-effective treatments to an existing roadway system and its appurtenances that preserves the system, retards future deterioration, and maintains or improves the functional condition of the system (without significantly increasing the structural capacity). Preventive maintenance is typically applied to pavements in good condition having significant remaining service life. As a major component of pavement preservation, preventive maintenance is a strategy of extending the service life by applying cost-effective treatments to the surface or near-surface of structurally sound pavements. Examples of preventive treatments include asphalt crack sealing, chip sealing, slurry or micro-surfacing, thin and ultra-thin hot-mix asphalt overlay, concrete joint sealing, diamond grinding, dowel-bar retrofit, and isolated, partial and/or full-depth concrete repairs to restore functionality of individual slabs.
