VICK Cycle 6

Final Report

Road Inventory and Condition Assessment of Paved Routes Vicksburg National Military Park

**Federal Highway Administration
Eastern Federal Lands Highway Division
Road Inventory Program (RIP)**

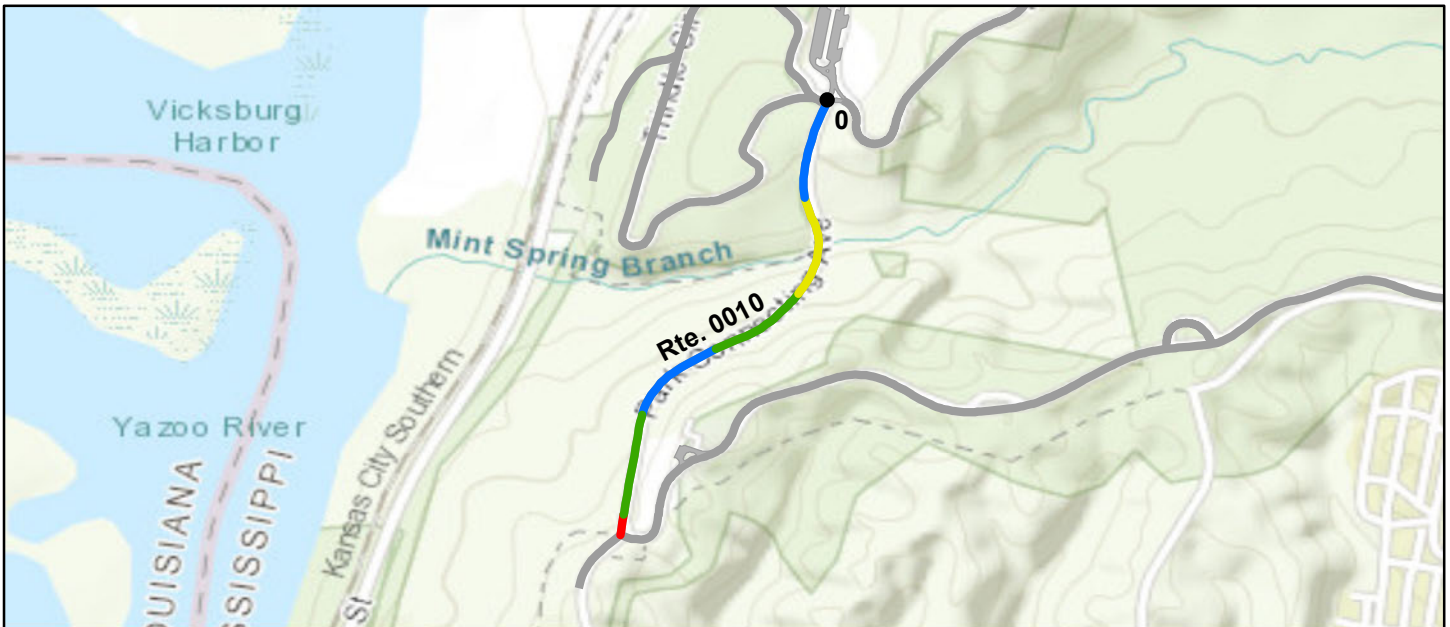
ROUTE 0010: CONNECTING AVENUE

Data Collection Vehicle (DCV) Rating

Colors on map represent condition scores at 0.10-mile intervals. See Appendix for definitions and formulas.

Inspection Date: 5/7/2019	Beginning Section MP	0				
Paved Length (Miles): 0.52	Section Length (MI)	0.52				
Surface Type: ASPHALT	Route Summary					
Roadway Condition Information						
Pavement Condition Rating (PCR)	91	91				
Surface Condition Rating (SCR)	95	95				
Roughness Condition Index (RCI)	84	84				
Distress Index Values						
Structural Crack Index	98	98				
Alligator Crack Index	100	100				
Longitudinal Crack Index	98	98				
Transverse Cracking Index	95	95				
Patching Index	100	100				
Rutting Index	99	99				
International Roughness Index (IRI)	157	157				
Lane & Width Information						
Number of Lanes	2	2				
Paved Width (ft)	20.5	20.5				
Lane Width (ft)	9.8	9.8

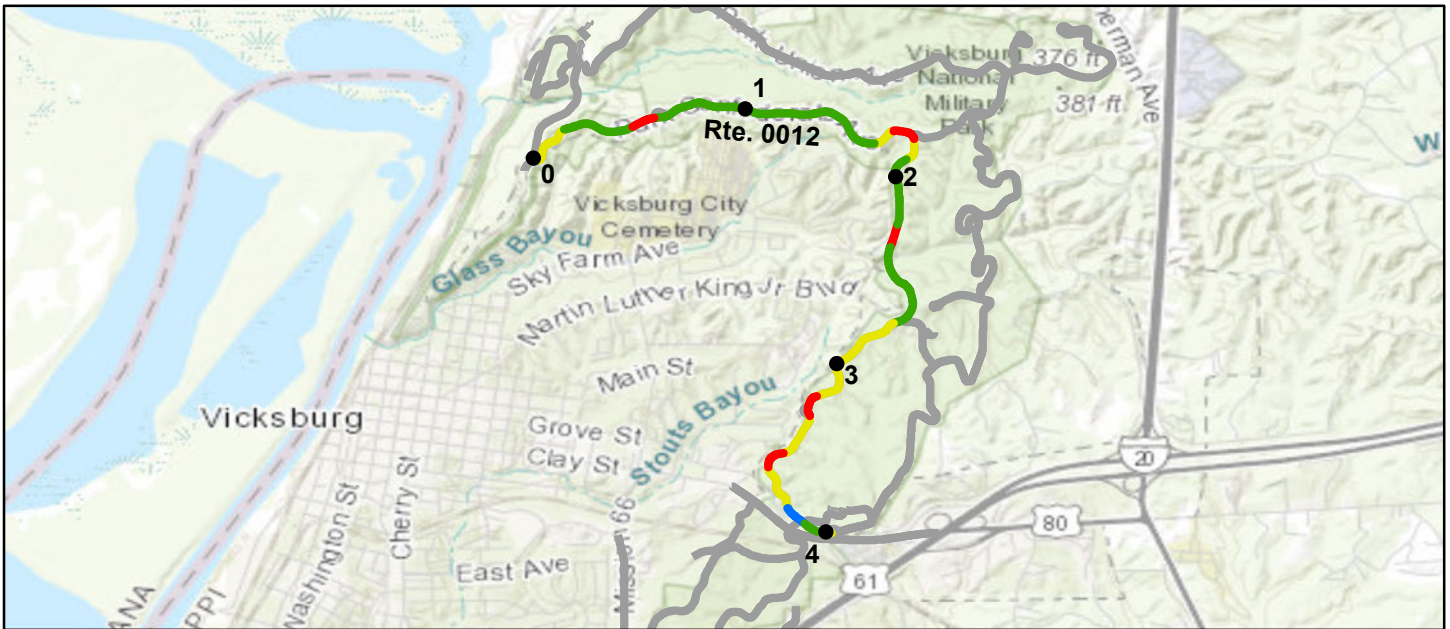
ROUTE 0012: CONFEDERATE AVENUE

Manual Rating

Colors on map represent condition scores at 0.10-mile intervals. See Appendix for definitions and formulas.

Inspection Date:	5/7/2019	Beginning Section MP	0	1	2	3	4
Paved Length (Miles):	4.05	Section Length (MI)	1	1	1	1	0.05
Surface Type:	CONCRETE	Route Summary					
Roadway Condition Information							
Pavement Condition Rating (PCR)	81	84	85	83	75	80	
Surface Condition Rating (SCR)	70	N/A	N/A	75	65	80	
Roughness Condition Index (RCI)	N/A	27	58	53	89	N/A	
Distress Index Values							
Structural Crack Index	86	N/A	N/A	82	86	93	
Alligator Crack Index	100	N/A	N/A	100	100	100	
Longitudinal Crack Index	86	N/A	N/A	82	86	93	
Transverse Cracking Index	70	N/A	N/A	75	65	80	
Patching Index	100	N/A	N/A	100	100	100	
Rutting Index	99	N/A	N/A	98	99	99	
International Roughness Index (IRI)	232	268	249	267	143	N/A	
Lane & Width Information							
Number of Lanes	1	1	1	1	1	1	
Paved Width (ft)	19.6	20.3	20.3	19	18.9	21	
Lane Width (ft)	19.1	18.8	20.3	19	18.4	21

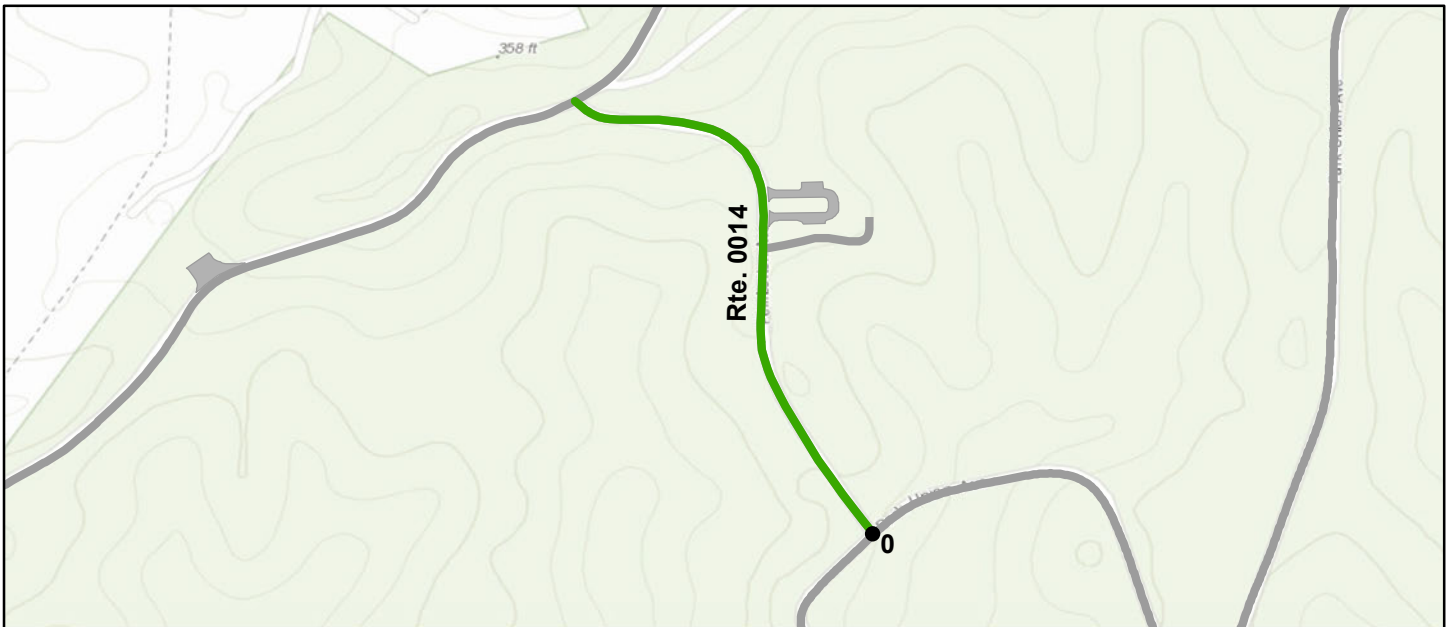
ROUTE 0014: PEMBERTON AVENUE

Manual Rating

Route Condition Legend – Pavement Condition Rating (PCR)							
Poor (0 - 60)		Fair (61- 84)		Good (85 - 94)		Excellent (95 - 100)	Not Rated
Colors on map represent condition scores at 0.10-mile intervals. See Appendix for definitions and formulas.							
Inspection Date:	5/7/2019	Beginning Section MP	0				
Paved Length (Miles):	0.27	Section Length (MI)	0.27				
Surface Type:	CONCRETE	Route Summary					
Roadway Condition Information							
Pavement Condition Rating (PCR)		89	89				
Surface Condition Rating (SCR)		N/A	N/A				
Roughness Condition Index (RCI)		N/A	N/A				
Distress Index Values							
Structural Crack Index		N/A	N/A				
Alligator Crack Index		N/A	N/A				
Longitudinal Crack Index		N/A	N/A				
Transverse Cracking Index		N/A	N/A				
Patching Index		N/A	N/A				
Rutting Index		N/A	N/A				
International Roughness Index (IRI)		N/A	N/A				
Lane & Width Information							
Number of Lanes		2	2				
Paved Width (ft)		18	18

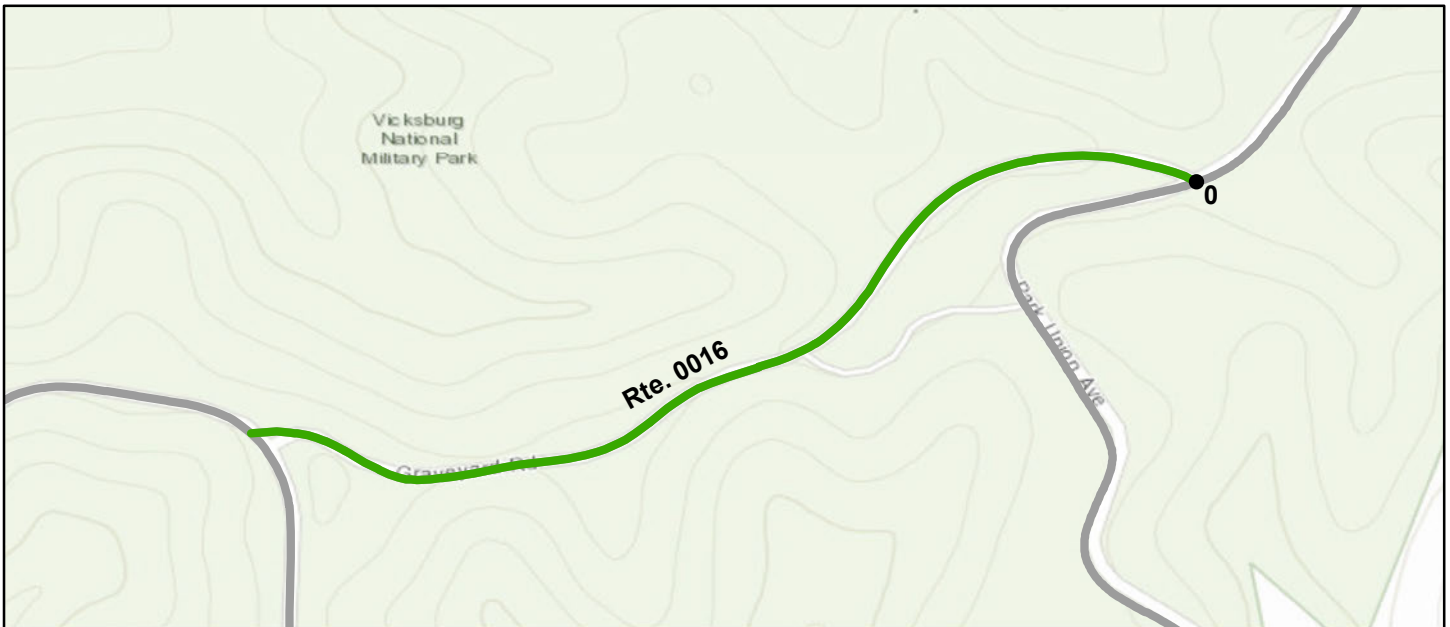
ROUTE 0016: OLD GRAVEYARD ROAD

Data Collection Vehicle (DCV) Rating

Colors on map represent condition scores at 0.10-mile intervals. See Appendix for definitions and formulas.

Inspection Date: 5/7/2019	Beginning Section MP	0				
Paved Length (Miles): 0.33	Section Length (MI)	0.33				
Surface Type: ASPHALT	Route Summary					
Roadway Condition Information						
Pavement Condition Rating (PCR)	89	89				
Surface Condition Rating (SCR)	89	89				
Roughness Condition Index (RCI)	N/A	N/A				
Distress Index Values						
Structural Crack Index	98	98				
Alligator Crack Index	100	100				
Longitudinal Crack Index	98	98				
Transverse Cracking Index	89	89				
Patching Index	100	100				
Rutting Index	99	99				
International Roughness Index (IRI)	N/A	N/A				
Lane & Width Information						
Number of Lanes	2	2				
Paved Width (ft)	19.2	19.2				
Lane Width (ft)	9.2	9.2

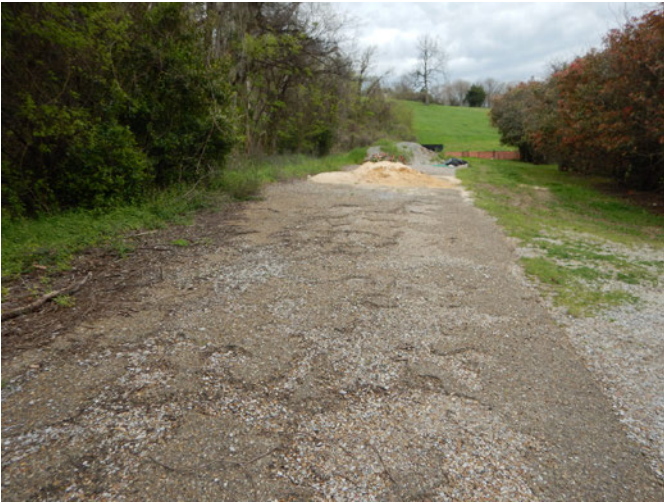
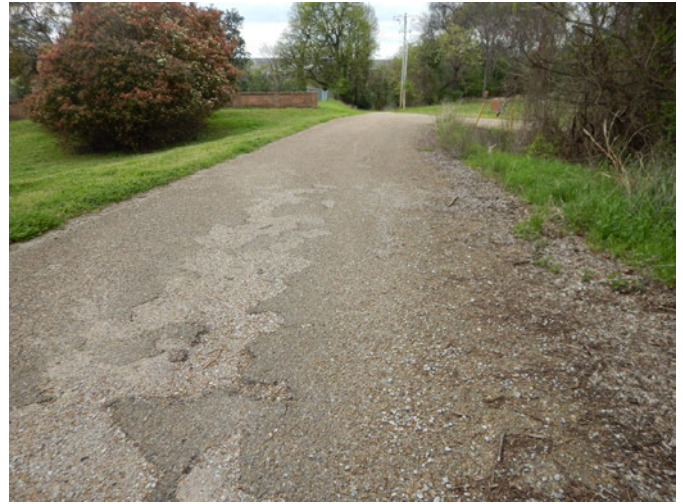
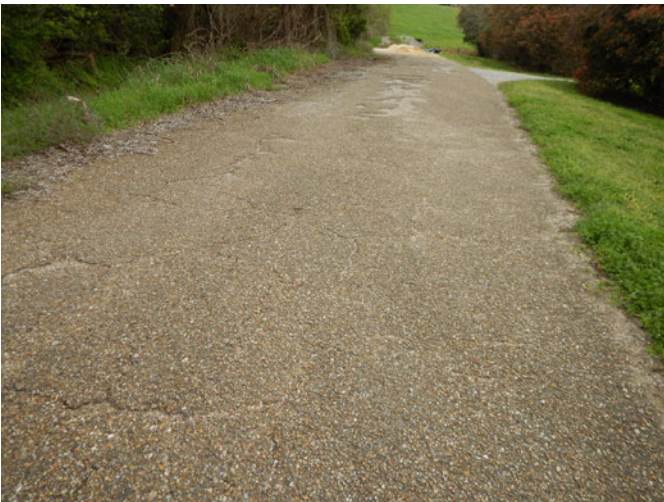
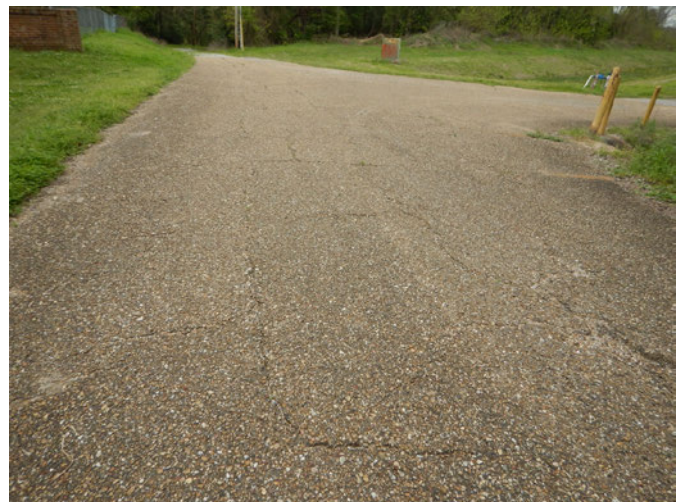
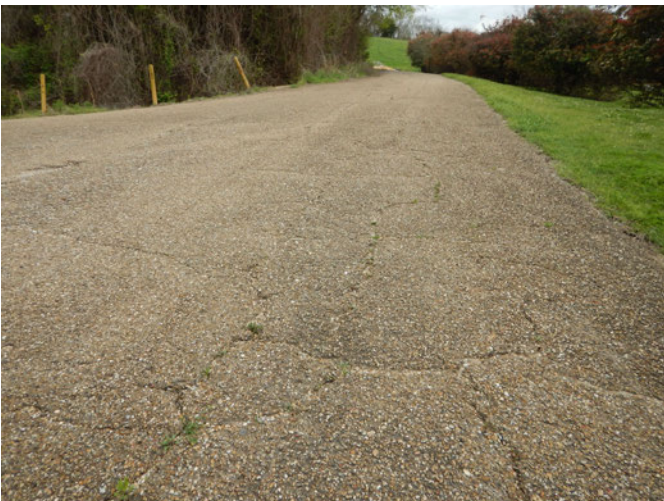
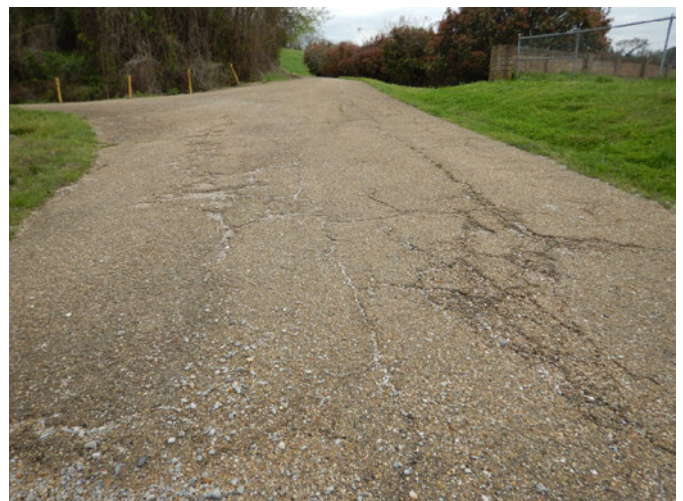
Condition Photos

Condition photos are shown only for manually rated roads. Use the PathView program to see images of DCV rated roads.

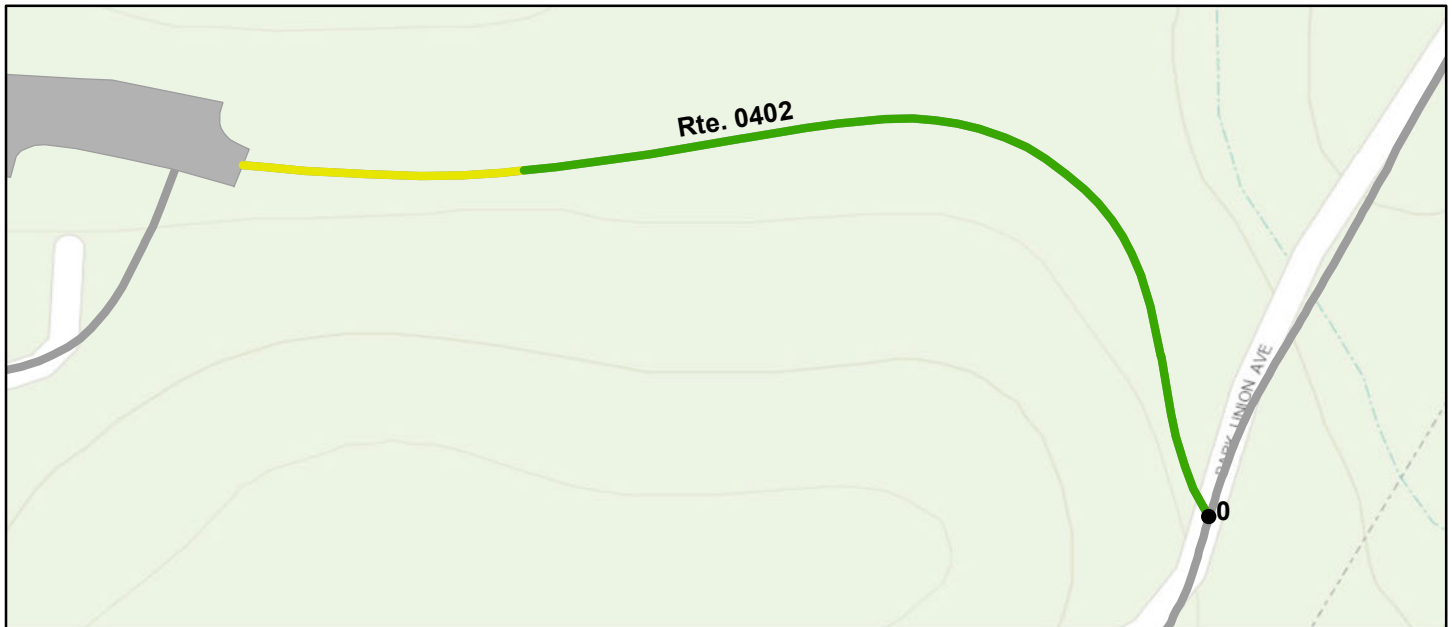
ROUTE 0402: MAINTENANCE ACCESS ROAD

Data Collection Vehicle (DCV) Rating

Route Condition Legend – Pavement Condition Rating (PCR)						
Poor (0 - 60)	Fair (61- 84)	Good (85 - 94)	Excellent (95 - 100)	Not Rated		
Colors on map represent condition scores at 0.10-mile intervals. See Appendix for definitions and formulas.						
Inspection Date: 5/7/2019	Beginning Section MP	0				
Paved Length (Miles): 0.13	Section Length (MI)	0.13				
Surface Type: ASPHALT	Route Summary					
Roadway Condition Information						
Pavement Condition Rating (PCR)	87	87				
Surface Condition Rating (SCR)	87	87				
Roughness Condition Index (RCI)	N/A	N/A				
Distress Index Values						
Structural Crack Index	87	87				
Alligator Crack Index	99	99				
Longitudinal Crack Index	88	88				
Transverse Cracking Index	92	92				
Patching Index	100	100				
Rutting Index	95	95				
International Roughness Index (IRI)	N/A	N/A				
Lane & Width Information						
Number of Lanes	2	2				
Paved Width (ft)	21.5	21.5				
Lane Width (ft)	11	11

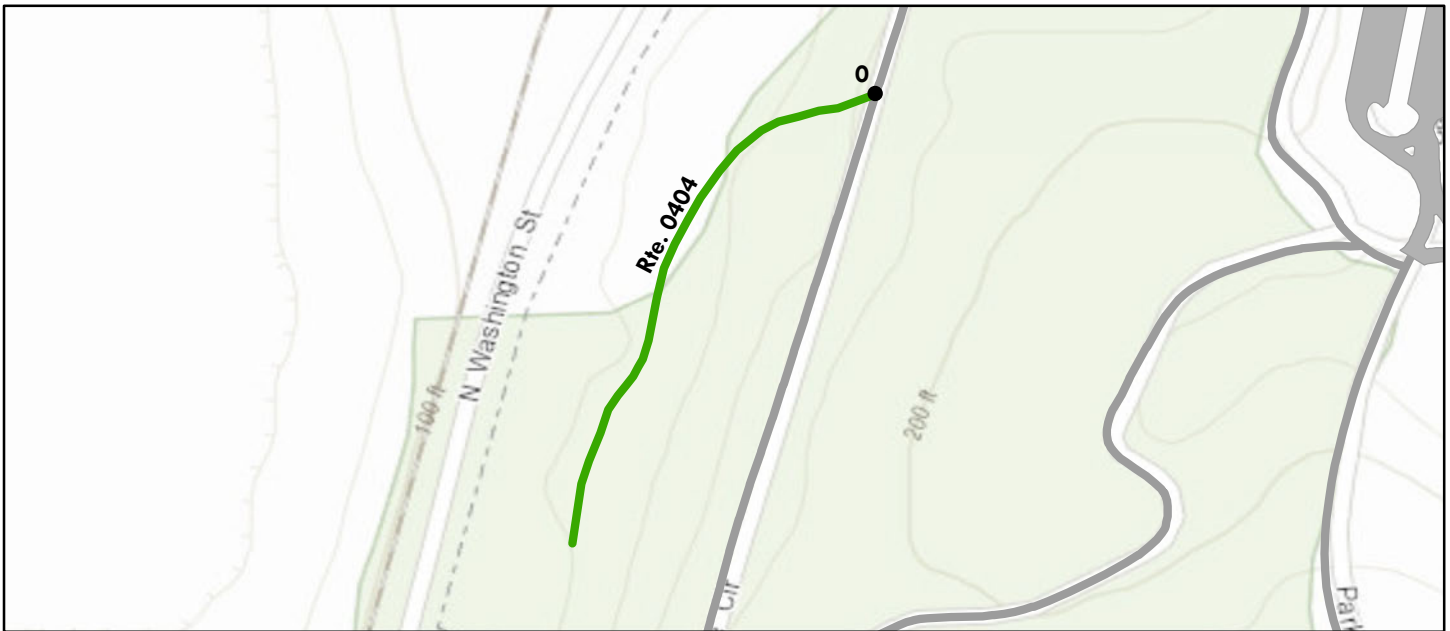
ROUTE 0404: CEMETERY MAINTENANCE ROAD

Manual Rating

Inspection Date: 3/18/2018	Beginning Section MP	0.00				
Paved Length (Miles): 0.15	Section Length (MI)	0.15				
Surface Type: ASPHALT	Route Summary					
Roadway Condition Information						
Pavement Condition Rating (PCR)	90	90				
Surface Condition Rating (SCR)	90	90				
Roughness Condition Index (RCI)	N/A	N/A				
Distress Index Values						
Structural Crack Index	N/A	N/A				
Alligator Crack Index	97	97				
Longitudinal Crack Index	97	97				
Transverse Cracking Index	90	90				
Patching Index	97	97				
Rutting Index	90	90				
International Roughness Index (IRI)	N/A	N/A				
Lane & Width Information						
Number of Lanes	1	1				
Paved Width (ft)	14	14				
Lane Width (ft)	14	14

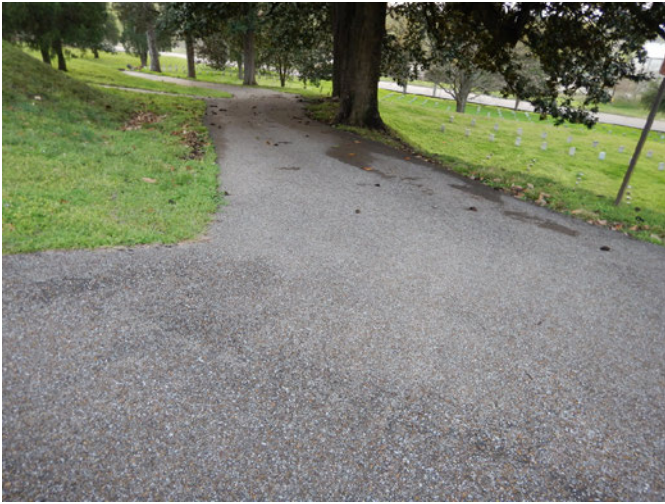
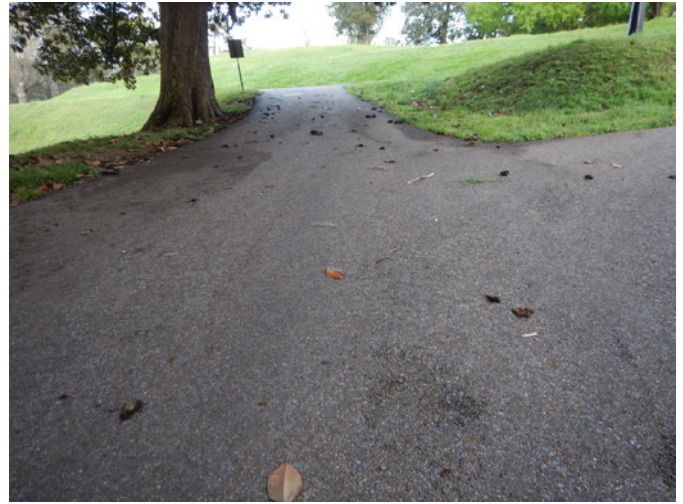
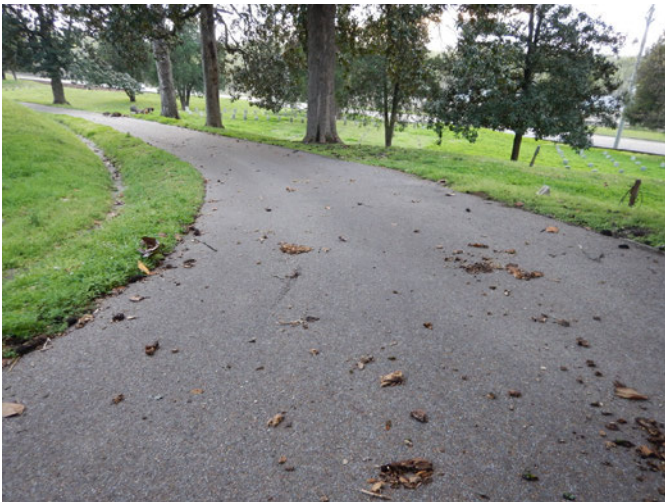
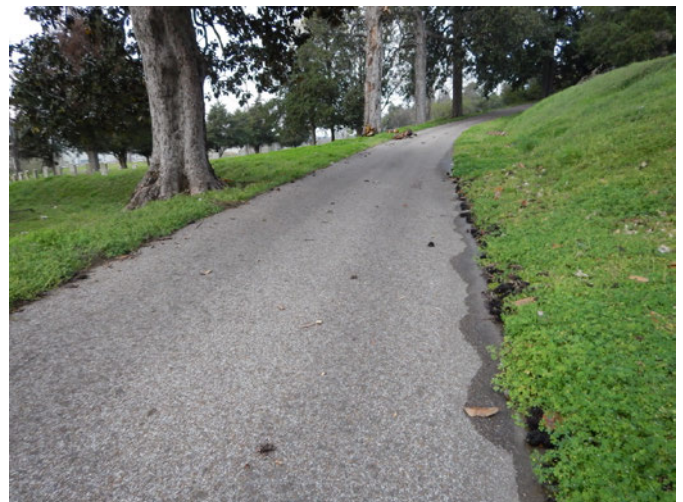
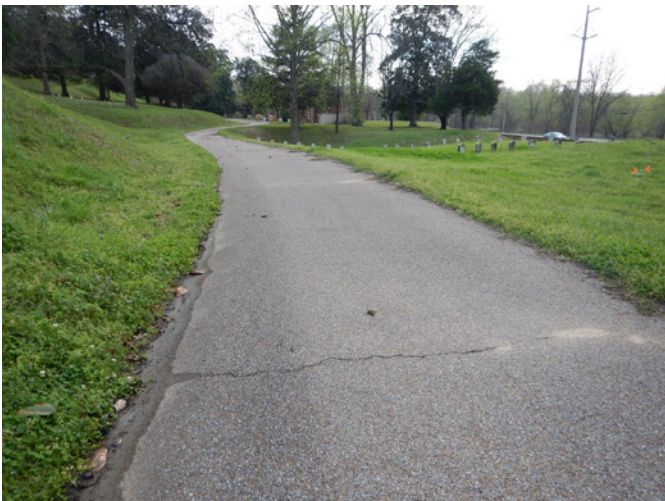
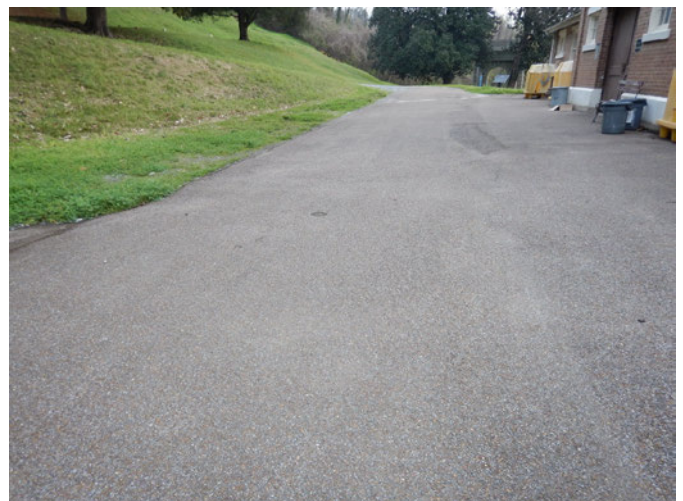
Condition Photos

Condition photos are shown only for manually rated roads. Use the PathView program to see images of DCV rated roads.

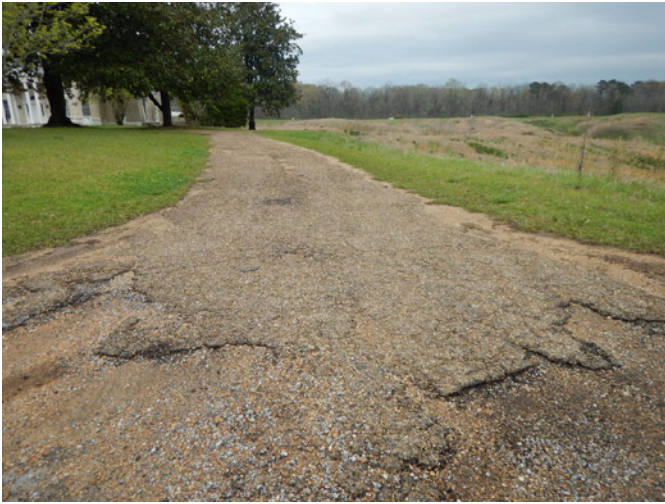
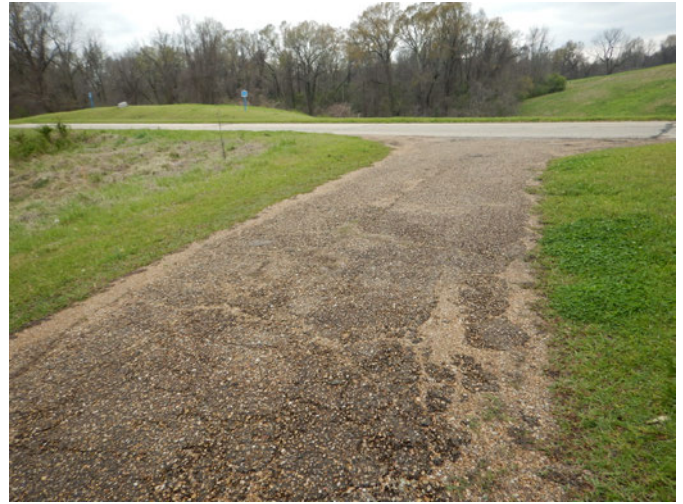
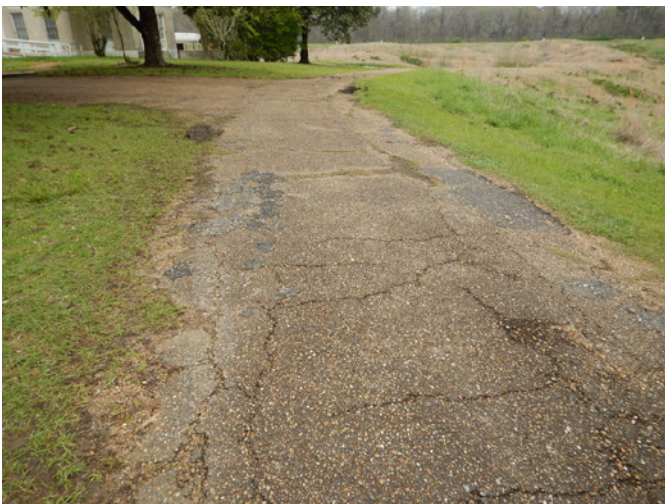
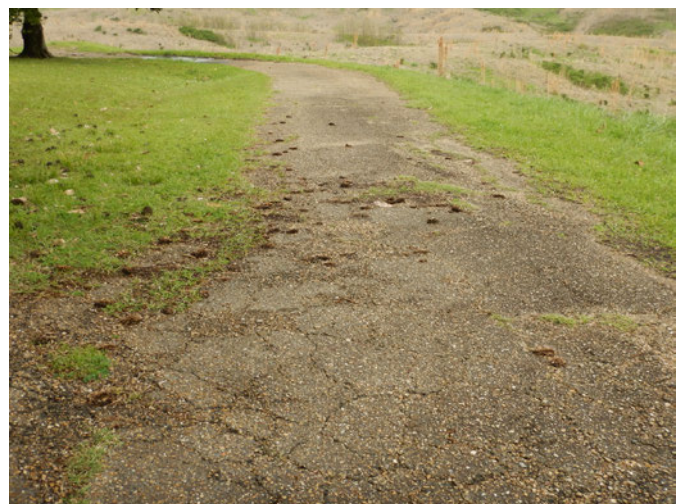
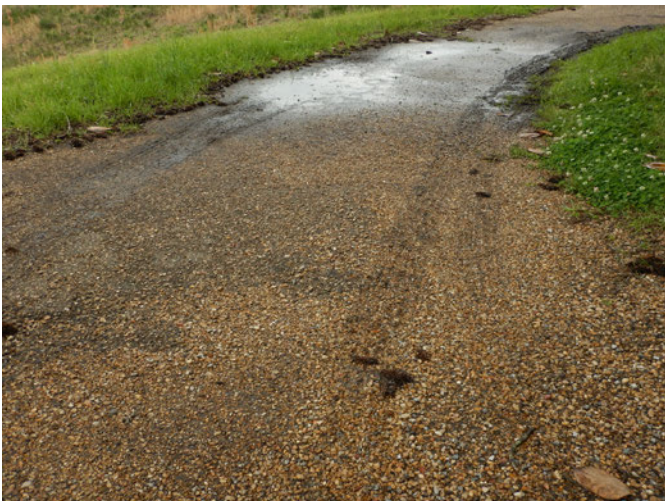
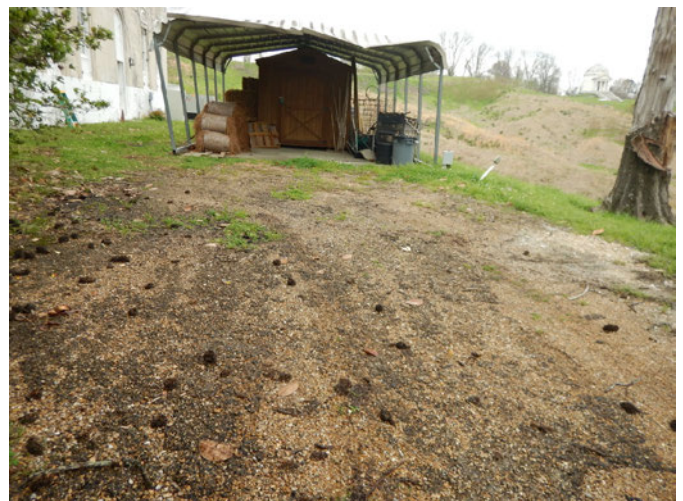
Condition Photos

Condition photos are shown only for manually rated roads. Use the PathView program to see images of DCV rated roads.

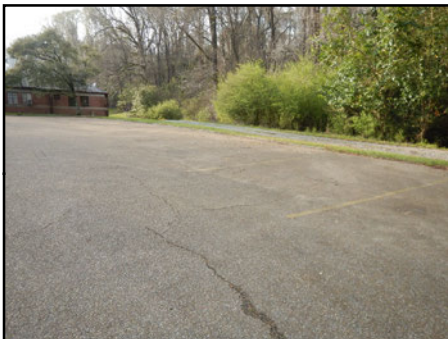
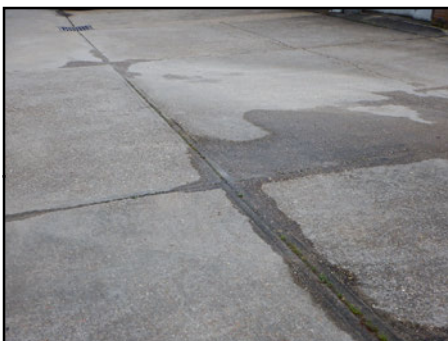
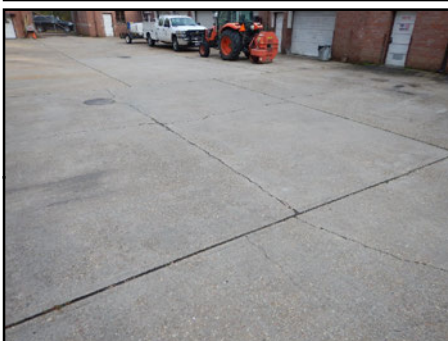
Inspection Date	FMSS Number	User Access	Surface Type
3/18/2018	74957	NONPUBLIC	CONCRETE
Area (Sq. Ft.)	Lane Miles (11' Widths)	Curb Reveal (Inches)	Curb Recommendation
18,195	0.313	5	DO NOTHING
Curb Type		Curb & Gutter Type	
CONCRETE		NO CURB AND GUTTER	
Pavement Recommendation		Condition Rating / PCR	
PREVENTIVE MAINTENANCE		GOOD / 90

Note: Parking area consists of multiple surface types: 1 part Asphalt at 7,651 square feet; 1 part Concrete at 10,544 square feet.

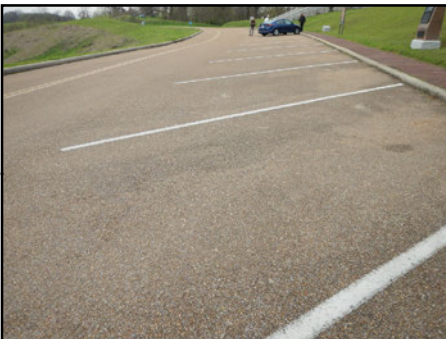
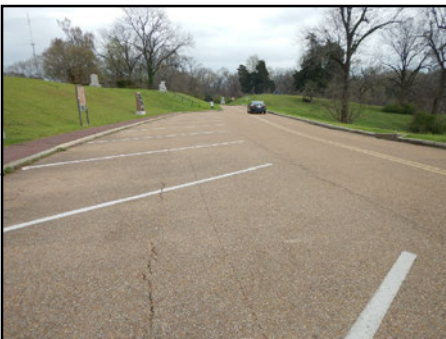
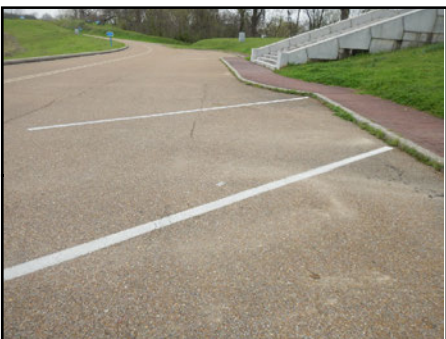
ROUTE 0901: ILLINOIS PARKING

Inspection Date	FMSS Number	User Access	Surface Type
3/18/2018	75284	PUBLIC	ASPHALT
Area (Sq. Ft.)	Lane Miles (11' Widths)	Curb Reveal (Inches)	Curb Recommendation
4,311	0.074	4	DO NOTHING
Curb Type		Curb & Gutter Type	
CONCRETE		NO CURB AND GUTTER	
Pavement Recommendation		Condition Rating / PCR	
PREVENTIVE MAINTENANCE		GOOD / 90

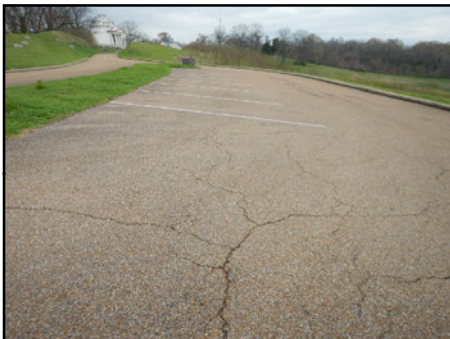
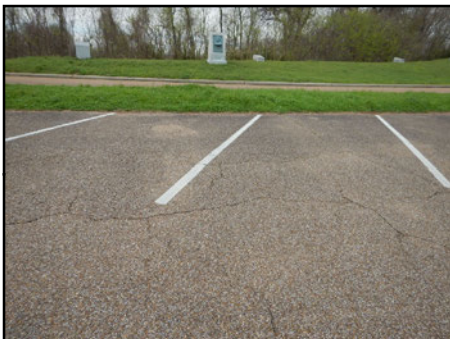
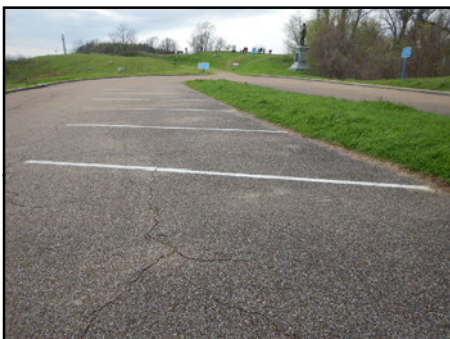
ROUTE 0902: THIRD LOUISIANA REDAN PARKING

Inspection Date	FMSS Number	User Access	Surface Type
3/18/2018	75281	PUBLIC	ASPHALT
Area (Sq. Ft.)	Lane Miles (11' Widths)	Curb Reveal (Inches)	Curb Recommendation
1,495	0.026	NOT APPLICABLE	NOT APPLICABLE
Curb Type		Curb & Gutter Type	
NO CURB		NO CURB AND GUTTER	
Pavement Recommendation		Condition Rating / PCR	
LIGHT 3R TREATMENTS		FAIR / 73

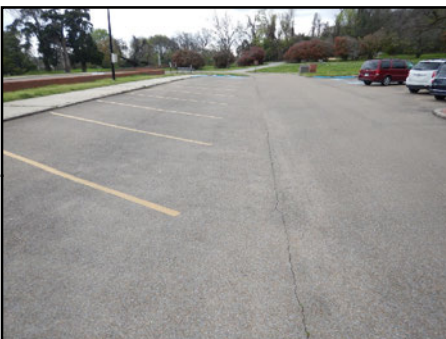
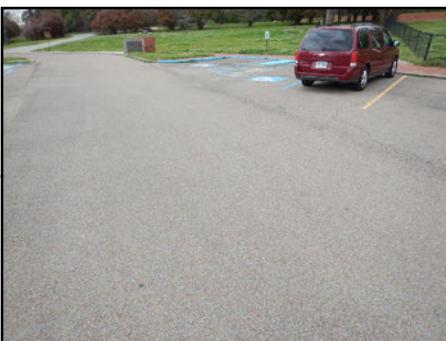
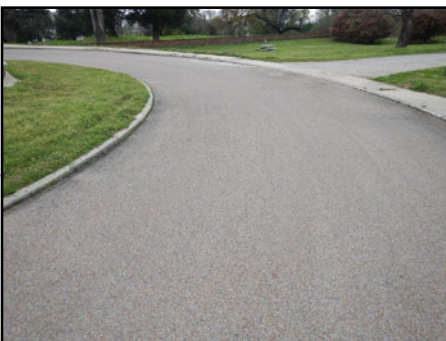
Inspection Date	FMSS Number	User Access	Surface Type
3/20/2018	75335	PUBLIC	ASPHALT
Area (Sq. Ft.)	Lane Miles (11' Widths)	Curb Reveal (Inches)	Curb Recommendation
42,949	0.739	3	DO NOTHING
Curb Type		Curb & Gutter Type	
CONCRETE		NO CURB AND GUTTER	
Pavement Recommendation		Condition Rating / PCR	
PREVENTIVE MAINTENANCE		GOOD / 90

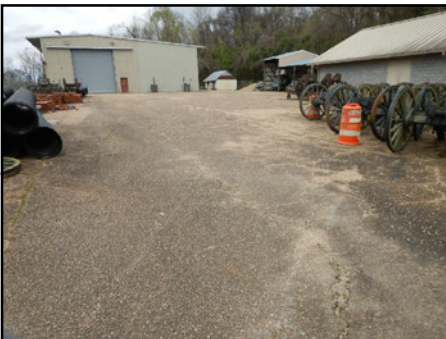
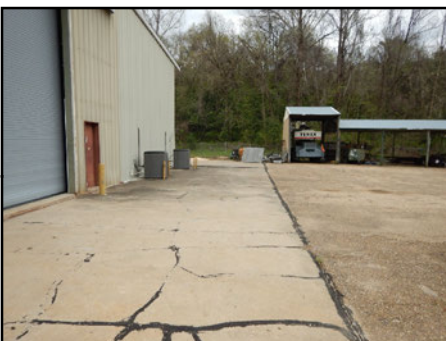
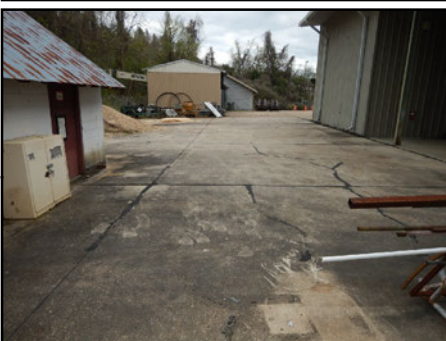
ROUTE 0910: CAIRO RESTORATION PARKING

Inspection Date	FMSS Number	User Access	Surface Type
3/20/2018	75336	NONPUBLIC	ASPHALT
Area (Sq. Ft.)	Lane Miles (11' Widths)	Curb Reveal (Inches)	Curb Recommendation
18,592	0.32	NOT APPLICABLE	NOT APPLICABLE
Curb Type		Curb & Gutter Type	
NO CURB		NO CURB AND GUTTER	
Pavement Recommendation		Condition Rating / PCR	
HEAVY 3R TREATMENTS		POOR / 53

Note: Parking area consists of multiple surface types: 1 part Asphalt at 13,719 square feet; 1 part Concrete at 4,873 square feet.

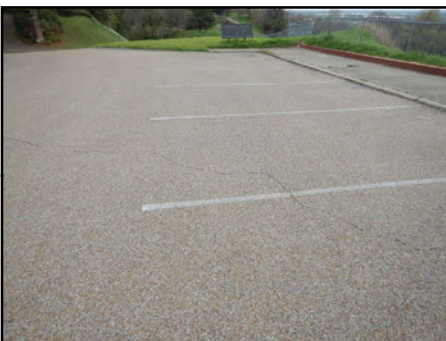
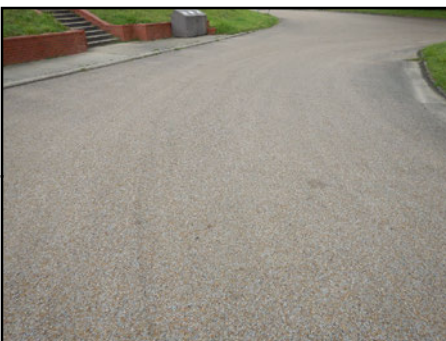
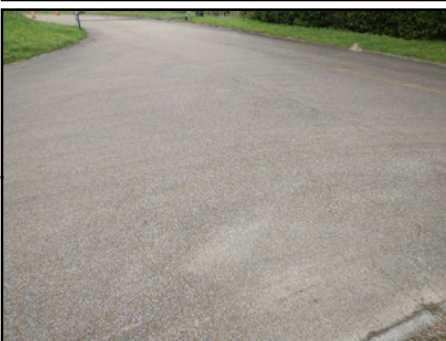
ROUTE 0911: FORT HILL PARKING

Inspection Date	FMSS Number	User Access	Surface Type
3/20/2018	74972	PUBLIC	ASPHALT
Area (Sq. Ft.)	Lane Miles (11' Widths)	Curb Reveal (Inches)	Curb Recommendation
6,049	0.104	2	DO NOTHING
Curb Type		Curb & Gutter Type	
CONCRETE		NO CURB AND GUTTER	
Pavement Recommendation		Condition Rating / PCR	
PREVENTIVE MAINTENANCE		GOOD / 90

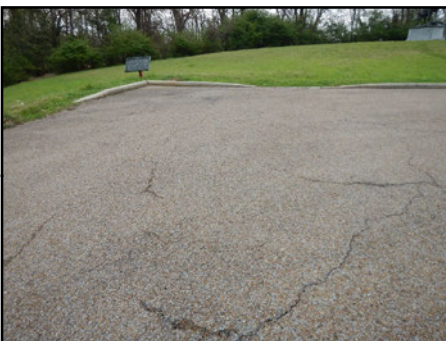
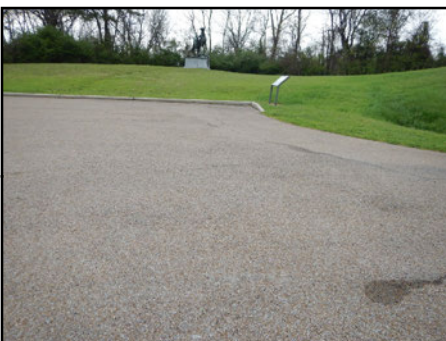
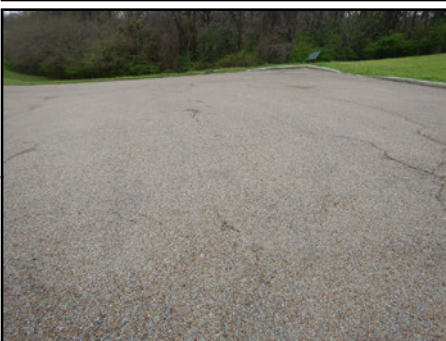
ROUTE 0913: LOUISIANA PARKING

Inspection Date	FMSS Number	User Access	Surface Type
3/18/2018	74976	PUBLIC	ASPHALT
Area (Sq. Ft.)	Lane Miles (11' Widths)	Curb Reveal (Inches)	Curb Recommendation
4,581	0.079	6	DO NOTHING
Curb Type		Curb & Gutter Type	
CONCRETE		NO CURB AND GUTTER	
Pavement Recommendation		Condition Rating / PCR	
PREVENTIVE MAINTENANCE		GOOD / 90

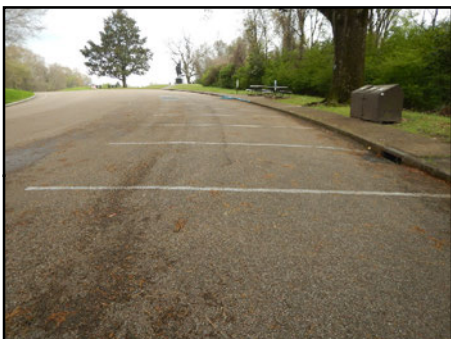
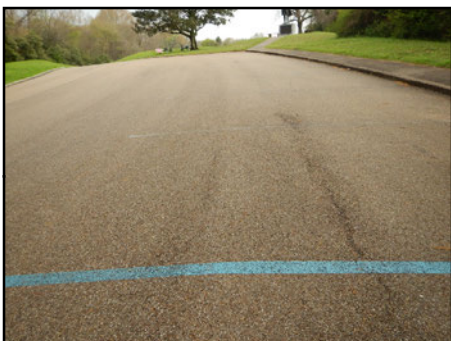
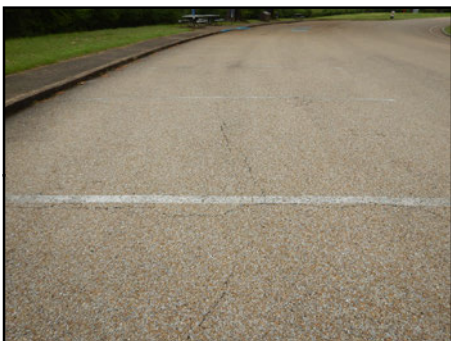
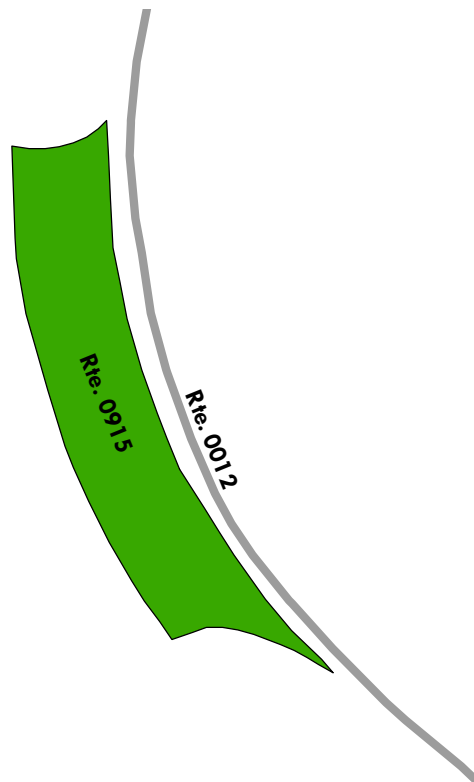
ROUTE 0915: JEFFERSON DAVIS/PICNIC PARKING A

Inspection Date	FMSS Number	User Access	Surface Type
3/18/2018	74990	PUBLIC	ASPHALT
Area (Sq. Ft.)	Lane Miles (11' Widths)	Curb Reveal (Inches)	Curb Recommendation
7,625	0.131	5	DO NOTHING
Curb Type		Curb & Gutter Type	
CONCRETE		NO CURB AND GUTTER	
Pavement Recommendation		Condition Rating / PCR	
PREVENTIVE MAINTENANCE		GOOD / 90

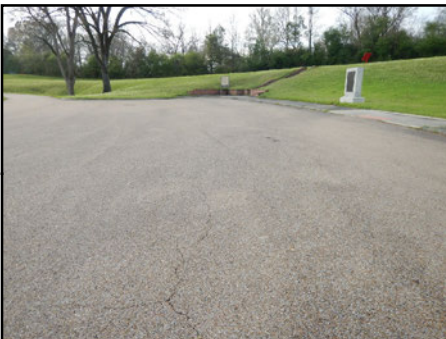
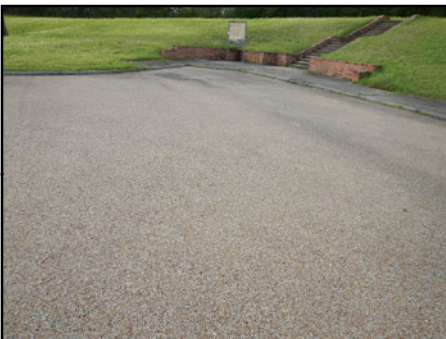
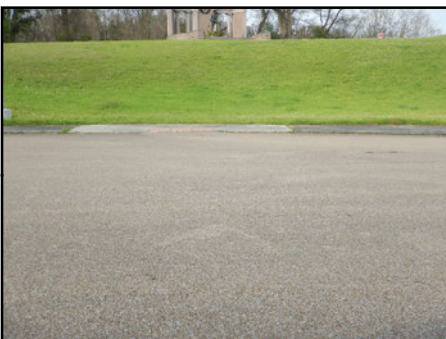
ROUTE 0916: TEXAS PARKING

Inspection Date	FMSS Number	User Access	Surface Type
3/18/2018	75037	PUBLIC	ASPHALT
Area (Sq. Ft.)	Lane Miles (11' Widths)	Curb Reveal (Inches)	Curb Recommendation
5,387	0.093	5	DO NOTHING
Curb Type		Curb & Gutter Type	
CONCRETE		NO CURB AND GUTTER	
Pavement Recommendation		Condition Rating / PCR	
PREVENTIVE MAINTENANCE		GOOD / 90

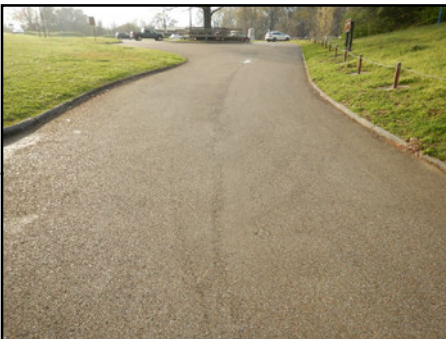
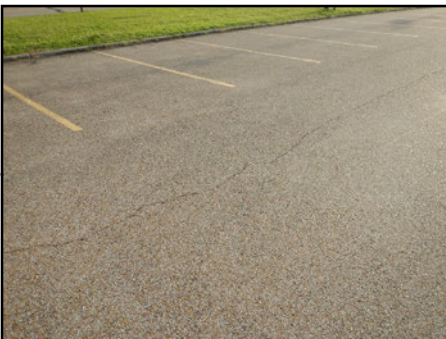
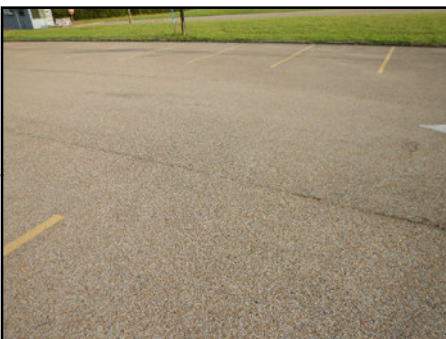
ROUTE 0919: VISITOR CENTER PARKING

Inspection Date	FMSS Number	User Access	Surface Type
3/18/2018	74940	PUBLIC	ASPHALT
Area (Sq. Ft.)	Lane Miles (11' Widths)	Curb Reveal (Inches)	Curb Recommendation
37,731	0.65	4	DO NOTHING
Curb Type		Curb & Gutter Type	
CONCRETE		NO CURB AND GUTTER	
Pavement Recommendation		Condition Rating / PCR	
PREVENTIVE MAINTENANCE		GOOD / 90

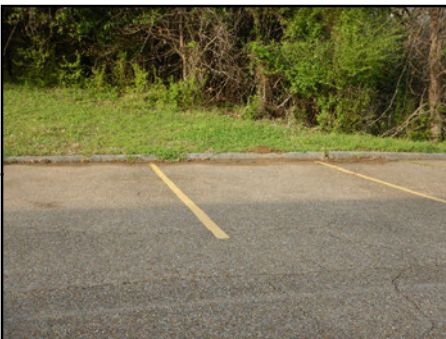
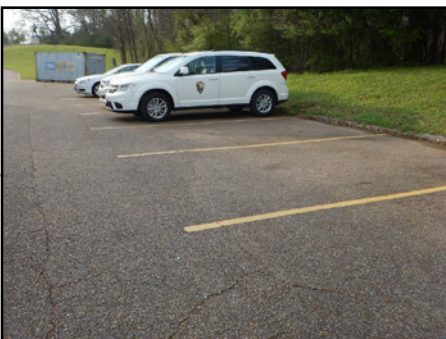
ROUTE 0920: HEADQUARTERS PARKING

Inspection Date	FMSS Number	User Access	Surface Type
3/18/2018	74946	NONPUBLIC	ASPHALT
Area (Sq. Ft.)	Lane Miles (11' Widths)	Curb Reveal (Inches)	Curb Recommendation
4,002	0.069	5	DO NOTHING
Curb Type		Curb & Gutter Type	
CONCRETE		NO CURB AND GUTTER	
Pavement Recommendation		Condition Rating / PCR	
PREVENTIVE MAINTENANCE		GOOD / 90

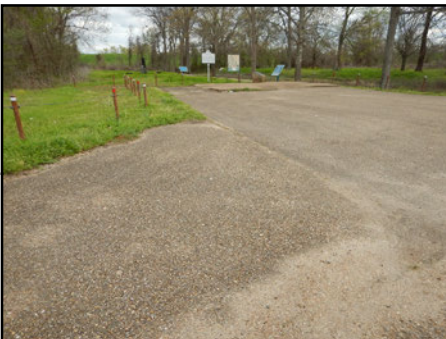
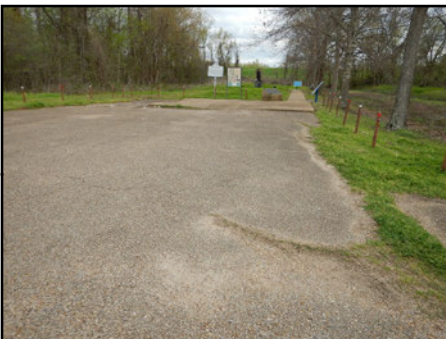
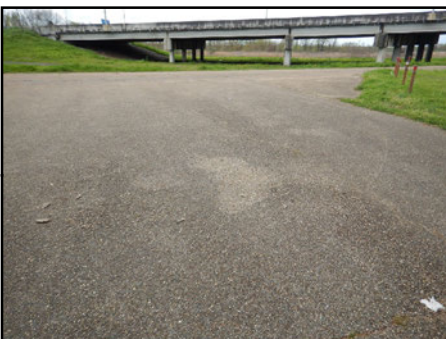
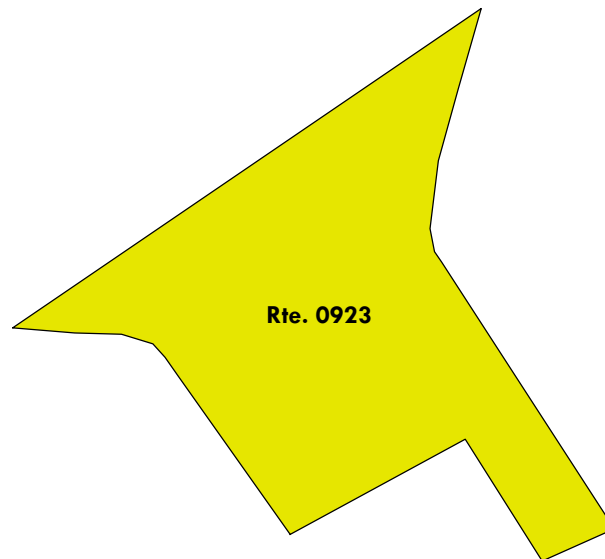
ROUTE 0923: GRANT'S CANAL

Inspection Date	FMSS Number	User Access	Surface Type
3/20/2018	75446	PUBLIC	ASPHALT
Area (Sq. Ft.)	Lane Miles (11' Widths)	Curb Reveal (Inches)	Curb Recommendation
2,483	0.043	NOT APPLICABLE	NOT APPLICABLE
Curb Type		Curb & Gutter Type	
NO CURB		NO CURB AND GUTTER	
Pavement Recommendation		Condition Rating / PCR	
LIGHT 3R TREATMENTS		FAIR / 73

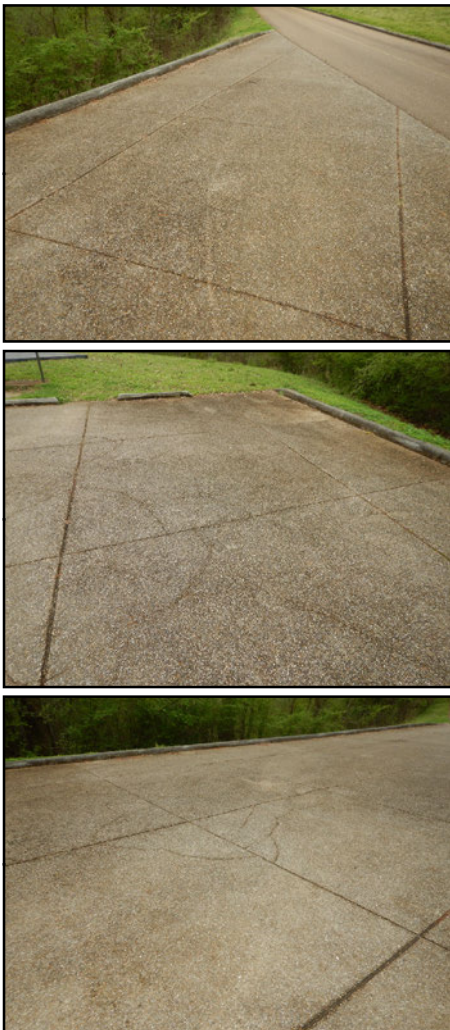
ROUTE 0924: AFRICAN AMERICAN MONUMENT PARKING

Inspection Date	FMSS Number	User Access	Surface Type
3/18/2018	231635	PUBLIC	CONCRETE
Area (Sq. Ft.)	Lane Miles (11' Widths)	Curb Reveal (Inches)	Curb Recommendation
1,997	0.034	5	DO NOTHING
Curb Type		Curb & Gutter Type	
CONCRETE		NO CURB AND GUTTER	
Pavement Recommendation		Condition Rating / PCR	
PREVENTIVE MAINTENANCE		GOOD / 90

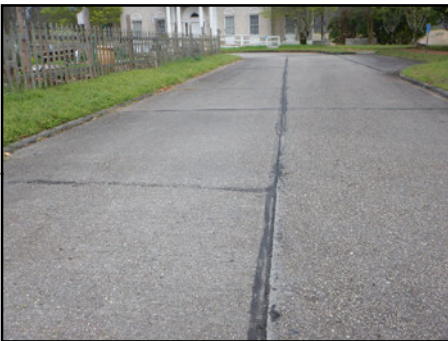
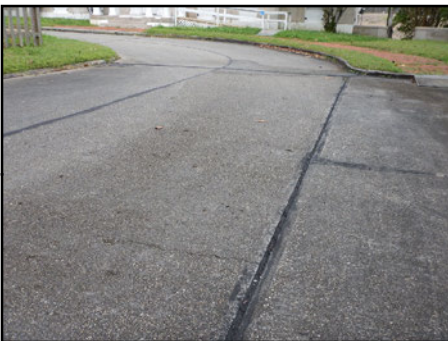
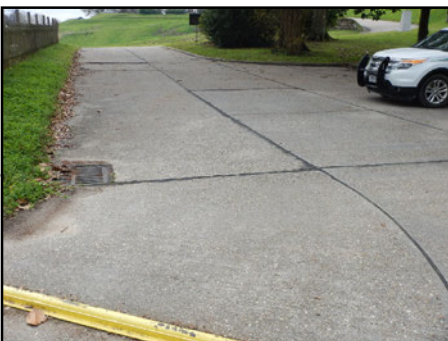
ROUTE 0926: OLD ADMINISTRATION LOOP PARKING

Inspection Date	FMSS Number	User Access	Surface Type
3/18/2018	75002	PUBLIC	CONCRETE
Area (Sq. Ft.)	Lane Miles (11' Widths)	Curb Reveal (Inches)	Curb Recommendation
8,196	0.141	4	DO NOTHING
Curb Type		Curb & Gutter Type	
CONCRETE		NO CURB AND GUTTER	
Pavement Recommendation		Condition Rating / PCR	
PREVENTIVE MAINTENANCE		GOOD / 90
