YOSE Cycle 6

Final Report

Road Inventory and Condition Assessment of Paved Routes Yosemite National Park

Report Date: April 2016

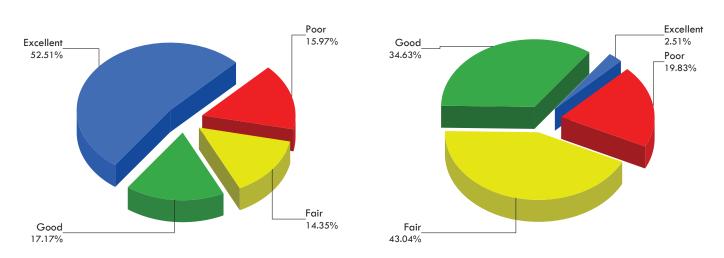
Figure 1: Pavement Condition Rating Breakdown for Paved Roads and Parking Areas

Parkwide Condition Percentages

Road Condition Percentages

Parking Area Condition Percentages

- Excellent / New: PCR of 95-100
 - o Pavements in this range will require only spot repairs
- Good: PCR of 85-94
 - o Pavements in this range will likely be candidates for Preventive Maintenance. Examples include Chip and Slurry Seals, Micro Surfacing and Thin Overlays.
- Fair: PCR of 61-84
 - o Pavements in this range will likely be candidates of Light Rehabilitation (L3R). Examples include singlelift overlays up to 2.5 inches in total thickness, milling and overlays.
- Poor: PCR of 0-60
 - o Pavements in this range will likely be candidates of Heavy Rehabilitation or Reconstruction (H3R or 4R). Examples include Pulverization, Multiple Lift Overlays, and Reconstruction.

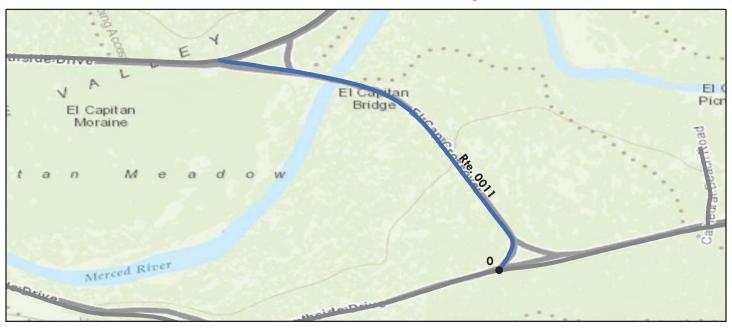
ROUTE 0011: EL CAPITAN CROSSOVER (EL CAPITAN BRIDGE ROAD)

Data Collection Vehicle (DCV) Rating

| 1 | Route Condition Leg | end – Pavement Cond | lition Rating (PCR) | |
| | Fair (61- 84) | Good (85 - 94) | Excellent (95 - 100) | Not Rated |

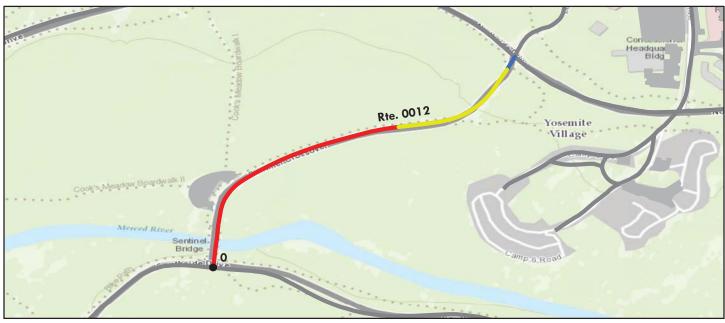
ROUTE 0012: SENTINEL DRIVE (SENTINEL BRIDGE ROAD)

Data Collection Vehicle (DCV) Rating

| | Route (| Condition Legend – Pav | ement Condi | tion Rating (| PCR) | | |
| Poor (0 - 60) | _ | | (85 - 94) | Excellent (9 | | Not Ra | ted |

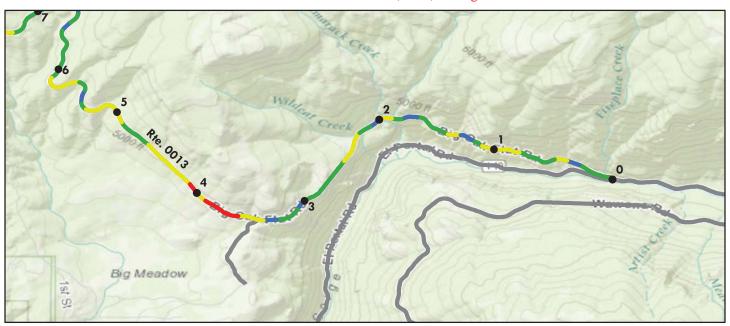
ROUTE 0013: BIG OAK FLAT ROAD

Data Collection Vehicle (DCV) Rating

| | Route C | Condition Legend – Pav | ement Condi | tion Rating (| PCR) | | |
|---|---|---|---|---|---|---|---|
| Pavement Condition Ratio | ng (PCR) | 93 | 90 | 92 | 89 | 74 | 76 |
| Surface Condition Rating (| SCR) | 93 | 93 | 91 | 87 | 70 | 76 |
| Roughness Condition Index | k (RCI) | 92 | 85 | 93 | 92 | 81 | 77 |

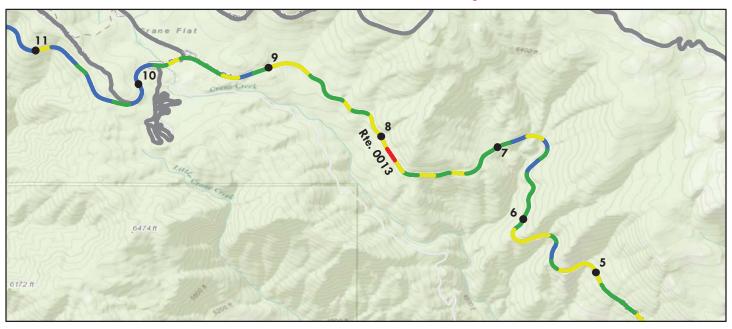
ROUTE 0013: BIG OAK FLAT ROAD

Data Collection Vehicle (DCV) Rating

| | Route C | Condition Legend – Pav | ement Condi | tion Rating (| PCR) | | |
|---|---|---|---|---|---|---|---|
| Pavement Condition Ratin | g (PCR) | 93 | 81 | 93 | 83 | 84 | 92 |
| Surface Condition Rating (S | SCR) | 93 | 83 | 97 | 80 | 84 | 95 |
| Roughness Condition Index | (RCI) | 92 | 78 | 87 | 88 | 84 | 88 |

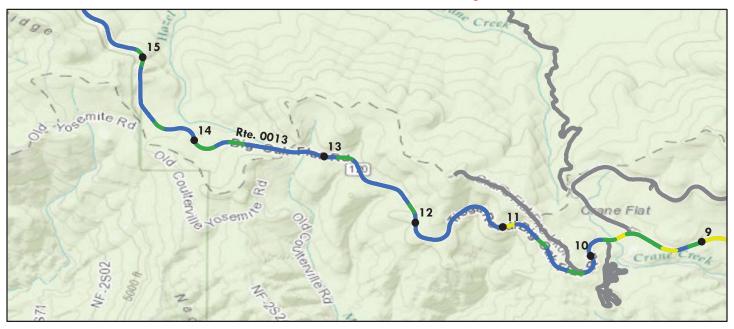
ROUTE 0013: BIG OAK FLAT ROAD

Data Collection Vehicle (DCV) Rating

| | Route C | ondition Legen | d _ Pave | ment Condi | tion Rating (| PCR) | | |
|---|---|---|---|---|---|---|---|---|
| Pavement Condition Rating (I | PCR) | 93 | | 97 | 98 | 97 | 96 | 97 |
| Surface Condition Rating (SCR | .) | 93 | | 95 | 97 | 95 | 93 | 95 |
| Roughness Condition Index (Ro | CI) | 92 | | 99 | 100 | 100 | 100 | 100 |

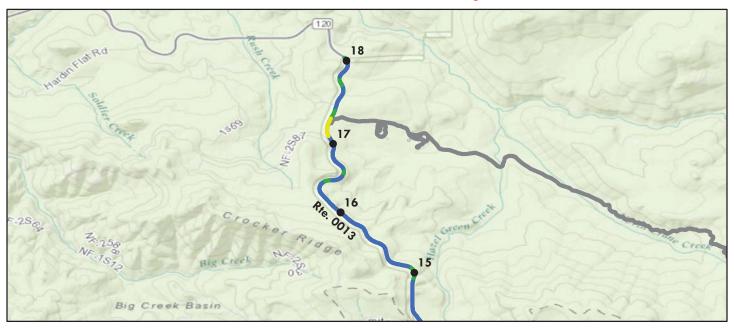
ROUTE 0013: BIG OAK FLAT ROAD

Data Collection Vehicle (DCV) Rating

| | Route (| Condition Legend – Pav | ement Condi | tion Rating (| PCR) | | |
|---|---|---|---|---|---|---|---|
| Pavement Condition | n Rating (PCR) | 93 | 97 | 96 | 93 | 94 | |
| Surface Condition Rating (SCR) | | 93 | 95 | 94 | 97 | 95 | |
| Roughness Condition | n Index (RCI) | 92 | 100 | 100 | 86 | 93 | |

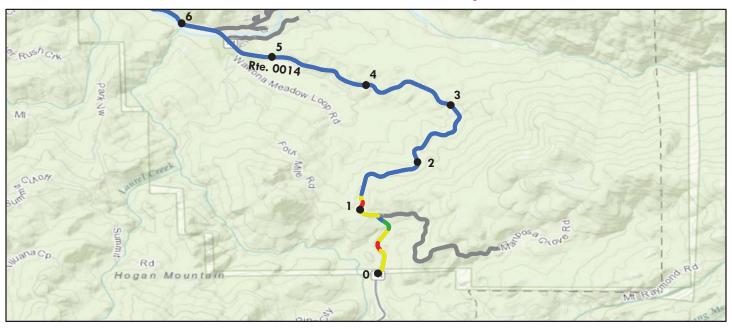
ROUTE 0014: WAWONA ROAD

Data Collection Vehicle (DCV) Rating

| P | oute Condition Legend – Pa | vement Condi | tion Rating (| PCR) | | |
|---|---|---|---|---|---|---|
| Pavement Condition Rating (PCR) | 99 | 74 | 95 | 100 | 100 | 100 |
| Surface Condition Rating (SCR) | 99 | 82 | 91 | 100 | 100 | 100 |
| Roughness Condition Index (RCI) | 100 | 62 | 100 | 100 | 100 | 100 |

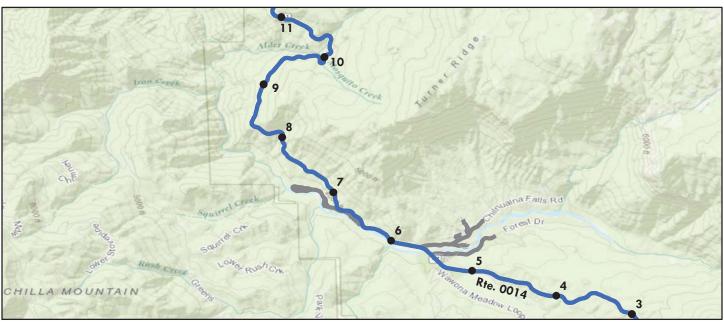
ROUTE 0014: WAWONA ROAD

Data Collection Vehicle (DCV) Rating

| | Route Cone | dition Legend – Pav | rement Condi | tion Rating (| PCR) | | |
|---|---|---|---|---|---|---|---|
| Pavement Condition Rating (Po | CR) | 99 | 100 | 100 | 100 | 100 | 100 |
| Surface Condition Rating (SCR) | | 99 | 100 | 100 | 100 | 100 | 100 |
| Roughness Condition Index (RC) | (1) | 100 | 100 | 100 | 100 | 100 | 100 |

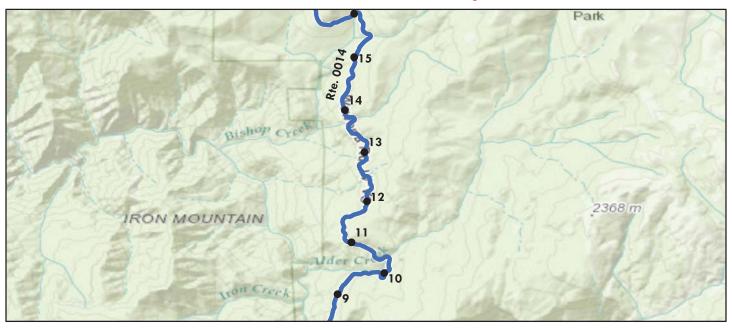
ROUTE 0014: WAWONA ROAD

Data Collection Vehicle (DCV) Rating

| | Route (| Condition Legend – Pav | ement Condi | tion Rating (| PCR) | | |
|---|---|---|---|---|---|---|---|
| Surface Condition R | tating (SCR) | 99 | 100 | 100 | 100 | 100 | 100 |

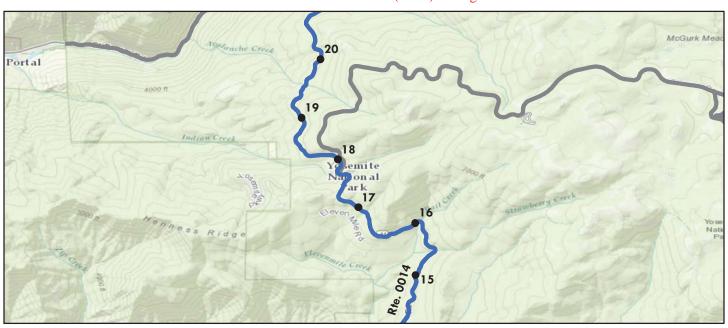
ROUTE 0014: WAWONA ROAD

Data Collection Vehicle (DCV) Rating

| Т | Route Condition Legend – P | avement Cond | ition Rating (| PCR) | | |
|---|---|---|---|---|---|---|
| Pavement Condition Rating (PCR |) 99 | 100 | 100 | 100 | 100 | 100 |
| Surface Condition Rating (SCR) | 99 | 100 | 100 | 100 | 100 | 100 |
| Roughness Condition Index (RCI) | 100 | 100 | 100 | 100 | 100 | 100 |

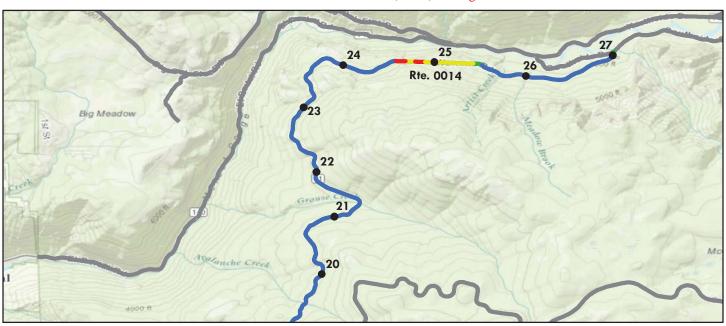
ROUTE 0014: WAWONA ROAD

Data Collection Vehicle (DCV) Rating

| P _t | ute Condition Legend – Pav | zement Condi | tion Rating (| PCR) | | |
|---|---|---|---|---|---|---|
| Pavement Condition Rating (PCR) | 99 | 100 | 100 | 100 | 100 | 99 |
| Surface Condition Rating (SCR) | 99 | 100 | 100 | 100 | 100 | 100 |
| Roughness Condition Index (RCI) | 100 | 100 | 100 | 100 | 100 | 98 |

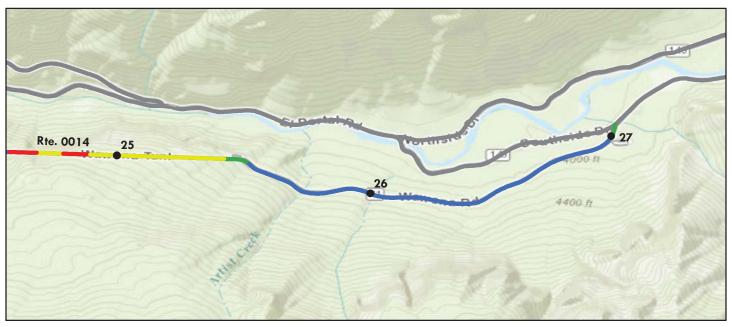
ROUTE 0014: WAWONA ROAD

Data Collection Vehicle (DCV) Rating

| | Route (| Condition Legend – Pav | ement Condi | tion Rating (| PCR) | | |
|---|---|---|---|---|---|---|---|
| Surface Condition R | ating (SCR) | 99 | 99 | 100 | 99 | | |

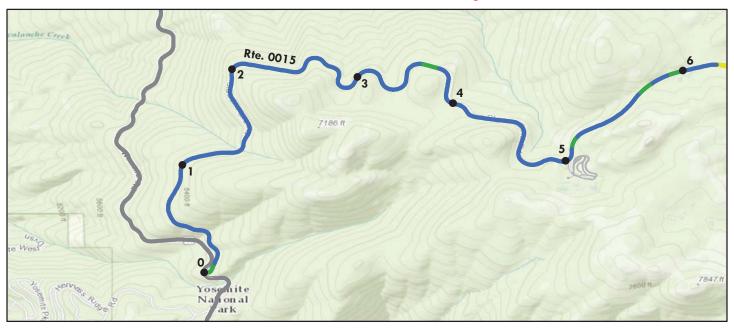
ROUTE 0015: GLACIER POINT ROAD

Data Collection Vehicle (DCV) Rating

| | Route C | Condition Legend – Pay | ement Condi | tion Rating (| PCR) | | |
|---|---|---|---|---|---|---|---|
| Pavement Condition Rati | ing (PCR) | 76 | 100 | 100 | 99 | 99 | 99 |
| Surface Condition Rating | (SCR) | 70 | 100 | 100 | 99 | 99 | 99 |
| Roughness Condition Inde | ex (RCI) | 85 | 100 | 100 | 100 | 100 | 100 |

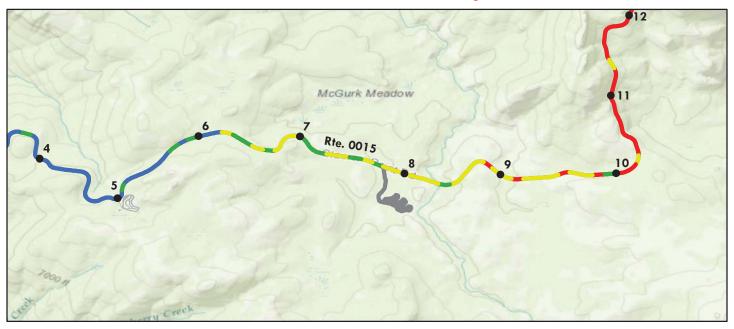
ROUTE 0015: GLACIER POINT ROAD

Data Collection Vehicle (DCV) Rating

| R | oute Condition Legend – Pay | vement Condi | ition Rating (| PCR) | | |
|---|---|---|---|---|---|---|
| Pavement Condition Rating (PCR) | 76 | 96 | 84 | 82 | 71 | 67 |
| Surface Condition Rating (SCR) | 70 | 94 | 81 | 78 | 67 | 54 |
| Roughness Condition Index (RCI) | 85 | 100 | 89 | 88 | 78 | 87 |

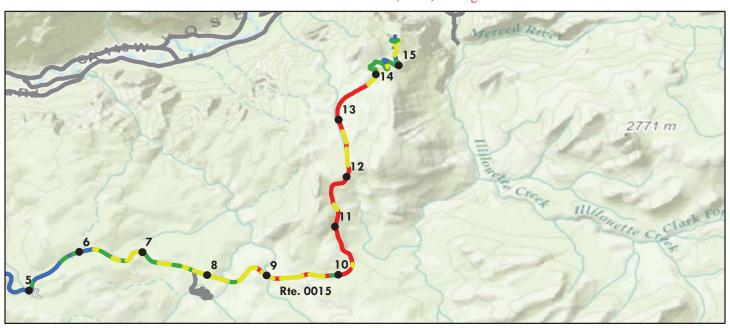
ROUTE 0015: GLACIER POINT ROAD

Data Collection Vehicle (DCV) Rating

| | Route C | Condition Legend – Pav | ement Condi | tion Rating (| PCR) | | |
|---|---|---|---|---|---|---|---|
| Pavement Condition Rating | g (PCR) | 76 | 23 | 44 | 56 | 44 | 85 |
| Surface Condition Rating (S | CR) | 70 | 0 | 29 | 51 | 29 | 92 |
| Roughness Condition Index | (RCI) | 85 | 58 | 67 | 64 | 67 | 75 |

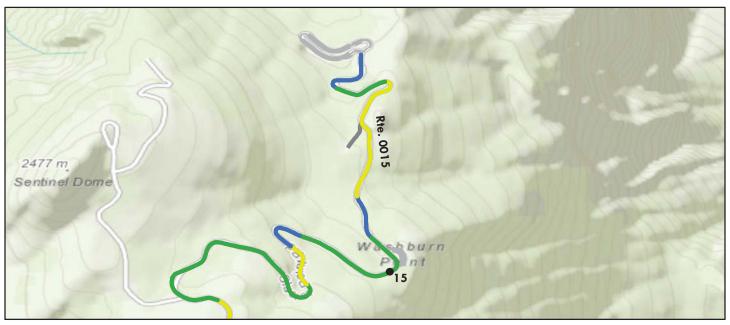
ROUTE 0015: GLACIER POINT ROAD

Data Collection Vehicle (DCV) Rating

| | Route Condit | ion Legend – Pav | vement Condi | tion Rating (| PCR) | | |
|---|---|---|---|---|---|---|---|
| Pavement Condition Rating (Po | | 76 | 84 | | | | |
| Surface Condition Rating (SCR) | · · | 70 | 91 | | | | |
| Roughness Condition Index (RC | I) | 85 | 74 | | | | |

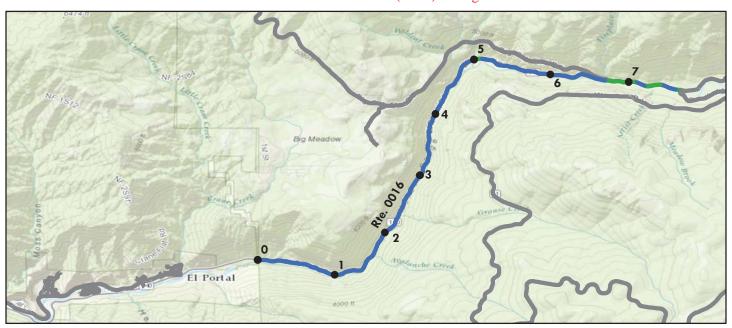
ROUTE 0016: EL PORTAL ROAD

Data Collection Vehicle (DCV) Rating

| | Route (| Condition Legend – Pay | zement Condi | tion Rating (| PCR) | | |
|---|---|---|---|---|---|---|---|
| Pavement Condition Rat | ing (PCR) | 99 | 99 | 99 | 99 | 100 | 100 |
| Surface Condition Rating | (SCR) | 99 | 99 | 99 | 99 | 100 | 100 |
| Roughness Condition Inde | ex (RCI) | 100 | 100 | 100 | 100 | 100 | 100 |

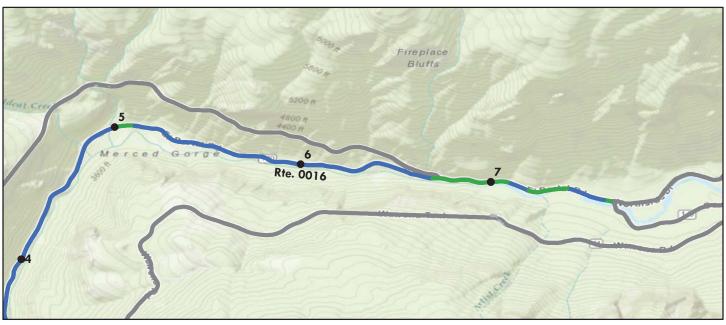
ROUTE 0016: EL PORTAL ROAD

Data Collection Vehicle (DCV) Rating

| | Route (| Condition Legend – Pav | ement Condi | tion Rating (| PCR) | | |
|---|---|---|---|---|---|---|---|
| Pavement Condition | n Rating (PCR) | 99 | 100 | 99 | 94 | | |
| Surface Condition Ra | ating (SCR) | 99 | 100 | 98 | 96 | | |
| Roughness Condition | n Index (RCI) | 100 | 100 | 100 | 90 | | |

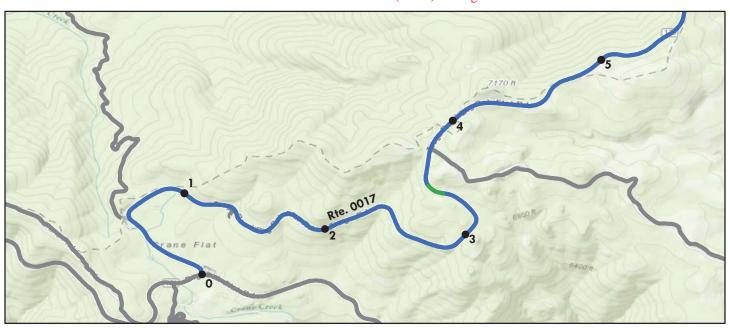
ROUTE 0017: TIOGA ROAD

Data Collection Vehicle (DCV) Rating

| | Route C | Condition Legend – | Pavement Condi | ition Rating (| PCR) | | |
|---|---|---|---|---|---|---|---|
| Pavement Condition Rating | (PCR) | 98 | 100 | 100 | 100 | 99 | 99 |
| Surface Condition Rating (SC | R) | 97 | 100 | 100 | 100 | 98 | 99 |
| Roughness Condition Index (F | RCI) | 100 | 100 | 100 | 100 | 100 | 100 |

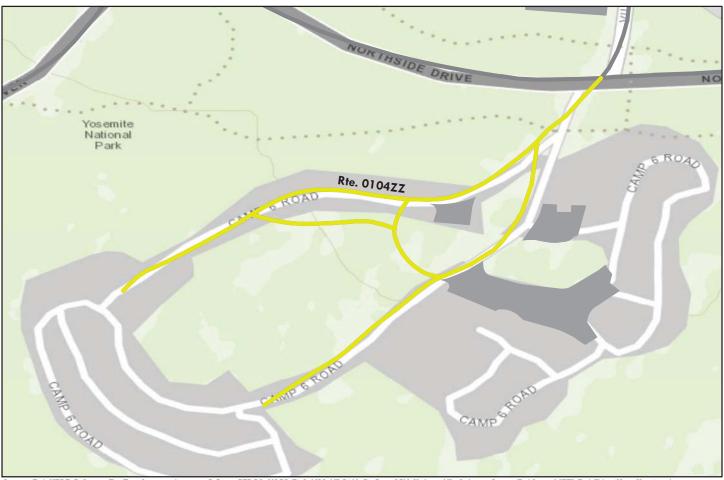
ROUTE 0104ZZ: CAMP 6 ROADS

Summary Route

Note: The weighted average summary PCR value is calculated from only the sections of road where the PCR was collected. The overall PCR for the summary route may not reflect individual subcomponent ratings.

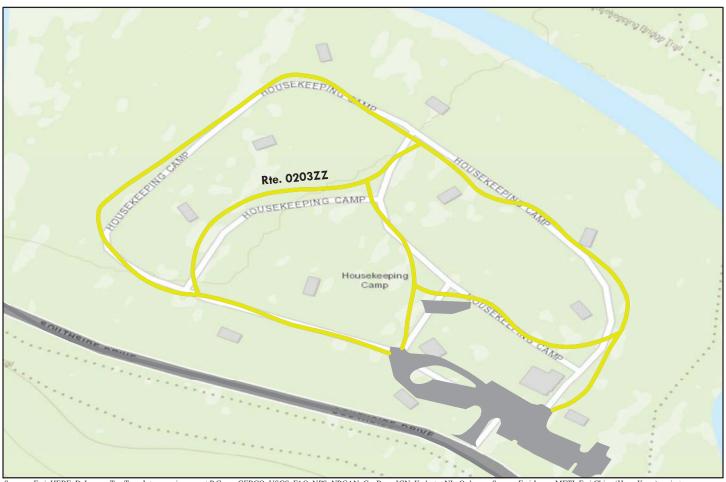
ROUTE 0203ZZ: HOUSEKEEPING CAMP ROADS

Summary Route

Note: The weighted average summary PCR value is calculated from only the sections of road where the PCR was collected. The overall PCR for the summary route may not reflect individual subcomponent ratings.

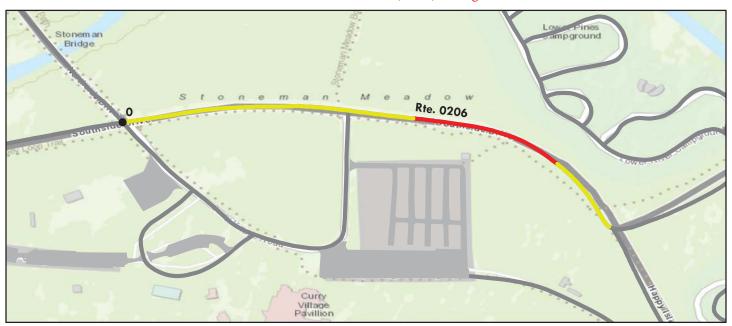
ROUTE 0206: NORTHSIDE DRIVE EXTENSION (STONEMAN STRAIGHTAWAY)

Data Collection Vehicle (DCV) Rating

| Rout | e Condition Legend – Pav | ement Cond | ition Rating (PCR) | |
|---|---|---|---|---|
| Pavement Condition Rating (PCR) | 59 | 59 | | |
| Alligator Crack Index | 79 | 79 | | |

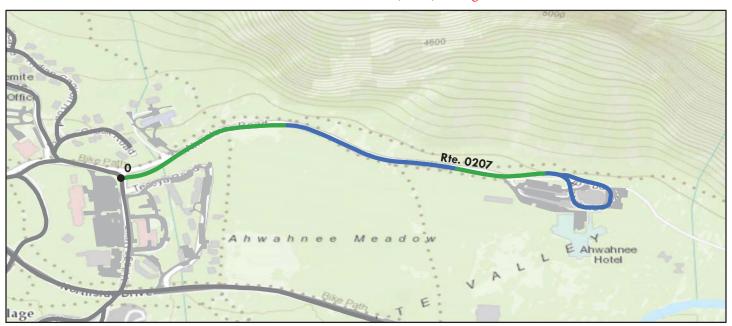
ROUTE 0207: AHWAHNEE DRIVE

Data Collection Vehicle (DCV) Rating

| | Route (| Condition Legend – Pav | ement Condi | tion Rating (| PCR) | | |
|---|---|---|---|---|---|---|---|
| Pavement Condition | Rating (PCR) | 92 | 92 | | | | |
| Roughness Condition | Index (RCI) | 82 | 82 | | | | |

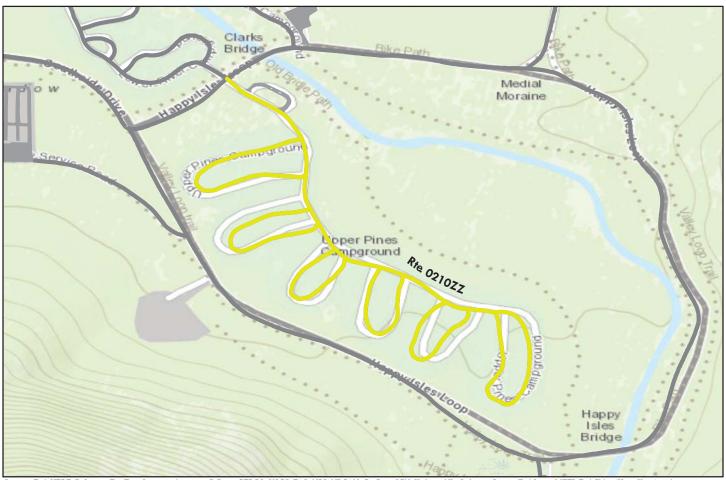
ROUTE 0210ZZ: UPPER PINES CAMPGROUND ROADS

Summary Route

Note: The weighted average summary PCR value is calculated from only the sections of road where the PCR was collected. The overall PCR for the summary route may not reflect individual subcomponent ratings.

| Toute may not reflect murvic | oute may not reflect individual subcomponent ratings. | | | | | | | | |
|---|--|---|---|---|---|--|---|---|--|
| Pavement Condition R | Rating (PCR) | 81 | | | | | | | |

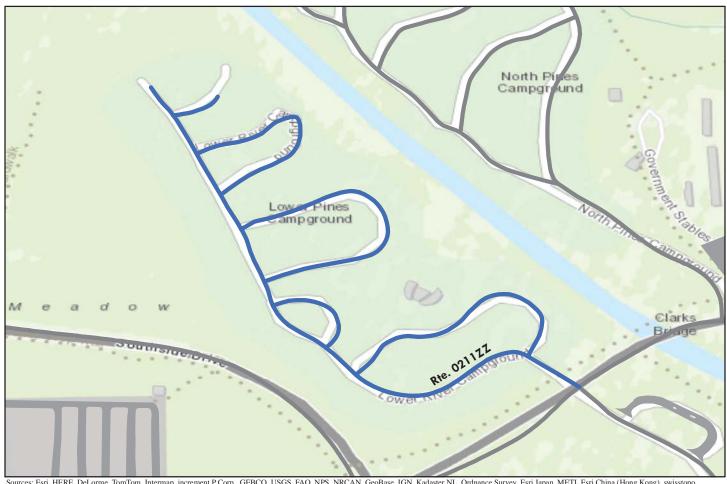
ROUTE 0211ZZ: LOWER PINES CAMPGROUND ROADS

Summary Route

Note: The weighted average summary PCR value is calculated from only the sections of road where the PCR was collected. The overall PCR for the summary route may not reflect individual subcomponent ratings

| oute may not reflect individual subcomponent ratings. | | | | | | | | |
|---|---|---|---|---|---|---|---|---|
| Pavement Condition | Rating (PCR) | 98 | | | | | | |

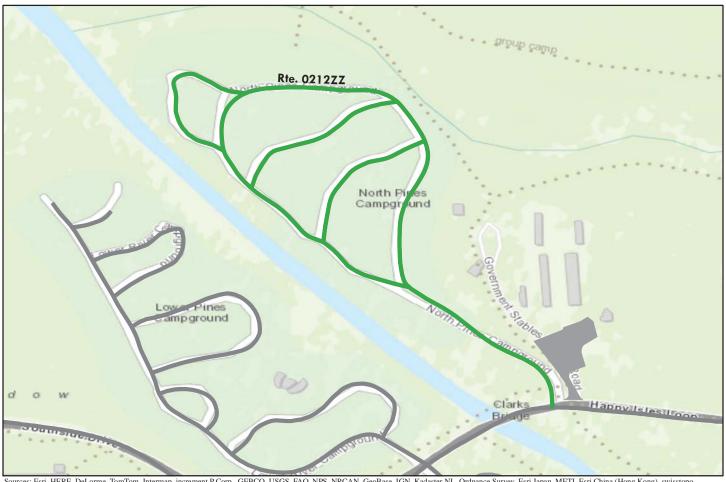
ROUTE 0212ZZ: NORTH PINES CAMPGROUND ROADS

Summary Route

Note: The weighted average summary PCR value is calculated from only the sections of road where the PCR was collected. The overall PCR for the summary route may not reflect individual subcomponent ratings.

| oute may not renect individual subcomponent ratings. | | | | | | | | |
|--|---|---|---|---|---|---|---|---|
| Pavement Condition | Rating (PCR) | 94 | | | | | | |

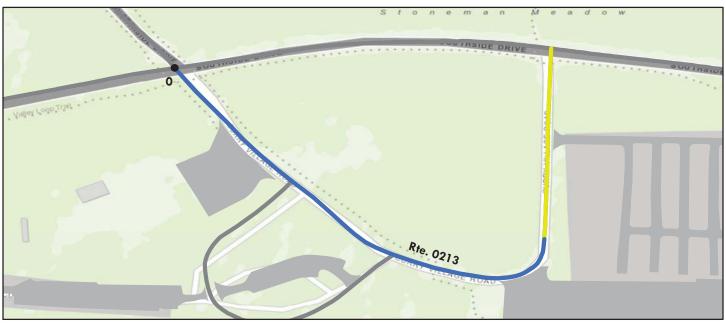
ROUTE 0213: CURRY VILLAGE DRIVE

Data Collection Vehicle (DCV) Rating

| | Route (| Condition Legend – Pav | ement Condi | ition Rating (| PCR) | | |
|---|---|---|---|---|---|---|---|
| Pavement Condition | Rating (PCR) | 88 | 88 | | | | |

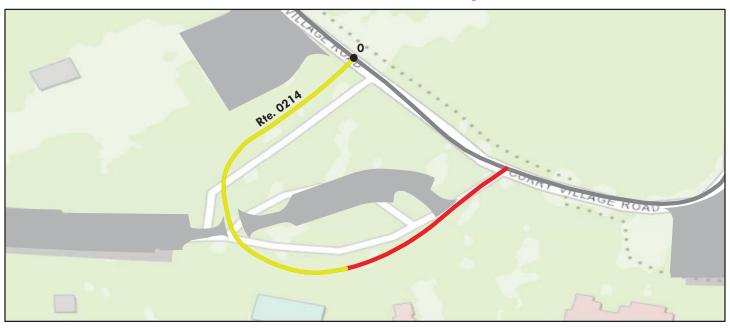
ROUTE 0214: CURRY VILLAGE REGISTRATION ROAD

Data Collection Vehicle (DCV) Rating

| | Route (| Condition Legend – Pav | ement Condi | tion Rating (| PCR) | | |
|---|---|---|---|---|---|---|---|
| Pavement Condition 1 | Rating (PCR) | 59 | 59 | | | | |

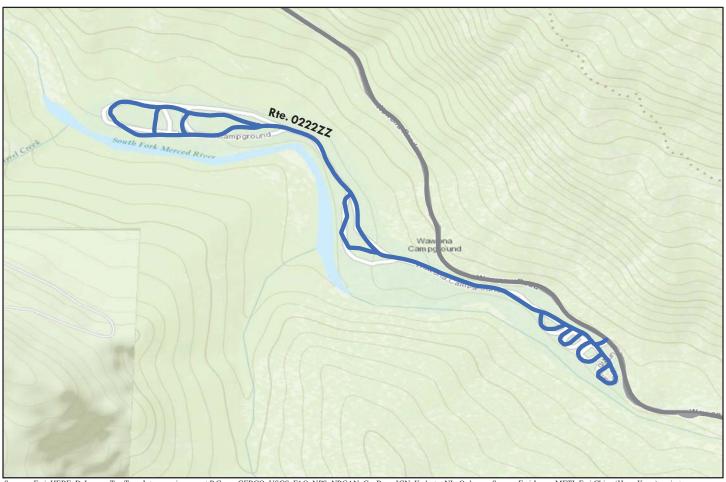
ROUTE 0222ZZ: WAWONA CAMPGROUND ROADS

Summary Route

Note: The weighted average summary PCR value is calculated from only the sections of road where the PCR was collected. The overall PCR for the summary route may not reflect individual subcomponent ratings.

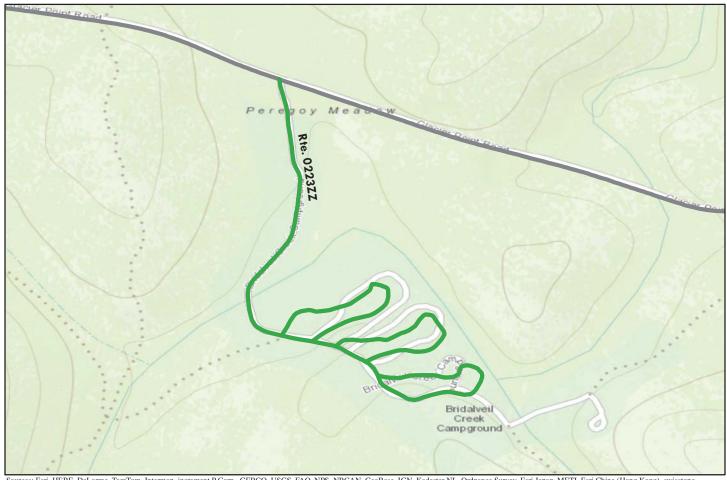
ROUTE 0223ZZ: BRIDALVEIL CREEK CAMPGROUND ROADS

Summary Route

Note: The weighted average summary PCR value is calculated from only the sections of road where the PCR was collected. The overall PCR for the summary route may not reflect individual subcomponent ratings

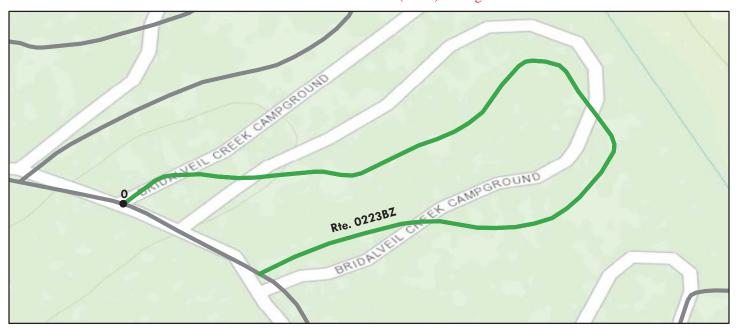
ROUTE 0223BZ: BRIDALVEIL CREEK CAMPGROUND LOOP B (SITES 38-68)

Subcomponent of Route YOSE-0223ZZ Data Collection Vehicle (DCV) Rating

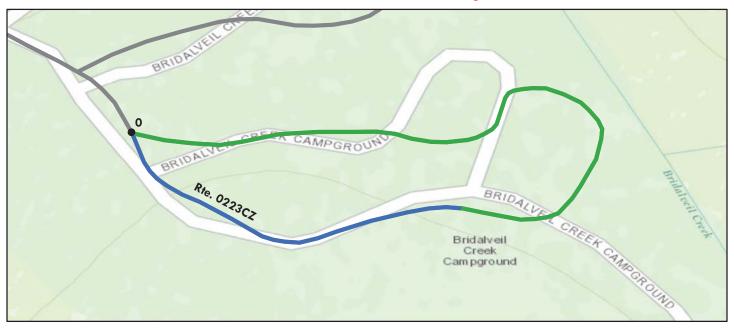
ROUTE 0223CZ: BRIDALVEIL CREEK CAMPGROUND LOOP C (SITES 69-108)

Subcomponent of Route YOSE-0223ZZ Data Collection Vehicle (DCV) Rating

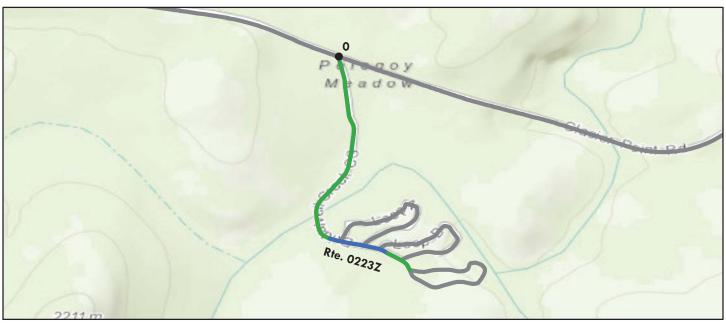
Subcomponent of Route YOSE-0223ZZ

Data Collection Vehicle (DCV) Rating

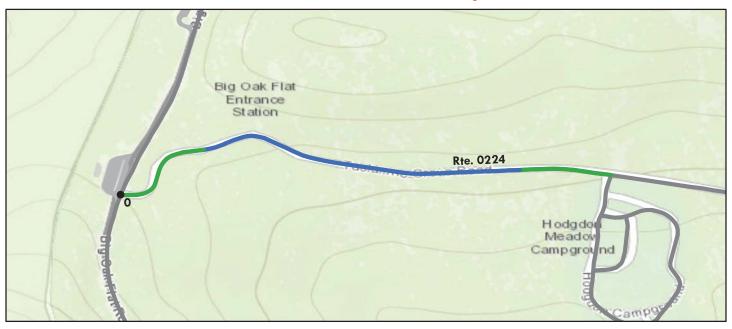
ROUTE 0224: HODGDON MEADOW ROAD (TUOLUMNE GROVE ROAD)

Data Collection Vehicle (DCV) Rating

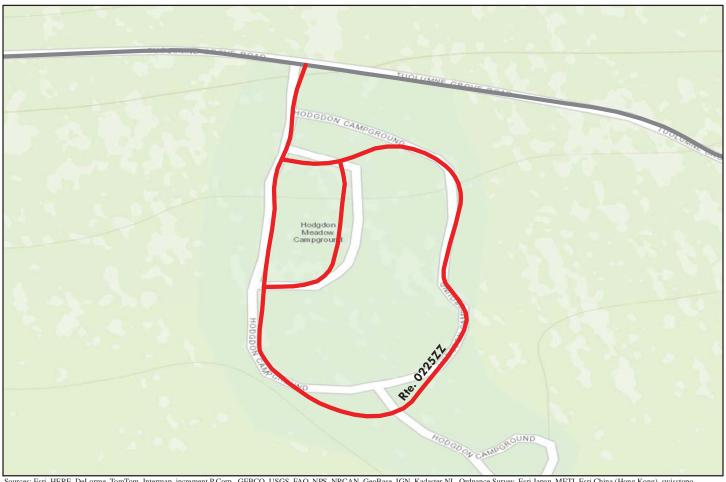
ROUTE 0225ZZ: HODGDON MEADOW CAMPGROUND LOOPS

Summary Route

Note: The weighted average summary PCR value is calculated from only the sections of road where the PCR was collected. The overall PCR for the summary route may not reflect individual subcomponent ratings.

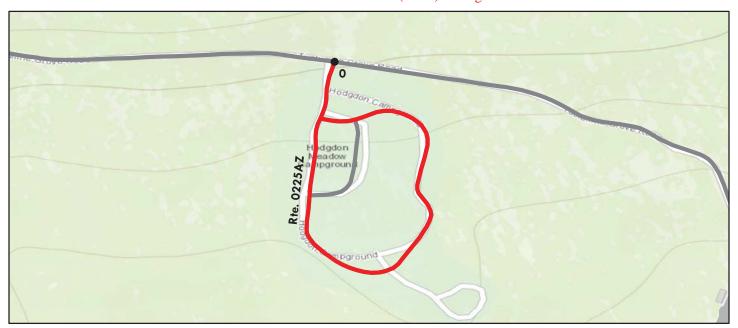
ROUTE 0225AZ: HODGDON MEADOW CAMPGROUND OUTER LOOP (SITES 1-85)

Subcomponent of Route YOSE-0225ZZ Data Collection Vehicle (DCV) Rating

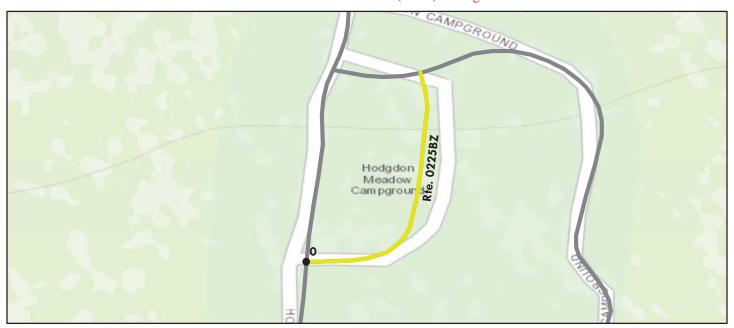
ROUTE 0225BZ: HODGDON MEADOW CAMPGROUND INNER LOOP (SITES 86-103)

Subcomponent of Route YOSE-0225ZZ Data Collection Vehicle (DCV) Rating

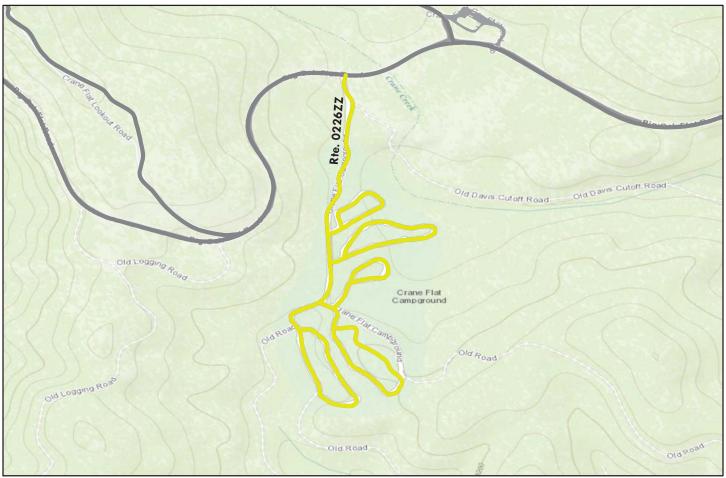
ROUTE 0226ZZ: CRANE FLAT CAMPGROUND LOOPS

Summary Route

Note: The weighted average summary PCR value is calculated from only the sections of road where the PCR was collected. The overall PCR for the summary route may not reflect individual subcomponent ratings.

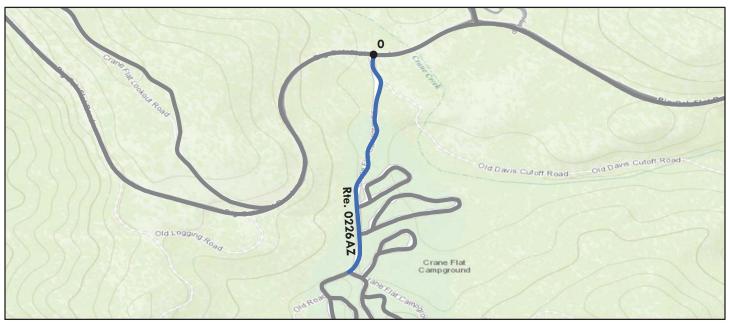
Subcomponent of Route YOSE-0226ZZ

Data Collection Vehicle (DCV) Rating

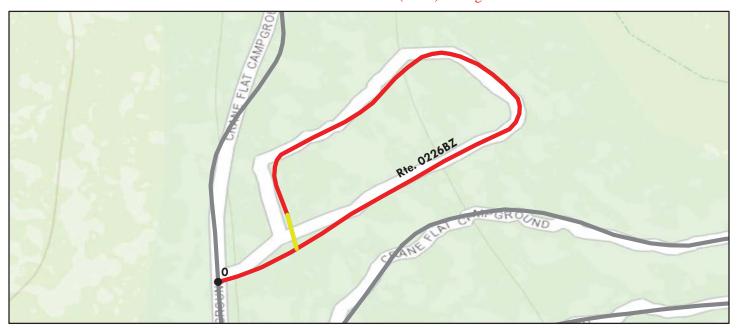
Subcomponent of Route YOSE-0226ZZ

Data Collection Vehicle (DCV) Rating

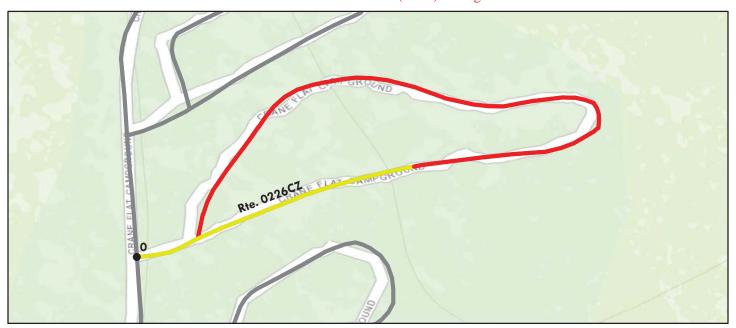
ROUTE 0226CZ: CRANE FLAT CAMPGROUND LOOP (SITES 201-246)

Subcomponent of Route YOSE-0226ZZ Data Collection Vehicle (DCV) Rating

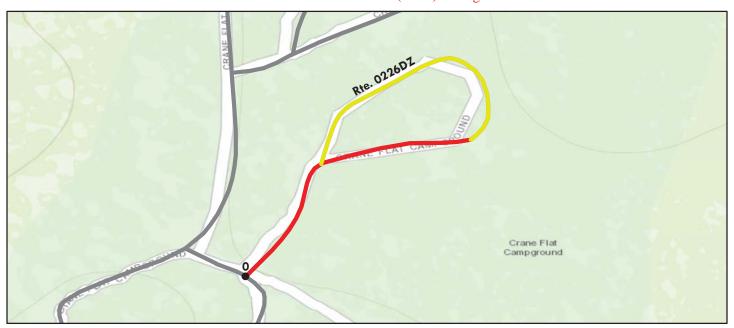
ROUTE 0226DZ: CRANE FLAT CAMPGROUND LOOP (SITES 301-326)

Subcomponent of Route YOSE-0226ZZ Data Collection Vehicle (DCV) Rating

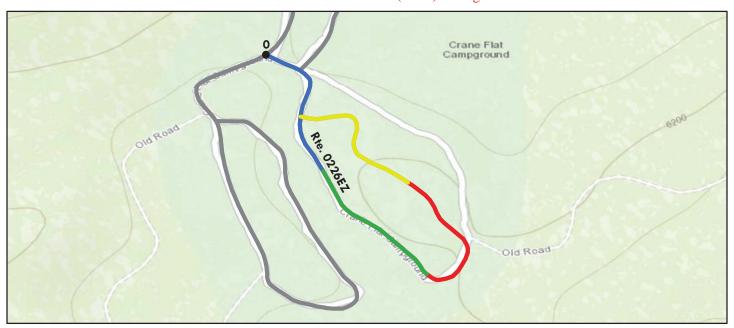
Subcomponent of Route YOSE-0226ZZ

Data Collection Vehicle (DCV) Rating

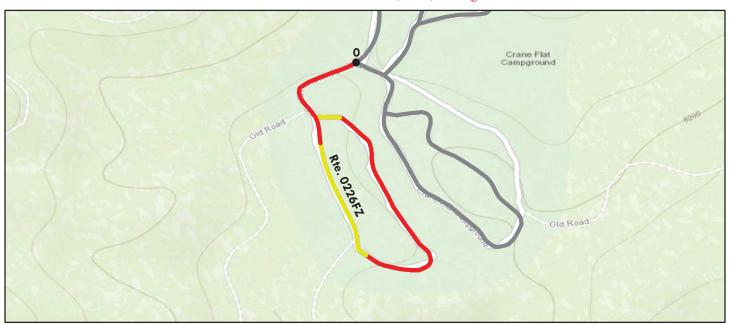
Subcomponent of Route YOSE-0226ZZ

Data Collection Vehicle (DCV) Rating

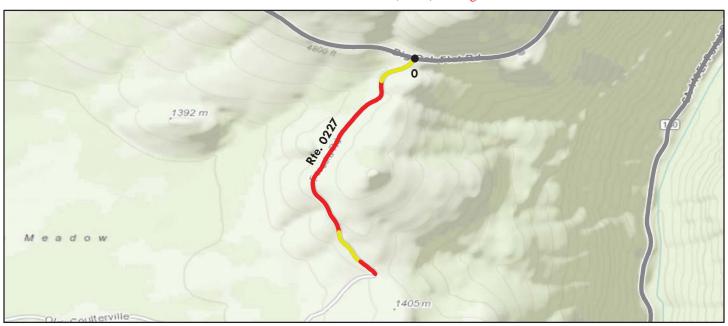
ROUTE 0227: FORESTA ROAD (EAST)

Data Collection Vehicle (DCV) Rating

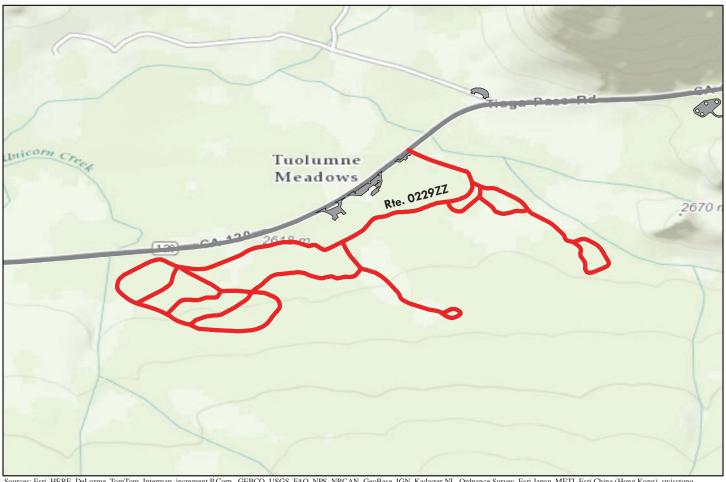
ROUTE 0229ZZ: TUOLUMNE MEADOWS CAMPGROUND ROADS

Summary Route

The condition shown on this page reflects the overall route condition; it might not reflect individual subcomponent ratings.

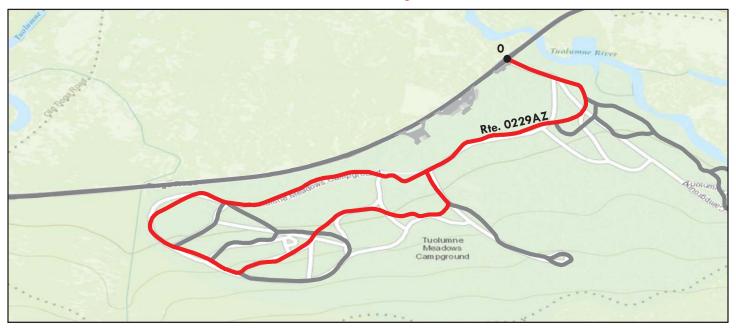
Subcomponent of Route YOSE-0229ZZ

Manual Rating

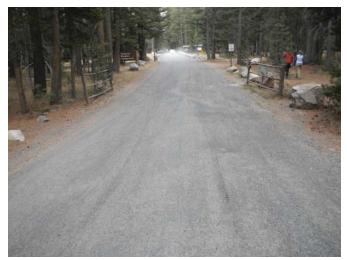
YOSE_0229AZ_9044.JPG

Condition Photos

Condition photos are shown only for manually rated roads. Use the PathView program to see images of DCV rated roads.

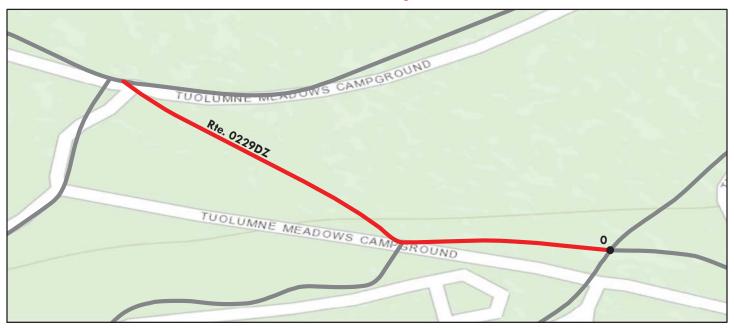
ROUTE 0229DZ: TUOLUMNE CAMPGROUND CUT THROUGH

Subcomponent of Route YOSE-0229ZZ

Manual Rating

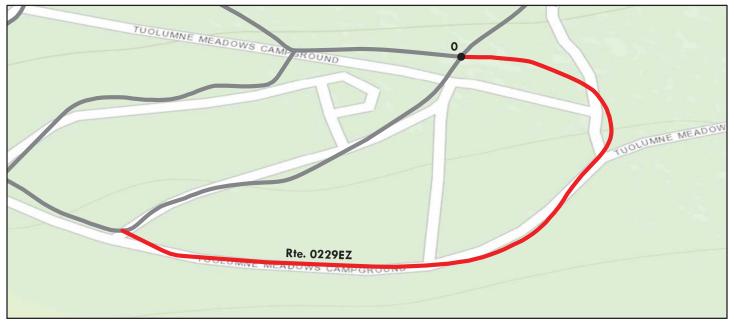
ROUTE 0229EZ: TUOLUMNE CAMPGROUND LOOP G

Subcomponent of Route YOSE-0229ZZ

Manual Rating

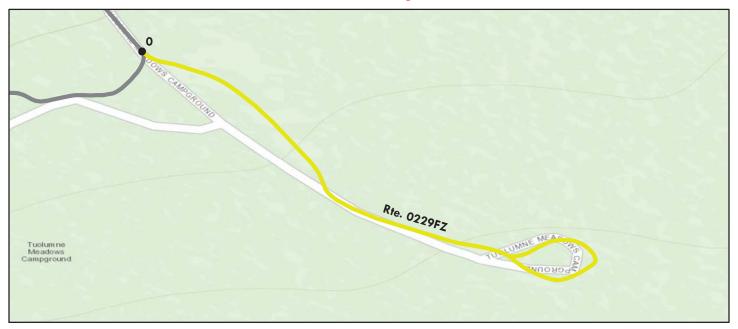
ROUTE 0229FZ: TUOLUMNE CAMPGROUND LOOP B (HORSE CAMP)

Subcomponent of Route YOSE-0229ZZ

Manual Rating

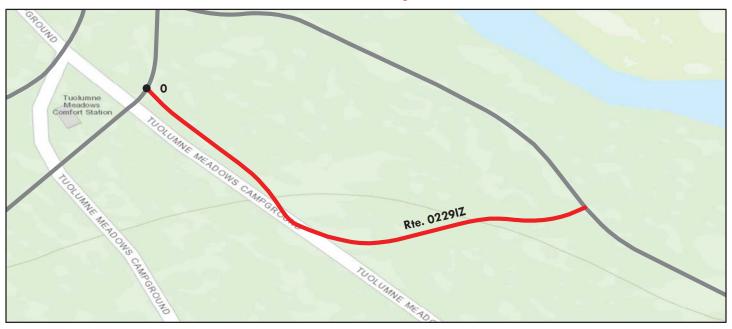
ROUTE 0229IZ: TUOLUMNE CAMPGROUND LOOP A (21-52)

Subcomponent of Route YOSE-0229ZZ

Manual Rating

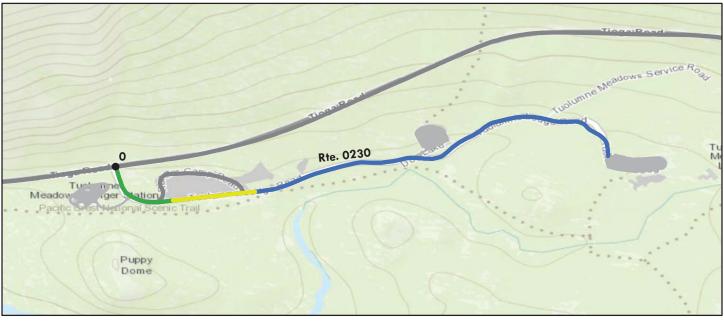
ROUTE 0230: TUOLUMNE LODGE ROAD

Data Collection Vehicle (DCV) Rating

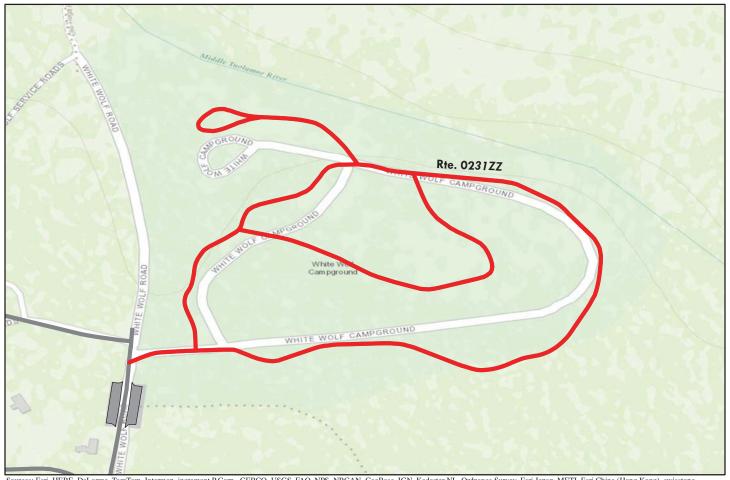
ROUTE 0231ZZ: WHITE WOLF CAMPGROUND ROADS

Summary Route

The condition shown on this page reflects the overall route condition; it might not reflect individual subcomponent ratings.

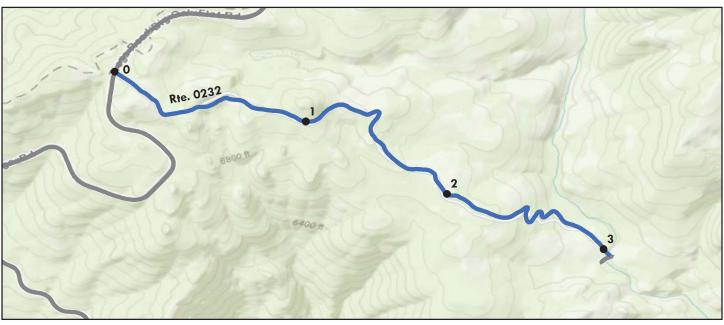
ROUTE 0232: TAMARACK FLAT CAMPGROUND ACCESS ROAD

Data Collection Vehicle (DCV) Rating

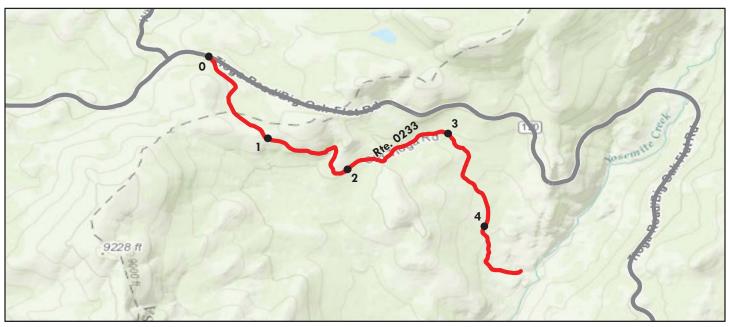
ROUTE 0233: YOSEMITE CREEK CAMPGROUND ACCESS ROAD

Manual Rating

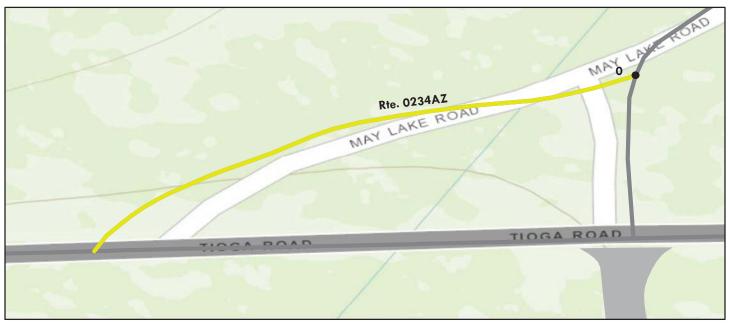
ROUTE 0234AZ: MAY LAKE ROAD SPUR

Subcomponent of Route YOSE-0234ZZ Data Collection Vehicle (DCV) Rating

| | Route (| Condition Legend – Pav | ement Condi | ition Rating (| PCR) | | |
|---|---|---|---|---|---|---|---|
| Pavement Condition | n Rating (PCR) | 81 | 81 | | | | |
| Surface Condition Ra | ating (SCR) | 81 | 81 | | | | |
| Structural Crack Inc | dex | 81 | 81 | | | | |
| Alligator Crack Inde | ex | 100 | 100 | | | | |
| Longitudinal Crack | Index | 81 | 81 | | | | |
| Transverse Cracking | g Index | 94 | 94 | | | | |

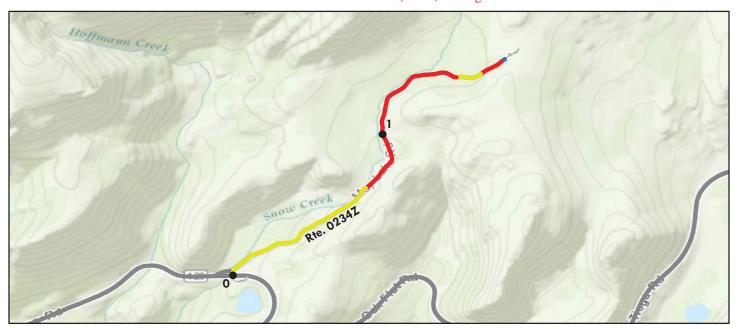
Subcomponent of Route YOSE-0234ZZ

Data Collection Vehicle (DCV) Rating

| | Route (| Condition Legend – Pav | ement Condi | tion Rating (| PCR) | | |
|---|---|---|---|---|---|---|--|
| Pavement Condition | Rating (PCR) | 30 | 61 | 0 | | | |
| Surface Condition Ra | ating (SCR) | 30 | 61 | 0 | | | |
| Structural Crack Ind | lex | 30 | 61 | 0 | | | |
| Alligator Crack Inde | ex | 63 | 90 | 25 | | | |
| Longitudinal Crack | Index | 67 | 71 | 60 | | | |
| Transverse Cracking | g Index | 87 | 83 | 91 | | | |

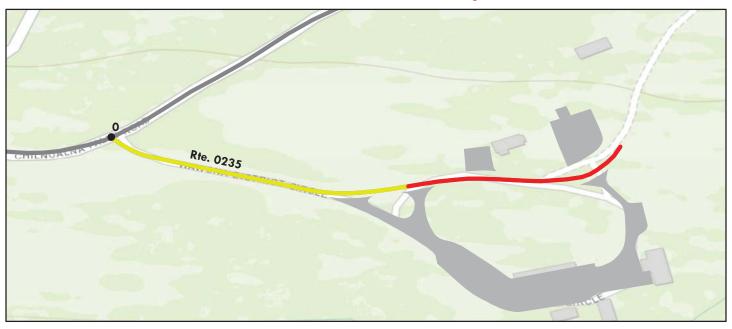
ROUTE 0235: WAWONA DISTRICT CIRCLE / RANGER STATION ROAD

Data Collection Vehicle (DCV) Rating

| | Route (| Condition Legend – Pav | ement Condi | tion Rating (| PCR) | | |
|---|---|---|---|---|---|---|---|
| Pavement Condition | Rating (PCR) | 60 | 60 | | | | |
| Surface Condition Rat | ting (SCR) | 60 | 60 | | | | |
| Structural Crack Inde | ex | 60 | 60 | | | | |
| Alligator Crack Inde | X | 67 | 67 | | | | |
| Longitudinal Crack I | Index | 93 | 93 | | | | |
| Transverse Cracking | Index | 94 | 94 | | | | |

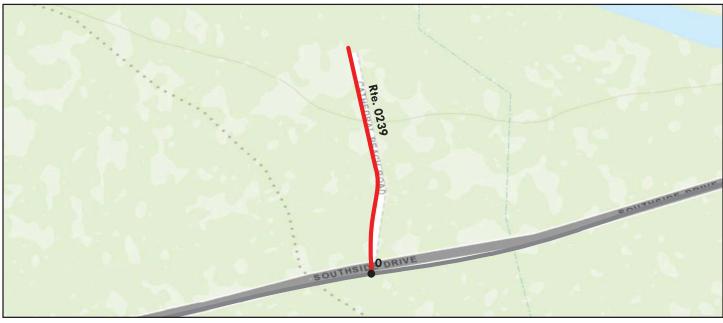
ROUTE 0239: CATHEDRAL BEACH PICNIC AREA ROAD

Manual Rating

| | Route (| Condition Legend – Pav | ement Condi | tion Rating (| PCR) | | |
|---|---|---|---|---|---|---|---|
| Pavement Condition | Rating (PCR) | 30 | 30 | | | | |
| Surface Condition Ra | ating (SCR) | 30 | 30 | | | | |
| Alligator Crack Inde | ex | 30 | 30 | | | | |
| Longitudinal Crack | Index | 53 | 53 | | | | |
| Transverse Cracking | g Index | 90 | 90 | | | | |

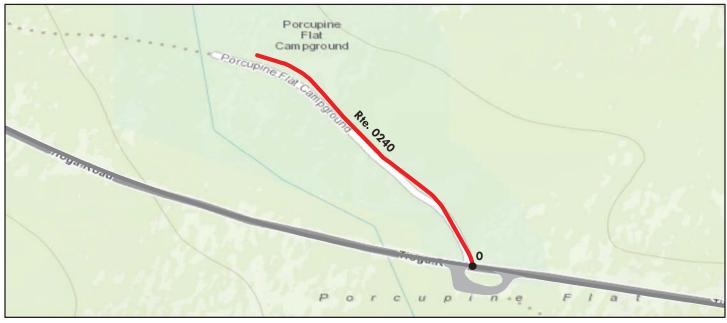
ROUTE 0240: PORCUPINE FLAT CAMPGROUND ACCESS ROAD

Manual Rating

| | Pouto (| Condition Legend – Pav | oment Condi | tion Dating (| DCD) | | |
|---|---|---|---|---|---|---|---|
| Pavement Condition | Rating (PCR) | 30 | 30 | | | | |
| Surface Condition Rat | ring (SCR) | 30 | 30 | | | | |
| Alligator Crack Inde | X | 30 | 30 | | | | |
| Longitudinal Crack I | ndex | 30 | 30 | | | | |
| Transverse Cracking | Index | 53 | 53 | | | | |

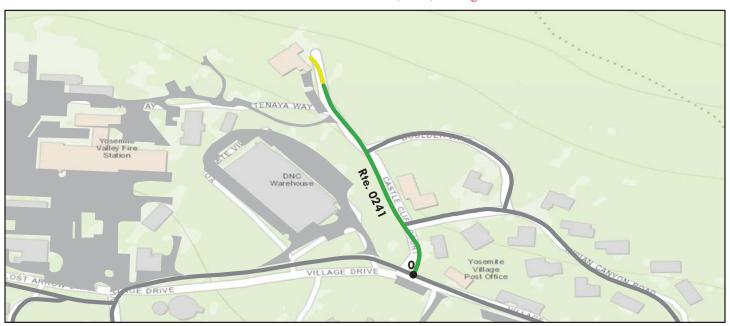
ROUTE 0241: CASTLE CLIFF COURT

Data Collection Vehicle (DCV) Rating

| Rom | e Condition Legend – Pav | ement Cond | ition Rating (PCR) | |
|---|---|---|---|---|
| Pavement Condition Rating (PCR) | 86 | 86 | | |
| Surface Condition Rating (SCR) | 86 | 86 | | |
| Structural Crack Index | 97 | 97 | | |
| Alligator Crack Index | 100 | 100 | | |
| Longitudinal Crack Index | 97 | 97 | | |
| Transverse Cracking Index | 86 | 86 | | |

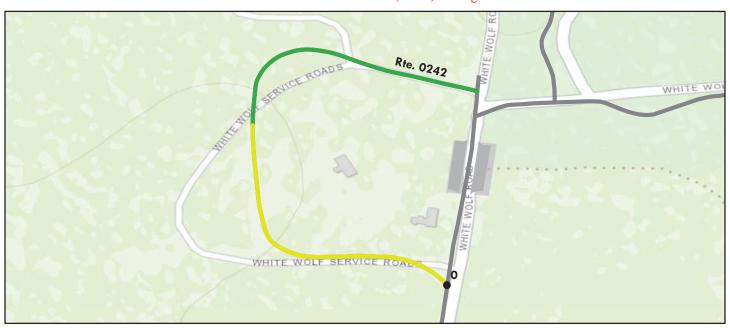
ROUTE 0242: WHITE WOLF LODGE ROAD

Data Collection Vehicle (DCV) Rating

| | Route (| Condition Legend – Pav | ement Condi | ition Rating (1 | PCR) | | |
|---|---|---|---|---|---|---|---|
| Pavement Condition | n Rating (PCR) | 82 | 82 | | | | |
| Surface Condition R | ating (SCR) | 82 | 82 | | | | |
| Structural Crack Inc | dex | 98 | 98 | | | | |
| Alligator Crack Ind | lex | 100 | 100 | | | | |
| Longitudinal Crack | Index | 98 | 98 | | | | |
| Transverse Crackin | g Index | 98 | 98 | | | | |

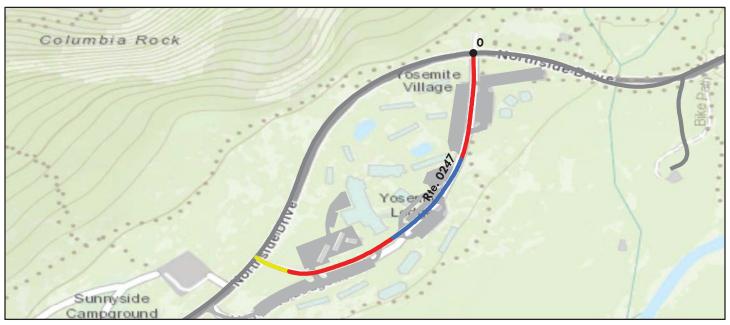
ROUTE 0247: YOSEMITE LODGE ROAD

Data Collection Vehicle (DCV) Rating

| | Route (| Condition Legend – Pav | ement Condi | ition Rating (| PCR) | | |
|---|---|---|---|---|---|---|---|
| Pavement Condition | n Rating (PCR) | 74 | 74 | | | | |
| Surface Condition Ra | ating (SCR) | 74 | 74 | | | | |
| Structural Crack Ind | lex | 78 | 78 | | | | |
| Alligator Crack Inde | ex | 85 | 85 | | | | |
| Longitudinal Crack | Index | 93 | 93 | | | | |
| Transverse Cracking | g Index | 74 | 74 | | | | |

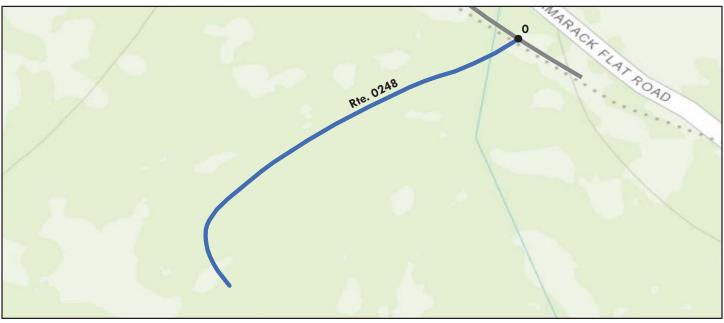
ROUTE 0248: TAMARACK FLAT CAMPGROUND ROADS

Data Collection Vehicle (DCV) Rating

| Rout | e Condition Legend – Pav | ement Cond | ition Rating (PCR) | |
|---|---|---|---|---|
| Pavement Condition Rating (PCR) | 98 | 98 | | |
| Surface Condition Rating (SCR) | 98 | 98 | | |
| Structural Crack Index | 100 | 100 | | |
| Alligator Crack Index | 100 | 100 | | |
| Longitudinal Crack Index | 100 | 100 | | |
| Transverse Cracking Index | 100 | 100 | | |

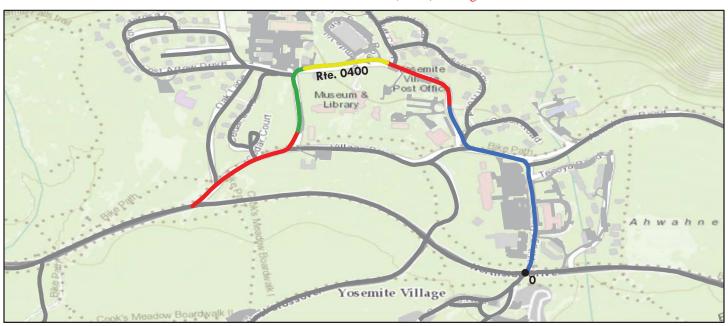
ROUTE 0400: VILLAGE DRIVE

Data Collection Vehicle (DCV) Rating

| Rout | e Condition Legend – Pav | rement Cond | ition Rating (PCR) | |
|---|---|---|---|---|
| Pavement Condition Rating (PCR) | 76 | 76 | | |
| Surface Condition Rating (SCR) | 76 | 76 | | |
| Structural Crack Index | 76 | 76 | | |
| Alligator Crack Index | 94 | 94 | | |
| Longitudinal Crack Index | 82 | 82 | | |
| Transverse Cracking Index | 76 | 76 | | |

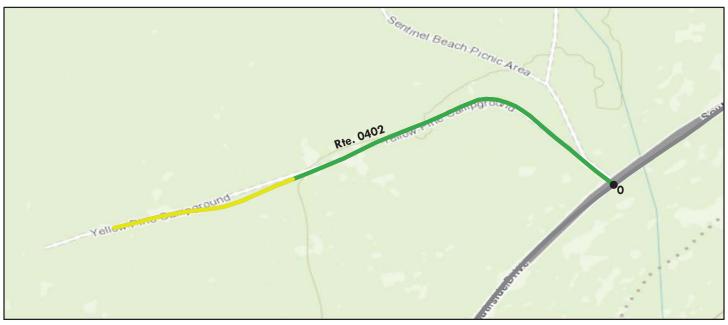
ROUTE 0402: YELLOW PINES CAMPGROUND ROAD

Data Collection Vehicle (DCV) Rating

| | Route (| Condition Legend – Pav | ement Condi | ition Rating (1 | PCR) | | | | |
|---|---|---|---|---|---|--|--|--|--|
| Pavement Condition | n Rating (PCR) | 86 | 86 | | | | | | |
| Surface Condition R | ating (SCR) | 86 | 86 | | | | | | |
| Structural Crack Inc | dex | 95 | 95 | | | | | | |
| Alligator Crack Ind | ex | 100 | 100 | | | | | | |
| Longitudinal Crack | Index | 95 | 95 | | | | | | |
| Transverse Crackin | g Index | 97 | 97 | | | | | | |
