YOSE Cycle 6

Final Report

Road Inventory and Condition Assessment of Paved Routes Yosemite National Park

Report Date: April 2016

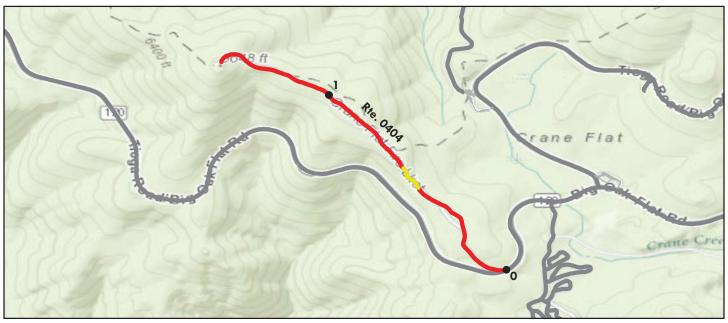
ROUTE 0404: CRANE FLAT HELIPORT ROAD

Data Collection Vehicle (DCV) Rating

| Rout | e Condition Legend – Pav | ement Condi | tion Rating (PC | CR) | |
|---|---|---|---|---|---|
| Pavement Condition Rating (PCR) | 28 | 29 | 27 | | |
| Surface Condition Rating (SCR) | 28 | 29 | 27 | | |
| Structural Crack Index | 28 | 29 | 27 | | |
| Alligator Crack Index | 71 | 70 | 73 | | |
| Longitudinal Crack Index | 57 | 59 | 54 | | |
| Transverse Cracking Index | 63 | 66 | 55 | | |

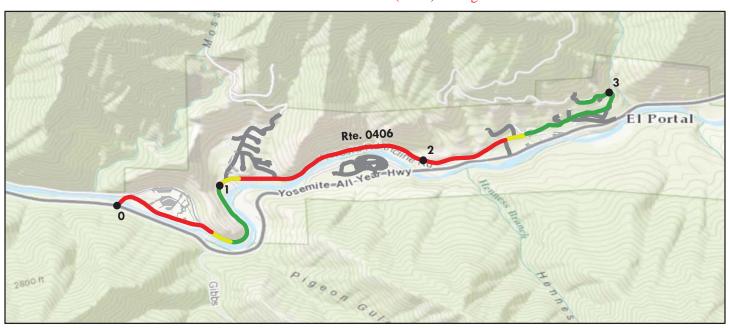
ROUTE 0406: FORESTA ROAD (WEST)

Data Collection Vehicle (DCV) Rating

| | Route (| Condition Legend – Pav | ement Condi | tion Rating (| PCR) | | |
|---|---|---|---|---|---|---|---|
| Pavement Condition Rati | ing (PCR) | 60 | 57 | 48 | 74 | 91 | |
| Surface Condition Rating | (SCR) | 58 | 46 | 40 | 74 | 91 | |
| Roughness Condition Inde | ex (RCI) | 62 | 73 | 59 | N/A | N/A | |
| Structural Crack Index | | 58 | 46 | 49 | 74 | 100 | |
| Alligator Crack Index | | 78 | 67 | 78 | 86 | 100 | |
| Longitudinal Crack Index | X | 80 | 79 | 71 | 88 | 100 | |
| Transverse Cracking Inde | ex | 61 | 65 | 40 | 74 | 99 | |

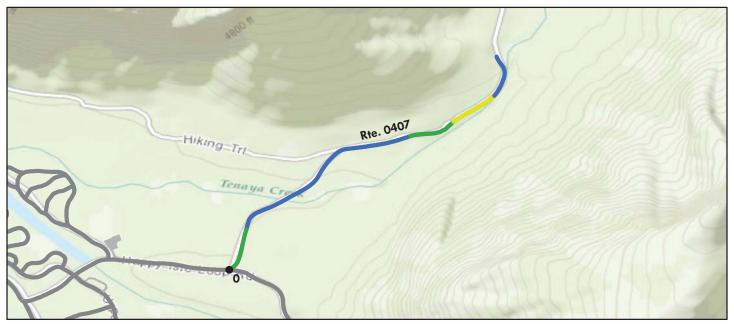
ROUTE 0407: MIRROR LAKE ROAD

Data Collection Vehicle (DCV) Rating

| | Route (| Condition Legend – Pav | ement Condi | ition Rating (| PCR) | | |
|---|---|---|---|---|---|---|---|
| Pavement Condition | Rating (PCR) | 96 | 96 | | | | |
| Surface Condition Rat | ing (SCR) | 96 | 96 | | | | |
| Structural Crack Inde | ex | 97 | 97 | | | | |
| Alligator Crack Index | X | 100 | 100 | | | | |
| Longitudinal Crack I | ndex | 97 | 97 | | | | |
| Transverse Cracking | Index | 98 | 98 | | | | |

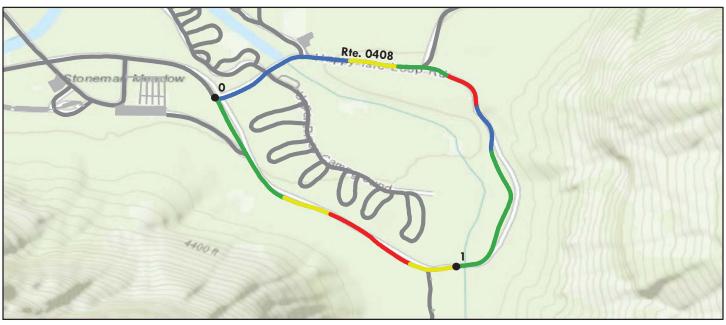
ROUTE 0408: HAPPY ISLES SHUTTLE LOOP

Data Collection Vehicle (DCV) Rating

| | Route (| Condition Legend – Pav | ement Condi | tion Rating (| PCR) | | |
|---|---|---|---|---|---|---|---|
| Pavement Condition I | Rating (PCR) | 78 | 88 | 54 | | | |
| Surface Condition Rati | ng (SCR) | 78 | 88 | 54 | | | |
| Structural Crack Inde | X | 78 | 94 | 54 | | | |
| Alligator Crack Index | | 85 | 98 | 65 | | | |
| Longitudinal Crack In | ndex | 93 | 96 | 89 | | | |
| Transverse Cracking 1 | Index | 91 | 88 | 96 | | | |

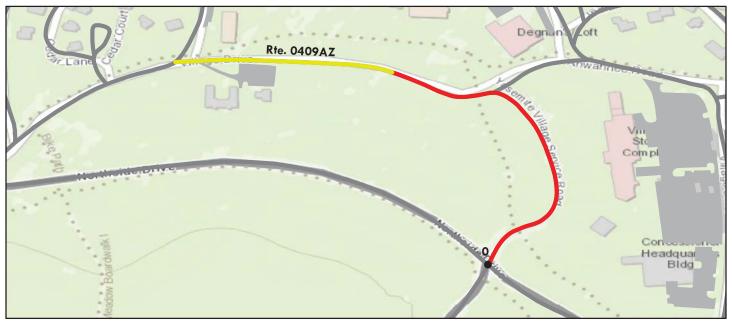
Subcomponent of Route YOSE-0409ZZ

Data Collection Vehicle (DCV) Rating

| | Route (| Condition Legend – Pav | ement Condi | tion Rating (| PCR) | | |
|---|---|---|---|---|---|---|---|
| Pavement Condition | Rating (PCR) | 45 | 45 | | | | |
| Surface Condition Rat | ing (SCR) | 45 | 45 | | | | |
| Structural Crack Inde | ex | 45 | 45 | | | | |
| Alligator Crack Index | X | 53 | 53 | | | | |
| Longitudinal Crack In | ndex | 92 | 92 | | | | |
| Transverse Cracking | Index | 83 | 83 | | | | |

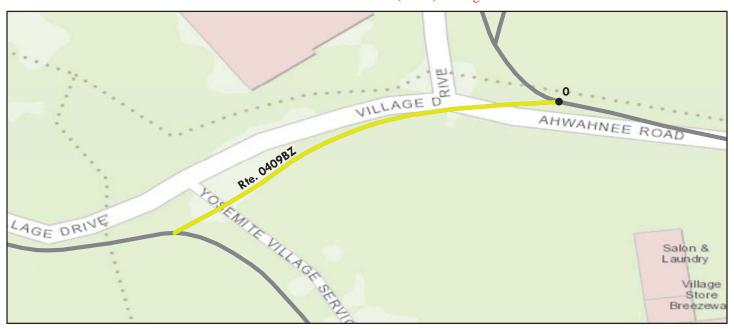
ROUTE 0409BZ: VILLAGE SHUTTLE SPUR ROAD

Subcomponent of Route YOSE-0409ZZ Data Collection Vehicle (DCV) Rating

| | Route Condition | Legend – Pa | vement Condi | tion Rating (| PCR) | | |
|---|---|---|---|---|---|---|---|
| Pavement Condition Rating (P | CR) | 81 | 81 | | | | |
| Surface Condition Rating (SCR) | | 81 | 81 | | | | |
| Structural Crack Index | | 96 | 96 | | | | |
| Alligator Crack Index | | 99 | 99 | | | | |
| Longitudinal Crack Index | | 97 | 97 | | | | |
| Transverse Cracking Index | | 81 | 81 | | | | |

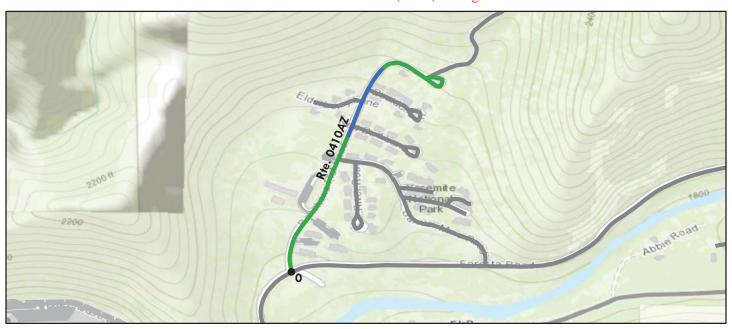
ROUTE 0410AZ: RANCHERIA FLAT ROAD

Subcomponent of Route YOSE-0410ZZ Data Collection Vehicle (DCV) Rating

| Rou | te Condition Legend – Pav | rement Cond | ition Rating (PCR) | |
|---|---|---|---|---|
| Pavement Condition Rating (PCR) | 94 | 94 | | |
| Surface Condition Rating (SCR) | 94 | 94 | | |
| Structural Crack Index | 98 | 98 | | |
| Alligator Crack Index | 100 | 100 | | |
| Longitudinal Crack Index | 98 | 98 | | |
| Transverse Cracking Index | 94 | 94 | | |

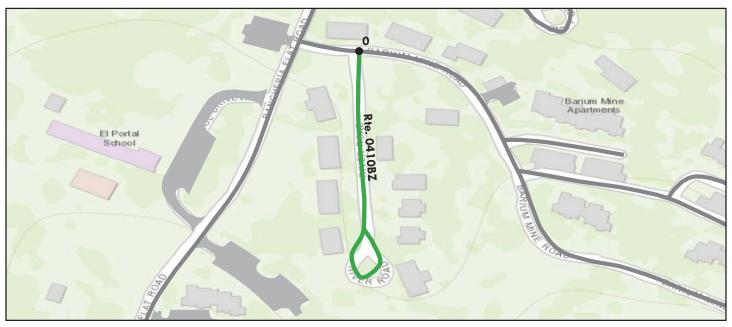
ROUTE 0410BZ: RIVER VIEW ROAD

Subcomponent of Route YOSE-0410ZZ Data Collection Vehicle (DCV) Rating

| | Route (| Condition Legend – Pav | ement Condi | ition Rating (F | PCR) | | |
|---|---|---|---|---|---|---|---|
| Pavement Condition | Rating (PCR) | 89 | 89 | | | | |
| Surface Condition Ra | ating (SCR) | 89 | 89 | | | | |
| Structural Crack Ind | lex | 92 | 92 | | | | |
| Alligator Crack Inde | ex | 100 | 100 | | | | |

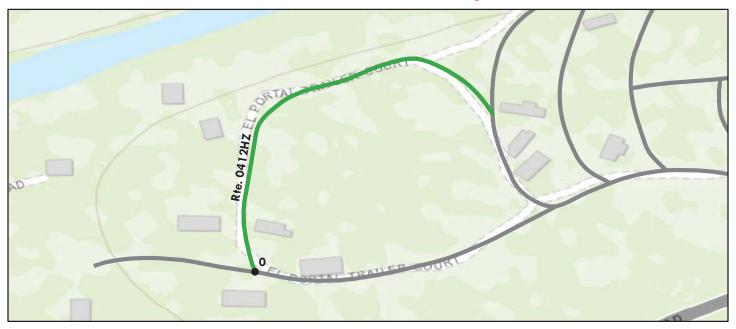
ROUTE 0412HZ: EL PORTAL TRAILER COURT ROAD H

Subcomponent of Route YOSE-0412ZZ Data Collection Vehicle (DCV) Rating

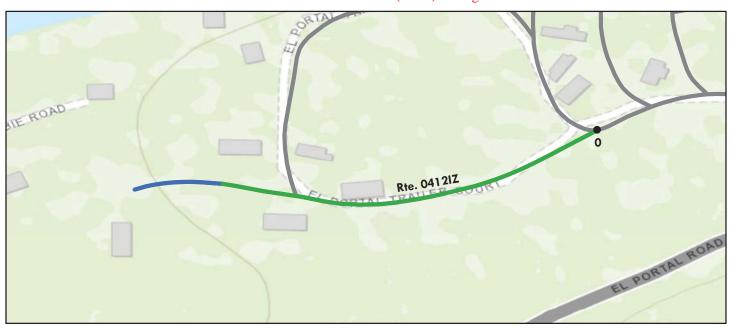
Subcomponent of Route YOSE-0412ZZ

Data Collection Vehicle (DCV) Rating

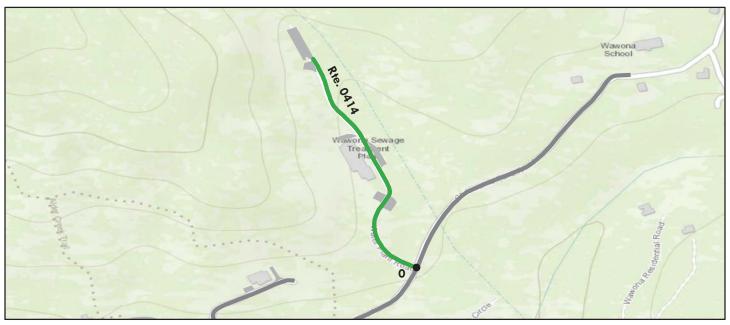
ROUTE 0414: WAWONA WASTE WATER TREATMENT ROAD

Data Collection Vehicle (DCV) Rating

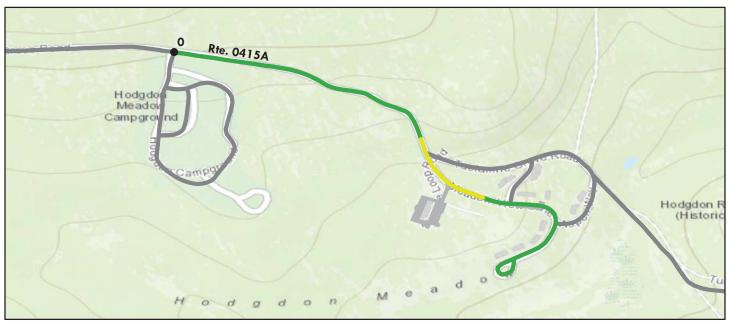
ROUTE 0415A: HODGDON MEADOW RESIDENCE ACCESS ROAD / MEADOW VIEW LANE

Data Collection Vehicle (DCV) Rating

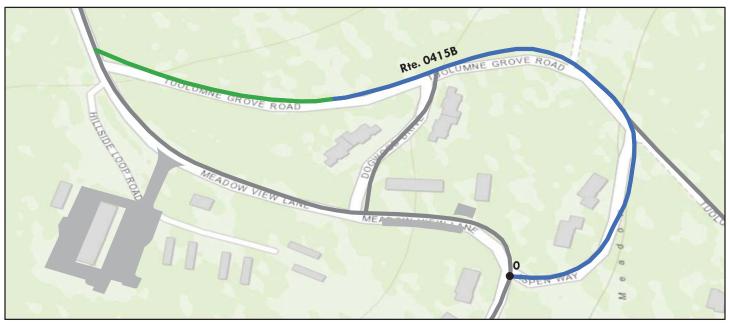
ROUTE 0415B: HODGDON MEADOW RESIDENCE ROAD / ASPEN WAY

Data Collection Vehicle (DCV) Rating

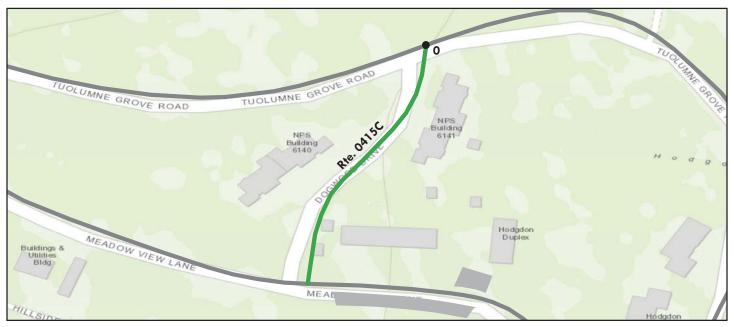
ROUTE 0415C: HODGDON MEADOW RESIDENCE ROAD / DOGWOOD DRIVE

Data Collection Vehicle (DCV) Rating

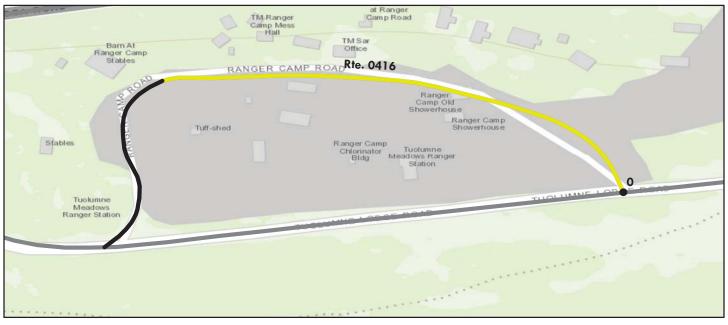
ROUTE 0416: TUOLUMNE RESIDENCES AND RANGER STATION ROAD

Data Collection Vehicle (DCV) Rating

Note: Condition data could not be collected on a portion of the route because it was covered with loose gravel.

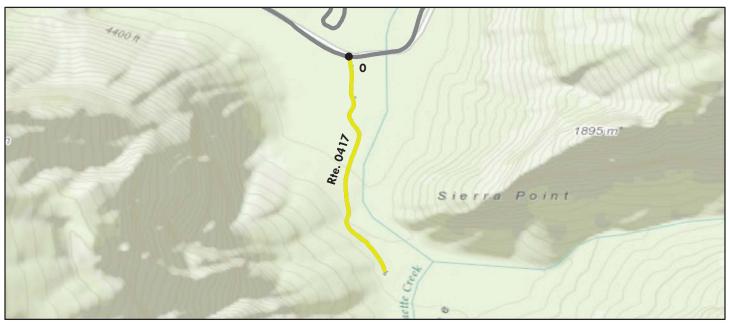
ROUTE 0417: HAPPY ISLES WATER TANK ACCESS ROAD

Data Collection Vehicle (DCV) Rating

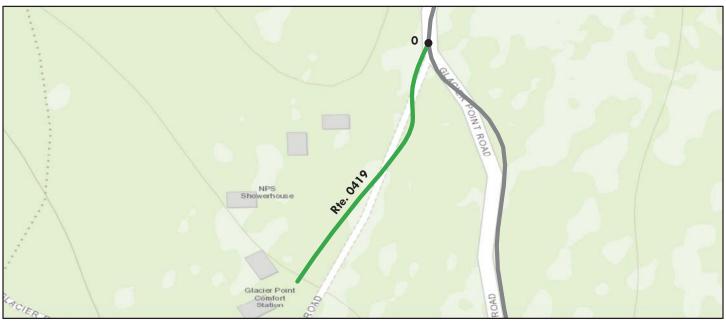
ROUTE 0419: GLACIER POINT RESIDENCE ROAD (RANGER STATION)

Data Collection Vehicle (DCV) Rating

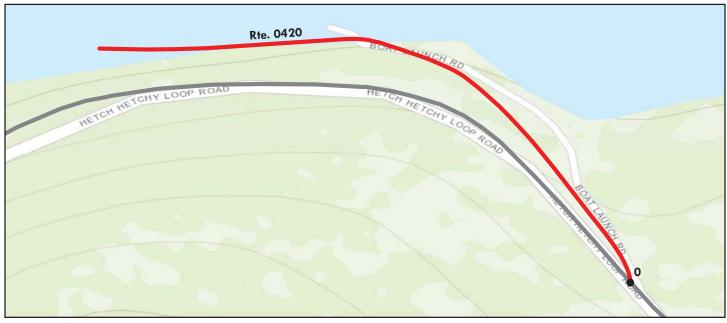
ROUTE 0420: O'SHAUGHNESSY DAM / BOAT ACCESS ROAD

Manual Rating

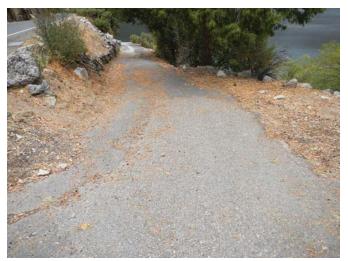
YOSE_0420_9093.JPG

Condition photos are shown only for manually rated roads. Use the PathView program to see images of DCV rated roads.

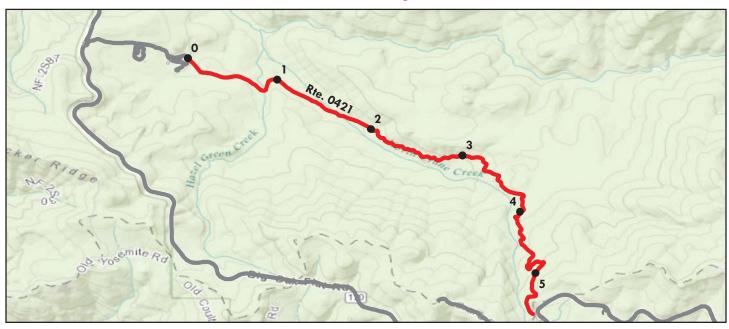
ROUTE 0421: OLD BIG OAK FLAT ROAD (VIA TUOLUMNE GROVE)

Manual Rating

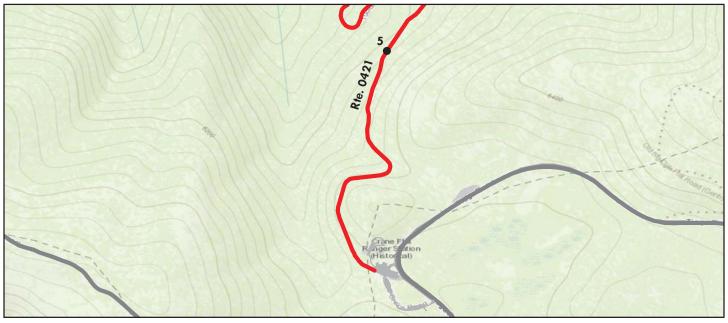
ROUTE 0421: OLD BIG OAK FLAT ROAD (VIA TUOLUMNE GROVE)

Manual Rating

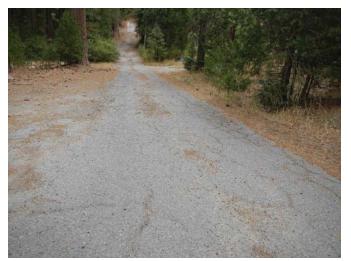
YOSE_0421_9145.JPG

Condition photos are shown only for manually rated roads. Use the PathView program to see images of DCV rated roads.

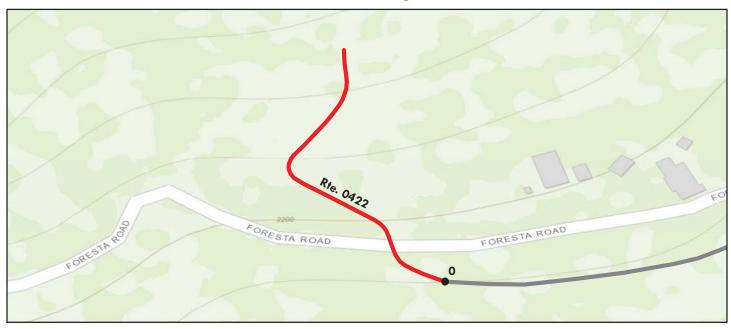
ROUTE 0422: WATER TANK #4 ROAD

Manual Rating

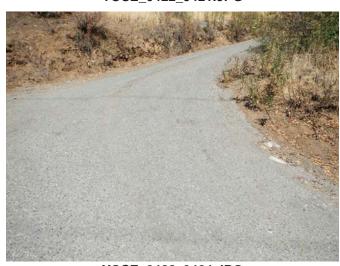
YOSE_0422_9424.JPG

Condition photos are shown only for manually rated roads. Use the PathView program to see images of DCV rated roads.

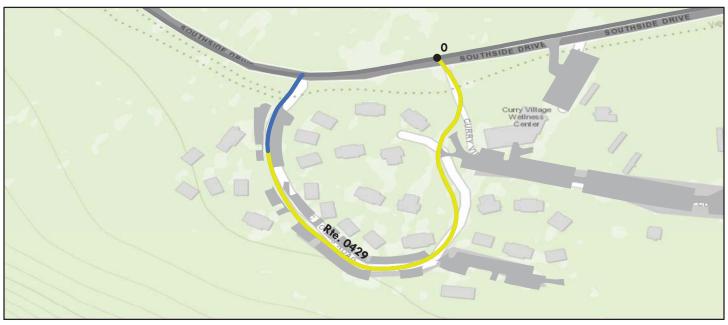
ROUTE 0429: SIERRA CIRCLE

Data Collection Vehicle (DCV) Rating

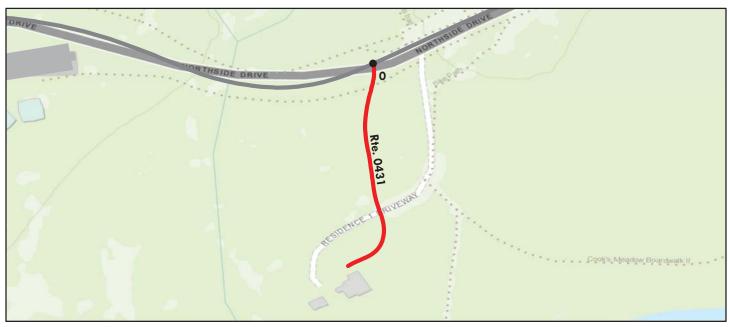
ROUTE 0431: VALLEY ONE RESIDENCE ROAD

Manual Rating

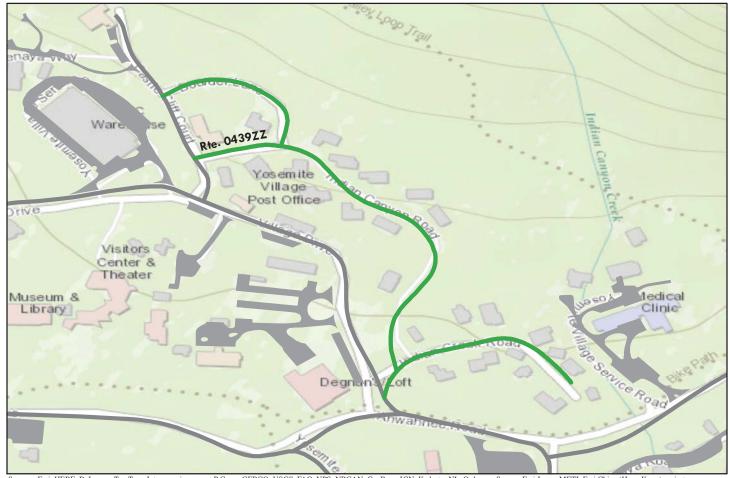
ROUTE 0439ZZ: UPPER TECOYA ROADS

Summary Route

Note: The weighted average summary PCR value is calculated from only the sections of road where the PCR was collected. The overall PCR for the summary route may not reflect individual subcomponent ratings.

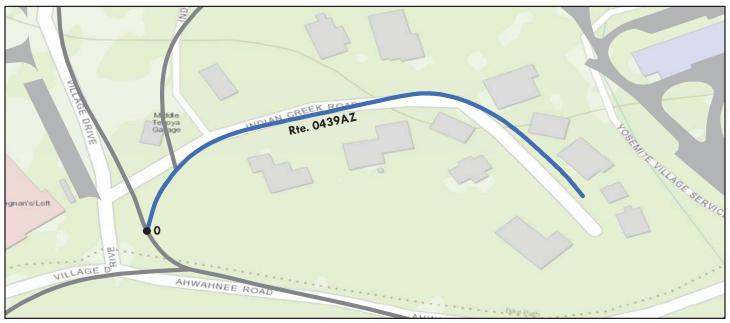
Subcomponent of Route YOSE-0439ZZ

Data Collection Vehicle (DCV) Rating

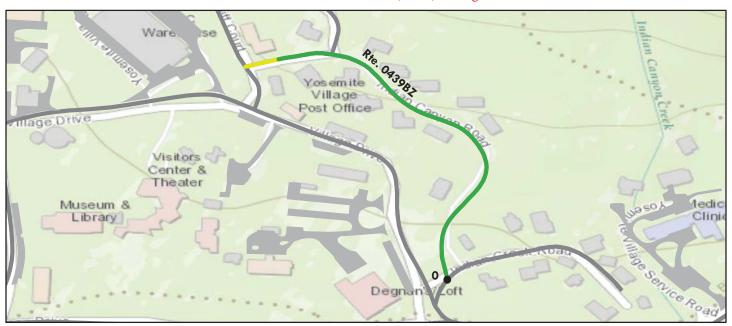
Subcomponent of Route YOSE-0439ZZ

Data Collection Vehicle (DCV) Rating

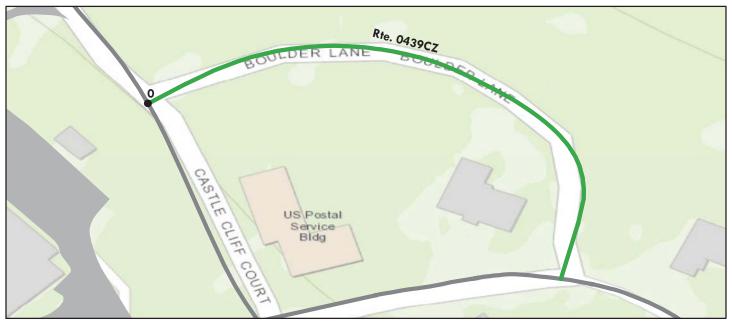
ROUTE 0439CZ: BOULDER LANE (VALLEY)

Subcomponent of Route YOSE-0439ZZ Data Collection Vehicle (DCV) Rating

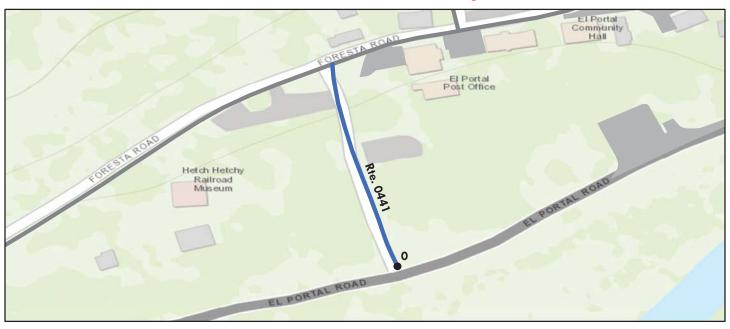
ROUTE 0441: EL PORTAL ROAD (FORESTA ROAD CONNECTOR)

Data Collection Vehicle (DCV) Rating

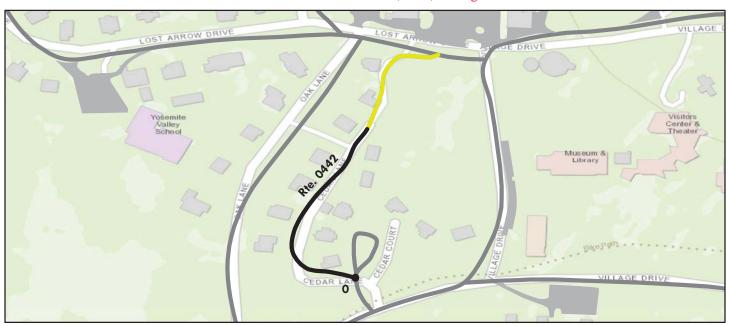
ROUTE 0442: CEDAR LANE

Data Collection Vehicle (DCV) Rating

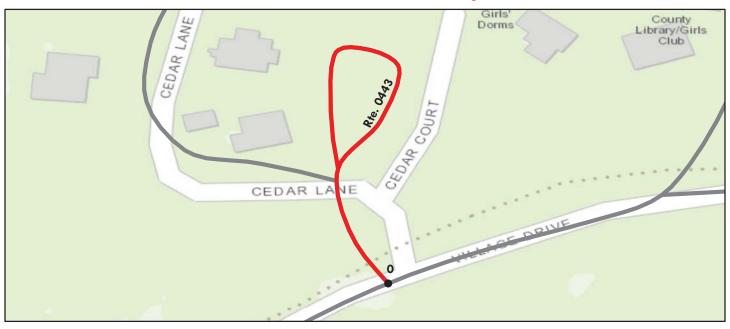
ROUTE 0443: CEDAR COURT

Data Collection Vehicle (DCV) Rating

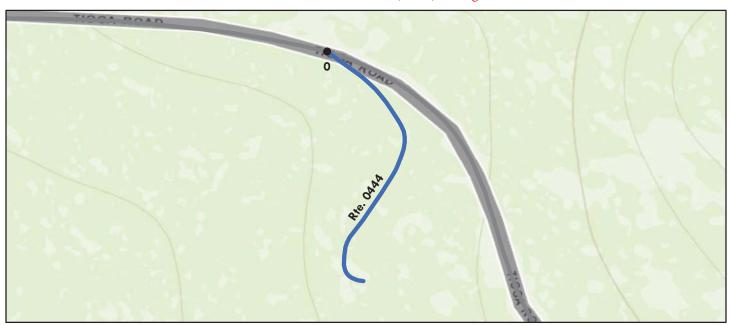
ROUTE 0444: TIOGA WATER TANK ROAD

Data Collection Vehicle (DCV) Rating

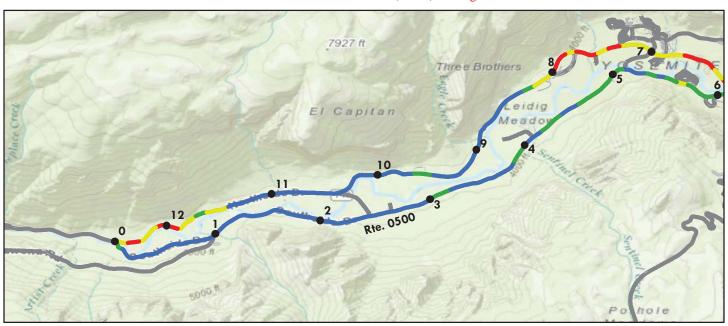
ROUTE 0500: VALLEY LOOP ROAD

Data Collection Vehicle (DCV) Rating

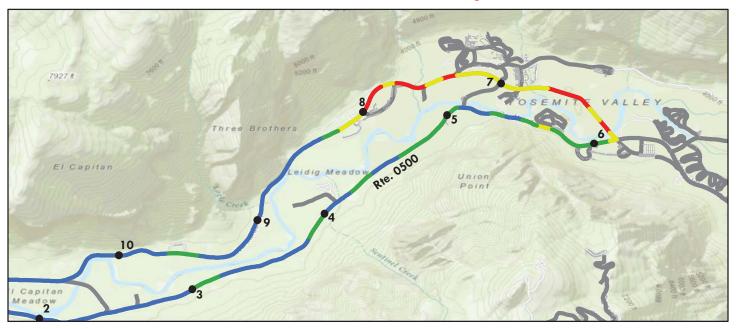
ROUTE 0500: VALLEY LOOP ROAD

Data Collection Vehicle (DCV) Rating

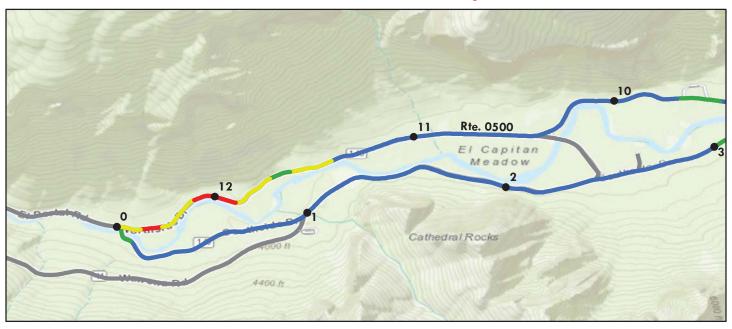
ROUTE 0500: VALLEY LOOP ROAD

Data Collection Vehicle (DCV) Rating

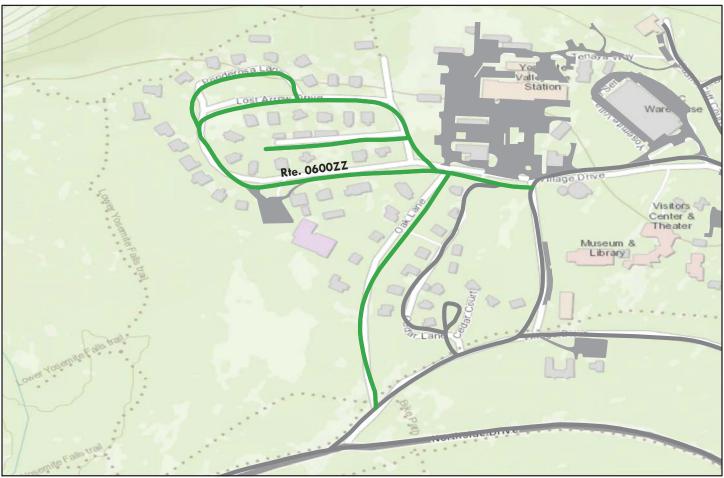
ROUTE 0600ZZ: VALLEY RESIDENCE ROADS

Summary Route

Note: The weighted average summary PCR value is calculated from only the sections of road where the PCR was collected. The overall PCR for the summary route may not reflect individual subcomponent ratings.

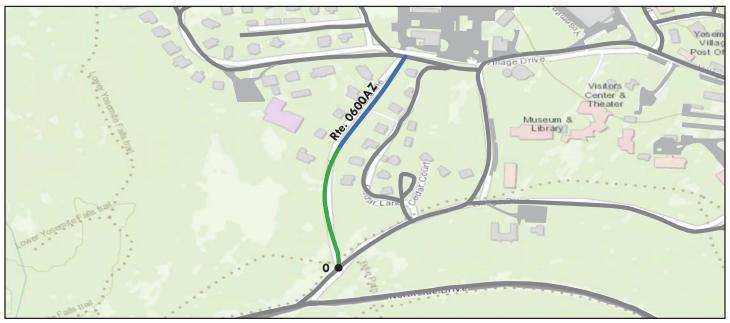
Subcomponent of Route YOSE-0600ZZ

Data Collection Vehicle (DCV) Rating

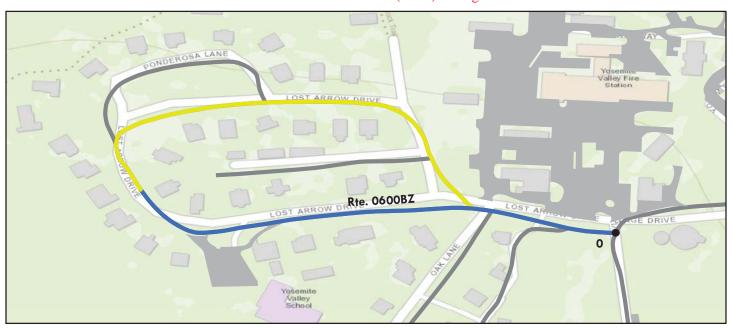
Subcomponent of Route YOSE-0600ZZ

Data Collection Vehicle (DCV) Rating

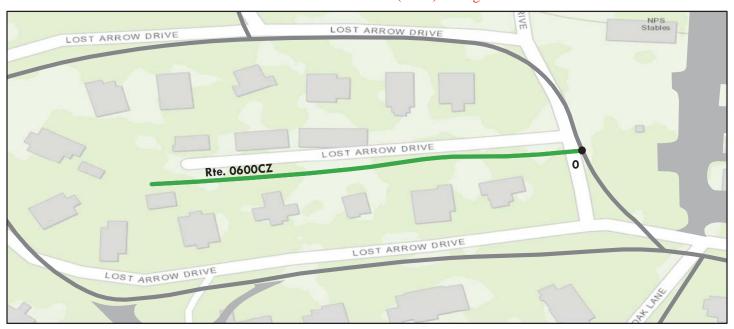
ROUTE 0600CZ: LOST ARROW INNER ROAD

Subcomponent of Route YOSE-0600ZZ Data Collection Vehicle (DCV) Rating

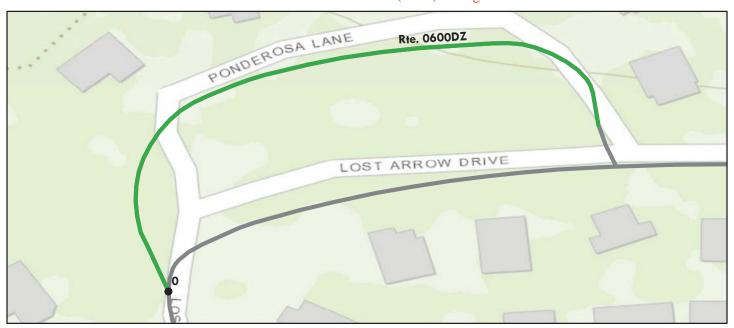
ROUTE 0600DZ: PONDEROSA LANE

Subcomponent of Route YOSE-0600ZZ Data Collection Vehicle (DCV) Rating

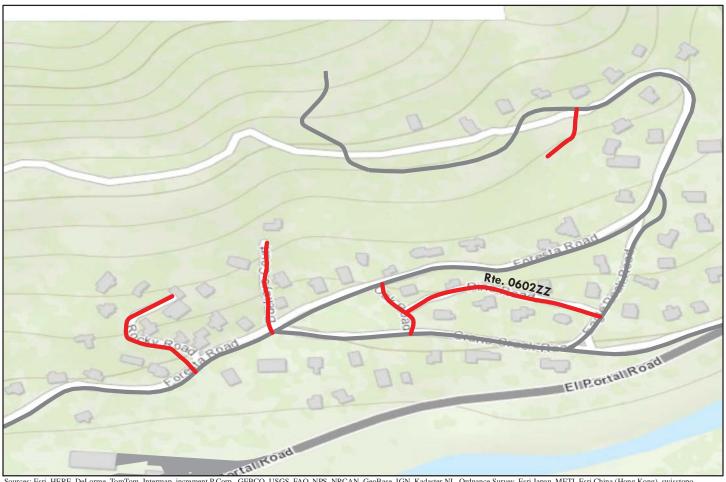
ROUTE 0602ZZ: OLD EL PORTAL RESIDENTIAL ROADS

Summary Route

Note: The weighted average summary PCR value is calculated from only the sections of road where the PCR was collected. The overall PCR for the summary route may not reflect individual subcomponent ratings.

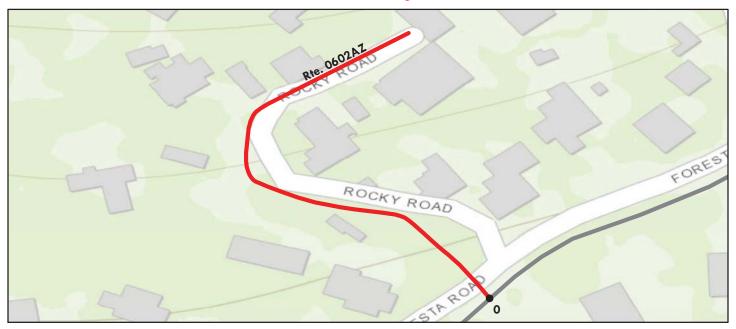
Subcomponent of Route YOSE-0602ZZ

Manual Rating

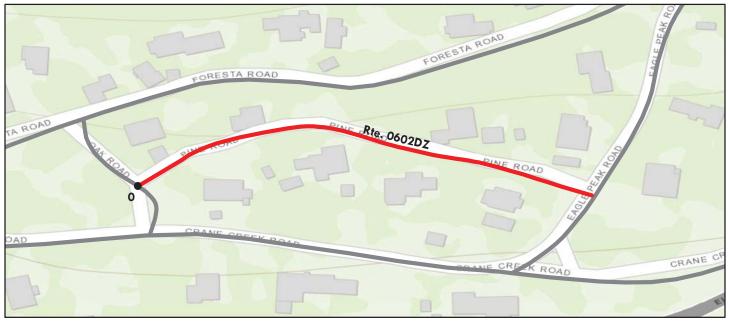
ROUTE 0602DZ: PINE ROAD

Manual Rating

| Route Condition Legend – Pavement Condition Rating (PCR) | | | | |
|--|---|---|---|---|
| Pavement Condition Rating (PCR) | 0 | 0 | | |
| Surface Condition Rating (SCR) | 0 | 0 | | |

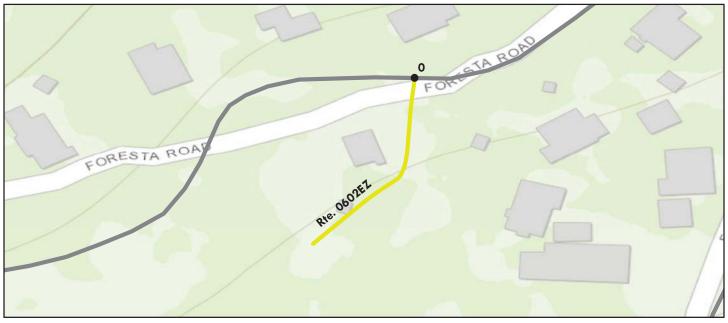
ROUTE 0602EZ: BUCKEYE COURT

Manual Rating

| Route Condition Legend – Pavement Condition Rating (PCR) | | | | | | | |
|--|---|---|---|---|--|---|---|
| Surface Condition R | ating (SCR) | 73 | 73 | | | | |
| Alligator Crack Ind | lex | 90 | 90 | | | | |

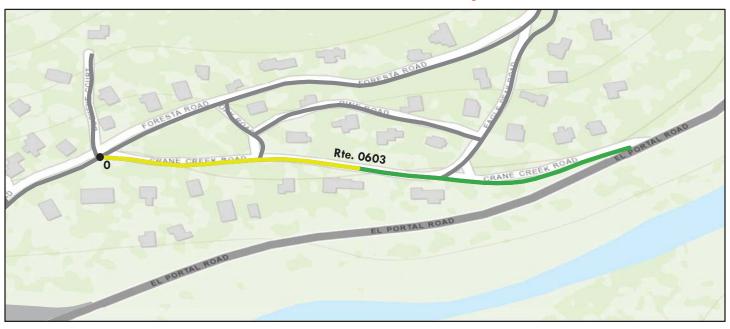
ROUTE 0603: CRANE CREEK ROAD

Data Collection Vehicle (DCV) Rating

| | Route Condition Legend – Pavement Condition Rating (PCR) | | | | | | |
|---|--|---|---|---|--|---|---|
| Pavement Condition | Rating (PCR) | 85 | 85 | | | | |
| Surface Condition Rat | ting (SCR) | 85 | 85 | | | | |

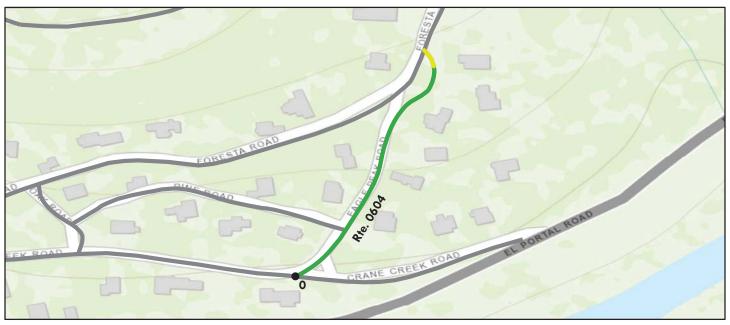
ROUTE 0604: EAGLE PEAK ROAD

Data Collection Vehicle (DCV) Rating

| Route Condition Legend – Pavement Condition Rating (PCR) | | | | | |
|--|---|---|---|---|--|
| Pavement Condition Rating (PCR) | 87 | 87 | | | |
| Surface Condition Rating (SCR) | 87 | 87 | | | |

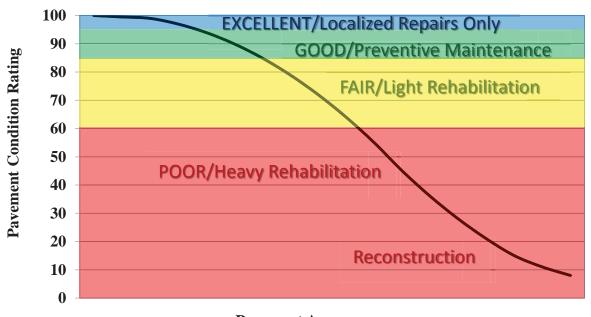
Condition Categories and Treatments

At this time, specific maintenance and rehabilitation activities should be evaluated and recommended at the project level. Site-specific conditions that influence treatment type should be determined based on performing a subsurface investigation and/or pavement condition survey, and not be based solely on RIP data. Additionally, RIP produces a snapshot of conditions the year in which the data was collected. For further information or to obtain additional PMS data from our (HPMA) please contact the Eastern Federal Lands pavement team.
