ACAD WIP Report

NPS Retaining Wall Inventory Program Acadia National Park

**Federal Lands Highway
Road Inventory Program**

Data Collection Date: August 2007
Report Date: October 2015

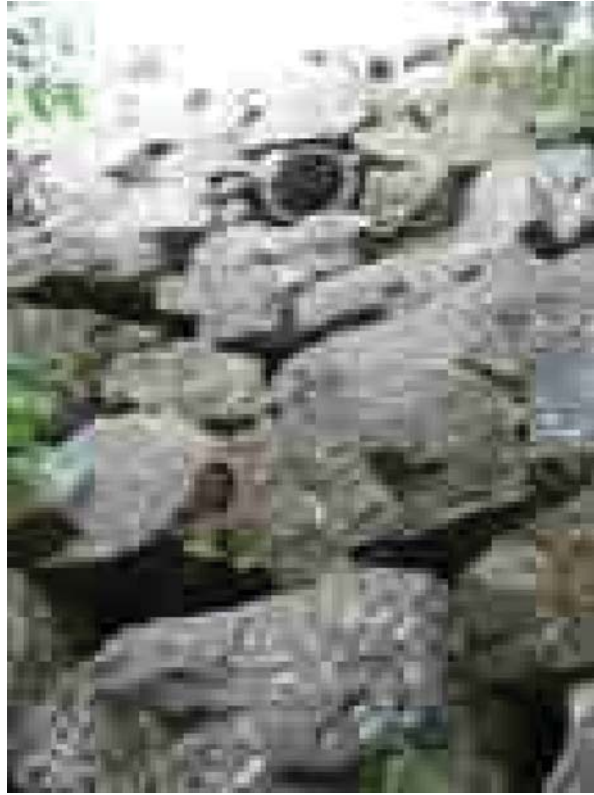
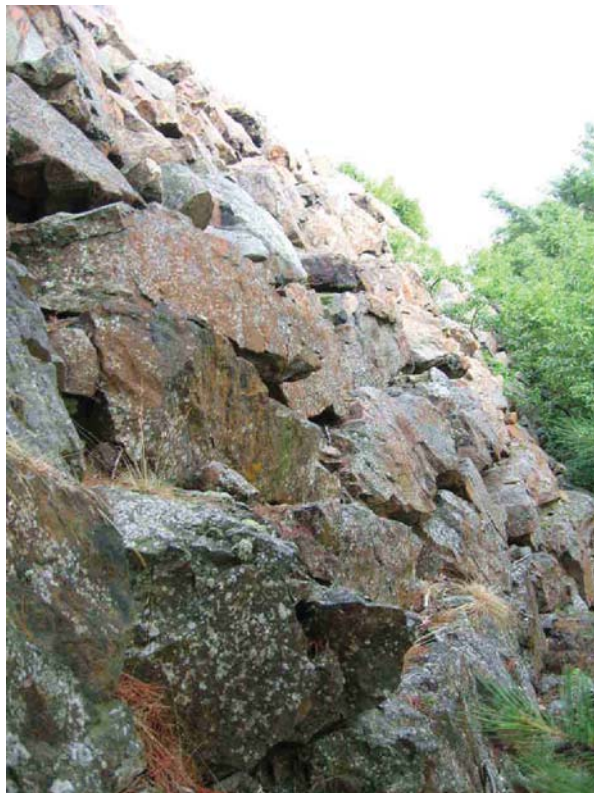
ACAD_0010ZZ_0.618_L_1.jpg

Element (Weighting Factor)	Narrative	Condition Rating (0 - 10)
PERFORMANCE 8.00	Good condition, some large voids and some vertical displacement on top	8
WALL FOUNDATION MATERIAL 8.00	Good solid granular material, no signs of settlement or rotation	9
PLACED STONE 8.00	Granite, minor weathering, 2' to 6' size boulders, low to moderate size burrows, vegetation growing through stone facing, but not effecting performance.	8
WALL DRAINS 0.50	None visible	8
CULVERT 0.50	16" concrete culvert functioning as intended , outlet 15 ft from bottom of wall	9
DOWNSLOPE 0.50	2H:1V slope, minor erosion, well vegetated, not impacting wall	9
LATERAL SLOPE 0.50	Minor surface erosion with trees and brush not impacting wall.	9
VEGETATION 0.50	Bushes and trees growing through stone openings not impacting wall	9
ROAD/SIDEWALK/SHOULDER 1.00	Road in good condition, minor surface cracking, some vertical displacement, top of wall & shoulder & guardwall appears to be older no recent movement	7

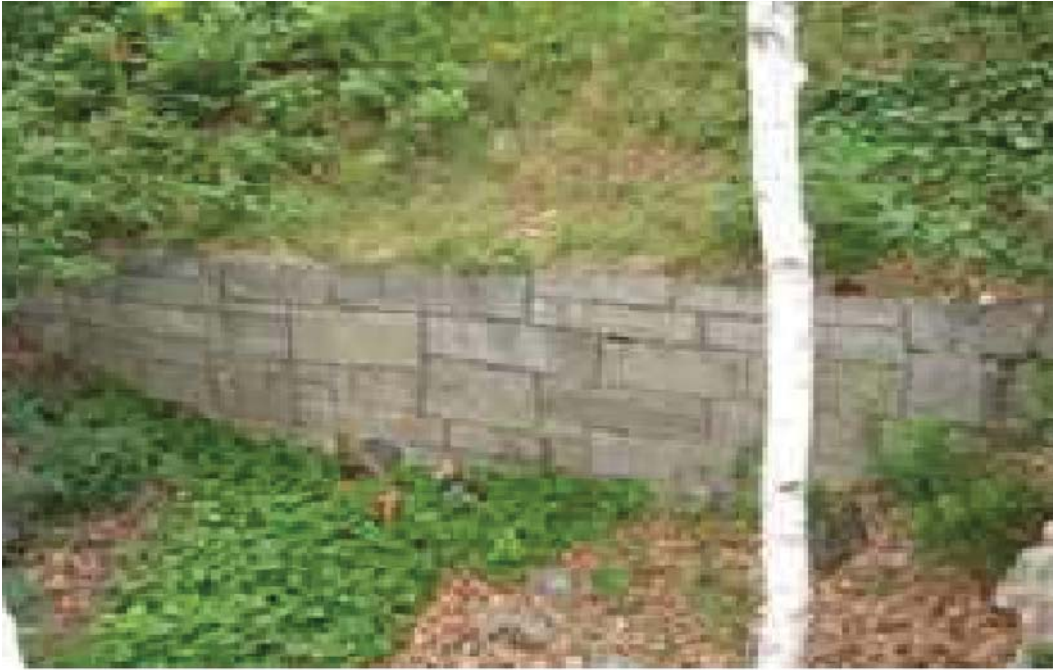
ACAD_0010ZZ_0.625_L_1.jpg

Element (Weighting Factor)	Narrative	Condition Rating (0 - 10)
PERFORMANCE 8.00	Good to excellent	9
WALL FOUNDATION MATERIAL 8.00	Good, possibly bedrock, no signs of settlement or movement	10
MORTAR 8.00	Minor cracking	9
STONE MASONRY 8.00	Good condition, no missing stones, granite blocks	9
LATERAL SLOPE 0.50	Minor surface erosion not impacting wall	8
CULVERT 0.50	16 inch concrete culvert, good condition	9
UPSLOPE 0.50	Looks good, no signs of erosion	9
WALL DRAINS 0.50	6" pipes assumed to act as wall drains, wall does not appear to have drainage issues	9
ROAD/SIDEWALK/SHOULDER 0.50	No signs of distress, there is a new overlay on road surface	10

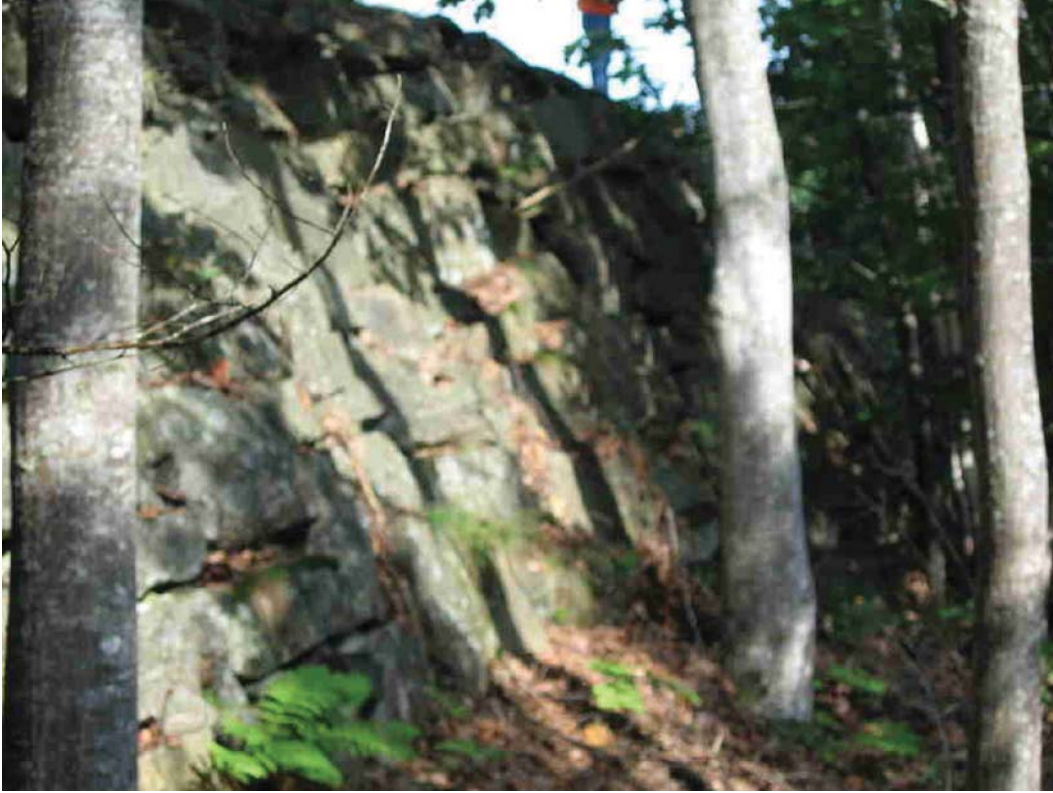
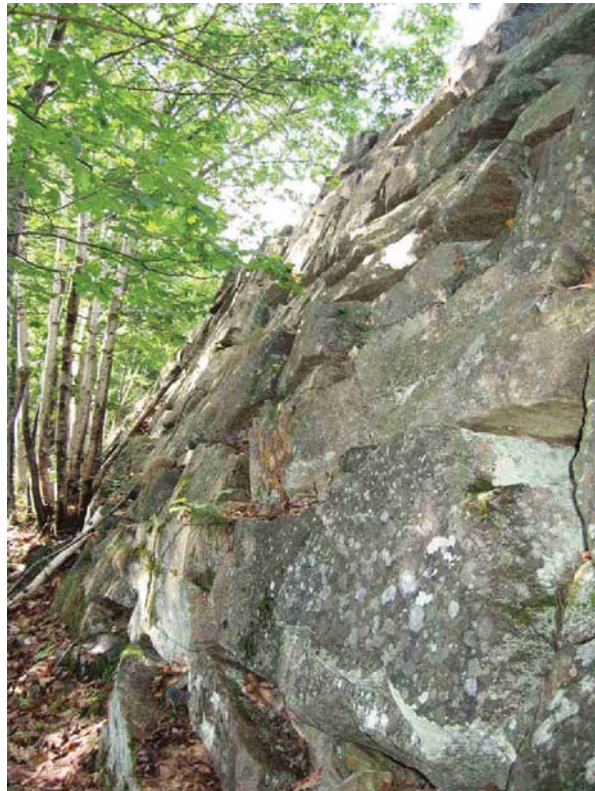
ACAD_0010ZZ_1.268_L_1.jpg

Element (Weighting Factor)	Narrative	Condition Rating (0 - 10)
PERFORMANCE 8.00	Good condition	7
WALL FOUNDATION MATERIAL 8.00	Looks good, down slope is variable from 2H:1V to almost vertical at rock outcrops	9
PLACED STONE 8.00	2 - 4 foot granite boulders, minor weathering, several voids, significant vegetation growing through wall face	7
DOWNSLOPE 0.50	Well vegetated minor to moderate signs of erosion not affecting wall	8
WALL DRAINS 0.50	None observed, No signs of distress	8
LATERAL SLOPE 0.50	Well vegetated minor to moderate signs of erosion not affecting wall	9
TRAFFIC BARRIER/FENCE 0.50	Stone barrier in good condition, none rotated or missing, some have settled, not impacting wall	9
ROAD/SIDEWALK/SHOULDER 1.00	Shoulder shows some vertical deflection possibly due to internal erosion of soil into wall, appears to have stabilized at this time.	7
VEGETATION 1.00	Well vegetated, small trees, brush, and grass. Not impacting wall at this time	7

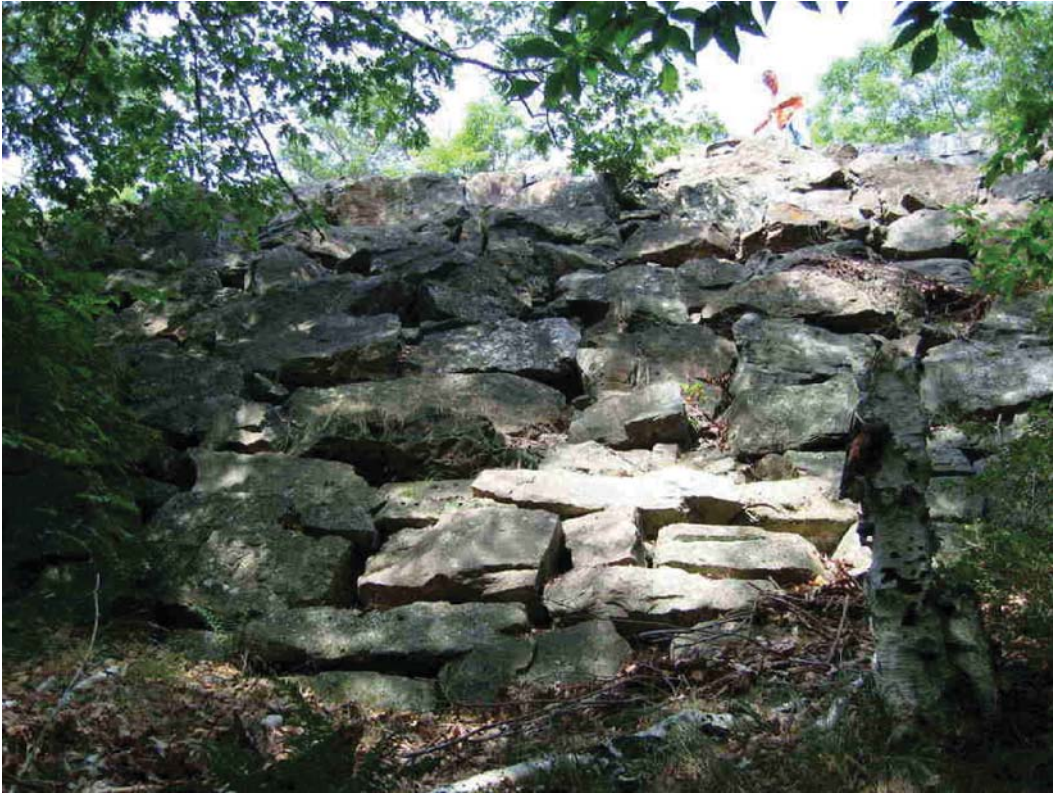
ACAD_0010ZZ_1.615_L_1.jpg

Element (Weighting Factor)	Narrative	Condition Rating (0 - 10)
PERFORMANCE 8.00	Good condition, some settlement, missing rocks, tree growing through facing	7
WALL FOUNDATION MATERIAL 8.00	Good foundation, steep slopes (1.5H:1V) to vertical at rock outcrops, some settlement at wall high point but appears stable now	8
PLACED STONE 8.00	2 - 4 foot granite boulders, minor weathering, voids, occasional missing rock	7
TRAFFIC BARRIER/FENCE 0.50	Some settlement of barrier	8
VEGETATION 0.50	Minor erosion, no effect to wall	8
WALL DRAINS 0.50	None observed, no related issues are apparent	8
DOWNSLOPE 0.50	Well vegetated steep, no problems observed	9
LATERAL SLOPE 0.50	Well vegetated steep, no problems observed	9
ROAD/SIDEWALK/SHOULDER 0.50	Road is in good condition, some settlement along shoulder appears to be due to foundation or internal erosion through voids, appears stable now	9

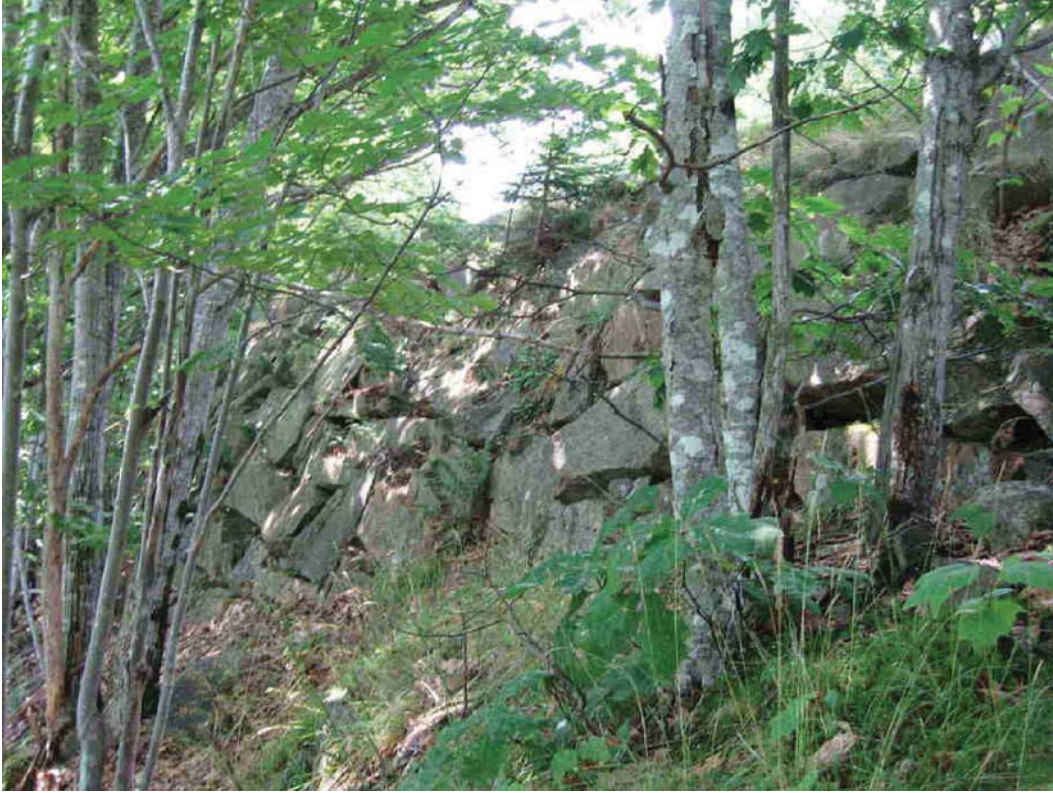
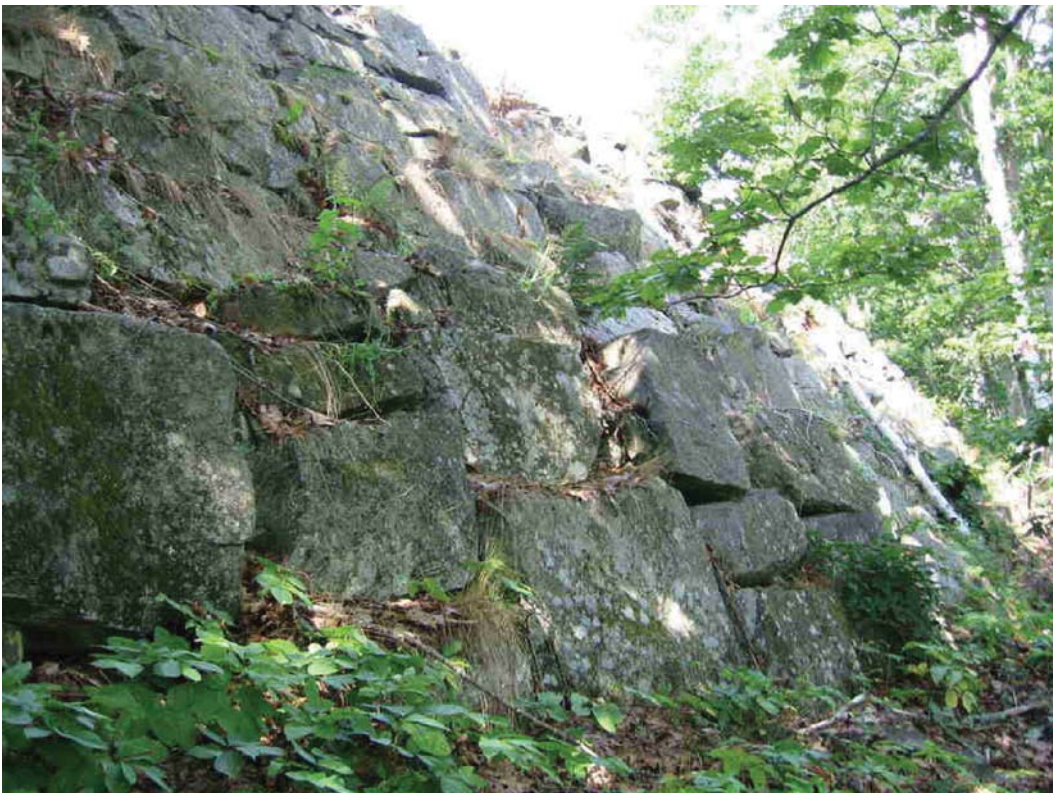
ACAD_0010ZZ_2.034_L_1.jpg

Element (Weighting Factor)	Narrative	Condition Rating (0 - 10)
PERFORMANCE 8.00	Good condition, some settlement, trees	7
WALL FOUNDATION MATERIAL 8.00	Good, no signs of distress	8
PLACED STONE 8.00	2 to 6 ft granite boulders, minor weathering, grass, brush and trees growing through wall face, some internal erosion of fill causing settlement	8
DOWNSLOPE 0.50	Well vegetated, 2H:1V slope, minor erosion	8
LATERAL SLOPE 0.50	Well vegetated	8
WALL DRAINS 0.50	None visible, no apparent impact to wall	8
TRAFFIC BARRIER/FENCE 0.50	Some rotation & settlement of guardwall due to internal erosion of fill, appears stable	9
CULVERT 1.00	18 in concrete culvert, joint appears to be open	5
ROAD/SIDEWALK/SHOULDER 1.00	Road in good condition, no signs of distress, some settlement of shoulder due to internal erosion	7

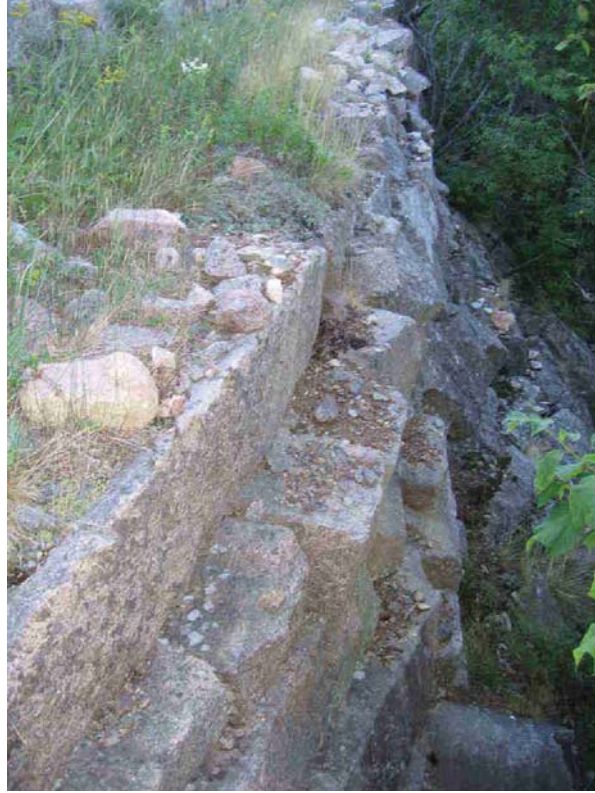
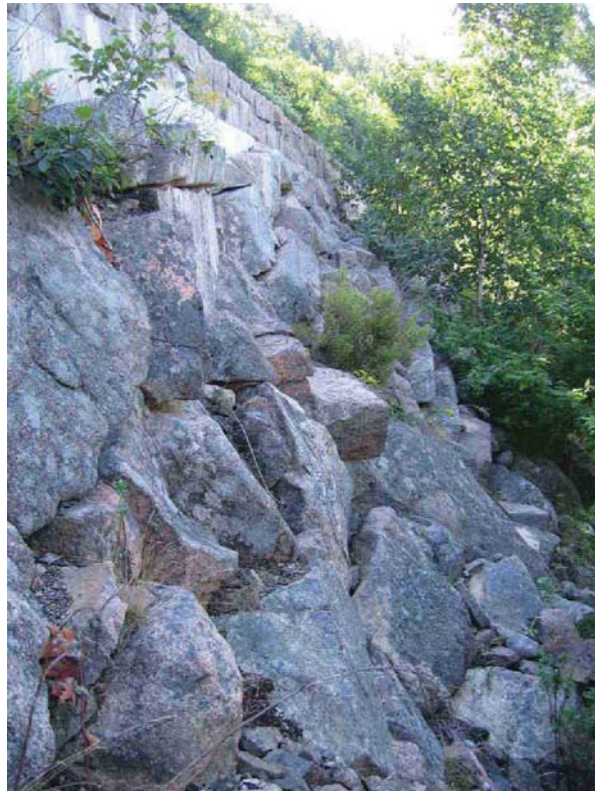
ACAD_0012_1.650_L_1.jpg

Element (Weighting Factor)	Narrative	Condition Rating (0 - 10)
PERFORMANCE 8.00	Fair to good condition, with some signs of movement.	7
WALL FOUNDATION MATERIAL 8.00	Minor signs of settlement and erosion, bedrock at other locations	7
PLACED STONE 8.00	Some voids, granite boulders in good condition, some weathering	7
CULVERT 0.50	Concrete culvert about 16-inch diameter at the north end.	8
TRAFFIC BARRIER/FENCE 0.50	Some settlement at grouted stone guardwall	8
VEGETATION 0.50	Grass, trees, and brush growing through face with minor impact.	8
WALL DRAINS 0.50	None observed.	8
ROAD/SIDEWALK/SHOULDER 0.50	Settlement at taller wall sections, road in good condition, no signs of distress	10
DOWNSLOPE 1.00	Good in some places, but moderate erosion in others. Does not appear to impact wall at this time.	7

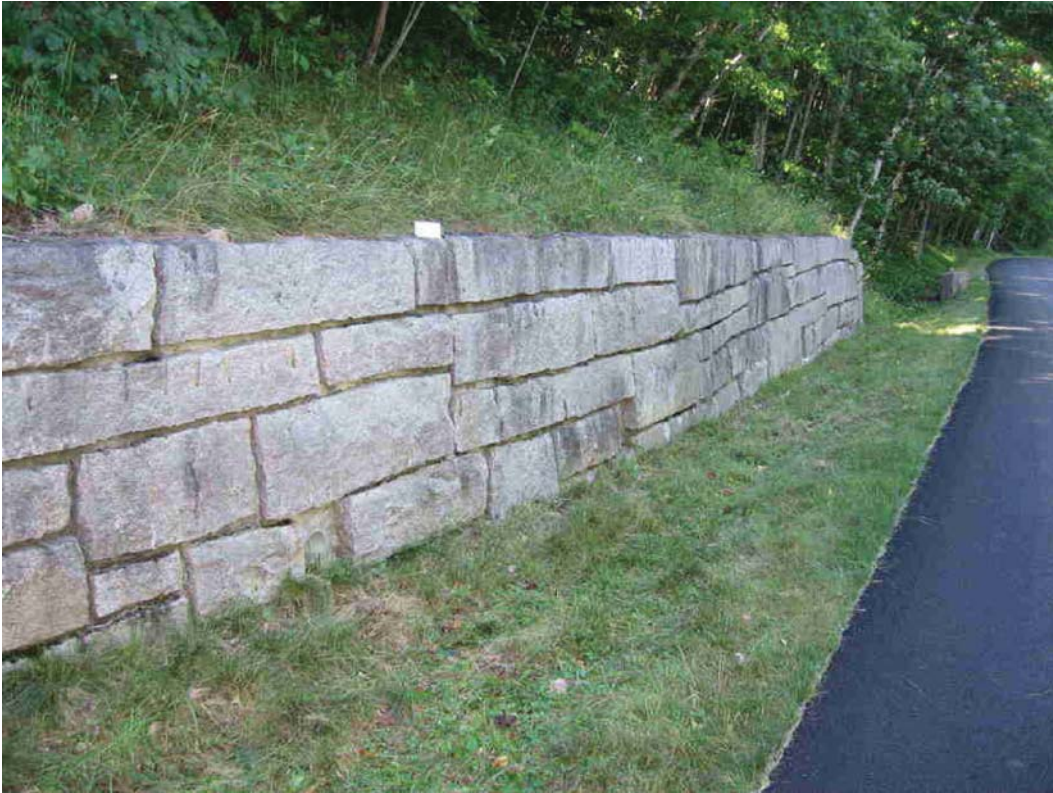
ACAD_0012_1.896_R_1.jpg

Element (Weighting Factor)	Narrative	Condition Rating (0 - 10)
PERFORMANCE 8.00	Good condition, performing as intended.	9
WALL FOUNDATION MATERIAL 8.00	Solid granular material at road edge, no signs of settlement or distress.	9
MORTAR 8.00	Minor cracking and spalling, functioning as intended.	8
STONE MASONRY 8.00	Minor cracking, strong granite split rock, minor oxidation and CaCO3 deposits.	9
UPSLOPE 0.50	About 2H:1V vegetated slope, not impacting the wall, minor creep observed in trees upslope.	8
CURB/BERM/DITCH 0.50	Ditch is in good condition, functioning as intended.	9
LATERAL SLOPE 0.50	Minor surface erosion at one end, not impacting the wall. Bedrock at the other end, not impacting the wall.	9
ROAD/SIDEWALK/SHOULDER 0.50	Road has new resurfacing with no signs of distress, shoulder has grass and is in good condition.	9
WALL DRAINS 0.50	Six PVC wall drains approximately 6-inches in diameter observed, open and functioning.	9

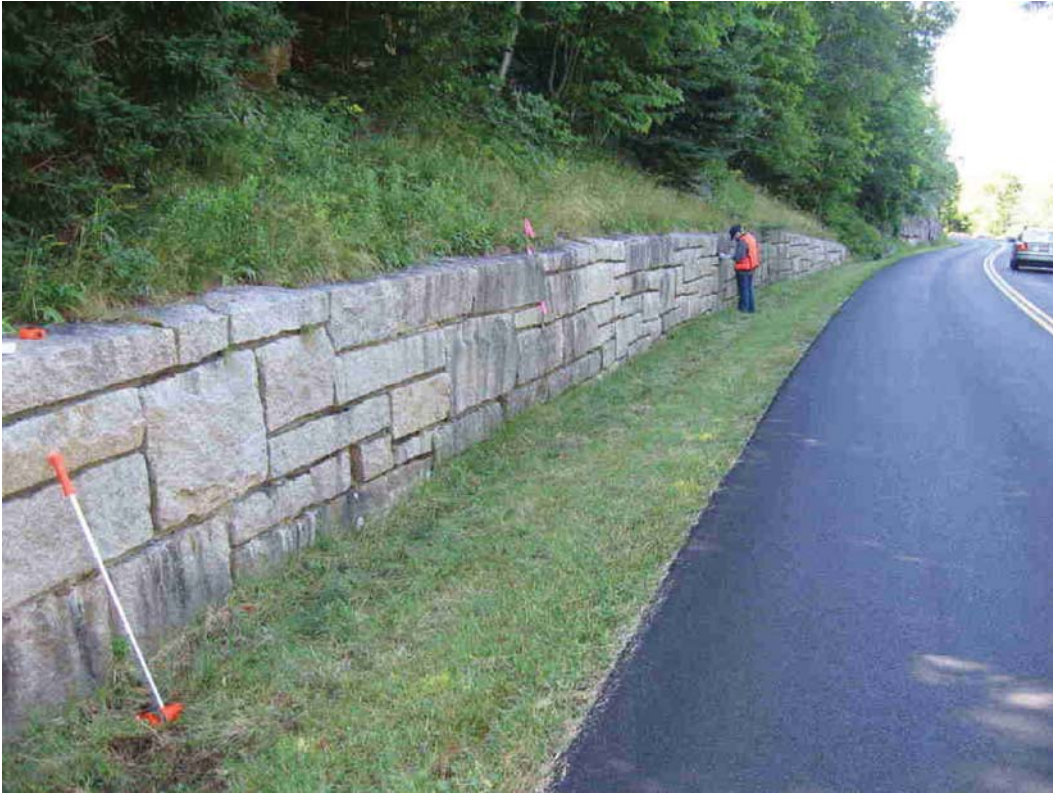
ACAD_0012_1.992_R_1.jpg

Element (Weighting Factor)	Narrative	Condition Rating (0 - 10)
PERFORMANCE 8.00	Good condition, performing as intended, minor movement from surface water flow from upslope.	8
WALL FOUNDATION MATERIAL 8.00	Solid granular material, no signs of settlement or distress.	9
MORTAR 8.00	Minor to moderate cracking and spalling, occasional missing sections.	8
STONE MASONRY 8.00	4-ft x 2-ft wide hard granite cut blocks, minor cracking, minor oxidation and weathering, minor moss, minor movement from surface water.	9
LATERAL SLOPE 0.50	Culvert at the beginning of wall and about 2H:1V slope at the end, not impacting wall.	8
UPSLOPE 0.50	About 2H:1V slope with grass and minor trees, not impacting wall.	8
CURB/BERM/DITCH 0.50	Unpaved v-ditch, performing as intended.	9
ROAD/SIDEWALK/SHOULDER 0.50	Road new overlay with no signs of distress.	9
WALL DRAINS 0.50	6-inch diameter PVC drains at 10-ft lateral spacing, open and performing well. Minor water-related issues associated with the wall.	9

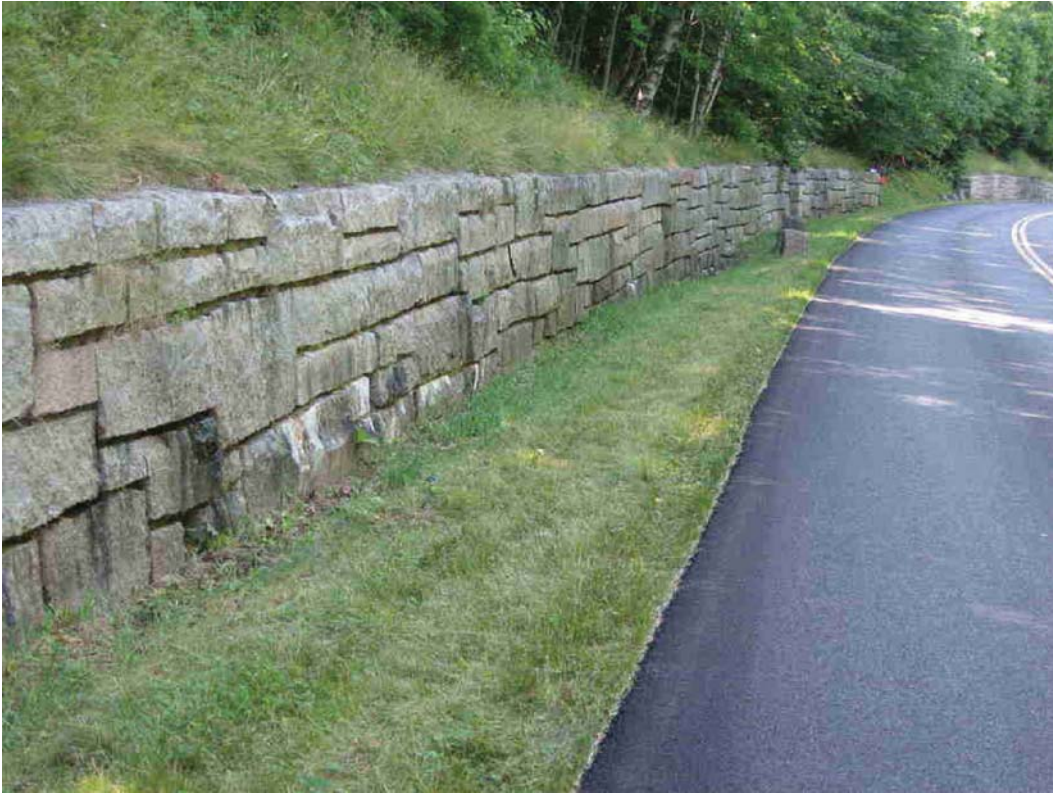
ACAD_0012_2.040_R_1.jpg

Element (Weighting Factor)	Narrative	Condition Rating (0 - 10)
PERFORMANCE 8.00	Good condition, minor drainage issues at isolated locations.	8
WALL FOUNDATION MATERIAL 8.00	Solid granular material, no signs of settlement or distress.	9
MORTAR 8.00	Minor cracking and spalling, overall fair to good condition, performing as intended, occasional missing pieces.	8
STONE MASONRY 8.00	4-ft x2-ft hard granite, minor cracking, minor oxidation and weathering at the surface, isolated locations of spalling at the face.	9
CULVERT 0.50	Drop inlet at the middle of the wall, about 16-inch diameter concrete, functioning as intended.	8
CURB/BERM/DITCH 0.50	Unpaved v-ditch in good condition.	9
LATERAL SLOPE 0.50	Minor surface erosion, not impacting the wall.	9
ROAD/SIDEWALK/SHOULDER 0.50	Road has new overlay with no signs of distress.	9
UPSLOPE 0.50	About 2H:1V slope with grass and brush, not impacting the wall.	9

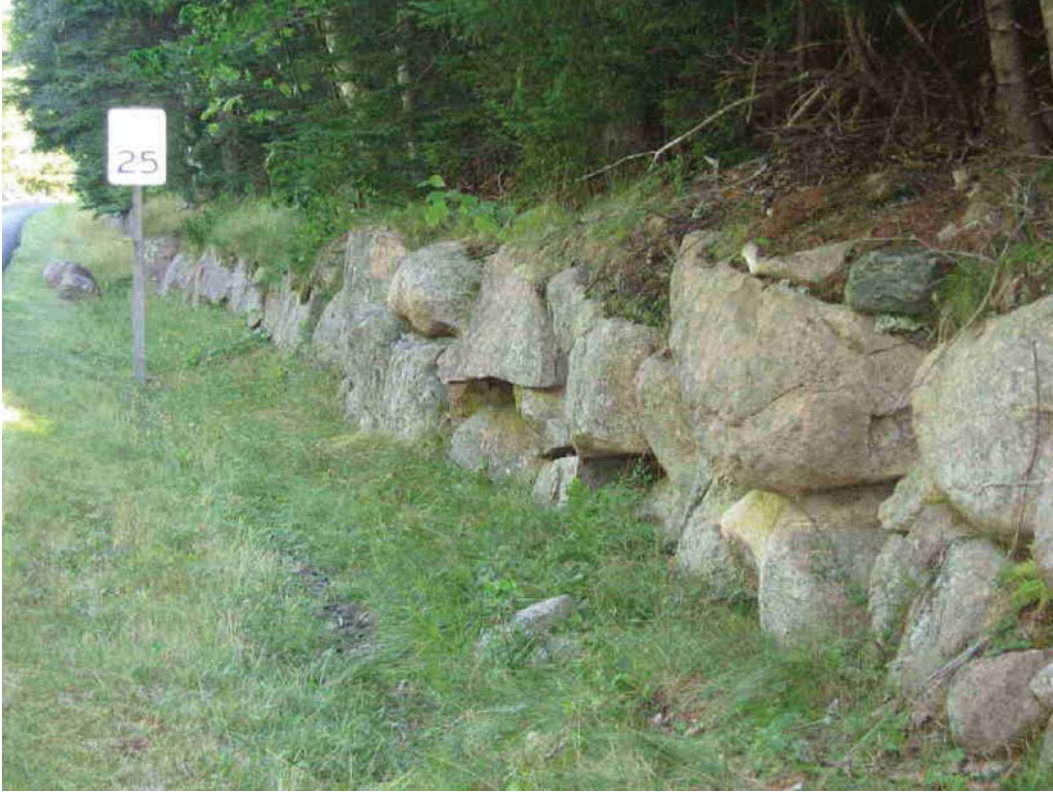
ACAD_0012_2.471_R_1.jpg

Element (Weighting Factor)	Narrative	Condition Rating (0 - 10)
PERFORMANCE 8.00	Fair to good condition, performing as intended, minor rotation and/or settlement at isolated locations.	7
WALL FOUNDATION MATERIAL 8.00	Solid granular material at road ditch.	9
PLACED STONE 8.00	Large granite boulders (2-4-ft diameter), primitive stacking, occasional voids with minor rotation and settlement of isolated elements at areas with more water infiltration.	7
CULVERT 0.50	Drop inlet at middle of wall, appears to function well (not clogged).	8
CURB/BERM/DITCH 0.50	Unpaved ditch in front of wall, functioning as intended.	8
LATERAL SLOPE 0.50	Gentle gradient with minor surface erosion, additional boulder added to start of wall.	8
UPSLOPE 0.50	About 2H:1V slope or less, with trees, grass, and shrubs, occasional sand deposits on top of the wall.	8
WALL DRAINS 0.50	None observed, occasional surface erosion, not significant impact on wall.	8

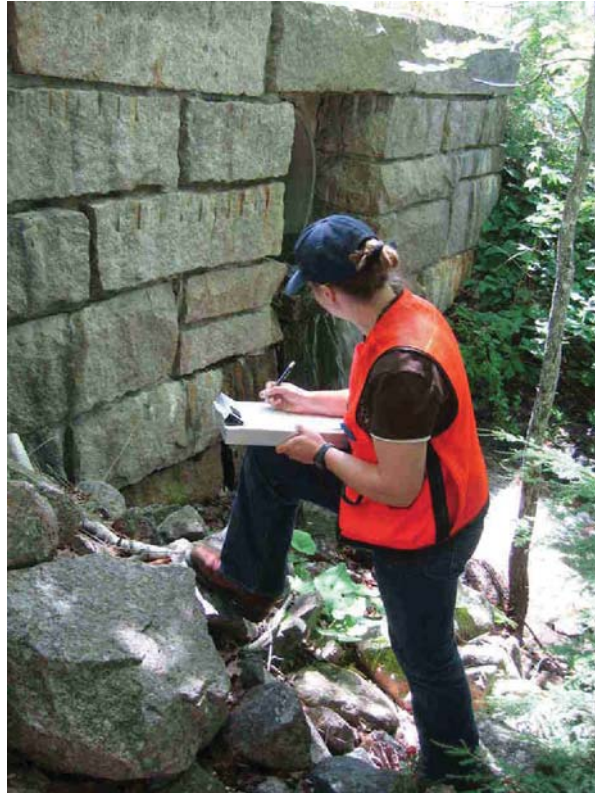
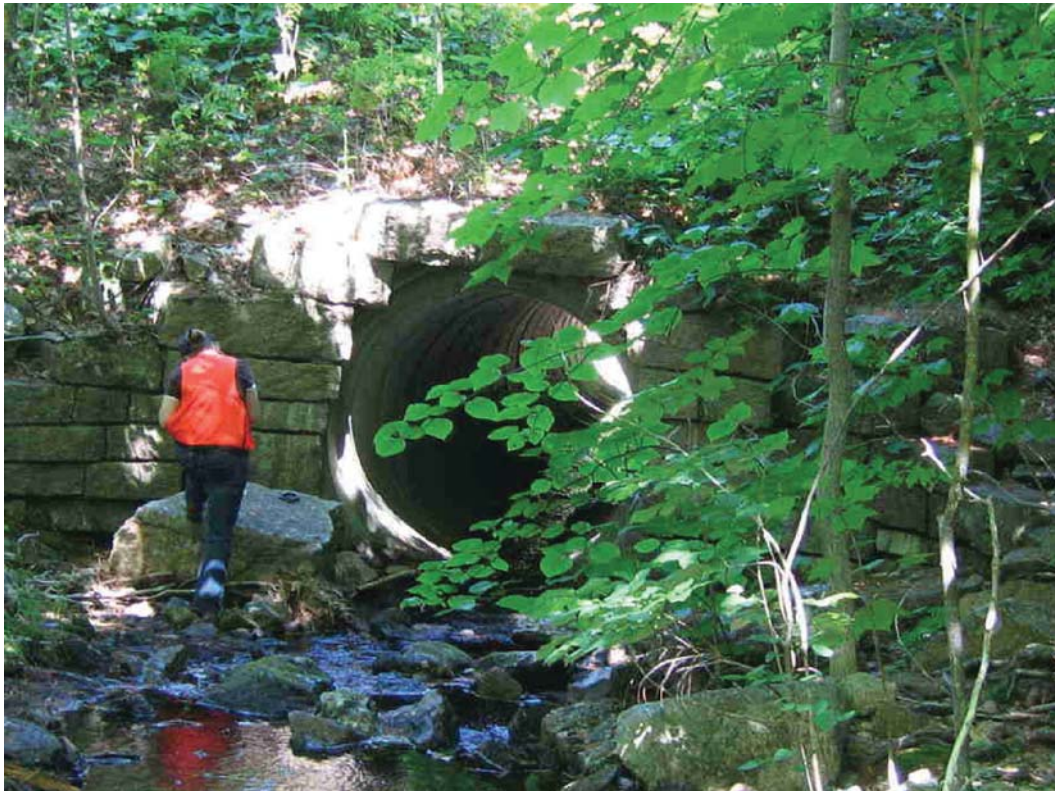
ACAD_0012_3.282_R_1.jpg

Element (Weighting Factor)	Narrative	Condition Rating (0 - 10)
PERFORMANCE 8.00	Fair condition, signs of low to moderate rotation or displacement at the wing walls, but performing as intended.	6
WALL FOUNDATION MATERIAL 8.00	Strong mortar foundation apron, alluvial sands and gravel at the base, occasional exposed concrete.	8
MORTAR 8.00	Moderate cracking and spalling at isolated locations, separated and missing mortar in isolated locations, but performing as intended.	6
STONE MASONRY 8.00	Strong granite blocks cut 1'x2' and 2'x4', minor weathering and CaCO3 staining, minor rotation (about 1-2") and displacement settlement.	7
CULVERT 0.50	72-inch diameter concrete culvert, good condition, gaps at the inlet side at the wall interface (1-3" wide), but not impacting performance.	8
LATERAL SLOPE 0.50	Minor to moderate surface erosion with extra boulders added for slope protection.	8
ROAD/SIDEWALK/SHOULDER 0.50	Road has new overlay with no signs of distress. Shoulder has a slope of about 2H:1V with grass, trees, brush.	8

DOWNSLOPE 0.50	Active stream channel, not impacting wall performance.	9
WALL DRAINS 0.50	None observed, water-related issues are not impacting the wall performance.	9

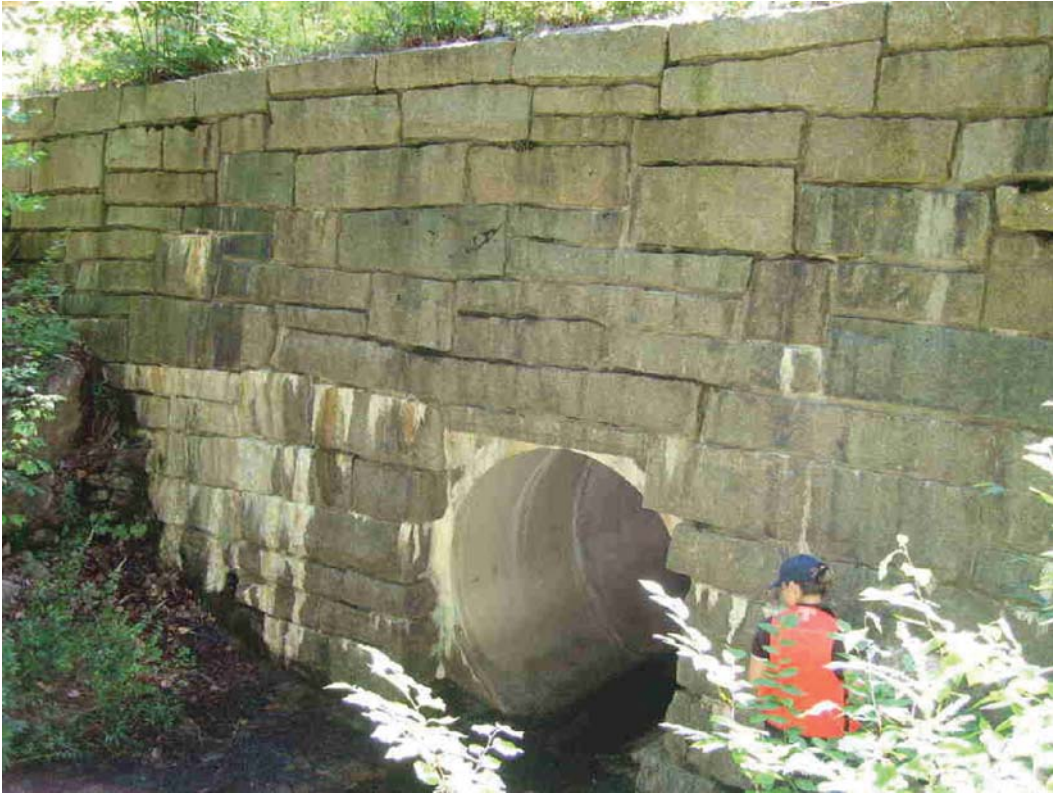
ACAD_0012_3.285_L_1.jpg

Element (Weighting Factor)	Narrative	Condition Rating (0 - 10)
PERFORMANCE 8.00	Good condition, performing as intended.	9
WALL FOUNDATION MATERIAL 8.00	Solid granular material or bedrock, stone masonry outlet (5ft length), no signs of distress.	9
MORTAR 8.00	Minor cracking and spalling at isolated locations, performing as intended.	9
STONE MASONRY 8.00	Solid granite (2ftx4ft) cut stone with minor cracks at isolated locations, minor weathering and CaCO3 staining where water infiltrates the wall, not impacting wall performance.	9
CULVERT 0.50	72-inch concrete box culvert, good condition.	9
DOWNSLOPE 0.50	Active stream channel, not impacting wall.	9
LATERAL SLOPE 0.50	Gentle slope, not impacting the wall.	9
ROAD/SIDEWALK/SHOULDER 0.50	Road has new overlay with no signs of distress. Shoulder is sloped at about 2H:1V, not impacting the wall.	9
WALL DRAINS 0.50	Three 6-inch outlets, open and functional, no water-related issues impacting the wall.	9

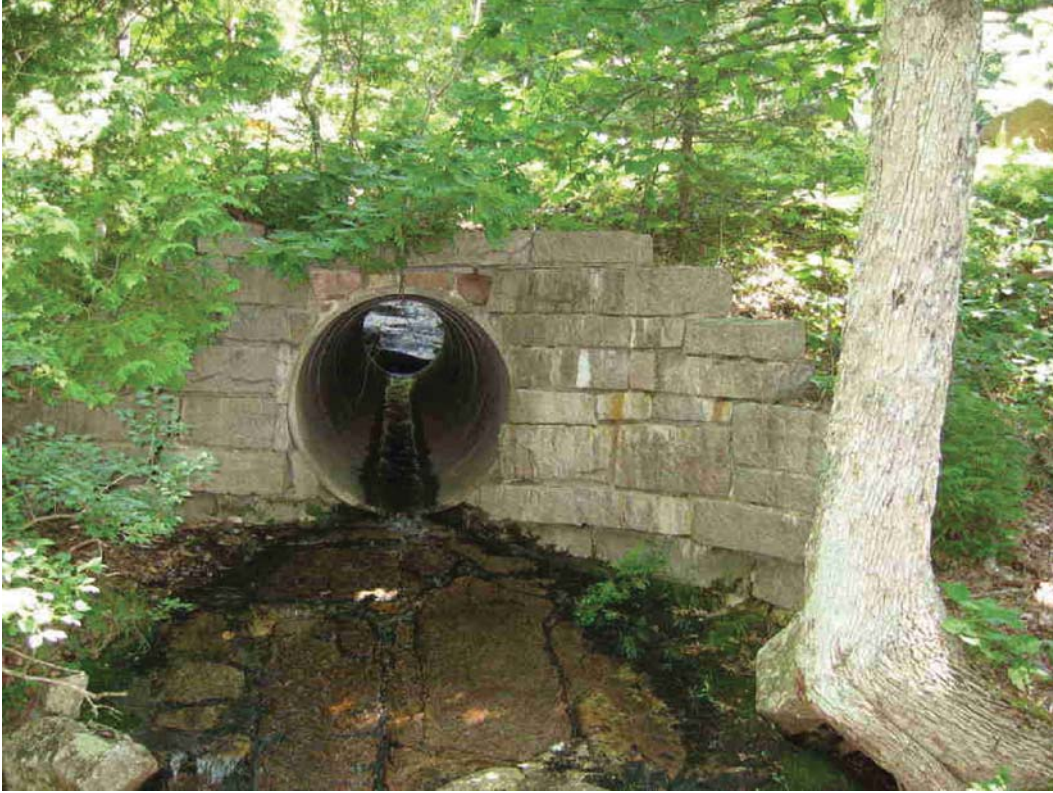
ACAD_0012_3.948_L_1.jpg

Element (Weighting Factor)	Narrative	Condition Rating (0 - 10)
PERFORMANCE 8.00	Good condition, minor rotation at the top (1") and displacement, but no signs of active or continuing movement.	8
WALL FOUNDATION MATERIAL 8.00	Solid granular material, no signs of significant settlement, with minor stone apron.	9
MORTAR 8.00	Minor cracking throughout, isolated spalling and missing pieces, minor gap between stones where missing mortar.	8
STONE MASONRY 8.00	4'x2' solid granite cut stone, minor weathering and CaCO3 deposits, minor signs of displacement and settlement (1"), performing as intended.	8
CULVERT 0.50	60-inch diameter concrete culvert outlet, minor displacement (1-3") in the mortar at the top stone, good condition, performing as intended.	9
DOWNSLOPE 0.50	Active stream channel, not impacting wall.	9
LATERAL SLOPE 0.50	Minor surface erosion, about 2H:1V slope, not impacting wall.	9
WALL DRAINS 0.50	None observed, water-related issues not impacting wall.	9

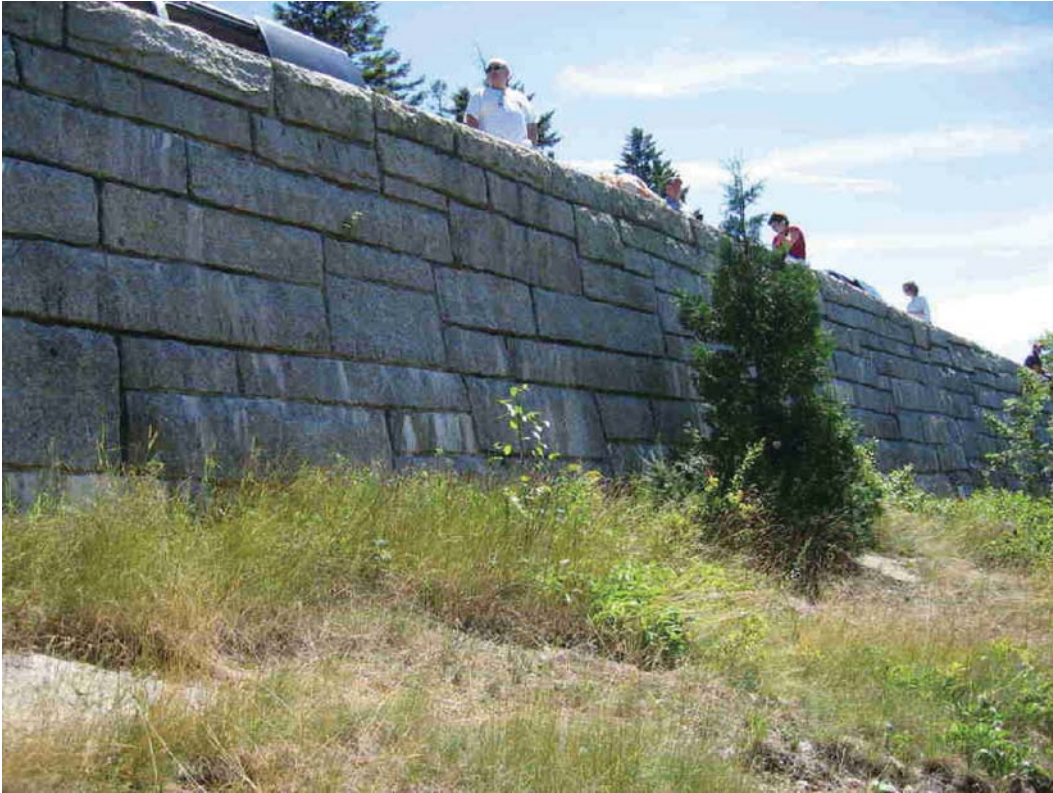
ACAD_0012_4.325_L_1.jpg

Element (Weighting Factor)	Narrative	Condition Rating (0 - 10)
PERFORMANCE 8.00	Good condition, performing as intended.	9
WALL FOUNDATION MATERIAL 8.00	Bedrock near surface, no signs of distress or settlement.	9
MORTAR 8.00	Minor cracking and spalling.	9
STONE MASONRY 8.00	Solid granite (4'x2') cut blocks, minor weathering and CaCO3 deposits, functioning as intended.	9
LATERAL SLOPE 0.50	Minor surface erosion.	8
DOWNSLOPE 0.50	About 3H:1V with shrubs, grass, trees, and bedrock near the surface.	9
ROAD/SIDEWALK/SHOULDER 0.50	Road has no signs of distress.	9
WALL DRAINS 0.50	6-inch outlet piles spaced at 10-foot centers, open and functioning.	9

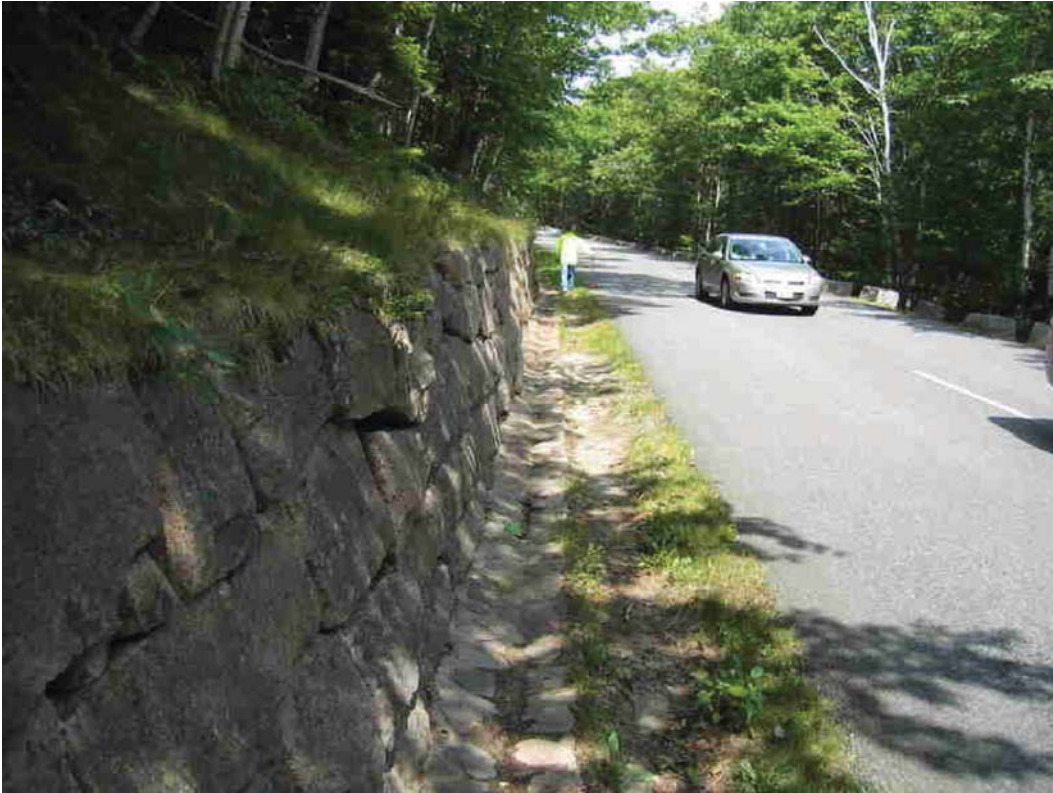
ACAD_0300_0.495_R_1.jpg

Wall ID:	ACAD-0300-.495-R		
Route Name:	PARK LOOP ROAD		
Inspection Date:	August 07, 2007	Approximate Year Built:	Unknown
*Wall Rating:	75	Maintenance Action:	No Action

Element (Weighting Factor)	Narrative	Condition Rating (0 - 10)
PERFORMANCE 8.00	Wall performance is generally as intended	7
WALL FOUNDATION MATERIAL 8.00	DENSE SOIL, MORTARED DITCH LINE, IMMEDIATELY AT TOE	8
STONE MASONRY 8.00	FRESH, HARD GRANITE	8
CURB/BERM/DITCH 0.50	Mortared stone ditch at toe - in durable but not impermeable condition	8
UPSLOPE 1.00	blueberry and shrubs, 2 ft deep cavity near beginning of wall and longitudinal depression along most of wall acts as collection ditch and increases infiltration behind wall.	6
LATERAL SLOPE 1.00	Beginning of wall is near scarp on bedrock outcrop but not impacting wall. End slope is 4:1 or flatter and forested.	7
ROAD/SIDEWALK/SHOULDER 1.00	Some raveling of pavement edge and erosion near ditch	7
WALL DRAINS 1.00	DROP INLET BUILT INTO DITCH NEAR EACH END PROVIDES SOME DRAINAGE BEHIND WALL. No other.	7

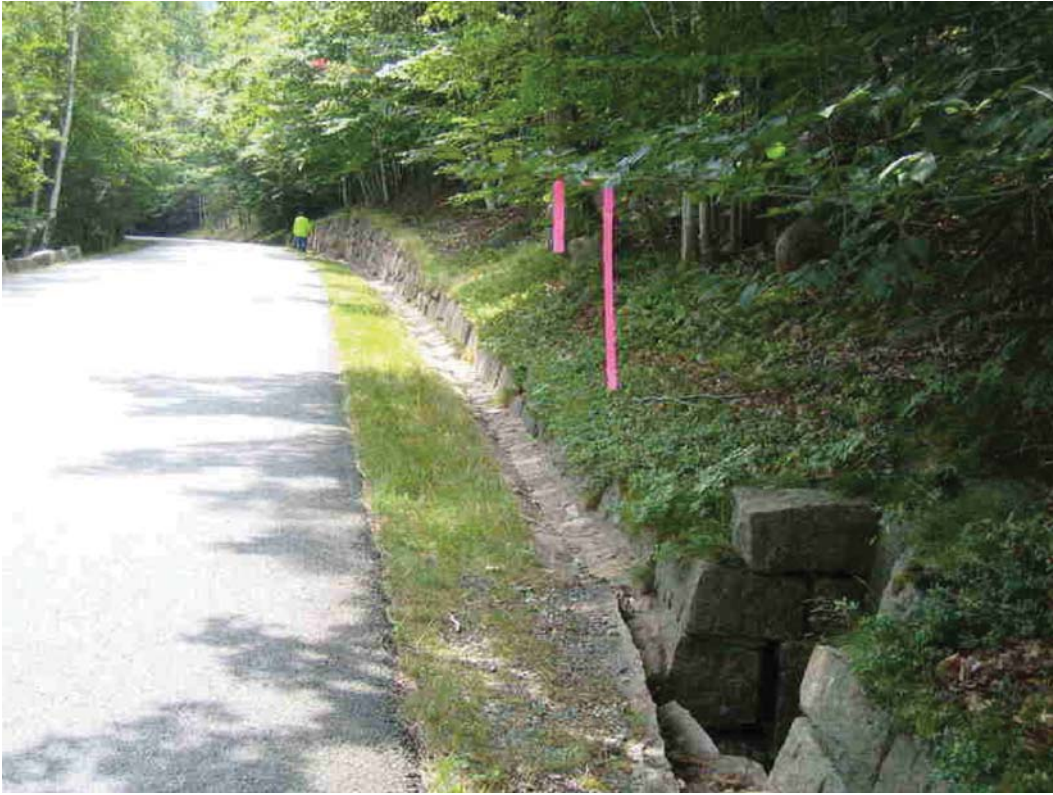
ACAD_0300_0.684_R_1.jpg

Wall ID:	ACAD-0300-.684-R		
Route Name:	PARK LOOP ROAD		
Inspection Date:	August 07, 2007	Approximate Year Built:	Unknown
*Wall Rating:	76	Maintenance Action:	No Action

Element (Weighting Factor)	Narrative	Condition Rating (0 - 10)
PERFORMANCE 8.00	Serving purpose very well	7
WALL FOUNDATION MATERIAL 8.00	Dense soil, mortared ditch line immediately at toe	8
STONE MASONRY 8.00	Fresh hard granite	8
CURB/BERM/DITCH 0.50	Mortared stone	8
LATERAL SLOPE 0.50	4:1 or flatter, grass and forested	8
UPSLOPE 1.00	Grass, then poplar trees 4 to 6 ft back	7
WALL DRAINS 1.00	Drop inlet built into ditch near each end provides some back drainage - no other	7

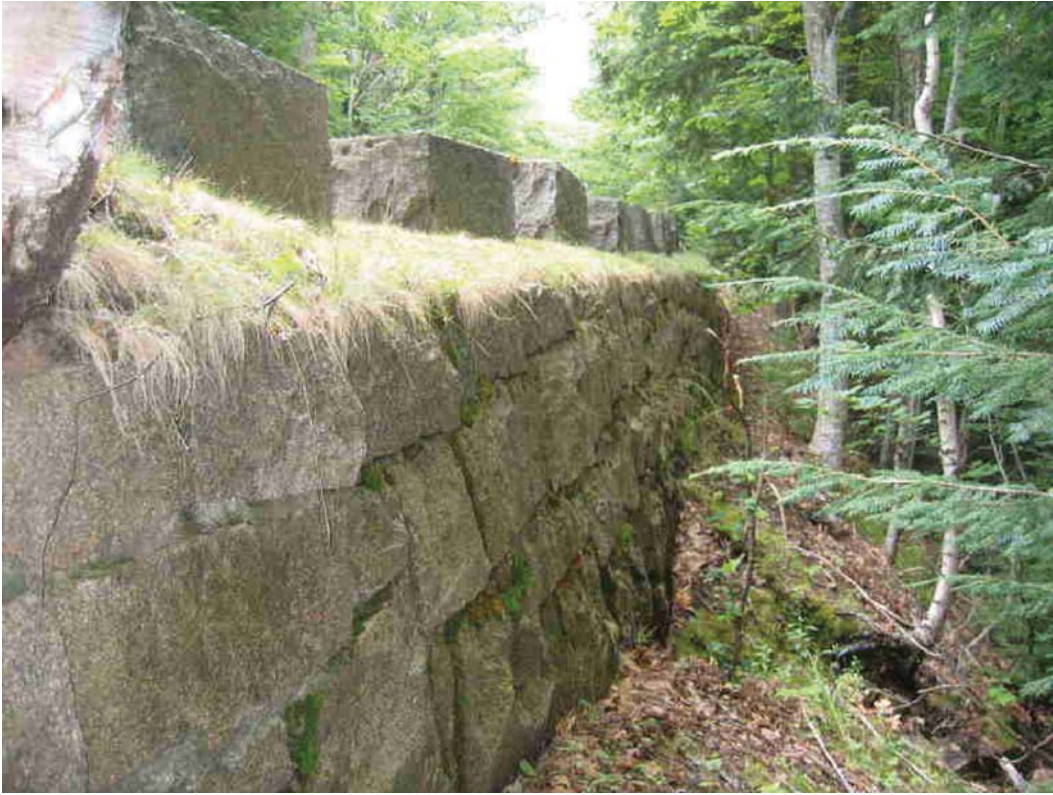
ACAD_0300_1.158_L_1.jpg

Wall ID:	ACAD-0300-1.158-L		
Route Name:	PARK LOOP ROAD		
Inspection Date:	August 07, 2007	Approximate Year Built:	Unknown
*Wall Rating:	72	Maintenance Action:	No Action

Element (Weighting Factor)	Narrative	Condition Rating (0 - 10)
PERFORMANCE 8.00	As expected, no visible global distress	8
WALL FOUNDATION MATERIAL 8.00	Dense soil	8
MORTAR 8.00	Cracked, 1/8" gaps, missing in places, loose	5
STONE MASONRY 8.00	Slightly weathered, hard granite, well-placed	8
LATERAL SLOPE 0.50	3H:1V, grassy, no erosion	8
CULVERT 1.00	rebar exposed in culvert	5
DOWNSLOPE 1.00	Erosion below pipe, forested and 1.5H:1V or flatter	7
WALL DRAINS 1.00	None, probably can drain through stone masonry	7

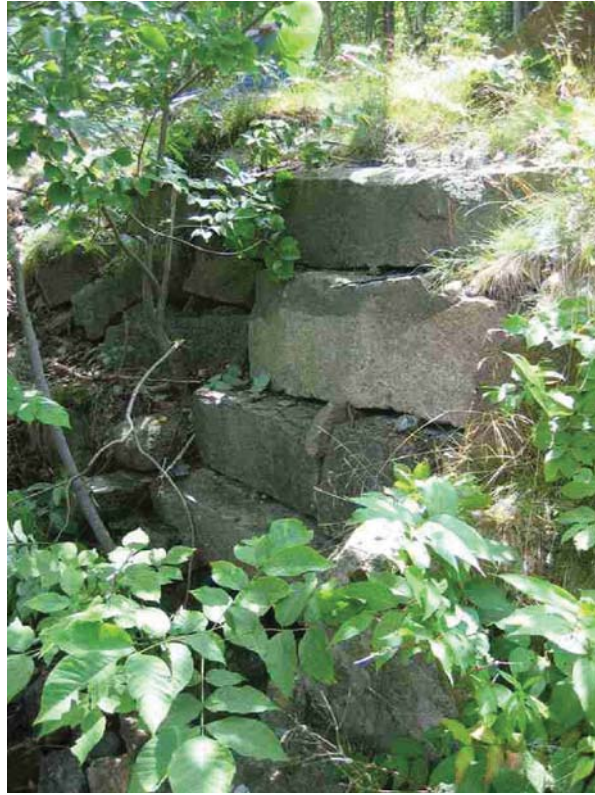
ACAD_0300_5.947_L_1.jpg

Wall ID:	ACAD-0300-5.947-L		
Route Name:	PARK LOOP ROAD		
Inspection Date:	August 07, 2007	Approximate Year Built:	Unknown
*Wall Rating:	70	Maintenance Action:	No Action

Element (Weighting Factor)	Narrative	Condition Rating (0 - 10)
PERFORMANCE 8.00	Good, not the best construction but functioning as intended.	7
WALL FOUNDATION MATERIAL 8.00	Natural stream bottom, no sign of settlement.	7
STONE MASONRY 8.00	Moderately to slightly weathered non-uniform block sizes. Lot of chinked pieces.	7
DOWNSLOPE 0.50	Bedrock present.	9
LATERAL SLOPE 1.00	Soil/rock mix, 1.5:1 to 2:1 soil slope, moderate erosion at wall end.	5
CULVERT 1.00	3'w X 2'h, natural bottom, not affecting wall performance.	7
WALL DRAINS 1.00	None visible. No sign of water related problems.	7

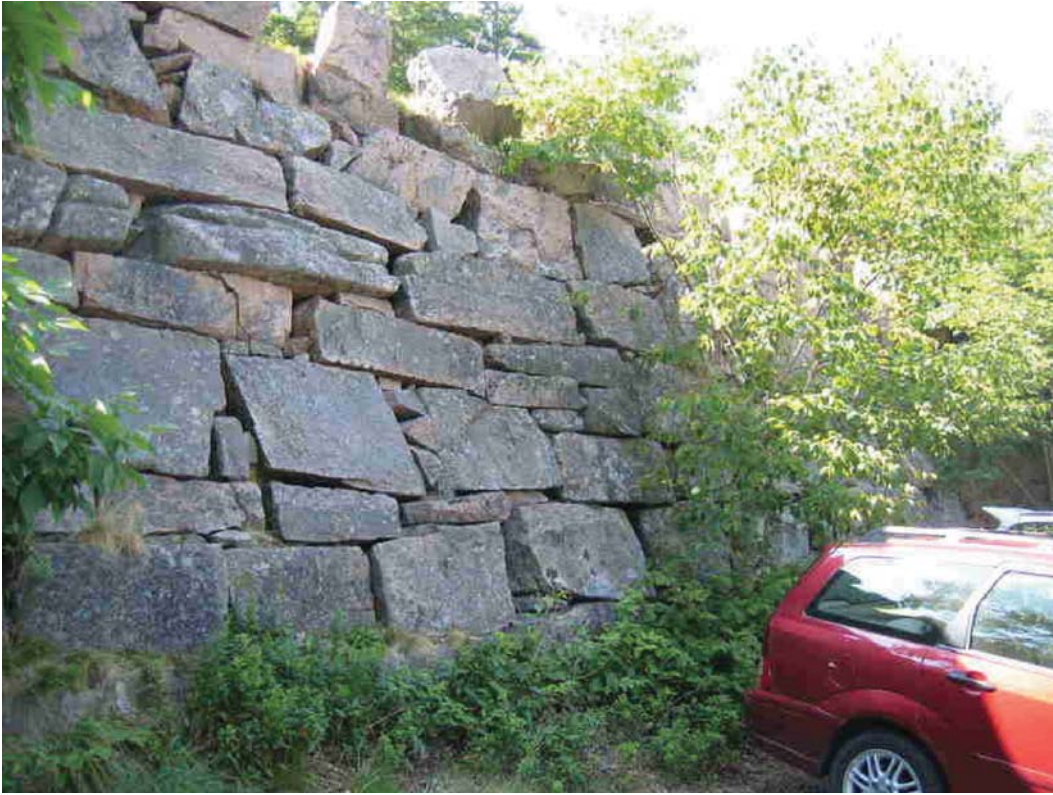
ACAD_0300_6.041_L_1.jpg

Wall ID:	ACAD-0300-6.041-L		
Route Name:	PARK LOOP ROAD		
Inspection Date:	August 07, 2007	Approximate Year Built:	Unknown
*Wall Rating:	76	Maintenance Action:	No Action

Element (Weighting Factor)	Narrative	Condition Rating (0 - 10)
PERFORMANCE 8.00	Good. Performing as intended.	8
WALL FOUNDATION MATERIAL 8.00	Founded on soil and bedrock at edge of parking lot. No sign of settlement.	7
STONE MASONRY 8.00	Slightly weathered to moderately weathered blocky granite.	8
LATERAL SLOPE 0.50	Ties into shallow soil over bedrock at wall start. Ties into bedrock at wall end.	8
WALL DRAINS 1.00	None visible. No sign of water related problems.	7
