ACAD WIP Report

NPS Retaining Wall Inventory Program Acadia National Park

**Federal Lands Highway
Road Inventory Program**

Data Collection Date: August 2007
Report Date: October 2015

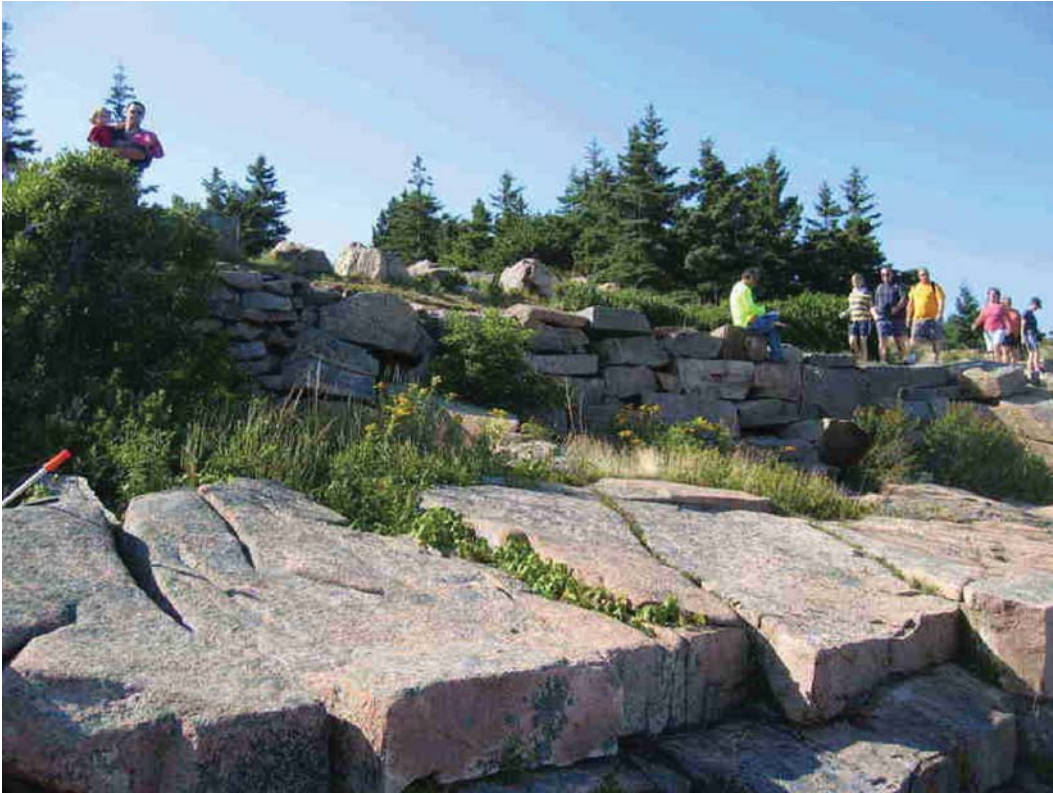
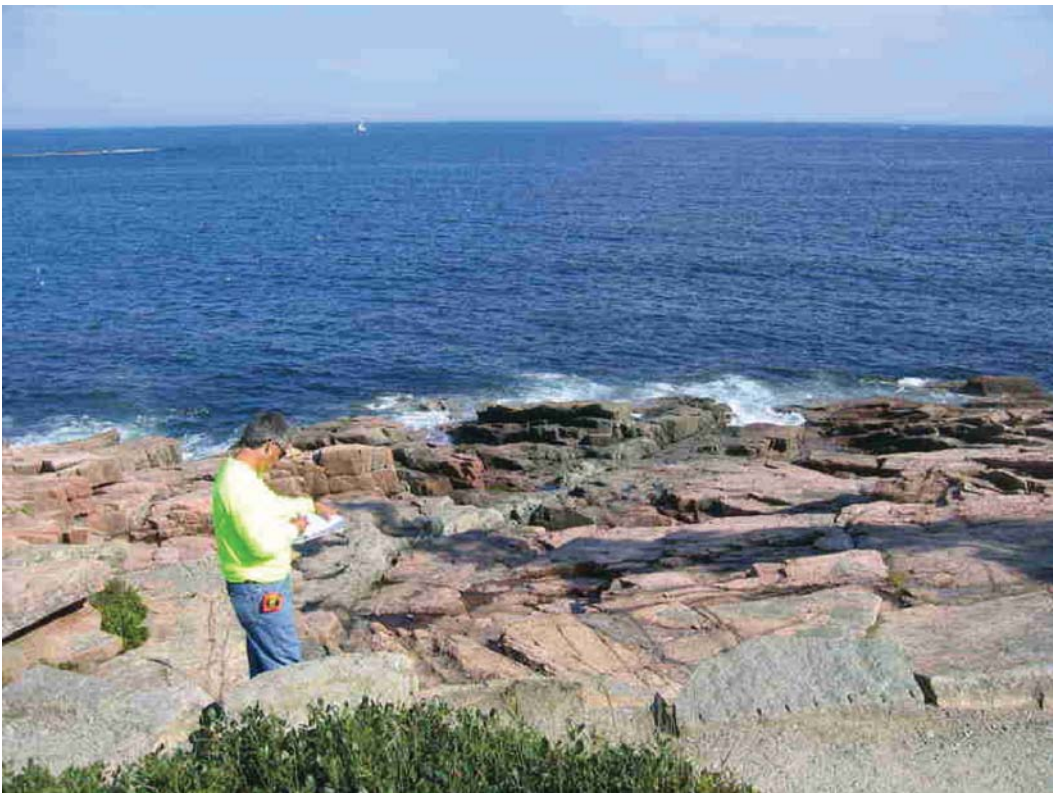
ACAD_0300_6.344_L_1.jpg

Wall ID:	ACAD-0300-6.344-L		
Route Name:	PARK LOOP ROAD		
Inspection Date:	August 07, 2007	Approximate Year Built:	Unknown
*Wall Rating:	80	Maintenance Action:	No Action

Element (Weighting Factor)	Narrative	Condition Rating (0 - 10)
PERFORMANCE 8.00	Good. Performing as intended.	7
WALL FOUNDATION MATERIAL 8.00	Founded on bedrock. No sign of settlement.	9
STONE MASONRY 8.00	Slightly weathered to moderately weathered blocky granite, stepped at wall start.	8
LATERAL SLOPE 0.50	Ties into bedrock at wall start. Ties into soil at wall end, 2:1 slope.	8
WALL DRAINS 0.50	None visible. No sign of water related problems.	8
DOWNSLOPE 0.50	Bedrock present.	9

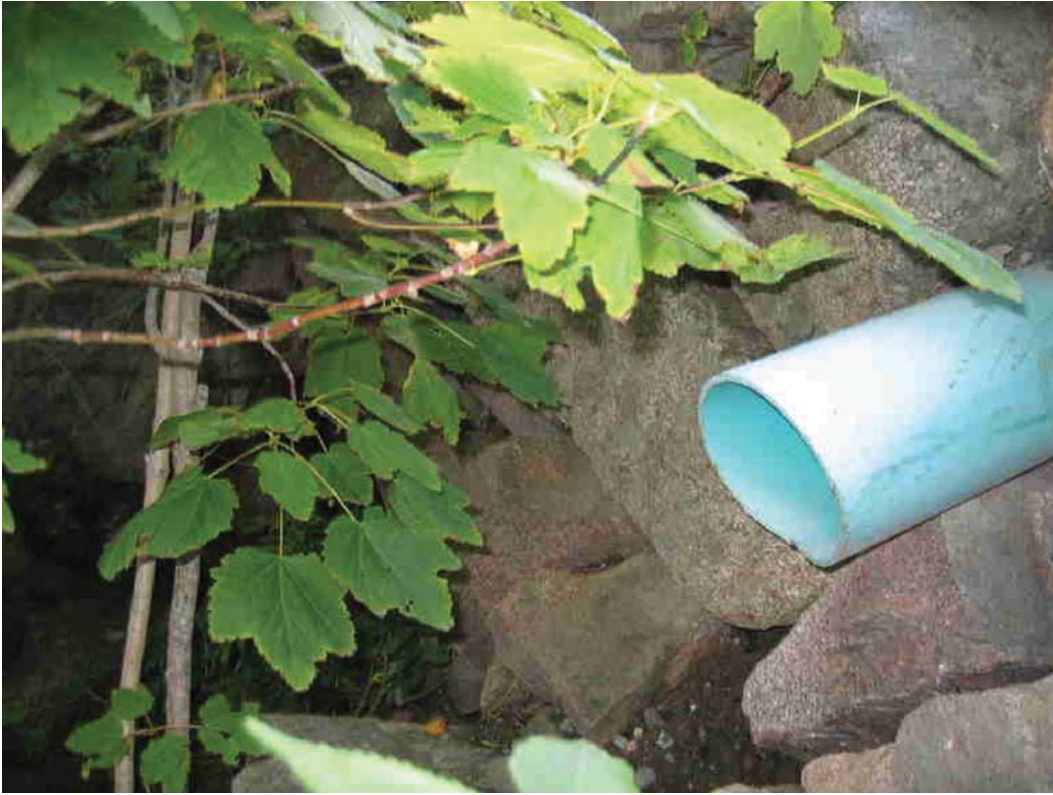
ACAD_0300_6.392_L_1.jpg

Wall ID:	ACAD-0300-6.392-L		
Route Name:	PARK LOOP ROAD		
Inspection Date:	August 07, 2007	Approximate Year Built:	Unknown
*Wall Rating:	70	Maintenance Action:	No Action

Wall Function:	Head Wall	Primary Wall Type:	Gravity - Dry Stone
Surface Treatment:		Secondary Wall Type:	
Secondary Surface Treatment:		Architectural Facing:	
General Description:	Culvert outlet, 18 in CMP, rusted. Also 6 in ABS drain pipe in wall

Element (Weighting Factor)	Narrative	Condition Rating (0 - 10)
PERFORMANCE 8.00	Low spot near beginning of wall takes overtopping flow, otherwise performance as intended.	7
WALL FOUNDATION MATERIAL 8.00	Dense soil, bedrock near surface.	8
PLACED STONE 8.00	Granite, placement appears almost random, not well constructed	6
DOWNSLOPE 0.50	5:1 h:v or flatter, forested	8
WALL DRAINS 0.50	6-inch ABS 18-inches below top of wall. Otherwise none but wall very permeable.	8
CULVERT 1.00	18-inch rusted CMP with invert 24-inches above base of wall	6
LATERAL SLOPE 1.00	Minor erosion at beginning of wall	7

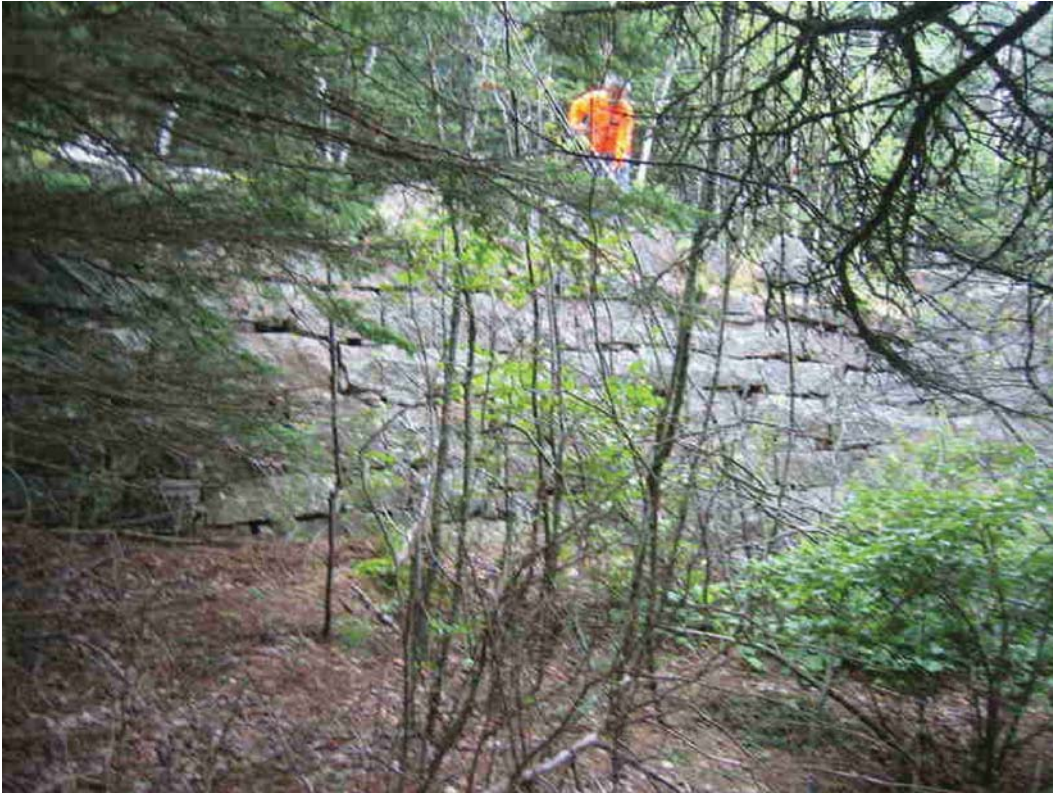
ACAD_0300_6.880_L_1.jpg

Wall ID:	ACAD-0300-6.88-L		
Route Name:	PARK LOOP ROAD		
Inspection Date:	August 08, 2007	Approximate Year Built:	Unknown
*Wall Rating:	80	Maintenance Action:	No Action

Element (Weighting Factor)	Narrative	Condition Rating (0 - 10)
PERFORMANCE 8.00	Performing as designed, no issues observed.	8
WALL FOUNDATION MATERIAL 8.00	Dense soil, forested, near surface bedrock or large boulders	8
PLACED STONE 8.00	Fresh hard granite, well placed, occasional chinking	8
LATERAL SLOPE 0.50	2h:1v or flatter, grassy with no erosion	8
WALL DRAINS 1.00	None - none deeded, permeable face	7

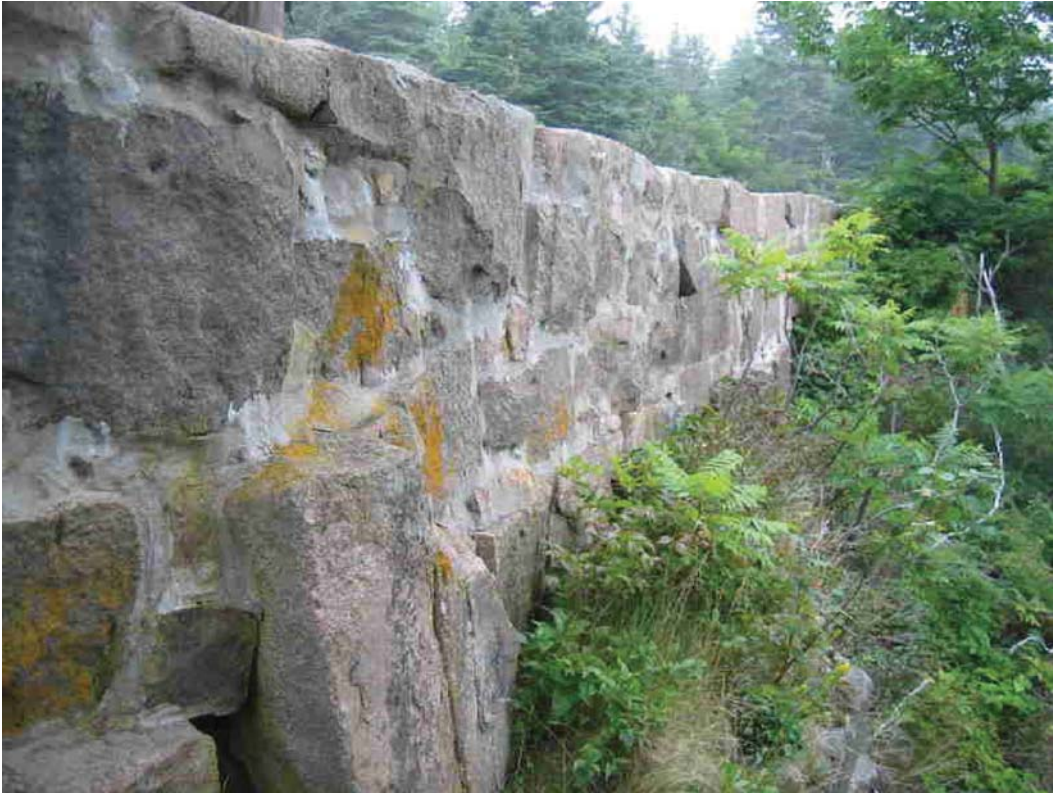
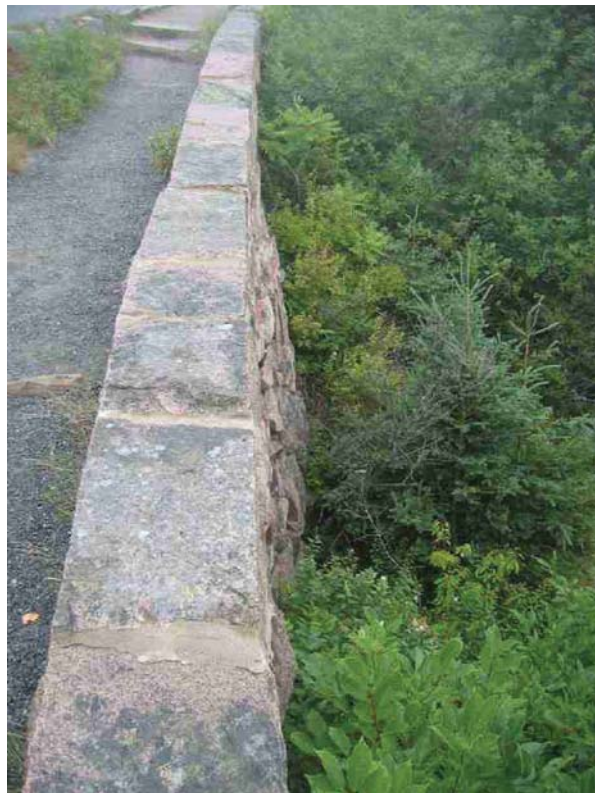
ACAD_0300_6.951_L_1.jpg

Wall ID:	ACAD-0300-6.951-L		
Route Name:	PARK LOOP ROAD		
Inspection Date:	August 08, 2007	Approximate Year Built:	Unknown
*Wall Rating:	70	Maintenance Action:	No Action

Element (Weighting Factor)	Narrative	Condition Rating (0 - 10)
PERFORMANCE 8.00	Mortared 3 times? Missing rocks and negative batter at guardwall	6
WALL FOUNDATION MATERIAL 8.00	Bedrock cliff, toppling joint attitude but apparently stable	8
MORTAR 8.00	Only at tall section. Brushed on outside, sloppy but sufficient, multiple stages?	7
PLACED STONE 8.00	Fresh, hard granite, roughly placed, sub-rounded	7
WALL DRAINS 0.50	None evident. No mortar near base of wall so drainage is possible.	8
LATERAL SLOPE 1.00	1.5h:1v soil shoulder to beach at each end. Minor erosion.	7

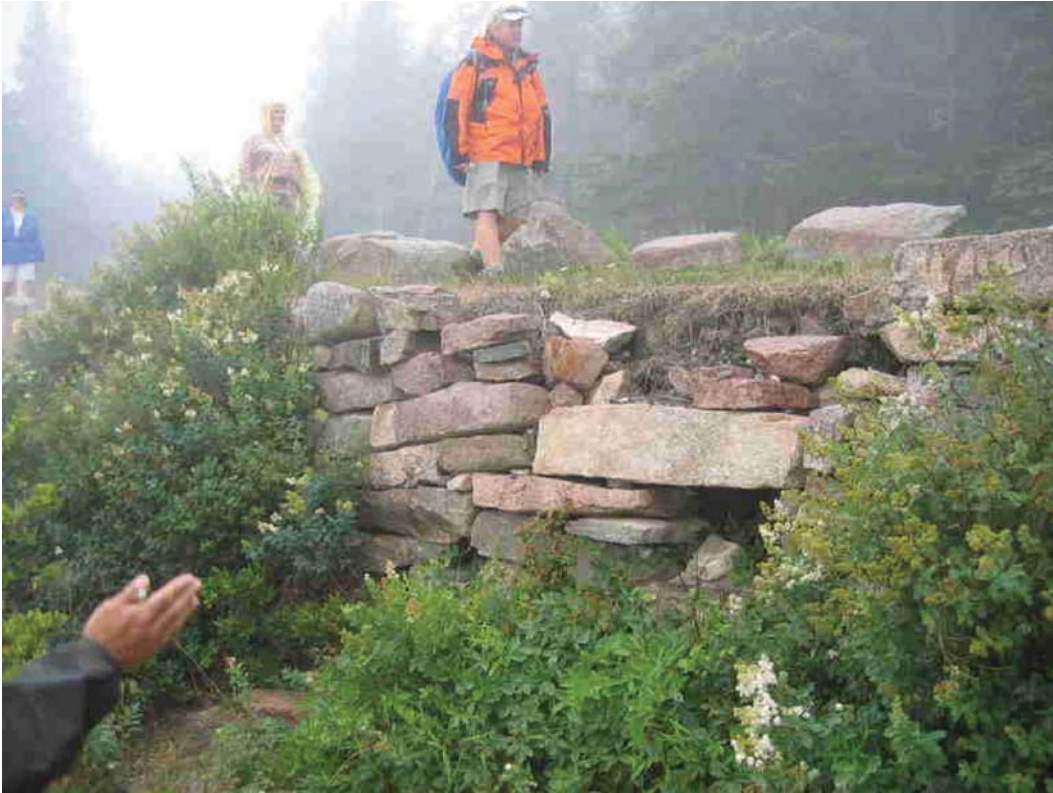
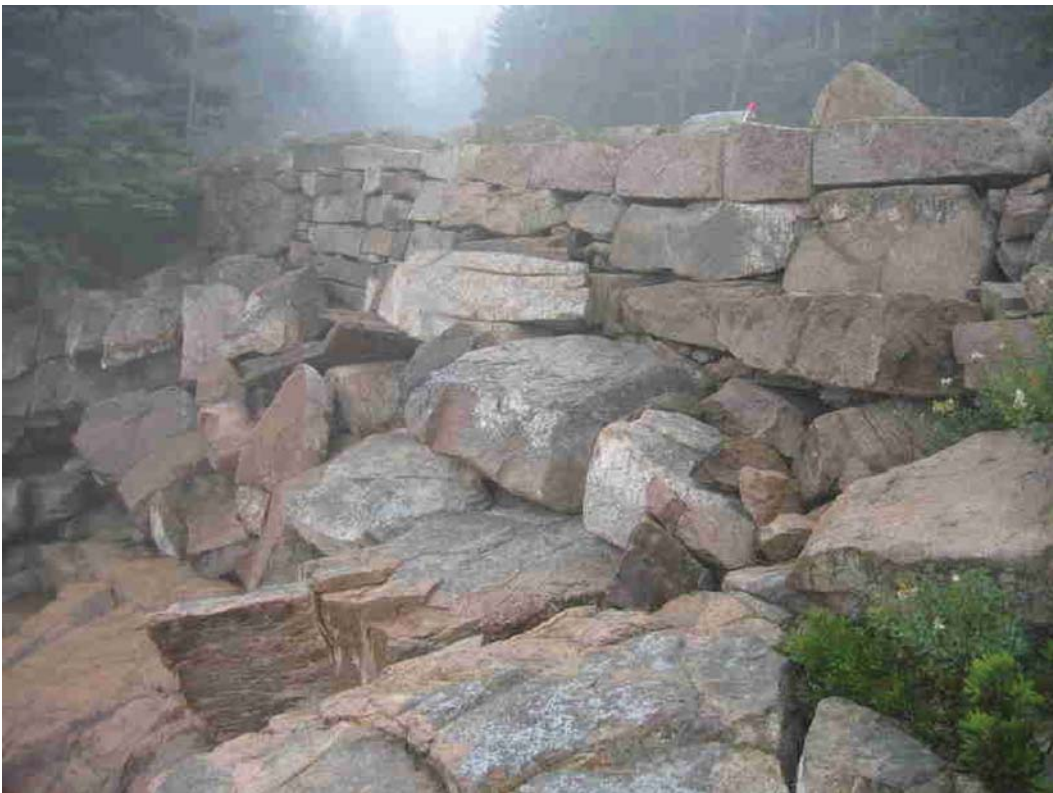
ACAD_0300_7.270_L_1.jpg

Wall ID:	ACAD-0300-7.27-L		
Route Name:	PARK LOOP ROAD		
Inspection Date:	August 08, 2007	Approximate Year Built:	Unknown
*Wall Rating:	55	Maintenance Action:	Replace Elements

Element (Weighting Factor)	Narrative	Condition Rating (0 - 10)
PERFORMANCE 8.00	Poor. Need some repair.	3
WALL FOUNDATION MATERIAL 8.00	Founded on bedrock. No sign of settlement.	8
PLACED STONE 8.00	Slightly weathered to moderately weathered granite, ranges from cut stone to angular blocks and small chinked pieces.	5
UPSLOPE 0.50	1:1 class 5 riprap for 6' and bedrock below.	8
WALL DRAINS 0.50	None visible. No sign of water related problems.	8
LATERAL SLOPE 1.00	Large boulders and shallow bedrock.	7

Failure Consequence:	MODERATE
Recommendation Narrative:	Remove and replace 100 sq. ft. of dry stacked rock wall: 100sq.ft @ \$50/sf = \$5,000
Repair Cost:	\$5,000

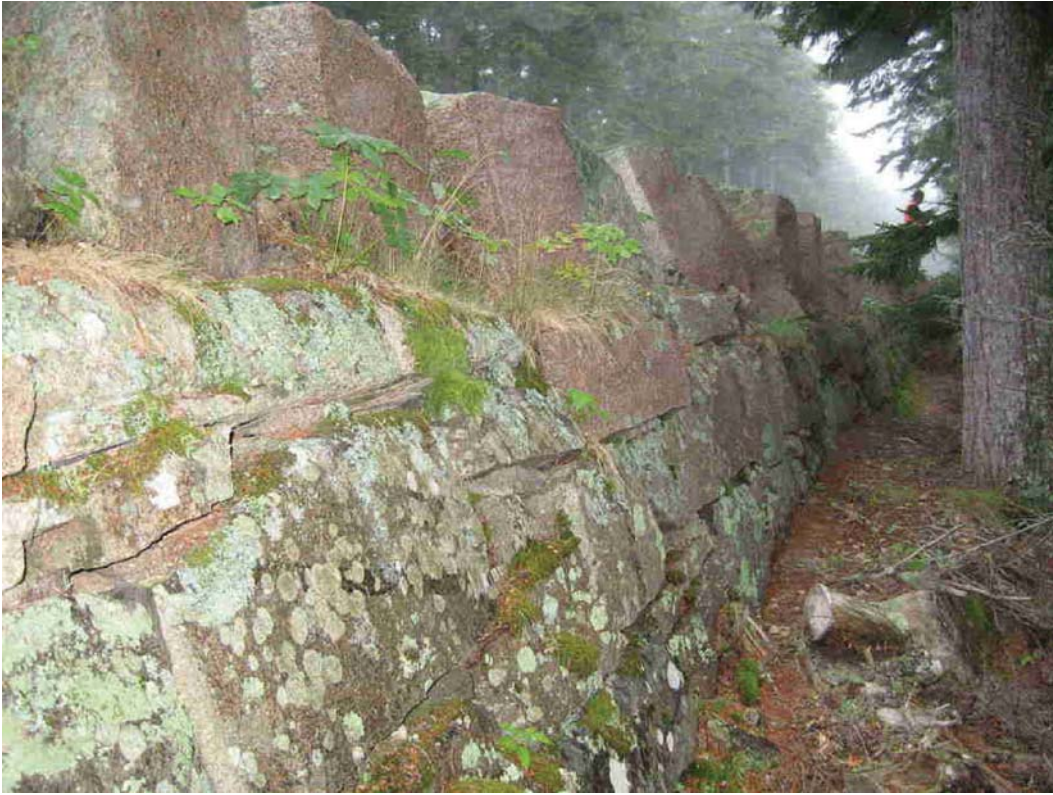
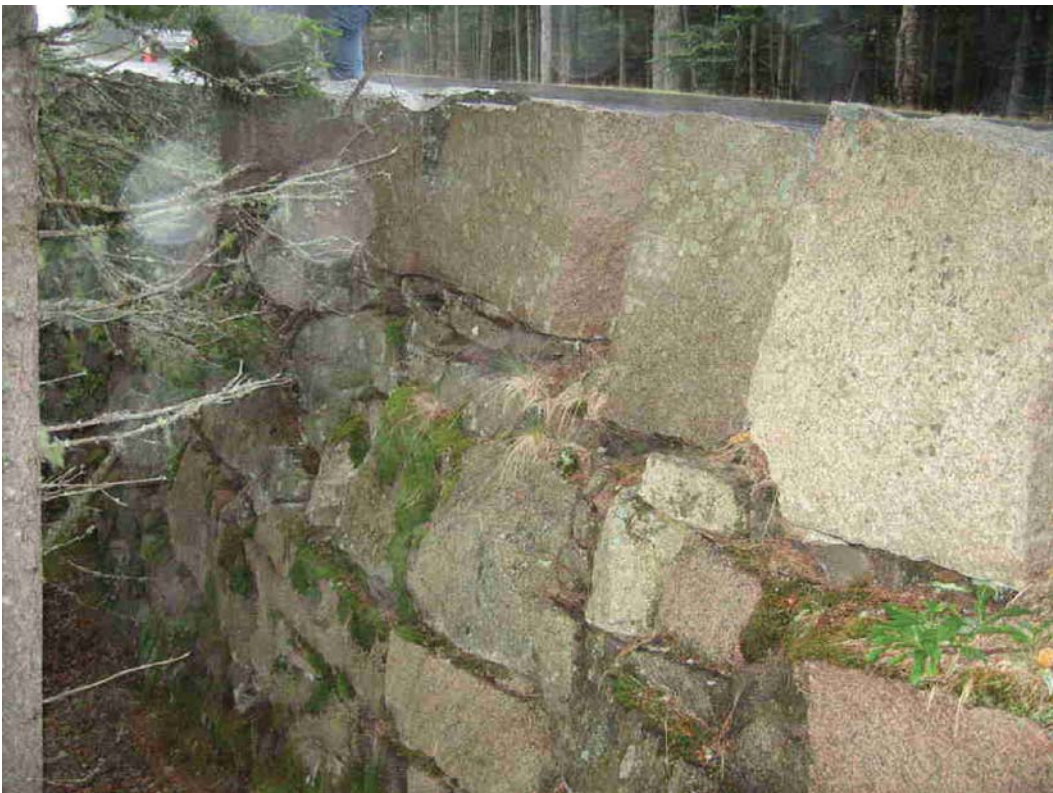
ACAD_0300_7.370_L_1.jpg

Wall ID:	ACAD-0300-7.37-L		
Route Name:	PARK LOOP ROAD		
Inspection Date:	August 08, 2007	Approximate Year Built:	Unknown
*Wall Rating:	81	Maintenance Action:	No Action

Element (Weighting Factor)	Narrative	Condition Rating (0 - 10)
PERFORMANCE 8.00	Good condition, performing as intended.	8
WALL FOUNDATION MATERIAL 8.00	Some evidence of past settlement, but stable.	8
PLACED STONE 8.00	Some weathering.	8
CULVERT 0.50	14-inch culvert, good condition.	8
TRAFFIC BARRIER/FENCE 0.50	Some blocks missing, not effecting wall performance, minor settlement and rotation.	8
VEGETATION 0.50	Moss, grass, not impacting wall.	8
WALL DRAINS 0.50	None observed, water-related issues not impacting the wall.	8
DOWNSLOPE 0.50	Good foundation, flat to 1.5H:1v, toe of slope well vegetated, some bedrock outcrop.	9
LATERAL SLOPE 0.50	No signs of distress, no erosion.	9

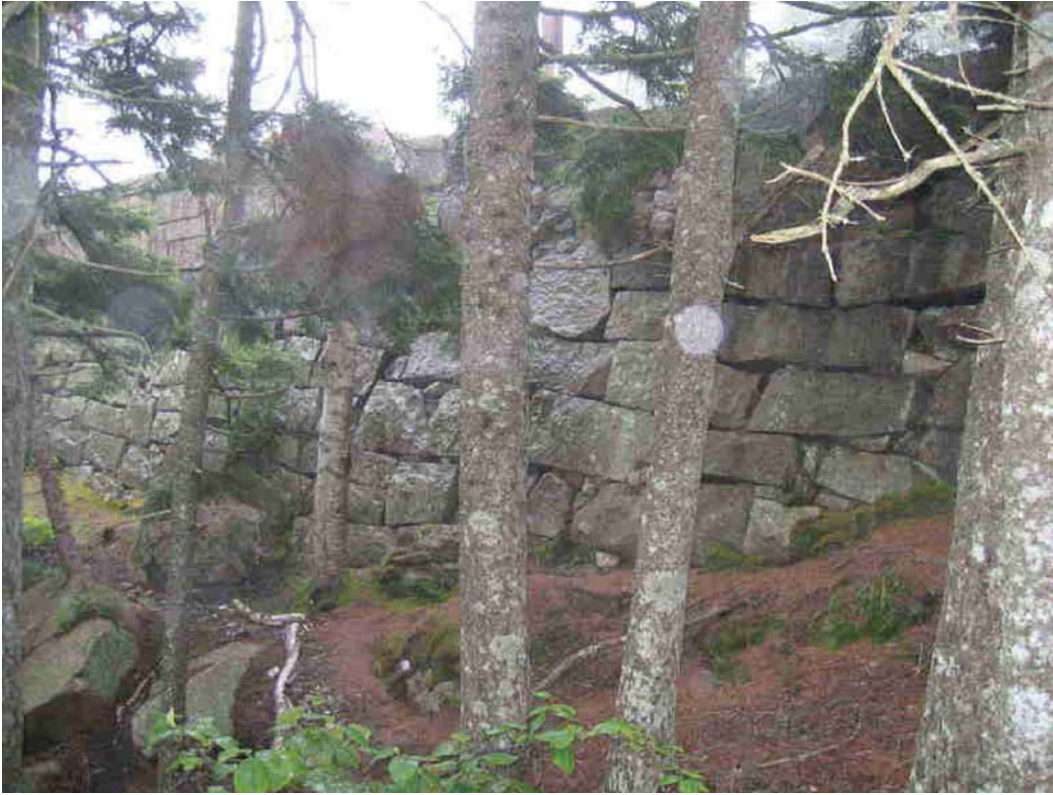
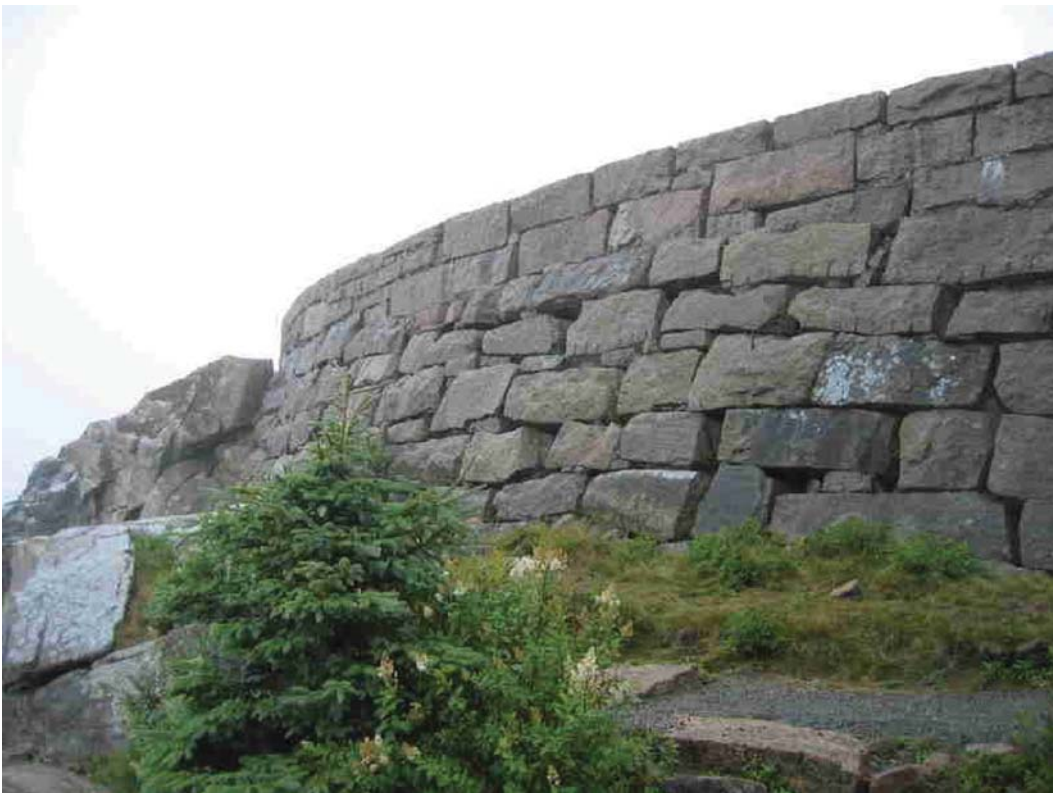
ACAD_0300_7.510_L_1.jpg

Wall ID:	ACAD-0300-7.51-L		
Route Name:	PARK LOOP ROAD		
Inspection Date:	August 08, 2007	Approximate Year Built:	Unknown
*Wall Rating:	79	Maintenance Action:	No Action

Element (Weighting Factor)	Narrative	Condition Rating (0 - 10)
PERFORMANCE 8.00	apparently older wall, but still performing as intended	8
WALL FOUNDATION MATERIAL 8.00	Dense soil and bedrock	8
STONE MASONRY 8.00	Large blocks of fresh, hard granite. Some pre-split	8
LATERAL SLOPE 0.50	3h:1v or flatter at start, 1:1 bedrock at end	8
WALL DRAINS 0.50	None, but none needed because of permeable face.	8
CULVERT 1.00	exists mid-height, with no projection, but bedrock is foundation and there is no scour	6

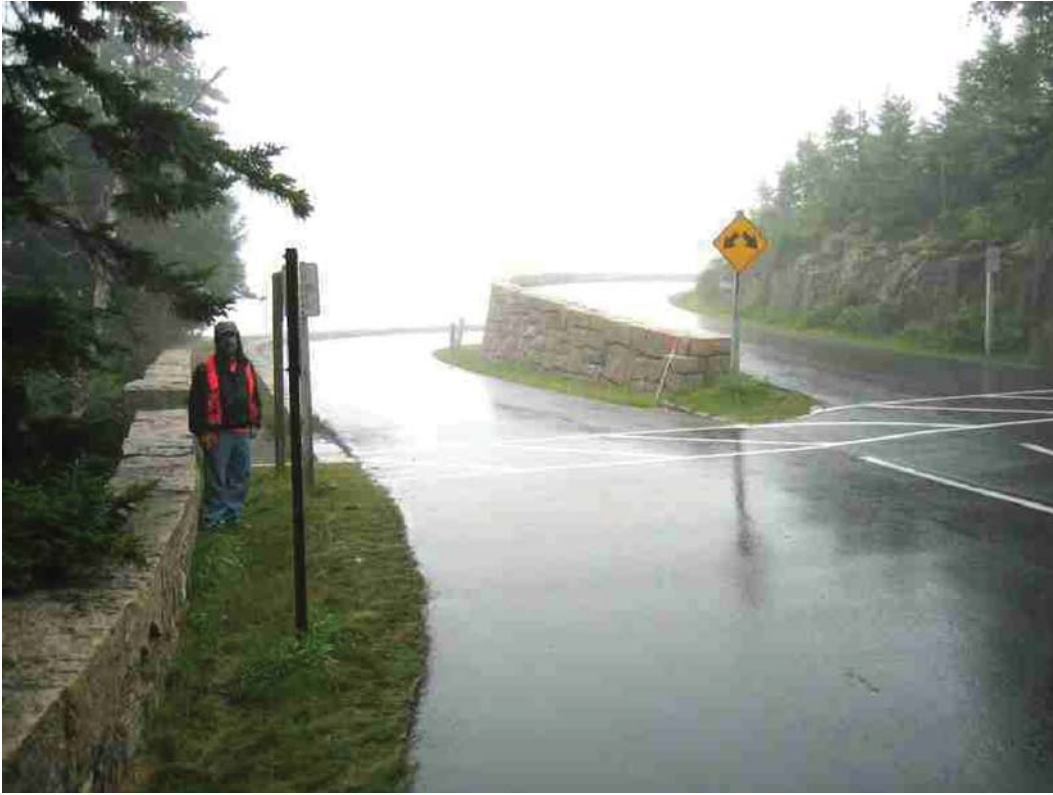
ACAD_0300_7.525_L_1.jpg

Wall ID:	ACAD-0300-7.525-L		
Route Name:	PARK LOOP ROAD		
Inspection Date:	August 08, 2007	Approximate Year Built:	Unknown
*Wall Rating:	82	Maintenance Action:	No Action

Wall Function:	Fill Wall	Primary Wall Type:	Gravity - Mortared Stone
Surface Treatment:		Secondary Wall Type:	
Secondary Surface Treatment:		Architectural Facing:	
General Description:	Centerline wall separating left and right lanes, recently constructed, some loose mortar.

Element (Weighting Factor)	Narrative	Condition Rating (0 - 10)
PERFORMANCE 8.00	New, no evident movement, performing as anticipated	9
WALL FOUNDATION MATERIAL 8.00	Dense soil, bedrock near surface	9
MORTAR 8.00	concrete mortar, loose, cracked and missing in places, but masonry is so good and this so occasional that it is not yet much of an issue	6
STONE MASONRY 8.00	Fresh, hard sub-angular granite with minor chinking	9
LATERAL SLOPE 0.50	Gentle taper to median of road	9
UPSLOPE 0.50	Pavement adjacent to wall - drains away from wall face	9
WALL DRAINS 1.00	none observed but top of wall is paved so infiltration minor	6

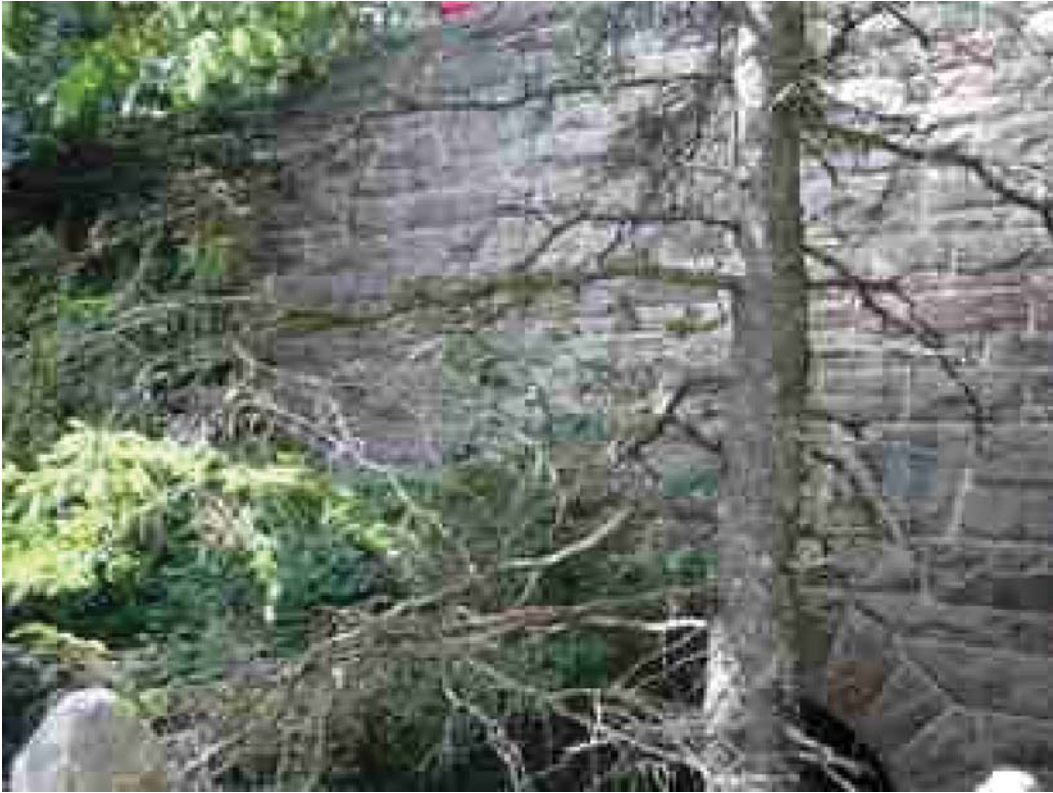
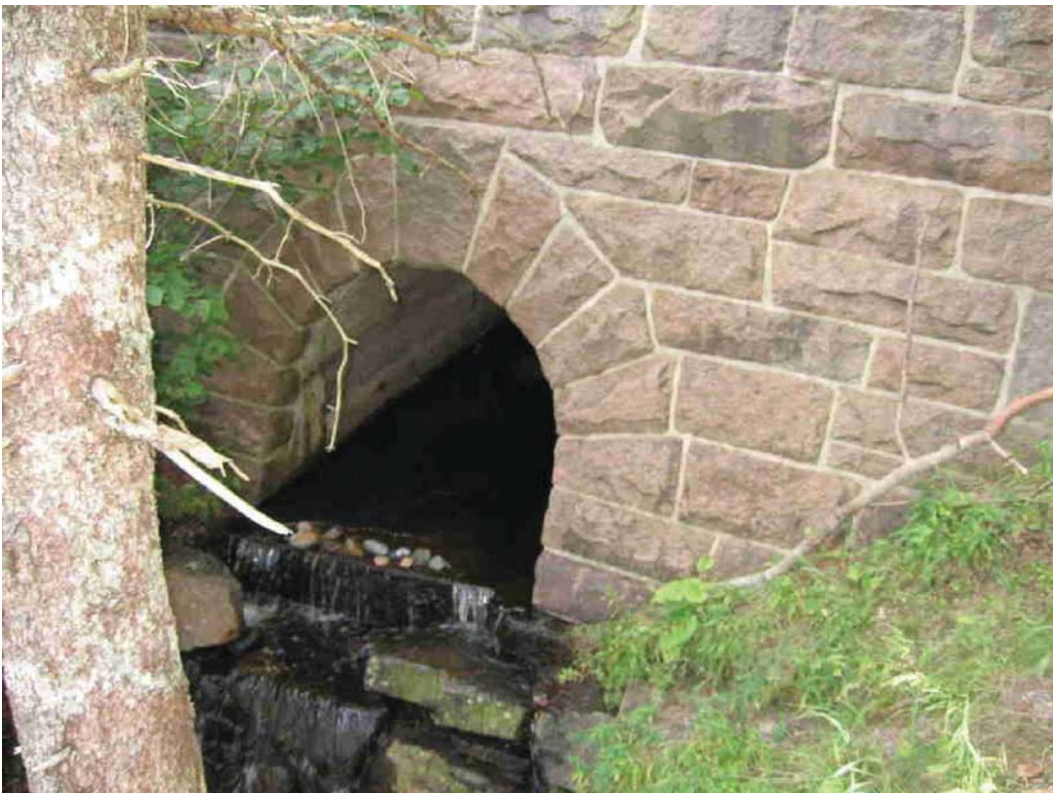
Wall ID:	ACAD-0300-10.408-L		
Route Name:	PARK LOOP ROAD		
Inspection Date:	August 09, 2007	Approximate Year Built:	Unknown
*Wall Rating:	90	Maintenance Action:	No Action

Element (Weighting Factor)	Narrative	Condition Rating (0 - 10)
PERFORMANCE 8.00	Good condition, performing as intended.	9
WALL FOUNDATION MATERIAL 8.00	Solid granular alluvial material, no signs of distress, settlement, or rotation.	9
MORTAR 8.00	Minor cracking and spalling at isolated locations, good condition.	9
STONE MASONRY 8.00	4'x2'x1' cut solid granite blocks, minor surface weathering, performing as intended.	9
CULVERT 0.50	6'Wx5'H concrete arch culvert, minor cracking, performing as intended.	9
DOWNSLOPE 0.50	Active alluvial stream channel at 3H:1V slope, not impacting the wall.	9
LATERAL SLOPE 0.50	Relatively flat with 2H:1V with minor surface erosion, bushes and trees, stairway down to the ocean at one side.	9
ROAD/SIDEWALK/SHOULDER 0.50	Road has new overlay with no signs of distress. Shoulder is relatively flat, not impacting wall.	9
WALL DRAINS 0.50	None observed, water-related issues not impacting wall.	9

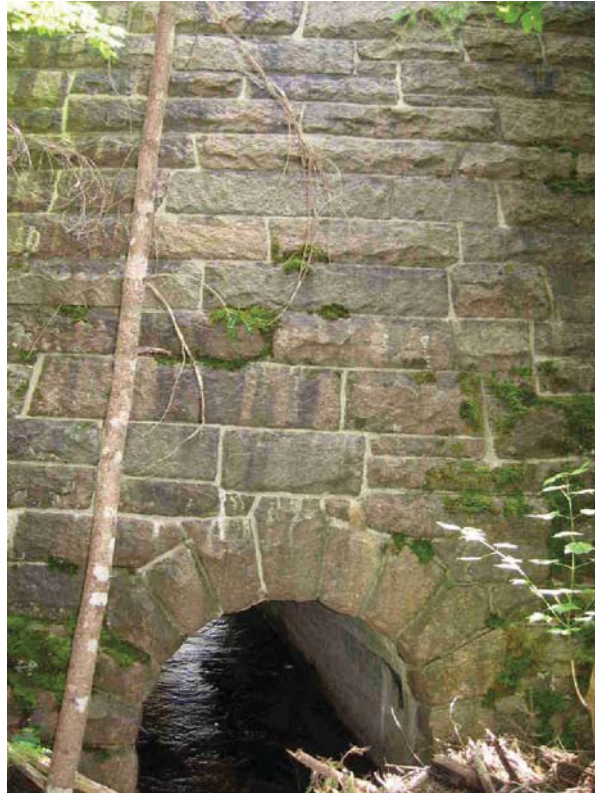
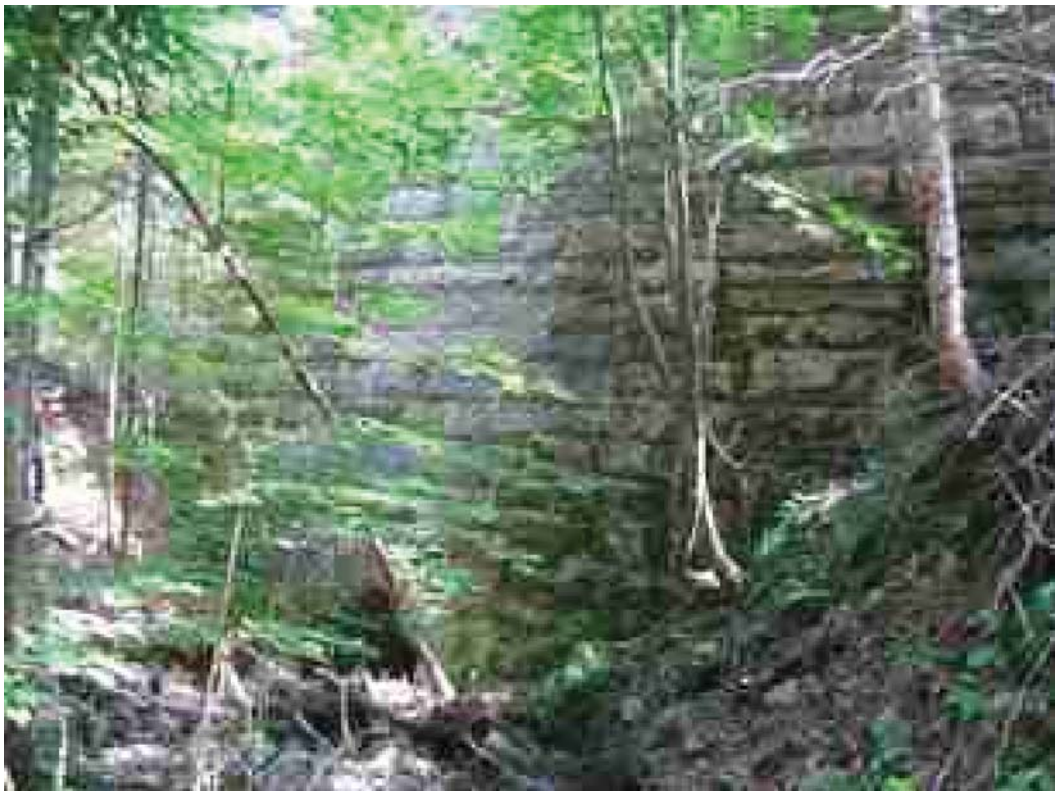
Wall ID:	ACAD-0300-10.408-R		
Route Name:	PARK LOOP ROAD		
Inspection Date:	August 09, 2007	Approximate Year Built:	Unknown
*Wall Rating:	90	Maintenance Action:	No Action

Element (Weighting Factor)	Narrative	Condition Rating (0 - 10)
PERFORMANCE 8.00	Good condition, performing as intended.	9
WALL FOUNDATION MATERIAL 8.00	Solid granular alluvial material, no signs of distress, settlement, or rotation.	9
MORTAR 8.00	Minor cracking and spalling at isolated locations, good condition.	9
STONE MASONRY 8.00	4'x2'x1' cut granite blocks, minor surface weathering and CaCO ₃ staining, minor moss coverage.	9
CULVERT 0.50	6'Wx5' H concrete arch culvert, minor cracking, performing as intended.	9
DOWNSLOPE 0.50	Active alluvial stream channel at 2H:1V slope, minor erosion at footings, not impacting wall performance.	9
LATERAL SLOPE 0.50	Relatively flat to 2H:1V, minor surface erosion, bushes and trees.	9
ROAD/SIDEWALK/SHOULDER 0.50	Road has new overlay and no signs of distress. Shoulder is relatively flat, not impacting the wall.	9
WALL DRAINS 0.50	Gap in blocks built into wall, functioning as intended, water-related issues not impacting wall.	9

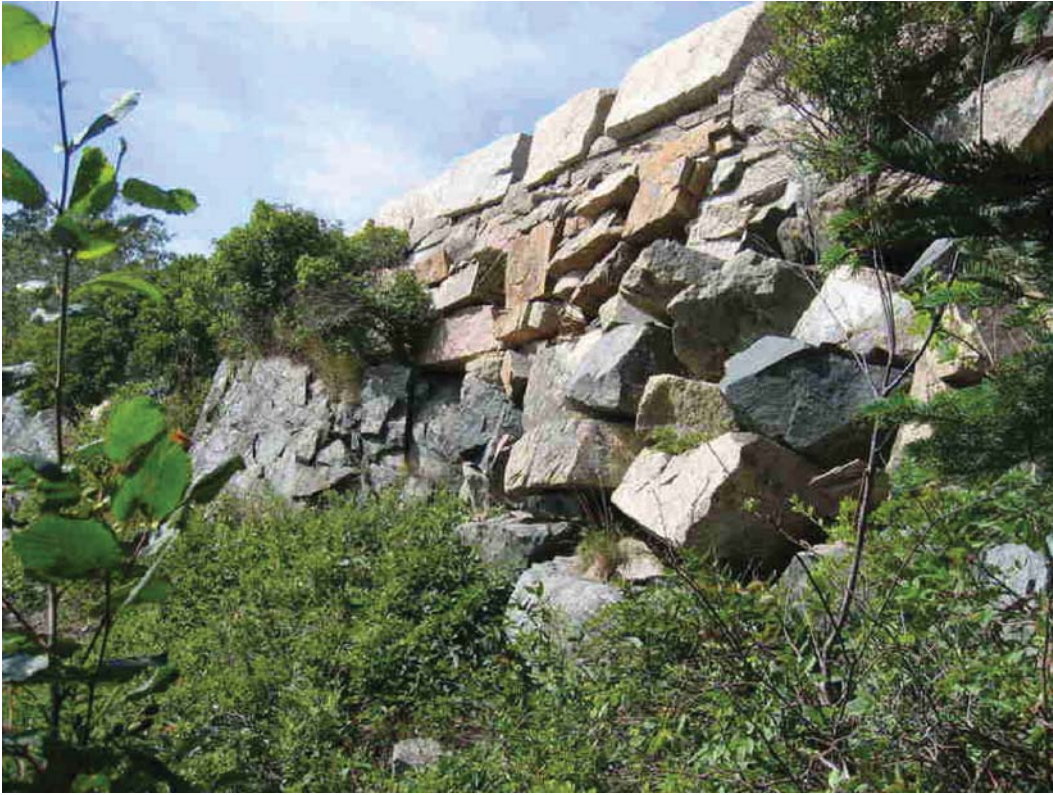
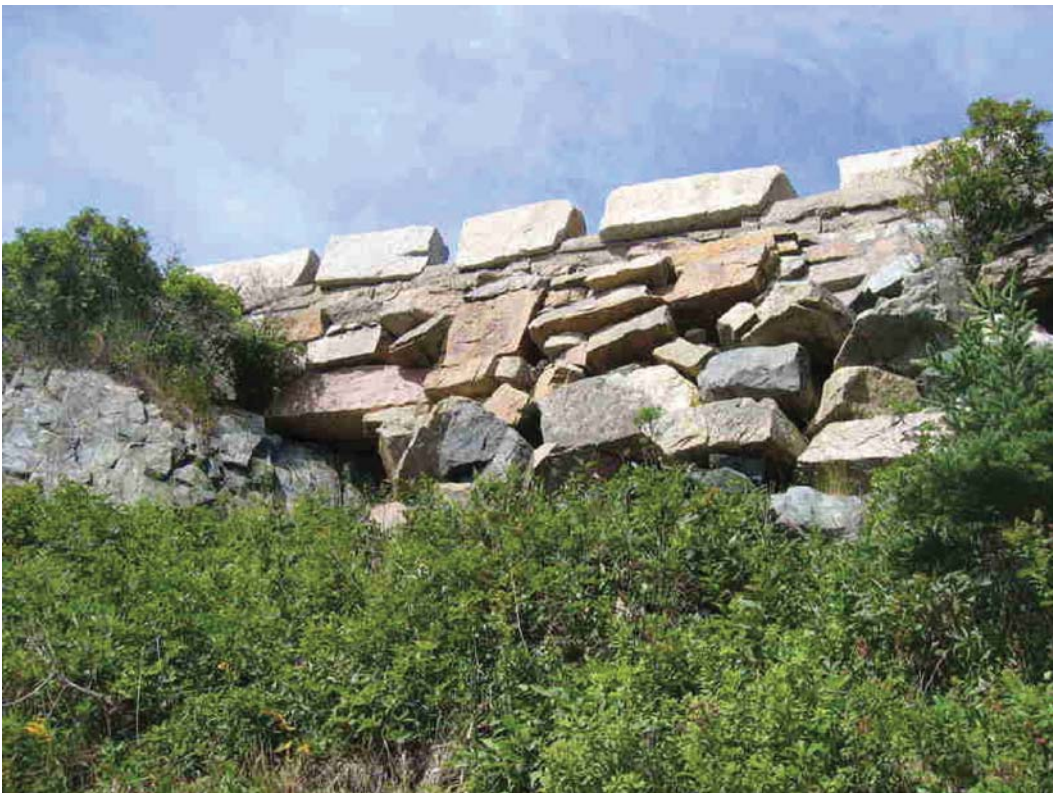
Wall ID:	ACAD-0300-10.637-L		
Route Name:	PARK LOOP ROAD		
Inspection Date:	August 09, 2007	Approximate Year Built:	Unknown
*Wall Rating:	58	Maintenance Action:	Repair Elements

Element (Weighting Factor)	Narrative	Condition Rating (0 - 10)
PERFORMANCE 8.00	Fair. Performing as intended, some repair under guardwall needed.	6
WALL FOUNDATION MATERIAL 8.00	Founded on soil/rock mix and bedrock, no sign of settlement.	7
STONE MASONRY 8.00	Upper portion of wall nicely stacked, sl. weathered granite. Lower 1/3 of wall consisting of crudely placed rock fill.	6
ROAD/SIDEWALK/SHOULDER 1.00	Settlement present at paved walkway near wall end.	4
DOWNSLOPE 1.00	Very steep soil over bedrock slope. Minor erosion.	6
LATERAL SLOPE 1.00	Steep soil over shallow bedrock slope at wall start. Gentle 3:1 grassy slope at wall end. No erosion.	7
WALL DRAINS 1.00	None visible. No sign of water related problems.	7
TRAFFIC BARRIER/FENCE 5.00	Footing below guardwall is undermined at wall start and wall end.	3

Failure Consequence:	HIGH
Recommendation Narrative:	70' X 2' X .5' area or 2.6 cu. Yds, Lean concrete @ \$100 = \$260, 8 hours labor @ \$55 per hr = \$440
Repair Cost:	\$700

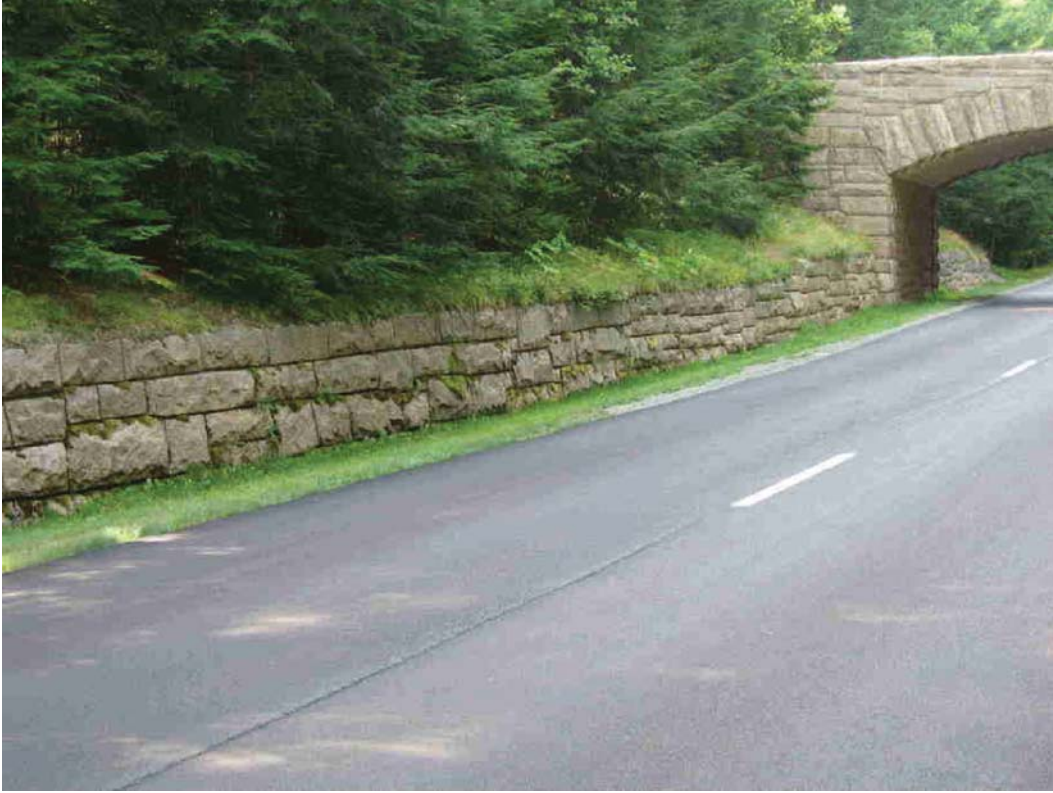
ACAD_0300_11.487_L_1.jpg

Wall ID:	ACAD-0300-11.487-L		
Route Name:	PARK LOOP ROAD		
Inspection Date:	August 09, 2007	Approximate Year Built:	Unknown
*Wall Rating:	89	Maintenance Action:	No Action

Element (Weighting Factor)	Narrative	Condition Rating (0 - 10)
PERFORMANCE 8.00	Excellent condition	9
WALL FOUNDATION MATERIAL 8.00	No signs of distress	9
MORTAR 8.00	Some minor cracks	9
STONE MASONRY 8.00	Minor weathering , good condition	9
LATERAL SLOPE 0.50	No erosion well vegetated	8
UPSLOPE 0.50	Well vegetated slight signs of erosion	8
ROAD/SIDEWALK/SHOULDER 0.50	No signs of distress	10
WALL DRAINS 1.00	Openings between blocks, silted up below grade	7

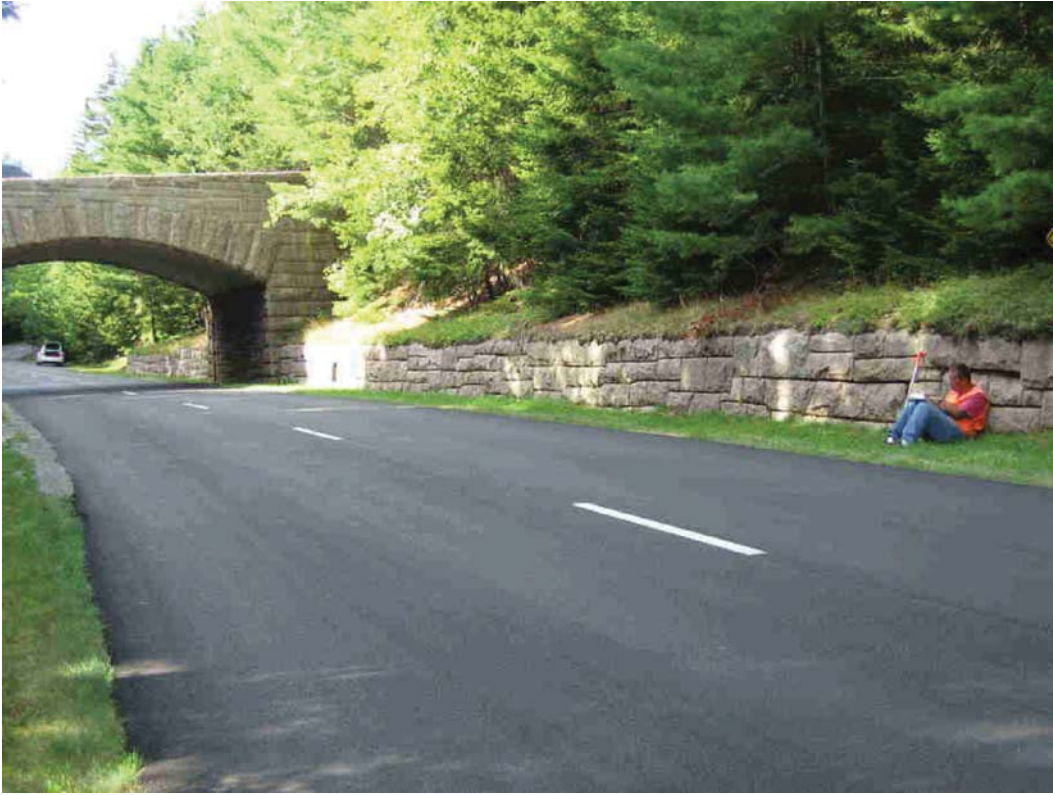
ACAD_0300_11.490_R_1.jpg

Wall ID:	ACAD-0300-11.49-R		
Route Name:	PARK LOOP ROAD		
Inspection Date:	August 09, 2007	Approximate Year Built:	Unknown
*Wall Rating:	89	Maintenance Action:	No Action

Element (Weighting Factor)	Narrative	Condition Rating (0 - 10)
PERFORMANCE 8.00	Excellent condition	9
WALL FOUNDATION MATERIAL 8.00	No signs of distress	9
MORTAR 8.00	Minor cracking	9
PLACED STONE 8.00	Slight weathering	9
CULVERT 0.50	18" CMP some corrosion but in working condition	8
LATERAL SLOPE 0.50	Minor erosion well vegetated	8
UPSLOPE 0.50	No signs of erosion	9
ROAD/SIDEWALK/SHOULDER 0.50	No signs of distress	10
WALL DRAINS 1.00	Opening between blocks silted in	7

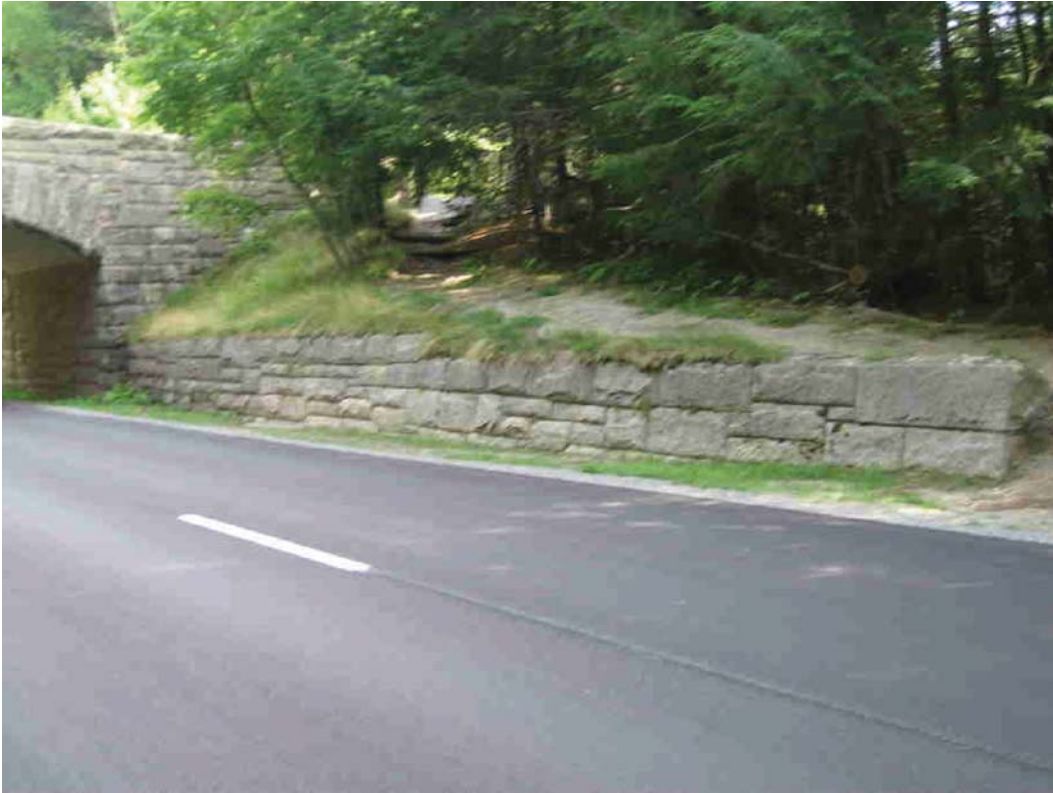
ACAD_0300_11.540_R_1.jpg

Wall ID:	ACAD-0300-11.54-R		
Route Name:	PARK LOOP ROAD		
Inspection Date:	August 09, 2007	Approximate Year Built:	Unknown
*Wall Rating:	88	Maintenance Action:	Repair Elements

Element (Weighting Factor)	Narrative	Condition Rating (0 - 10)
PERFORMANCE 8.00	Excellent condition	9
WALL FOUNDATION MATERIAL 8.00	No signs of distress	9
MORTAR 8.00	Some minor cracks	9
PLACED STONE 8.00	Good condition minor weathering	9
WALL DRAINS 0.50	None visible	8
ROAD/SIDEWALK/SHOULDER 0.50	No signs of distress	10
LATERAL SLOPE 1.00	Erosion control not working, significant erosion	6
UPSLOPE 1.00	Erosion control not working, significant erosion	6

Failure Consequence:	LOW
Recommendation Narrative:	Erosion control 78' x 8' = 70 sy @ \$5/sy = \$350, grading & placing materials, 2 people / 6 hrs@\$55/hr = \$880, equip. hrs =\$500,seeding \$100. Total = \$1,830.Redirect surface water from bridge away from wall.
Repair Cost:	\$1,830

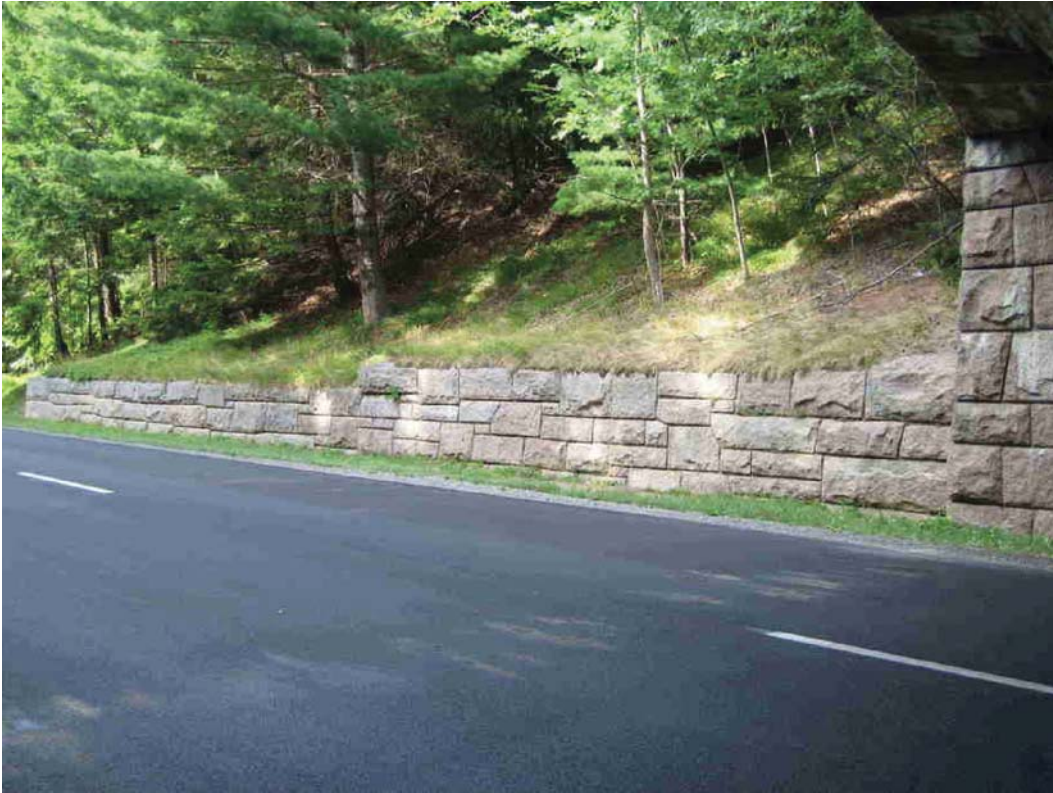
ACAD_0300_11.541_L_1.jpg

Wall ID:	ACAD-0300-11.541-L		
Route Name:	PARK LOOP ROAD		
Inspection Date:	August 09, 2007	Approximate Year Built:	Unknown
*Wall Rating:	89	Maintenance Action:	No Action

Element (Weighting Factor)	Narrative	Condition Rating (0 - 10)
PERFORMANCE 8.00	Excellent condition	9
WALL FOUNDATION MATERIAL 8.00	No signs of distress	9
MORTAR 8.00	Minor cracks	9
STONE MASONRY 8.00	Minor weathering, good condition	9
LATERAL SLOPE 0.50	Slight erosion	8
UPSLOPE 0.50	Signs of erosion	8
ROAD/SIDEWALK/SHOULDER 0.50	No signs of distress	10
WALL DRAINS 1.00	Holes between blocks silted in below grade	7
