ACAD WIP Report

NPS Retaining Wall Inventory Program Acadia National Park

**Federal Lands Highway
Road Inventory Program**

Data Collection Date: August 2007
Report Date: October 2015

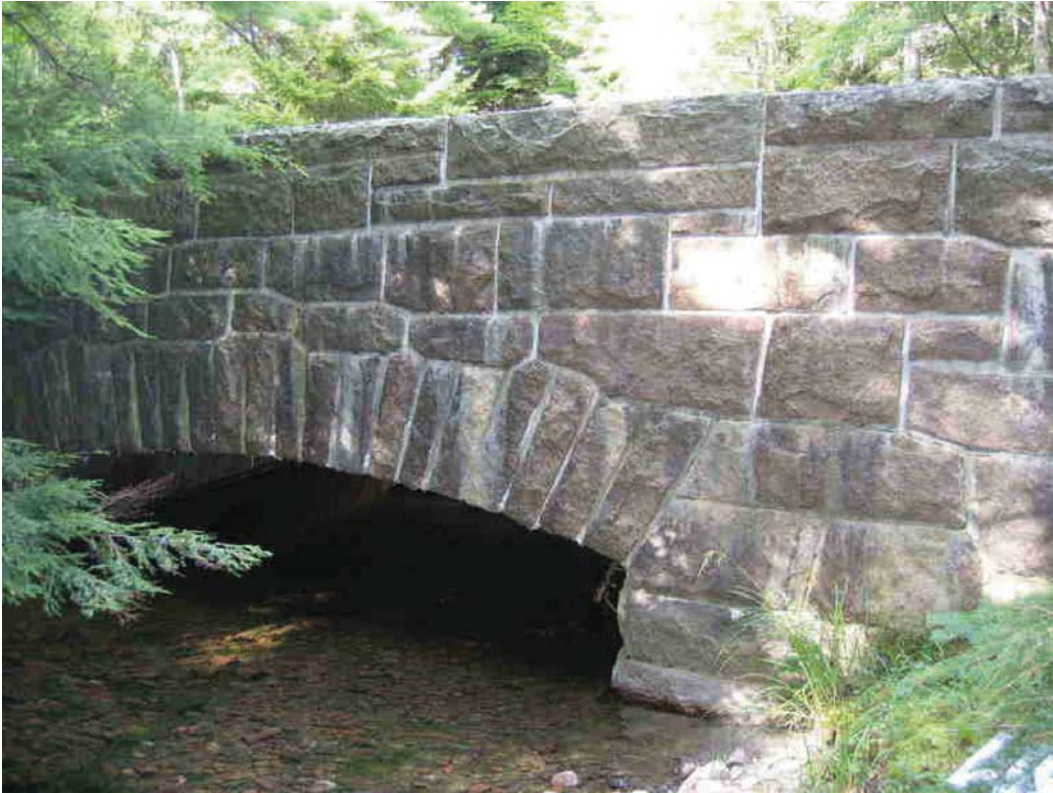
ACAD_0300_11.589_L_1.jpg

Wall ID:	ACAD-0300-11.589-L		
Route Name:	PARK LOOP ROAD		
Inspection Date:	August 09, 2007	Approximate Year Built:	Unknown
*Wall Rating:	84	Maintenance Action:	No Action

Element (Weighting Factor)	Narrative	Condition Rating (0 - 10)
PERFORMANCE 8.00	Performing as intended.	8
WALL FOUNDATION MATERIAL 8.00	Dense alluvium, limited scour potential.	8
MORTAR 8.00	Some calcium precipitate, moss (minor), no cracking.	9
STONE MASONRY 8.00	Fresh, hard granite; well crafted.	9
LATERAL SLOPE 0.50	3:1 slope. End stones rest on exposed CIP concrete, perhaps erosion occurred in the past.	8
WALL DRAINS 1.00	None, no signs of drainage related distress.	7

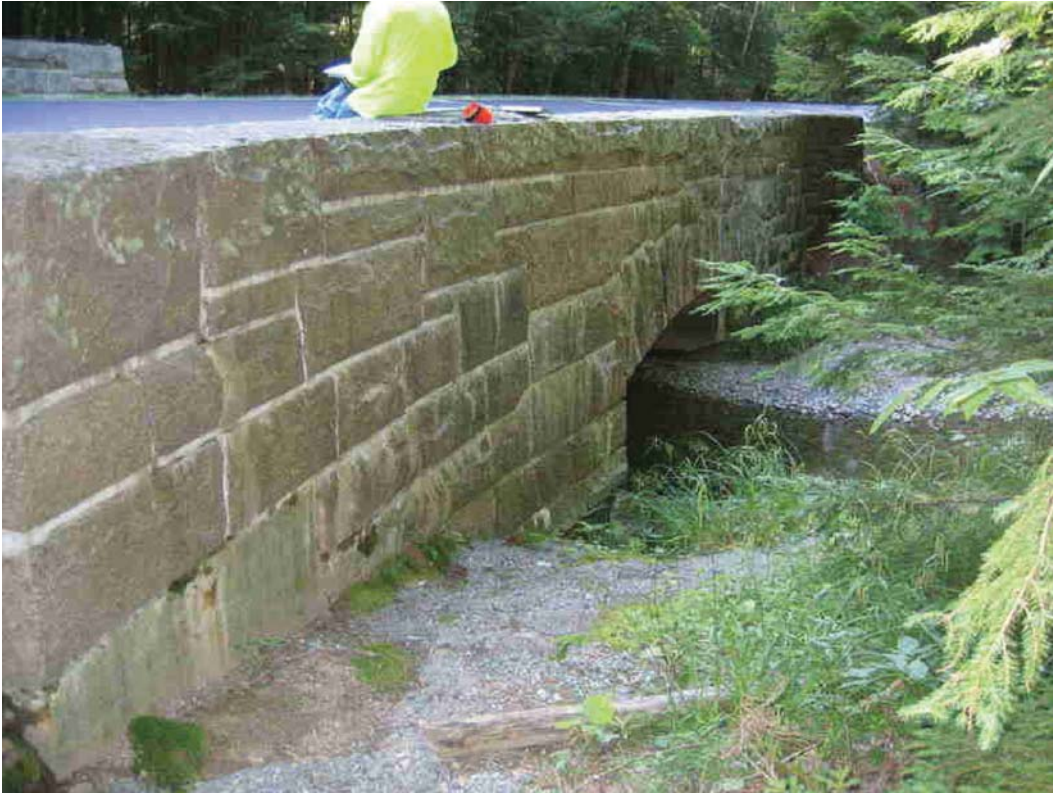
ACAD_0300_11.592_R_1.jpg

Wall ID:	ACAD-0300-11.592-R		
Route Name:	PARK LOOP ROAD		
Inspection Date:	August 09, 2007	Approximate Year Built:	Unknown
*Wall Rating:	84	Maintenance Action:	No Action

Element (Weighting Factor)	Narrative	Condition Rating (0 - 10)
PERFORMANCE 8.00	Good. Performing as intended.	8
WALL FOUNDATION MATERIAL 8.00	Founded on stream channel, no sign of settlement.	8
MORTAR 8.00	No spalling or cracks, very good and recently constructed.	9
STONE MASONRY 8.00	Fresh granite blocks, well cut and well placed.	9
LATERAL SLOPE 1.00	2:1 soil slope with minor erosion at wall start.	5
WALL DRAINS 1.00	None visible. No sign of water related problems.	7

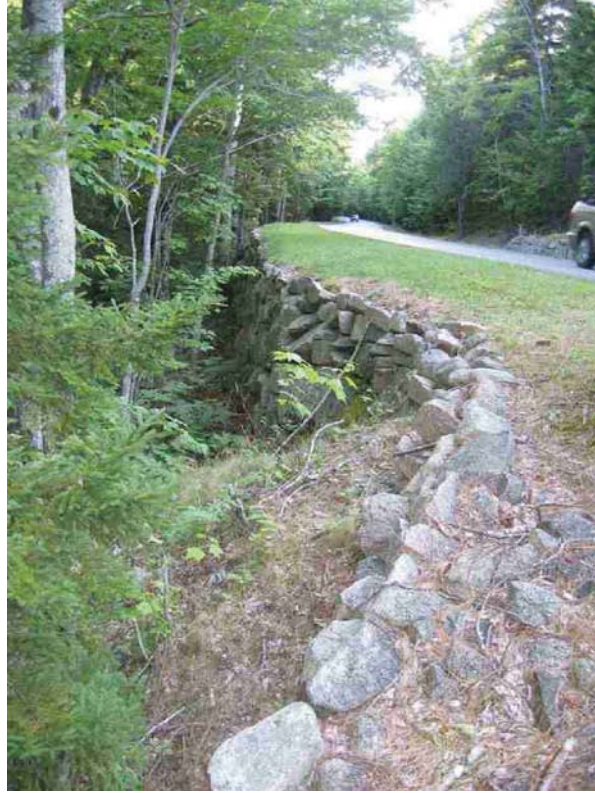
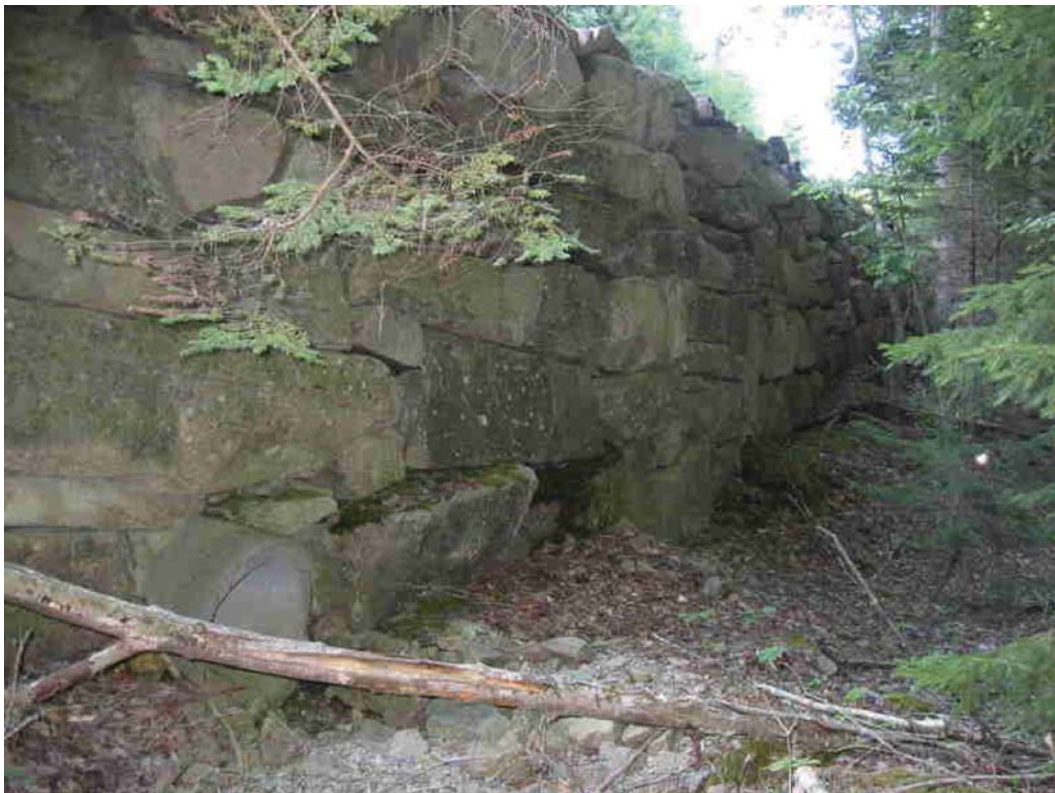
Wall ID:	ACAD-0300-11.66-R		
Route Name:	PARK LOOP ROAD		
Inspection Date:	August 09, 2007	Approximate Year Built:	Unknown
*Wall Rating:	76	Maintenance Action:	No Action

Element (Weighting Factor)	Narrative	Condition Rating (0 - 10)
PERFORMANCE 8.00	Old wall still performing well.	8
WALL FOUNDATION MATERIAL 8.00	Dense soil, gentle slope.	8
PLACED STONE 8.00	Large to very large rocks except at wall end. Well crafted of angular to sub rounded granite.	7
DOWNSLOPE 0.50	Gentle slope.	8
WALL DRAINS 0.50	2 ABS green drains 6" noted, evidence of past flow, otherwise free draining face.	8
LATERAL SLOPE 1.00	3:1 slope. Soil.	7
ROAD/SIDEWALK/SHOULDER 1.00	Grass slopes towards wall depression, concentrated from near wall beginning.	7

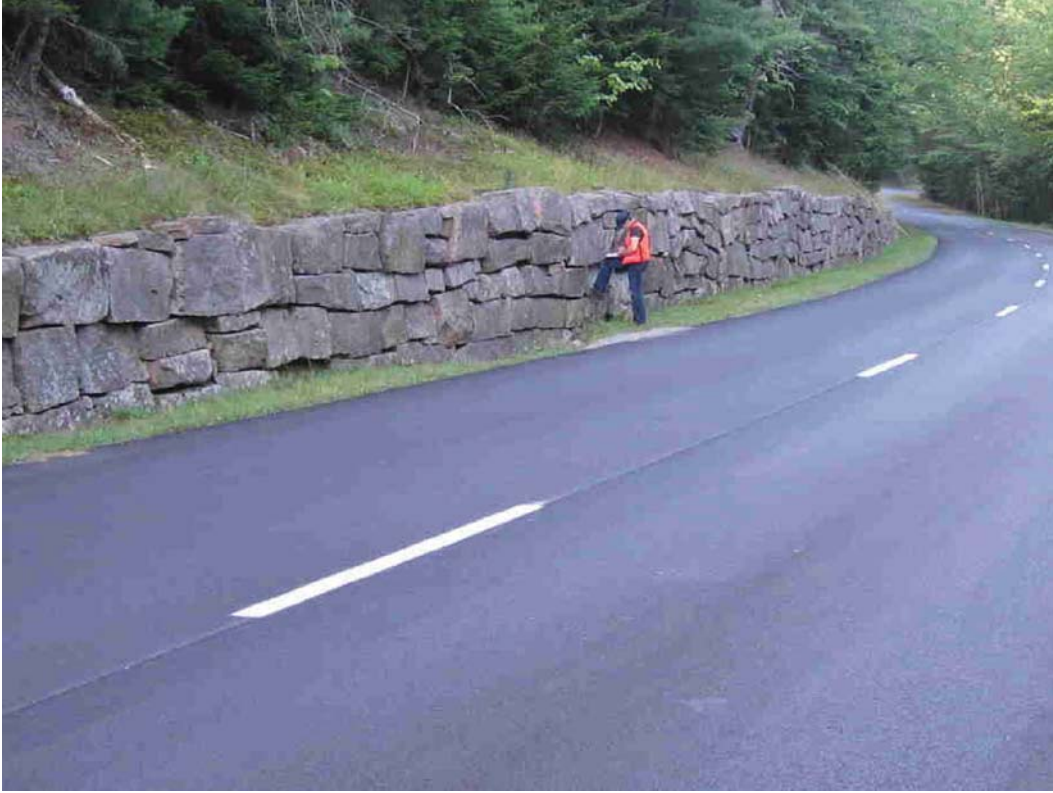
ACAD_0300_11.688_L_1.jpg

Wall ID:	ACAD-0300-11.688-L		
Route Name:	PARK LOOP ROAD		
Inspection Date:	August 09, 2007	Approximate Year Built:	Unknown
*Wall Rating:	71	Maintenance Action:	No Action

Element (Weighting Factor)	Narrative	Condition Rating (0 - 10)
PERFORMANCE 8.00	Fair to good condition, minor signs of rotation and settlement.	7
WALL FOUNDATION MATERIAL 8.00	Solid granular fill material (roadway/shoulder), minor indications of settlement and erosion at the base, but not actively moving.	7
PLACED STONE 8.00	2'-4' diameter solid granite rounded boulders, minor surface weathering, primitive construction, slight rotation out of vertical, small pieces eroding in places, many 3-4" voids throughout.	7
LATERAL SLOPE 0.50	About 2H:1V slope with grass similar to upslope.	8
UPSLOPE 0.50	About 3H:1V slope with grass and small trees, occasionally soft with water, no observed erosion.	8
WALL DRAINS 0.50	None observed, voids are serving as drainage paths.	8
CULVERT 0.50	Inlet in the middle of the wall, minor erosion, functioning as intended.	9
ROAD/SIDEWALK/SHOULDER 1.00	Road has a new overlay and no signs of distress. Shoulder has moderate erosion at the inlet.	7

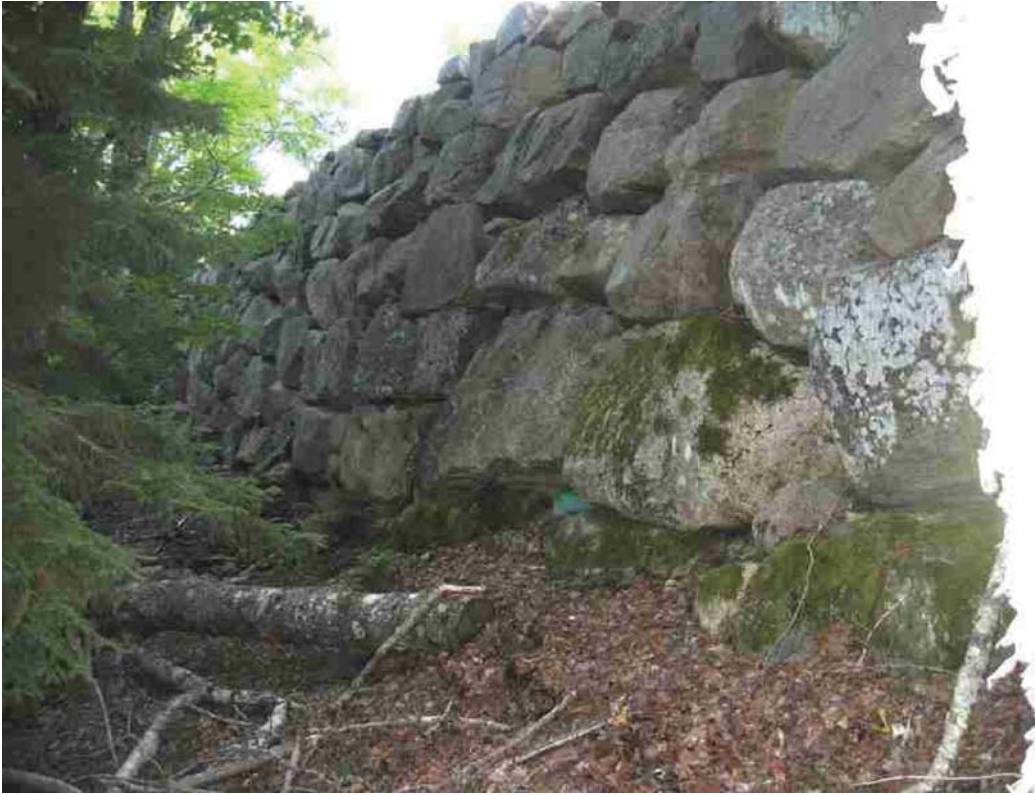
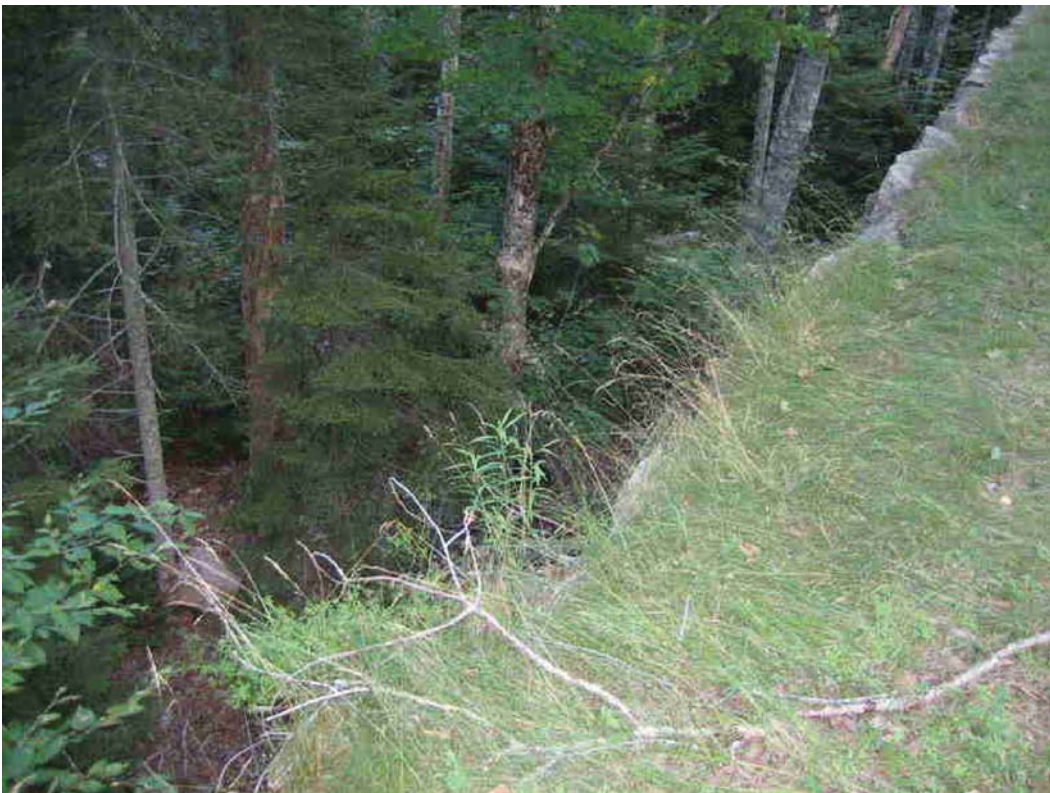
Wall ID:	ACAD-0300-11.721-R		
Route Name:	PARK LOOP ROAD		
Inspection Date:	August 09, 2007	Approximate Year Built:	Unknown
*Wall Rating:	72	Maintenance Action:	No Action

Element (Weighting Factor)	Narrative	Condition Rating (0 - 10)
PERFORMANCE 8.00	Good. Performing as intended.	7
WALL FOUNDATION MATERIAL 8.00	Founded on soil, no sign of settlement.	7
PLACED STONE 8.00	Large (3' X 4') blocky granite, slightly weathered.	8
DOWNSLOPE 0.50	Gentle 4:1 slope, well vegetated slope, no sign of erosion.	8
LATERAL SLOPE 1.00	1.5:1 soil slope at wall start, moderate erosion. 2:1 soil slope at wall end, very minor erosion.	5
CULVERT 1.00	24" concrete pipe, not affecting wall performance.	7
ROAD/SIDEWALK/SHOULDER 1.00	Wide turf shoulder, no sign of distress.	7
WALL DRAINS 1.00	6" weep holes, appear to be functioning fine.	7

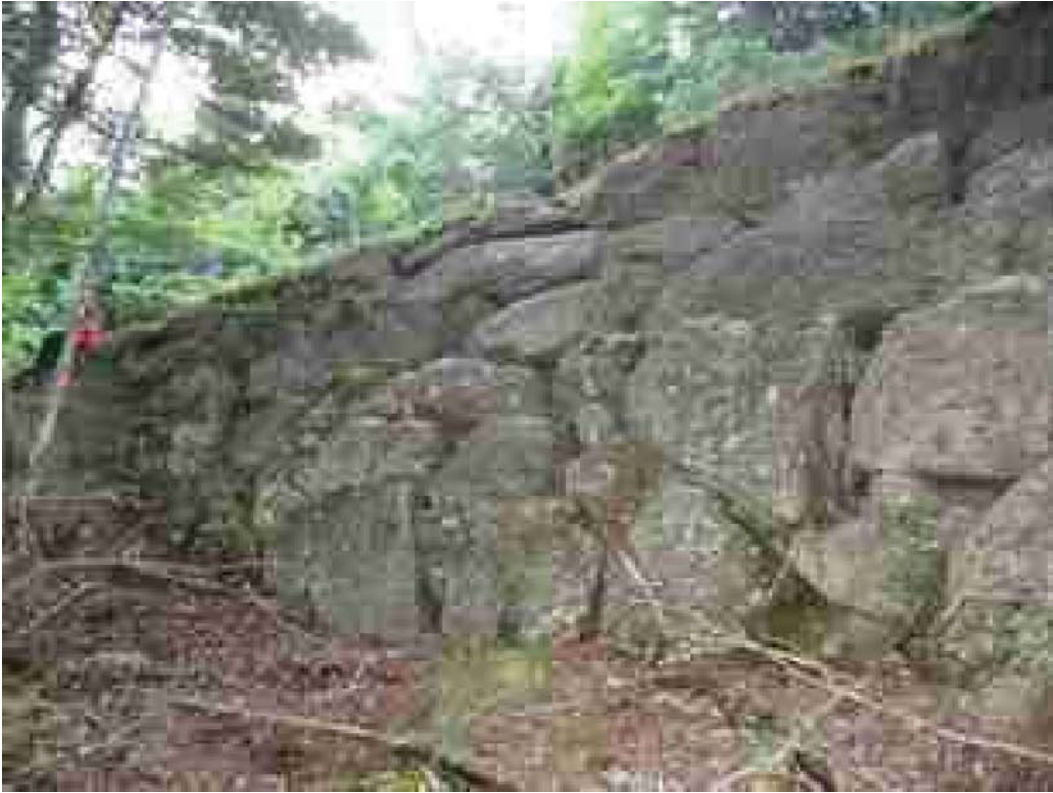
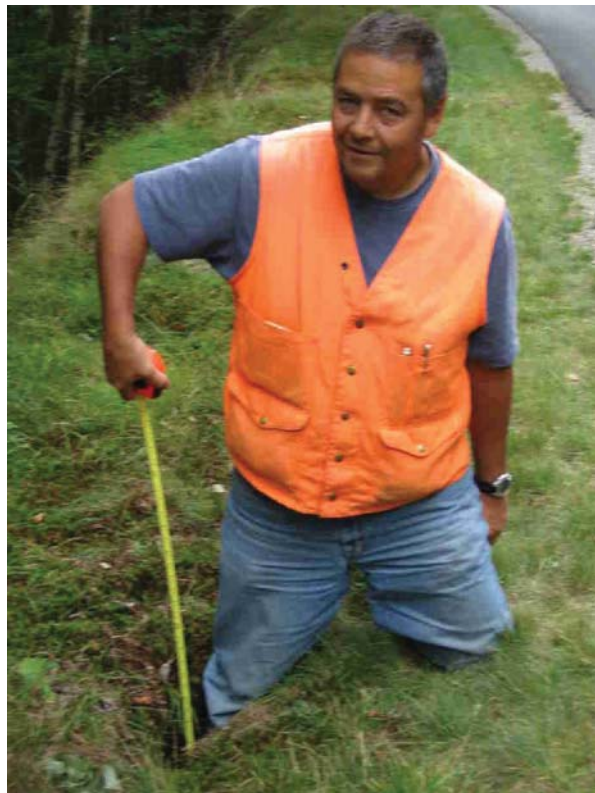
Wall ID:	ACAD-0300-11.957-R		
Route Name:	PARK LOOP ROAD		
Inspection Date:	August 09, 2007	Approximate Year Built:	Unknown
*Wall Rating:	60	Maintenance Action:	Repair Elements

Element (Weighting Factor)	Narrative	Condition Rating (0 - 10)
PERFORMANCE 8.00	Fair condition, active internal erosion that may impact the road, allowing voids to form.	5
WALL FOUNDATION MATERIAL 8.00	Granular materials, minor settlement and movement at the base of the wall.	8
PLACED STONE 8.00	1-5' diameter granite boulders, large voids (3-4ft wide) behind some rocks, primitive construction.	5
DOWNSLOPE 0.50	About 2H:1V slope with minor surface erosion, grass and trees vegetate the surface, not impacting the wall.	9
LATERAL SLOPE 0.50	About 2H:1V slope, minor surface erosion, not impacting the wall.	9
ROAD/SIDEWALK/SHOULDER 1.00	Road had a new overlay with no signs of distress. Shoulder has erosion bowls at numerous locations with voids and holes.	5
WALL DRAINS 1.00	None observed, water travels through wall elements, surface water problems.	5
CULVERT 1.00	16" diameter concrete culvert, performing function but appears undersized with damage at the outlet.	6

Failure Consequence:	MODERATE
Recommendation Narrative:	Remove 3 feet of material at the shoulder, place geotextile separator: 9' wide x 224' long = 2224 yd @ \$2/yd2 = \$500, replace, re-compact shoulder with granular material: 4032/27 = 150yds, @\$30/yd3 = \$4,478, top 6" - replace topsoil.
Repair Cost:	\$13,378

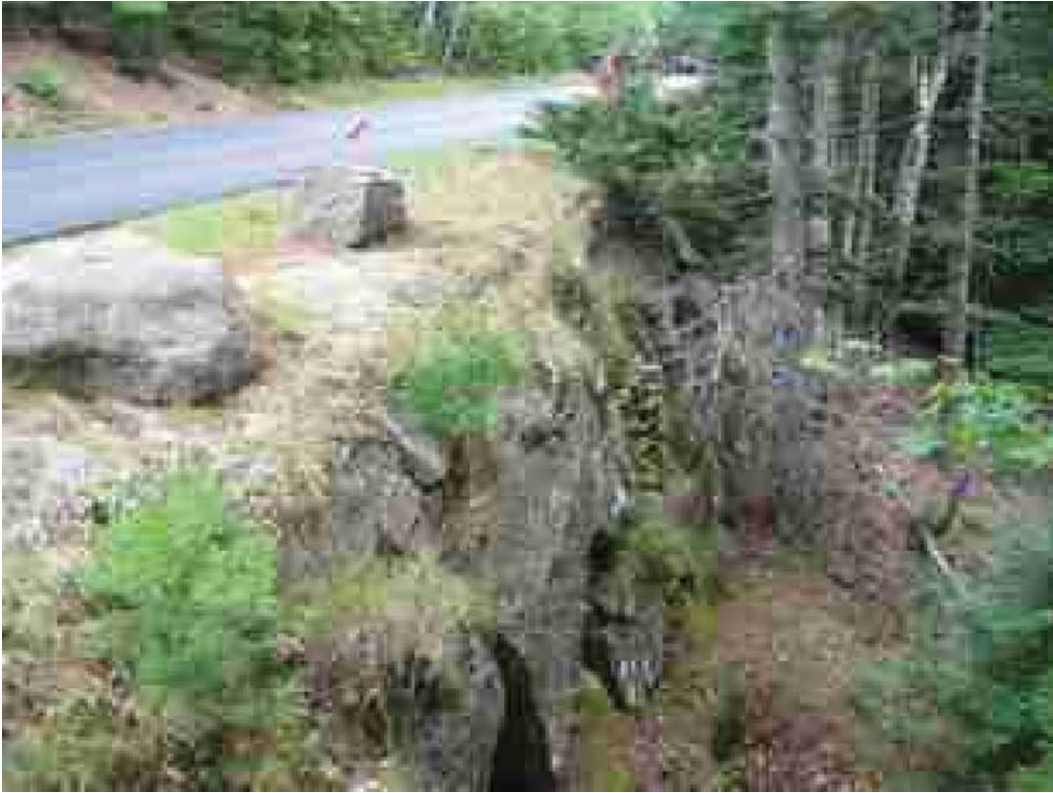
ACAD_0300_12.079_R_1.jpg

Wall ID:	ACAD-0300-12.079-R		
Route Name:	PARK LOOP ROAD		
Inspection Date:	August 10, 2007	Approximate Year Built:	Unknown
*Wall Rating:	64	Maintenance Action:	No Action

Element (Weighting Factor)	Narrative	Condition Rating (0 - 10)
PERFORMANCE 8.00	Fair condition, many surface erosion holes in the roadway shoulder, but does not compromise wall function. This area should be monitored because the erosion could progress to a point where it could impact the wall performance.	6
WALL FOUNDATION MATERIAL 8.00	Solid granular material, occasional loose, soft areas, minor signs of rotation and settlement.	7
PLACED STONE 8.00	1-4' diameter granite boulders, many voids throughout, signs of internal erosion, but functioning as intended (due to large size of boulders with good contact).	6
DOWNSLOPE 0.50	About 2H:1V vegetated slope with trees, shrubs, grass, not impacting wall.	8
LATERAL SLOPE 0.50	Minor surface erosion, minor impact to wall, tapers to the sides.	8
TRAFFIC BARRIER/FENCE 0.50	Granite boulders at the top of the wall, 2 missing (unrelated), minor settlement above wall, signs of small surface depressions.	8

ROAD/SIDEWALK/SHOULDER 1.00	Road has new overlay with no signs of distress. Shoulder has moderate number of holes, settlement areas indicating surface erosion, minor impact on wall function.	5
CULVERT 1.00	16-inch diameter concrete pipe outlet, half-way silted in, not fully functional.	6
WALL DRAINS 1.00	None observed, water drains through the wall elements, lack of controlled drainage may be leading to wall distress.	6

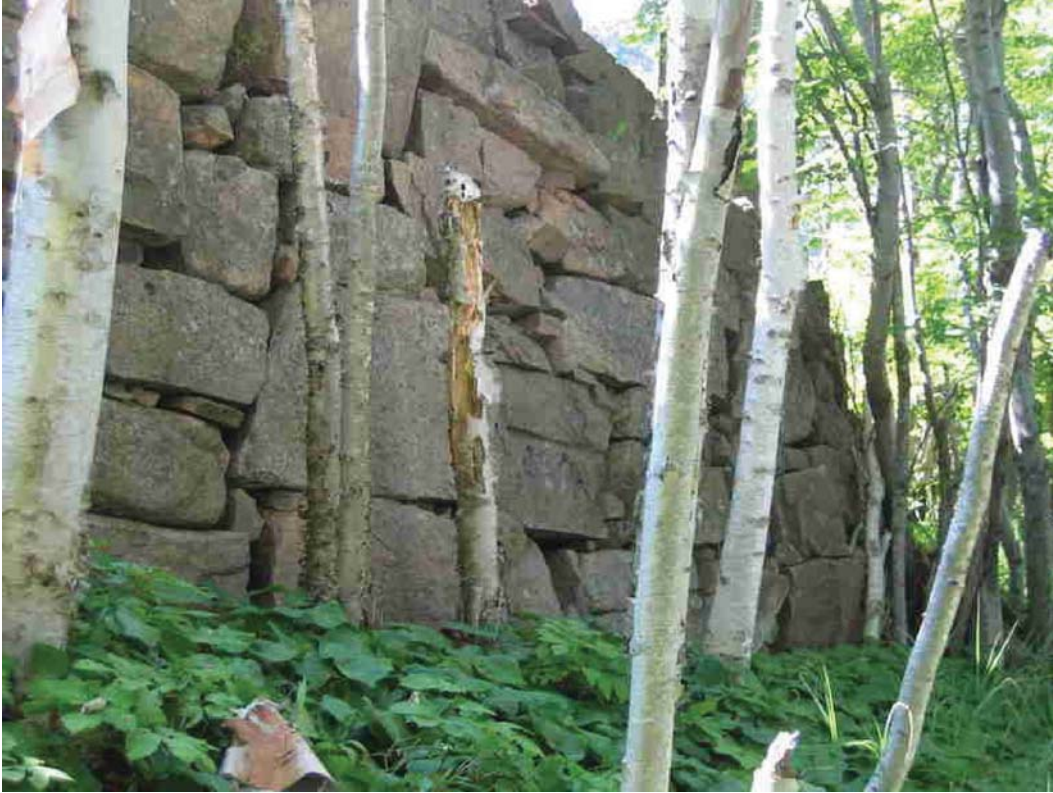
ACAD_0919_0.000_P3_1.jpg

Acadia National Park
ROUTE 0919: UPPER SAND BEACH PARKING AREA

Retaining Wall Condition Photos
