# BLRI WIP Report

## NPS Retaining Wall Inventory Program Blue Ridge Parkway

Federal Highway Administration  
Eastern Federal Lands Highway Division  
Road Inventory Program (RIP)

# Blue Ridge Parkway in North Carolina and Virginia

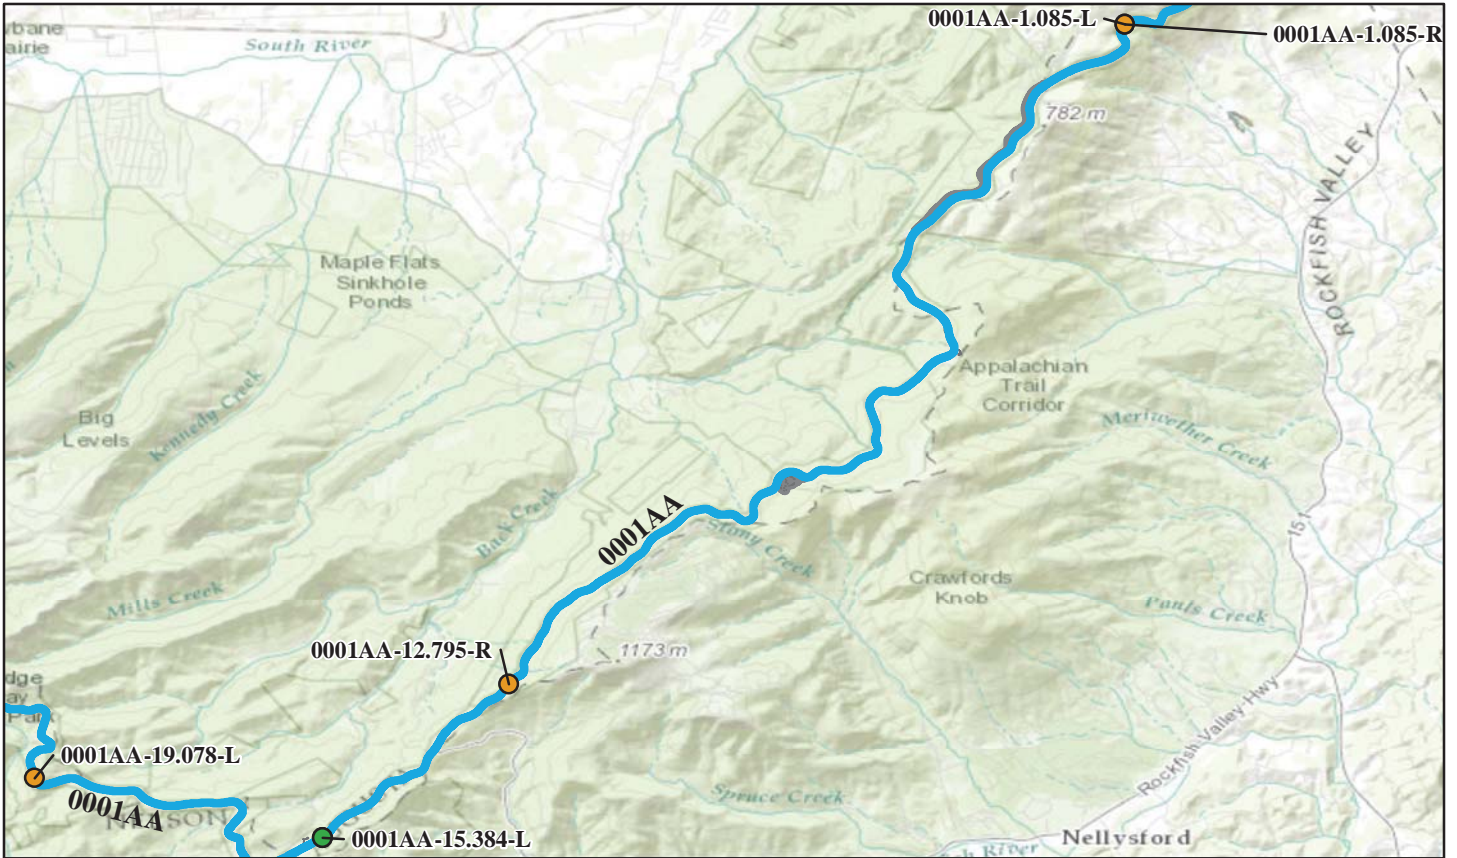
## ROUTE 0001AA: BLUE RIDGE PARKWAY - MONTEBELLO SUB-DISTRICT

Wall ID Inspection Date:	Wall Area (Sq. Ft.)	Wall Length (Ft.)	Wall Type	Wall Function	Overall Rating	Repair Cost
BLRI-0001AA-1.085-L 1/29/2008	130	24	Gravity - Mortared Stone	Head Wall	68	\$0.00
BLRI-0001AA-1.085-R 2/29/2008	110	22	Gravity - Mortared Stone	Head Wall	70	\$0.00
BLRI-0001AA-12.795-R 1/29/2008	3,170	264	Gravity - Mortared Stone	Fill Wall	69	\$550.00
BLRI-0001AA-15.384-L 1/29/2008	160	38	Gravity - Mortared Stone	Head Wall	70	\$6,655.00
BLRI-0001AA-15.384-R 1/29/2008	160	38	Gravity - Mortared Stone	Head Wall	72	\$0.00

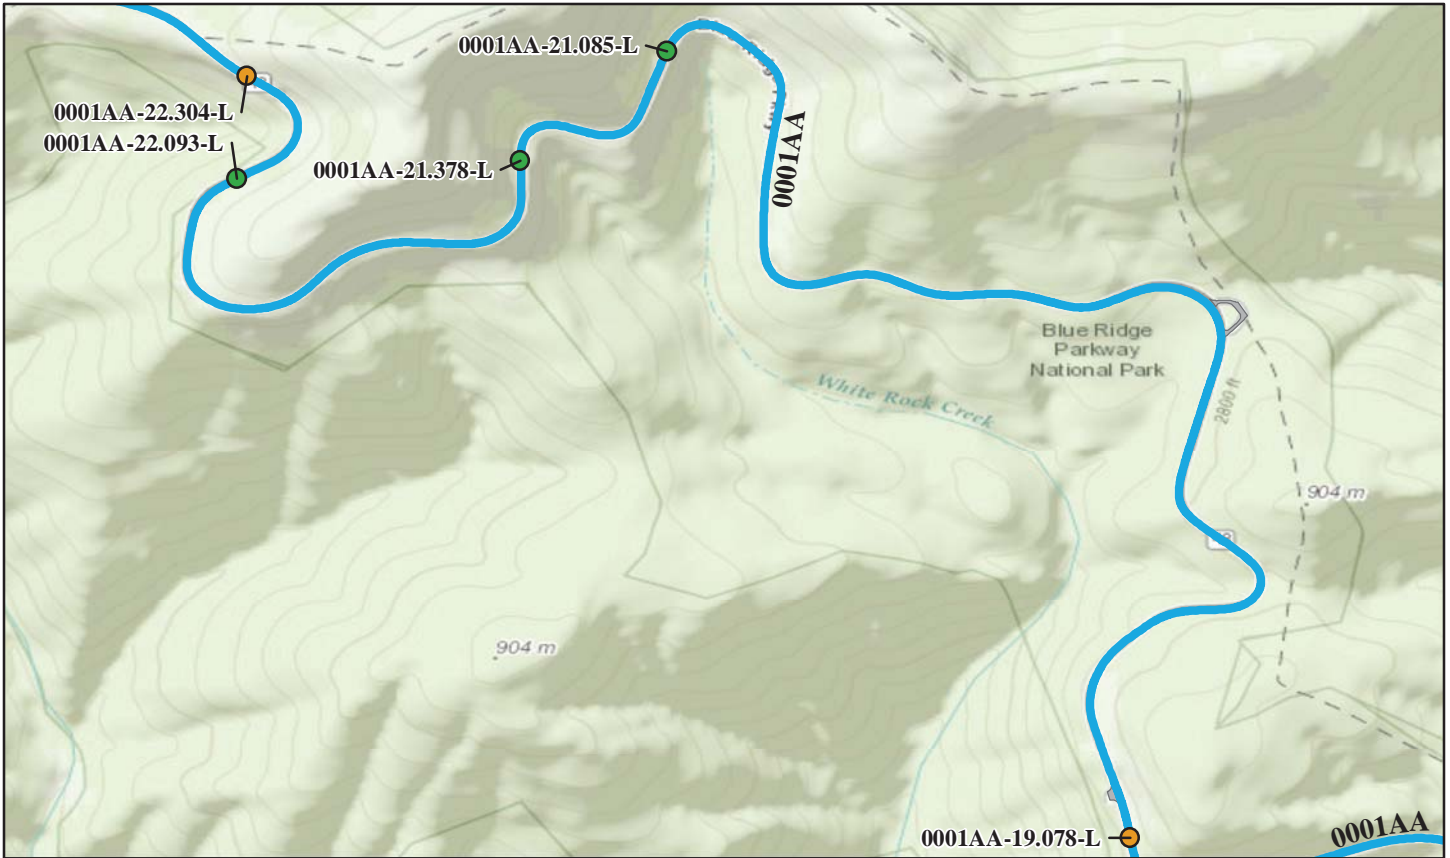
## ROUTE 0001AA: BLUE RIDGE PARKWAY - MONTEBELLO SUB-DISTRICT

Wall ID Inspection Date:	Wall Area (Sq. Ft.)	Wall Length (Ft.)	Wall Type	Wall Function	Overall Rating	Repair Cost
BLRI-0001AA-19.078-L 1/29/2008	1,680	140	Gravity - Mortared Stone	Fill Wall	67	\$15,100.00
BLRI-0001AA-21.085-L 1/29/2008	4,900	612	Gravity - Mortared Stone	Fill Wall	70	\$0.00
BLRI-0001AA-21.378-L 1/29/2008	5,000	602	Gravity - Mortared Stone	Fill Wall	70	\$1,500.00
BLRI-0001AA-22.093-L 1/29/2008	3,510	390	Gravity - Mortared Stone	Fill Wall	70	\$0.00
BLRI-0001AA-22.304-L 1/29/2008	2,600	264	Gravity - Mortared Stone	Fill Wall	68	\$19,500.00

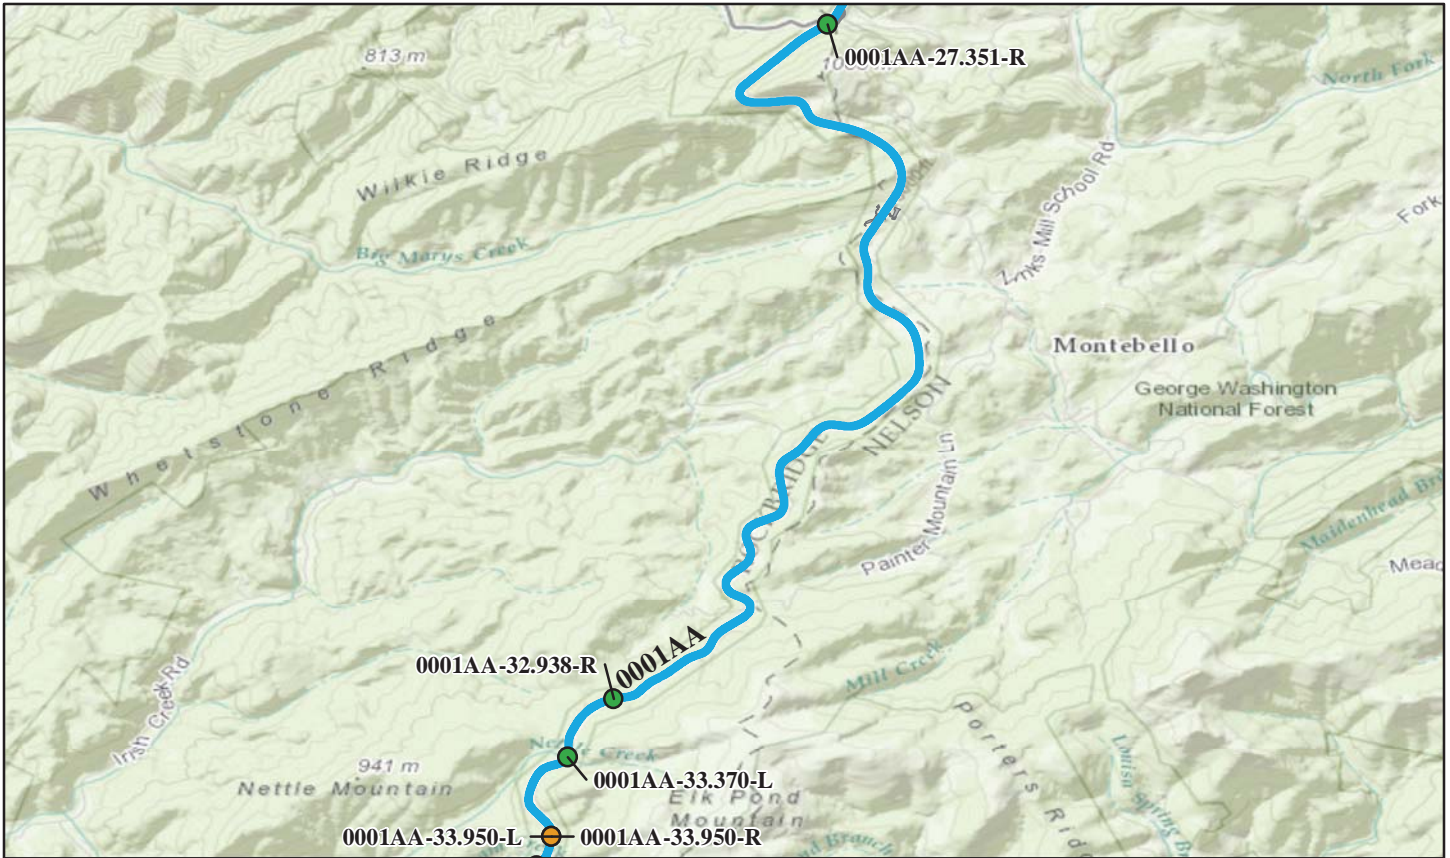
## ROUTE 0001AA: BLUE RIDGE PARKWAY - MONTEBELLO SUB-DISTRICT

Wall ID Inspection Date:	Wall Area (Sq. Ft.)	Wall Length (Ft.)	Wall Type	Wall Function	Overall Rating	Repair Cost
BLRI-0001AA-27.351-R 1/29/2008	180	22	Gravity - Mortared Stone	Head Wall	70	\$0.00
BLRI-0001AA-32.938-R 1/28/2008	90	20	Gravity - Mortared Stone	Head Wall	70	\$0.00
BLRI-0001AA-33.370-L 1/28/2008	140	35	Gravity - Mortared Stone	Head Wall	70	\$0.00
BLRI-0001AA-33.950-L 1/28/2008	180	36	Gravity - Mortared Stone	Head Wall	68	\$3,750.00
BLRI-0001AA-33.950-R 1/28/2008	150	36	Gravity - Mortared Stone	Head Wall	72	\$0.00

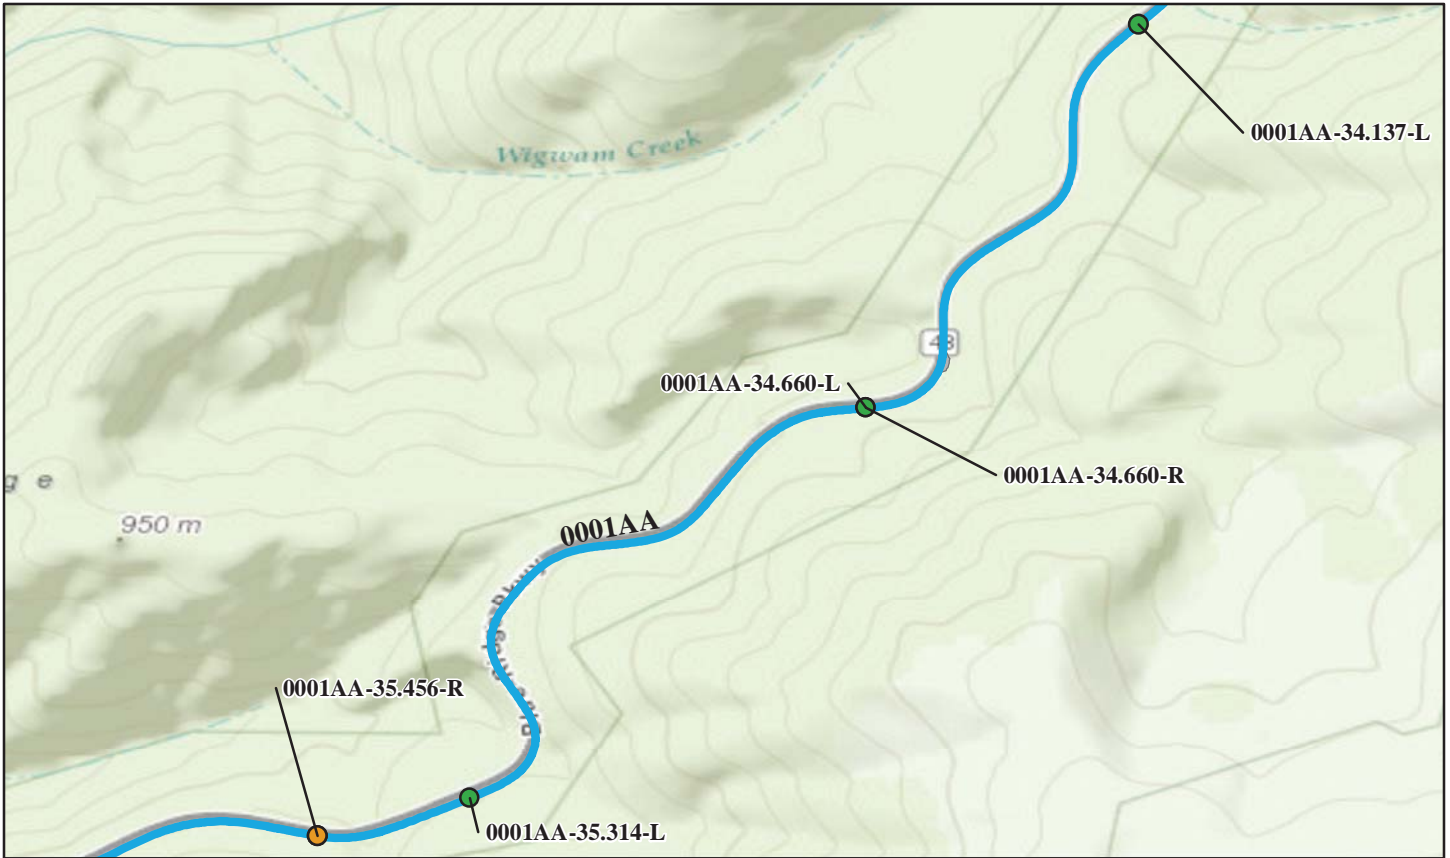
## ROUTE 0001AA: BLUE RIDGE PARKWAY - MONTEBELLO SUB-DISTRICT

Wall ID Inspection Date:	Wall Area (Sq. Ft.)	Wall Length (Ft.)	Wall Type	Wall Function	Overall Rating	Repair Cost
BLRI-0001AA-34.137-L 1/28/2008	120	29	Gravity - Mortared Stone	Head Wall	70	\$0.00
BLRI-0001AA-34.660-L 1/28/2008	120	30	Gravity - Mortared Stone	Head Wall	70	\$0.00
BLRI-0001AA-34.660-R 1/28/2008	120	30	Gravity - Mortared Stone	Head Wall	68	\$0.00
BLRI-0001AA-35.314-L 1/28/2008	85	30	Gravity - Mortared Stone	Head Wall	70	\$0.00
BLRI-0001AA-35.456-L 1/28/2008	160	36	Gravity - Mortared Stone	Head Wall	65	\$1,500.00

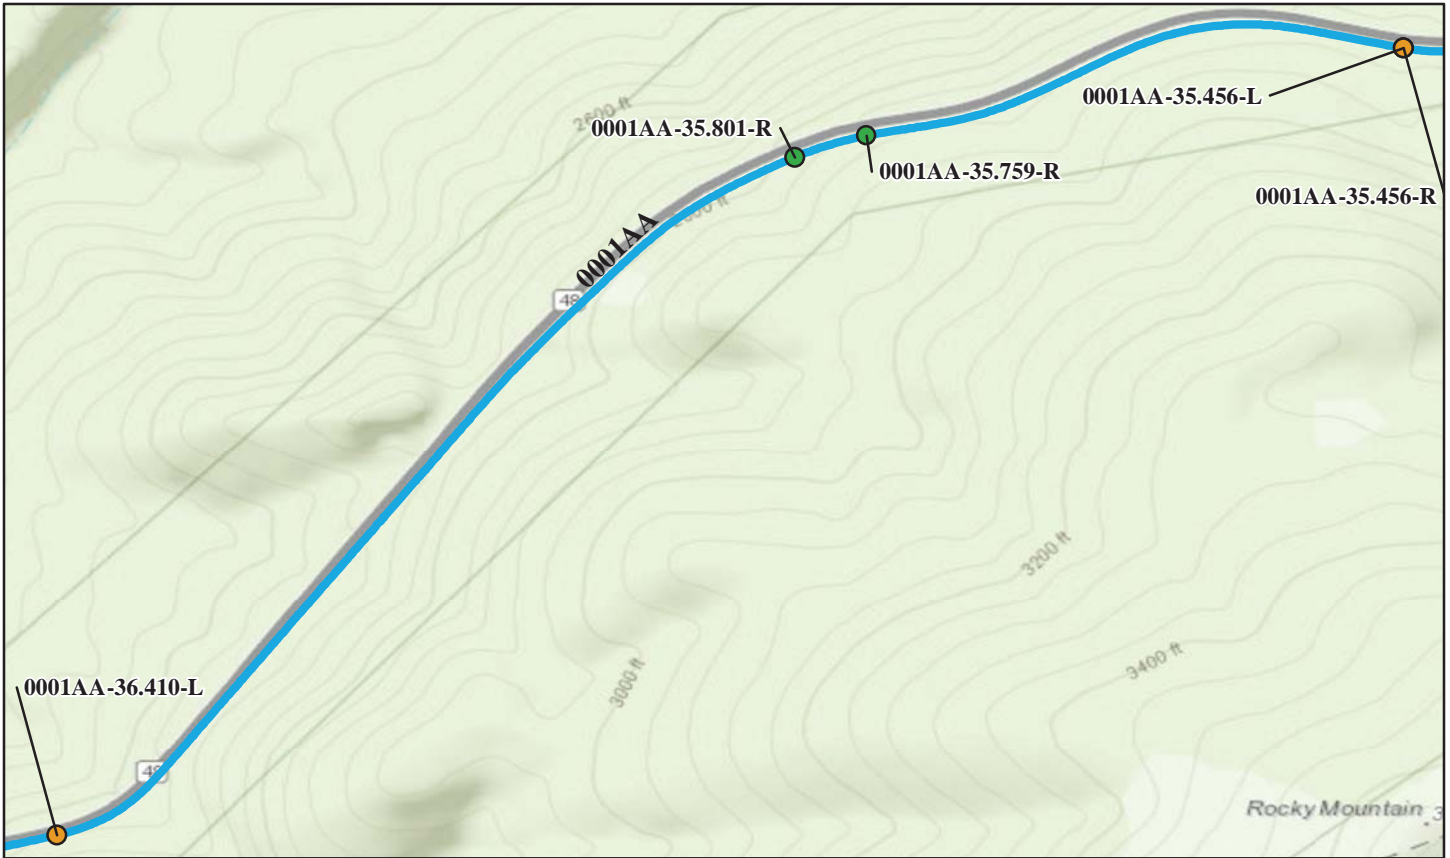
## ROUTE 0001AA: BLUE RIDGE PARKWAY - MONTEBELLO SUB-DISTRICT

Wall ID Inspection Date:	Wall Area (Sq. Ft.)	Wall Length (Ft.)	Wall Type	Wall Function	Overall Rating	Repair Cost
BLRI-0001AA-35.456-R 1/28/2008	180	36	Gravity - Mortared Stone	Head Wall	69	\$0.00
BLRI-0001AA-35.759-R 1/28/2008	160	30	Gravity - Mortared Stone	Head Wall	70	\$0.00
BLRI-0001AA-35.801-R 1/28/2008	3,200	227	Gravity - Mortared Stone	Fill Wall	70	\$0.00
BLRI-0001AA-36.410-L 1/28/2008	275	40	Gravity - Mortared Stone	Head Wall	65	\$9,090.00

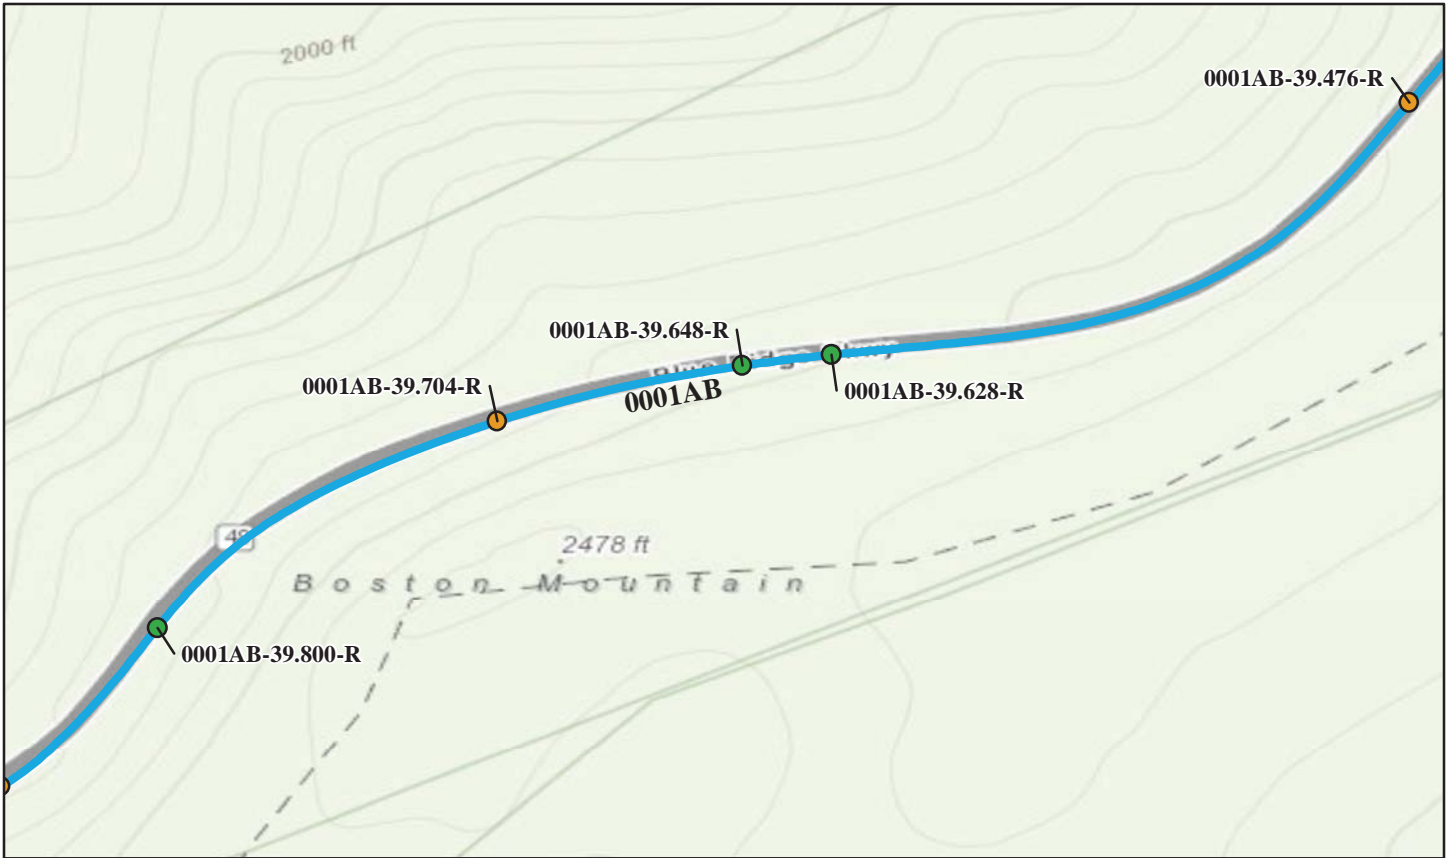
## ROUTE 0001AB: BLUE RIDGE PARKWAY - JAMES RIVER SUB-DISTRICT

Wall ID Inspection Date:	Wall Area (Sq. Ft.)	Wall Length (Ft.)	Wall Type	Wall Function	Overall Rating	Repair Cost
BLRI-0001AB-39.476-R 1/28/2008	2,200	211	Gravity - Mortared Stone	Fill Wall	69	\$0.00
BLRI-0001AB-39.628-R 1/28/2008	1,000	115	Gravity - Mortared Stone	Fill Wall	70	\$0.00
BLRI-0001AB-39.648-R 1/28/2008	600	100	Gravity - Mortared Stone	Fill Wall	70	\$0.00
BLRI-0001AB-39.704-R 1/28/2008	3,330	370	Gravity - Mortared Stone	Fill Wall	69	\$0.00
BLRI-0001AB-39.800-R 1/28/2008	2,030	238	Gravity - Mortared Stone	Fill Wall	70	\$0.00

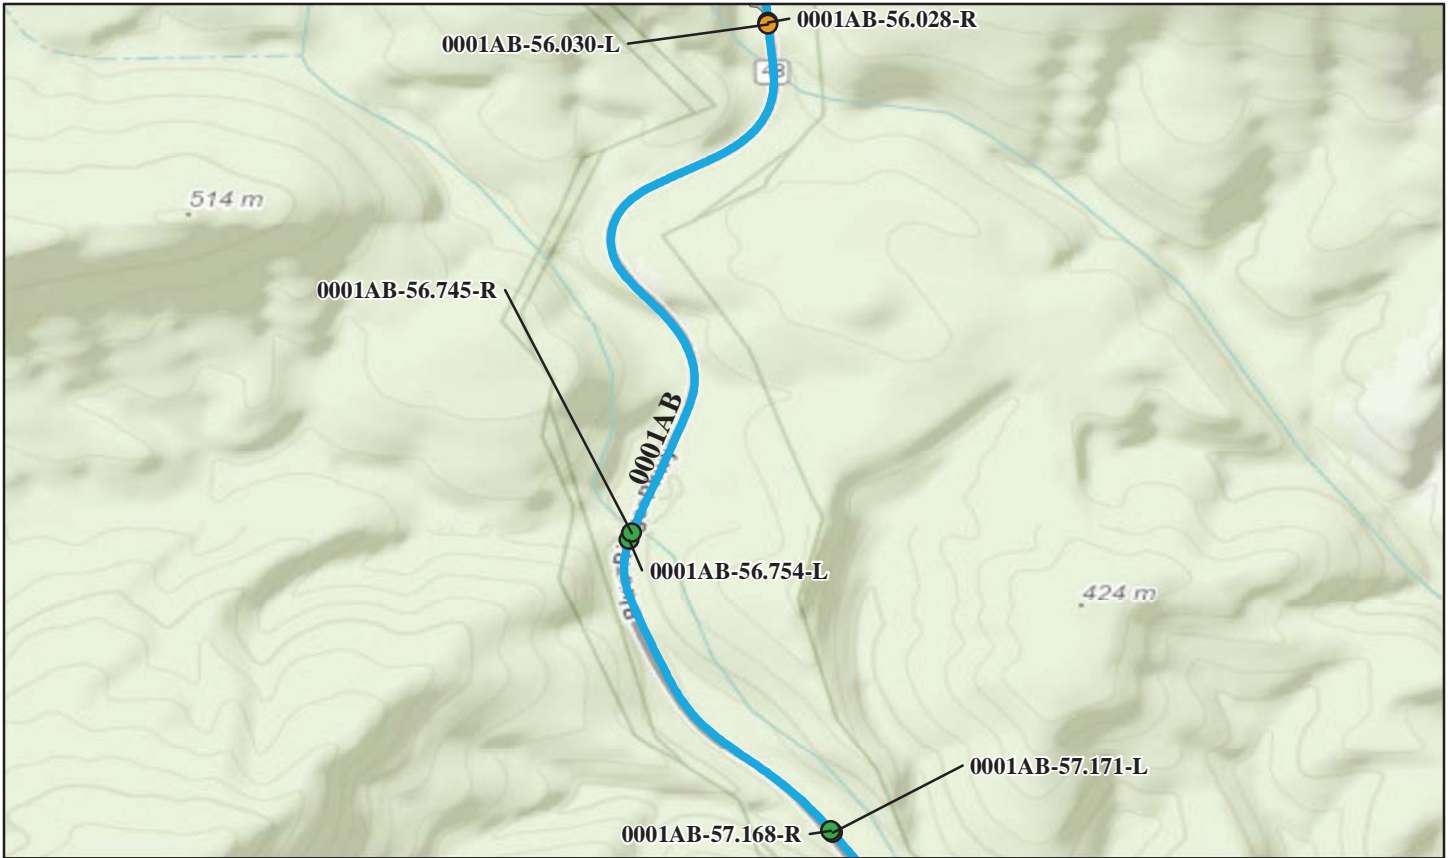
## ROUTE 0001AB: BLUE RIDGE PARKWAY - JAMES RIVER SUB-DISTRICT

Wall ID Inspection Date:	Wall Area (Sq. Ft.)	Wall Length (Ft.)	Wall Type	Wall Function	Overall Rating	Repair Cost
BLRI-0001AB-56.030-L 1/28/2008	380	52	Gravity - Mortared Stone	Head Wall	66	\$0.00
BLRI-0001AB-56.745-R 1/28/2008	320	90	Gravity - Mortared Stone	Head Wall	70	\$0.00
BLRI-0001AB-56.754-L 1/28/2008	320	84	Gravity - Mortared Stone	Head Wall	70	\$0.00
BLRI-0001AB-57.168-R 1/28/2008	170	58	Gravity - Mortared Stone	Head Wall	70	\$0.00
BLRI-0001AB-57.171-L 1/28/2008	240	80	Gravity - Mortared Stone	Head Wall	70	\$1,125.00

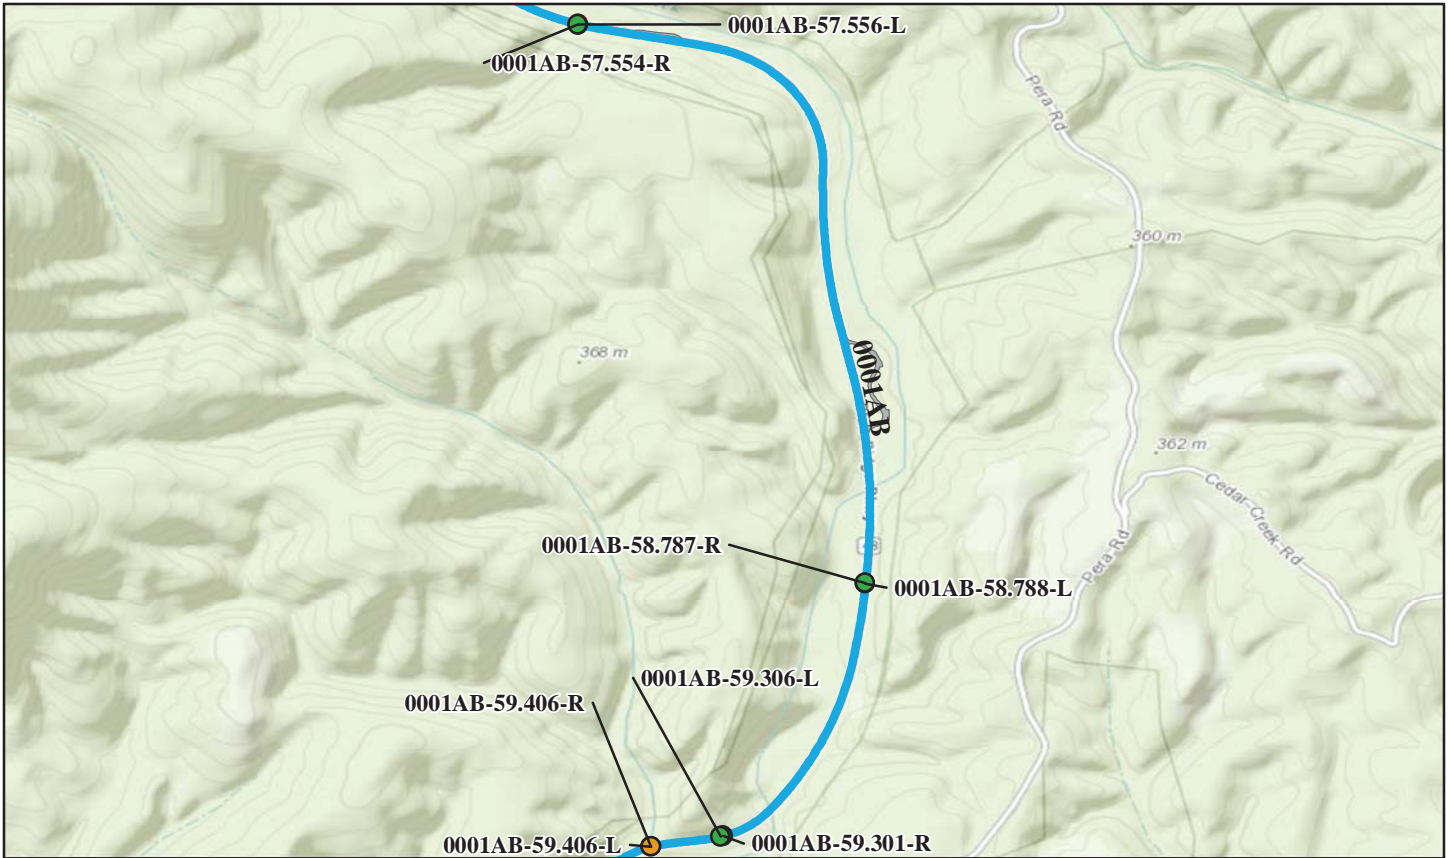
## ROUTE 0001AB: BLUE RIDGE PARKWAY - JAMES RIVER SUB-DISTRICT

Wall ID Inspection Date:	Wall Area (Sq. Ft.)	Wall Length (Ft.)	Wall Type	Wall Function	Overall Rating	Repair Cost
BLRI-0001AB-57.554-R 1/28/2008	120	25	Gravity - Mortared Stone	Head Wall	70	\$0.00
BLRI-0001AB-57.556-L 1/28/2008	160	36	Gravity - Mortared Stone	Head Wall	70	\$0.00
BLRI-0001AB-58.787-R 1/28/2008	900	113	Gravity - Mortared Stone	Head Wall	70	\$0.00
BLRI-0001AB-58.788-L 1/28/2008	650	100	Gravity - Mortared Stone	Head Wall	70	\$0.00
BLRI-0001AB-59.301-R 1/28/2008	700	75	Gravity - Mortared Stone	Head Wall	70	\$0.00

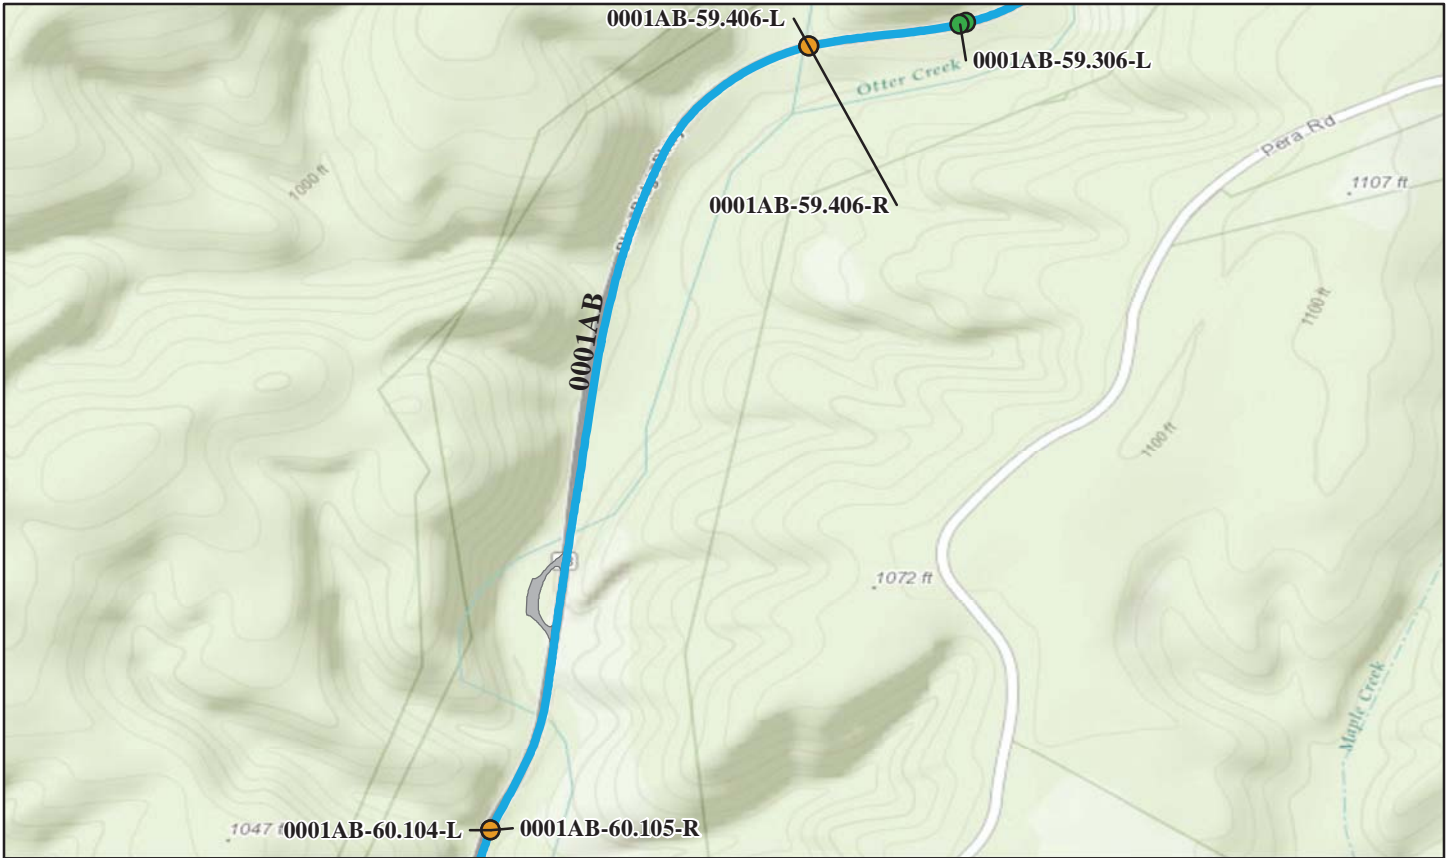
## ROUTE 0001AB: BLUE RIDGE PARKWAY - JAMES RIVER SUB-DISTRICT

Wall ID Inspection Date:	Wall Area (Sq. Ft.)	Wall Length (Ft.)	Wall Type	Wall Function	Overall Rating	Repair Cost
BLRI-0001AB-59.306-L 1/28/2008	400	60	Gravity - Mortared Stone	Head Wall	70	\$0.00
BLRI-0001AB-59.406-L 1/28/2008	350	50	Gravity - Mortared Stone	Head Wall	68	\$0.00
BLRI-0001AB-59.406-R 1/28/2008	350	50	Gravity - Mortared Stone	Head Wall	68	\$0.00
BLRI-0001AB-60.104-L 1/28/2008	120	30	Gravity - Mortared Stone	Head Wall	68	\$2,250.00
BLRI-0001AB-60.105-R 1/28/2008	120	30	Gravity - Mortared Stone	Head Wall	70	\$0.00

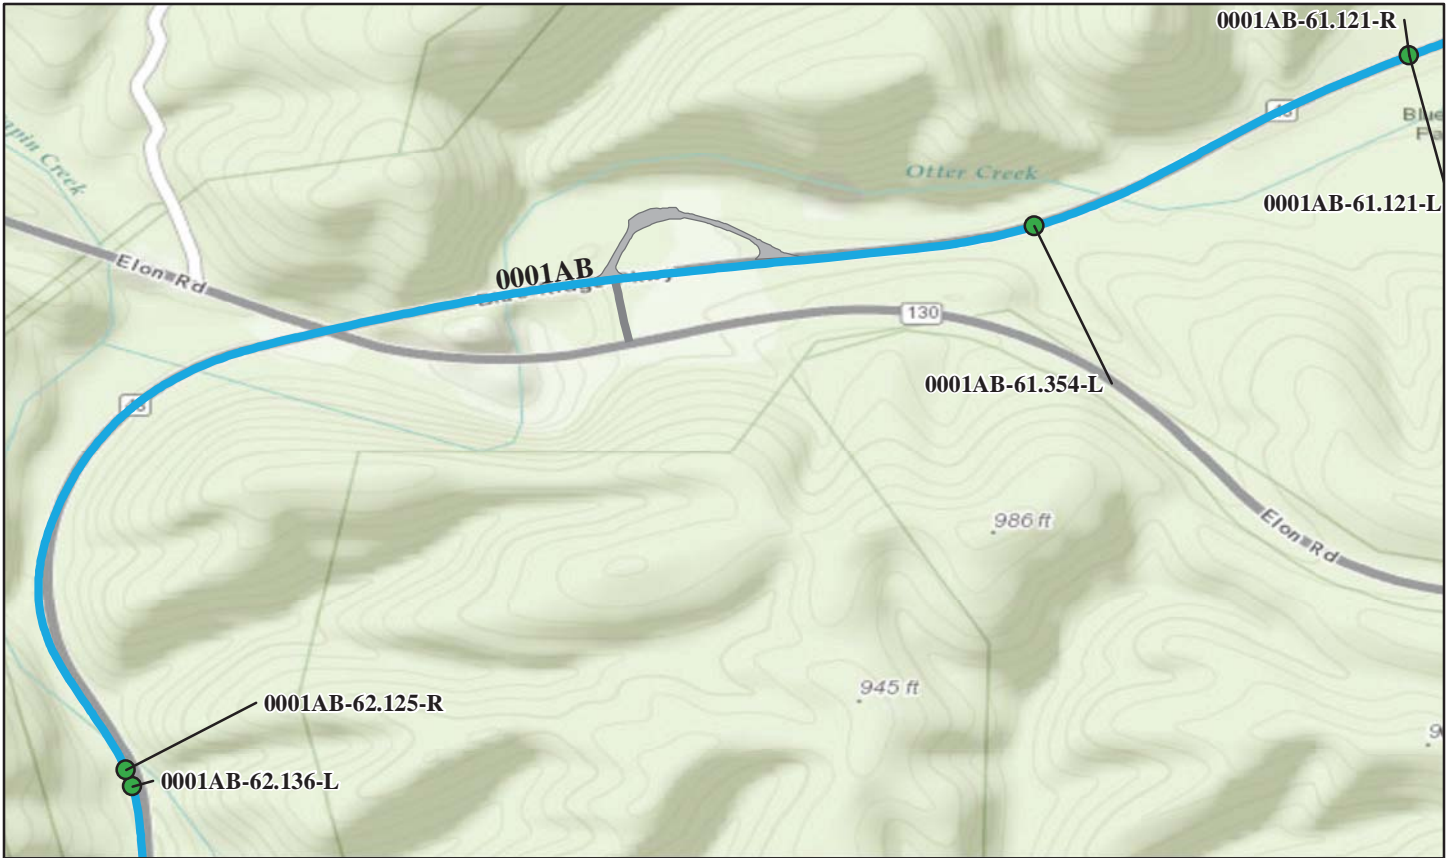
## ROUTE 0001AB: BLUE RIDGE PARKWAY - JAMES RIVER SUB-DISTRICT

Wall ID Inspection Date:	Wall Area (Sq. Ft.)	Wall Length (Ft.)	Wall Type	Wall Function	Overall Rating	Repair Cost
BLRI-0001AB-61.121-L 12/6/2007	150	29	Gravity - Mortared Stone	Head Wall	51	\$22,100.00
BLRI-0001AB-61.121-R 12/6/2007	115	23	Gravity - Mortared Stone	Head Wall	72	\$1,820.00
BLRI-0001AB-61.354-L 12/6/2007	80	20	Gravity - Mortared Stone	Head Wall	70	\$0.00
BLRI-0001AB-62.125-R 12/6/2007	700	80	Gravity - Mortared Stone	Head Wall	70	\$1,800.00
BLRI-0001AB-62.136-L 12/6/2007	700	80	Gravity - Mortared Stone	Head Wall	70	\$0.00

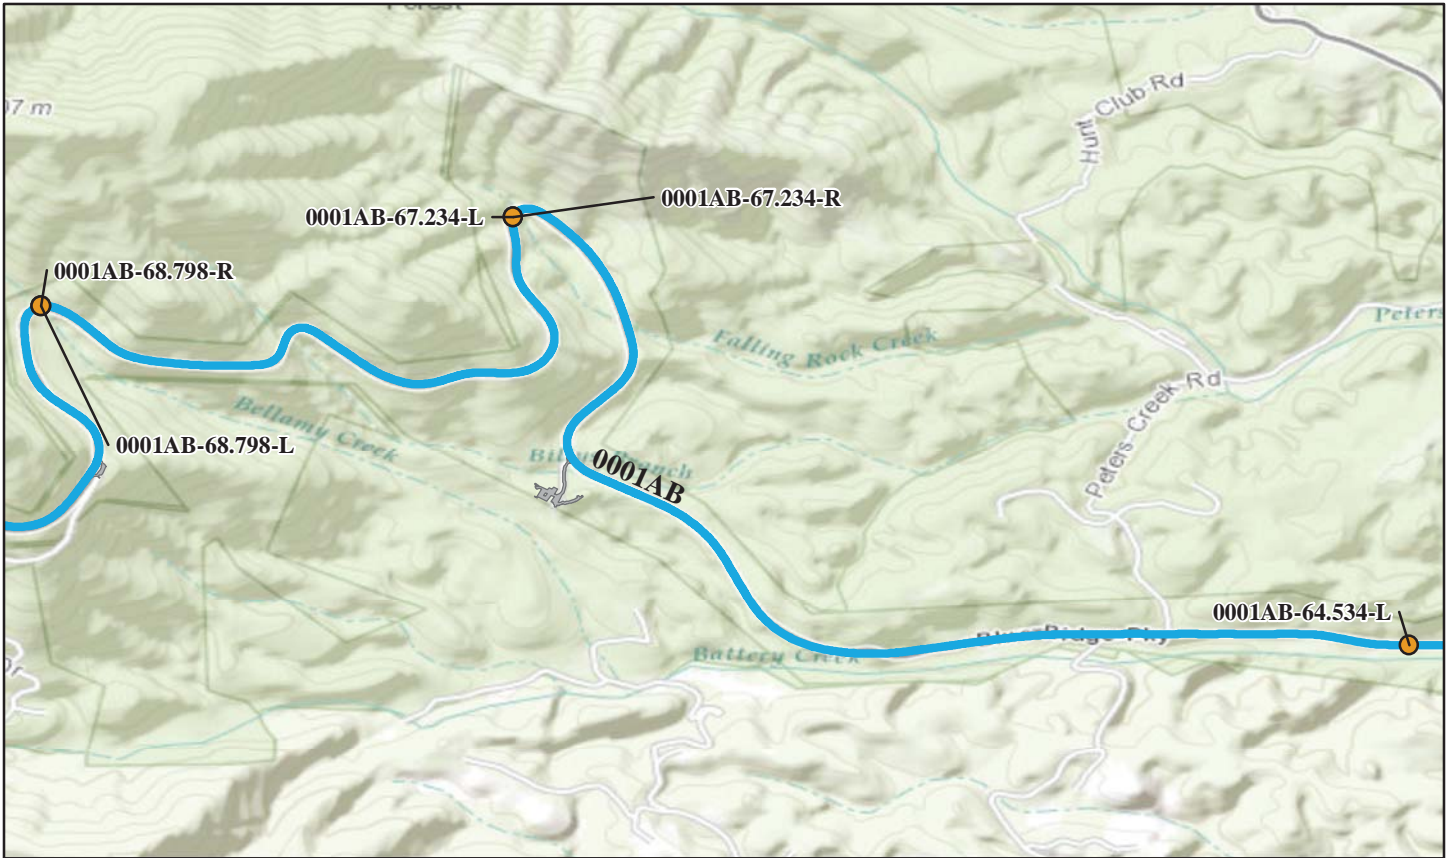
## ROUTE 0001AB: BLUE RIDGE PARKWAY - JAMES RIVER SUB-DISTRICT

Wall ID Inspection Date:	Wall Area (Sq. Ft.)	Wall Length (Ft.)	Wall Type	Wall Function	Overall Rating	Repair Cost
BLRI-0001AB-64.534-L 12/6/2007	1,892	172	Gravity - Mortared Stone	Fill Wall	67	\$1,505.00
BLRI-0001AB-67.234-L 12/6/2007	180	35	Gravity - Mortared Stone	Head Wall	69	\$660.00
BLRI-0001AB-67.234-R 12/6/2007	100	24	Gravity - Mortared Stone	Head Wall	69	\$550.00
BLRI-0001AB-68.798-L 12/6/2007	140	33	Gravity - Mortared Stone	Head Wall	65	\$0.00
BLRI-0001AB-68.798-R 12/6/2007	140	33	Gravity - Mortared Stone	Head Wall	63	\$18,175.00

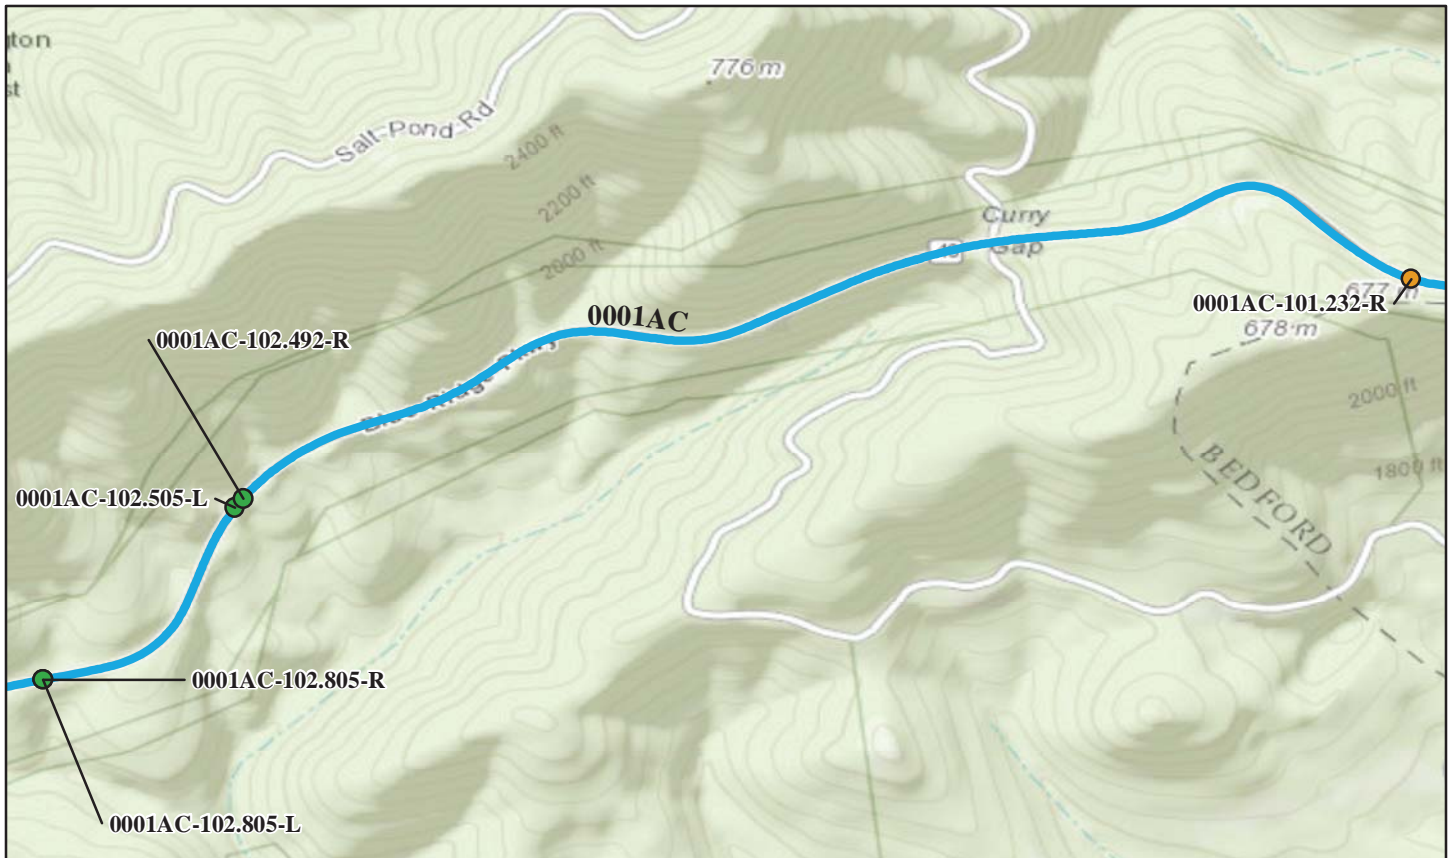
## ROUTE 0001AC: BLUE RIDGE PARKWAY - PEAKS OF OTTER SUB-DISTRICT

Wall ID Inspection Date:	Wall Area (Sq. Ft.)	Wall Length (Ft.)	Wall Type	Wall Function	Overall Rating	Repair Cost
BLRI-0001AC-101.232-R 12/4/2007	3,600	365	Gravity - Mortared Stone	Fill Wall	67	\$1,000.00
BLRI-0001AC-102.492-R 12/4/2007	80	24	Gravity - Mortared Stone	Head Wall	70	\$0.00
BLRI-0001AC-102.505-L 12/4/2007	80	24	Gravity - Mortared Stone	Head Wall	70	\$0.00
BLRI-0001AC-102.805-L 12/4/2007	56	18	Gravity - Mortared Stone	Head Wall	70	\$0.00
BLRI-0001AC-102.805-R 12/4/2007	56	18	Gravity - Mortared Stone	Head Wall	70	\$0.00

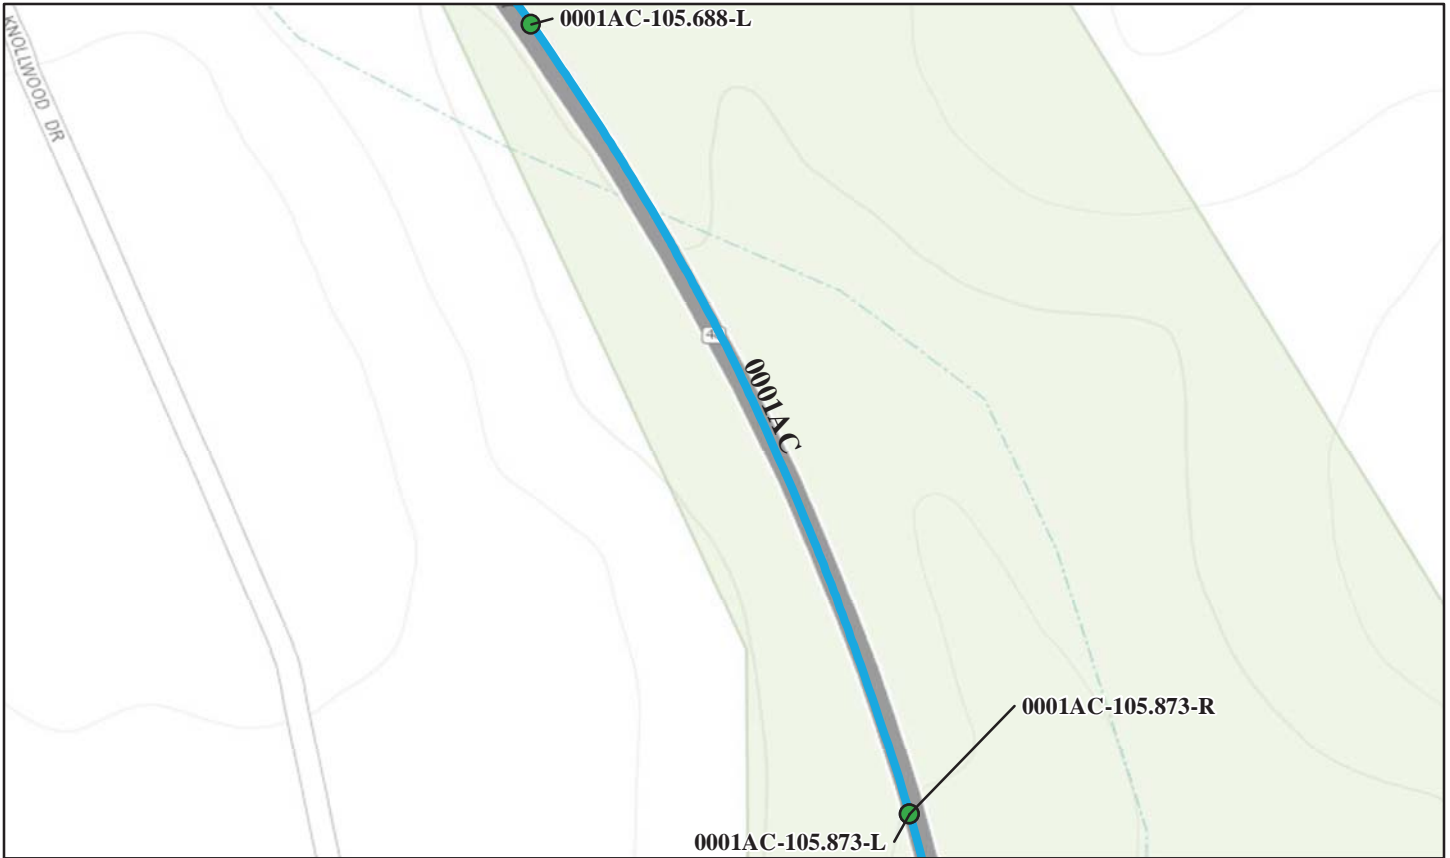
## ROUTE 0001AC: BLUE RIDGE PARKWAY - PEAKS OF OTTER SUB-DISTRICT

Wall ID Inspection Date:	Wall Area (Sq. Ft.)	Wall Length (Ft.)	Wall Type	Wall Function	Overall Rating	Repair Cost
BLRI-0001AC-105.688-L 12/4/2007	148	44	Gravity - Mortared Stone	Head Wall	70	\$0.00
BLRI-0001AC-105.873-L 12/4/2007	160	39	Gravity - Mortared Stone	Head Wall	70	\$0.00
BLRI-0001AC-105.873-R 12/4/2007	100	24	Gravity - Mortared Stone	Head Wall	68	\$1,795.00

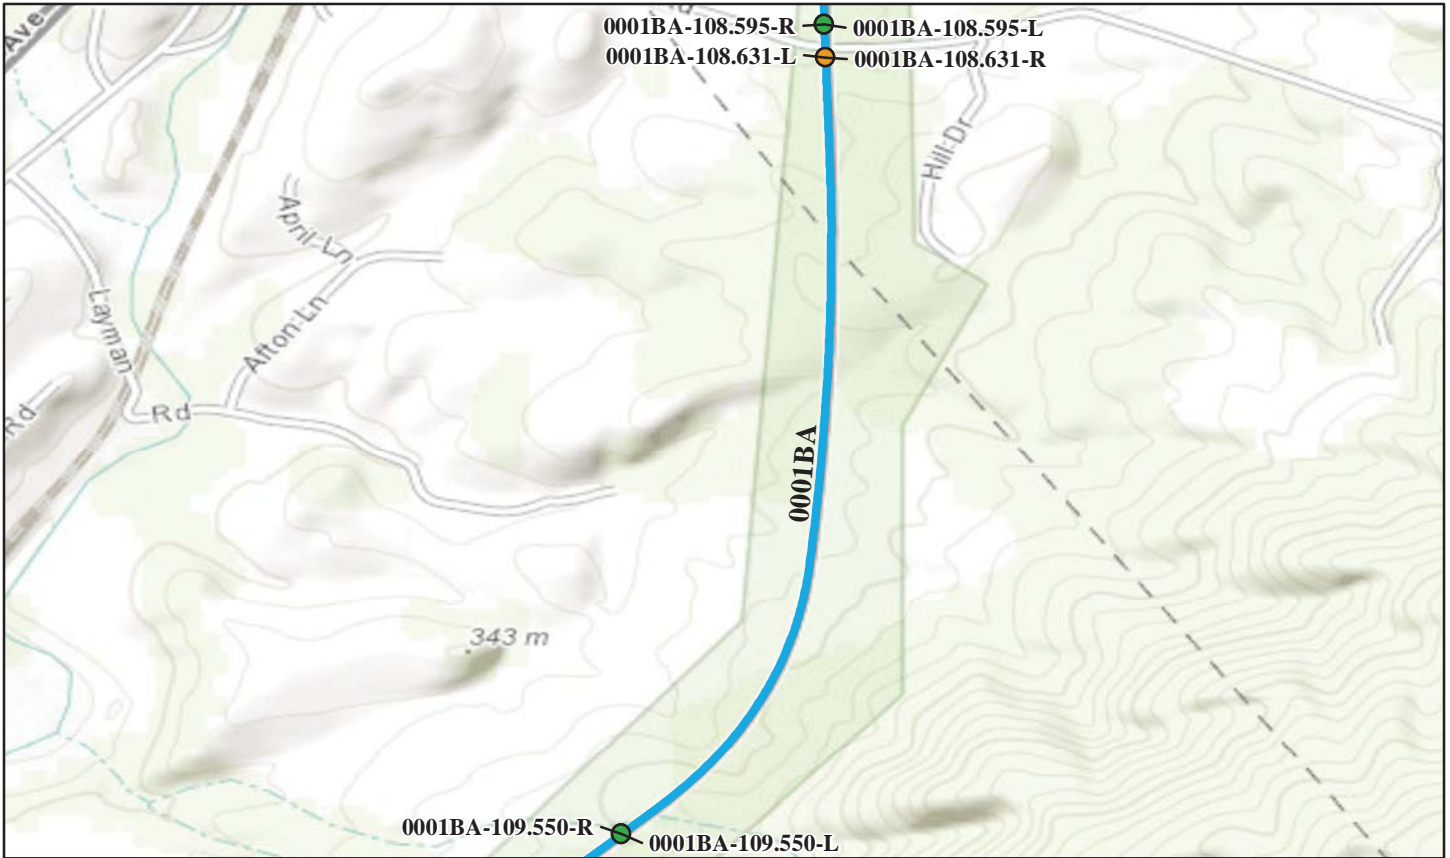
## ROUTE 0001BA: BLUE RIDGE PARKWAY - ROANOKE VALLEY SUB-DISTRICT

Wall ID Inspection Date:	Wall Area (Sq. Ft.)	Wall Length (Ft.)	Wall Type	Wall Function	Overall Rating	Repair Cost
BLRI-0001BA-108.595-L 12/4/2007	130	34	Cantilever - Concrete	Head Wall	72	\$550.00
BLRI-0001BA-108.595-R 12/4/2007	130	34	Cantilever - Concrete	Head Wall	69	\$0.00
BLRI-0001BA-108.631-L 12/4/2007	130	35	Cantilever - Concrete	Head Wall	69	\$2,180.00
BLRI-0001BA-108.631-R 12/4/2007	130	35	Cantilever - Concrete	Head Wall	69	\$2,180.00
BLRI-0001BA-109.550-L 12/4/2007	200	45	Cantilever - Concrete	Head Wall	70	\$0.00

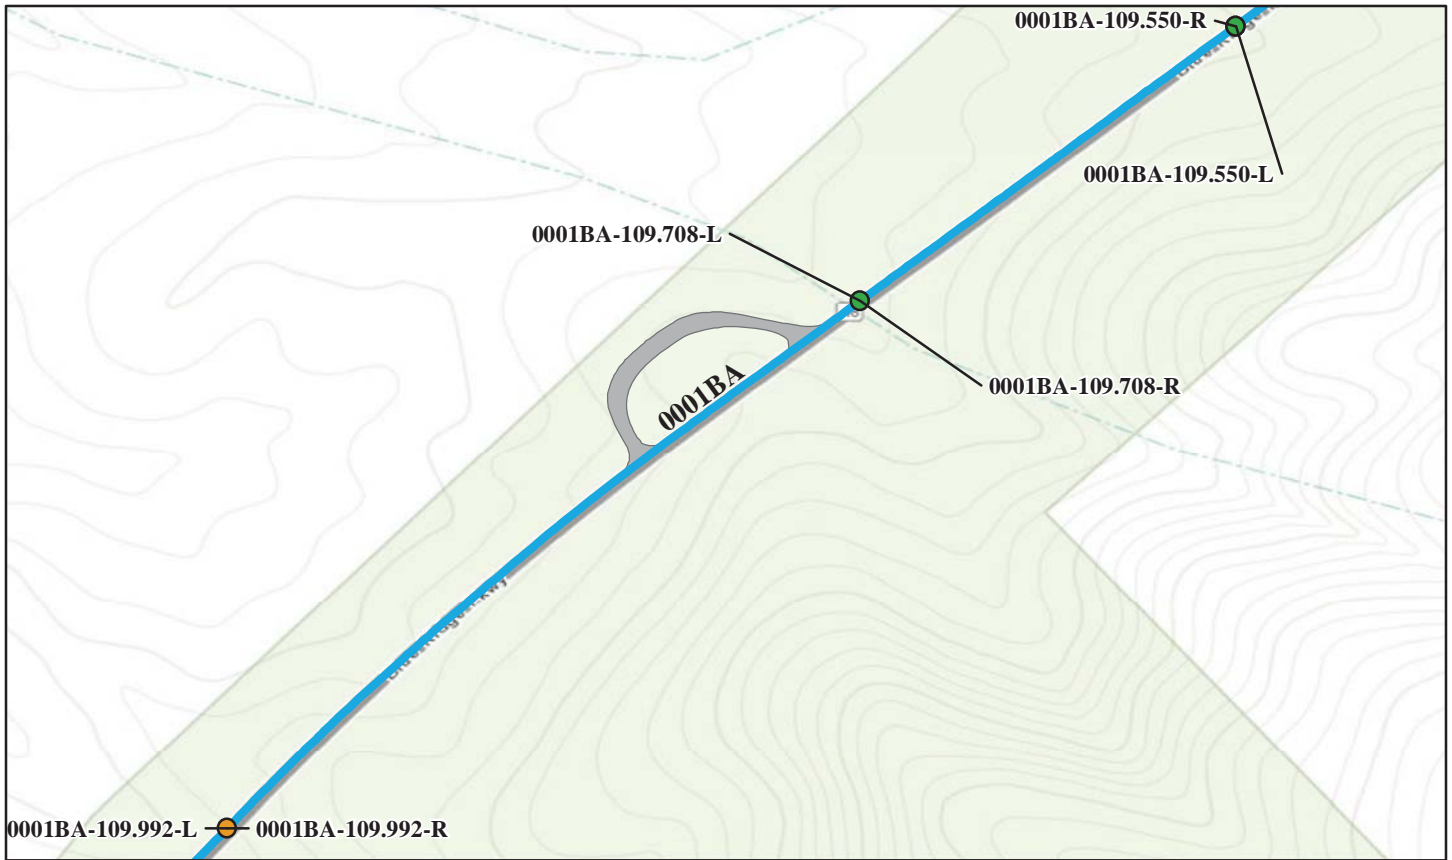
## ROUTE 0001BA: BLUE RIDGE PARKWAY - ROANOKE VALLEY SUB-DISTRICT

Wall ID Inspection Date:	Wall Area (Sq. Ft.)	Wall Length (Ft.)	Wall Type	Wall Function	Overall Rating	Repair Cost
BLRI-0001BA-109.550-R 12/4/2007	200	45	Cantilever - Concrete	Head Wall	70	\$0.00
BLRI-0001BA-109.708-L 12/4/2007	140	34	Cantilever - Concrete	Head Wall	72	\$550.00
BLRI-0001BA-109.708-R 12/4/2007	140	34	Cantilever - Concrete	Head Wall	56	\$2,255.00
BLRI-0001BA-109.992-L 12/3/2007	100	26	Cantilever - Concrete	Head Wall	69	\$0.00
BLRI-0001BA-109.992-R 12/3/2007	120	27	Cantilever - Concrete	Head Wall	50	\$2,345.00

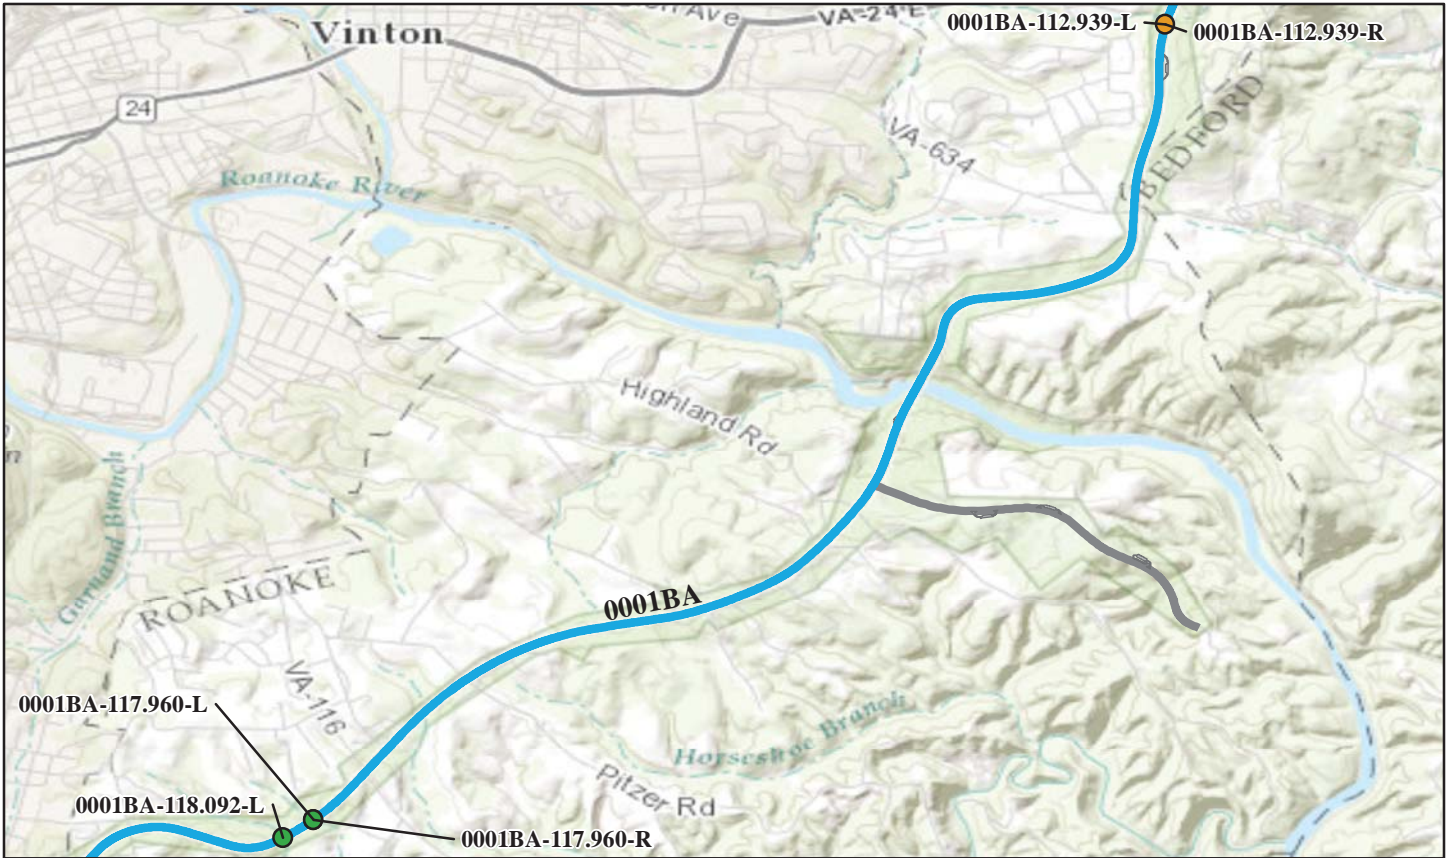
## ROUTE 0001BA: BLUE RIDGE PARKWAY - ROANOKE VALLEY SUB-DISTRICT

Wall ID Inspection Date:	Wall Area (Sq. Ft.)	Wall Length (Ft.)	Wall Type	Wall Function	Overall Rating	Repair Cost
BLRI-0001BA-112.939-L 12/3/2007	100	20	Cantilever - Concrete	Head Wall	67	\$900.00
BLRI-0001BA-112.939-R 12/3/2007	290	35	Cantilever - Concrete	Head Wall	45	\$26,500.00
BLRI-0001BA-117.960-L 12/3/2007	100	22	Cantilever - Concrete	Head Wall	70	\$0.00
BLRI-0001BA-117.960-R 12/3/2007	70	15	Cantilever - Concrete	Head Wall	64	\$1,430.00
BLRI-0001BA-118.092-L 12/3/2007	36	12	Cantilever - Concrete	Head Wall	72	\$0.00
