# BLRI WIP Report

## NPS Retaining Wall Inventory Program Blue Ridge Parkway

Federal Highway Administration  
Eastern Federal Lands Highway Division  
Road Inventory Program (RIP)

# Blue Ridge Parkway in North Carolina and Virginia

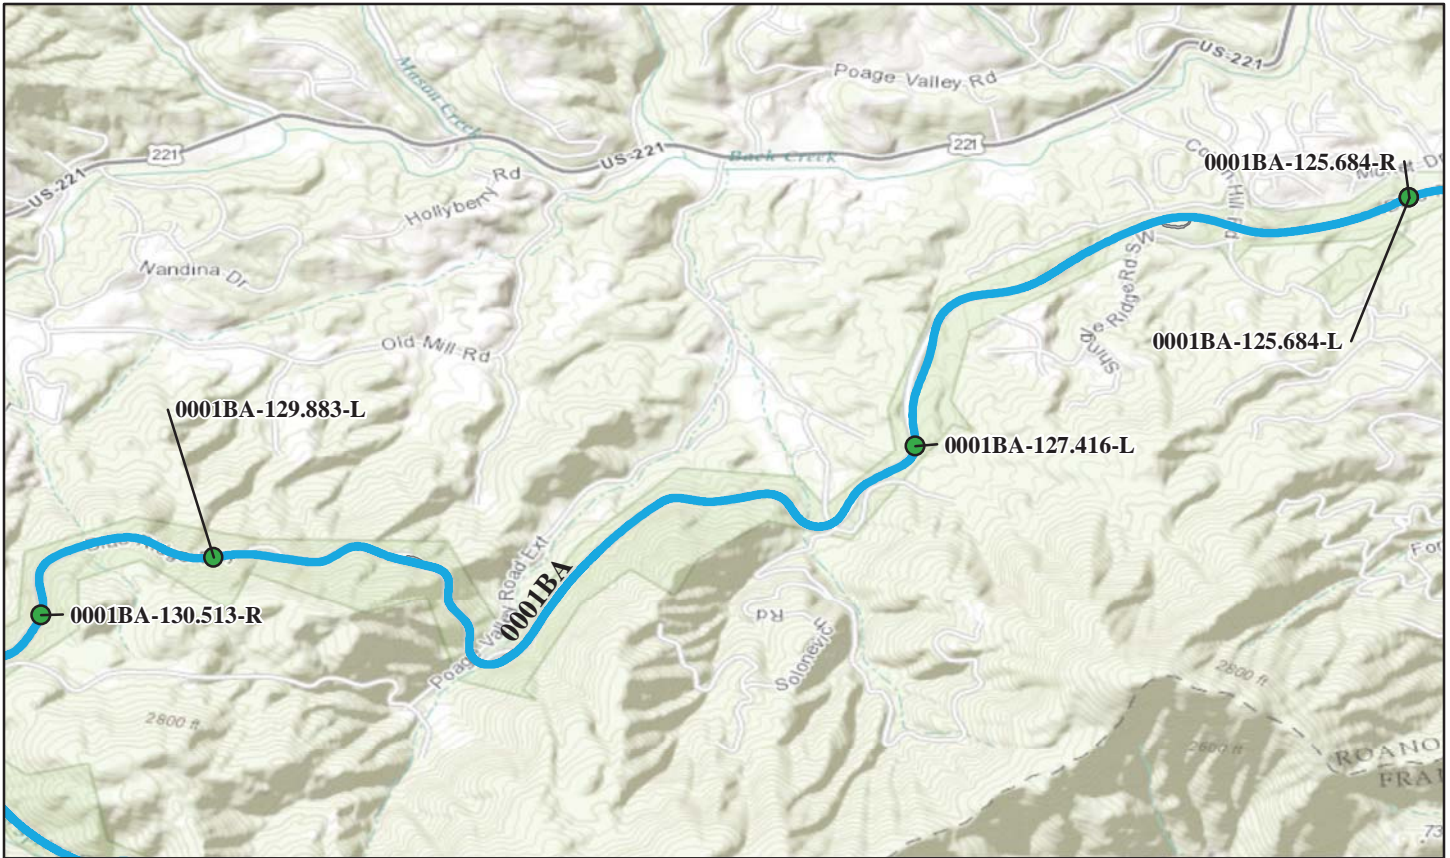
## ROUTE 0001BA: BLUE RIDGE PARKWAY - ROANOKE VALLEY SUB-DISTRICT

Wall ID Inspection Date:	Wall Area (Sq. Ft.)	Wall Length (Ft.)	Wall Type	Wall Function	Overall Rating	Repair Cost
BLRI-0001BA-125.684-L 11/30/2007	220	40	Cantilever - Concrete	Head Wall	70	\$0.00
BLRI-0001BA-125.684-R 11/30/2007	220	40	Cantilever - Concrete	Head Wall	70	\$0.00
BLRI-0001BA-127.416-L 11/30/2007	60	29	Cantilever - Concrete	Head Wall	70	\$0.00
BLRI-0001BA-129.883-L 11/30/2007	400	104	Gravity - Mortared Stone	Fill Wall	70	\$0.00
BLRI-0001BA-130.513-R 11/30/2007	440	110	Gravity - Mortared Stone	Fill Wall	73	\$0.00

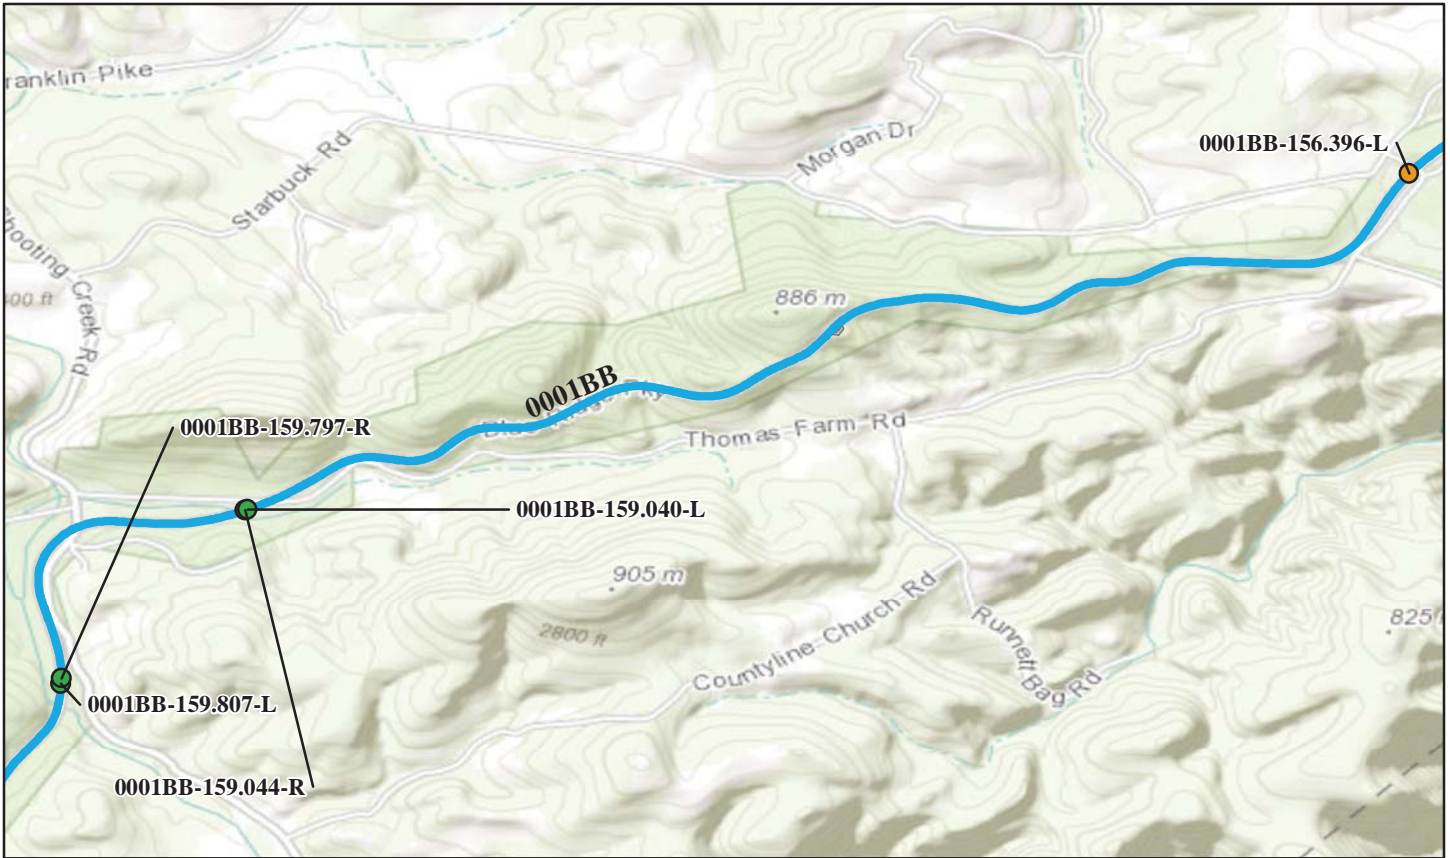
## ROUTE 0001BB: BLUE RIDGE PARKWAY - ROCKY KNOB SUB-DISTRICT

Wall ID Inspection Date:	Wall Area (Sq. Ft.)	Wall Length (Ft.)	Wall Type	Wall Function	Overall Rating	Repair Cost
BLRI-0001BB-156.396-L 11/29/2007	110	28	Gravity - Mortared Stone	Head Wall	65	\$3,750.00
BLRI-0001BB-159.040-L 11/29/2007	200	47	Gravity - Mortared Stone	Head Wall	70	\$0.00
BLRI-0001BB-159.044-R 11/29/2007	180	44	Gravity - Mortared Stone	Head Wall	68	\$1,500.00
BLRI-0001BB-159.797-R 11/29/2007	400	72	Gravity - Mortared Stone	Head Wall	70	\$0.00
BLRI-0001BB-159.807-L 11/29/2007	420	76	Gravity - Mortared Stone	Head Wall	70	\$0.00

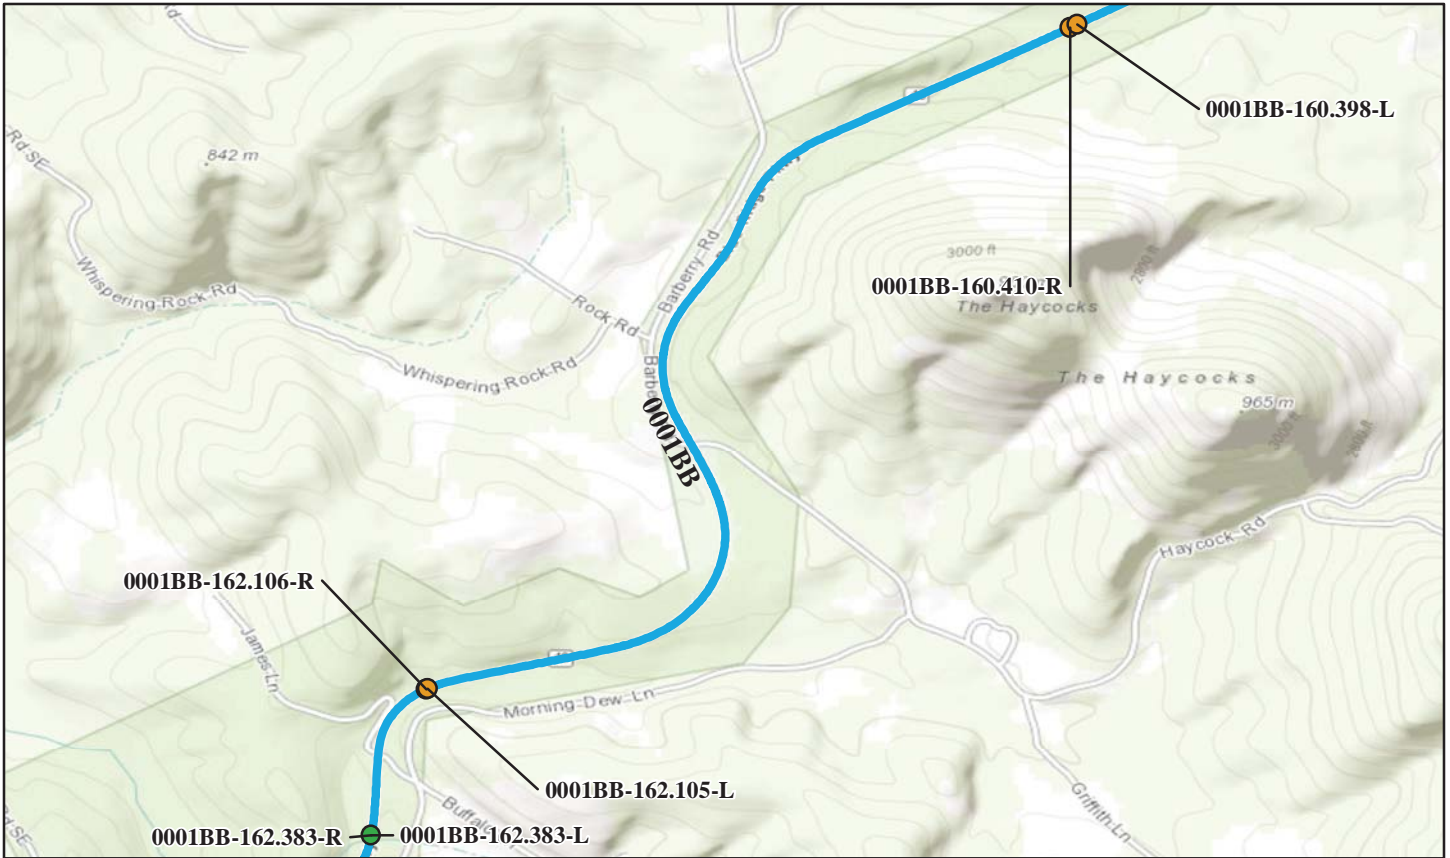
## ROUTE 0001BB: BLUE RIDGE PARKWAY - ROCKY KNOB SUB-DISTRICT

Wall ID Inspection Date:	Wall Area (Sq. Ft.)	Wall Length (Ft.)	Wall Type	Wall Function	Overall Rating	Repair Cost
BLRI-0001BB-160.398-L 11/29/2007	155	47	Gravity - Mortared Stone	Head Wall	66	\$5,625.00
BLRI-0001BB-160.410-R 11/29/2007	255	67	Gravity - Mortared Stone	Head Wall	68	\$2,250.00
BLRI-0001BB-162.105-L 11/29/2007	260	63	Gravity - Mortared Stone	Head Wall	68	\$0.00
BLRI-0001BB-162.106-R 11/29/2007	170	42	Gravity - Mortared Stone	Head Wall	70	\$0.00
BLRI-0001BB-162.383-L 11/29/2007	100	25	Gravity - Mortared Stone	Head Wall	70	\$0.00

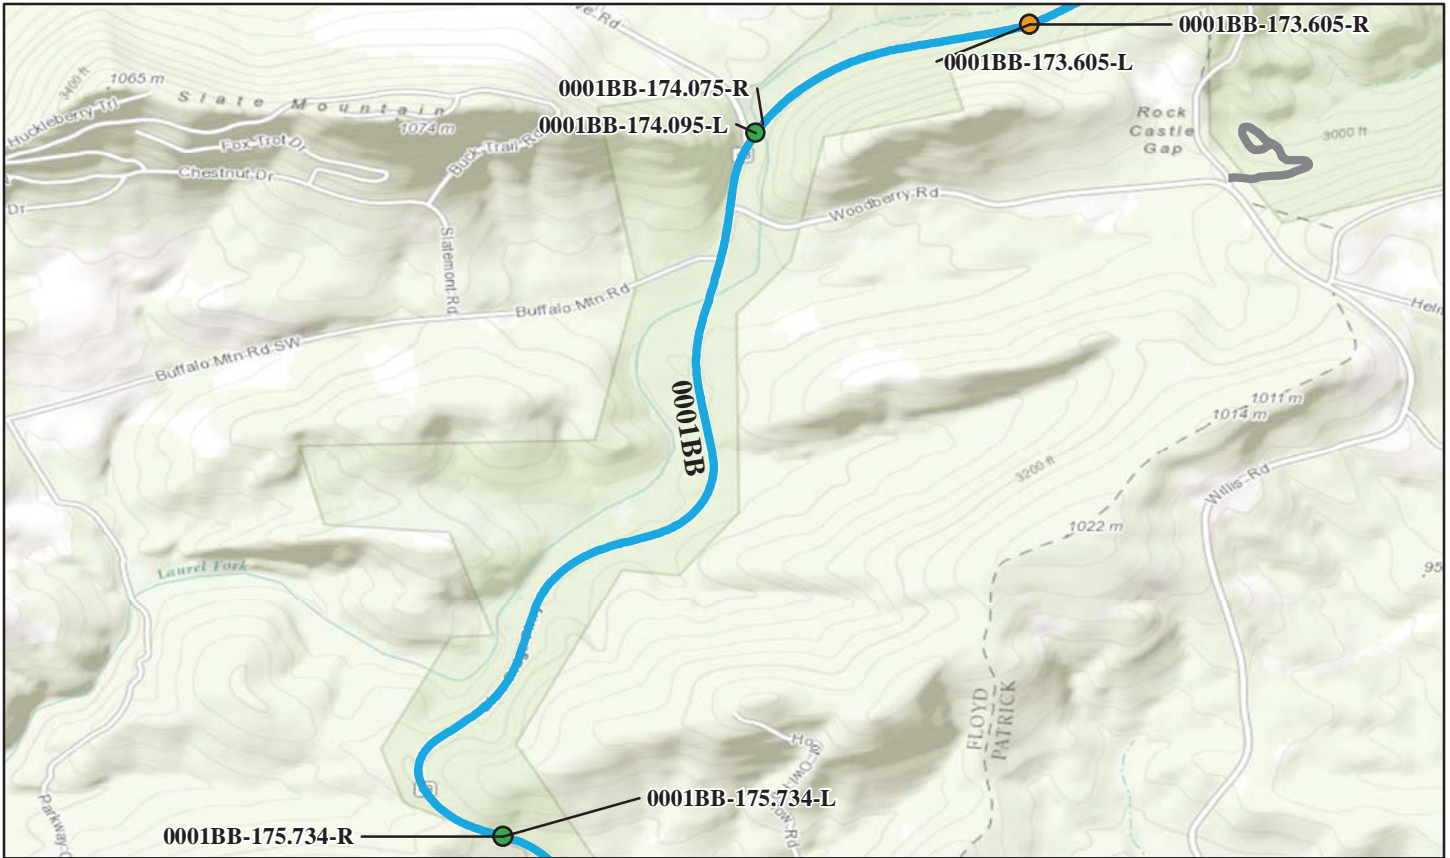
## ROUTE 0001BB: BLUE RIDGE PARKWAY - ROCKY KNOB SUB-DISTRICT

Wall ID Inspection Date:	Wall Area (Sq. Ft.)	Wall Length (Ft.)	Wall Type	Wall Function	Overall Rating	Repair Cost
BLRI-0001BB-173.605-L 11/29/2007	150	32	Gravity - Mortared Stone	Head Wall	68	\$450.00
BLRI-0001BB-173.605-R 11/29/2007	150	32	Gravity - Mortared Stone	Head Wall	70	\$0.00
BLRI-0001BB-174.075-R 11/29/2007	250	50	Gravity - Mortared Stone	Head Wall	59	\$9,600.00
BLRI-0001BB-174.095-L 11/29/2007	250	50	Gravity - Mortared Stone	Head Wall	70	\$760.00
BLRI-0001BB-175.734-L 11/29/2007	190	43	Gravity - Mortared Stone	Head Wall	70	\$0.00

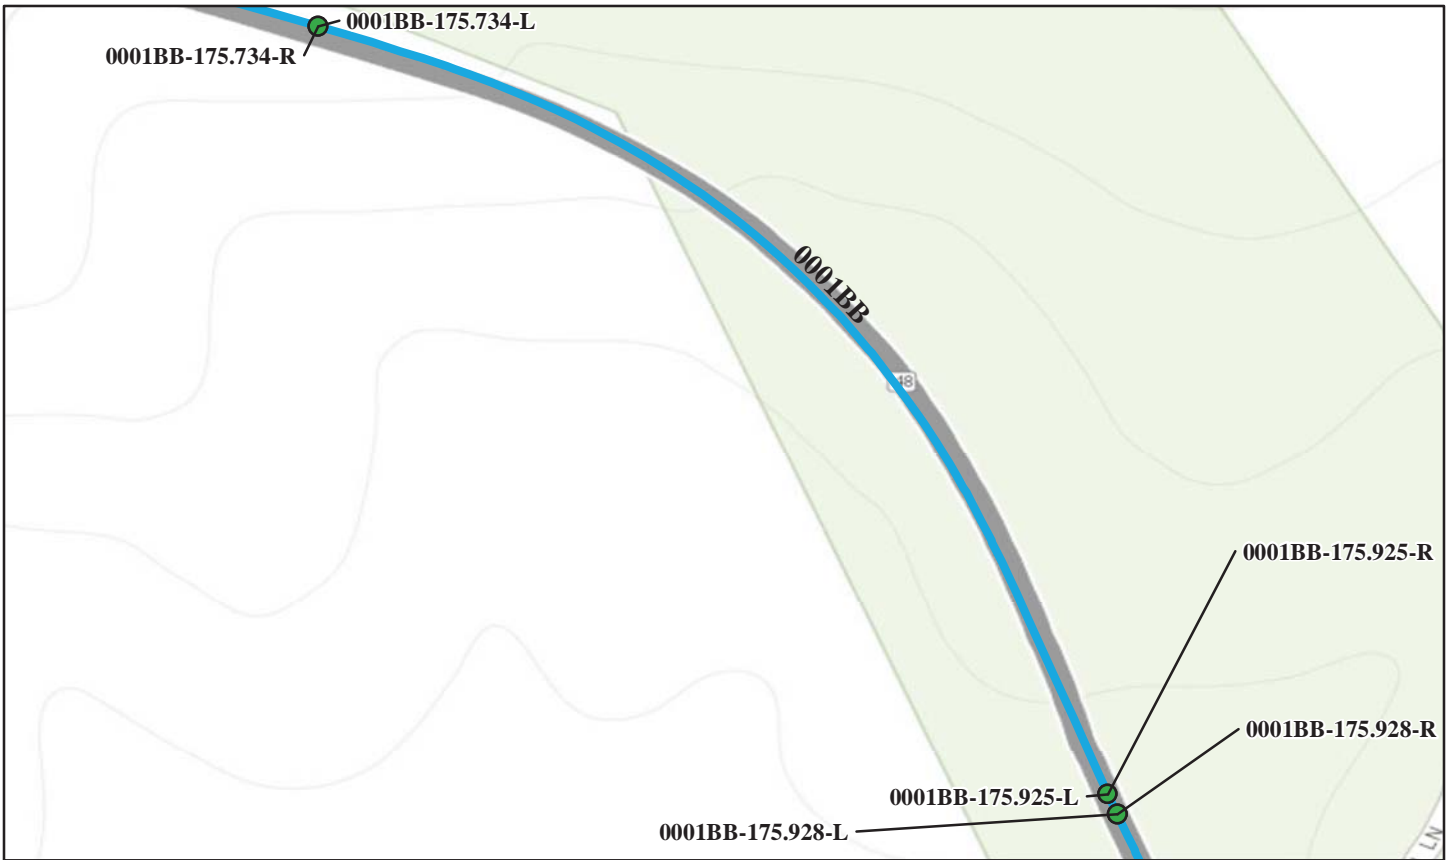
## ROUTE 0001BB: BLUE RIDGE PARKWAY - ROCKY KNOB SUB-DISTRICT

Wall ID Inspection Date:	Wall Area (Sq. Ft.)	Wall Length (Ft.)	Wall Type	Wall Function	Overall Rating	Repair Cost
BLRI-0001BB-175.734-R 11/29/2007	190	43	Gravity - Mortared Stone	Head Wall	70	\$0.00
BLRI-0001BB-175.925-L 11/29/2007	100	26	Gravity - Mortared Stone	Head Wall	70	\$0.00
BLRI-0001BB-175.925-R 11/29/2007	100	26	Gravity - Mortared Stone	Head Wall	70	\$0.00
BLRI-0001BB-175.928-L 11/28/2007	80	26	Gravity - Mortared Stone	Head Wall	70	\$750.00
BLRI-0001BB-175.928-R 11/28/2007	80	26	Gravity - Mortared Stone	Head Wall	72	\$0.00

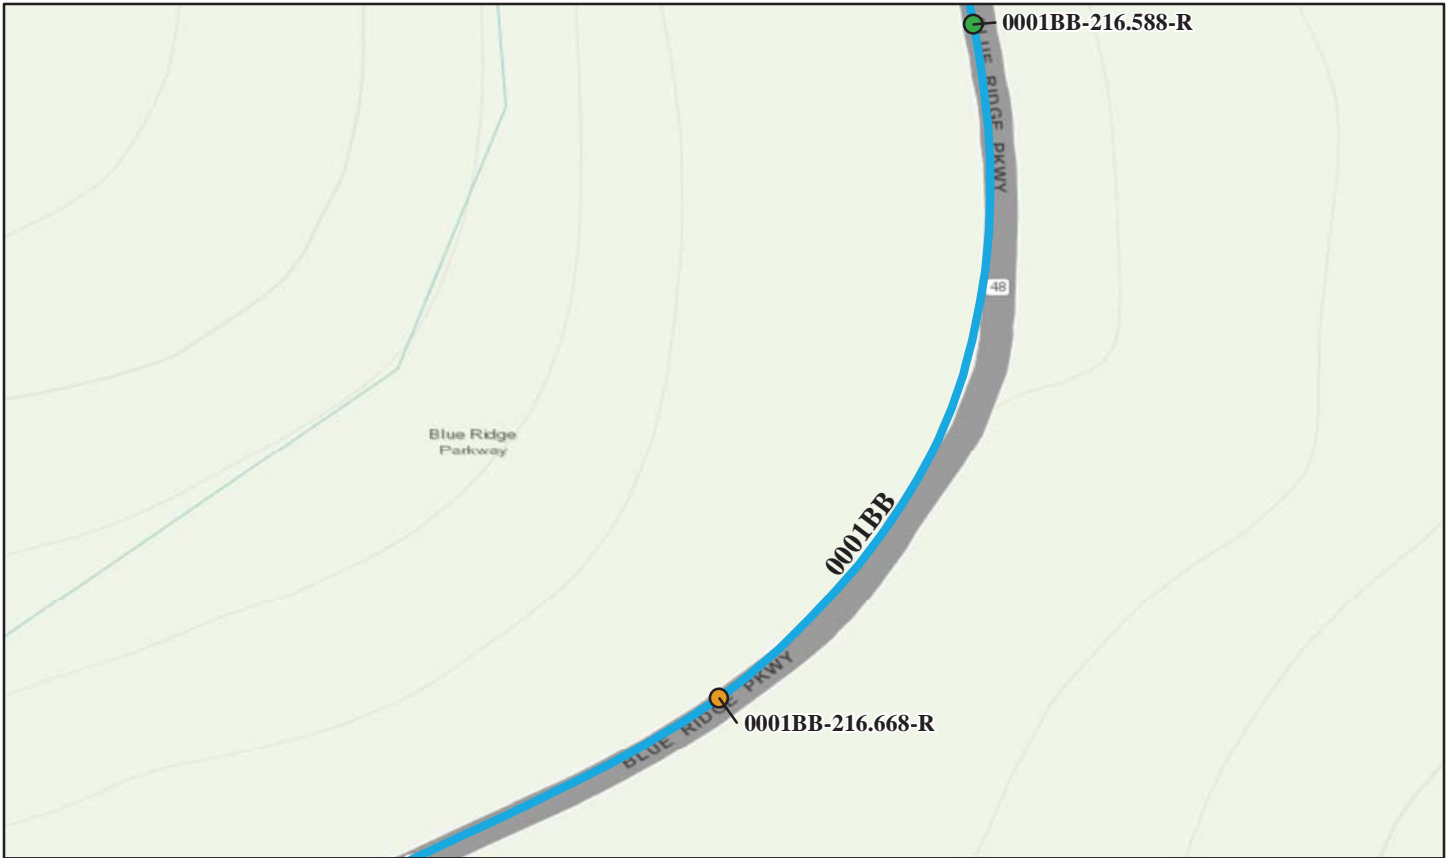
## ROUTE 0001BB: BLUE RIDGE PARKWAY - ROCKY KNOB SUB-DISTRICT

Wall ID Inspection Date:	Wall Area (Sq. Ft.)	Wall Length (Ft.)	Wall Type	Wall Function	Overall Rating	Repair Cost
BLRI-0001BB-216.588-R 11/27/2007	2,450	315	Gravity - Mortared Stone	Fill Wall	70	\$0.00
BLRI-0001BB-216.668-R 11/28/2007	490	140	Gravity - Mortared Stone	Fill Wall	63	\$41,300.00

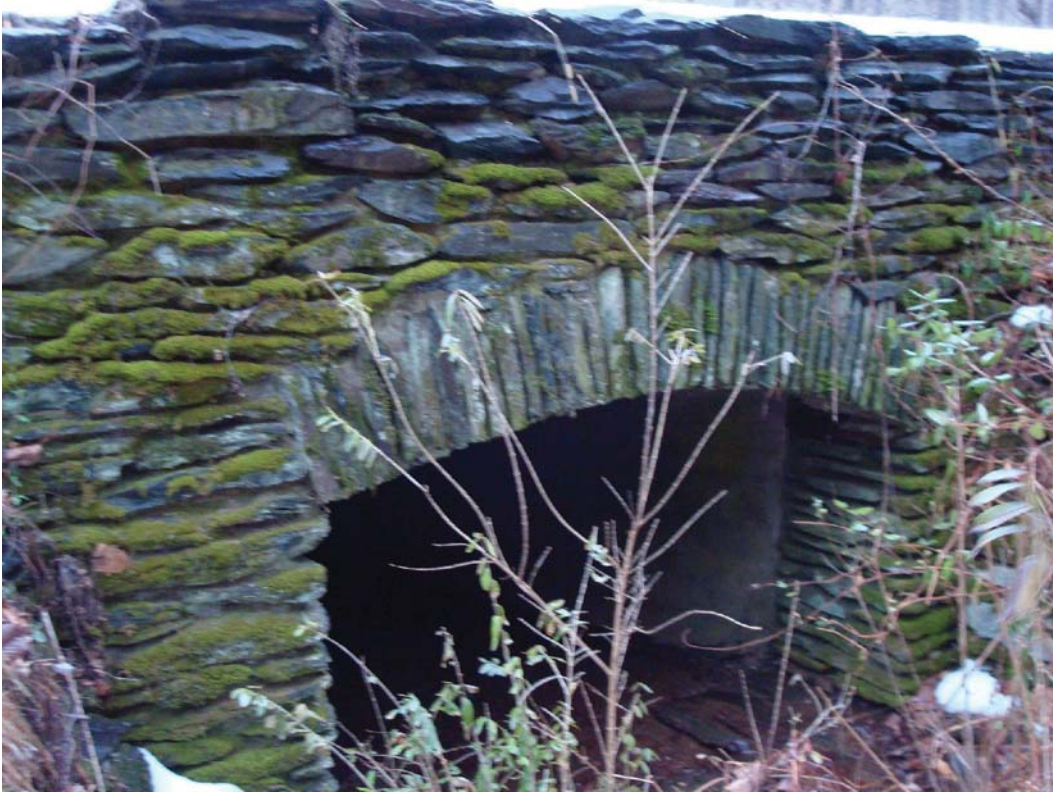
BLRI\_0001AA\_1.085\_R\_1.JPG

<b>Element (Weighting Factor)</b>	<b>Narrative</b>	<b>Condition Rating (0 - 10)</b>
PERFORMANCE 8.00	No global distress.	7
WALL FOUNDATION MATERIAL 8.00	Sand and gravel, slight scour	7
MORTAR 8.00	sound and durable.	7
STONE MASONRY 8.00	No degradation.	7
LATERAL SLOPE 0.50	Flat	8
UPSLOPE 0.50	Gradual.	8
CULVERT 1.00	Concrete box 5' high by 8' wide.	7
DOWNSLOPE 1.00	Rising	7
WALL DRAINS 1.00	Weepholes 10' on center	7

<b>Failure Consequence:</b>	LOW
<b>Recommendation Narrative:</b>	None
<b>Repair Cost:</b>	\$0

<b>Wall ID:</b>	BLRI-0001AA-1.085-R		
<b>Route Name:</b>	BLUE RIDGE PARKWAY - MONTEBELLO SUB-DISTRICT		
<b>Inspection Date:</b>	February 29, 2008	<b>Approximate Year Built:</b>	1940
<b>*Wall Rating:</b>	70	<b>Maintenance Action:</b>	No Action

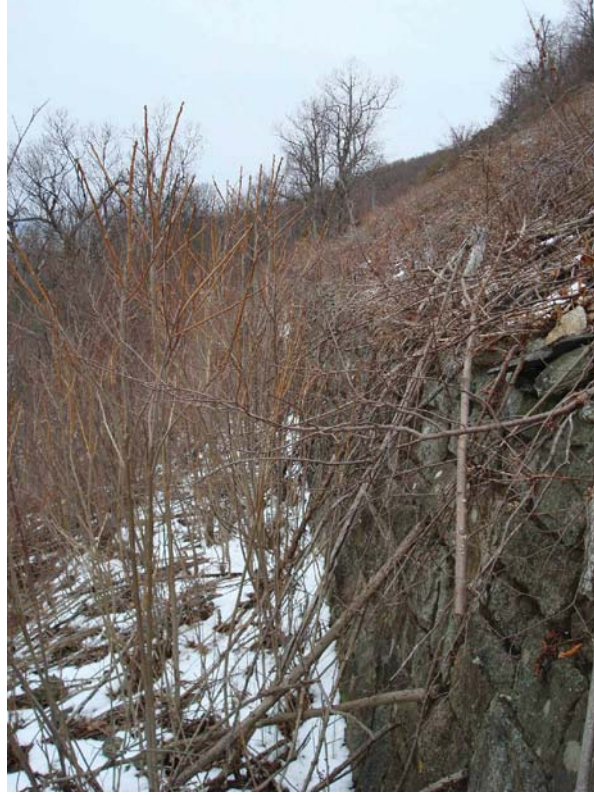
BLRI\_0001AA\_12.795\_R\_1.JPG

<b>Element (Weighting Factor)</b>	<b>Narrative</b>	<b>Condition Rating (0 - 10)</b>
PERFORMANCE 8.00	No global distress.	7
WALL FOUNDATION MATERIAL 8.00	Bed Rock or soil.	7
MORTAR 8.00	Sound and durable.	7
STONE MASONRY 8.00	No degradation	7
UPSLOPE 1.00	1.5:1	5
VEGETATION 1.00	Vegetation in front of wall, not affecting wall function.	6
DOWNSLOPE 1.00	3:1	7
LATERAL SLOPE 1.00	Gradual.	7
WALL DRAINS 1.00	None observed.	7

<b>Failure Consequence:</b>	MODERATE
<b>Recommendation Narrative:</b>	Clear vegetation in front of wall. 10 hrs * \$55/hr = \$550
<b>Repair Cost:</b>	\$550

<b>Wall ID:</b>	BLRI-0001AA-12.795-R		
<b>Route Name:</b>	BLUE RIDGE PARKWAY - MONTEBELLO SUB-DISTRICT		
<b>Inspection Date:</b>	January 29, 2008	<b>Approximate Year Built:</b>	1940
<b>*Wall Rating:</b>	69	<b>Maintenance Action:</b>	Maintenance

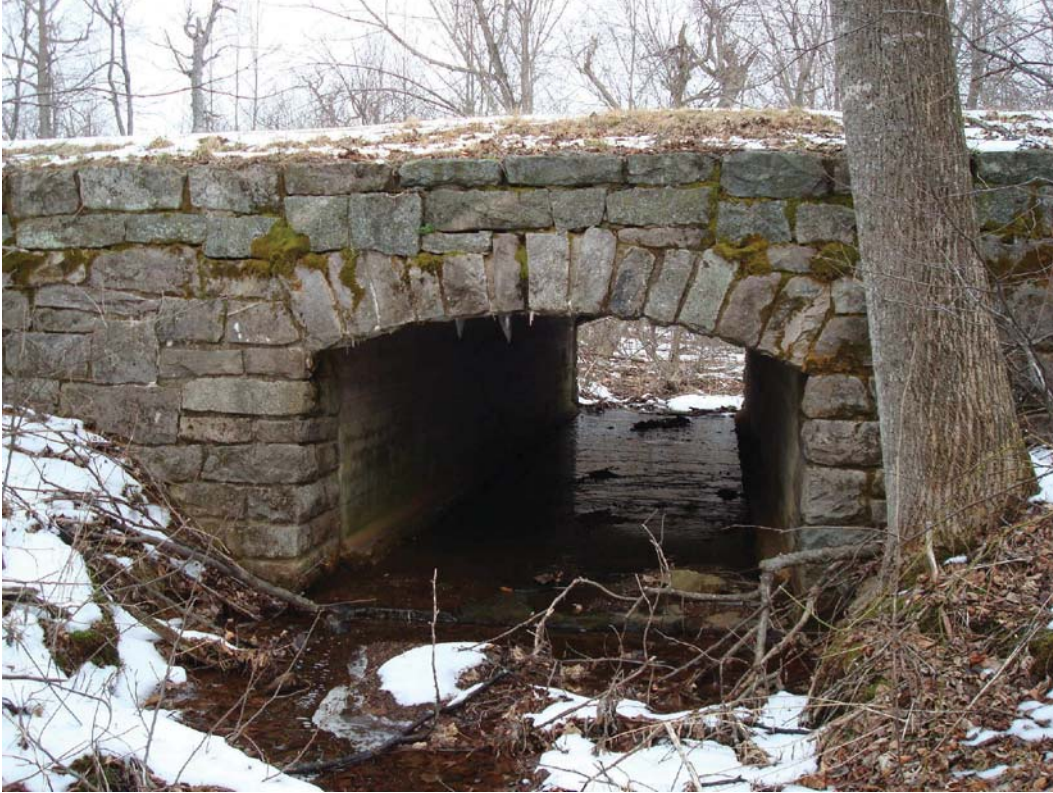
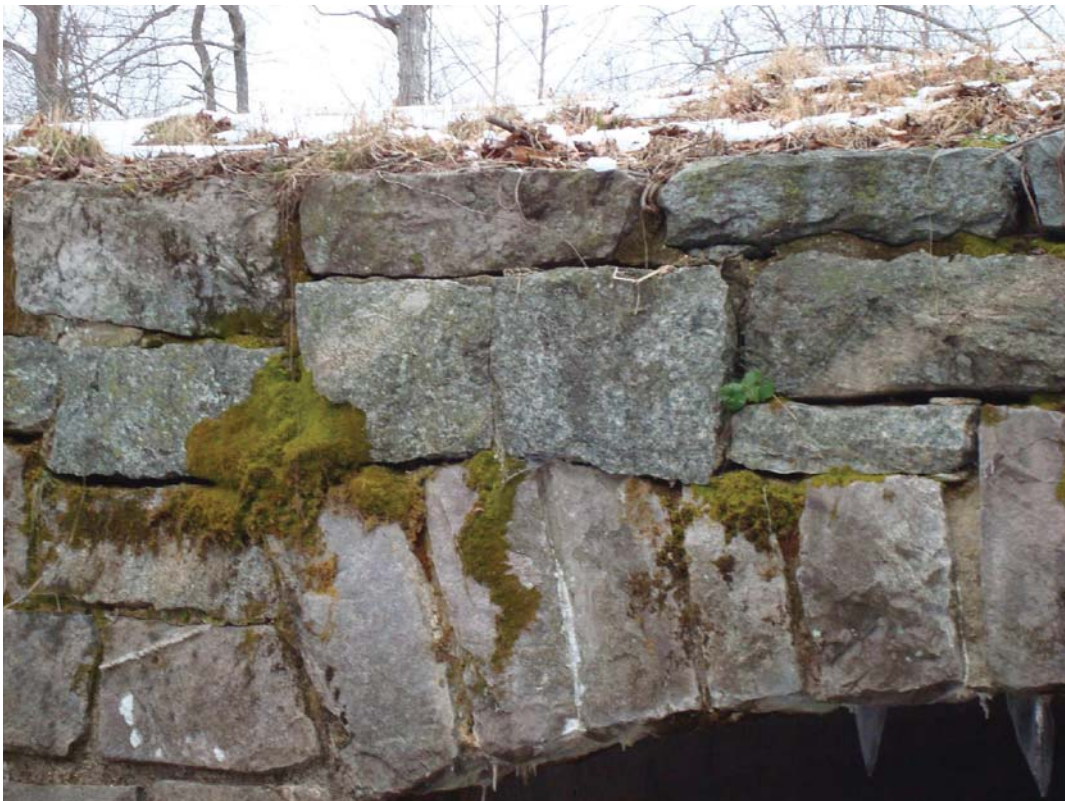
BLRI\_0001AA\_15.384\_L\_1.JPG

<b>Element (Weighting Factor)</b>	<b>Narrative</b>	<b>Condition Rating (0 - 10)</b>
PERFORMANCE 8.00	No global distress.	7
WALL FOUNDATION MATERIAL 8.00	Sand, no settlement or erosion.	7
MORTAR 8.00	Repoint mortar on upper two feet - 2'x38'	7
STONE MASONRY 8.00	No degradation	7
DOWNSLOPE 0.50	Flat	8
CULVERT 1.00	6' high by 10' wide concrete box.	7
LATERAL SLOPE 1.00	Flat	7
UPSLOPE 1.00	Gradual	7
VEGETATION 1.00	18" diameter tree directly in front of wall, not affecting wall, but could in the future.	7

<b>Failure Consequence:</b>	LOW
<b>Recommendation Narrative:</b>	Repoint mortar - 76 S.F. * \$75/S.F. = \$5,700. Remove Tree - \$955
<b>Repair Cost:</b>	\$6,655

<b>Wall ID:</b>	BLRI-0001AA-15.384-L		
<b>Route Name:</b>	BLUE RIDGE PARKWAY - MONTEBELLO SUB-DISTRICT		
<b>Inspection Date:</b>	January 29, 2008	<b>Approximate Year Built:</b>	1940
<b>*Wall Rating:</b>	70	<b>Maintenance Action:</b>	Repair Elements

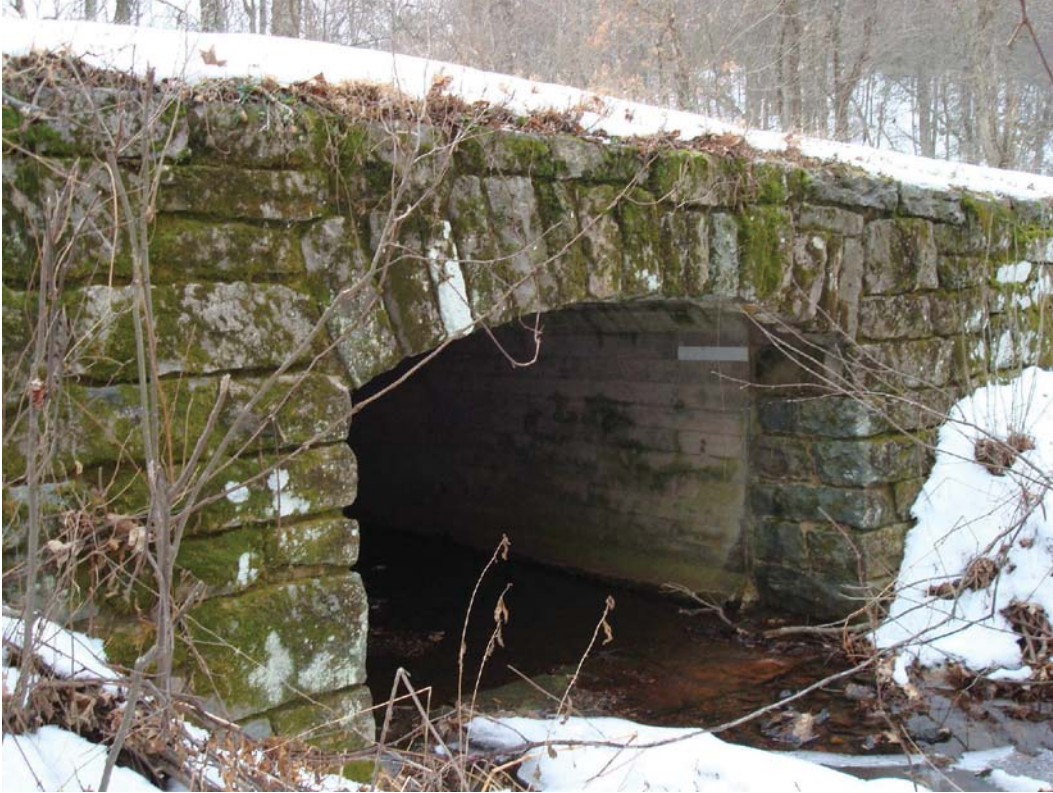
BLRI\_0001AA\_15.384\_R\_1.JPG

<b>Element (Weighting Factor)</b>	<b>Narrative</b>	<b>Condition Rating (0 - 10)</b>
PERFORMANCE 8.00	No global distress.	7
WALL FOUNDATION MATERIAL 8.00	Sand, no settlement or erosion.	7
STONE MASONRY 8.00	No degradation	7
MORTAR 8.00	Sound and durable.	8
DOWNSLOPE 0.50	Flat	8
CULVERT 1.00	6' high by 10' wide concrete box.	7
LATERAL SLOPE 1.00	Flat	7
UPSLOPE 1.00	Gradual.	7
WALL DRAINS 1.00	Weepholes 10' on center	7

<b>Failure Consequence:</b>	MODERATE
<b>Recommendation Narrative:</b>	None
<b>Repair Cost:</b>	\$0

<b>Wall ID:</b>	BLRI-0001AA-15.384-R		
<b>Route Name:</b>	BLUE RIDGE PARKWAY - MONTEBELLO SUB-DISTRICT		
<b>Inspection Date:</b>	January 29, 2008	<b>Approximate Year Built:</b>	1940
<b>*Wall Rating:</b>	72	<b>Maintenance Action:</b>	No Action

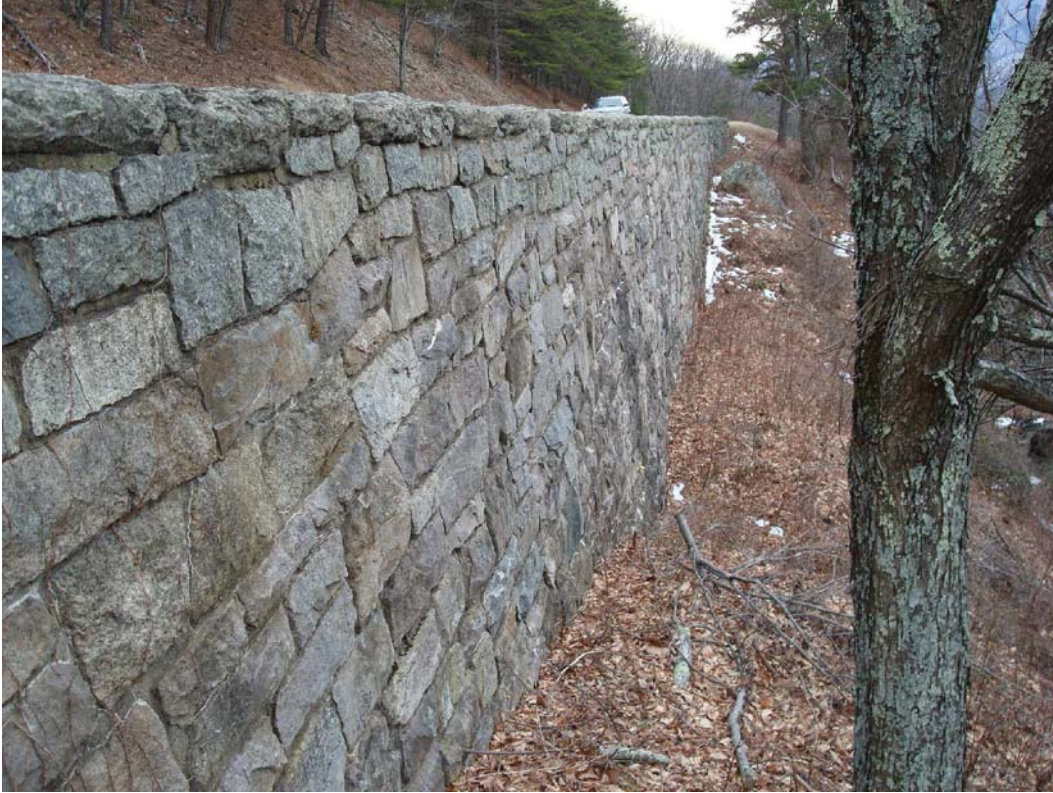
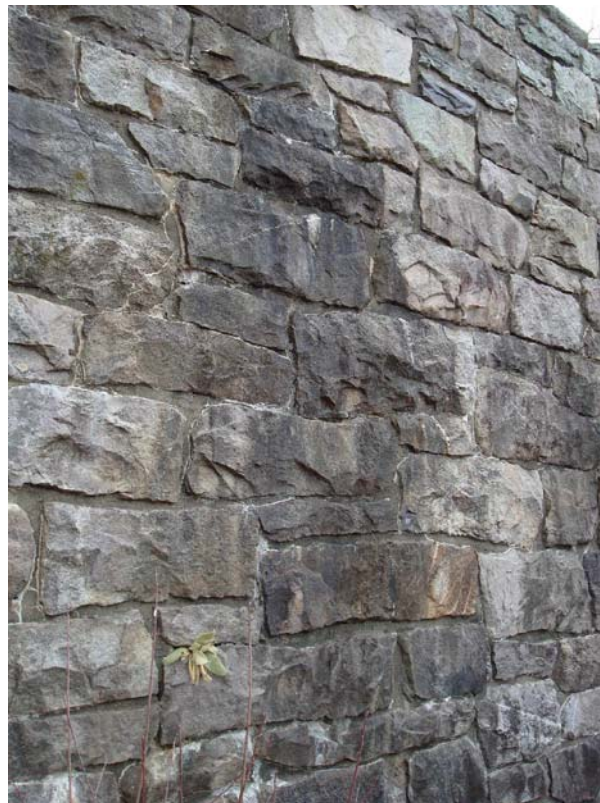
BLRI\_0001AA\_19.078\_L\_1.JPG

<b>Element (Weighting Factor)</b>	<b>Narrative</b>	<b>Condition Rating (0 - 10)</b>
PERFORMANCE 8.00	No global distress.	7
WALL FOUNDATION MATERIAL 8.00	Soil or rock. No settlement or erosion.	7
MORTAR 8.00	Sound and durable except 10% cracked or missing.	6
STONE MASONRY 8.00	No degradation.	7
CULVERT 1.00	2' diameter concrete and exposed reinforcing steel. Soil fills more than 50% of pipe.	5
DOWNSLOPE 1.00	Flat for 10' and then 3:1	7
LATERAL SLOPE 1.00	Gradual.	7
ROAD/SIDEWALK/SHOULDER 1.00	Shoulder is flat and some settlement.	7
WALL DRAINS 1.00	None observed.	7

<b>Failure Consequence:</b>	MODERATE
<b>Recommendation Narrative:</b>	Repoint Mortar - 10% of wall area - 168 S.F. * \$75/S.F. = \$12,600. Repair Culvert face - \$500. Remove soil from culvert - \$2,000.
<b>Repair Cost:</b>	\$15,100

<b>Wall ID:</b>	BLRI-0001AA-19.078-L		
<b>Route Name:</b>	BLUE RIDGE PARKWAY - MONTEBELLO SUB-DISTRICT		
<b>Inspection Date:</b>	January 29, 2008	<b>Approximate Year Built:</b>	1940
<b>*Wall Rating:</b>	67	<b>Maintenance Action:</b>	Repair Elements

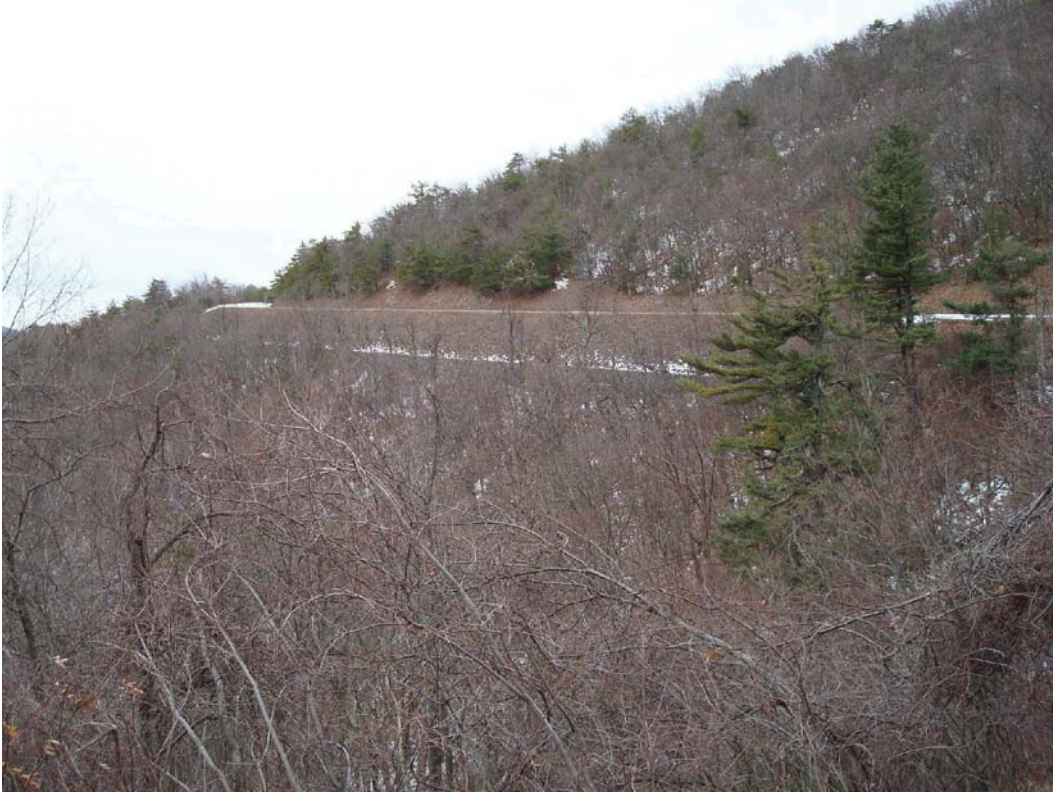
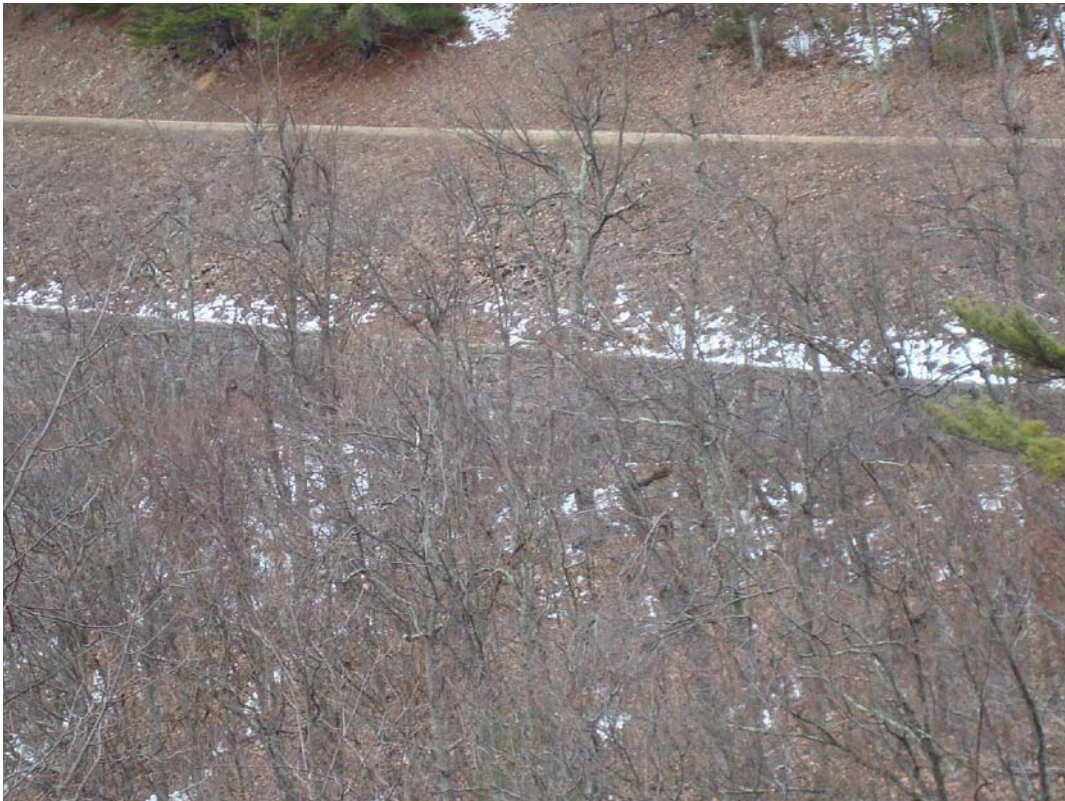
**BLRI\_0001AA\_21.085\_L\_1.JPG**

<b>Element (Weighting Factor)</b>	<b>Narrative</b>	<b>Condition Rating (0 - 10)</b>
PERFORMANCE 8.00	No global distress.	7
WALL FOUNDATION MATERIAL 8.00	Soil or rock. No settlement or erosion.	7
MORTAR 8.00	Sound and durable with minor cracking.	7
STONE MASONRY 8.00	No degradation.	7
UPSLOPE 1.00	1.5:1	6
CULVERT 1.00	18" concrete pipe, joint 1/4" offset.	7
DOWNSLOPE 1.00	Flat for 5' and then 4:1	7
LATERAL SLOPE 1.00	Gradual.	7
WALL DRAINS 1.00	Weepholes 10' on center	7

<b>Failure Consequence:</b>	MODERATE
<b>Recommendation Narrative:</b>	None
<b>Repair Cost:</b>	\$0

<b>Wall ID:</b>	BLRI-0001AA-21.085-L		
<b>Route Name:</b>	BLUE RIDGE PARKWAY - MONTEBELLO SUB-DISTRICT		
<b>Inspection Date:</b>	January 29, 2008	<b>Approximate Year Built:</b>	1940
<b>*Wall Rating:</b>	70	<b>Maintenance Action:</b>	No Action

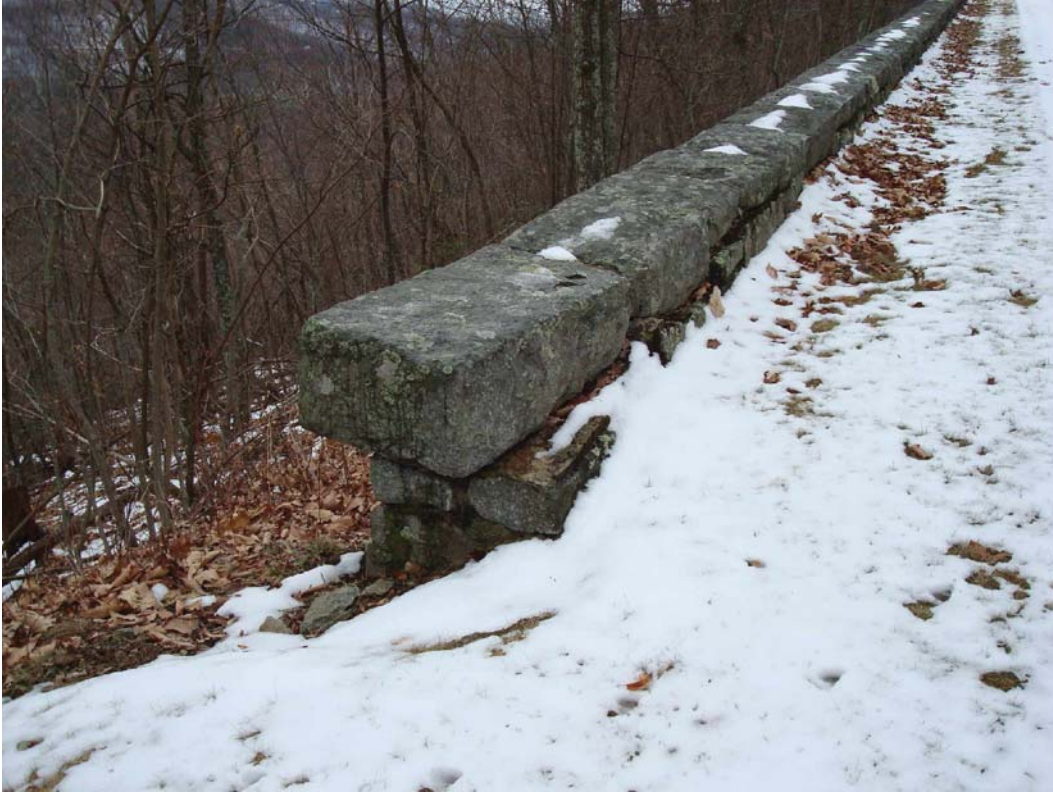
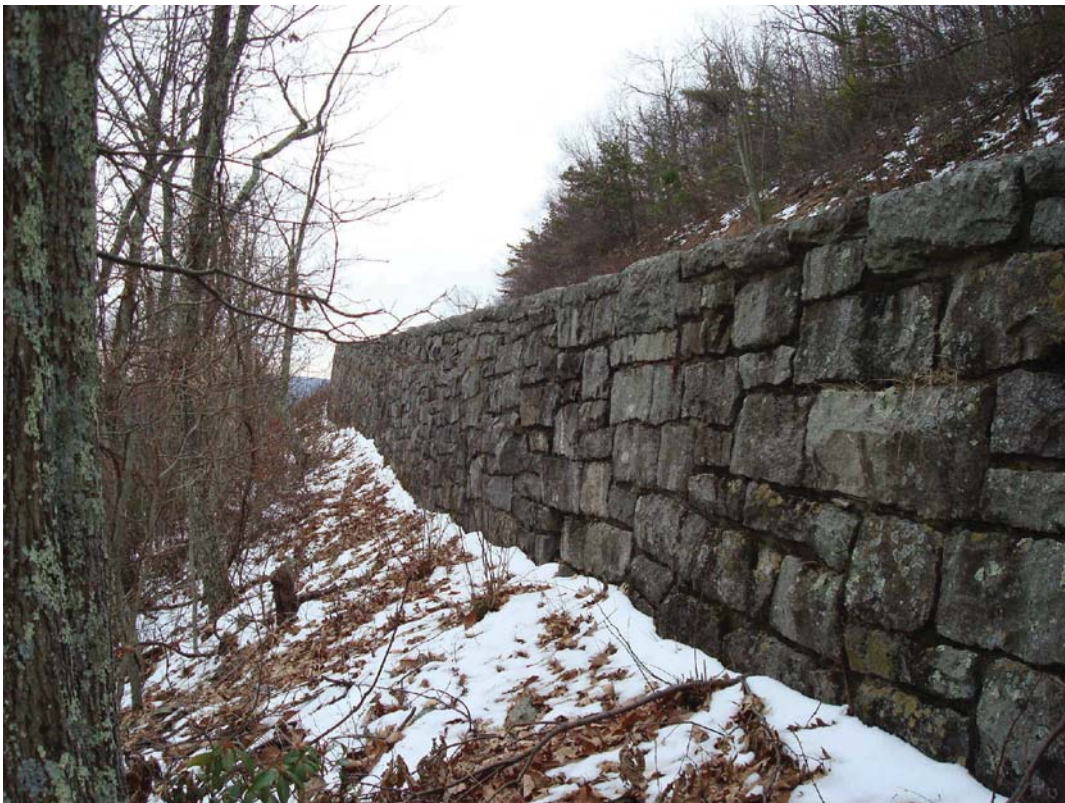
BLRI\_0001AA\_21.378\_L\_1.JPG

<b>Element (Weighting Factor)</b>	<b>Narrative</b>	<b>Condition Rating (0 - 10)</b>
PERFORMANCE 8.00	No global distress.	7
WALL FOUNDATION MATERIAL 8.00	Soil or rock. No settlement or erosion.	7
MORTAR 8.00	Sound and durable minor cracking.	7
STONE MASONRY 8.00	No degradation. 10' by 2' area needs to be reset.	7
CULVERT 1.00	Two 18" diameter concrete culverts	7
DOWNSLOPE 1.00	Flat for 2' and then 3:1	7
LATERAL SLOPE 1.00	Gradual.	7
UPSLOPE 1.00	1.5:1	7
WALL DRAINS 1.00	Weepholes 10' on center	7

<b>Failure Consequence:</b>	MODERATE
<b>Recommendation Narrative:</b>	Reset stones - 20 S.F. * \$75/S.F. = \$1,500
<b>Repair Cost:</b>	\$1,500

<b>Wall ID:</b>	BLRI-0001AA-21.378-L		
<b>Route Name:</b>	BLUE RIDGE PARKWAY - MONTEBELLO SUB-DISTRICT		
<b>Inspection Date:</b>	January 29, 2008	<b>Approximate Year Built:</b>	1940
<b>*Wall Rating:</b>	70	<b>Maintenance Action:</b>	Repair Elements

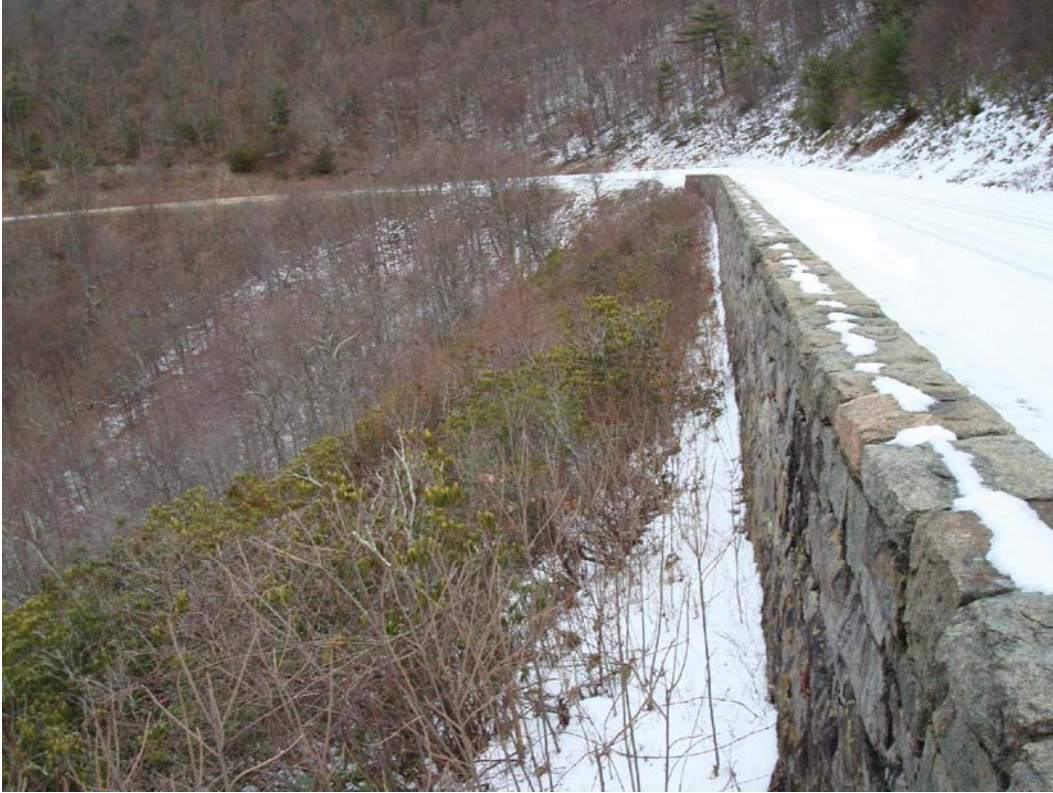
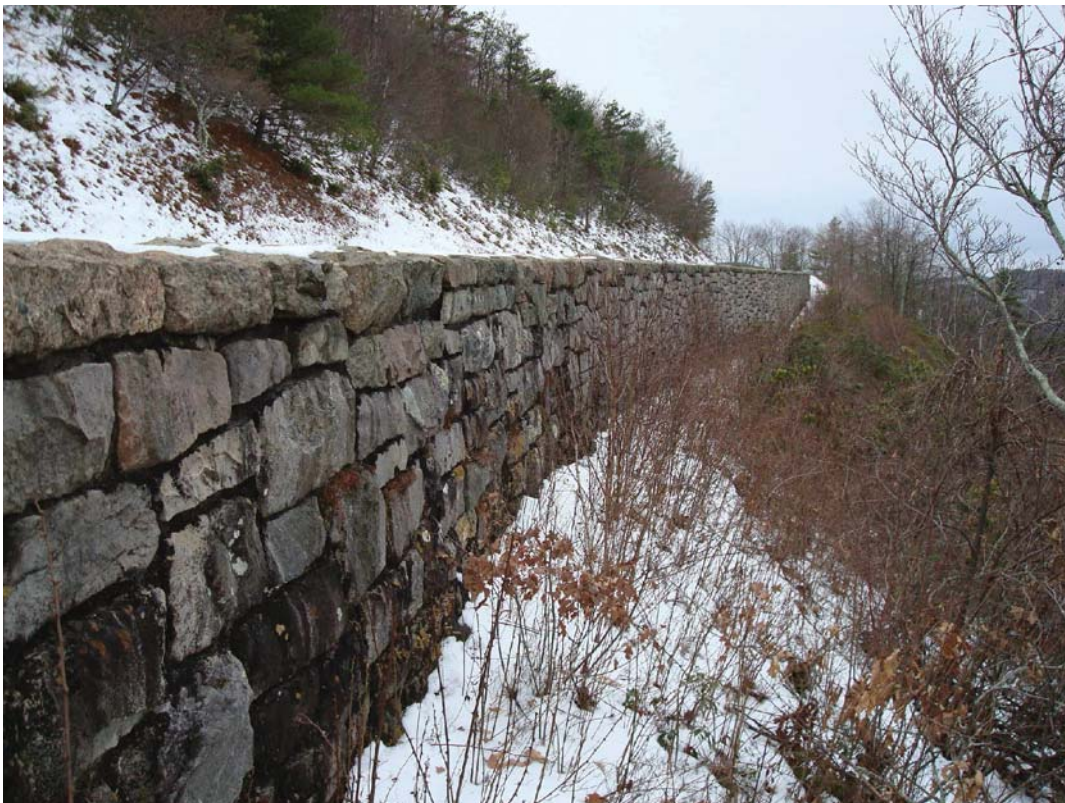
BLRI\_0001AA\_22.304\_L\_1.JPG

<b>Element (Weighting Factor)</b>	<b>Narrative</b>	<b>Condition Rating (0 - 10)</b>
PERFORMANCE 8.00	No global distress.	7
WALL FOUNDATION MATERIAL 8.00	Gravelly soil, possible bedrock. No settlement or erosion.	7
MORTAR 8.00	Minor cracking and minor missing - 10%	6
STONE MASONRY 8.00	No degradation.	7
ROAD/SIDEWALK/SHOULDER 0.50	Flat shoulder.	8
DOWNSLOPE 1.00	Flat for 5' and then 3:1	7
LATERAL SLOPE 1.00	Gradual.	7
WALL DRAINS 1.00	Weepholes 10' on center	7

<b>Failure Consequence:</b>	MODERATE
<b>Recommendation Narrative:</b>	Repoint 10% of wall area. 260 S.F. * \$75/S.F. = \$19,500
<b>Repair Cost:</b>	\$19,500

<b>Wall ID:</b>	BLRI-0001AA-22.304-L		
<b>Route Name:</b>	BLUE RIDGE PARKWAY - MONTEBELLO SUB-DISTRICT		
<b>Inspection Date:</b>	January 29, 2008	<b>Approximate Year Built:</b>	1940
<b>*Wall Rating:</b>	68	<b>Maintenance Action:</b>	Repair Elements

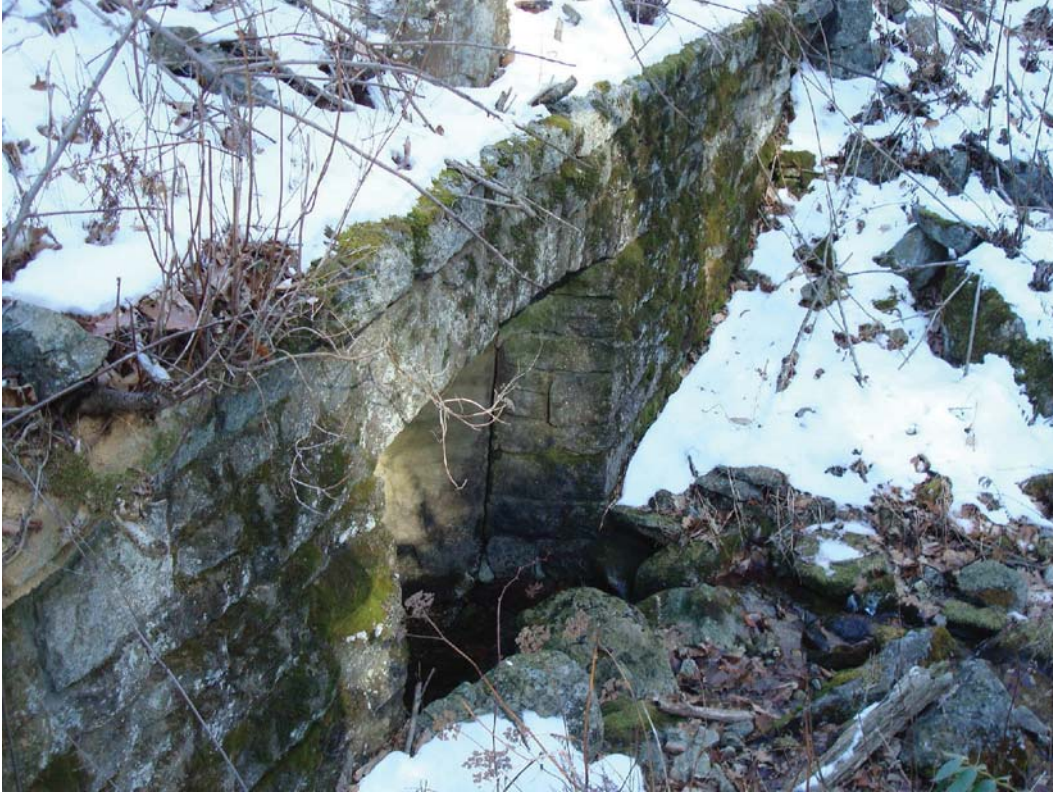
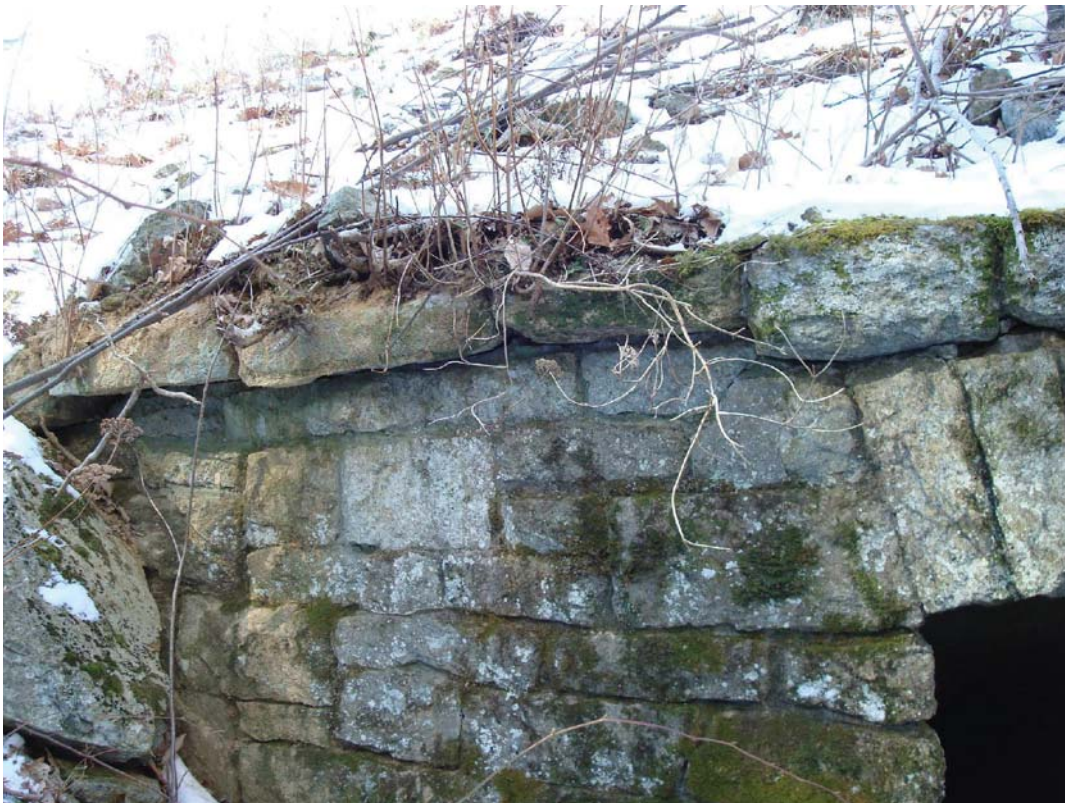
BLRI\_0001AA\_36.410\_L\_1.JPG

BLRI\_0001AA\_36.410\_L\_2.JPG

<b>Wall ID:</b>	BLRI-0001AA-36.410-L		
<b>Route Name:</b>	BLUE RIDGE PARKWAY - MONTEBELLO SUB-DISTRICT		
<b>Inspection Date:</b>	January 28, 2008	<b>Approximate Year Built:</b>	1940
<b>*Wall Rating:</b>	65	<b>Maintenance Action:</b>	Repair Elements

<b>Element (Weighting Factor)</b>	<b>Narrative</b>	<b>Condition Rating (0 - 10)</b>
PERFORMANCE 8.00	Upper two feet of wall have moving stones that are out of place.	5
WALL FOUNDATION MATERIAL 8.00	Soil and cobbles. No settlement or erosion.	7
MORTAR 8.00	Sound and durable. Missing where wall movement.	7
STONE MASONRY 8.00	No degradation.	7
UPSLOPE 1.00	1.5:1	6
CULVERT 1.00	8' x 8' concrete box.	7
DOWNSLOPE 1.00	Rising.	7
LATERAL SLOPE 1.00	Gradual.	7
WALL DRAINS 1.00	Weepholes 10' on centers.	7

<b>Failure Consequence:</b>	LOW
<b>Recommendation Narrative:</b>	Reset Capstones. Repoint mortar - 80 S.F. * \$75/S.F. = \$6,000. Labor - move stones and hand excavation - 10 hrs * \$55/hr = \$550. Free draining backfill - 3 ft. deep x 40' long x 2' back = 9 C.Y. 9 C.Y. x \$60/C.Y. = \$540. Horizontal drain pipe behind wall.
<b>Repair Cost:</b>	\$9,090
