# BLRI WIP Report

## NPS Retaining Wall Inventory Program Blue Ridge Parkway

Federal Highway Administration  
Eastern Federal Lands Highway Division  
Road Inventory Program (RIP)

# Blue Ridge Parkway in North Carolina and Virginia

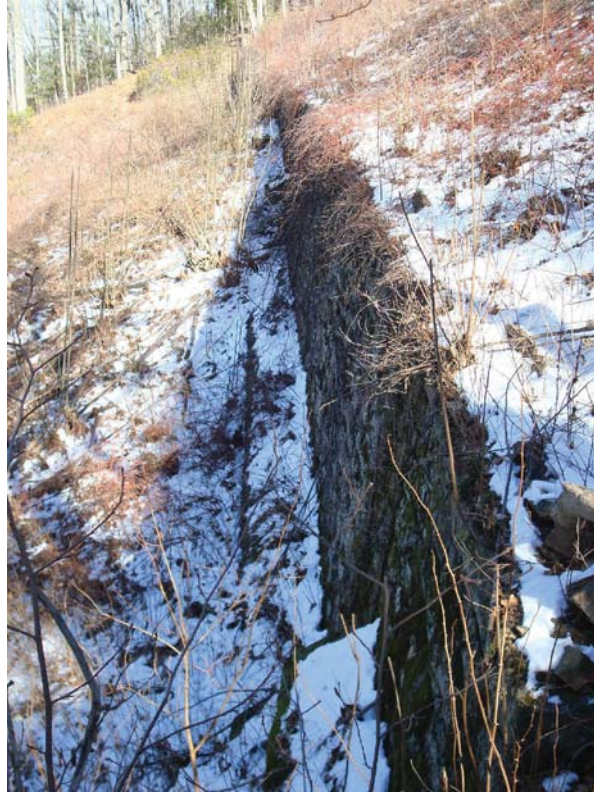
BLRI\_0001AB\_39.476\_R\_1.JPG

<b>Wall ID:</b>	BLRI-0001AB-39.476-R		
<b>Route Name:</b>	BLUE RIDGE PARKWAY - JAMES RIVER SUB-DISTRICT		
<b>Inspection Date:</b>	January 28, 2008	<b>Approximate Year Built:</b>	1940
<b>*Wall Rating:</b>	69	<b>Maintenance Action:</b>	No Action

<b>Element (Weighting Factor)</b>	<b>Narrative</b>	<b>Condition Rating (0 - 10)</b>
PERFORMANCE 8.00	No global distress.	7
WALL FOUNDATION MATERIAL 8.00	Bedrock or soil. No settlement or erosion.	7
MORTAR 8.00	Sound and durable.	7
STONE MASONRY 8.00	No degradation.	7
DOWNSLOPE 1.00	2:1	6
UPSLOPE 1.00	1.5:1	6
LATERAL SLOPE 1.00	Gradual.	7
WALL DRAINS 1.00	Not observed.	7

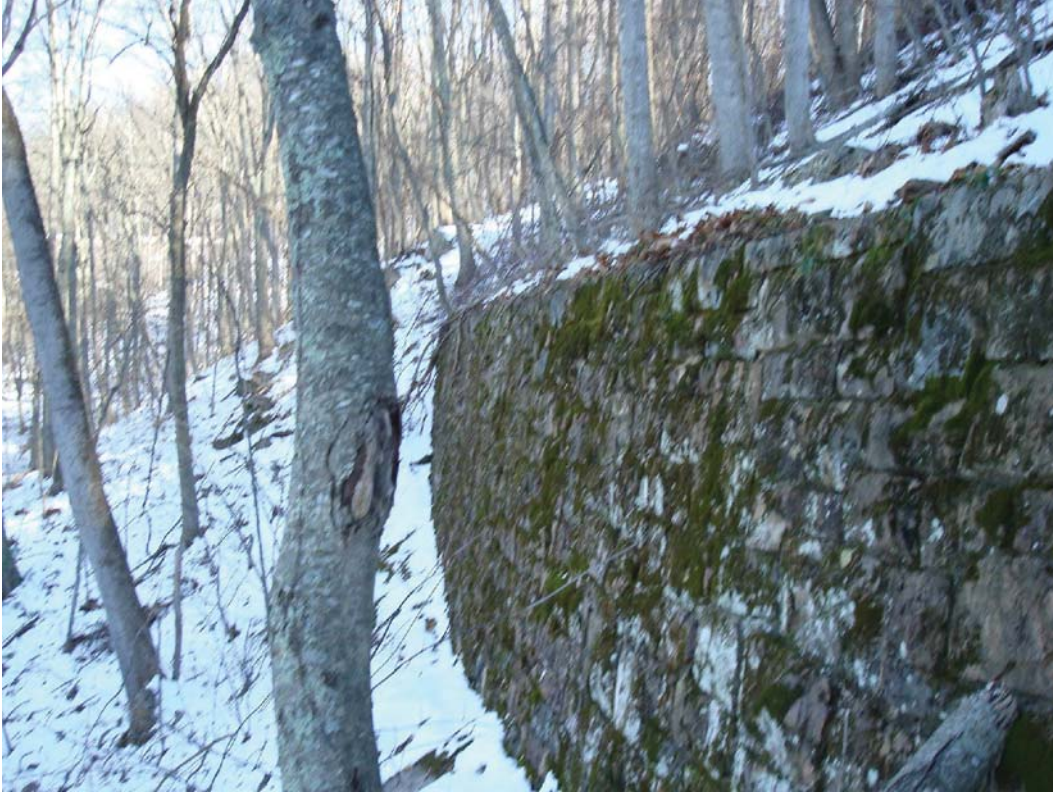
BLRI\_0001AB\_39.628\_R\_1.JPG

<b>Wall ID:</b>	BLRI-0001AB-39.628-R		
<b>Route Name:</b>	BLUE RIDGE PARKWAY - JAMES RIVER SUB-DISTRICT		
<b>Inspection Date:</b>	January 28, 2008	<b>Approximate Year Built:</b>	1940
<b>*Wall Rating:</b>	70	<b>Maintenance Action:</b>	No Action

<b>Element (Weighting Factor)</b>	<b>Narrative</b>	<b>Condition Rating (0 - 10)</b>
PERFORMANCE 8.00	No global distress.	7
WALL FOUNDATION MATERIAL 8.00	Soil and cobbles	7
MORTAR 8.00	Sound and durable.	7
STONE MASONRY 8.00	No degradation.	7
UPSLOPE 1.00	2:1	6
DOWNSLOPE 1.00	3:1	7
LATERAL SLOPE 1.00	Gradual.	7
WALL DRAINS 1.00	Variably spaced weepholes.	7

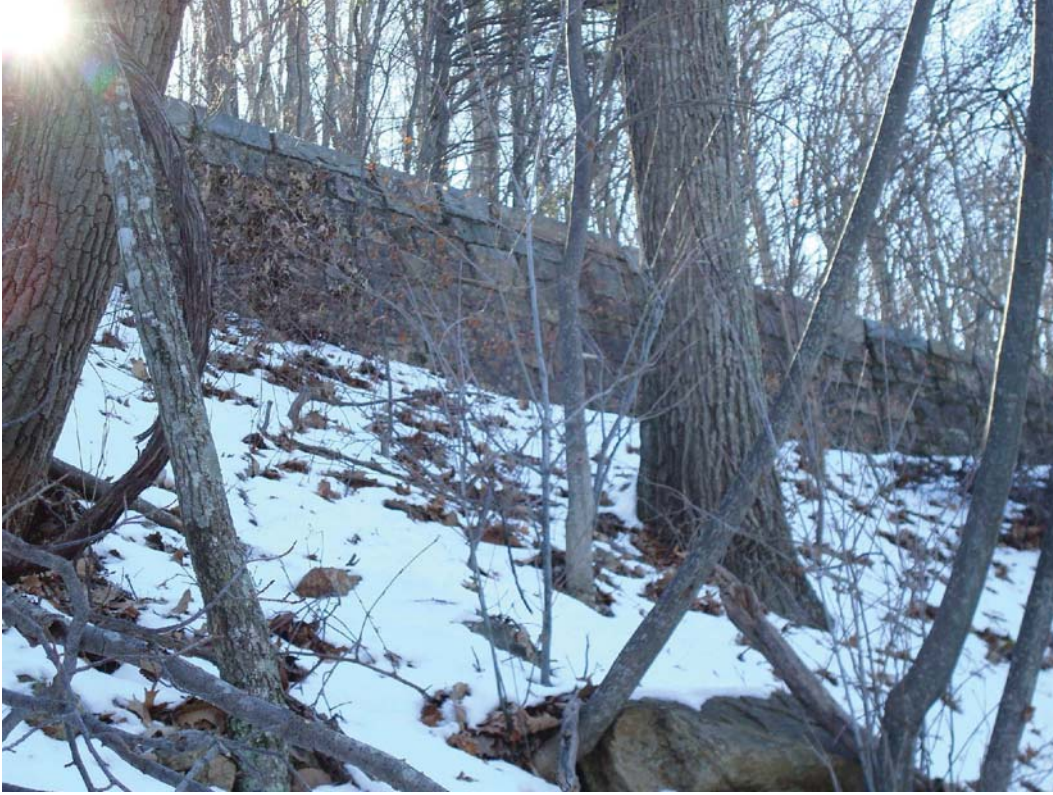
BLRI\_0001AB\_39.648\_R\_1.JPG

<b>Wall ID:</b>	BLRI-0001AB-39.648-R		
<b>Route Name:</b>	BLUE RIDGE PARKWAY - JAMES RIVER SUB-DISTRICT		
<b>Inspection Date:</b>	January 28, 2008	<b>Approximate Year Built:</b>	1940
<b>*Wall Rating:</b>	70	<b>Maintenance Action:</b>	No Action

<b>Element (Weighting Factor)</b>	<b>Narrative</b>	<b>Condition Rating (0 - 10)</b>
PERFORMANCE 8.00	No global distress.	7
WALL FOUNDATION MATERIAL 8.00	Soil and cobbles. No settlement or erosion	7
MORTAR 8.00	Sound and durable.	7
STONE MASONRY 8.00	No degradation.	7
ROAD/SIDEWALK/SHOULDER 0.50	Flat shoulder.	8
DOWNSLOPE 1.00	2:1	7
LATERAL SLOPE 1.00	Gradual.	7
WALL DRAINS 1.00	Variably spaced weepholes	7

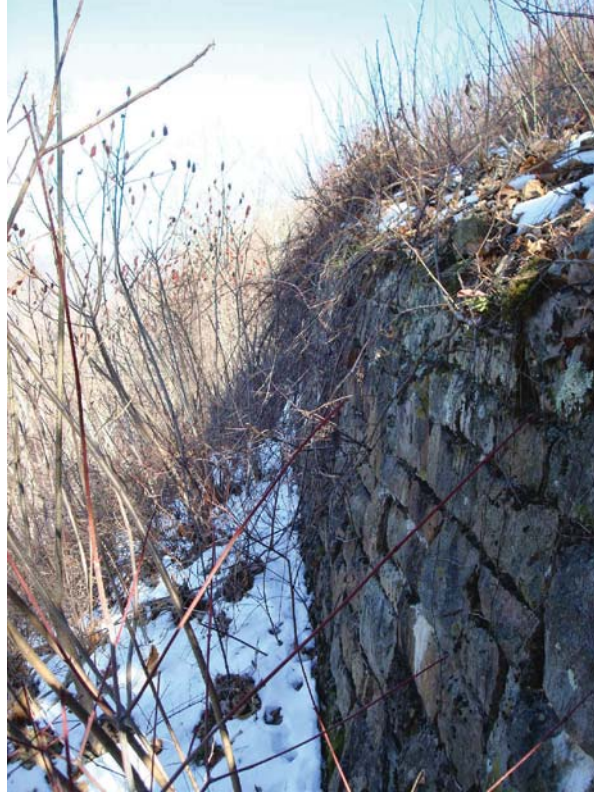
BLRI\_0001AB\_39.704\_R\_1.JPG

<b>Wall ID:</b>	BLRI-0001AB-39.704-R		
<b>Route Name:</b>	BLUE RIDGE PARKWAY - JAMES RIVER SUB-DISTRICT		
<b>Inspection Date:</b>	January 28, 2008	<b>Approximate Year Built:</b>	1940
<b>*Wall Rating:</b>	69	<b>Maintenance Action:</b>	No Action

<b>Element (Weighting Factor)</b>	<b>Narrative</b>	<b>Condition Rating (0 - 10)</b>
PERFORMANCE 8.00	No global distress.	7
WALL FOUNDATION MATERIAL 8.00	Soil and cobbles.	7
MORTAR 8.00	Sound and durable.	7
STONE MASONRY 8.00	No degradation.	7
DOWNSLOPE 1.00	1.5:1	6
UPSLOPE 1.00	1.5:1	6
LATERAL SLOPE 1.00	Gradual.	7
WALL DRAINS 1.00	Variably spaced weepholes.	7

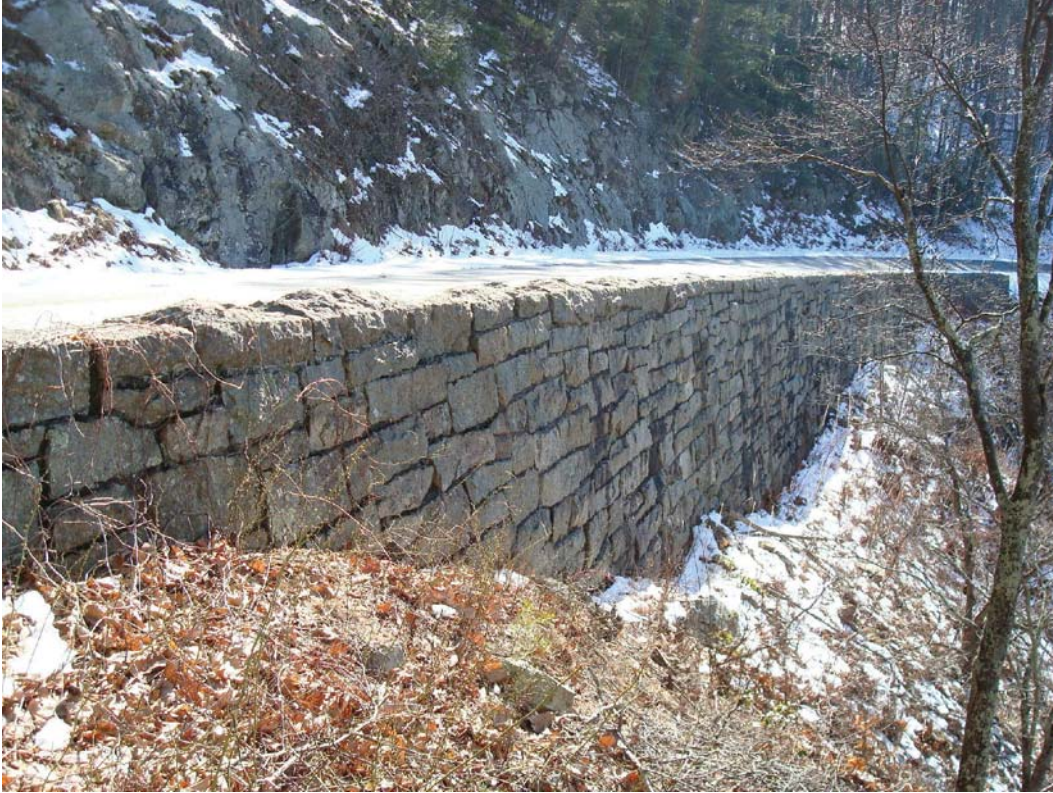
BLRI\_0001AB\_39.800\_R\_1.JPG

<b>Wall ID:</b>	BLRI-0001AB-39.800-R		
<b>Route Name:</b>	BLUE RIDGE PARKWAY - JAMES RIVER SUB-DISTRICT		
<b>Inspection Date:</b>	January 28, 2008	<b>Approximate Year Built:</b>	1940
<b>*Wall Rating:</b>	70	<b>Maintenance Action:</b>	No Action

<b>Element (Weighting Factor)</b>	<b>Narrative</b>	<b>Condition Rating (0 - 10)</b>
PERFORMANCE 8.00	No global distress.	7
WALL FOUNDATION MATERIAL 8.00	Soil and cobbles. No settlement or erosion	7
MORTAR 8.00	Sound and durable.	7
STONE MASONRY 8.00	No degradation.	7
ROAD/SIDEWALK/SHOULDER 0.50	Flat shoulder.	8
DOWNSLOPE 1.00	1.5:1 Steep	6
LATERAL SLOPE 1.00	Gradual.	7
WALL DRAINS 1.00	Variably spaced weepholes.	7

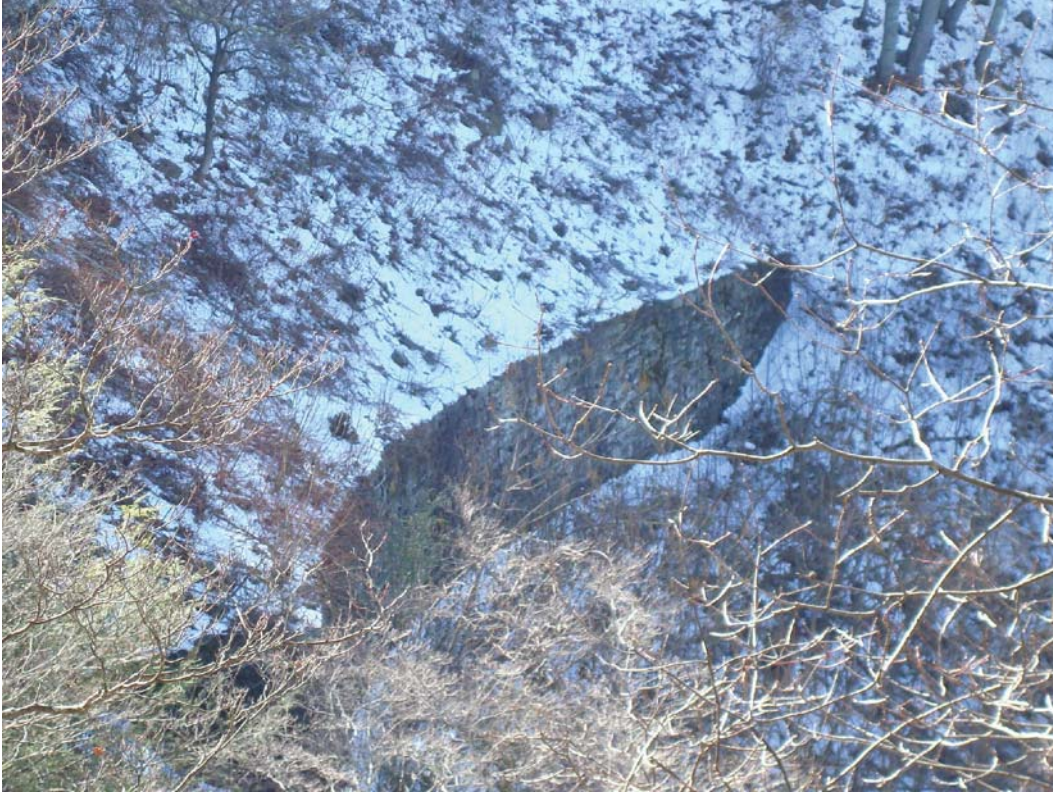
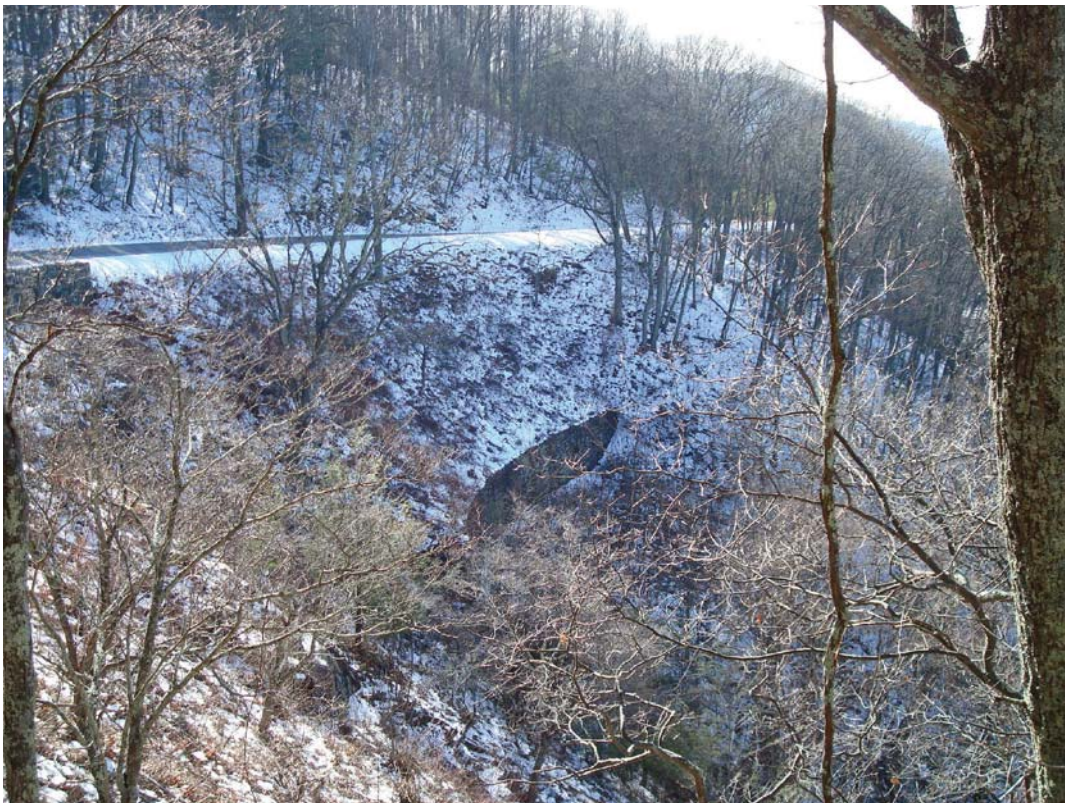
BLRI\_0001AB\_39.856\_R\_1.JPG

BLRI\_0001AB\_39.856\_R\_2.JPG

<b>Wall ID:</b>	BLRI-0001AB-39.856-R		
<b>Route Name:</b>	BLUE RIDGE PARKWAY - JAMES RIVER SUB-DISTRICT		
<b>Inspection Date:</b>	January 28, 2008	<b>Approximate Year Built:</b>	1940
<b>*Wall Rating:</b>	69	<b>Maintenance Action:</b>	No Action

<b>Wall Function:</b>	Fill Wall	<b>Primary Wall Type:</b>	Gravity - Mortared Stone
<b>Surface Treatment:</b>		<b>Secondary Wall Type:</b>	
<b>Secondary Surface Treatment:</b>		<b>Architectural Facing:</b>	
<b>General Description:</b>	Observed wall from distance, scaled length from plans Park MP 39.720

<b>Element (Weighting Factor)</b>	<b>Narrative</b>	<b>Condition Rating (0 - 10)</b>
PERFORMANCE 8.00	No apparent global distress, observed from large distance	7
WALL FOUNDATION MATERIAL 8.00	Soil and cobbles, no apparent settlement or erosion	7
MORTAR 8.00	sound and durable	7
STONE MASONRY 8.00	No degradation	7
DOWNSLOPE 1.00	1.5H:1V	6
UPSLOPE 1.00	1.5H:1V	6
LATERAL SLOPE 1.00	Gradual	7
WALL DRAINS 1.00	Likely weepholes based on nearby wall construction	7

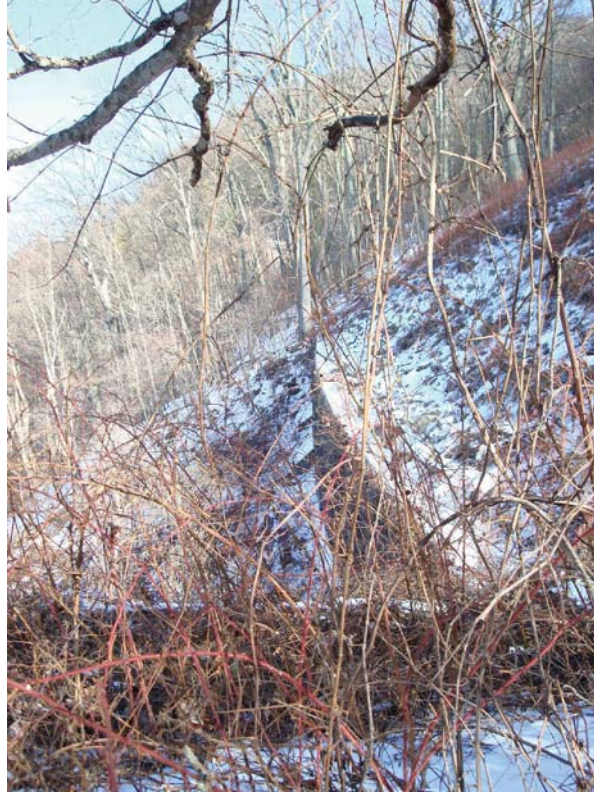
BLRI\_0001AB\_39.944\_R\_1.JPG

<b>Wall ID:</b>	BLRI-0001AB-39.944-R		
<b>Route Name:</b>	BLUE RIDGE PARKWAY - JAMES RIVER SUB-DISTRICT		
<b>Inspection Date:</b>	January 28, 2008	<b>Approximate Year Built:</b>	1940
<b>*Wall Rating:</b>	70	<b>Maintenance Action:</b>	No Action

<b>Element (Weighting Factor)</b>	<b>Narrative</b>	<b>Condition Rating (0 - 10)</b>
PERFORMANCE 8.00	No global distress. Not observed close up	7
WALL FOUNDATION MATERIAL 8.00	Soil and cobbles.	7
MORTAR 8.00	Sound and durable.	7
STONE MASONRY 8.00	No degradation.	7
DOWNSLOPE 1.00	2:1	7
LATERAL SLOPE 1.00	Gradual.	7
UPSLOPE 1.00	2:1	7
WALL DRAINS 1.00	Variably spaced weepholes.	7

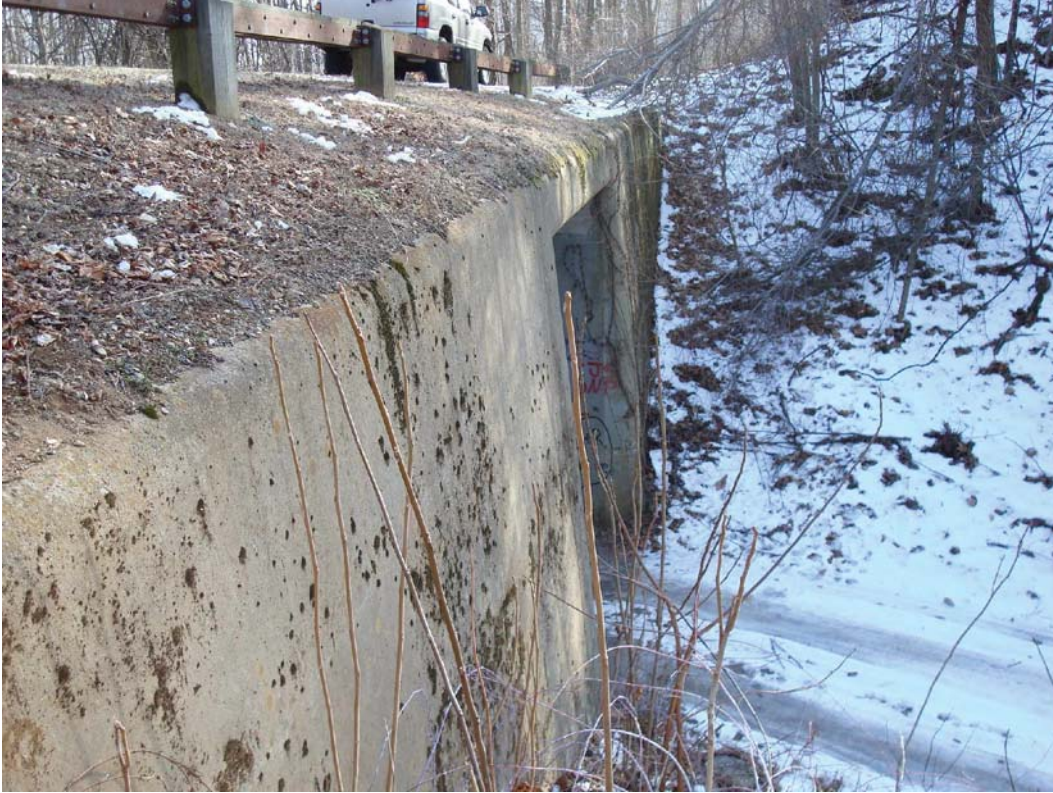
BLRI\_0001AB\_46.998\_R\_1.JPG

<b>Wall ID:</b>	BLRI-0001AB-46.998-R		
<b>Route Name:</b>	BLUE RIDGE PARKWAY - JAMES RIVER SUB-DISTRICT		
<b>Inspection Date:</b>	January 28, 2008	<b>Approximate Year Built:</b>	1940
<b>*Wall Rating:</b>	70	<b>Maintenance Action:</b>	No Action

<b>Element (Weighting Factor)</b>	<b>Narrative</b>	<b>Condition Rating (0 - 10)</b>
PERFORMANCE 8.00	No global distress.	7
WALL FOUNDATION MATERIAL 8.00	Soil. No settlement or erosion.	7
CONCRETE 8.00	Sound and durable.	7
CULVERT 1.00	18'W x 12'H concrete box	7
DOWNSLOPE 1.00	Flat roadbed.	7
LATERAL SLOPE 1.00	Gradual.	7
ROAD/SIDEWALK/SHOULDER 1.00	Flat shoulder.	7
WALL DRAINS 1.00	None observed.	7

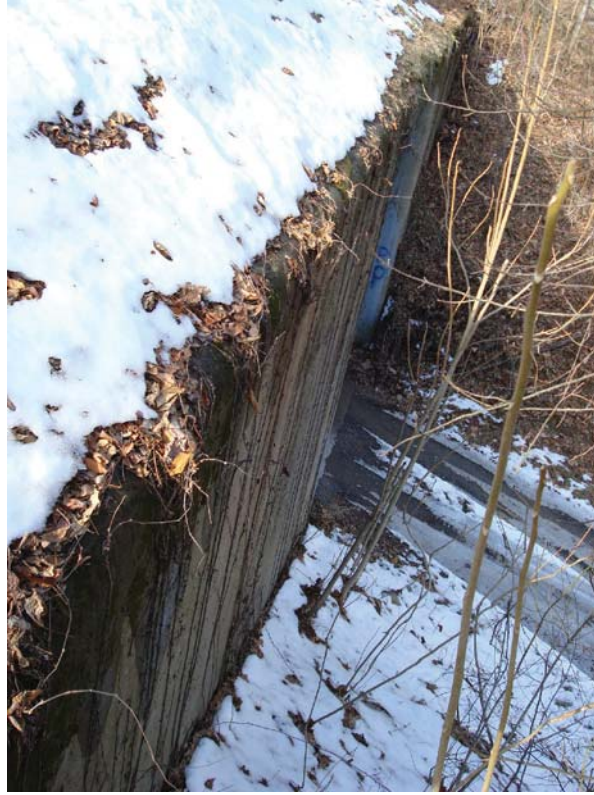
BLRI\_0001AB\_47.006\_L\_1.JPG

<b>Wall ID:</b>	BLRI-0001AB-47.006-L		
<b>Route Name:</b>	BLUE RIDGE PARKWAY - JAMES RIVER SUB-DISTRICT		
<b>Inspection Date:</b>	January 28, 2008	<b>Approximate Year Built:</b>	1940
<b>*Wall Rating:</b>	70	<b>Maintenance Action:</b>	No Action

<b>Element (Weighting Factor)</b>	<b>Narrative</b>	<b>Condition Rating (0 - 10)</b>
PERFORMANCE 8.00	No global distress.	7
WALL FOUNDATION MATERIAL 8.00	Soil. No settlement or erosion.	7
CONCRETE 8.00	Sound and durable.	7
CULVERT 1.00	18' W x 12'H concrete box	7
DOWNSLOPE 1.00	Flat roadbed.	7
LATERAL SLOPE 1.00	Gradual.	7
ROAD/SIDEWALK/SHOULDER 1.00	Flat shoulder.	7
WALL DRAINS 1.00	None observed.	7

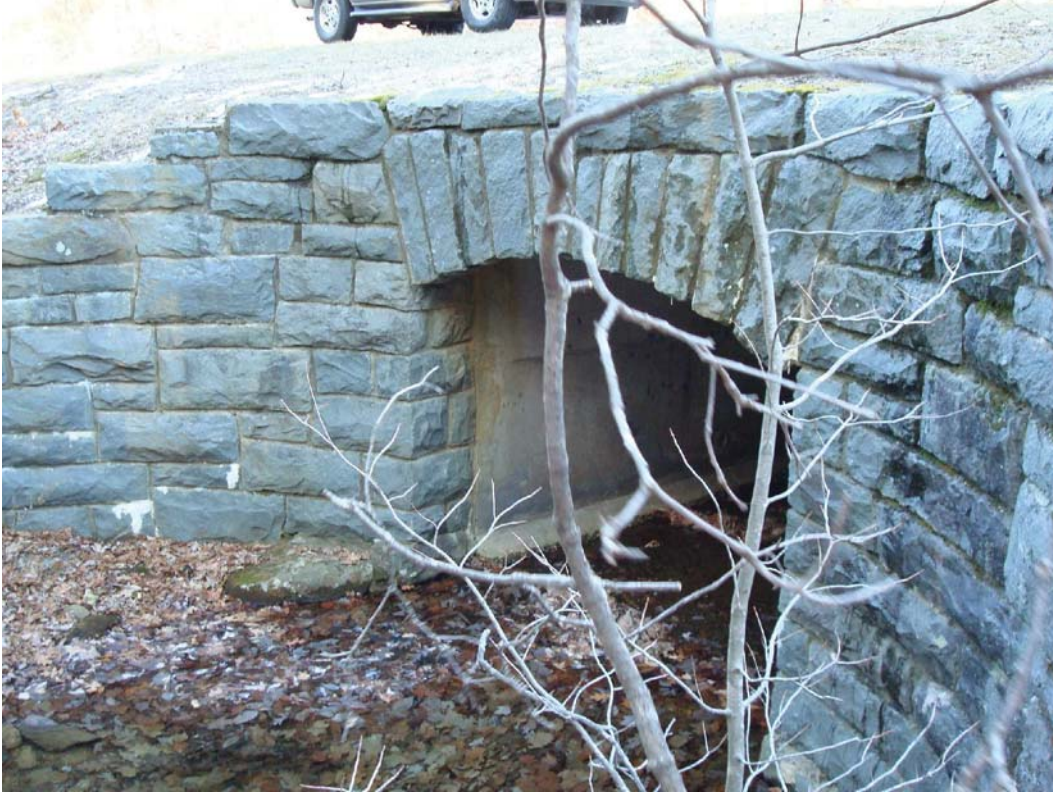
BLRI\_0001AB\_56.028\_R\_1.JPG

<b>Wall ID:</b>	BLRI-0001AB-56.028-R		
<b>Route Name:</b>	BLUE RIDGE PARKWAY - JAMES RIVER SUB-DISTRICT		
<b>Inspection Date:</b>	January 28, 2008	<b>Approximate Year Built:</b>	1940
<b>*Wall Rating:</b>	66	<b>Maintenance Action:</b>	Repair Elements

<b>Element (Weighting Factor)</b>	<b>Narrative</b>	<b>Condition Rating (0 - 10)</b>
PERFORMANCE 8.00	No global distress but moderate scour.	6
WALL FOUNDATION MATERIAL 8.00	Sand and gravel. No settlement, some erosion around headwall	6
MORTAR 8.00	Sound and durable.	7
STONE MASONRY 8.00	Replace cap stone.	7
DOWNSLOPE 0.50	Flat.	8
LATERAL SLOPE 0.50	Flat.	8
UPSLOPE 0.50	Gradual.	8
CULVERT 1.00	8' high by 9' wide	7
WALL DRAINS 1.00	Weepholes present.	7

<b>Failure Consequence:</b>	MODERATE
<b>Recommendation Narrative:</b>	Replace cap stone. S.F. x \$620/S.F. = \$1,240.
<b>Repair Cost:</b>	\$1,240

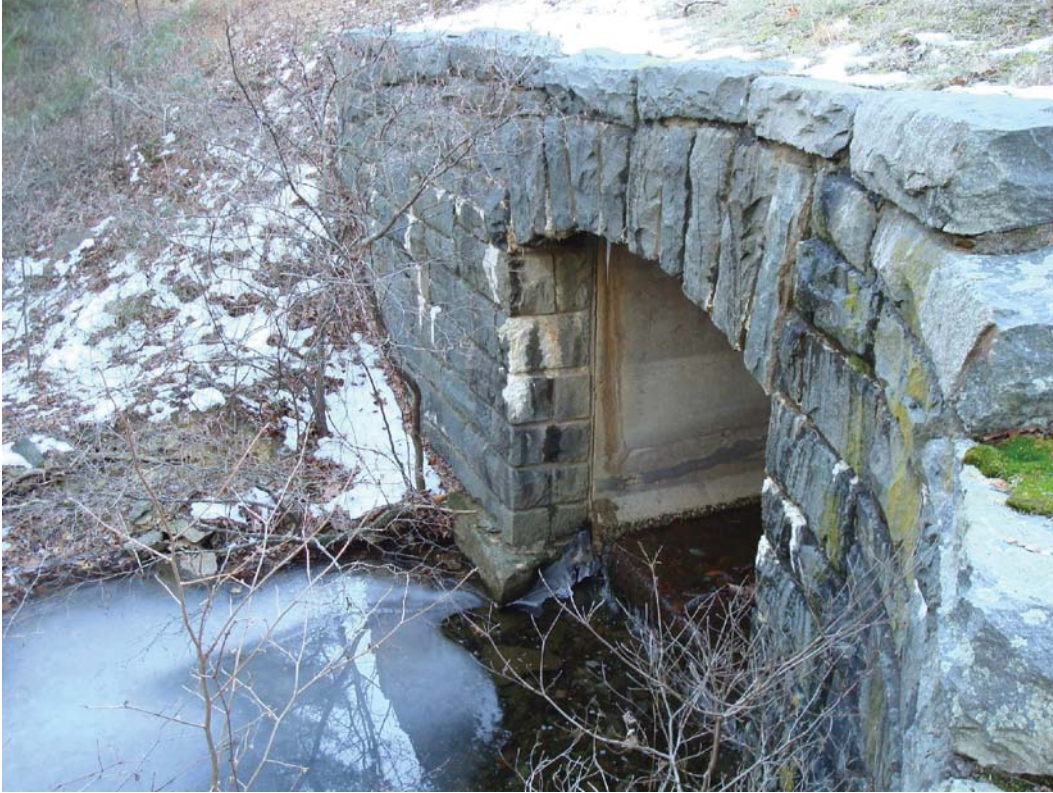
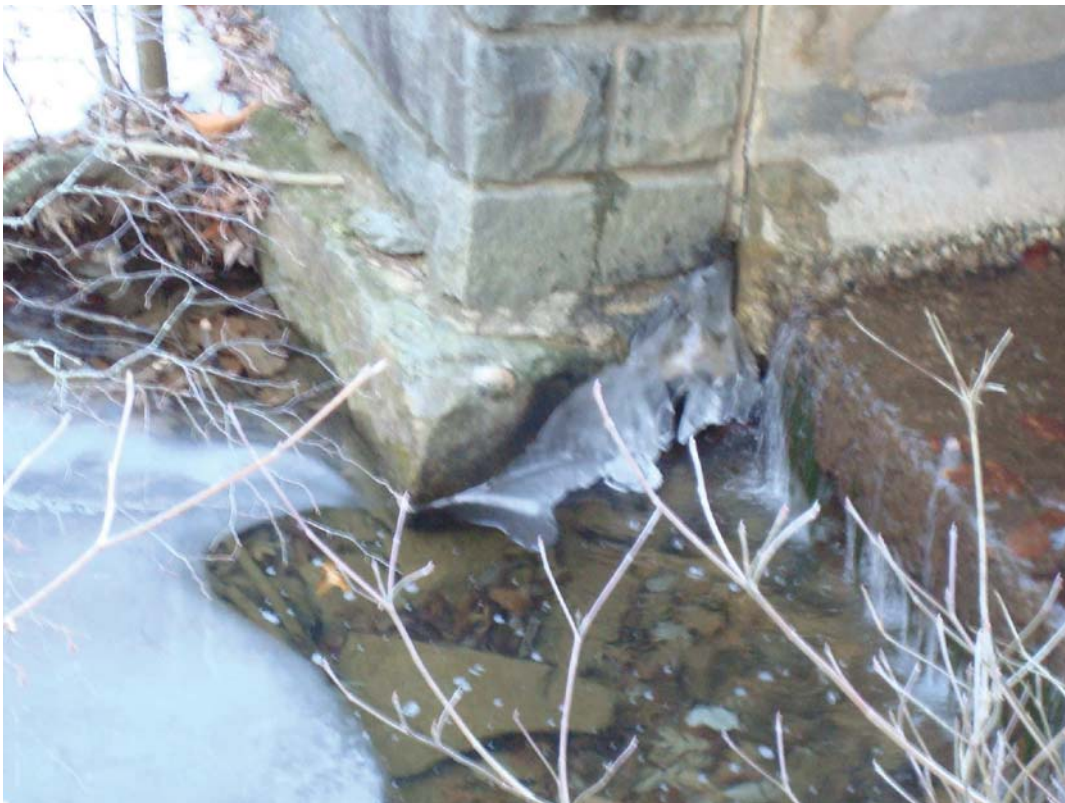
BLRI\_0001AB\_56.030\_L\_1.JPG

BLRI\_0001AB\_56.030\_L\_2.JPG

<b>Wall ID:</b>	BLRI-0001AB-56.030-L		
<b>Route Name:</b>	BLUE RIDGE PARKWAY - JAMES RIVER SUB-DISTRICT		
<b>Inspection Date:</b>	January 28, 2008	<b>Approximate Year Built:</b>	1940
<b>*Wall Rating:</b>	66	<b>Maintenance Action:</b>	No Action

<b>Element (Weighting Factor)</b>	<b>Narrative</b>	<b>Condition Rating (0 - 10)</b>
PERFORMANCE 8.00	No global distress but moderate scour.	6
WALL FOUNDATION MATERIAL 8.00	Sand and gravel. Some erosion around head wall. Moderate scour under foundation. No settlement.	6
MORTAR 8.00	Sound and durable.	7
STONE MASONRY 8.00	No degradation.	7
DOWNSLOPE 0.50	Flat.	8
LATERAL SLOPE 0.50	Flat.	8
UPSLOPE 0.50	Gradual.	8
CULVERT 1.00	8' high by 9' wide	7
WALL DRAINS 1.00	Weepholes present.	7

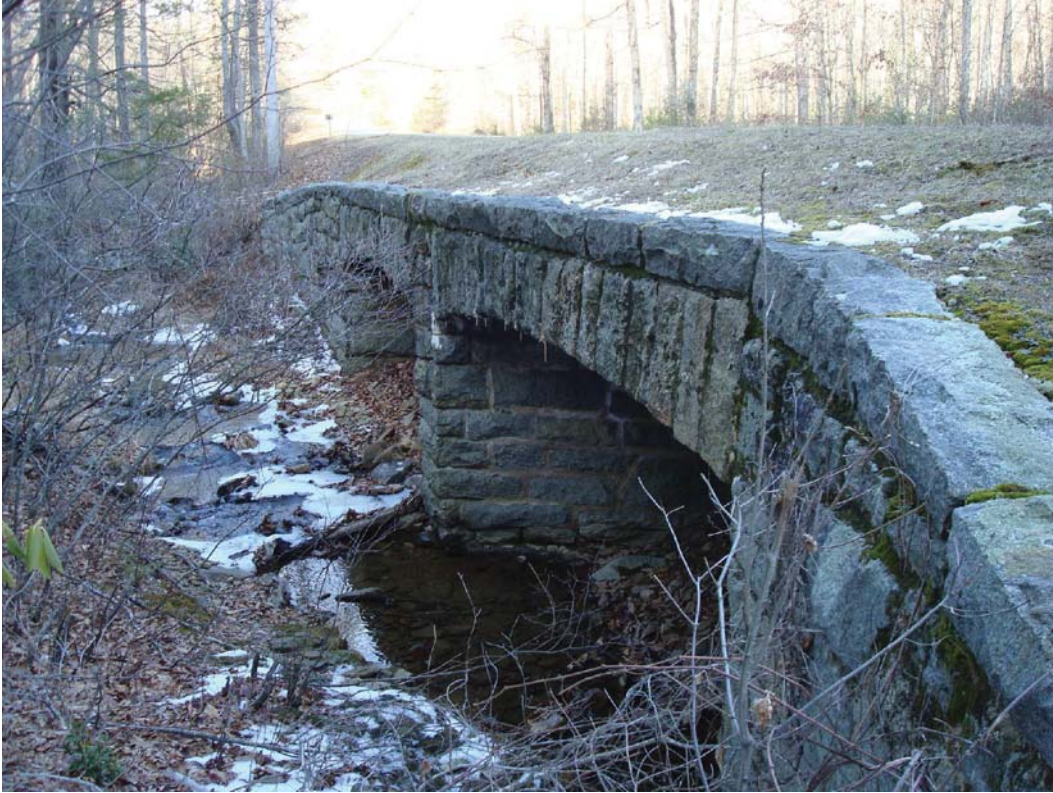
BLRI\_0001AB\_56.745\_R\_1.JPG

<b>Wall ID:</b>	BLRI-0001AB-56.745-R		
<b>Route Name:</b>	BLUE RIDGE PARKWAY - JAMES RIVER SUB-DISTRICT		
<b>Inspection Date:</b>	January 28, 2008	<b>Approximate Year Built:</b>	1940
<b>*Wall Rating:</b>	70	<b>Maintenance Action:</b>	No Action

<b>Element (Weighting Factor)</b>	<b>Narrative</b>	<b>Condition Rating (0 - 10)</b>
PERFORMANCE 8.00	No global distress.	7
WALL FOUNDATION MATERIAL 8.00	Sand, soil, and cobbles. No settlement or erosion.	7
MORTAR 8.00	Sound and durable.	7
STONE MASONRY 8.00	No degradation.	7
DOWNSLOPE 0.50	Flat.	8
LATERAL SLOPE 0.50	Flat.	8
ROAD/SIDEWALK/SHOULDER 0.50	Gradual shoulder.	8
CULVERT 1.00	17' wide by 10' high.	7
WALL DRAINS 1.00	None observed.	7

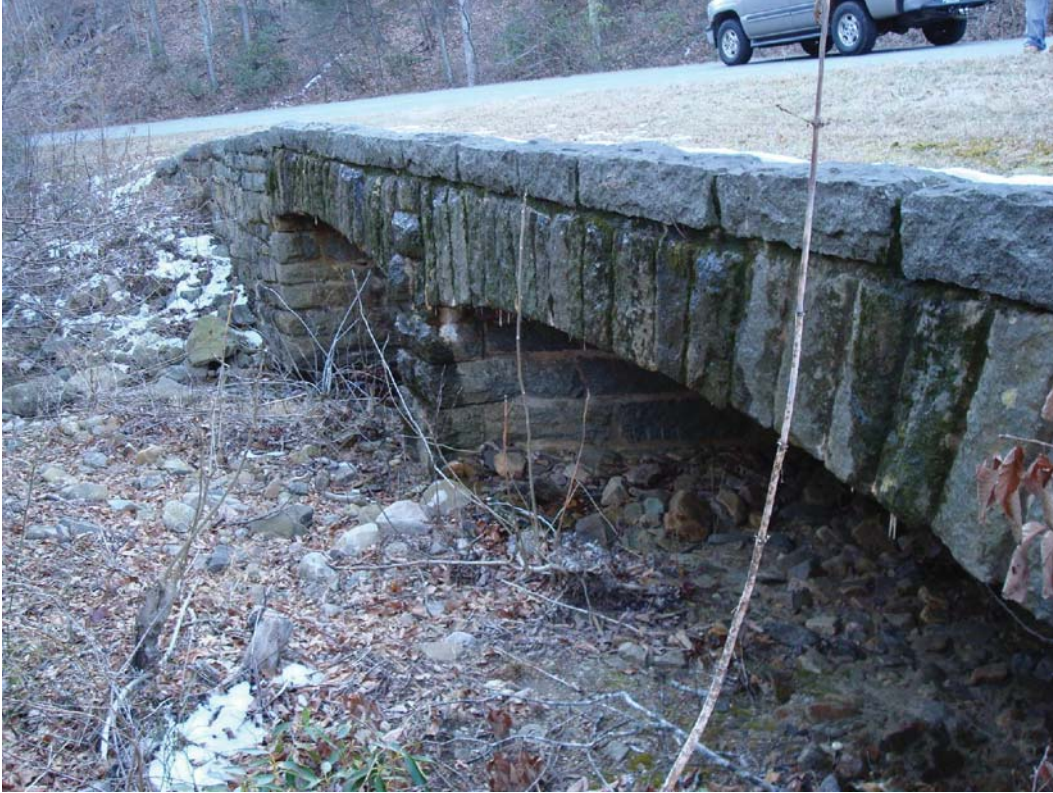
BLRI\_0001AB\_56.754\_L\_1.JPG

<b>Wall ID:</b>	BLRI-0001AB-56.754-L		
<b>Route Name:</b>	BLUE RIDGE PARKWAY - JAMES RIVER SUB-DISTRICT		
<b>Inspection Date:</b>	January 28, 2008	<b>Approximate Year Built:</b>	1940
<b>*Wall Rating:</b>	70	<b>Maintenance Action:</b>	No Action

<b>Element (Weighting Factor)</b>	<b>Narrative</b>	<b>Condition Rating (0 - 10)</b>
PERFORMANCE 8.00	No global distress.	7
WALL FOUNDATION MATERIAL 8.00	Sand, soil, and cobbles. No settlement or erosion.	7
MORTAR 8.00	Sound and durable.	7
STONE MASONRY 8.00	No degradation.	7
DOWNSLOPE 0.50	Flat.	8
LATERAL SLOPE 0.50	Flat.	8
ROAD/SIDEWALK/SHOULDER 0.50	Gradual.	8
CULVERT 1.00	17' wide x 10' high	7
WALL DRAINS 1.00	None observed.	7

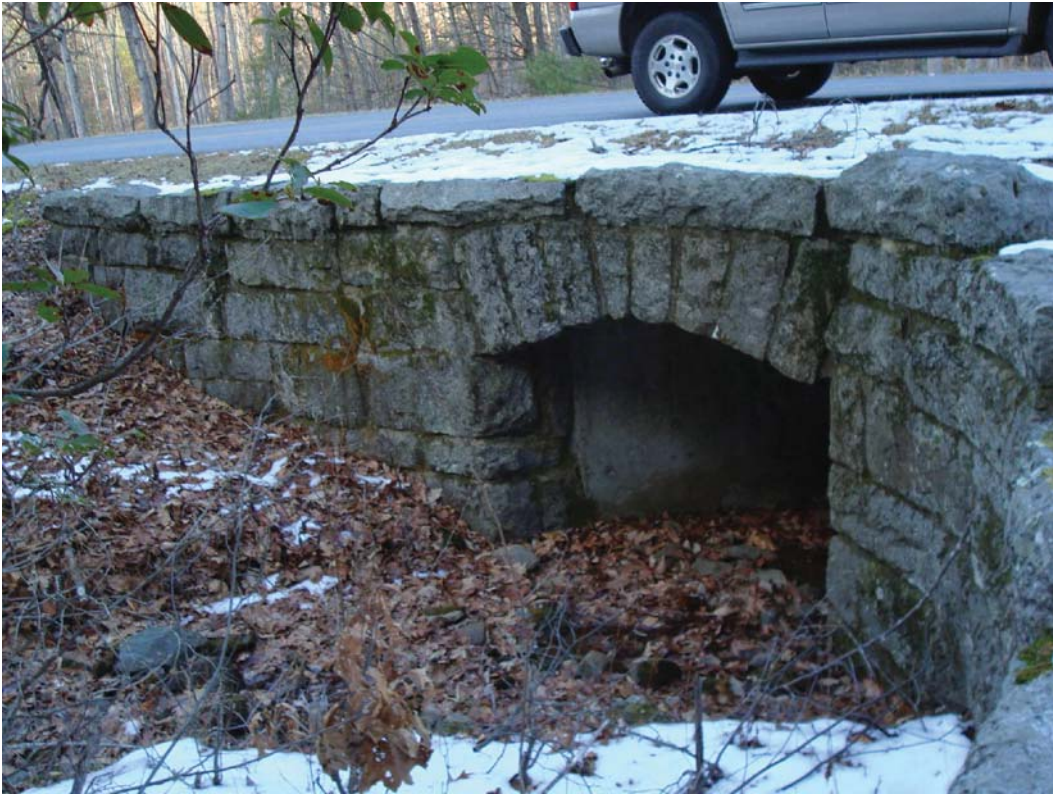
BLRI\_0001AB\_57.168\_R\_1.JPG

<b>Wall ID:</b>	BLRI-0001AB-57.168-R		
<b>Route Name:</b>	BLUE RIDGE PARKWAY - JAMES RIVER SUB-DISTRICT		
<b>Inspection Date:</b>	January 28, 2008	<b>Approximate Year Built:</b>	1940
<b>*Wall Rating:</b>	70	<b>Maintenance Action:</b>	No Action

<b>Element (Weighting Factor)</b>	<b>Narrative</b>	<b>Condition Rating (0 - 10)</b>
PERFORMANCE 8.00	No global distress.	7
WALL FOUNDATION MATERIAL 8.00	Soil. No settlement or erosion.	7
MORTAR 8.00	Sound and durable.	7
STONE MASONRY 8.00	No degradation.	7
DOWNSLOPE 0.50	Flat	8
LATERAL SLOPE 0.50	Flat.	8
ROAD/SIDEWALK/SHOULDER 0.50	Flat shoulder.	8
CULVERT 1.00	7' wide by 4' high concrete box.	7
WALL DRAINS 1.00	None observed.	7

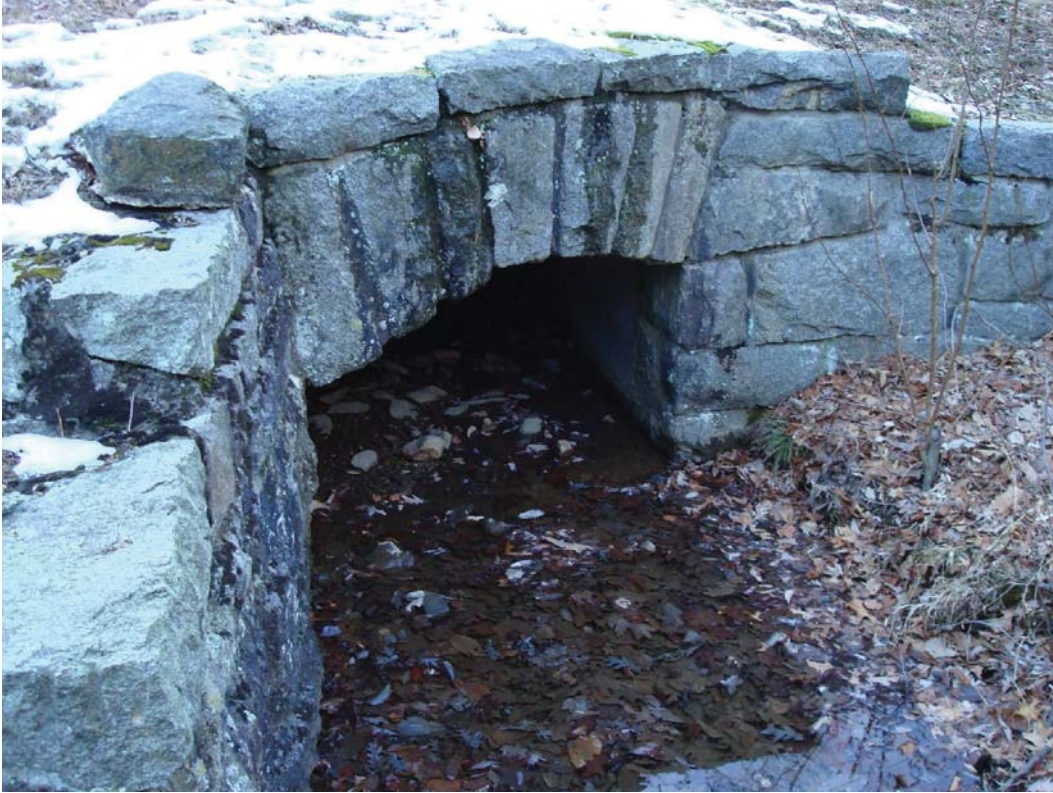
BLRI\_0001AB\_57.171\_L\_1.JPG

<b>Wall ID:</b>	BLRI-0001AB-57.171-L		
<b>Route Name:</b>	BLUE RIDGE PARKWAY - JAMES RIVER SUB-DISTRICT		
<b>Inspection Date:</b>	January 28, 2008	<b>Approximate Year Built:</b>	1940
<b>*Wall Rating:</b>	70	<b>Maintenance Action:</b>	Repair Elements

<b>Element (Weighting Factor)</b>	<b>Narrative</b>	<b>Condition Rating (0 - 10)</b>
PERFORMANCE 8.00	No global distress.	7
WALL FOUNDATION MATERIAL 8.00	Soil. No settlement or erosion.	7
MORTAR 8.00	Sound and durable	7
STONE MASONRY 8.00	Reset capstone.	7
DOWNSLOPE 0.50	Flat.	8
LATERAL SLOPE 0.50	Flat.	8
CULVERT 1.00	7' wide by 4' high concrete box.	7
ROAD/SIDEWALK/SHOULDER 1.00	Flat shoulder	7
WALL DRAINS 1.00	None observed.	7

<b>Failure Consequence:</b>	LOW
<b>Recommendation Narrative:</b>	Reset Capstone, repoint mortar 15 S.F. x \$75/S.F. = \$1,125.
<b>Repair Cost:</b>	\$1,125

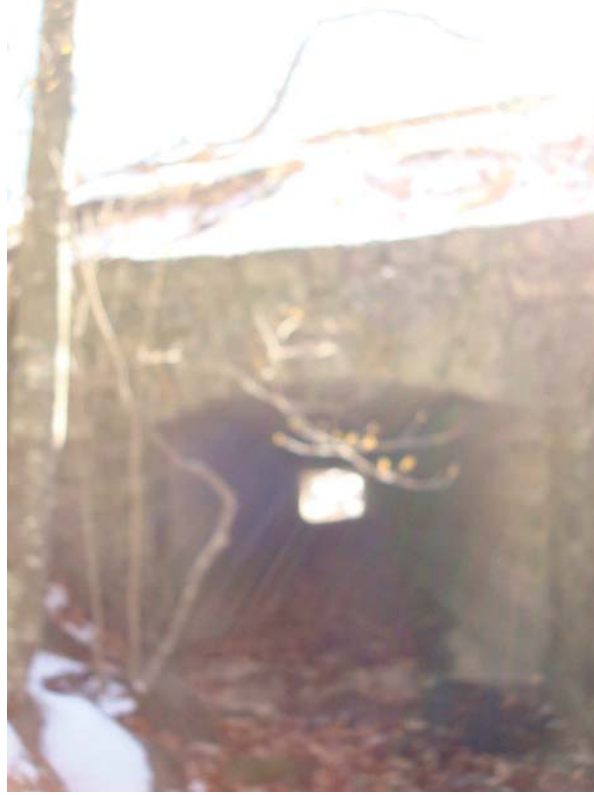
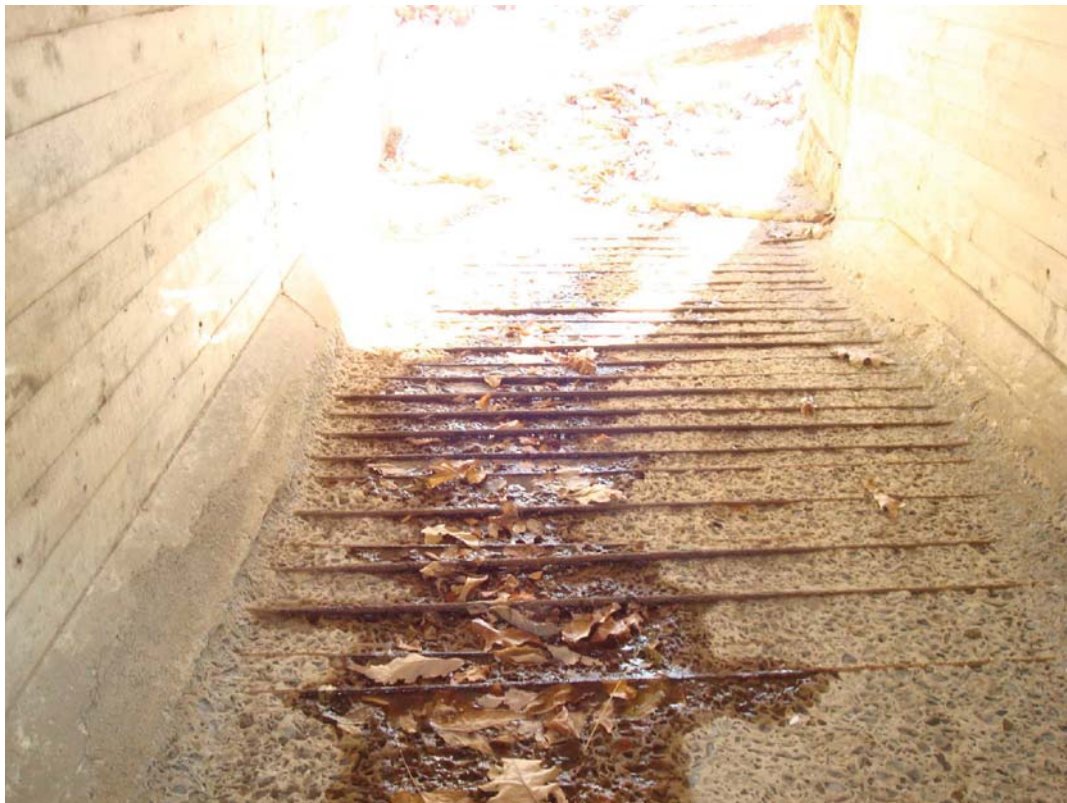
BLRI\_0001AB\_68.798\_R\_1.JPG

<b>Element (Weighting Factor)</b>	<b>Narrative</b>	<b>Condition Rating (0 - 10)</b>
PERFORMANCE 8.00	No global distress. Culvert needs significant repairs.	5
WALL FOUNDATION MATERIAL 8.00	Cobbly/bouldery soil. No settlement. Scour beneath/in front of culvert = 4' x 2' x 1'	6
MORTAR 8.00	Sound and durable.	7
STONE MASONRY 8.00	No degradation.	7
CULVERT 1.00	6.4' high by 8' wide concrete box by 150' long. Exposed reinforced steel at bottom, crack around interior perimeter, bottom of culvert pitted (lost aggregate) and wavy (eroded) throughout, fissured/fractured.	4
TRAFFIC BARRIER/FENCE 0.50	PT post and rail.	8
DOWNSLOPE 1.00	Streambed, slight rise.	7
LATERAL SLOPE 1.00	Slight slope.	7
UPSLOPE 1.00	Flat then 2H:1V	7

<b>Failure Consequence:</b>	MODERATE
<b>Recommendation Narrative:</b>	Reseal culvert floor, grout cracks - 8'x150' = 1,200 S.F., 1,200 S.F. * \$15/S.F. = \$18,000. Lean concrete apron in front of culvert - say 1 C.Y. * \$175/C.Y. = \$175.
<b>Repair Cost:</b>	\$18,175

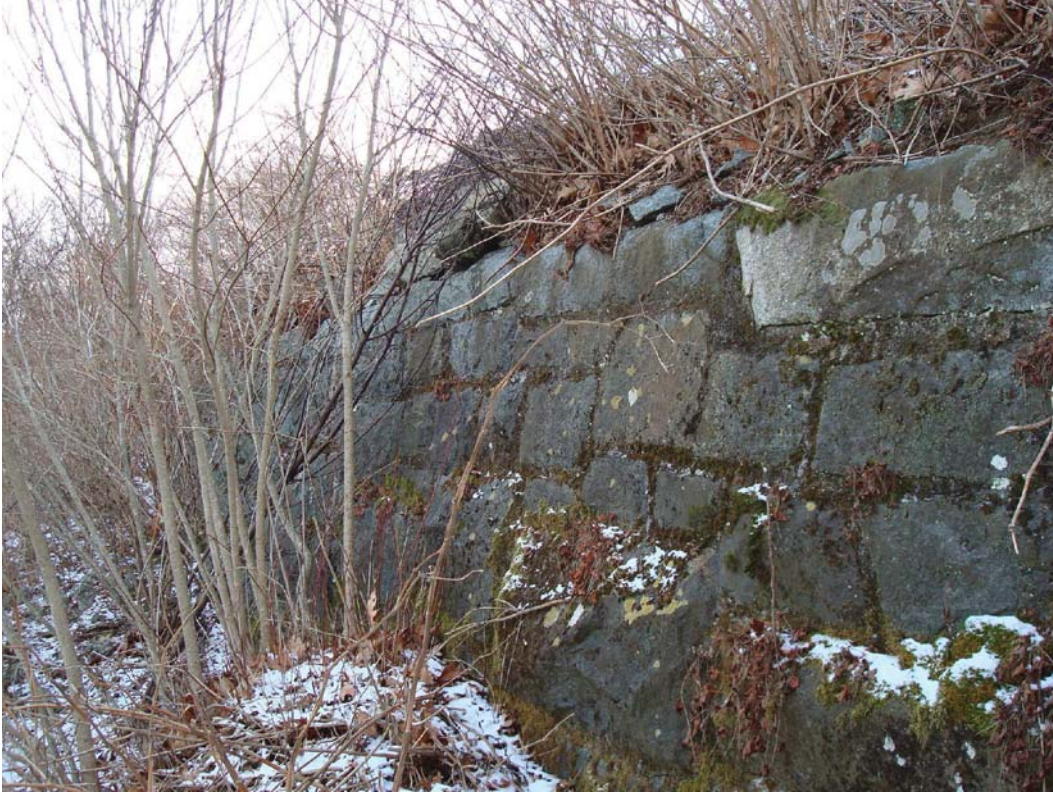
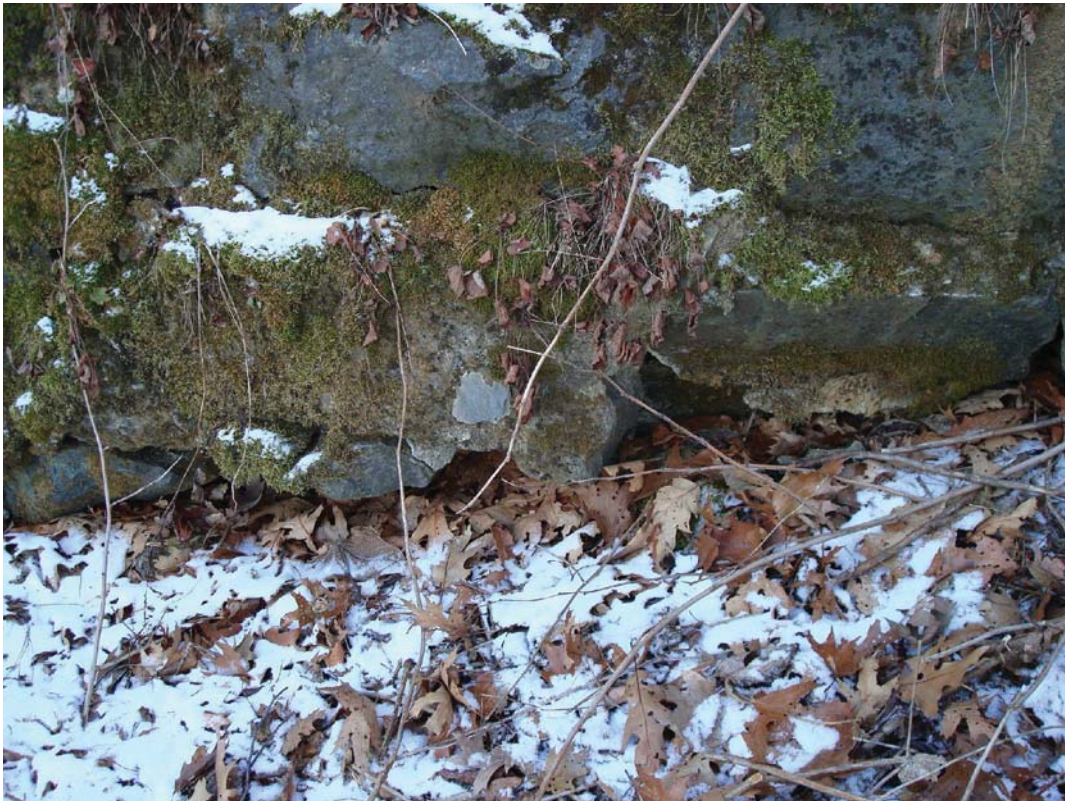
BLRI\_0001AC\_75.822\_R\_1.JPG

<b>Element (Weighting Factor)</b>	<b>Narrative</b>	<b>Condition Rating (0 - 10)</b>
PERFORMANCE 8.00	No global distress	7
WALL FOUNDATION MATERIAL 8.00	Soil/rock No settlement or erosion	7
MORTAR 8.00	10% minor cracking, otherwise sound and durable	7
STONE MASONRY 8.00	No degradation	8
TRAFFIC BARRIER/FENCE 0.50	Wood rail, no distress	8
VEGETATION 1.00	Vegetation covers top of wall and in front	6
DOWNSLOPE 1.00	2H:1V	7
LATERAL SLOPE 1.00	Gradual	7
WALL DRAINS 1.00	None	7

<b>Failure Consequence:</b>	LOW
<b>Recommendation Narrative:</b>	Clear vegetation on top and 5' width in front of wall - 10 hrs x \$55/hr = \$550
<b>Repair Cost:</b>	\$550

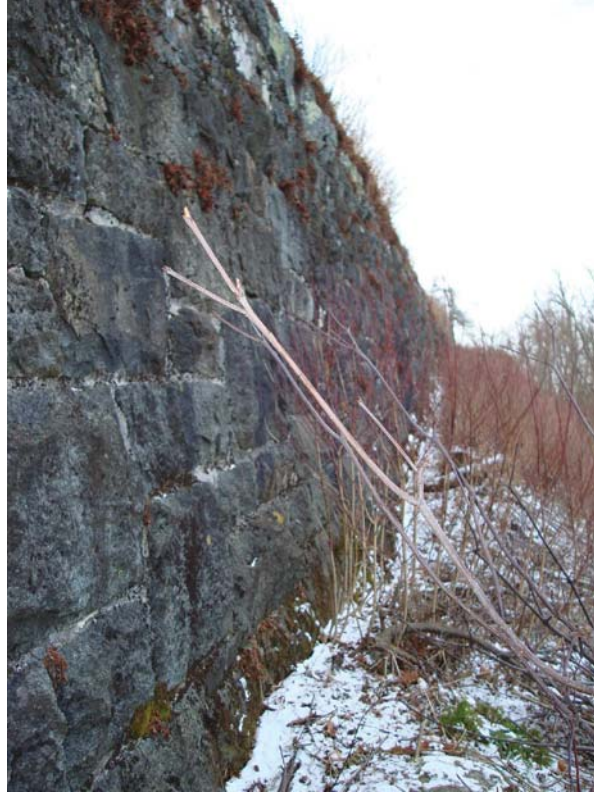
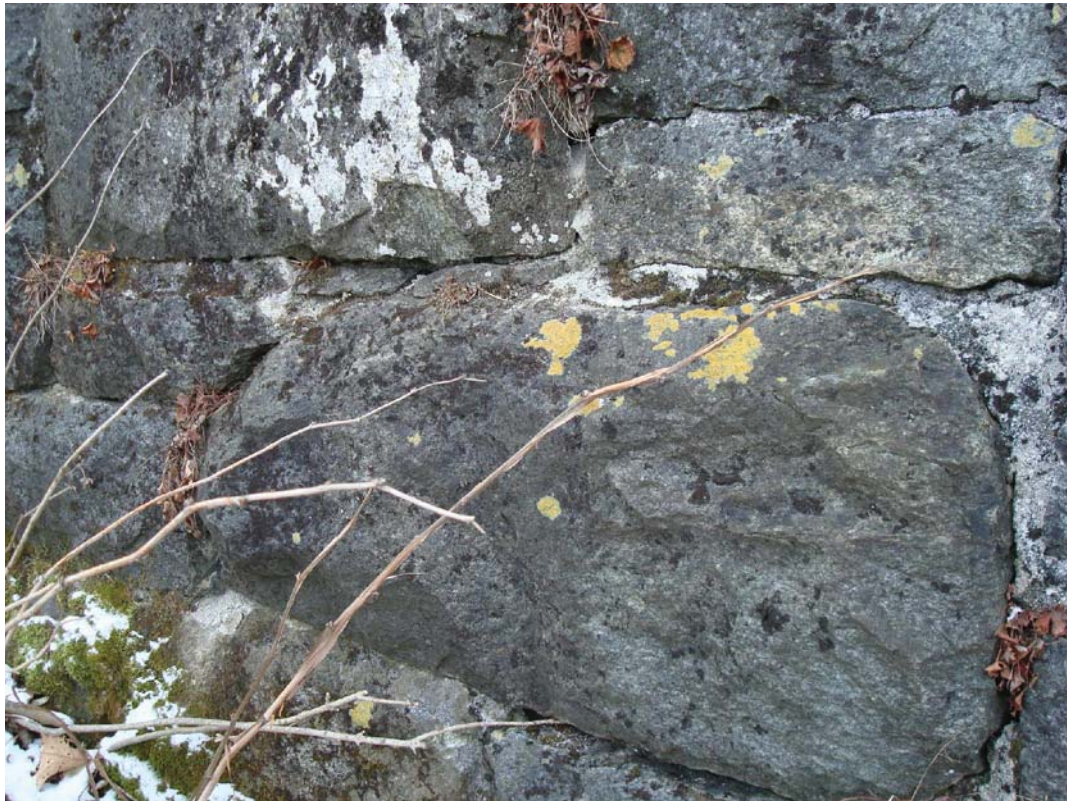
BLRI\_0001AC\_75.901\_R\_1.JPG

<b>Element (Weighting Factor)</b>	<b>Narrative</b>	<b>Condition Rating (0 - 10)</b>
PERFORMANCE 8.00	No global distress	7
WALL FOUNDATION MATERIAL 8.00	Soil No settlement or erosion	7
MORTAR 8.00	20% missing, cracked	6
STONE MASONRY 8.00	No degradation	8
TRAFFIC BARRIER/FENCE 0.50	Wood rail, no distress	8
DOWNSLOPE 1.00	Flat 6', then 1H:1V	6
UPSLOPE 1.00	Flat 14', then 1.5H:1V	6
LATERAL SLOPE 1.00	Gradual	7
WALL DRAINS 1.00	None	7

<b>Failure Consequence:</b>	LOW
<b>Recommendation Narrative:</b>	Repoint mortar - 20% x 3,050 sf = 610 sf, 610 sf x \$75/sf = \$45,750
<b>Repair Cost:</b>	\$45,750

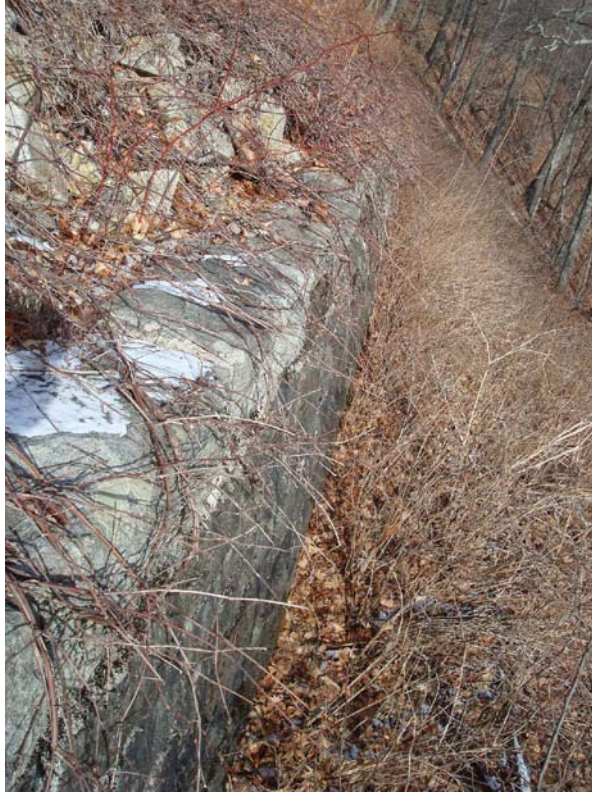
BLRI\_0001AC\_79.392\_L\_1.JPG

<b>Element (Weighting Factor)</b>	<b>Narrative</b>	<b>Condition Rating (0 - 10)</b>
PERFORMANCE 8.00	No global distress	7
WALL FOUNDATION MATERIAL 8.00	Rock/soil No settlement or erosion	7
MORTAR 8.00	Sound and durable	7
STONE MASONRY 8.00	No degradation	7
UPSLOPE 1.00	1H:1V	5
DOWNSLOPE 1.00	Flat, then 3H:1V	7
LATERAL SLOPE 1.00	Gradual	7
WALL DRAINS 1.00	Not observed	7
