# BLRI WIP Report

## NPS Retaining Wall Inventory Program Blue Ridge Parkway

Federal Highway Administration  
Eastern Federal Lands Highway Division  
Road Inventory Program (RIP)

# Blue Ridge Parkway in North Carolina and Virginia

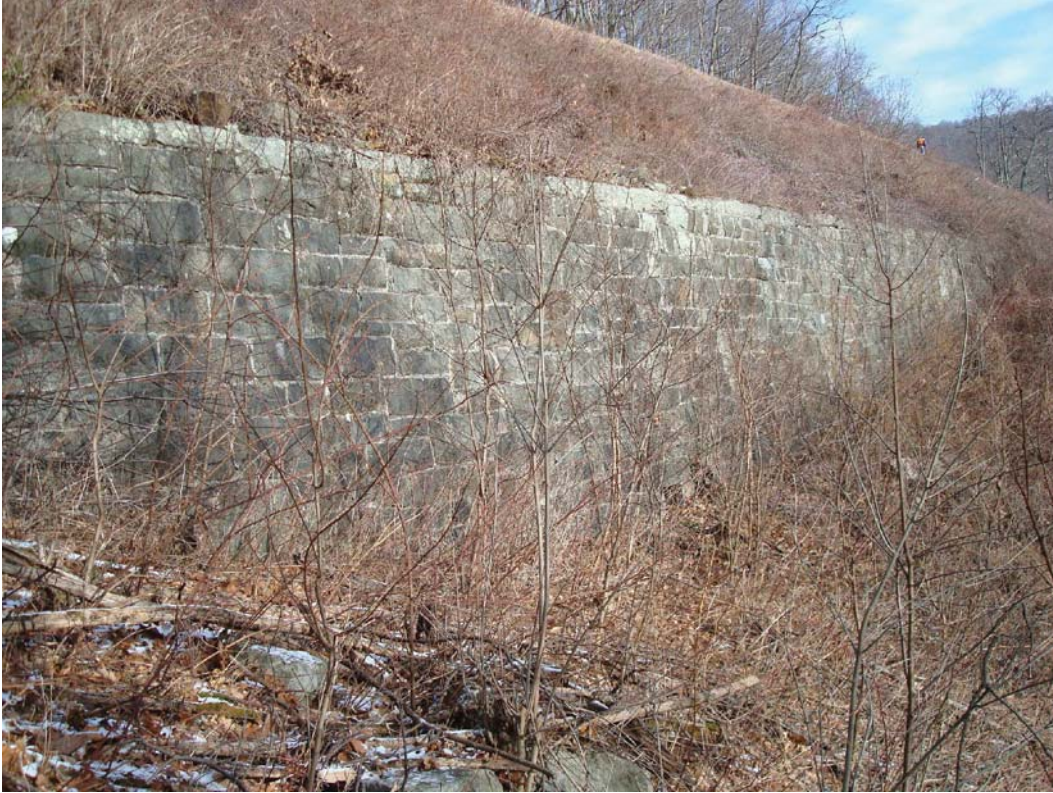
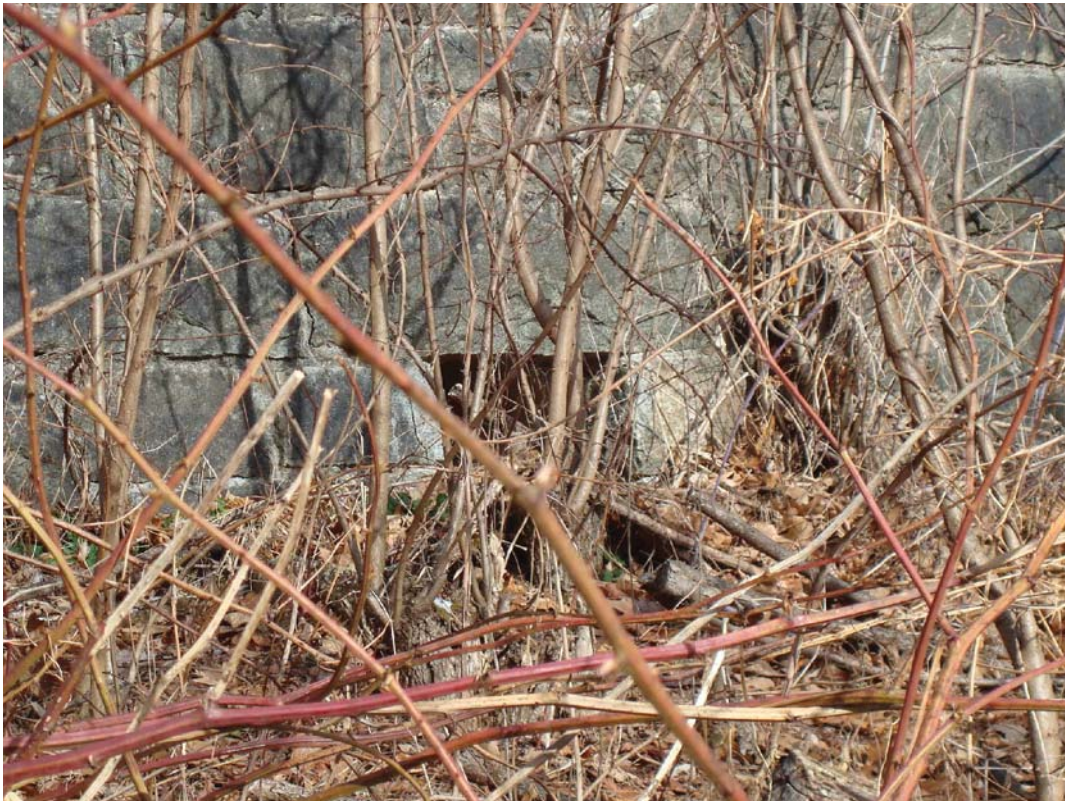
BLRI\_0001AC\_79.473\_L\_1.JPG

<b>Element (Weighting Factor)</b>	<b>Narrative</b>	<b>Condition Rating (0 - 10)</b>
PERFORMANCE 8.00	No global distress	7
WALL FOUNDATION MATERIAL 8.00	Soil/rock No settlement or erosion	7
MORTAR 8.00	Loose capstones, 3'x15' = 45 sf Repoint/reset	6
STONE MASONRY 8.00	No degradation	7
UPSLOPE 1.00	Steep, 1H:1V	5
CULVERT 1.00	Square culvert, 2' x 2', no apparent distress	7
DOWNSLOPE 1.00	4H:1V to 2H:1V	7
LATERAL SLOPE 1.00	Gradual	7
WALL DRAINS 1.00	None	7

<b>Failure Consequence:</b>	MODERATE
<b>Recommendation Narrative:</b>	Reset Capstones - 45 sf x \$160/sf = \$7,200
<b>Repair Cost:</b>	\$7,200

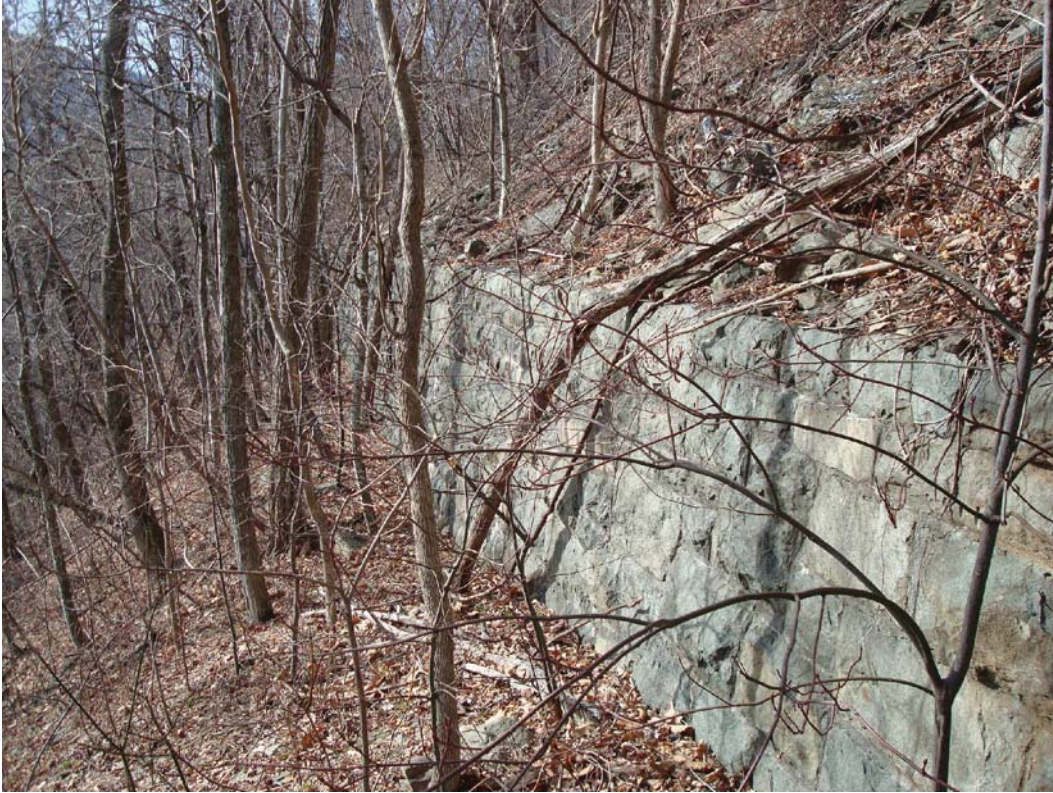
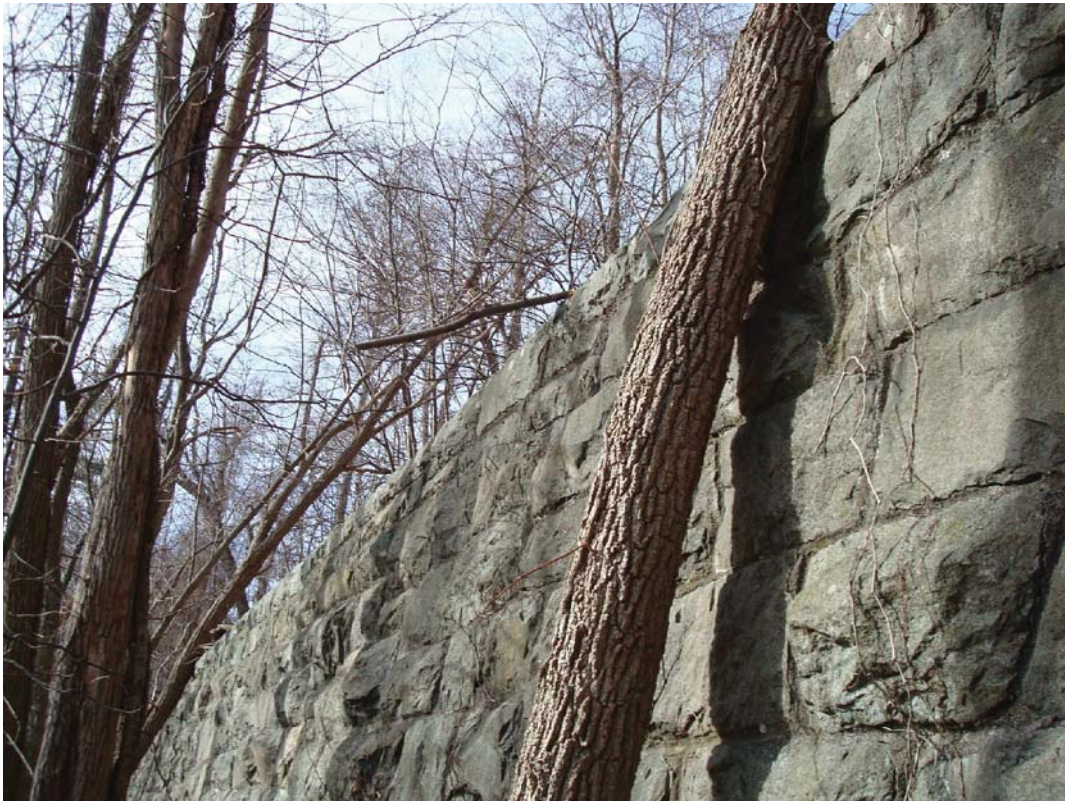
BLRI\_0001AC\_82.912\_L\_1.JPG

<b>Element (Weighting Factor)</b>	<b>Narrative</b>	<b>Condition Rating (0 - 10)</b>
PERFORMANCE 8.00	No global distress	7
WALL FOUNDATION MATERIAL 8.00	Soil/rock No settlement or erosion	7
MORTAR 8.00	Sound and durable	7
STONE MASONRY 8.00	No degradation	8
UPSLOPE 1.00	1H:1V	5
DOWNSLOPE 1.00	Flat, then 2H:1V	6
VEGETATION 1.00	2 trees leaning on wall - need to be cut	6
LATERAL SLOPE 1.00	Gradual	7
WALL DRAINS 1.00	None	7

<b>Failure Consequence:</b>	LOW
<b>Recommendation Narrative:</b>	Cut 2 trees - \$955/tree x 2 trees = \$1,910
<b>Repair Cost:</b>	\$1,910

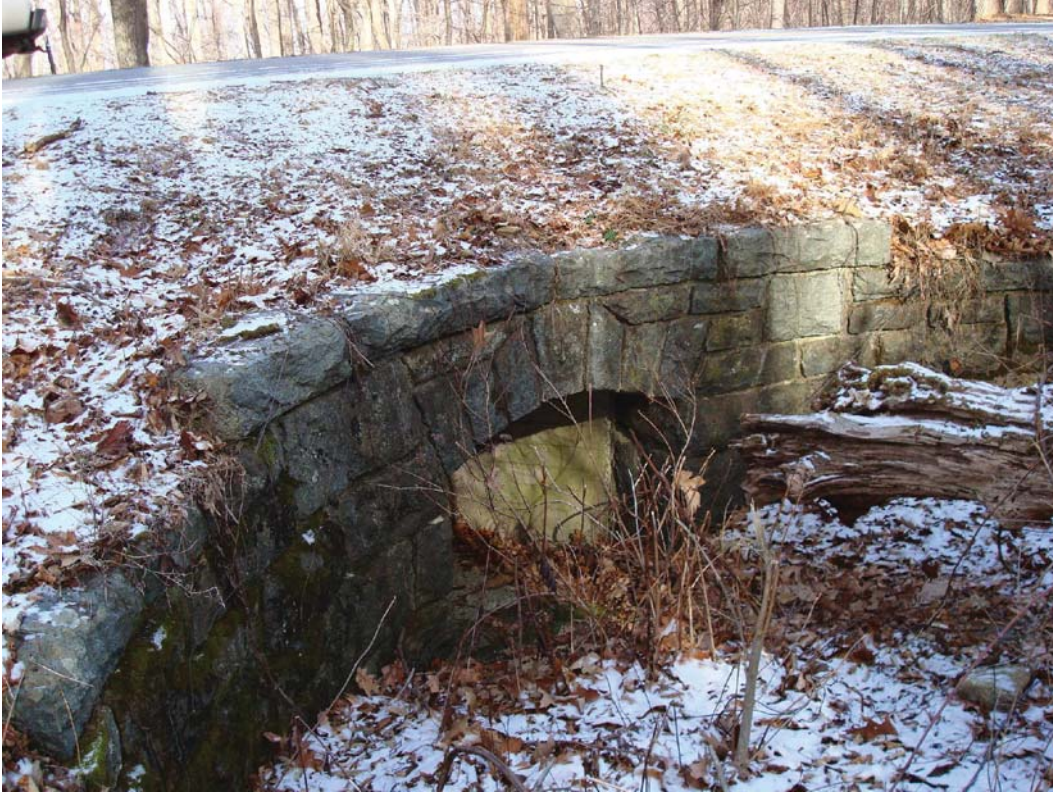
BLRI\_0001AC\_84.753\_L\_1.JPG

<b>Element (Weighting Factor)</b>	<b>Narrative</b>	<b>Condition Rating (0 - 10)</b>
PERFORMANCE 8.00	No global distress	7
WALL FOUNDATION MATERIAL 8.00	Bouldery soil No settlement or erosion	7
MORTAR 8.00	Overall sound and durable, slight cracking/missing mortar	7
STONE MASONRY 8.00	No degradation	7
UPSLOPE 0.50	Gradual slope	8
CULVERT 1.00	4'H x 5'W concrete box	7
DOWNSLOPE 1.00	Upsloping	7
LATERAL SLOPE 1.00	Gradual slope	7
WALL DRAINS 1.00	None	7

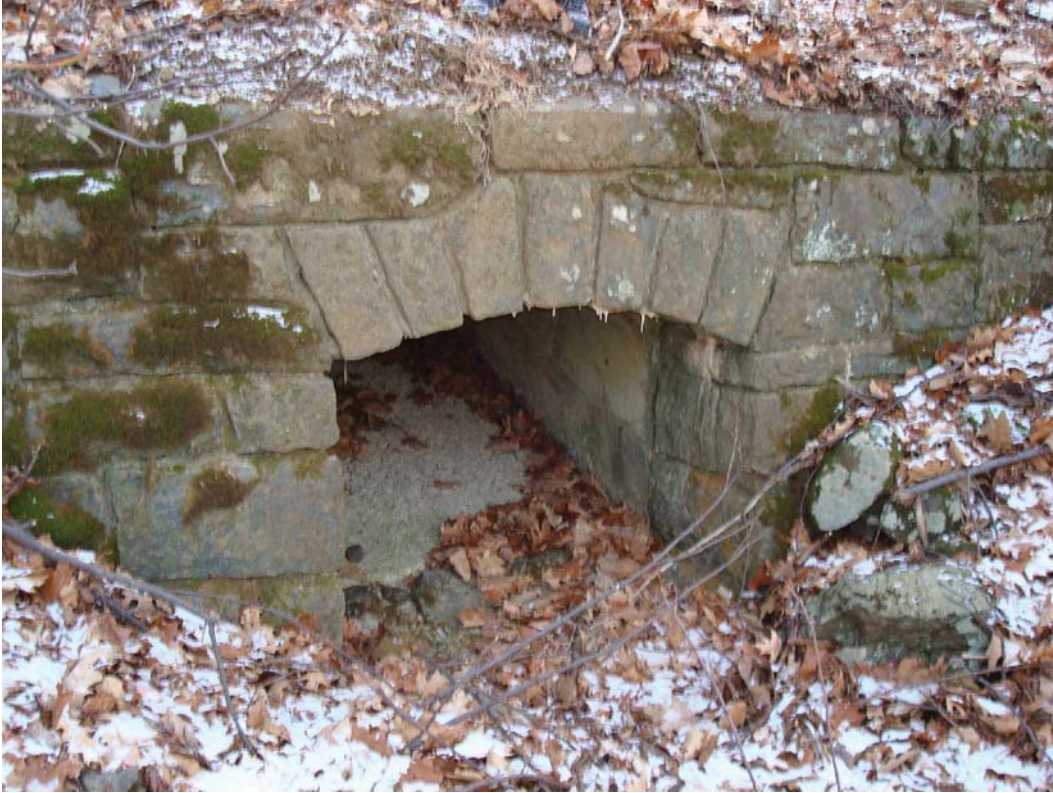
BLRI\_0001AC\_84.753\_R\_1.JPG

<b>Element (Weighting Factor)</b>	<b>Narrative</b>	<b>Condition Rating (0 - 10)</b>
PERFORMANCE 8.00	No global distress	7
WALL FOUNDATION MATERIAL 8.00	Bouldery soil No settlement or erosion	7
MORTAR 8.00	Sound and durable slight cracking, missing mortar	7
STONE MASONRY 8.00	No degradation	7
UPSLOPE 0.50	Gradual slope	8
CULVERT 1.00	5'W x 4'H concrete box	7
DOWNSLOPE 1.00	Upsloping	7
LATERAL SLOPE 1.00	Gradual slope	7
WALL DRAINS 1.00	none	7

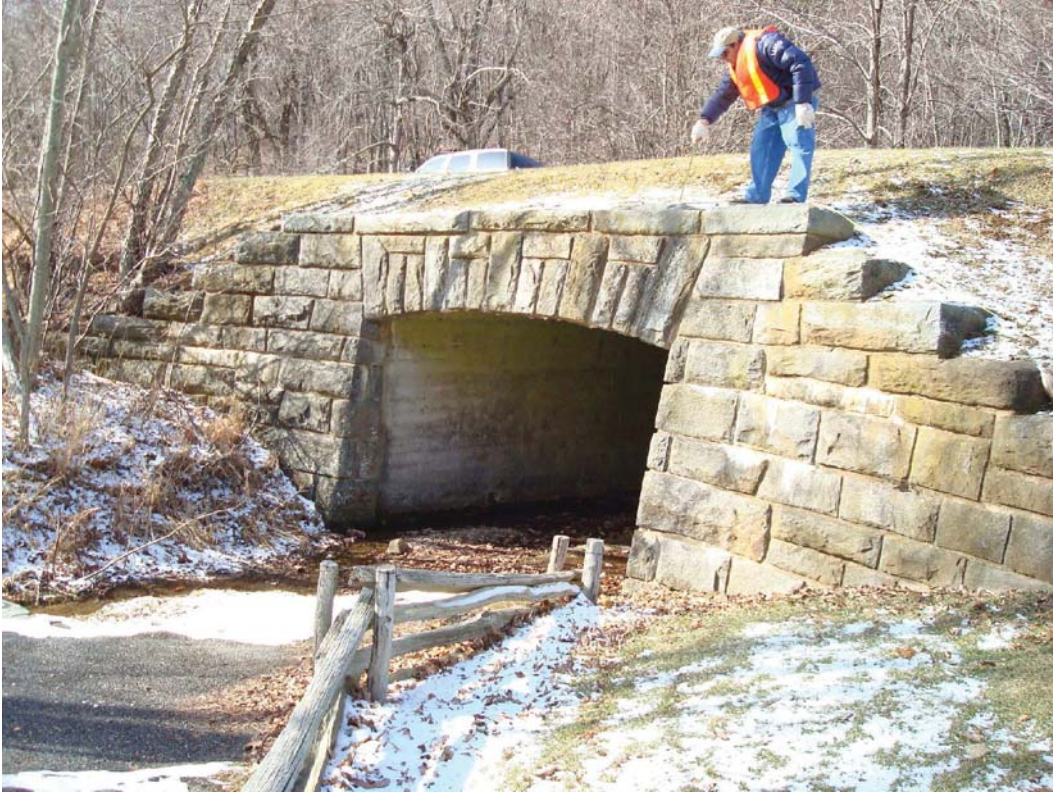
BLRI\_0001AC\_85.792\_L\_1.JPG

<b>Element (Weighting Factor)</b>	<b>Narrative</b>	<b>Condition Rating (0 - 10)</b>
PERFORMANCE 8.00	No global distress	8
WALL FOUNDATION MATERIAL 8.00	Soil No settlement or erosion	7
MORTAR 8.00	Sound and durable	7
STONE MASONRY 8.00	No degradation	8
DOWNSLOPE 0.50	Gradual, trail	8
LATERAL SLOPE 0.50	Flat	8
ROAD/SIDEWALK/SHOULDER 0.50	Nearly flat, grassy shoulder	8
CULVERT 1.00	8'H x 11.5'W concrete box Asphalt approach, partial portland cement concrete sidewalk inside	7
WALL DRAINS 1.00	Weep holes 10' on center, square	7

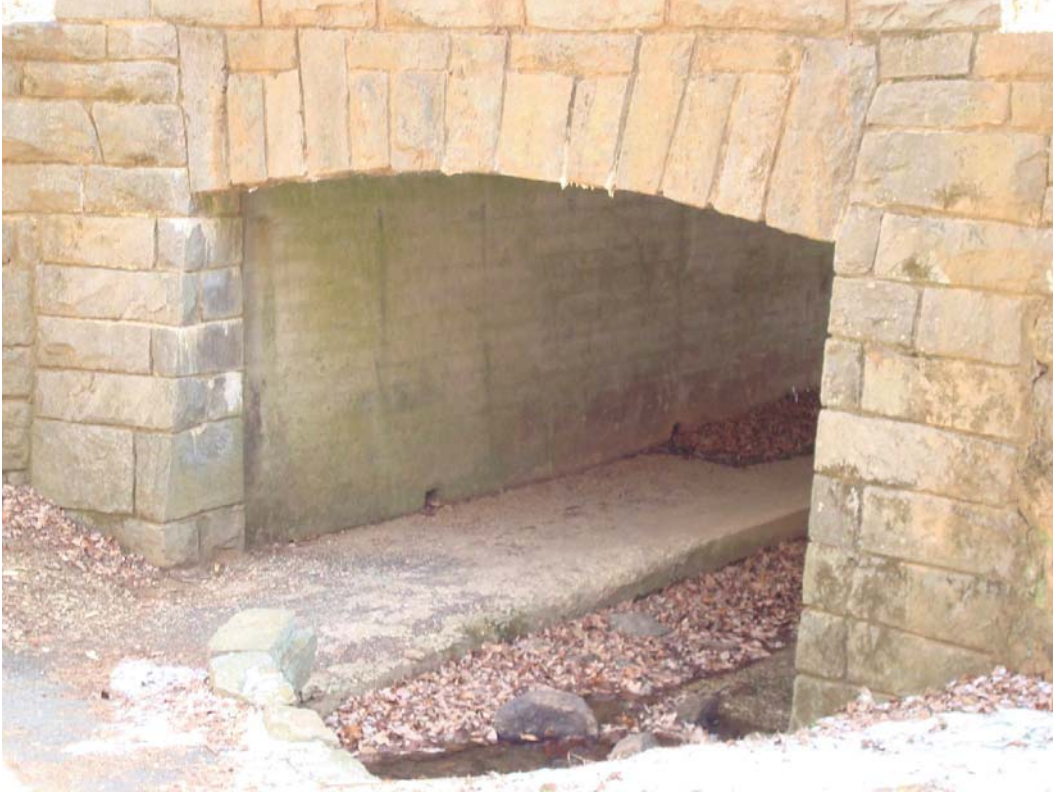
BLRI\_0001AC\_85.792\_R\_1.JPG

<b>Element (Weighting Factor)</b>	<b>Narrative</b>	<b>Condition Rating (0 - 10)</b>
PERFORMANCE 8.00	No global distress	7
WALL FOUNDATION MATERIAL 8.00	Soil No settlement or erosion	7
MORTAR 8.00	Sound and durable	7
STONE MASONRY 8.00	No degradation	8
DOWNSLOPE 0.50	Gradual, trail	8
LATERAL SLOPE 0.50	Flat	8
ROAD/SIDEWALK/SHOULDER 0.50	Nearly flat, grassy shoulder	8
CULVERT 1.00	8'H x 11.5'W concrete box Asphalt approach, partial portland cement concrete sidewalk inside	7
WALL DRAINS 1.00	Weep holes, 10' on center, square	7

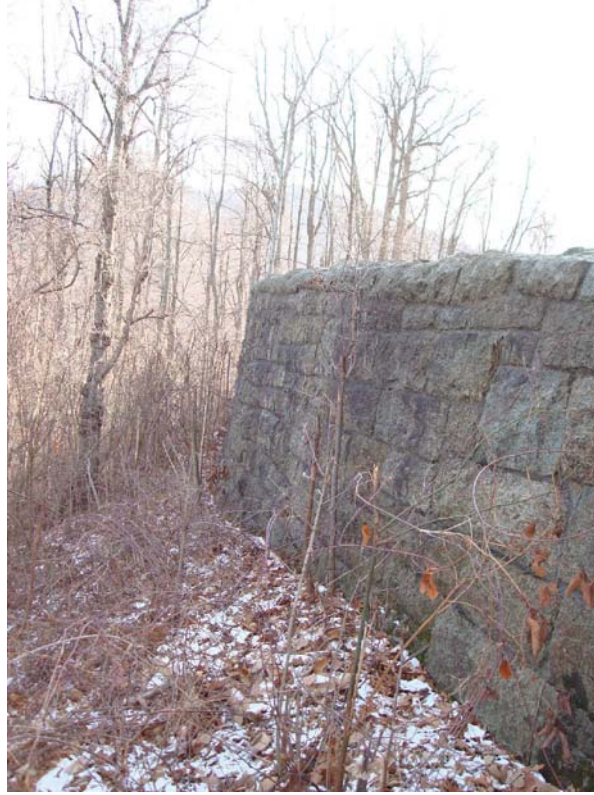
BLRI\_0001AC\_88.438\_R\_1.JPG

<b>Element (Weighting Factor)</b>	<b>Narrative</b>	<b>Condition Rating (0 - 10)</b>
PERFORMANCE 8.00	No global distress	7
WALL FOUNDATION MATERIAL 8.00	No settlement or erosion	7
MORTAR 8.00	Sound and durable	7
STONE MASONRY 8.00	No degradation	7
ROAD/SIDEWALK/SHOULDER 0.50	Flat shoulder	8
DOWNSLOPE 1.00	3H:1V	7
LATERAL SLOPE 1.00	Gradual	7
WALL DRAINS 1.00	None observed	7

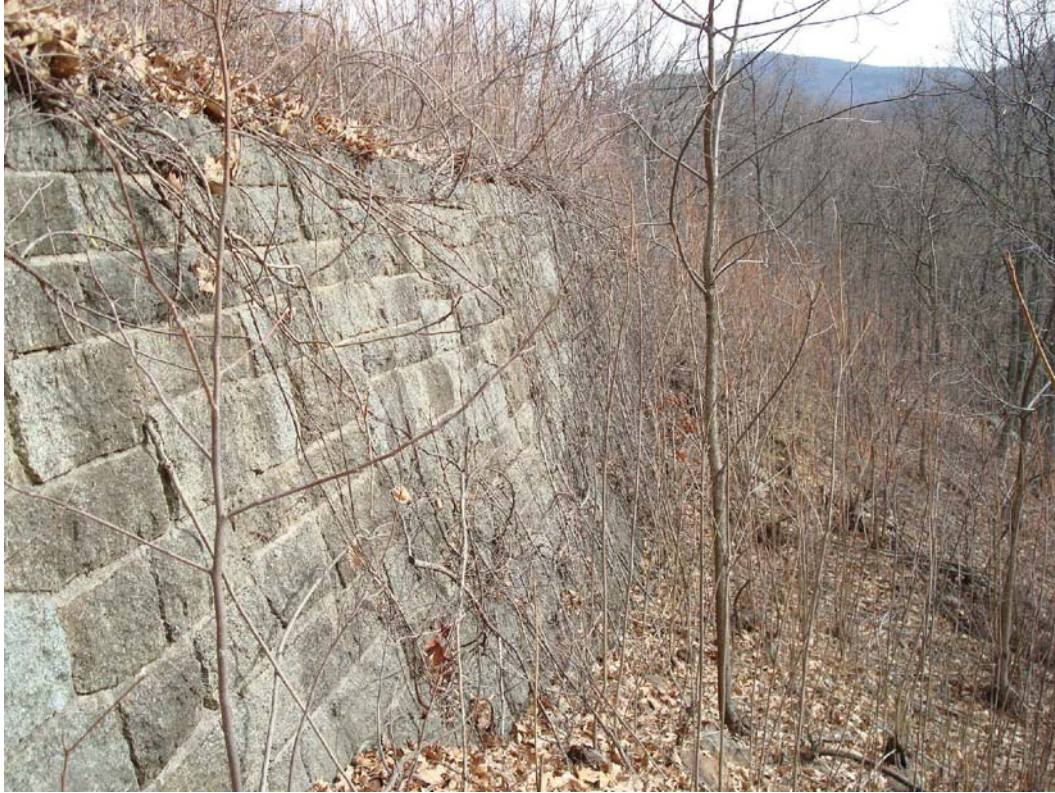
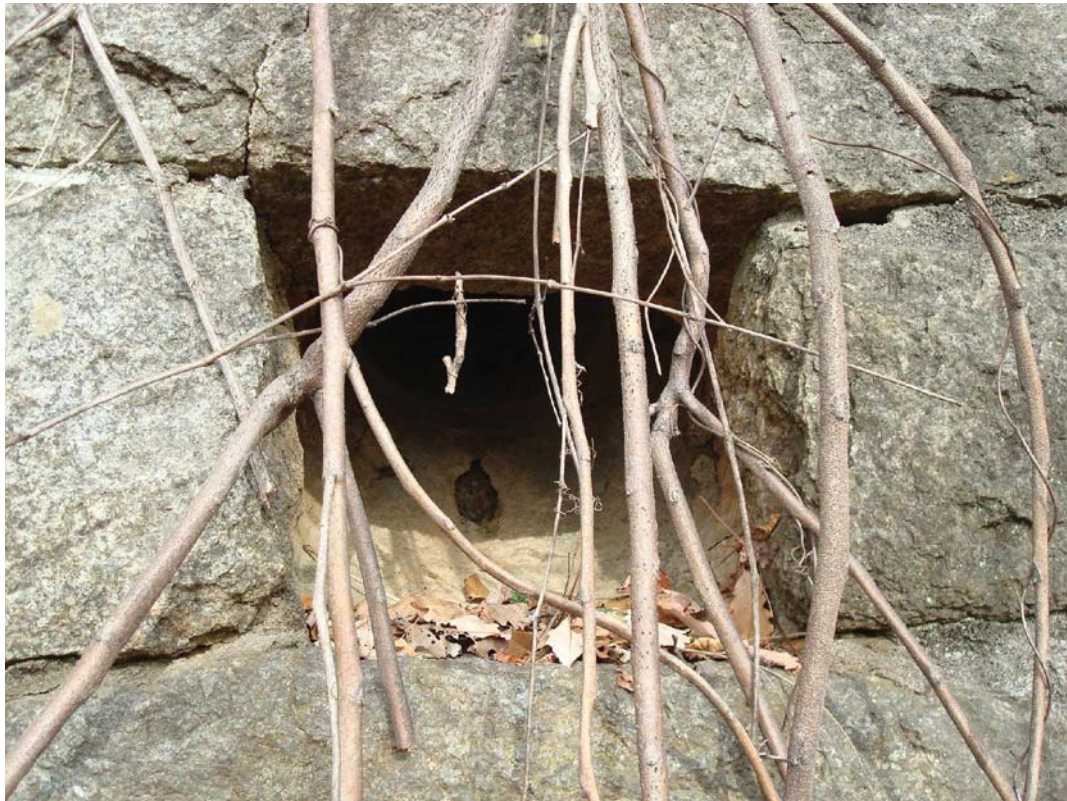
BLRI\_0001AC\_89.744\_L\_1.JPG

<b>Element (Weighting Factor)</b>	<b>Narrative</b>	<b>Condition Rating (0 - 10)</b>
PERFORMANCE 8.00	No global distress	7
WALL FOUNDATION MATERIAL 8.00	Bouldery soil No settlement or erosion	7
MORTAR 8.00	Sound and durable	7
STONE MASONRY 8.00	No degradation	7
VEGETATION 1.00	Vegetation at top	6
CULVERT 1.00	18" concrete pipe culvert	7
DOWNSLOPE 1.00	3H:1V	7
LATERAL SLOPE 1.00	Gradual	7
UPSLOPE 1.00	2H:1V	7

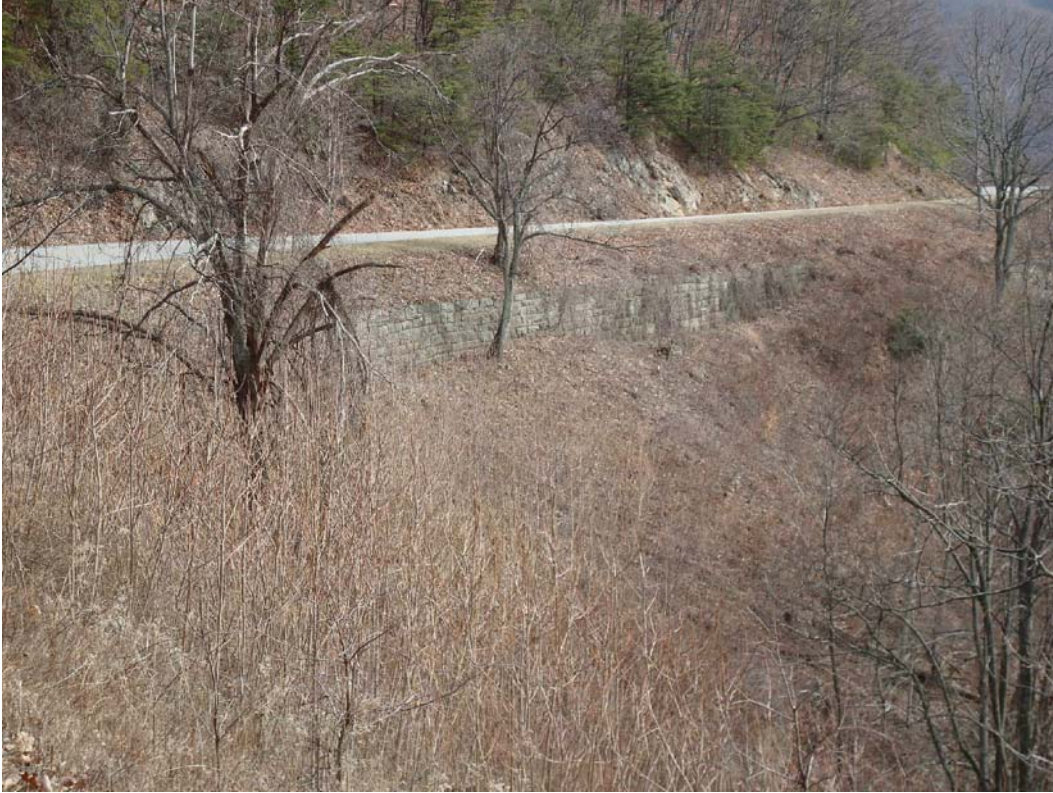
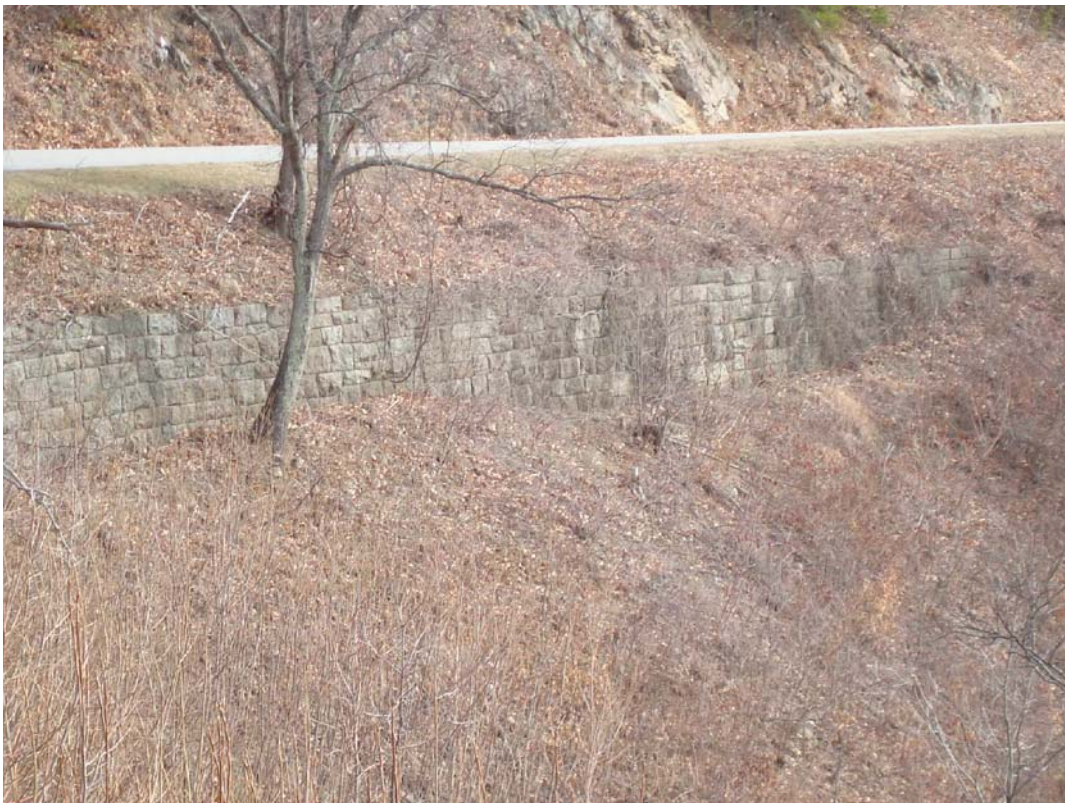
BLRI\_0001AC\_89.856\_L\_1.JPG

<b>Element (Weighting Factor)</b>	<b>Narrative</b>	<b>Condition Rating (0 - 10)</b>
PERFORMANCE 8.00	No global distress	7
WALL FOUNDATION MATERIAL 8.00	Soil No settlement or erosion	7
MORTAR 8.00	sound and durable	7
STONE MASONRY 8.00	No degradation	7
DOWNSLOPE 1.00	3H:1V	7
LATERAL SLOPE 1.00	Gradual slope	7
UPSLOPE 1.00	2H:1V	7
VEGETATION 1.00	Vegetation growing on top of wall	7
WALL DRAINS 1.00	None	7

<b>Failure Consequence:</b>	MODERATE
<b>Recommendation Narrative:</b>	Clear vegetation on top of wall - 10 hrs x \$55/hr = \$550
<b>Repair Cost:</b>	\$550

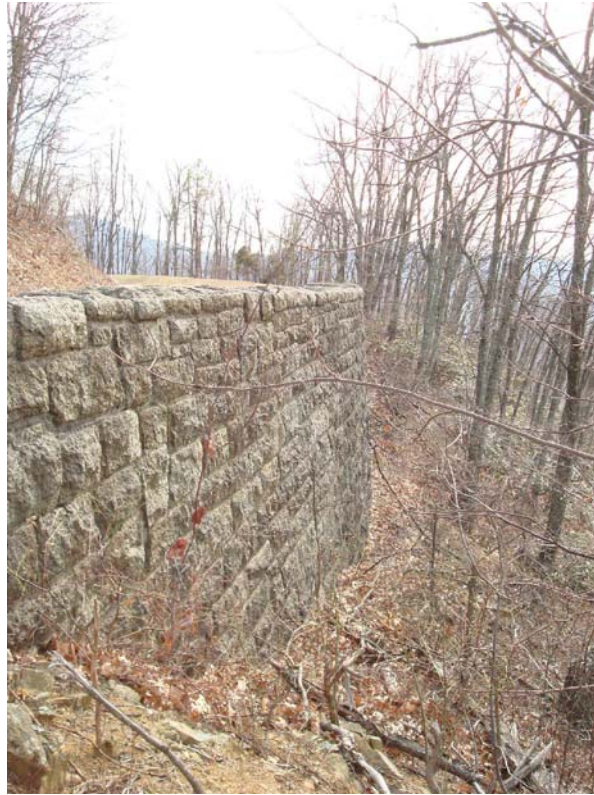
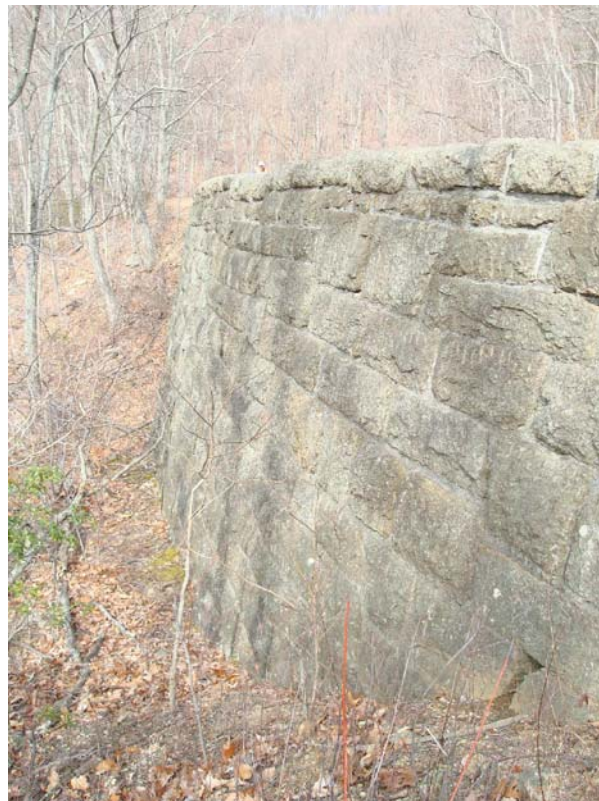
**BLRI\_0001AC\_90.031\_L\_1.JPG**

<b>Element (Weighting Factor)</b>	<b>Narrative</b>	<b>Condition Rating (0 - 10)</b>
PERFORMANCE 8.00	No global distress	7
WALL FOUNDATION MATERIAL 8.00	Soil No settlement or erosion	7
MORTAR 8.00	Some mortar separation at top Wall has been repointed recently	7
STONE MASONRY 8.00	No degradation	7
LATERAL SLOPE 0.50	Flat	8
ROAD/SIDEWALK/SHOULDER 0.50	Flat shoulder	8
DOWNSLOPE 1.00	3H:1V	7
WALL DRAINS 1.00	None	7

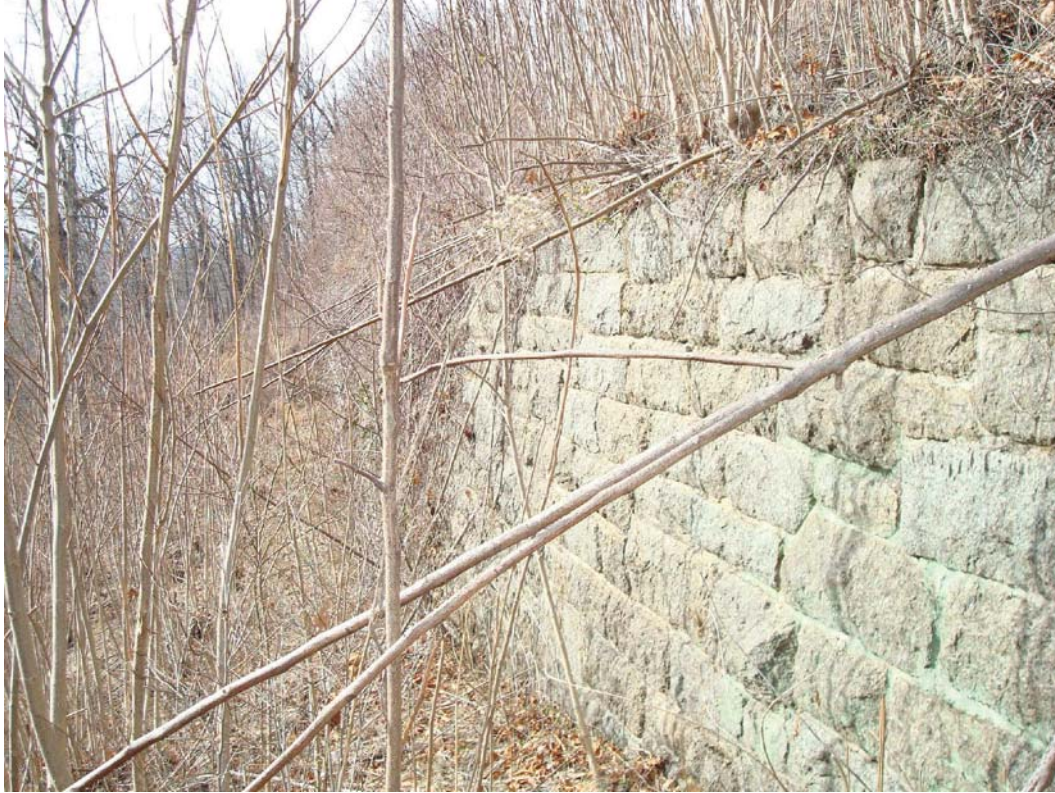
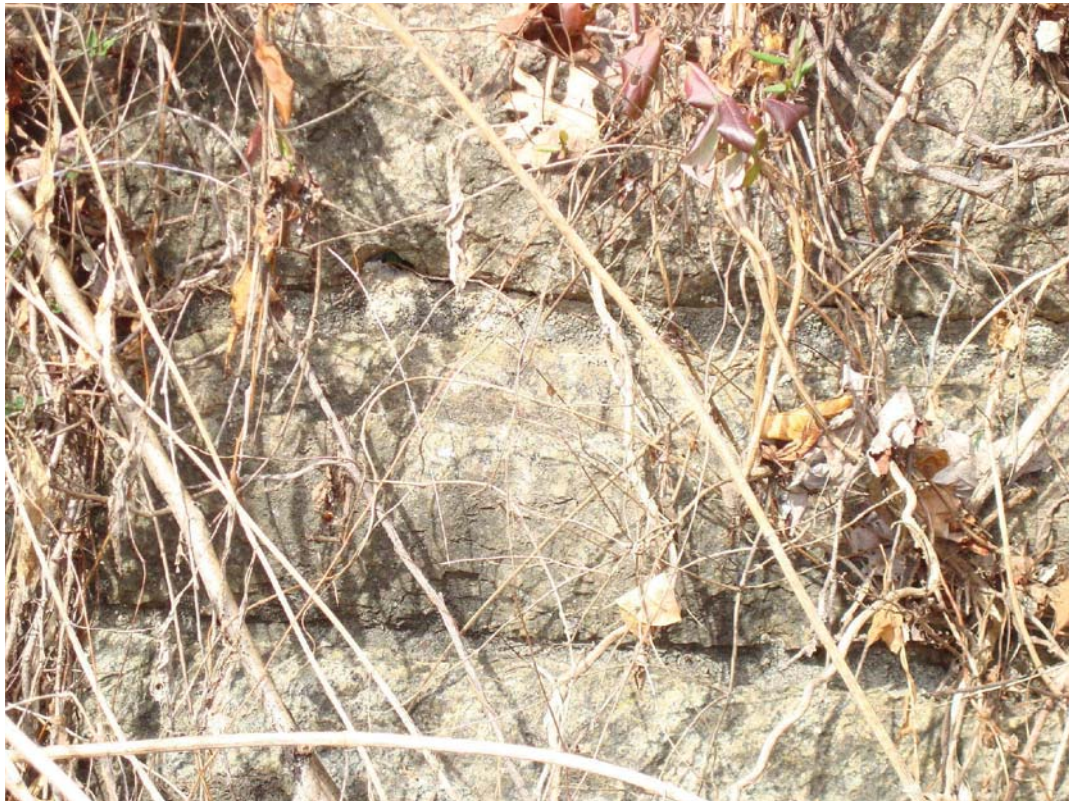
BLRI\_0001AC\_91.804\_L\_1.JPG

<b>Element (Weighting Factor)</b>	<b>Narrative</b>	<b>Condition Rating (0 - 10)</b>
PERFORMANCE 8.00	No global distress	7
WALL FOUNDATION MATERIAL 8.00	Soil No settlement or erosion	7
MORTAR 8.00	Sound and durable minor cracking	7
STONE MASONRY 8.00	No degradation	7
VEGETATION 1.00	Vegetation at top remove vegetation	6
DOWNSLOPE 1.00	2.5H:1V	7
LATERAL SLOPE 1.00	Gradual	7
UPSLOPE 1.00	4H:1V	7
WALL DRAINS 1.00	None	7

<b>Failure Consequence:</b>	LOW
<b>Recommendation Narrative:</b>	Clear vegetation at top of wall - 10 hrs x \$55/hr = \$550
<b>Repair Cost:</b>	\$550

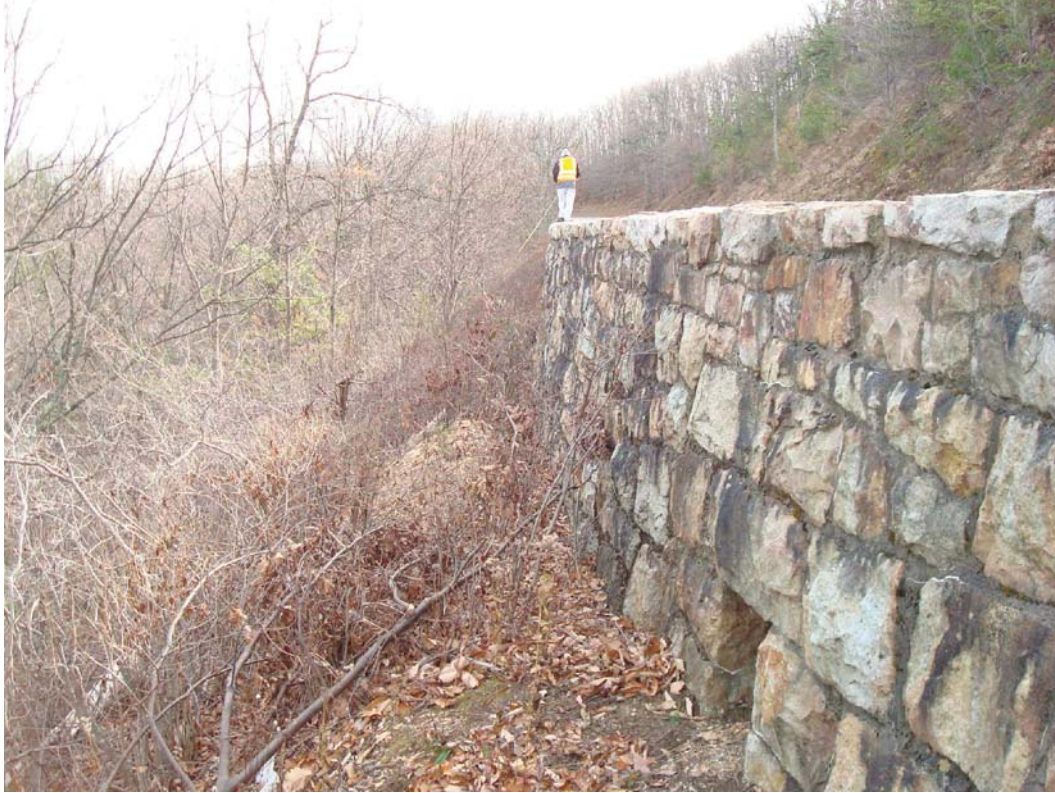
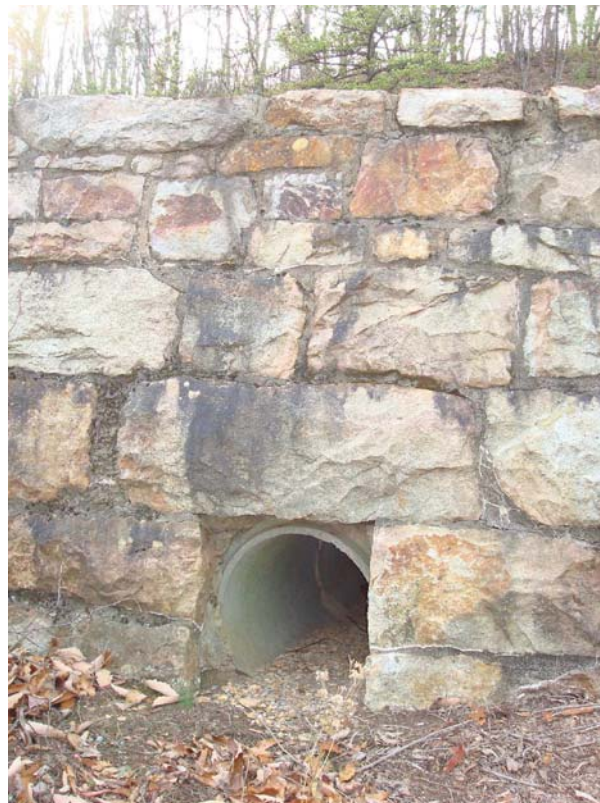
**BLRI\_0001AC\_101.232\_R\_1.JPG**

<b>Wall ID:</b>	BLRI-0001AC-101.232-R		
<b>Route Name:</b>	BLUE RIDGE PARKWAY - PEAKS OF OTTER SUB-DISTRICT		
<b>Inspection Date:</b>	December 04, 2007	<b>Approximate Year Built:</b>	1940
<b>*Wall Rating:</b>	67	<b>Maintenance Action:</b>	Repair Elements

<b>Element (Weighting Factor)</b>	<b>Narrative</b>	<b>Condition Rating (0 - 10)</b>
PERFORMANCE 8.00	No global distress. Culvert pipe settlement.	6
WALL FOUNDATION MATERIAL 8.00	None observed.	7
MORTAR 8.00	Sound and durable.	7
STONE MASONRY 8.00	No degradation	7
ROAD/SIDEWALK/SHOULDER 0.50	Flat, grassy.	8
CULVERT 1.00	2 culverts. North end has 18" diameter RCP with 6" settlement 4' back. South end has 22" diameter RCP with 1/2" settlement 4' back behind wall.	5
DOWNSLOPE 1.00	Flat 10' then 2H:1V	7
LATERAL SLOPE 1.00	Slightly sloped.	7
WALL DRAINS 1.00	None observed.	7

<b>Failure Consequence:</b>	LOW
<b>Recommendation Narrative:</b>	Grout pipe joints - \$500 * 2 = \$1,000
<b>Repair Cost:</b>	\$1,000

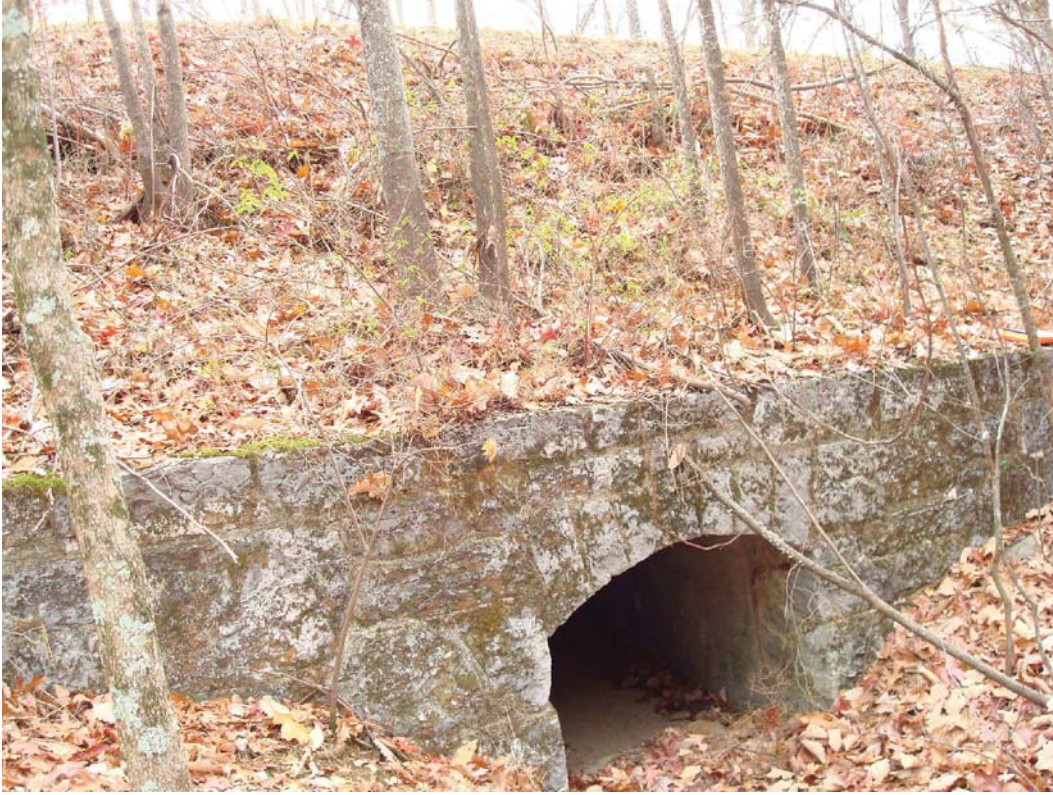
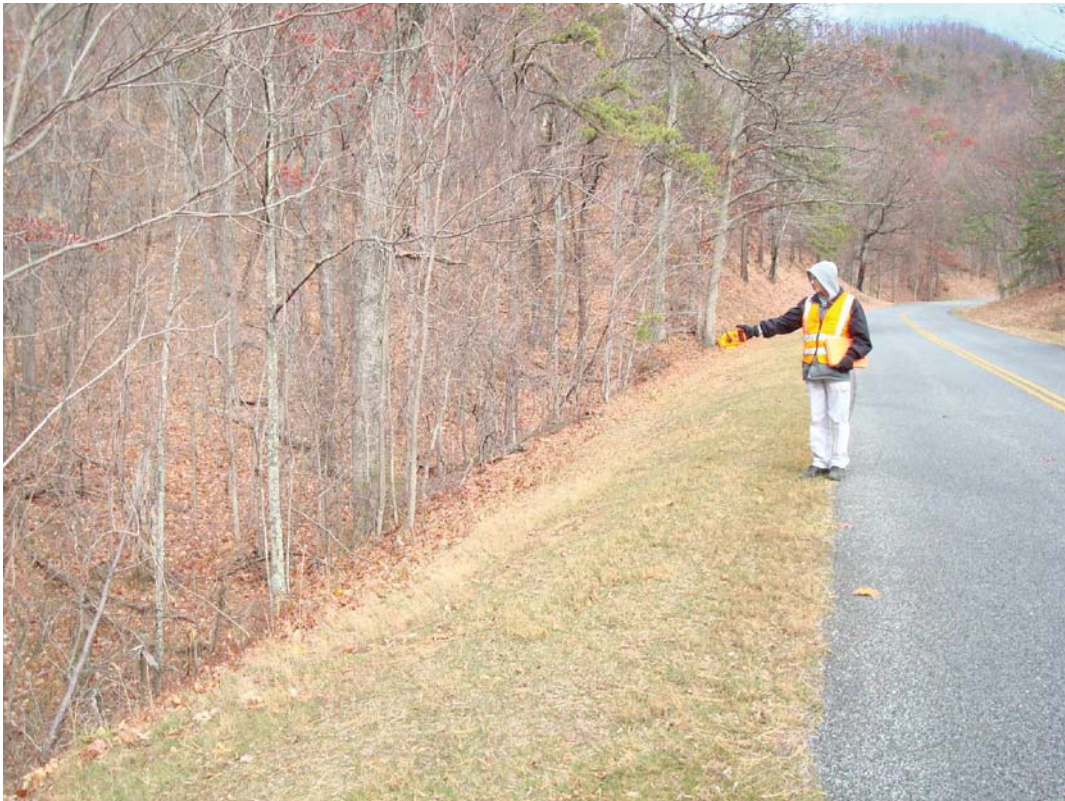
BLRI\_0001AC\_102.492\_R\_1.JPG

<b>Wall ID:</b>	BLRI-0001AC-102.492-R		
<b>Route Name:</b>	BLUE RIDGE PARKWAY - PEAKS OF OTTER SUB-DISTRICT		
<b>Inspection Date:</b>	December 04, 2007	<b>Approximate Year Built:</b>	1940
<b>*Wall Rating:</b>	70	<b>Maintenance Action:</b>	No Action

<b>Element (Weighting Factor)</b>	<b>Narrative</b>	<b>Condition Rating (0 - 10)</b>
PERFORMANCE 8.00	No global distress.	7
WALL FOUNDATION MATERIAL 8.00	Gravelly soil. No settlement or erosion.	7
MORTAR 8.00	Sound and durable.	7
STONE MASONRY 8.00	No degradation. Some moss.	7
LATERAL SLOPE 0.50	Gradual.	8
CULVERT 1.00	4.1' high by 4.1' wide concrete box.	7
DOWNSLOPE 1.00	Slight upslope.	7
UPSLOPE 1.00	2H:1V	7
WALL DRAINS 1.00	Rectangular weepholes 10' on center.	7

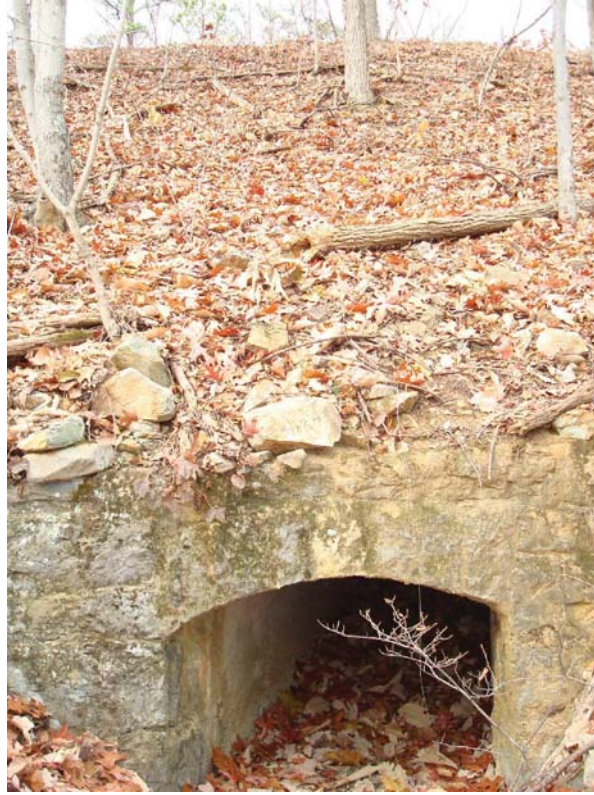
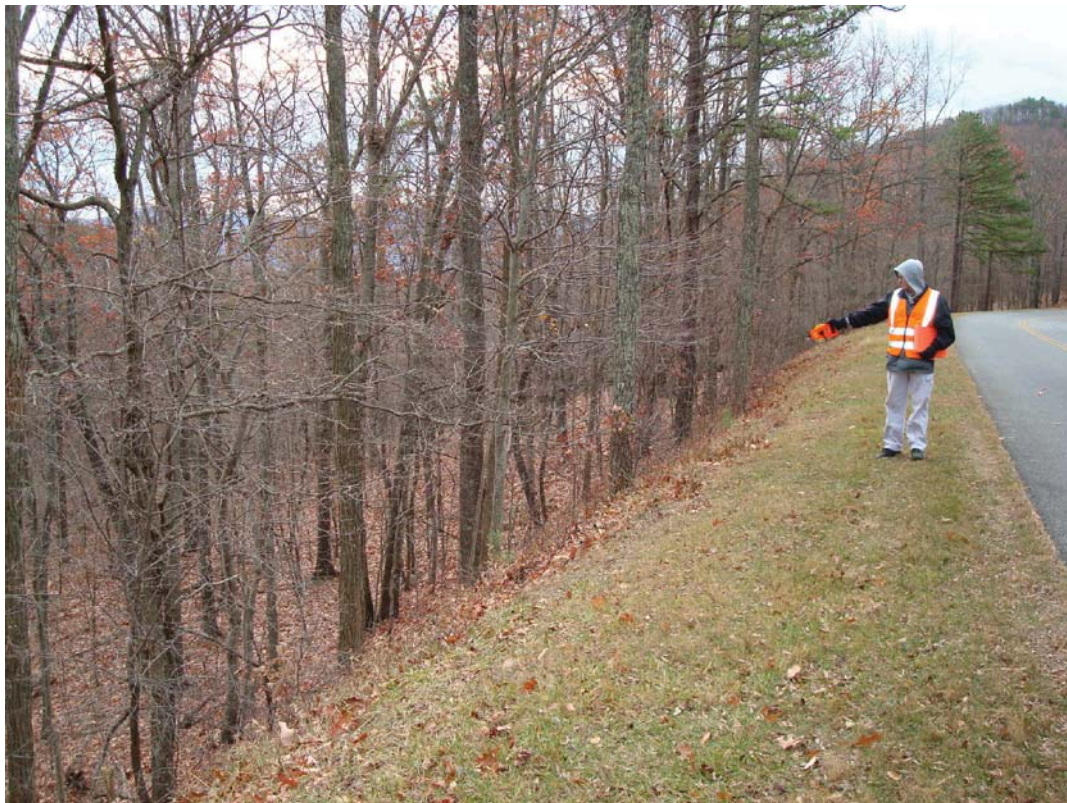
BLRI\_0001AC\_102.505\_L\_1.JPG

<b>Wall ID:</b>	BLRI-0001AC-102.505-L		
<b>Route Name:</b>	BLUE RIDGE PARKWAY - PEAKS OF OTTER SUB-DISTRICT		
<b>Inspection Date:</b>	December 04, 2007	<b>Approximate Year Built:</b>	1940
<b>*Wall Rating:</b>	70	<b>Maintenance Action:</b>	No Action

<b>Element (Weighting Factor)</b>	<b>Narrative</b>	<b>Condition Rating (0 - 10)</b>
PERFORMANCE 8.00	No global distress.	7
WALL FOUNDATION MATERIAL 8.00	Gravelly soil. No settlement or erosion.	7
MORTAR 8.00	Sound and durable.	7
STONE MASONRY 8.00	No degradation. Some moss.	7
LATERAL SLOPE 0.50	Gradual.	8
CULVERT 1.00	4.1' wide by 4.1' high concrete box.	7
DOWNSLOPE 1.00	Slight upslope.	7
UPSLOPE 1.00	2H:1V	7
WALL DRAINS 1.00	Rectangular weepholes 10' on center.	7

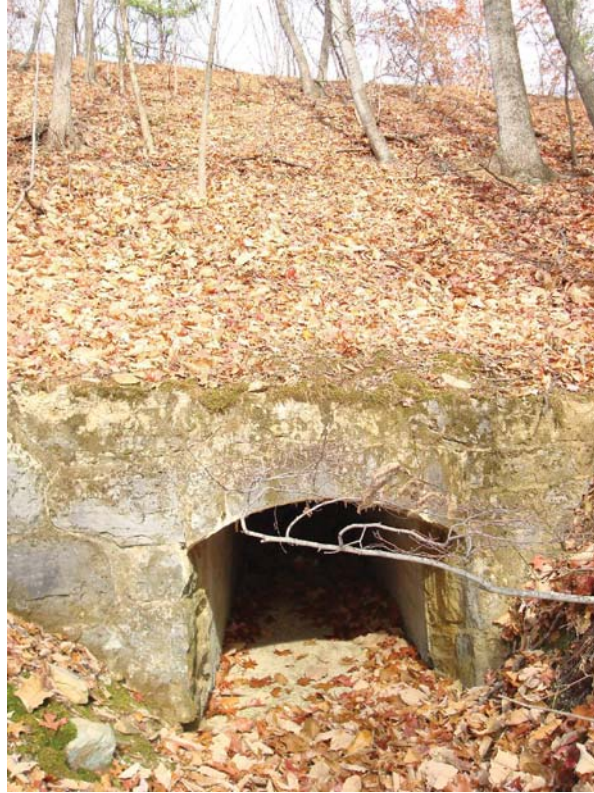
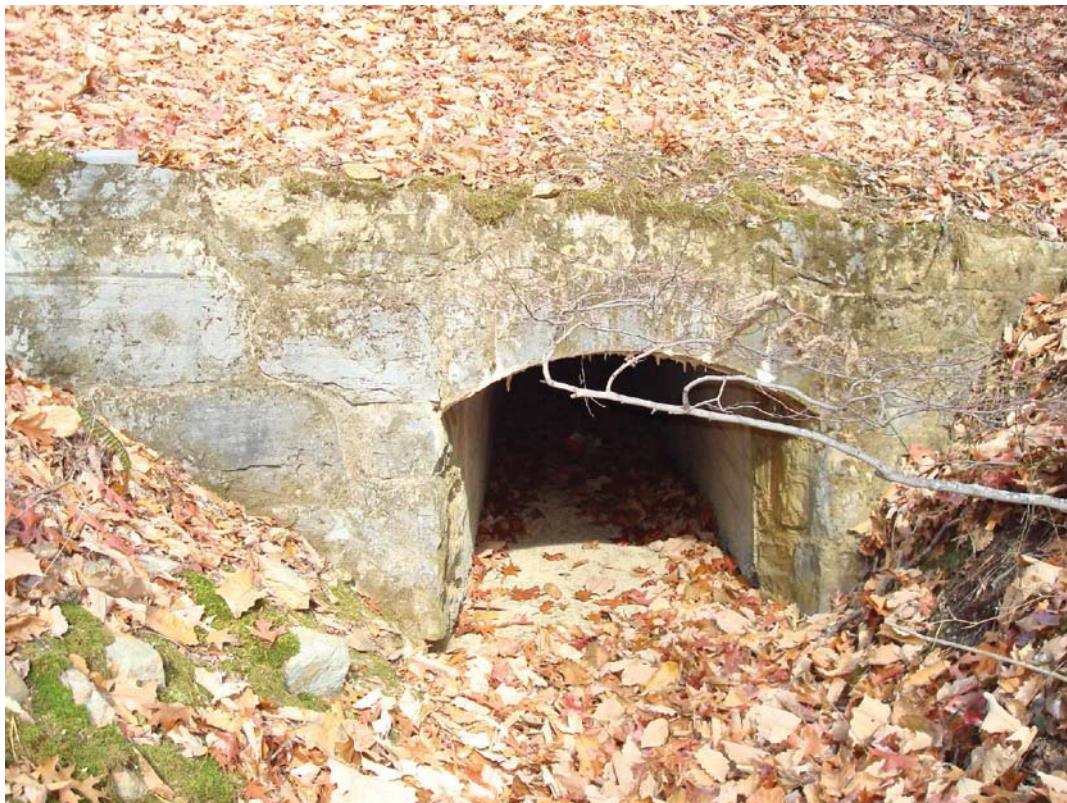
BLRI\_0001AC\_102.805\_L\_1.JPG

<b>Wall ID:</b>	BLRI-0001AC-102.805-L		
<b>Route Name:</b>	BLUE RIDGE PARKWAY - PEAKS OF OTTER SUB-DISTRICT		
<b>Inspection Date:</b>	December 04, 2007	<b>Approximate Year Built:</b>	1940
<b>*Wall Rating:</b>	70	<b>Maintenance Action:</b>	No Action

<b>Element (Weighting Factor)</b>	<b>Narrative</b>	<b>Condition Rating (0 - 10)</b>
PERFORMANCE 8.00	No global distress.	7
WALL FOUNDATION MATERIAL 8.00	Cobbly soil. No settlement or erosion.	7
MORTAR 8.00	Sound and durable.	7
STONE MASONRY 8.00	No degradation.	7
CULVERT 1.00	4' x 4' concrete box.	7
DOWNSLOPE 1.00	Slight upslope, dry streambed.	7
LATERAL SLOPE 1.00	Gradual.	7
UPSLOPE 1.00	Flat 8' then 2H:1V	7
WALL DRAINS 1.00	Rectangular weepholes 10' on center	7
