# BLRI WIP Report

## NPS Retaining Wall Inventory Program Blue Ridge Parkway

Federal Highway Administration  
Eastern Federal Lands Highway Division  
Road Inventory Program (RIP)

# Blue Ridge Parkway in North Carolina and Virginia

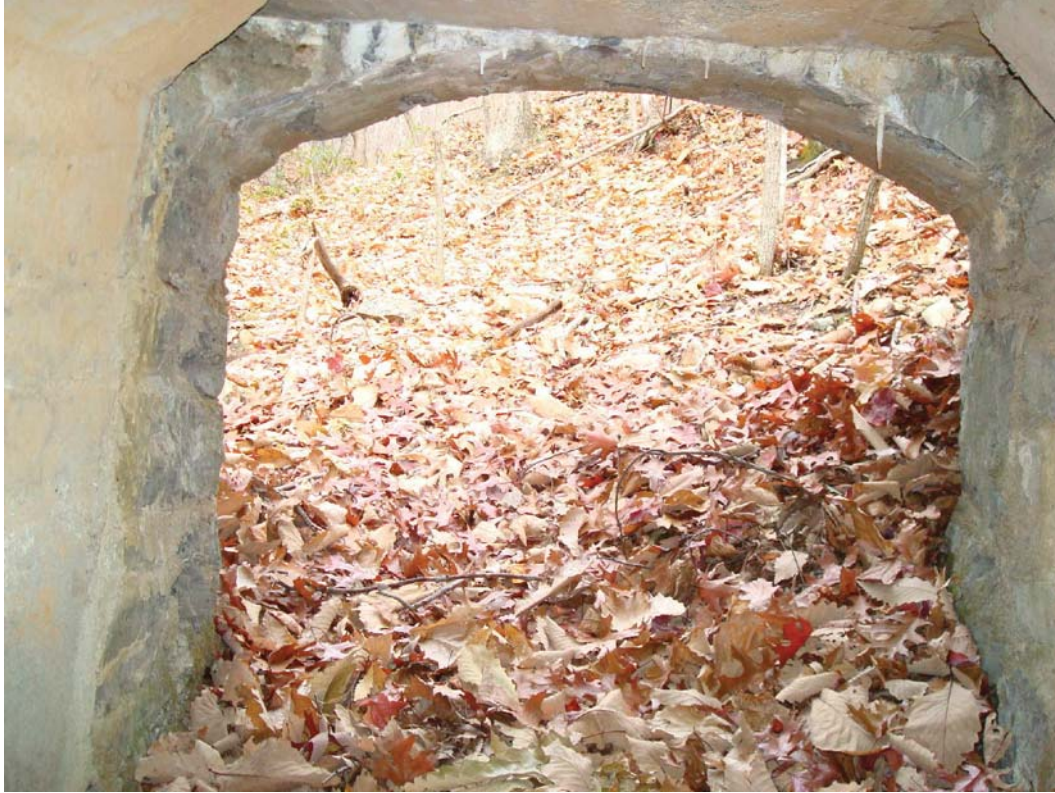
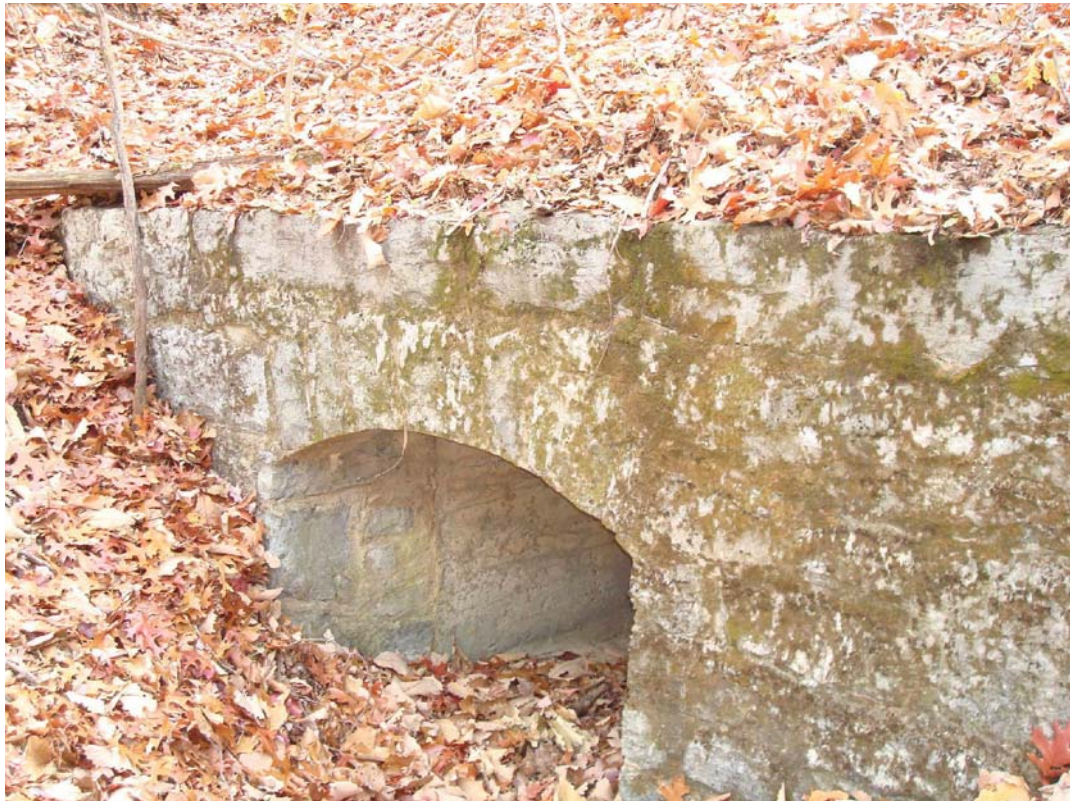
BLRI\_0001AC\_102.805\_R\_1.JPG

<b>Wall ID:</b>	BLRI-0001AC-102.805-R		
<b>Route Name:</b>	BLUE RIDGE PARKWAY - PEAKS OF OTTER SUB-DISTRICT		
<b>Inspection Date:</b>	December 04, 2007	<b>Approximate Year Built:</b>	1940
<b>*Wall Rating:</b>	70	<b>Maintenance Action:</b>	No Action

<b>Element (Weighting Factor)</b>	<b>Narrative</b>	<b>Condition Rating (0 - 10)</b>
PERFORMANCE 8.00	No global distress.	7
WALL FOUNDATION MATERIAL 8.00	Cobbly soil. No settlement or erosion.	7
MORTAR 8.00	Sound and durable.	7
STONE MASONRY 8.00	No degradation.	7
DOWNSLOPE 1.00	Dry streambed.	7
LATERAL SLOPE 1.00	Gradual.	7
UPSLOPE 1.00	Flat then 2H:1V	7
WALL DRAINS 1.00	Rectangular weepholes 10' on center.	7

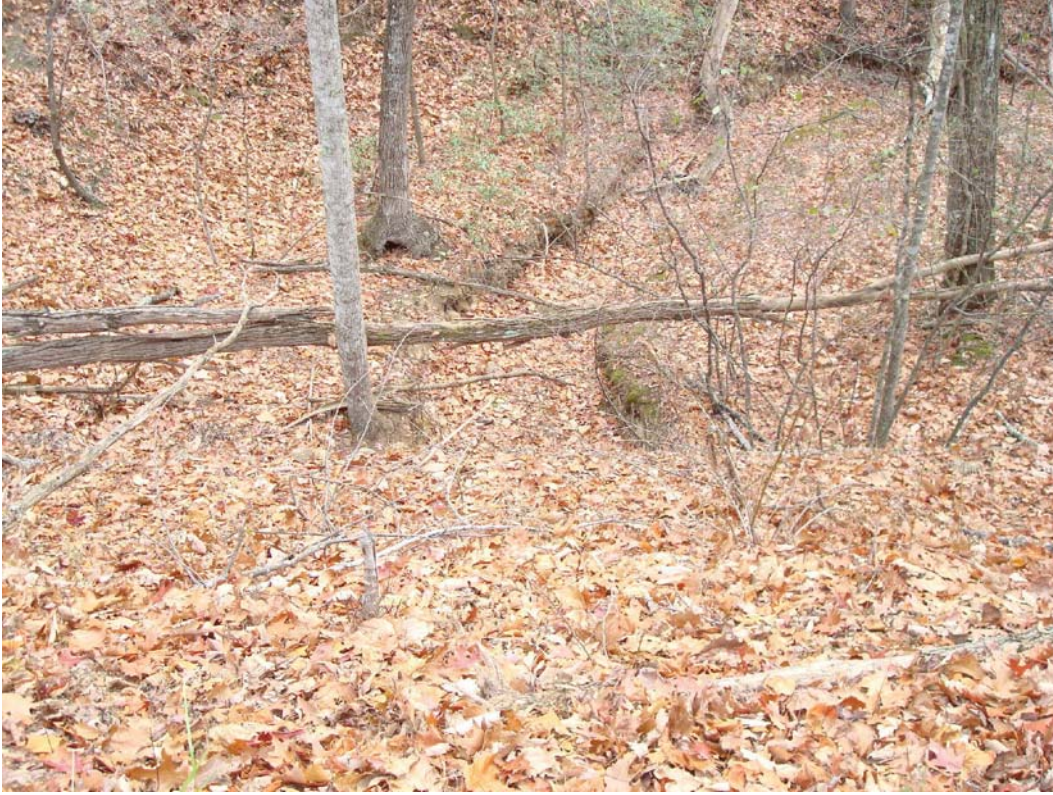
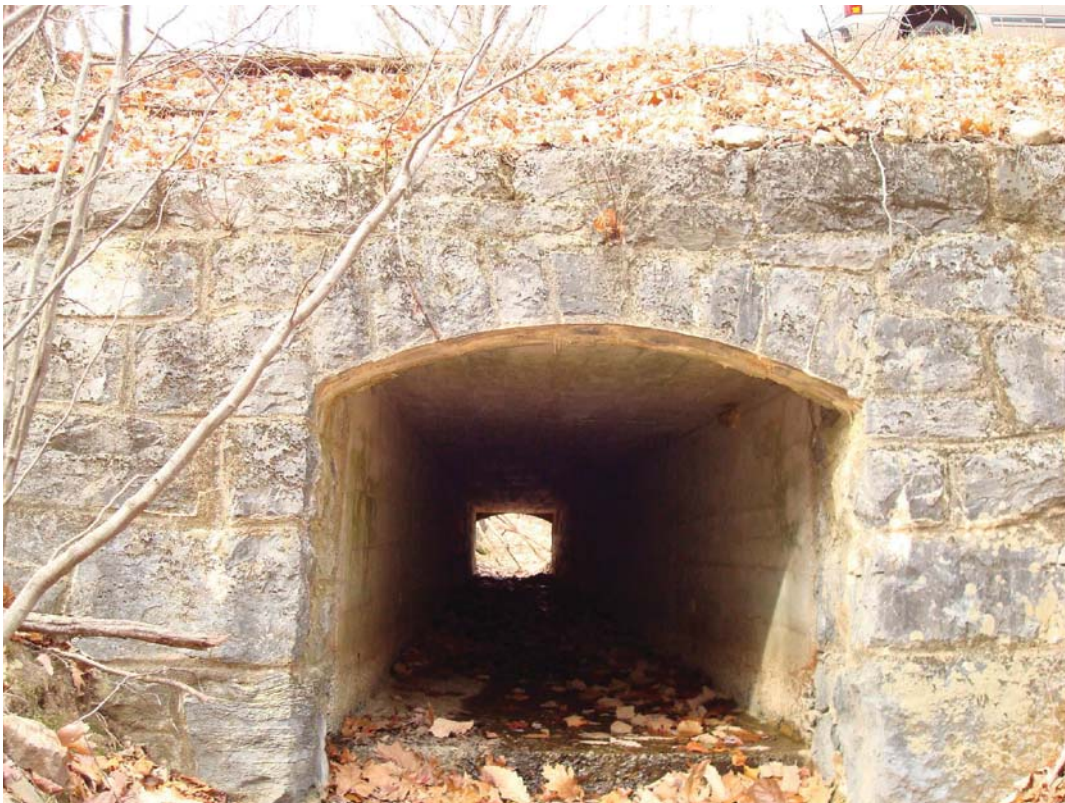
BLRI\_0001AC\_103.088\_L\_1.JPG

<b>Wall ID:</b>	BLRI-0001AC-103.088-L		
<b>Route Name:</b>	BLUE RIDGE PARKWAY - PEAKS OF OTTER SUB-DISTRICT		
<b>Inspection Date:</b>	December 04, 2007	<b>Approximate Year Built:</b>	1940
<b>*Wall Rating:</b>	68	<b>Maintenance Action:</b>	Repair Elements

<b>Element (Weighting Factor)</b>	<b>Narrative</b>	<b>Condition Rating (0 - 10)</b>
PERFORMANCE 8.00	No global distress. Extend concrete to help prevent scour.	7
WALL FOUNDATION MATERIAL 8.00	Gravelly soil. No settlement, slight scour.	6
MORTAR 8.00	Sound and durable. Evidence of repair, missing 3-5 l.f. at entrance.	7
STONE MASONRY 8.00	No degradation.	7
LATERAL SLOPE 0.50	Gradual.	8
CULVERT 1.00	6.1' wide by 5.1' high concrete box.	7
DOWNSLOPE 1.00	Flat, dry streambed.	7
ROAD/SIDEWALK/SHOULDER 1.00	Gravel and grass.	7
WALL DRAINS 1.00	Rectangular weepholes 10' on center	7

<b>Failure Consequence:</b>	MODERATE
<b>Recommendation Narrative:</b>	Place concrete fill to extend culvert base at the outlet. 6' x 1' x 2' = 12 c.f. 1 c.y.*\$330/c.y. = \$330. Labor - 20 hrs * \$55/hr = \$1,100
<b>Repair Cost:</b>	\$1,430

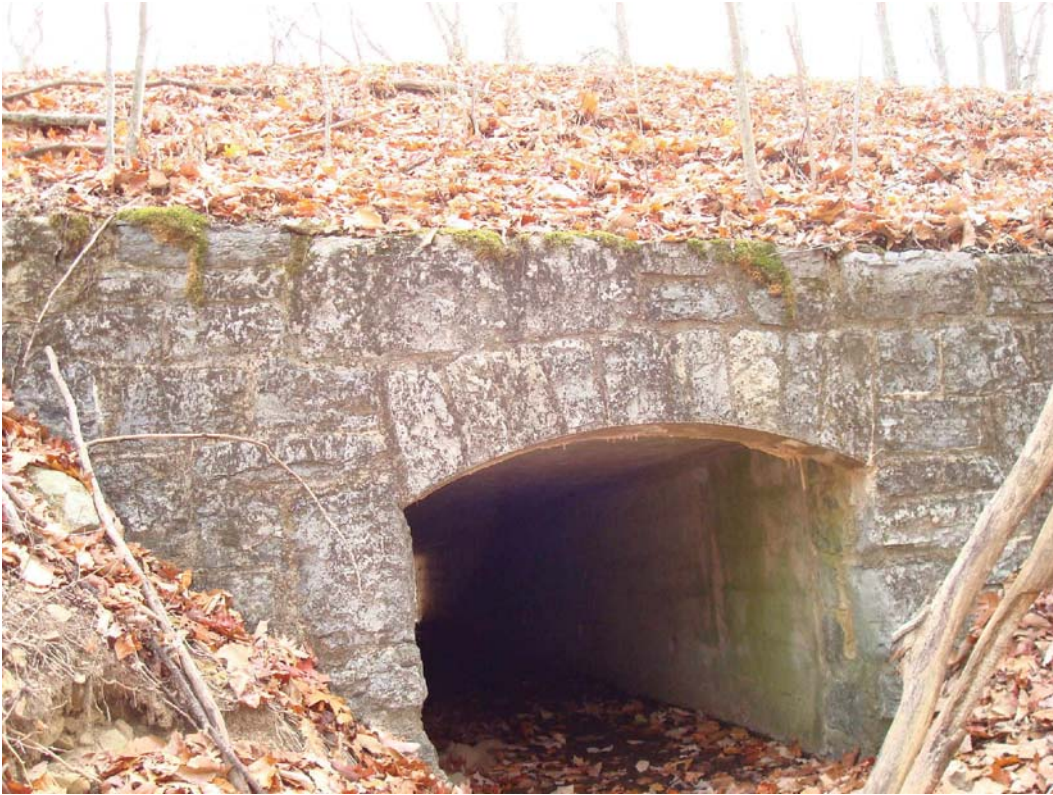
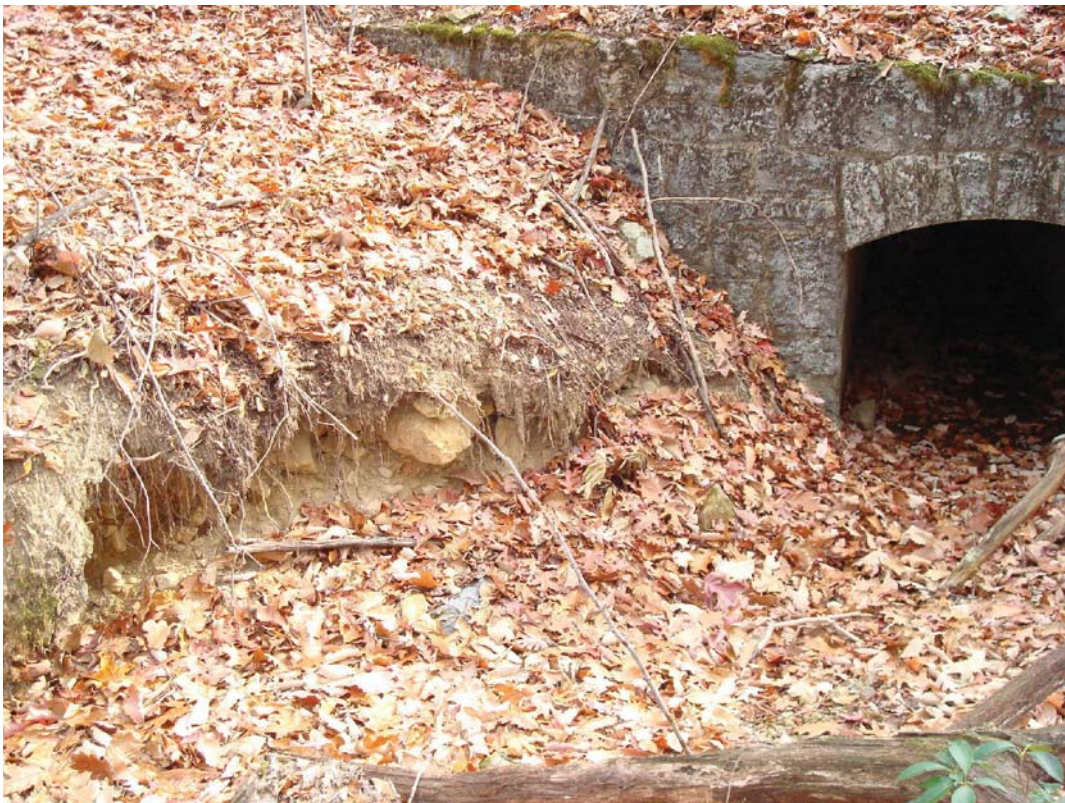
BLRI\_0001AC\_103.090\_R\_1.JPG

<b>Wall ID:</b>	BLRI-0001AC-103.090-R		
<b>Route Name:</b>	BLUE RIDGE PARKWAY - PEAKS OF OTTER SUB-DISTRICT		
<b>Inspection Date:</b>	December 04, 2007	<b>Approximate Year Built:</b>	1940
<b>*Wall Rating:</b>	70	<b>Maintenance Action:</b>	No Action

<b>Element (Weighting Factor)</b>	<b>Narrative</b>	<b>Condition Rating (0 - 10)</b>
PERFORMANCE 8.00	No global distress.	7
WALL FOUNDATION MATERIAL 8.00	Gravelly soil. No settlement or erosion.	7
MORTAR 8.00	Sound and durable.	7
STONE MASONRY 8.00	No degradation.	7
LATERAL SLOPE 0.50	Gradual.	8
CULVERT 1.00	6.1' wide by 5.1' high concrete box.	7
DOWNSLOPE 1.00	Flat, dry streambed.	7
ROAD/SIDEWALK/SHOULDER 1.00	Gravel and grass.	7
WALL DRAINS 1.00	Rectangular weepholes 10' on center.	7

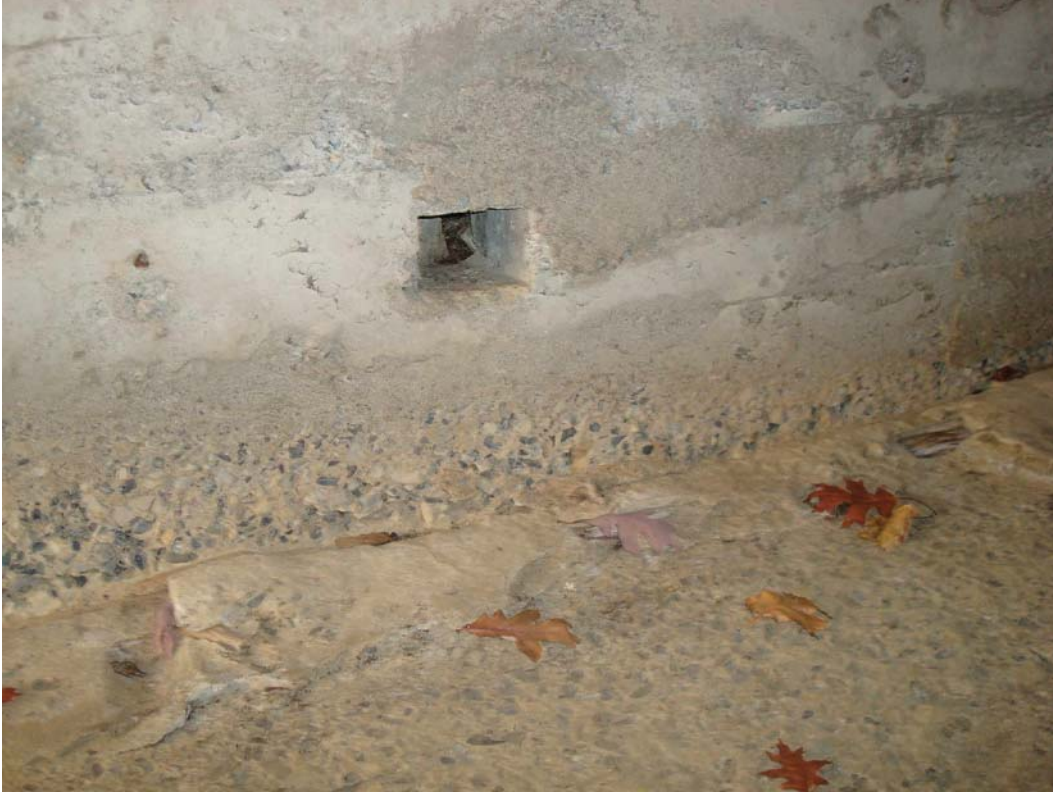
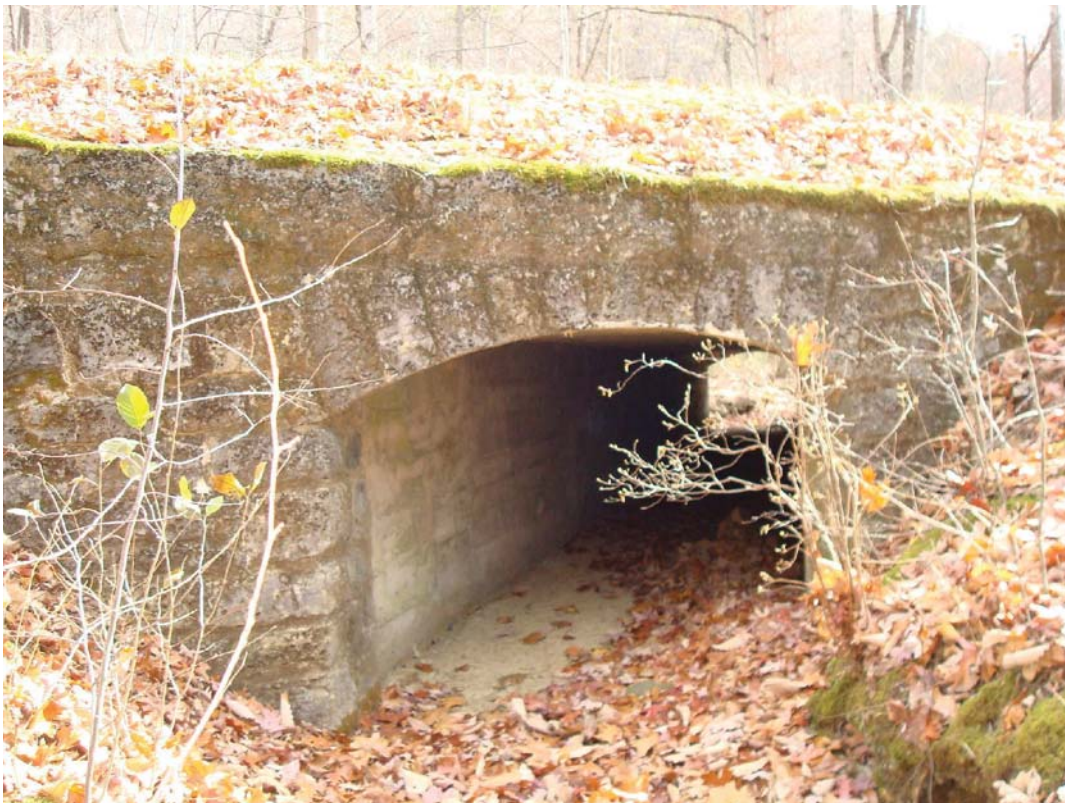
BLRI\_0001AC\_103.264\_R\_1.JPG

<b>Wall ID:</b>	BLRI-0001AC-103.264-R		
<b>Route Name:</b>	BLUE RIDGE PARKWAY - PEAKS OF OTTER SUB-DISTRICT		
<b>Inspection Date:</b>	December 04, 2007	<b>Approximate Year Built:</b>	1940
<b>*Wall Rating:</b>	70	<b>Maintenance Action:</b>	No Action

<b>Element (Weighting Factor)</b>	<b>Narrative</b>	<b>Condition Rating (0 - 10)</b>
PERFORMANCE 8.00	No global distress.	7
WALL FOUNDATION MATERIAL 8.00	Cobbly soil. No settlement or erosion.	7
MORTAR 8.00	Sound and durable.	7
STONE MASONRY 8.00	No degradation.	7
LATERAL SLOPE 0.50	Gradual.	8
DOWNSLOPE 1.00	Flat, dry streambed.	7
ROAD/SIDEWALK/SHOULDER 1.00	Gravel and grass.	7
WALL DRAINS 1.00	Rectangular weepholes 10' on center	7

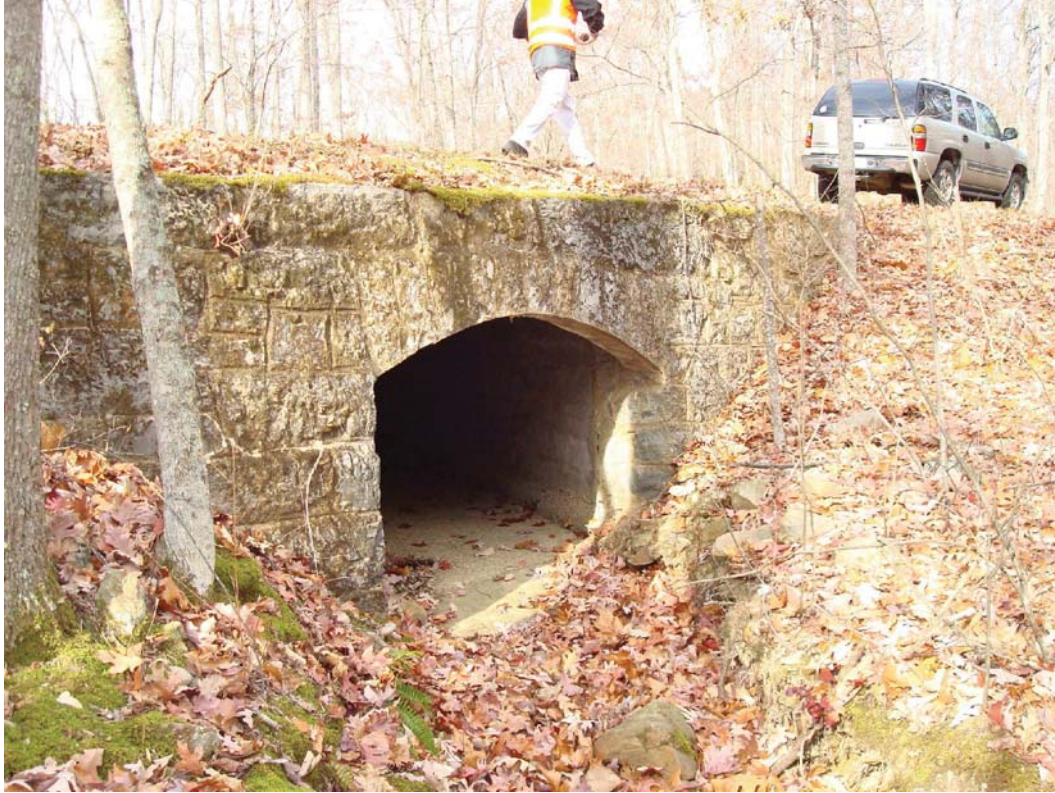
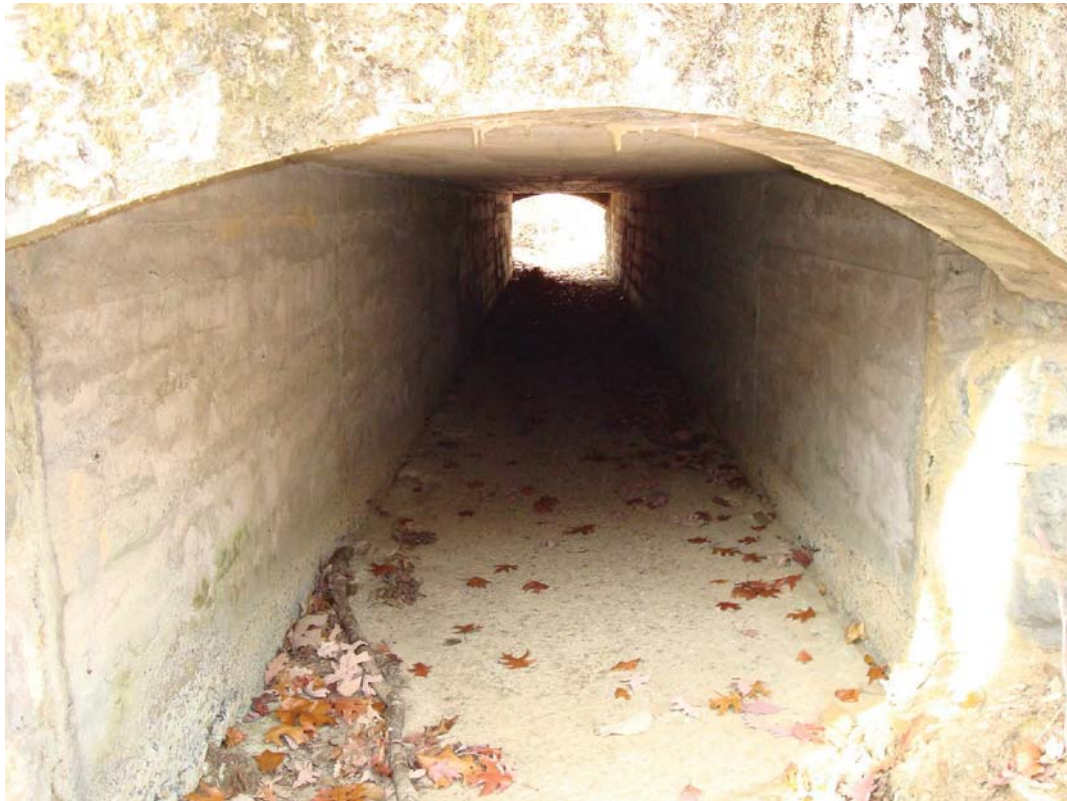
BLRI\_0001AC\_103.271\_L\_1.JPG

<b>Wall ID:</b>	BLRI-0001AC-103.271-L		
<b>Route Name:</b>	BLUE RIDGE PARKWAY - PEAKS OF OTTER SUB-DISTRICT		
<b>Inspection Date:</b>	December 04, 2007	<b>Approximate Year Built:</b>	1940
<b>*Wall Rating:</b>	70	<b>Maintenance Action:</b>	No Action

<b>Element (Weighting Factor)</b>	<b>Narrative</b>	<b>Condition Rating (0 - 10)</b>
PERFORMANCE 8.00	No global distress.	7
WALL FOUNDATION MATERIAL 8.00	Cobbly soil. No settlement or erosion.	7
MORTAR 8.00	Sound and durable.	7
STONE MASONRY 8.00	No degradation.	7
LATERAL SLOPE 0.50	Gradual.	8
CULVERT 1.00	6.1' high by 5.1' wide concrete box.	7
DOWNSLOPE 1.00	Flat, dry streambed.	7
ROAD/SIDEWALK/SHOULDER 1.00	Gravel and grass.	7
WALL DRAINS 1.00	Rectangular weepholes 10' on center. (weep hole size = 6.5" x 4.5")	7

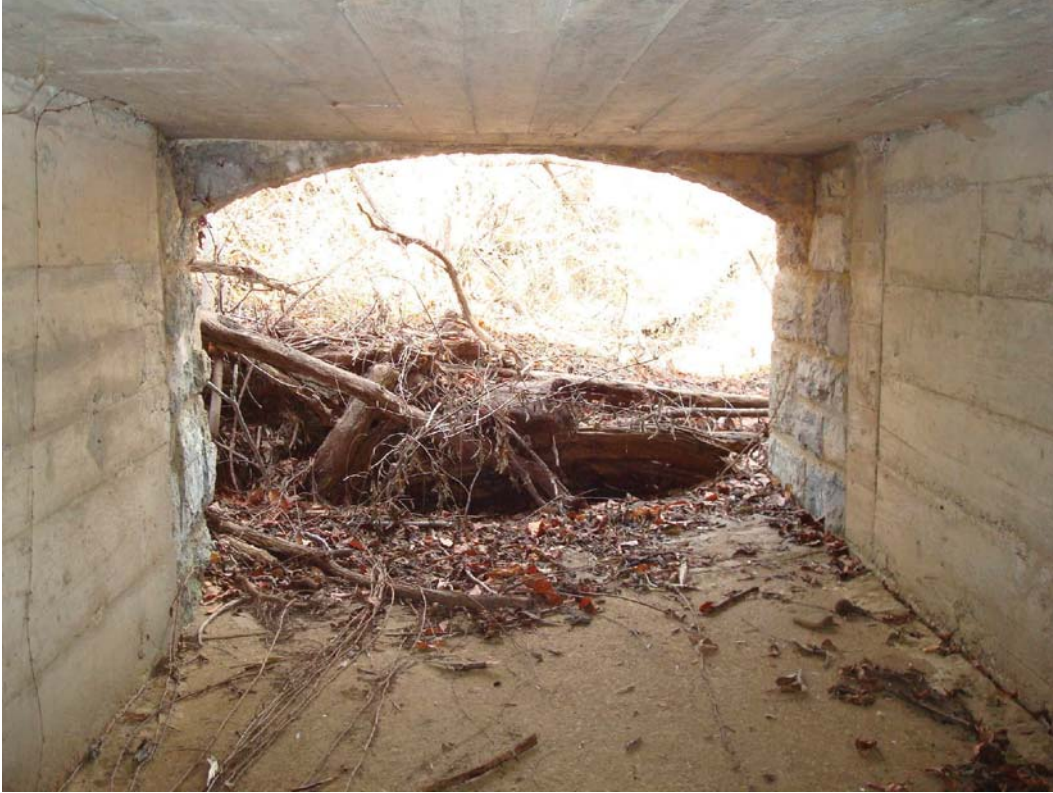
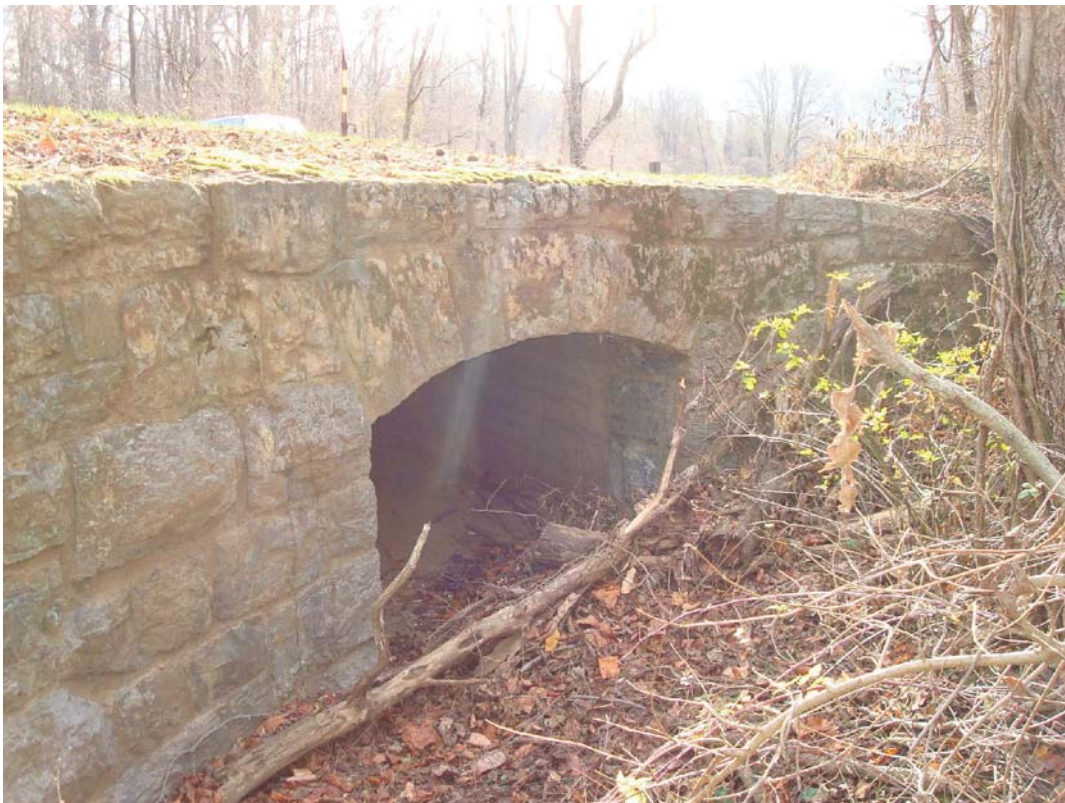
BLRI\_0001AC\_105.673\_R\_1.JPG

<b>Wall ID:</b>	BLRI-0001AC-105.673-R		
<b>Route Name:</b>	BLUE RIDGE PARKWAY - PEAKS OF OTTER SUB-DISTRICT		
<b>Inspection Date:</b>	December 04, 2007	<b>Approximate Year Built:</b>	1940
<b>*Wall Rating:</b>	66	<b>Maintenance Action:</b>	Maintenance

<b>Element (Weighting Factor)</b>	<b>Narrative</b>	<b>Condition Rating (0 - 10)</b>
PERFORMANCE 8.00	No global distress.	7
WALL FOUNDATION MATERIAL 8.00	Gravelly sand. No settlement or erosion.	7
MORTAR 8.00	Sound and durable.	7
STONE MASONRY 8.00	No degradation.	7
LATERAL SLOPE 0.50	Flat.	8
ROAD/SIDEWALK/SHOULDER 0.50	Flat, grassy.	8
VEGETATION 1.00	Brush piling up near entrance.	5
DOWNSLOPE 1.00	Dry streambed, slight scour in front of wall.	7
WALL DRAINS 1.00	Rectangular weepholes on 9' centers.	7

<b>Failure Consequence:</b>	MODERATE
<b>Recommendation Narrative:</b>	Clear brush at opening - 10 hrs*\$55/hr = \$550
<b>Repair Cost:</b>	\$550

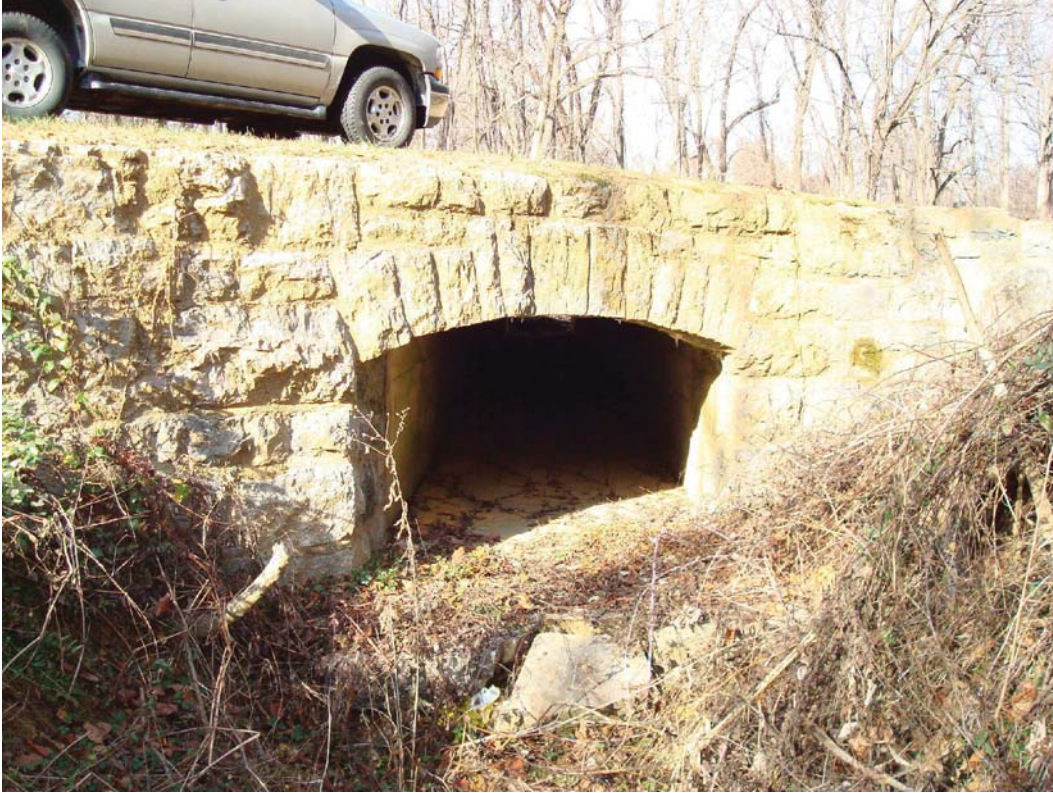
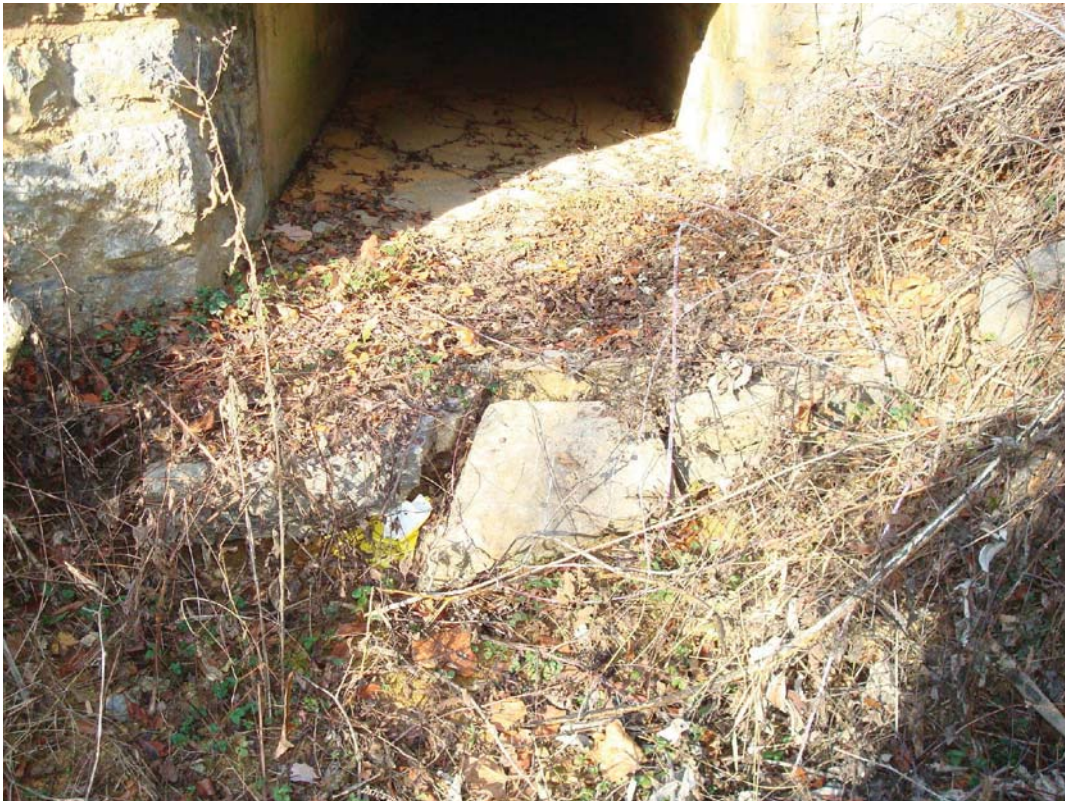
BLRI\_0001AC\_105.688\_L\_1.JPG

<b>Wall ID:</b>	BLRI-0001AC-105.688-L		
<b>Route Name:</b>	BLUE RIDGE PARKWAY - PEAKS OF OTTER SUB-DISTRICT		
<b>Inspection Date:</b>	December 04, 2007	<b>Approximate Year Built:</b>	1940
<b>*Wall Rating:</b>	70	<b>Maintenance Action:</b>	No Action

<b>Element (Weighting Factor)</b>	<b>Narrative</b>	<b>Condition Rating (0 - 10)</b>
PERFORMANCE 8.00	No global distress.	7
WALL FOUNDATION MATERIAL 8.00	Gravelly sand. No settlement or erosion.	7
MORTAR 8.00	Sound and durable.	7
STONE MASONRY 8.00	No degradation.	7
LATERAL SLOPE 0.50	Flat.	8
ROAD/SIDEWALK/SHOULDER 0.50	Flat, grassy.	8
CULVERT 1.00	4' high by 6.4' wide concrete box.	7
DOWNSLOPE 1.00	Dry streambed, slight scour in front of wall.	7
WALL DRAINS 1.00	Rectangular weepholes 9' on center	7

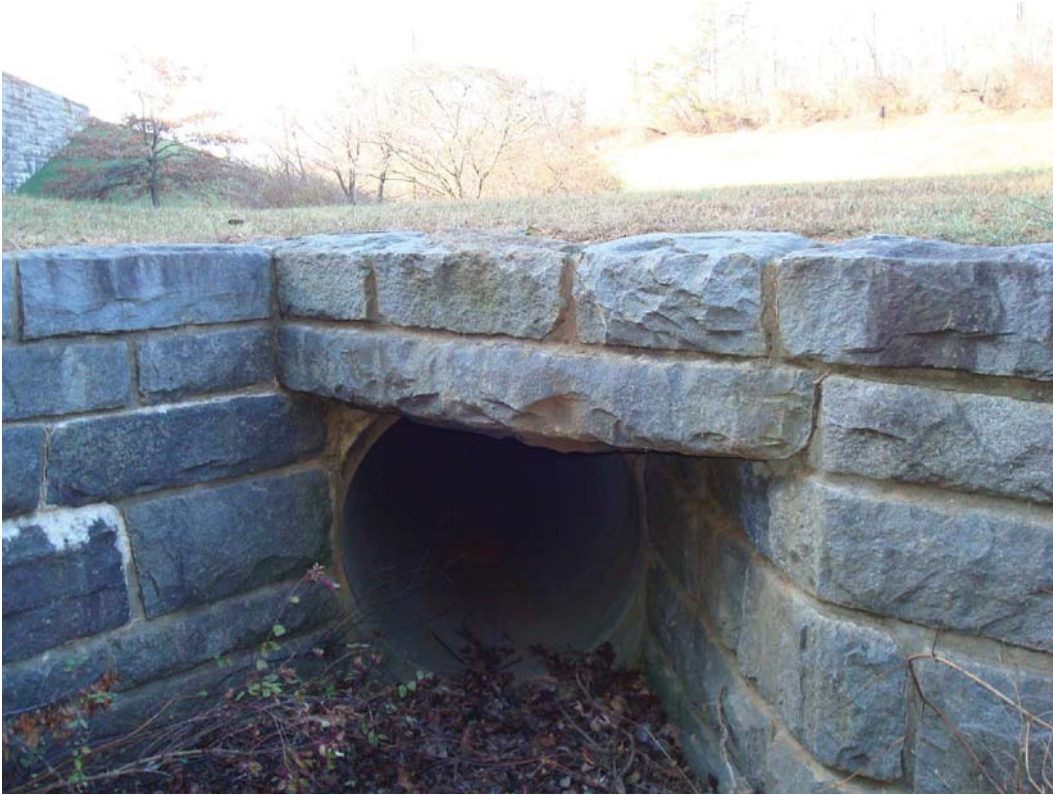
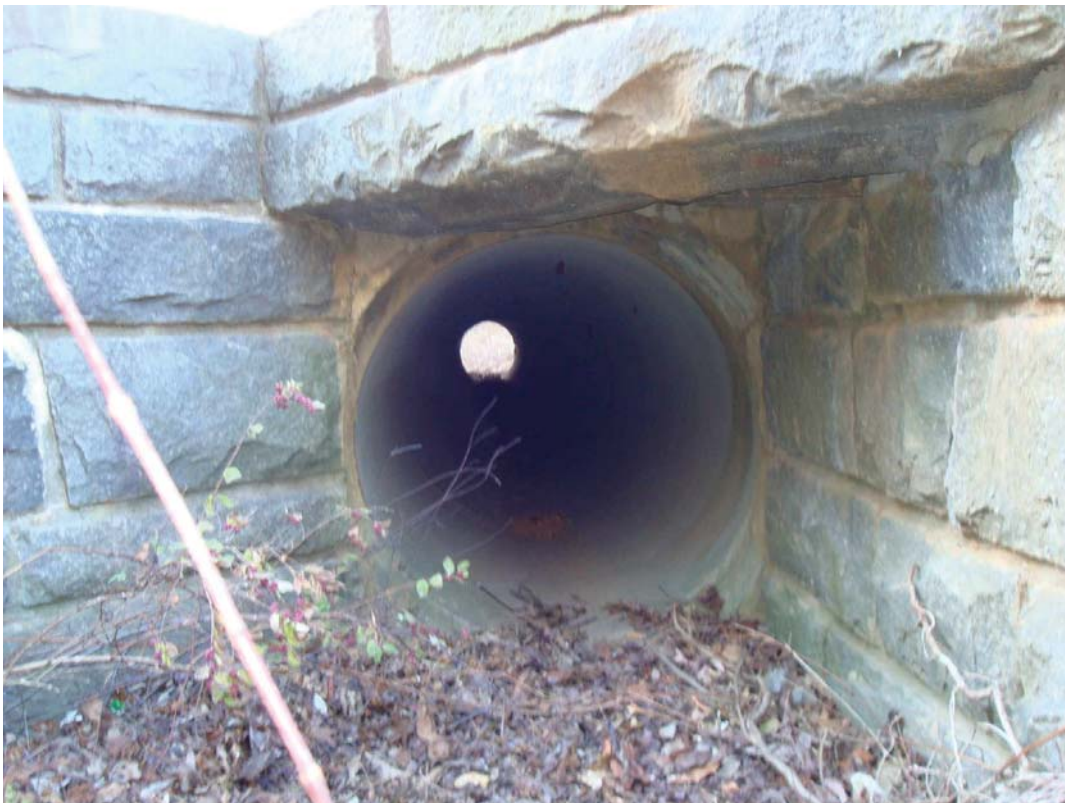
BLRI\_0001AC\_105.873\_L\_1.JPG

<b>Wall ID:</b>	BLRI-0001AC-105.873-L		
<b>Route Name:</b>	BLUE RIDGE PARKWAY - PEAKS OF OTTER SUB-DISTRICT		
<b>Inspection Date:</b>	December 04, 2007	<b>Approximate Year Built:</b>	1940
<b>*Wall Rating:</b>	70	<b>Maintenance Action:</b>	No Action

<b>Element (Weighting Factor)</b>	<b>Narrative</b>	<b>Condition Rating (0 - 10)</b>
PERFORMANCE 8.00	No global distress	7
WALL FOUNDATION MATERIAL 8.00	Gravelly sand No settlement or erosion	7
MORTAR 8.00	sound and durable, slight cracking and separation	7
STONE MASONRY 8.00	No degradation	7
LATERAL SLOPE 0.50	Flat	8
ROAD/SIDEWALK/SHOULDER 0.50	Flat, grassy shoulder	8
CULVERT 1.00	4' diameter RCP, good condition	7
DOWNSLOPE 1.00	Rises, concrete drainage channel goes into culvert	7
WALL DRAINS 1.00	None	7

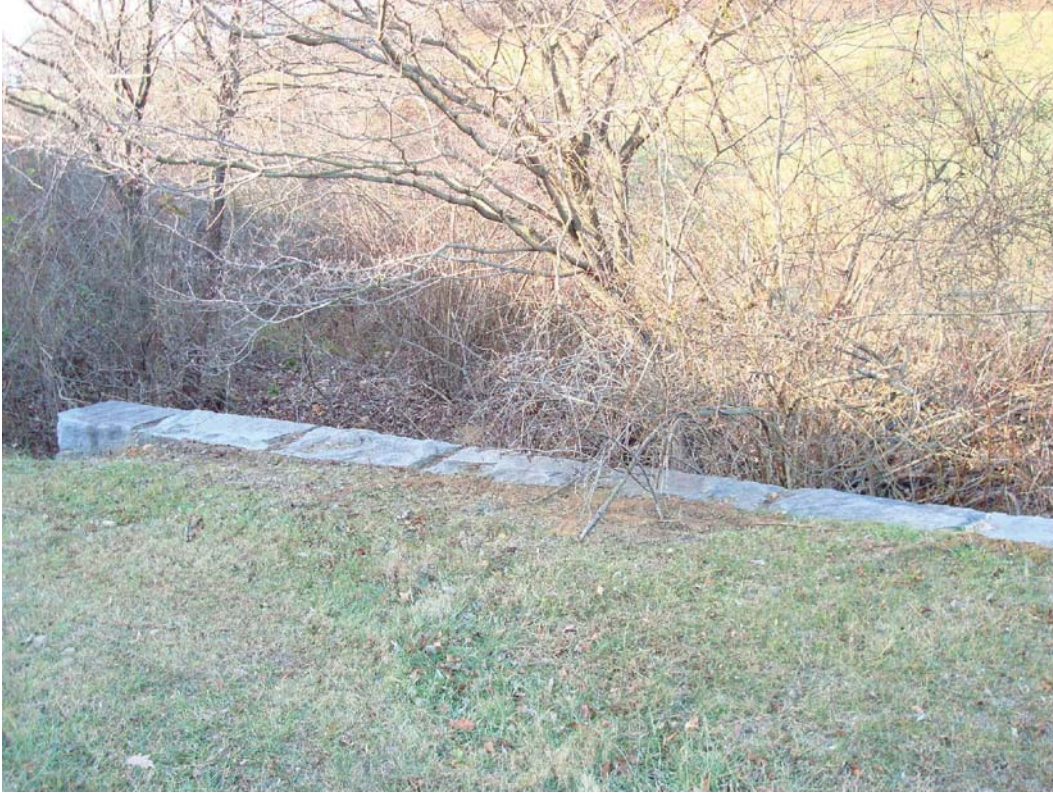
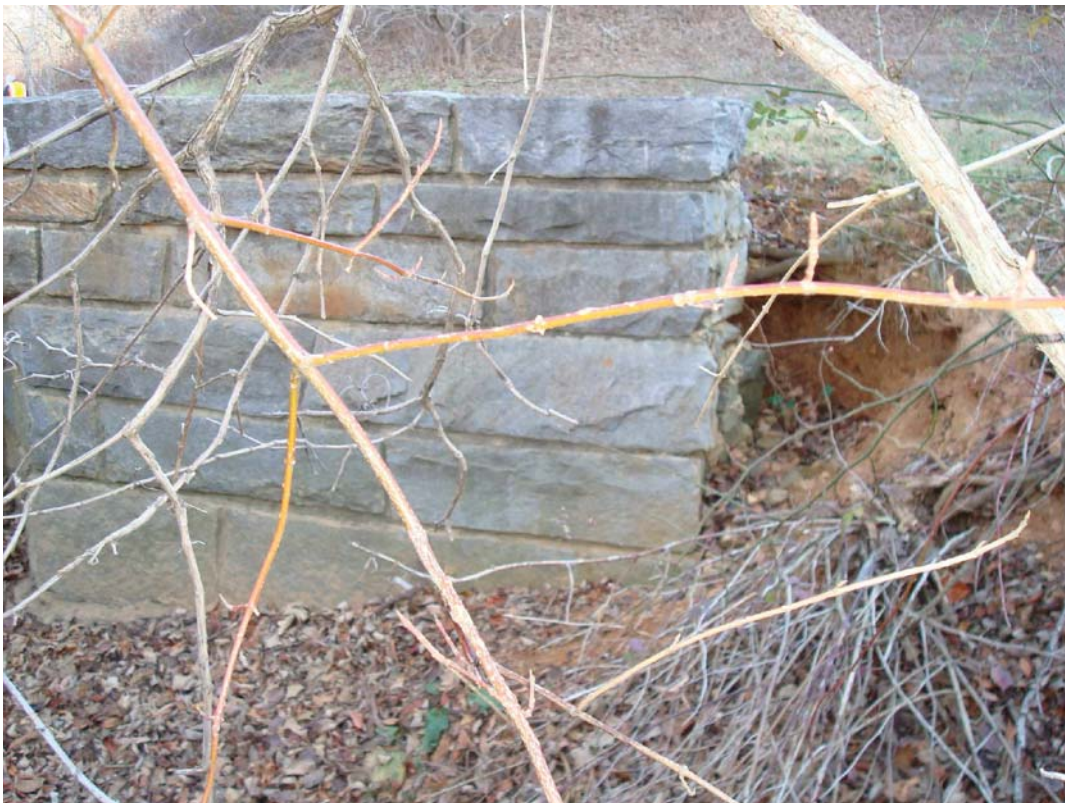
BLRI\_0001AC\_105.873\_R\_1.JPG

<b>Wall ID:</b>	BLRI-0001AC-105.873-R		
<b>Route Name:</b>	BLUE RIDGE PARKWAY - PEAKS OF OTTER SUB-DISTRICT		
<b>Inspection Date:</b>	December 04, 2007	<b>Approximate Year Built:</b>	1940
<b>*Wall Rating:</b>	68	<b>Maintenance Action:</b>	Repair Elements

<b>Element (Weighting Factor)</b>	<b>Narrative</b>	<b>Condition Rating (0 - 10)</b>
PERFORMANCE 8.00	No global distress erosion behind wall south corner	7
WALL FOUNDATION MATERIAL 8.00	Gravelly sand. Erosion on south end corner wall.	6
MORTAR 8.00	Sound and durable.	7
STONE MASONRY 8.00	No degradation.	7
LATERAL SLOPE 0.50	Flat.	8
ROAD/SIDEWALK/SHOULDER 0.50	Flat, grassy.	8
CULVERT 1.00	Assume 4' by 4' concrete box.	7
DOWNSLOPE 1.00	Dry streambed.	7
WALL DRAINS 1.00	None observed.	7

<b>Failure Consequence:</b>	MODERATE
<b>Recommendation Narrative:</b>	Repair Eroded area - 2'H x 5'L x 1'W. Fill - unclassified borrow - 1 cy * \$35/cy = \$35. Turf Reinforcement Mat - 2 sy * \$5/sy = \$5. Labor - 10 hrs * \$55/hr = \$550. Dump Truck - 10 hrs * \$120/hr = \$1,200.
<b>Repair Cost:</b>	\$1,795

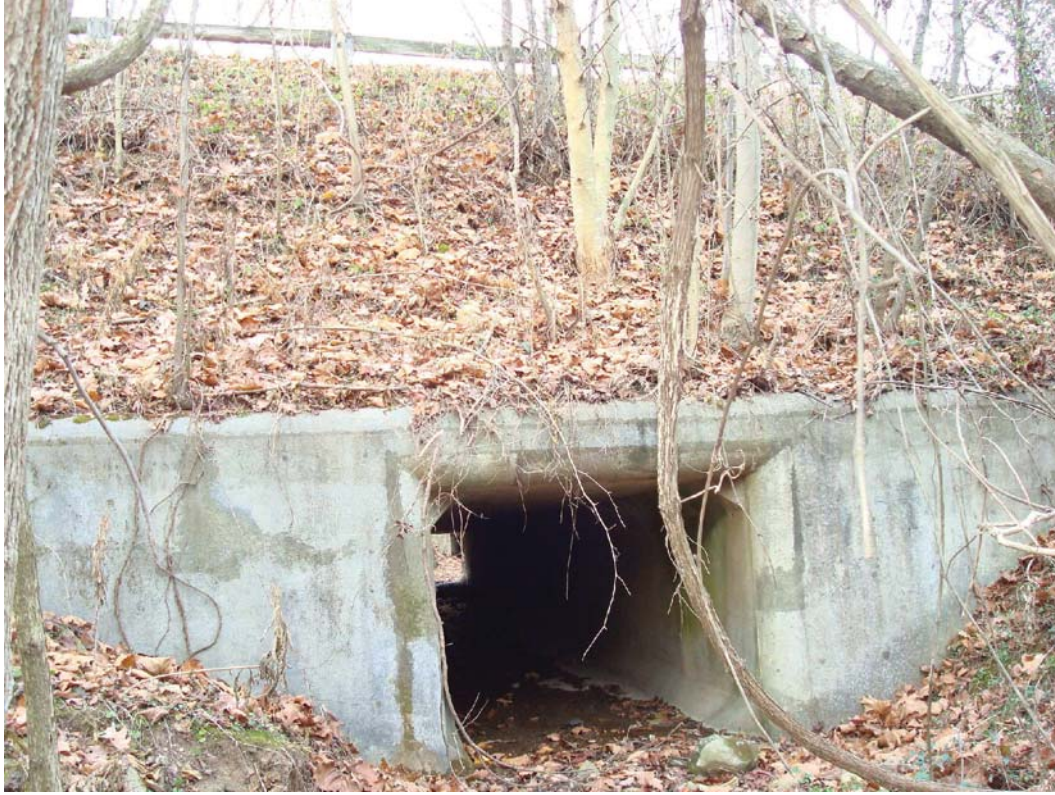
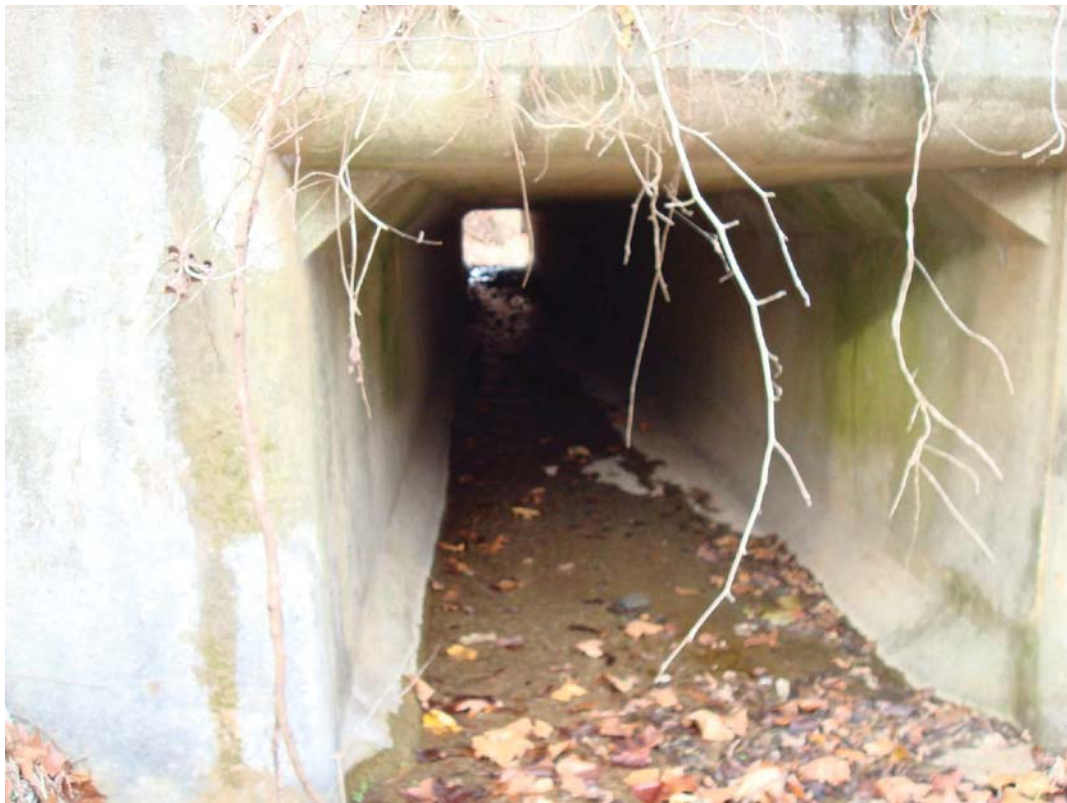
BLRI\_0001BA\_108.595\_L\_1.JPG

<b>Wall ID:</b>	BLRI-0001BA-108.595-L		
<b>Route Name:</b>	BLUE RIDGE PARKWAY - ROANOKE VALLEY SUB-DISTRICT		
<b>Inspection Date:</b>	December 04, 2007	<b>Approximate Year Built:</b>	1950
<b>*Wall Rating:</b>	72	<b>Maintenance Action:</b>	Maintenance

<b>Element (Weighting Factor)</b>	<b>Narrative</b>	<b>Condition Rating (0 - 10)</b>
PERFORMANCE 8.00	No global distress.	7
WALL FOUNDATION MATERIAL 8.00	Gravelly sand with silt. No settlement or erosion	7
CONCRETE 8.00	Sound and durable.	8
TRAFFIC BARRIER/FENCE 1.00	Aged wood/concrete post	5
VEGETATION 1.00	Small trees at the top.	6
CULVERT 1.00	5' high by 6' wide concrete box.	7
DOWNSLOPE 1.00	Flat, streambed.	7
LATERAL SLOPE 1.00	Gradual.	7
UPSLOPE 1.00	2H:1V	7

<b>Failure Consequence:</b>	LOW
<b>Recommendation Narrative:</b>	Remove 4 small trees (2"-6") - 10 hrs x \$55/hr = \$550
<b>Repair Cost:</b>	\$550

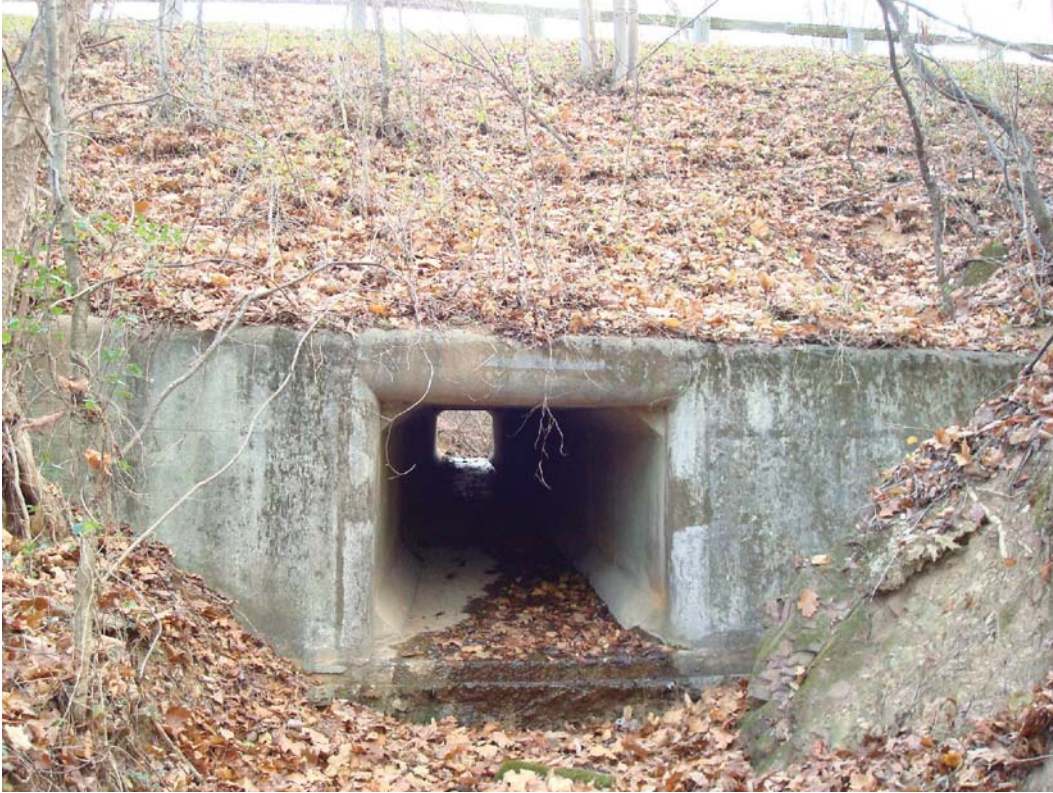
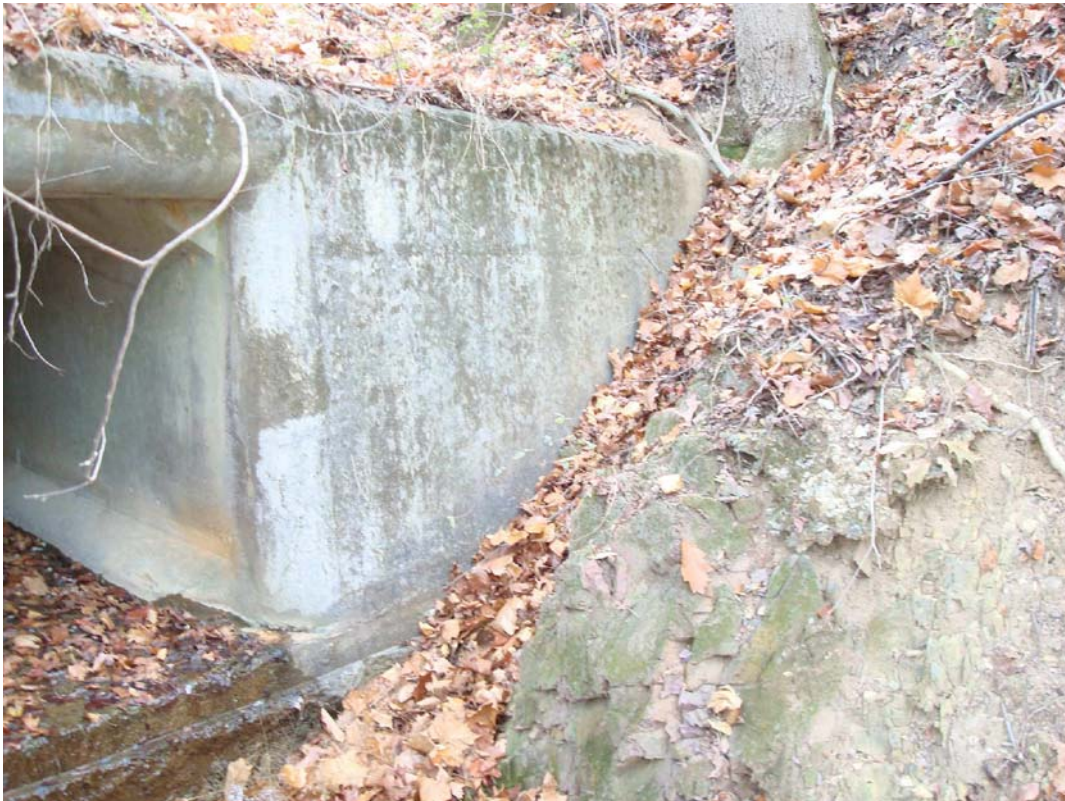
BLRI\_0001BA\_108.595\_R\_1.JPG

<b>Wall ID:</b>	BLRI-0001BA-108.595-R		
<b>Route Name:</b>	BLUE RIDGE PARKWAY - ROANOKE VALLEY SUB-DISTRICT		
<b>Inspection Date:</b>	December 04, 2007	<b>Approximate Year Built:</b>	1950
<b>*Wall Rating:</b>	69	<b>Maintenance Action:</b>	No Action

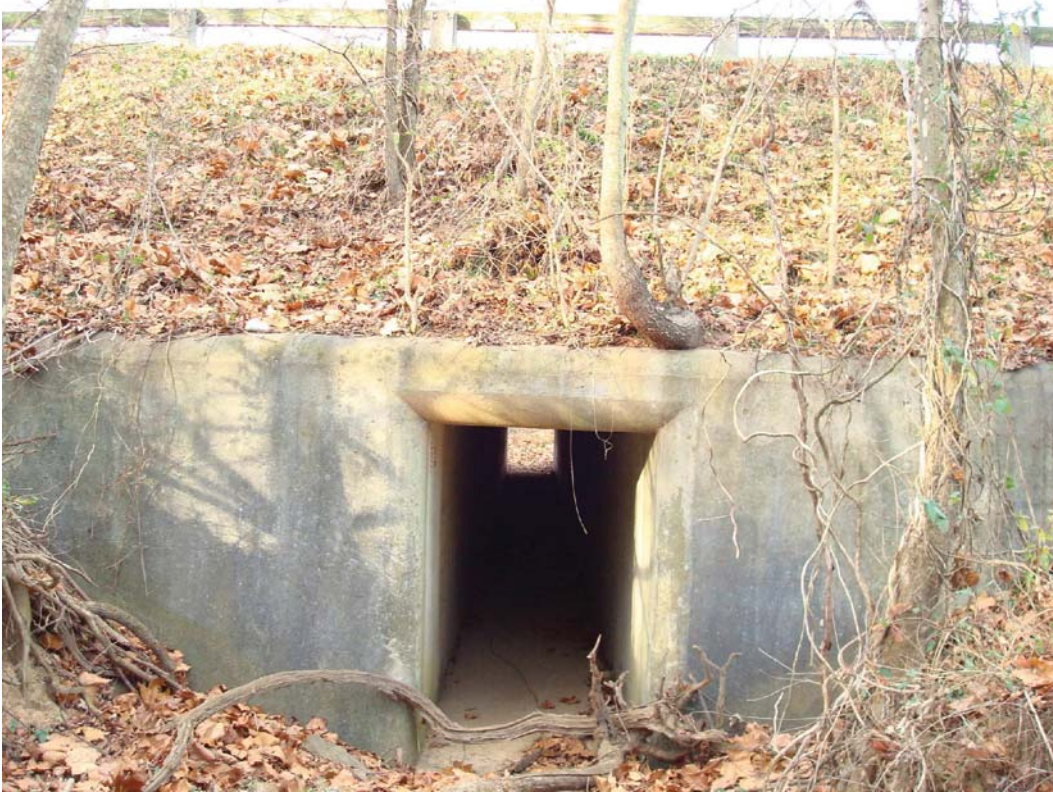
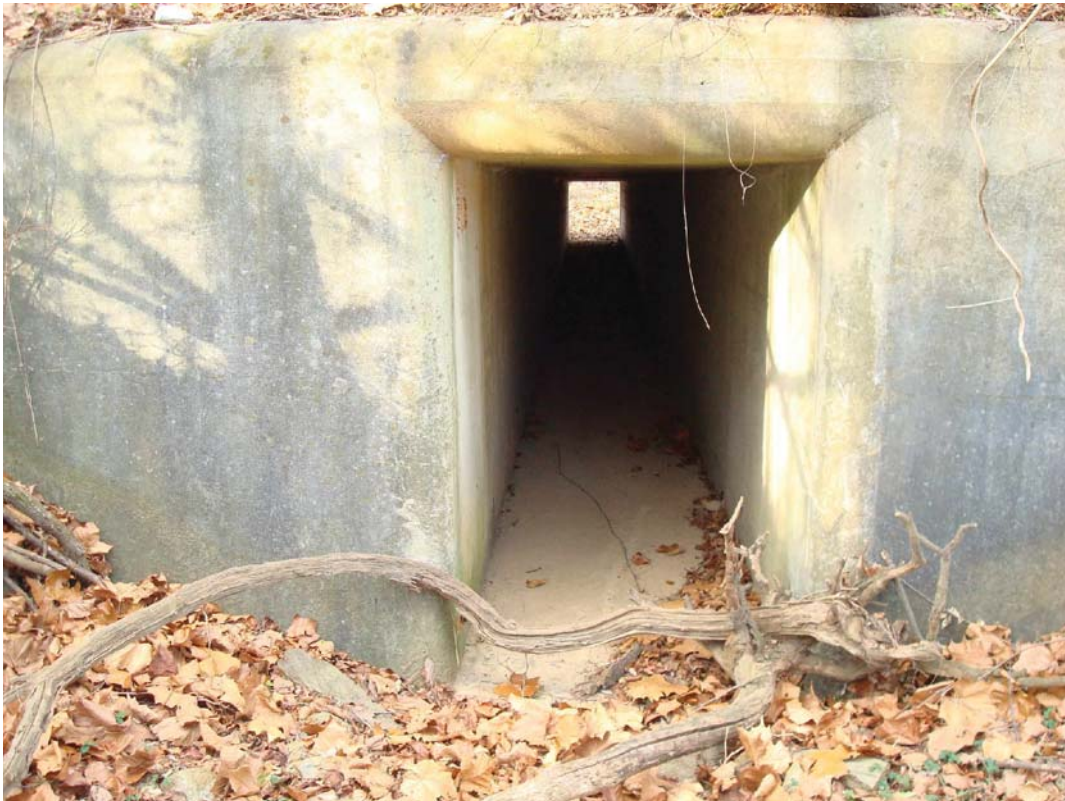
BLRI\_0001BA\_108.631\_L\_1.JPG

<b>Wall ID:</b>	BLRI-0001BA-108.631-L		
<b>Route Name:</b>	BLUE RIDGE PARKWAY - ROANOKE VALLEY SUB-DISTRICT		
<b>Inspection Date:</b>	December 04, 2007	<b>Approximate Year Built:</b>	1950
<b>*Wall Rating:</b>	69	<b>Maintenance Action:</b>	Maintenance
