# BLRI WIP Report

## NPS Retaining Wall Inventory Program Blue Ridge Parkway

Federal Highway Administration  
Eastern Federal Lands Highway Division  
Road Inventory Program (RIP)

# Blue Ridge Parkway in North Carolina and Virginia

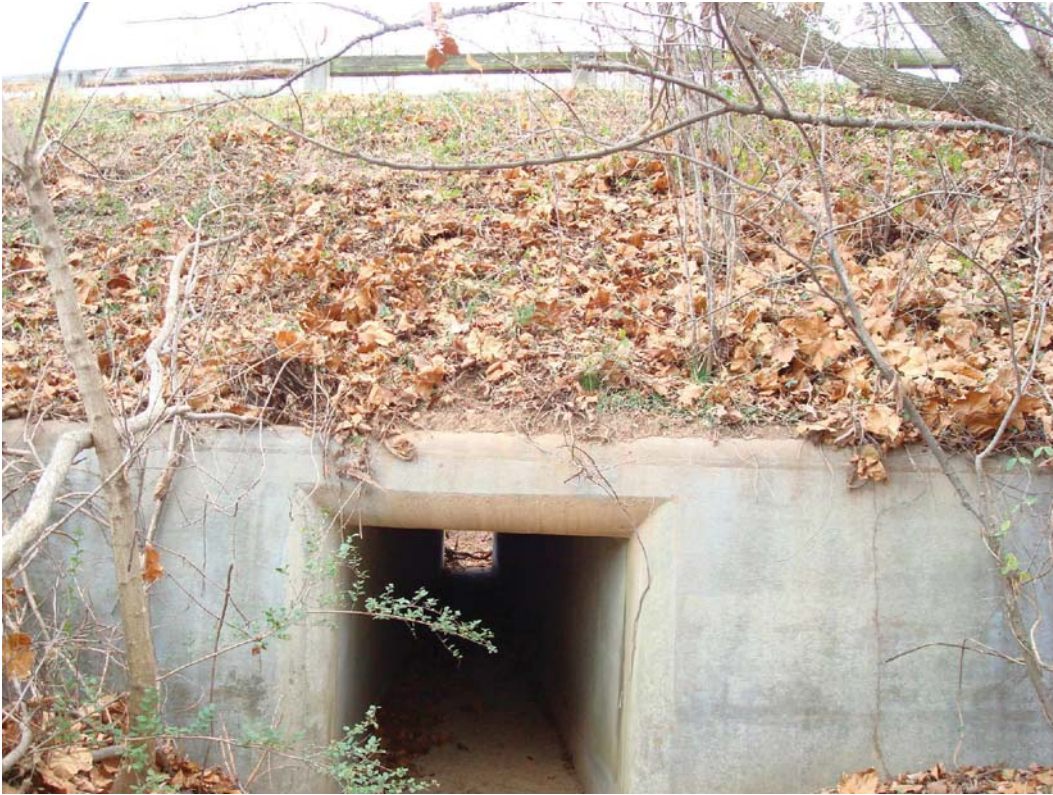
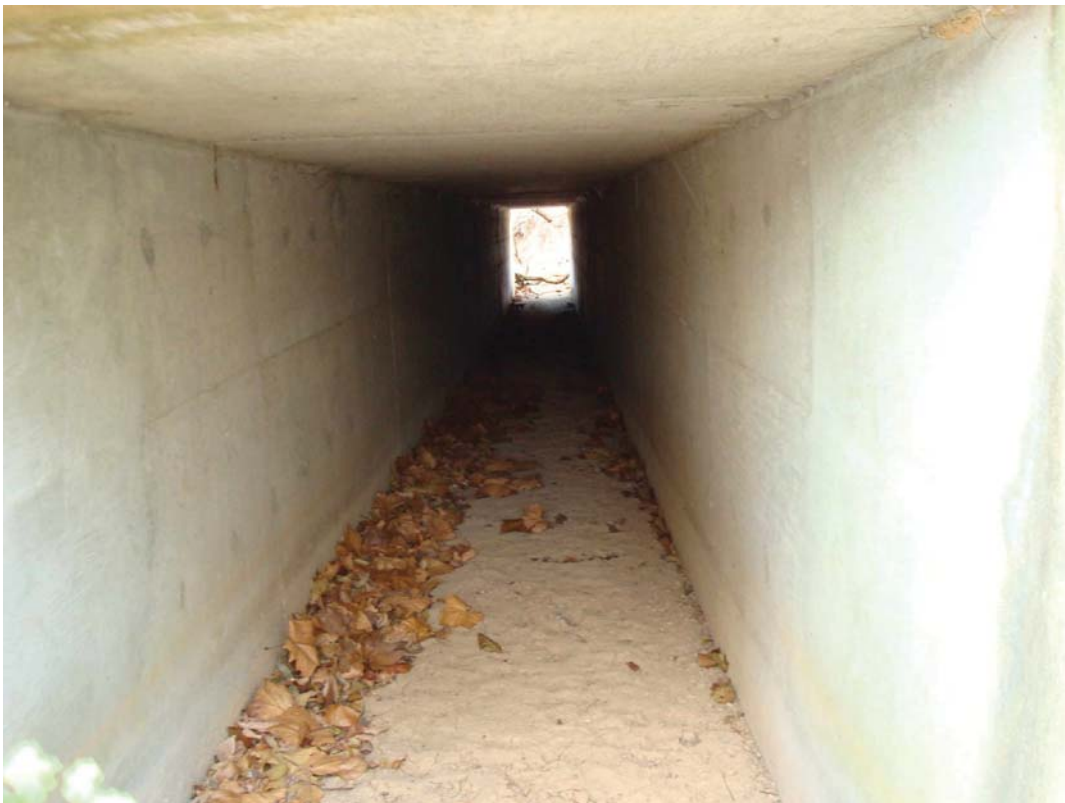
BLRI\_0001BA\_108.631\_R\_1.JPG

<b>Wall ID:</b>	BLRI-0001BA-108.631-R		
<b>Route Name:</b>	BLUE RIDGE PARKWAY - ROANOKE VALLEY SUB-DISTRICT		
<b>Inspection Date:</b>	December 04, 2007	<b>Approximate Year Built:</b>	1950
<b>*Wall Rating:</b>	69	<b>Maintenance Action:</b>	Repair Elements

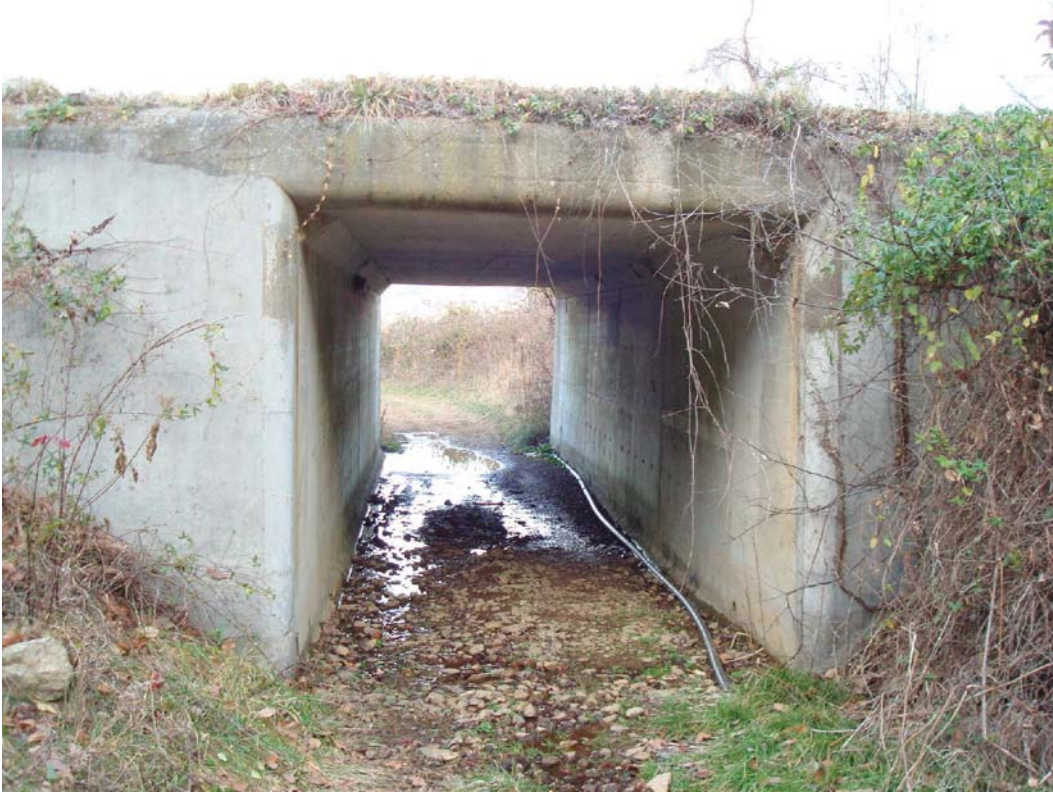
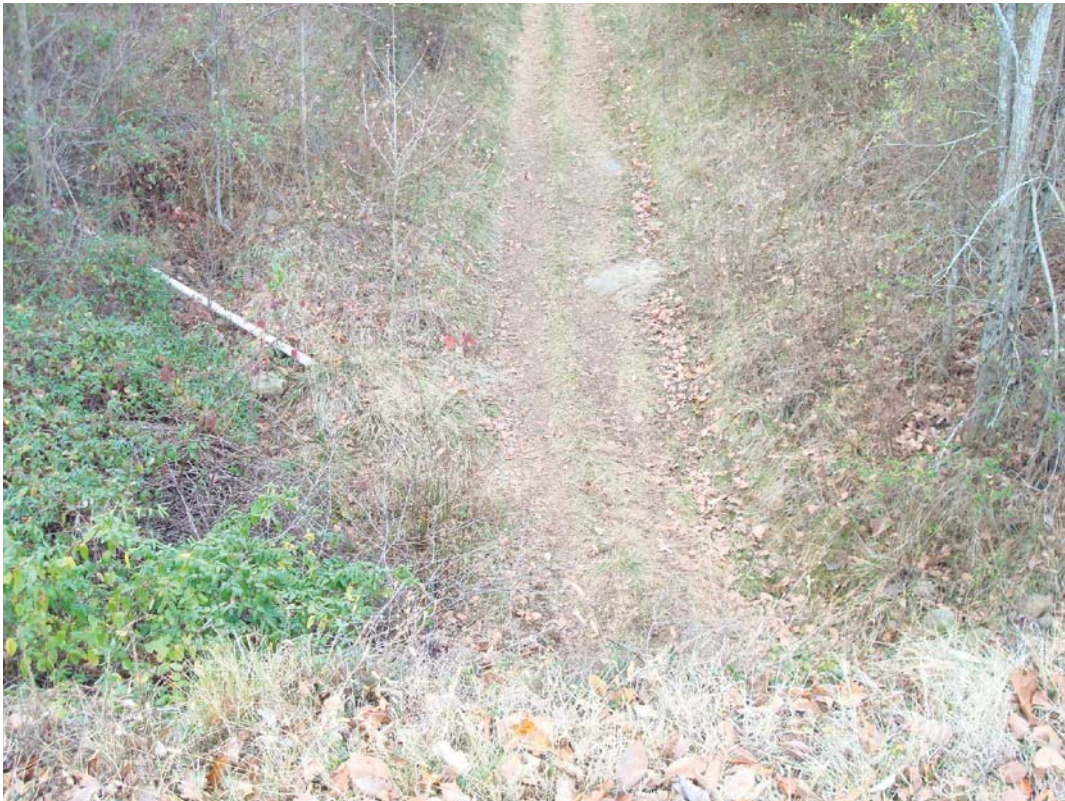
BLRI\_0001BA\_109.550\_L\_1.JPG

<b>Wall ID:</b>	BLRI-0001BA-109.550-L		
<b>Route Name:</b>	BLUE RIDGE PARKWAY - ROANOKE VALLEY SUB-DISTRICT		
<b>Inspection Date:</b>	December 04, 2007	<b>Approximate Year Built:</b>	1950
<b>*Wall Rating:</b>	70	<b>Maintenance Action:</b>	No Action

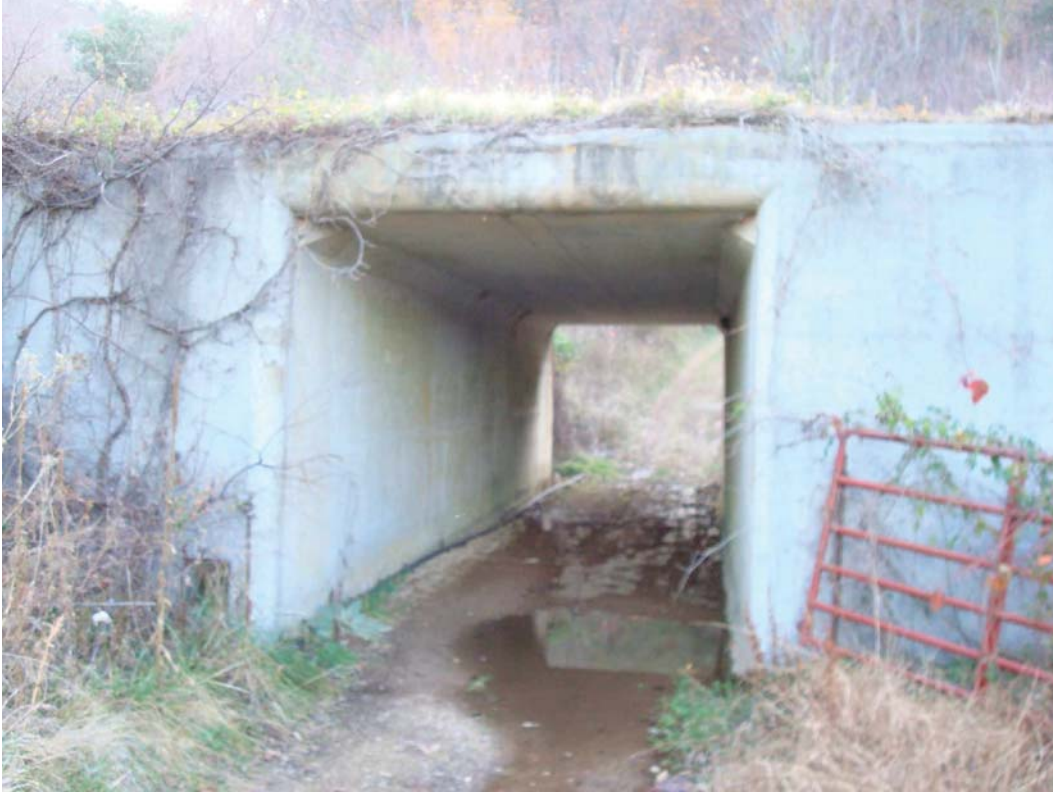
BLRI\_0001BA\_109.550\_R\_1.JPG

<b>Wall ID:</b>	BLRI-0001BA-109.550-R		
<b>Route Name:</b>	BLUE RIDGE PARKWAY - ROANOKE VALLEY SUB-DISTRICT		
<b>Inspection Date:</b>	December 04, 2007	<b>Approximate Year Built:</b>	1950
<b>*Wall Rating:</b>	70	<b>Maintenance Action:</b>	No Action

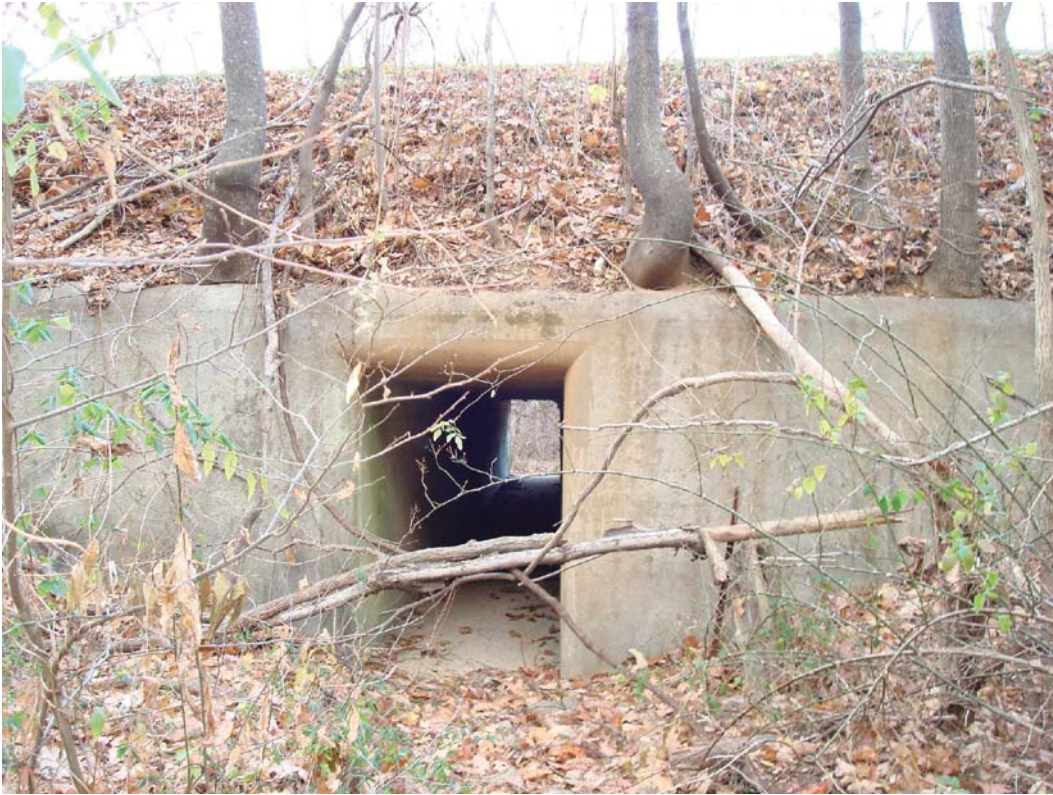
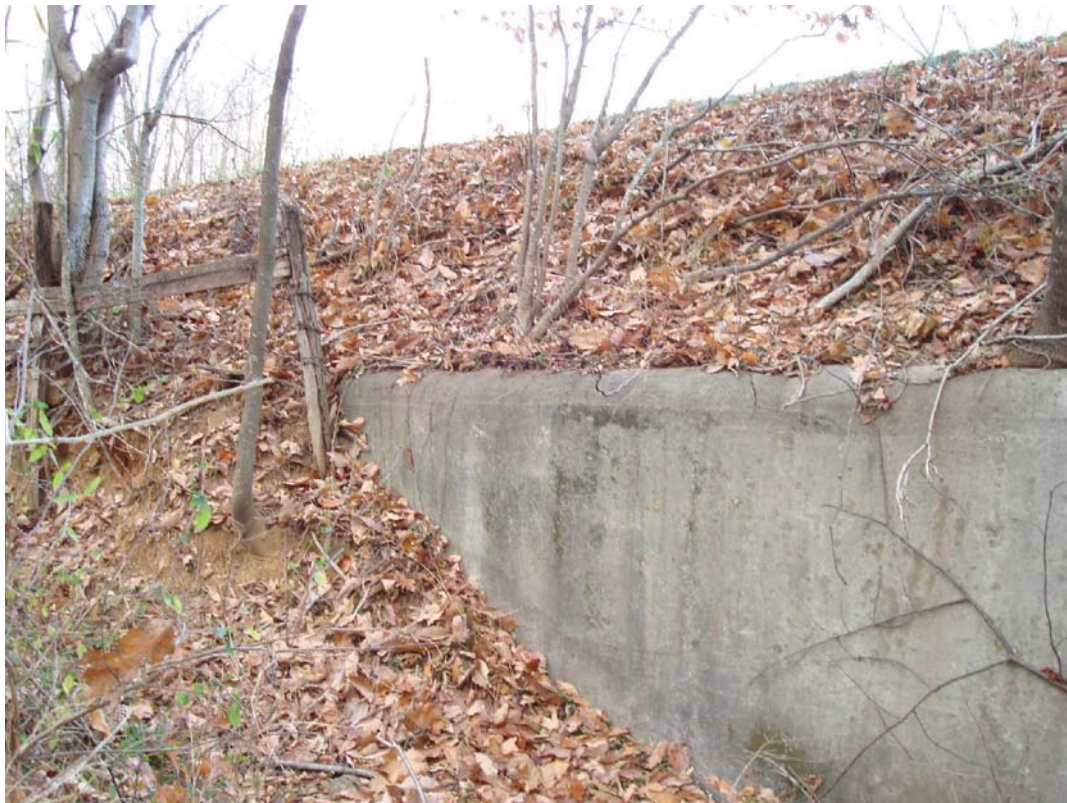
BLRI\_0001BA\_109.708\_L\_1.JPG

<b>Wall ID:</b>	BLRI-0001BA-109.708-L		
<b>Route Name:</b>	BLUE RIDGE PARKWAY - ROANOKE VALLEY SUB-DISTRICT		
<b>Inspection Date:</b>	December 04, 2007	<b>Approximate Year Built:</b>	1950
<b>*Wall Rating:</b>	72	<b>Maintenance Action:</b>	Maintenance

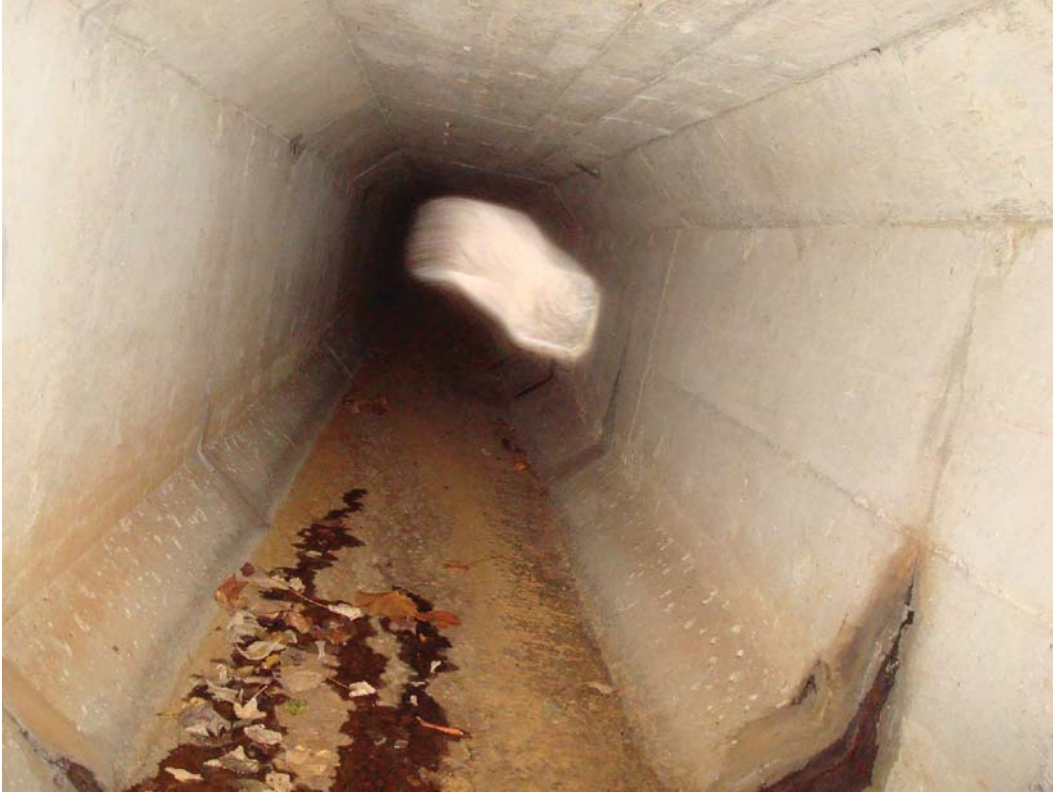
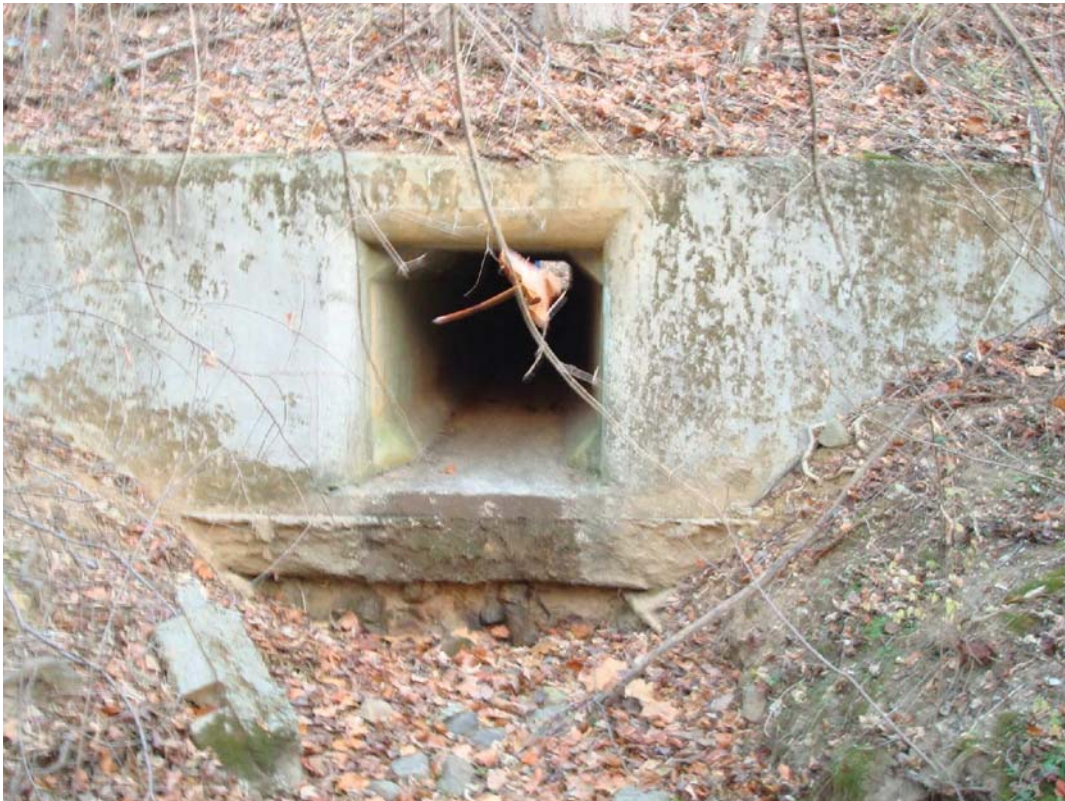
BLRI\_0001BA\_109.992\_R\_1.JPG

<b>Element (Weighting Factor)</b>	<b>Narrative</b>	<b>Condition Rating (0 - 10)</b>
PERFORMANCE 8.00	Needs repair to scour	4
WALL FOUNDATION MATERIAL 8.00	Cobbles, sand with gravel, and some silt. No settlement. Scour and undermined - 15" x 15" x 9'	4
CONCRETE 8.00	Sound and durable. Minor floor degradation	6
UPSLOPE 1.00	Steep.	6
CULVERT 1.00	4' x 4' box culvert with exposed rebar inside, spalled concrete.	7
DOWNSLOPE 1.00	Slight upslope.	7
LATERAL SLOPE 1.00	Uniform, gradual.	7
WALL DRAINS 1.00	None observed.	7

<b>Failure Consequence:</b>	LOW
<b>Recommendation Narrative:</b>	Install grouted riprap outlet apron, uppermost level ungrouted - 5 cy x \$330/cy = \$1,650 (includes labor). Clean and coat rebar - 10 L.F. x \$10/L.F. = \$100. Patch concrete spalls - 3 S.F. x \$15/S.F. = \$45. Labor - 10 hrs x \$55/hr = \$550
<b>Repair Cost:</b>	\$2,345

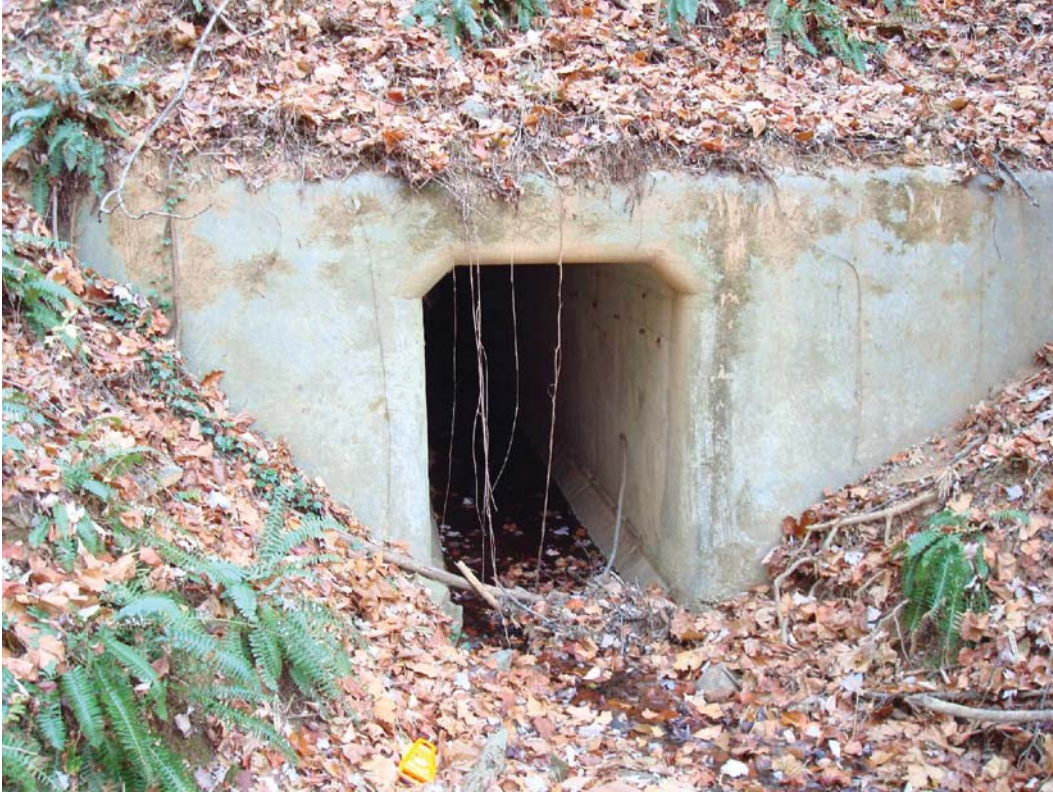
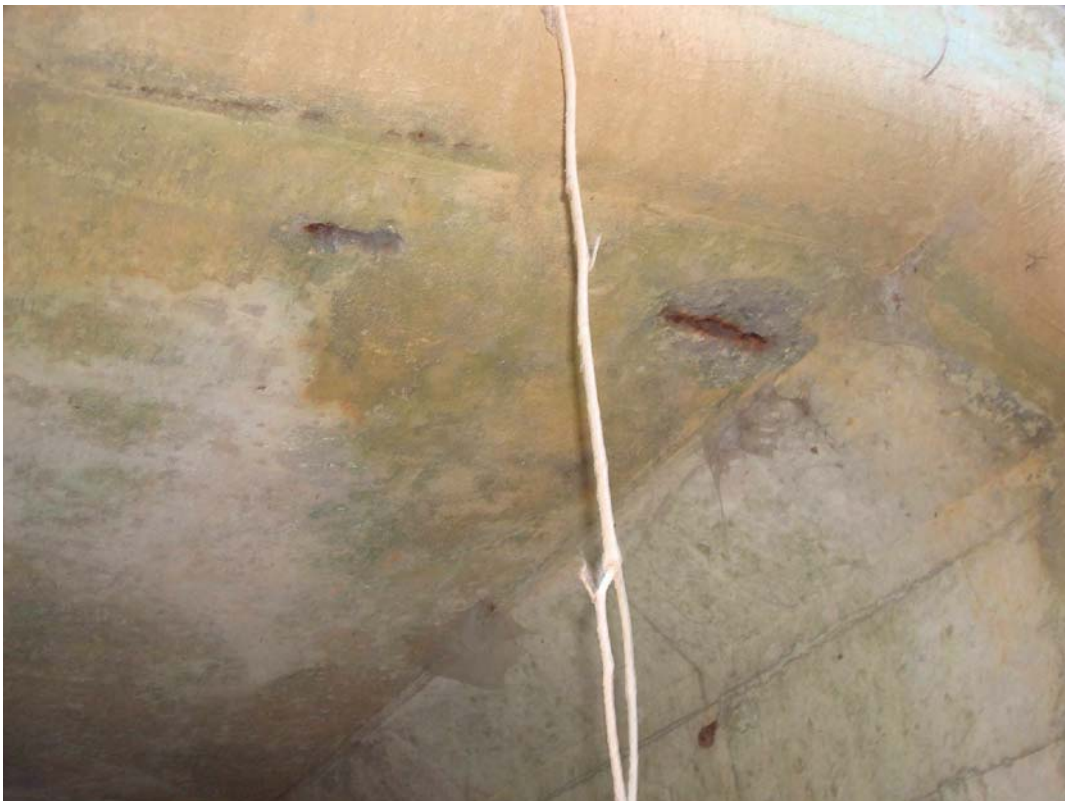
BLRI\_0001BA\_112.939\_L\_1.JPG

<b>Element (Weighting Factor)</b>	<b>Narrative</b>	<b>Condition Rating (0 - 10)</b>
PERFORMANCE 8.00	No global distress.	7
WALL FOUNDATION MATERIAL 8.00	Soil with boulders. Stream. No settlement or erosion.	7
CONCRETE 8.00	Sound and durable overall. Few spalls	6
UPSLOPE 1.00	Steep, wooded.	6
CULVERT 1.00	6' high by 4' wide concrete box. No degradation, minor weathering, few spalls	7
DOWNSLOPE 1.00	Flat, streambed.	7
LATERAL SLOPE 1.00	Uniform, gradual.	7
WALL DRAINS 1.00	None observed.	7

<b>Failure Consequence:</b>	LOW
<b>Recommendation Narrative:</b>	Clean and coat rebar - 20 L.F. x \$10/L.F. = \$200. Patch concrete spalls - 10 S.F. x \$15/S.F. = \$150. Labor - 10 hrs x \$55/hr = \$550
<b>Repair Cost:</b>	\$900

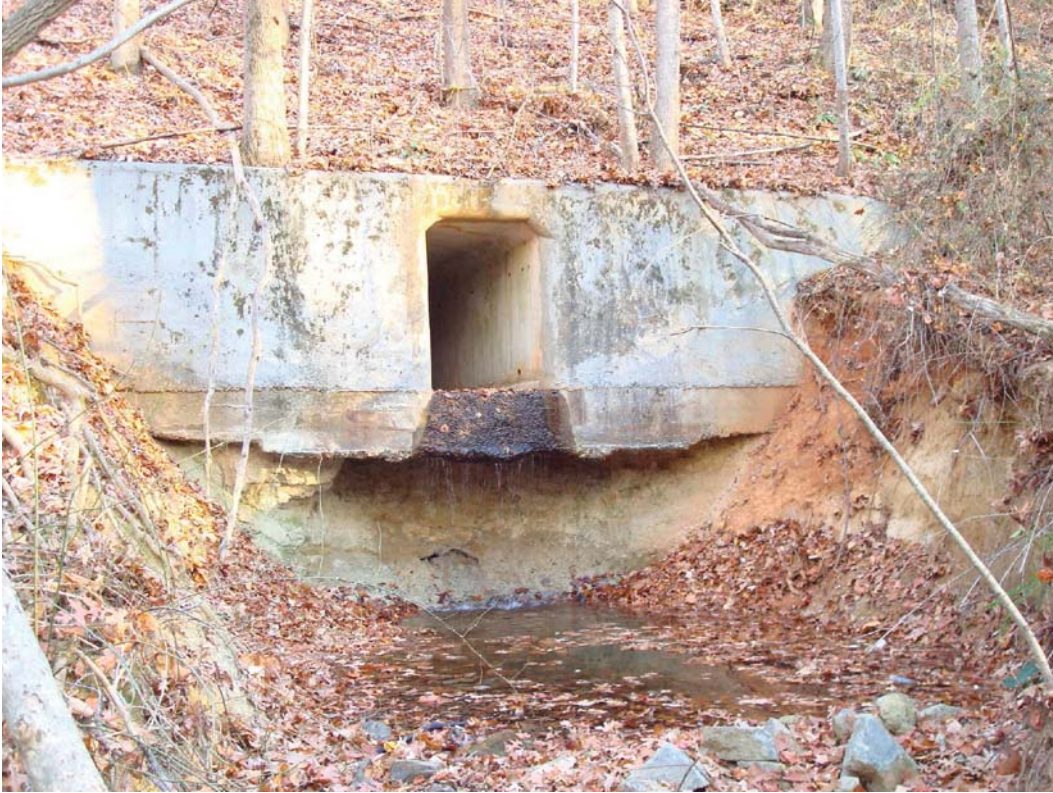
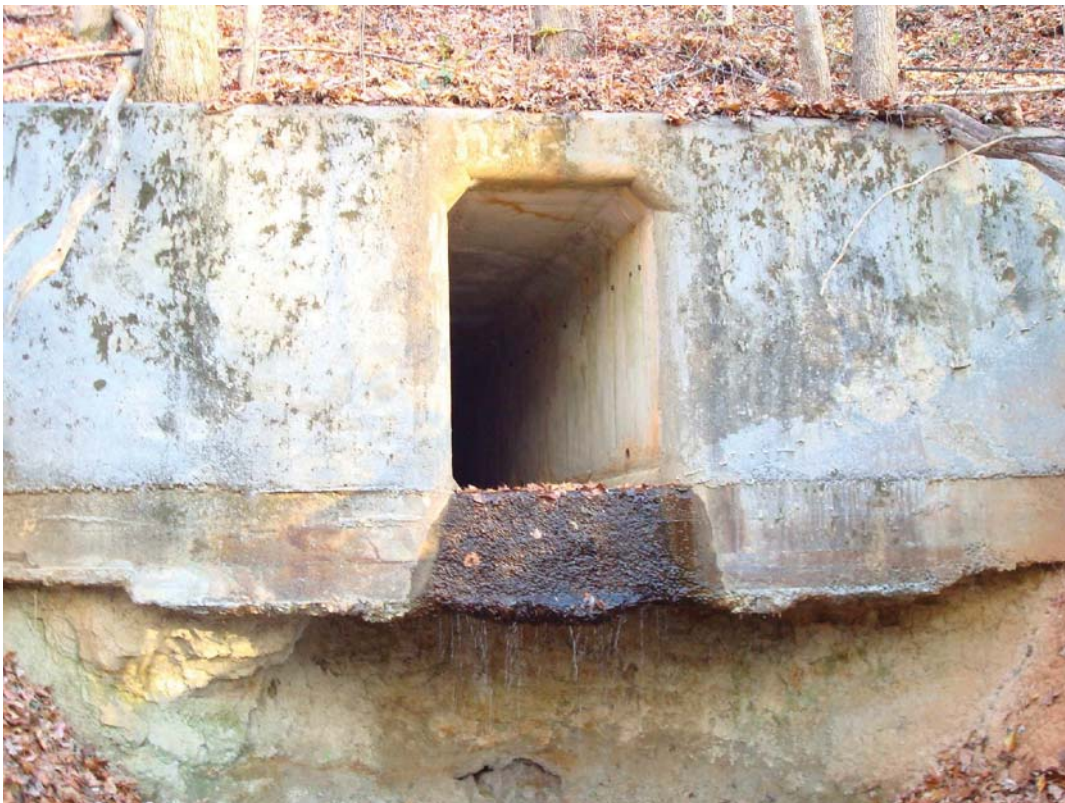
BLRI\_0001BA\_112.939\_R\_1.JPG

<b>Element (Weighting Factor)</b>	<b>Narrative</b>	<b>Condition Rating (0 - 10)</b>
PERFORMANCE 8.00	Structural/global stability threatened.	3
WALL FOUNDATION MATERIAL 8.00	Severe scour hole - 5'H x 25'L x 6.5'D Very erodible material - gray silt, some sand, little clay, low plasticity.	2
CONCRETE 8.00	Aged, otherwise sound and durable.	7
CULVERT 1.00	6' high by 4' wide concrete box.	7
DOWNSLOPE 1.00	Flat, stream bed.	7
LATERAL SLOPE 1.00	Uniform, gradual.	7
UPSLOPE 1.00	Steep, wooded.	7
WALL DRAINS 1.00	Circular drains.	7

<b>Failure Consequence:</b>	LOW
<b>Recommendation Narrative:</b>	Install grouted riprap apron to 2' below footing. Place geotextile over riprap within limits of footing. Finish with ungrouted riprap to grade and taper out to 25' beyond face. Hole volume: Below footing - 25' x 5' x 6.5' = 25 cy. Beyond wall 23' x 25' x
<b>Repair Cost:</b>	\$26,500

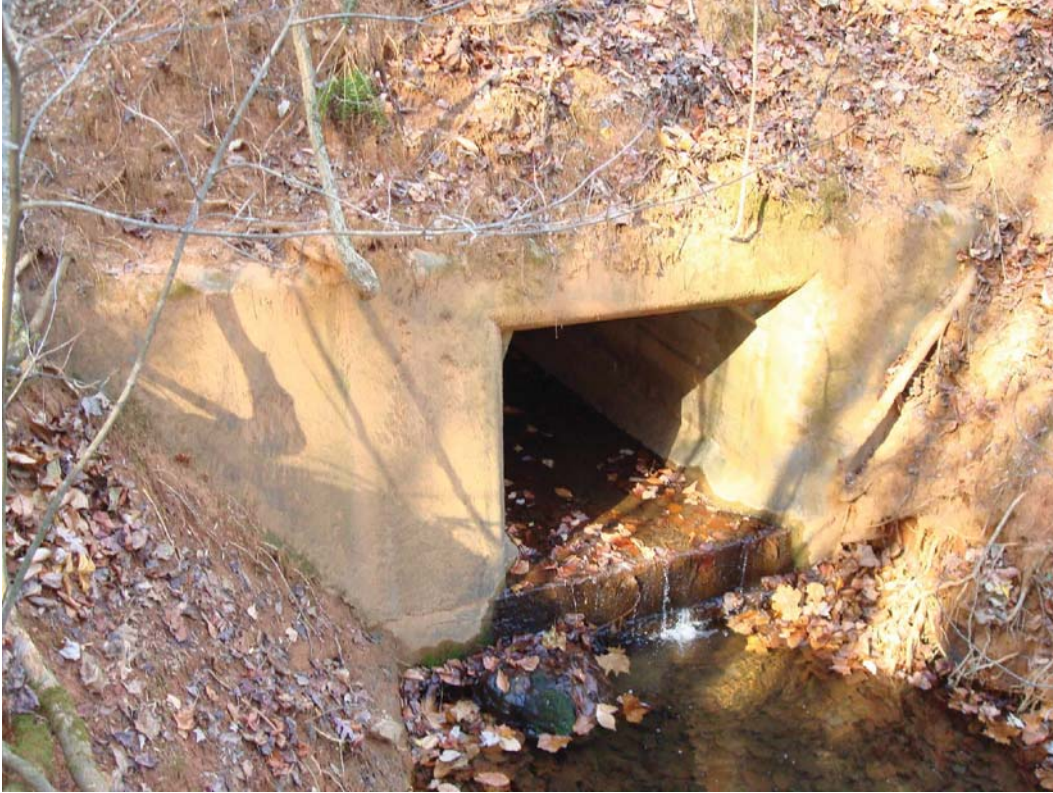
BLRI\_0001BA\_117.960\_L\_1.JPG

<b>Element (Weighting Factor)</b>	<b>Narrative</b>	<b>Condition Rating (0 - 10)</b>
PERFORMANCE 8.00	No global distress.	7
WALL FOUNDATION MATERIAL 8.00	Sand, little silt, little gravel No settlement or erosion.	7
CONCRETE 8.00	Sound and durable. Slight exposed steel.	7
CULVERT 0.50	4' high by 5' wide	8
LATERAL SLOPE 0.50	Uniform, gradual.	8
UPSLOPE 1.00	Steeper than 1:1	5
DOWNSLOPE 1.00	Flat streambed.	7
WALL DRAINS 1.00	None observed.	7

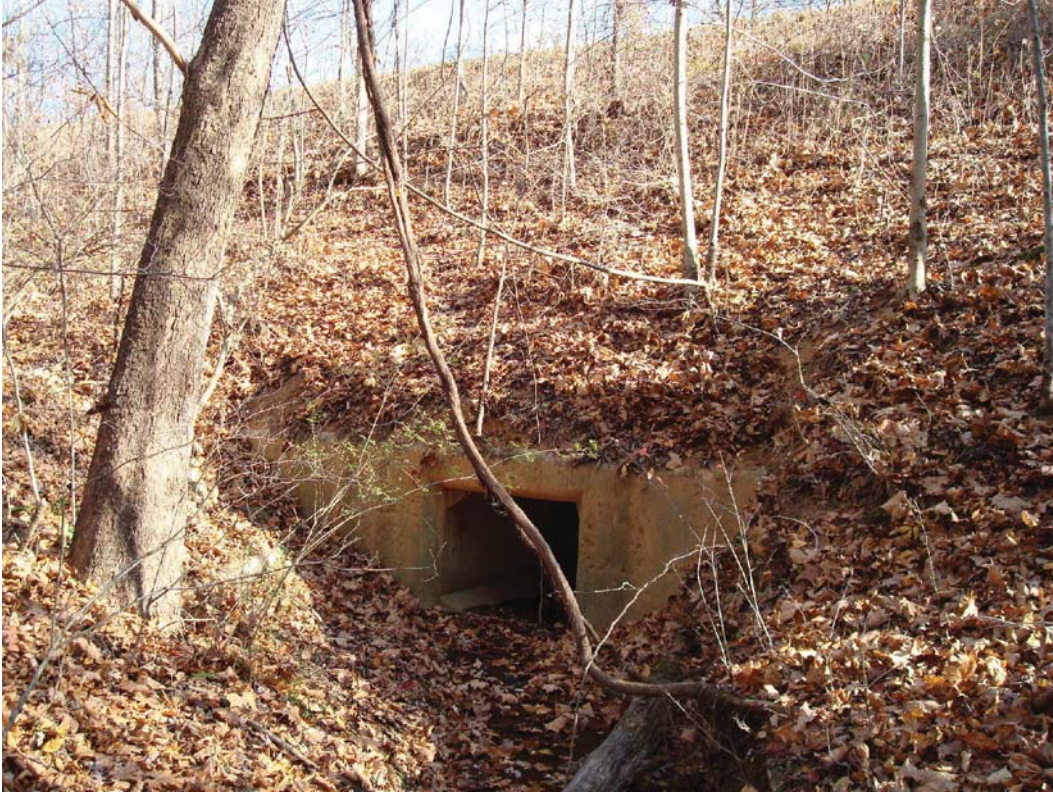
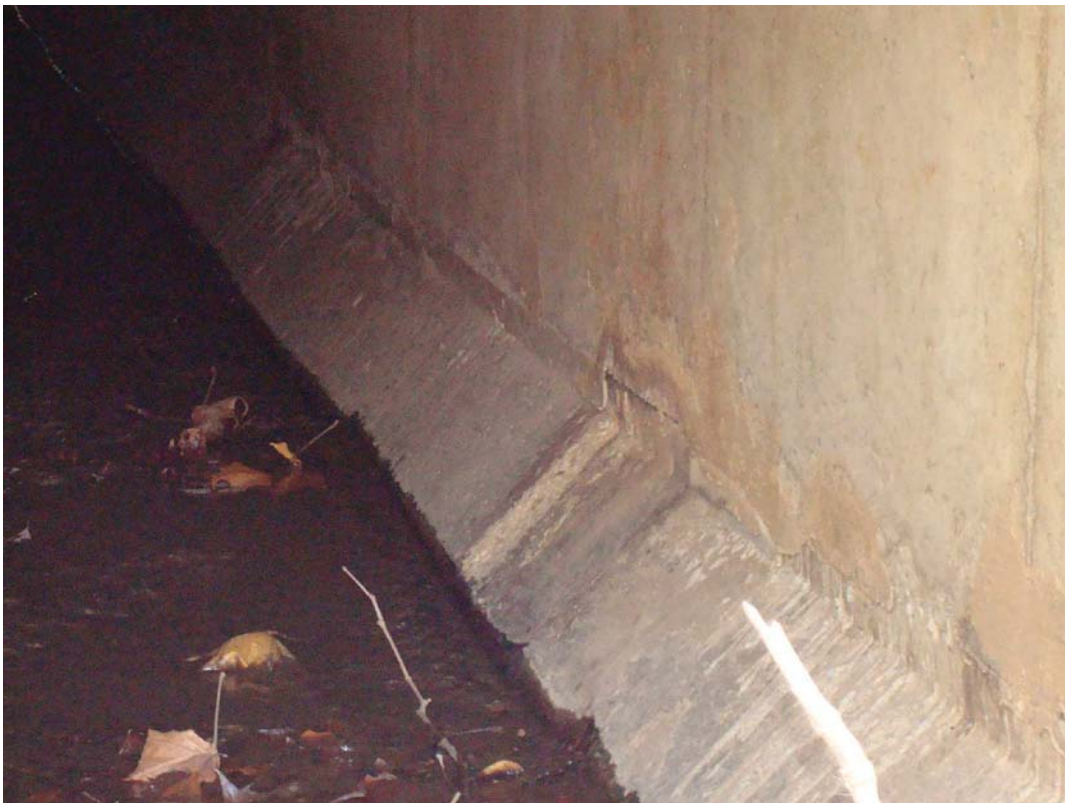
BLRI\_0001BA\_117.960\_R\_1.JPG

<b>Element (Weighting Factor)</b>	<b>Narrative</b>	<b>Condition Rating (0 - 10)</b>
PERFORMANCE 8.00	No global distress. Fix undermining.	6
WALL FOUNDATION MATERIAL 8.00	Sand, little silt, and little gravel. No settlement. Slight scour undermining outlet (2' high by 8' wide by 1' deep).	5
CONCRETE 8.00	Sound and durable.	8
CULVERT 0.50	4' high by 5' wide concrete box	8
LATERAL SLOPE 0.50	Uniform, gradual.	8
UPSLOPE 1.00	Steeper than 1:1	5
DOWNSLOPE 1.00	Flat streambed.	7
WALL DRAINS 1.00	None observed.	7

<b>Failure Consequence:</b>	LOW
<b>Recommendation Narrative:</b>	Grouted riprap - 2' x 8' x 1' = say 1 cy x \$330/cy = \$330. Labor \$55/hr x 20 hrs = \$1,100.
<b>Repair Cost:</b>	\$1,430

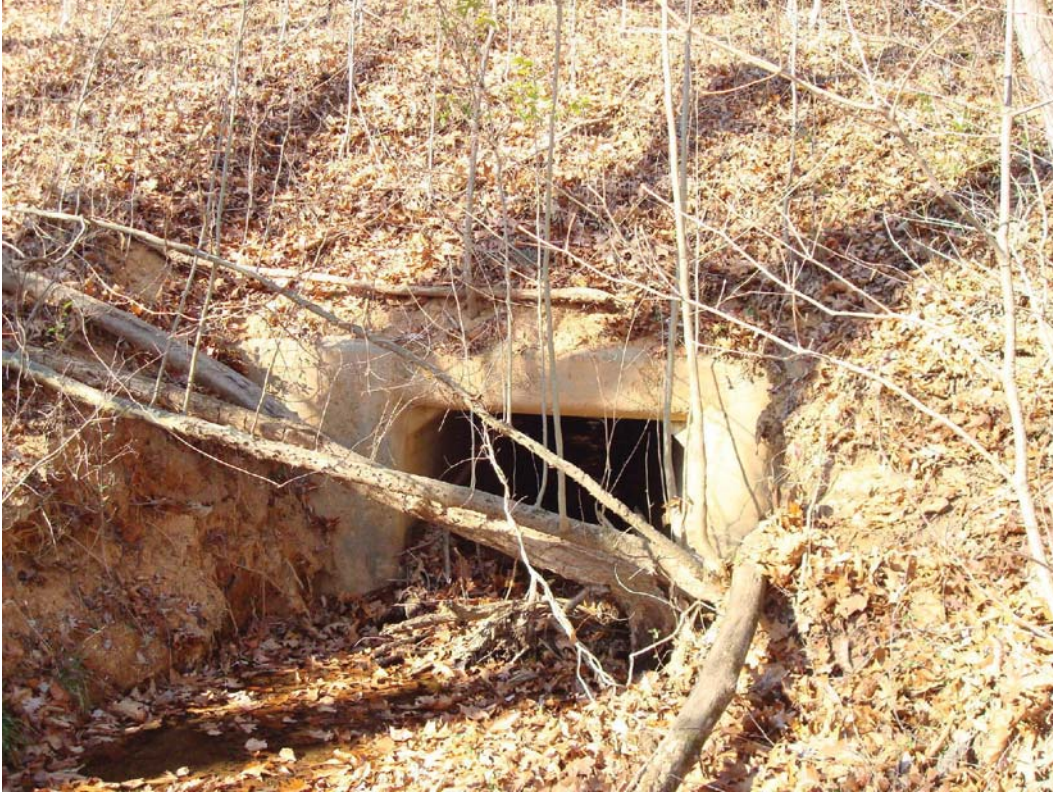
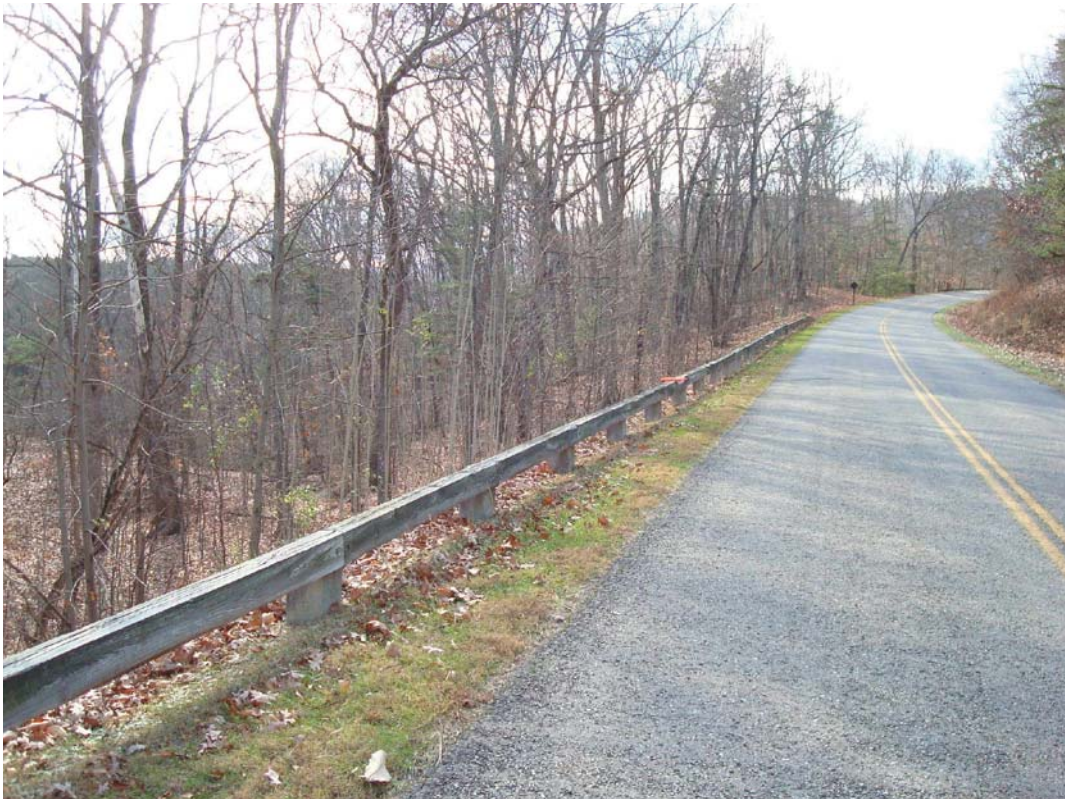
BLRI\_0001BA\_118.092\_L\_1.JPG

<b>Element (Weighting Factor)</b>	<b>Narrative</b>	<b>Condition Rating (0 - 10)</b>
PERFORMANCE 8.00	No global distress.	7
WALL FOUNDATION MATERIAL 8.00	Sand and little silt. No settlement. Some scour on the sides not underneath.	7
CONCRETE 8.00	Sound and durable. Soil covers part of headwall, unknown actual length	8
CULVERT 0.50	6' wide by 3' high concrete box.	8
UPSLOPE 1.00	Steep.	6
DOWNSLOPE 1.00	Flat, streambed.	7
LATERAL SLOPE 1.00	Uniform, gradual.	7
ROAD/SIDEWALK/SHOULDER 1.00	Aged wood barrier with concrete posts.	7
VEGETATION 1.00	Trees on top, small fallen trees in front.	7

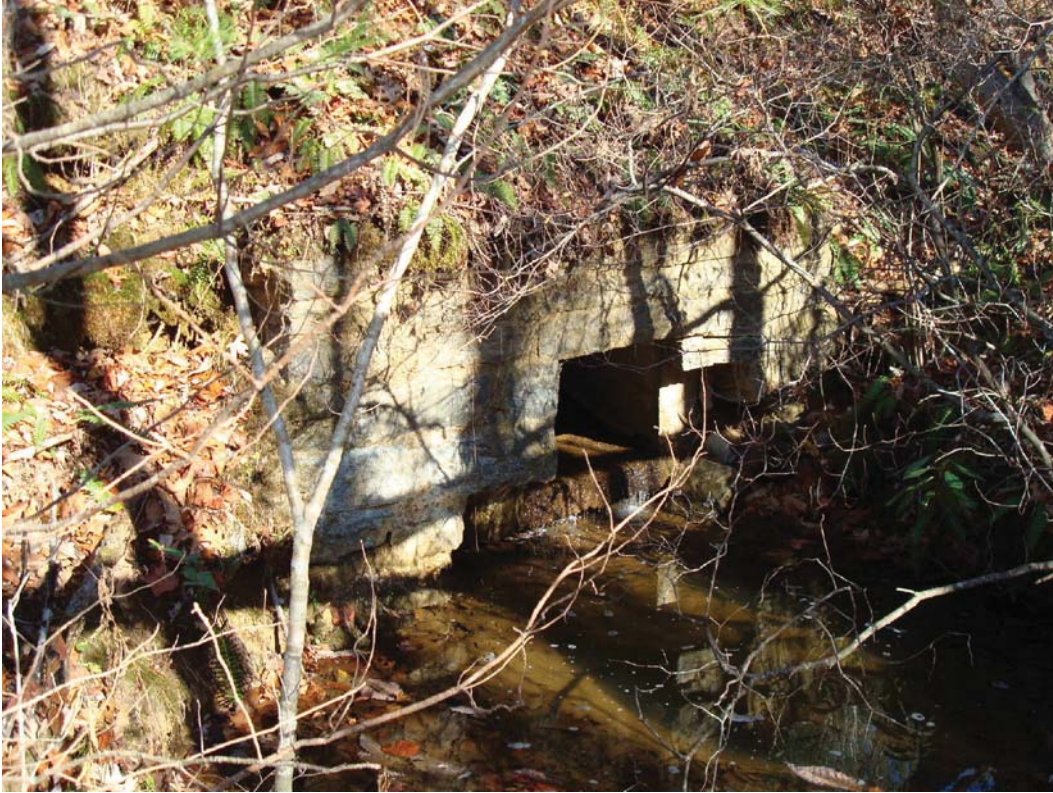
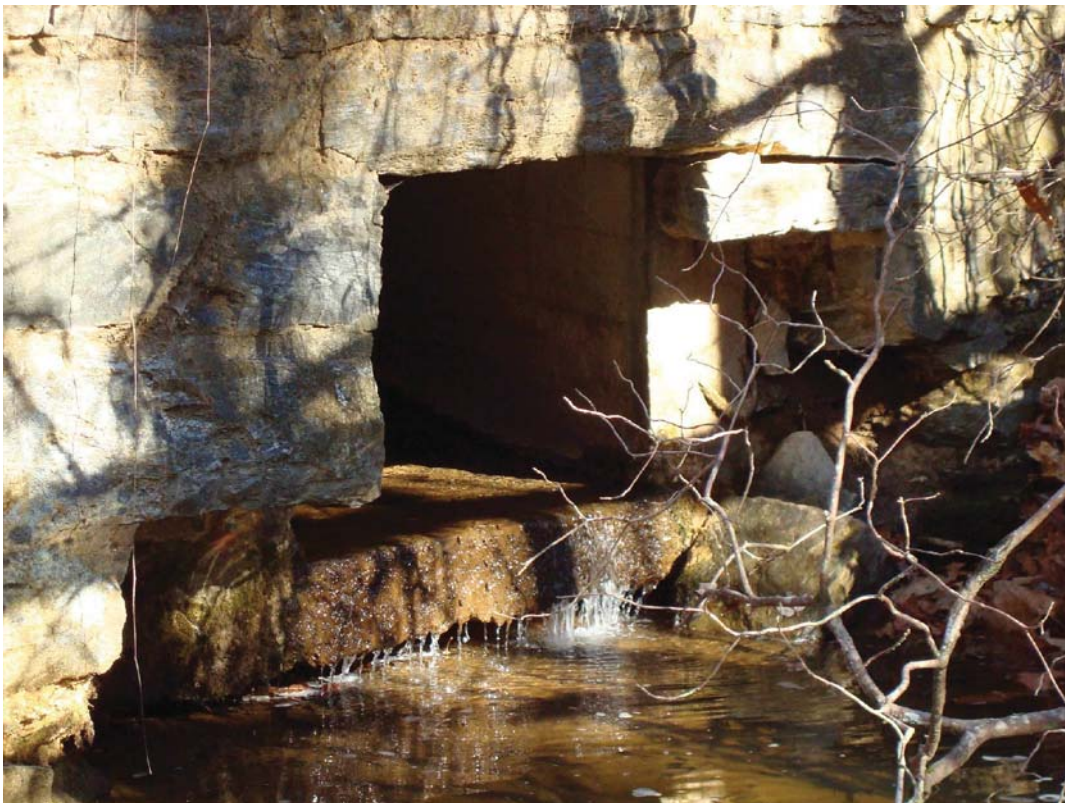
BLRI\_0001BB\_210.059\_L\_1.JPG

<b>Element (Weighting Factor)</b>	<b>Narrative</b>	<b>Condition Rating (0 - 10)</b>
PERFORMANCE 8.00	Global distress to wall, wall falling apart. Needs to be replaced.	4
WALL FOUNDATION MATERIAL 8.00	Soil Undermined 1' H x 5'W x 1'D, scour hole in front of outlet evident	4
STONE MASONRY 8.00	Many missing stones, 1/4th of wall Cracks in stone from stress	4
MORTAR 8.00	Missing, cracked, stones separating throughout	6
LATERAL SLOPE 1.00	Sloping, eroded heavily at south end - 5' x 5' x 2'. Some erosion at north end	4
UPSLOPE 1.00	Gradual then steep for last 8' horizontally	5
CULVERT 1.00	3'W x 3'H concrete box, some chips in concrete	6
WALL DRAINS 1.00	Not visible	6
DOWNSLOPE 1.00	Flat streambed	7

<b>Failure Consequence:</b>	LOW
<b>Recommendation Narrative:</b>	Remove/Replace headwall, and extend additional 6' to the south - 18' x 5' - 9 s.f. = 81 s.f., 81 s.f. x \$350/s.f. = \$28,350. Place select fill in eroded area - 5' x 5' x 2' = 2 cy x \$60/c.y. = \$120. Construct lean concrete apron in front of headwall, fill u
<b>Repair Cost:</b>	\$41,700

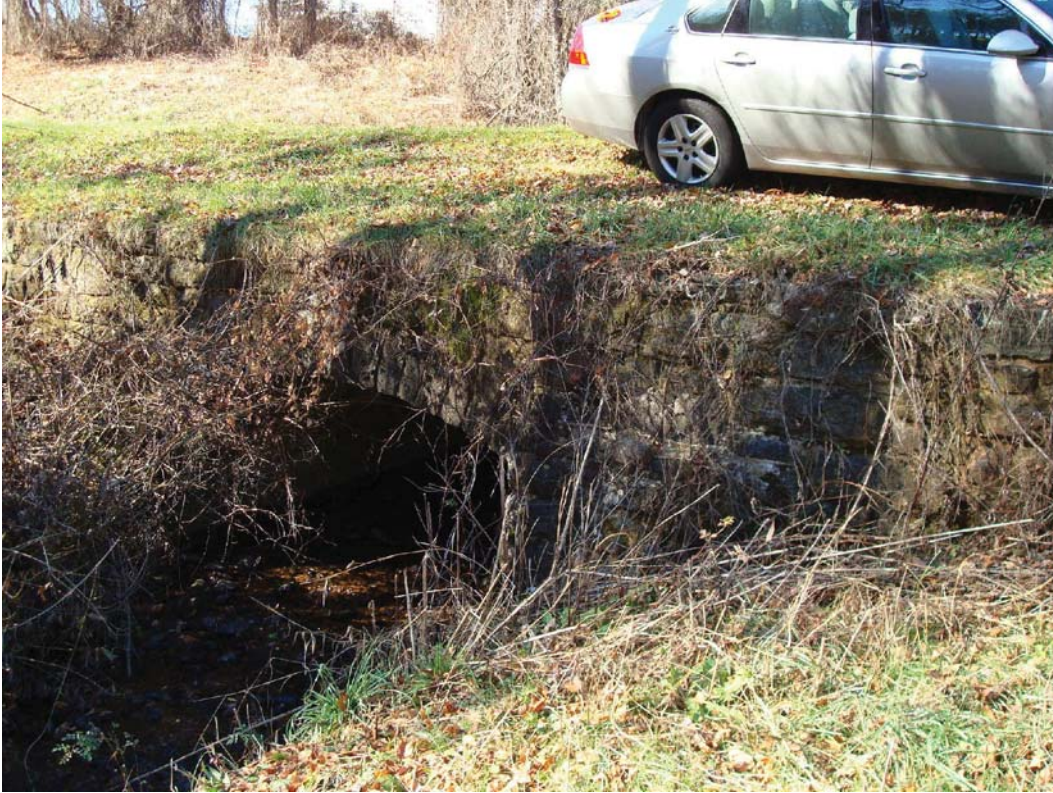
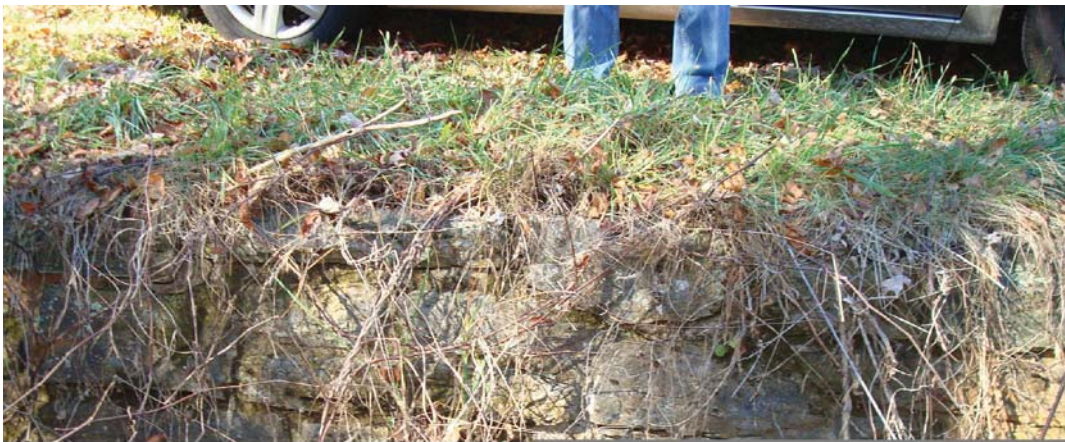
BLRI\_0001BB\_210.652\_L\_1.JPG

<b>Element (Weighting Factor)</b>	<b>Narrative</b>	<b>Condition Rating (0 - 10)</b>
PERFORMANCE 8.00	No global distress	7
WALL FOUNDATION MATERIAL 8.00	Soil, rocky No settlement or erosion	7
STONE MASONRY 8.00	Missing 2 stones - approx. 7 s.f.	6
MORTAR 8.00	Some separation of mortar	7
ROAD/SIDEWALK/SHOULDER 0.50	Grassy shoulder	8
WALL DRAINS 1.00	Functioning drains, but some drains are at current stream level	6
CULVERT 1.00	5.5'H x 8'W box with arch top	7
DOWNSLOPE 1.00	Flat, streambed	7
LATERAL SLOPE 1.00	Flat, grassy	7

<b>Failure Consequence:</b>	LOW
<b>Recommendation Narrative:</b>	Replace 2 capstones - 7 s.f. x \$250/s.f. = \$1,750
<b>Repair Cost:</b>	\$1,750

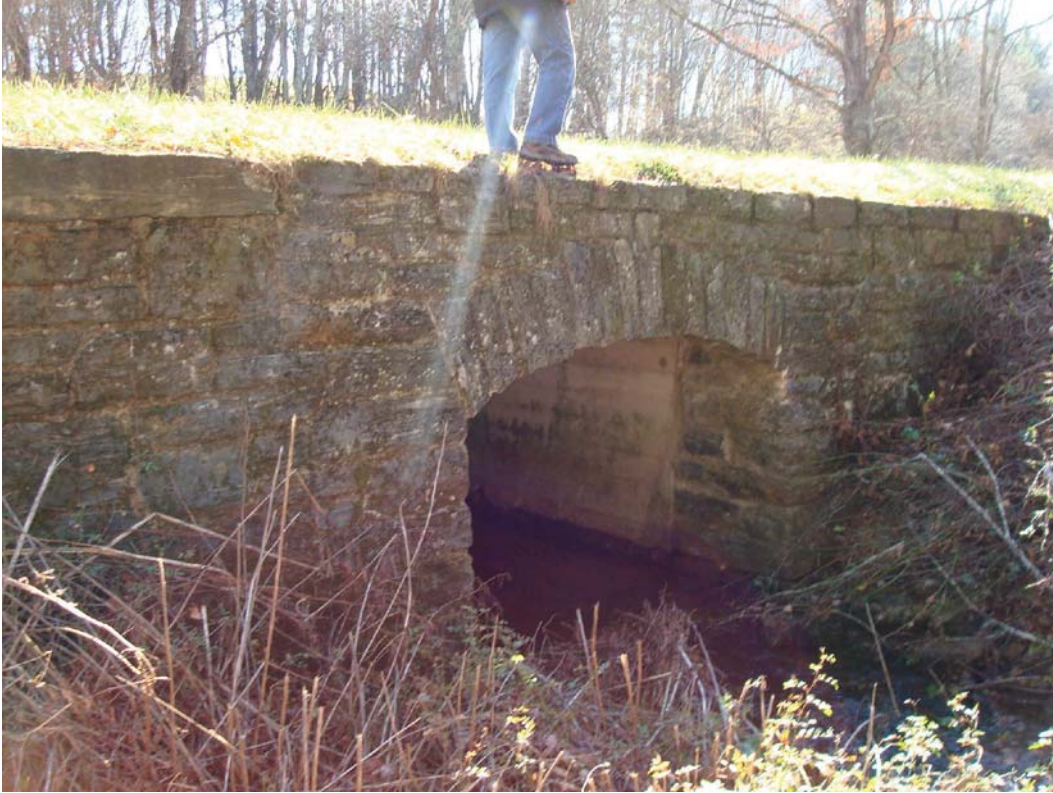
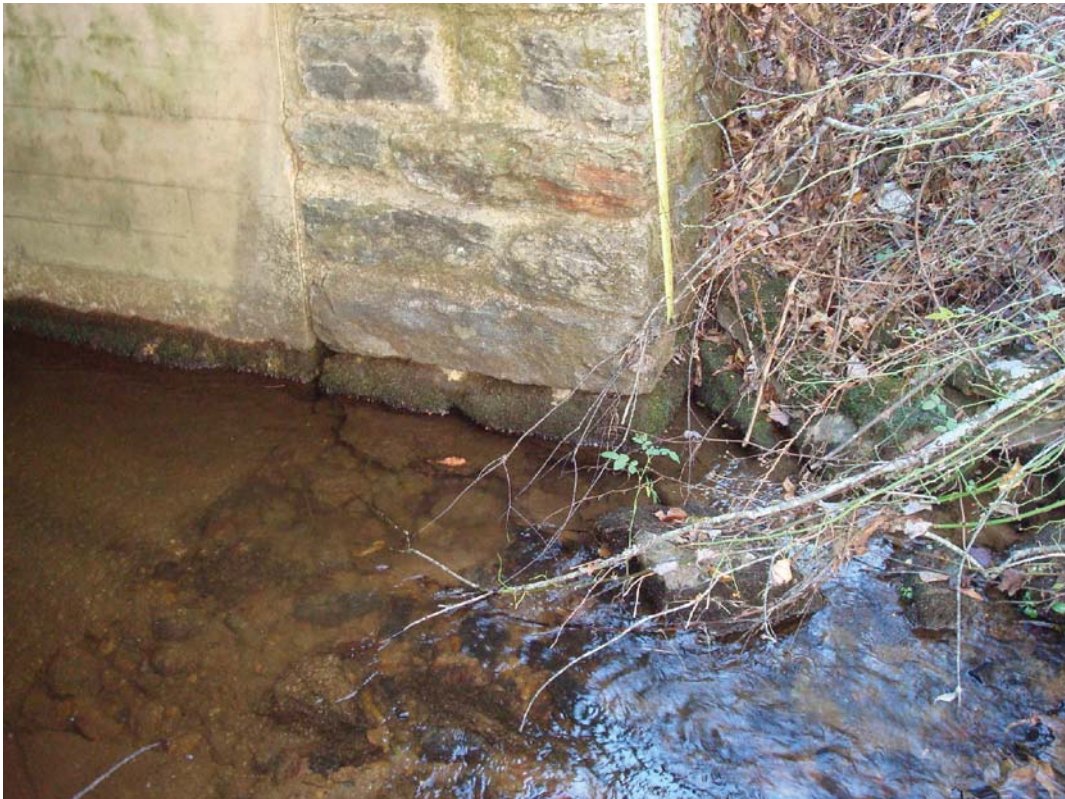
BLRI\_0001BB\_210.652\_R\_1.JPG

<b>Element (Weighting Factor)</b>	<b>Narrative</b>	<b>Condition Rating (0 - 10)</b>
PERFORMANCE 8.00	No global distress	7
WALL FOUNDATION MATERIAL 8.00	Soil, rocky Slight scour	7
MORTAR 8.00	Some separation, mortar missing 2'	6
STONE MASONRY 8.00	No degradation, missing capstone (approx. 3 s.f.), moss covered	7
LATERAL SLOPE 0.50	Flat, grassy	8
ROAD/SIDEWALK/SHOULDER 0.50	Grassy shoulder	8
WALL DRAINS 1.00	Functioning drains, but some drains at current stream level	6
CULVERT 1.00	5.5'H x 8'W box with arch top	7
DOWNSLOPE 1.00	Flat, streambed	7

<b>Failure Consequence:</b>	LOW
<b>Recommendation Narrative:</b>	Replace Capstone - 3 s.f. x \$250/s.f. = \$750. Repoint Mortar - 10 s.f. x \$75/s.f. = \$750
<b>Repair Cost:</b>	\$1,500
