# BLRI WIP Report

## NPS Retaining Wall Inventory Program Blue Ridge Parkway

Federal Highway Administration  
Eastern Federal Lands Highway Division  
Road Inventory Program (RIP)

# Blue Ridge Parkway in North Carolina and Virginia

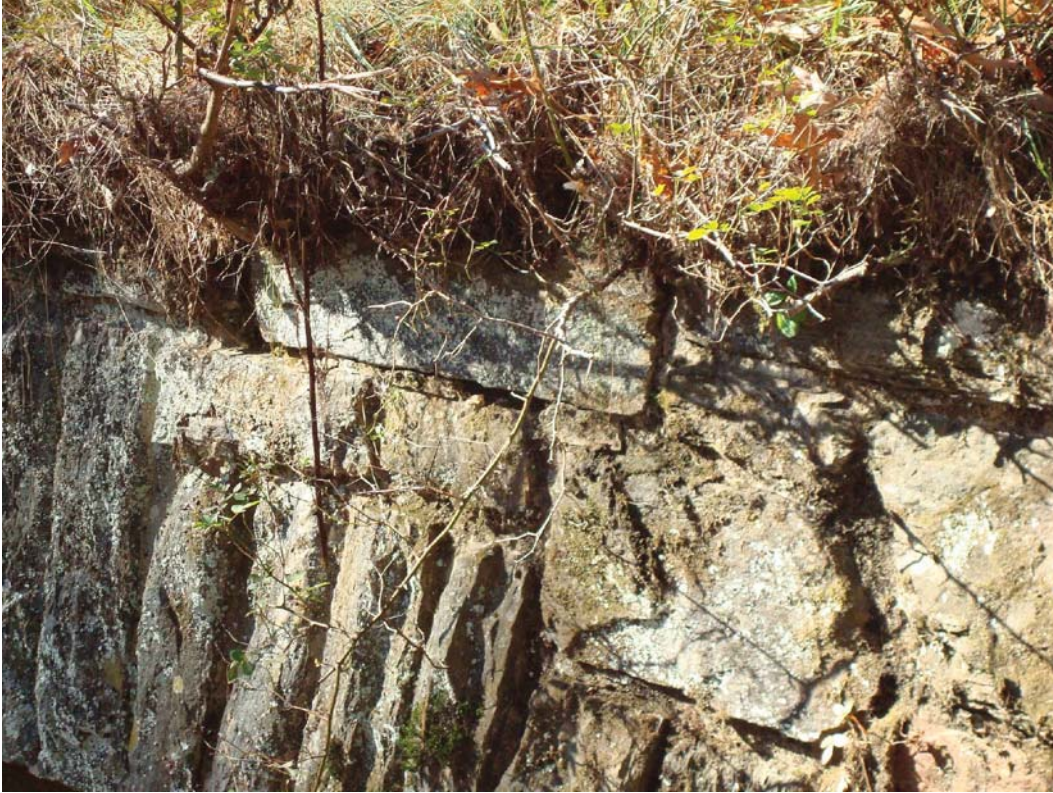
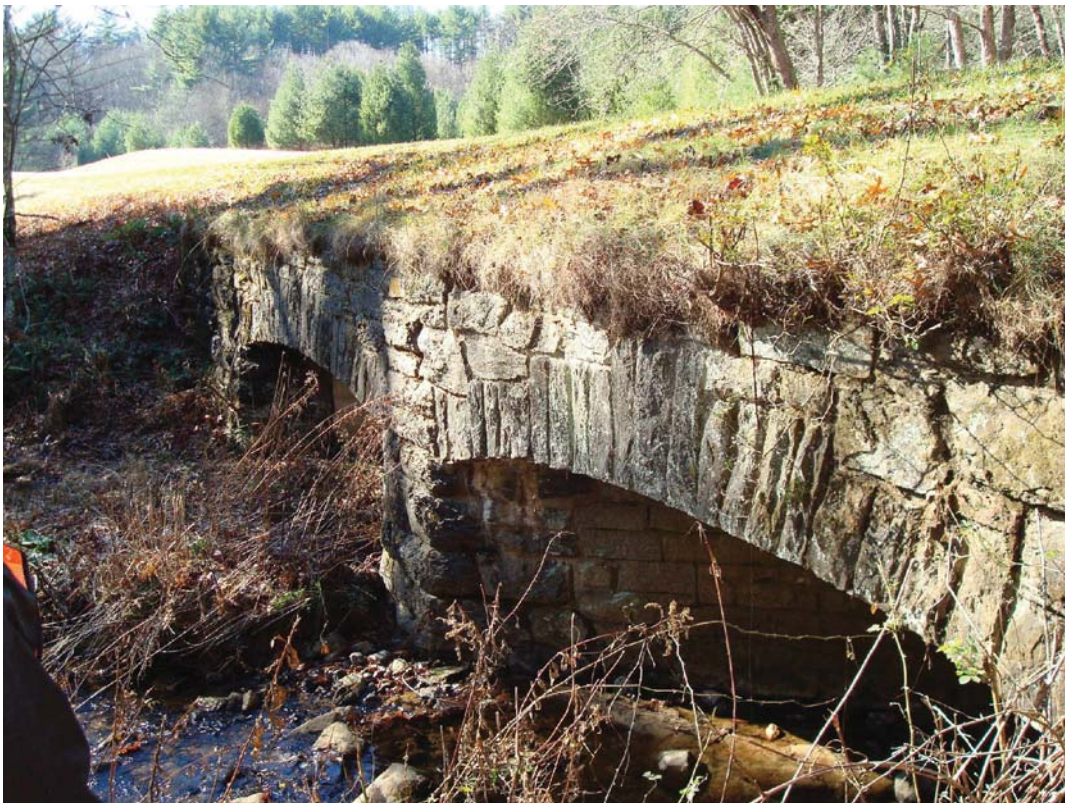
BLRI\_0001BB\_211.679\_L\_1.JPG

<b>Element (Weighting Factor)</b>	<b>Narrative</b>	<b>Condition Rating (0 - 10)</b>
PERFORMANCE 8.00	No global distress	7
WALL FOUNDATION MATERIAL 8.00	Rocky soil No settlement or erosion	7
MORTAR 8.00	Sound and durable Slight mortar loss - approximately 5 s.f. at top	7
STONE MASONRY 8.00	No degradation	7
LATERAL SLOPE 0.50	Flat, grassy	8
ROAD/SIDEWALK/SHOULDER 0.50	Flat, grassy shoulder	8
WALL DRAINS 0.50	Weep holes inside culvert, 8' on center, all functioning	8
CULVERT 1.00	Two 15'W x 6'H box culvert, concrete bottom, arch at top	7
DOWNSLOPE 1.00	Flat streambed	7

<b>Failure Consequence:</b>	LOW
<b>Recommendation Narrative:</b>	Repoint mortar at top of wall - 8 s.f. x \$75/s.f. = \$600.
<b>Repair Cost:</b>	\$600

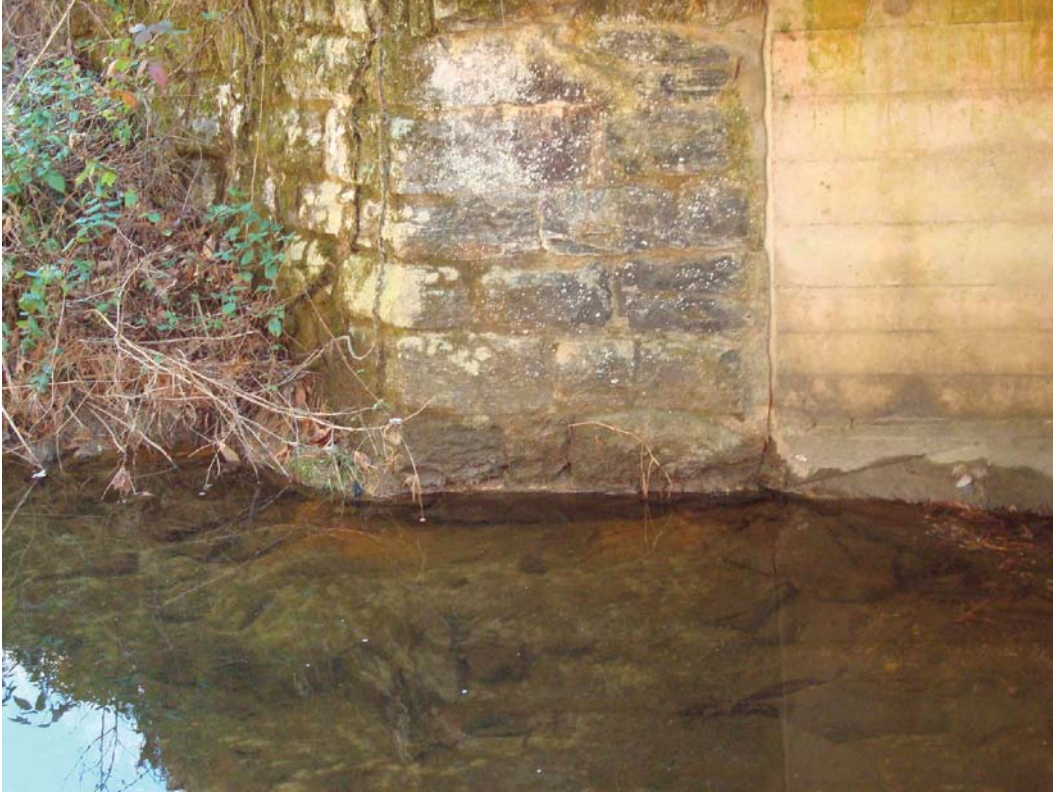
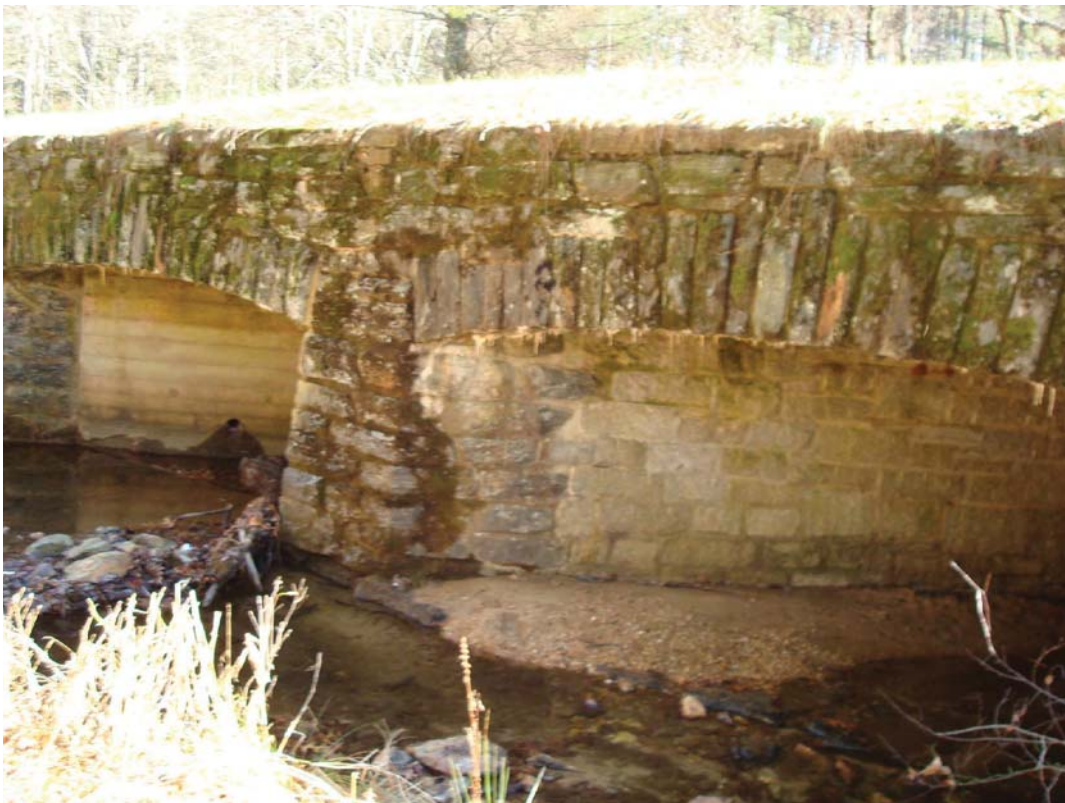
BLRI\_0001BB\_211.679\_R\_1.JPG

<b>Element (Weighting Factor)</b>	<b>Narrative</b>	<b>Condition Rating (0 - 10)</b>
PERFORMANCE 8.00	Erosion around top corner No global distress	7
WALL FOUNDATION MATERIAL 8.00	Rocky soil No settlement, slight scour	7
MORTAR 8.00	Sound and durable, slight separation, moss covered	7
STONE MASONRY 8.00	No degradation	7
LATERAL SLOPE 0.50	Flat, grassy	8
ROAD/SIDEWALK/SHOULDER 0.50	Flat, grassy shoulder	8
WALL DRAINS 0.50	Weep holes inside culvert, 8' on center, all functioning	8
CULVERT 1.00	Two 15'W x 6'H box culvert, concrete bottom, arch at top	7
DOWNSLOPE 1.00	Flat streambed	7

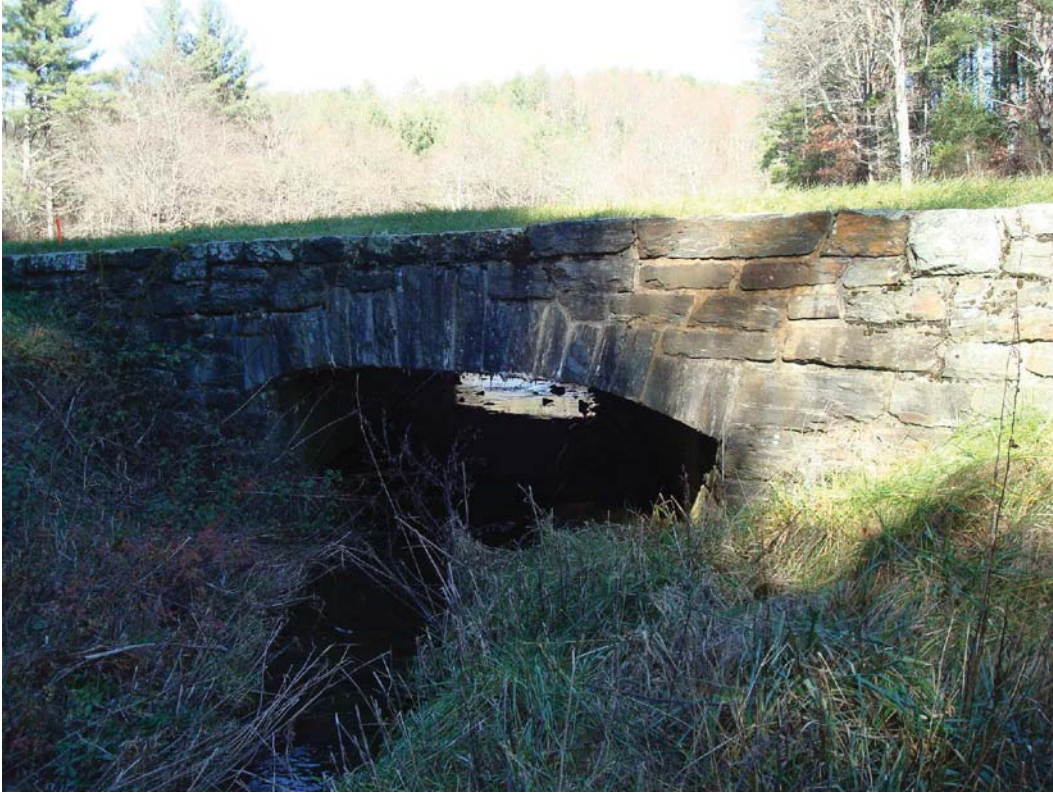
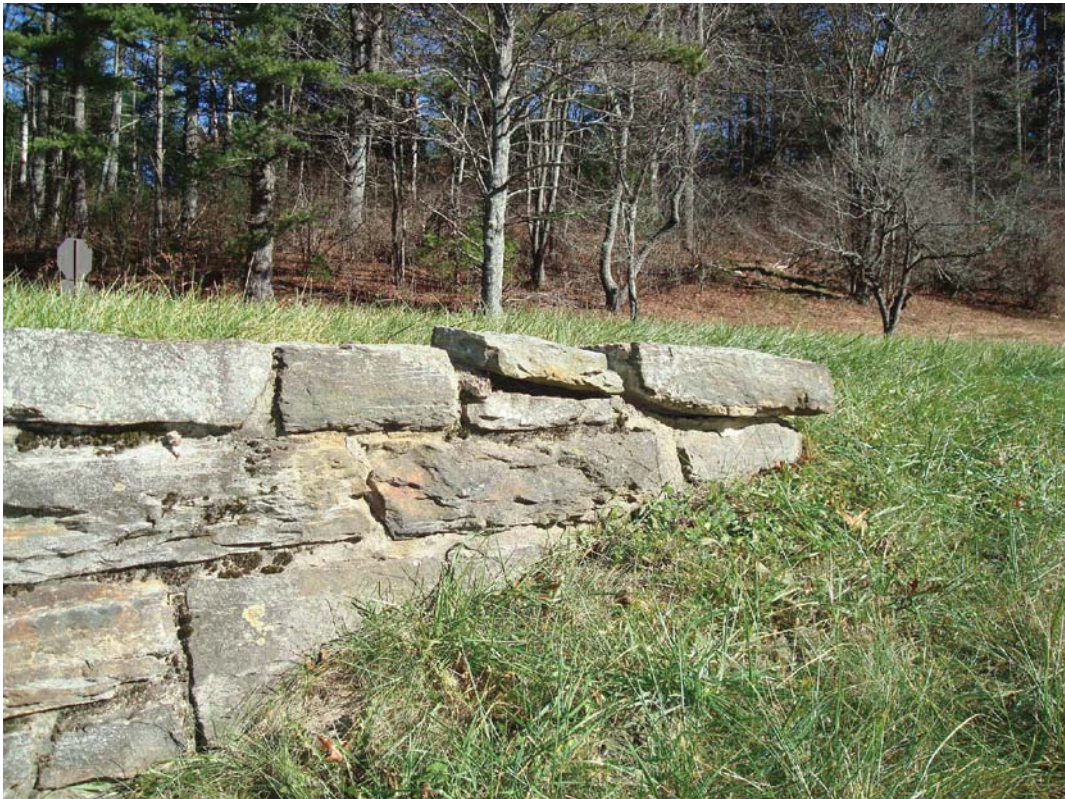
BLRI\_0001BB\_215.495\_L\_1.JPG

<b>Element (Weighting Factor)</b>	<b>Narrative</b>	<b>Condition Rating (0 - 10)</b>
PERFORMANCE 8.00	No global distress	7
WALL FOUNDATION MATERIAL 8.00	Gravelly soil No settlement or erosion	7
MORTAR 8.00	Sound and durable, minor separation	7
STONE MASONRY 8.00	No degradation, moss and lichens, 2 loose stones	7
LATERAL SLOPE 0.50	Flat, grassy. Gravel road on south end.	8
CULVERT 1.00	4.5'H x 14'W concrete box	7
DOWNSLOPE 1.00	Streambed, flat	7
ROAD/SIDEWALK/SHOULDER 1.00	Soft shoulder, grassy	7
WALL DRAINS 1.00	No drains, but no drainage problems evident	7

<b>Failure Consequence:</b>	LOW
<b>Recommendation Narrative:</b>	Reset capstones on north end - 7 s.f. x \$250/s.f. = \$1,750.
<b>Repair Cost:</b>	\$1,750

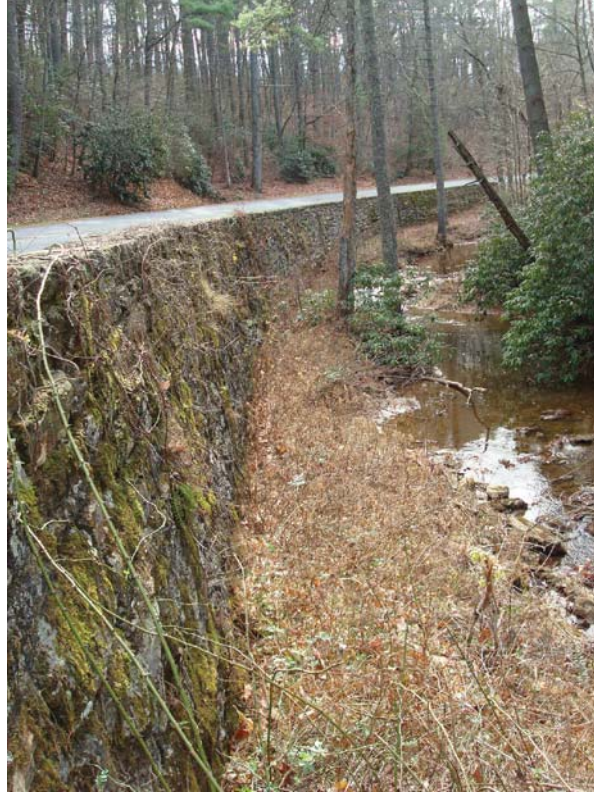
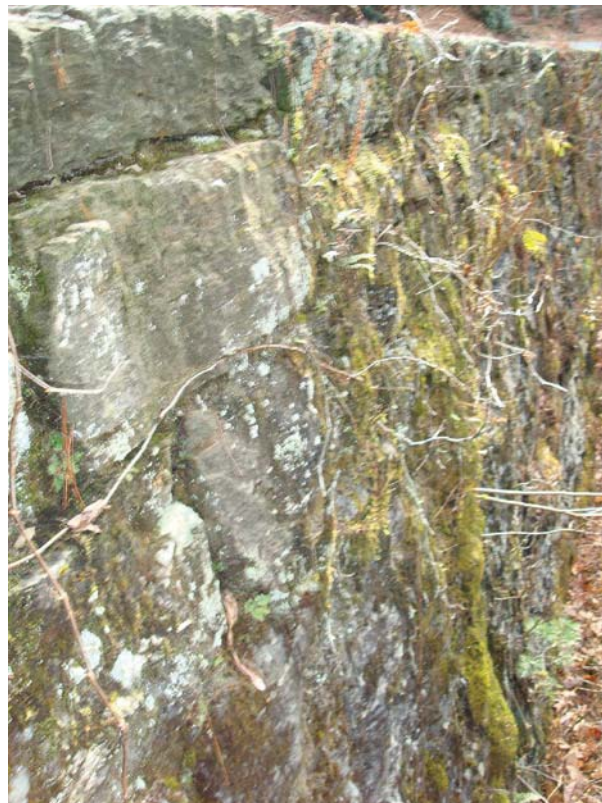
BLRI\_0001BB\_216.588\_R\_1.JPG

<b>Element (Weighting Factor)</b>	<b>Narrative</b>	<b>Condition Rating (0 - 10)</b>
PERFORMANCE 8.00	No global distress Monitor encroaching erosion at wall base	7
WALL FOUNDATION MATERIAL 8.00	Stony material in stream No settlement or erosion at foundation	7
MORTAR 8.00	Sound and durable, mossy	7
STONE MASONRY 8.00	No degradation, mossy	7
LATERAL SLOPE 0.50	Flat, grassy	8
VEGETATION 0.50	Slight vegetation on face, no adverse effect	8
DOWNSLOPE 1.00	Plateau for 6'-8', then stream	7
ROAD/SIDEWALK/SHOULDER 1.00	Flat, grassy shoulder, soft	7
WALL DRAINS 1.00	None through wall, top drains for roadway drainage	7

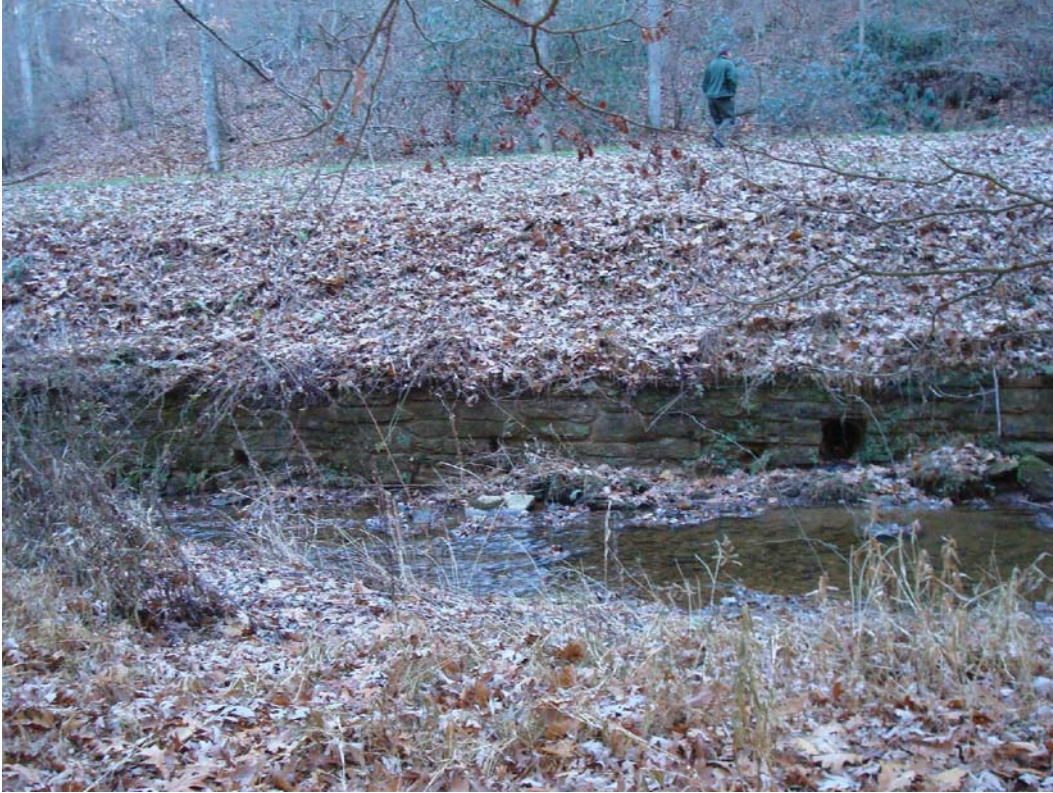
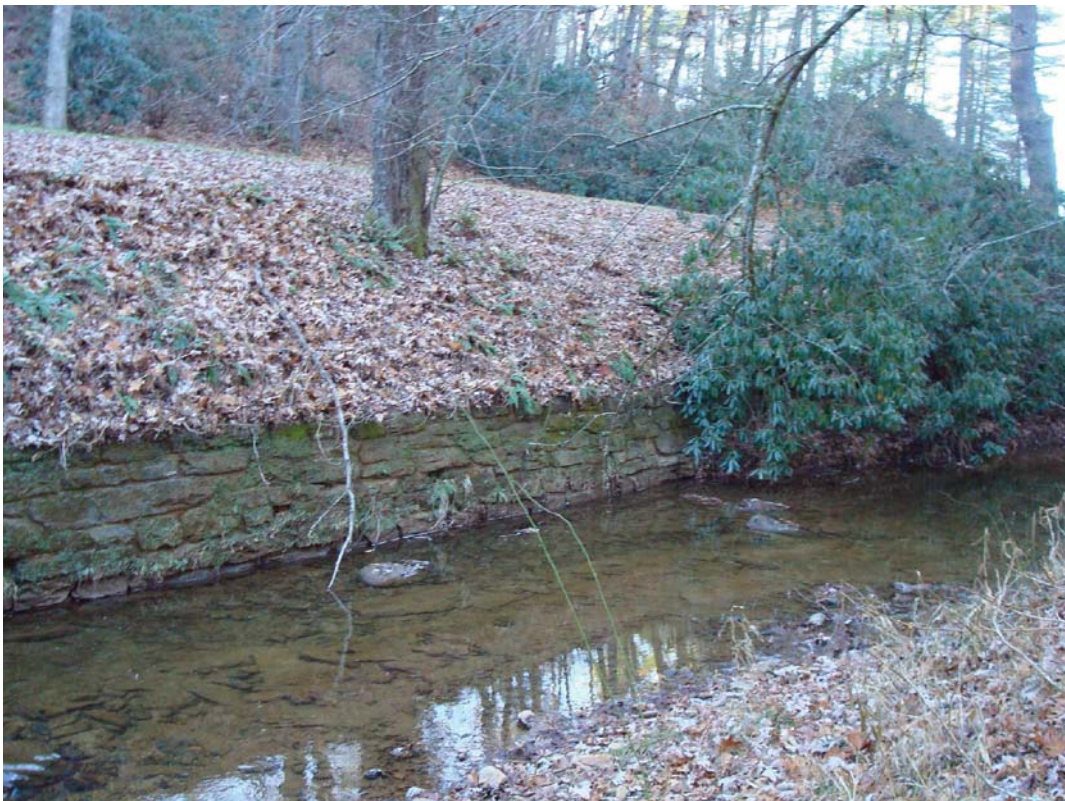
BLRI\_0001BB\_216.668\_R\_1.JPG

<b>Wall Function:</b>	Fill Wall	<b>Primary Wall Type:</b>	Gravity - Mortared Stone
<b>Surface Treatment:</b>		<b>Secondary Wall Type:</b>	
<b>Secondary Surface Treatment:</b>		<b>Architectural Facing:</b>	
<b>General Description:</b>	Wall covered with vegetation and difficult to find, has soil failure adjacent to wall

Element (Weighting Factor)	Narrative	Condition Rating (0 - 10)
PERFORMANCE 8.00	18' x 18' x 5' deep circular failure immediately north of wall - needs repair and extension of wall	6
WALL FOUNDATION MATERIAL 8.00	Rock/soil No settlement, erosion at south end -recent	5
MORTAR 8.00	Sound and durable, mossy	7
STONE MASONRY 8.00	No degradation	7
DOWNSLOPE 1.00	Gradual, streambed, high water during rainfall events	6
CULVERT 1.00	18" corrugated metal	7
LATERAL SLOPE 1.00	Flat, grassy	7
UPSLOPE 1.00	2H:1V	7
WALL DRAINS 1.00	Weep holes, steel pipe, 10' on center	7

<b>Failure Consequence:</b>	MODERATE
<b>Recommendation Narrative:</b>	Extend wall 40' to north in high erosion area - 40' x 4' H = 160 s.f. x \$160/s.f. = \$25,600. Dowel into rock - rock bot - 5 bolts x 10' x \$90/l.f. = \$4,500. Backfill failed area with select fill - 18' x 18' x 5' x 0.5 = 30 c.y. x \$60/c.y. = \$1,800. Riprap prot
<b>Repair Cost:</b>	\$41,300

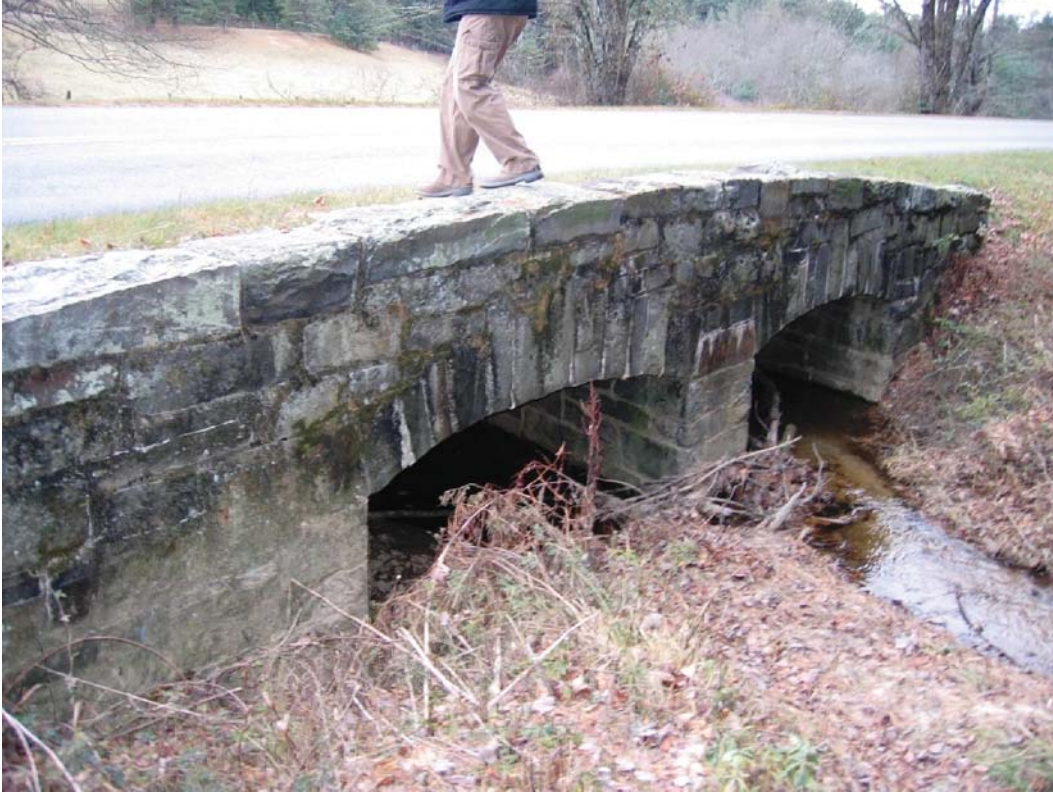
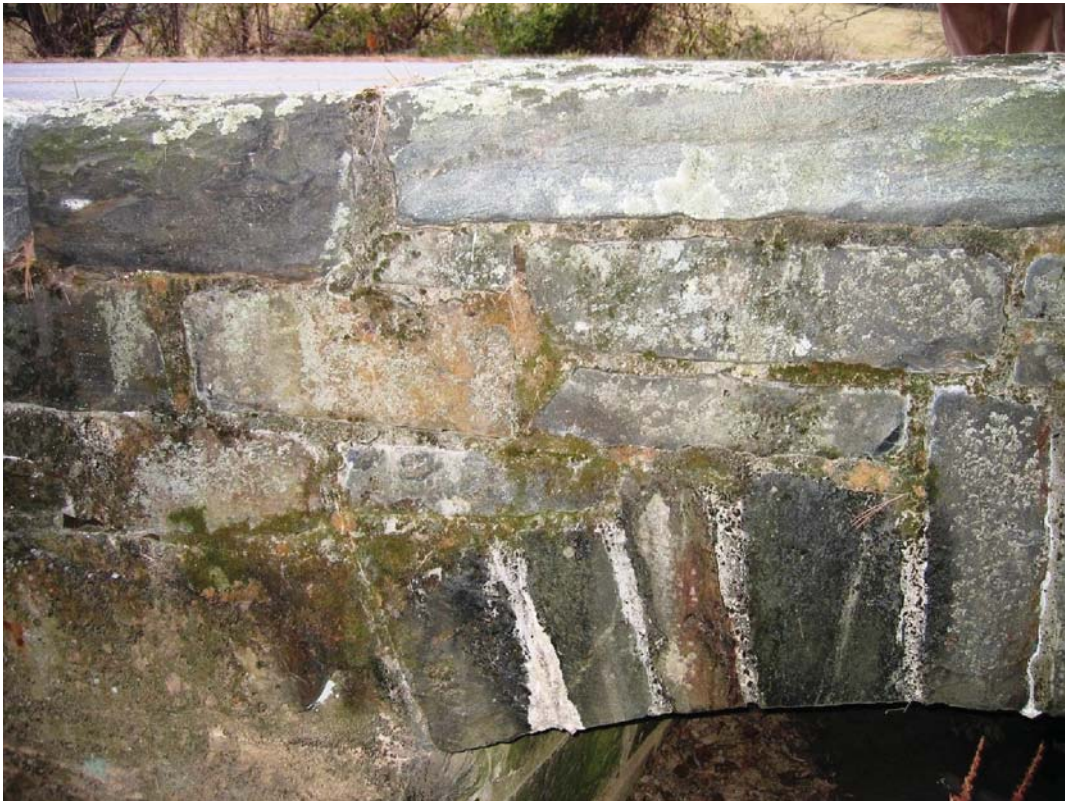
BLRI\_0001CA\_222.042\_R\_1.jpg

<b>Element (Weighting Factor)</b>	<b>Narrative</b>	<b>Condition Rating (0 - 10)</b>
PERFORMANCE 8.00	No signs of global distress. Minor mortar weathering.	8
WALL FOUNDATION MATERIAL 8.00	Not visible, but no signs of scour or settlement.	7
MORTAR 8.00	Cracked, minor missing elements, hard/durable. Does not require repointing.	7
STONE MASONRY 8.00	Hard, durable, no signs of cracking, no missing blocks, minor weathering.	9
CULVERT 0.50	Minor channel erosion, weathered structure. Functioning well.	8
DOWNSLOPE 0.50	Drainage channel is stable. No signs of down-cutting or bank erosion.	8
LATERAL SLOPE 0.50	Very stable. No signs of slumping or erosion.	9
ROAD/SIDEWALK/SHOULDER 0.50	No wall related impacts. Very good condition.	9
WALL DRAINS 1.00	None visible, some seepage through cracked mortar, minor impact.	7

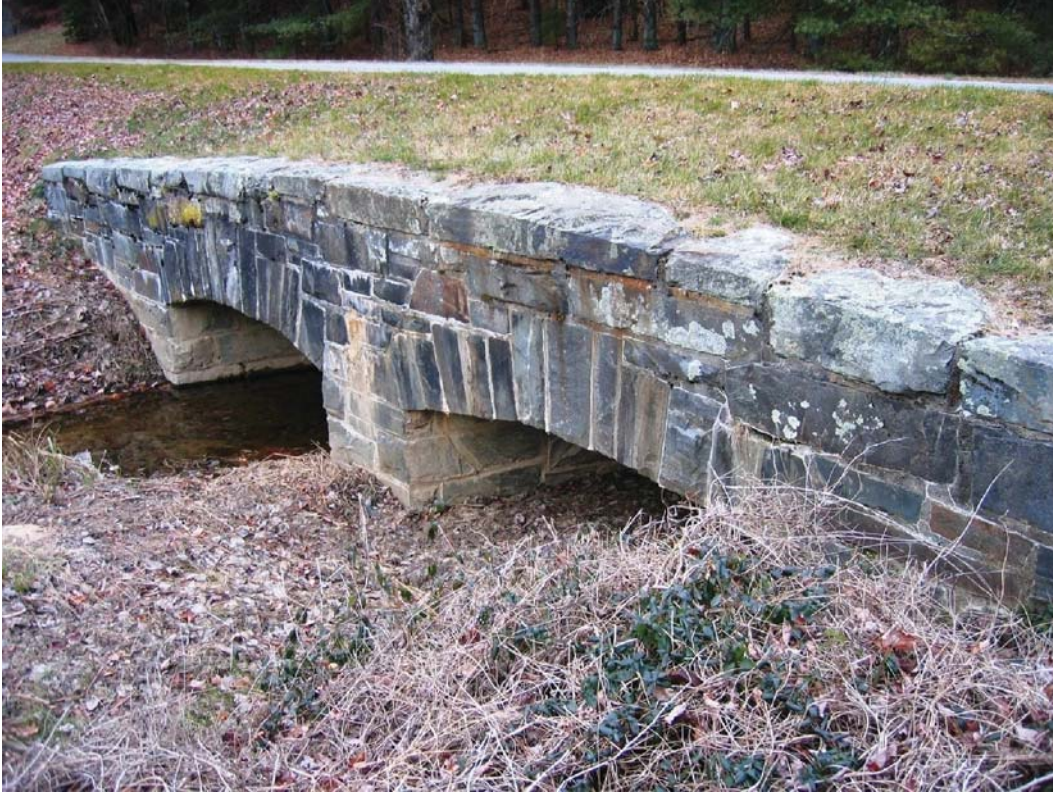
BLRI\_0001CA\_222.045\_L\_1.jpg

<b>Element (Weighting Factor)</b>	<b>Narrative</b>	<b>Condition Rating (0 - 10)</b>
PERFORMANCE 8.00	No signs of global distress. Minor mortar weathering.	8
WALL FOUNDATION MATERIAL 8.00	Not visible, but no signs of scour or settlement.	7
MORTAR 8.00	Cracked, minor missing elements, hard/durable. Does not require repointing.	7
STONE MASONRY 8.00	Hard, durable, no signs of cracking, no missing blocks, minor weathering.	9
CULVERT 0.50	Functioning as intended. Minor channel erosion. Weathered structure.	8
DOWNSLOPE 0.50	Drainage channel is stable. No signs of down-cutting or bank erosion.	8
LATERAL SLOPE 0.50	Very stable. No signs of slumping or erosion.	9
ROAD/SIDEWALK/SHOULDER 0.50	No wall related impacts. Very good condition.	9
WALL DRAINS 1.00	None visible. Some seepage through cracked mortar.	7

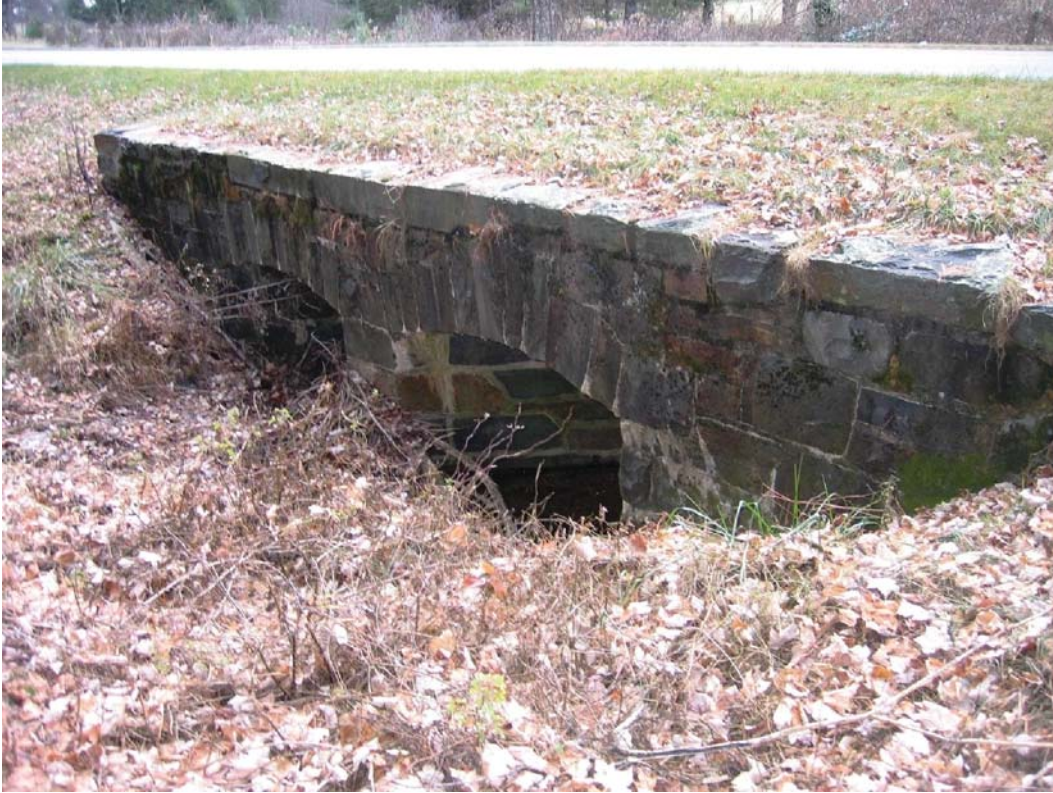
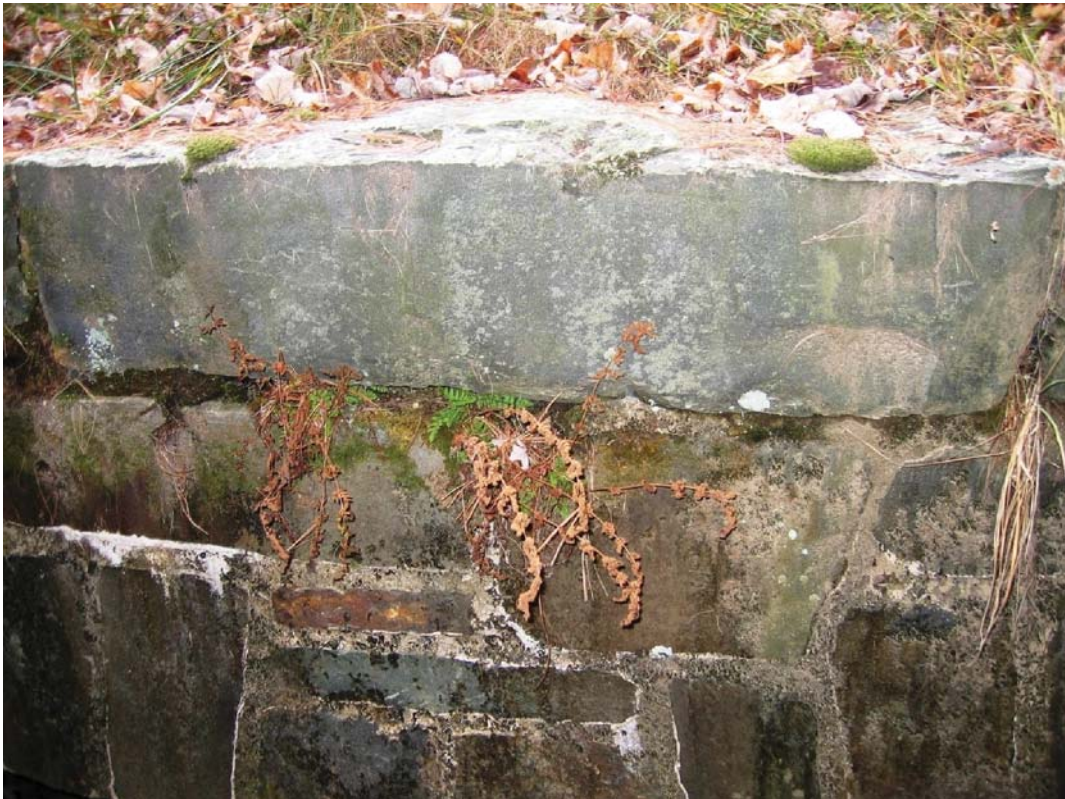
BLRI\_0001CA\_222.433\_R\_1.jpg

<b>Element (Weighting Factor)</b>	<b>Narrative</b>	<b>Condition Rating (0 - 10)</b>
PERFORMANCE 8.00	No signs of global distress or settlement. Minor mortar weathering.	8
WALL FOUNDATION MATERIAL 8.00	Not visible, but no signs of scour or settlement.	7
MORTAR 8.00	Cracked, weathered, some missing in top course, minor grass/moss growing from cracks.	6
STONE MASONRY 8.00	Hard, durable, no signs of cracking, no missing blocks, minor weathering.	8
CULVERT 0.50	Weathered, but functioning as intended. No seepage/scour.	8
DOWNSLOPE 0.50	Drainage channel is stable. No signs of scour or bank erosion.	8
LATERAL SLOPE 0.50	Very stable. No signs of slumping or erosion.	8
ROAD/SIDEWALK/SHOULDER 0.50	No wall related impacts. Very good condition.	8
WALL DRAINS 1.00	None visible. Some seepage through top course where mortar is cracked/missing.	7

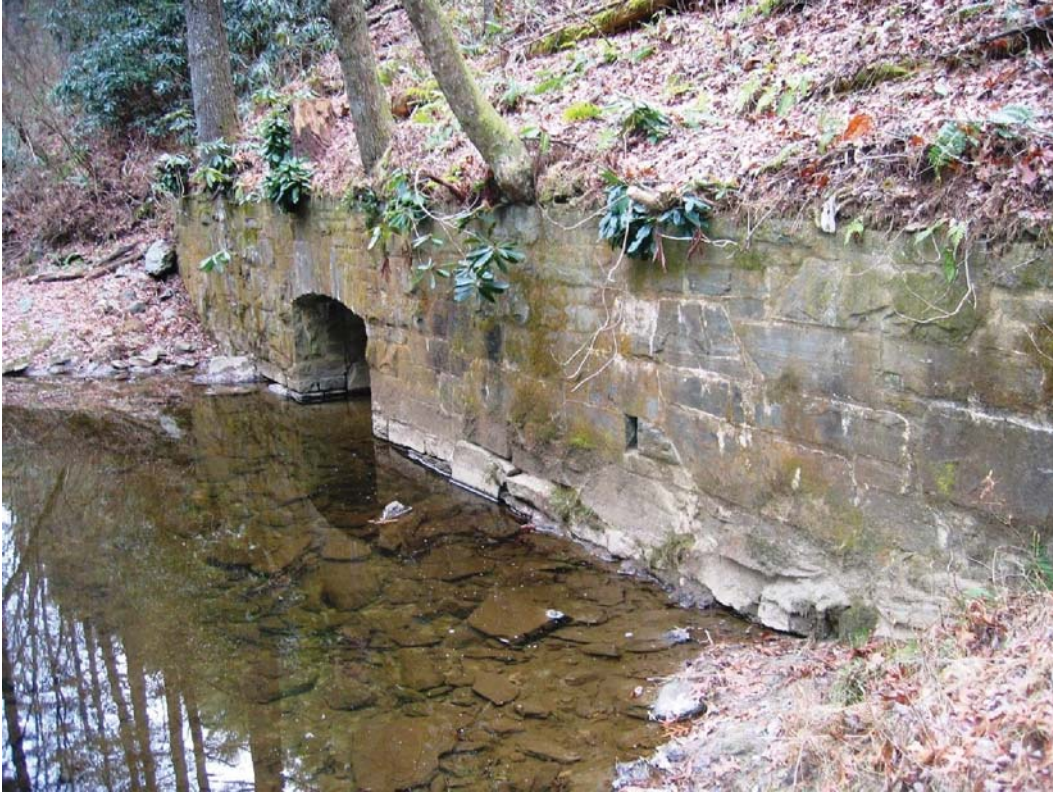
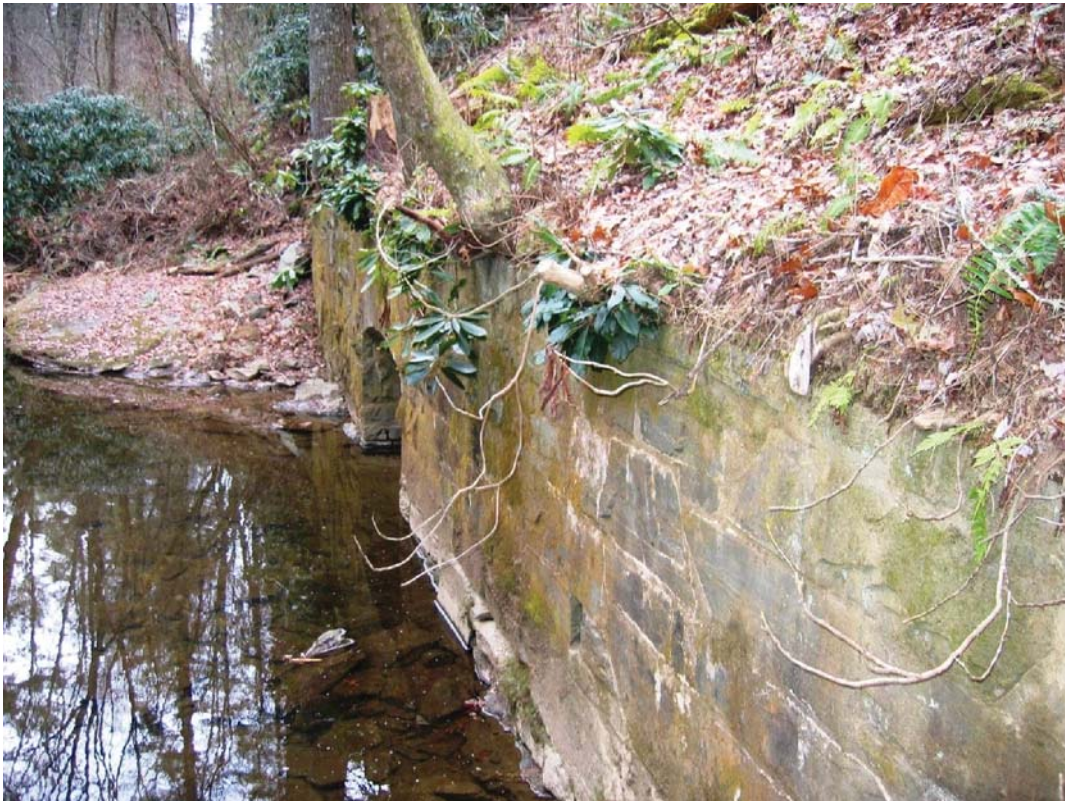
BLRI\_0001CA\_224.997\_L\_1.jpg

<b>Element (Weighting Factor)</b>	<b>Narrative</b>	<b>Condition Rating (0 - 10)</b>
PERFORMANCE 8.00	No signs of global distress. Wall will benefit from tree/brush removal.	8
WALL FOUNDATION MATERIAL 8.00	Underwater. Appears to be rock fill/bedrock. No signs of wall settlement or scour.	7
MORTAR 8.00	Weathered, cracking in some blocks, mortar is missing/scoured along wall toe.	6
STONE MASONRY 8.00	Well cut, hard, durable blocks showing no signs of cracking. No missing blocks.	8
CULVERT 0.50	Functioning as intended. Minor channel erosion. Weathered.	8
DOWNSLOPE 0.50	Drainage channel is stable. No signs of scour or bank erosion.	8
UPSLOPE 0.50	1.5H:1V well vegetated upslope showing no signs of slumping or erosion distress.	8
VEGETATION 1.00	3 large trees growing at top of wall. Appear to be dead. Need to be removed along with brush. Minor impact at the present.	6
LATERAL SLOPE 1.00	Well vegetated. Minor erosion at down steam convergence.	7

<b>Failure Consequence:</b>	MODERATE
<b>Recommendation Narrative:</b>	Remove trees from top of wall: Labor: 6 hours @ \$55.00 per hr. = \$330.00
<b>Repair Cost:</b>	\$330

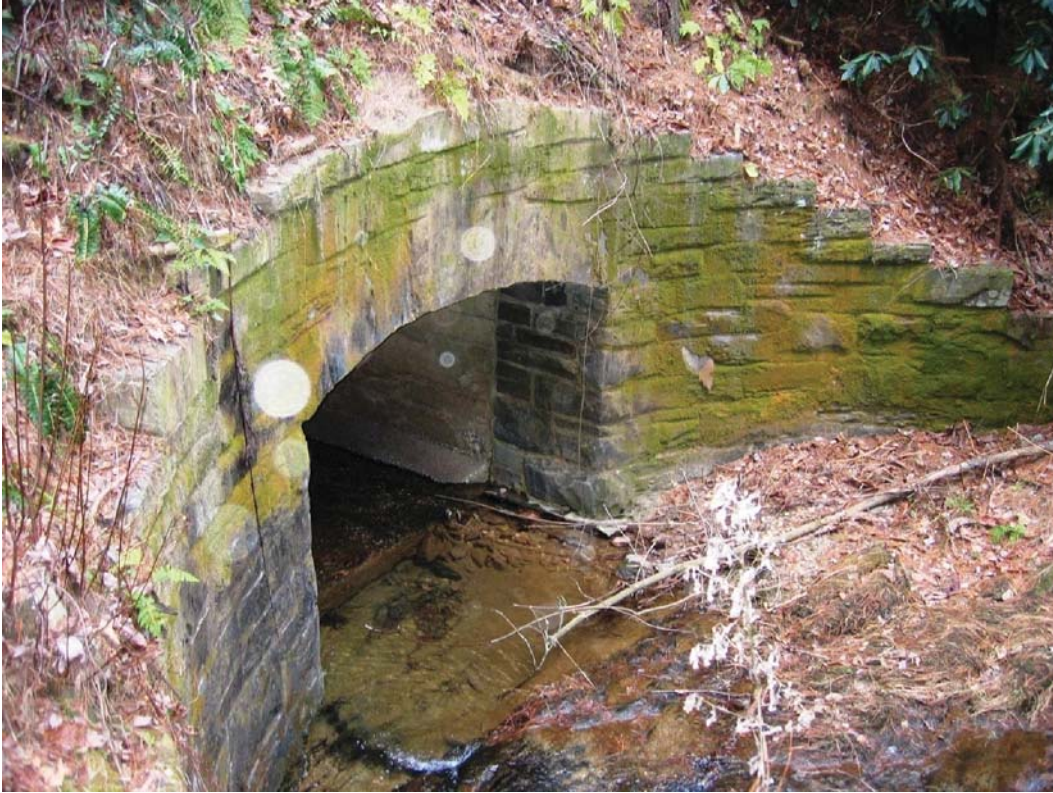
BLRI\_0001CA\_225.003\_R\_1.jpg

<b>Element (Weighting Factor)</b>	<b>Narrative</b>	<b>Condition Rating (0 - 10)</b>
PERFORMANCE 8.00	No signs of global distress. Structure is stable with no signs of cracking, displacement, settlement.	8
WALL FOUNDATION MATERIAL 8.00	Bedrock, very stable.	9
MORTAR 8.00	Difficult to see, mossy. No missing mortar. Appears intact.	7
STONE MASONRY 8.00	Sound, durable, mossy. No missing blocks.	8
CULVERT 0.50	Functioning as intended. Minor channel erosion.	8
LATERAL SLOPE 0.50	Minor slope erosion, well vegetated.	8
ROAD/SIDEWALK/SHOULDER 0.50	No wall related impacts. Very good condition.	8
UPSLOPE 0.50	Well vegetated 1.5H:1V slope. Very stable.	8
WALL DRAINS 0.50	None visible. Some seepage through the wall. No water-related distress.	8

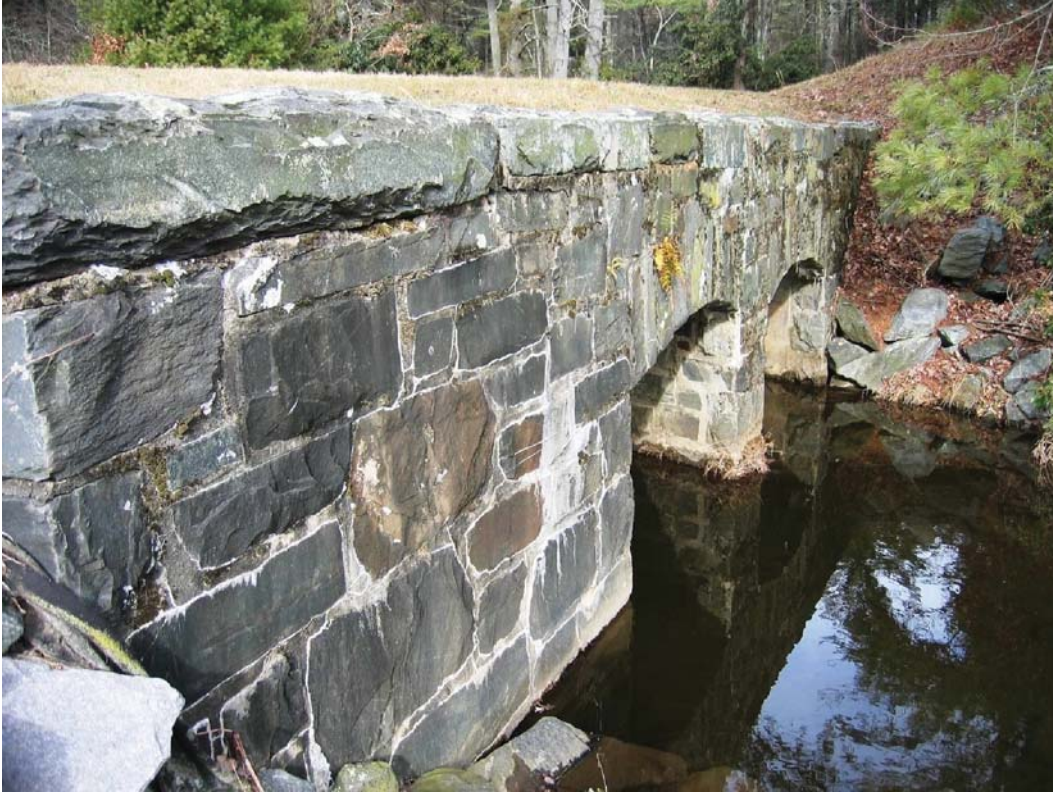
BLRI\_0001CA\_225.426\_L\_1.jpg

<b>Element (Weighting Factor)</b>	<b>Narrative</b>	<b>Condition Rating (0 - 10)</b>
PERFORMANCE 8.00	No signs of global distress.	8
WALL FOUNDATION MATERIAL 8.00	No signs of scour or settlement. Good bearing.	8
MORTAR 8.00	Cracked, weathered along top courses. Appears to have been patched. Generally intact.	7
STONE MASONRY 8.00	Well cut, hard, durable.	8
CULVERT 0.50	Weathered, but no seepage around culvert. Minor channel erosion.	8
ROAD/SIDEWALK/SHOULDER 0.50	No wall related impacts. Very good condition.	8
DOWNSLOPE 0.50	Armored channel, very stable.	9
LATERAL SLOPE 0.50	Armored with granite riprap.	10
WALL DRAINS 1.00	None visible. Some minor seepage through mortar.	7

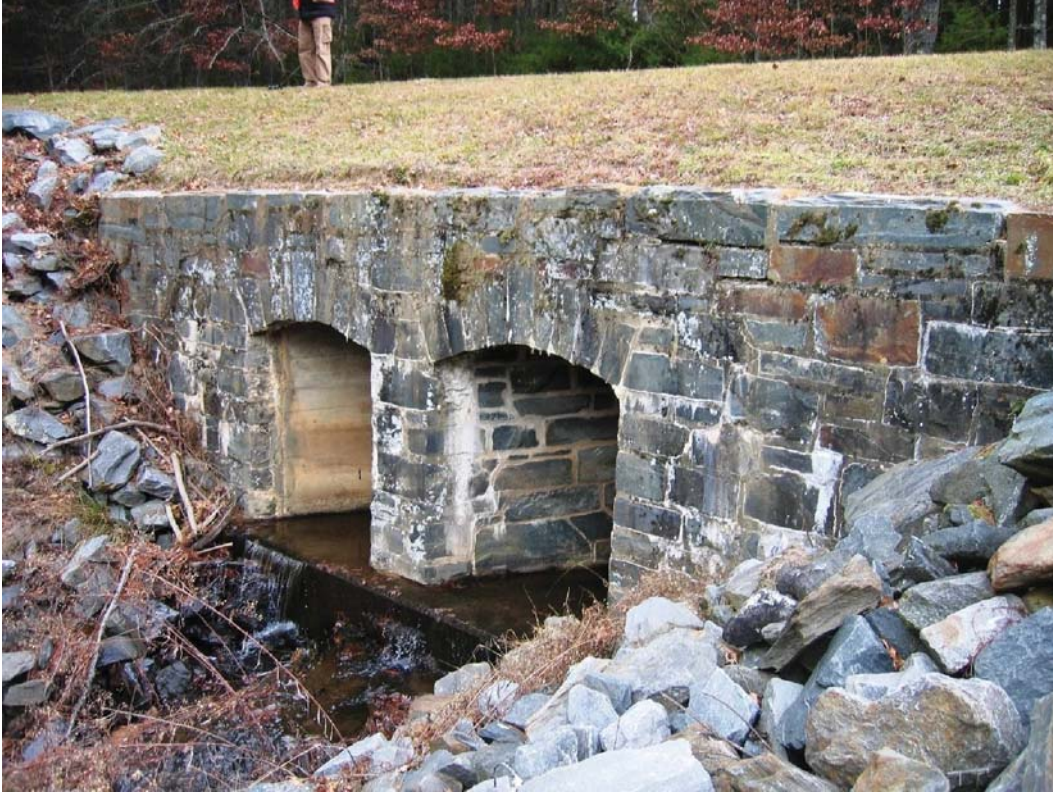
BLRI\_0001CA\_225.426\_R\_1.jpg

<b>Element (Weighting Factor)</b>	<b>Narrative</b>	<b>Condition Rating (0 - 10)</b>
PERFORMANCE 8.00	No signs of global distress. Functioning as originally built.	8
WALL FOUNDATION MATERIAL 8.00	Underwater. No signs of scour or settlement.	7
MORTAR 8.00	Minor cracking and weathering. Generally intact, hard, durable.	8
STONE MASONRY 8.00	Hard, durable, no missing blocks.	8
CULVERT 0.50	No significant distress. No seepage. Minor channel erosion.	8
DOWNSLOPE 0.50	Lake bottom.	8
ROAD/SIDEWALK/SHOULDER 0.50	No wall related distress. Very good condition.	8
LATERAL SLOPE 0.50	Armored with granite riprap. Very stable.	10
WALL DRAINS 1.00	None visible. Some seepage between blocks.	7

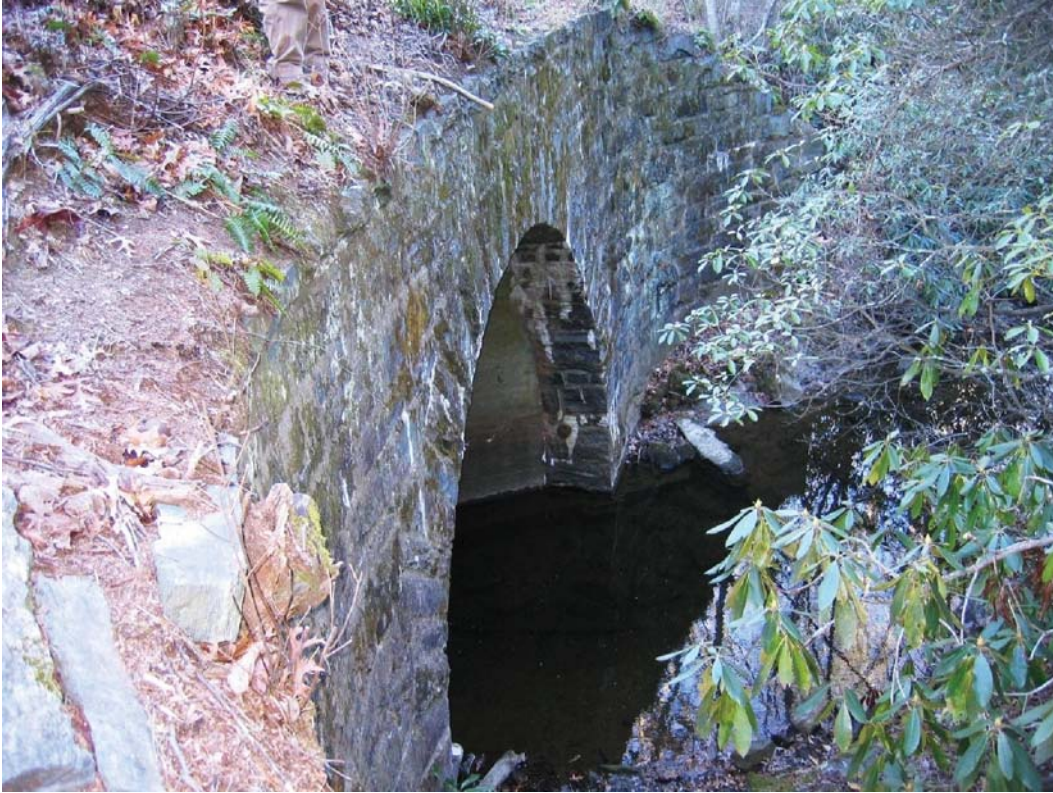
BLRI\_0001CA\_229.416\_L\_1.jpg

<b>Element (Weighting Factor)</b>	<b>Narrative</b>	<b>Condition Rating (0 - 10)</b>
PERFORMANCE 8.00	No signs of global distress.	8
WALL FOUNDATION MATERIAL 8.00	Large rock, well graded gravels, excellent bearing.	9
MORTAR 8.00	Weathered with minor cracking. Generally intact, hard, durable.	8
STONE MASONRY 8.00	Hard, durable; no missing blocks.	8
CULVERT 0.50	Functioning as intended. Minor weathering/channel erosion.	8
DOWNSLOPE 0.50	Stable stream channel. No evidence of scour.	8
ROAD/SIDEWALK/SHOULDER 0.50	No wall-related distress.	8
UPSLOPE 0.50	1.5H:1V grassy slope. No slumping. Very minor erosion.	8
VEGETATION 0.50	Recently trimmed trees/shrubs from top of wall.	9

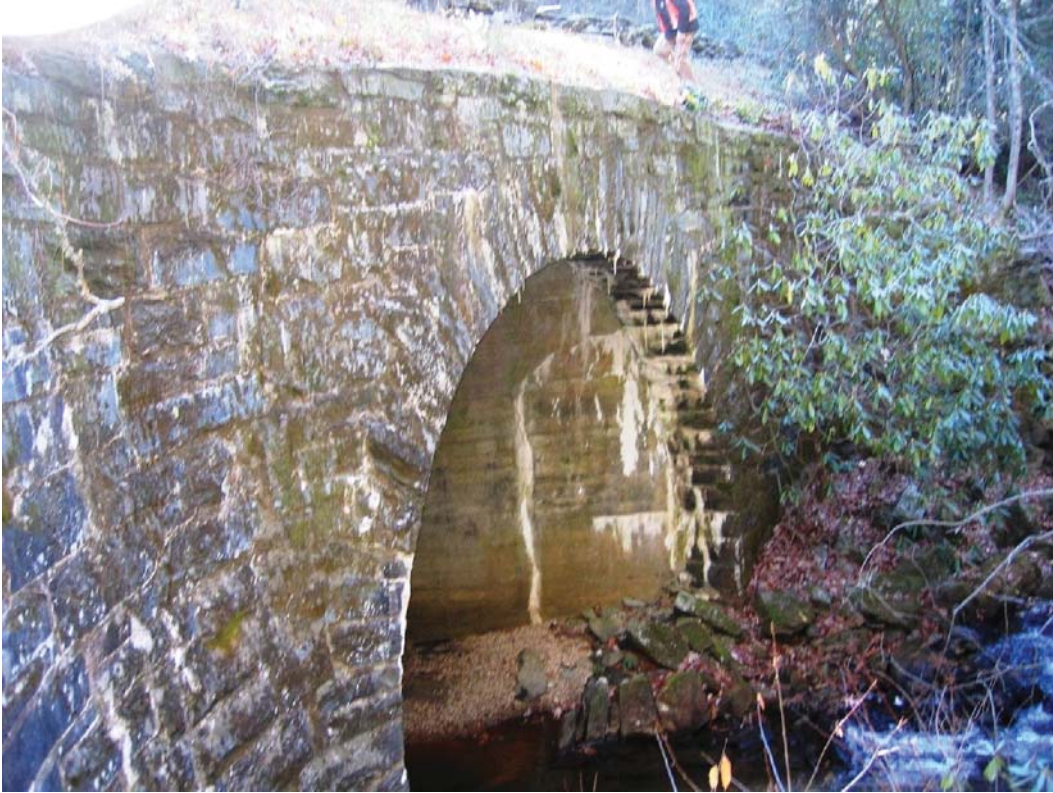
BLRI\_0001CA\_229.416\_R\_1.jpg

<b>Element (Weighting Factor)</b>	<b>Narrative</b>	<b>Condition Rating (0 - 10)</b>
PERFORMANCE 8.00	No signs of global distress. Structure is weathered but well-built.	8
WALL FOUNDATION MATERIAL 8.00	Large boulder, bedrock. Very stable bearing.	9
MORTAR 8.00	Weathered with minor cracking, but generally intact, durable and hard.	8
STONE MASONRY 8.00	Hard, durable; no missing blocks.	8
CULVERT 0.50	Functioning as intended. Weathered, but no seepage evident.	8
DOWNSLOPE 0.50	Stable stream channel. No scour at toe of headwall.	8
LATERAL SLOPE 0.50	Well vegetated. No signs of slumping or significant erosion.	8
ROAD/SIDEWALK/SHOULDER 0.50	No wall-related distress.	8
UPSLOPE 0.50	2H:1V, grassy slope. No slumping or erosion.	8

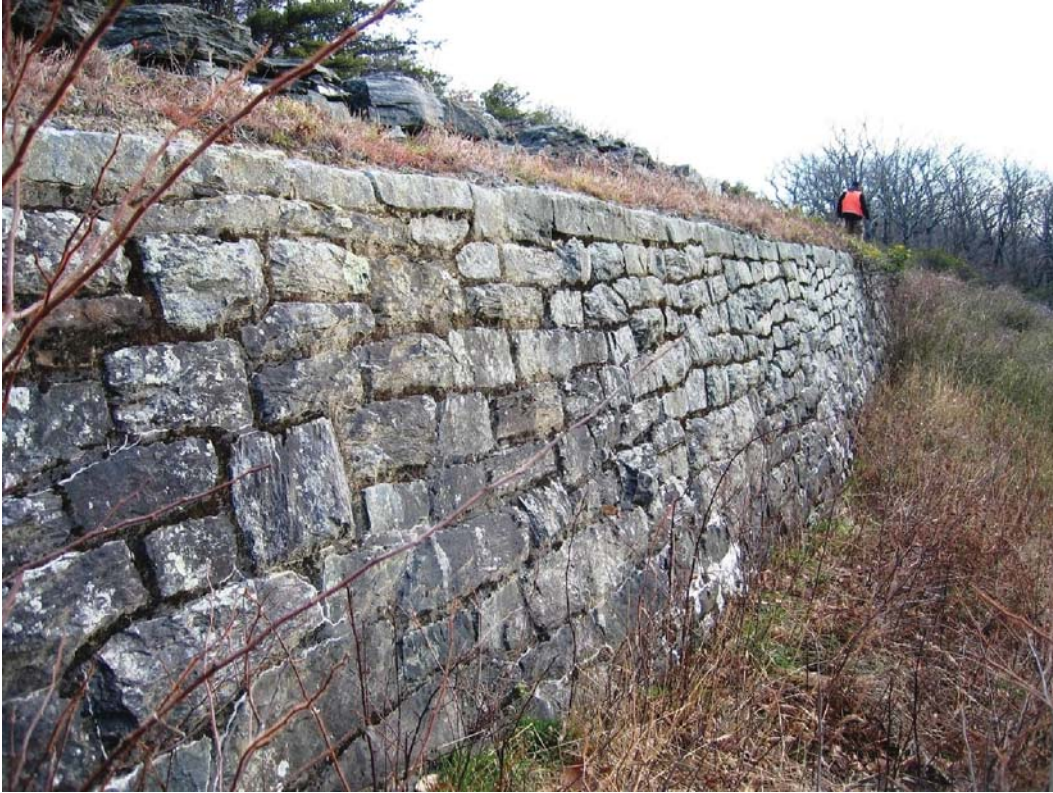
BLRI\_0001CA\_233.285\_L\_1.jpg

<b>Element (Weighting Factor)</b>	<b>Narrative</b>	<b>Condition Rating (0 - 10)</b>
PERFORMANCE 8.00	No signs of global instability. Very well built.	8
WALL FOUNDATION MATERIAL 8.00	Rock fill from road cut. Very strong/stable.	9
MORTAR 8.00	Sound, durable, minor cracking, intact.	8
STONE MASONRY 8.00	Strong, hard, minor weathering. Very well laid.	9
DOWNSLOPE 0.50	Well vegetated soils over rockfill. Very stable. No signs of slumping/erosion.	8
LATERAL SLOPE 0.50	No significant erosion at either end. Stable slopes.	8
VEGETATION 0.50	Recently cut along top of wall. Toe shrubs not impacting wall; helping to stabilize toe slope.	8
WALL DRAINS 0.50	None visible. No significant seepage through wall.	8
ROAD/SIDEWALK/SHOULDER 0.50	No wall related distress. Very good condition.	9
