# BLRI WIP Report

## NPS Retaining Wall Inventory Program Blue Ridge Parkway

Federal Highway Administration  
Eastern Federal Lands Highway Division  
Road Inventory Program (RIP)

# Blue Ridge Parkway in North Carolina and Virginia

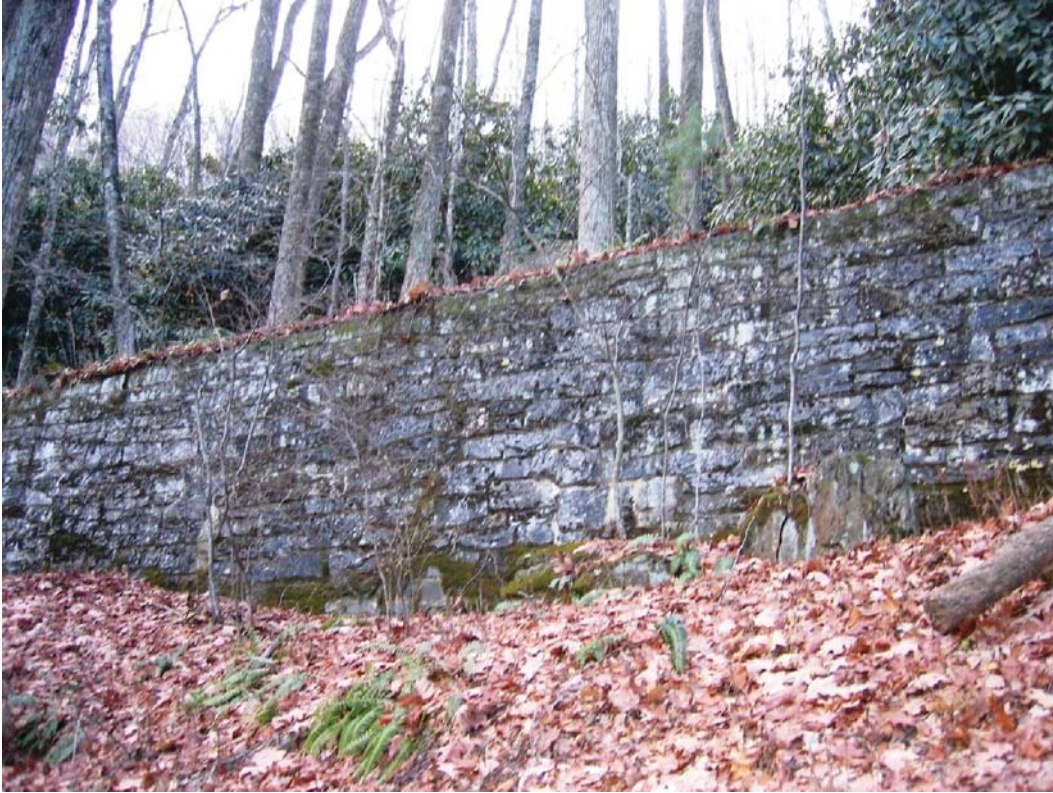
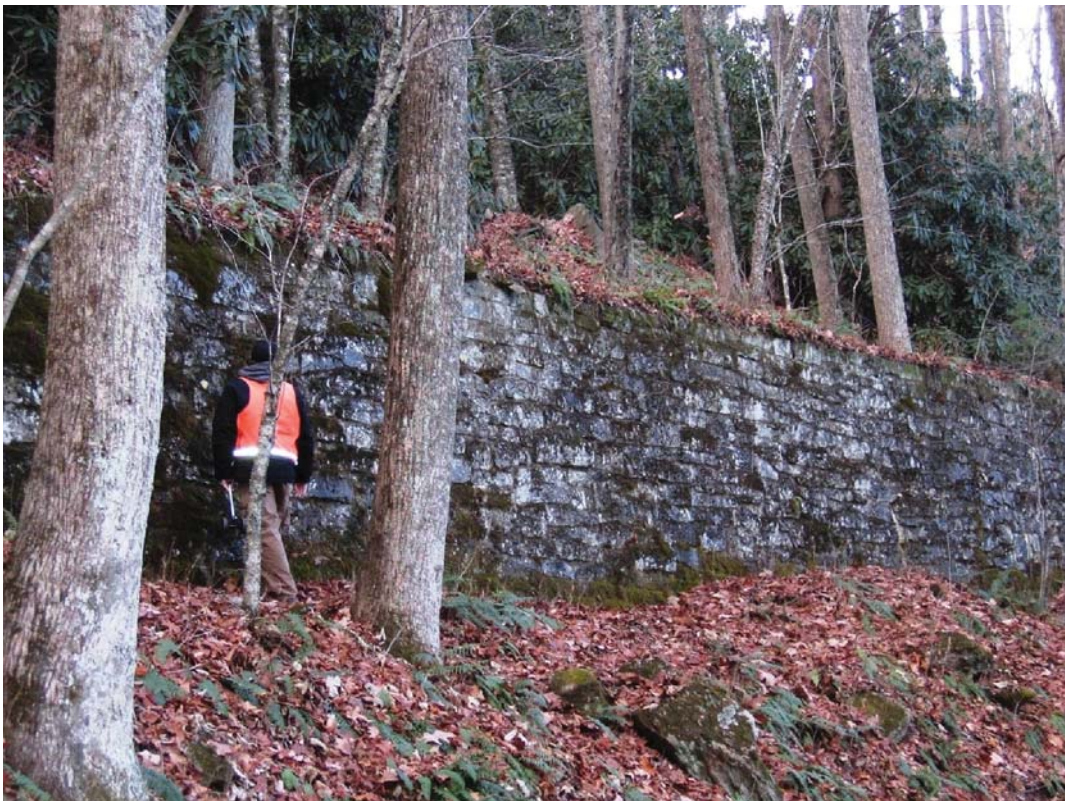
BLRI\_0001CA\_234.418\_R\_1.jpg

<b>Element (Weighting Factor)</b>	<b>Narrative</b>	<b>Condition Rating (0 - 10)</b>
PERFORMANCE 8.00	No signs of global distress or deformation due to trees.	8
WALL FOUNDATION MATERIAL 8.00	Rock fill/bedrock. Very stable.	9
MORTAR 8.00	Weathered, but largely intact. Minor cracking. Lot of moss suggesting more cracking.	7
STONE MASONRY 8.00	Hard, durable, no signs of cracking, no missing blocks, minor weathering.	8
DOWNSLOPE 0.50	Rock fill to roadway.	8
LATERAL SLOPE 0.50	Stable well vegetated slope. No slumping/erosion.	8
UPSLOPE 0.50	1.5H:1V , well vegetated, stable slope with minor erosion.	8
VEGETATION 1.00	Small trees, shrubs and several large trees above/below wall. No apparent impact from trees.	7
WALL DRAINS 1.00	None visible. Seepage through wall at various locations.	7

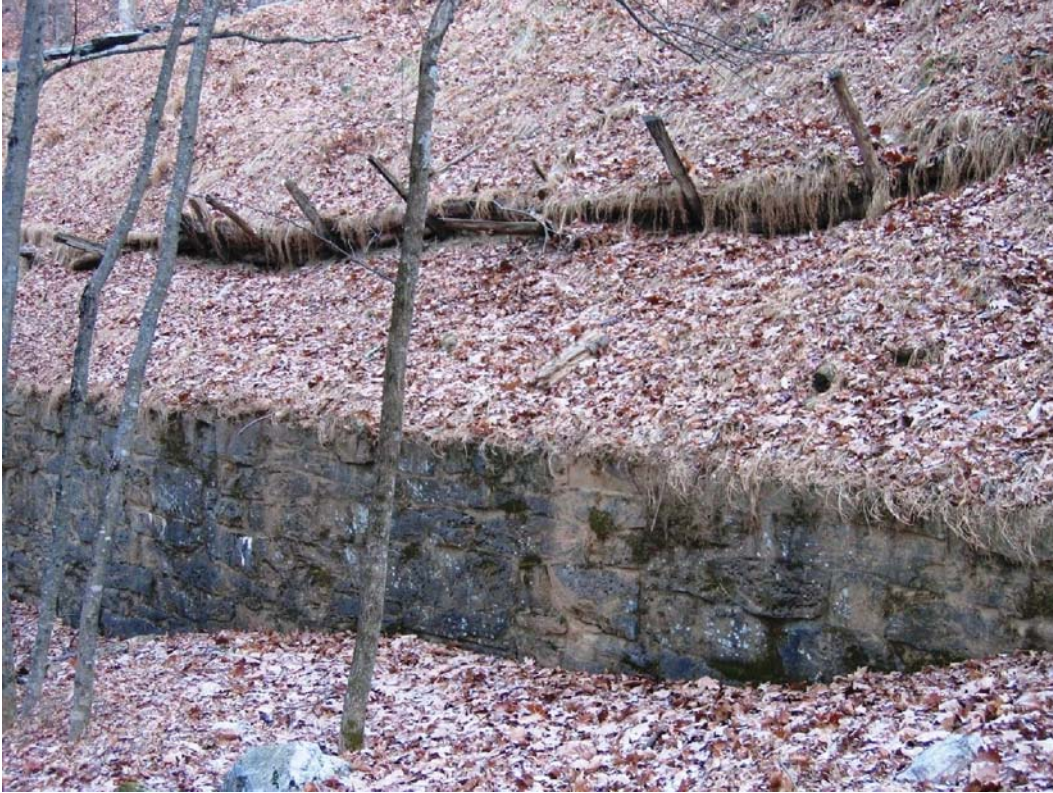
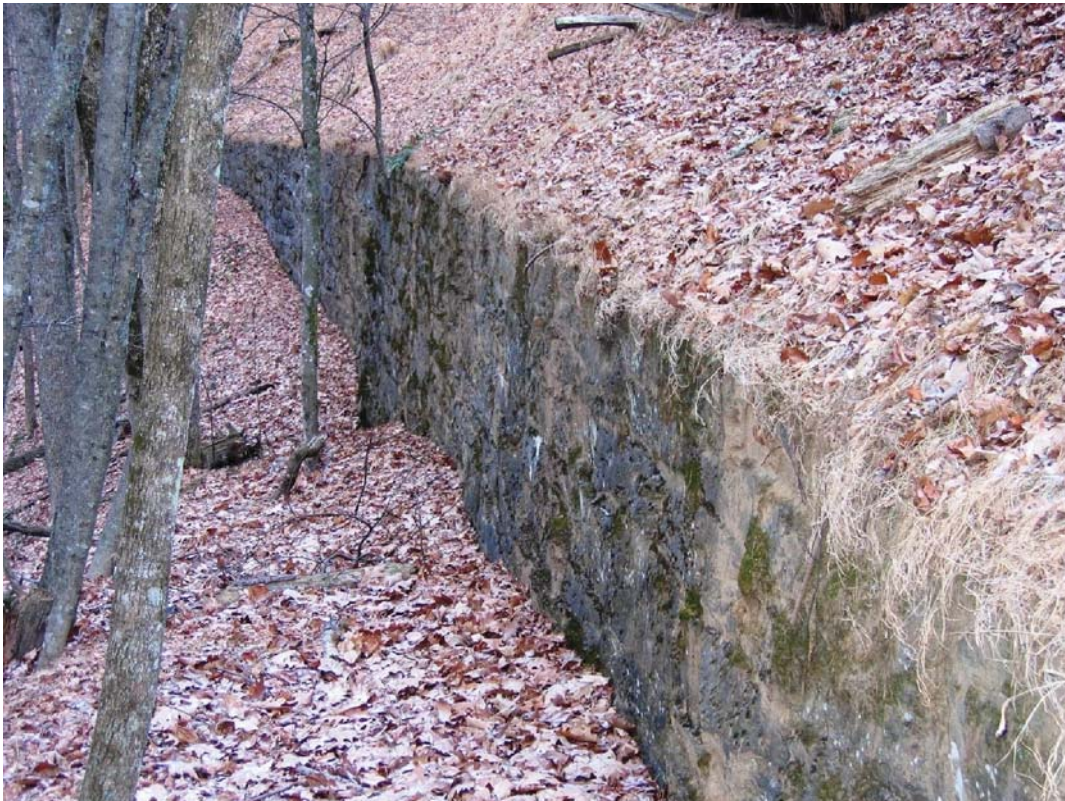
BLRI\_0001CA\_239.662\_L\_1.jpg

<b>Wall Function:</b>	Fill Wall	<b>Primary Wall Type:</b>	Gravity - Mortared Stone
<b>Surface Treatment:</b>		<b>Secondary Wall Type:</b>	Other - Fence Post Rail
<b>Secondary Surface Treatment:</b>		<b>Architectural Facing:</b>	
<b>General Description:</b>	Mortared stone masonry fill wall downslope from roadway with fencepost and rail slope retention wall just above (this is a failing secondary wall)

<b>Element (Weighting Factor)</b>	<b>Narrative</b>	<b>Condition Rating (0 - 10)</b>
PERFORMANCE 8.00	No signs of global distress. Wall is in excellent overall condition.	9
WALL FOUNDATION MATERIAL 8.00	Rock fill. Very good bearing. No signs of settlement.	9
MORTAR 8.00	Durable, hard, intact no missing elements. Excellent condition, only minor cracking at isolated locations.	9
STONE MASONRY 8.00	Hard, durable, no signs of cracking, no missing blocks, no appreciable weathering.	9
CULVERT 0.50	Culvert at mid-wall is functioning without impacts to wall stability. Minor outlet erosion.	8
DOWNSLOPE 0.50	1.5H:1V downslope. Drainage just below wall; appears stable.	8
LATERAL SLOPE 0.50	Minor slumping/erosion. Generally very stable. Light vegetation.	8
WALL DRAINS 0.50	Occasional drains. Appears to be open and functioning. Minor evidence of seepage along wall.	8
UPSLOPE 1.00	1.5H:1V + over steepened slope. Slumping vegetated timber rails to retain slumpy soil.	7

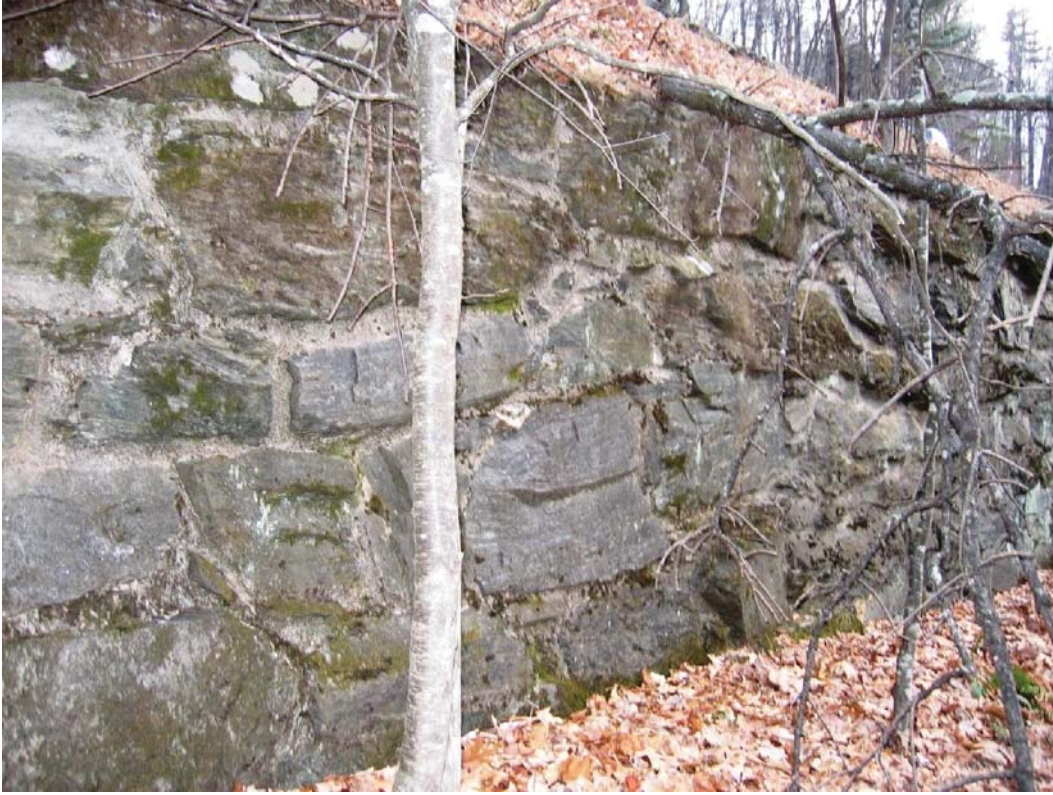
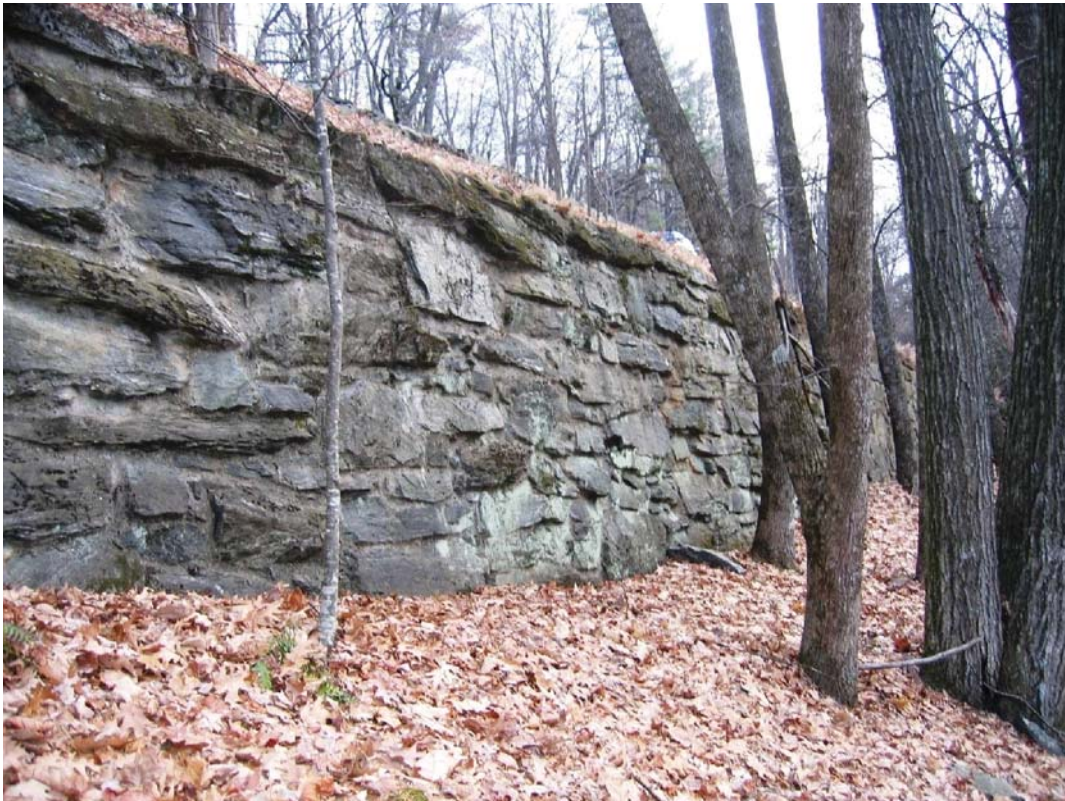
BLRI\_0001CA\_239.733\_L\_1.jpg

<b>Element (Weighting Factor)</b>	<b>Narrative</b>	<b>Condition Rating (0 - 10)</b>
PERFORMANCE 8.00	One vertical crack through wall height at 1/3 wall length from down station end. No signs of global distress. Wall is in excellent overall condition.	9
WALL FOUNDATION MATERIAL 8.00	Top was buried in leaves; no indication of settlement. Appears to be good gearing.	8
MORTAR 8.00	Durable, hard, intact no missing elements. Minor cracks at isolated locations. Generally excellent condition.	9
STONE MASONRY 8.00	Hard, durable, no signs of cracking, no missing blocks. Excellent condition.	9
DOWNSLOPE 0.50	1.5H:1V , stable downslope. No slumping/erosion.	8
LATERAL SLOPE 0.50	Stable. No signs of slumping or erosion.	8
TRAFFIC BARRIER/FENCE 0.50	Dry laid stone guardwall shows no wall-related distress.	8
UPSLOPE 0.50	Moderately vegetated (grass, small bushes) 1.5H:1V slope. Minor surficial slumping.	8
CULVERT 0.50	Culvert outlet at down station end is functioning. No wall distress due to culvert or outlet downslope erosion.	9

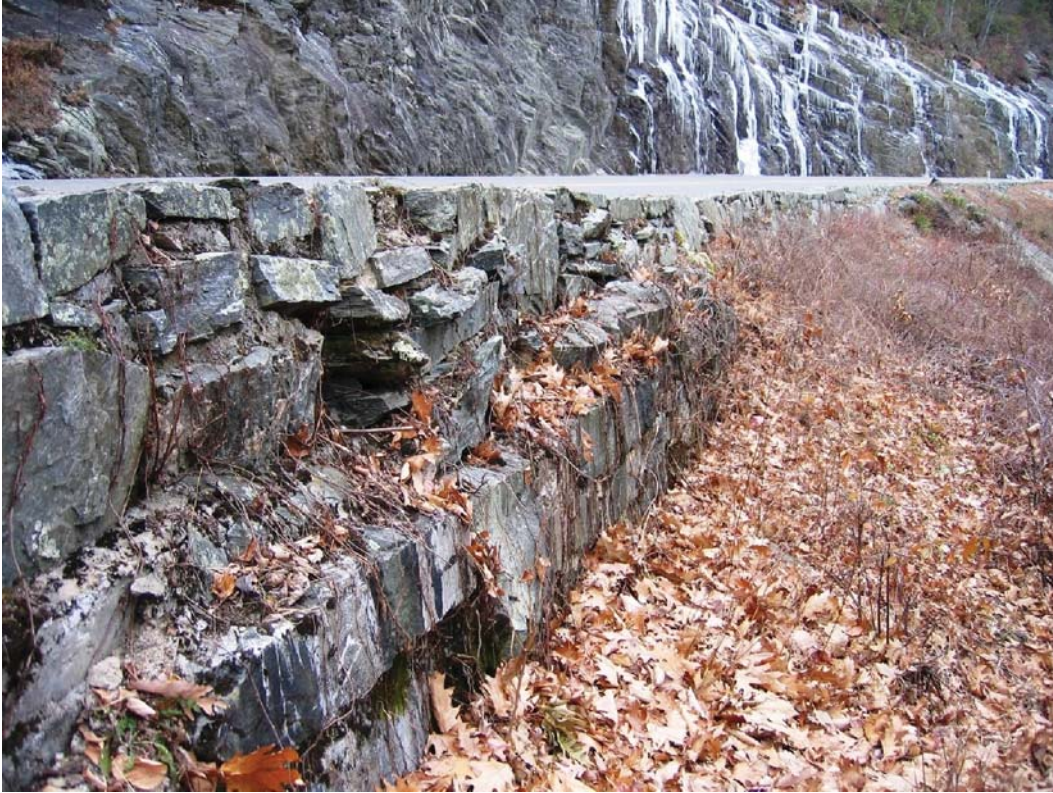
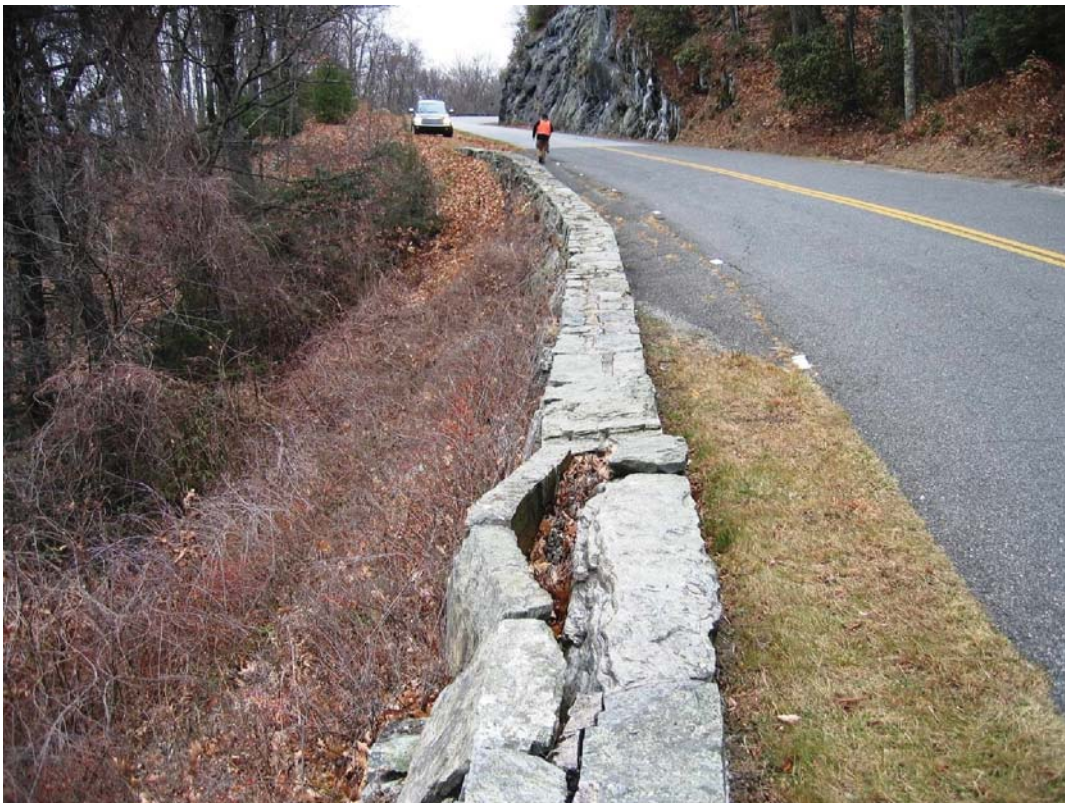
BLRI\_0001CA\_242.153\_R\_1.jpg

<b>Element (Weighting Factor)</b>	<b>Narrative</b>	<b>Condition Rating (0 - 10)</b>
PERFORMANCE 8.00	Wall is sliding out downslope. Possible global failure due to failed culvert. Roadway settlement is severe.	3
WALL FOUNDATION MATERIAL 8.00	Obscured by leaves. Wall has moved downslope, so assume soft, saturated soils.	5
MORTAR 8.00	Missing, severely cracked, high weathered throughout.	3
STONE MASONRY 8.00	Hard, durable rock. Blocks are displaced. Some chinking, some blocks are missing.	6
DOWNSLOPE 0.50	Steep, well-vegetated, generally stable slope conditions.	8
LATERAL SLOPE 0.50	Well-vegetated slope with minor erosion at one end, rock outcrop at other end. No significant distress.	8
TRAFFIC BARRIER/FENCE 1.00	Stone masonry parapet is displaced as a result of wall movement. One section appears to have been struck by a vehicle.	5
WALL DRAINS 1.00	No drains visible. Obvious water problems due to outbound roadway super accumulating water along top of wall.	5

ROAD/SIDEWALK/SHOULDER 5.00	Severe outboard settlement behind wall. Lane cracking to centerline. Numerous patches.	3

<b>Failure Consequence:</b>	HIGH
<b>Recommendation Narrative:</b>	Conduct geotech investigation. \$25,000. Remove/replace stone masonry retaining wall, salvage wall rock. Rebuild wall with suitable drop inlets, using recovered stone. 62 cubic yards @ \$3,195 per c.y. = \$198,100. Install deep roadway patch to centerli
<b>Repair Cost:</b>	\$305,775

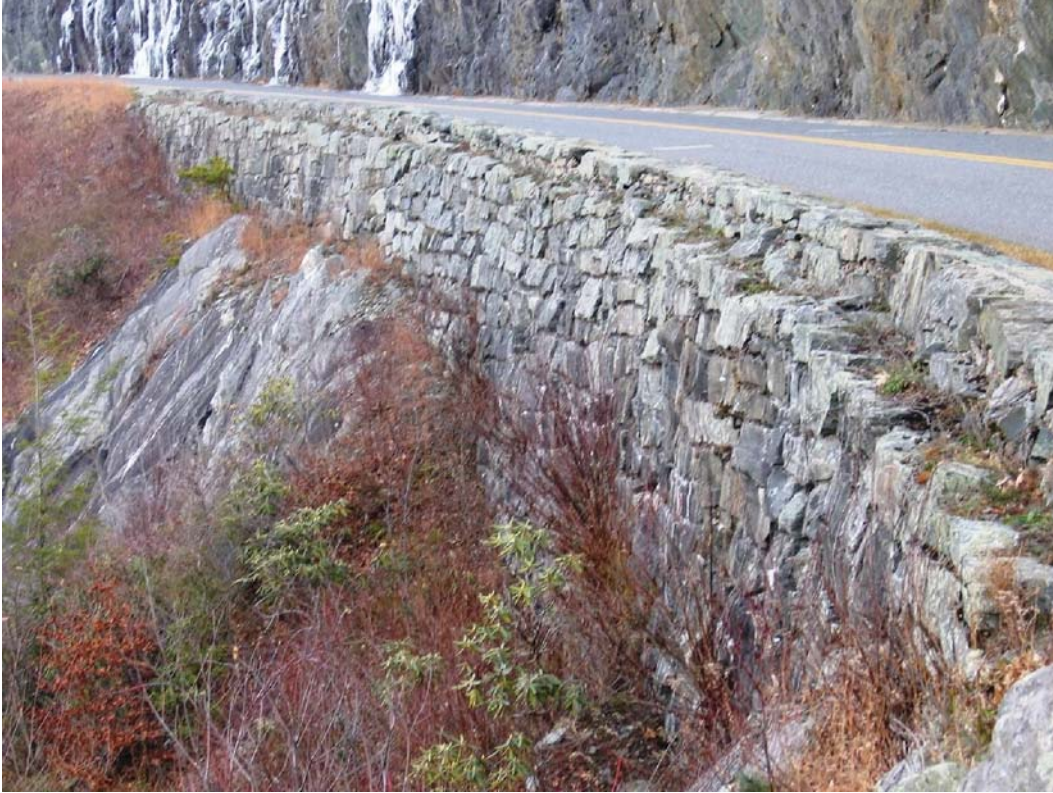
BLRI\_0001CA\_242.241\_R\_1.jpg

<b>Element (Weighting Factor)</b>	<b>Narrative</b>	<b>Condition Rating (0 - 10)</b>
PERFORMANCE 8.00	No signs of global instability, bulging, or sliding. Parapet looks far worse due to weathering.	8
WALL FOUNDATION MATERIAL 8.00	Generally bedrock. Very stable.	10
MORTAR 8.00	Mortar shows shrinkage and cracking over top of wall. Weathered but functioning. Difficult access to wall face due to high exposure.	7
STONE MASONRY 8.00	Hard, durable, slightly weathered with no significant cracking. Parapet is missing blocks.	8
LATERAL SLOPE 0.50	Bedrock outcrop on one ends, steep stable fill at other end.	8
WALL DRAINS 0.50	None visible. No evidence of water-related settlement. No ice formation on wall, though inboard cut is iced.	8
DOWNSLOPE 0.50	Bedrock outcrop or rockfill. Very stable.	9
VEGETATION 1.00	Minor bushes growing through wall at isolated locations. No impact to wall structure.	6
TRAFFIC BARRIER/FENCE 1.00	Parapet is cracked along joints, has missing blocks, generally highly weathered. Damage is not related to wall instability.	7

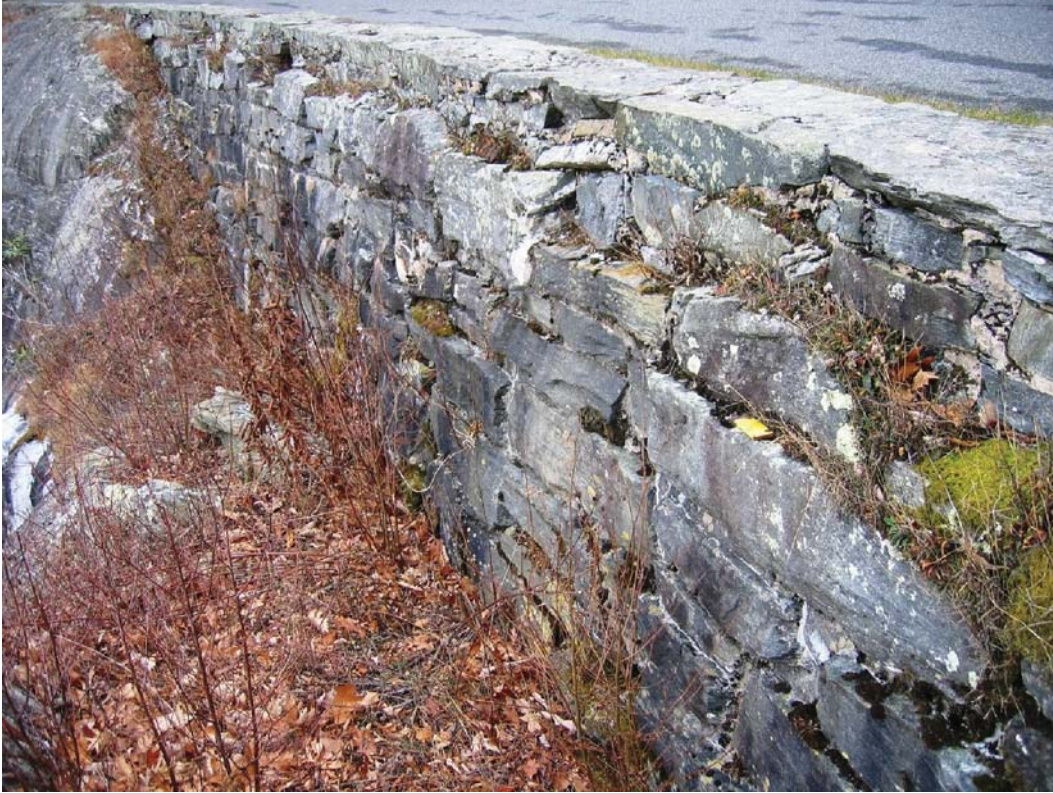
BLRI\_0001CA\_242.313\_R\_1.jpg

<b>Element (Weighting Factor)</b>	<b>Narrative</b>	<b>Condition Rating (0 - 10)</b>
PERFORMANCE 8.00	With exception of weathered parapet, wall shows no signs of settlement, or global instability.	9
WALL FOUNDATION MATERIAL 8.00	Bedrock, very stable.	10
MORTAR 8.00	Parapet mortar is cracked, missing in locations and weathered. Wall mortar is generally intact with minor shrinkage cracking.	8
STONE MASONRY 8.00	Hard, durable stone with minor weathering.	9
ROAD/SIDEWALK/SHOULDER 0.50	No signs of wall related distress. Good condition.	8
WALL DRAINS 0.50	Visible weep holes. Appear to be functioning. Minor wall seepage.	8
DOWNSLOPE 0.50	Bedrock, very stable.	10
LATERAL SLOPE 0.50	Bedrock, very stable.	10
TRAFFIC BARRIER/FENCE 1.00	Parapet is highly weathered, with missing mortar and displaced blocks. No damage due to wall movement.	7

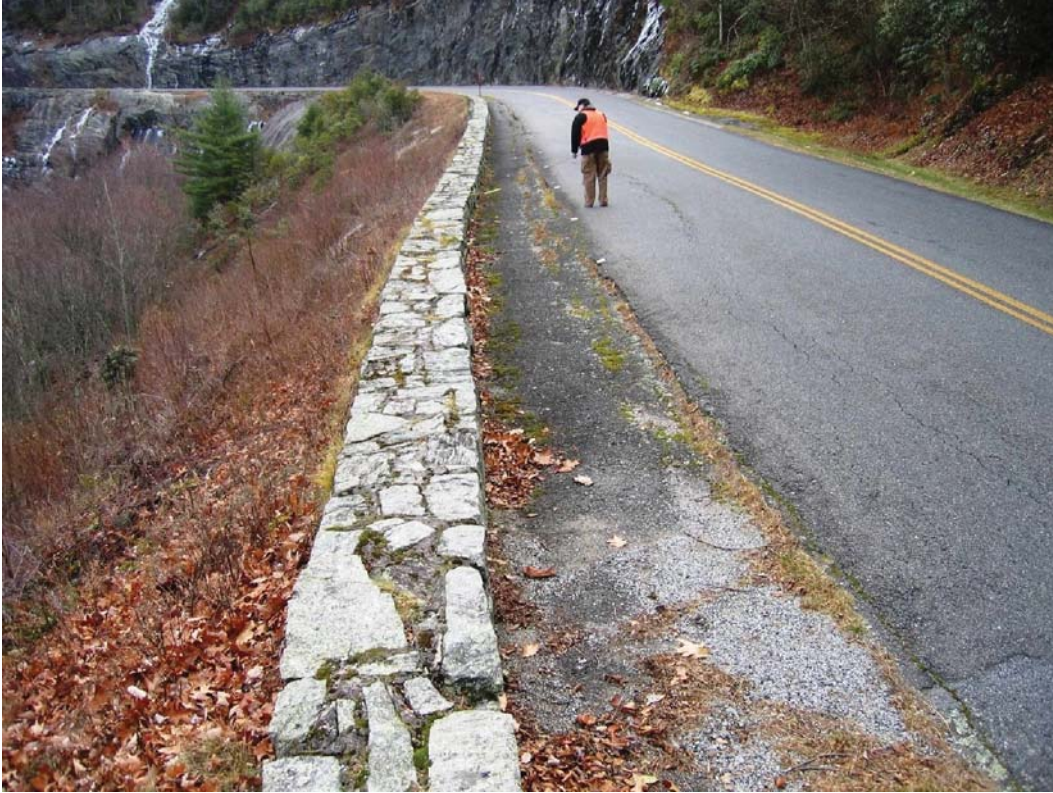
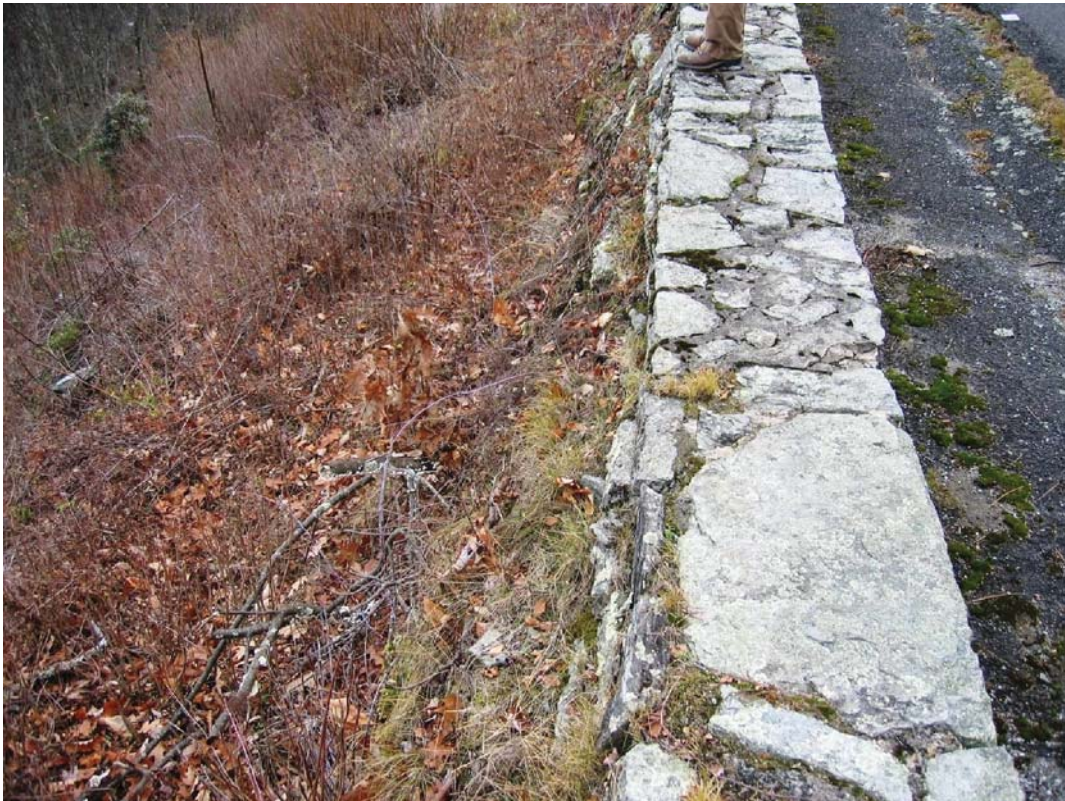
BLRI\_0001CA\_242.388\_R\_1.jpg

<b>Element (Weighting Factor)</b>	<b>Narrative</b>	<b>Condition Rating (0 - 10)</b>
PERFORMANCE 8.00	Wall may be settling/sliding at one location. Needs to be monitored over next few years. Difficult to tell with last pavement.	6
WALL FOUNDATION MATERIAL 8.00	Appears to be rockfill with soil in-filling. No signs of slumping ground, though roadway shows signs of settlement.	6
MORTAR 8.00	Signs of substantial shrinkage, cracking due to grass growing throughout face.	6
STONE MASONRY 8.00	Hard, durable rock. Does not appear to be any missing.	8
DOWNSLOPE 0.50	Generally stable rockfill with vegetated soil infilling.	8
ROAD/SIDEWALK/SHOULDER 1.00	Half-moon cracking and longitudinal settlement cracking evident. Two pavement lifts make wall appear to have settled, but not as severe as it looks.	6
TRAFFIC BARRIER/FENCE 1.00	Parapet shows some alignment displacement in one location, possibly due to wall movement.	6

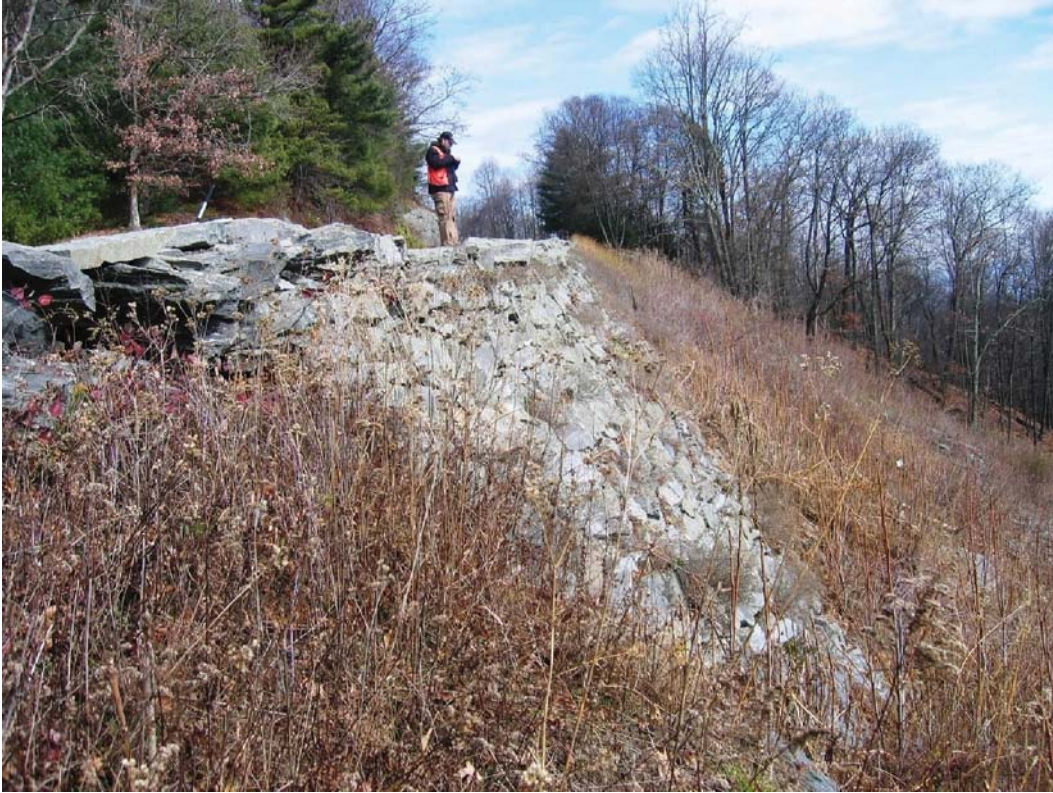
BLRI\_0001CA\_245.175\_L\_1.jpg

<b>Element (Weighting Factor)</b>	<b>Narrative</b>	<b>Condition Rating (0 - 10)</b>
PERFORMANCE 8.00	No signs of global instability, settlement, or deformation.	8
WALL FOUNDATION MATERIAL 8.00	Stable rockfill; good bearing.	9
PLACED STONE 8.00	Large, well-placed hard angular, durable rock with minor weathering. Appears moderately chinked.	8
DOWNSLOPE 0.50	Well-vegetated rock fill. Very stable.	8
LATERAL SLOPE 0.50	Well vegetated soil slopes with no significant erosion/slumping.	8
TRAFFIC BARRIER/FENCE 0.50	Mortared stone guardwall shows no sign of wall-related distress.	8
ROAD/SIDEWALK/SHOULDER 0.50	No sign of wall-related distress. Roadway in good condition.	9
WALL DRAINS 0.50	Free-draining. No signs of water impacts.	9

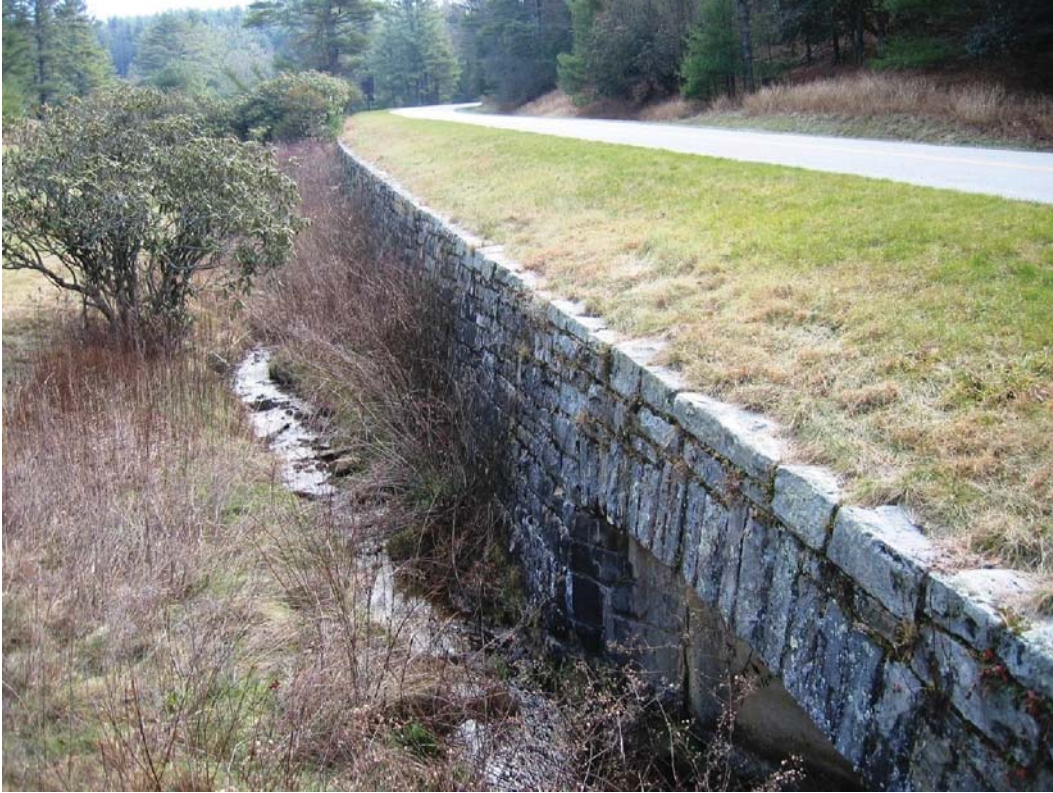
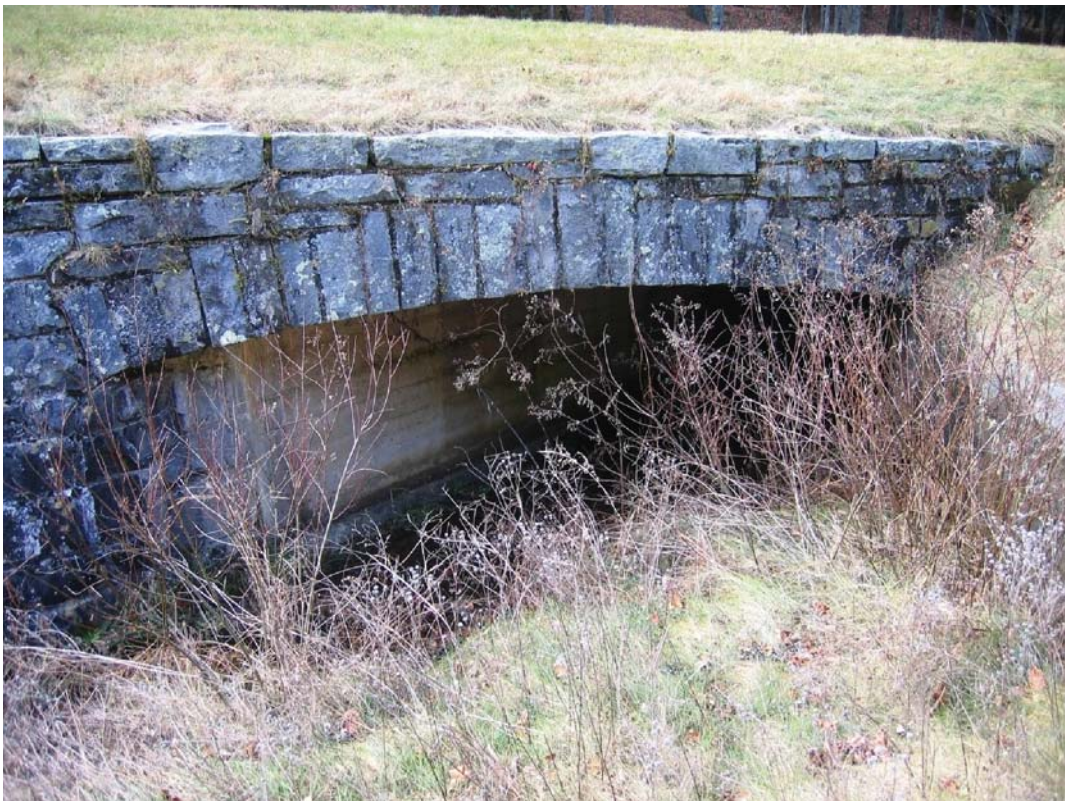
BLRI\_0001CA\_245.685\_R\_1.jpg

<b>Element (Weighting Factor)</b>	<b>Narrative</b>	<b>Condition Rating (0 - 10)</b>
PERFORMANCE 8.00	No signs of global instability or settlement due to scour.	8
WALL FOUNDATION MATERIAL 8.00	No signs of settlement, despite flowing water at wall toe.	8
MORTAR 8.00	Weathered, cracked, missing in many locations along top course (not impacting wall). Generally intact over lower 2/3s of wall.	6
STONE MASONRY 8.00	Hard, durable, well-cut and placed stone. None cracked or missing.	9
DOWNSLOPE 0.50	Flowing drainage. Appears stable.	8
LATERAL SLOPE 0.50	Gentle, stable side slopes. No erosion/slumping.	8
ROAD/SIDEWALK/SHOULDER 0.50	Road is in great condition. No sign of wall-related distress.	9
CURB/BERM/DITCH 1.00	Flowing water at toe of wall is scouring at only one isolated location, but very minor.	6
WALL DRAINS 1.00	Frequent wall drains appear open and functioning. Some seepage through wall face, but mostly surface water runoff.	7

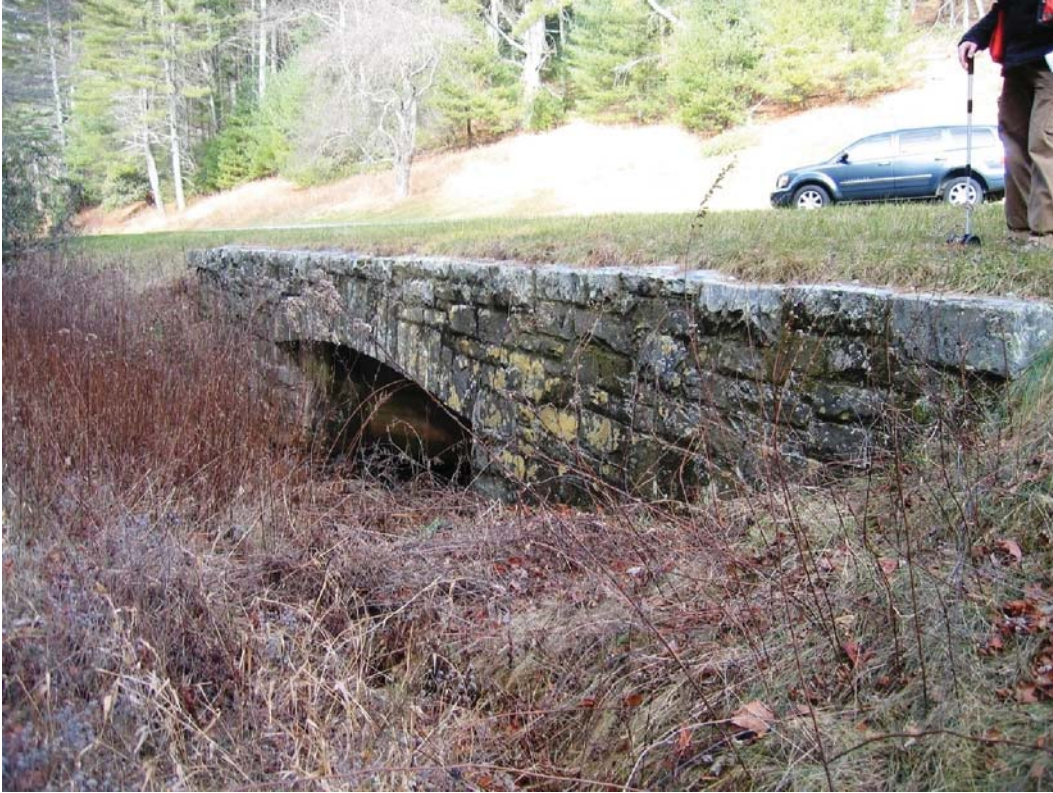
BLRI\_0001CA\_245.727\_L\_1.jpg

<b>Element (Weighting Factor)</b>	<b>Narrative</b>	<b>Condition Rating (0 - 10)</b>
PERFORMANCE 8.00	No signs of global or structural instability.	8
WALL FOUNDATION MATERIAL 8.00	No signs of settlement or scour. Good bearing.	8
MORTAR 8.00	Cracked in some locations, but generally intact, hard, solid.	8
STONE MASONRY 8.00	Hard, durable, well-cut and placed stone work.	9
CULVERT 0.50	No significant distress, weathered, minor channel erosion.	8
LATERAL SLOPE 0.50	No signs of distress. Gentle, stable slopes.	8
WALL DRAINS 0.50	None visible. Minor seepage through the wall. No water issues.	8
DOWNSLOPE 0.50	Drainage outlet. No significant scour/erosion. Very stable.	9
ROAD/SIDEWALK/SHOULDER 0.50	No sign of wall-related distress. Roadway in good condition.	9

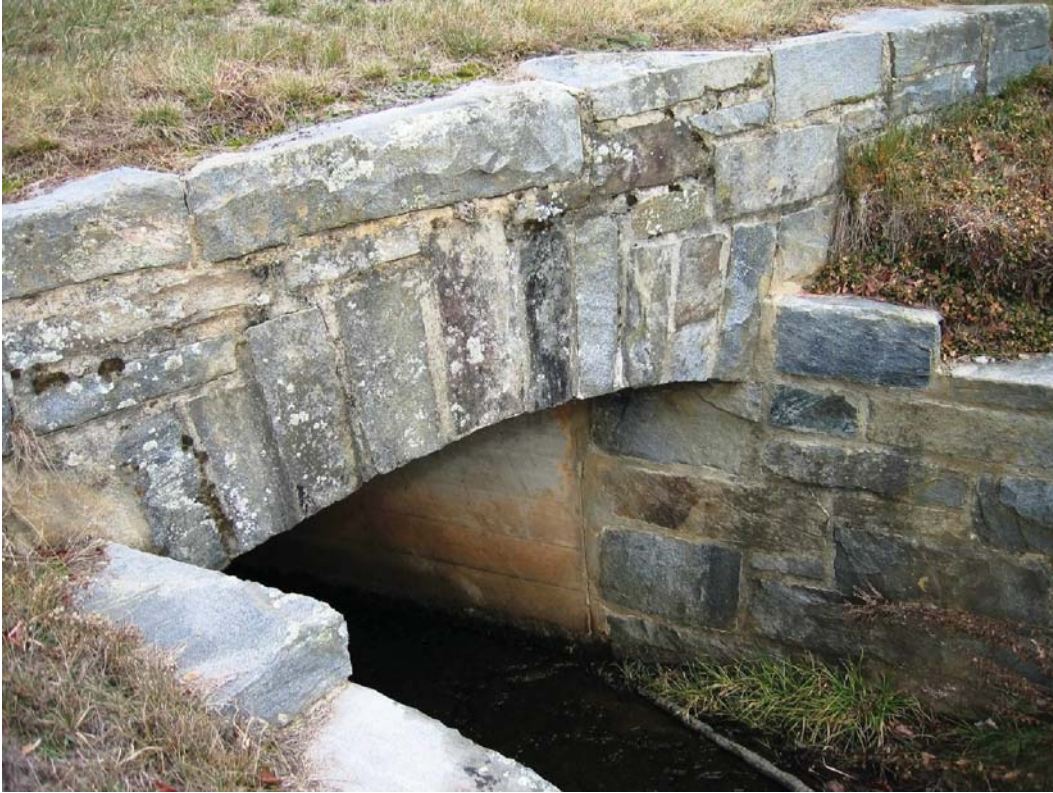
BLRI\_0001CA\_247.866\_L\_1.jpg

<b>Element (Weighting Factor)</b>	<b>Narrative</b>	<b>Condition Rating (0 - 10)</b>
PERFORMANCE 8.00	No signs of global or structural instability.	8
WALL FOUNDATION MATERIAL 8.00	No signs of settlement or scour. Good bearing.	8
MORTAR 8.00	Minor cracking, but generally hard, durable, and intact.	8
STONE MASONRY 8.00	Hard, durable, well-cut and placed stone work. No missing blocks.	9
CULVERT 0.50	No significant distress. Functioning as intended. Minor erosion, but no scour or seepage.	8
DOWNSLOPE 0.50	Channel inlet. Very stable.	8
ROAD/SIDEWALK/SHOULDER 0.50	Minor cracking due to culvert fill settlement. No distress due to headwall.	8
WALL DRAINS 0.50	None visible. Minor seepage through the wall. No settlement or water issues.	8
LATERAL SLOPE 0.50	Gentle, well vegetated stable soil slopes.	9

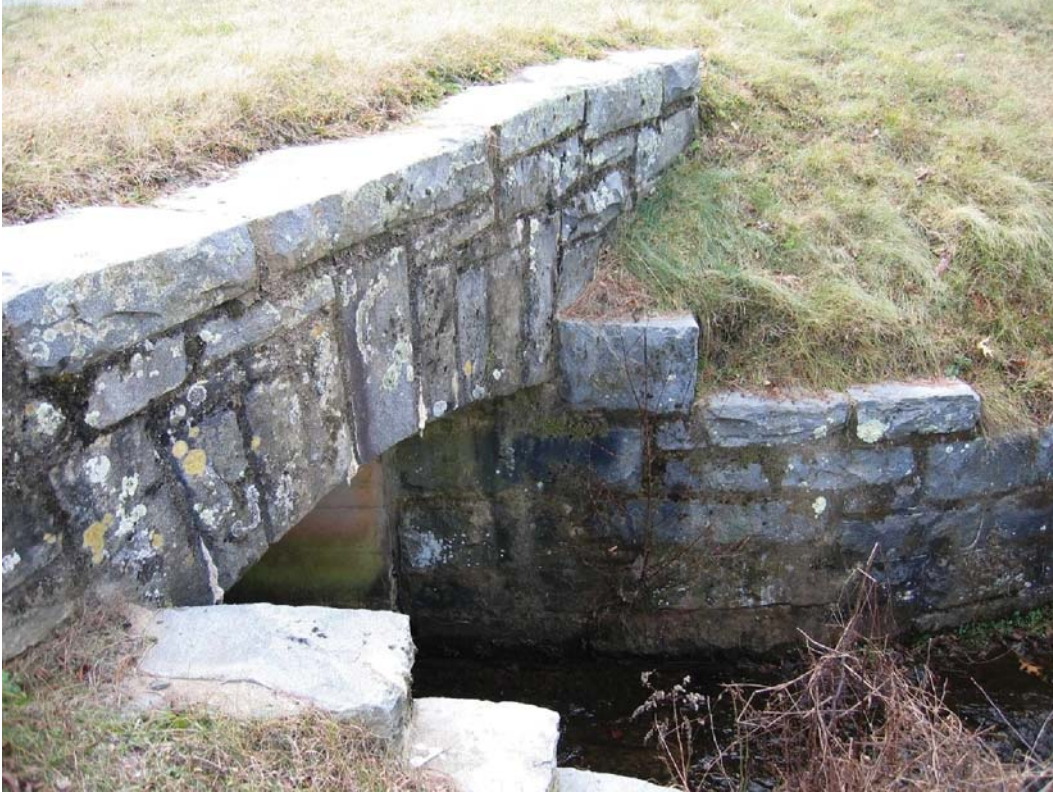
BLRI\_0001CA\_247.871\_R\_1.jpg

<b>Element (Weighting Factor)</b>	<b>Narrative</b>	<b>Condition Rating (0 - 10)</b>
PERFORMANCE 8.00	No signs of global or structural instability.	8
WALL FOUNDATION MATERIAL 8.00	No signs of settlement or scour. Good bearing.	8
MORTAR 8.00	Minor cracking, but generally hard, durable, and intact.	8
STONE MASONRY 8.00	Hard, durable, well-cut and placed stone work. No missing/cracked blocks.	9
CURB/BERM/DITCH 0.50	No significant distress. Functioning as intended. Minor erosion.	8
DOWNSLOPE 0.50	Outlet channel. Stable.	8
ROAD/SIDEWALK/SHOULDER 0.50	Minor pavement cracking due to culvert fill settlement. No wall-related distress.	8
LATERAL SLOPE 0.50	Gentle soil slopes. Well vegetated, no erosion.	9
WALL DRAINS 1.00	None visible. Minor seepage through the wall. No water issues.	7

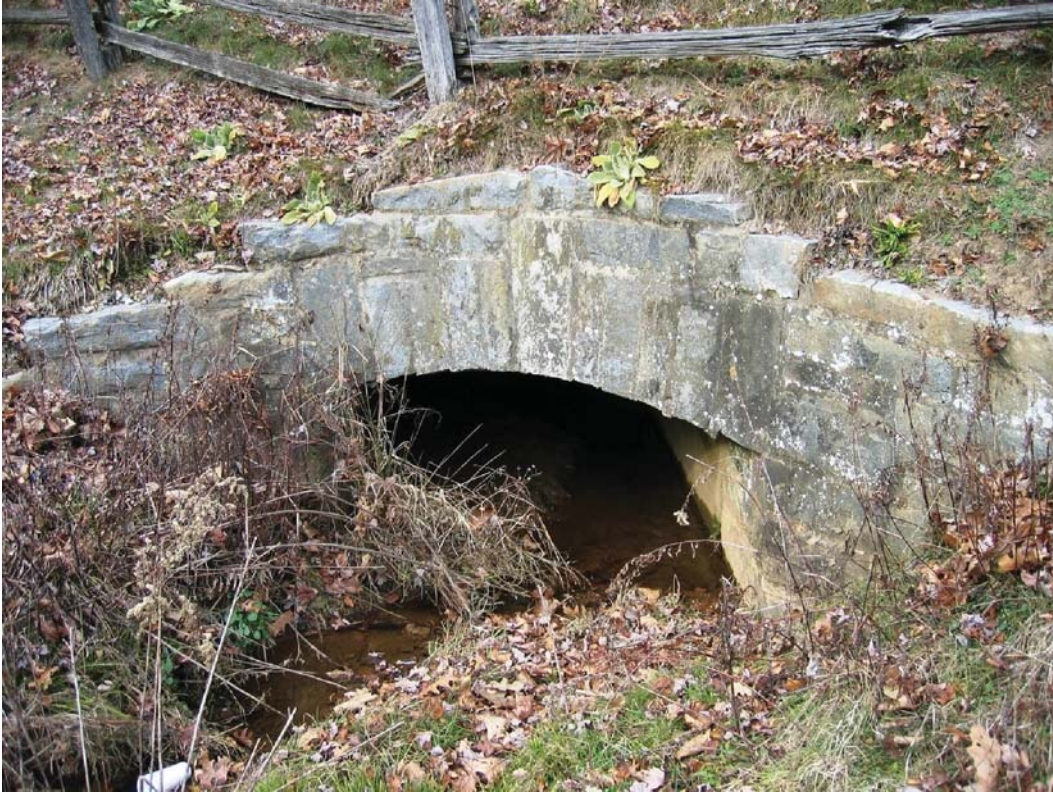
BLRI\_0001CA\_248.143\_L\_1.jpg

<b>Element (Weighting Factor)</b>	<b>Narrative</b>	<b>Condition Rating (0 - 10)</b>
PERFORMANCE 8.00	No signs of global or structural instability.	8
WALL FOUNDATION MATERIAL 8.00	Not visible due to silt. Assumed good bearing due to no settlement.	8
MORTAR 8.00	Minor cracking, but generally hard, durable, and intact.	8
STONE MASONRY 8.00	Hard, durable, stone. No missing/cracked blocks.	9
CULVERT 0.50	Functioning as intended. Minor channel erosion. No scour/cracking.	8
DOWNSLOPE 0.50	Stream channel inlet. Very stable.	8
ROAD/SIDEWALK/SHOULDER 0.50	No sign of wall-related distress.	8
UPSLOPE 0.50	Stable, sodded slope.	8
WALL DRAINS 0.50	None visible. No water issues.	8

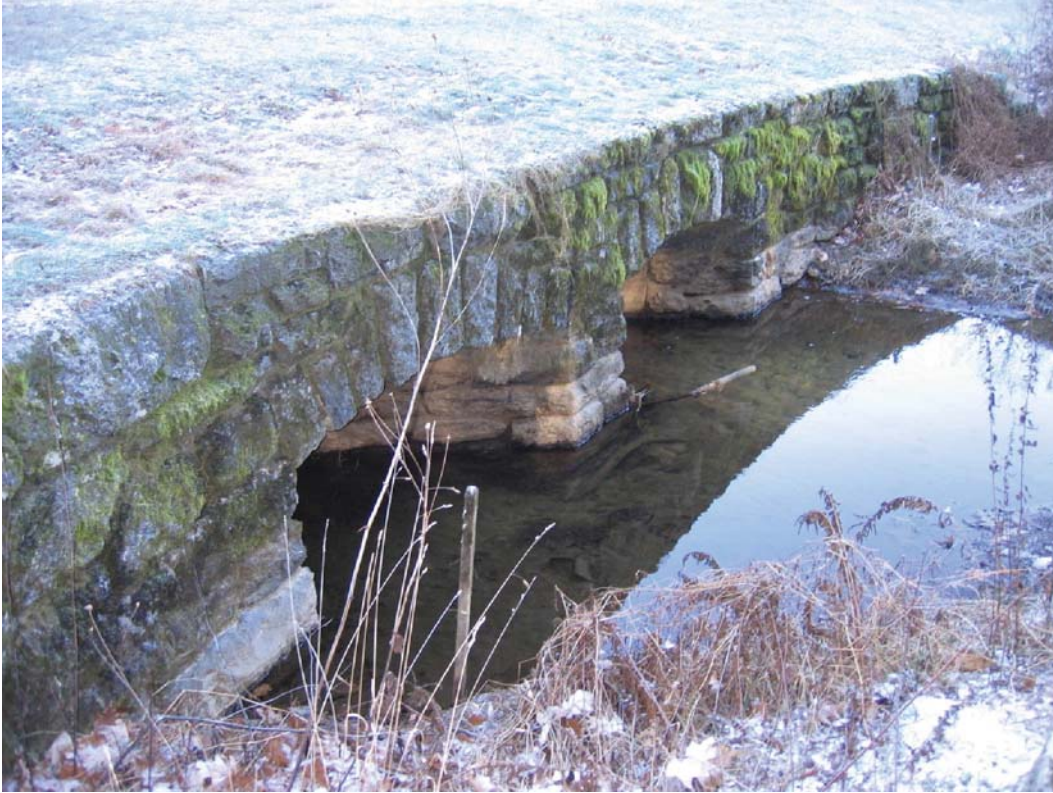
BLRI\_0001CB\_286.083\_L\_1.jpg

<b>Element (Weighting Factor)</b>	<b>Narrative</b>	<b>Condition Rating (0 - 10)</b>
PERFORMANCE 8.00	Structure is weathered, but shows no signs of global instability.	7
WALL FOUNDATION MATERIAL 8.00	No signs of wingwall settlement. Appears to be suitable bearing.	8
MORTAR 8.00	Moderately weathered, but generally intact. Largely obscured due to moss.	7
STONE MASONRY 8.00	Weathered, yet hard, durable stone. No missing or cracked blocks, though many are moss covered.	8
CULVERT 0.50	Functioning as intended. No evidence of culvert cracking/seepage. Minor channel erosion. Generally in good, yet weathered condition.	8
DOWNSLOPE 0.50	Outlet stream channel. Appears stable.	8
ROAD/SIDEWALK/SHOULDER 0.50	No wall-related distress.	8
LATERAL SLOPE 0.50	Gentle, well vegetated side slopes; no distress.	9
WALL DRAINS 1.00	None visible. Some seepage evident.	7

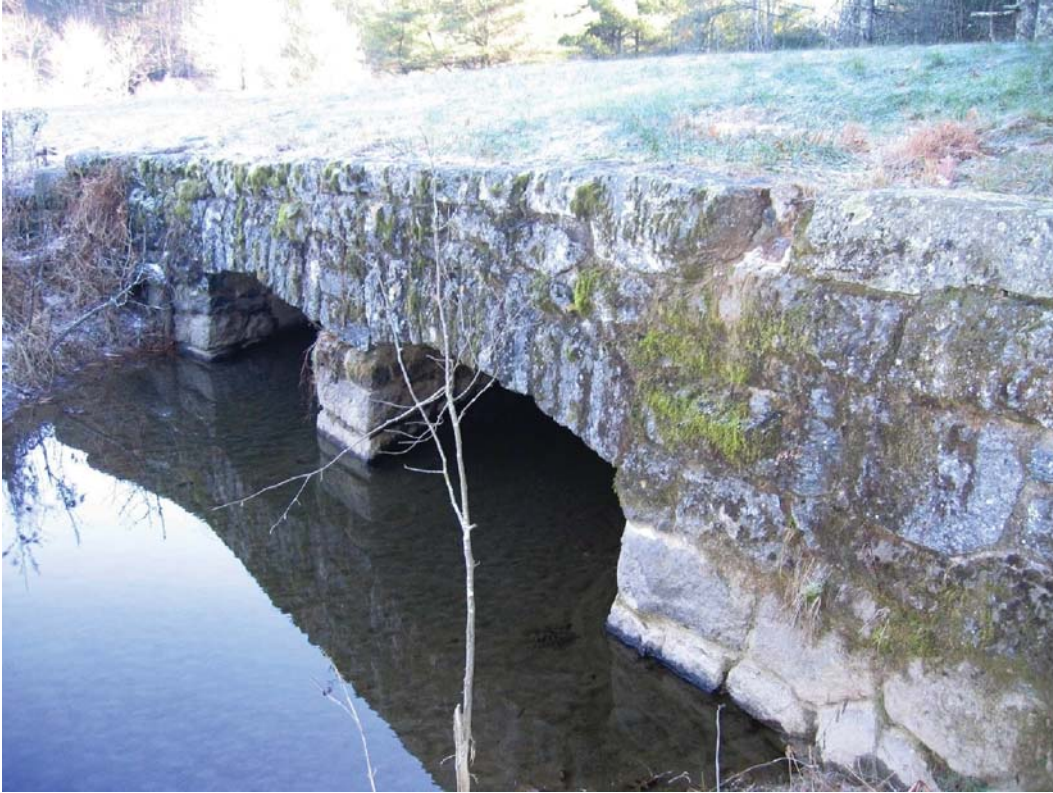
BLRI\_0001CB\_286.092\_R\_1.jpg

<b>Element (Weighting Factor)</b>	<b>Narrative</b>	<b>Condition Rating (0 - 10)</b>
PERFORMANCE 8.00	No signs of global or structural instability.	8
WALL FOUNDATION MATERIAL 8.00	Large boulders; very stable.	9
MORTAR 8.00	Obscured by moss over much of wall, but generally intact., hard with shrinking and cracking throughout.	7
STONE MASONRY 8.00	Hard, durable, well-cut and placed stones. No missing/cracked blocks.	9
CULVERT 0.50	Weathered structure with minor scour. No cracking or leakage evident.	8
ROAD/SIDEWALK/SHOULDER 0.50	Minor longitudinal cracking. No wall-related distress.	8
TRAFFIC BARRIER/FENCE 0.50	Stone masonry parapet is in good shape. No wall-related distress.	8
DOWNSLOPE 0.50	Stream outlet, very stable.	9
LATERAL SLOPE 1.00	Erosion along down station end; not impacting headwall.	7

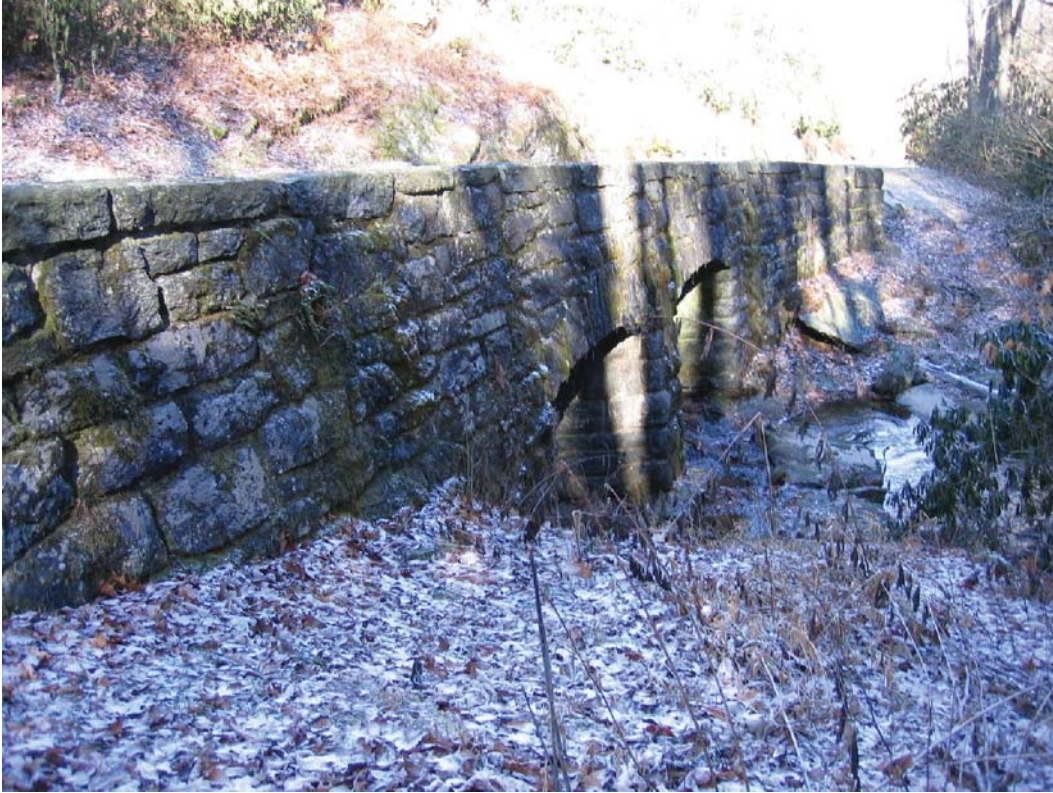
BLRI\_0001CB\_286.805\_L\_1.jpg

<b>Element (Weighting Factor)</b>	<b>Narrative</b>	<b>Condition Rating (0 - 10)</b>
PERFORMANCE 8.00	Weathered, but no signs of global or structural instability, displacement or settlement.	8
WALL FOUNDATION MATERIAL 8.00	No signs of settlement along the wall, parapet, or roadway. No scour visible.	8
MORTAR 8.00	Moderately weathered, but generally intact and hard. Significant cracking along top courses, but does not affect wall performance.	7
STONE MASONRY 8.00	Hard, durable, well-cut and placed stones. No missing/cracked blocks, but substantial portion of wall obscured by moss.	9
CULVERT 0.50	Both culverts are open, functioning as intended. Minor channel erosion and scour. No signs of leakage or settlement. Weathered structures.	8
LATERAL SLOPE 0.50	Gentle, well vegetated end slopes.	8
ROAD/SIDEWALK/SHOULDER 0.50	Minor cracking; no signs of wall-related distress.	8
TRAFFIC BARRIER/FENCE 0.50	Parapet shows no signs of wall-related distress.	8
