# BLRI WIP Report

## NPS Retaining Wall Inventory Program Blue Ridge Parkway

Federal Highway Administration  
Eastern Federal Lands Highway Division  
Road Inventory Program (RIP)

# Blue Ridge Parkway in North Carolina and Virginia

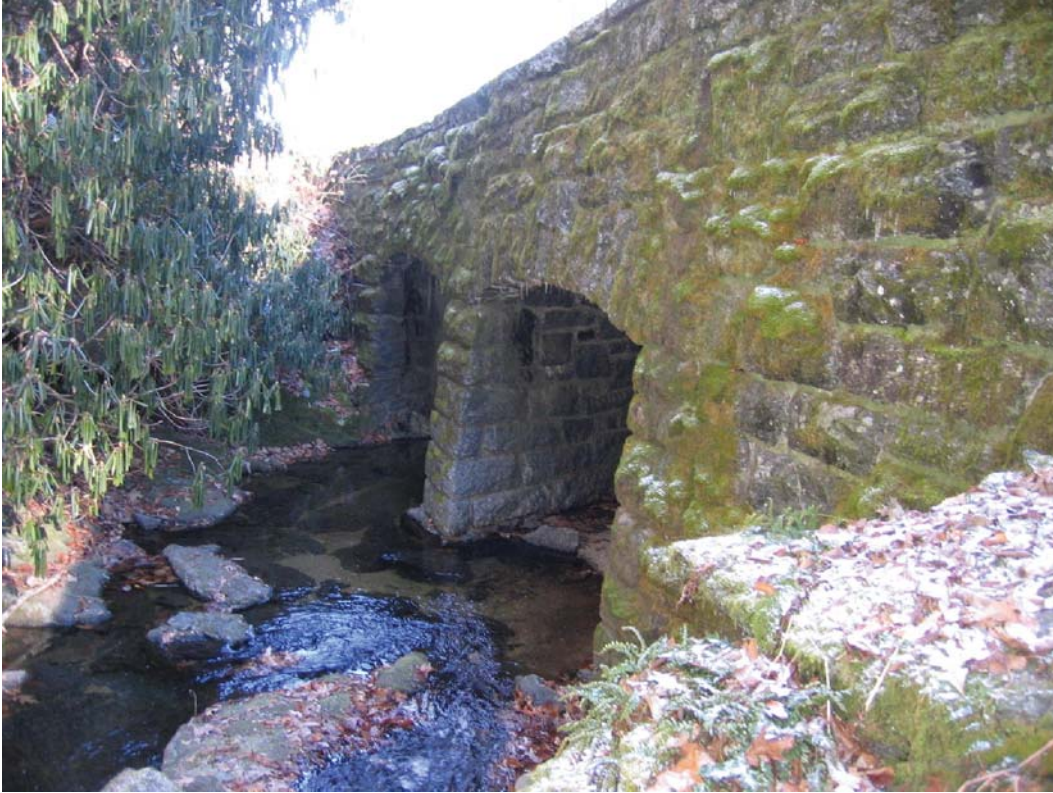
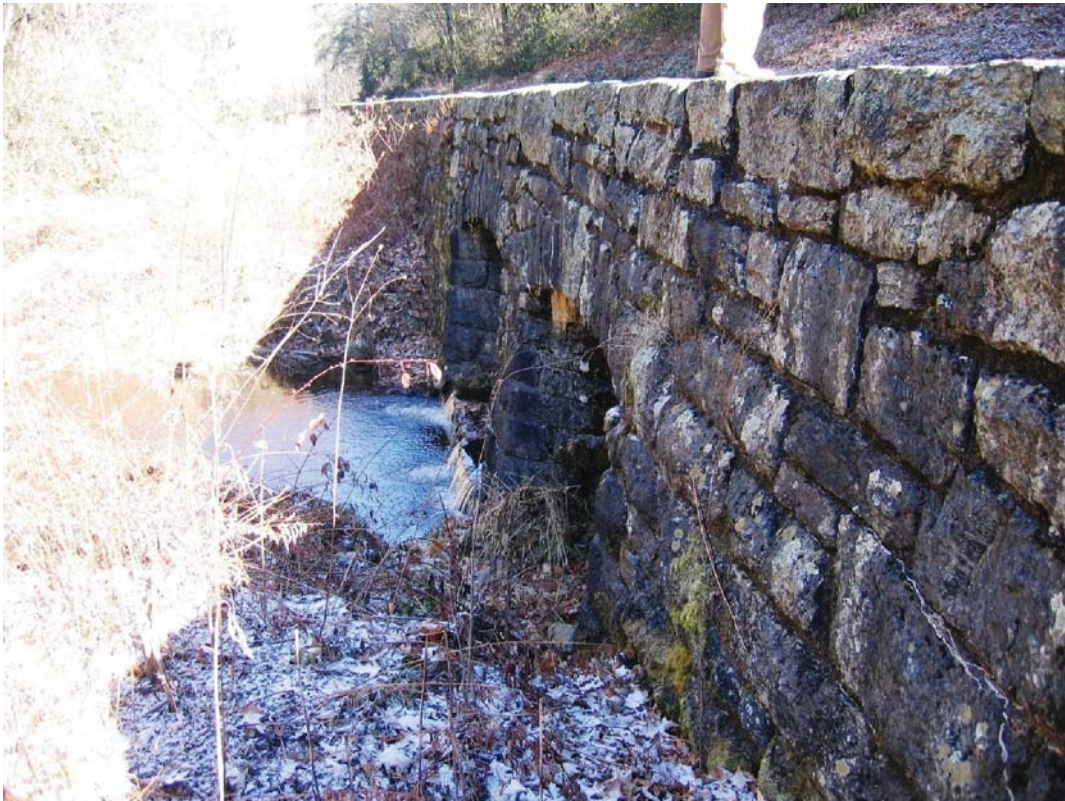
BLRI\_0001CB\_286.810\_R\_1.jpg

<b>Element (Weighting Factor)</b>	<b>Narrative</b>	<b>Condition Rating (0 - 10)</b>
PERFORMANCE 8.00	Wall is weathered, but no signs of global or structural distress.	8
WALL FOUNDATION MATERIAL 8.00	No signs of scour/settlement. Boulder fill.	9
MORTAR 8.00	Moderately weathered, but generally intact and hard. No missing mortar except along top course, no wall impact.	7
STONE MASONRY 8.00	Hard, durable, well-cut and placed stones. No missing/cracked blocks.	9
CULVERT 0.50	Culvert is functioning as intended; weathered, but intact.	8
LATERAL SLOPE 0.50	Well vegetated stable side slopes.	8
DOWNSLOPE 0.50	Stable stream channel.	9
ROAD/SIDEWALK/SHOULDER 0.50	No wall-related distress. Very good condition.	9
WALL DRAINS 1.00	None visible. Seepage evident through mortar cracking.	7

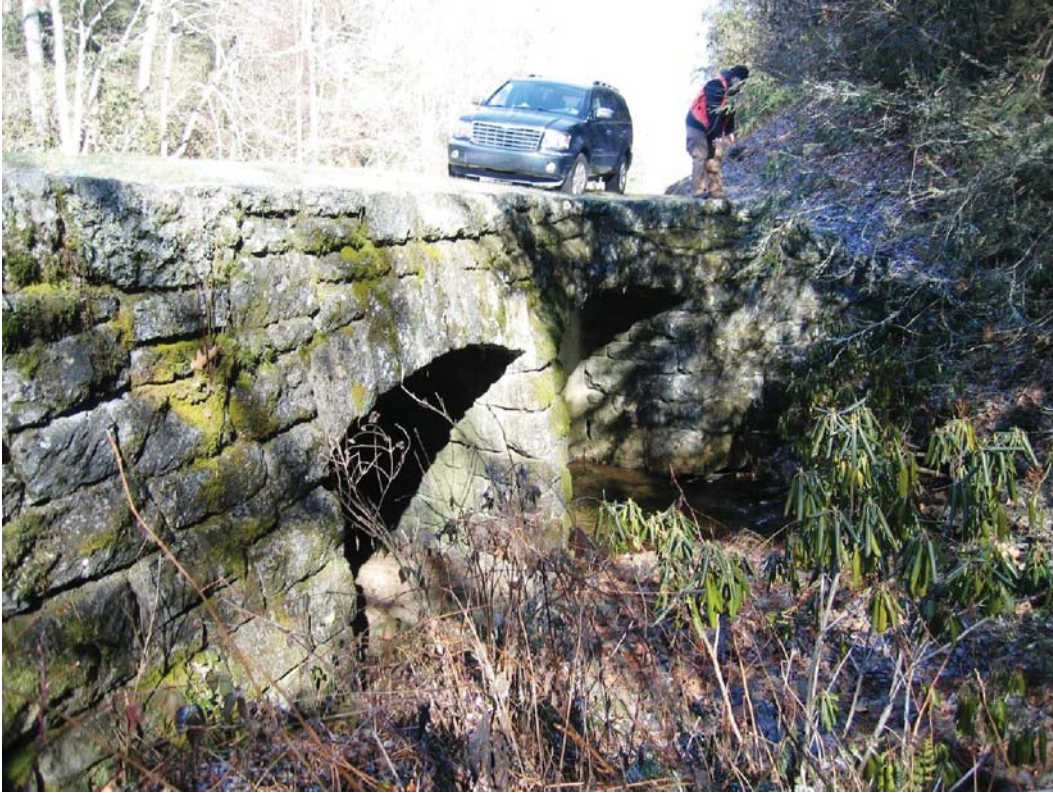
BLRI\_0001CB\_286.925\_L\_1.jpg

<b>Element (Weighting Factor)</b>	<b>Narrative</b>	<b>Condition Rating (0 - 10)</b>
PERFORMANCE 8.00	No global stability distress; however, stream has scoured under pier and culvert and needs repair.	5
WALL FOUNDATION MATERIAL 8.00	Scour at wall toe. No signs of settlement.	5
MORTAR 8.00	Weathered, cracked with missing mortar in scoured section of wall.	5
STONE MASONRY 8.00	Hard, durable, well-cut and placed stones. No missing/cracked blocks. Moss obscures much of wall.	8
DOWNSLOPE 0.50	Stable stream channel outlet.	8
LATERAL SLOPE 0.50	No slumping/erosion; stable slopes.	9
ROAD/SIDEWALK/SHOULDER 0.50	No wall-related distress. Very good condition.	9
UPSLOPE 0.50	Gentle, well vegetated; no erosion/slumping.	9
CULVERT 1.00	Scoured under outlet edge and under wall blocks. Needs to be repaired to mitigate headwall damage in the future.	5

<b>Failure Consequence:</b>	HIGH
<b>Recommendation Narrative:</b>	Repair scour along headwall toe: Place grouted riprap along outlet toe. 33 cubic yards @ \$330 per c.y. = \$11,000
<b>Repair Cost:</b>	\$11,000

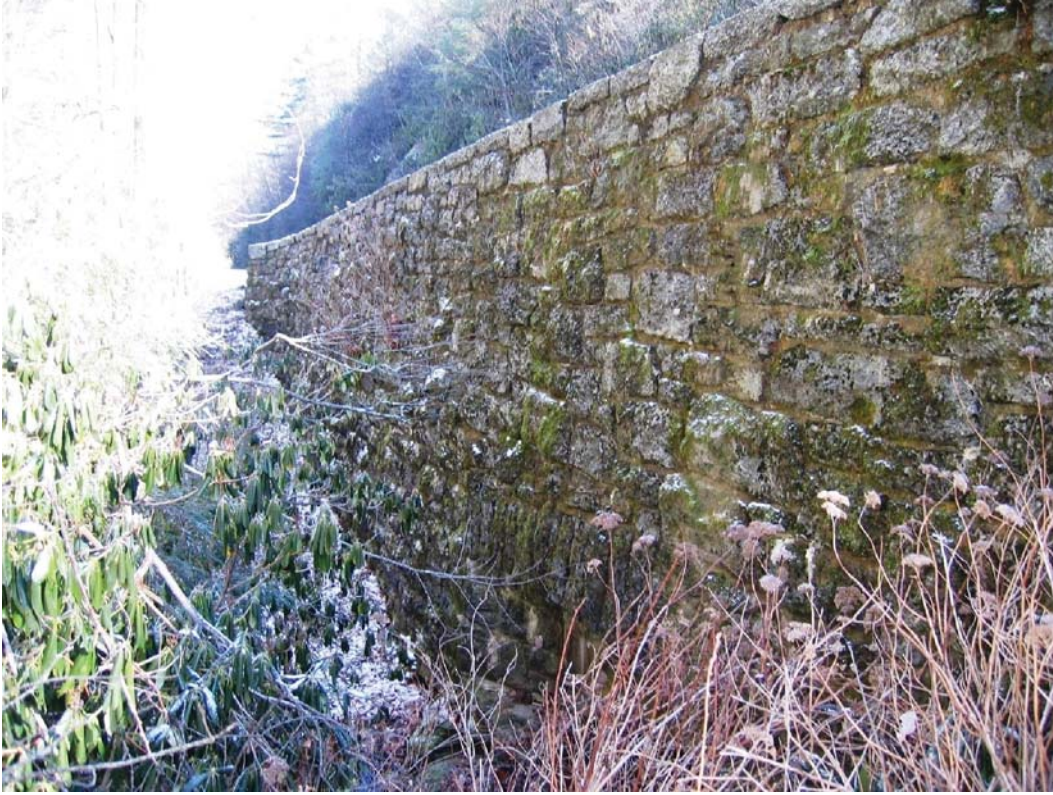
BLRI\_0001CB\_287.680\_R\_1.jpg

<b>Element (Weighting Factor)</b>	<b>Narrative</b>	<b>Condition Rating (0 - 10)</b>
PERFORMANCE 8.00	Left wing wall is cracked and needs to be patched. Otherwise, no global distress.	6
WALL FOUNDATION MATERIAL 8.00	Stable, good bearing materials. Left wingwall may be settling a bit.	7
MORTAR 8.00	Cracked and weathered, but generally strong, hard and intact. Left wingwall is cracked vertically, requiring patch.	6
STONE MASONRY 8.00	Hard, durable, stones with no missing/cracked blocks.	9
CULVERT 0.50	Appears to be functioning. Outlet obscured by leaves and branch debris.	8
DOWNSLOPE 0.50	Stable stream channel.	8
ROAD/SIDEWALK/SHOULDER 0.50	No signs of wall-related distress.	8
UPSLOPE 0.50	Well vegetated. 1.5H:1V stable slope.	8
VEGETATION 1.00	Small trees growing along top of wall may be impacting upper courses. Roots may be to blame for wingwall crack.	4

<b>Failure Consequence:</b>	MODERATE
<b>Recommendation Narrative:</b>	Remove trees from top of wall and patch vertical crack in left wingwall. Labor: 4 hours @ \$55 per hr. = \$220. Cement patch, lump sum = \$50. Total = \$270.00
<b>Repair Cost:</b>	\$270

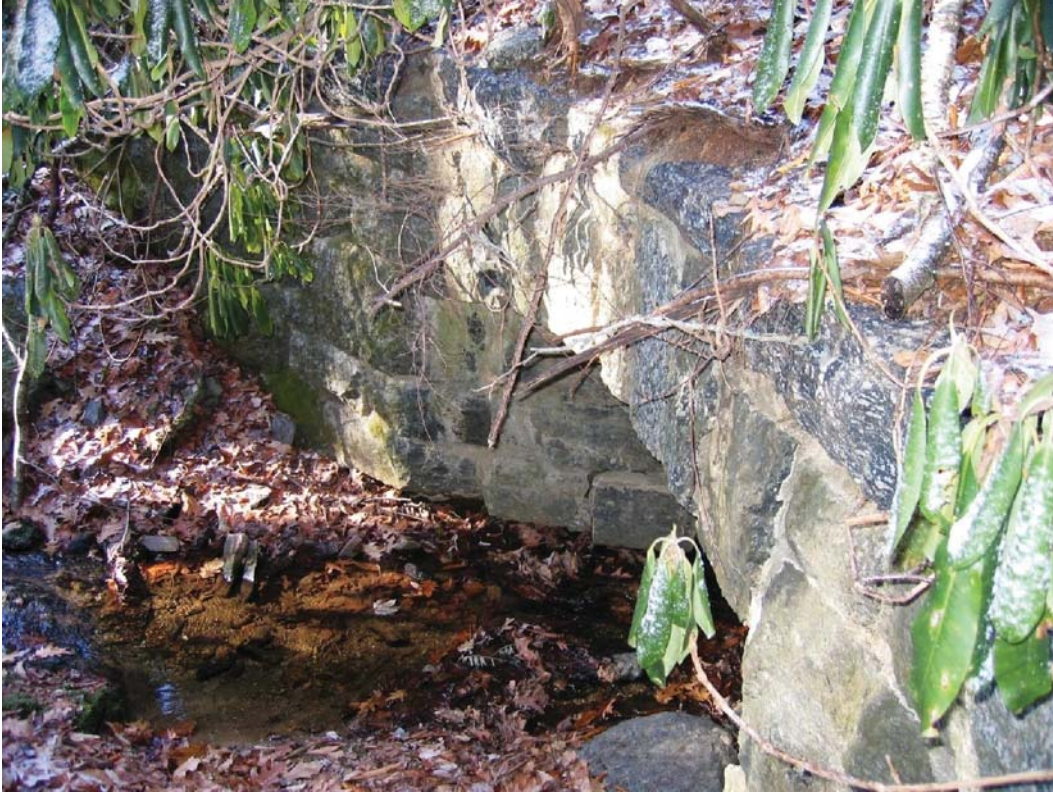
BLRI\_0001CB\_287.709\_L\_1.jpg

<b>Element (Weighting Factor)</b>	<b>Narrative</b>	<b>Condition Rating (0 - 10)</b>
PERFORMANCE 8.00	No signs of global or structural distress.	9
WALL FOUNDATION MATERIAL 8.00	No signs of settlement or erosion. Appears to have well-prepared bench.	8
MORTAR 8.00	Hard, intact with minor shrinkage cracking.	8
STONE MASONRY 8.00	Hard, nearly fresh, durable, well-cut/placed stone with no cracked or missing blocks.	9
LATERAL SLOPE 0.50	Rock outcrop on one end, stable soil slope (well vegetated) on other end.	8
ROAD/SIDEWALK/SHOULDER 0.50	Occasional transverse cracking possibly related to retained fill settlement.	8
WALL DRAINS 0.50	None visible, minor seepage through wall face.	8
TRAFFIC BARRIER/FENCE 0.50	Mortared stone parapet is in good shape with no wall-related distress.	9
DOWNSLOPE 1.00	Steep, well vegetated soil slope with erosion gully about half way down wall, but not impacting wall.	6

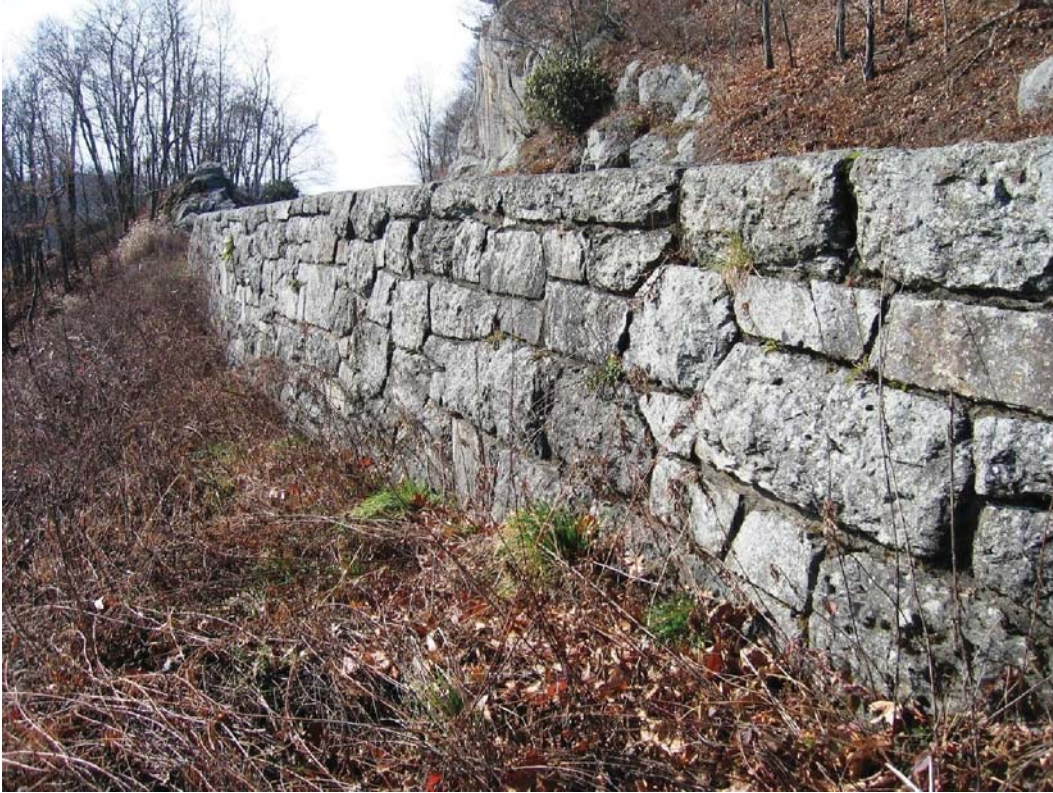
BLRI\_0001CB\_290.235\_L\_1.jpg

<b>Element (Weighting Factor)</b>	<b>Narrative</b>	<b>Condition Rating (0 - 10)</b>
PERFORMANCE 8.00	No signs of global or structural distress. Wall is performing well-just ugly as hell. Concrete panels show very minor weathering.	8
WALL FOUNDATION MATERIAL 8.00	No signs of wall settlement or foundation erosion. Well prepared construction bench.	9
WIRE/GEOSYNTHETIC FACING 8.00	Precast concrete panels are in place, intact, with no cracking or distortion. Joints are well-aligned.	8
ARCHITECTURAL FACING 0.50	Precast panels are intact. Colored aggregate is intact.	8
DOWNSLOPE 0.50	Wide bench transitioning to stable slope.	8
LATERAL SLOPE 0.50	Well vegetated, stable, side slopes no erosion or slumping.	8
ROAD/SIDEWALK/SHOULDER 0.50	Minor transverse cracking. No apparent wall-related distress.	8
VEGETATION 0.50	Minor bushes growing out between panels at a few locations. No wall impact.	8
TRAFFIC BARRIER/FENCE 0.50	Mortared stone guardwall shows no signs of wall-related distress.	9

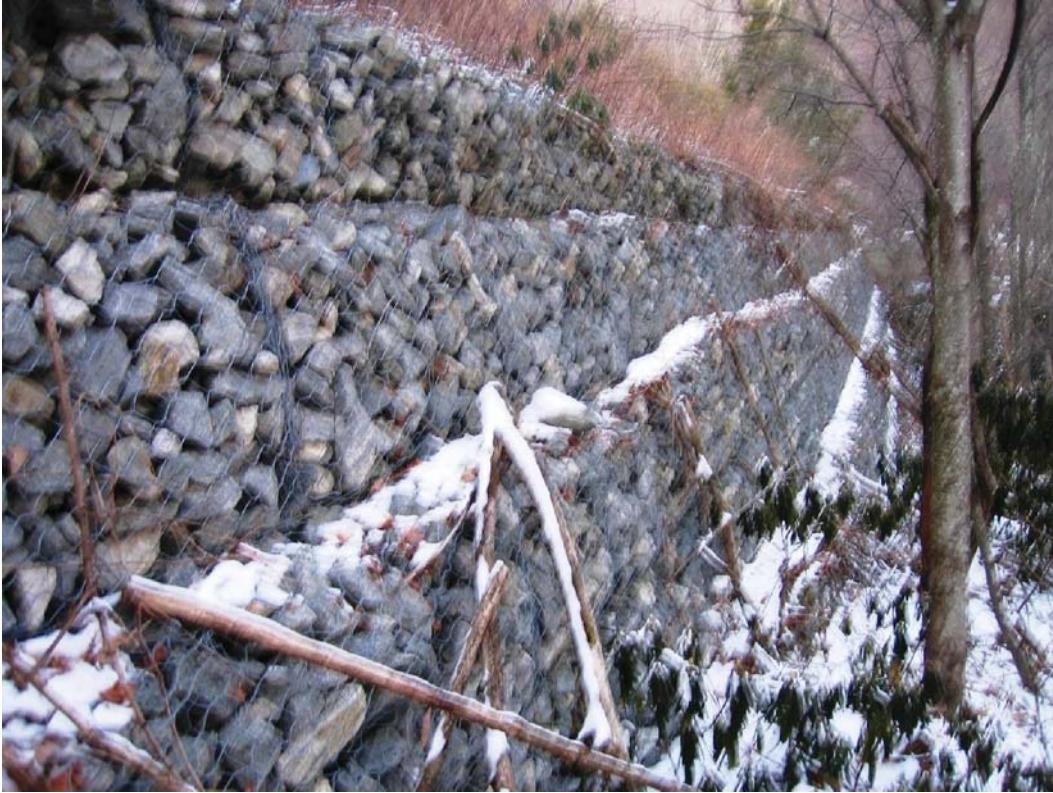
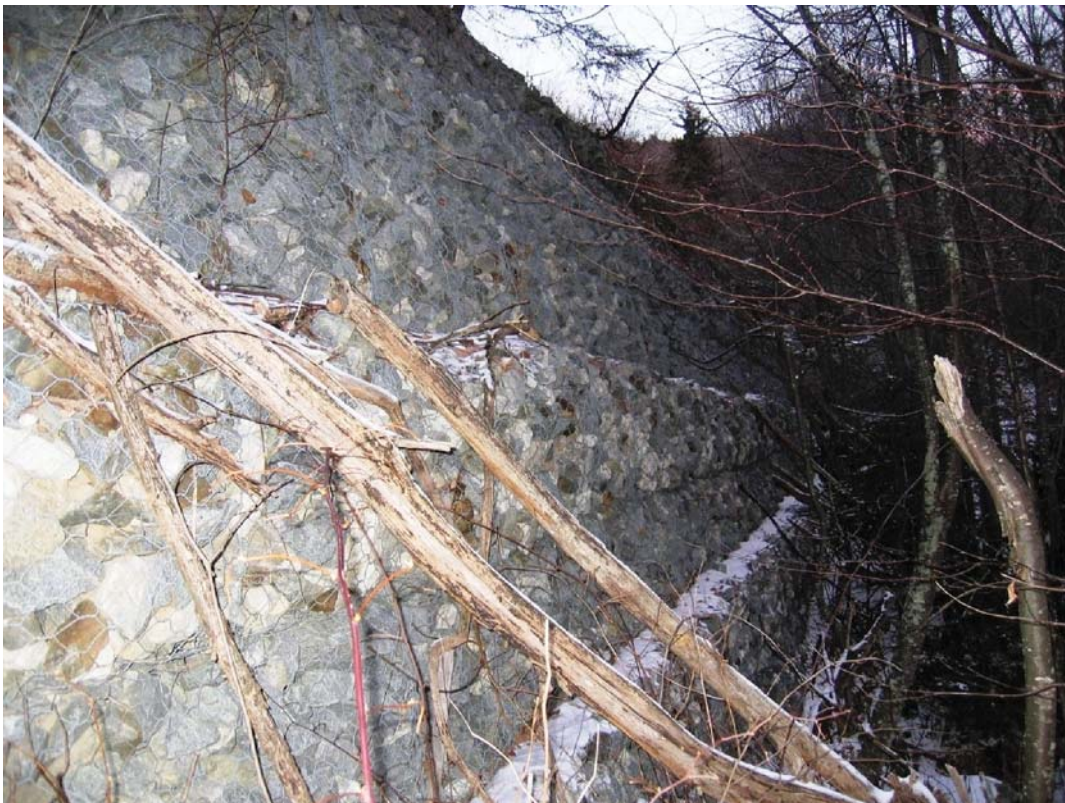
BLRI\_0001CB\_305.499\_L\_1.jpg

<b>Element (Weighting Factor)</b>	<b>Narrative</b>	<b>Condition Rating (0 - 10)</b>
PERFORMANCE 8.00	No signs of distortion, settlement or basket failure. Globally stable.	9
WALL FOUNDATION MATERIAL 8.00	No signs of settlement/erosion. Mostly rock fill.	9
WIRE/GEOSYNTHETIC FACING 8.00	Wire baskets are intact; no distortion or failed baskets. No corrosion on wires. Rock fill is fresh, hard, durable.	9
ROAD/SIDEWALK/SHOULDER 0.50	Minor transverse cracking; unrelated to wall. No significant sub grade settlement.	8
UPSLOPE 0.50	Well vegetated, stable 1.5H:1V slope.	8
VEGETATION 0.50	Small trees, vines growing along top of wall; no impact to wall.	8
DOWNSLOPE 0.50	Rock fill transitioning to wooded side slope. Very stable.	9
WALL DRAINS 0.50	Free draining. No drainage issues. No seepage around wall base.	9
LATERAL SLOPE 1.00	Erosion gullies either end, but not impacting wall.	7

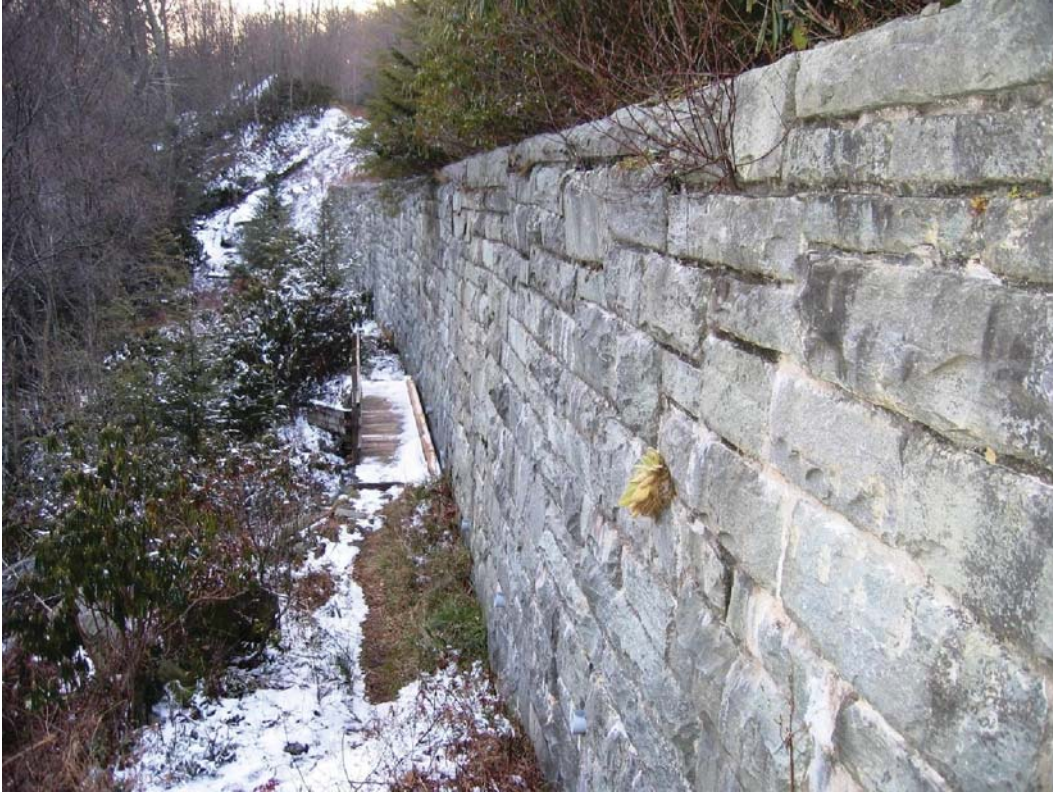
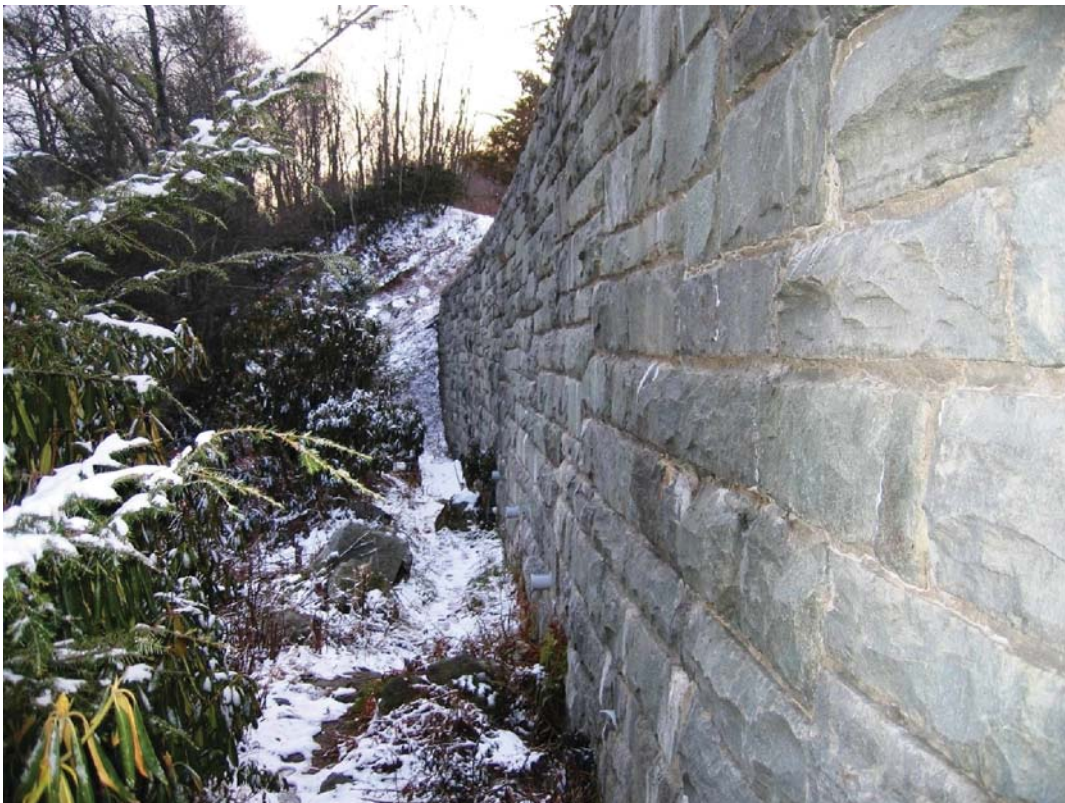
BLRI\_0001CB\_305.820\_L\_1.jpg

<b>Element (Weighting Factor)</b>	<b>Narrative</b>	<b>Condition Rating (0 - 10)</b>
PERFORMANCE 8.00	No global distress	7
WALL FOUNDATION MATERIAL 8.00	Soil, no observed settlement or cracks	7
MORTAR 8.00	Some moss and vegetation	7
STONE MASONRY 8.00	Some moss and efflorescence	7
ROAD/SIDEWALK/SHOULDER 0.50	Grass, flat, no distress	8
CULVERT 1.00	Concrete box culvert, 7'W x 5'H	7
DOWNSLOPE 1.00	Heavily wooded, no distress	7
LATERAL SLOPE 1.00	Heavily wooded, no distress	7
WALL DRAINS 1.00	No drainage-related problems	7

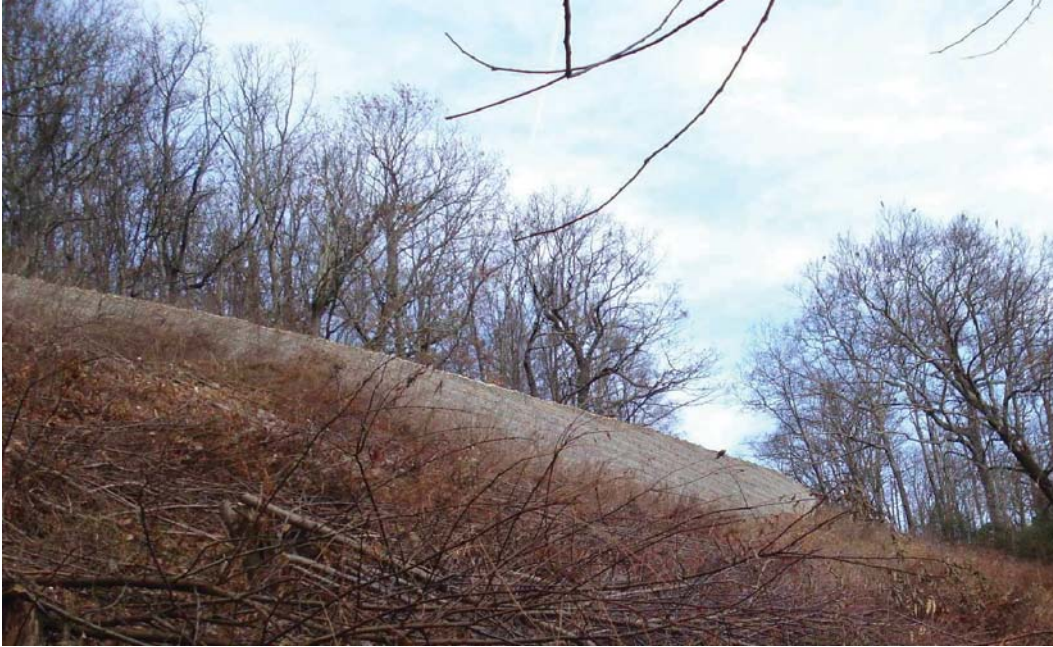
BLRI\_0001DA\_323.159\_L\_1.JPG

<b>Element (Weighting Factor)</b>	<b>Narrative</b>	<b>Condition Rating (0 - 10)</b>
PERFORMANCE 8.00	No global distress	9
WALL FOUNDATION MATERIAL 8.00	Soil, no observed settlement or cracks	9
WIRE/GEOSYNTHETIC FACING 8.00	Good condition, no corrosion observed	9
ROAD/SIDEWALK/SHOULDER 0.50	Grass, flat, no distress	9
WALL DRAINS 0.50	No drainage-related problems	9
DOWNSLOPE 1.00	Steep slope, wooded, no distress	6
LATERAL SLOPE 1.00	Steep slope, wooded, no distress	6

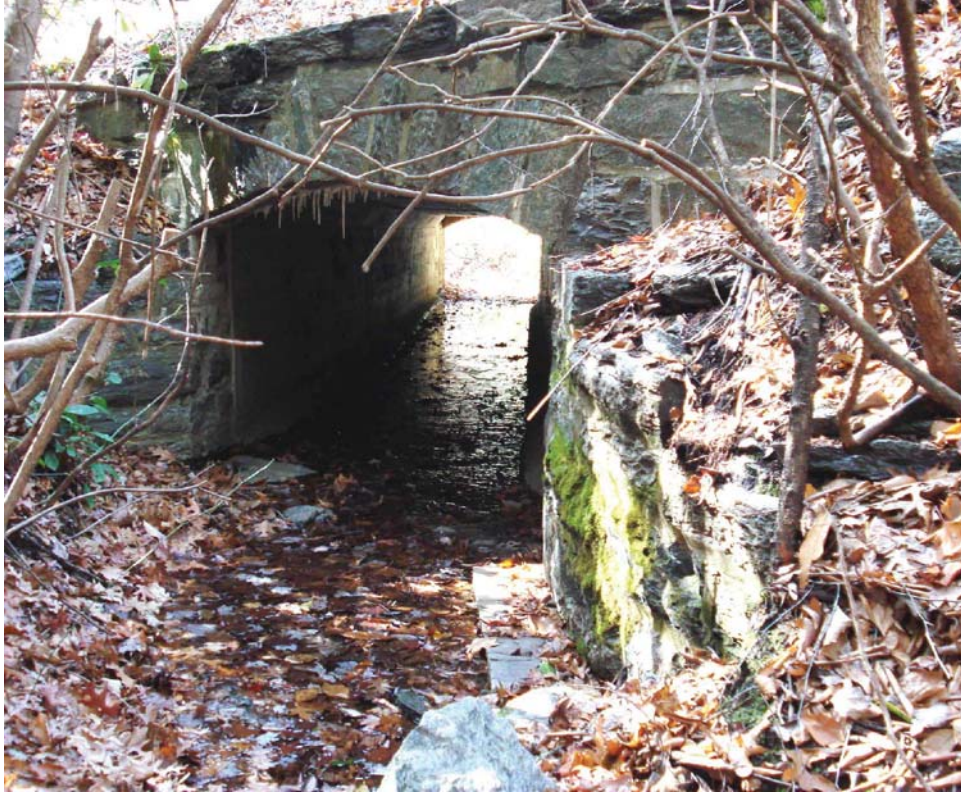
BLRI\_0001DA\_323.724\_L\_1.JPG

<b>Element (Weighting Factor)</b>	<b>Narrative</b>	<b>Condition Rating (0 - 10)</b>
PERFORMANCE 8.00	No global distress	7
WALL FOUNDATION MATERIAL 8.00	Soil, no observed settlement or erosion	8
CONCRETE 8.00	Good condition, cast in place, minor cracks, some moss and efflorescence	7
MORTAR 8.00	Some moss	7
STONE MASONRY 8.00	Sound and durable	7
ROAD/SIDEWALK/SHOULDER 0.50	Grass shoulder, no distress	8
UPSLOPE 0.50	Grass, gently sloping, no distress	8
WALL DRAINS 0.50	No drainage-related problems	8
CULVERT 1.00	concrete box, on a skew, 14'H x 3.5'W	7

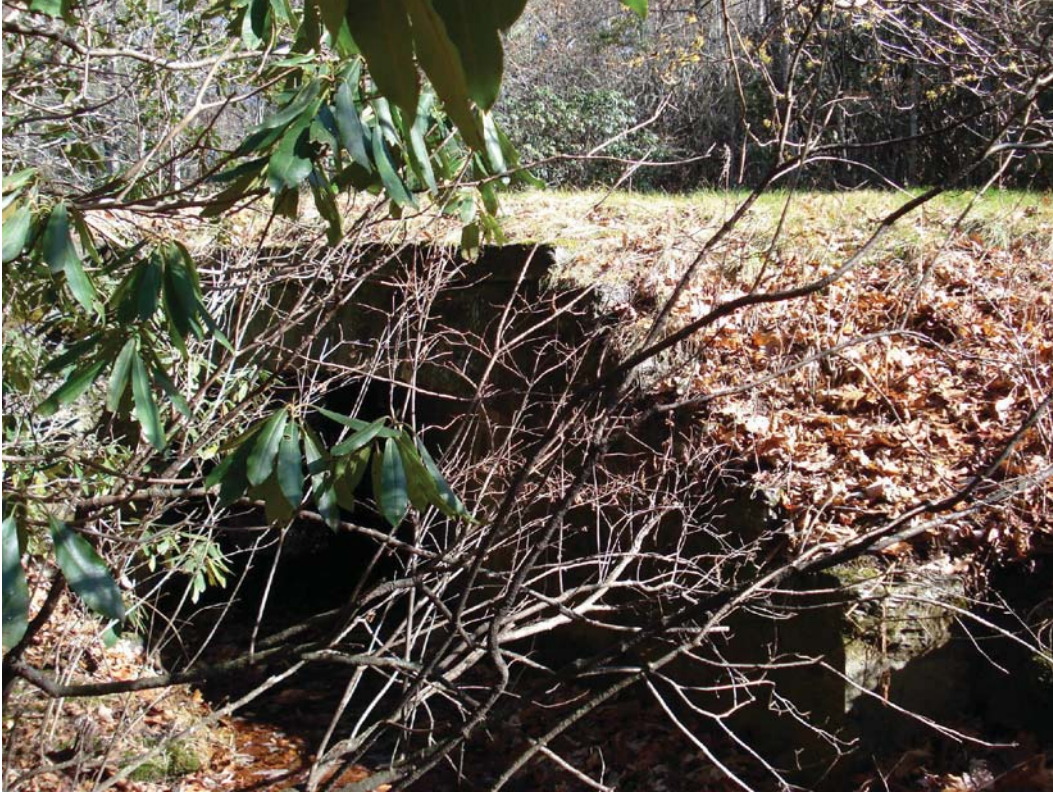
BLRI\_0001DA\_323.724\_R\_1.JPG

<b>Element (Weighting Factor)</b>	<b>Narrative</b>	<b>Condition Rating (0 - 10)</b>
PERFORMANCE 8.00	Good condition, no global distress	7
WALL FOUNDATION MATERIAL 8.00	Soil, no observed settlement or cracks	8
CONCRETE 8.00	Good condition, cast in place, some minor cracks, efflorescence	7
MORTAR 8.00	Some moss	7
STONE MASONRY 8.00	Sound and durable	7
ROAD/SIDEWALK/SHOULDER 0.50	Grass shoulder, no distress	8
UPSLOPE 0.50	Grass, gently sloping, no distress	8
WALL DRAINS 0.50	No observed drainage-associated problems	8
CULVERT 1.00	concrete box culvert, 9'W x 5'H	7

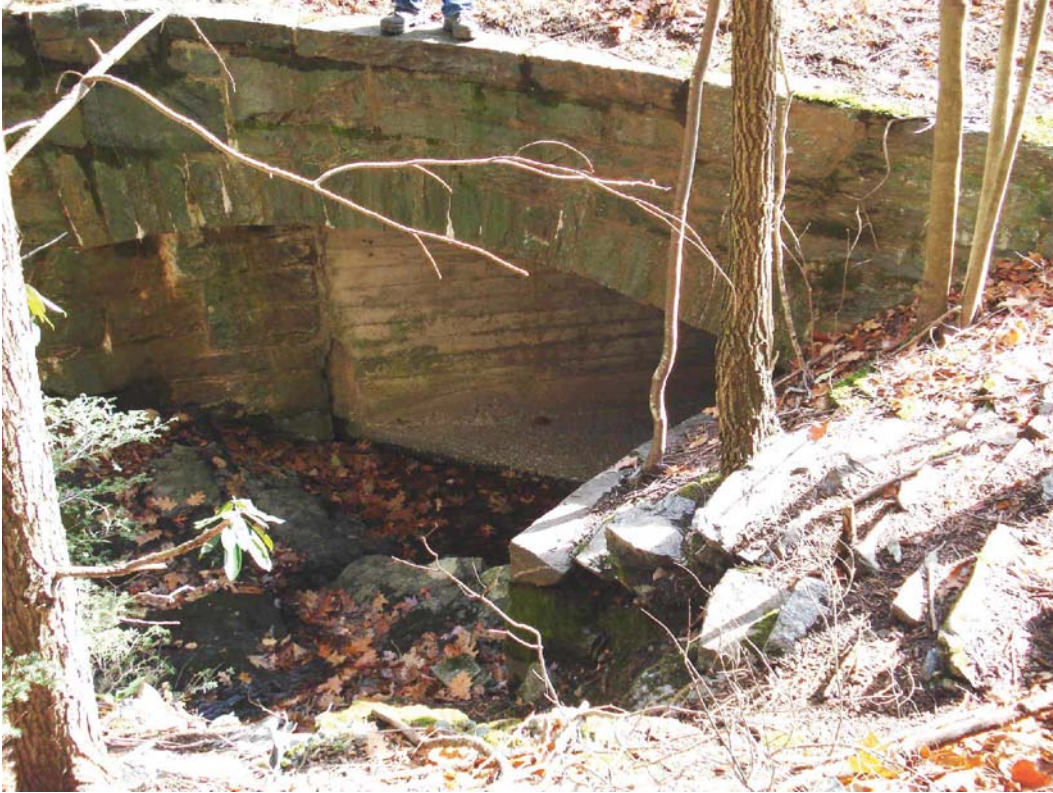
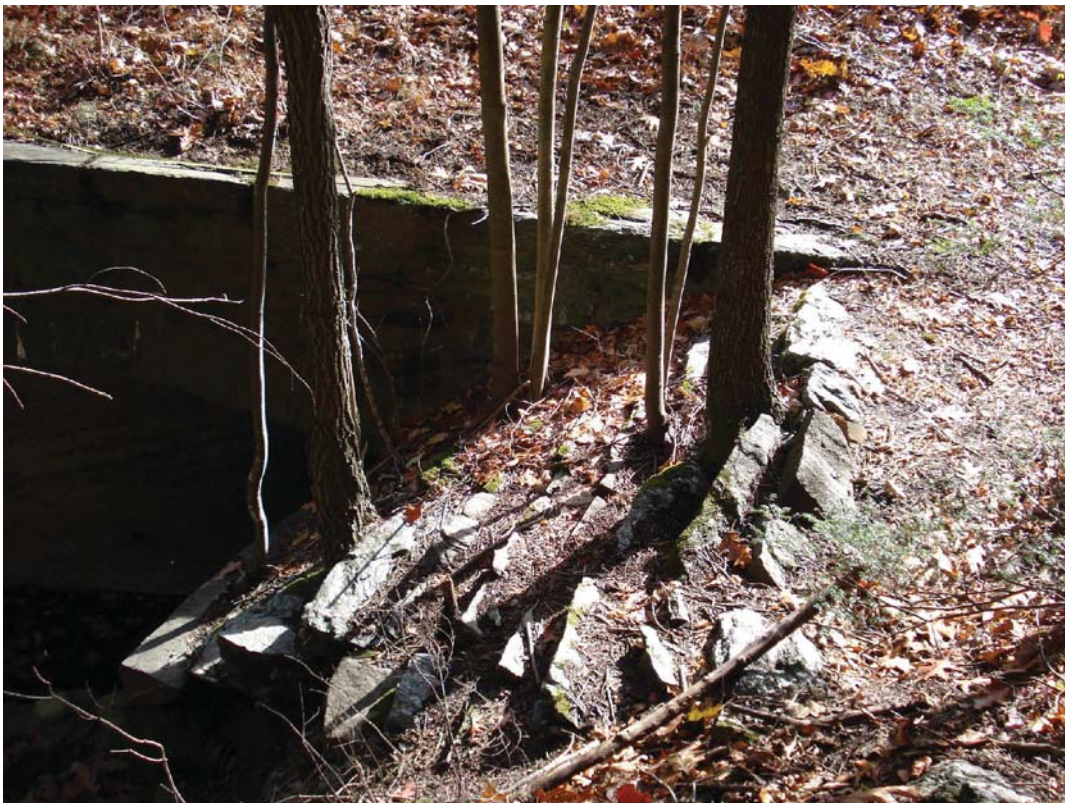
BLRI\_0001DA\_323.969\_R\_1.JPG

<b>Element (Weighting Factor)</b>	<b>Narrative</b>	<b>Condition Rating (0 - 10)</b>
PERFORMANCE 8.00	No global distress	7
WALL FOUNDATION MATERIAL 8.00	Soil, no evidence of settlement or cracks	8
MORTAR 8.00	Some moss and efflorescence	7
STONE MASONRY 8.00	Sound and durable	7
ROAD/SIDEWALK/SHOULDER 0.50	Grass, no distress	8
WALL DRAINS 0.50	No drainage-related problems	8
CULVERT 1.00	Concrete box, skew, 14'H x 3.5'W	7
DOWNSLOPE 1.00	Heavily wooded, steep slopes, no distress	7
LATERAL SLOPE 1.00	Heavily wooded, steep slopes, no distress	7

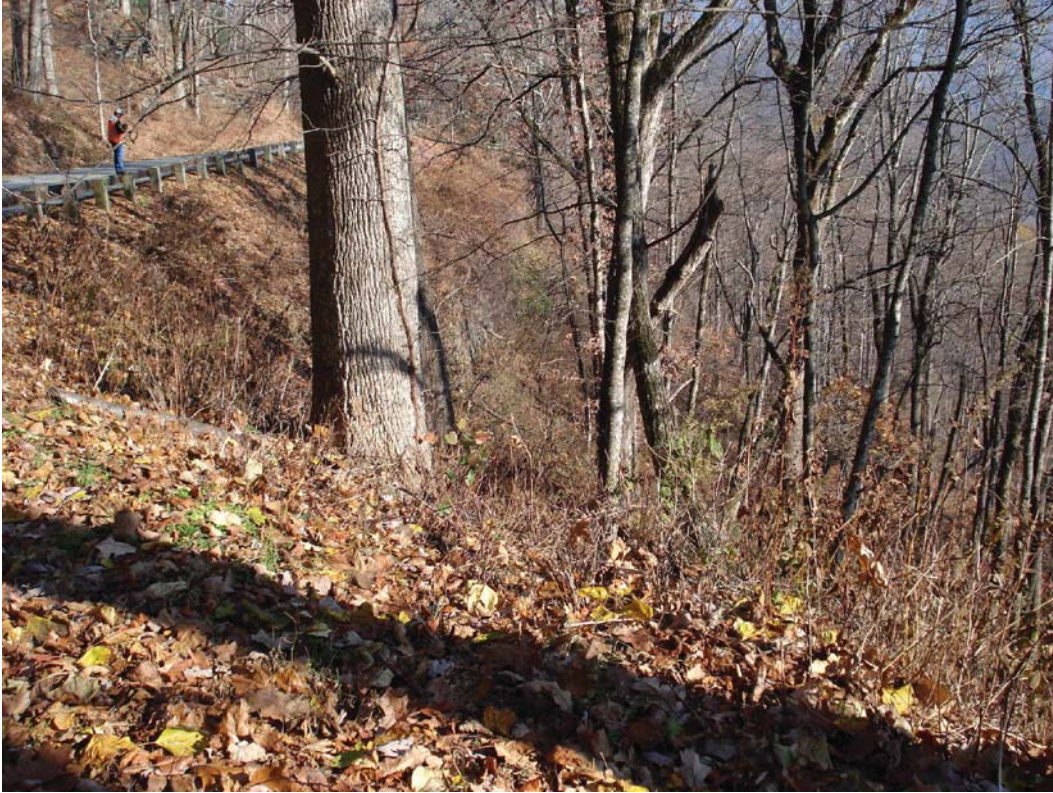
BLRI\_0001DA\_326.701\_L\_1.JPG

<b>Element (Weighting Factor)</b>	<b>Narrative</b>	<b>Condition Rating (0 - 10)</b>
PERFORMANCE 8.00	Fair condition, no global distress	6
WALL FOUNDATION MATERIAL 8.00	Soil/rock, no observed settlement or cracks	7
MORTAR 8.00	Fair condition, some deterioration	6
STONE MASONRY 8.00	Fair condition, some moss, some efflorescence	6
ROAD/SIDEWALK/SHOULDER 0.50	Grass, relatively flat	8
DOWNSLOPE 1.00	Steep slope, heavily wooded, no distress	6
LATERAL SLOPE 1.00	Steep slope, heavily wooded, no distress	6
VEGETATION 1.00	vegetation in front of wall	6
WALL DRAINS 1.00	No drainage-related problems	7

<b>Failure Consequence:</b>	HIGH
<b>Recommendation Narrative:</b>	Clear vegetation in front of wall. Labor - 10 hrs x \$55/hr = \$550
<b>Repair Cost:</b>	\$550

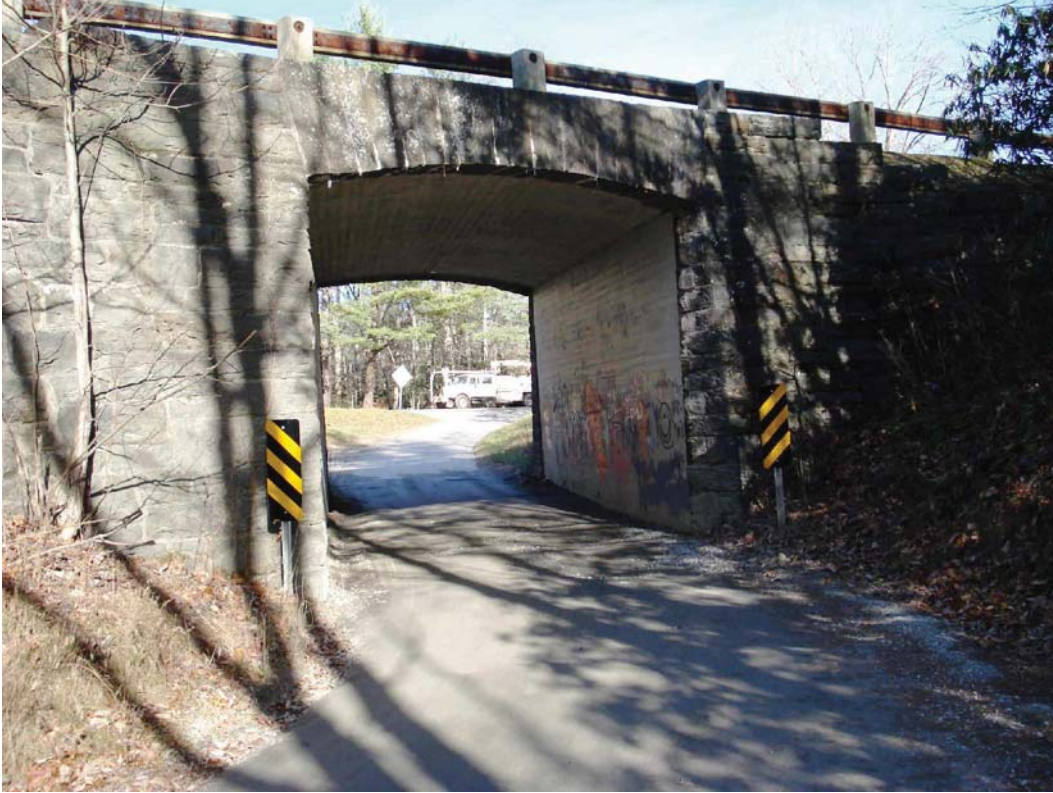
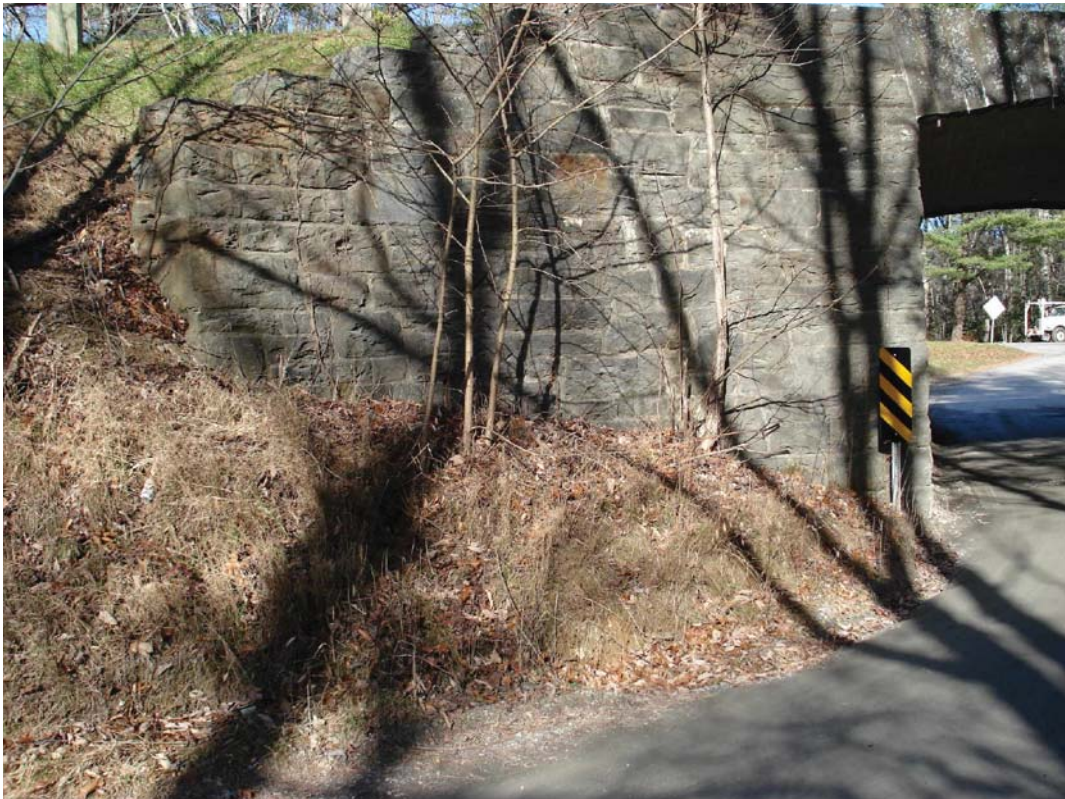
BLRI\_0001DA\_328.491\_L\_1.JPG

<b>Element (Weighting Factor)</b>	<b>Narrative</b>	<b>Condition Rating (0 - 10)</b>
PERFORMANCE 8.00	No global distress	8
WALL FOUNDATION MATERIAL 8.00	Soil, no observed settlement or cracks	8
MORTAR 8.00	Sound and durable	7
STONE MASONRY 8.00	Sound and durable	8
CULVERT 0.50	17' x 17' box culvert, in good condition	8
DOWNSLOPE 0.50	1 lane road in good condition	8
LATERAL SLOPE 0.50	Grass, no distress	8
ROAD/SIDEWALK/SHOULDER 0.50	Grass shoulder, no distress	8
WALL DRAINS 0.50	Weep holes, No problems associated with drainage	8

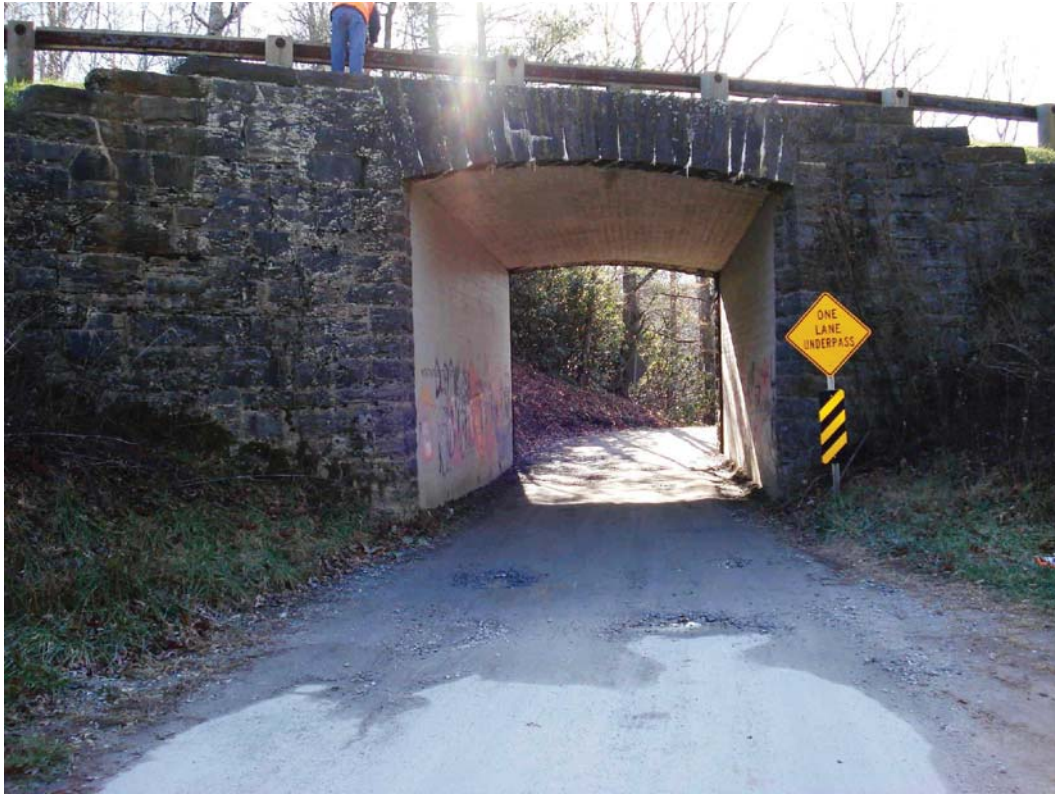
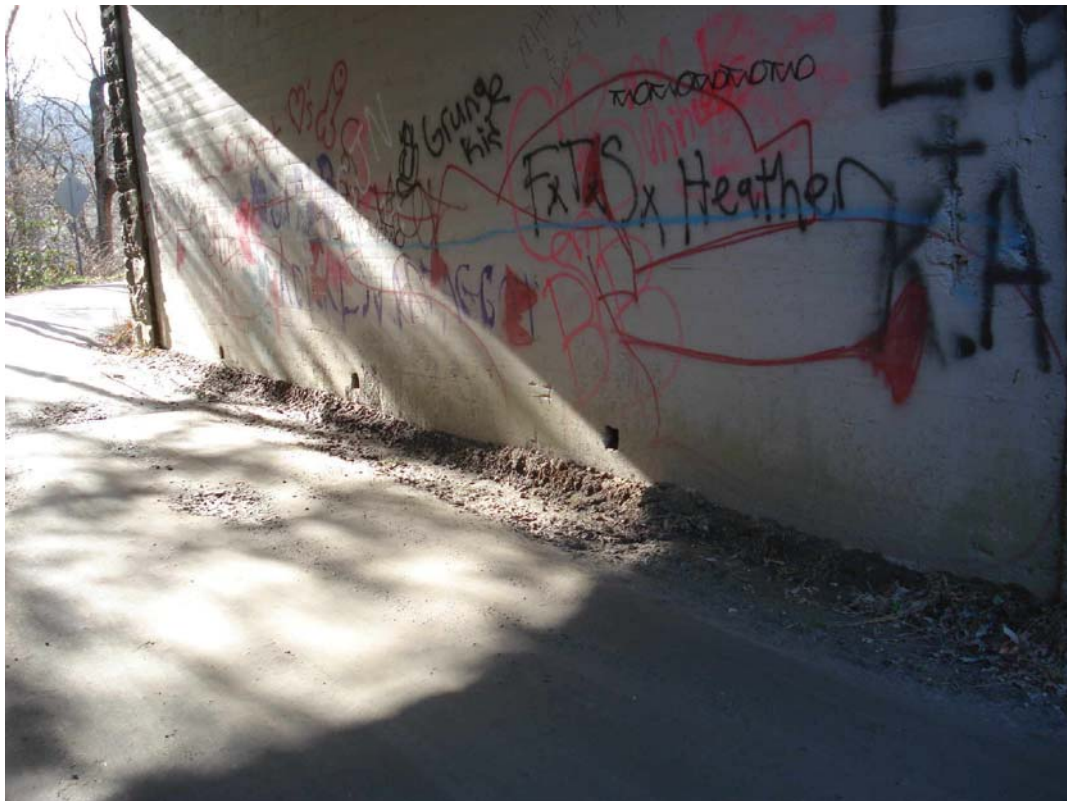
BLRI\_0001DA\_328.491\_R\_1.JPG

<b>Element (Weighting Factor)</b>	<b>Narrative</b>	<b>Condition Rating (0 - 10)</b>
PERFORMANCE 8.00	Good condition, no global distress	8
WALL FOUNDATION MATERIAL 8.00	Soil, no observed settlement or cracks	8
MORTAR 8.00	Good condition, sound and durable	8
STONE MASONRY 8.00	Sound and durable	8
DOWNSLOPE 0.50	1 lane road in good condition	8
LATERAL SLOPE 0.50	Grass, no distress, not affecting wall performance	8
ROAD/SIDEWALK/SHOULDER 0.50	Grass shoulder, no distress	8
UPSLOPE 0.50	Grass, gently sloping, no distress	8
VEGETATION 0.50	Grass, no distress, not affecting wall performance	8

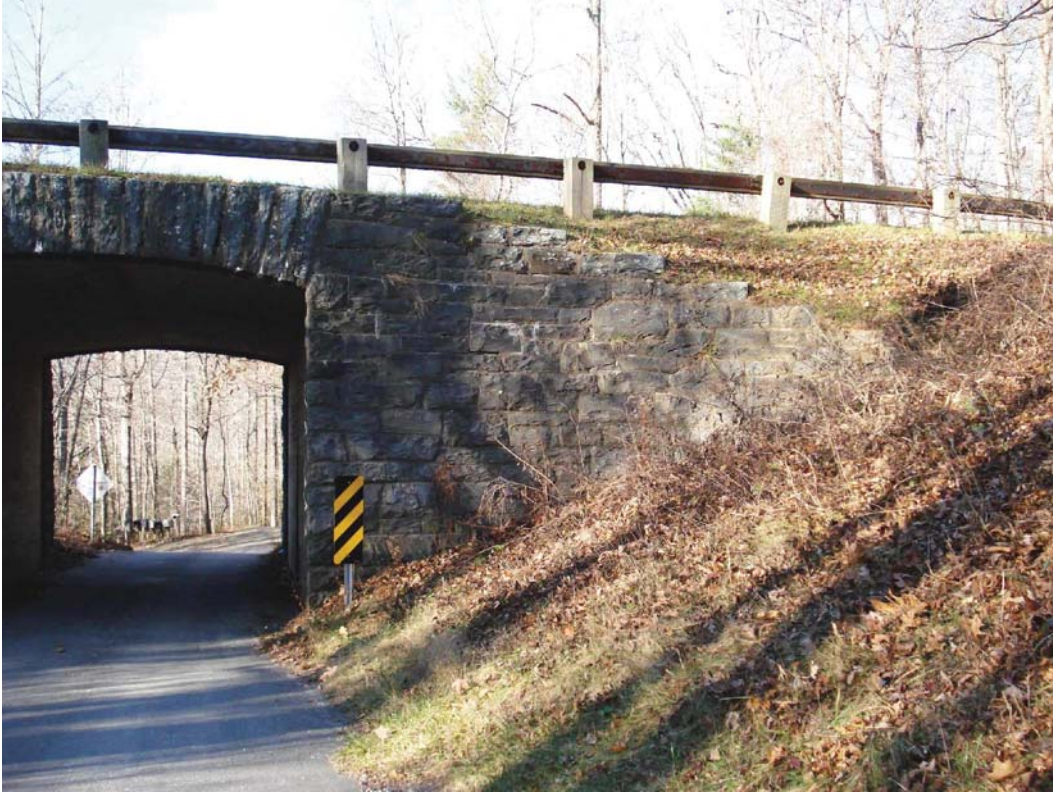
BLRI\_0001DA\_333.625\_L\_1.JPG

<b>Element (Weighting Factor)</b>	<b>Narrative</b>	<b>Condition Rating (0 - 10)</b>
PERFORMANCE 8.00	No global distress	8
WALL FOUNDATION MATERIAL 8.00	Soil, no observed settlement or cracks	8
MORTAR 8.00	Sound and durable	8
STONE MASONRY 8.00	Sound and durable	8
DOWNSLOPE 0.50	1 lane road in good condition	8
LATERAL SLOPE 0.50	Grass, no distress	8
ROAD/SIDEWALK/SHOULDER 0.50	Grass shoulder, no distress	8
WALL DRAINS 0.50	Weep holes, No problems associated with drainage	8
CULVERT 1.00	16' x 17' box culvert, in good condition	7

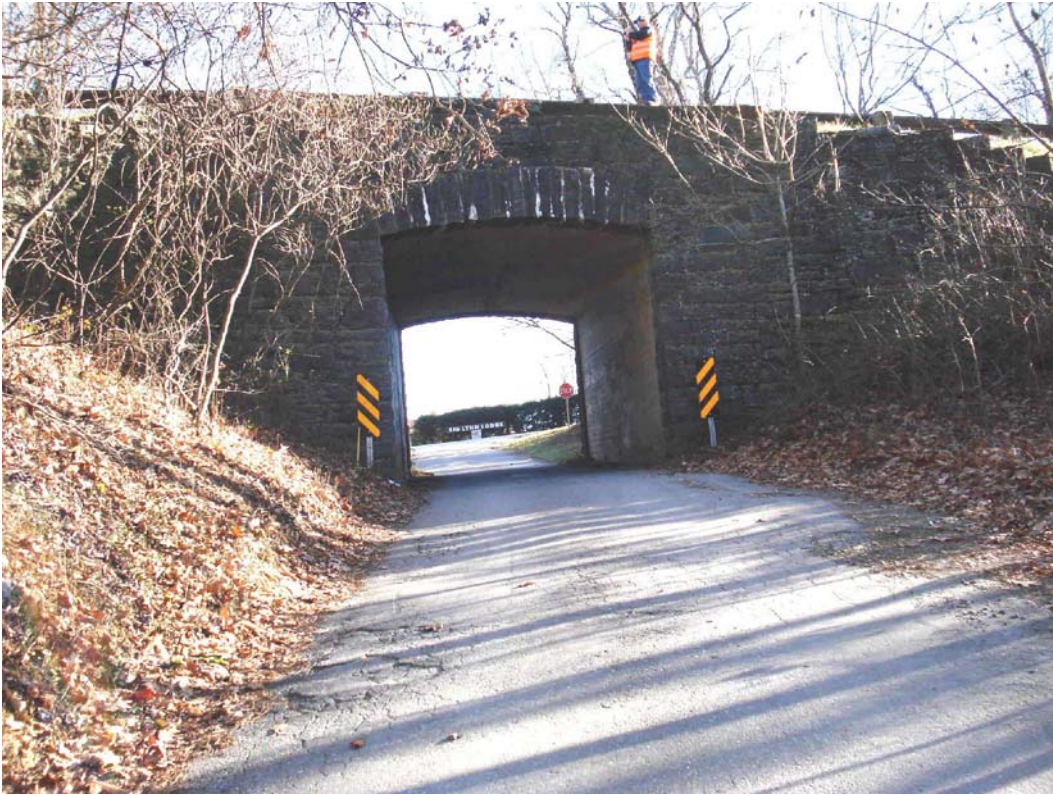
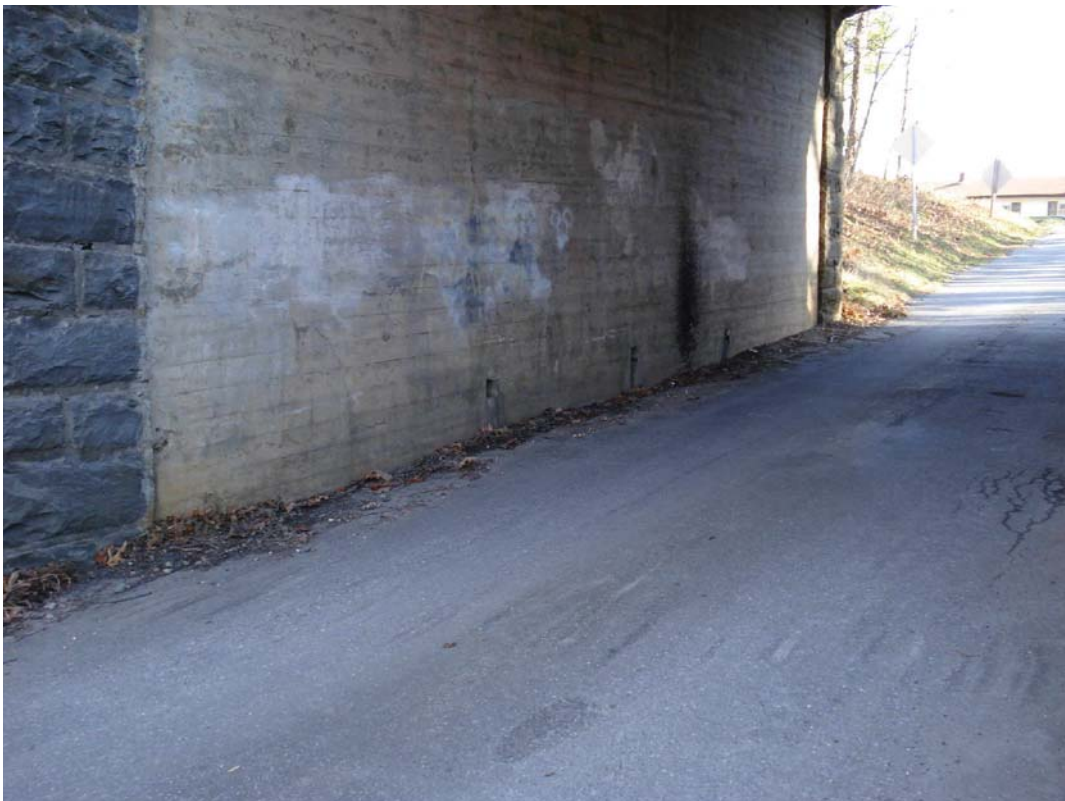
BLRI\_0001DA\_333.625\_R\_1.JPG

<b>Element (Weighting Factor)</b>	<b>Narrative</b>	<b>Condition Rating (0 - 10)</b>
PERFORMANCE 8.00	No global distress	8
WALL FOUNDATION MATERIAL 8.00	Soil, no observed settlement or cracks	8
MORTAR 8.00	Sound and durable	8
STONE MASONRY 8.00	Sound and durable	8
DOWNSLOPE 0.50	1 lane road in good condition	8
LATERAL SLOPE 0.50	Grass, no distress	8
ROAD/SIDEWALK/SHOULDER 0.50	Grass shoulder, no distress	8
WALL DRAINS 0.50	Weep holes, No problems associated with drainage	8
CULVERT 1.00	17' x 17' box culvert, in good condition	7
