# BLRI WIP Report

## NPS Retaining Wall Inventory Program Blue Ridge Parkway

Federal Highway Administration  
Eastern Federal Lands Highway Division  
Road Inventory Program (RIP)

# Blue Ridge Parkway in North Carolina and Virginia

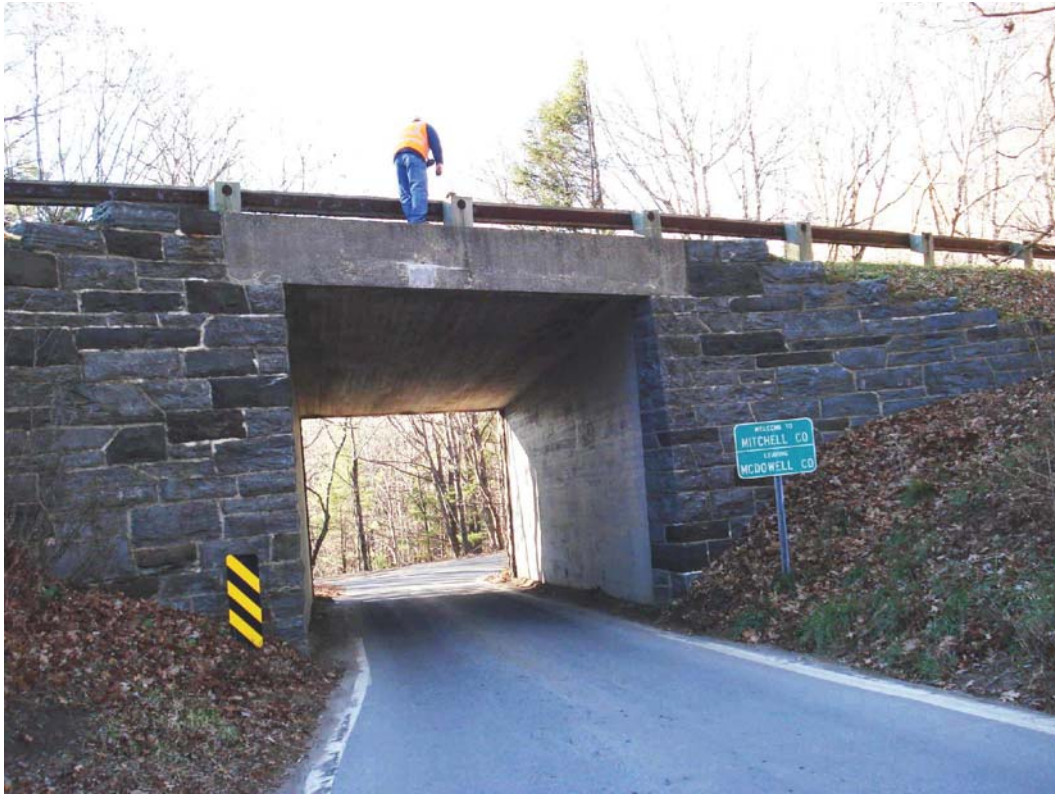
BLRI\_0001DA\_336.475\_L\_1.JPG

<b>Element (Weighting Factor)</b>	<b>Narrative</b>	<b>Condition Rating (0 - 10)</b>
PERFORMANCE 8.00	No global distress	7
WALL FOUNDATION MATERIAL 8.00	Soil, no observed settlement or cracks	8
MORTAR 8.00	Sound and durable	8
STONE MASONRY 8.00	Sound and durable	8
DOWNSLOPE 0.50	1 lane road in good condition	8
LATERAL SLOPE 0.50	Grass, no distress	8
ROAD/SIDEWALK/SHOULDER 0.50	Grass shoulder, no distress	8
CULVERT 1.00	16' x 18.5' box culvert, in good condition	6
WALL DRAINS 1.00	Weep holes, partially filled with soil	6

<b>Failure Consequence:</b>	HIGH
<b>Recommendation Narrative:</b>	Clean weep holes - 10 hrs labor x \$55/hr = \$550. Patch Spalls - 10 sf x \$15/sf = \$150. Labor - 20 hrs x \$55/hr = \$1,100
<b>Repair Cost:</b>	\$1,800

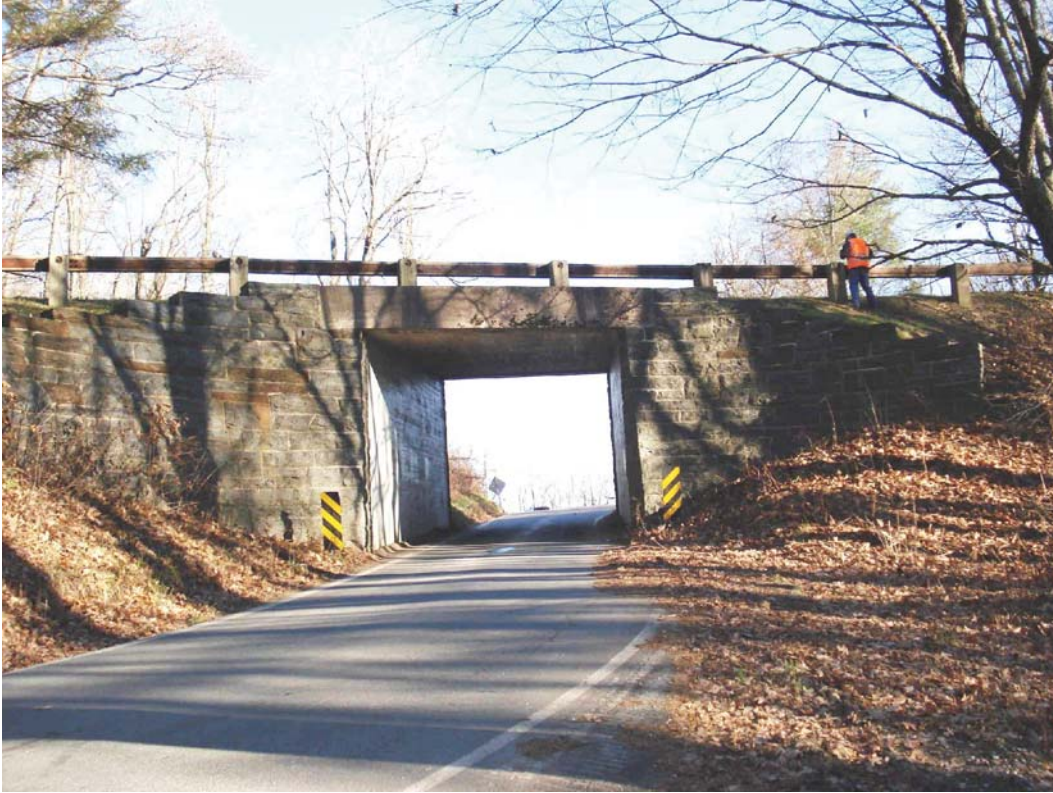
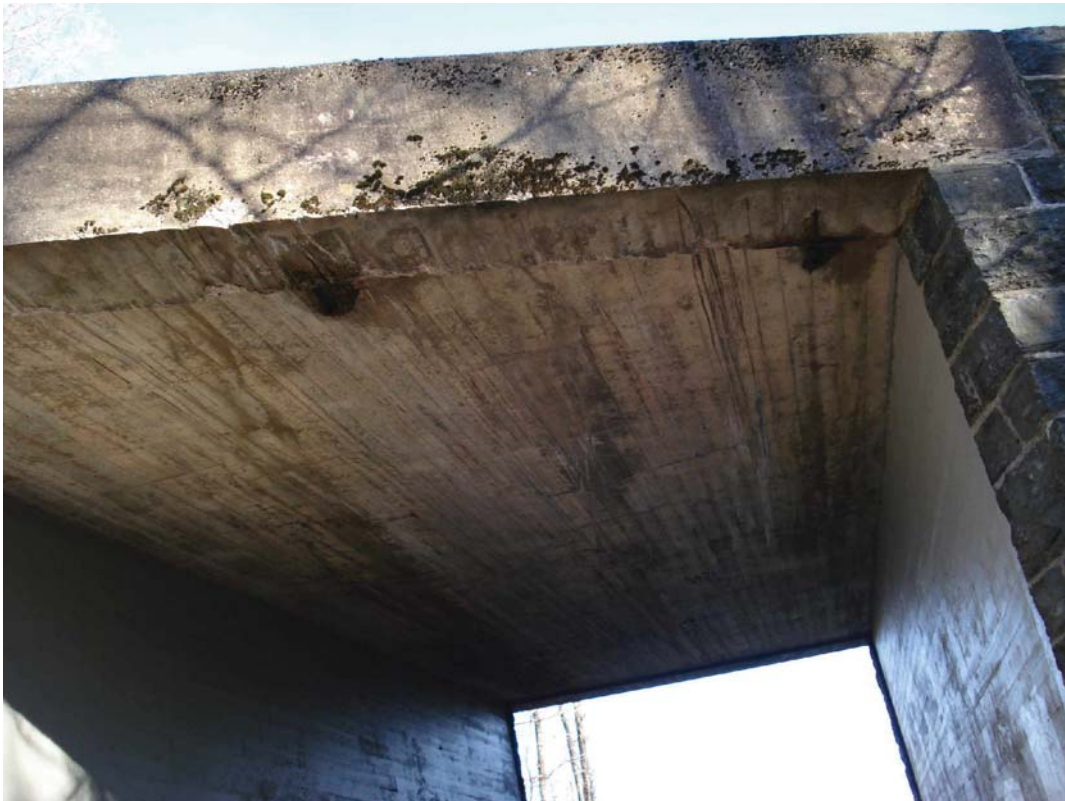
BLRI\_0001DA\_336.475\_R\_1.JPG

<b>Element (Weighting Factor)</b>	<b>Narrative</b>	<b>Condition Rating (0 - 10)</b>
PERFORMANCE 8.00	No global distress	7
WALL FOUNDATION MATERIAL 8.00	Soil, no observed settlement or cracks	8
MORTAR 8.00	Sound and durable	8
STONE MASONRY 8.00	Sound and durable	8
DOWNSLOPE 0.50	1 lane road in good condition	8
LATERAL SLOPE 0.50	Grass, no distress	8
ROAD/SIDEWALK/SHOULDER 0.50	Grass shoulder, no distress	8
WALL DRAINS 1.00	Weep holes, partially soil filled	6
CULVERT 1.00	18.5' x 16' box culvert, in good condition	7

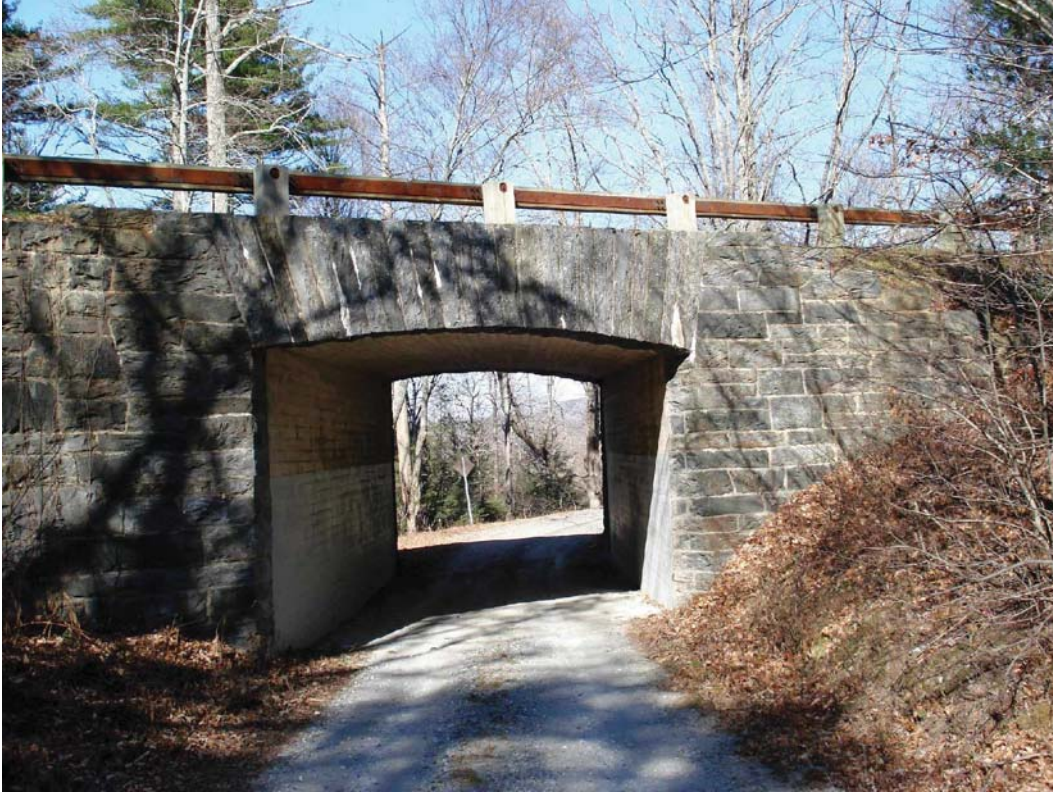
BLRI\_0001DA\_337.345\_L\_1.JPG

<b>Element (Weighting Factor)</b>	<b>Narrative</b>	<b>Condition Rating (0 - 10)</b>
PERFORMANCE 8.00	No global distress	8
WALL FOUNDATION MATERIAL 8.00	Soil, no observed settlement or cracks	8
MORTAR 8.00	Minor efflorescence	8
STONE MASONRY 8.00	Minor moss and efflorescence	8
CULVERT 0.50	19'W x 17'H culvert/overpass	8
ROAD/SIDEWALK/SHOULDER 0.50	Grass, flat, no distress	8
VEGETATION 0.50	Minor vegetation	8
WALL DRAINS 0.50	No drainage-related problems	8
DOWNSLOPE 1.00	Gravel road	7

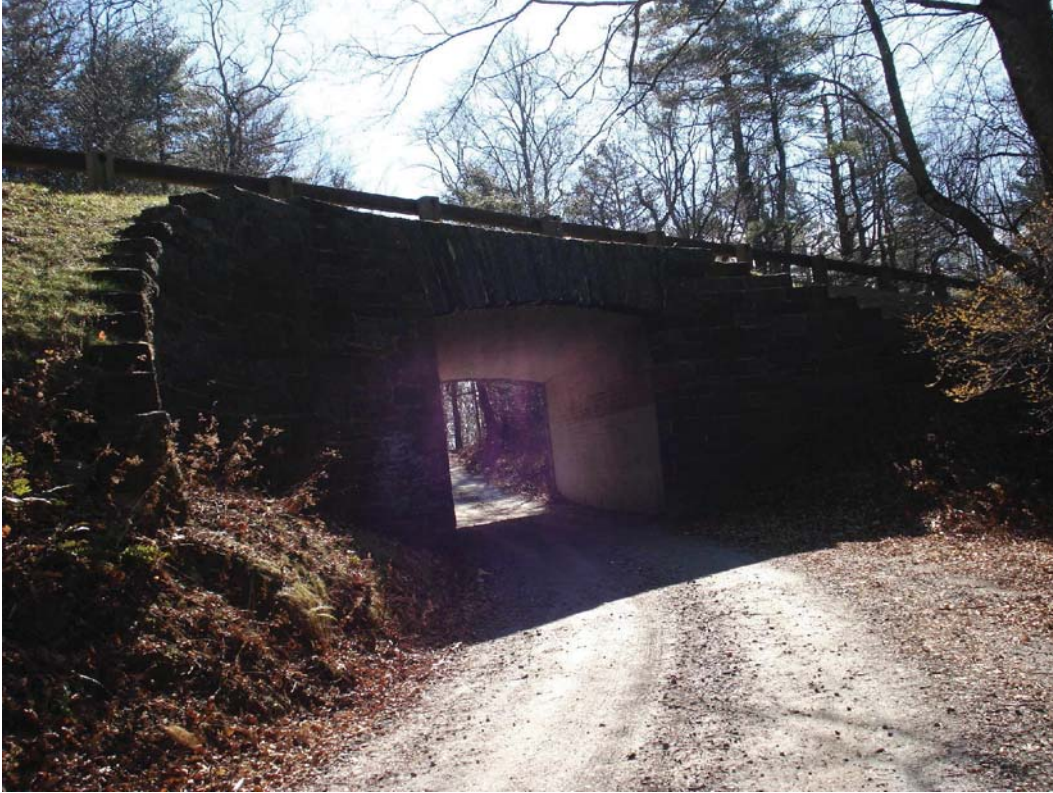
BLRI\_0001DA\_337.345\_R\_1.JPG

<b>Element (Weighting Factor)</b>	<b>Narrative</b>	<b>Condition Rating (0 - 10)</b>
PERFORMANCE 8.00	No global distress	8
WALL FOUNDATION MATERIAL 8.00	Soil, no observed settlement or cracks	8
MORTAR 8.00	Good condition, minor efflorescence`	8
STONE MASONRY 8.00	Minor moss and efflorescence	8
CULVERT 0.50	19'W x 17'H culvert/overpass	8
ROAD/SIDEWALK/SHOULDER 0.50	Grass, flat, no distress	8
VEGETATION 0.50	Minor vegetation on wall	8
WALL DRAINS 0.50	No drainage-related problems	8
DOWNSLOPE 1.00	Gravel road	7

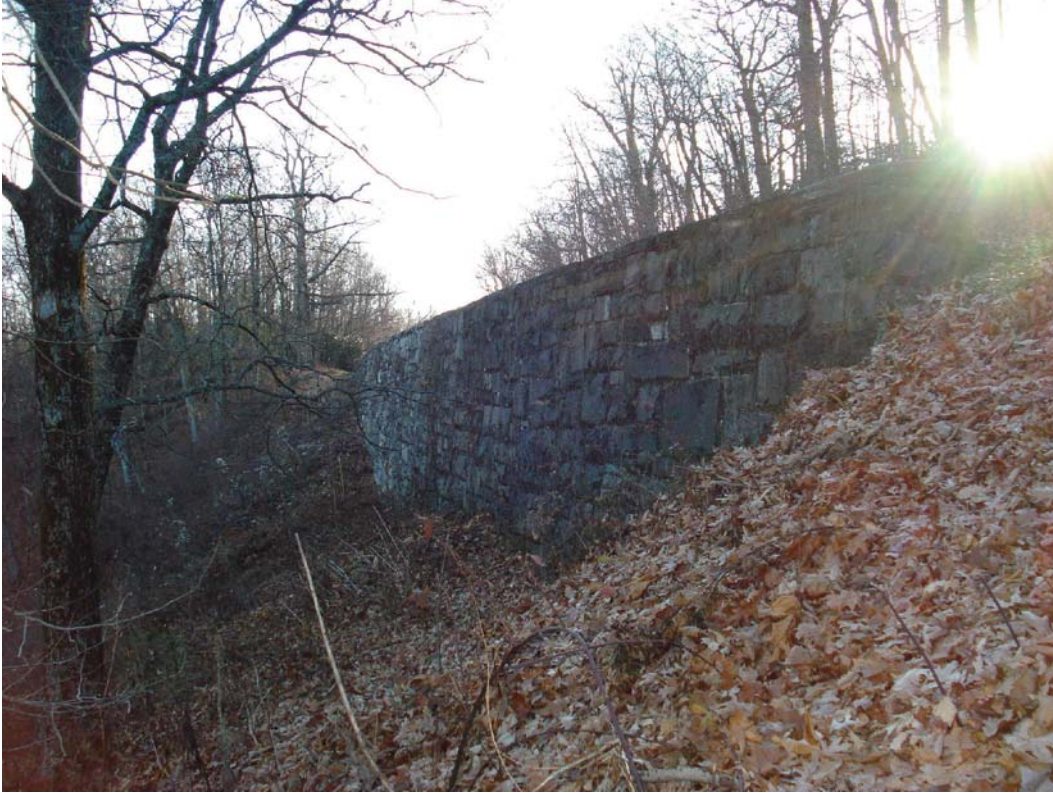
BLRI\_0001DA\_341.116\_L\_1.JPG

<b>Element (Weighting Factor)</b>	<b>Narrative</b>	<b>Condition Rating (0 - 10)</b>
PERFORMANCE 8.00	No global distress	7
WALL FOUNDATION MATERIAL 8.00	Soil/rock, no observed settlement or cracks	7
MORTAR 8.00	Fair condition, some moss and efflorescence	6
STONE MASONRY 8.00	Good condition, some moss and efflorescence	7
ROAD/SIDEWALK/SHOULDER 0.50	Grass, flat, no distress	8
WALL DRAINS 0.50	No drainage-related problems	8
DOWNSLOPE 1.00	Steep slope, heavily wooded, no distress	6
LATERAL SLOPE 1.00	Steep slope, heavily wooded, no distress	6
VEGETATION 1.00	Vegetation in front of wall, no distress	6

<b>Failure Consequence:</b>	HIGH
<b>Recommendation Narrative:</b>	Clear vegetation in front of wall - 10 hrs x \$55/hr = \$550
<b>Repair Cost:</b>	\$550

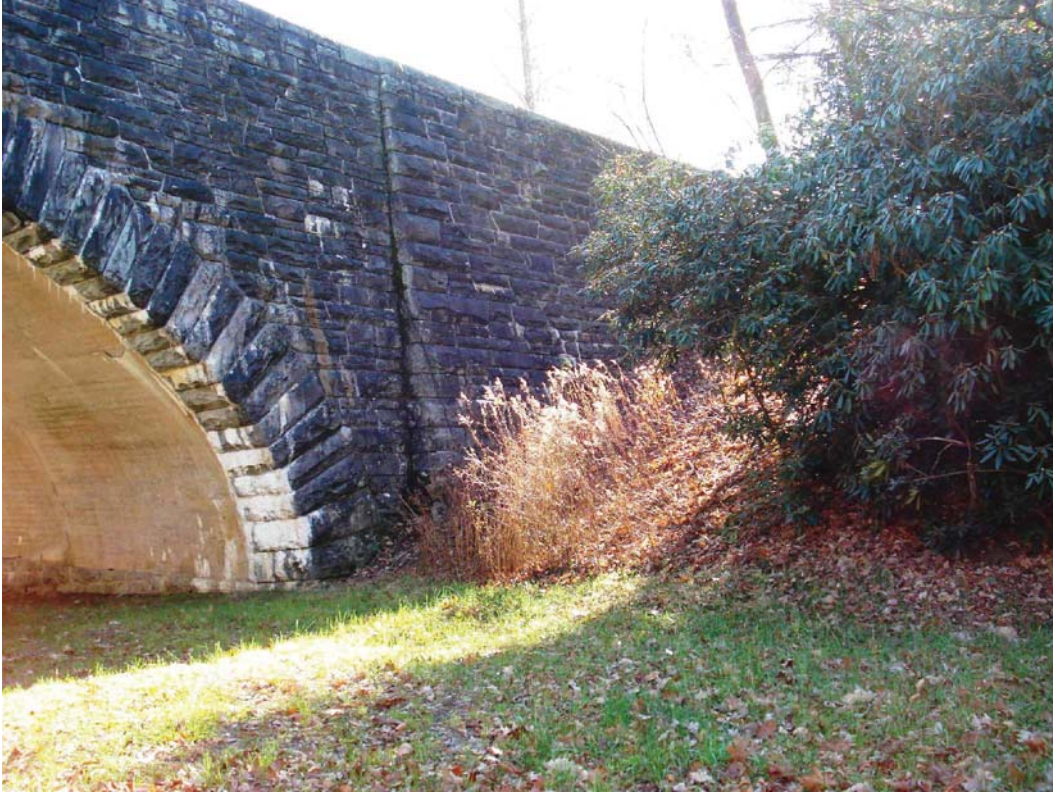
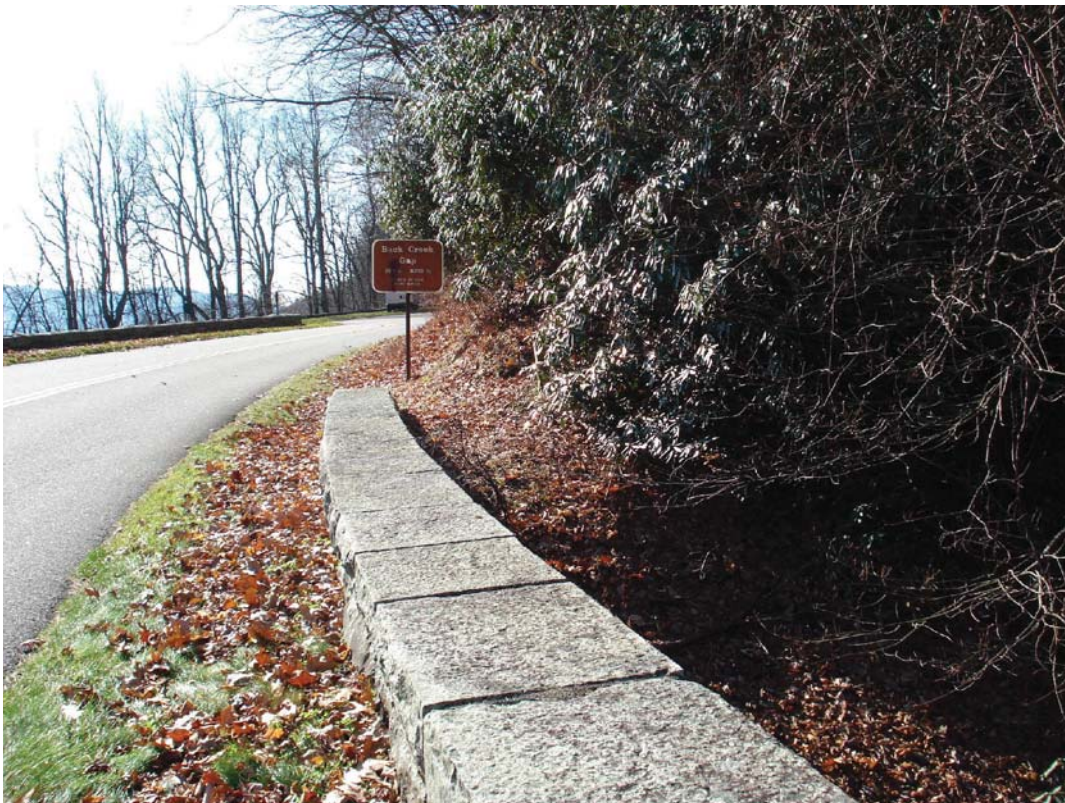
BLRI\_0001DA\_344.951\_R\_1.JPG

<b>Element (Weighting Factor)</b>	<b>Narrative</b>	<b>Condition Rating (0 - 10)</b>
PERFORMANCE 8.00	No global distress	7
WALL FOUNDATION MATERIAL 8.00	Soil, no observed settlement or cracks	8
MORTAR 8.00	Minor moss, efflorescence. Minor mortar loss	7
STONE MASONRY 8.00	Minor moss and efflorescence	7
ROAD/SIDEWALK/SHOULDER 0.50	Grass, flat, no distress	8
WALL DRAINS 0.50	No drainage-related problems	8
DOWNSLOPE 1.00	Gentle slope, grass with some scattered trees, no distress	7
LATERAL SLOPE 1.00	Gentle slope, some scattered trees, no distress	7

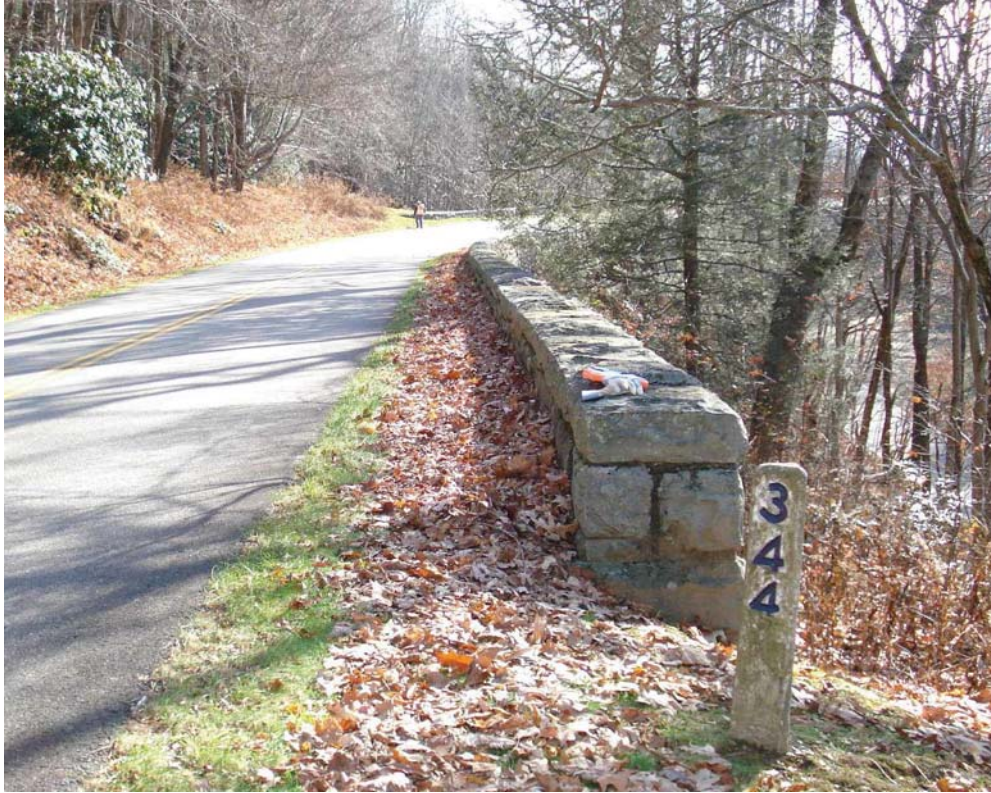
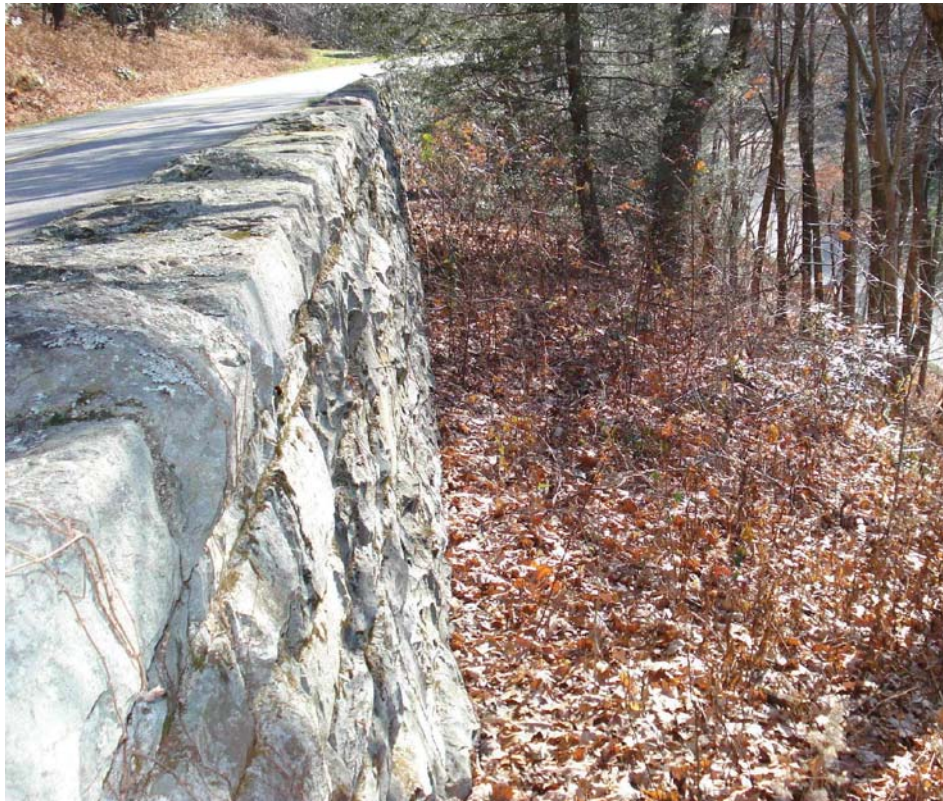
BLRI\_0001DA\_344.996\_R\_1.JPG

<b>Element (Weighting Factor)</b>	<b>Narrative</b>	<b>Condition Rating (0 - 10)</b>
PERFORMANCE 8.00	No global distress	7
WALL FOUNDATION MATERIAL 8.00	Soil, no observed settlement or cracks	8
MORTAR 8.00	Minor moss	7
STONE MASONRY 8.00	Minor moss and efflorescence	7
ROAD/SIDEWALK/SHOULDER 0.50	Grass, no distress	8
WALL DRAINS 0.50	No drainage-related problems	8
DOWNSLOPE 1.00	Steep slope covered with brush and some trees, no distress	7
LATERAL SLOPE 1.00	Steep slope covered with brush and some trees, no distress	7
VEGETATION 1.00	Brush and some trees, no distress	7

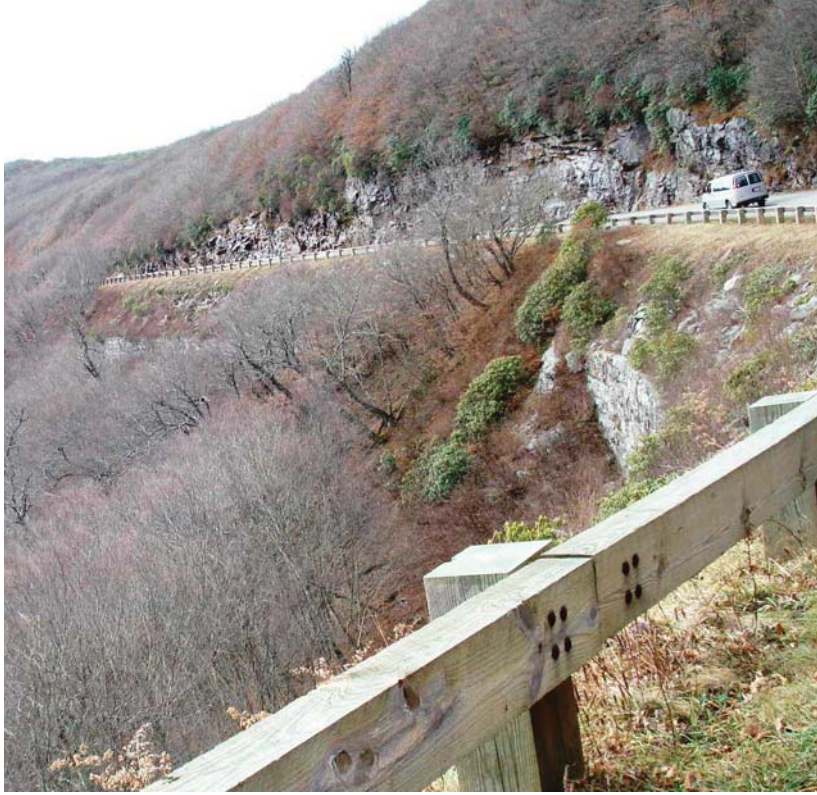
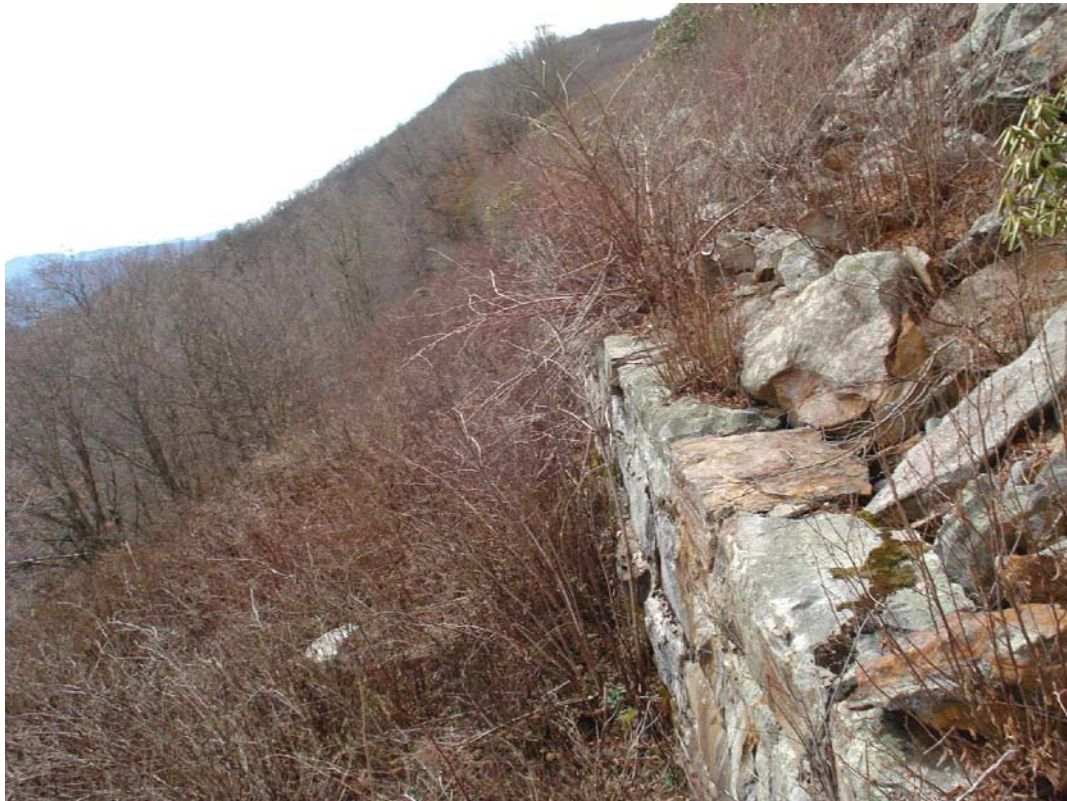
BLRI\_0001DB\_366.124\_L\_1.JPG

<b>Wall ID:</b>	BLRI-0001DB-366.124-L		
<b>Route Name:</b>	BLUE RIDGE PARKWAY - OTEEN SUB-DISTRICT		
<b>Inspection Date:</b>	December 01, 2007	<b>Approximate Year Built:</b>	Unknown
<b>*Wall Rating:</b>	62	<b>Maintenance Action:</b>	No Action

<b>Element (Weighting Factor)</b>	<b>Narrative</b>	<b>Condition Rating (0 - 10)</b>
PERFORMANCE 8.00	No global distress	6
WALL FOUNDATION MATERIAL 8.00	Soil/rock, no settlement or cracks	7
MORTAR 8.00	Some moss and missing sections	6
STONE MASONRY 8.00	Some deterioration and missing sections	6
DOWNSLOPE 1.00	Very steep, heavily wooded, no distress	5
LATERAL SLOPE 1.00	Very steep, heavily wooded, no distress	5
UPSLOPE 1.00	Very steep, heavily wooded, no distress	5
ROAD/SIDEWALK/SHOULDER 1.00	Some cracks in the pavement	7
VEGETATION 1.00	Vegetation growing in front of wall, not affecting wall performance	7

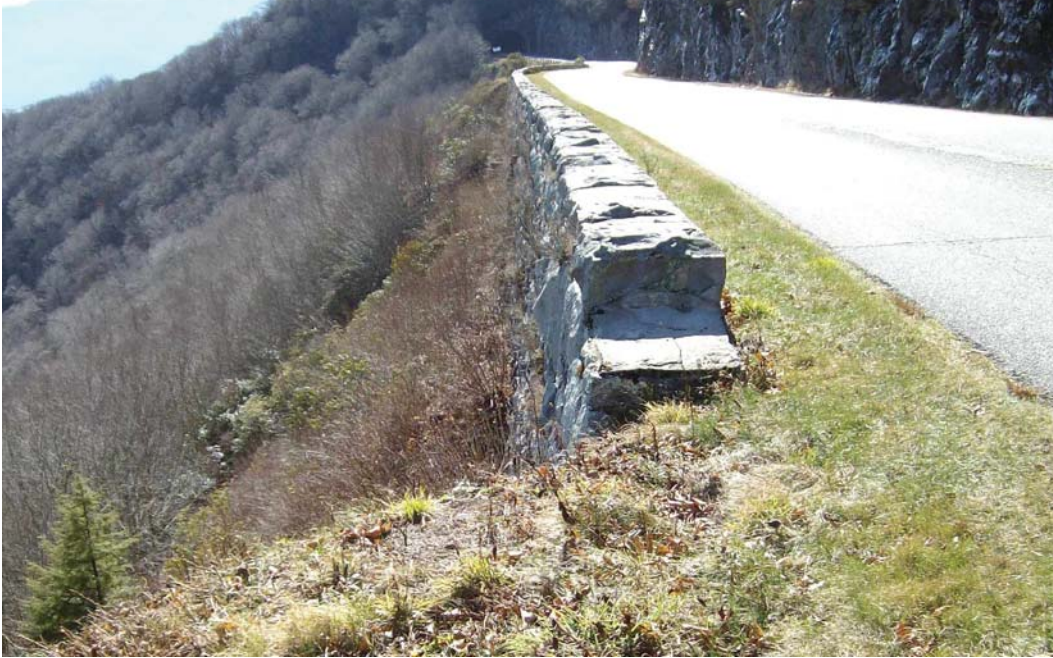
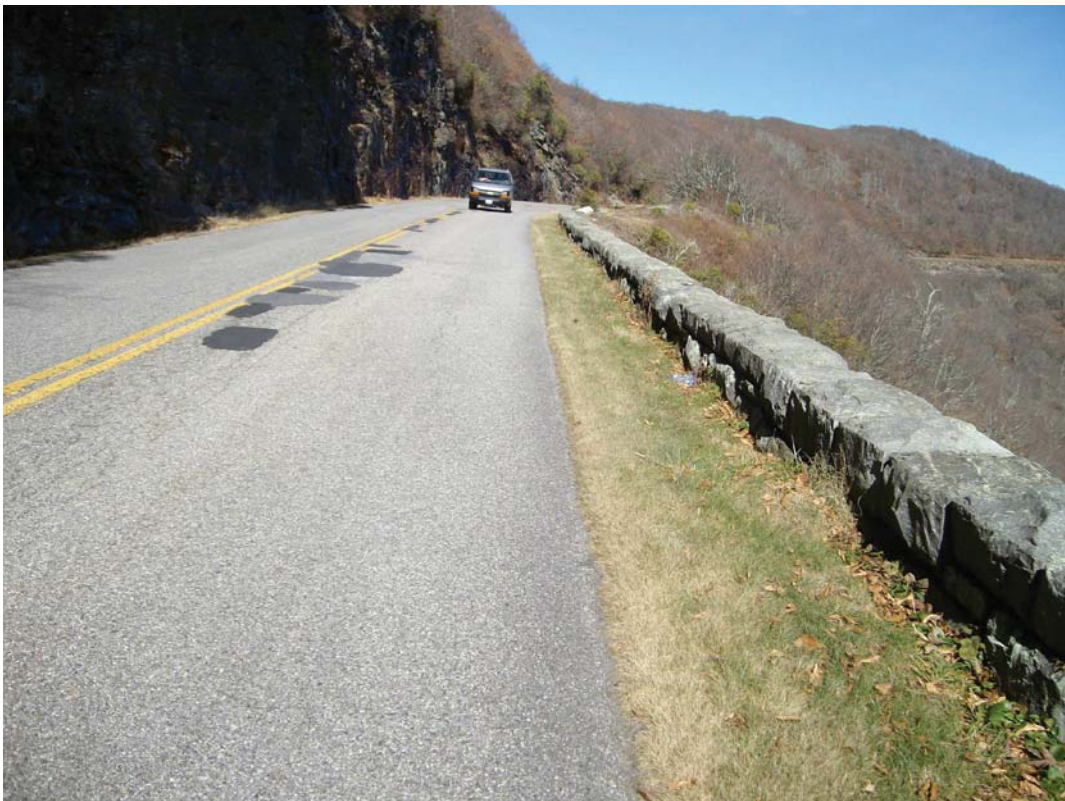
BLRI\_0001DB\_366.362\_L\_1.JPG

<b>Wall ID:</b>	BLRI-0001DB-366.362-L		
<b>Route Name:</b>	BLUE RIDGE PARKWAY - OTEEN SUB-DISTRICT		
<b>Inspection Date:</b>	December 01, 2007	<b>Approximate Year Built:</b>	Unknown
<b>*Wall Rating:</b>	62	<b>Maintenance Action:</b>	No Action

<b>Element (Weighting Factor)</b>	<b>Narrative</b>	<b>Condition Rating (0 - 10)</b>
PERFORMANCE 8.00	No global distress	6
WALL FOUNDATION MATERIAL 8.00	Soil/rock, no settlement or cracks	7
MORTAR 8.00	Minor missing sections	6
STONE MASONRY 8.00	Some deterioration, 1 missing block	6
DOWNSLOPE 1.00	Very steep, heavily wooded, no distress	5
LATERAL SLOPE 1.00	Very steep, heavily wooded, no distress	5
ROAD/SIDEWALK/SHOULDER 1.00	Some pavement patch	7
VEGETATION 1.00	Minor vegetation on wall face, some brush in front of wall, not affecting wall performance	7
WALL DRAINS 1.00	No drainage-related problems	7

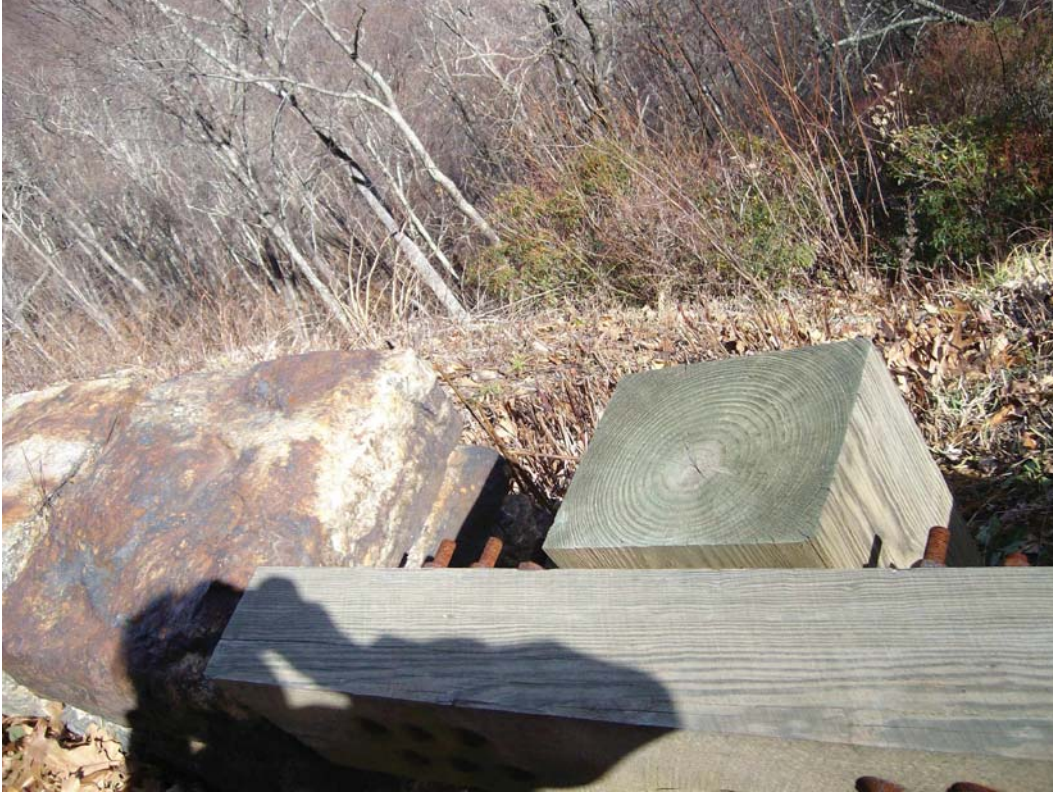
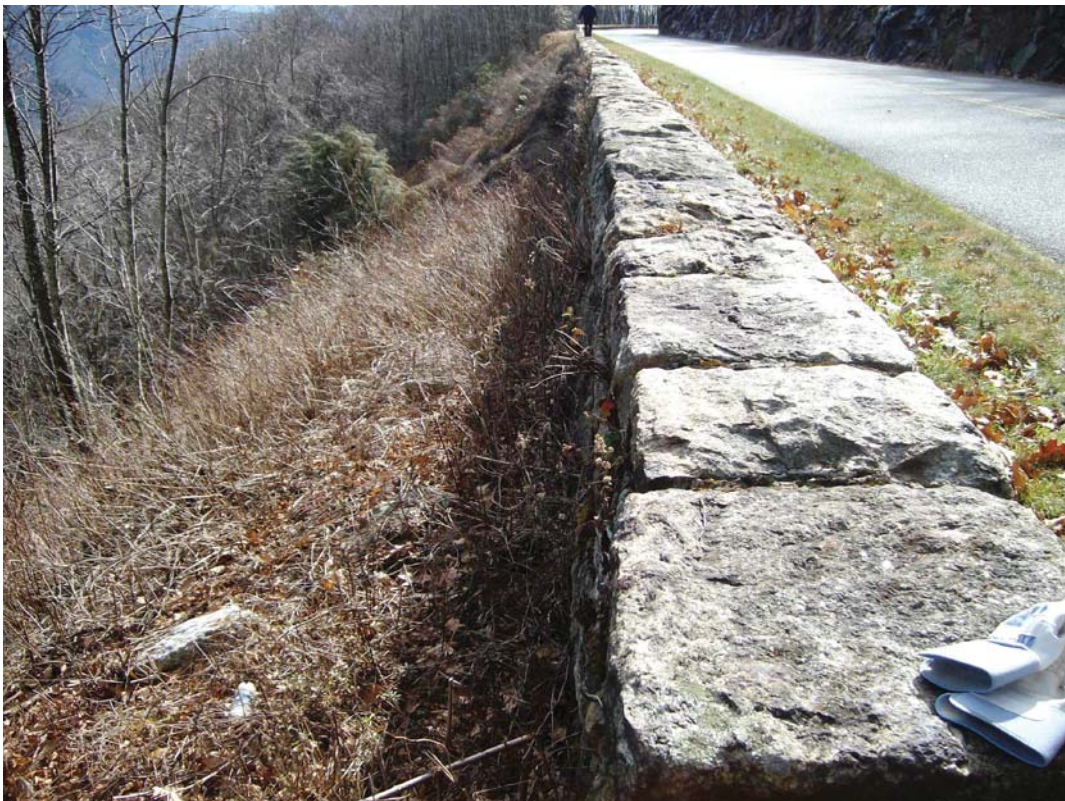
BLRI\_0001DB\_369.544\_L\_1.JPG

<b>Wall ID:</b>	BLRI-0001DB-369.544-L		
<b>Route Name:</b>	BLUE RIDGE PARKWAY - OTEEN SUB-DISTRICT		
<b>Inspection Date:</b>	December 01, 2007	<b>Approximate Year Built:</b>	Unknown
<b>*Wall Rating:</b>	65	<b>Maintenance Action:</b>	No Action

<b>Element (Weighting Factor)</b>	<b>Narrative</b>	<b>Condition Rating (0 - 10)</b>
PERFORMANCE 8.00	No global distress	7
WALL FOUNDATION MATERIAL 8.00	Soil/rock, no settlement or cracks	7
MORTAR 8.00	Some missing sections	6
STONE MASONRY 8.00	Some moss and deterioration	6
DOWNSLOPE 1.00	Very steep, heavily wooded, no distress	6
LATERAL SLOPE 1.00	Very steep, heavily wooded, no distress	6
ROAD/SIDEWALK/SHOULDER 1.00	Minor cracks on the pavement	7
VEGETATION 1.00	Minor vegetation on face, some brush in front of wall, not affecting wall performance	7
WALL DRAINS 1.00	No drainage-related problems	7

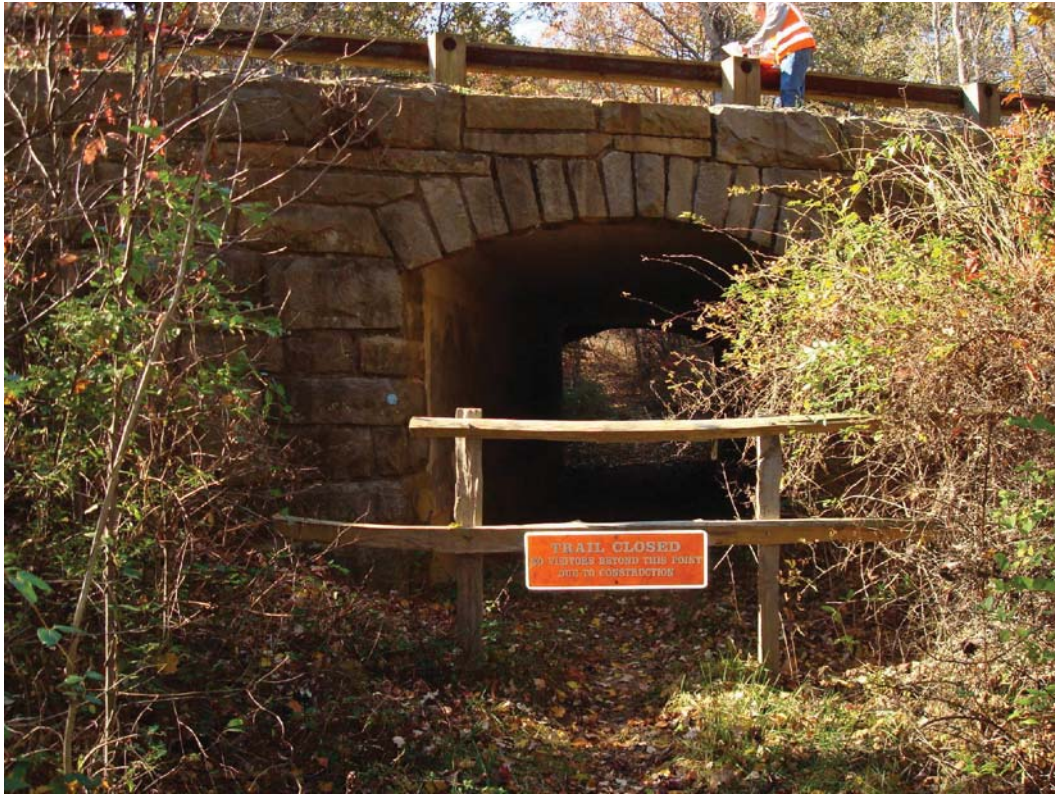
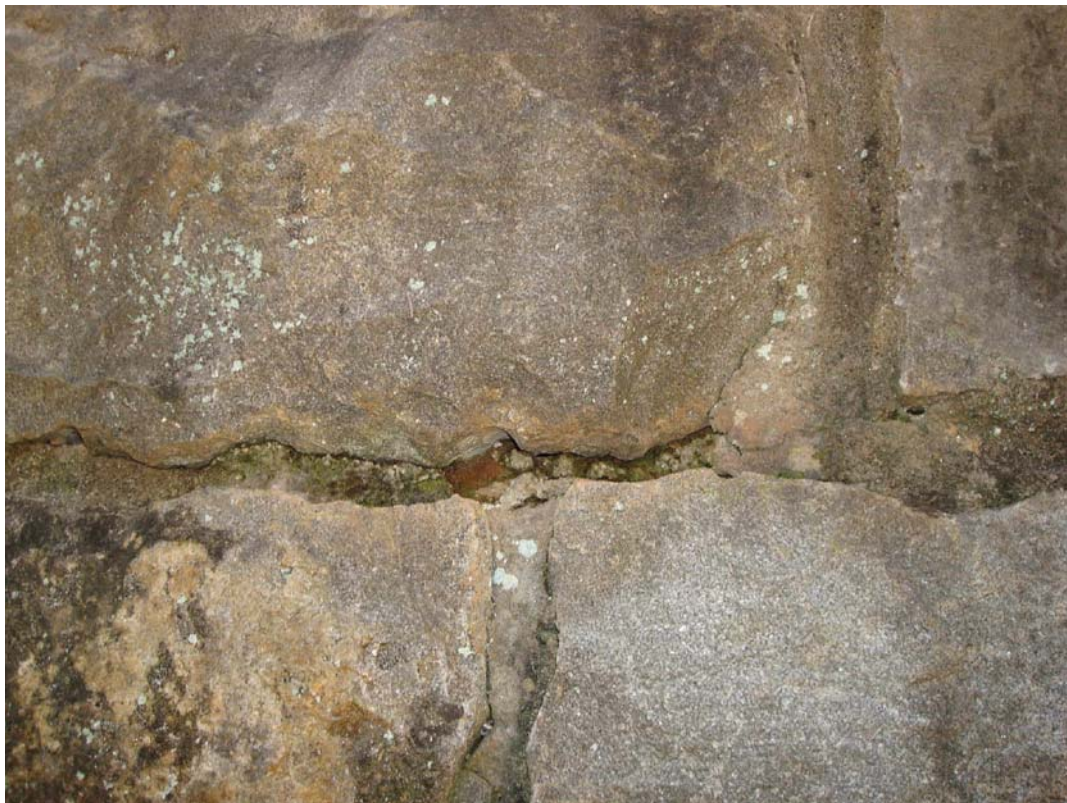
BLRI\_0001DB\_385.179\_L\_1.JPG

<b>Wall ID:</b>	BLRI-0001DB-385.179-L		
<b>Route Name:</b>	BLUE RIDGE PARKWAY - OTEEN SUB-DISTRICT		
<b>Inspection Date:</b>	November 08, 2007	<b>Approximate Year Built:</b>	1955
<b>*Wall Rating:</b>	68	<b>Maintenance Action:</b>	Repair Elements

<b>Element (Weighting Factor)</b>	<b>Narrative</b>	<b>Condition Rating (0 - 10)</b>
PERFORMANCE 8.00	No global distress	7
WALL FOUNDATION MATERIAL 8.00	soil, no settlement or erosion	8
MORTAR 8.00	20% cracked or separated, repoint	5
STONE MASONRY 8.00	Minor chips, overall no degradation of stone	7
DOWNSLOPE 0.50	Gradual	8
WALL DRAINS 1.00	Weep holes 10' on center, partially filled with soil	6
CULVERT 1.00	12'H x 9'W Minor spalling at weep holes	7
LATERAL SLOPE 1.00	Moderate slope, wooded	7
ROAD/SIDEWALK/SHOULDER 1.00	Grass shoulder	7

<b>Failure Consequence:</b>	MODERATE
<b>Recommendation Narrative:</b>	Repoint 20% = 57 sf x \$75/sf = \$4,275. Clean weep holes - 5 hrs x \$55/hr = \$275
<b>Repair Cost:</b>	\$4,550

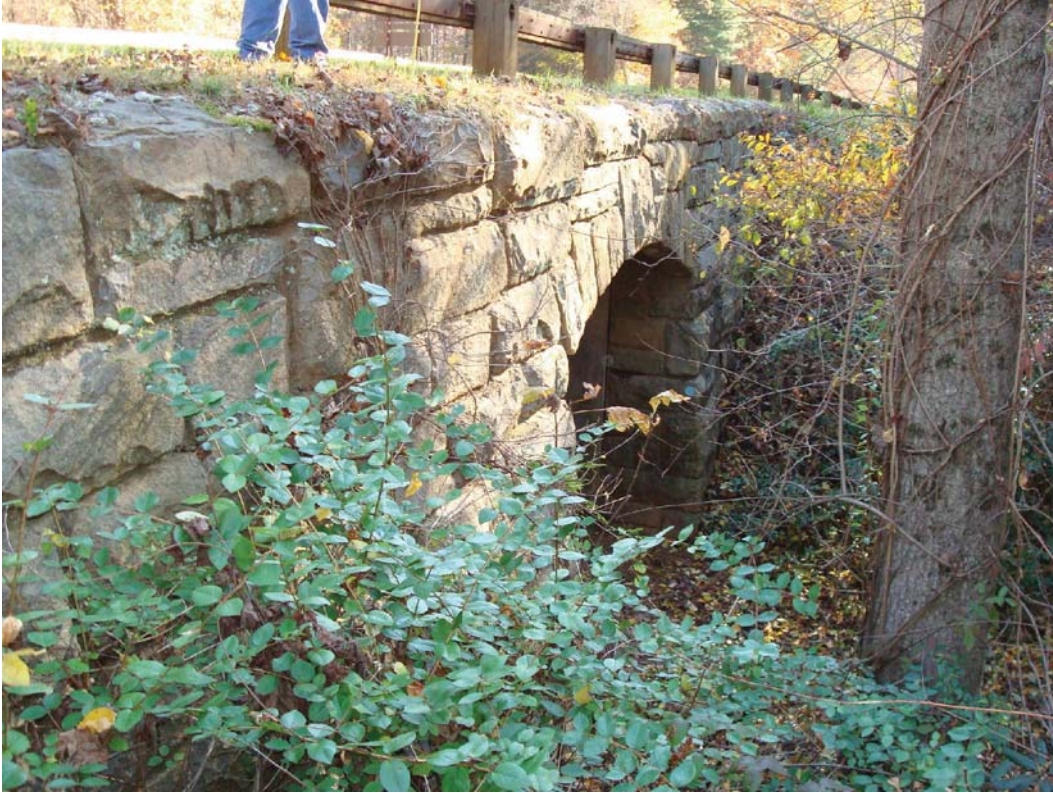
BLRI\_0001DB\_385.179\_R\_1.JPG

<b>Wall ID:</b>	BLRI-0001DB-385.179-R		
<b>Route Name:</b>	BLUE RIDGE PARKWAY - OTEEN SUB-DISTRICT		
<b>Inspection Date:</b>	November 08, 2007	<b>Approximate Year Built:</b>	1955
<b>*Wall Rating:</b>	74	<b>Maintenance Action:</b>	No Action

<b>Element (Weighting Factor)</b>	<b>Narrative</b>	<b>Condition Rating (0 - 10)</b>
PERFORMANCE 8.00	No global distress	7
WALL FOUNDATION MATERIAL 8.00	Soil, no settlement or erosion	8
MORTAR 8.00	Sound and durable	7
STONE MASONRY 8.00	No degradation	8
CULVERT 0.50	12'W x 9'H	8
DOWNSLOPE 0.50	Flat dirt road	8
WALL DRAINS 1.00	Weep holes 10' on center, partially filled with soil	6
LATERAL SLOPE 1.00	Gradual slope, wooded	7
ROAD/SIDEWALK/SHOULDER 1.00	Grass shoulder	7

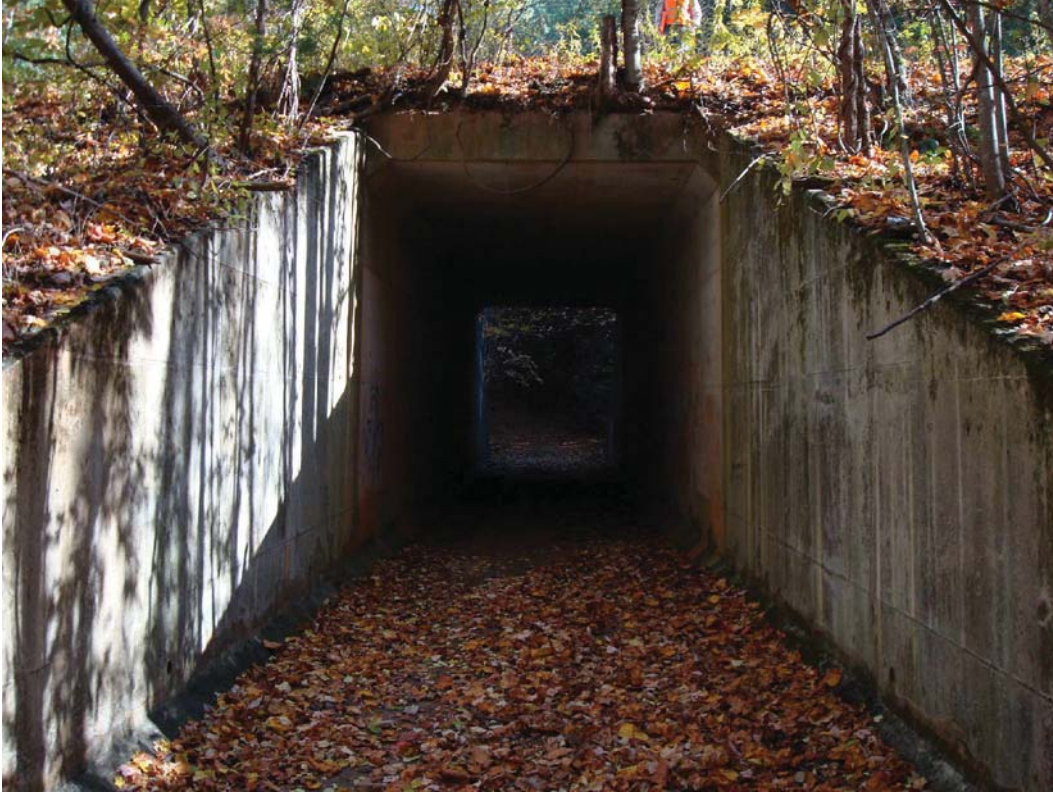
BLRI\_0001DB\_388.028\_R\_1.JPG

<b>Wall ID:</b>	BLRI-0001DB-388.028-R		
<b>Route Name:</b>	BLUE RIDGE PARKWAY - OTEEN SUB-DISTRICT		
<b>Inspection Date:</b>	November 08, 2007	<b>Approximate Year Built:</b>	1955
<b>*Wall Rating:</b>	75	<b>Maintenance Action:</b>	Maintenance

<b>Element (Weighting Factor)</b>	<b>Narrative</b>	<b>Condition Rating (0 - 10)</b>
PERFORMANCE 8.00	No global distress	7
WALL FOUNDATION MATERIAL 8.00	Soil, no settlement or erosion	8
CONCRETE 8.00	Sound and durable	8
CULVERT 0.50	14'W x 16'H concrete box	8
VEGETATION 1.00	Trees on sides and top of wall	5
WALL DRAINS 1.00	Weep holes 10' on center, filled with soil, weep holes need to be cleaned	6
DOWNSLOPE 1.00	Gradual, dirt road	7
LATERAL SLOPE 1.00	Gradual, wooded	7
UPSLOPE 1.00	Grassy, trees	7

<b>Failure Consequence:</b>	MODERATE
<b>Recommendation Narrative:</b>	Clean weep holes - 10 hrs. Cut trees - 10 hrs. 20 hrs labor x \$55/hr = \$1,100
<b>Repair Cost:</b>	\$1,100

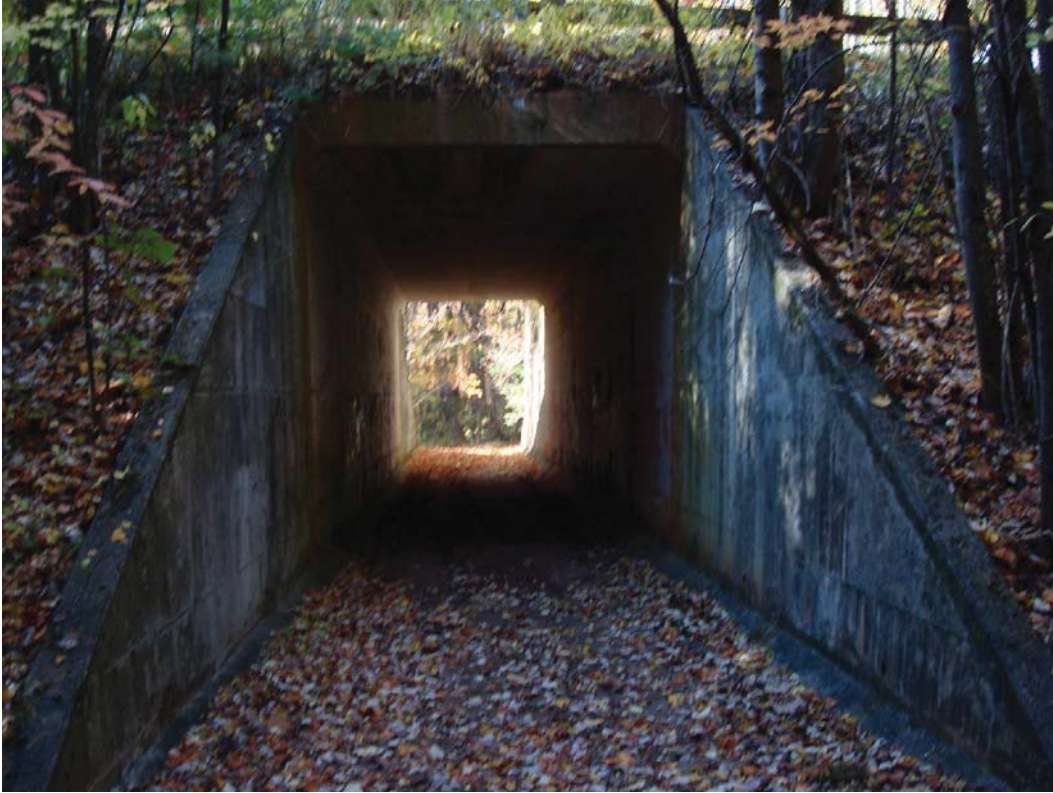
BLRI\_0001DB\_388.031\_L\_1.JPG

<b>Wall ID:</b>	BLRI-0001DB-388.031-L		
<b>Route Name:</b>	BLUE RIDGE PARKWAY - OTEEN SUB-DISTRICT		
<b>Inspection Date:</b>	November 08, 2007	<b>Approximate Year Built:</b>	1955
<b>*Wall Rating:</b>	75	<b>Maintenance Action:</b>	Maintenance

<b>Element (Weighting Factor)</b>	<b>Narrative</b>	<b>Condition Rating (0 - 10)</b>
PERFORMANCE 8.00	No global distress	7
WALL FOUNDATION MATERIAL 8.00	Soil, no settlement or erosion	8
CONCRETE 8.00	Sound and durable	8
CULVERT 0.50	14'W x 16'H concrete box	8
VEGETATION 1.00	Trees on sides and top of wall	5
WALL DRAINS 1.00	Weep holes 10' on center, filled partially with soil, weepholes need to be cleaned	6
DOWNSLOPE 1.00	Gradual, dirt road	7
LATERAL SLOPE 1.00	Gradual, wooded	7
UPSLOPE 1.00	Grass and trees	7

<b>Failure Consequence:</b>	MODERATE
<b>Recommendation Narrative:</b>	Clean Weep Holes - 10 hrs. Clear vegetation - 10 hrs. 20 hrs labor x \$55/hr = \$1,100
<b>Repair Cost:</b>	\$1,100

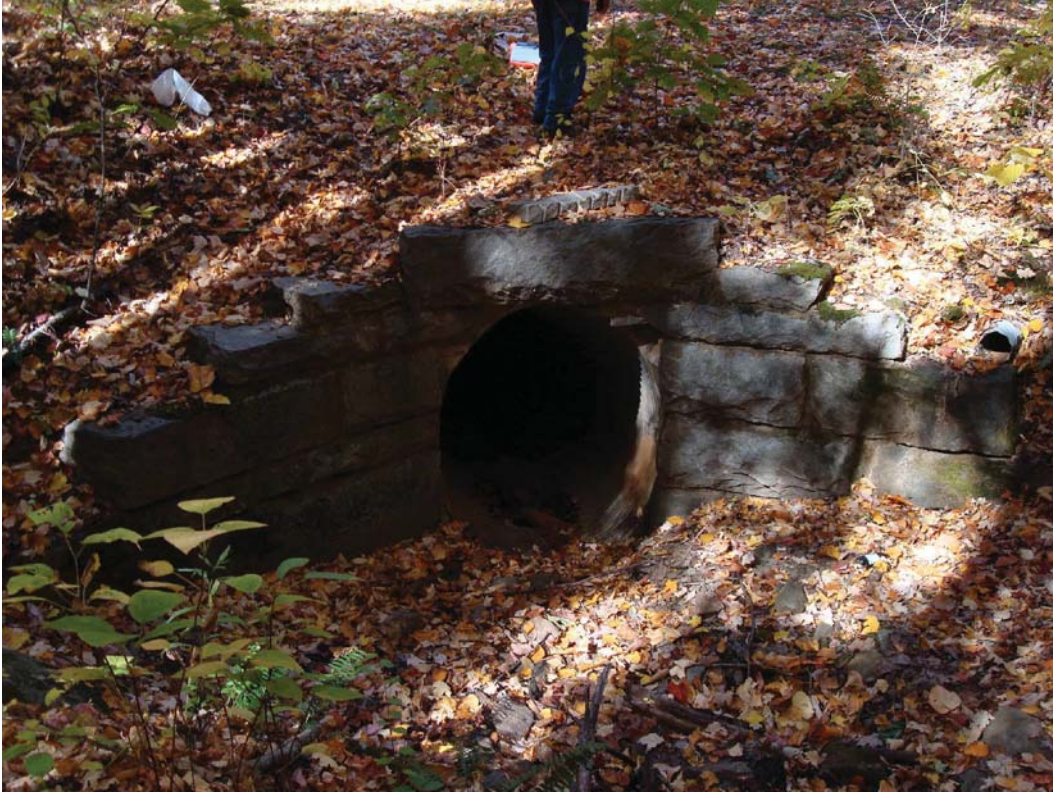
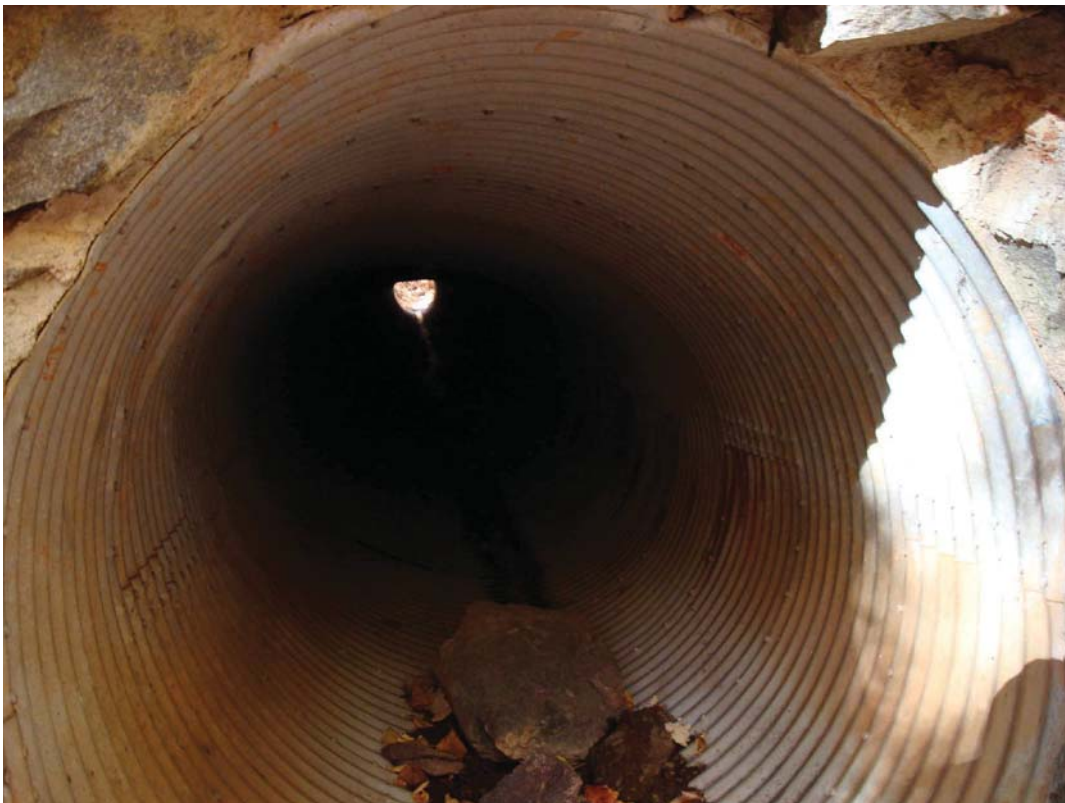
BLRI\_0001DB\_388.512\_L\_1.JPG

<b>Wall ID:</b>	BLRI-0001DB-388.512-L		
<b>Route Name:</b>	BLUE RIDGE PARKWAY - OTEEN SUB-DISTRICT		
<b>Inspection Date:</b>	November 08, 2007	<b>Approximate Year Built:</b>	1955
<b>*Wall Rating:</b>	50	<b>Maintenance Action:</b>	Repair Elements

<b>Element (Weighting Factor)</b>	<b>Narrative</b>	<b>Condition Rating (0 - 10)</b>
PERFORMANCE 8.00	Stability of wall is threatened by undermining of foundation	4
WALL FOUNDATION MATERIAL 8.00	Eroded/scoured, no evidence of settlement 8'L x 2'H x 1'D void under foundation, exposed rebar	3
CONCRETE 8.00	Sound and durable	7
LATERAL SLOPE 1.00	Steep and eroded	5
DOWNSLOPE 1.00	2.5H:1V, wooded	6
CULVERT 1.00	4' diameter galvanized corrugated circular metal pipe	7
UPSLOPE 1.00	Lightly wooded, 2.5H:1V	7
WALL DRAINS 1.00	None	7

<b>Failure Consequence:</b>	LOW
<b>Recommendation Narrative:</b>	Place riprap protection stone at base, sides of stream, underneath foundation - 20'W x 15'L x 2'D = 23 cy x \$130/cy = \$2,990. Geotextile - erosion control at base of riprap - 20' x 15' = 30 sy x \$5/sy = \$150. Labor - 25 hrs x \$55/hr = \$1,375. Dump Truck - 25 h
<b>Repair Cost:</b>	\$14,205
