# BLRI WIP Report

## NPS Retaining Wall Inventory Program Blue Ridge Parkway

Federal Highway Administration  
Eastern Federal Lands Highway Division  
Road Inventory Program (RIP)

# Blue Ridge Parkway in North Carolina and Virginia

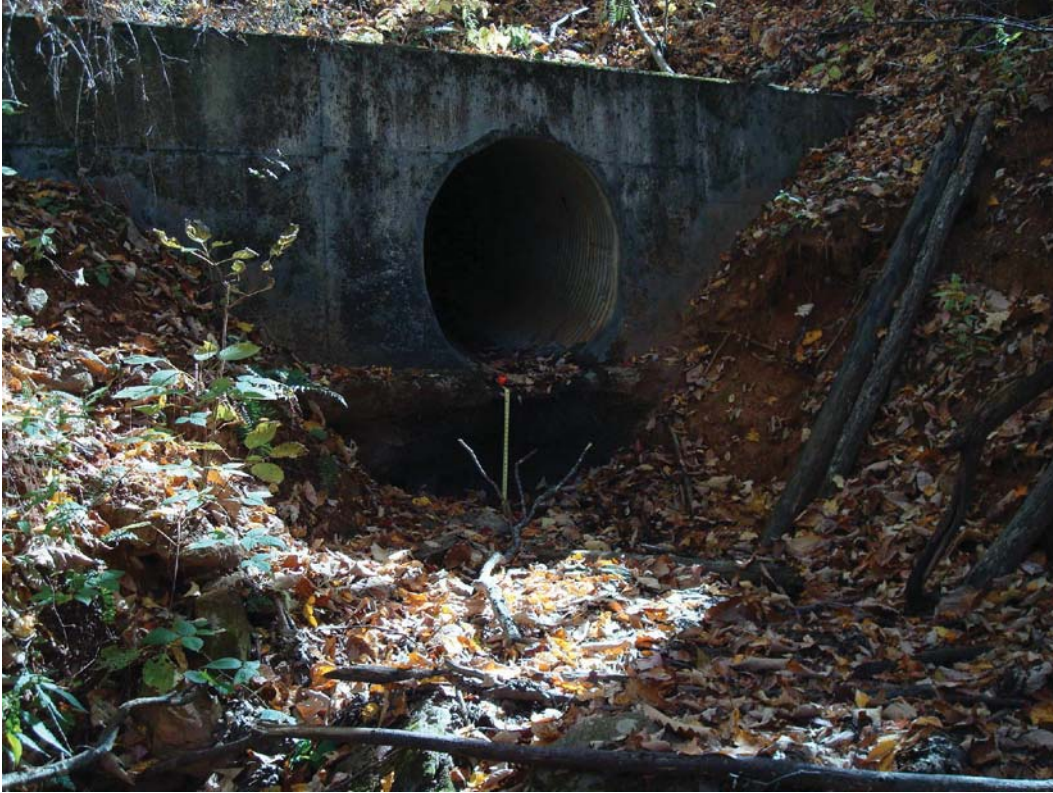
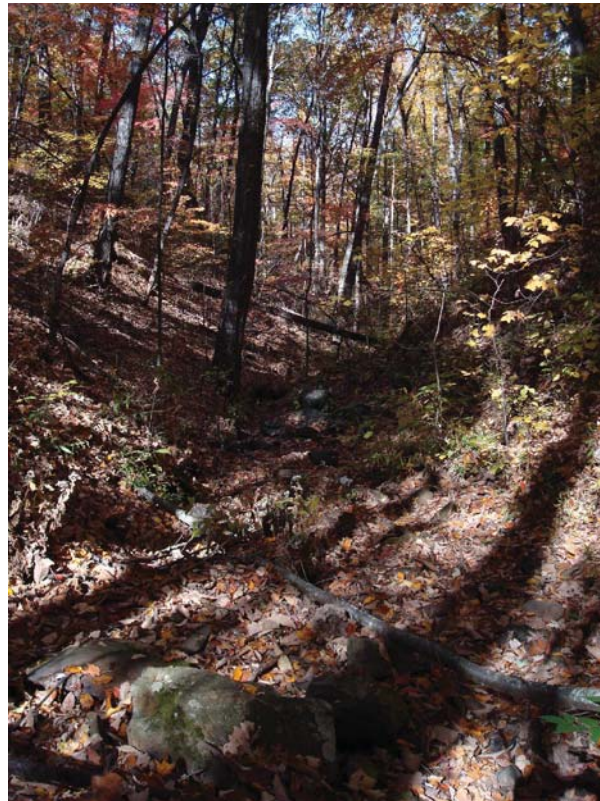
BLRI\_0001DB\_388.512\_R\_1.JPG

<b>Wall ID:</b>	BLRI-0001DB-388.512-R		
<b>Route Name:</b>	BLUE RIDGE PARKWAY - OTEEN SUB-DISTRICT		
<b>Inspection Date:</b>	November 08, 2007	<b>Approximate Year Built:</b>	1955
<b>*Wall Rating:</b>	71	<b>Maintenance Action:</b>	Repair Elements

<b>Element (Weighting Factor)</b>	<b>Narrative</b>	<b>Condition Rating (0 - 10)</b>
PERFORMANCE 8.00	No global distress, needs some maintenance.	7
WALL FOUNDATION MATERIAL 8.00	Soil, no settlement or erosion.	7
MORTAR 8.00	Overall sound and durable, missing 5%	7
STONE MASONRY 8.00	Good, no cracks.	8
LATERAL SLOPE 1.00	1H:1V rocky, soil eroded from embankment	5
DOWNSLOPE 1.00	3H:1V rising, rocky, in drainage channel	6
CULVERT 1.00	Galvanized metal 4ft diameter, not corroded.	7
UPSLOPE 1.00	Grassed, gentle slope	7
WALL DRAINS 1.00	No problems associated with drainage	7

<b>Failure Consequence:</b>	LOW
<b>Recommendation Narrative:</b>	Repoint Mortar - 45 sf x \$75/sf = \$300. Labor - 8 hrs x \$55/hr = \$440.
<b>Repair Cost:</b>	\$740

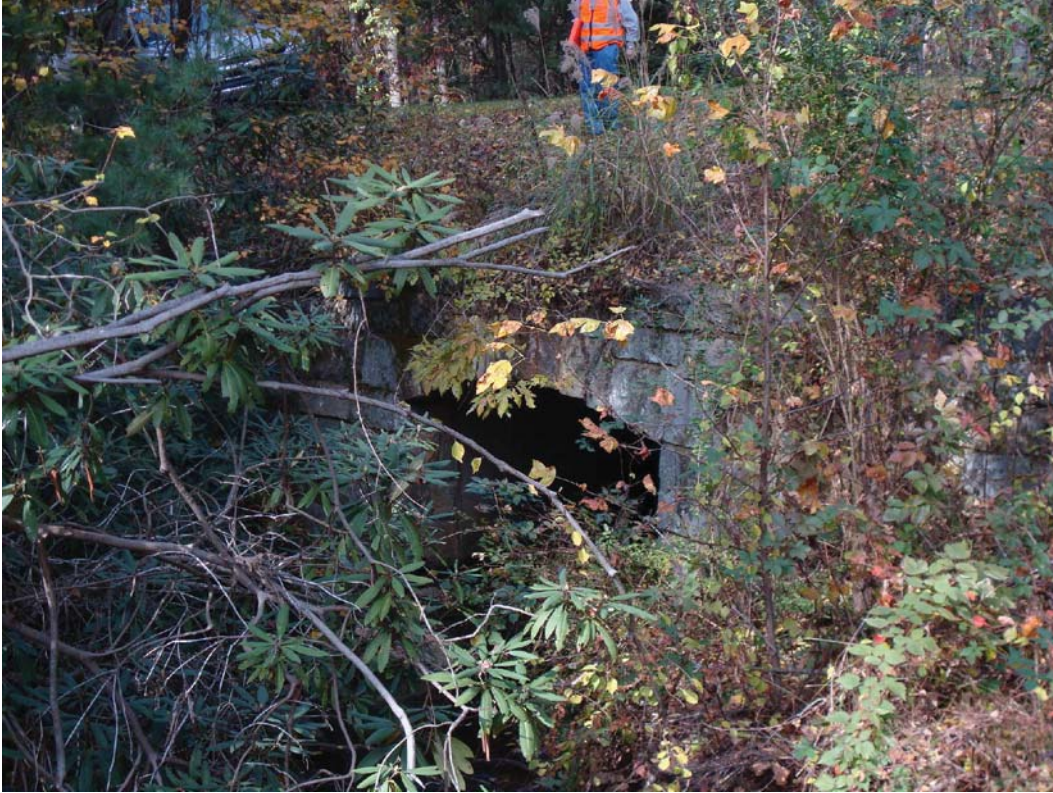
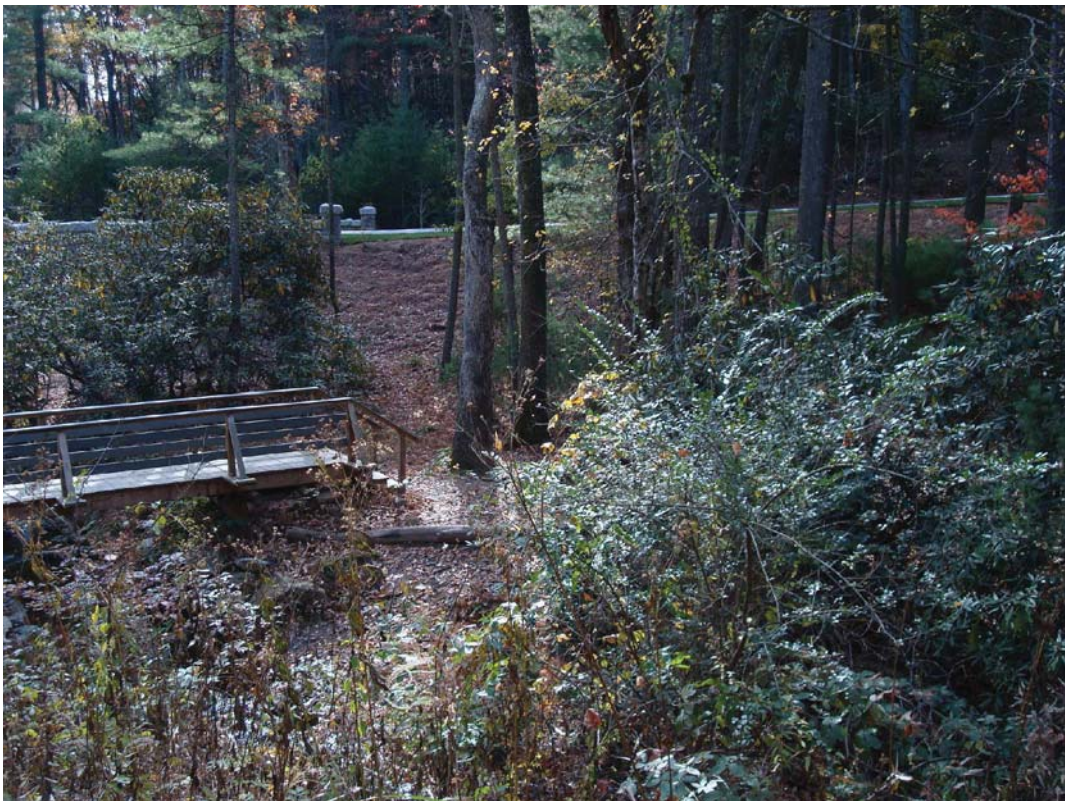
BLRI\_0001DB\_390.342\_L\_1.JPG

<b>Wall ID:</b>	BLRI-0001DB-390.342-L		
<b>Route Name:</b>	BLUE RIDGE PARKWAY - OTEEN SUB-DISTRICT		
<b>Inspection Date:</b>	November 08, 2007	<b>Approximate Year Built:</b>	1955
<b>*Wall Rating:</b>	70	<b>Maintenance Action:</b>	Repair Elements

<b>Element (Weighting Factor)</b>	<b>Narrative</b>	<b>Condition Rating (0 - 10)</b>
PERFORMANCE 8.00	No global distress.	7
WALL FOUNDATION MATERIAL 8.00	Some minor scour, no settlement.	7
MORTAR 8.00	Sound and durable, minor separation - 5% missing	6
STONE MASONRY 8.00	Good, no degradation.	8
VEGETATION 1.00	Trees 1ft diameter growing against the wall.	6
CULVERT 1.00	11.5'W x 7.5'H concrete box	7
DOWNSLOPE 1.00	Streambed	7
LATERAL SLOPE 1.00	Gradual wooded.	7
ROAD/SIDEWALK/SHOULDER 1.00	Grass shoulder	7

<b>Failure Consequence:</b>	MODERATE
<b>Recommendation Narrative:</b>	Repoint mortar - 10 sf x \$75/sf = 4750
<b>Repair Cost:</b>	\$750

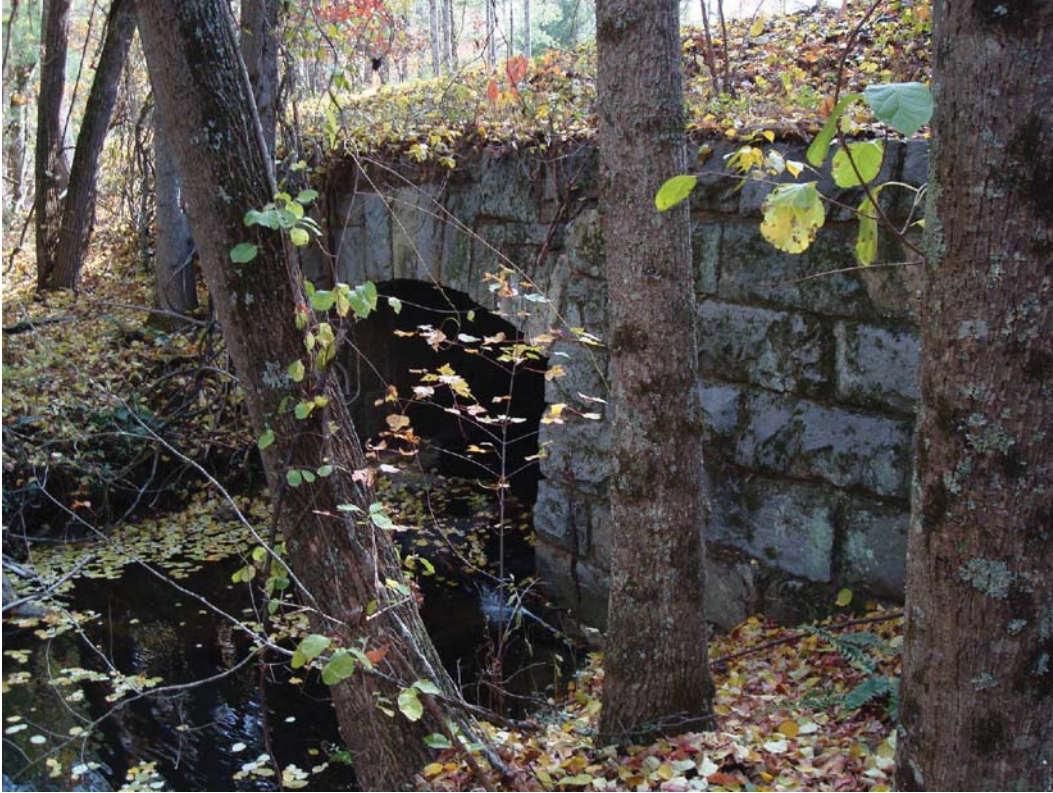
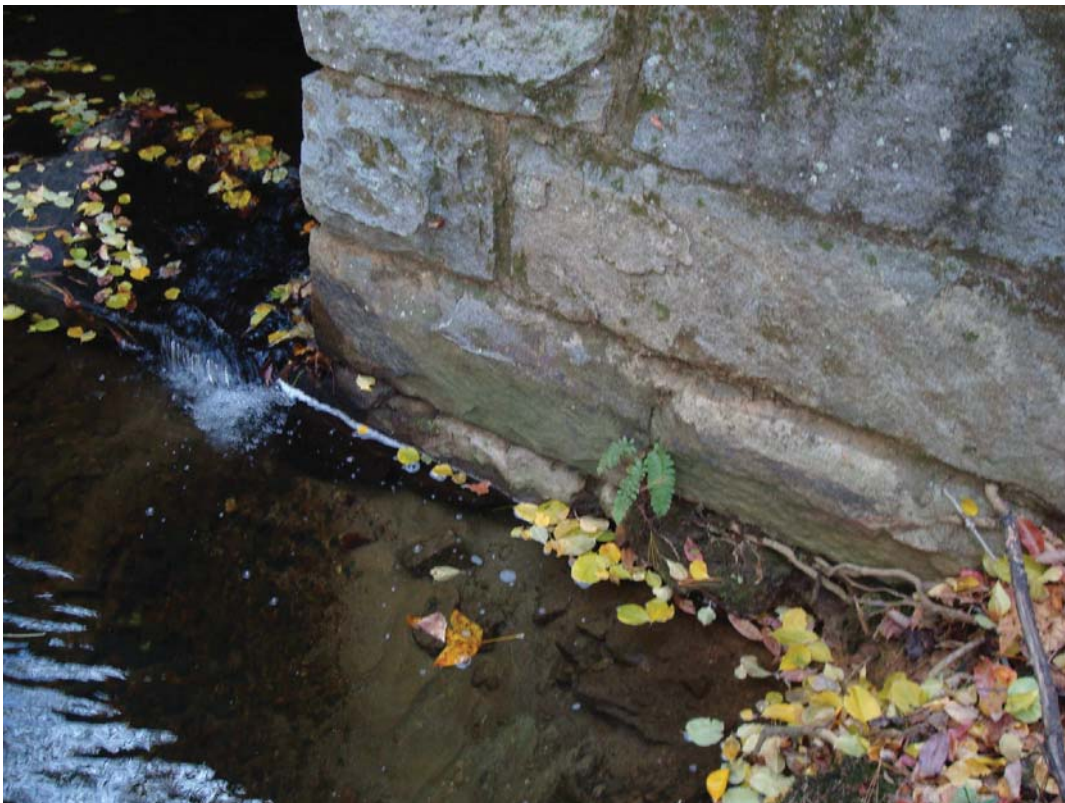
BLRI\_0001DB\_390.342\_R\_1.JPG

<b>Wall ID:</b>	BLRI-0001DB-390.342-R		
<b>Route Name:</b>	BLUE RIDGE PARKWAY - OTEEN SUB-DISTRICT		
<b>Inspection Date:</b>	November 08, 2007	<b>Approximate Year Built:</b>	1955
<b>*Wall Rating:</b>	70	<b>Maintenance Action:</b>	Repair Elements

<b>Element (Weighting Factor)</b>	<b>Narrative</b>	<b>Condition Rating (0 - 10)</b>
PERFORMANCE 8.00	No global distress	7
WALL FOUNDATION MATERIAL 8.00	Soil, no settlement, slight scour,	7
MORTAR 8.00	Sound and durable, minor separation, 5% missing.	6
STONE MASONRY 8.00	Good, no degradation.	8
CULVERT 1.00	10ft W x 7ft H, good condition	7
DOWNSLOPE 1.00	Streambed	7
LATERAL SLOPE 1.00	Gradual wooded	7
ROAD/SIDEWALK/SHOULDER 1.00	Grass shoulder	7
VEGETATION 1.00	Some small vegetation at the top	7

<b>Failure Consequence:</b>	MODERATE
<b>Recommendation Narrative:</b>	Repoint Mortar - 7 sf x \$75/sf = \$525
<b>Repair Cost:</b>	\$525

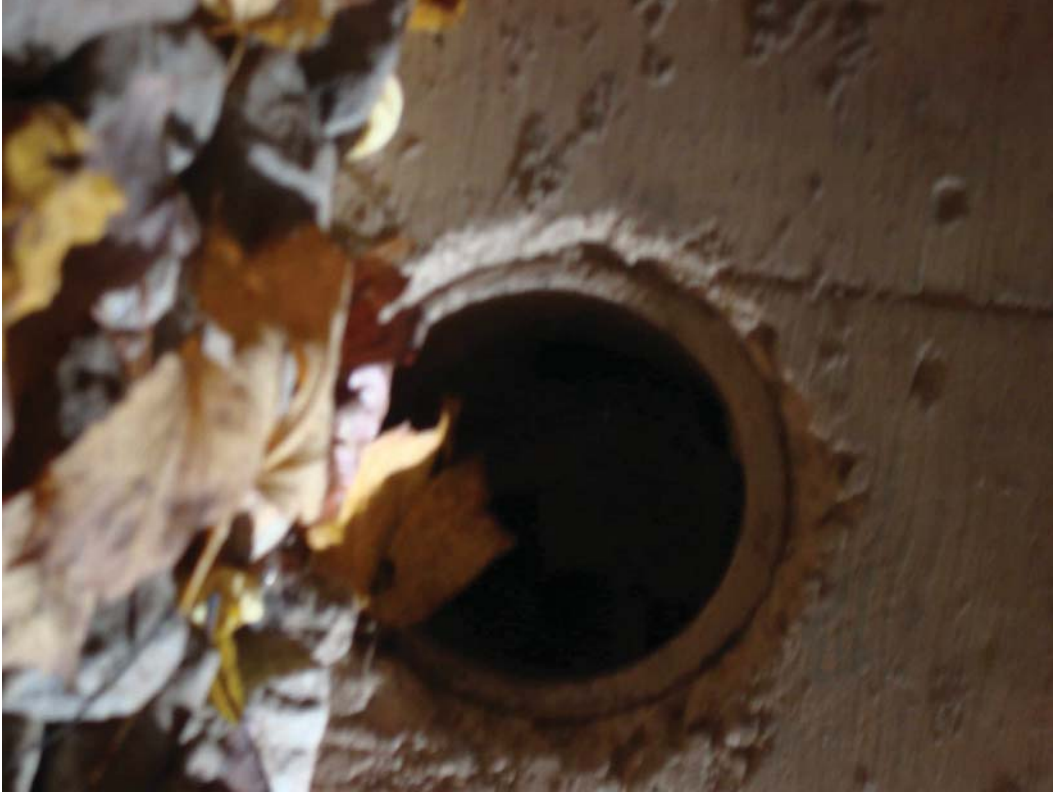
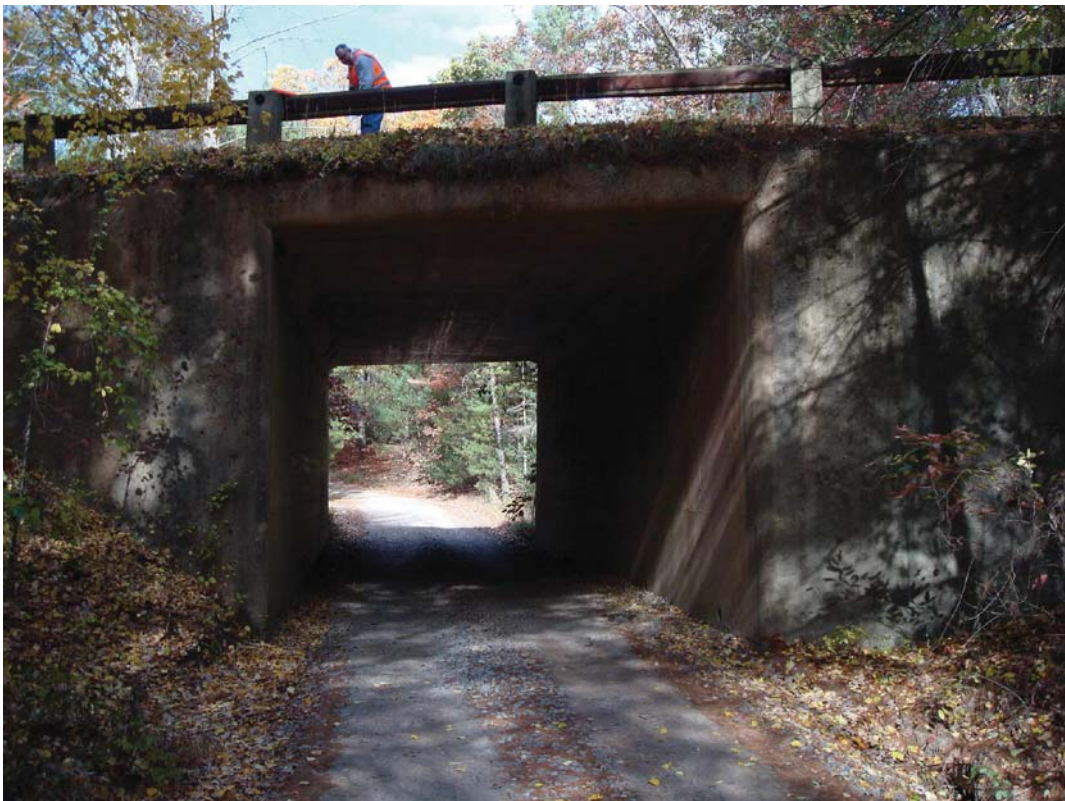
BLRI\_0001DB\_390.895\_L\_1.JPG

<b>Wall ID:</b>	BLRI-0001DB-390.895-L		
<b>Route Name:</b>	BLUE RIDGE PARKWAY - OTEEN SUB-DISTRICT		
<b>Inspection Date:</b>	November 08, 2007	<b>Approximate Year Built:</b>	1955
<b>*Wall Rating:</b>	78	<b>Maintenance Action:</b>	Maintenance

<b>Element (Weighting Factor)</b>	<b>Narrative</b>	<b>Condition Rating (0 - 10)</b>
PERFORMANCE 8.00	No global distress.	8
WALL FOUNDATION MATERIAL 8.00	On soil, no settlement or erosion.	8
CONCRETE 8.00	Minor, good conditions, sound and durable.	8
CULVERT 0.50	15ft W x 13 ft H concrete box	8
DOWNSLOPE 0.50	Flat, gravel road	8
WALL DRAINS 1.00	Weep holes 10 ft center to center, filled with soil, not affecting the wall.	5
LATERAL SLOPE 1.00	Gradual, wooded.	7
ROAD/SIDEWALK/SHOULDER 1.00	Grass shoulder	7
TRAFFIC BARRIER/FENCE 1.00	Pressure treated guard wall	7

<b>Failure Consequence:</b>	HIGH
<b>Recommendation Narrative:</b>	Clean weep holes - 20 hrs x \$55/hr = \$1,100
<b>Repair Cost:</b>	\$1,100

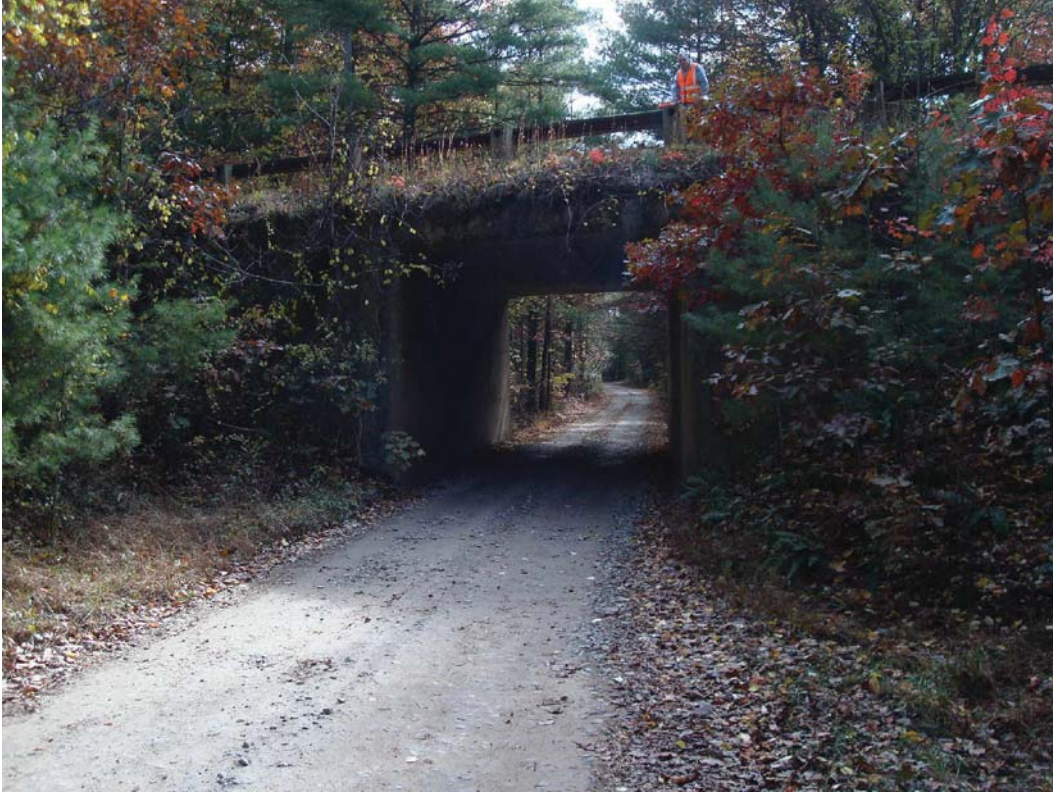
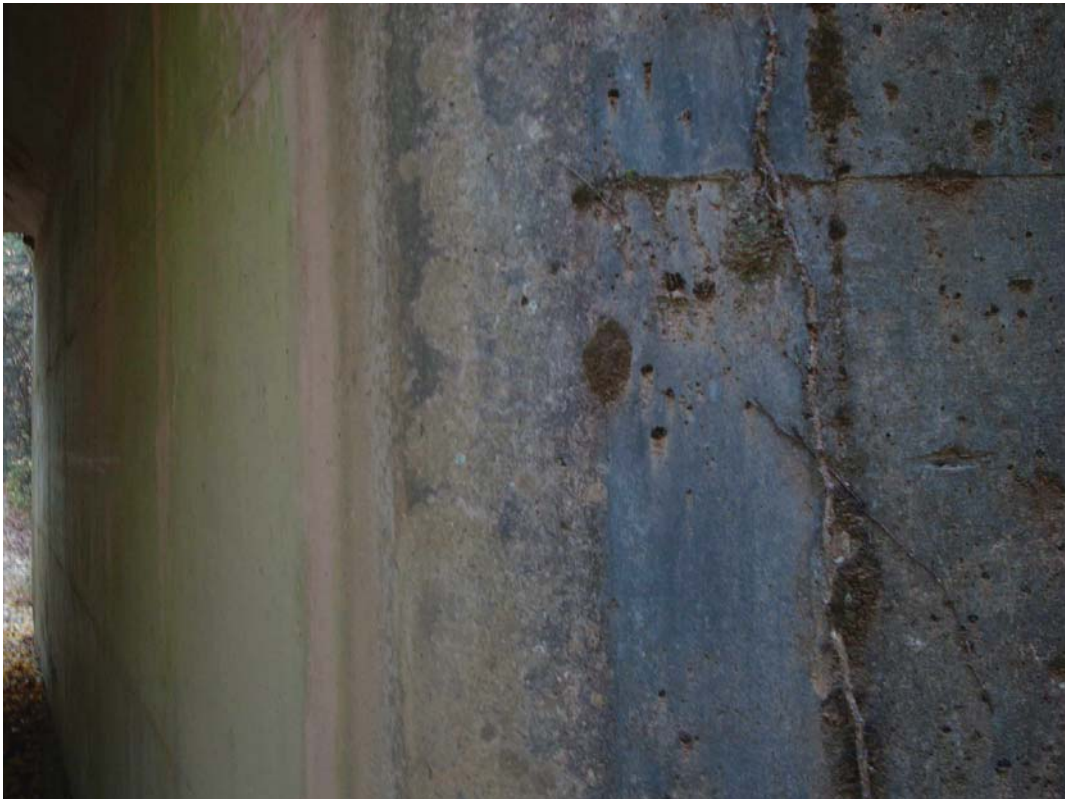
BLRI\_0001DB\_390.895\_R\_1.JPG

<b>Wall ID:</b>	BLRI-0001DB-390.895-R		
<b>Route Name:</b>	BLUE RIDGE PARKWAY - OTEEN SUB-DISTRICT		
<b>Inspection Date:</b>	November 08, 2007	<b>Approximate Year Built:</b>	1955
<b>*Wall Rating:</b>	78	<b>Maintenance Action:</b>	Maintenance

<b>Element (Weighting Factor)</b>	<b>Narrative</b>	<b>Condition Rating (0 - 10)</b>
PERFORMANCE 8.00	No global distress	8
WALL FOUNDATION MATERIAL 8.00	Soil, no settlement or erosion	8
CONCRETE 8.00	Overall sound and durable, minor spalling	8
CULVERT 0.50	15'W x 13'H concrete box	8
DOWNSLOPE 0.50	Flat, gravel roadway	8
WALL DRAINS 1.00	Weep holes, 10' on center, filled with soil, not affecting performance	5
LATERAL SLOPE 1.00	Gradual, wooded	7
ROAD/SIDEWALK/SHOULDER 1.00	Grass shoulder	7
TRAFFIC BARRIER/FENCE 1.00	Wood guardrail	7

<b>Failure Consequence:</b>	HIGH
<b>Recommendation Narrative:</b>	Clean weep holes - 10 hrs x \$55/hr = \$550
<b>Repair Cost:</b>	\$550

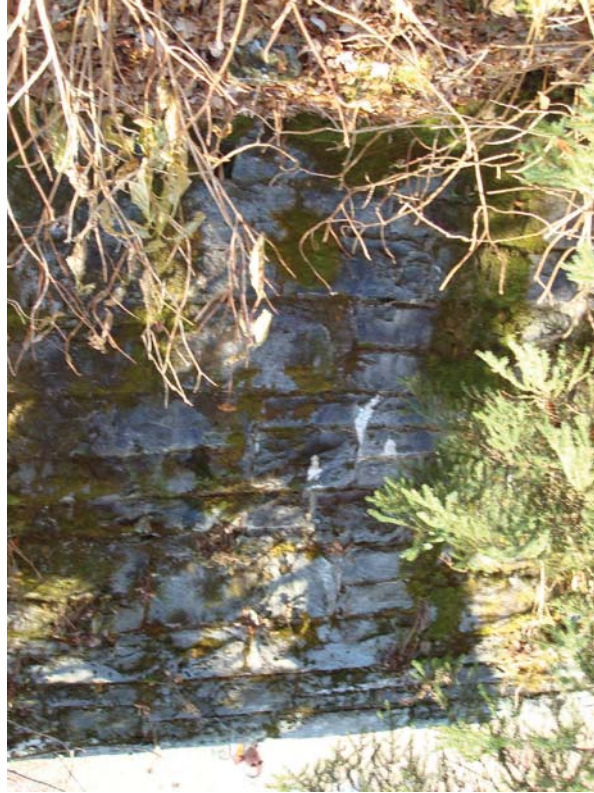
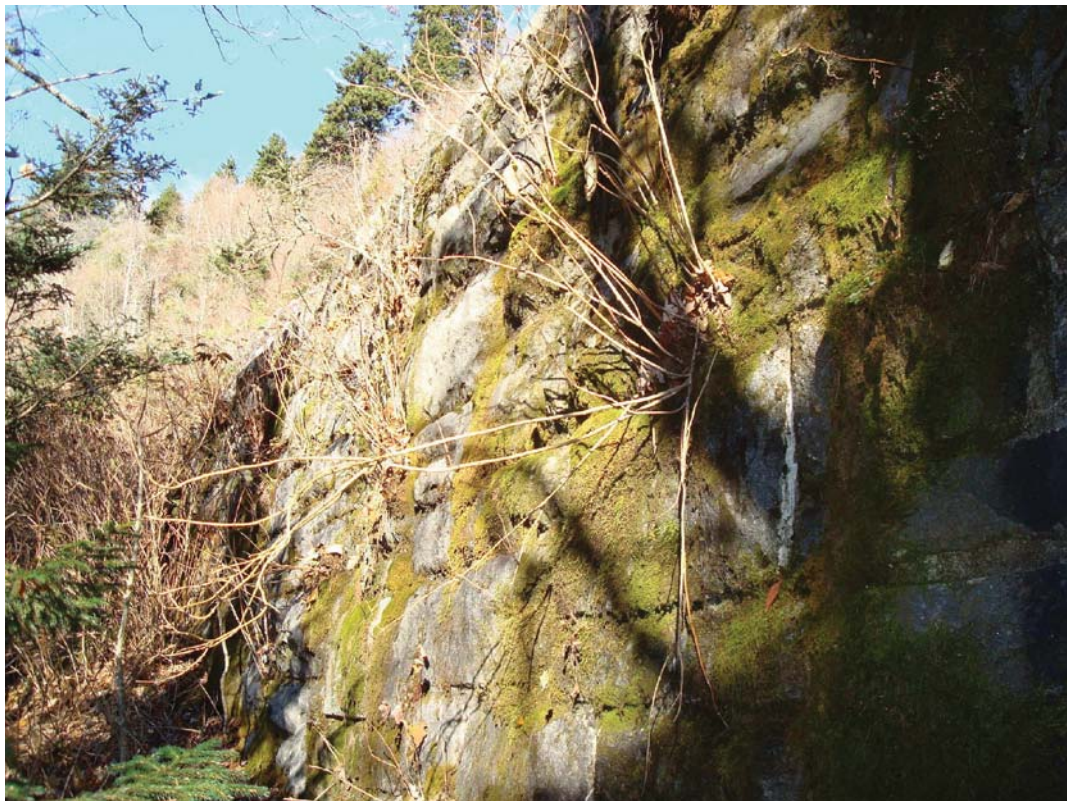
BLRI\_0001DC\_423.034\_L\_1.JPG

<b>Element (Weighting Factor)</b>	<b>Narrative</b>	<b>Condition Rating (0 - 10)</b>
PERFORMANCE 8.00	No global distress	7
WALL FOUNDATION MATERIAL 8.00	Appears to be on soil, no settlement, slight erosion at the center	7
MORTAR 8.00	Discoloration, occasional efflorescence, sound and durable	7
STONE MASONRY 8.00	No fractures or degradation	8
VEGETATION 1.00	Some moss on wall, sapling growing on the side of the wall	6
DOWNSLOPE 1.00	2H:1V, wooded, small trees	7
LATERAL SLOPE 1.00	3H:1V, wooded, small trees	7
ROAD/SIDEWALK/SHOULDER 1.00	Grass shoulder	7
WALL DRAINS 1.00	2 rectangular openings, but blocks 15' on center at the central portion of the wall, no problems associated with drainage	7

<b>Wall ID:</b>	BLRI-0001DC-423.034-L		
<b>Route Name:</b>	BLUE RIDGE PARKWAY - BALSAM GAP SUB-DISTRICT		
<b>Inspection Date:</b>	November 07, 2007	<b>Approximate Year Built:</b>	1945
<b>*Wall Rating:</b>	72	<b>Maintenance Action:</b>	Maintenance

<b>Failure Consequence:</b>	HIGH
<b>Recommendation Narrative:</b>	Remove vegetation from face - 10 hrs x \$55/hr = \$550
<b>Repair Cost:</b>	\$550

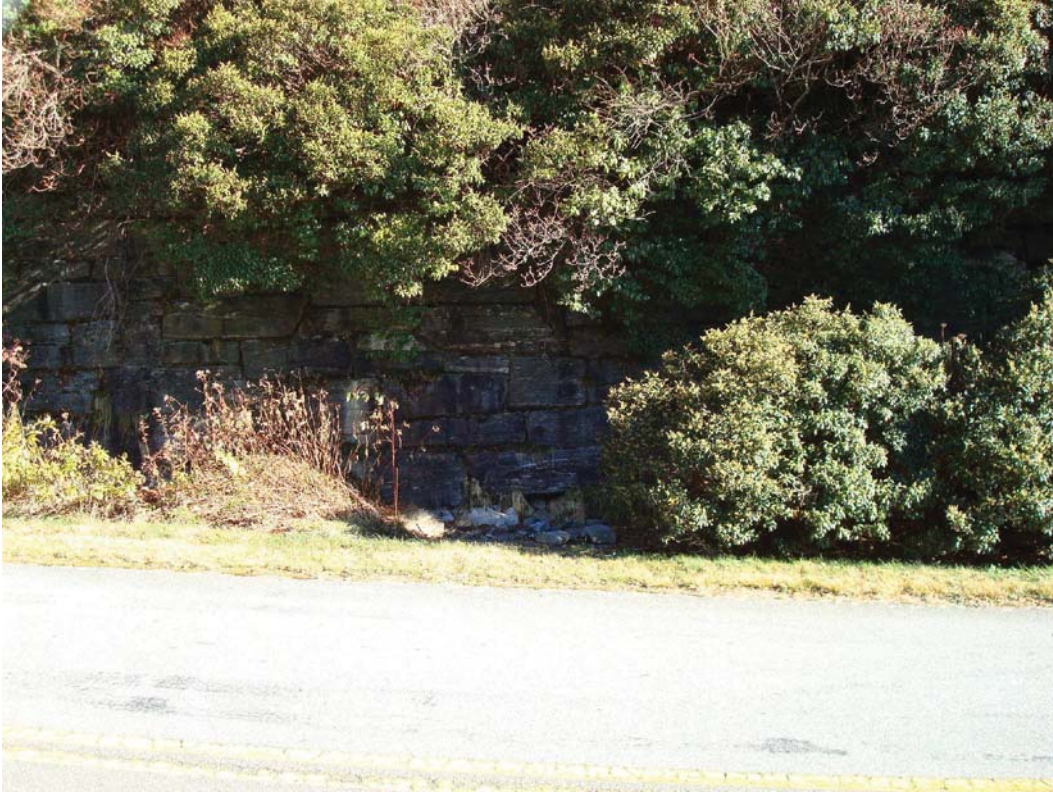
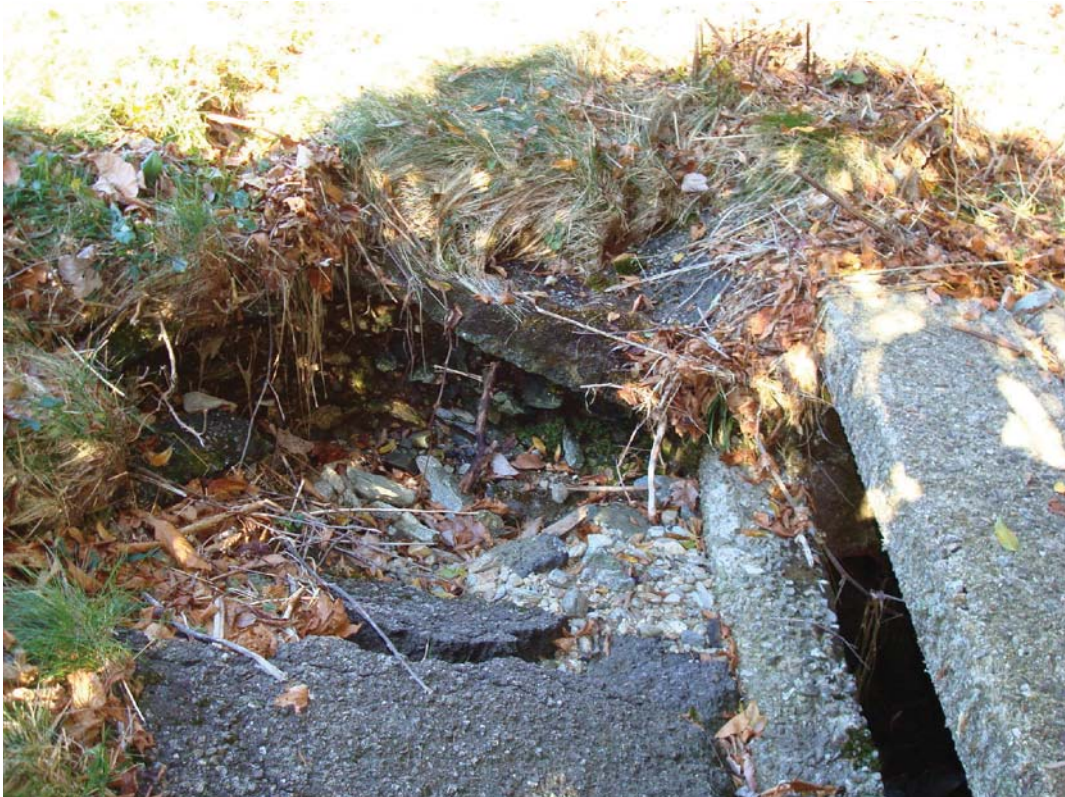
BLRI\_0001DC\_423.036\_R\_1.JPG

<b>Element (Weighting Factor)</b>	<b>Narrative</b>	<b>Condition Rating (0 - 10)</b>
PERFORMANCE 8.00	No global distress, needs repair	6
WALL FOUNDATION MATERIAL 8.00	Soil, no settlement, slight undermining	7
MORTAR 8.00	Discolored, aged, occasional efflorescence, slight separation	5
STONE MASONRY 8.00	Sound and durable	8
ROAD/SIDEWALK/SHOULDER 0.50	Grass shoulder	8
VEGETATION 1.00	Moss and grass growing on the face, shrubs on the top of the wall	6
WALL DRAINS 1.00	2 weepholes blocked, 15' center to center, unknown diameter concrete pipe drains to the inlet	6
LATERAL SLOPE 1.00	Rock outcrops	7
UPSLOPE 1.00	Heavily wooded, 4H:1V	7

<b>Wall ID:</b>	BLRI-0001DC-423.036-R		
<b>Route Name:</b>	BLUE RIDGE PARKWAY - BALSAM GAP SUB-DISTRICT		
<b>Inspection Date:</b>	November 07, 2007	<b>Approximate Year Built:</b>	1945
<b>*Wall Rating:</b>	65	<b>Maintenance Action:</b>	Repair Elements

<b>Failure Consequence:</b>	MODERATE
<b>Recommendation Narrative:</b>	Repoint mortar - 100 sf x \$75/sf = \$7,500. Clear vegetation - 20 hrs x \$55/hr = \$1,100. Repair drainage channel. Asphalt patch - 5' x 2' = say 2 sy x \$45/sy = \$90. Foundation fill - 10 sf x 2'D = say 1 cy x \$45/cy = \$45. Dump Truck - 8 hrs x \$120/hr = \$960
<b>Repair Cost:</b>	\$9,695

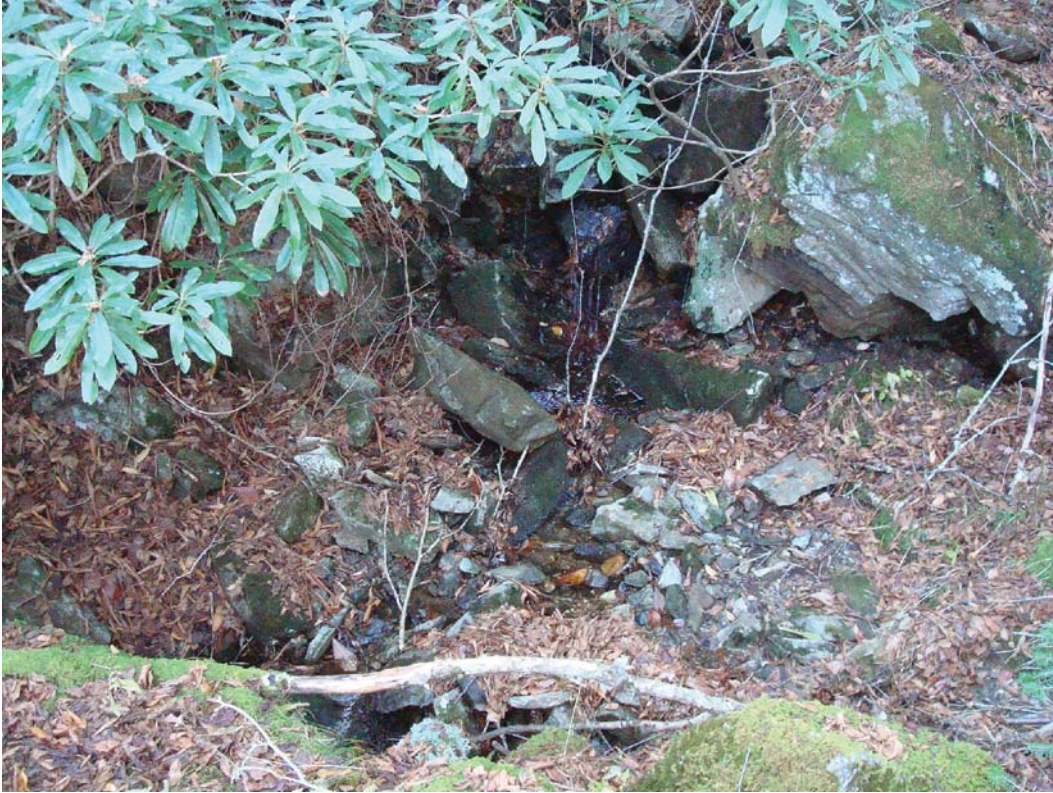
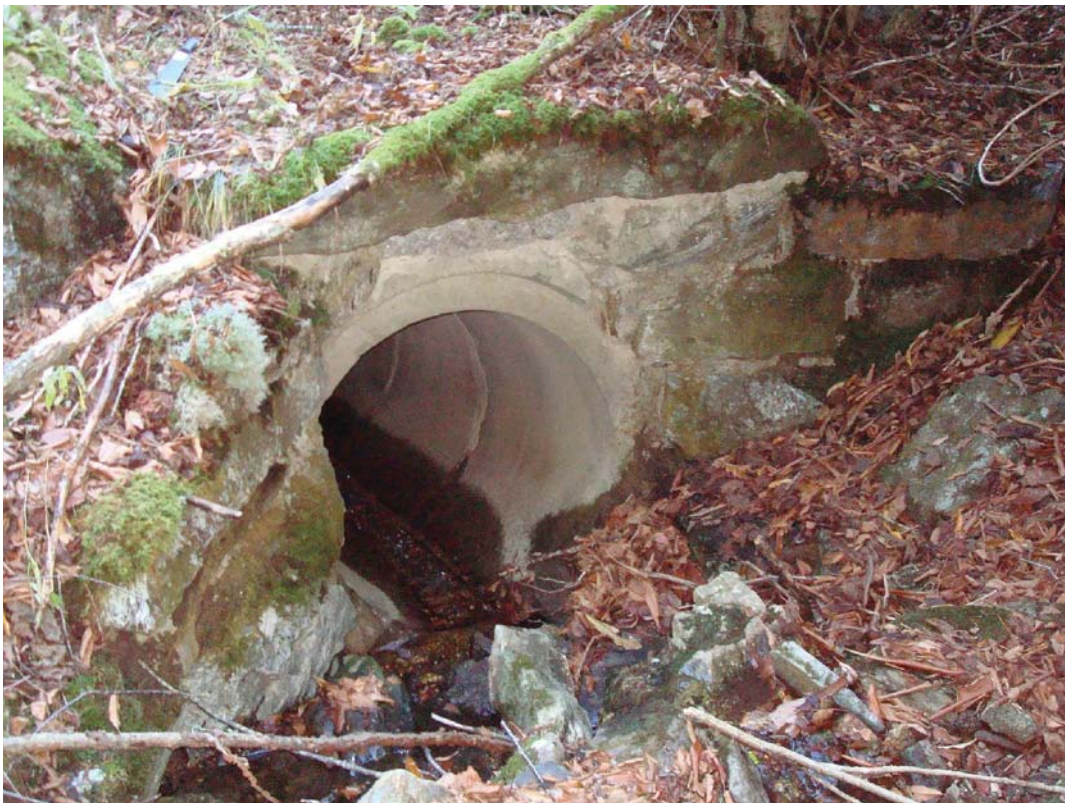
BLRI\_0001DC\_430.378\_L\_1.JPG

<b>Element (Weighting Factor)</b>	<b>Narrative</b>	<b>Condition Rating (0 - 10)</b>
PERFORMANCE 8.00	Moderate distress to the culvert, no global distress	6
WALL FOUNDATION MATERIAL 8.00	No settlement or erosion.	7
MORTAR 8.00	Sound and durable.	7
STONE MASONRY 8.00	No cracks or distress	8
VEGETATION 0.50	Moss with stones, no affecting drainage.	8
CULVERT 1.00	3.5-ft diameter, concrete circular pipe, bottom rebar is scoured/exposed across the entire length.	5
DOWNSLOPE 1.00	Streambed	7
LATERAL SLOPE 1.00	2H:1V wooded	7
UPSLOPE 1.00	2H:1V wooded	7

<b>Wall ID:</b>	BLRI-0001DC-430.378-L		
<b>Route Name:</b>	BLUE RIDGE PARKWAY - BALSAM GAP SUB-DISTRICT		
<b>Inspection Date:</b>	November 06, 2007	<b>Approximate Year Built:</b>	1945
<b>*Wall Rating:</b>	70	<b>Maintenance Action:</b>	Repair Elements

<b>Failure Consequence:</b>	LOW
<b>Recommendation Narrative:</b>	Pipe - Repair bottom of culvert (0.7'W x 90'L x 0.25'D) with lean concrete - 1 cy x \$1,470/cy = \$1,470. Labor - 20 hrs x \$55/hr = \$1,100
<b>Repair Cost:</b>	\$2,570

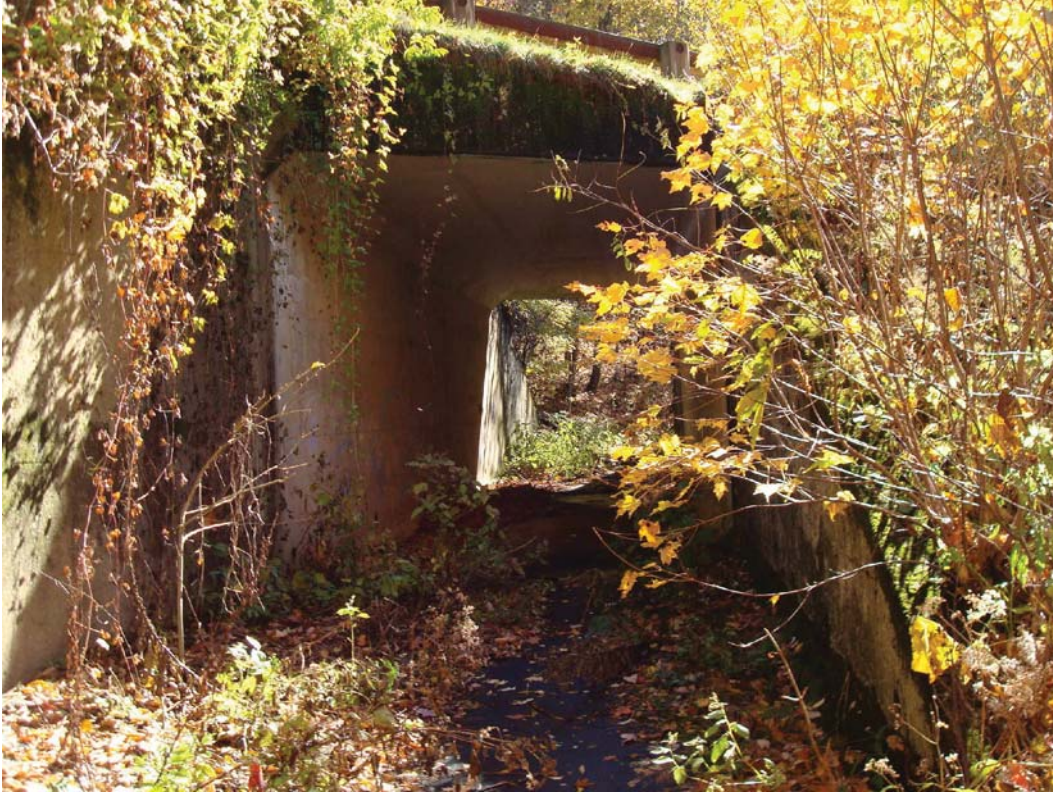
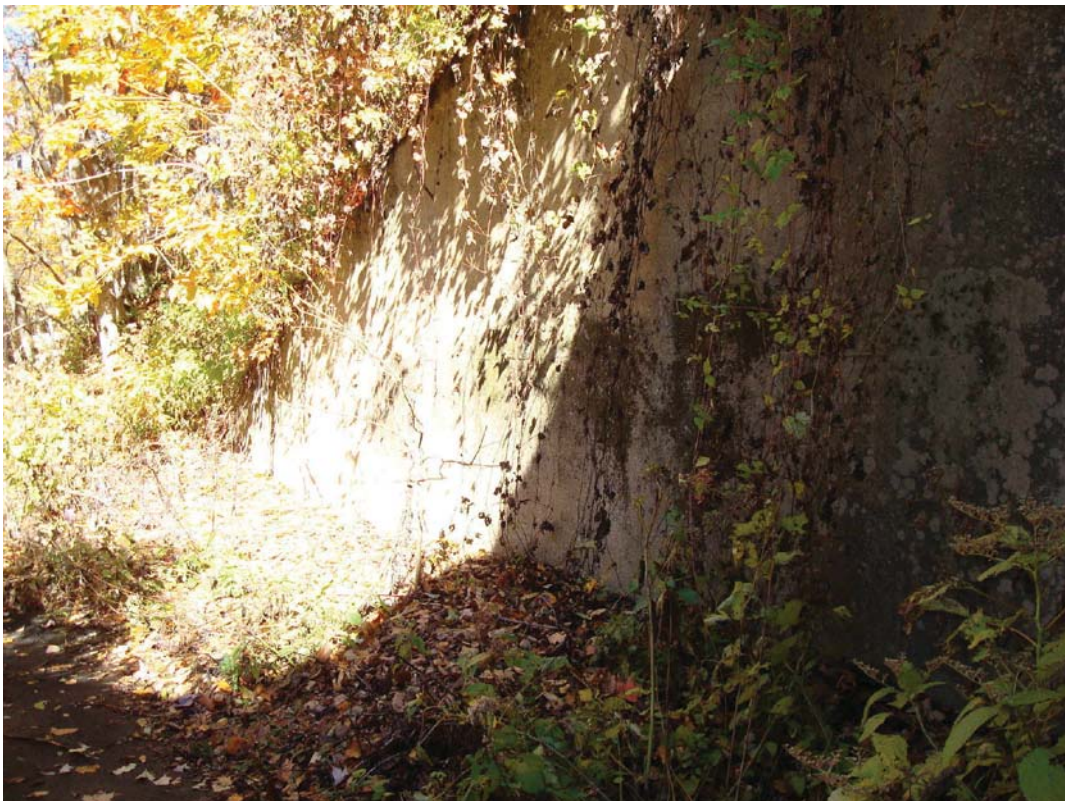
BLRI\_0001DC\_442.546\_R\_1.JPG

<b>Element (Weighting Factor)</b>	<b>Narrative</b>	<b>Condition Rating (0 - 10)</b>
PERFORMANCE 8.00	No global distress	7
WALL FOUNDATION MATERIAL 8.00	Soil, no settlement or erosion.	7
CONCRETE 8.00	Sound and durable.	8
CULVERT 0.50	14ft x 14ft concrete box	8
DOWNSLOPE 0.50	Relatively flat path.	8
ROAD/SIDEWALK/SHOULDER 0.50	Grassy shoulder	8
TRAFFIC BARRIER/FENCE 0.50	Guardrail good condition	8
WALL DRAINS 1.00	Weepholes 10' on center, pipes filled >50% with soil, no apparent distress to wall	5
LATERAL SLOPE 1.00	Steep, wooded.	7

<b>Wall ID:</b>	BLRI-0001DC-442.546-R		
<b>Route Name:</b>	BLUE RIDGE PARKWAY - BALSAM GAP SUB-DISTRICT		
<b>Inspection Date:</b>	November 06, 2007	<b>Approximate Year Built:</b>	1955
<b>*Wall Rating:</b>	73	<b>Maintenance Action:</b>	Maintenance

<b>Failure Consequence:</b>	MODERATE
<b>Recommendation Narrative:</b>	Clean weepholes - 10 hrs x \$55/hr = \$550. Remove vegetation from culvert floor - 10 hrs x \$55/hr = \$550.
<b>Repair Cost:</b>	\$1,100

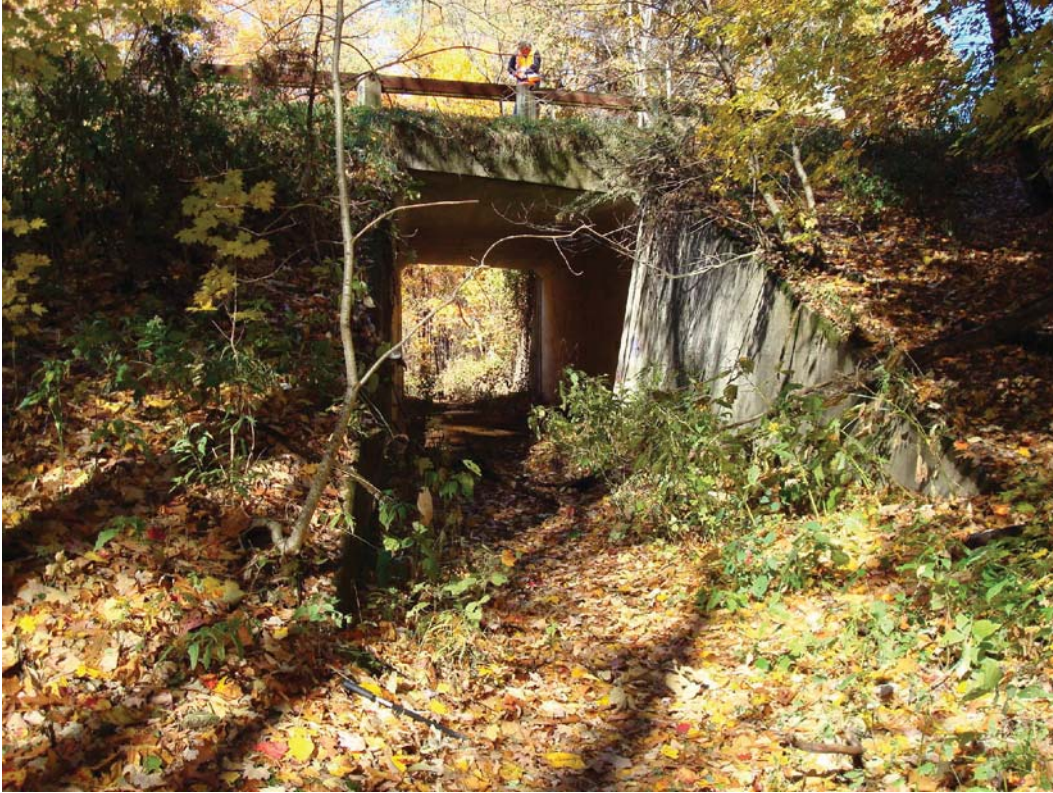
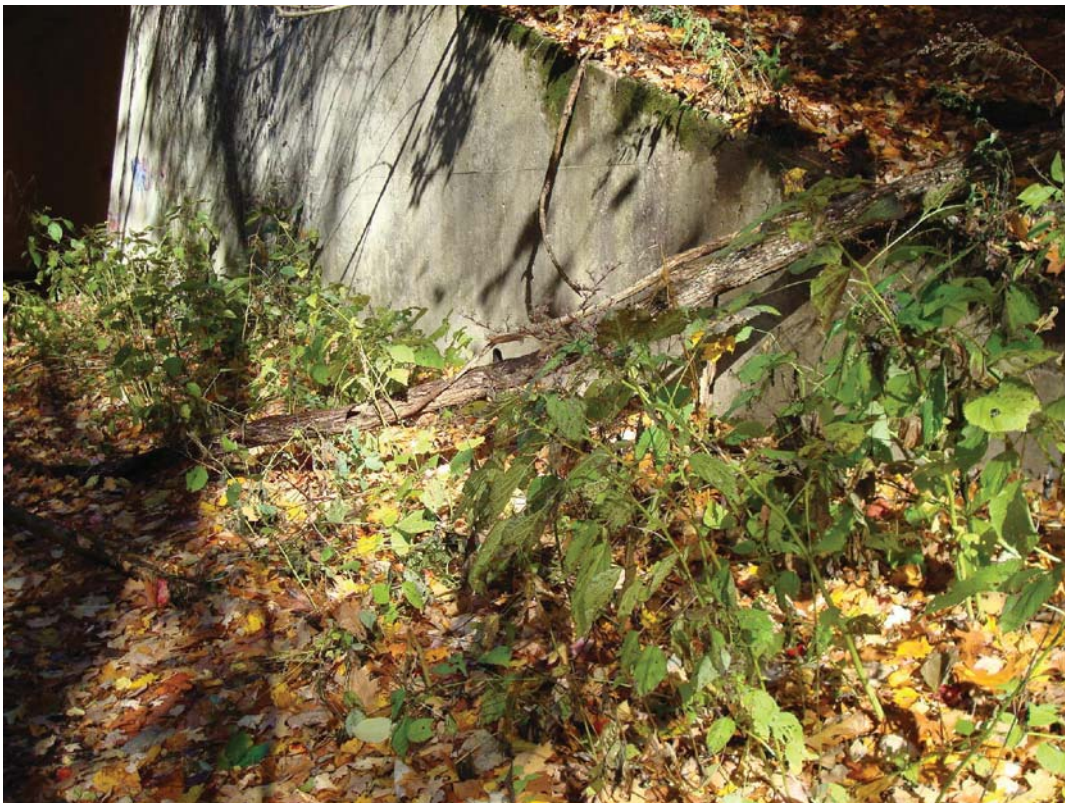
BLRI\_0001DC\_442.555\_L\_1.JPG

Element (Weighting Factor)	Narrative	Condition Rating (0 - 10)
PERFORMANCE 8.00	No global distress.	7
WALL FOUNDATION MATERIAL 8.00	Soil, no settlement or erosion.	7
CONCRETE 8.00	Sound and durable.	8
CULVERT 0.50	14ft X 14ft concrete box	8
DOWNSLOPE 0.50	Relatively flat path	8
ROAD/SIDEWALK/SHOULDER 0.50	Grassy shoulder	8
TRAFFIC BARRIER/FENCE 0.50	Guard rail, good condition	8
WALL DRAINS 1.00	Weepholes 10' on center, pipes filled >50% with soil, no apparent distress to wall	5
VEGETATION 1.00	Significant vegetation growing inside the culvert, needs to be removed	6

<b>Wall ID:</b>	BLRI-0001DC-442.555-L		
<b>Route Name:</b>	BLUE RIDGE PARKWAY - BALSAM GAP SUB-DISTRICT		
<b>Inspection Date:</b>	November 06, 2007	<b>Approximate Year Built:</b>	1955
<b>*Wall Rating:</b>	72	<b>Maintenance Action:</b>	Maintenance

<b>Failure Consequence:</b>	MODERATE
<b>Recommendation Narrative:</b>	Clean weep holes - 10 hrs x \$55/hr = \$550. Clear vegetation - 10 hrs x \$55/hr = \$550.
<b>Repair Cost:</b>	\$1,100

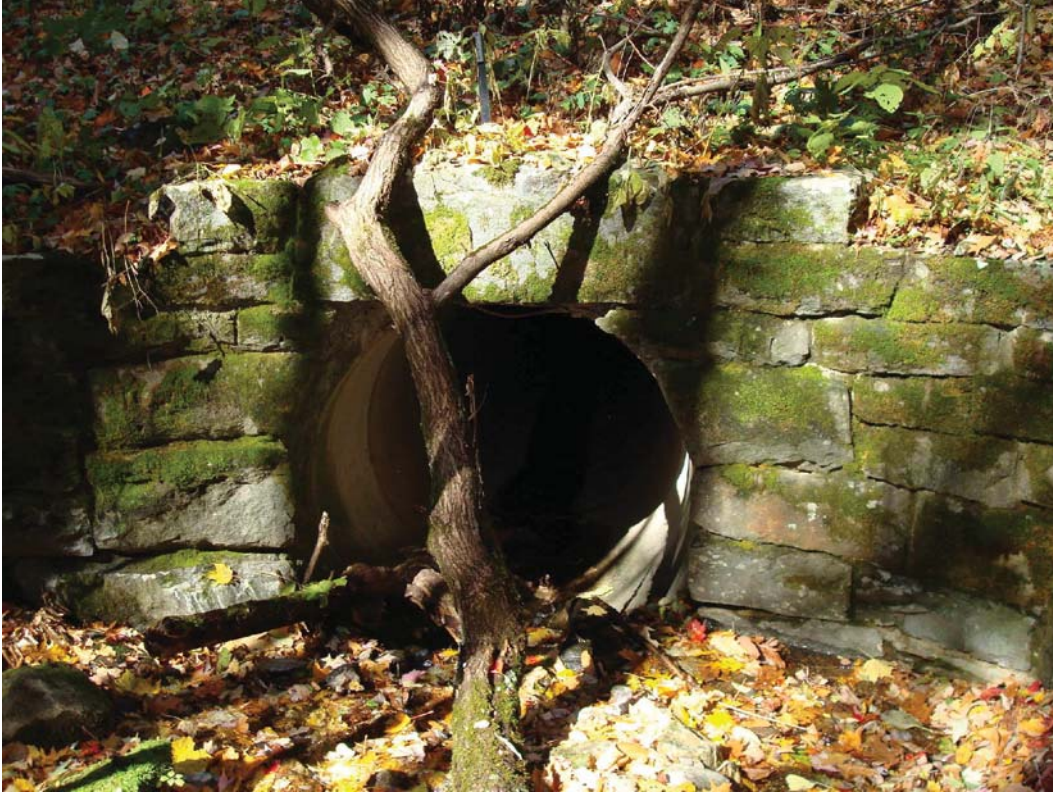
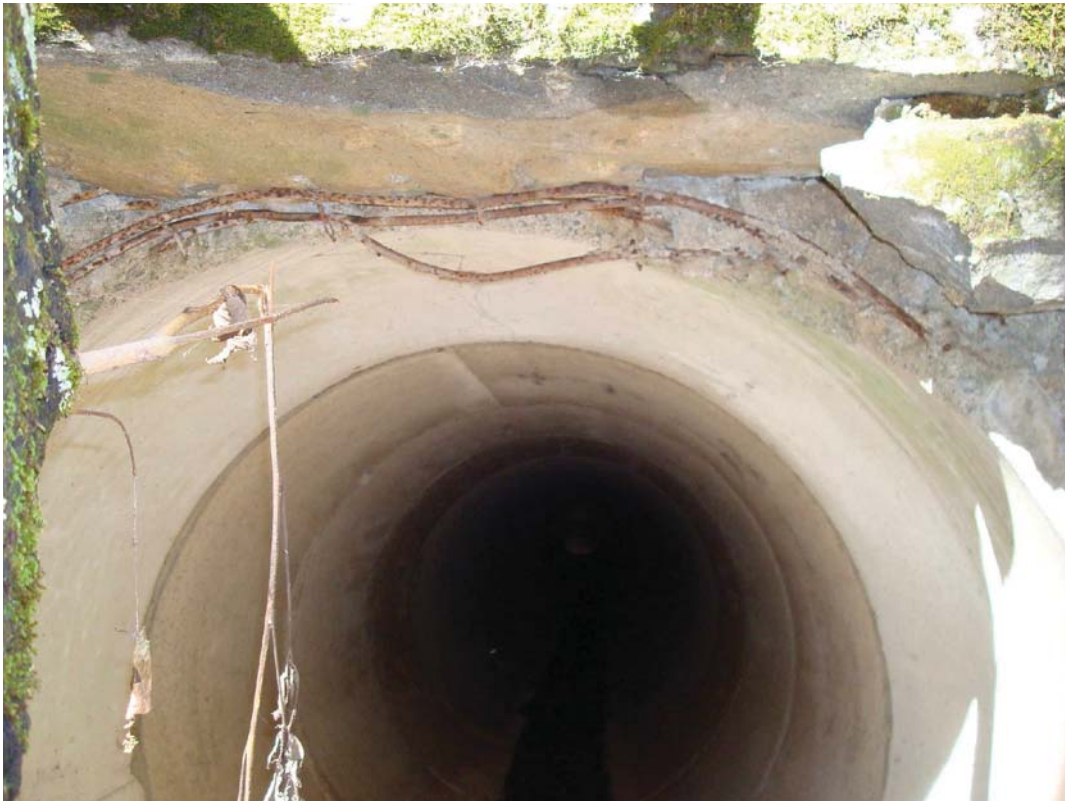
BLRI\_0001DC\_442.575\_L\_1.JPG

<b>Element (Weighting Factor)</b>	<b>Narrative</b>	<b>Condition Rating (0 - 10)</b>
PERFORMANCE 8.00	No global distress, required elements repair	6
WALL FOUNDATION MATERIAL 8.00	Soil, no settlement or erosion.	7
MORTAR 8.00	Moderate age-related mortar loss/separation - 25% of wall	5
STONE MASONRY 8.00	No distress	7
DOWNSLOPE 0.50	Creek	8
VEGETATION 0.50	Mossy, does not affect wall performance	8
CULVERT 1.00	Concrete, 5ft diameter, moderate spalling at top front, exposed reinforced steel.	5
LATERAL SLOPE 1.00	Steep, wooded	6
UPSLOPE 1.00	4H:1V lightly wooded.	7

<b>Wall ID:</b>	BLRI-0001DC-442.575-L		
<b>Route Name:</b>	BLUE RIDGE PARKWAY - BALSAM GAP SUB-DISTRICT		
<b>Inspection Date:</b>	November 06, 2007	<b>Approximate Year Built:</b>	1955
<b>*Wall Rating:</b>	63	<b>Maintenance Action:</b>	Repair Elements

<b>Failure Consequence:</b>	LOW
<b>Recommendation Narrative:</b>	Repoint Mortar - 22 sf x \$75/sf = \$1,650. Repair concrete on pipe - 1 cy x \$1,470/cy = \$1,470
<b>Repair Cost:</b>	\$3,120

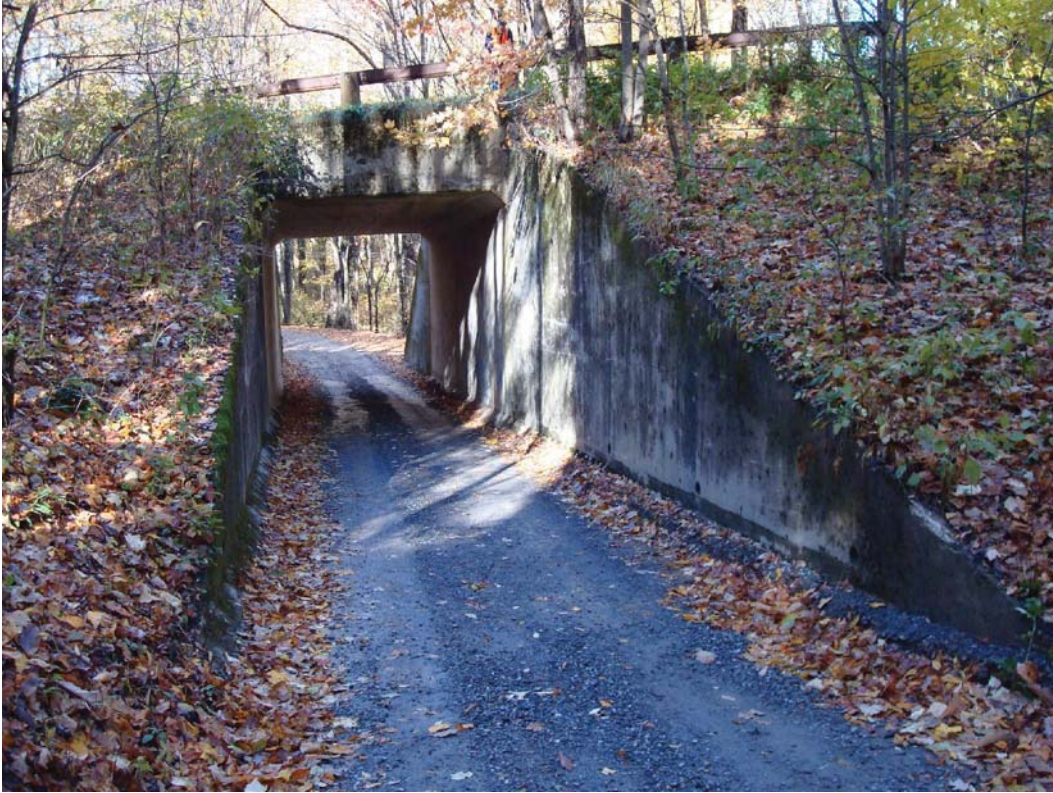
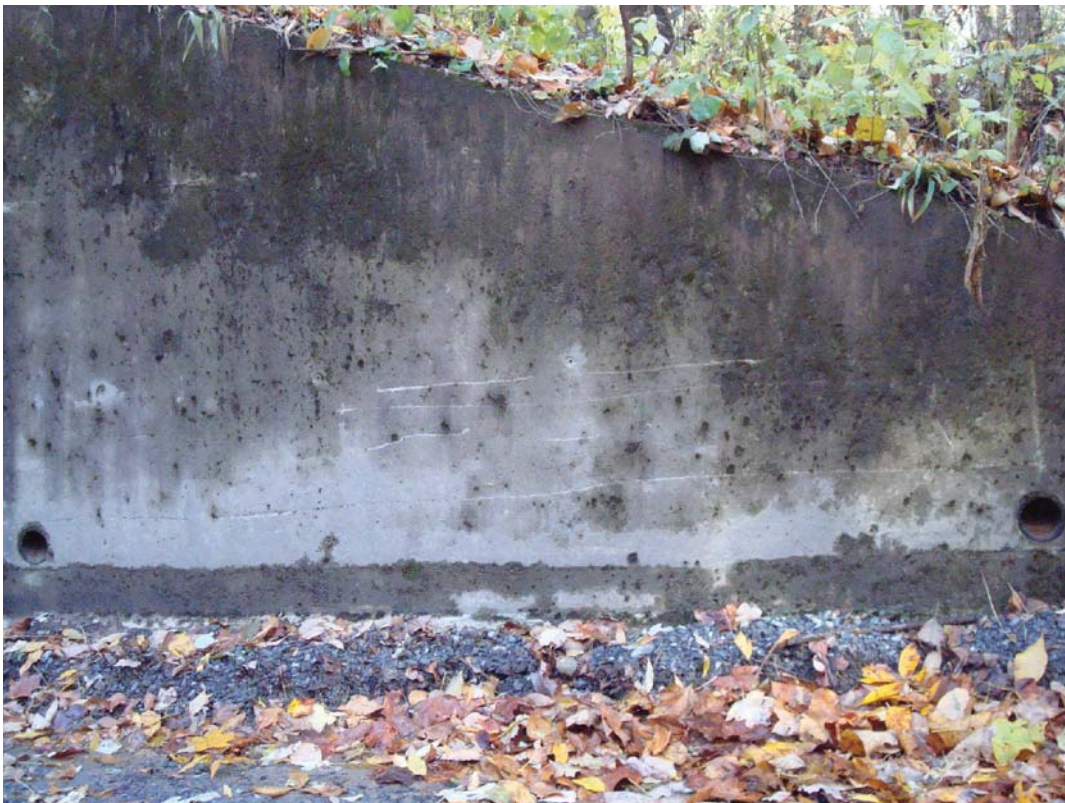
BLRI\_0001DC\_443.142\_L\_1.JPG

<b>Element (Weighting Factor)</b>	<b>Narrative</b>	<b>Condition Rating (0 - 10)</b>
PERFORMANCE 8.00	No global distress	7
WALL FOUNDATION MATERIAL 8.00	Soil, no settlement or erosion.	8
CONCRETE 8.00	Minor pits, minor moss	7
CULVERT 0.50	14 ft W X 12 ft H, concrete	8
ROAD/SIDEWALK/SHOULDER 0.50	Grassy	8
VEGETATION 0.50	Moss, not affecting wall performance	8
WALL DRAINS 1.00	Weep holes, 4" diameter steel, 10.0 ft on center, pipes filled 50% with soil.	5
DOWNSLOPE 1.00	Gravel road	7
LATERAL SLOPE 1.00	Gradual, wooded	7

<b>Wall ID:</b>	BLRI-0001DC-443.142-L		
<b>Route Name:</b>	BLUE RIDGE PARKWAY - BALSAM GAP SUB-DISTRICT		
<b>Inspection Date:</b>	November 06, 2007	<b>Approximate Year Built:</b>	1955
<b>*Wall Rating:</b>	73	<b>Maintenance Action:</b>	Maintenance

<b>Failure Consequence:</b>	MODERATE
<b>Recommendation Narrative:</b>	Clean weep holes - 10 hrs x \$55/hr = \$550
<b>Repair Cost:</b>	\$550
