# BLRI WIP Report

## NPS Retaining Wall Inventory Program Blue Ridge Parkway

Federal Highway Administration  
Eastern Federal Lands Highway Division  
Road Inventory Program (RIP)

# Blue Ridge Parkway in North Carolina and Virginia

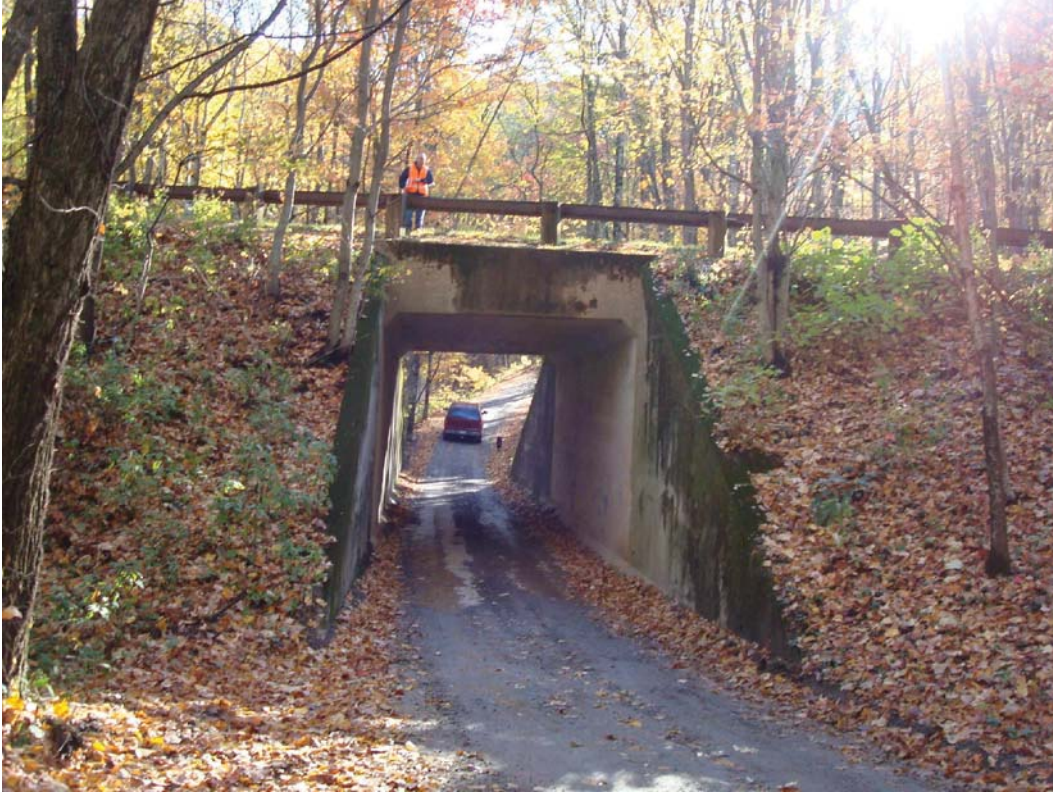
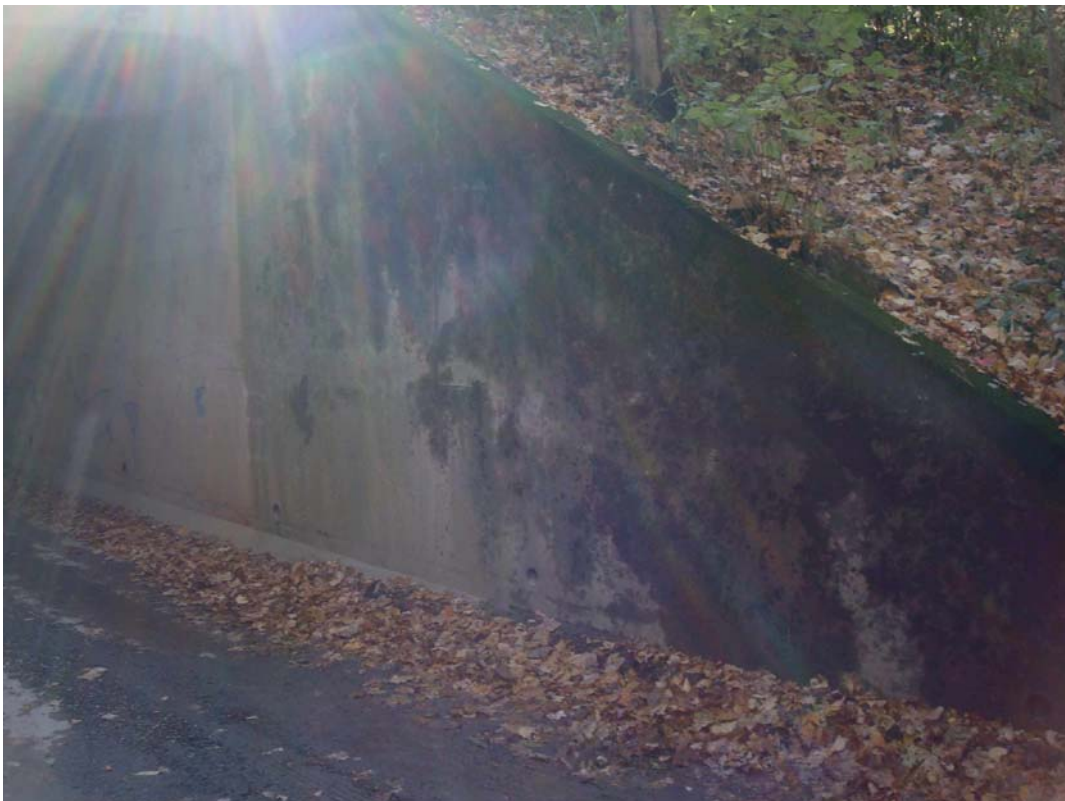
BLRI\_0001DC\_443.142\_R\_1.JPG

<b>Element (Weighting Factor)</b>	<b>Narrative</b>	<b>Condition Rating (0 - 10)</b>
PERFORMANCE 8.00	No global distress	7
WALL FOUNDATION MATERIAL 8.00	Soil, no settlement or erosion.	8
CONCRETE 8.00	Minor pits, minor moss.	7
CULVERT 0.50	Concrete, dimension 14ft W X 12ft H.	8
ROAD/SIDEWALK/SHOULDER 0.50	Grassy	8
VEGETATION 0.50	Moss on wall face, not affecting wall performance	8
WALL DRAINS 1.00	Weep holes, 4" diameter steel, 10.0 ft on center, pipes filled 50% with soil.	5
DOWNSLOPE 1.00	Gravel roadway, flat	7
LATERAL SLOPE 1.00	Gradual, wooded.	7

<b>Wall ID:</b>	BLRI-0001DC-443.142-R		
<b>Route Name:</b>	BLUE RIDGE PARKWAY - BALSAM GAP SUB-DISTRICT		
<b>Inspection Date:</b>	November 06, 2007	<b>Approximate Year Built:</b>	1955
<b>*Wall Rating:</b>	73	<b>Maintenance Action:</b>	Maintenance

<b>Failure Consequence:</b>	MODERATE
<b>Recommendation Narrative:</b>	Clean weep holes - 10 hrs x \$55/hr = \$550
<b>Repair Cost:</b>	\$550

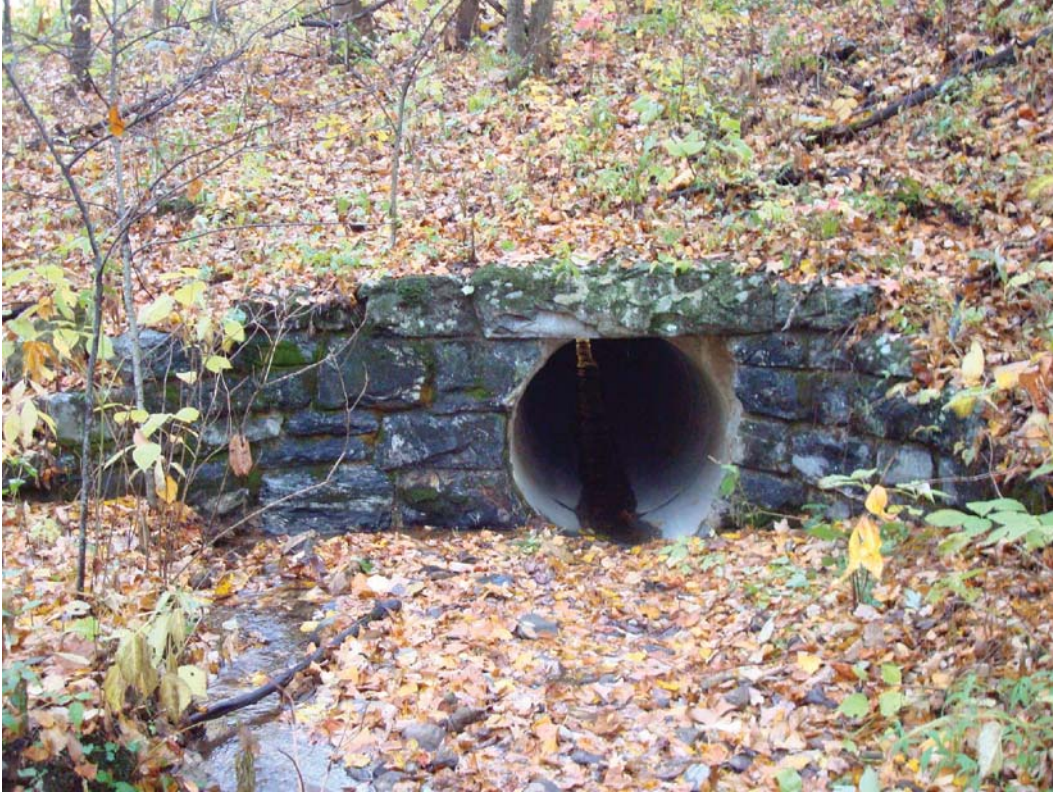
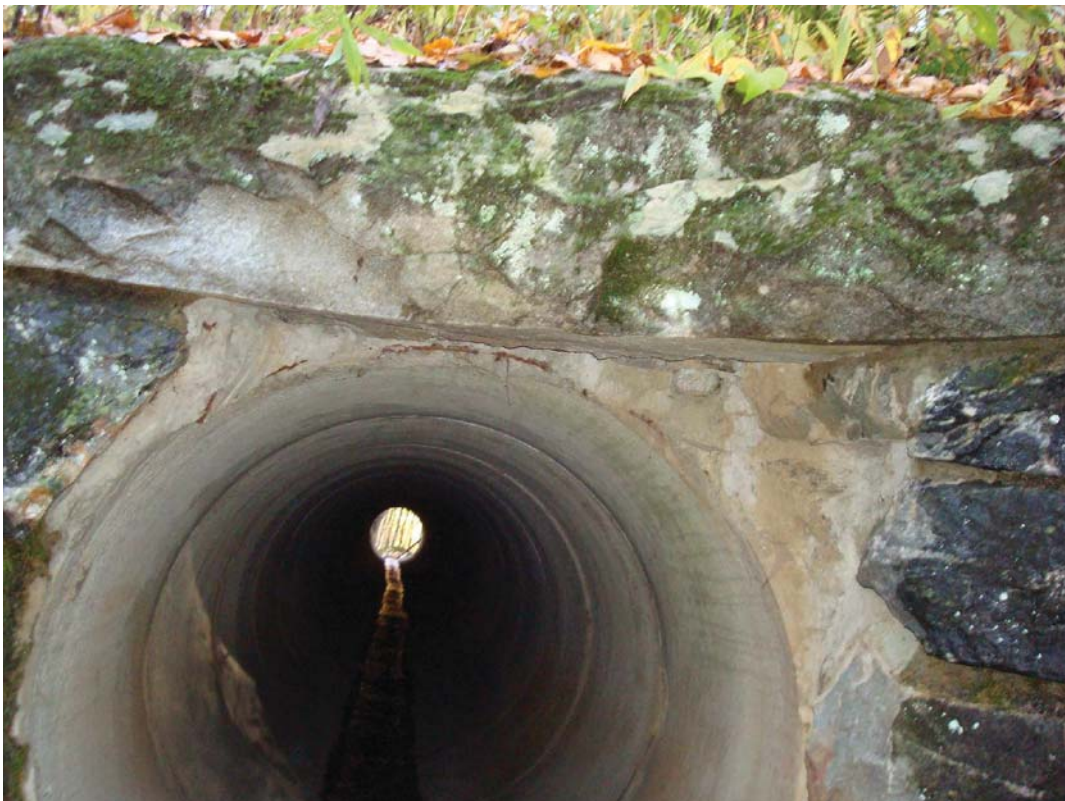
BLRI\_0001DC\_443.446\_L\_1.JPG

<b>Element (Weighting Factor)</b>	<b>Narrative</b>	<b>Condition Rating (0 - 10)</b>
PERFORMANCE 8.00	No global distress, high degree of local distress, evidence of replaced wall.	6
WALL FOUNDATION MATERIAL 8.00	Soil, no evidence of settlement, slight undermining, erosion down stream with evidence of past failure.	5
MORTAR 8.00	Sound and durable, moss covered.	7
STONE MASONRY 8.00	No distress, moss covered.	7
DOWNSLOPE 1.00	Rocky and steep for a short distance, riprap, undermined in the past and failed/eroded at sides	5
WALL DRAINS 1.00	Erosion around top and sides of the head wall.	6
CULVERT 1.00	5 ft concrete culvert, one segment 4 ft long separated from culvert, repaired the wall since then.	7
LATERAL SLOPE 1.00	Gradual, wooded	7
UPSLOPE 1.00	2H:1V, wooded.	7

<b>Wall ID:</b>	BLRI-0001DC-443.446-L		
<b>Route Name:</b>	BLUE RIDGE PARKWAY - BALSAM GAP SUB-DISTRICT		
<b>Inspection Date:</b>	November 06, 2007	<b>Approximate Year Built:</b>	1955
<b>*Wall Rating:</b>	63	<b>Maintenance Action:</b>	Repair Elements

<b>Failure Consequence:</b>	LOW
<b>Recommendation Narrative:</b>	Remove 4" diameter tree at top of wall - \$955. Riprap downstream and on back and sides of culvert - 30' x 20' x 2' + 2' x 10' x 2' = 45 cy, 45 cy x \$200/cy = \$9,000. Erosion control geotextile - 30' x 20' + 2' x 10', 69 sy x \$5/sy = 4345. Backhoe - \$150/hr + Dump T
<b>Repair Cost:</b>	\$16,800

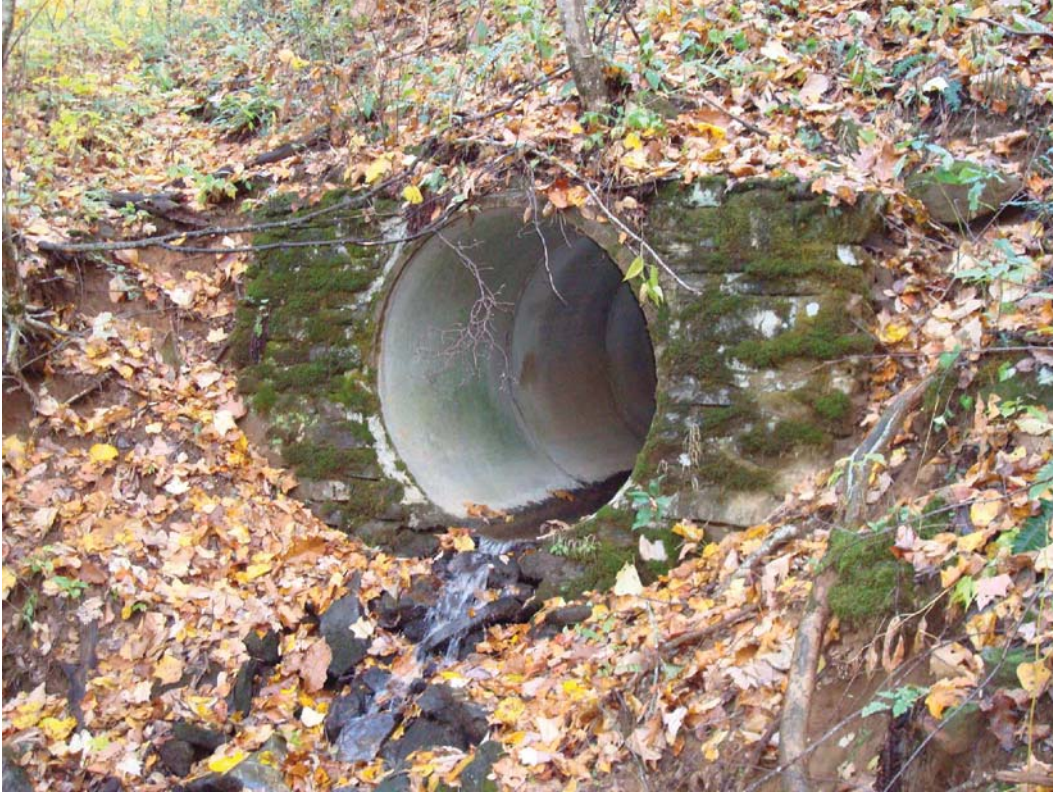
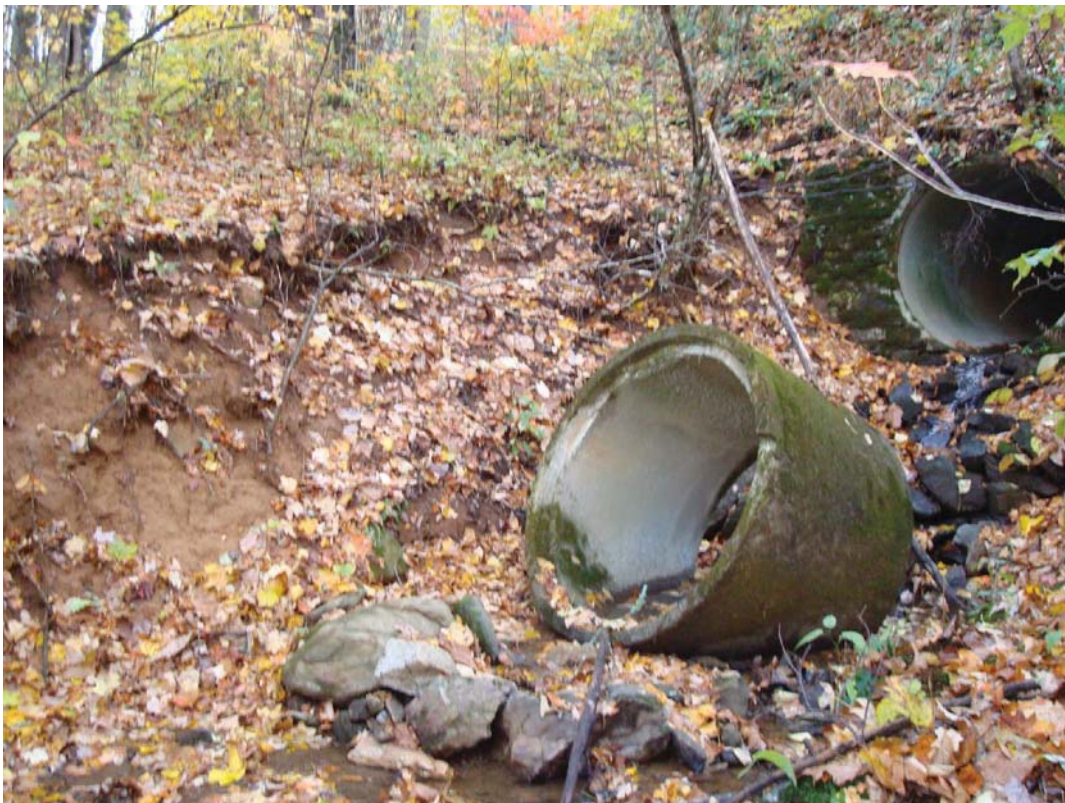
BLRI\_0001DC\_443.446\_R\_1.JPG

<b>Element (Weighting Factor)</b>	<b>Narrative</b>	<b>Condition Rating (0 - 10)</b>
PERFORMANCE 8.00	No evidence of global distress.	7
WALL FOUNDATION MATERIAL 8.00	No evidence of settlement, slight erosion.	7
MORTAR 8.00	Evidence of previous patching	6
STONE MASONRY 8.00	Chipped are 2' long and 6" high	7
CULVERT 0.50	5 ft diameter circular concrete	8
VEGETATION 0.50	Some moss.	8
DOWNSLOPE 1.00	Gradual, stream bed.	7
LATERAL SLOPE 1.00	Gradual south side, steep north side, wooded.	7
UPSLOPE 1.00	4H:1V, wooded.	7

<b>Wall ID:</b>	BLRI-0001DC-443.446-R		
<b>Route Name:</b>	BLUE RIDGE PARKWAY - BALSAM GAP SUB-DISTRICT		
<b>Inspection Date:</b>	November 06, 2007	<b>Approximate Year Built:</b>	1955
<b>*Wall Rating:</b>	68	<b>Maintenance Action:</b>	No Action

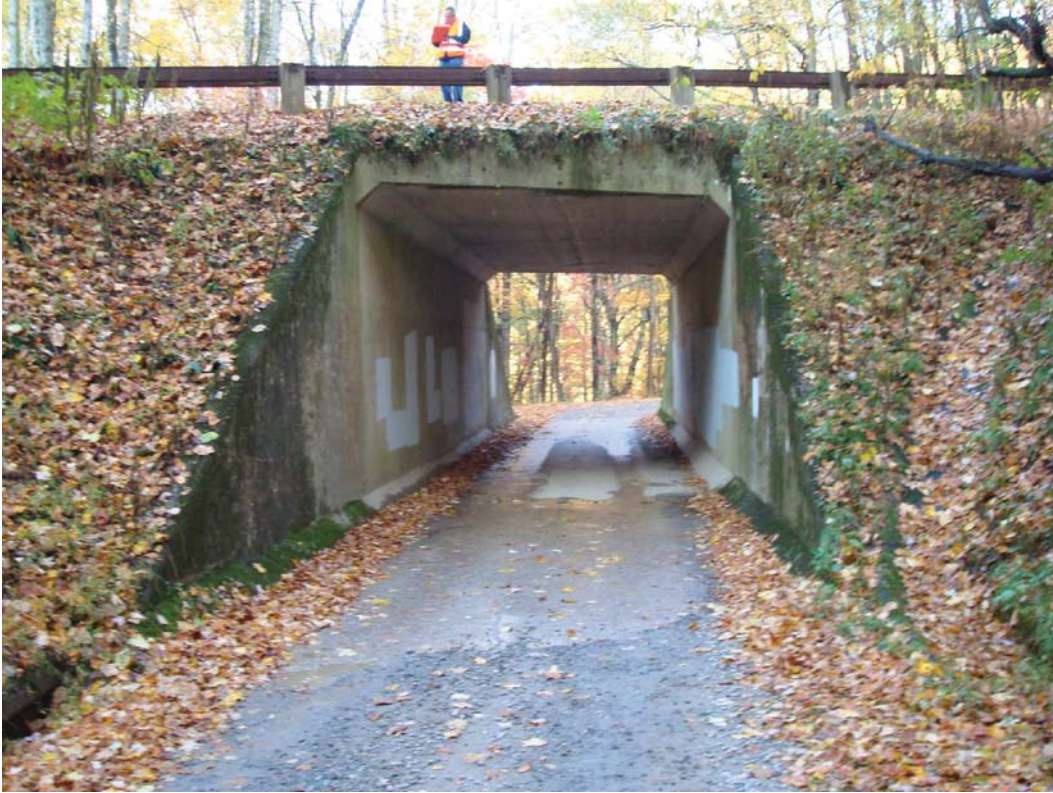
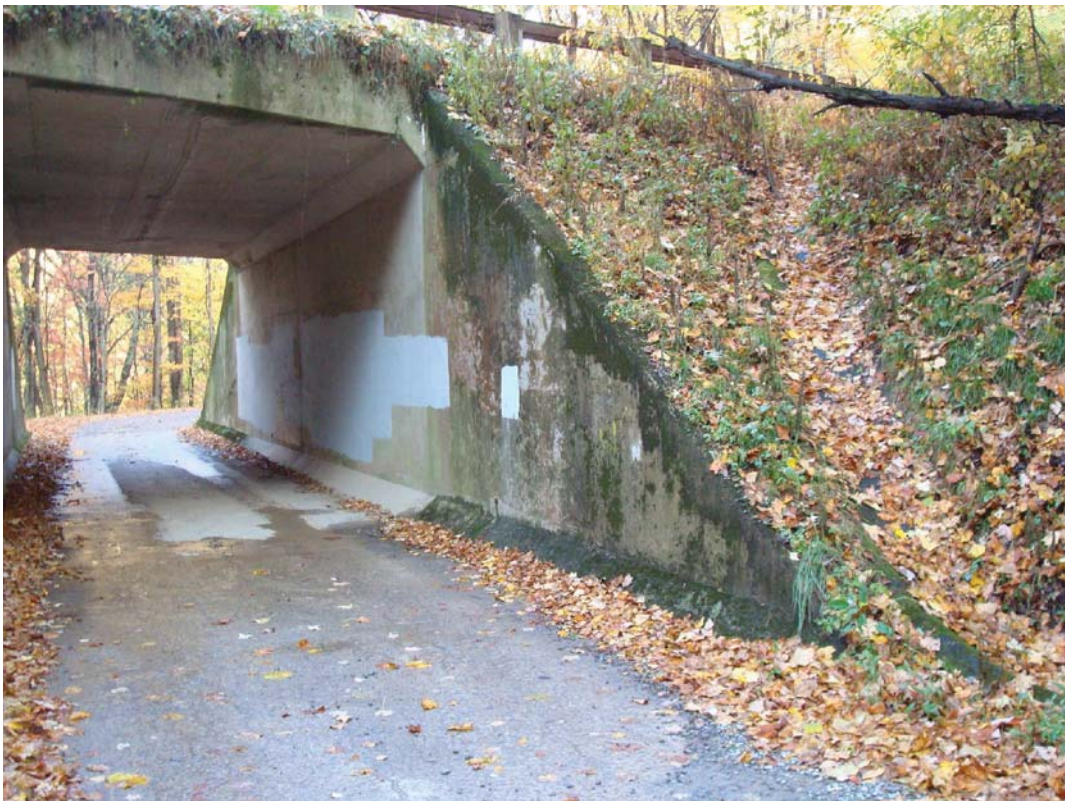
BLRI\_0001DC\_445.511\_R\_1.JPG

<b>Element (Weighting Factor)</b>	<b>Narrative</b>	<b>Condition Rating (0 - 10)</b>
PERFORMANCE 8.00	No evidence of global distress.	7
WALL FOUNDATION MATERIAL 8.00	Soil, no evidence of settlement or distress.	7
CONCRETE 8.00	Overall little distress, evidence of patching.	6
DOWNSLOPE 0.50	Flat, gravel road.	8
ROAD/SIDEWALK/SHOULDER 0.50	Covered with grass, no distress	8
VEGETATION 0.50	moss, does not affect structure	8
WALL DRAINS 1.00	One weep hole is plugged on the north side, weep holes 10' on center	6
CULVERT 1.00	Box culvert, 16'W x 14.5'H, concrete slab on bottom, 25'Long wingwalls	7
CURB/BERM/DITCH 1.00	South side asphalt drain to ditch.	7

<b>Wall ID:</b>	BLRI-0001DC-445.511-R		
<b>Route Name:</b>	BLUE RIDGE PARKWAY - BALSAM GAP SUB-DISTRICT		
<b>Inspection Date:</b>	November 06, 2007	<b>Approximate Year Built:</b>	1955
<b>*Wall Rating:</b>	67	<b>Maintenance Action:</b>	No Action

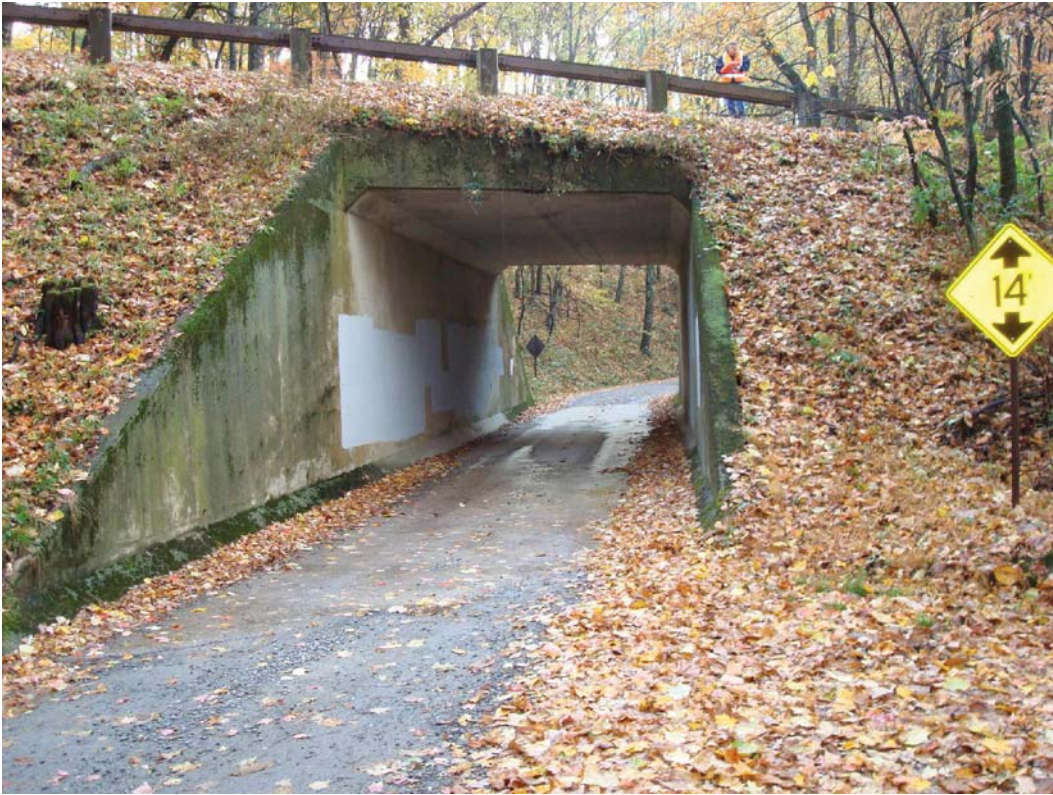
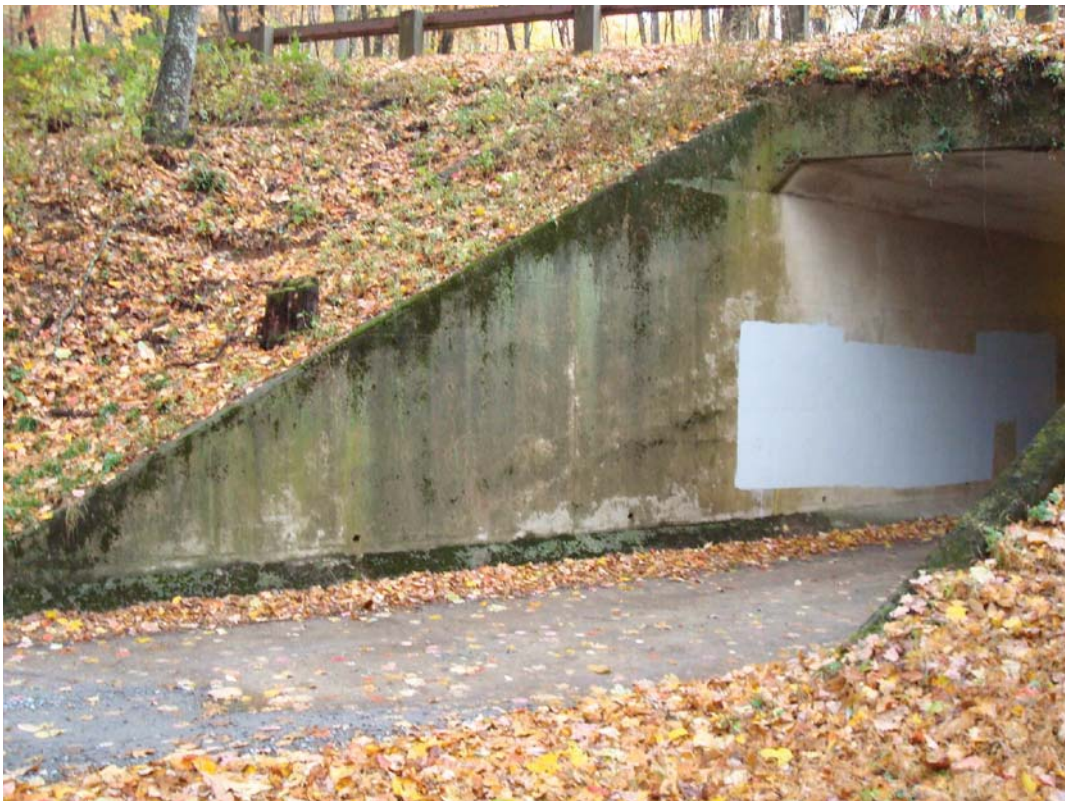
BLRI\_0001DC\_445.516\_L\_1.JPG

<b>Element (Weighting Factor)</b>	<b>Narrative</b>	<b>Condition Rating (0 - 10)</b>
PERFORMANCE 8.00	No global distress	7
WALL FOUNDATION MATERIAL 8.00	Soil, not evidence of settlement or erosion	7
CONCRETE 8.00	Evidence of patching, overall little distress	6
DOWNSLOPE 0.50	Flat, gravel road	8
ROAD/SIDEWALK/SHOULDER 0.50	Covered with grass, no distress.	8
VEGETATION 0.50	Moss, does not affect structure	8
WALL DRAINS 0.50	Weep holes 10 ft center to center, no problem with drainage.	8
CULVERT 1.00	Box culvert 16 ft W X 14.5 ft H, concrete slab, wing walls 25 ft long, good conditions.	7
LATERAL SLOPE 1.00	Gradual wooded	7

<b>Wall ID:</b>	BLRI-0001DC-445.516-L		
<b>Route Name:</b>	BLUE RIDGE PARKWAY - BALSAM GAP SUB-DISTRICT		
<b>Inspection Date:</b>	November 06, 2007	<b>Approximate Year Built:</b>	1955
<b>*Wall Rating:</b>	68	<b>Maintenance Action:</b>	No Action

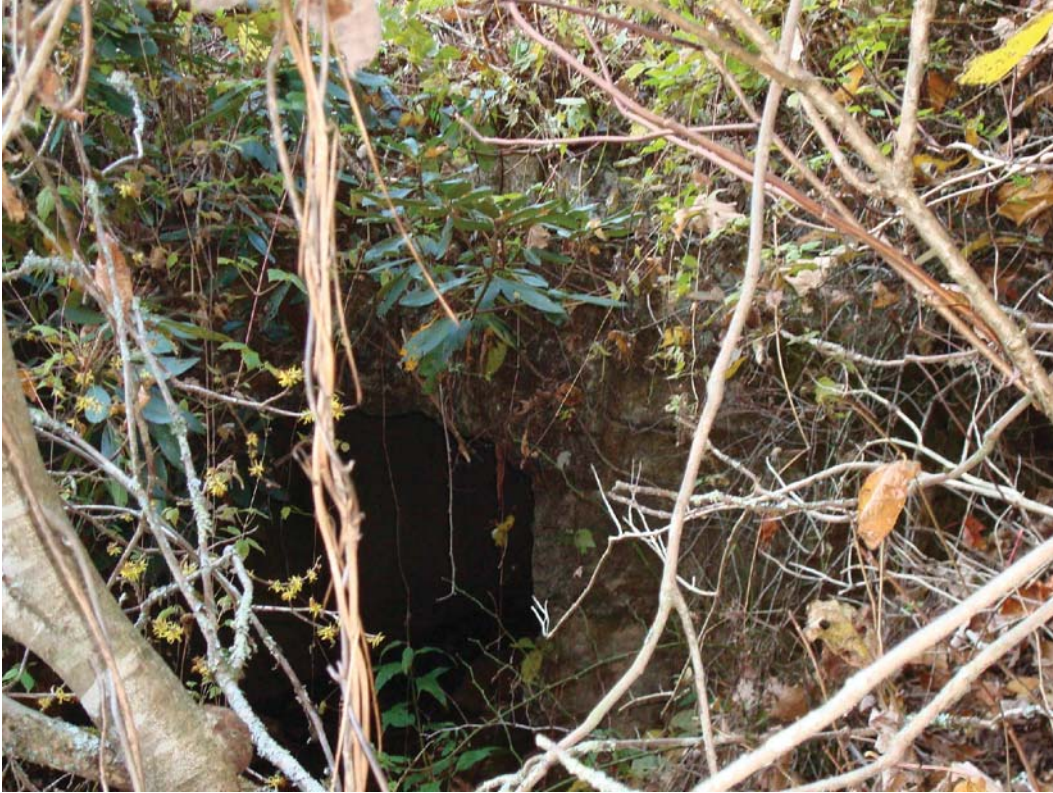
BLRI\_0001DC\_447.346\_L\_1.JPG

<b>Element (Weighting Factor)</b>	<b>Narrative</b>	<b>Condition Rating (0 - 10)</b>
PERFORMANCE 8.00	No global distress, needs minor repointing	7
WALL FOUNDATION MATERIAL 8.00	Soil, no settlement, slight erosion	7
MORTAR 8.00	Frequently missing or chipped - 15%	5
STONE MASONRY 8.00	Good condition, no distress	8
VEGETATION 1.00	Not affecting wall performance, heavy, makes wall inaccessible.	5
CULVERT 1.00	5 ft x 5 ft concrete box	7
DOWNSLOPE 1.00	4H:1V Streambed	7
LATERAL SLOPE 1.00	Gradual slope, wooded	7
UPSLOPE 1.00	3H:1V Grassy	7

<b>Wall ID:</b>	BLRI-0001DC-447.346-L		
<b>Route Name:</b>	BLUE RIDGE PARKWAY - BALSAM GAP SUB-DISTRICT		
<b>Inspection Date:</b>	November 05, 2007	<b>Approximate Year Built:</b>	1955
<b>*Wall Rating:</b>	67	<b>Maintenance Action:</b>	Repair Elements

<b>Failure Consequence:</b>	LOW
<b>Recommendation Narrative:</b>	Repoint mortar - 15 sf x \$75/sf = \$1,125. Clear vegetation - 10 hrs x \$55/hr = \$550
<b>Repair Cost:</b>	\$1,675

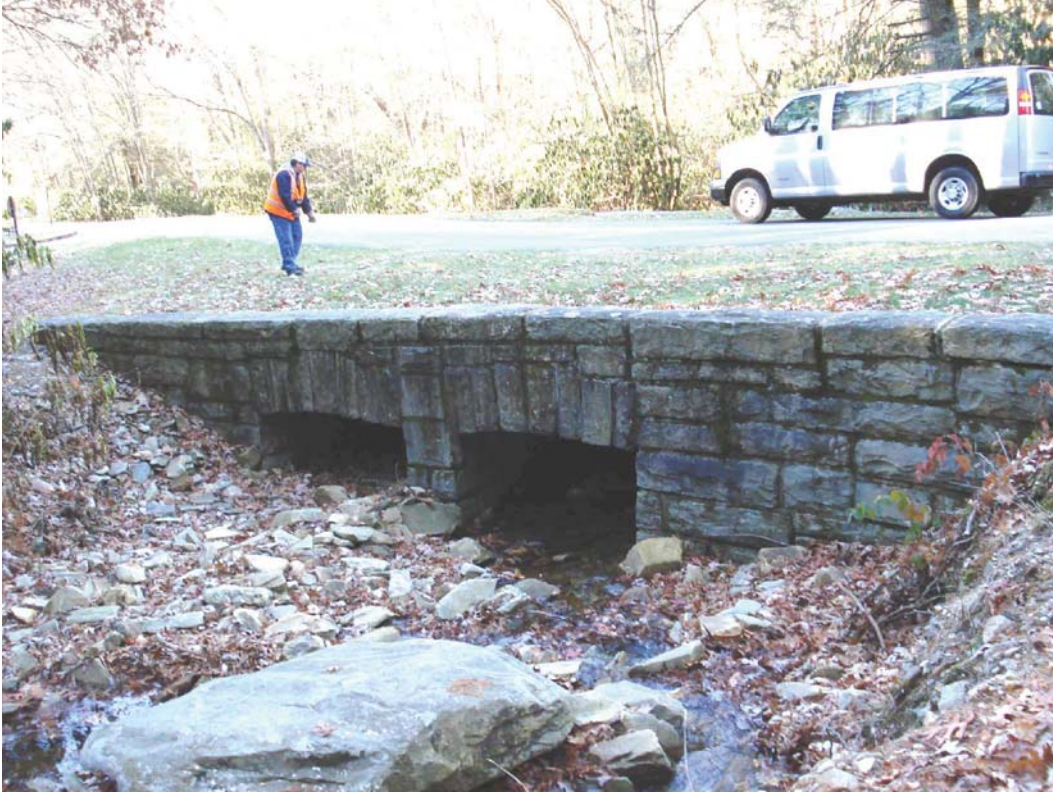
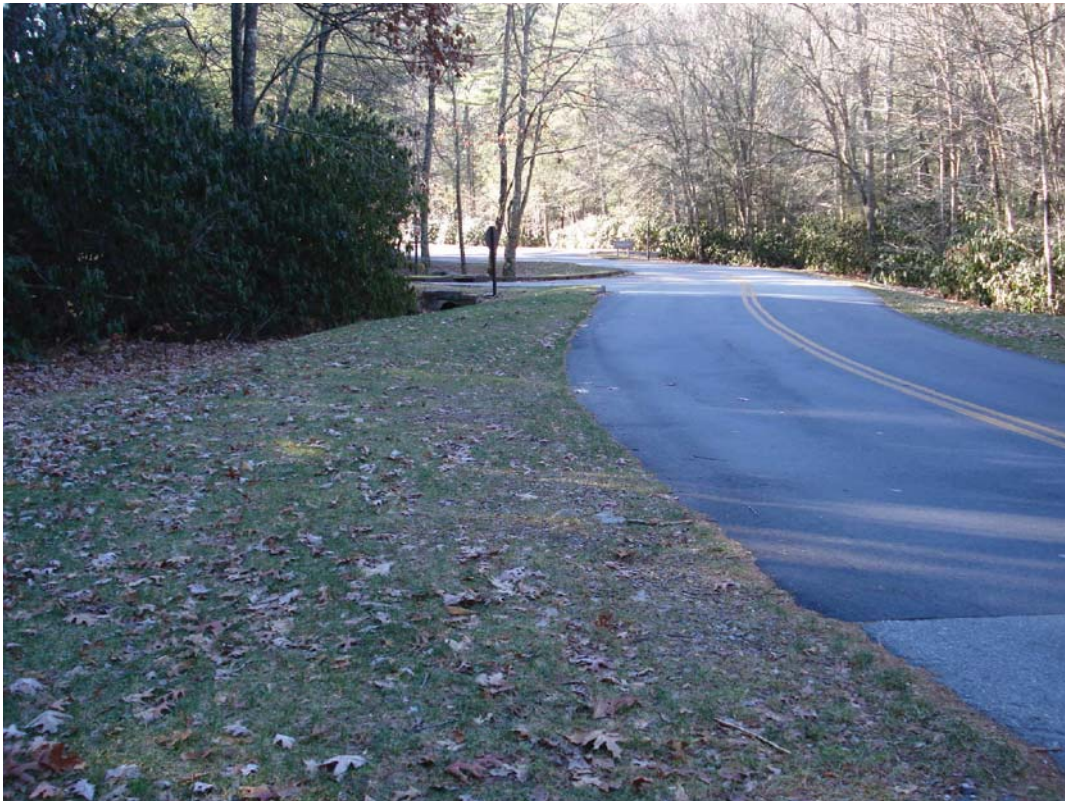
**BLRI\_0212\_1.354\_L\_1.JPG**

**BLRI\_0212\_1.354\_L\_2.JPG**

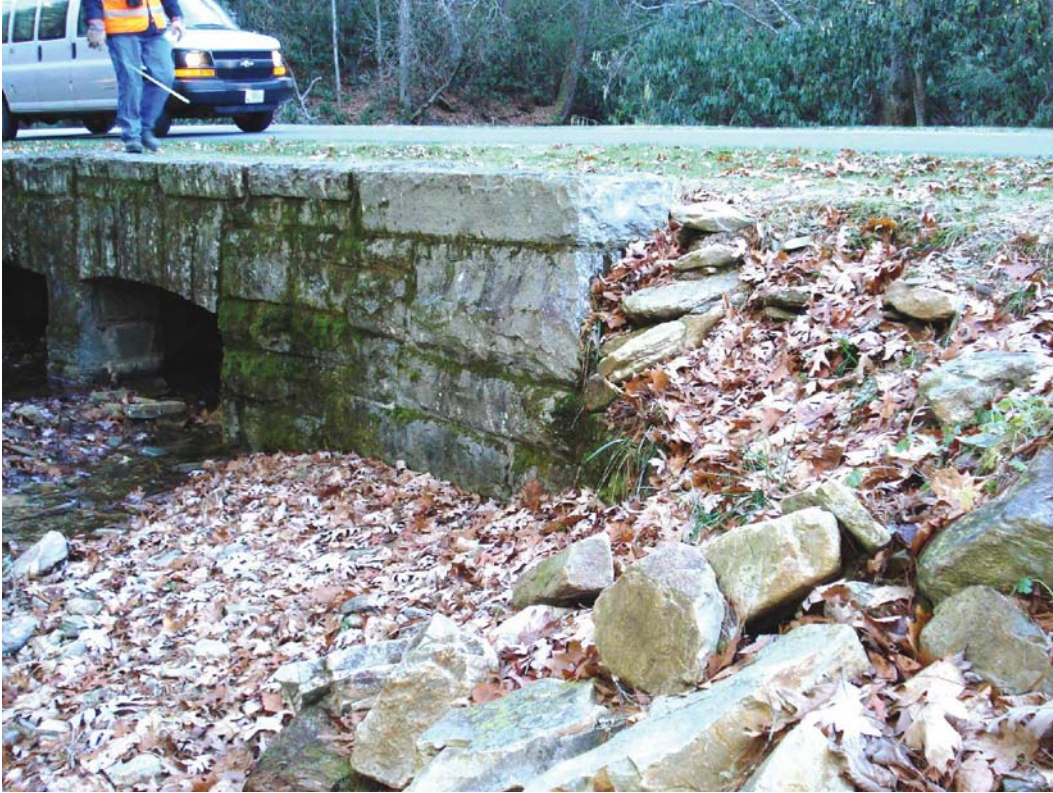
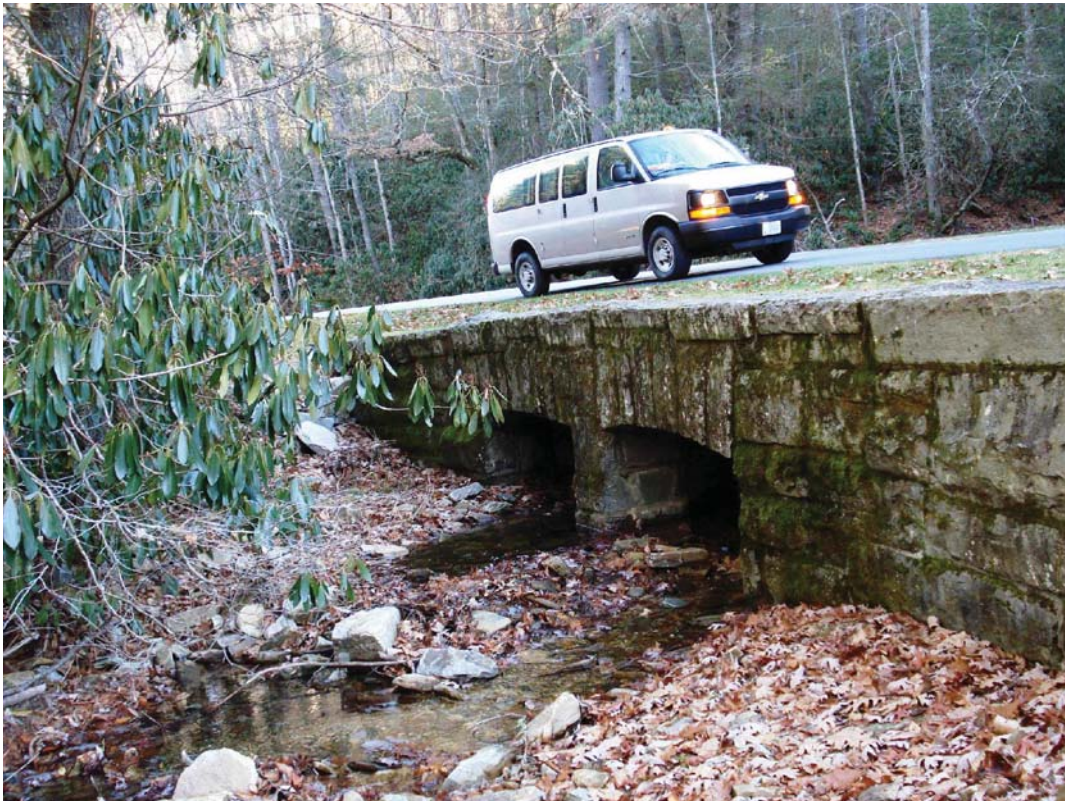
**BLRI\_0212\_1.360\_R\_1.JPG**

**BLRI\_0212\_1.360\_R\_2.JPG**

<b>Wall ID:</b>	BLRI-0212-1.360-R		
<b>Route Name:</b>	LINVILLE RIVER SPUR ROAD		
<b>Inspection Date:</b>	November 28, 2007	<b>Approximate Year Built:</b>	Unknown
<b>*Wall Rating:</b>	70	<b>Maintenance Action:</b>	No Action

<b>Element (Weighting Factor)</b>	<b>Narrative</b>	<b>Condition Rating (0 - 10)</b>
PERFORMANCE 8.00	No global distress	7
WALL FOUNDATION MATERIAL 8.00	Soil, no observed settlement or cracks	7
MORTAR 8.00	Some moss	7
STONE MASONRY 8.00	Minor cracks, some moss, cast in place	7
ROAD/SIDEWALK/SHOULDER 0.50	Grassed shoulder, no distress	8
UPSLOPE 0.50	Gently sloping, no distress, vegetated	8
WALL DRAINS 0.50	No observed drainage problems	8
CULVERT 1.00	2 concrete box culverts, 8'W x 4'H each, good condition	7
DOWNSLOPE 1.00	Heavily wooded, no distress, does not affect wall performance	7

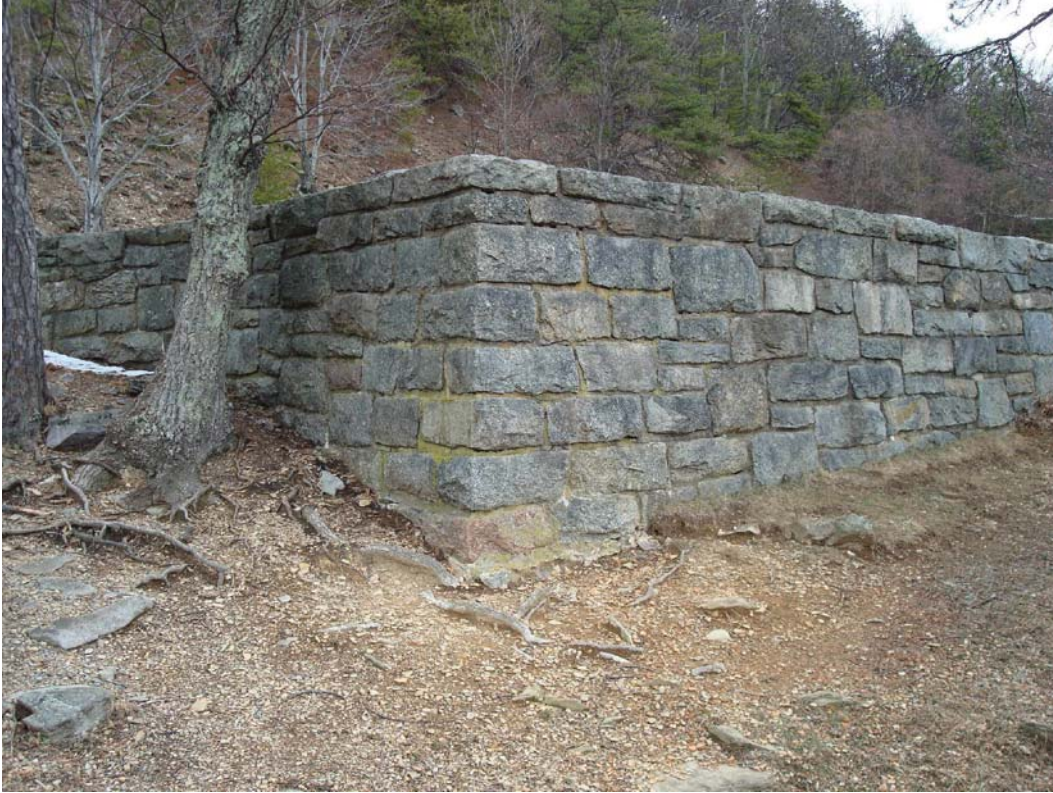
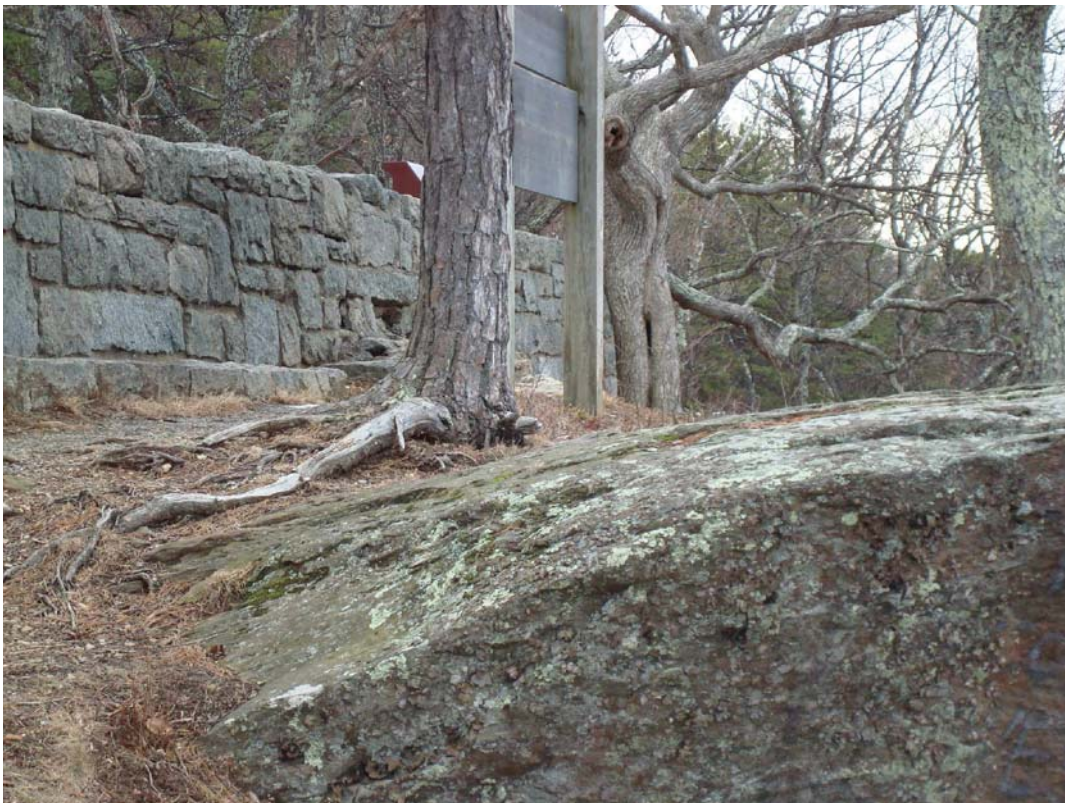
**BLRI\_0910\_0.000\_P1\_1.JPG**

**BLRI\_0910\_0.000\_P1\_2.JPG**

<b>Wall ID:</b>	BLRI-0910-0.000-P1		
<b>Route Name:</b>	20-MINUTE CLIFF OVERLOOK		
<b>Inspection Date:</b>	January 29, 2008	<b>Approximate Year Built:</b>	1940
<b>*Wall Rating:</b>	61	<b>Maintenance Action:</b>	Repair Elements

<b>Element (Weighting Factor)</b>	<b>Narrative</b>	<b>Condition Rating (0 - 10)</b>
PERFORMANCE 8.00	No global distress. Isolated wall facing failure from former picnic table location	5
WALL FOUNDATION MATERIAL 8.00	Bedrock.	7
MORTAR 8.00	Significant cracking some missing pieces.	5
STONE MASONRY 8.00	No degradation.	7
LATERAL SLOPE 1.00	Flat.	7
ROAD/SIDEWALK/SHOULDER 1.00	Paved sidewalk.	7
UPSLOPE 1.00	Flat bedrock for 25' and then cliff.	7
WALL DRAINS 1.00	None observed.	7

<b>Failure Consequence:</b>	LOW
<b>Recommendation Narrative:</b>	Replace stones 6'x3' - 18 S.F. * \$650 /S.F. = \$11,700. Repoint mortar - 290 S.F. * \$75/S.F. = \$21,750
<b>Repair Cost:</b>	\$33,450

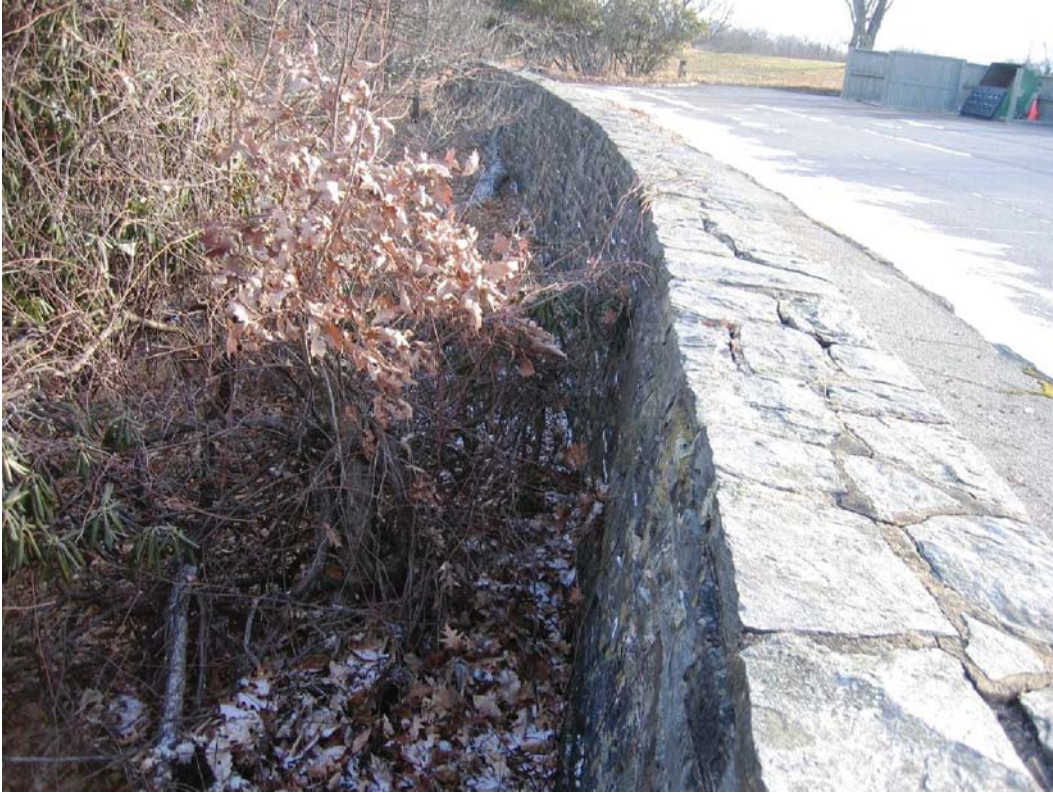
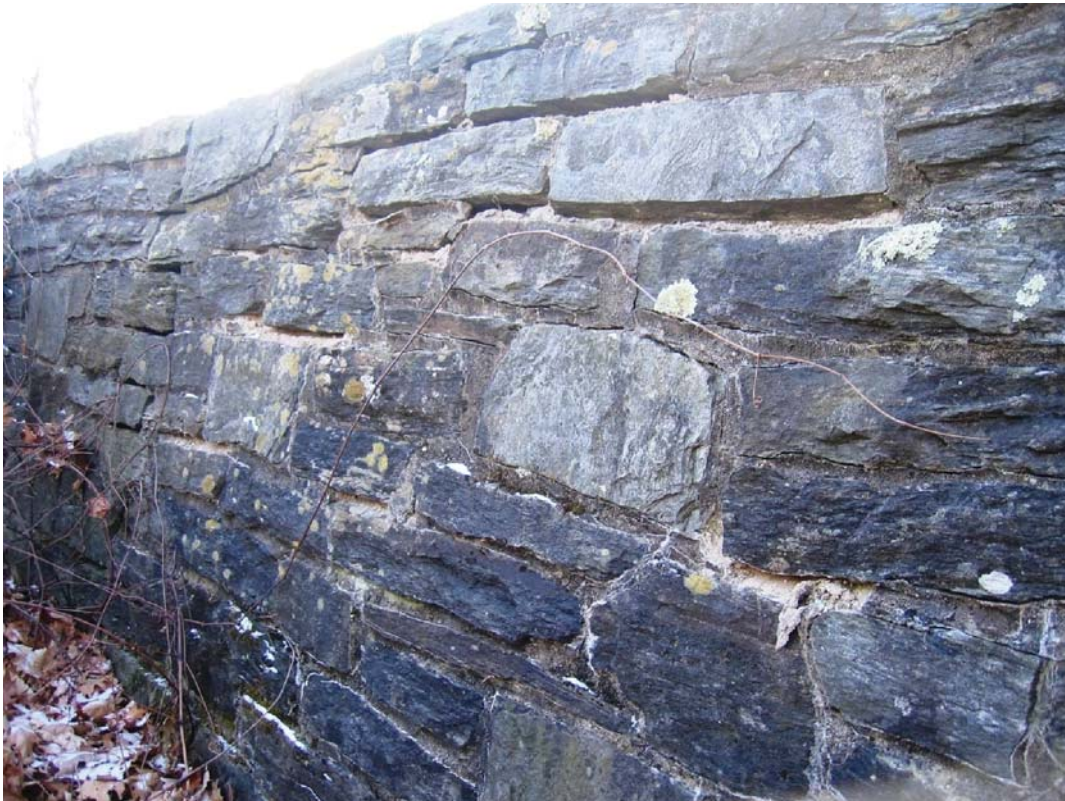
**BLRI\_1010\_0.000\_P1\_1.jpg**

**BLRI\_1010\_0.000\_P1\_2.jpg**

<b>Wall ID:</b>	BLRI-1010-0.000-P1		
<b>Route Name:</b>	BLUFFS RESTAURANT PARKING		
<b>Inspection Date:</b>	December 05, 2007	<b>Approximate Year Built:</b>	1940
<b>*Wall Rating:</b>	64	<b>Maintenance Action:</b>	Repair Elements

<b>Element (Weighting Factor)</b>	<b>Narrative</b>	<b>Condition Rating (0 - 10)</b>
PERFORMANCE 8.00	No signs of global instability. Structure is suffering weathering of mortar joints.	6
WALL FOUNDATION MATERIAL 8.00	Obscured by leaves/trees. Gentle toe slope with no signs of erosion/settlement.	8
MORTAR 8.00	Mortar is highly weathered and /or missing in ~ 20% of wall area; mostly near top of wall in the parapet. Rest of mortar is weathered and cracked, but intact and functioning.	3
STONE MASONRY 8.00	Hard, durable, no signs of cracking, no missing blocks.	8
CULVERT 0.50	Small drain outlets that appear to be functioning. No downslope erosion problems/tough to see due to leaves.	8
ROAD/SIDEWALK/SHOULDER 0.50	No apparent problems associated with wall, but observed by leaves at many locations.	8
DOWNSLOPE 0.50	Very gentle, stable downslope with trees and shrubs.	9
LATERAL SLOPE 0.50	Very gentle side slopes with no signs of distress.	9

<b>Failure Consequence:</b>	MODERATE
<b>Recommendation Narrative:</b>	Repoint approximately 20% of the wall, mostly the parapet section: Repoint 20% of wall area @ \$75 per sq. ft. by ~ 480 sq. ft. of wall = \$36,000.00
<b>Repair Cost:</b>	\$36,000

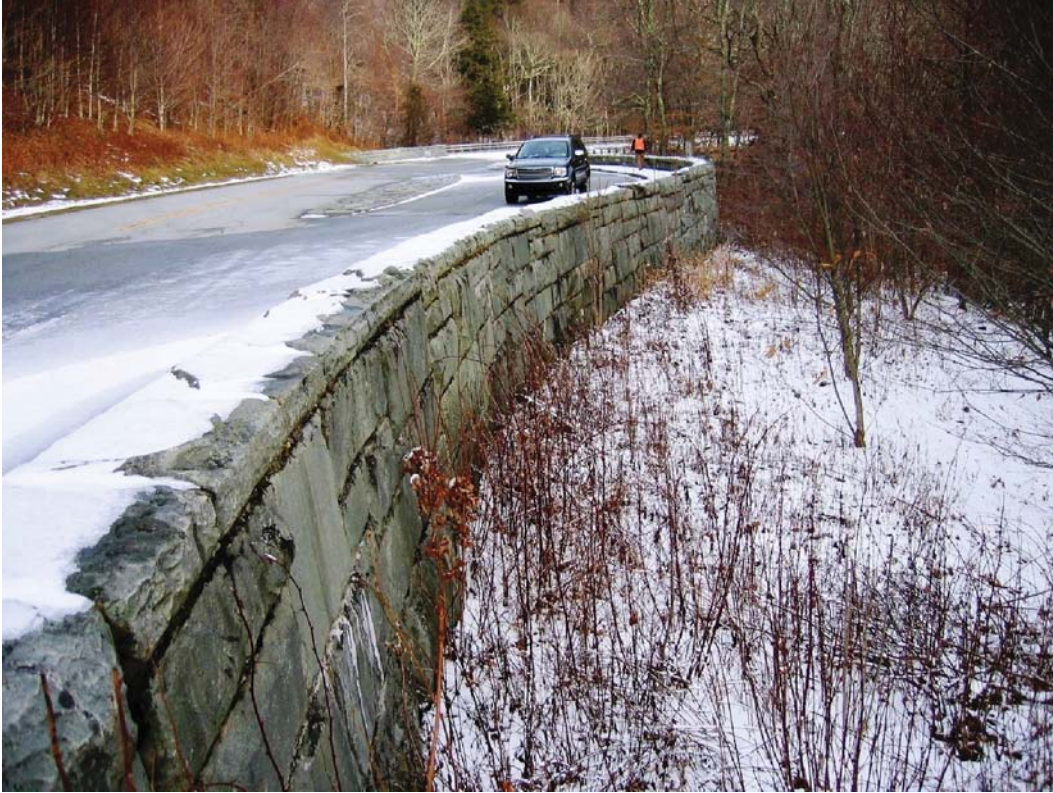
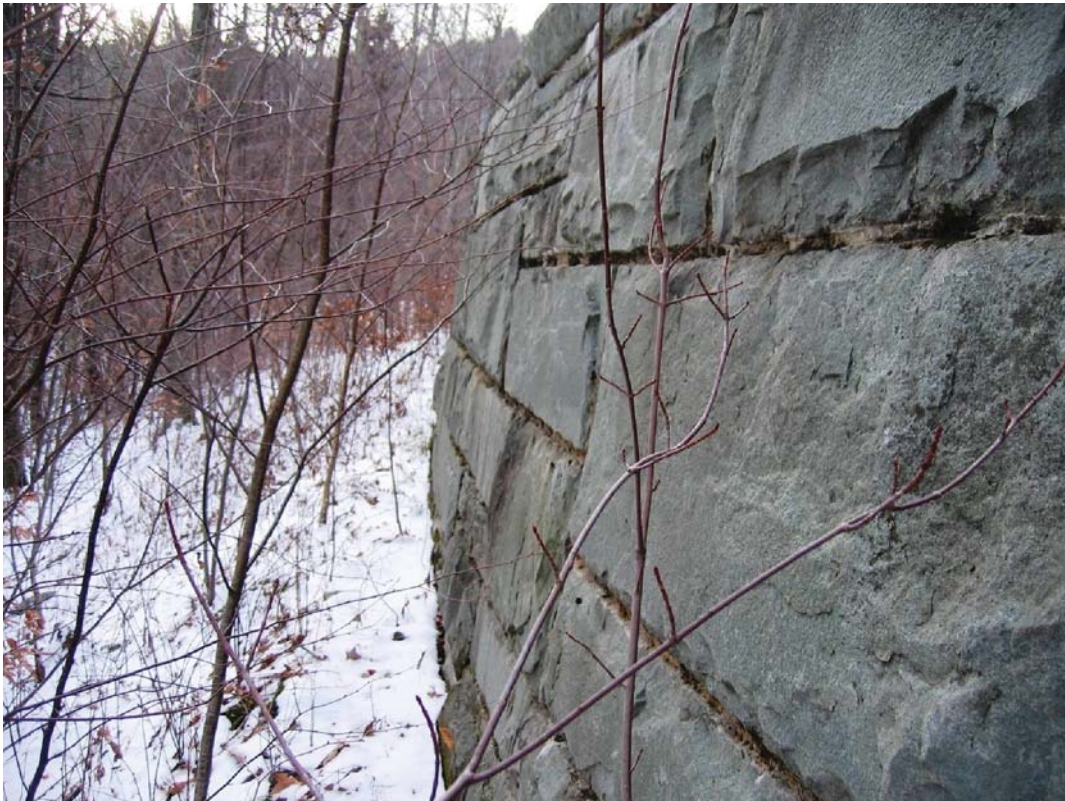
**BLRI\_1049\_0.000\_P1\_1.jpg**

**BLRI\_1049\_0.000\_P1\_2.jpg**

<b>Wall ID:</b>	BLRI-1049-0.000-P1		
<b>Route Name:</b>	WILSON CREEK OVERLOOK		
<b>Inspection Date:</b>	December 06, 2007	<b>Approximate Year Built:</b>	Unknown
<b>*Wall Rating:</b>	90	<b>Maintenance Action:</b>	No Action

<b>Element (Weighting Factor)</b>	<b>Narrative</b>	<b>Condition Rating (0 - 10)</b>
PERFORMANCE 8.00	Excellent wall performance; like new. No global or structural distress.	9
WALL FOUNDATION MATERIAL 8.00	No sign of settlement or erosion. Good bearing.	9
MORTAR 8.00	Hard, durable, intact with minor shrinkage cracking. None missing. Very good condition.	9
STONE MASONRY 8.00	Hard, durable, well-cut /placed stone with no missing / cracked blocks. Very good condition.	9
DOWNSLOPE 0.50	Well constructed bench, well vegetated stable slope with no erosion or slumping.	9
LATERAL SLOPE 0.50	Very stable rock buttressed upstation side slope. Stable soil slope at downstation end.	9
ROAD/SIDEWALK/SHOULDER 0.50	Snow covered. No apparent settlement/displacement.	9
TRAFFIC BARRIER/FENCE 0.50	Mortared stone masonry guardwall shows no distress due to wall settlement.	9
WALL DRAINS 0.50	Open,frequent minor seepage through wall.	9

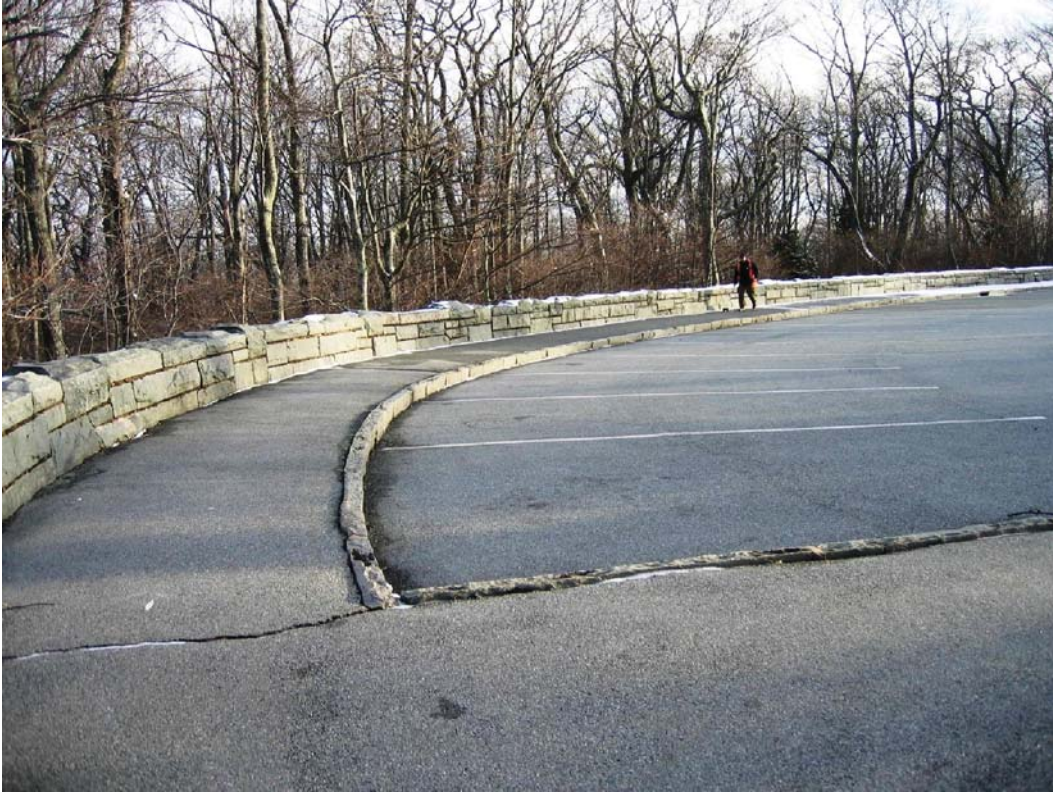
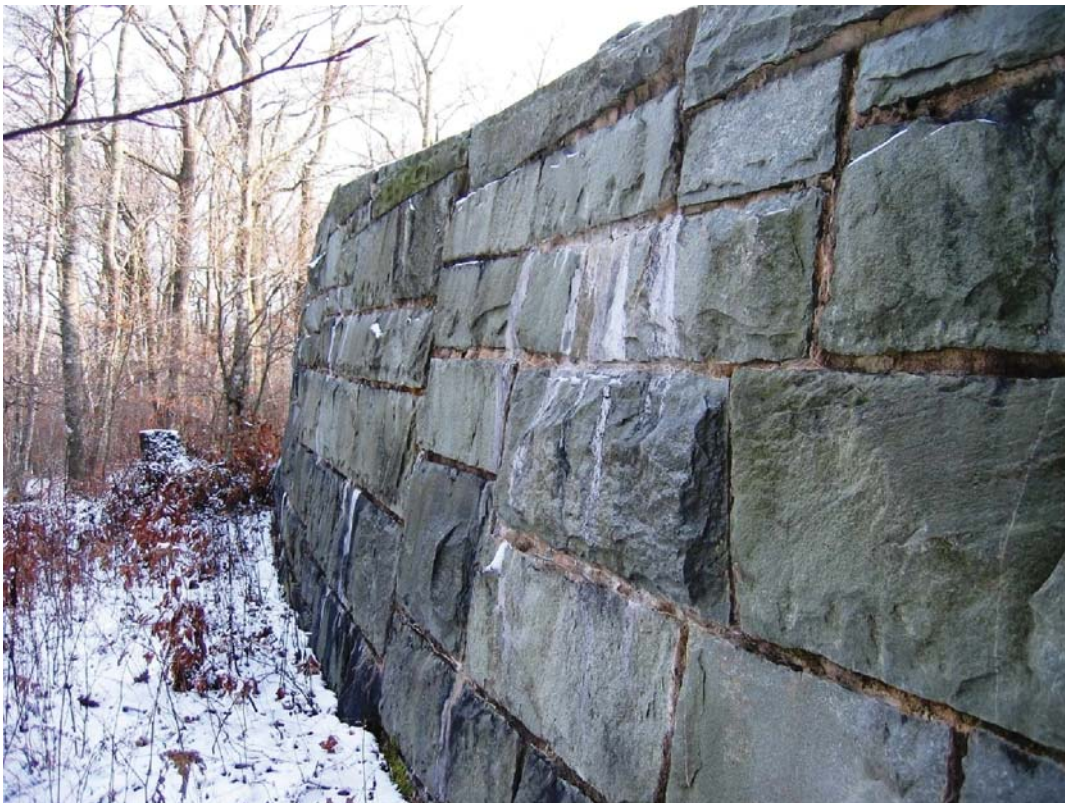
**BLRI\_1051\_0.000\_P1\_1.jpg**

**BLRI\_1051\_0.000\_P1\_2.jpg**

<b>Wall ID:</b>	BLRI-1051-0.000-P1		
<b>Route Name:</b>	LINN COVE VISITOR CENTER PARKING		
<b>Inspection Date:</b>	December 06, 2007	<b>Approximate Year Built:</b>	Unknown
<b>*Wall Rating:</b>	87	<b>Maintenance Action:</b>	No Action

<b>Element (Weighting Factor)</b>	<b>Narrative</b>	<b>Condition Rating (0 - 10)</b>
PERFORMANCE 8.00	Excellent condition. No signs of distress.	9
WALL FOUNDATION MATERIAL 8.00	No signs of settlement/erosion. Good bearing material.	8
MORTAR 8.00	Shrinkage cracking evident, particularly in upper courses. No missing mortar. Generally, hard, durable, intact.	8
STONE MASONRY 8.00	Hard, durable, fresh. No cracked or missing stone. Excellent condition.	10
ROAD/SIDEWALK/SHOULDER 0.50	Snow covered. No signs of fill settlement or cracking.	8
TRAFFIC BARRIER/FENCE 0.50	Mortared masonry stone parapet showed no wall related distress. Minor mortar cracking.	8
WALL DRAINS 0.50	Open, frequent. Minor seepage through cracked mortar. No drainage issues.	8
DOWNSLOPE 0.50	Well vegetated stable slope. No slumping or eroded areas. Good wall bench.	9
LATERAL SLOPE 0.50	Gentle, stable end slopes. No sign of erosion/slumping.	9
