# BLRI WIP Report

## NPS Retaining Wall Inventory Program Blue Ridge Parkway

Federal Highway Administration  
Eastern Federal Lands Highway Division  
Road Inventory Program (RIP)

# Blue Ridge Parkway in North Carolina and Virginia

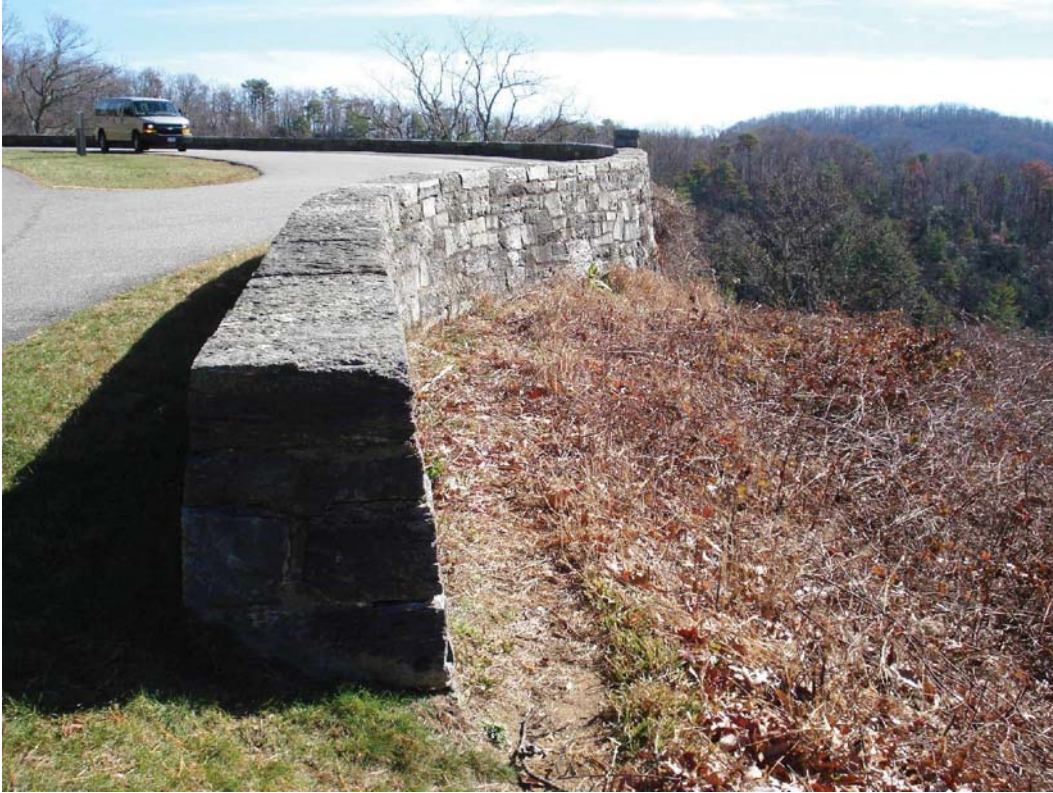
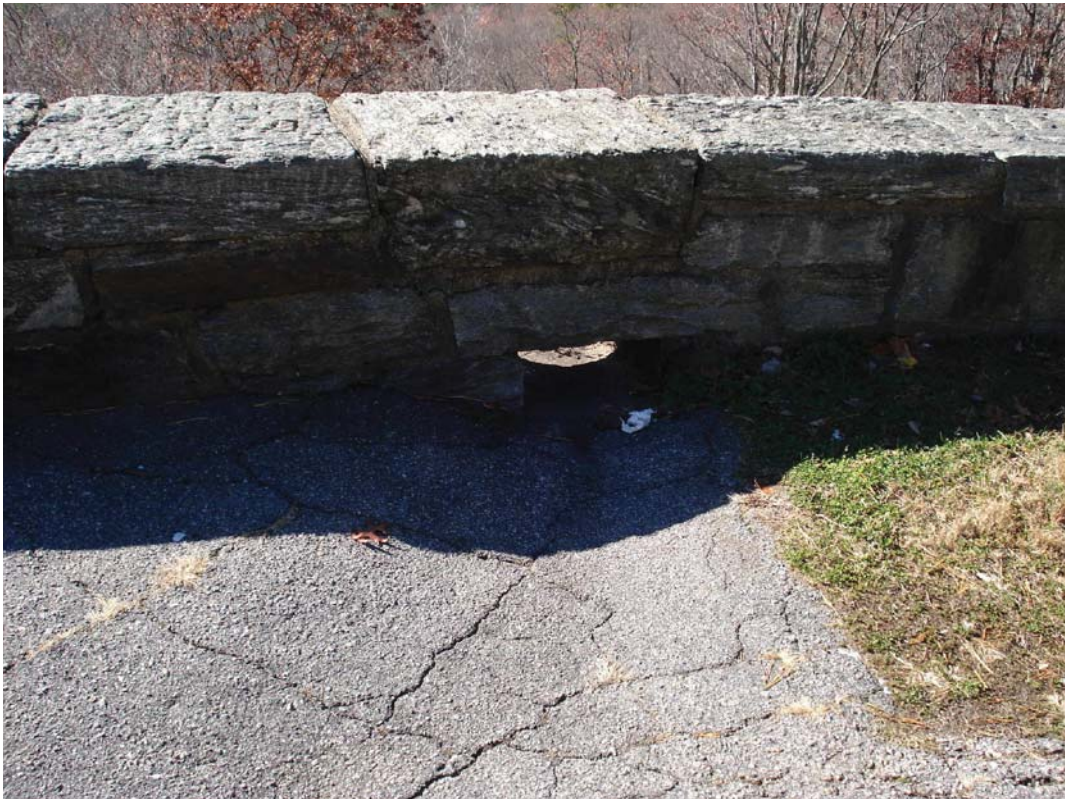
BLRI\_1066\_0.000\_P1\_1.JPG

BLRI\_1066\_0.000\_P1\_2.JPG

<b>Wall ID:</b>	BLRI-1066-0.000-P1		
<b>Route Name:</b>	BEAR DEN OVERLOOK		
<b>Inspection Date:</b>	November 28, 2007	<b>Approximate Year Built:</b>	Unknown
<b>*Wall Rating:</b>	75	<b>Maintenance Action:</b>	Maintenance

<b>Element (Weighting Factor)</b>	<b>Narrative</b>	<b>Condition Rating (0 - 10)</b>
PERFORMANCE 8.00	Good performance, no global distress	7
WALL FOUNDATION MATERIAL 8.00	Soil, no evidence of settlement or distress	8
STONE MASONRY 8.00	Good condition, some vegetation, minor cracks	7
MORTAR 8.00	Good condition, minor deterioration	8
ROAD/SIDEWALK/SHOULDER 0.50	Grass shoulder, no distress. Paved sidewalk some distress not related to wall distress	8
WALL DRAINS 0.50	3-4 weepholes. No drainage-related problems	8
DOWNSLOPE 1.00	Steep slope, heavily wooded, no distress	7
LATERAL SLOPE 1.00	Steep slope, heavily wooded, no distress	7
VEGETATION 1.00	Steep slope, heavily wooded, no distress	7

<b>Failure Consequence:</b>	HIGH
<b>Recommendation Narrative:</b>	Clear vegetation - 10 hrs x \$55/hr = \$550
<b>Repair Cost:</b>	\$550

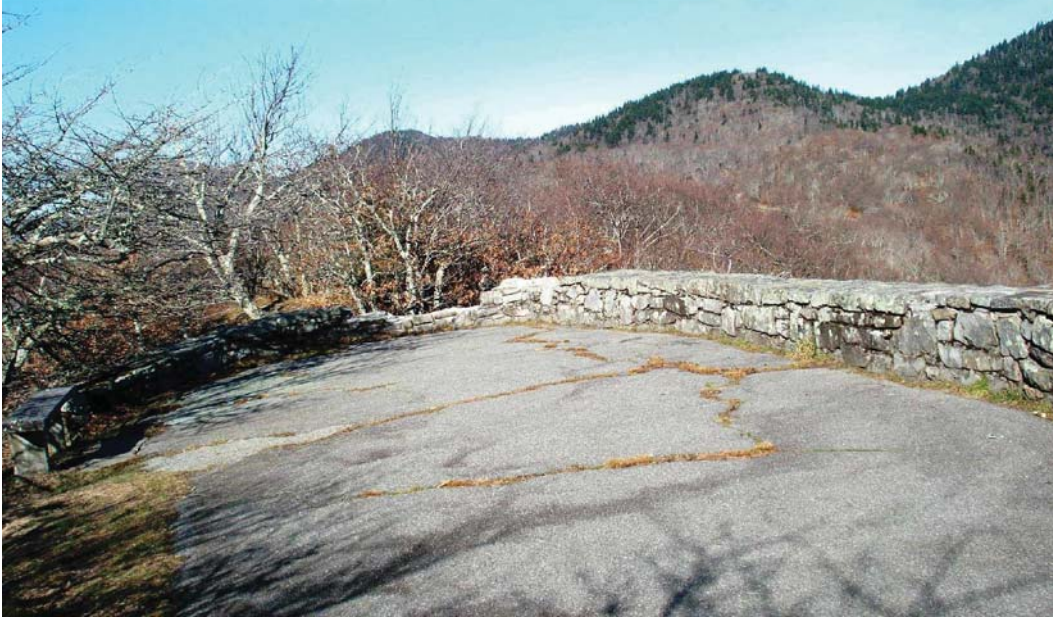
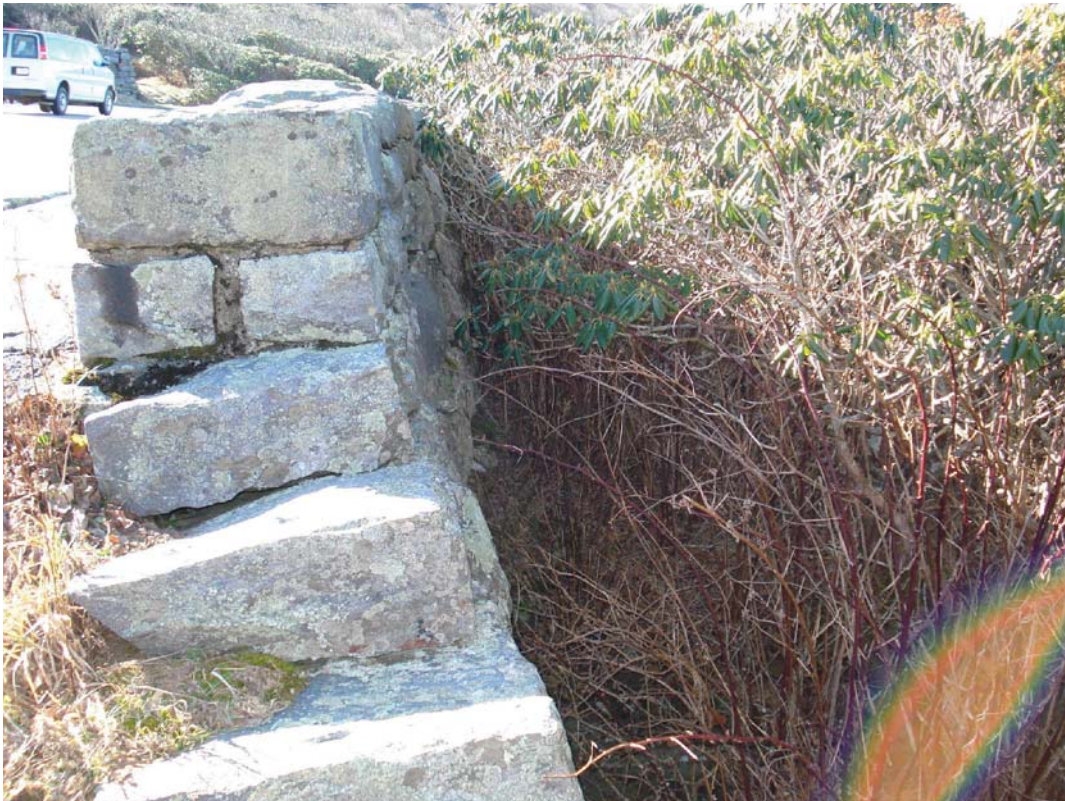
**BLRI\_1085\_0.000\_P1\_1.JPG**

**BLRI\_1085\_0.000\_P1\_2.JPG**

<b>Wall ID:</b>	BLRI-1085-0.000-P1		
<b>Route Name:</b>	CRAGGY DOME OVERLOOK		
<b>Inspection Date:</b>	November 30, 2007	<b>Approximate Year Built:</b>	Unknown
<b>*Wall Rating:</b>	41	<b>Maintenance Action:</b>	Repair Elements

<b>Element (Weighting Factor)</b>	<b>Narrative</b>	<b>Condition Rating (0 - 10)</b>
PERFORMANCE 8.00	Poor condition, wall bulging, cracked pavement	4
WALL FOUNDATION MATERIAL 8.00	Soil, evidence of wall/foundation movement, some trees at foundation level	4
MORTAR 8.00	Poor condition, lot of moss and efflorescence, some sections have no mortar	4
STONE MASONRY 8.00	Poor condition, lot of moss and efflorescence, some missing sections	4
DOWNSLOPE 1.00	Steep slope, heavily wooded, no distress	6
LATERAL SLOPE 1.00	Steep slope, heavily wooded, no distress	6
VEGETATION 1.00	Trees and shrubs growing close to wall	6
WALL DRAINS 1.00	No problems associated with drainage, parking lot contains some storm drains, weep holes observed	7
ROAD/SIDEWALK/SHOULDER 5.00	Many cracks and distressed areas, especially the shoulders	3

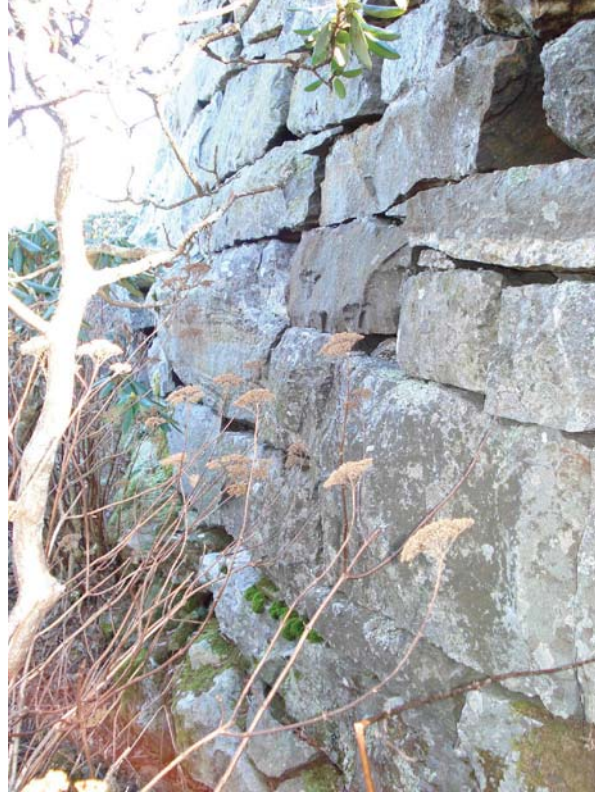
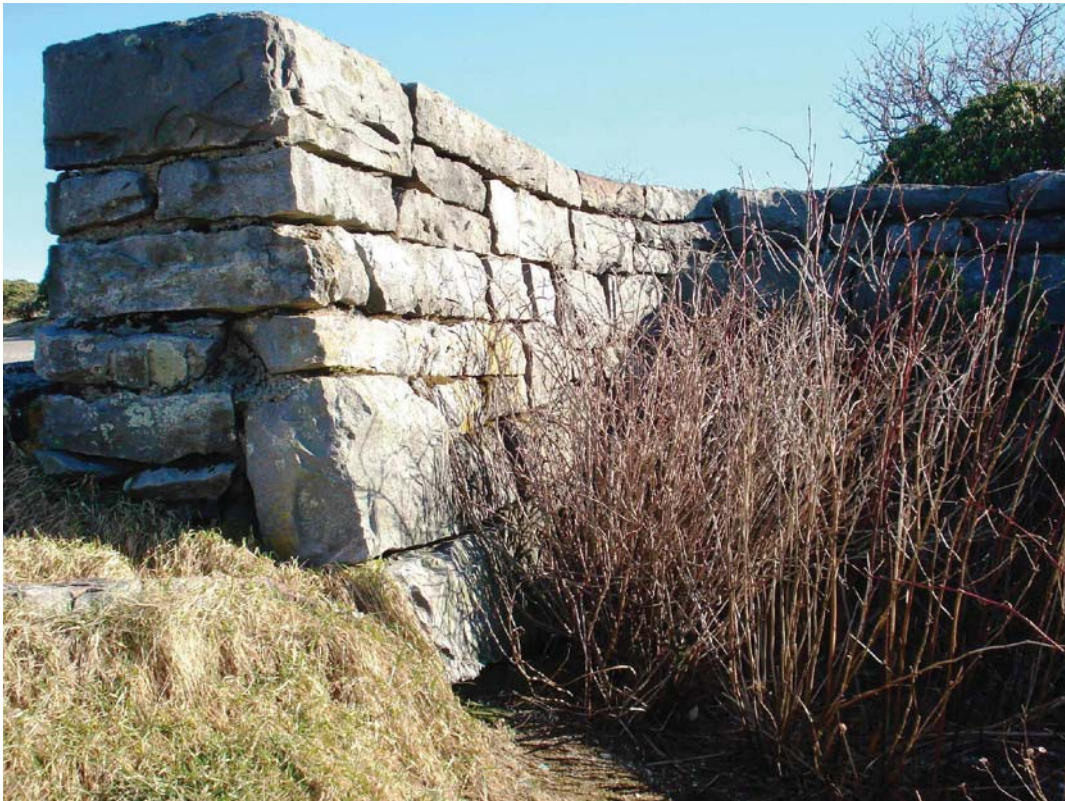
**BLRI\_1085\_0.000\_P2\_1.JPG**

**BLRI\_1085\_0.000\_P2\_2.JPG**

<b>Wall ID:</b>	BLRI-1085-0.000-P2		
<b>Route Name:</b>	CRAGGY DOME OVERLOOK		
<b>Inspection Date:</b>	November 30, 2007	<b>Approximate Year Built:</b>	Unknown
<b>*Wall Rating:</b>	42	<b>Maintenance Action:</b>	Repair Elements

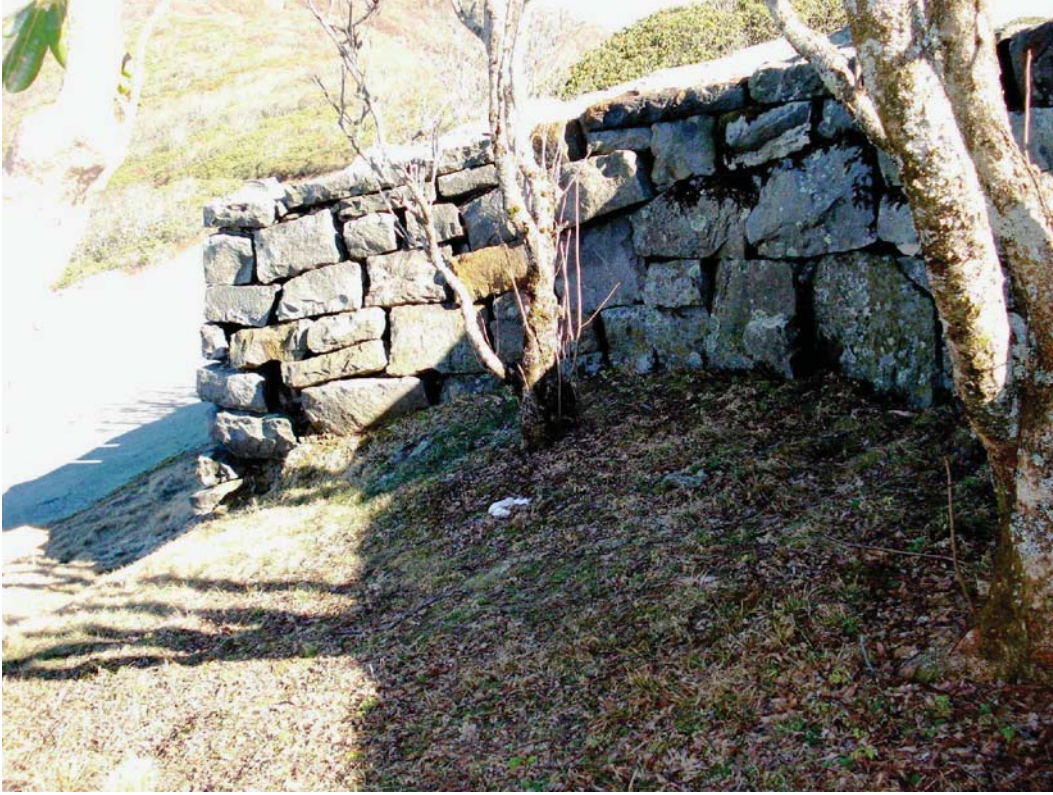
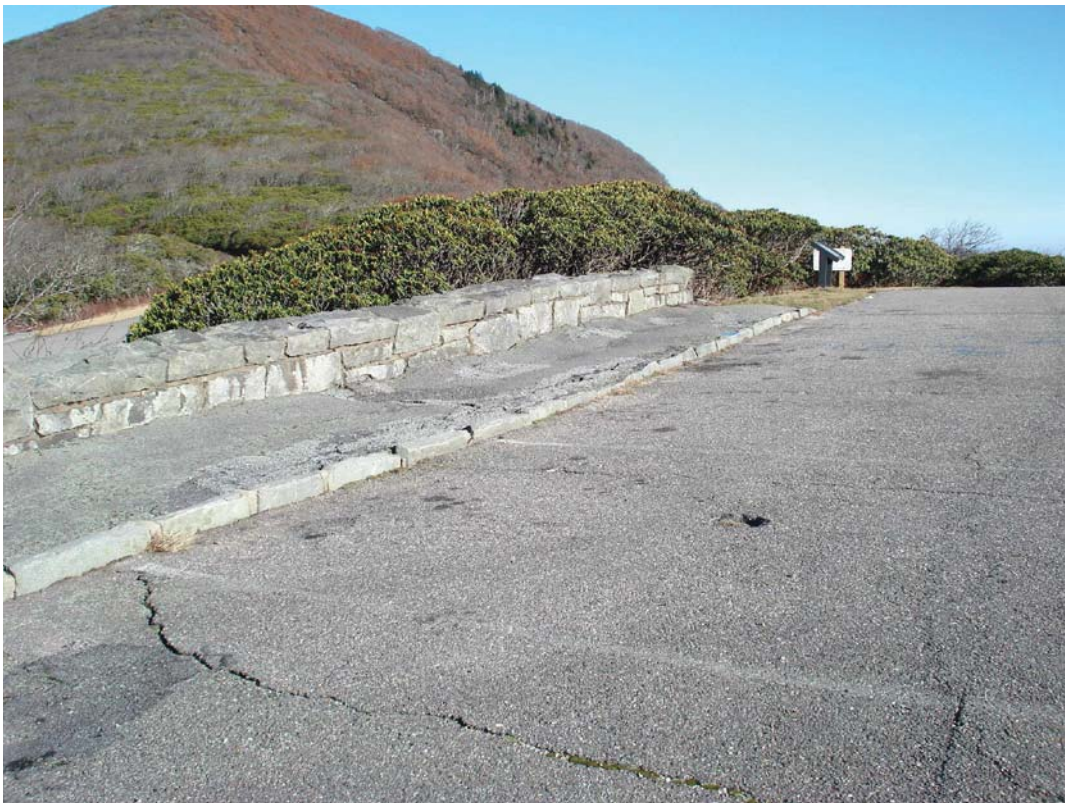
**BLRI\_1085\_0.000\_P3\_1.JPG**

**BLRI\_1085\_0.000\_P3\_2.JPG**

<b>Wall ID:</b>	BLRI-1085-0.000-P3		
<b>Route Name:</b>	CRAGGY DOME OVERLOOK		
<b>Inspection Date:</b>	November 30, 2007	<b>Approximate Year Built:</b>	Unknown
<b>*Wall Rating:</b>	58	<b>Maintenance Action:</b>	Repair Elements
