NPS Retaining Wall Inventory Program Great Smoky Mountains National Park

**Federal Lands Highway
Road Inventory Program**

Federal Highway Administration
Eastern Federal Lands Highway Division
Road Inventory Program (RIP)

Data Collection Date: April 2011
Report Date: November 2015

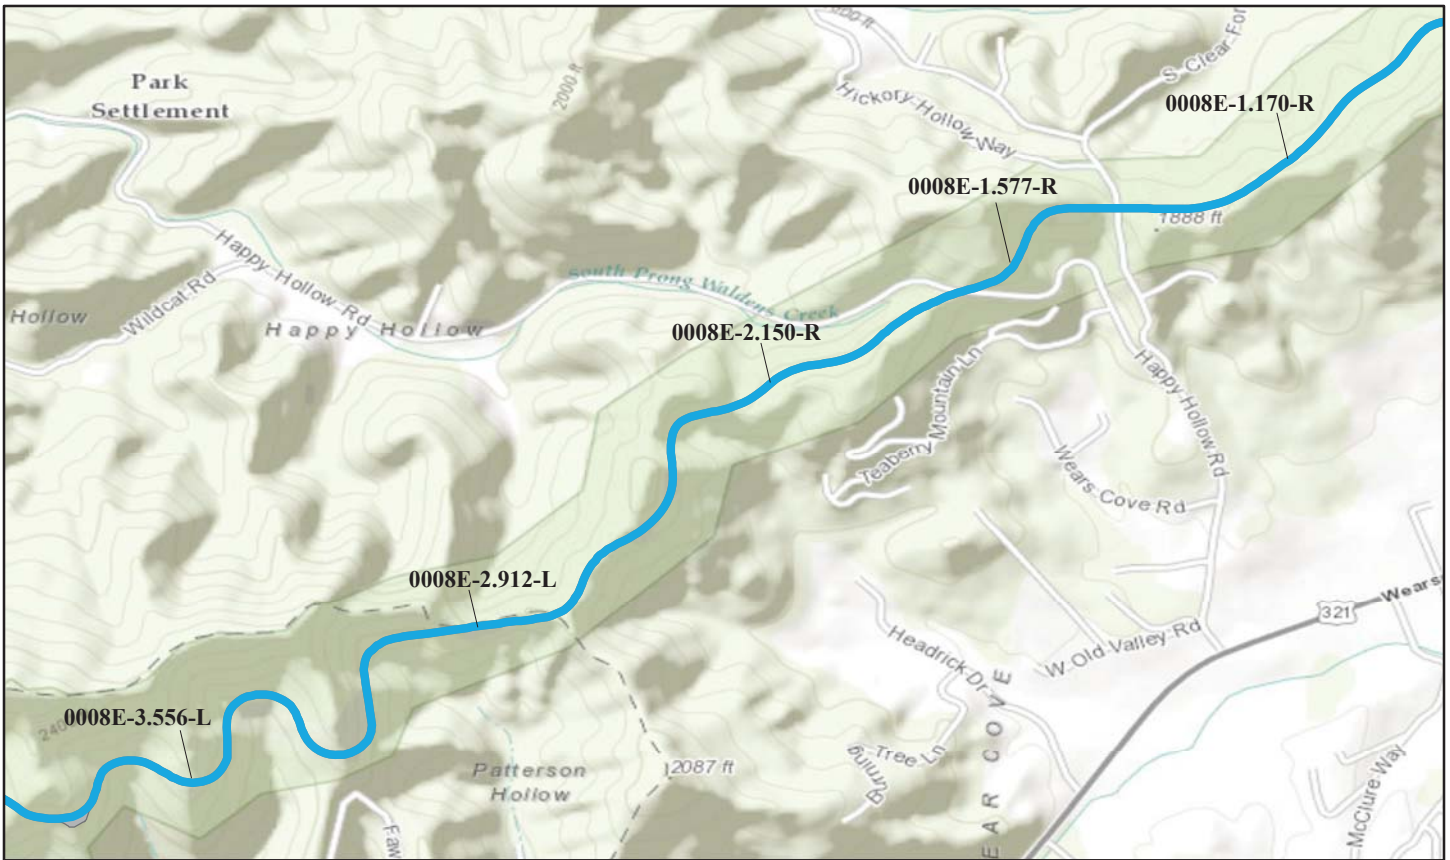
ROUTE 0008E: FOOTHILLS PARKWAY SECTION 8E

Wall ID Inspection Date:	Wall Area (Sq. Ft.)	Wall Length (Ft.)	Wall Type	Wall Function	Overall Rating	Repair Cost
GRSM-0008E-1.170-R 4/19/2011	8,600	322	Other -Tie back Panel Wall	Cut Wall		
GRSM-0008E-1.577-R 4/19/2011	9550	422	MSE - Precast Panel	Fill Wall		
GRSM-0008E-2.150-R 4/19/2011	3040	276	MSE - Precast Panel	Fill Wall		
GRSM-0008E-2.912-L 4/19/2011	4500	195	MSE - Precast Panel	Fill Wall		
GRSM-0008E-3.556-L 4/19/2011	7250	330	MSE - Precast Panel	Fill Wall

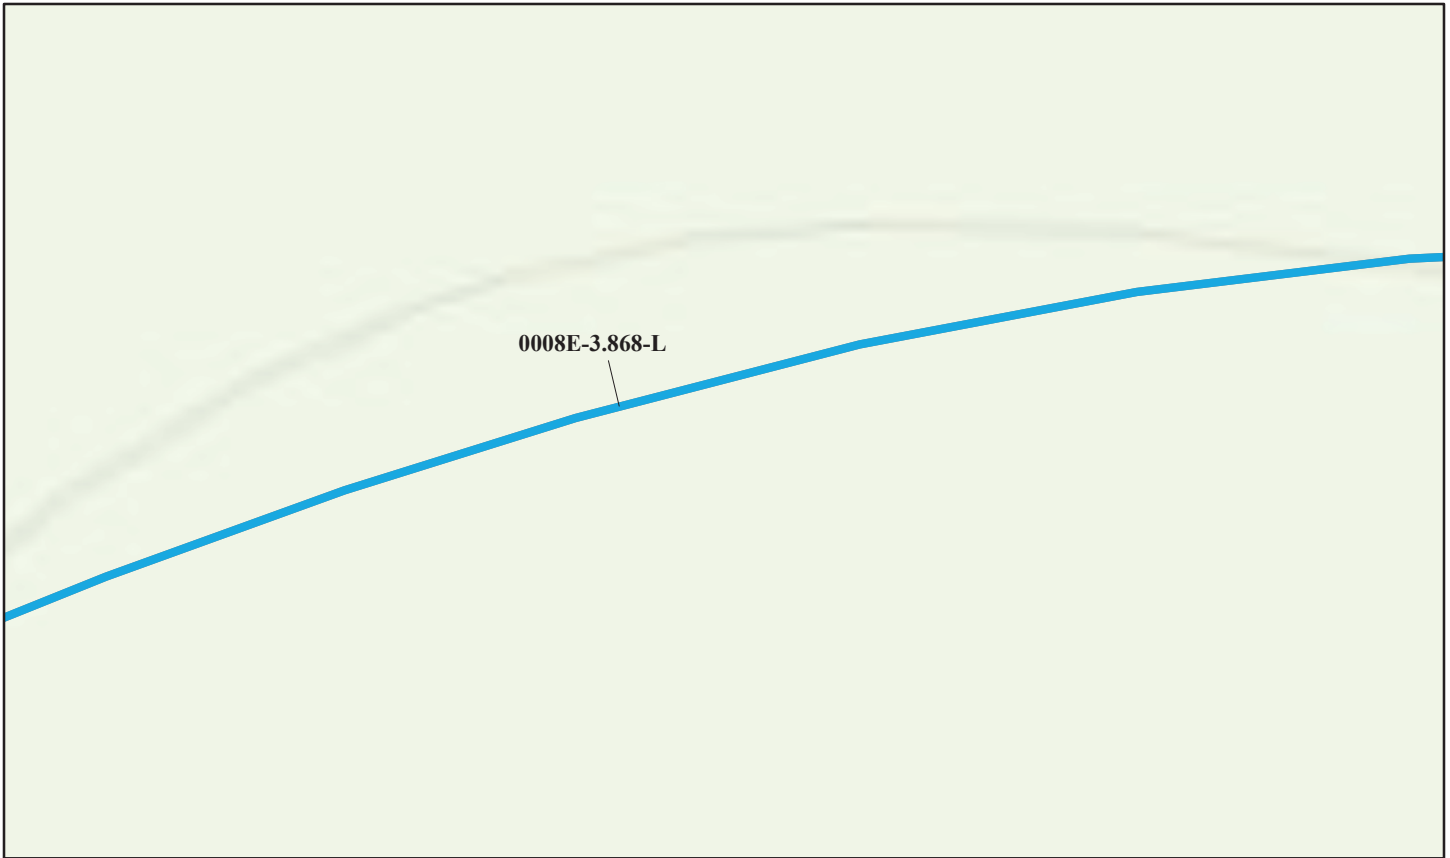
ROUTE 0008E: FOOTHILLS PARKWAY SECTION 8E

Wall ID Inspection Date:	Wall Area (Sq. Ft.)	Wall Length (Ft.)	Wall Type	Wall Function	Overall Rating	Repair Cost
GRSM-0008E-3.868-L 4/19/2011	640	80	Gravity - Dry Stone	Fill Wall

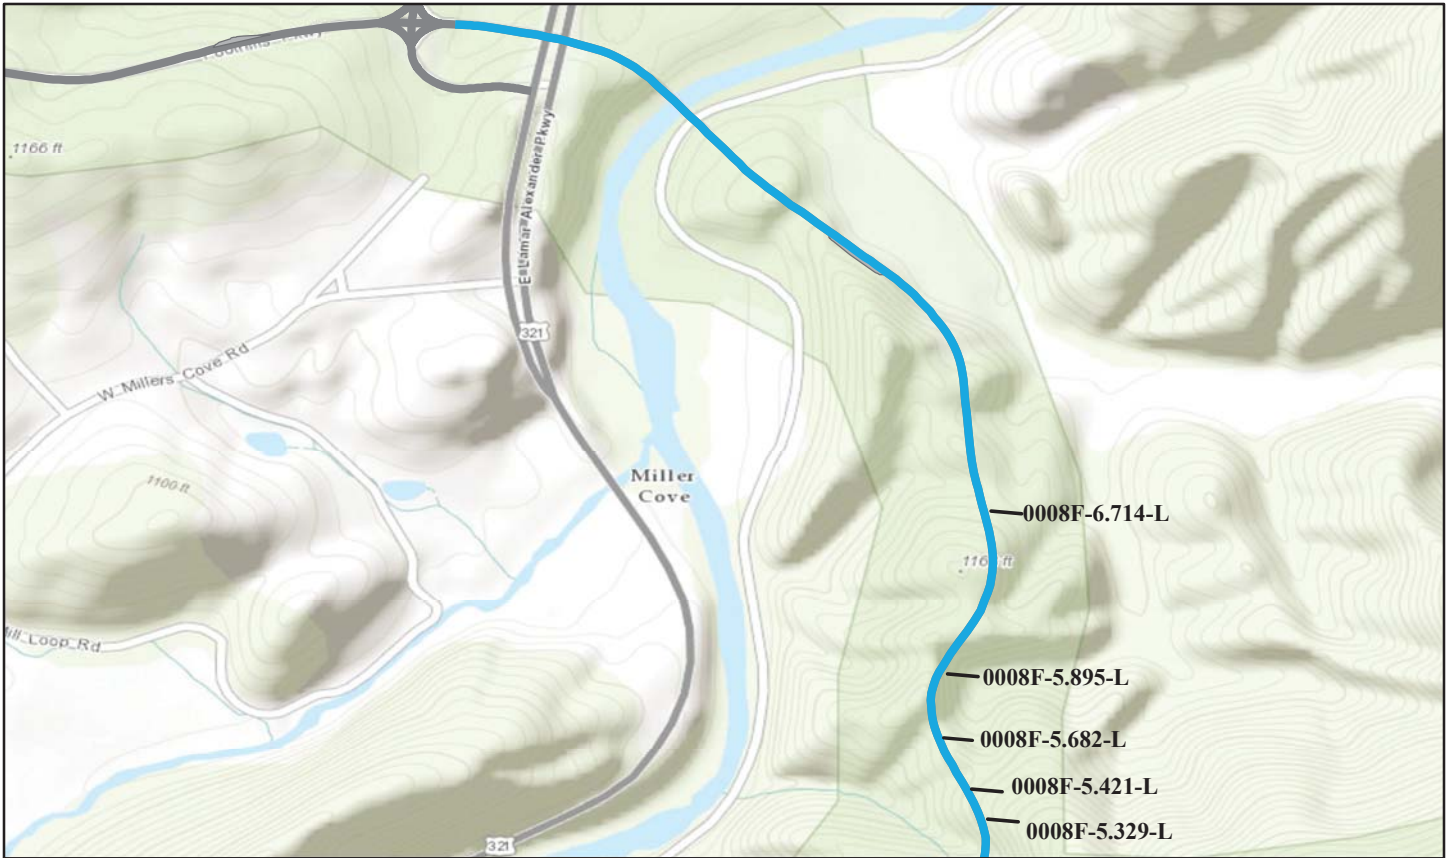
ROUTE 0008F: FOOTHILLS PARKWAY SECTION 8F

Wall ID Inspection Date:	Wall Area (Sq. Ft.)	Wall Length (Ft.)	Wall Type	Wall Function	Overall Rating	Repair Cost
GRSM-0008F-5.329-L 4/19/2011	130	20	Cantilever - Concrete	Fill Wall		
GRSM-0008F-5.421-L 4/19/2011	4250	250	Cantilever - Concrete	Fill Wall		
GRSM-0008F-5.682-L 4/19/2011	936	117	Cantilever - Concrete	Fill Wall		
GRSM-0008F-5.895-L 4/19/2011	3934	319	MSE - Precast Panel	Fill Wall		
GRSM-0008F-6.714-L 4/19/2011	10	200	MSE - Precast Panel	Fill Wall

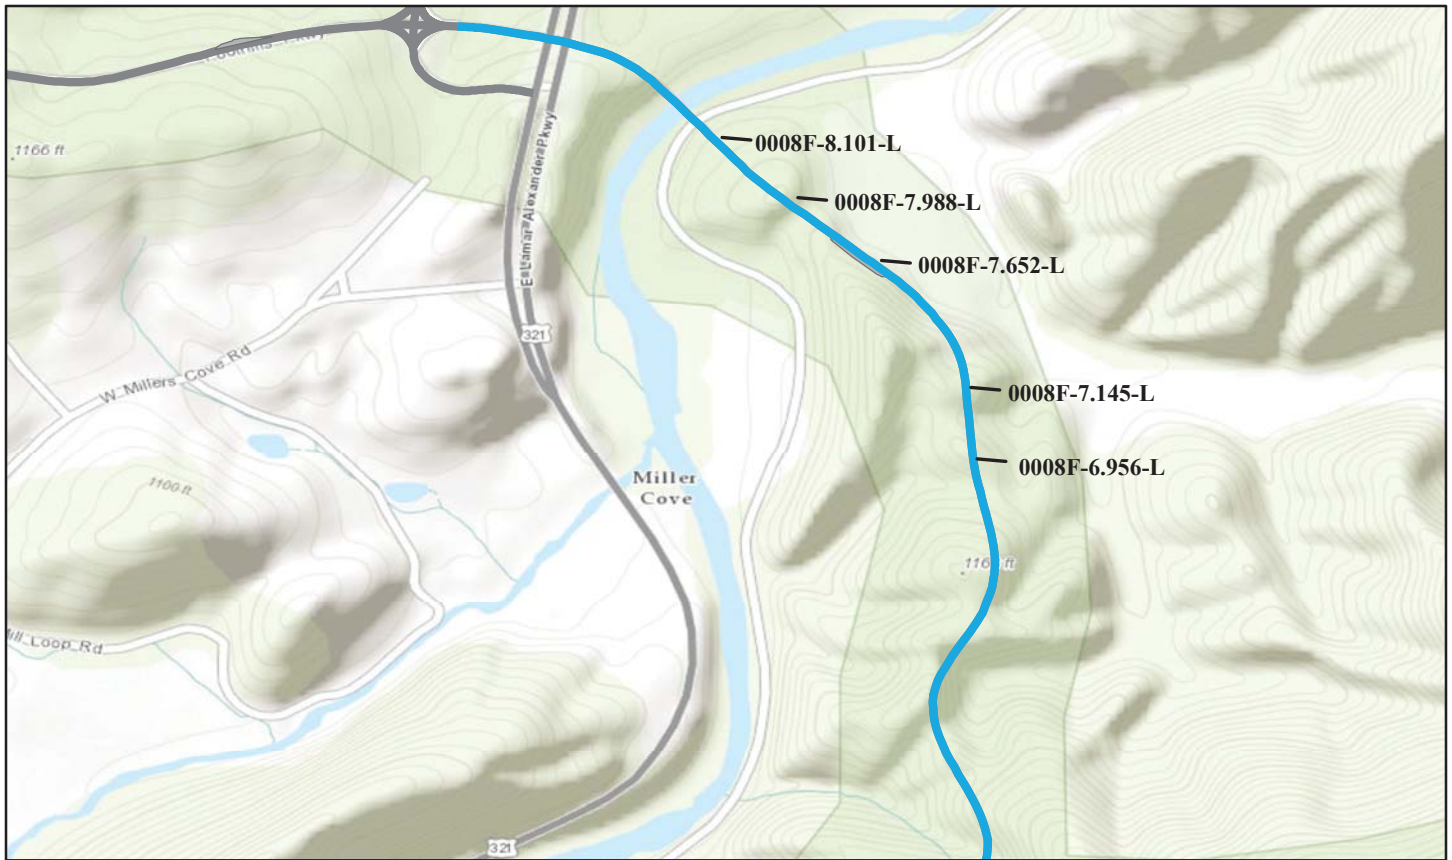
ROUTE 0008F: FOOTHILLS PARKWAY SECTION 8F

Wall ID Inspection Date:	Wall Area (Sq. Ft.)	Wall Length (Ft.)	Wall Type	Wall Function	Overall Rating	Repair Cost
GRSM-0008F-6.956-L 4/19/2011	1,000	75	MSE - Precast Panel	Fill Wall		
GRSM-0008F-7.145-L 4/19/2011	1220	152	MSE - Precast Panel	Fill Wall		
GRSM-0008F-7.652-L 4/19/2011	1785	135	MSE - Precast Panel	Fill Wall		
GRSM-0008F-7.988-L 4/19/2011	10	120	MSE - Precast Panel	Fill Wall		
GRSM-0008F-8.101-L 4/19/2011	8100	281	MSE - Precast Panel	Fill Wall

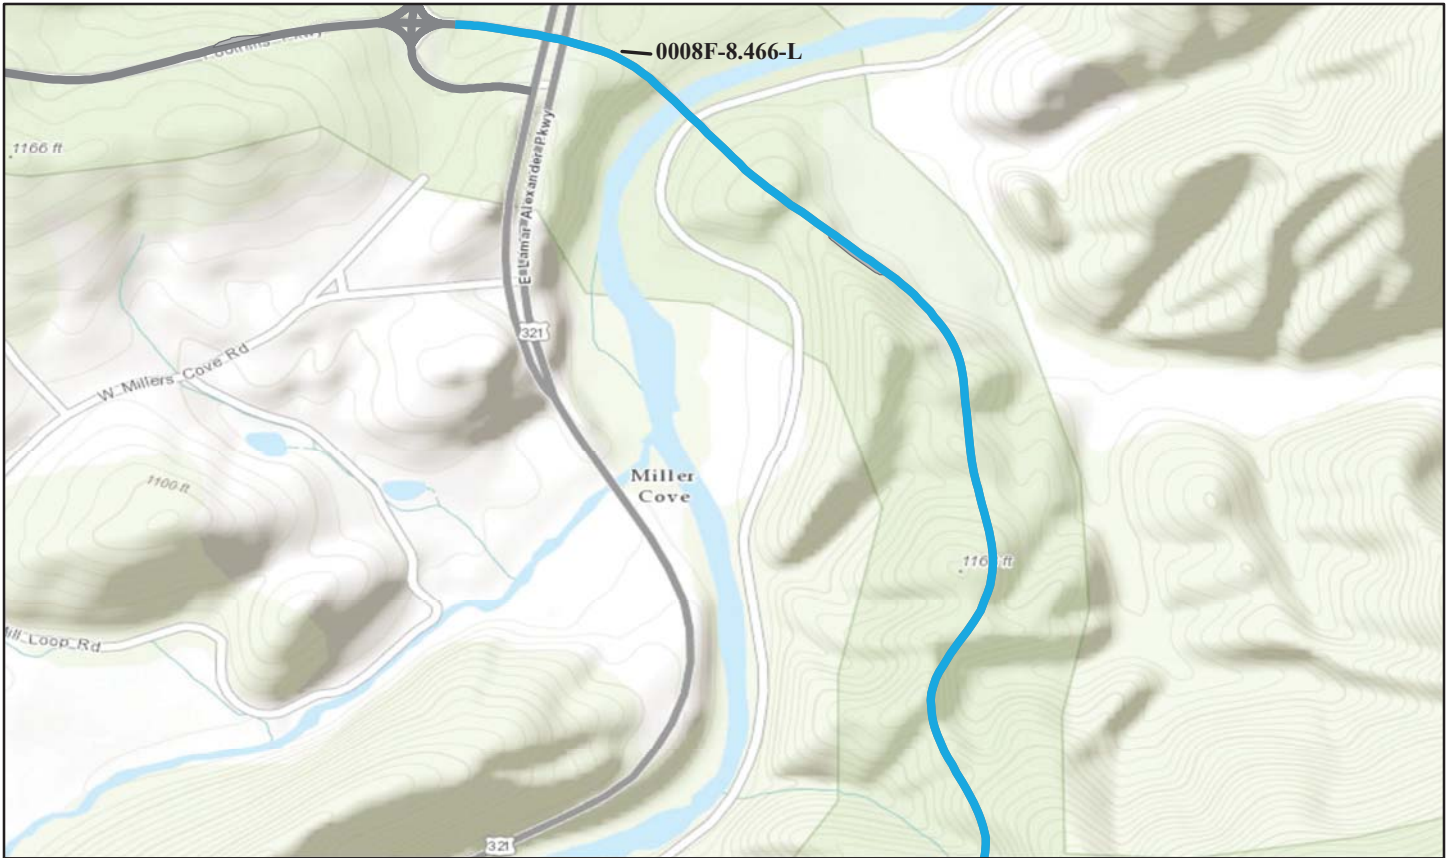
ROUTE 0008F: FOOTHILLS PARKWAY SECTION 8F

Wall ID Inspection Date:	Wall Area (Sq. Ft.)	Wall Length (Ft.)	Wall Type	Wall Function	Overall Rating	Repair Cost
GRSM-0008F-8.466-L 4/19/2011	1,864	92	MSE - Precast Panel	Fill Wall

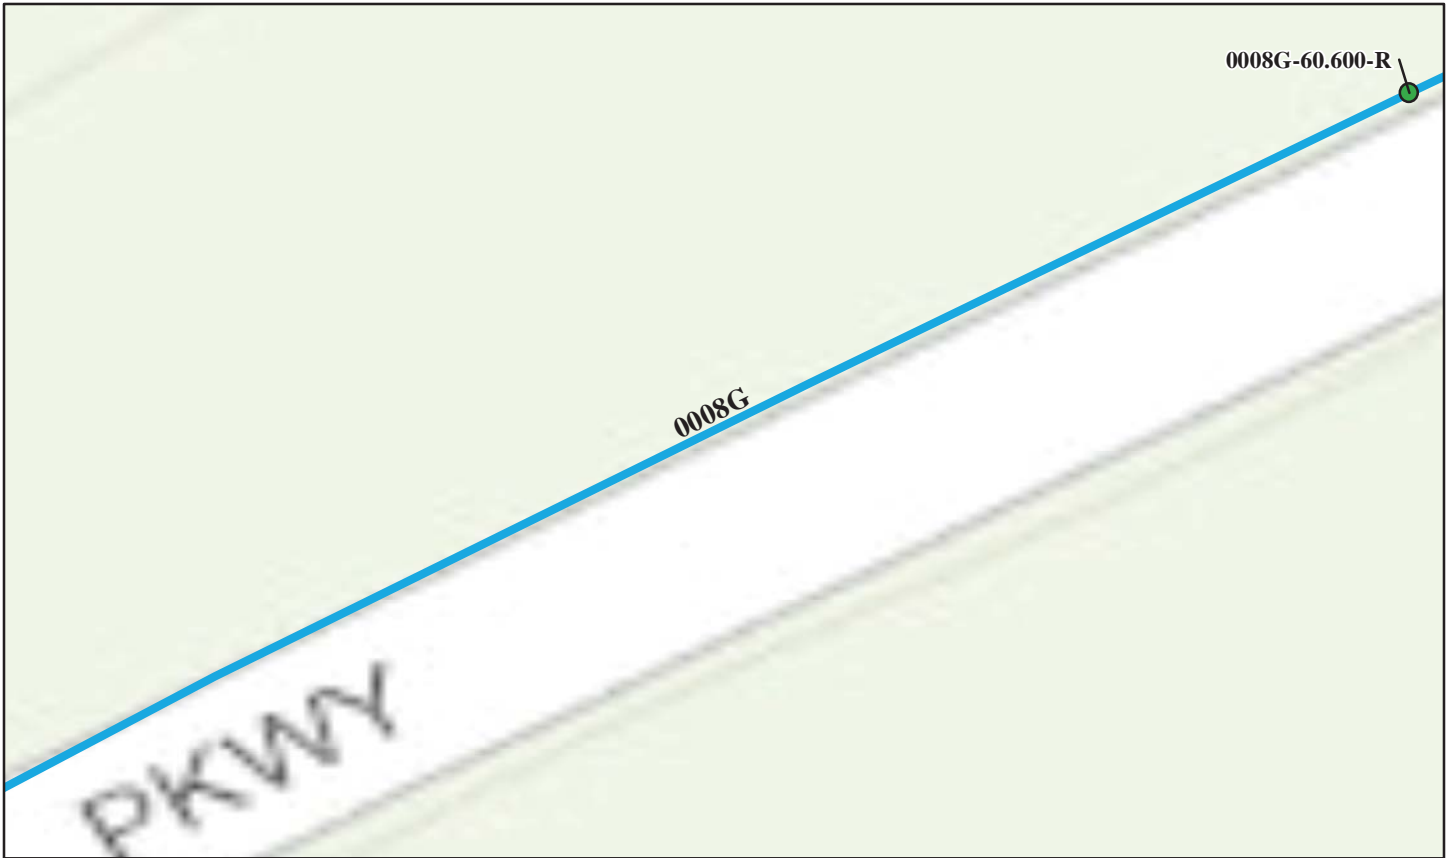
ROUTE 0008G: FOOTHILLS PARKWAY SECTION 8G

Wall ID Inspection Date:	Wall Area (Sq. Ft.)	Wall Length (Ft.)	Wall Type	Wall Function	Overall Rating	Repair Cost
GRSM-0008G-60.600-R 12/1/2007	1,445	115	MSE - Precast Panel	Fill Wall	83	\$0.00

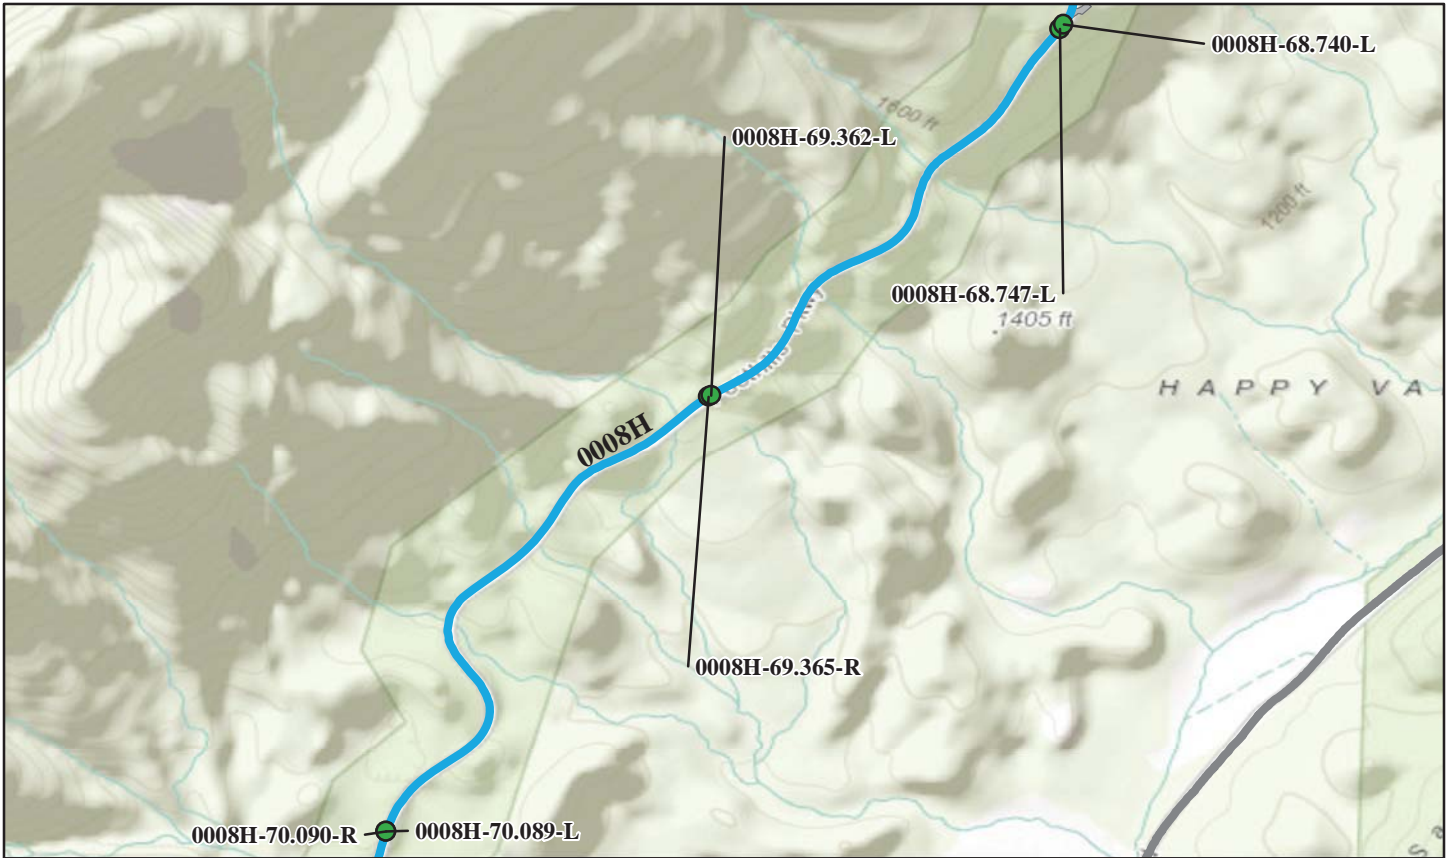
ROUTE 0008H: FOOTHILLS PARKWAY SECTION 8H

Wall ID Inspection Date:	Wall Area (Sq. Ft.)	Wall Length (Ft.)	Wall Type	Wall Function	Overall Rating	Repair Cost
GRSM-0008H-68.740-L 12/1/2007	255	58	Cantilever - Concrete	Head Wall	84	\$0.00
GRSM-0008H-68.747-L 12/1/2007	145	36	Cantilever - Concrete	Head Wall	90	\$0.00
GRSM-0008H-69.362-L 12/1/2007	160	40	Cantilever - Concrete	Head Wall	87	\$0.00
GRSM-0008H-69.365-R 12/1/2007	190	46	Cantilever - Concrete	Head Wall	84	\$0.00
GRSM-0008H-70.089-L 12/1/2007	320	56	Cantilever - Concrete	Head Wall	83	\$0.00

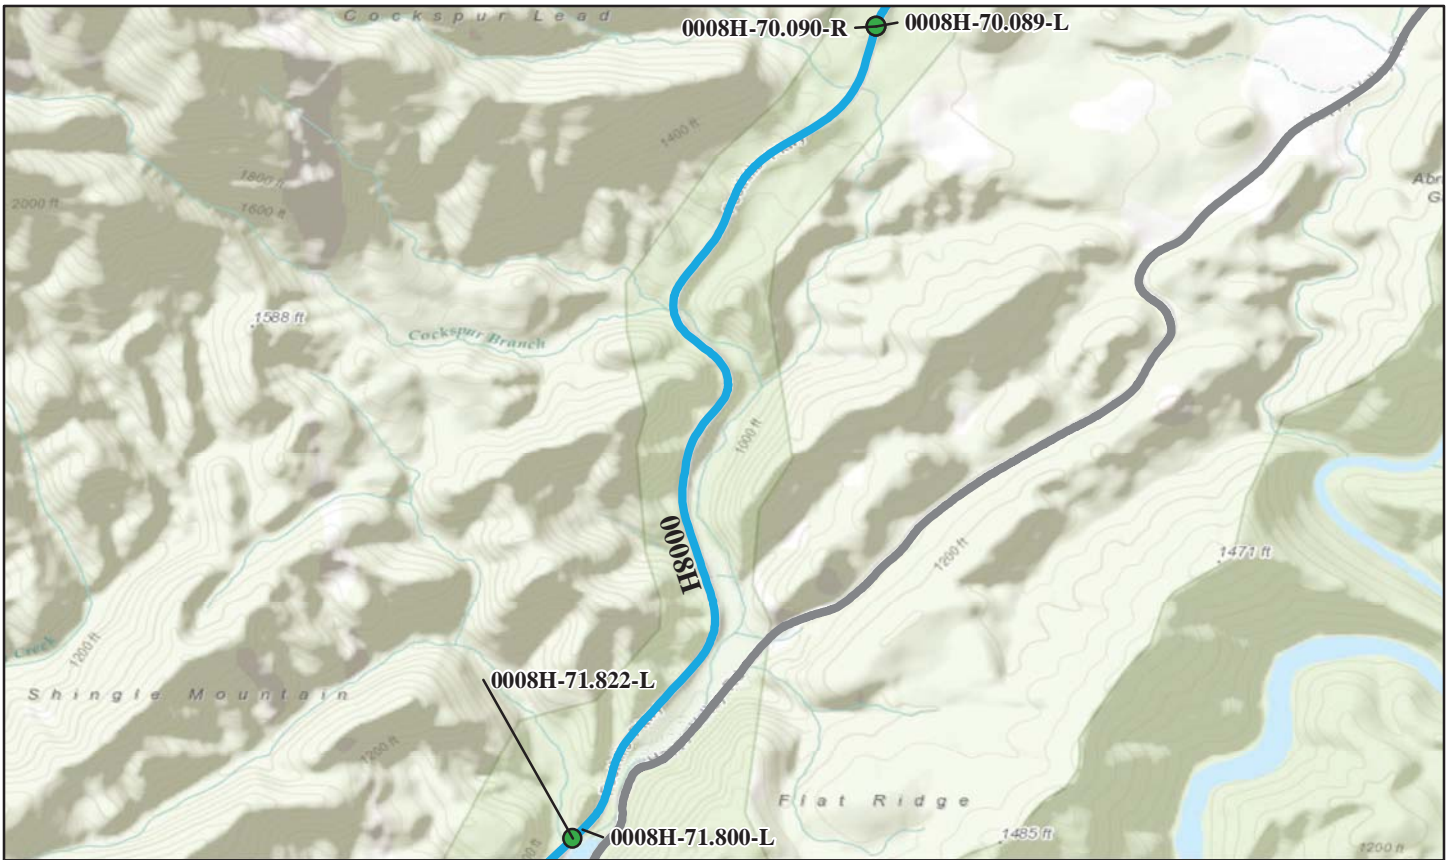
ROUTE 0008H: FOOTHILLS PARKWAY SECTION 8H

Wall ID Inspection Date:	Wall Area (Sq. Ft.)	Wall Length (Ft.)	Wall Type	Wall Function	Overall Rating	Repair Cost
GRSM-0008H-70.090-R 12/1/2007	320	56	Cantilever - Concrete	Head Wall	87	\$0.00
GRSM-0008H-71.800-L 12/1/2007	70	23	Gravity - Mortared Stone	Head Wall	52	\$4,385.00
GRSM-0008H-71.822-L 12/1/2007	90	18	Gravity - Mortared Stone	Head Wall	73	\$9,950.00

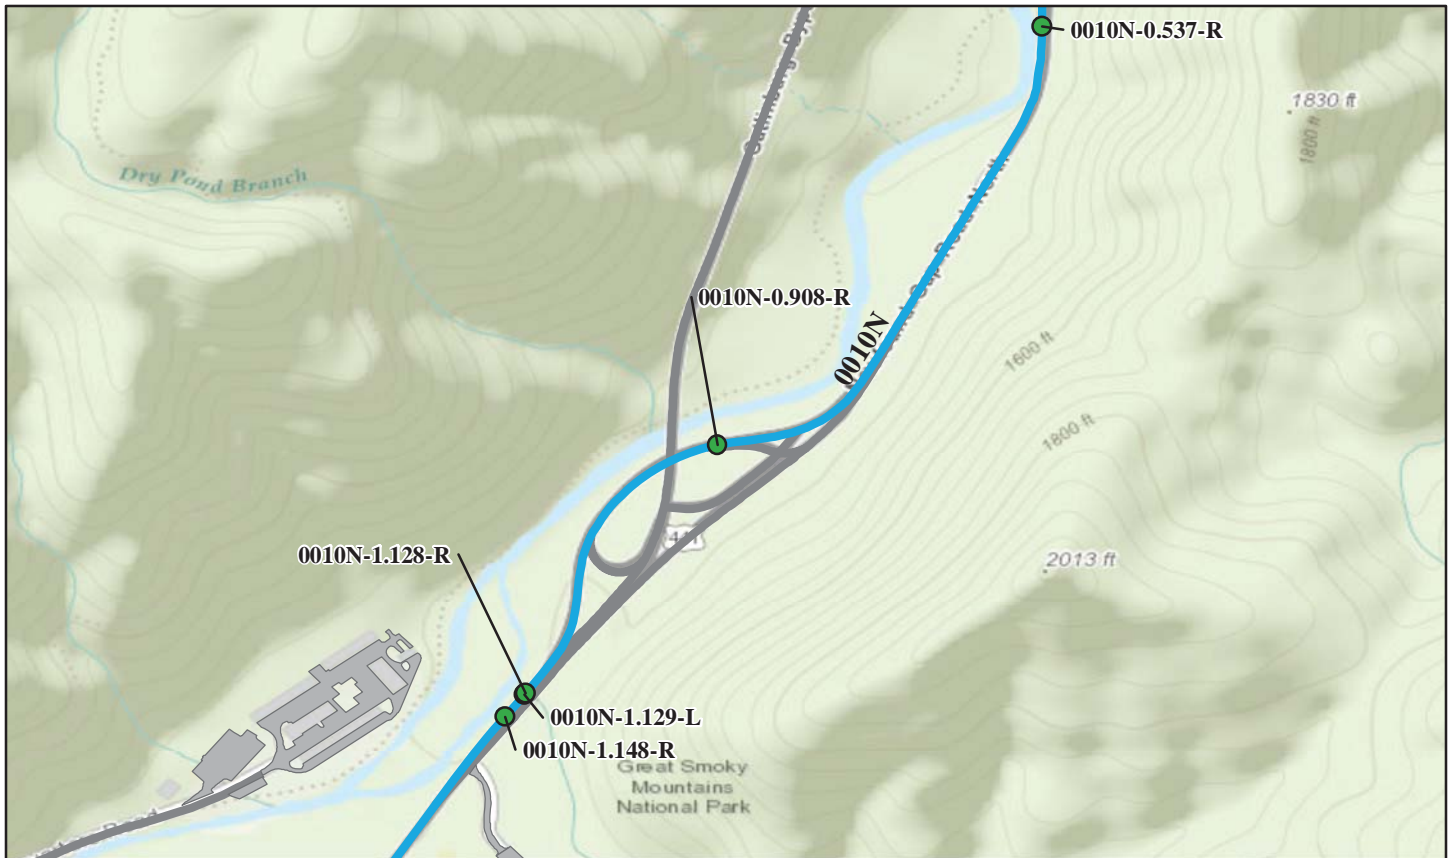
ROUTE 0010N: NEWFOUND GAP ROAD NORTH

Wall ID Inspection Date:	Wall Area (Sq. Ft.)	Wall Length (Ft.)	Wall Type	Wall Function	Overall Rating	Repair Cost
GRSM-0010N-0.537-R 6/18/2007	2,670	306	Gravity - Mortared Stone	Fill Wall	85	\$0.00
GRSM-0010N-0.908-R 6/11/2007	2,648	284	Gravity - Mortared Stone	Fill Wall	85	\$0.00
GRSM-0010N-1.128-R 6/12/2007	235	38	Gravity - Mortared Stone	Head Wall	83	\$0.00
GRSM-0010N-1.129-L 6/12/2007	170	48	Gravity - Mortared Stone	Head Wall	88	\$0.00
GRSM-0010N-1.148-R 6/12/2007	6,886	540	Gravity - Mortared Stone	Fill Wall	85	\$0.00

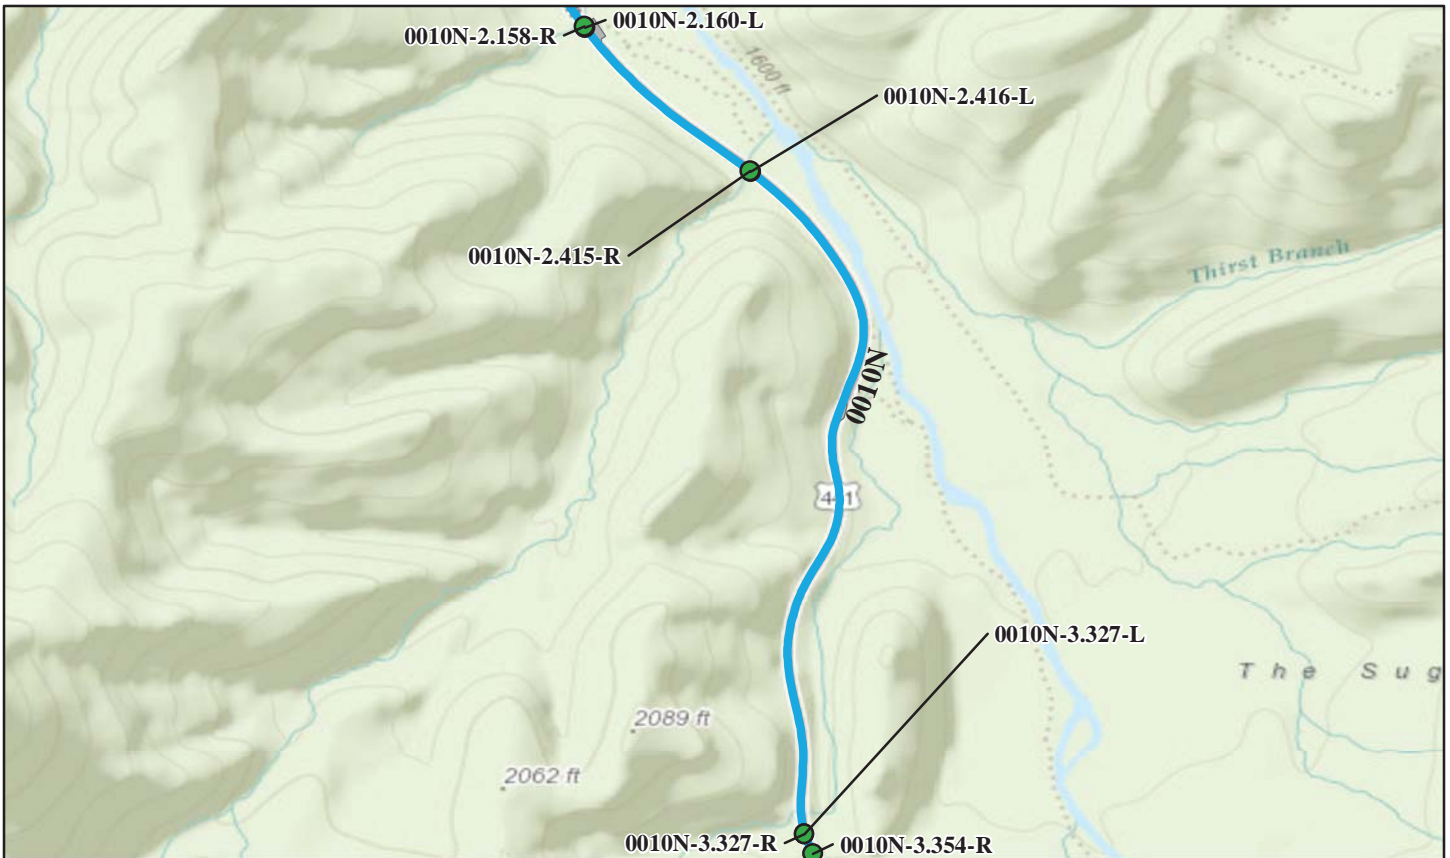
ROUTE 0010N: NEWFOUND GAP ROAD NORTH

Wall ID Inspection Date:	Wall Area (Sq. Ft.)	Wall Length (Ft.)	Wall Type	Wall Function	Overall Rating	Repair Cost
GRSM-0010N-2.158-R 6/12/2007	53	20	Gravity - Mortared Stone	Head Wall	85	\$0.00
GRSM-0010N-2.160-L 6/12/2007	43	16	Gravity - Mortared Stone	Head Wall	85	\$0.00
GRSM-0010N-2.415-R 6/12/2007	248	52	Gravity - Mortared Stone	Head Wall	88	\$0.00
GRSM-0010N-2.416-L 6/12/2007	342	58	Gravity - Mortared Stone	Head Wall	88	\$0.00
GRSM-0010N-3.327-L 6/26/2007	250	37	Gravity - Mortared Stone	Head Wall	82	\$500.00

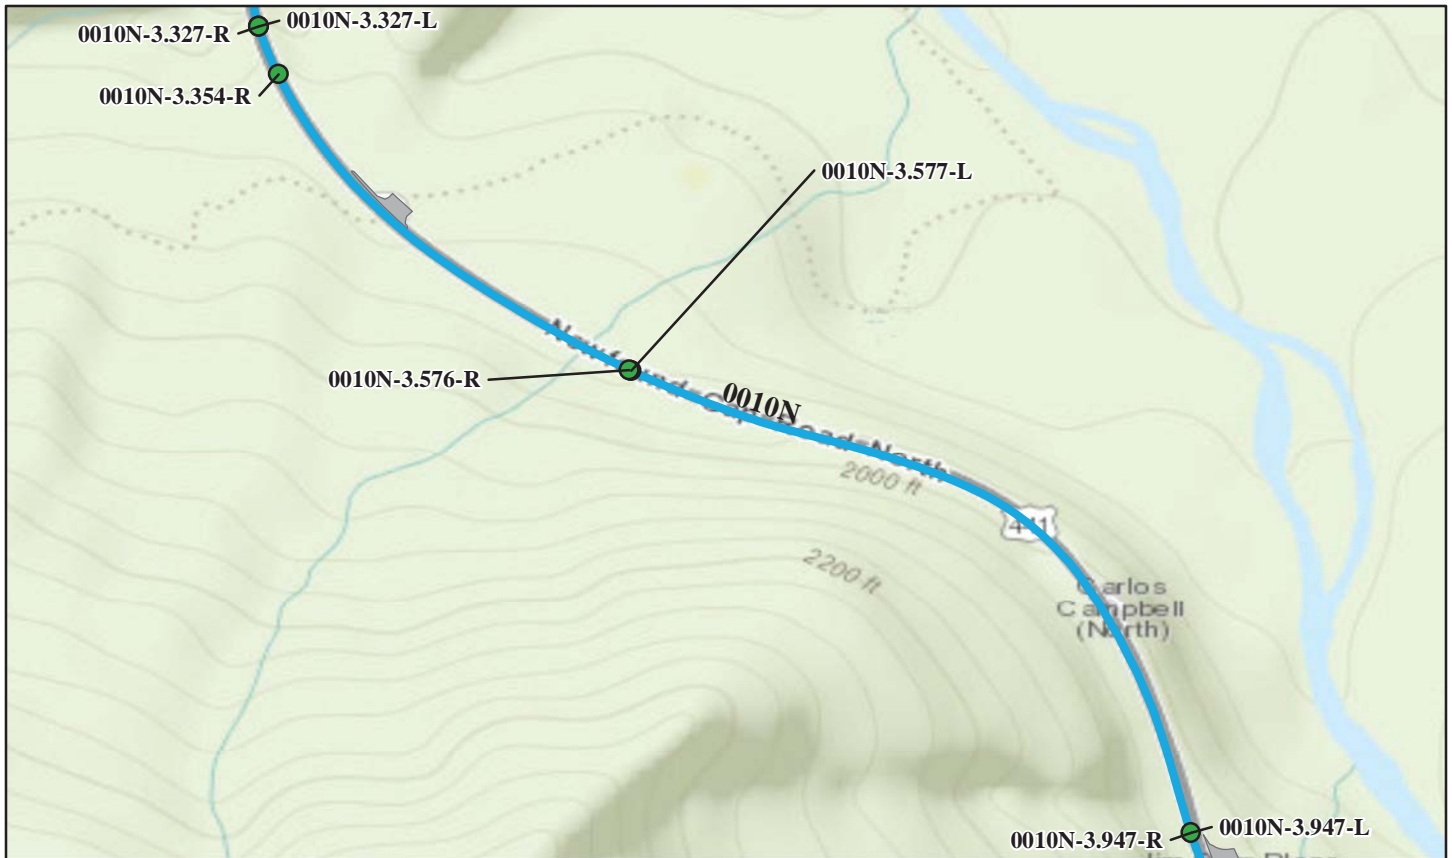
ROUTE 0010N: NEWFOUND GAP ROAD NORTH

Wall ID Inspection Date:	Wall Area (Sq. Ft.)	Wall Length (Ft.)	Wall Type	Wall Function	Overall Rating	Repair Cost
GRSM-0010N-3.327-R 6/12/2007	165	41	Gravity - Mortared Stone	Head Wall	88	\$0.00
GRSM-0010N-3.354-R 6/12/2007	165	41	Gravity - Mortared Stone	Head Wall	87	\$0.00
GRSM-0010N-3.576-R 6/12/2007	23	17	Gravity - Mortared Stone	Head Wall	85	\$0.00
GRSM-0010N-3.577-L 6/12/2007	57	15	Gravity - Mortared Stone	Head Wall	83	\$0.00
GRSM-0010N-3.947-L 6/12/2007	138	26	Gravity - Mortared Stone	Head Wall	49	\$44,400.00

Wall Identification	Failure Consequence⁽¹⁾	Wall Rating⁽²⁾	Recommended Action⁽³⁾	2007 Repair Costs⁽⁴⁾
GRSM-0010N-11.304-L	LOW	37	REPLACE WALL	\$52,500
GRSM-0010N-3.947-L	HIGH	49	REPLACE WALL	\$44,400
GRSM-0011S-1.852-L	HIGH	45	REPAIR ELEMENTS	\$50,500
GRSM-0017-4.988-L	MODERATE	45	REPLACE WALL	\$345,713
GRSM-0700-7.000-R	LOW	34	NO ACTION	\$0
GRSM-0982-0.000-P1	LOW	48	REPLACE WALL	\$43,526

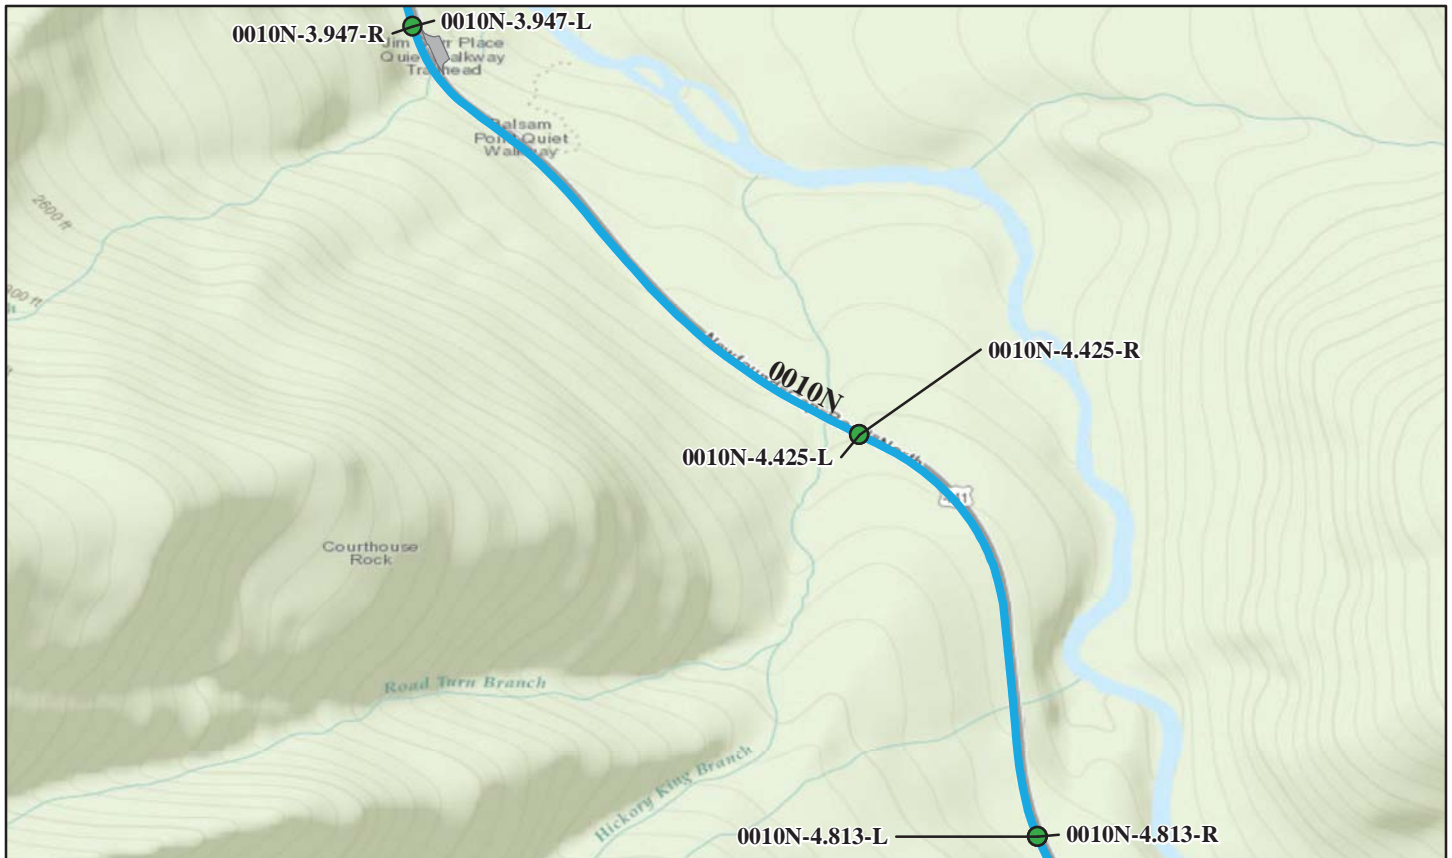
ROUTE 0010N: NEWFOUND GAP ROAD NORTH

Wall ID Inspection Date:	Wall Area (Sq. Ft.)	Wall Length (Ft.)	Wall Type	Wall Function	Overall Rating	Repair Cost
GRSM-0010N-3.947-R 6/12/2007	46	18	Gravity - Mortared Stone	Head Wall	85	\$0.00
GRSM-0010N-4.425-L 6/12/2007	133	30	Gravity - Mortared Stone	Head Wall	87	\$0.00
GRSM-0010N-4.425-R 6/12/2007	150	30	Gravity - Mortared Stone	Head Wall	87	\$0.00
GRSM-0010N-4.813-L 6/12/2007	18	11	Gravity - Mortared Stone	Head Wall	88	\$0.00
GRSM-0010N-4.813-R 6/12/2007	41	13	Gravity - Mortared Stone	Head Wall	88	\$0.00

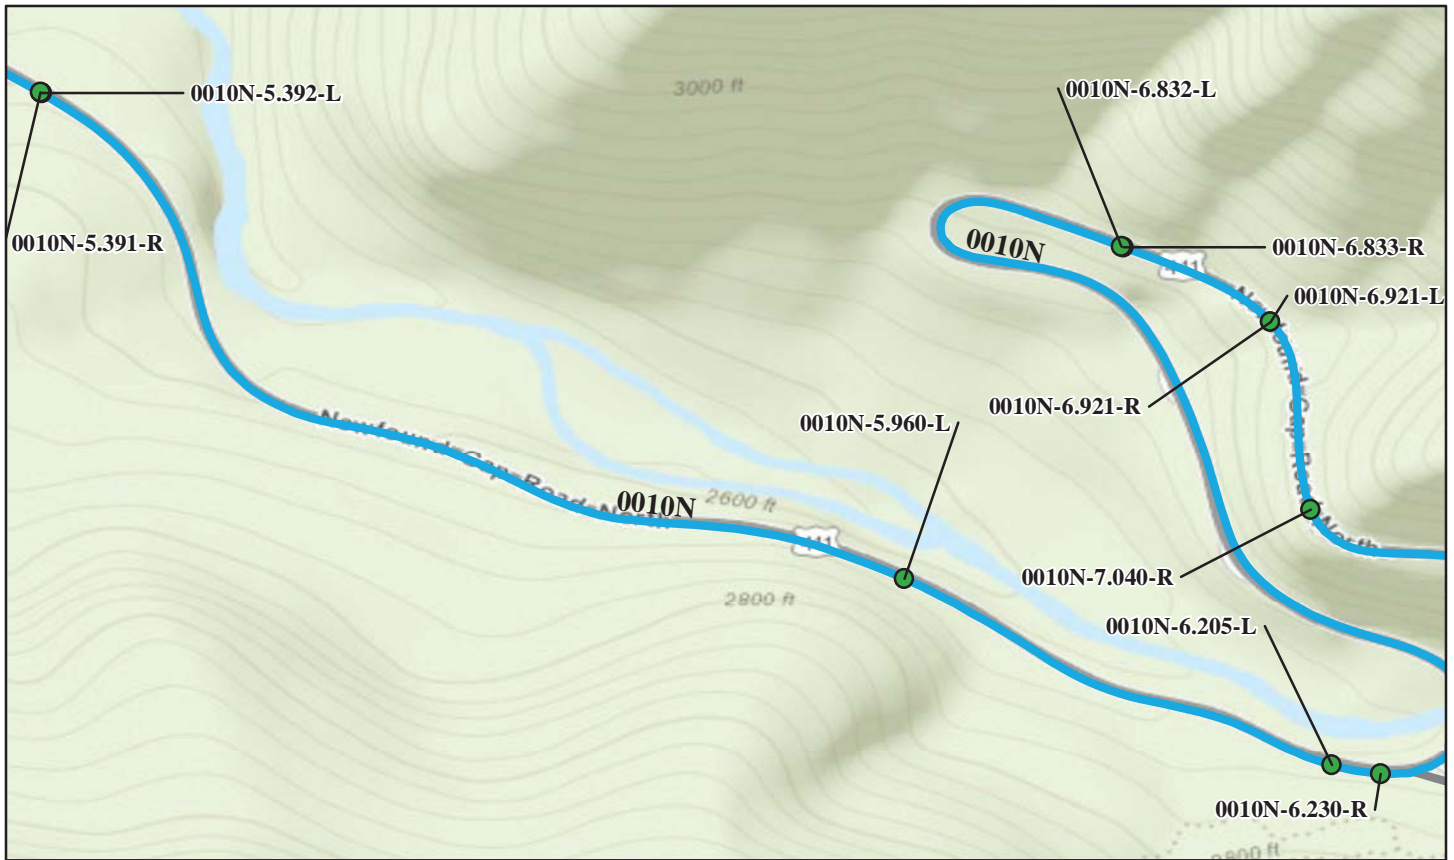
ROUTE 0010N: NEWFOUND GAP ROAD NORTH

Wall ID Inspection Date:	Wall Area (Sq. Ft.)	Wall Length (Ft.)	Wall Type	Wall Function	Overall Rating	Repair Cost
GRSM-0010N-5.391-R 6/12/2007	114	32	Gravity - Mortared Stone	Head Wall	88	\$0.00
GRSM-0010N-5.392-L 6/12/2007	157	32	Gravity - Mortared Stone	Head Wall	87	\$0.00
GRSM-0010N-5.960-L 6/12/2007	657	167	Gravity - Mortared Stone	Fill Wall	85	\$0.00
GRSM-0010N-6.205-L 6/13/2007	2,420	220	Gravity - Mortared Stone	Fill Wall	88	\$0.00
GRSM-0010N-6.230-R 6/13/2007	77	18	Gravity - Mortared Stone	Head Wall	88	\$0.00

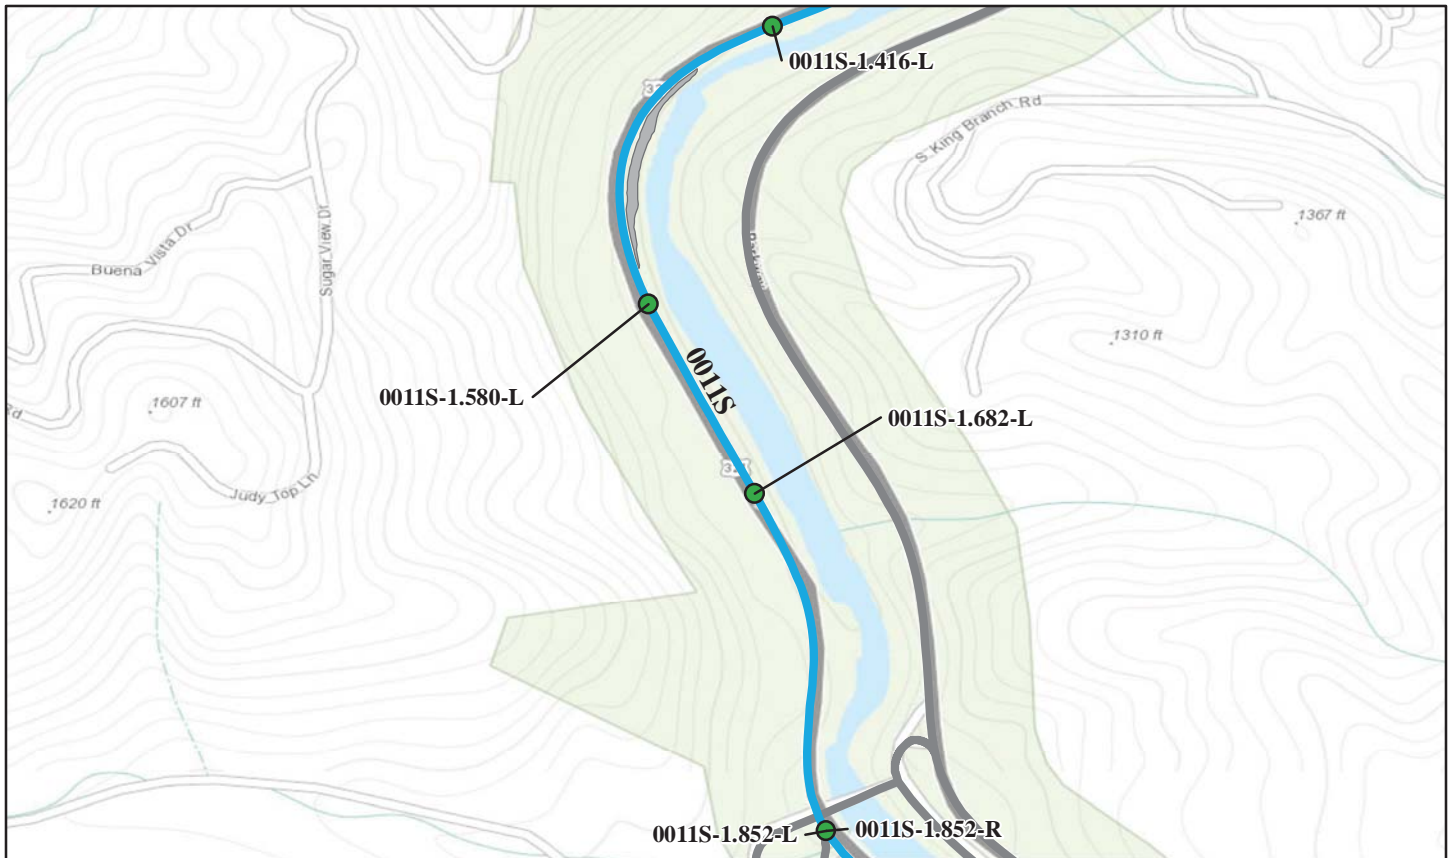
ROUTE 0011S: GATLINBURG SPUR ROAD (SOUTHBOUND)

Wall ID Inspection Date:	Wall Area (Sq. Ft.)	Wall Length (Ft.)	Wall Type	Wall Function	Overall Rating	Repair Cost
GRSM-0011S-1.416-L 6/19/2007	3,092	265	Gravity - Mortared Stone	Fill Wall	73	\$39,750.00
GRSM-0011S-1.580-L 6/19/2007	55	14	Gravity - Mortared Stone	Head Wall	83	\$0.00
GRSM-0011S-1.682-L 6/19/2007	49	14	Gravity - Mortared Stone	Head Wall	88	\$220.00
GRSM-0011S-1.852-L 6/19/2007	156	26	Gravity - Mortared Stone	Head Wall	45	\$50,500.00
GRSM-0011S-1.852-R 6/19/2007	94	29	Gravity - Mortared Stone	Head Wall	76	\$5,991.00

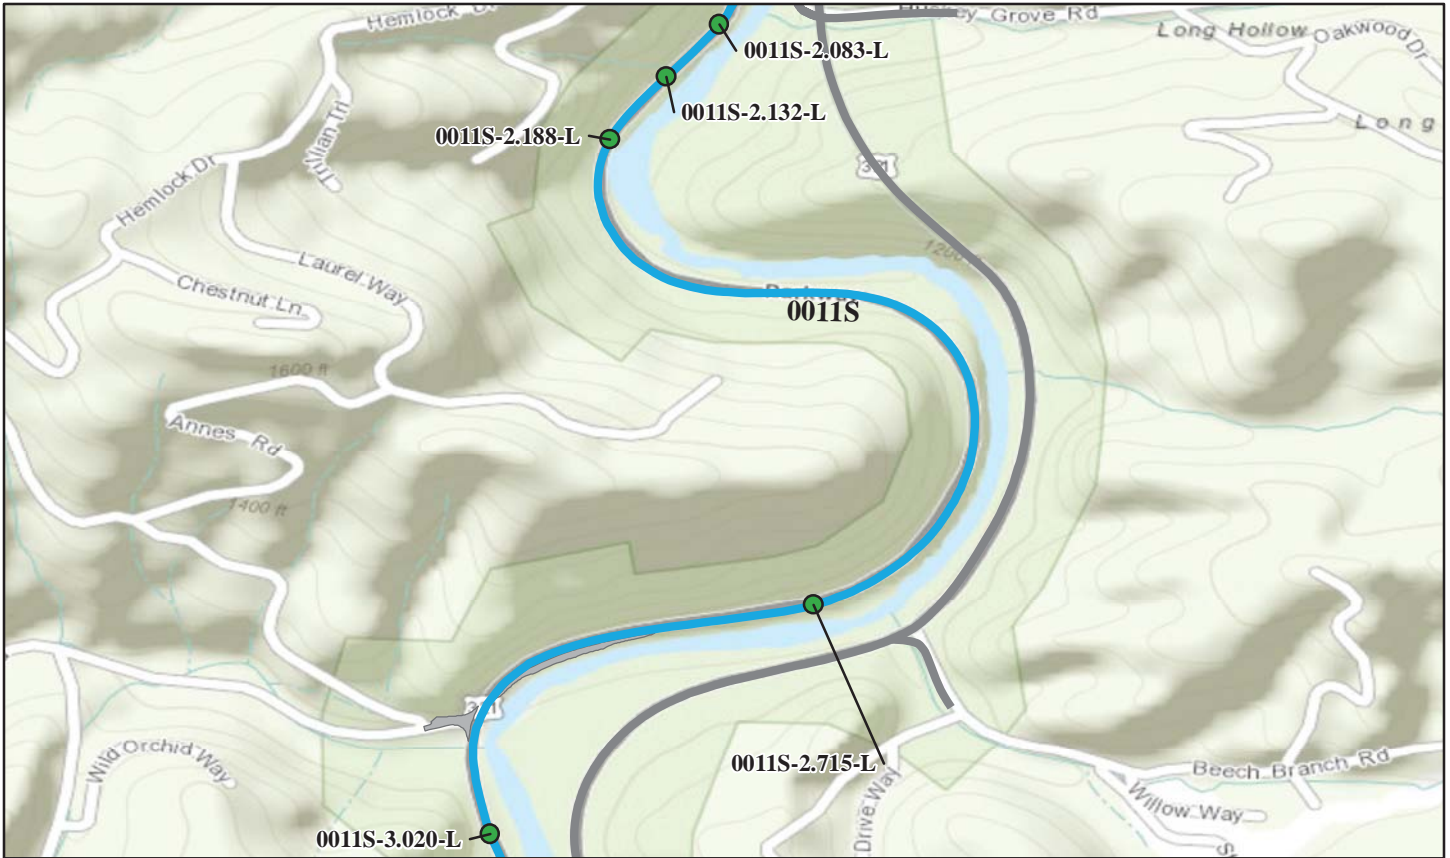
ROUTE 0011S: GATLINBURG SPUR ROAD (SOUTHBOUND)

Wall ID Inspection Date:	Wall Area (Sq. Ft.)	Wall Length (Ft.)	Wall Type	Wall Function	Overall Rating	Repair Cost
GRSM-0011S-2.083-L 6/20/2007	51	12	Gravity - Mortared Stone	Head Wall	75	\$1,441.00
GRSM-0011S-2.132-L 6/20/2007	65	16	Gravity - Mortared Stone	Head Wall	87	\$440.00
GRSM-0011S-2.188-L 6/20/2007	1,708	170	Gravity - Mortared Stone	Fill Wall	87	\$684.00
GRSM-0011S-2.715-L 6/20/2007	36	12	Gravity - Mortared Stone	Head Wall	72	\$739.00
GRSM-0011S-3.020-L 6/20/2007	41	18	Gravity - Mortared Stone	Head Wall	85	\$0.00

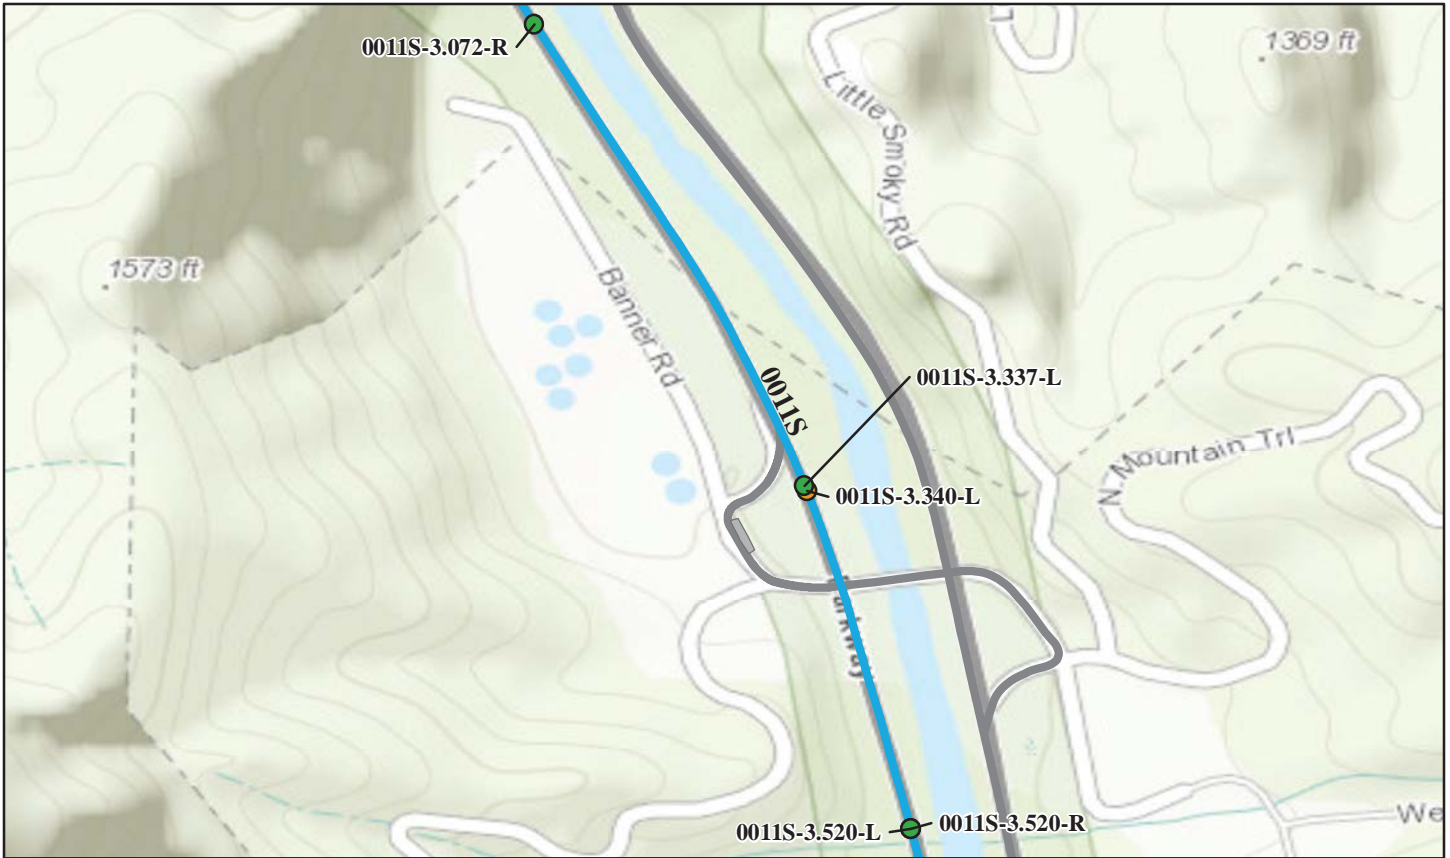
ROUTE 0011S: GATLINBURG SPUR ROAD (SOUTHBOUND)

Wall ID Inspection Date:	Wall Area (Sq. Ft.)	Wall Length (Ft.)	Wall Type	Wall Function	Overall Rating	Repair Cost
GRSM-0011S-3.072-R 6/20/2007	46	15	Gravity - Mortared Stone	Head Wall	90	\$0.00
GRSM-0011S-3.337-L 6/20/2007	56	20	Gravity - Mortared Stone	Head Wall	80	\$2,015.00
GRSM-0011S-3.340-L 6/20/2007	62	20	Gravity - Mortared Stone	Head Wall	69	\$750.00
GRSM-0011S-3.520-L 6/20/2007	115	24	Gravity - Mortared Stone	Head Wall	80	\$1,500.00
GRSM-0011S-3.520-R 6/20/2007	96	21	Gravity - Mortared Stone	Head Wall	84	\$3,432.00
