NPS Retaining Wall Inventory Program Great Smoky Mountains National Park

**Federal Lands Highway
Road Inventory Program**

Federal Highway Administration
Eastern Federal Lands Highway Division
Road Inventory Program (RIP)

Data Collection Date: April 2011
Report Date: November 2015

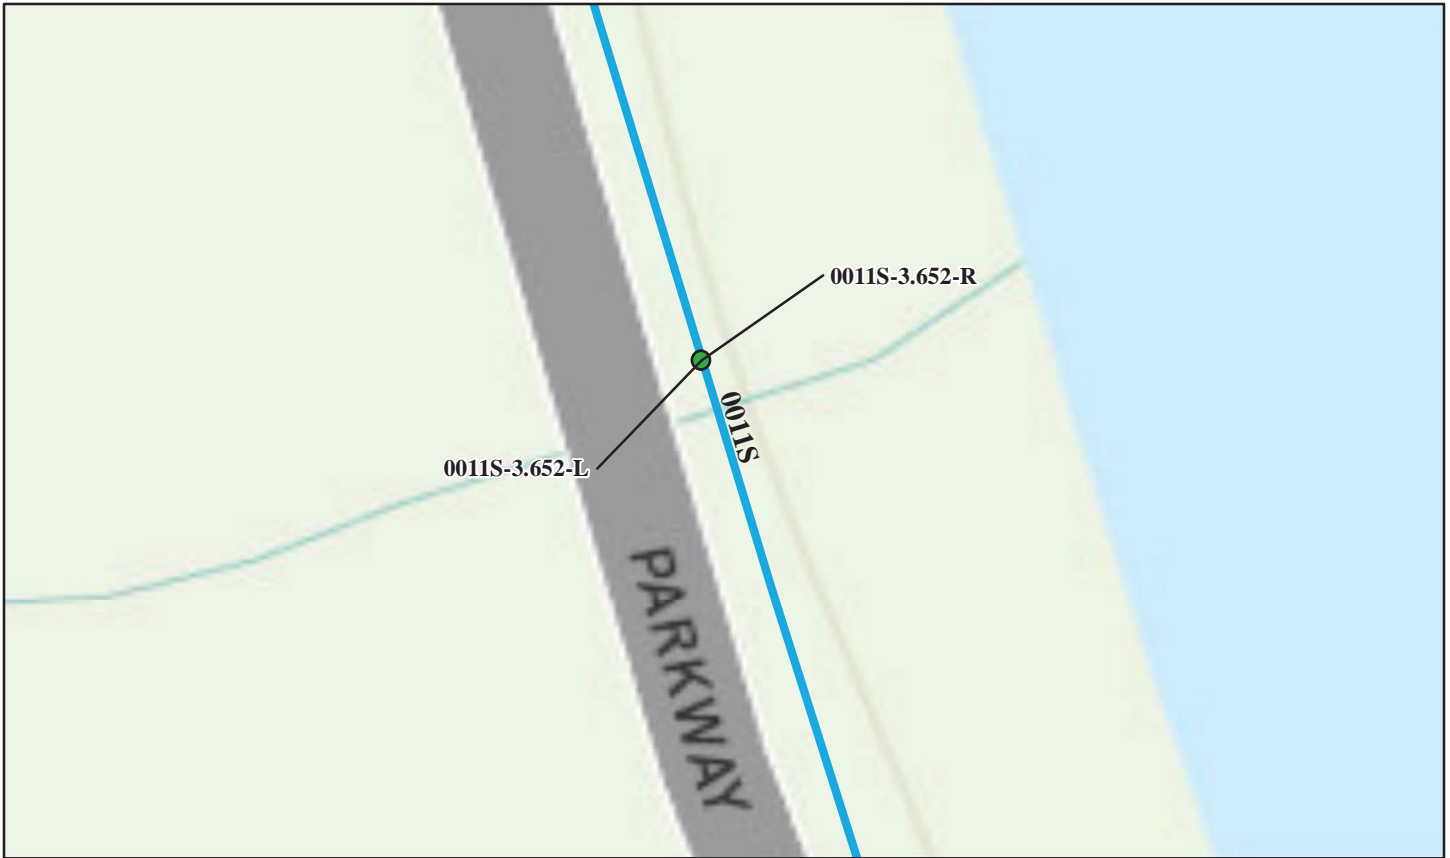
ROUTE 0011S: GATLINBURG SPUR ROAD (SOUTHBOUND)

Wall ID Inspection Date:	Wall Area (Sq. Ft.)	Wall Length (Ft.)	Wall Type	Wall Function	Overall Rating	Repair Cost
GRSM-0011S-3.652-L 6/20/2007	91	24	Gravity - Mortared Stone	Head Wall	78	\$6,484.00
GRSM-0011S-3.652-R 6/20/2007	91	24	Gravity - Mortared Stone	Head Wall	75	\$6,225.00

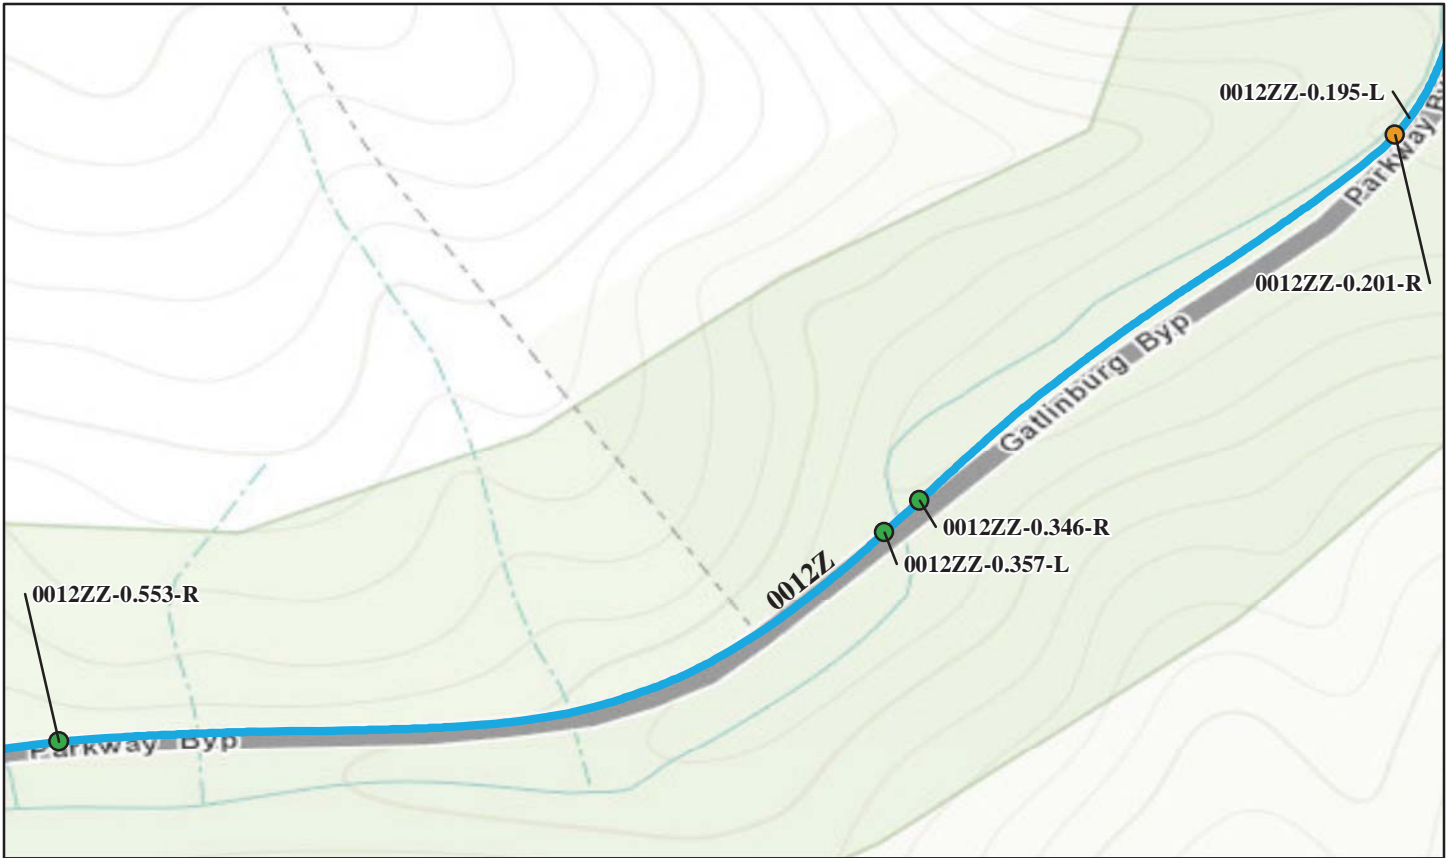
ROUTE 0012ZZ: GATLINBURG BYPASS ROAD AND RAMPS

Wall ID Inspection Date:	Wall Area (Sq. Ft.)	Wall Length (Ft.)	Wall Type	Wall Function	Overall Rating	Repair Cost
GRSM-0012ZZ-0.195-L 6/20/2007	222	35	Gravity - Mortared Stone	Head Wall	57	\$86,260.00
GRSM-0012ZZ-0.201-R 6/20/2007	114	28	Gravity - Mortared Stone	Head Wall	67	\$14,756.00
GRSM-0012ZZ-0.346-R 6/20/2007	188	33	Gravity - Mortared Stone	Head Wall	83	\$0.00
GRSM-0012ZZ-0.357-L 6/20/2007	187	40	Gravity - Mortared Stone	Head Wall	83	\$330.00
GRSM-0012ZZ-0.553-R 6/20/2007	116	25	Gravity - Mortared Stone	Head Wall	83	\$375.00

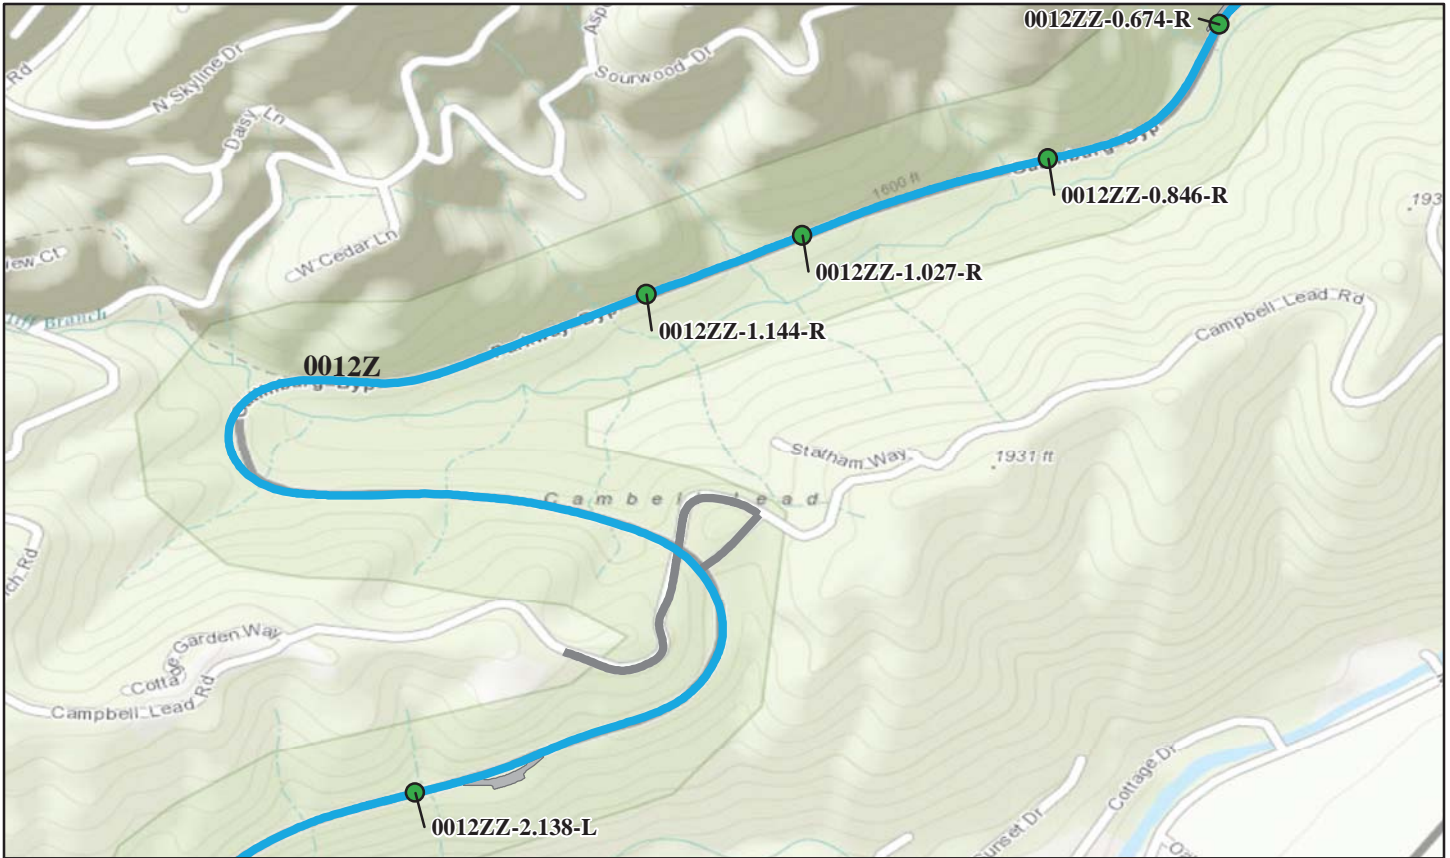
ROUTE 0012ZZ: GATLINBURG BYPASS ROAD AND RAMPS

Wall ID Inspection Date:	Wall Area (Sq. Ft.)	Wall Length (Ft.)	Wall Type	Wall Function	Overall Rating	Repair Cost
GRSM-0012ZZ-0.674-R 6/20/2007	269	28	Gravity - Mortared Stone	Head Wall	80	\$6,267.00
GRSM-0012ZZ-0.846-R 6/20/2007	35	17	Gravity - Mortared Stone	Head Wall	85	\$781.00
GRSM-0012ZZ-1.027-R 6/20/2007	140	24	Gravity - Mortared Stone	Head Wall	76	\$1,795.00
GRSM-0012ZZ-1.144-R 6/20/2007	77	20	Gravity - Mortared Stone	Head Wall	76	\$1,664.00
GRSM-0012ZZ-2.138-L 6/20/2007	5,108	547	Crib - Concrete	Fill Wall	83	\$1,555.00

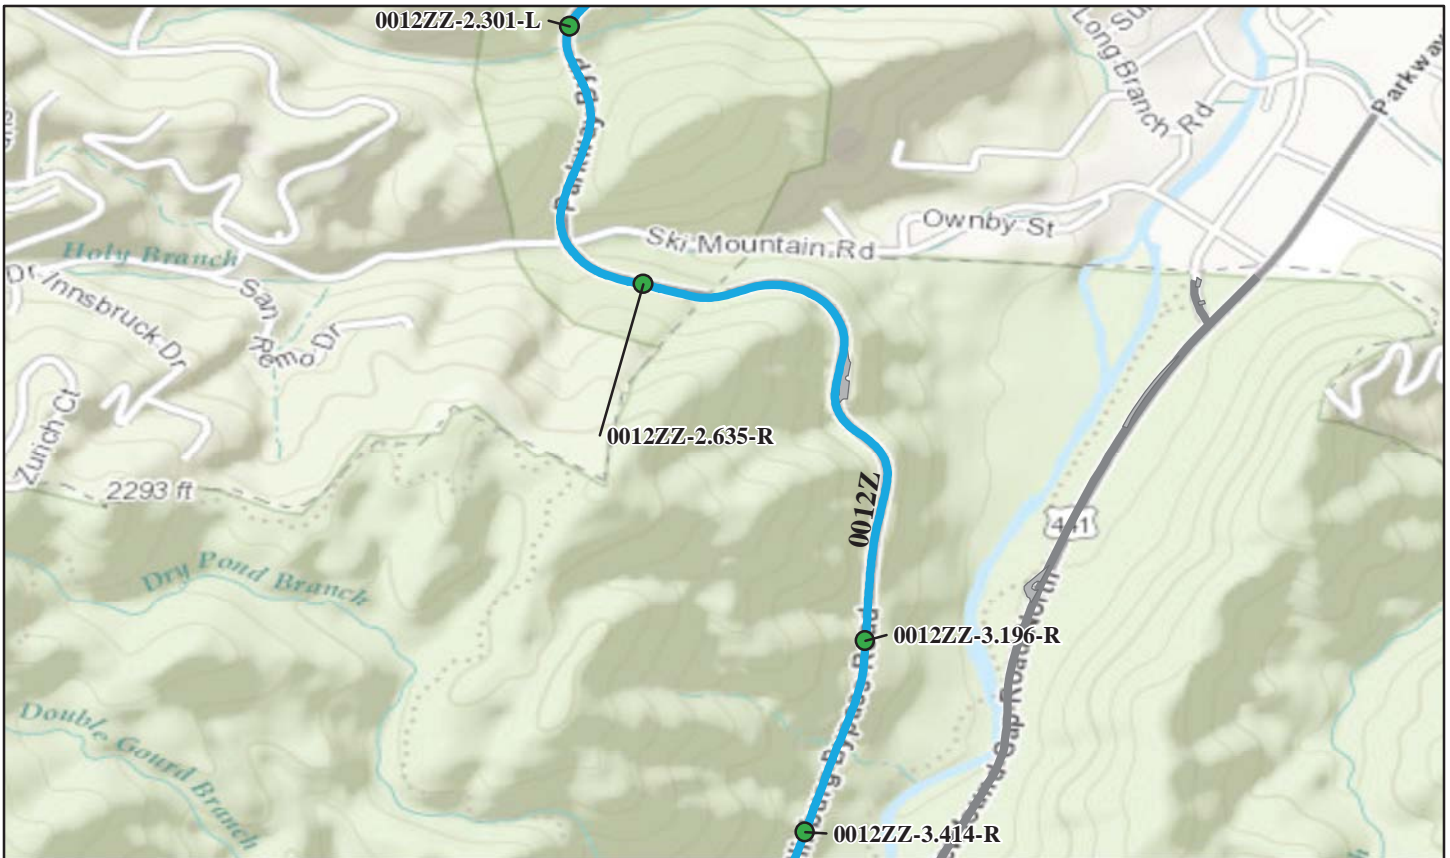
ROUTE 0012ZZ: GATLINBURG BYPASS ROAD AND RAMPS

Wall ID Inspection Date:	Wall Area (Sq. Ft.)	Wall Length (Ft.)	Wall Type	Wall Function	Overall Rating	Repair Cost
GRSM-0012ZZ-2.301-L 6/20/2007	2,809	310	Crib - Concrete	Fill Wall	97	\$1,850.00
GRSM-0012ZZ-2.635-R 6/20/2007	2,788	690	Crib - Concrete	Cut Wall	87	\$0.00
GRSM-0012ZZ-3.196-R 6/20/2007	38	16	Gravity - Mortared Stone	Head Wall	87	\$0.00
GRSM-0012ZZ-3.414-R 6/20/2007	222	48	Gravity - Mortared Stone	Head Wall	80	\$1,320.00

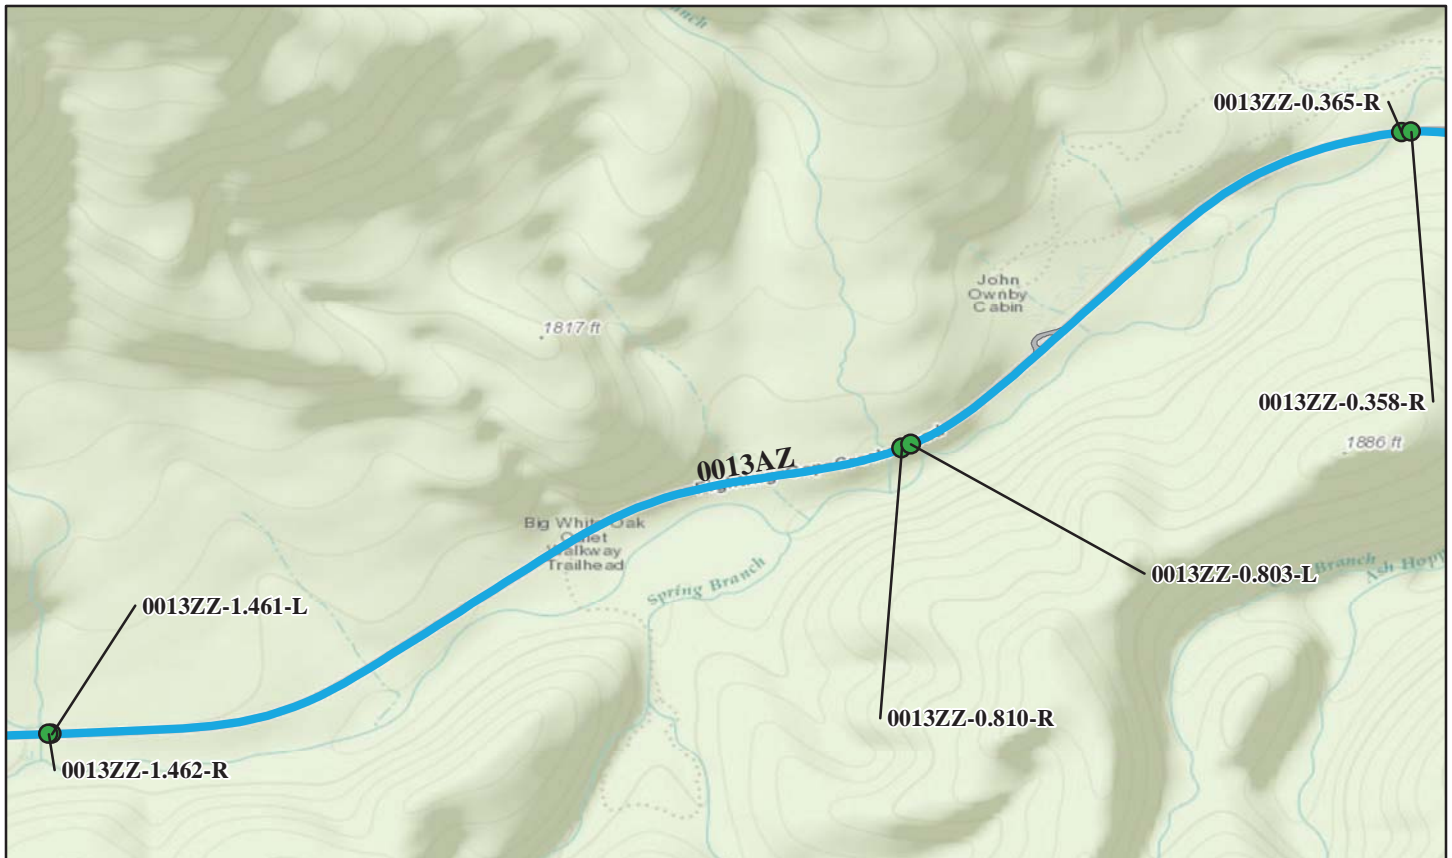
ROUTE 0013ZZ: FIGHTING CREEK GAP ROAD AND SPUR

Wall ID Inspection Date:	Wall Area (Sq. Ft.)	Wall Length (Ft.)	Wall Type	Wall Function	Overall Rating	Repair Cost
GRSM-0013ZZ-0.358-R 11/27/2007	1,000	125	Gravity - Mortared Stone	Head Wall	87	\$0.00
GRSM-0013ZZ-0.365-R 11/27/2007	1,000	125	Gravity - Mortared Stone	Head Wall	85	\$0.00
GRSM-0013ZZ-0.803-L 11/27/2007	70	20	Gravity - Dry Stone	Head Wall	77	\$0.00
GRSM-0013ZZ-0.810-R 11/27/2007	82	20	Gravity - Mortared Stone	Head Wall	86	\$0.00
GRSM-0013ZZ-1.461-L 11/27/2007	164	38	Gravity - Mortared Stone	Head Wall	83	\$0.00

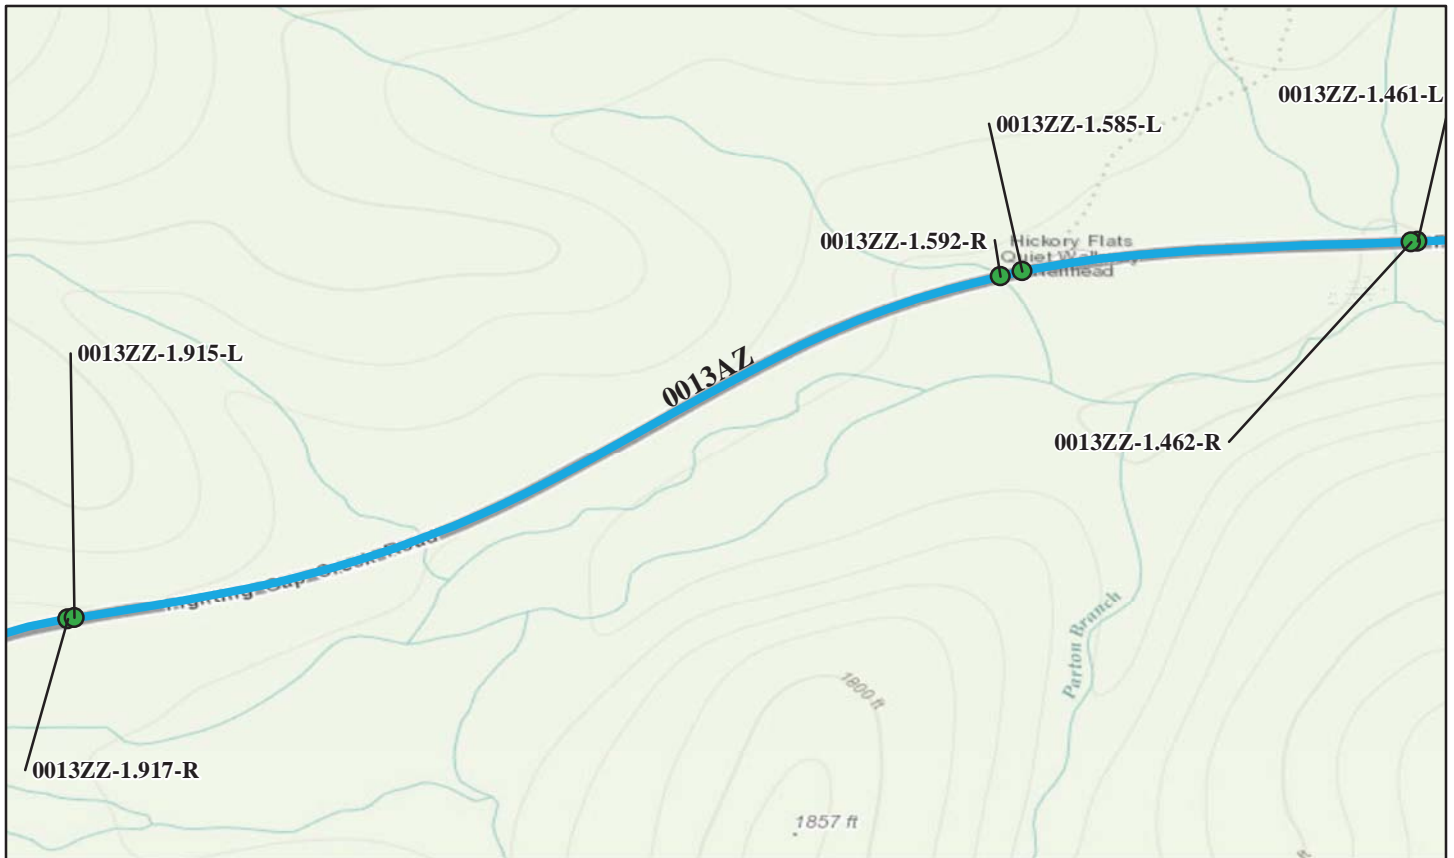
ROUTE 0013ZZ: FIGHTING CREEK GAP ROAD AND SPUR

Wall ID Inspection Date:	Wall Area (Sq. Ft.)	Wall Length (Ft.)	Wall Type	Wall Function	Overall Rating	Repair Cost
GRSM-0013ZZ-1.462-R 11/27/2007	164	38	Gravity - Mortared Stone	Head Wall	87	\$0.00
GRSM-0013ZZ-1.585-L 11/27/2007	74	25	Gravity - Mortared Stone	Head Wall	80	\$5,720.00
GRSM-0013ZZ-1.592-R 11/27/2007	74	25	Gravity - Mortared Stone	Head Wall	82	\$0.00
GRSM-0013ZZ-1.915-L 11/27/2007	265	45	Gravity - Mortared Stone	Head Wall	90	\$0.00
GRSM-0013ZZ-1.917-R 11/27/2007	313	45	Gravity - Mortared Stone	Head Wall	87	\$0.00

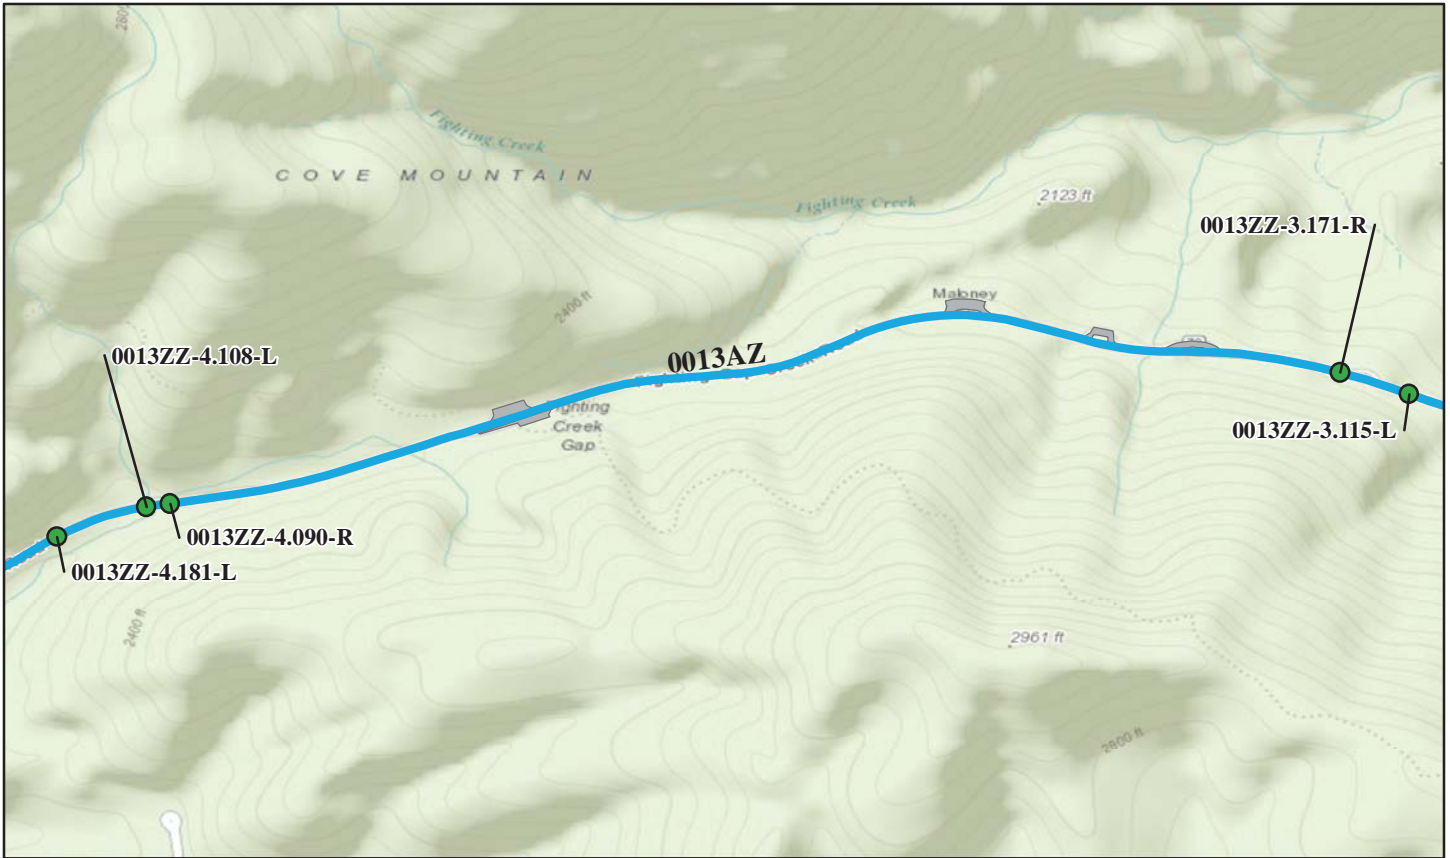
ROUTE 0013ZZ: FIGHTING CREEK GAP ROAD AND SPUR

Wall ID Inspection Date:	Wall Area (Sq. Ft.)	Wall Length (Ft.)	Wall Type	Wall Function	Overall Rating	Repair Cost
GRSM-0013ZZ-3.115-L 11/27/2007	1,220	220	Crib - Concrete	Slope Protection	74	\$3,690.00
GRSM-0013ZZ-3.171-R 11/27/2007	3,635	337	MSE - Precast Panel	Fill Wall	90	\$0.00
GRSM-0013ZZ-4.090-R 11/27/2007	132	30	Gravity - Mortared Stone	Head Wall	80	\$0.00
GRSM-0013ZZ-4.108-L 11/27/2007	150	30	Gravity - Mortared Stone	Head Wall	82	\$0.00
GRSM-0013ZZ-4.181-L 11/27/2007	683	91	Gravity - Mortared Stone	Head Wall	85	\$0.00

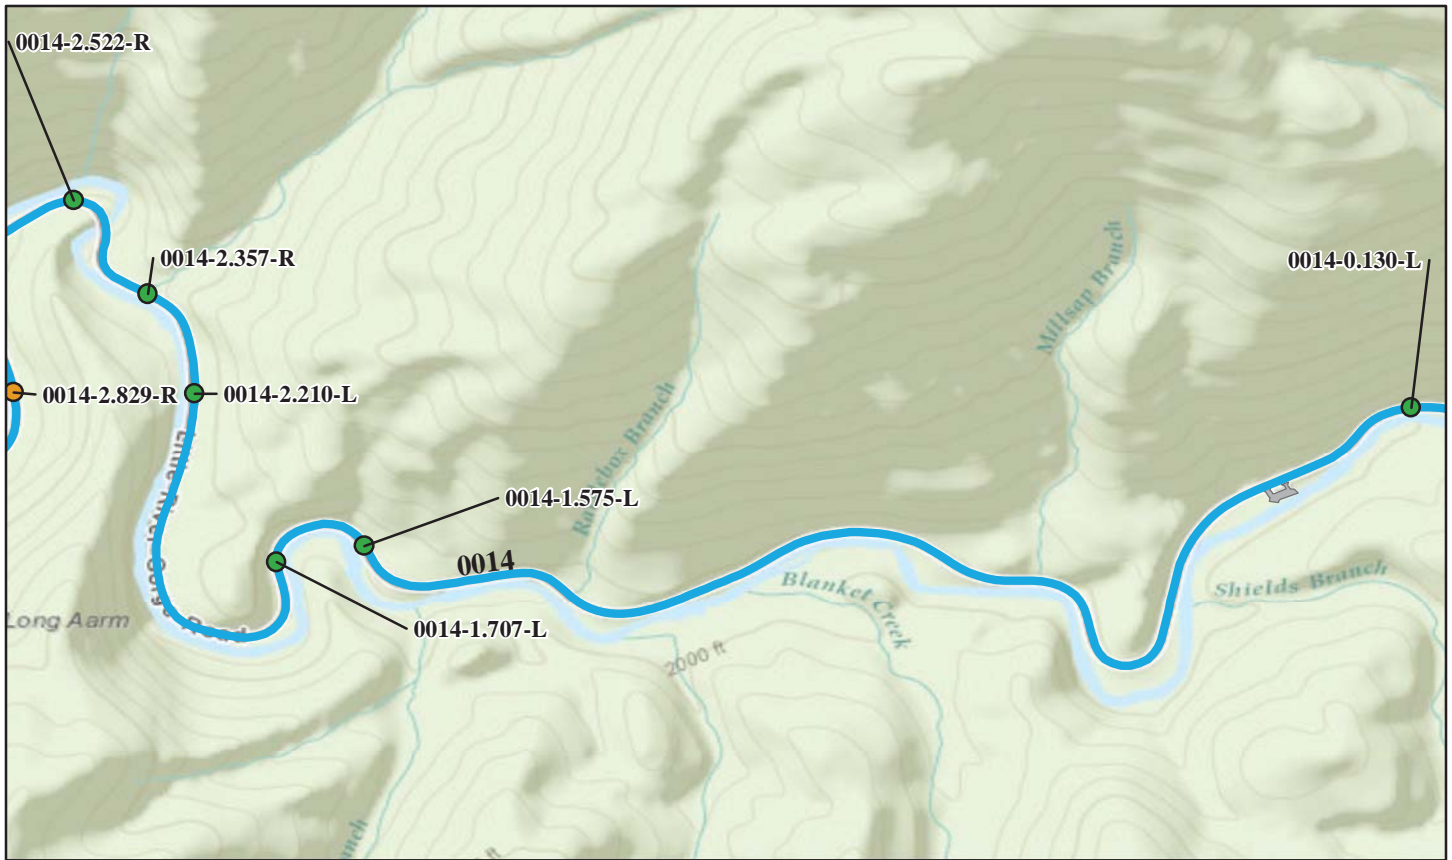
ROUTE 0014: LITTLE RIVER GORGE ROAD

Wall ID Inspection Date:	Wall Area (Sq. Ft.)	Wall Length (Ft.)	Wall Type	Wall Function	Overall Rating	Repair Cost
GRSM-0014-0.130-L 11/27/2007	3,445	265	Gravity - Mortared Stone	Fill Wall	76	\$0.00
GRSM-0014-1.575-L 11/27/2007	2,282	306	Gravity - Mortared Stone	Fill Wall	90	\$0.00
GRSM-0014-1.707-L 11/28/2007	2,409	219	Gravity - Mortared Stone	Fill Wall	90	\$0.00
GRSM-0014-2.210-L 11/28/2007	10,193	703	Gravity - Mortared Stone	Fill Wall	70	\$0.00
GRSM-0014-2.357-R 11/28/2007	120	24	Gravity - Mortared Stone	Head Wall	80	\$0.00

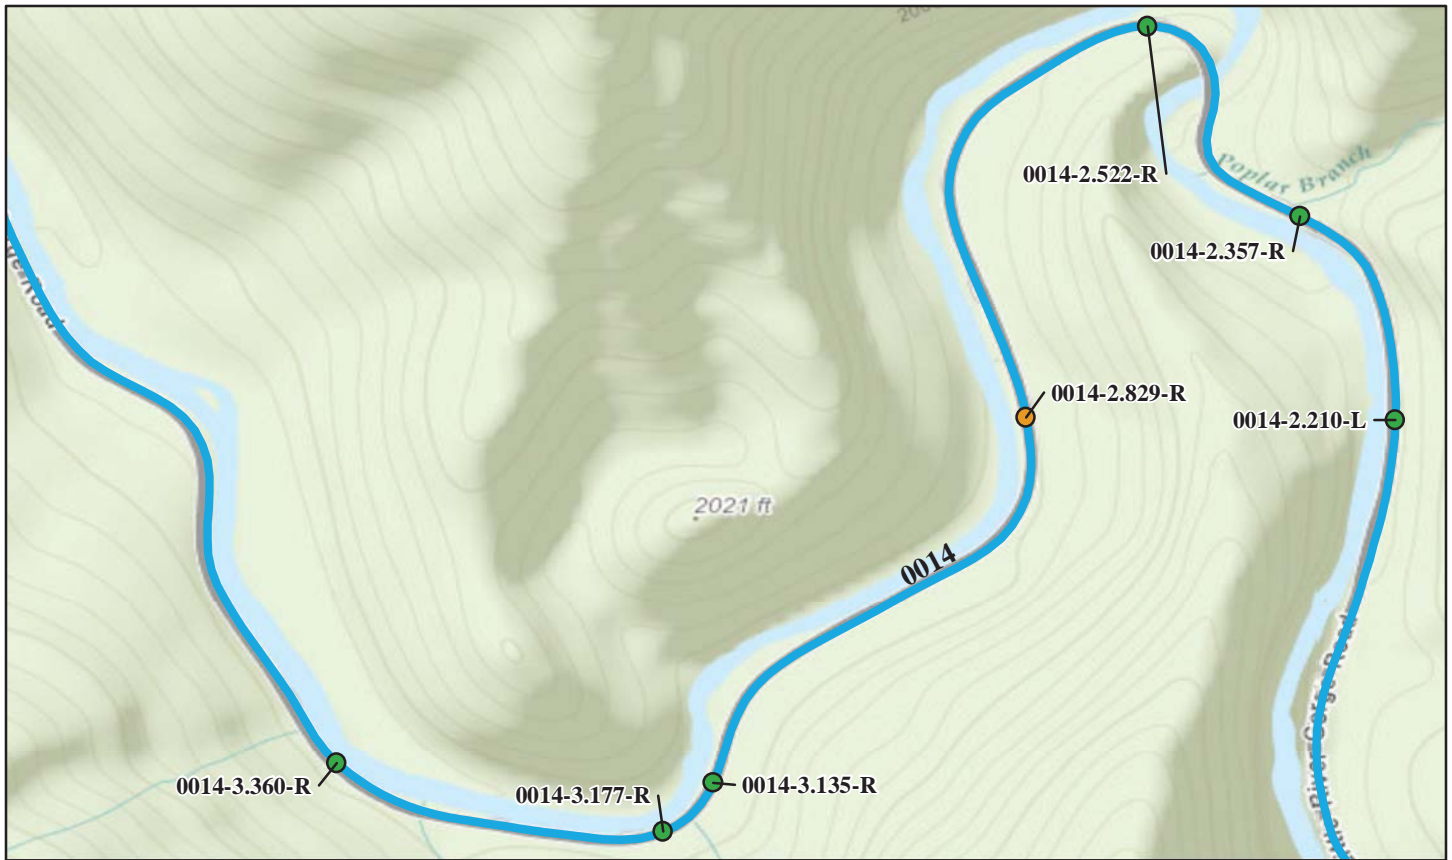
ROUTE 0014: LITTLE RIVER GORGE ROAD

Wall ID Inspection Date:	Wall Area (Sq. Ft.)	Wall Length (Ft.)	Wall Type	Wall Function	Overall Rating	Repair Cost
GRSM-0014-2.522-R 11/28/2007	2,559	209	Gravity - Mortared Stone	Fill Wall	82	\$0.00
GRSM-0014-2.829-R 11/28/2007	9,674	691	Gravity - Mortared Stone	Fill Wall	65	\$42,000.00
GRSM-0014-3.135-R 11/28/2007	818	102	Gravity - Dry Stone	Fill Wall	87	\$0.00
GRSM-0014-3.177-R 11/28/2007	3,633	303	Gravity - Mortared Stone	Fill Wall	82	\$0.00
GRSM-0014-3.360-R 11/28/2007	1,742	152	Gravity - Mortared Stone	Fill Wall	90	\$0.00

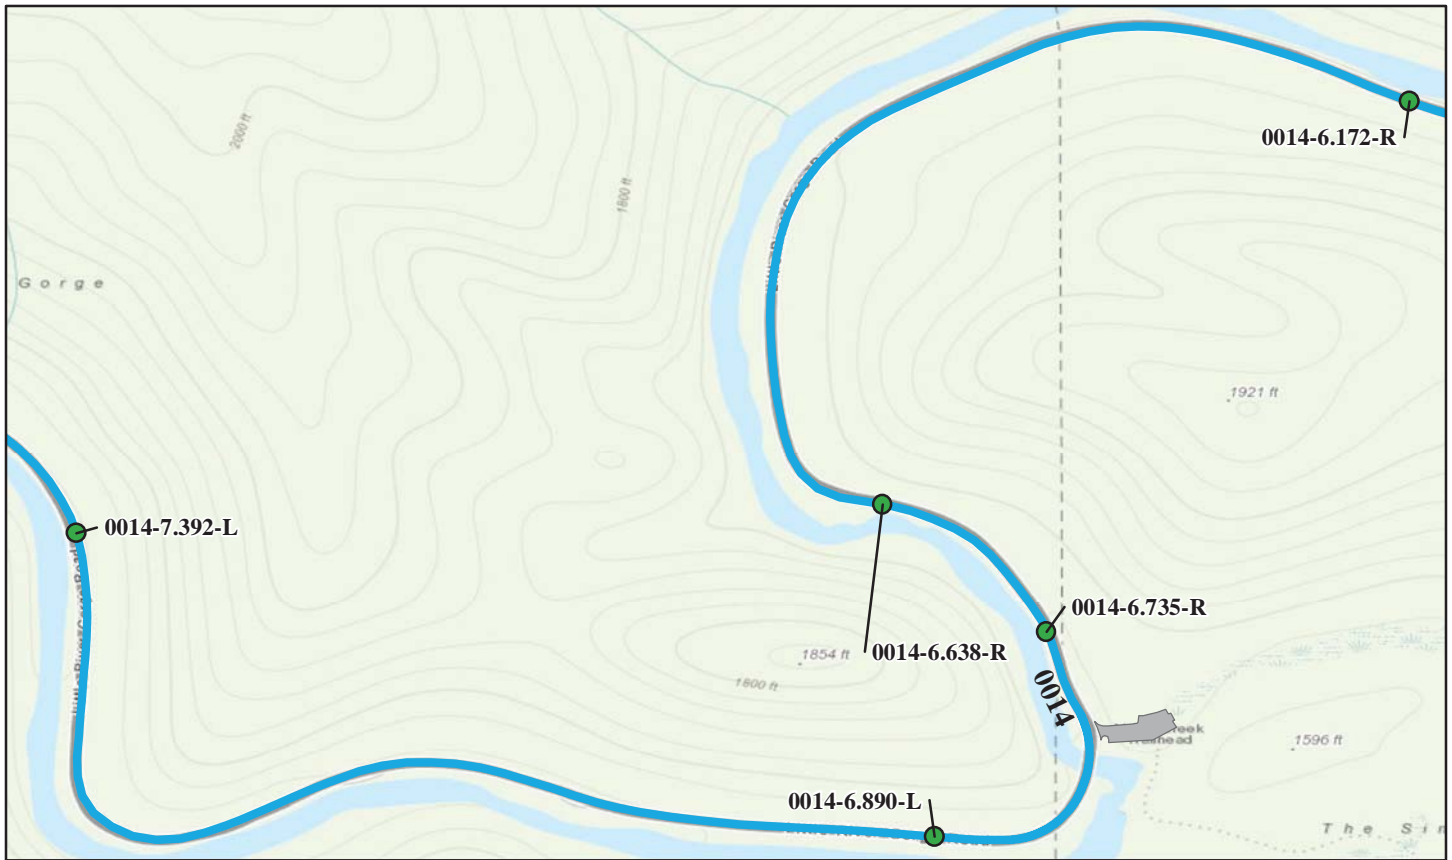
ROUTE 0014: LITTLE RIVER GORGE ROAD

Wall ID Inspection Date:	Wall Area (Sq. Ft.)	Wall Length (Ft.)	Wall Type	Wall Function	Overall Rating	Repair Cost
GRSM-0014-6.172-R 11/28/2007	1,233	137	Gravity - Mortared Stone	Fill Wall	84	\$0.00
GRSM-0014-6.638-R 11/28/2007	1,690	169	Gravity - Dry Stone	Fill Wall	83	\$0.00
GRSM-0014-6.735-R 11/28/2007	1,230	123	Gravity - Dry Stone	Fill Wall	79	\$0.00
GRSM-0014-6.890-L 11/28/2007	1,076	84	Gravity - Mortared Stone	Bridge Wall	88	\$0.00
GRSM-0014-7.392-L 11/28/2007	1,878	171	Gravity - Mortared Stone	Fill Wall	71	\$0.00

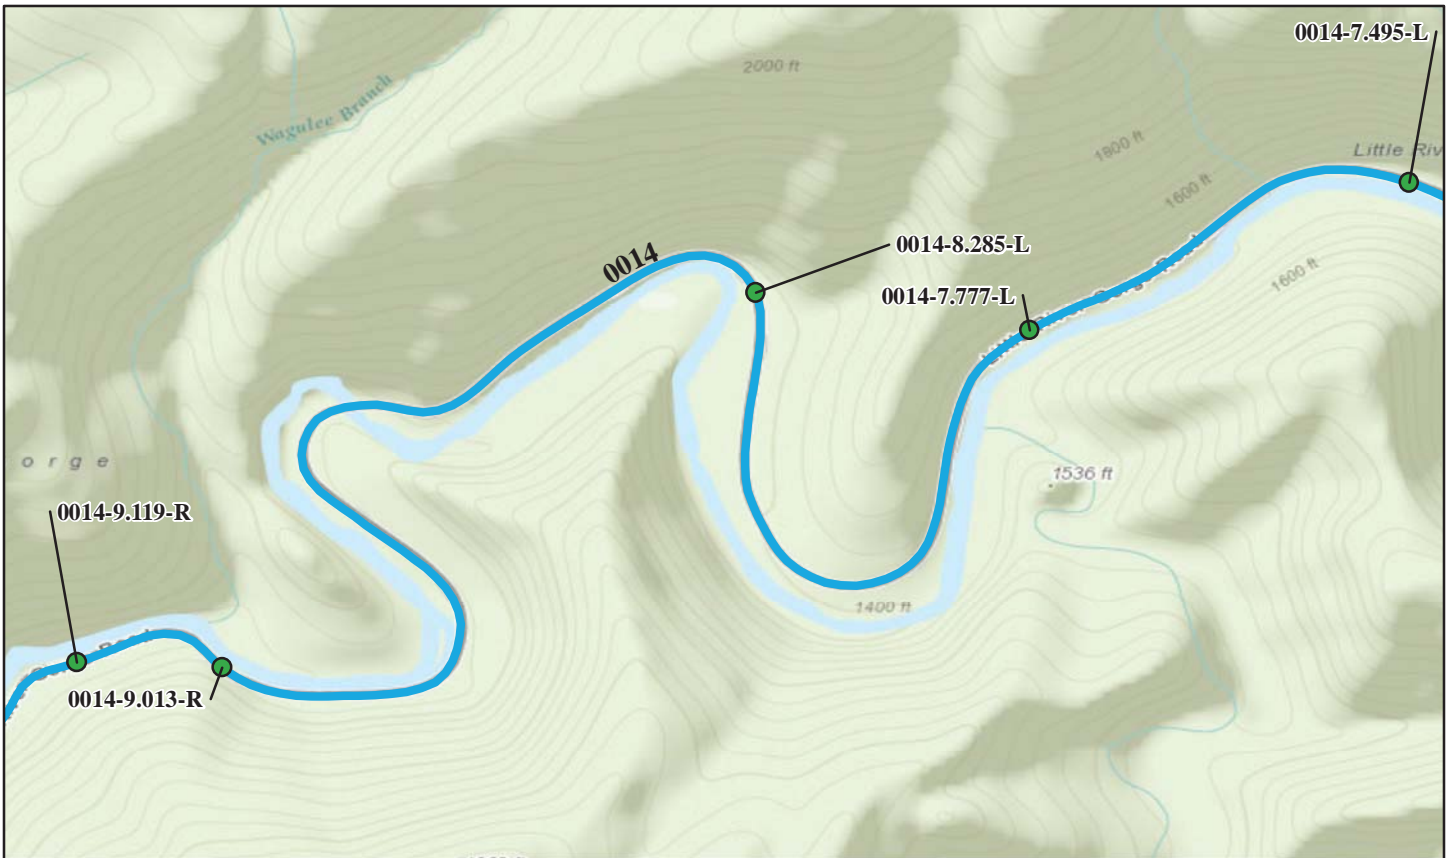
ROUTE 0014: LITTLE RIVER GORGE ROAD

Wall ID Inspection Date:	Wall Area (Sq. Ft.)	Wall Length (Ft.)	Wall Type	Wall Function	Overall Rating	Repair Cost
GRSM-0014-7.495-L 11/28/2007	9,560	741	Gravity - Mortared Stone	Fill Wall	82	\$0.00
GRSM-0014-7.777-L 11/28/2007	6,858	606	Gravity - Mortared Stone	Fill Wall	84	\$0.00
GRSM-0014-8.285-L 11/28/2007	8,161	517	Gravity - Mortared Stone	Fill Wall	89	\$0.00
GRSM-0014-9.013-R 11/28/2007	6,192	531	Gravity - Mortared Stone	Fill Wall	77	\$0.00
GRSM-0014-9.119-R 11/28/2007	1,689	163	Gravity - Mortared Stone	Fill Wall	80	\$0.00

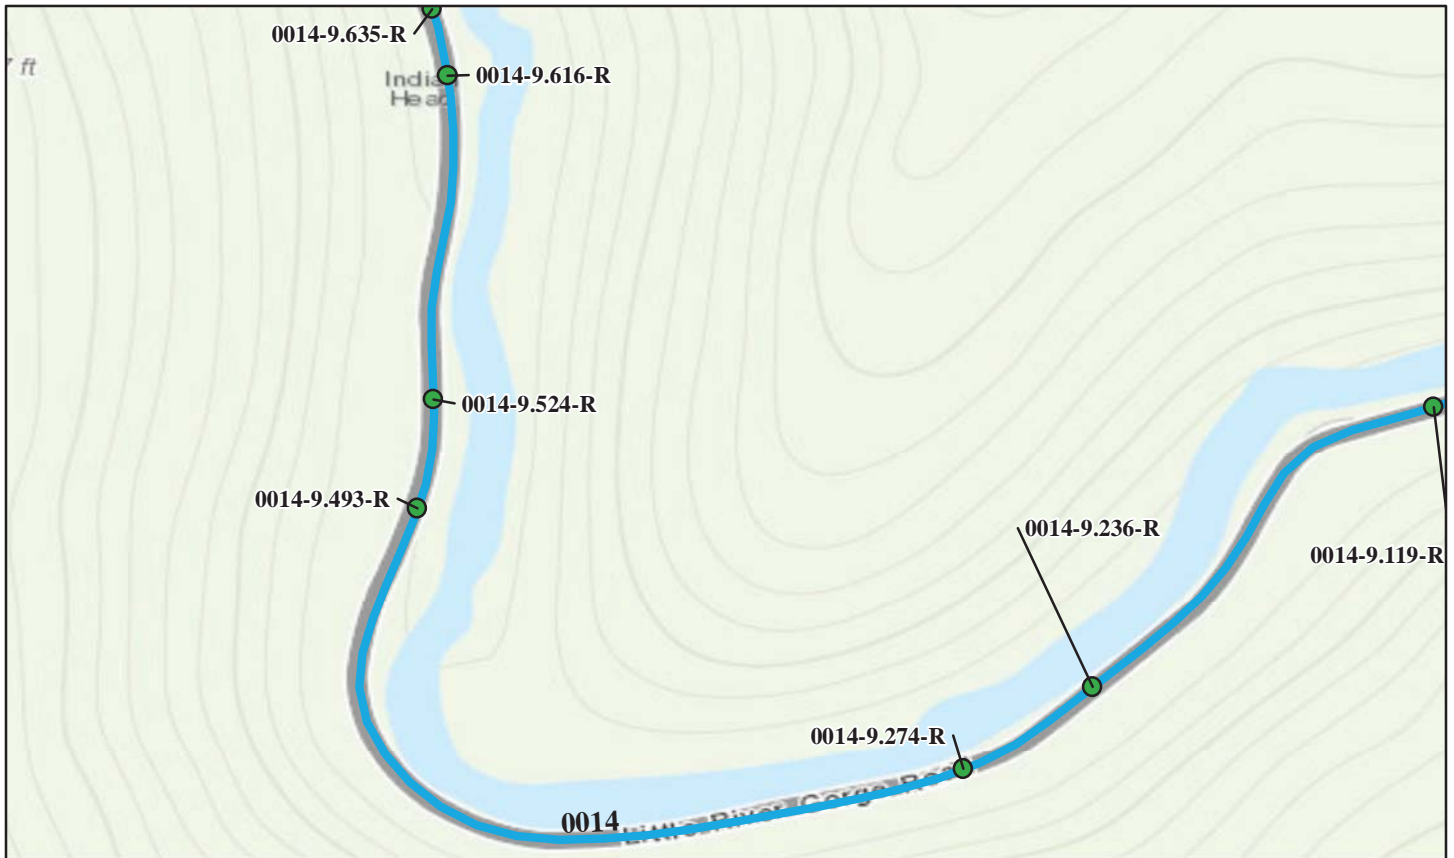
ROUTE 0014: LITTLE RIVER GORGE ROAD

Wall ID Inspection Date:	Wall Area (Sq. Ft.)	Wall Length (Ft.)	Wall Type	Wall Function	Overall Rating	Repair Cost
GRSM-0014-9.236-R 11/28/2007	1,080	72	Gravity - Mortared Stone	Fill Wall	80	\$0.00
GRSM-0014-9.274-R 11/28/2007	3,828	357	Gravity - Mortared Stone	Fill Wall	80	\$0.00
GRSM-0014-9.493-R 11/28/2007	2,875	281	Gravity - Mortared Stone	Fill Wall	80	\$0.00
GRSM-0014-9.524-R 11/28/2007	1,740	145	Gravity - Mortared Stone	Fill Wall	85	\$0.00
GRSM-0014-9.616-R 12/10/2007	1,035	84	Gravity - Mortared Stone	Fill Wall	88	\$0.00

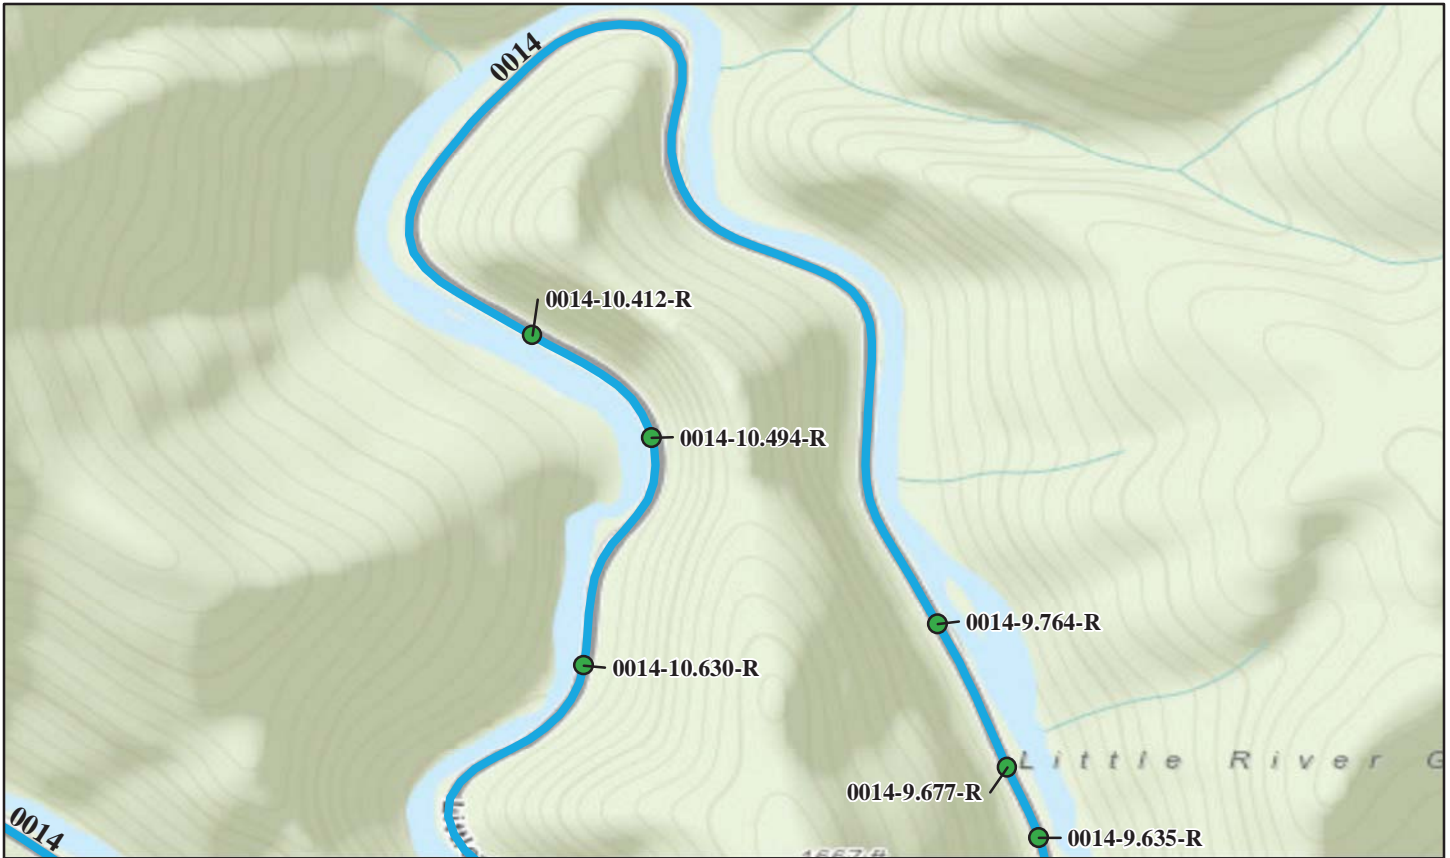
ROUTE 0014: LITTLE RIVER GORGE ROAD

Wall ID Inspection Date:	Wall Area (Sq. Ft.)	Wall Length (Ft.)	Wall Type	Wall Function	Overall Rating	Repair Cost
GRSM-0014-9.635-R 11/28/2007	1,109	140	Gravity - Mortared Stone	Fill Wall	85	\$0.00
GRSM-0014-9.677-R 11/28/2007	1,807	218	Gravity - Mortared Stone	Fill Wall	85	\$0.00
GRSM-0014-9.764-R 11/28/2007	1,805	140	Gravity - Mortared Stone	Fill Wall	85	\$0.00
GRSM-0014-10.412-R 11/28/2007	1,716	143	Gravity - Mortared Stone	Slope Protection	90	\$0.00
GRSM-0014-10.494-R 11/28/2007	4,985	525	Gravity - Mortared Stone	Fill Wall	82	\$0.00

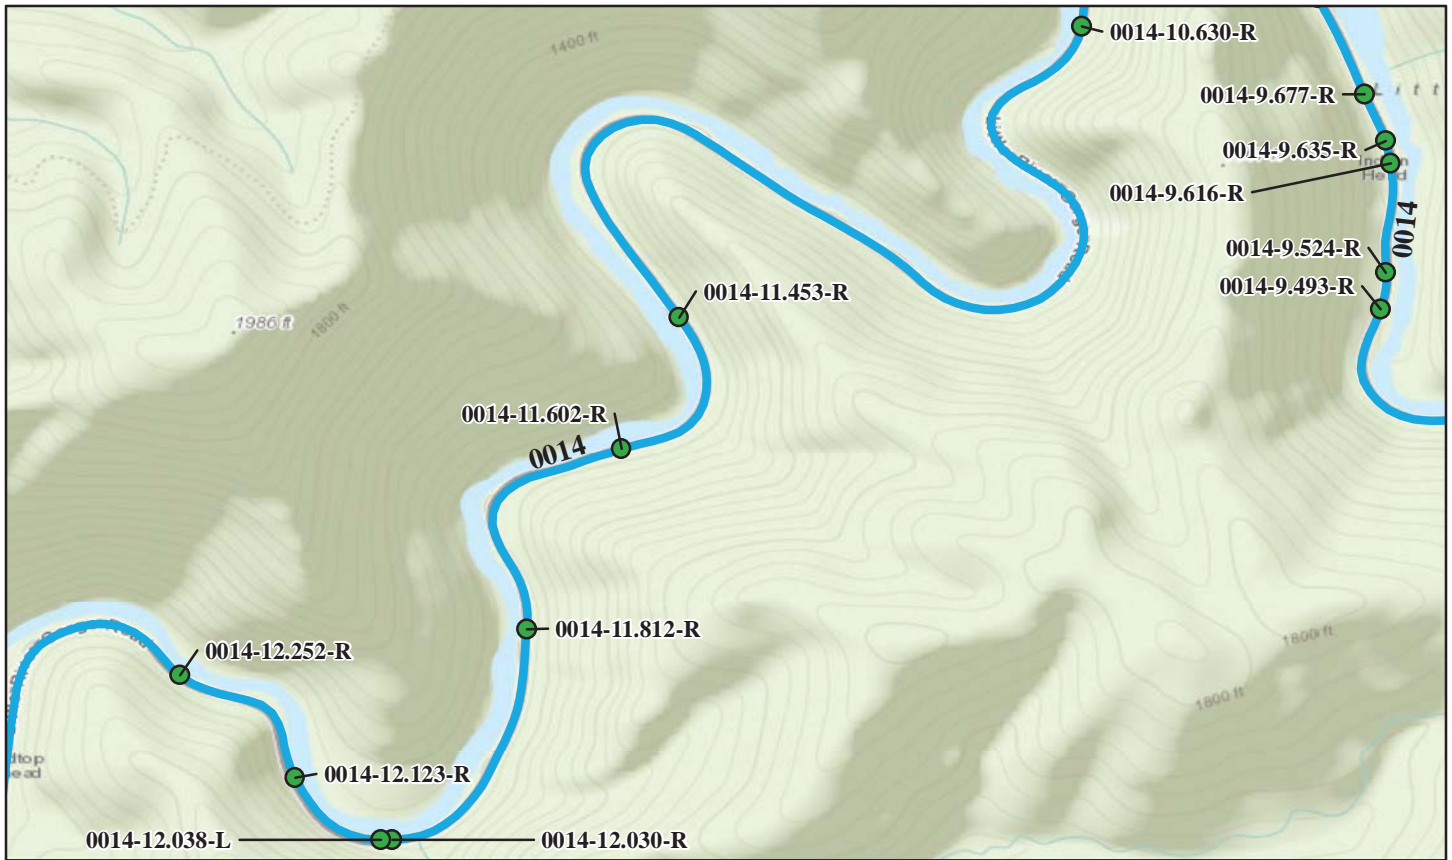
ROUTE 0014: LITTLE RIVER GORGE ROAD

Wall ID Inspection Date:	Wall Area (Sq. Ft.)	Wall Length (Ft.)	Wall Type	Wall Function	Overall Rating	Repair Cost
GRSM-0014-10.630-R 11/28/2007	2,500	342	Gravity - Mortared Stone	Fill Wall	85	\$0.00
GRSM-0014-11.453-R 11/28/2007	342	38	Gravity - Mortared Stone	Fill Wall	82	\$0.00
GRSM-0014-11.602-R 11/28/2007	1,485	184	Gravity - Mortared Stone	Fill Wall	80	\$0.00
GRSM-0014-11.812-R 11/28/2007	2,083	248	Gravity - Mortared Stone	Fill Wall	82	\$0.00
GRSM-0014-12.030-R 11/28/2007	883	102	Gravity - Mortared Stone	Fill Wall	86	\$0.00

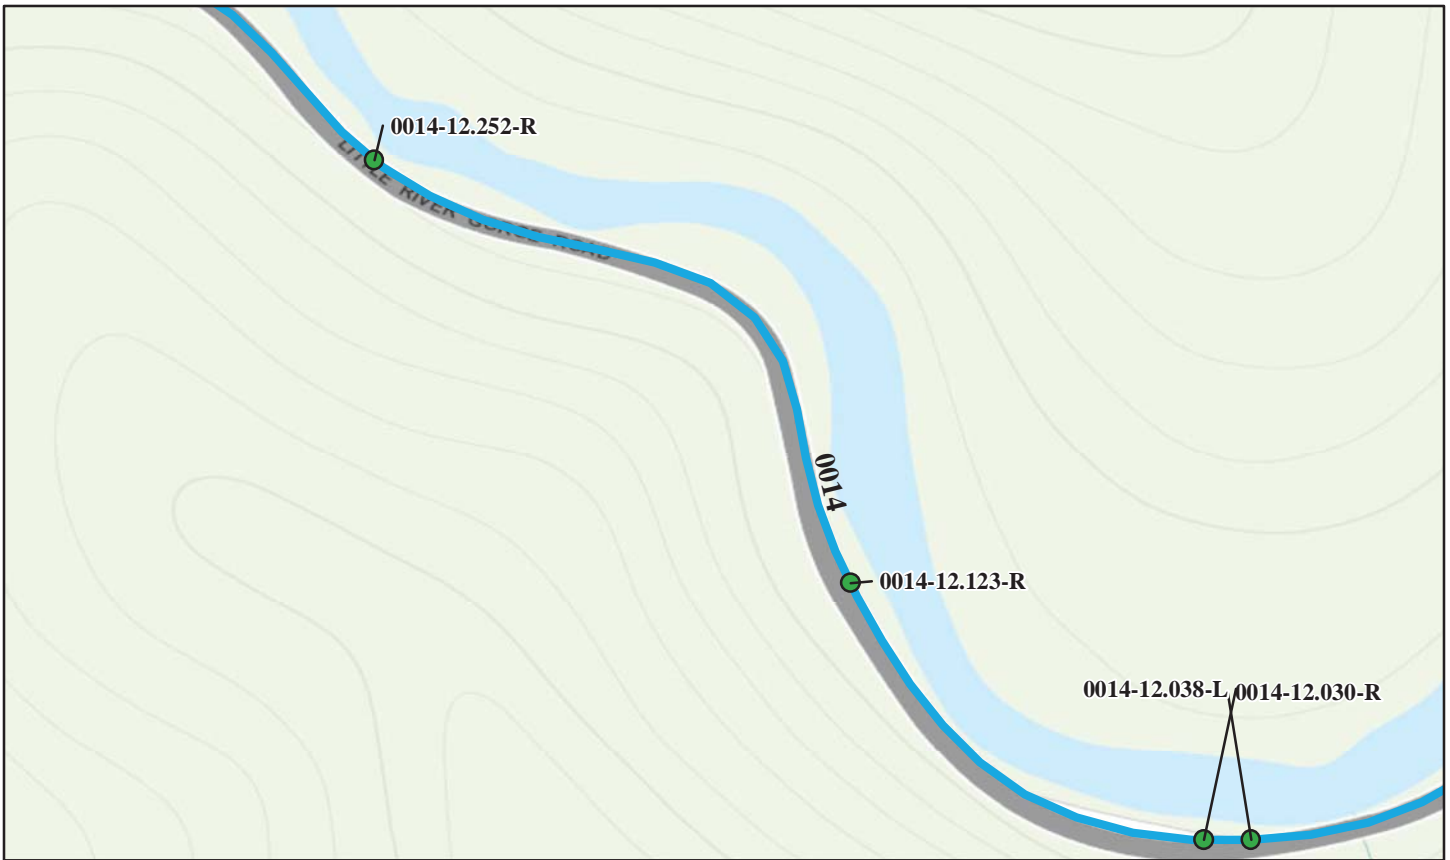
ROUTE 0014: LITTLE RIVER GORGE ROAD

Wall ID Inspection Date:	Wall Area (Sq. Ft.)	Wall Length (Ft.)	Wall Type	Wall Function	Overall Rating	Repair Cost
GRSM-0014-12.038-L 11/28/2007	253	44	Cantilever - Concrete	Head Wall	90	\$0.00
GRSM-0014-12.123-R 11/28/2007	653	90	Gravity - Mortared Stone	Fill Wall	82	\$0.00
GRSM-0014-12.252-R 11/28/2007	1,904	179	Gravity - Mortared Stone	Slope Protection	88	\$0.00

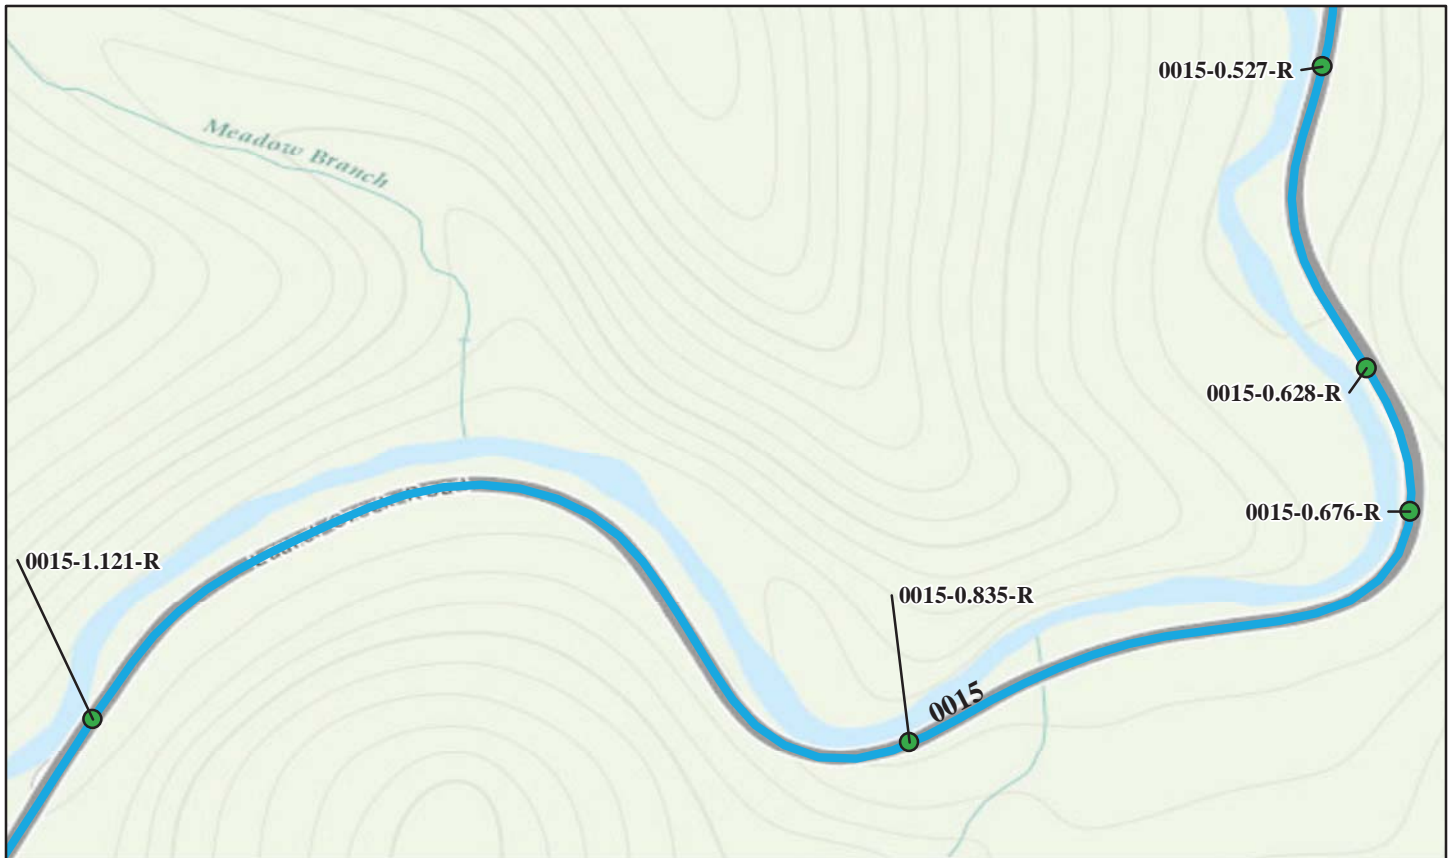
ROUTE 0015: LAUREL CREEK ROAD

Wall ID Inspection Date:	Wall Area (Sq. Ft.)	Wall Length (Ft.)	Wall Type	Wall Function	Overall Rating	Repair Cost
GRSM-0015-0.527-R 11/29/2007	3,970	336	Gravity - Mortared Stone	Fill Wall	85	\$0.00
GRSM-0015-0.628-R 11/29/2007	1,300	116	Gravity - Mortared Stone	Fill Wall	83	\$0.00
GRSM-0015-0.676-R 11/29/2007	2,583	248	Gravity - Mortared Stone	Fill Wall	82	\$0.00
GRSM-0015-0.835-R 11/29/2007	4,016	309	Gravity - Mortared Stone	Fill Wall	78	\$20,280.00
GRSM-0015-1.121-R 11/29/2007	1,900	150	Gravity - Mortared Stone	Fill Wall	85	\$0.00
