NPS Retaining Wall Inventory Program Great Smoky Mountains National Park

**Federal Lands Highway
Road Inventory Program**

Federal Highway Administration
Eastern Federal Lands Highway Division
Road Inventory Program (RIP)

Data Collection Date: April 2011
Report Date: November 2015

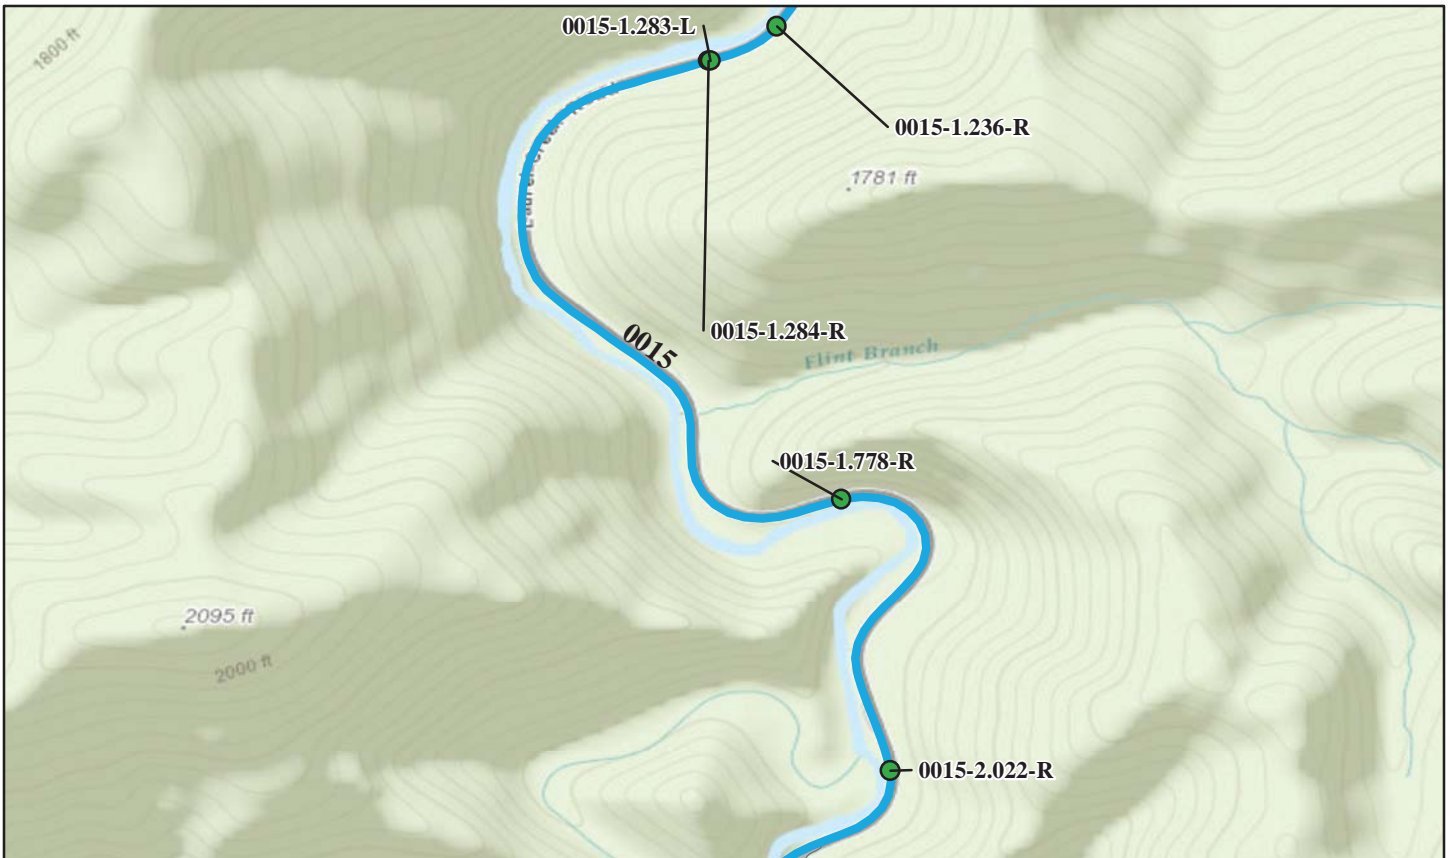
ROUTE 0015: LAUREL CREEK ROAD

Wall ID Inspection Date:	Wall Area (Sq. Ft.)	Wall Length (Ft.)	Wall Type	Wall Function	Overall Rating	Repair Cost
GRSM-0015-1.236-R 11/29/2007	1,283	137	Gravity - Mortared Stone	Fill Wall	82	\$0.00
GRSM-0015-1.283-L 11/29/2007	131	27	Gravity - Mortared Stone	Head Wall	83	\$0.00
GRSM-0015-1.284-R 11/29/2007	205	35	Gravity - Mortared Stone	Head Wall	83	\$0.00
GRSM-0015-1.778-R 11/29/2007	3,756	417	Gravity - Mortared Stone	Fill Wall	84	\$0.00
GRSM-0015-2.022-R 11/29/2007	1,687	269	Gravity - Mortared Stone	Fill Wall	82	\$0.00

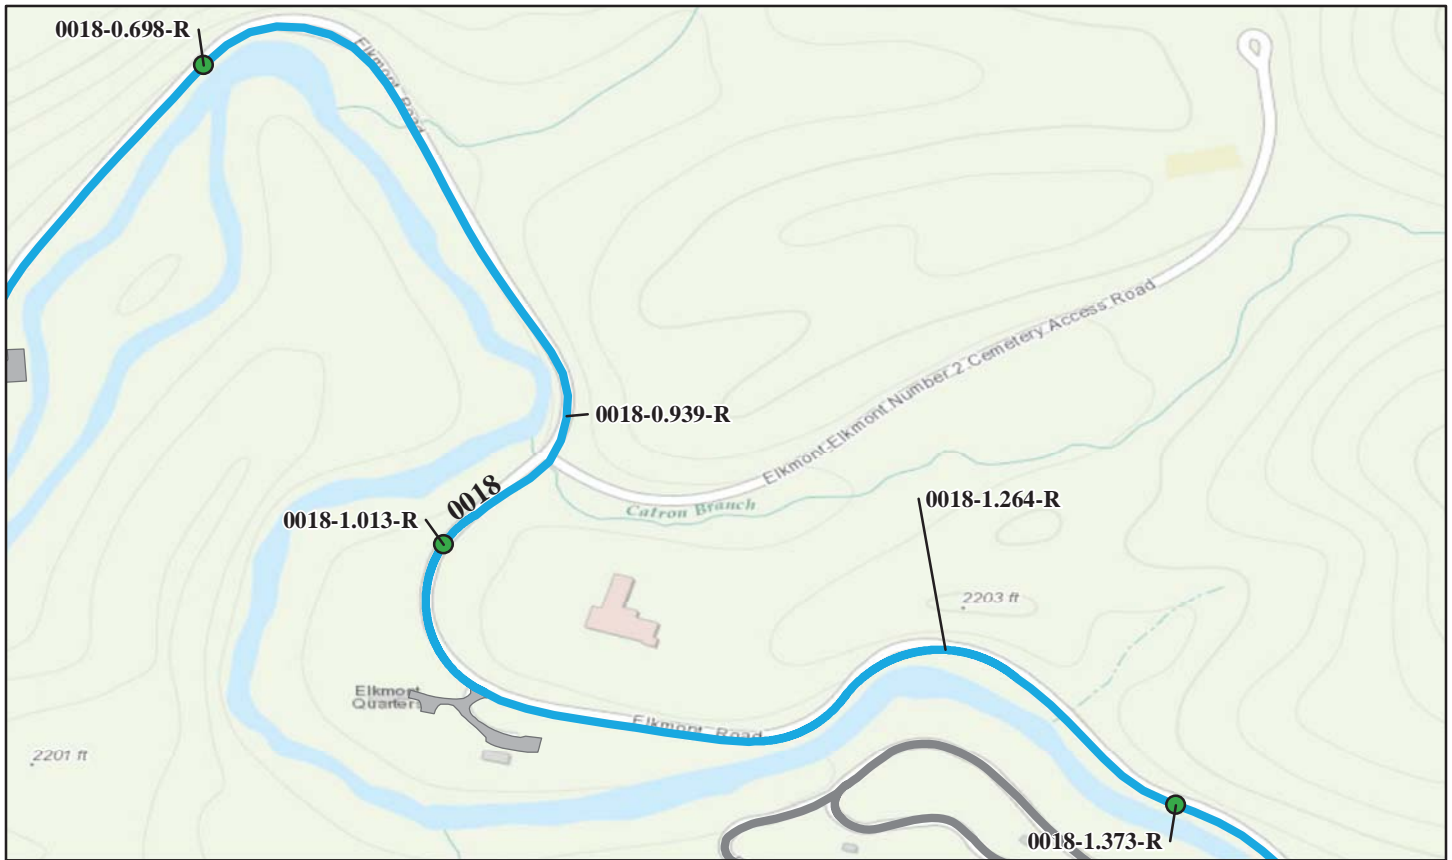
ROUTE 0018: ELKMONT ROAD

Wall ID Inspection Date:	Wall Area (Sq. Ft.)	Wall Length (Ft.)	Wall Type	Wall Function	Overall Rating	Repair Cost
GRSM-0018-0.698-R 11/27/2007	3,722	309	Gravity - Mortared Stone	Fill Wall	89	\$0.00
GRSM-0018-0.939-R 11/27/2007	1,200	120	Gravity - Dry Stone	Fill Wall	58	\$3,284.00
GRSM-0018-1.013-R 11/27/2007	145	14	Gravity - Mortared Stone	Head Wall	75	\$0.00
GRSM-0018-1.264-R 11/27/2007	3,432	286	Gravity - Dry Stone	Fill Wall	56	\$6,760.00
GRSM-0018-1.373-R 11/27/2007	1,520	152	Gravity - Dry Stone	Fill Wall	90	\$0.00

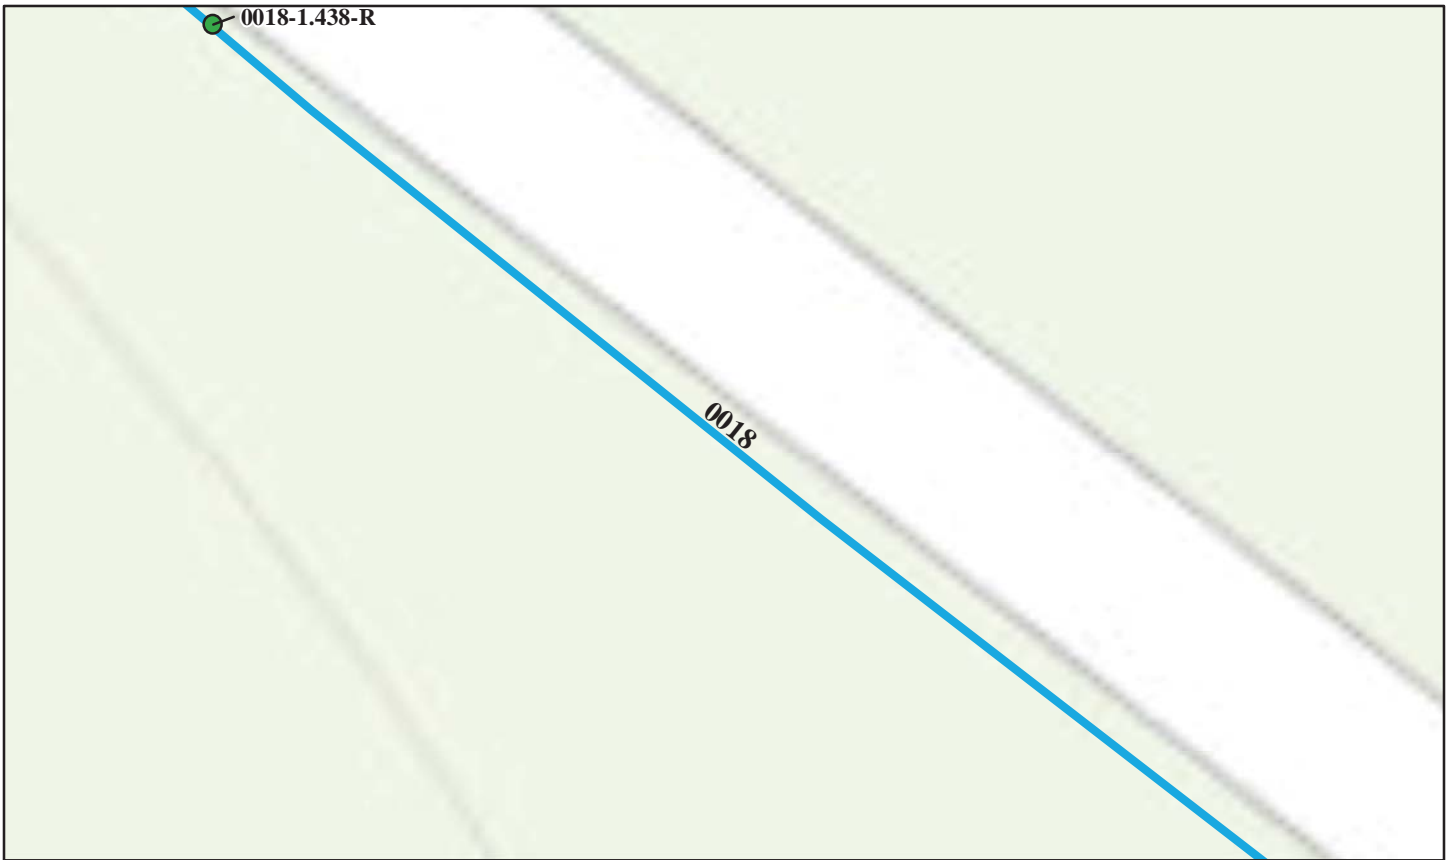
ROUTE 0018: ELKMONT ROAD

Wall ID Inspection Date:	Wall Area (Sq. Ft.)	Wall Length (Ft.)	Wall Type	Wall Function	Overall Rating	Repair Cost
GRSM-0018-1.438-R 11/27/2007	1,224	102	Gravity - Mortared Stone	Fill Wall	90	\$0.00

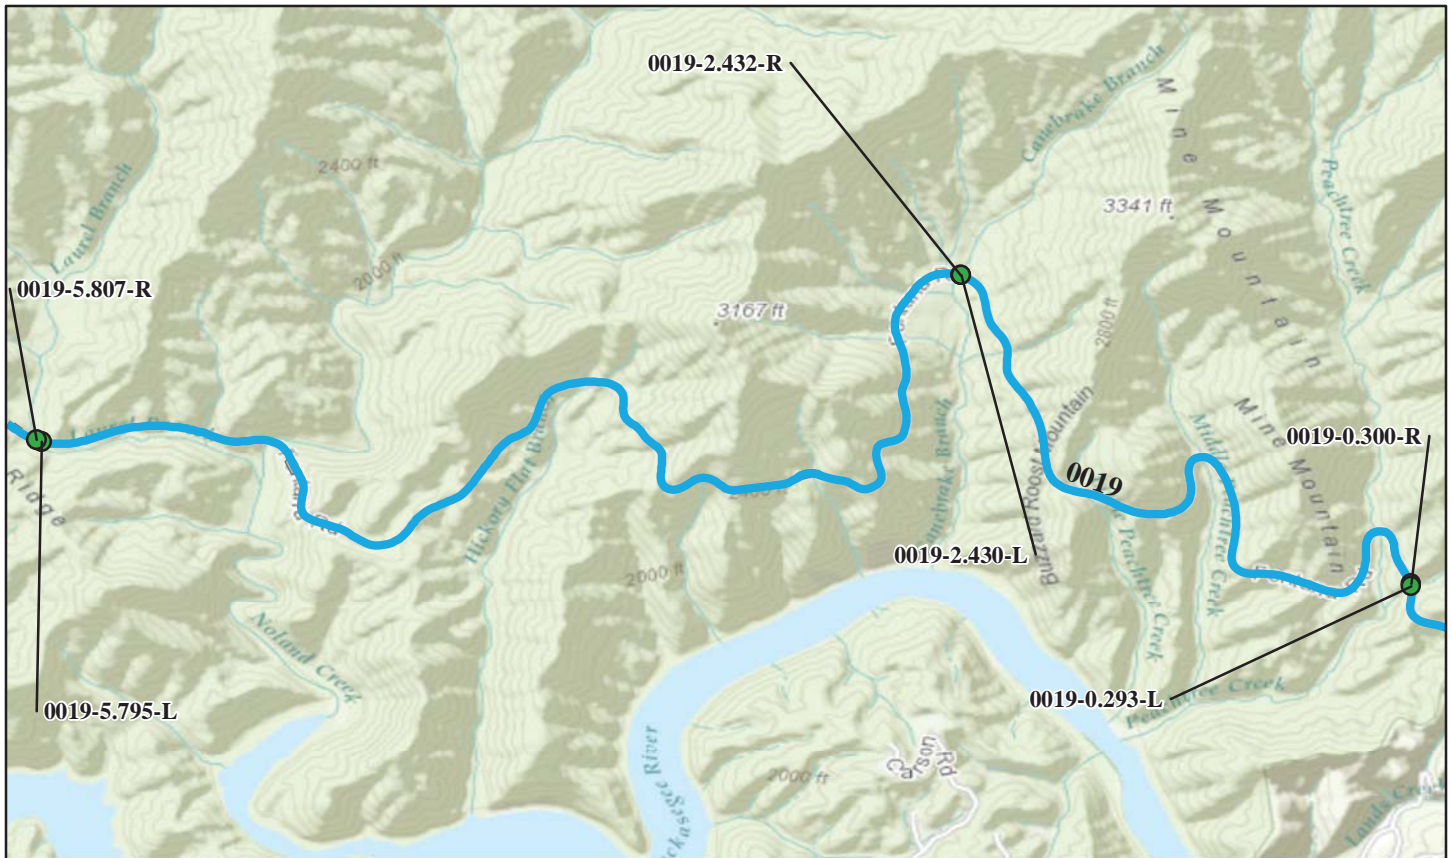
ROUTE 0019: LAKEVIEW DRIVE EAST

Wall ID Inspection Date:	Wall Area (Sq. Ft.)	Wall Length (Ft.)	Wall Type	Wall Function	Overall Rating	Repair Cost
GRSM-0019-0.293-L 12/1/2007	124	27	Gravity - Mortared Stone	Head Wall	79	\$2,190.00
GRSM-0019-0.300-R 12/1/2007	158	36	Gravity - Mortared Stone	Head Wall	88	\$0.00
GRSM-0019-2.430-L 12/1/2007	77	23	Gravity - Mortared Stone	Head Wall	90	\$0.00
GRSM-0019-2.432-R 12/1/2007	101	27	Gravity - Mortared Stone	Head Wall	88	\$0.00
GRSM-0019-5.795-L 12/1/2007	68	18	Gravity - Mass Concrete	Head Wall	94	\$0.00

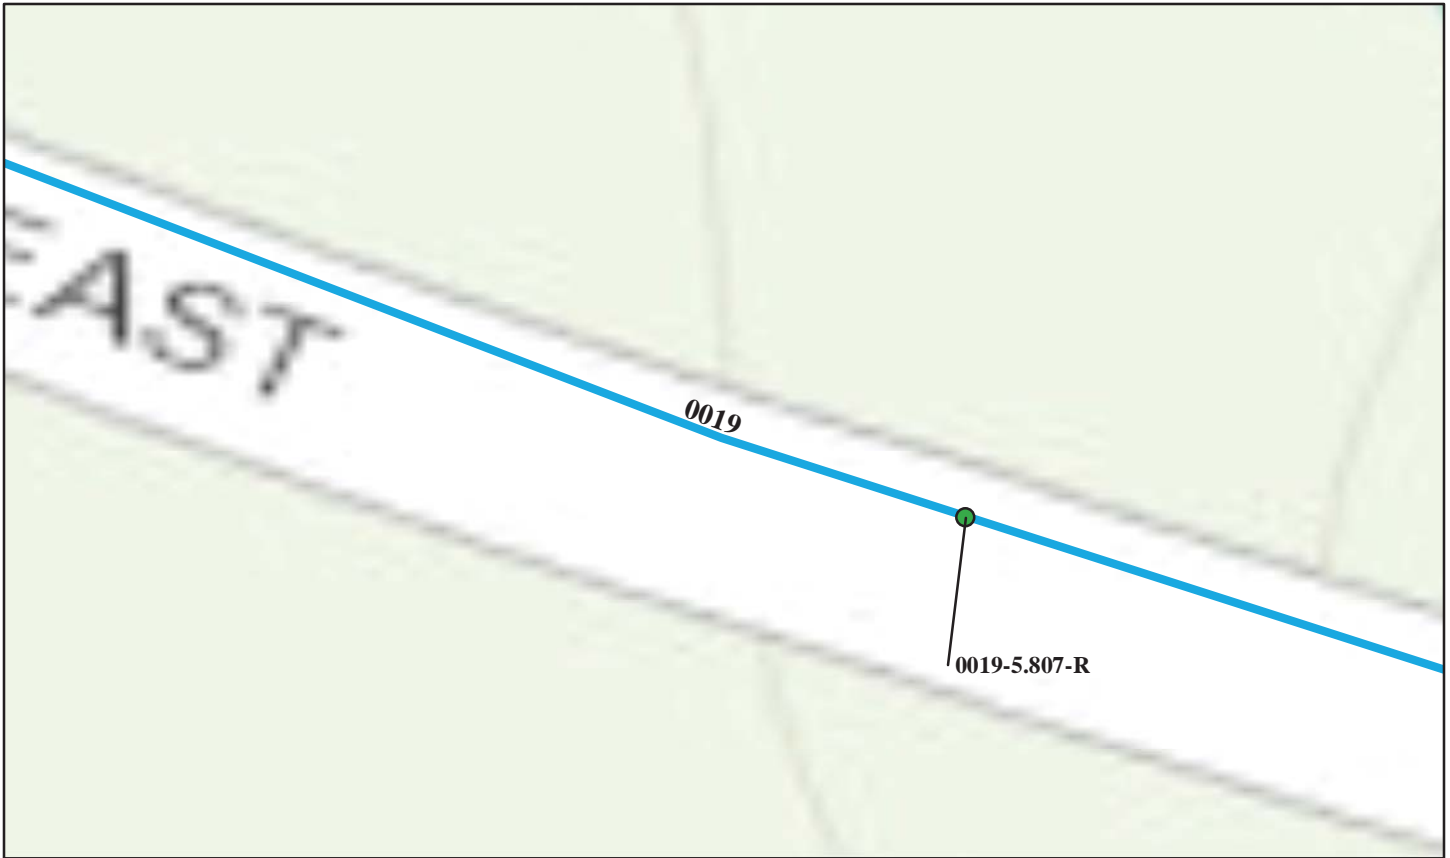
ROUTE 0019: LAKEVIEW DRIVE EAST

Wall ID Inspection Date:	Wall Area (Sq. Ft.)	Wall Length (Ft.)	Wall Type	Wall Function	Overall Rating	Repair Cost
GRSM-0019-5.807-R 12/1/2007	96	25	Gravity - Mass Concrete	Head Wall	90	\$0.00

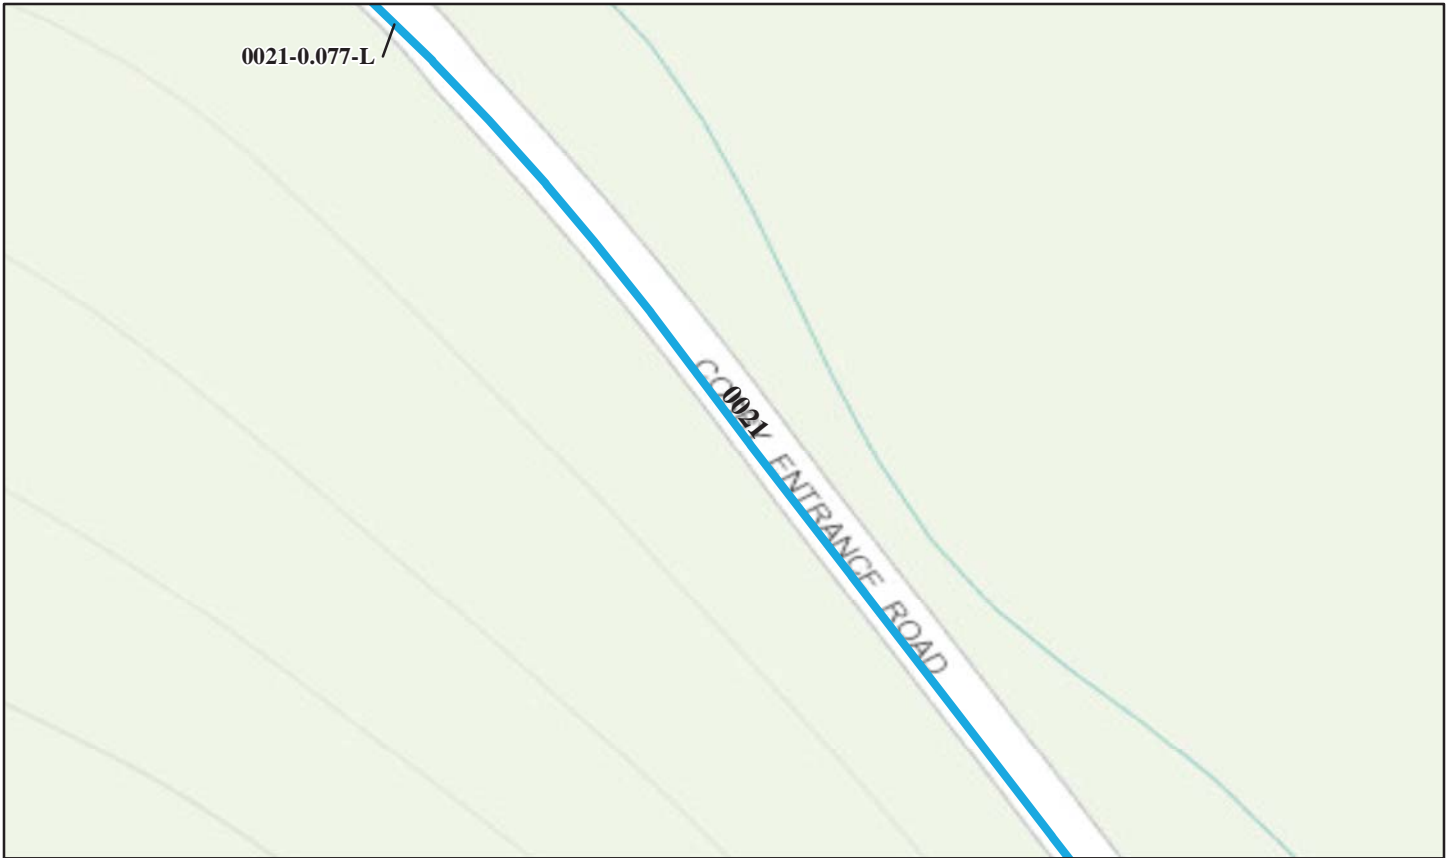
ROUTE 0021: COSBY ENTRANCE ROAD

Wall ID Inspection Date:	Wall Area (Sq. Ft.)	Wall Length (Ft.)	Wall Type	Wall Function	Overall Rating	Repair Cost
GRSM-0021-0.077-L 11/30/2007	1,774	333	Gravity - Mortared Stone	Fill Wall	59	\$63,885.00

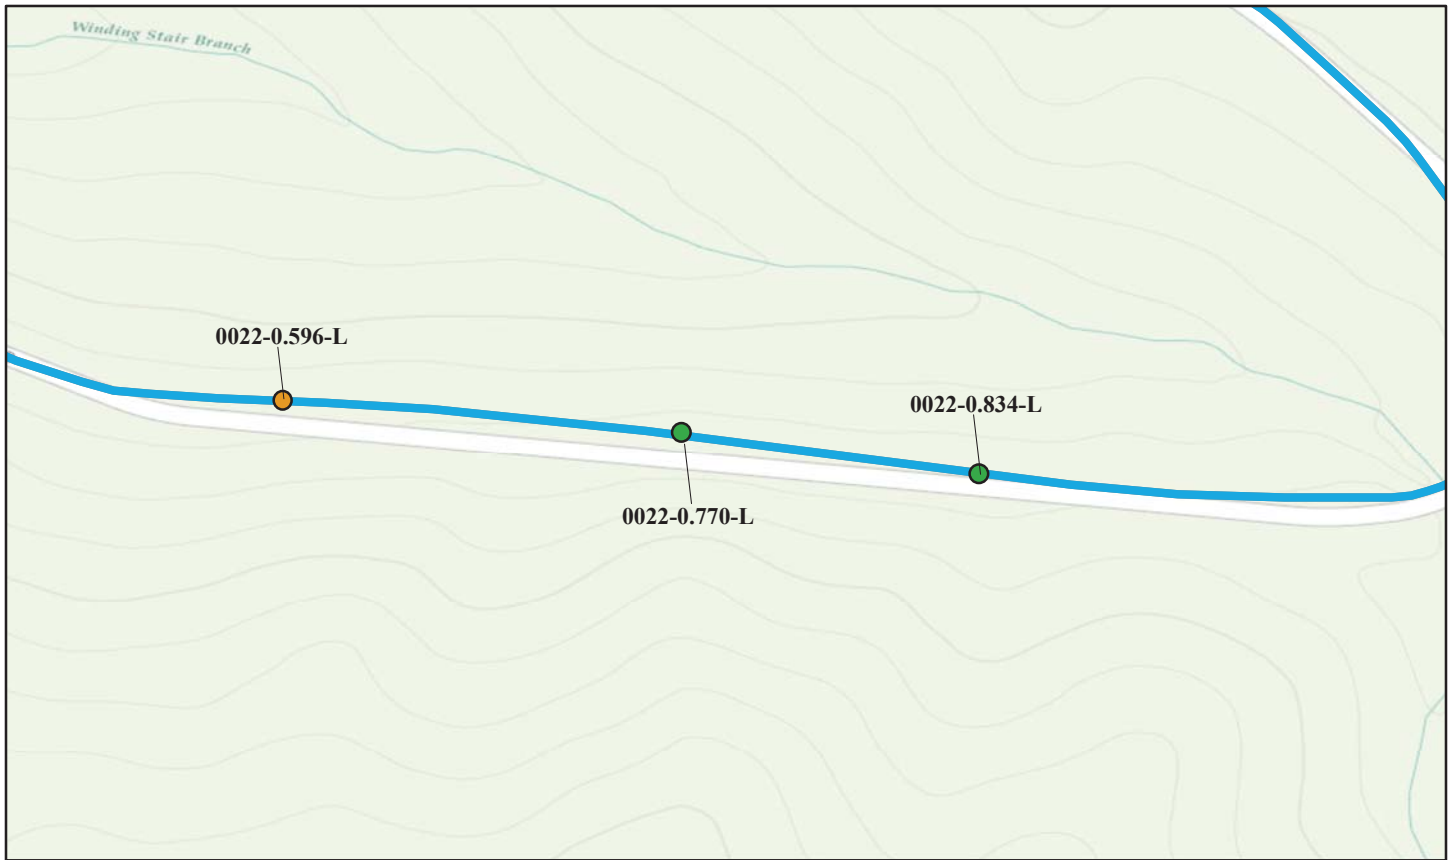
ROUTE 0022: CATALOOCHEE ENTRANCE ROAD

Wall ID Inspection Date:	Wall Area (Sq. Ft.)	Wall Length (Ft.)	Wall Type	Wall Function	Overall Rating	Repair Cost
GRSM-0022-0.596-L 12/3/2007	175	25	Gravity - Mortared Stone	Head Wall	58	\$0.00
GRSM-0022-0.770-L 12/3/2007	957	87	Gravity - Mortared Stone	Cut Wall	75	\$0.00
GRSM-0022-0.834-L 12/3/2007	920	115	Gravity - Mortared Stone	Cut Wall	77	\$0.00

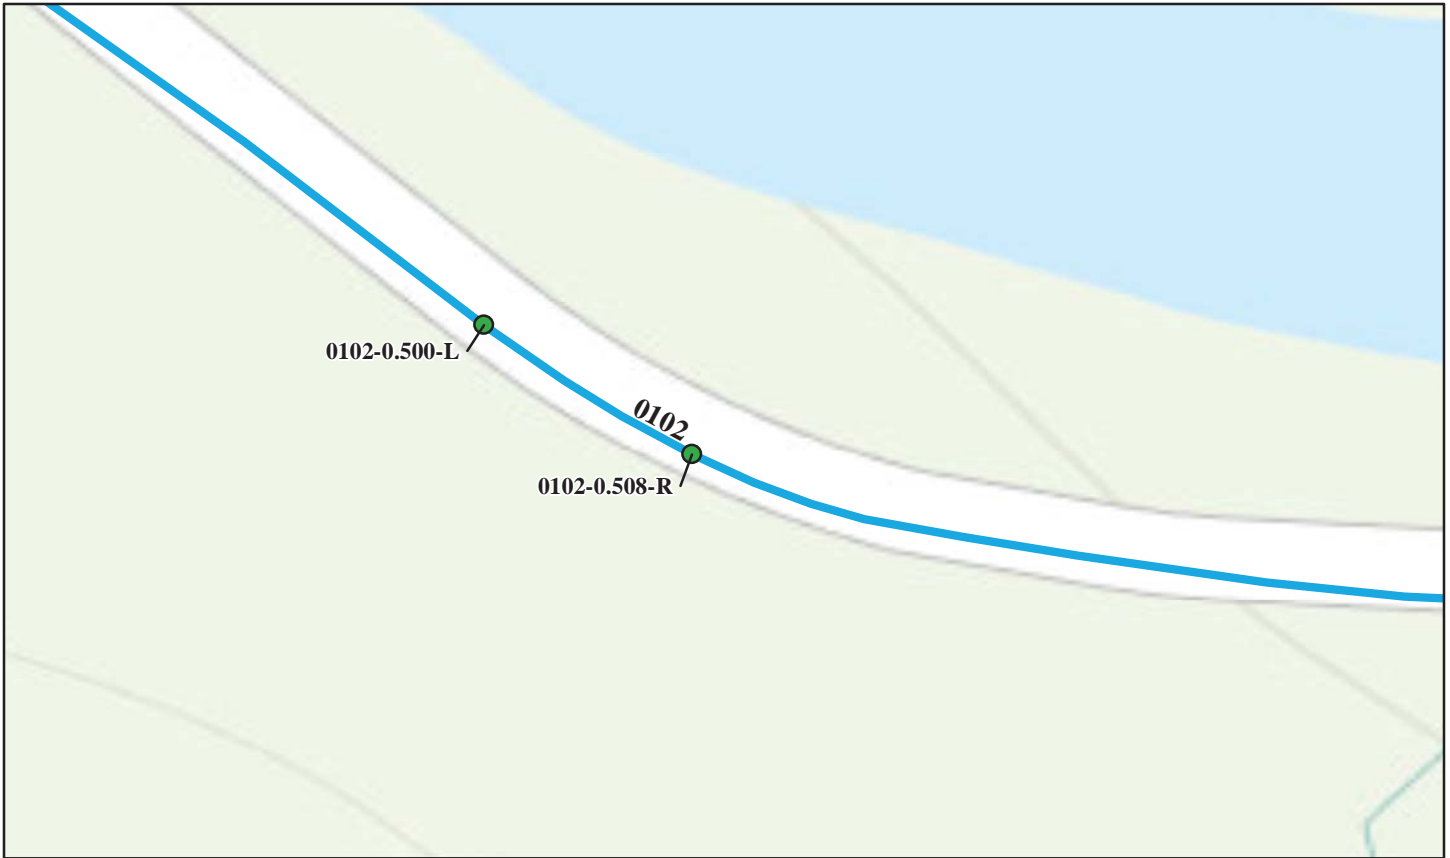
ROUTE 0102: GREENBRIER ROAD

Wall ID Inspection Date:	Wall Area (Sq. Ft.)	Wall Length (Ft.)	Wall Type	Wall Function	Overall Rating	Repair Cost
GRSM-0102-0.500-L 12/3/2007	558	93	Gravity - Dry Stone	Fill Wall	75	\$3,210.00
GRSM-0102-0.508-R 12/3/2007	205	37	Gravity - Dry Stone	Head Wall	80	\$0.00

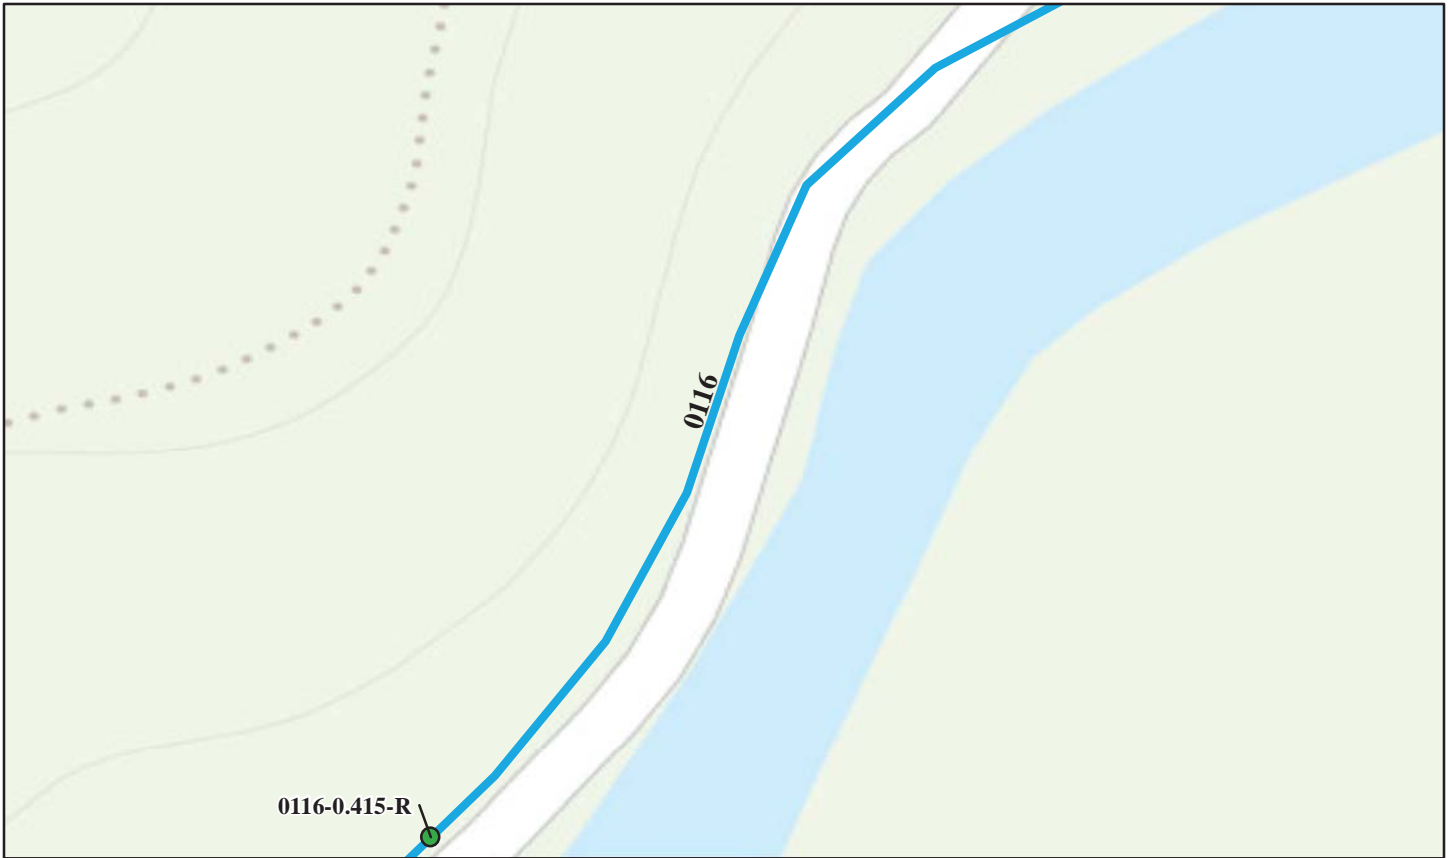
ROUTE 0116: WEST DEEP CREEK ROAD

Wall ID Inspection Date:	Wall Area (Sq. Ft.)	Wall Length (Ft.)	Wall Type	Wall Function	Overall Rating	Repair Cost
GRSM-0116-0.415-R 12/1/2007	3,321	300	Gravity - Dry Stone	Fill Wall	90	\$0.00

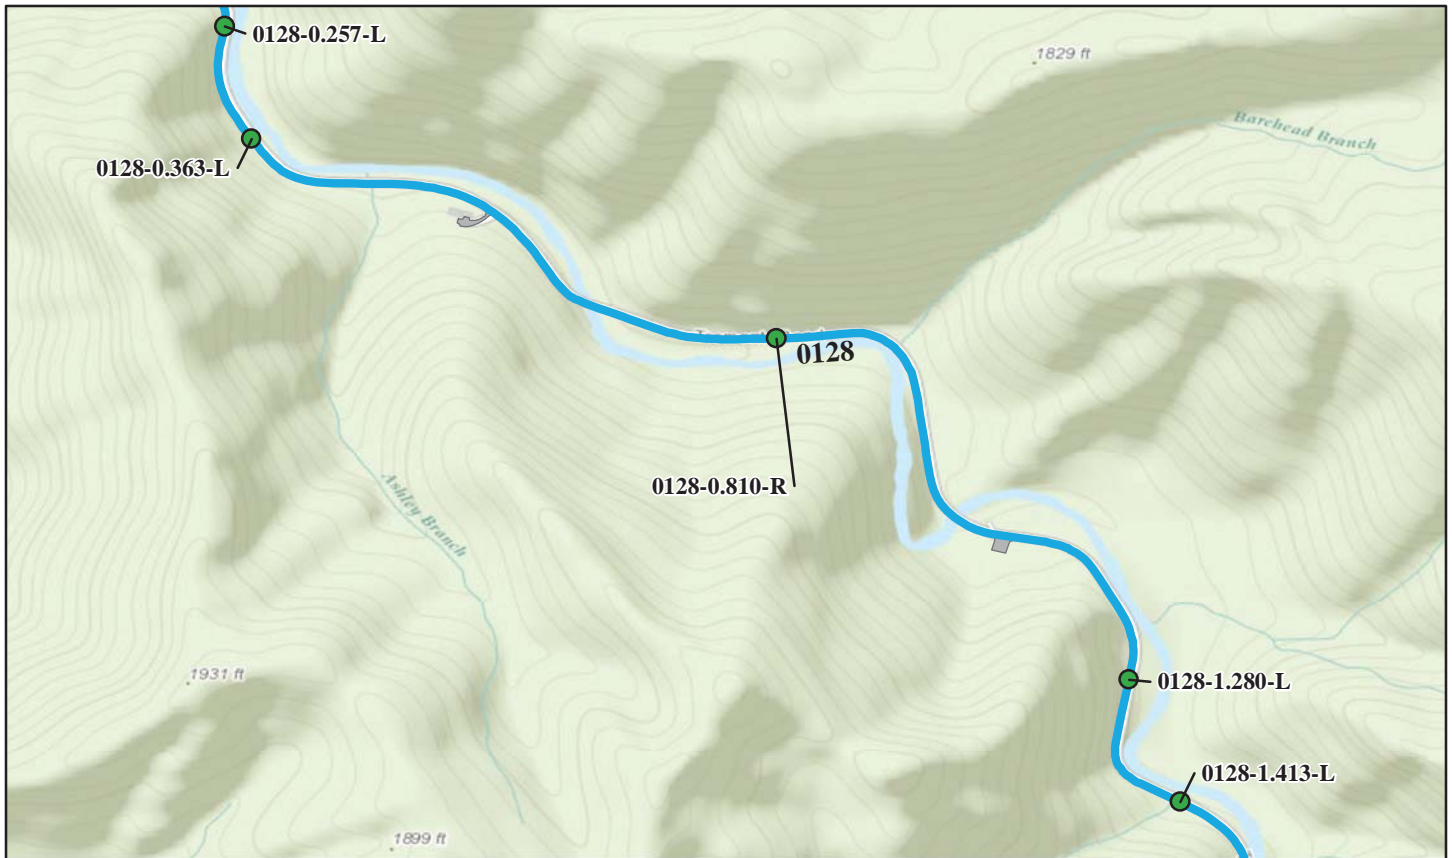
ROUTE 0128: TREMONT ROAD

Wall ID Inspection Date:	Wall Area (Sq. Ft.)	Wall Length (Ft.)	Wall Type	Wall Function	Overall Rating	Repair Cost
GRSM-0128-0.257-L 11/29/2007	590	95	Gravity - Mortared Stone	Fill Wall	78	\$0.00
GRSM-0128-0.363-L 11/29/2007	1,210	119	Gravity - Mortared Stone	Fill Wall	90	\$0.00
GRSM-0128-0.810-R 11/29/2007	2,477	245	Gravity - Mortared Stone	Fill Wall	85	\$0.00
GRSM-0128-1.280-L 11/29/2007	690	107	Gravity - Mortared Stone	Fill Wall	82	\$0.00
GRSM-0128-1.413-L 11/29/2007	2,634	311	Gravity - Mortared Stone	Fill Wall	90	\$0.00

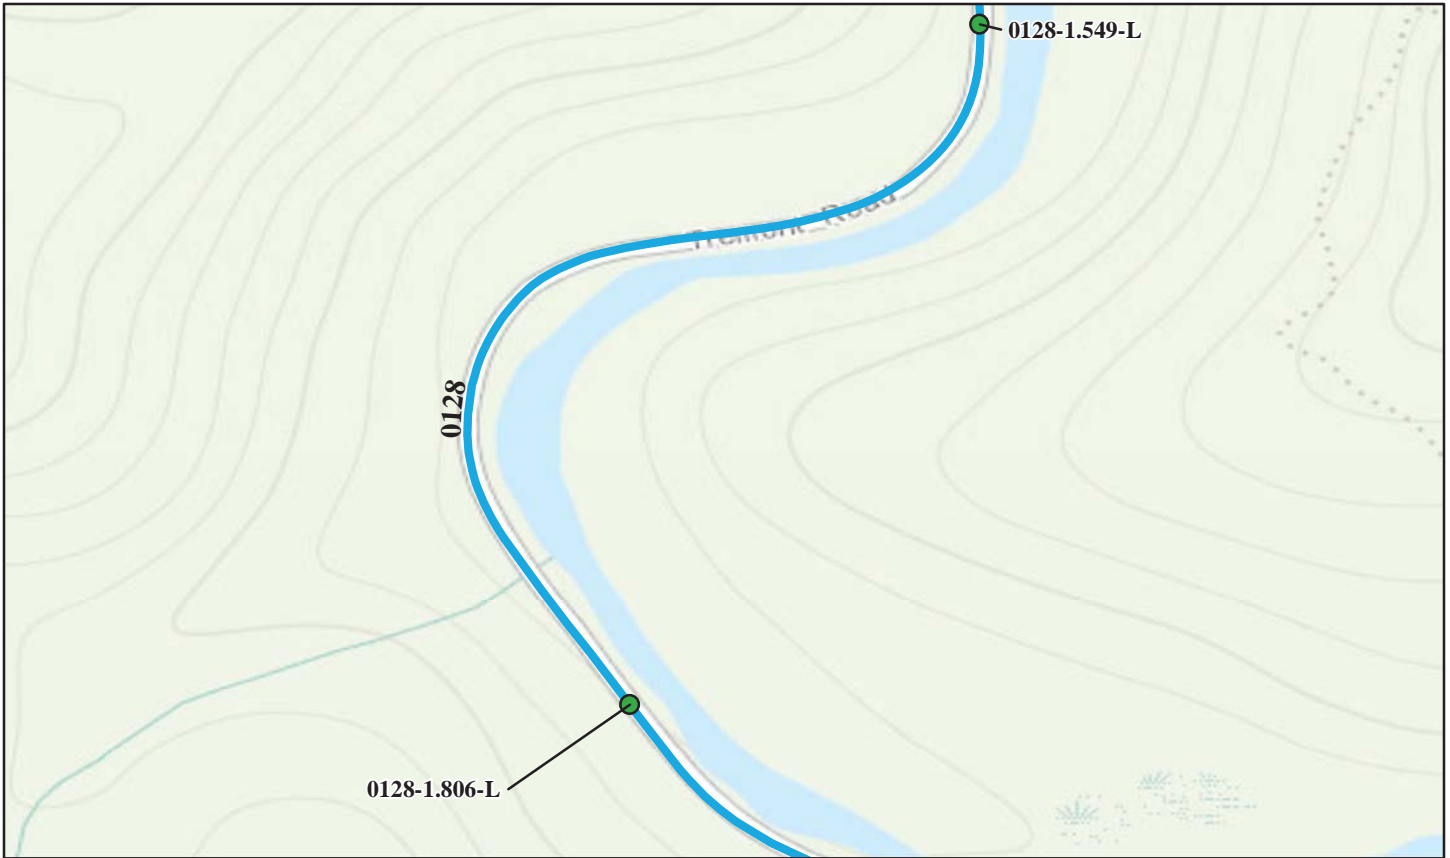
ROUTE 0128: TREMONT ROAD

Wall ID Inspection Date:	Wall Area (Sq. Ft.)	Wall Length (Ft.)	Wall Type	Wall Function	Overall Rating	Repair Cost
GRSM-0128-1.549-L 11/29/2007	1,340	200	Gravity - Mortared Stone	Fill Wall	90	\$0.00
GRSM-0128-1.806-L 11/29/2007	2,070	238	Gravity - Mortared Stone	Fill Wall	90	\$0.00

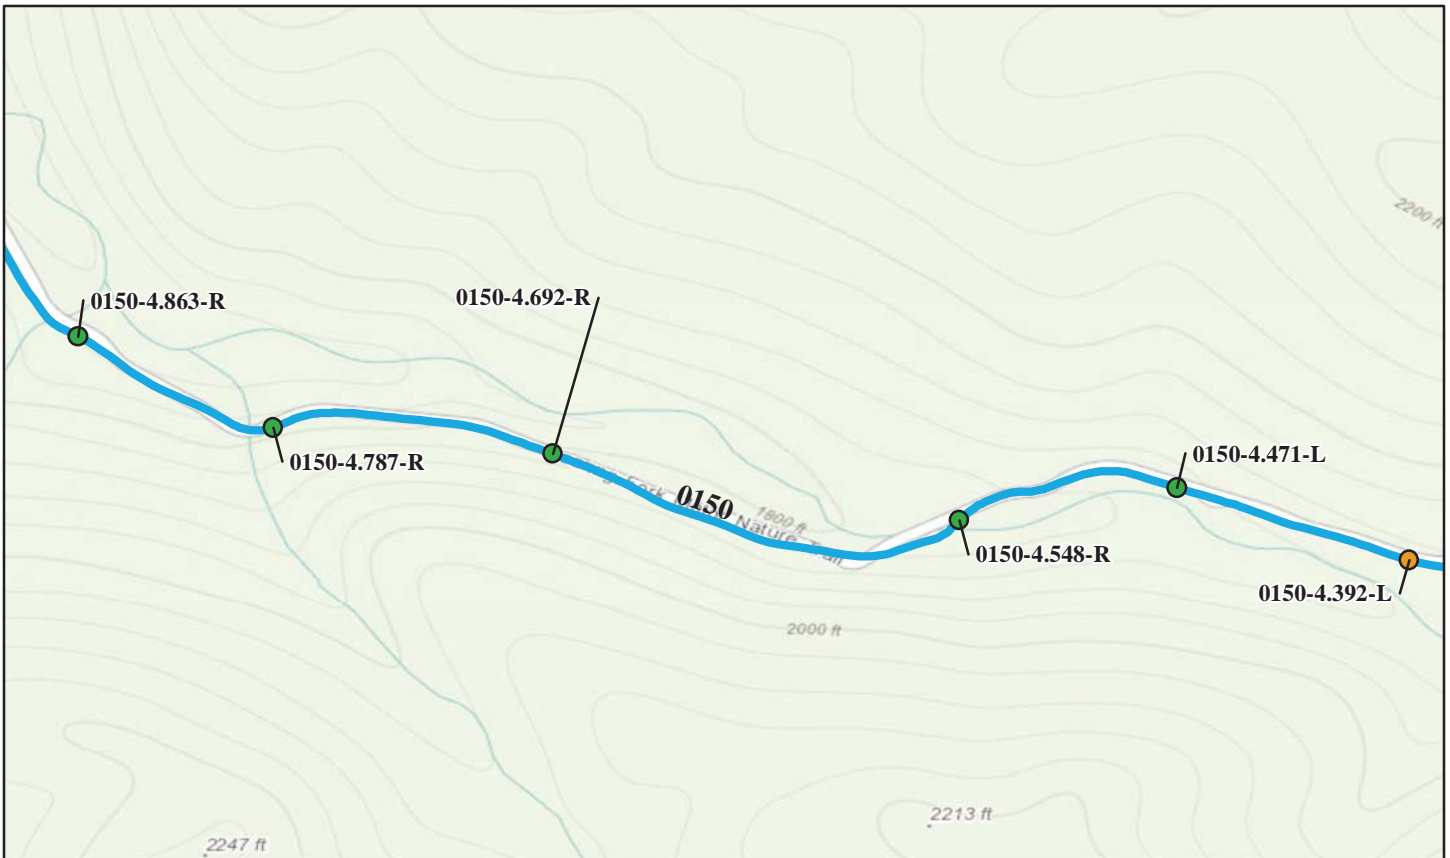
ROUTE 0150: ROARING FORK MOTOR NATURE TRAIL

Wall ID Inspection Date:	Wall Area (Sq. Ft.)	Wall Length (Ft.)	Wall Type	Wall Function	Overall Rating	Repair Cost
GRSM-0150-4.392-L 12/3/2007	188	52	Gravity - Mortared Stone	Fill Wall	69	\$10,520.00
GRSM-0150-4.471-L 12/3/2007	234	65	Gravity - Mortared Stone	Fill Wall	85	\$0.00
GRSM-0150-4.548-R 12/3/2007	888	96	Gravity - Mortared Stone	Fill Wall	72	\$23,670.00
GRSM-0150-4.692-R 12/3/2007	132	35	Gravity - Mortared Stone	Fill Wall	74	\$3,312.00
GRSM-0150-4.787-R 12/3/2007	324	68	Gravity - Dry Stone	Fill Wall	84	\$0.00

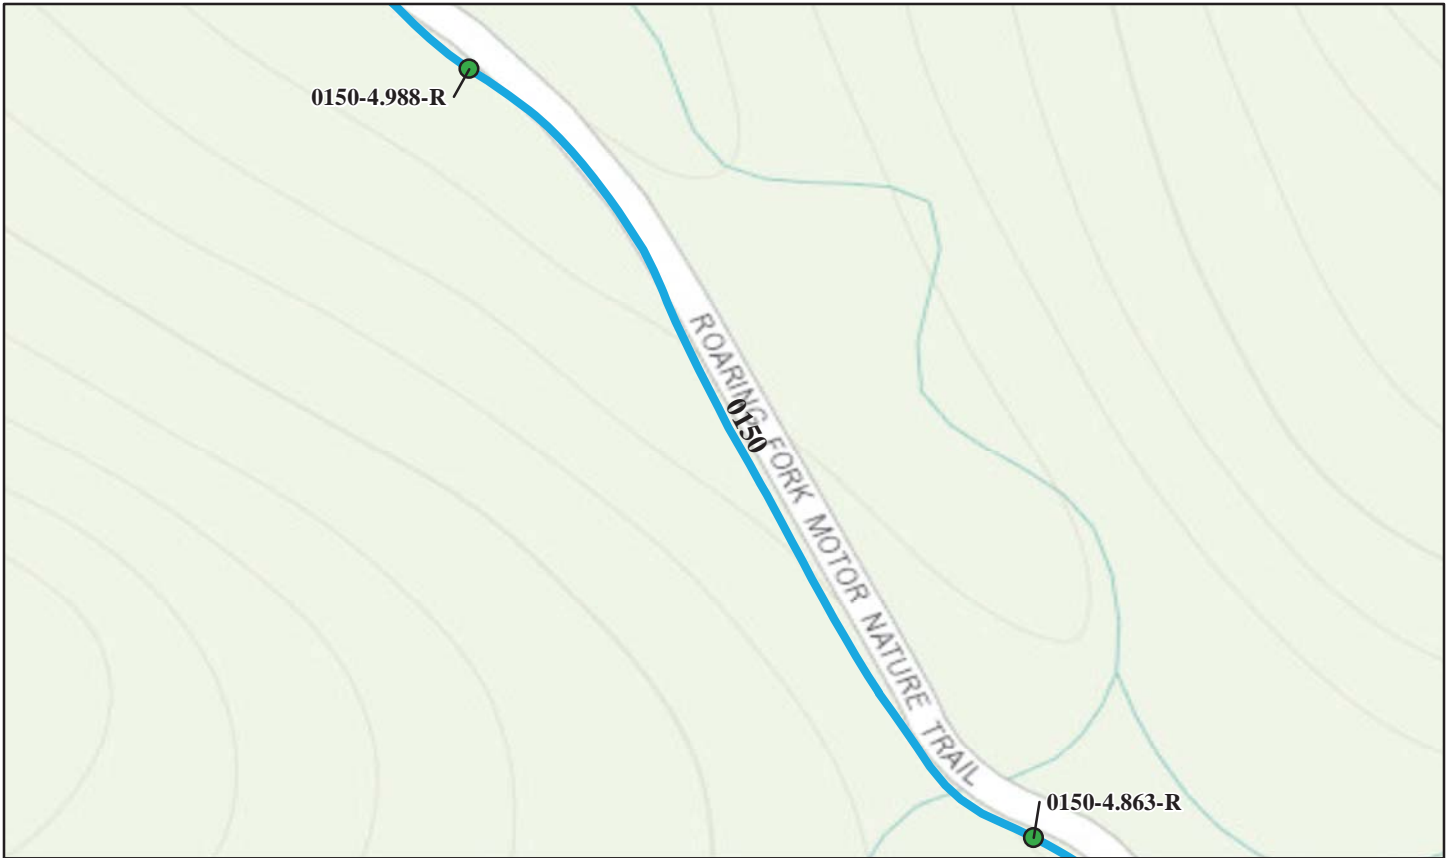
ROUTE 0150: ROARING FORK MOTOR NATURE TRAIL

Wall ID Inspection Date:	Wall Area (Sq. Ft.)	Wall Length (Ft.)	Wall Type	Wall Function	Overall Rating	Repair Cost
GRSM-0150-4.863-R 12/3/2007	527	101	Gravity - Dry Stone	Fill Wall	83	\$0.00
GRSM-0150-4.988-R 12/3/2007	253	44	Gravity - Mortared Stone	Fill Wall	87	\$0.00

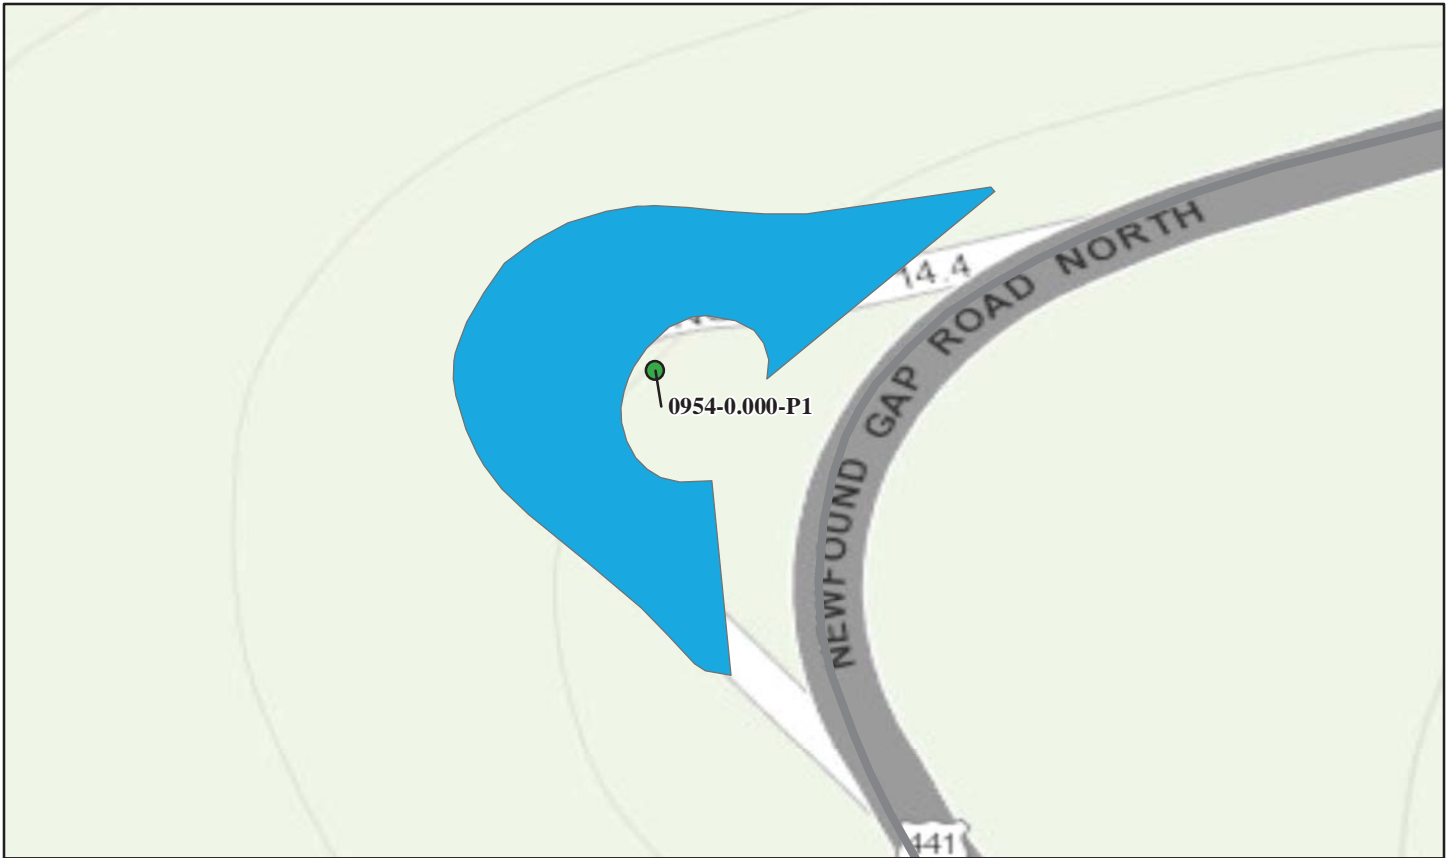
ROUTE 0954: PARKING AT MP 14.4

Wall ID Inspection Date:	Wall Area (Sq. Ft.)	Wall Length (Ft.)	Wall Type	Wall Function	Overall Rating	Repair Cost
GRSM-0954-0.000-P1 6/15/2007	2058	255	Gravity - Mortared Stone	Fill Wall	77	\$20,579.00

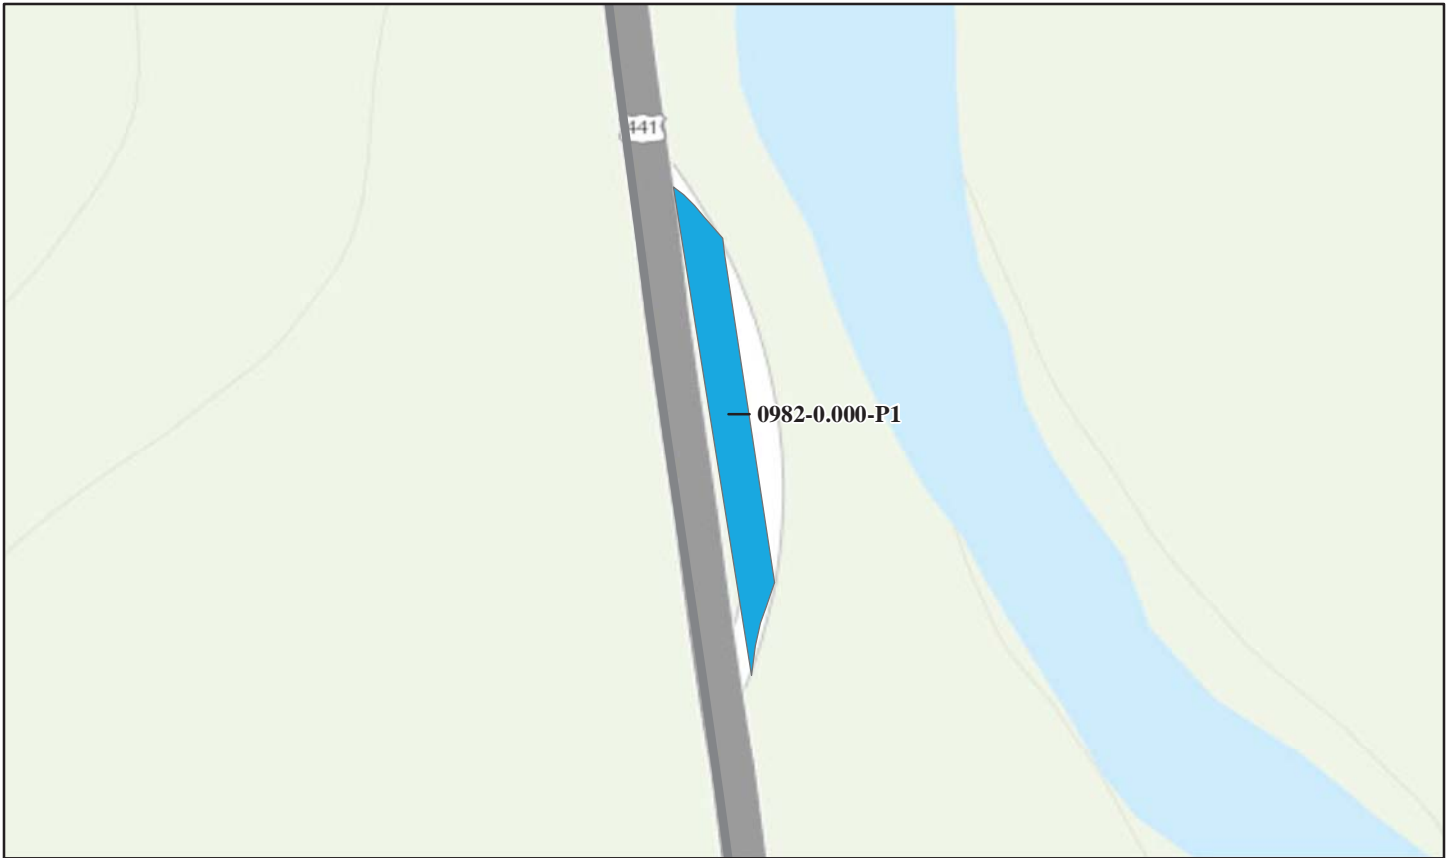
ROUTE 0982: COUCHES CREEK PARKING (OCONALUFTEE RIVER PULLOUT PARKING #12)

Wall ID Inspection Date:	Wall Area (Sq. Ft.)	Wall Length (Ft.)	Wall Type	Wall Function	Overall Rating	Repair Cost
GRSM-0982-0.000-P1 6/16/2007	161	28	Crib - Concrete	Fill Wall	48	\$43,526.00

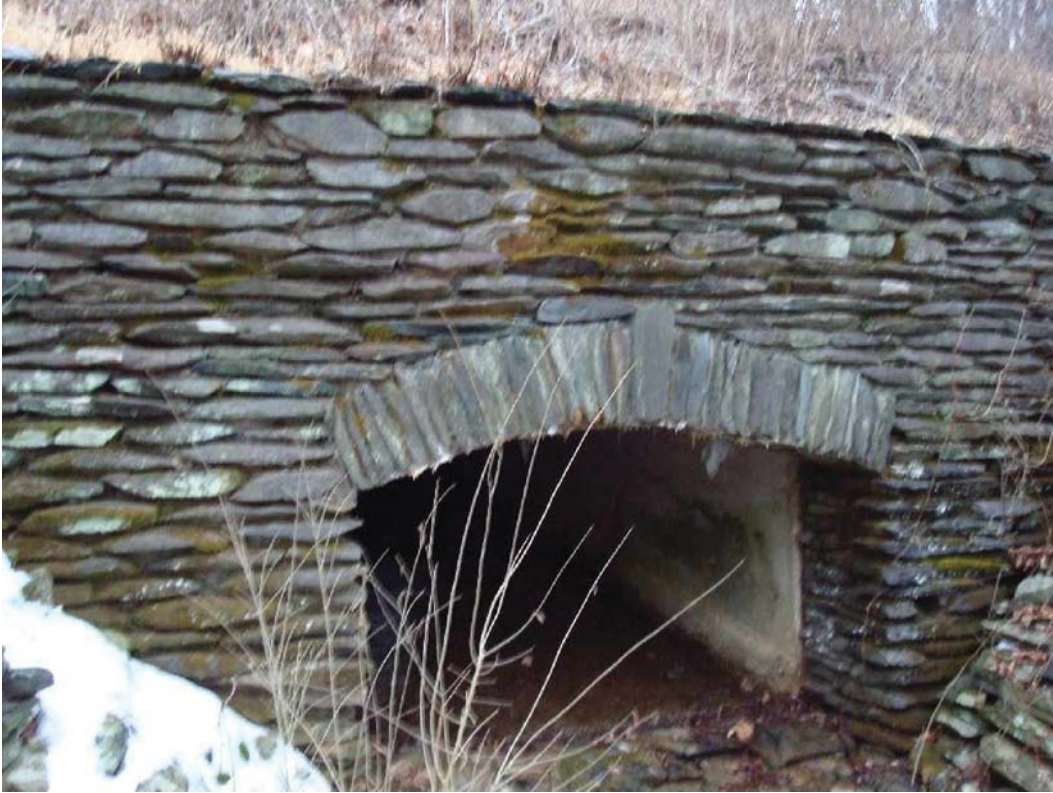
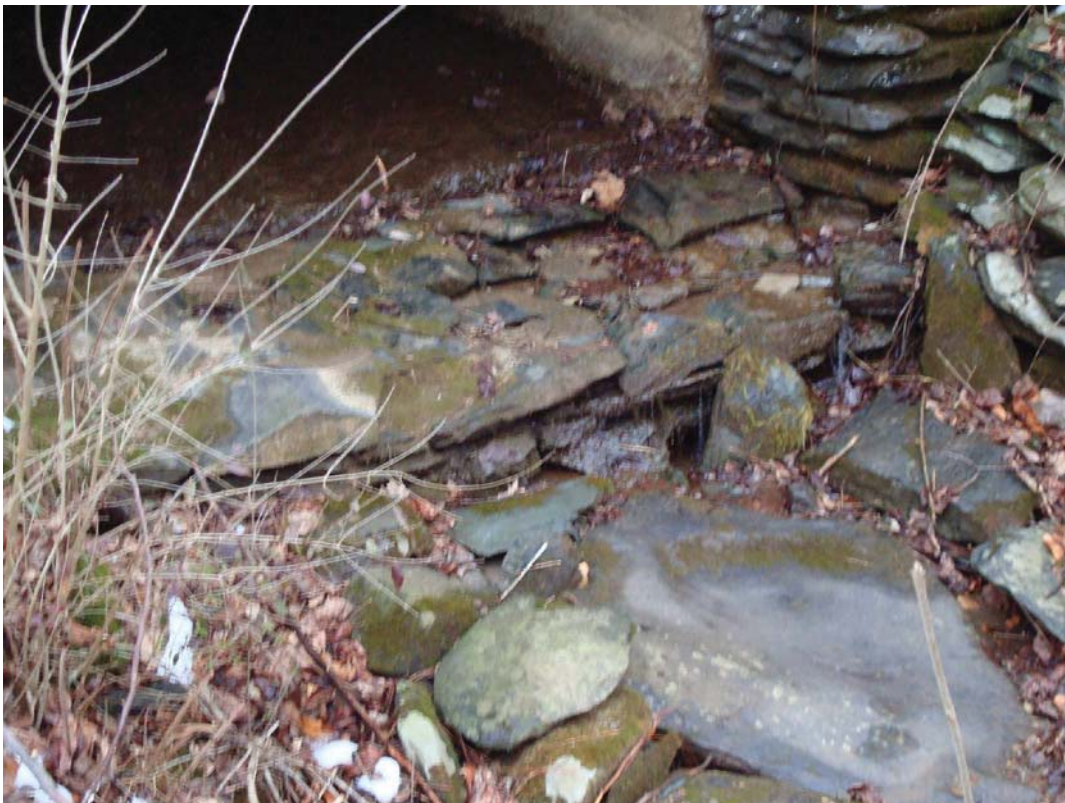
GRSM_0008A_2.460_L_1.jpg

Element (Weighting Factor)	Narrative	Condition Rating (0 - 10)
PERFORMANCE 8.00	As intended	9
WALL FOUNDATION MATERIAL 8.00	Abandoned road bed, no distress	9
CONCRETE 8.00	No distress	9
LATERAL SLOPE 0.50	Stable embankment, no distress.	9
ROAD/SIDEWALK/SHOULDER 0.50	No distress	9
UPSLOPE 0.50	Stable embankment, no distress.	9
WALL DRAINS 0.50	Weeps at toe, no distress.	9
