NPS Retaining Wall Inventory Program Great Smoky Mountains National Park

**Federal Lands Highway
Road Inventory Program**

Federal Highway Administration
Eastern Federal Lands Highway Division
Road Inventory Program (RIP)

Data Collection Date: April 2011
Report Date: November 2015

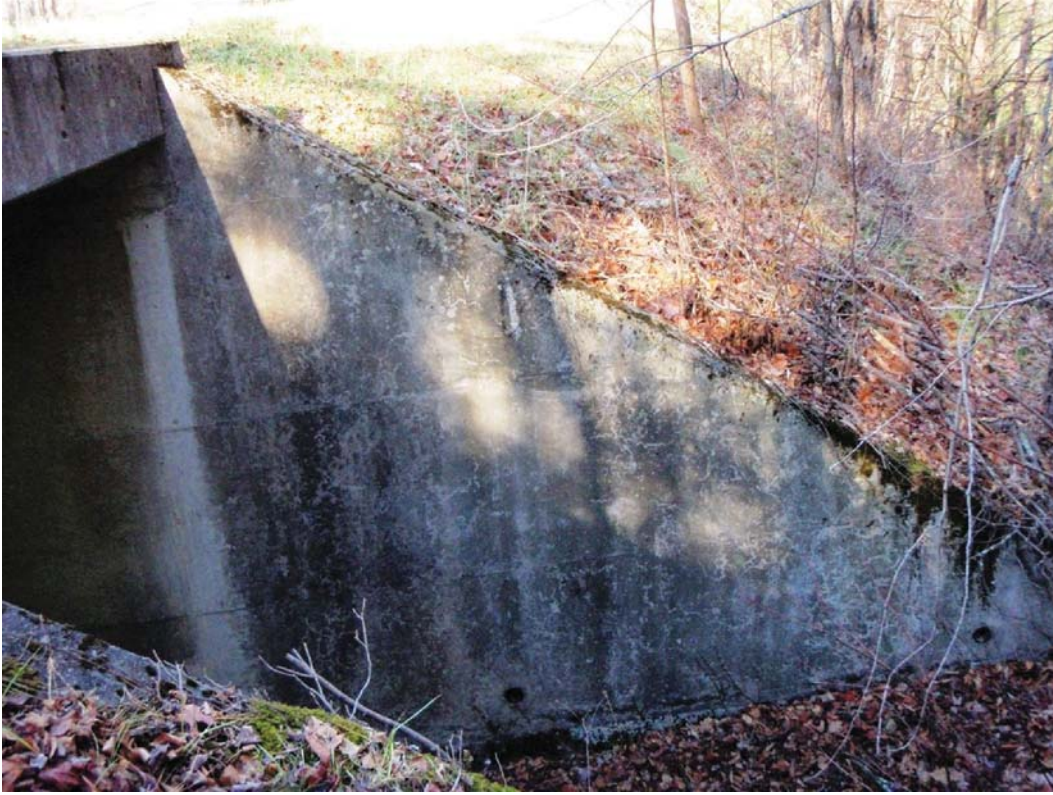
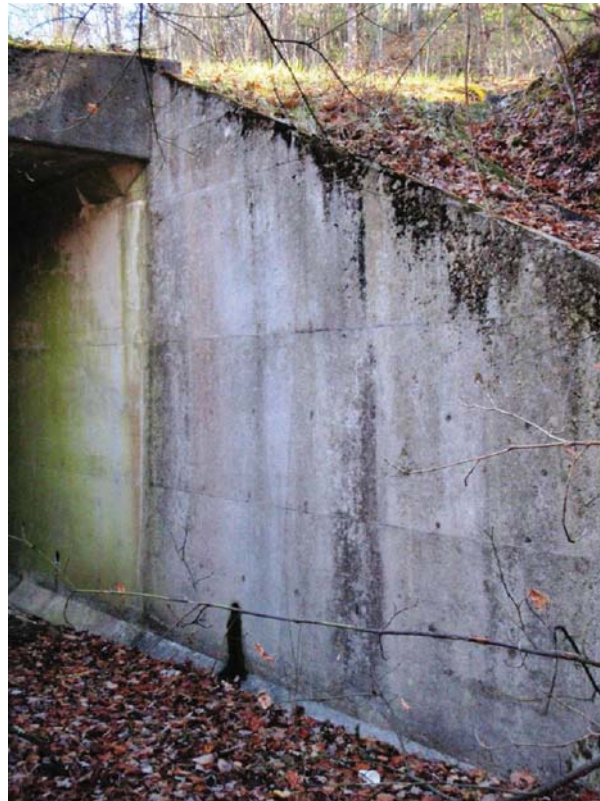
GRSM_0008A_2.460_R_1.jpg

Wall ID:	GRSM-0008A-2.460-R		
Route Name:	FOOTHILLS PARKWAY SECTION 8A		
Inspection Date:	December 03, 2007	Approximate Year Built:	1965
*Wall Rating:	90	Maintenance Action:	No Action

Element (Weighting Factor)	Narrative	Condition Rating (0 - 10)
PERFORMANCE 8.00	As intended	9
WALL FOUNDATION MATERIAL 8.00	Abandoned road bed, no distress.	9
CONCRETE 8.00	No distress.	9
LATERAL SLOPE 0.50	Stable embankment, no distress	9
ROAD/SIDEWALK/SHOULDER 0.50	No distress	9
UPSLOPE 0.50	Stable embankment, no distress	9
WALL DRAINS 0.50	Weeps at toe, no distress	9

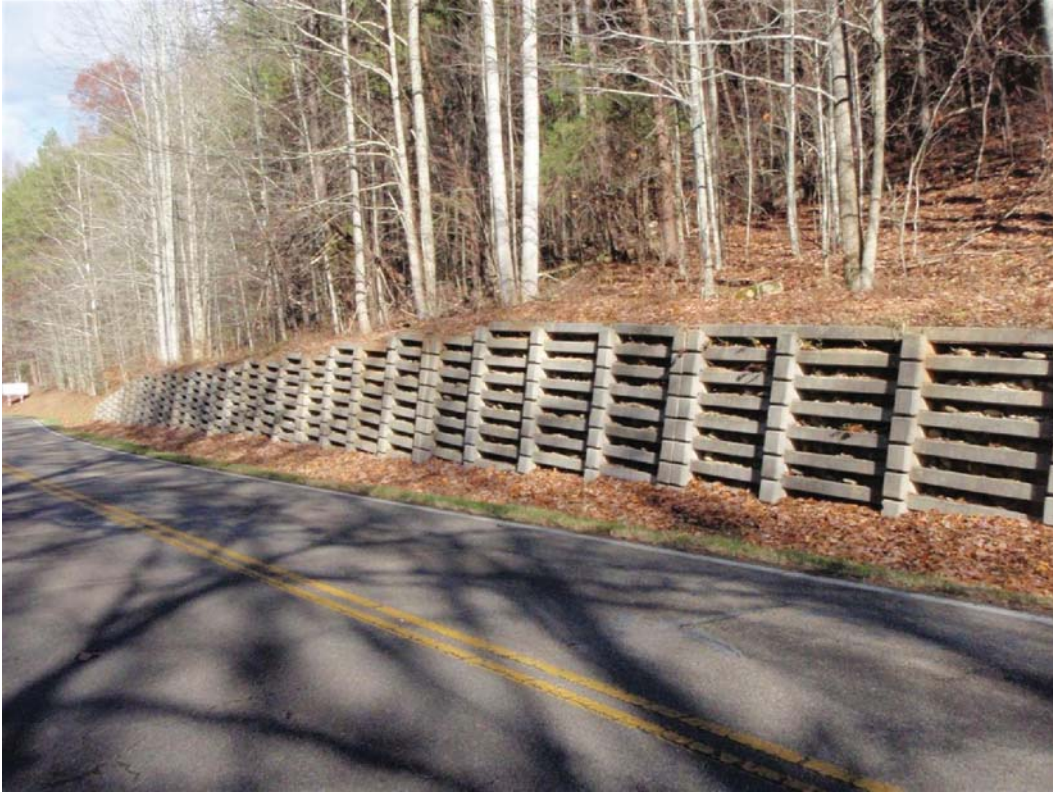
GRSM_0008A_5.295_L_1.jpg

Wall ID:	GRSM-0008A-5.295-L		
Route Name:	FOOTHILLS PARKWAY SECTION 8A		
Inspection Date:	December 03, 2007	Approximate Year Built:	1965
*Wall Rating:	93	Maintenance Action:	No Action

Element (Weighting Factor)	Narrative	Condition Rating (0 - 10)
PERFORMANCE 8.00	As intended	9
WALL FOUNDATION MATERIAL 8.00	Stable, flat soil/paved ditch. No distress.	9
BIN OR CRIB 8.00	No distress	10
LATERAL SLOPE 0.50	Stable slope, no distress.	9
ROAD/SIDEWALK/SHOULDER 0.50	No distress	9
UPSLOPE 0.50	Stable slope, no distress.	9
WALL DRAINS 0.50	Free draining face, no distress.	10

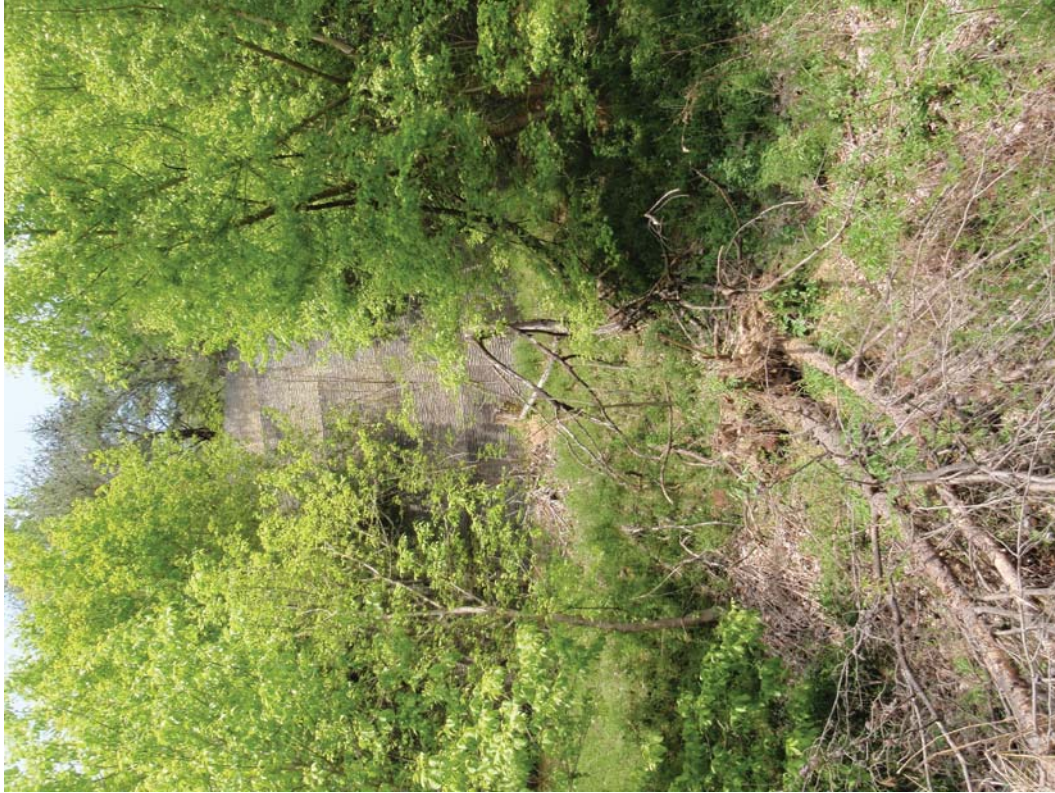
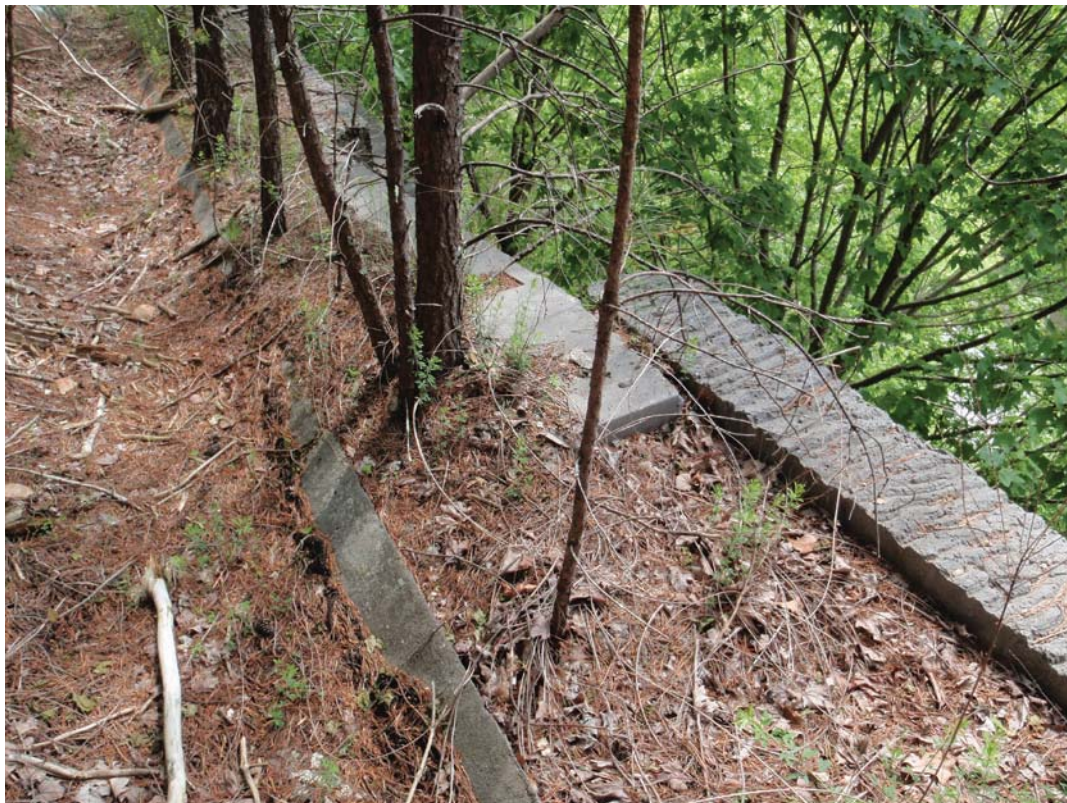
GRSM_0008E_1.170_R_1.jpg

Wall ID:	GRSM-0008E-1.170-R		
Route Name:	FOOTHILLS PARKWAY SECTION 8E		
Inspection Date:	April 19, 2011	Approximate Year Built:	1968
*Wall Rating:	No data available	Maintenance Action:	No data available
Wall Description			
Wall Function:	Cut Wall	Primary Wall Type:	Other -Tie back Panel Wall
Surface Treatment:	Color Additive	Secondary Wall Type:	
Secondary Surface Treatment:		Architectural Facing:	Formlined Concrete
General Description:	Multi-tiered, concrete panel (8 ft x 10 ft), tie-back wall. Wall starts at station 616+75 and corresponds to RW1 per the 1984 8E6 as-built plans.		
Wall Measurements			
Wall Length (ft.):	322	Face Area (sq.):	8600
Average Wall Height (ft.):	26	Face Angle (deg.):	75
Maximum Wall Height (ft.):	38	Vertical Offset (ft.):	0

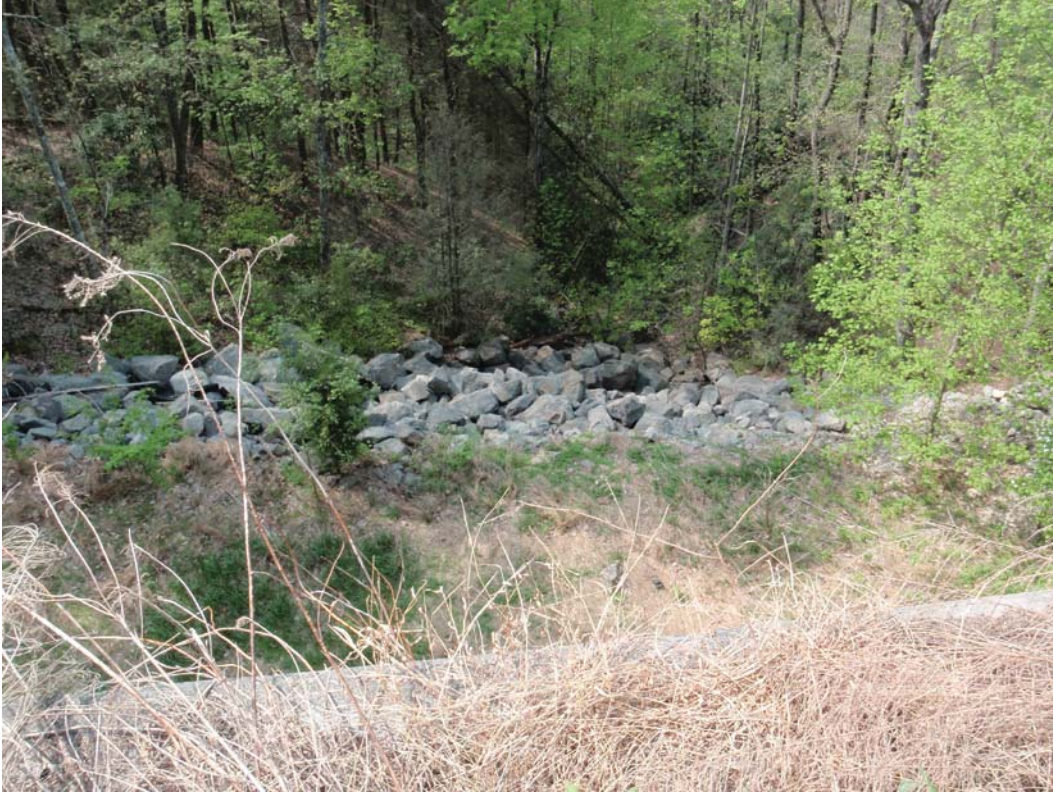
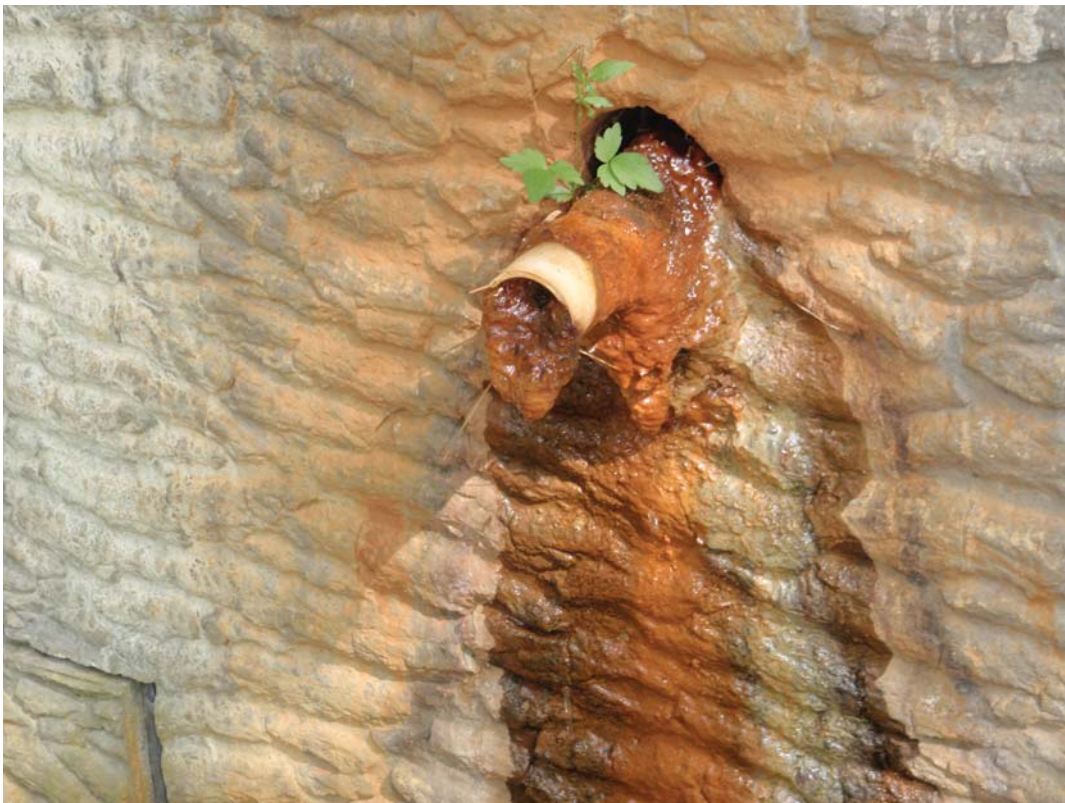
GRSM_0008E_1.577_R_1.jpg

Wall ID:	GRSM-0008E-1.577-R		
Route Name:	FOOTHILLS PARKWAY SECTION 8E		
Inspection Date:	April 19, 2011	Approximate Year Built:	1968
*Wall Rating:	No data available	Maintenance Action:	No data available
Wall Description			
Wall Function:	Fill Wall	Primary Wall Type:	MSE - Precast Panel
Surface Treatment:	Color Additive	Secondary Wall Type:	
Secondary Surface Treatment:		Architectural Facing:	Formlined Concrete
General Description:	Reinforced Earth Co. pre-cast panel MSE wall with a formlined panel relief and colored concrete. Wall starts at station 638+25 and corresponds to RW2 per the 1984 8E6 as-built plans. Large rock fill 20 ft below the wall.		
Wall Measurements			
Wall Length (ft.):	422	Face Area (sq.):	9550
Average Wall Height (ft.):	22	Face Angle (deg.):	85
Maximum Wall Height (ft.):	40	Vertical Offset (ft.):	-22

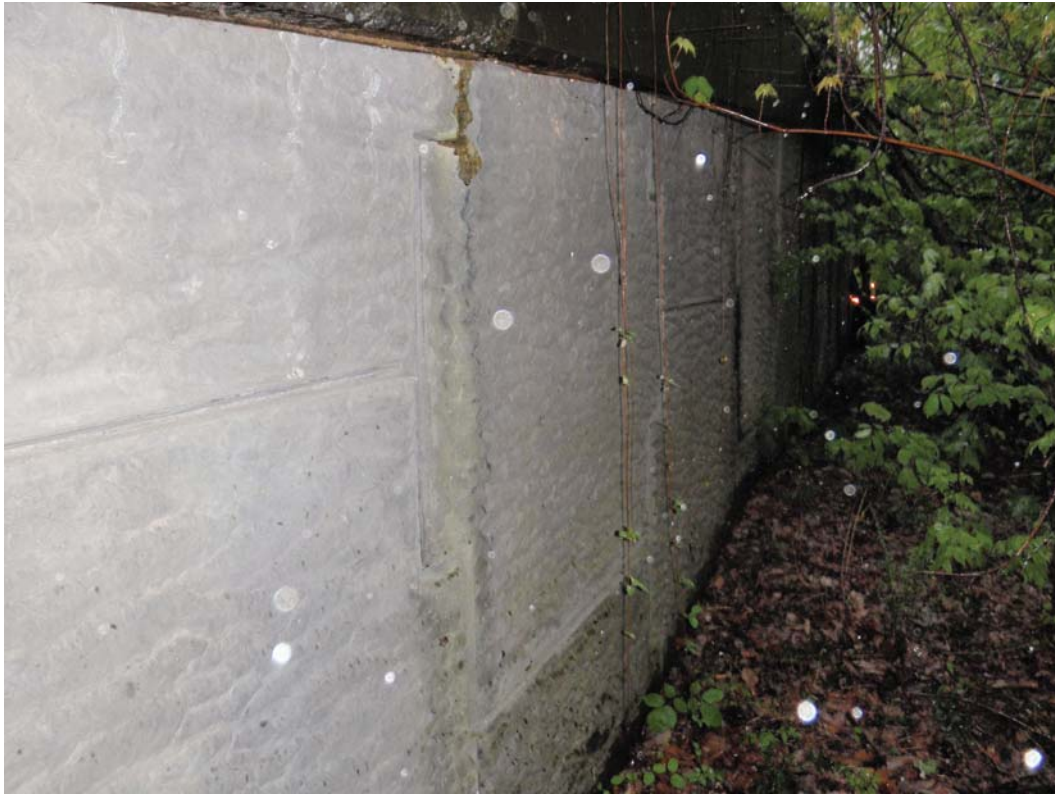
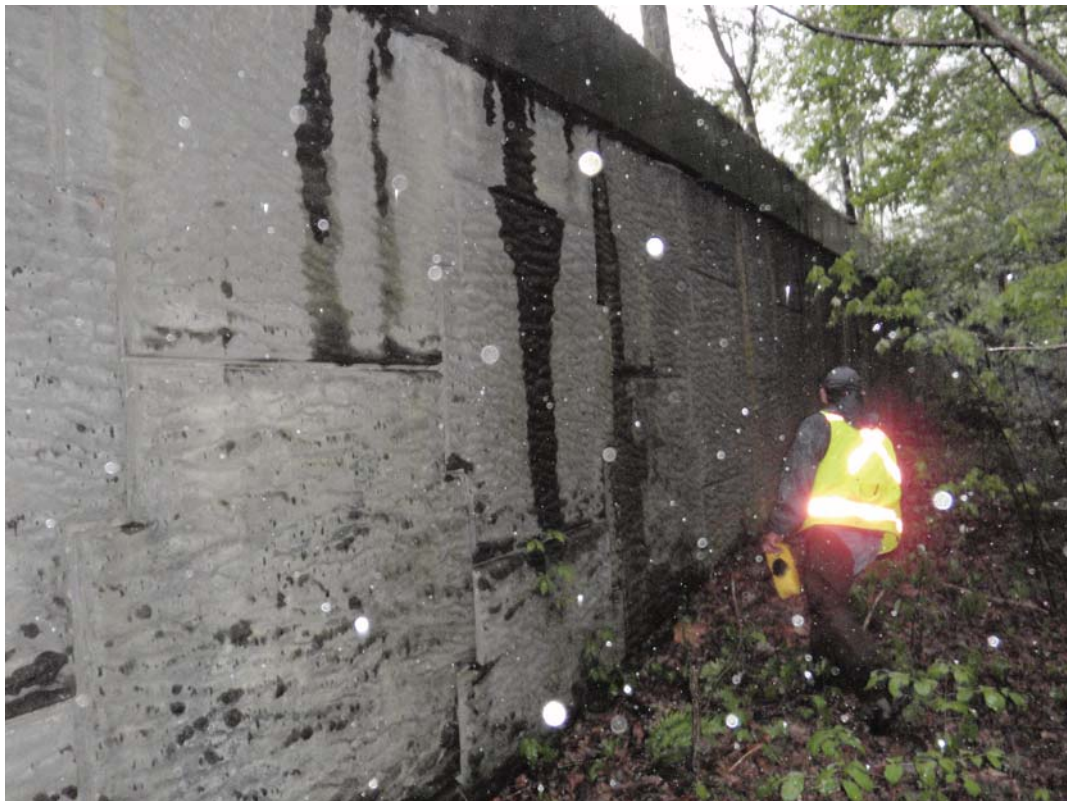
GRSM_0008E_2.150_R_1.jpg

Wall ID:	GRSM-0008E-2.150-R		
Route Name:	FOOTHILLS PARKWAY SECTION 8E		
Inspection Date:	April 19, 2011	Approximate Year Built:	1968
*Wall Rating:	No data available	Maintenance Action:	No data available
Wall Description			
Wall Function:	Fill Wall	Primary Wall Type:	MSE - Precast Panel
Surface Treatment:	Color Additive	Secondary Wall Type:	
Secondary Surface Treatment:		Architectural Facing:	Fractured Fin Concrete
General Description:	Reinforced Earth Co. pre-cast panel MSE wall with a formed panel relief and colored concrete. Wall starts at station 668+50 and corresponds to RW8 per the 1984 8E6 as-built plans.		
Wall Measurements			
Wall Length (ft.):	276	Face Area (sq.):	3040
Average Wall Height (ft.):	11	Face Angle (deg.):	88
Maximum Wall Height (ft.):	13	Vertical Offset (ft.):	-3

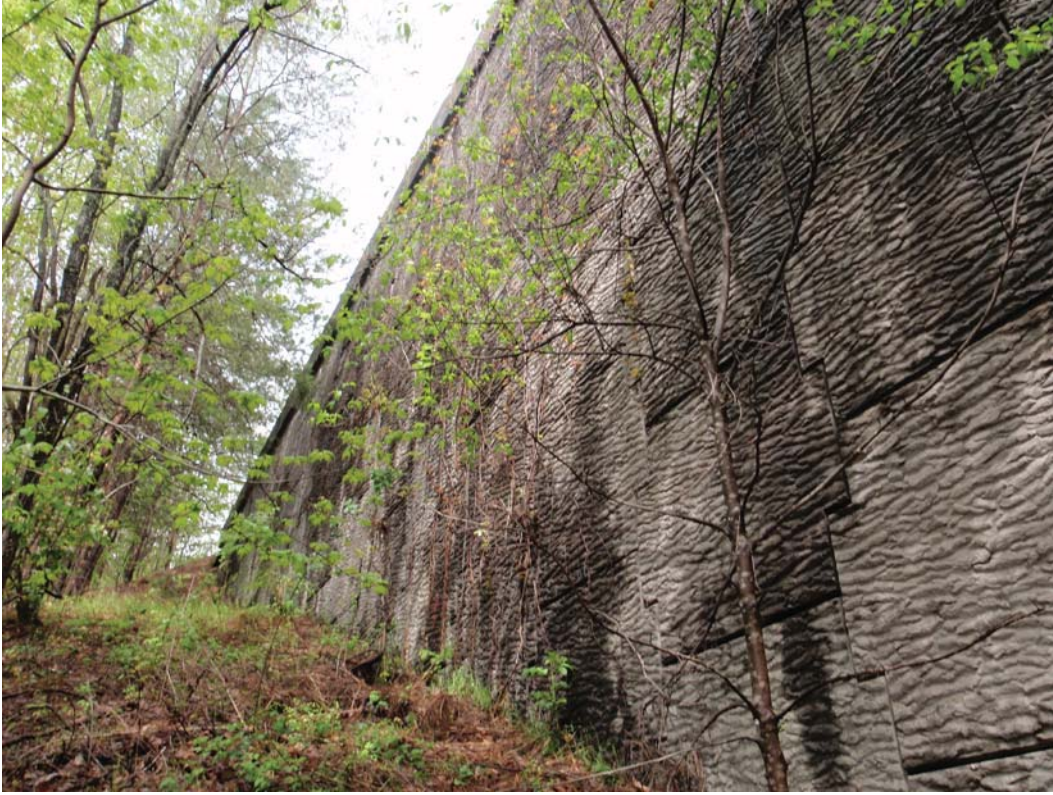
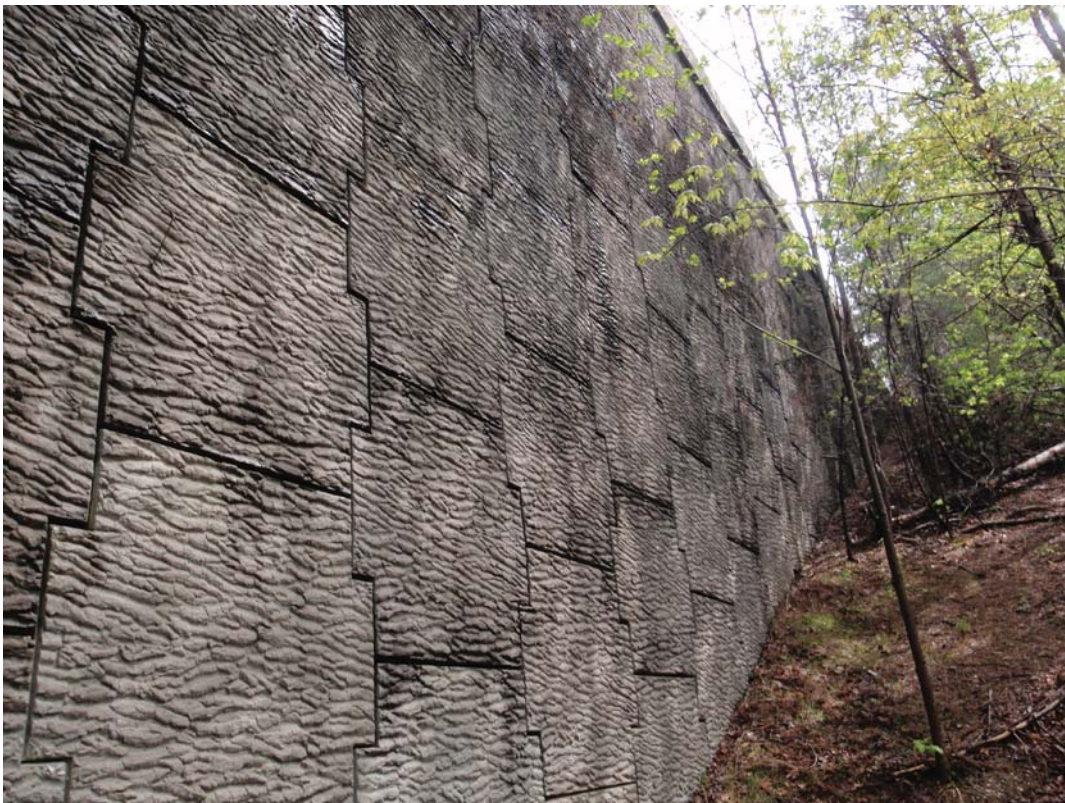
GRSM_0008E_2.912_L_1.jpg

Wall ID:	GRSM-0008E-2.912-L		
Route Name:	FOOTHILLS PARKWAY SECTION 8E		
Inspection Date:	April 19, 2011	Approximate Year Built:	Unknown
*Wall Rating:	No data available	Maintenance Action:	No data available
Wall Description			
Wall Function:	Fill Wall	Primary Wall Type:	MSE - Precast Panel
Surface Treatment:	Color Additive	Secondary Wall Type:	
Secondary Surface Treatment:		Architectural Facing:	Formlined Concrete
General Description:	Reinforced Earth Co. pre-cast panel MSE wall with a formlined panel relief and colored concrete. Wall starts at station 708+75 and corresponds to RW12 per the 1984 8E6 as-built plans.		
Wall Measurements			
Wall Length (ft.):	195	Face Area (sq.):	4500
Average Wall Height (ft.):	23	Face Angle (deg.):	86
Maximum Wall Height (ft.):	42	Vertical Offset (ft.):	-3

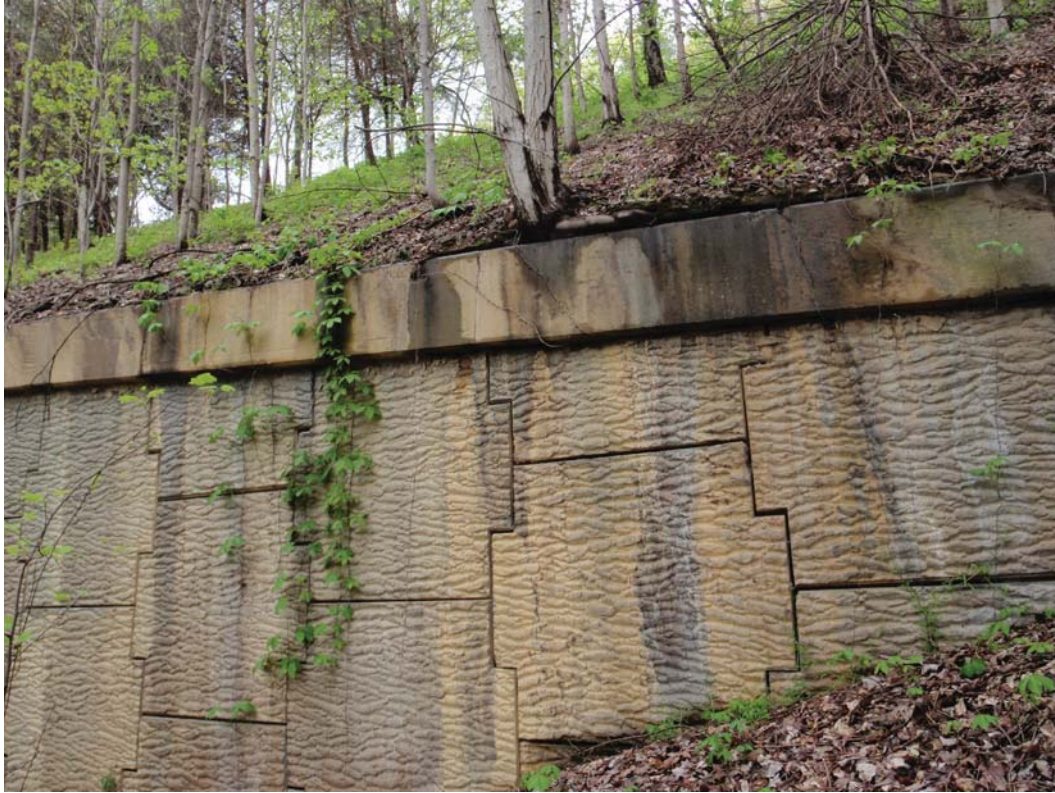
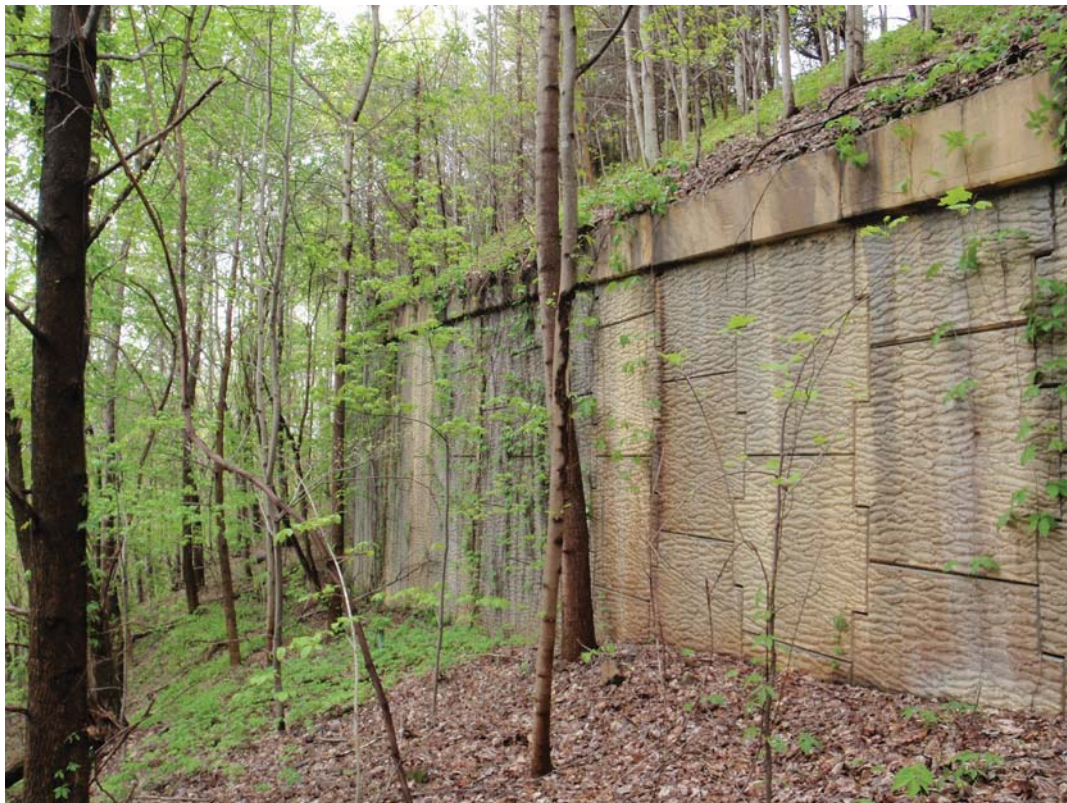
GRSM_0008E_3.556_L_1.jpg

Wall ID:	GRSM-0008E-3.556-L		
Route Name:	FOOTHILLS PARKWAY SECTION 8E		
Inspection Date:	April 19, 2011	Approximate Year Built:	1968
*Wall Rating:	No data available	Maintenance Action:	No data available
Wall Description			
Wall Function:	Fill Wall	Primary Wall Type:	MSE - Precast Panel
Surface Treatment:	Color Additive	Secondary Wall Type:	
Secondary Surface Treatment:		Architectural Facing:	Formlined Concrete
General Description:	Reinforced Earth Co. pre-cast panel MSE wall with a formlined panel relief and colored concrete. Wall starts at station 742+75 and corresponds to RW15 per the 1984 8E6 as-built plans.		
Wall Measurements			
Wall Length (ft.):	330	Face Area (sq.):	7250
Average Wall Height (ft.):	21	Face Angle (deg.):	88
Maximum Wall Height (ft.):	27	Vertical Offset (ft.):	-50

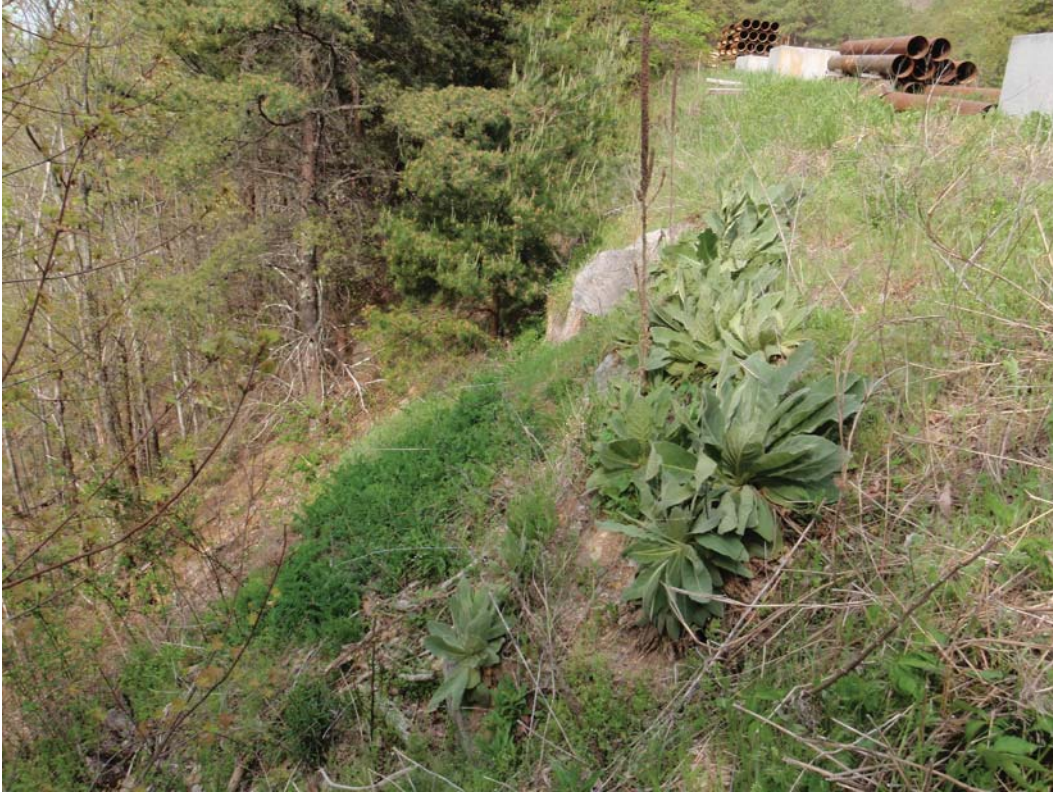
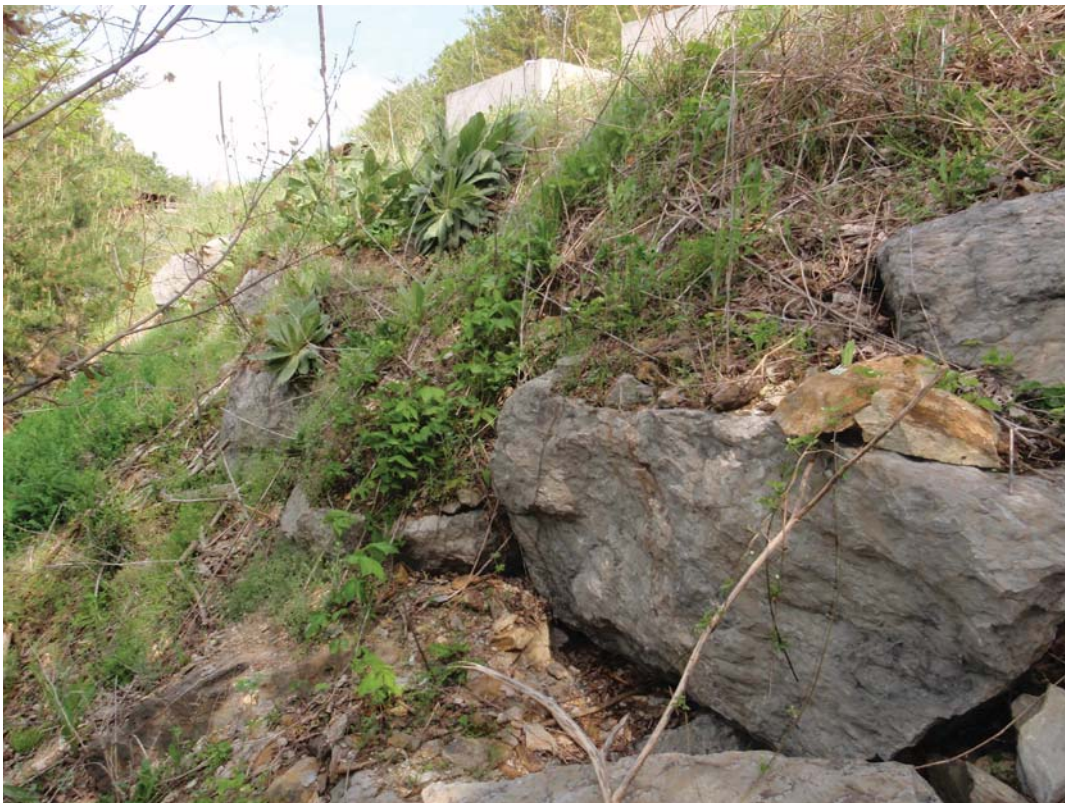
GRSM_0008E_3.868_L_1.jpg

Wall ID:	GRSM-0008E-3.868-L		
Route Name:	FOOTHILLS PARKWAY SECTION 8E		
Inspection Date:	April 19, 2011	Approximate Year Built:	1968
*Wall Rating:	No data available	Maintenance Action:	No data available
Wall Description			
Wall Function:	Fill Wall	Primary Wall Type:	Gravity - Dry Stone
Surface Treatment:		Secondary Wall Type:	
Secondary Surface Treatment:		Architectural Facing:	
General Description:	Poorly placed, large boulder (2+ ft diameter), dry-laid stone wall. Similar to a rockery construction, but poorly crafted. Wall starts at station 759+25 and corresponds to RW16 per the 1984 8E6 as-built plans.		
Wall Measurements			
Wall Length (ft.):	80	Face Area (sq.):	640
Average Wall Height (ft.):	8	Face Angle (deg.):	48
Maximum Wall Height (ft.):	10	Vertical Offset (ft.):	-3

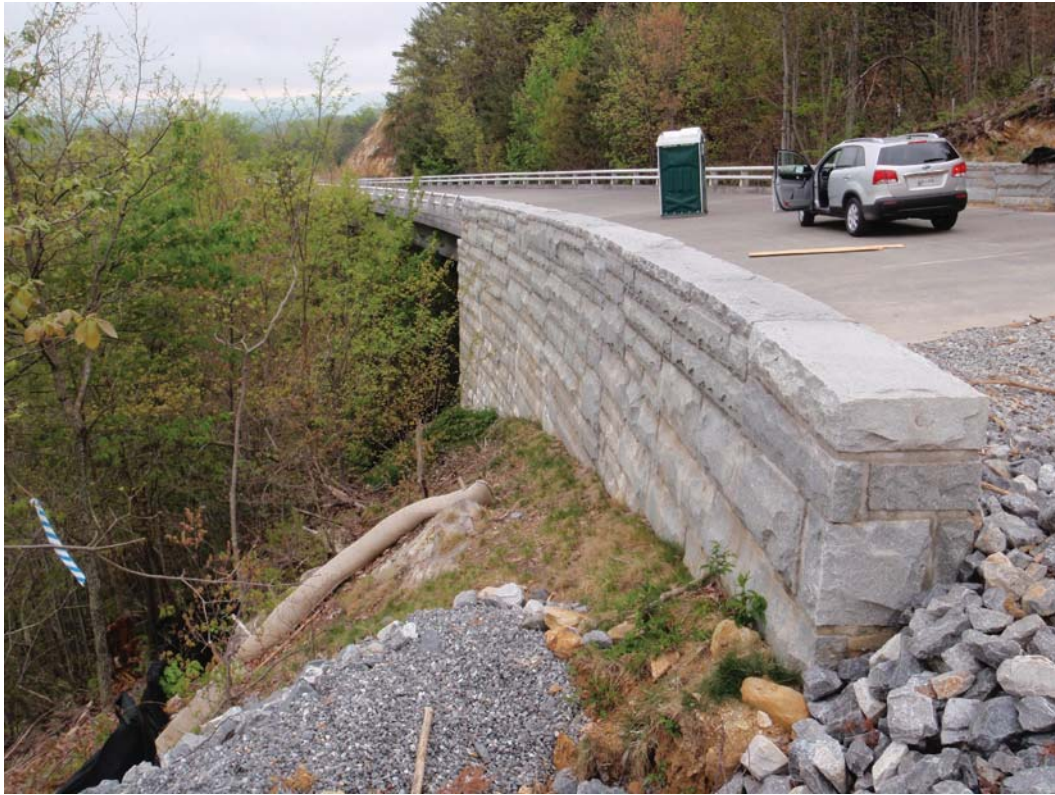
GRSM_0008F_5.329_L_1.jpg

Wall ID:	GRSM-0008F-5.329-L		
Route Name:	FOOTHILLS PARKWAY SECTION 8F		
Inspection Date:	April 19, 2011	Approximate Year Built:	2007
*Wall Rating:	No data available	Maintenance Action:	No data available
Wall Description			
Wall Function:	Fill Wall	Primary Wall Type:	Cantilever - Concrete
Surface Treatment:		Secondary Wall Type:	
Secondary Surface Treatment:		Architectural Facing:	Stone Veneer
General Description:	Concrete cantilever wall with granite stone veneer. Originally inspected 12/07. Updated 4/11. Wall is extension of bridge abutment approach wall at east end of Bridge No.8. Wall starts at station 836+38 per the 1983 8E6 as-builts.		
Wall Measurements			
Wall Length (ft.):	20	Face Area (sq.):	130
Average Wall Height (ft.):	6	Face Angle (deg.):	85
Maximum Wall Height (ft.):	13	Vertical Offset (ft.):	0

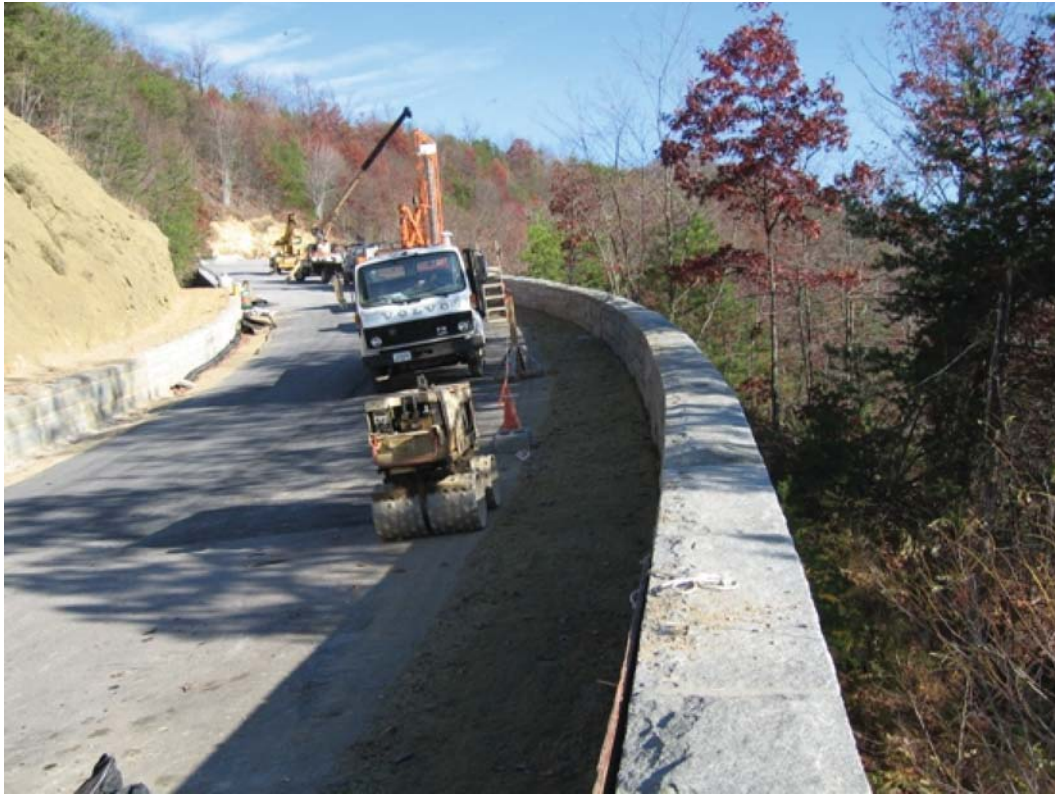
GRSM_0008F_5.421_L_1.jpg

Wall ID:	GRSM-0008F-5.421-L		
Route Name:	FOOTHILLS PARKWAY SECTION 8F		
Inspection Date:	April 19, 2011	Approximate Year Built:	2005
*Wall Rating:	No data available	Maintenance Action:	No data available
Wall Description			
Wall Function:	Fill Wall	Primary Wall Type:	Cantilever - Concrete
Surface Treatment:		Secondary Wall Type:	
Secondary Surface Treatment:		Architectural Facing:	Stone Veneer
General Description:	Concrete cantilever wall with granite stone veneer. Wall sits between Bridge 8 and 9. Wall was originally inspected 12/07. Wall starts at station 838+72 per the 1983 8E6 as-builts.		
Wall Measurements			
Wall Length (ft.):	250	Face Area (sq.):	4250
Average Wall Height (ft.):	0	Face Angle (deg.):	85
Maximum Wall Height (ft.):	30	Vertical Offset (ft.):	0

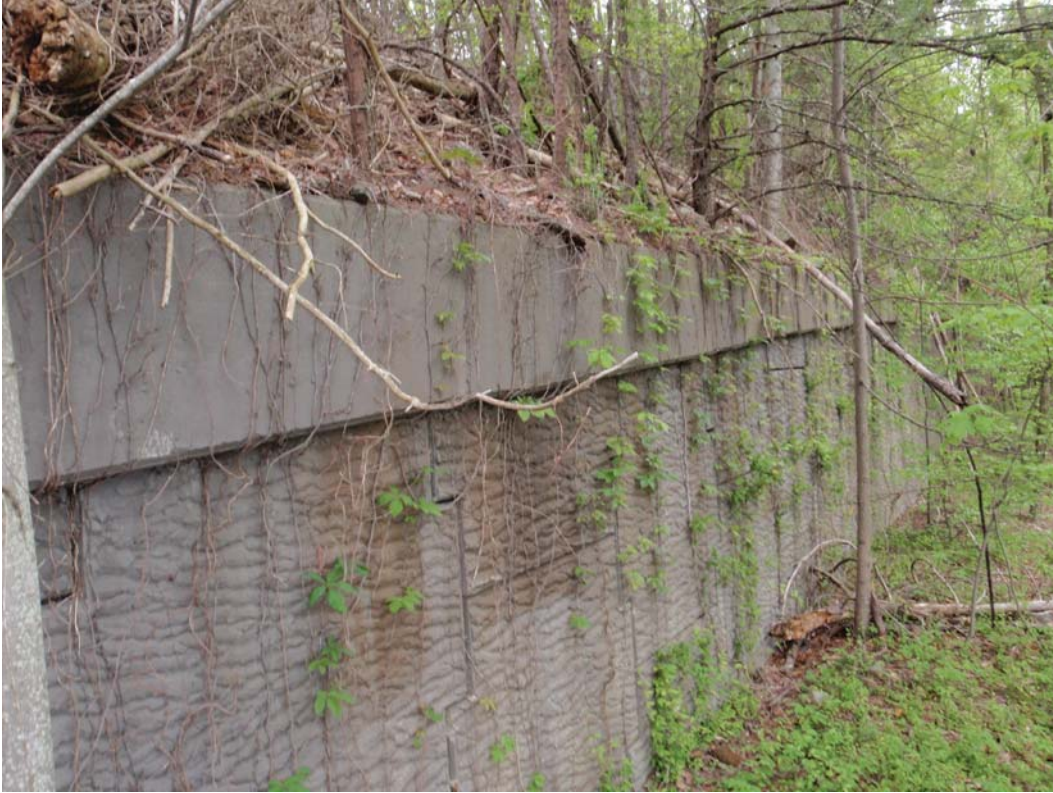
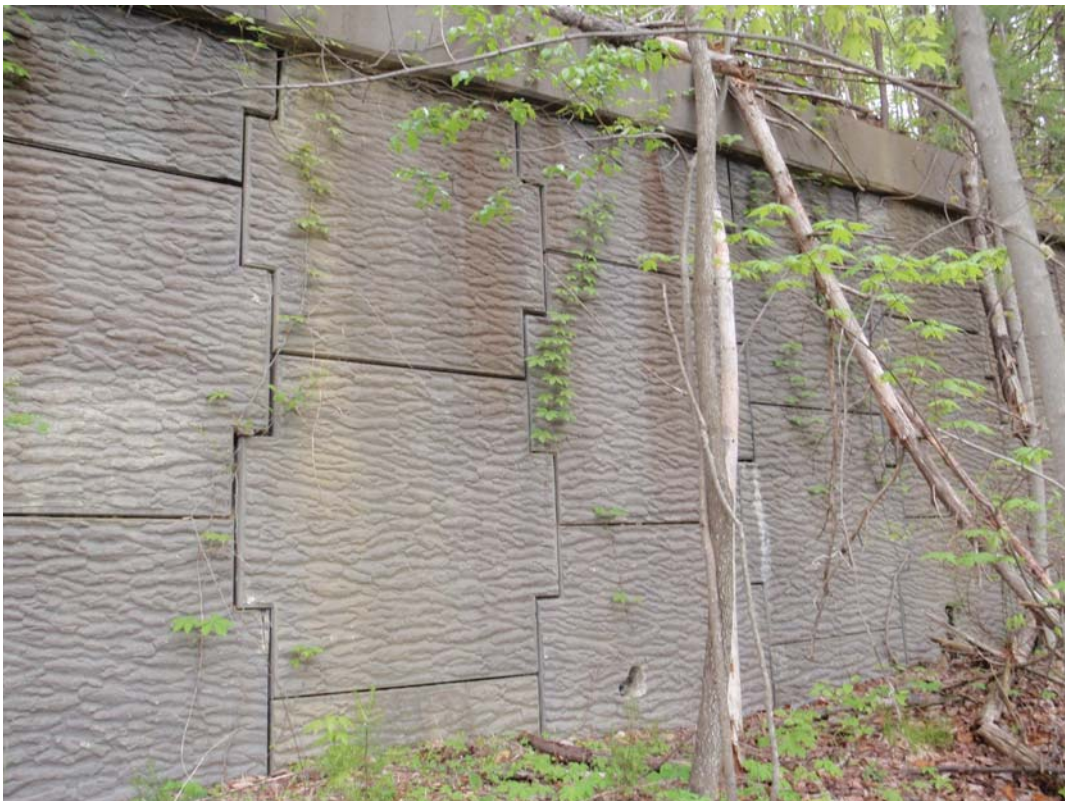
GRSM_0008F_5.895_L_1.jpg

Wall ID:	GRSM-0008F-5.895-L		
Route Name:	FOOTHILLS PARKWAY SECTION 8F		
Inspection Date:	April 19, 2011	Approximate Year Built:	1968
*Wall Rating:	No data available	Maintenance Action:	No data available
Wall Description			
Wall Function:	Fill Wall	Primary Wall Type:	MSE - Precast Panel
Surface Treatment:	Color Additive	Secondary Wall Type:	
Secondary Surface Treatment:		Architectural Facing:	Formlined Concrete
General Description:	Reinforced Earth Co. pre-cast panel MSE wall with a formlined panel relief and colored concrete. Wall is located well below roadway. Originally inspected 12/07. Wall starts at station 866+25 and corresponds to RW5 per the 1984 8E6 as-built plans.		
Wall Measurements			
Wall Length (ft.):	319	Face Area (sq.):	3934
Average Wall Height (ft.):	12	Face Angle (deg.):	85
Maximum Wall Height (ft.):	15	Vertical Offset (ft.):	-26

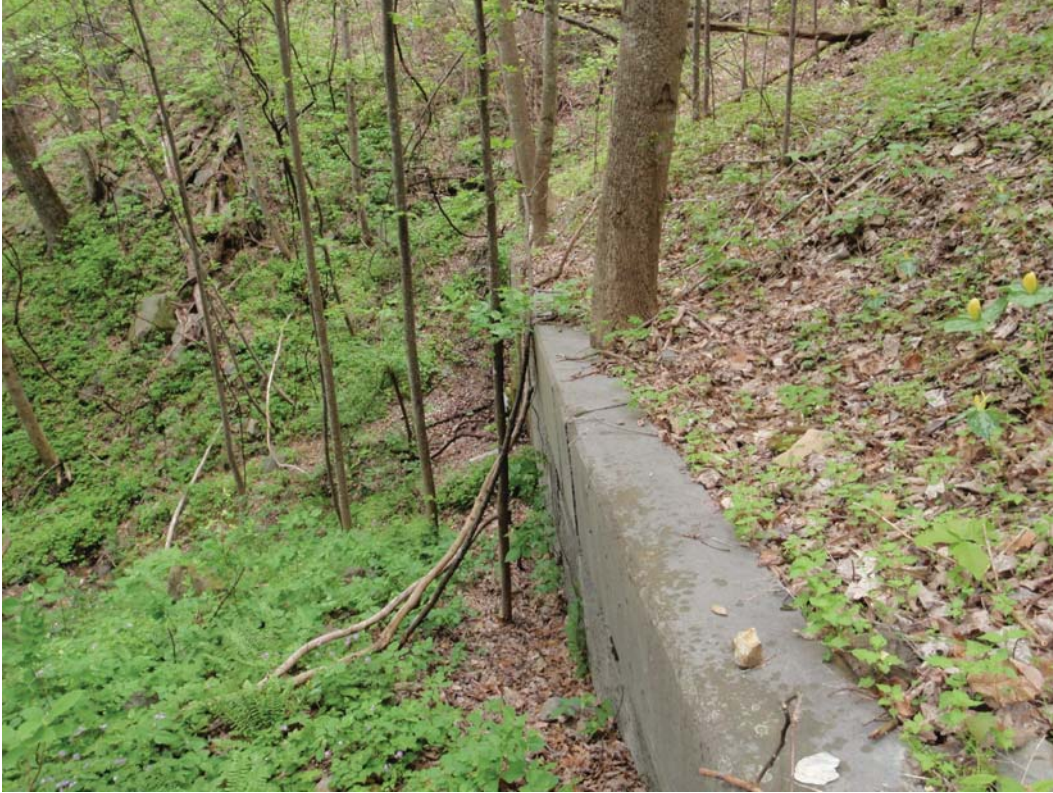
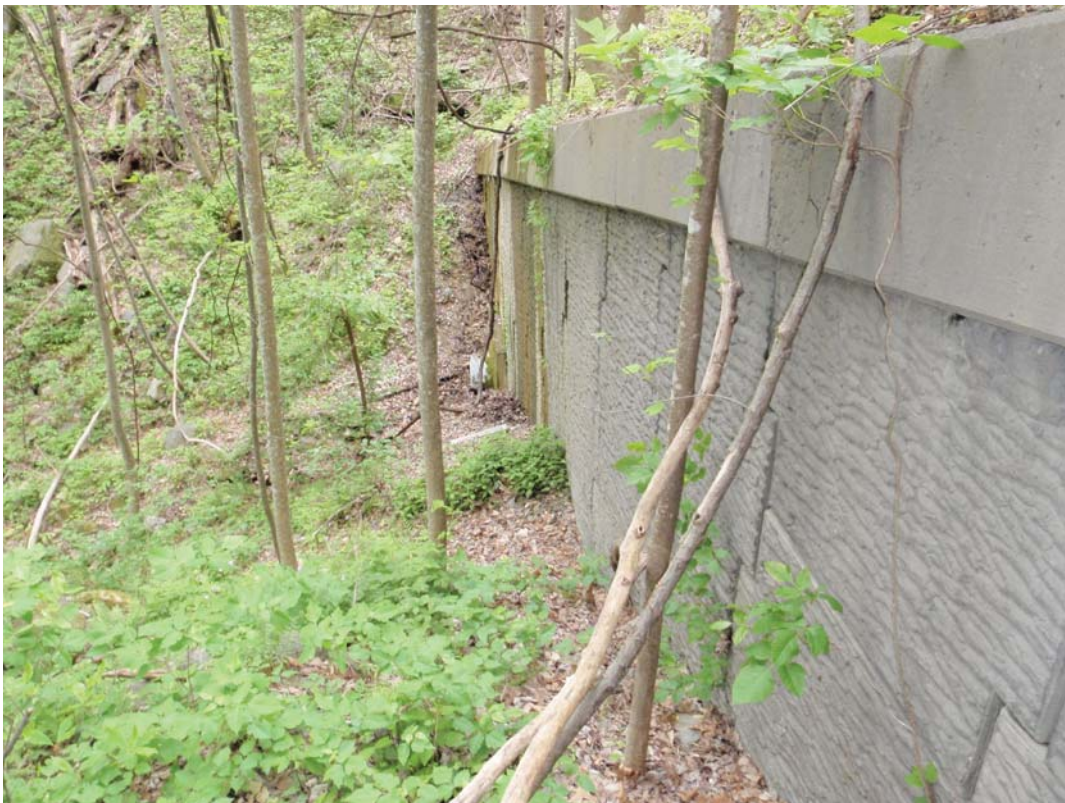
GRSM_0008F_6.956_L_1.jpg

Wall ID:	GRSM-0008F-6.956-L		
Route Name:	FOOTHILLS PARKWAY SECTION 8F		
Inspection Date:	April 19, 2011	Approximate Year Built:	1968
*Wall Rating:	No data available	Maintenance Action:	No data available
Wall Description			
Wall Function:	Fill Wall	Primary Wall Type:	MSE - Precast Panel
Surface Treatment:	Color Additive	Secondary Wall Type:	
Secondary Surface Treatment:		Architectural Facing:	Formlined Concrete
General Description:	Reinforced Earth Co. pre-cast panel MSE wall with a formlined panel relief and colored concrete. Originally inspected 12/07. Wall starts at station 922+25 and corresponds to RW8 per the 1984 8E6 as-built plans.		
Wall Measurements			
Wall Length (ft.):	75	Face Area (sq.):	1000
Average Wall Height (ft.):	13	Face Angle (deg.):	85
Maximum Wall Height (ft.):	14	Vertical Offset (ft.):	-75

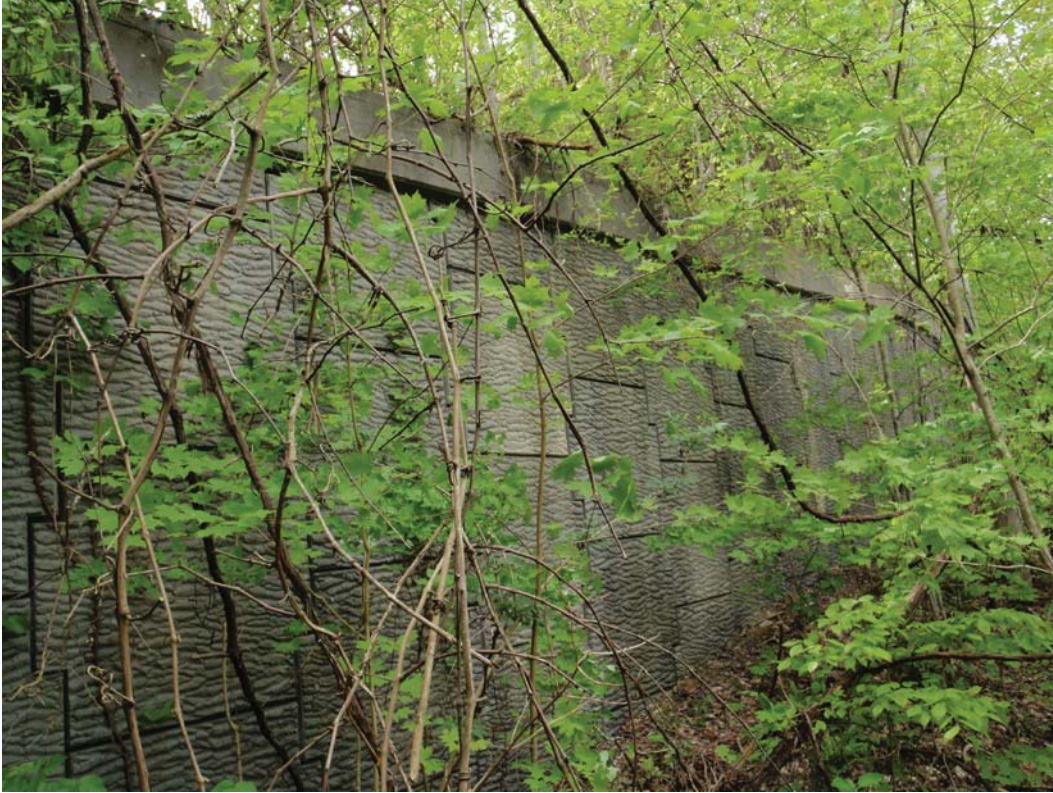
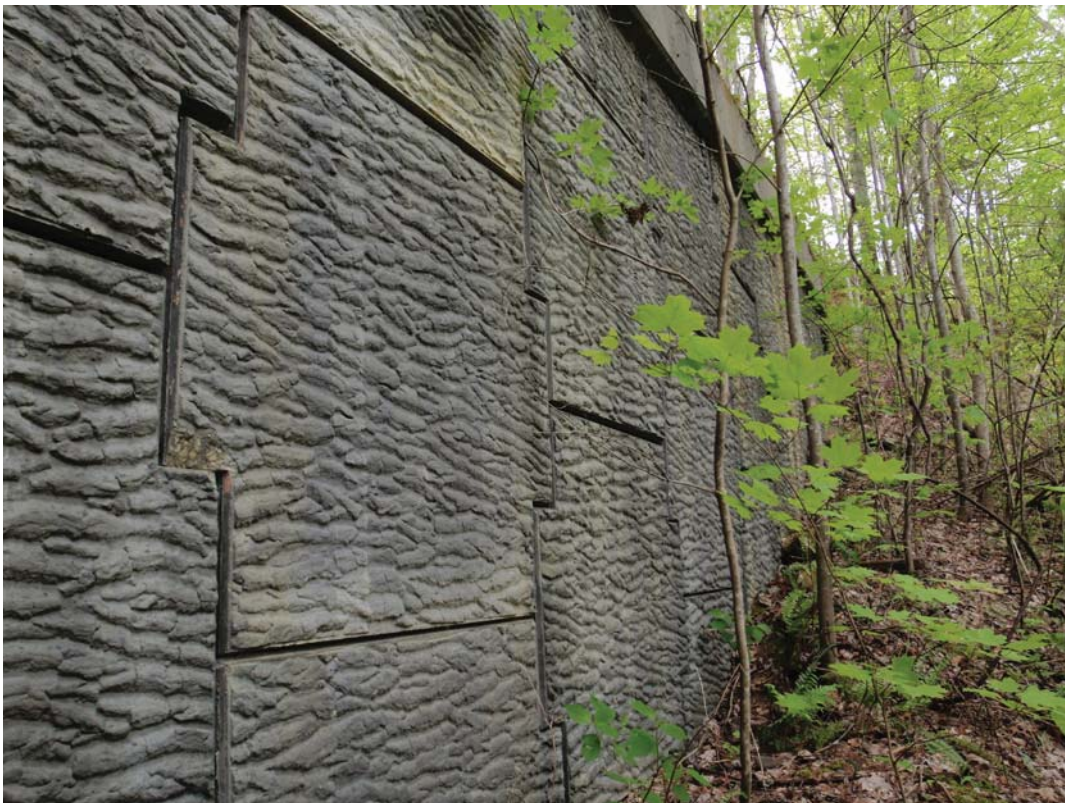
GRSM_0008F_7.652_L_1.jpg

Wall ID:	GRSM-0008F-7.652-L		
Route Name:	FOOTHILLS PARKWAY SECTION 8F		
Inspection Date:	April 19, 2011	Approximate Year Built:	1968
*Wall Rating:	No data available	Maintenance Action:	No data available
Wall Description			
Wall Function:	Fill Wall	Primary Wall Type:	MSE - Precast Panel
Surface Treatment:	Color Additive	Secondary Wall Type:	
Secondary Surface Treatment:		Architectural Facing:	Formlined Concrete
General Description:	Reinforced Earth Co. pre-cast panel MSE wall with a formlined panel relief and colored concrete. Originally inspected 12/07. Wall starts at station 959+00 and corresponds to RW11 per the 1984 8E6 as-built plans.		
Wall Measurements			
Wall Length (ft.):	135	Face Area (sq.):	1785
Average Wall Height (ft.):	13	Face Angle (deg.):	85
Maximum Wall Height (ft.):	17	Vertical Offset (ft.):	-53
