NPS Retaining Wall Inventory Program Great Smoky Mountains National Park

**Federal Lands Highway
Road Inventory Program**

Federal Highway Administration
Eastern Federal Lands Highway Division
Road Inventory Program (RIP)

Data Collection Date: April 2011
Report Date: November 2015

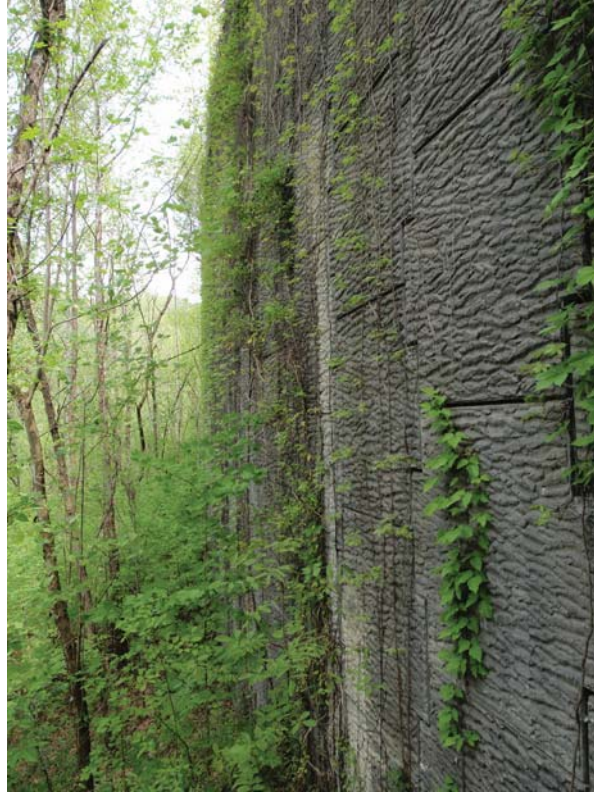
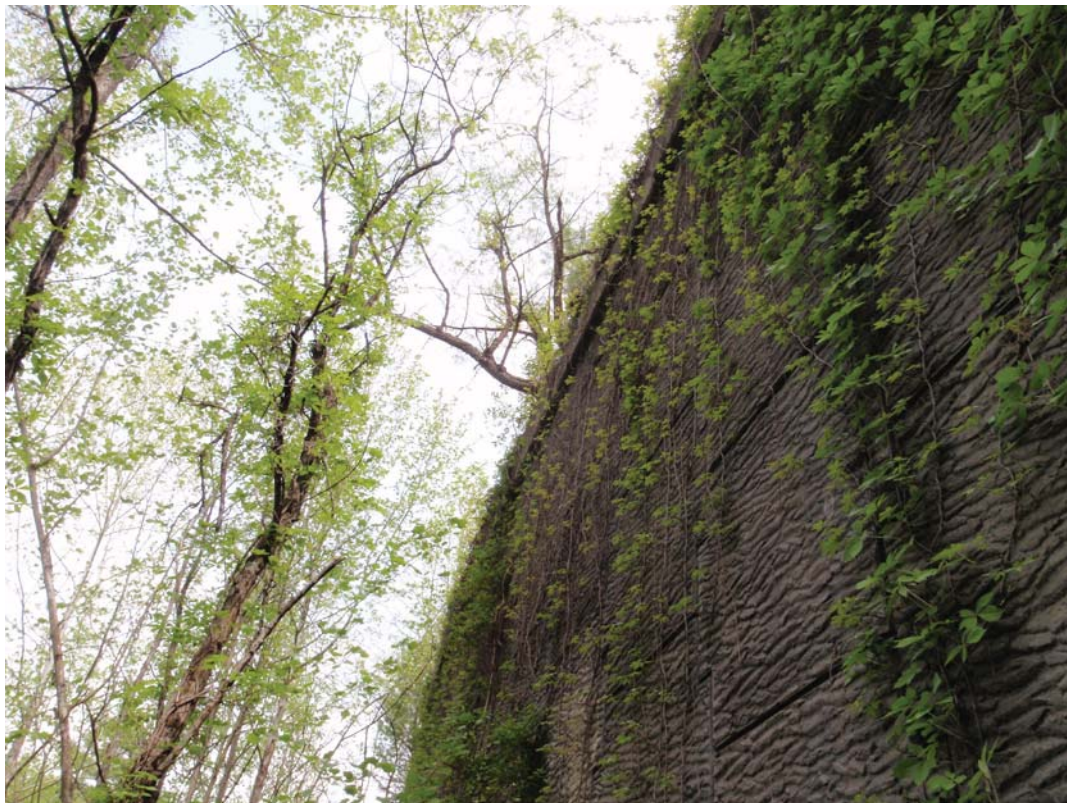
GRSM_0008F_8.101_L_1.jpg

Wall ID:	GRSM-0008F-8.101-L		
Route Name:	FOOTHILLS PARKWAY SECTION 8F		
Inspection Date:	April 19, 2011	Approximate Year Built:	1968
*Wall Rating:	No data available	Maintenance Action:	No data available
Wall Description			
Wall Function:	Fill Wall	Primary Wall Type:	MSE - Precast Panel
Surface Treatment:	Color Additive	Secondary Wall Type:	
Secondary Surface Treatment:		Architectural Facing:	Formlined Concrete
General Description:	Reinforced Earth Co. pre-cast panel MSE wall with a formlined panel relief and colored concrete. Originally inspected 12/07. Wall starts at station 982+75 and corresponds to RW14 per the 1984 8E6 as-built plans.		
Wall Measurements			
Wall Length (ft.):	281	Face Area (sq.):	8100
Average Wall Height (ft.):	28	Face Angle (deg.):	85
Maximum Wall Height (ft.):	41	Vertical Offset (ft.):	-30

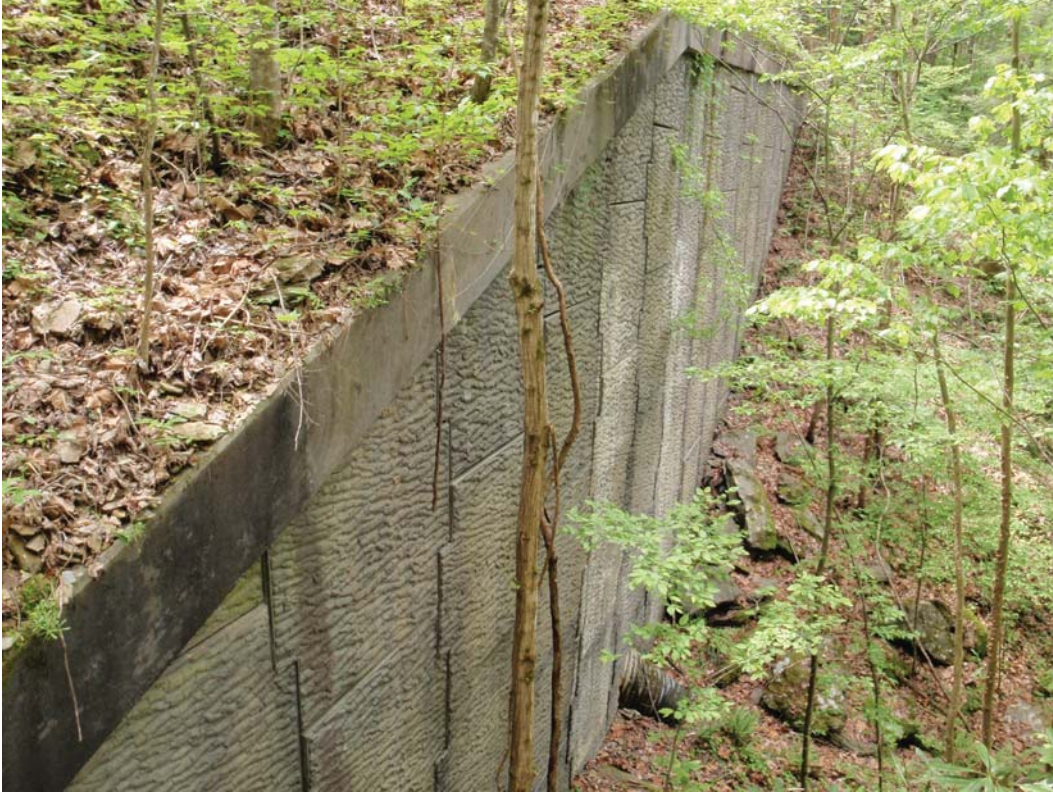
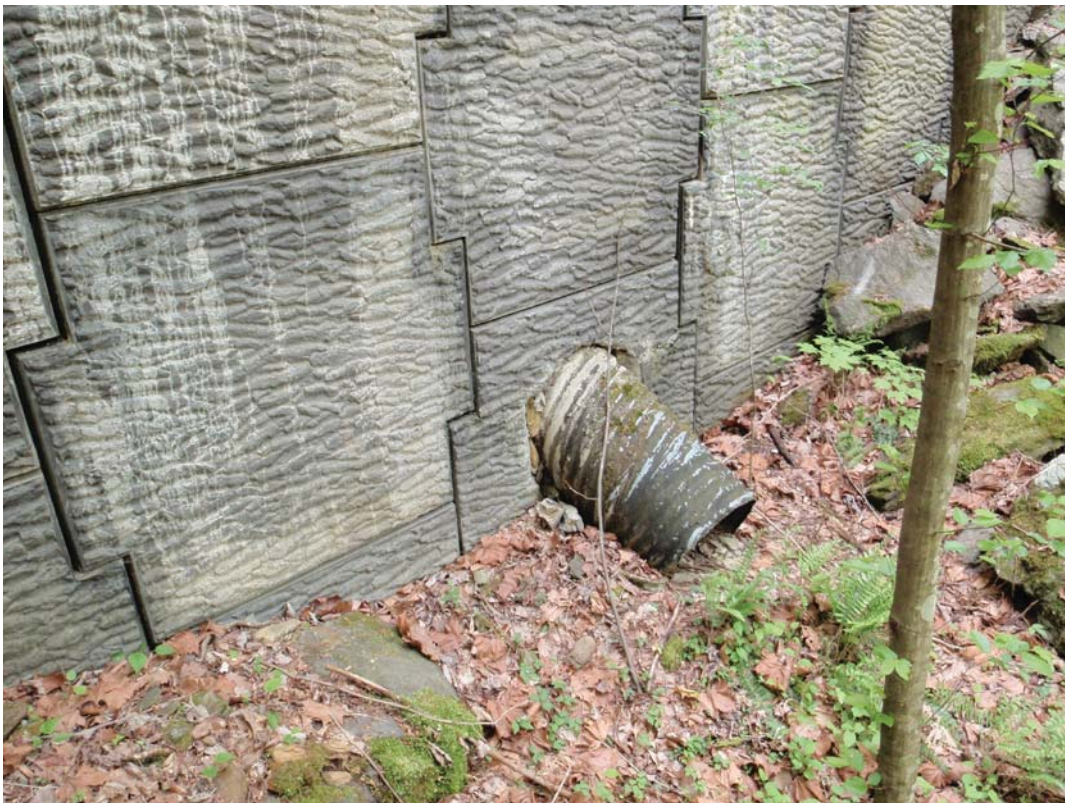
GRSM_0008F_8.466_L_1.jpg

Wall ID:	GRSM-0008F-8.466-L		
Route Name:	FOOTHILLS PARKWAY SECTION 8F		
Inspection Date:	April 19, 2011	Approximate Year Built:	1968
*Wall Rating:	No data available	Maintenance Action:	No data available
Wall Description			
Wall Function:	Fill Wall	Primary Wall Type:	MSE - Precast Panel
Surface Treatment:	Color Additive	Secondary Wall Type:	
Secondary Surface Treatment:		Architectural Facing:	Formlined Concrete
General Description:	Reinforced Earth Co. pre-cast panel MSE wall with a formlined panel relief and colored concrete. Originally inspected 12/07. Wall starts at station 1002+00 and corresponds to RW16 per the 1984 8E6 as-built plans.		
Wall Measurements			
Wall Length (ft.):	92	Face Area (sq.):	1864
Average Wall Height (ft.):	20	Face Angle (deg.):	85
Maximum Wall Height (ft.):	29	Vertical Offset (ft.):	-50

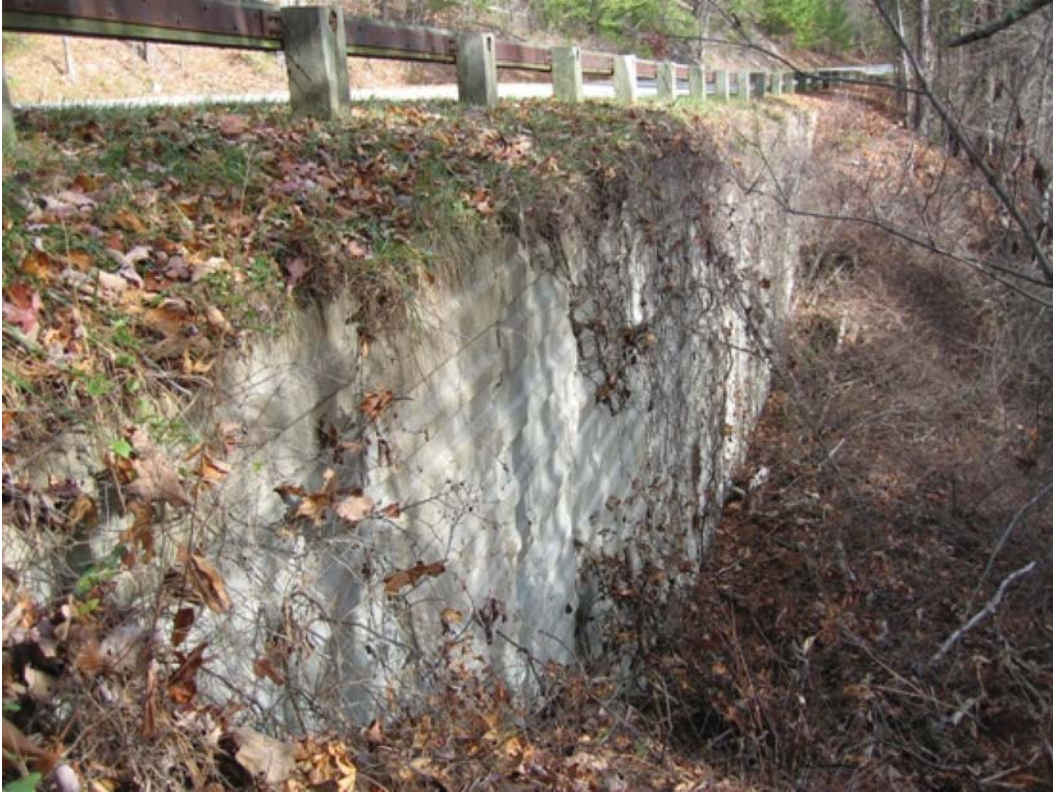
GRSM_0008G_60.600_R_1.jpg

Element (Weighting Factor)	Narrative	Condition Rating (0 - 10)
PERFORMANCE 8.00	Good condition, performing as intended.	8
WALL FOUNDATION MATERIAL 8.00	Solid granular material, no signs of foundation distress.	9
CONCRETE 8.00	Facing element, minor cracking at the face, minor push-out of top row of elements, not impacting wall performance.	8
ARCHITECTURAL FACING 0.50	Concrete facing elements, minor push-out at top row of elements, not impacting wall performance.	8
LATERAL SLOPE 0.50	Steep slopes at 1.5H:1V slopes, moderate surface erosion, not impacting wall.	8
DOWNSLOPE 0.50	5-6 foot wide flat bench, then 2H:1V gentle slope, no signs of distress.	9
ROAD/SIDEWALK/SHOULDER 0.50	Road has no signs of distress. Shoulder is flat grassy bench, no signs of distress.	9
TRAFFIC BARRIER/FENCE 0.50	Guardrail at top of wall, no signs of distress.	9
WALL DRAINS 0.50	None observed, assumed buried, not impacting wall performance.	9

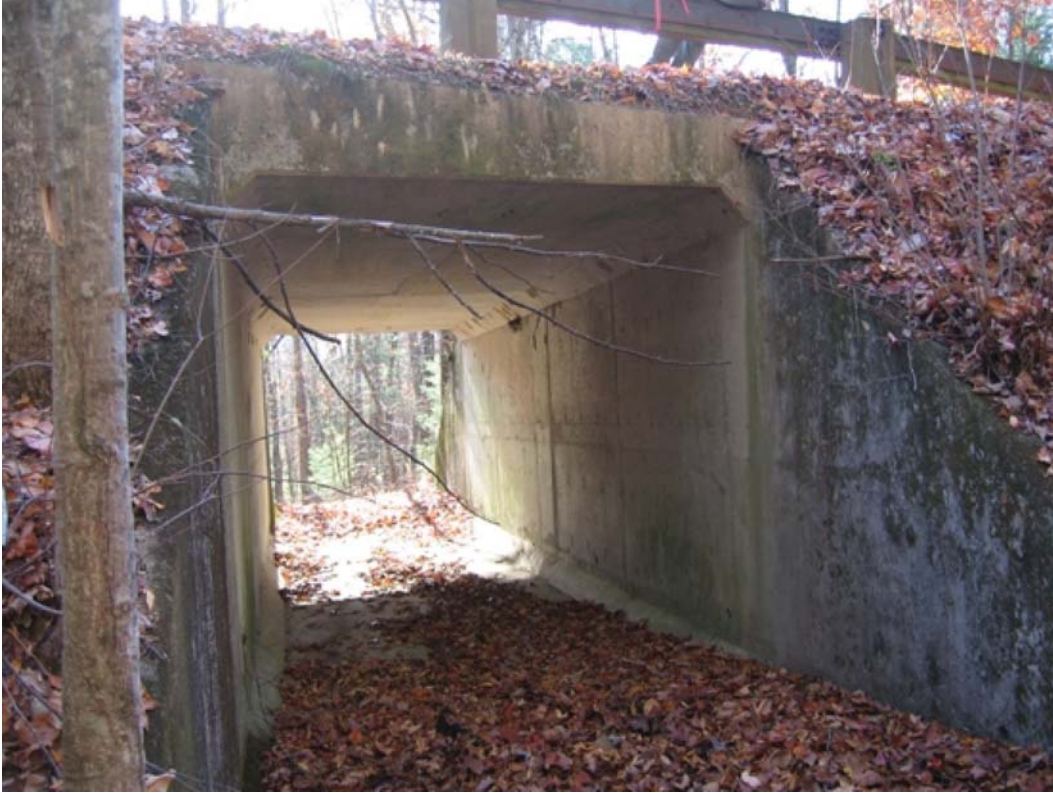
GRSM_0008H_69.362_L_1.jpg

Element (Weighting Factor)	Narrative	Condition Rating (0 - 10)
PERFORMANCE 8.00	As designed.	9
WALL FOUNDATION MATERIAL 8.00	Granular soil and rock.	9
CONCRETE 8.00	Weathered, lichen present, no distress.	8
LATERAL SLOPE 0.50	Treed embankment fill.	9
ROAD/SIDEWALK/SHOULDER 0.50	No distress.	9
TRAFFIC BARRIER/FENCE 0.50	No distress.	9
UPSLOPE 0.50	Gentle wooded area.	9
WALL DRAINS 0.50	3-inch diameter weep holes, no distress.	9

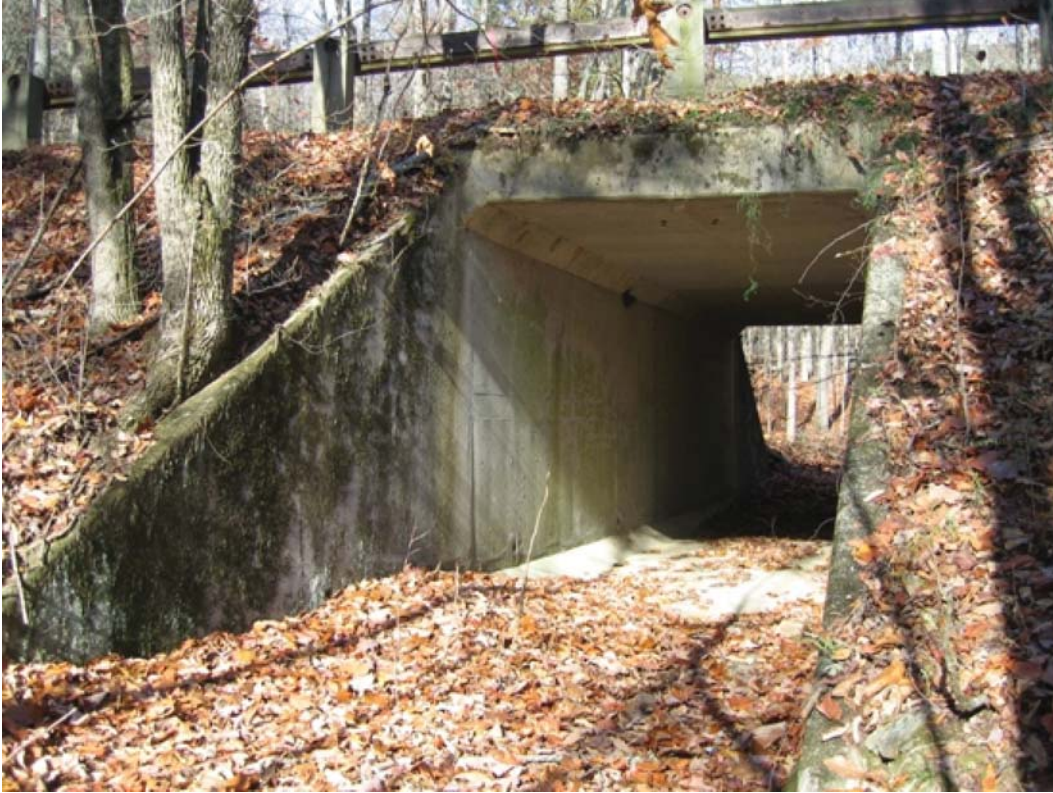
GRSM_0008H_69.365_R_1.jpg

Element (Weighting Factor)	Narrative	Condition Rating (0 - 10)
PERFORMANCE 8.00	Good condition, performing as intended.	8
WALL FOUNDATION MATERIAL 8.00	Solid granular material in alluvial channel, no signs of foundation distress.	9
CONCRETE 8.00	Minor cracking, pitting at the face, moss cover, performing as intended.	8
LATERAL SLOPE 0.50	Steep 1.5H:1V slopes with vegetation and trees.	8
CULVERT 0.50	10' x 10' CBC, performing as intended.	9
DOWNSLOPE 0.50	Active stream channel, flat outlet apron, not impacting wall, no signs of distress.	9
ROAD/SIDEWALK/SHOULDER 0.50	Road has no signs of distress. Shoulder is grassy 2-3 foot wide bench, no signs of distress.	9
TRAFFIC BARRIER/FENCE 0.50	Guardrail at top, no signs of distress.	9
WALL DRAINS 0.50	3 -inch PVC at 10 foot intervals, performing as intended.	9

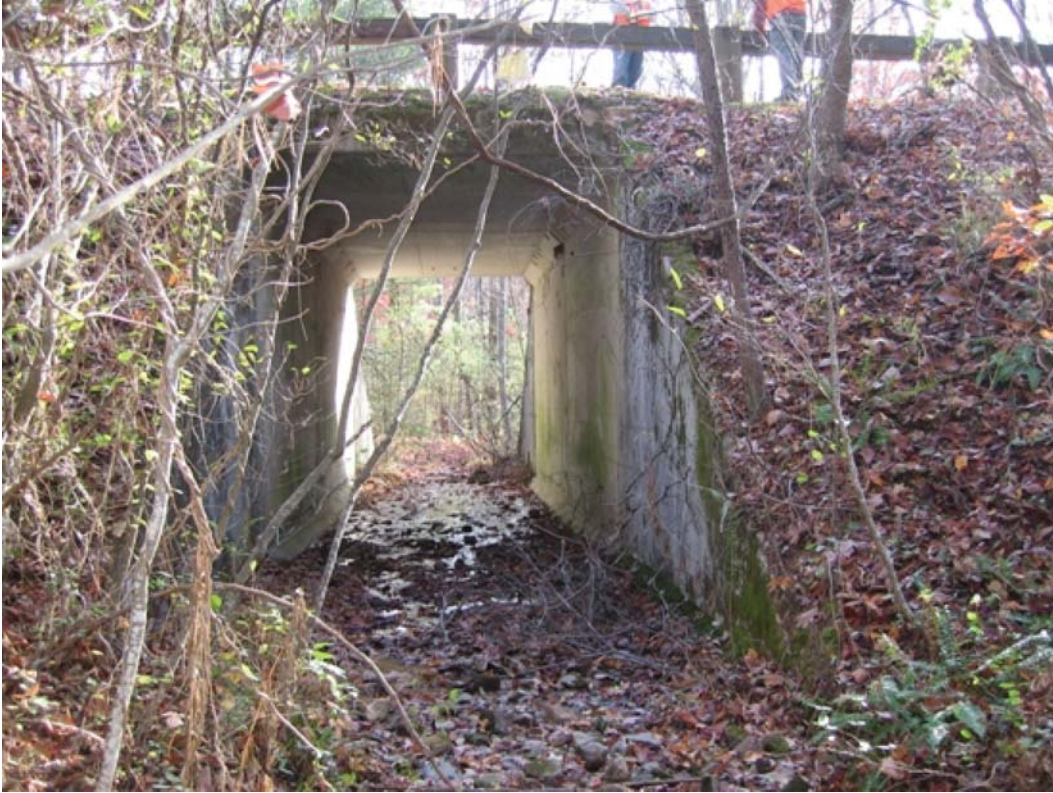
GRSM_0008H_70.090_R_1.jpg

Element (Weighting Factor)	Narrative	Condition Rating (0 - 10)
PERFORMANCE 8.00	As designed.	9
WALL FOUNDATION MATERIAL 8.00	Firm granular soil.	9
CONCRETE 8.00	Slightly weathered no cracking observed, mossy.	8
LATERAL SLOPE 0.50	Embankment fill, grassy with trees.	9
ROAD/SIDEWALK/SHOULDER 0.50	No distress.	9
UPSLOPE 0.50	Flat streambed river rock.	9
WALL DRAINS 0.50	3-inch weep holes at 10-foot on center spacing.	9

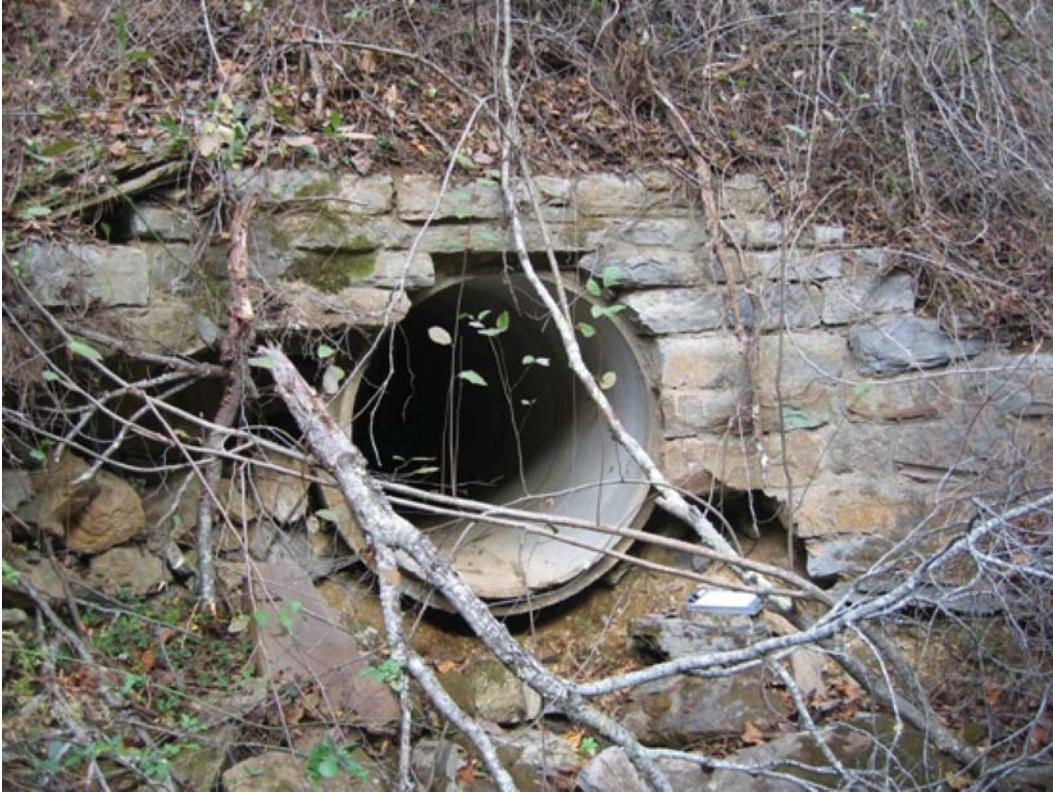
GRSM_0008H_71.800_L_1.jpg

Element (Weighting Factor)	Narrative	Condition Rating (0 - 10)
PERFORMANCE 8.00	Poor condition, severe undermining at base (voids), but not impacting roadway.	5
WALL FOUNDATION MATERIAL 8.00	Rock fill and granular material, voids and undermining at outlet.	5
MORTAR 8.00	Concrete mortar, extensive debonding throughout, severe cracking and voids at concrete pipe outlet, pipe still functioning.	4
STONE MASONRY 8.00	1-2 foot diameter limestone and sandstone blocks, moderate surface weathering, moss cover, missing adjacent to the base (undermining).	6
CULVERT 0.50	5-foot diameter concrete pipe, moderate displacement at joints, performing as intended.	8
ROAD/SIDEWALK/SHOULDER 0.50	Road has no signs of distress. Shoulder is steep slope at 1.5H:1V with heavy vegetation.	8
WALL DRAINS 0.50	None observed, not impacting wall performance.	9
DOWNSLOPE 1.00	Outlet to pond, moderate undercut and erosion.	6
LATERAL SLOPE 1.00	Steep slope at 1.5H:1V , heavy vegetation, moderate surface erosion.	7

Failure Consequence:	LOW
Recommendation Narrative:	Fill voids at outlet: Volume left = 5ft high x 7ft wide x 3 feet deep = 105 ft3 = 4 cyd, volume right = 4ft high x 7ft wide x 3 feet deep = 84ft3 = 3cyd, Total = 7 cyd. Mob/demob = \$1000. Pumper truck with concrete = 4 hrs x \$210/hr = \$840. Lean concrete
Repair Cost:	\$4,385

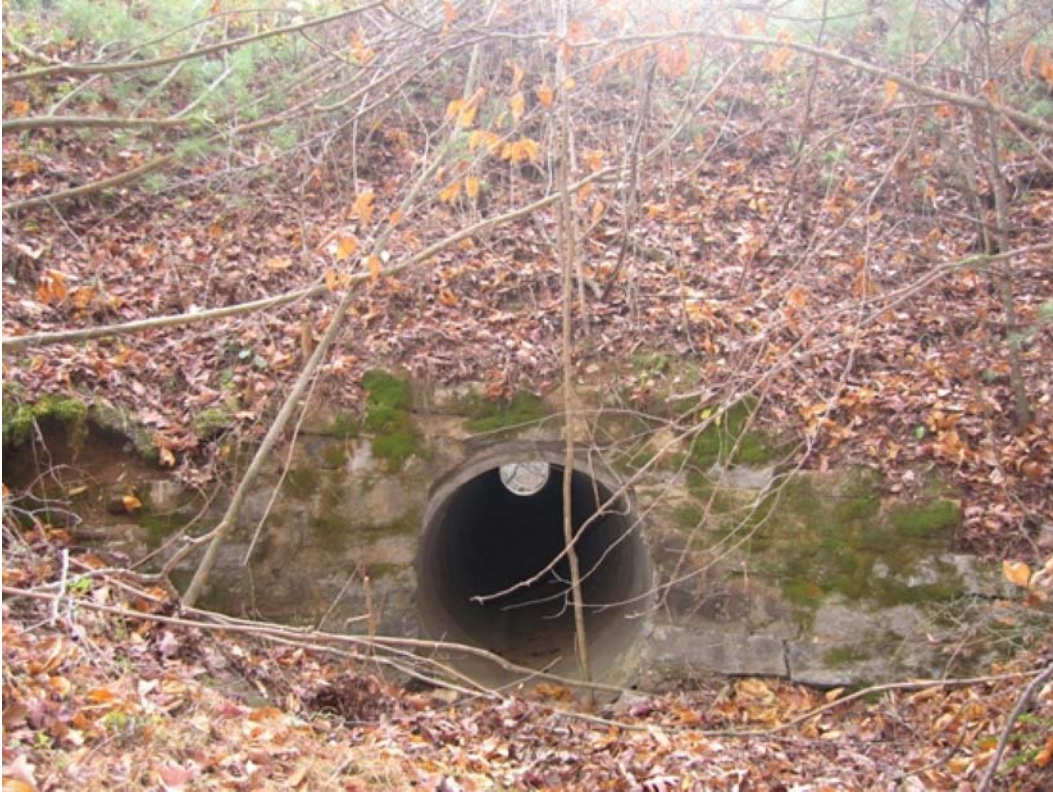
GRSM_0008H_71.822_L_1.jpg

Element (Weighting Factor)	Narrative	Condition Rating (0 - 10)
PERFORMANCE 8.00	As required.	7
WALL FOUNDATION MATERIAL 8.00	Firm granular soil.	9
MORTAR 8.00	Extensive debonding, some cracking, and some missing.	5
STONE MASONRY 8.00	Moss, little to some weathering, some missing stones at base.	8
ROAD/SIDEWALK/SHOULDER 0.50	Road - no distress. Shoulder - steep vegetated some raveling.	8
UPSLOPE 0.50	Flat stream bed.	9
WALL DRAINS 0.50	No distress.	9
LATERAL SLOPE 1.00	Minor erosion of embankment fill at both ends.	7

Failure Consequence:	LOW
Recommendation Narrative:	Repoint entire wall 90 sq.ft. x \$75/sq.ft. = \$6,750. Replace/reset 1 cubic yard of stone, use local material = \$3,200. The access to the wall is steep, but there is plenty of staging area along the road.
Repair Cost:	\$9,950

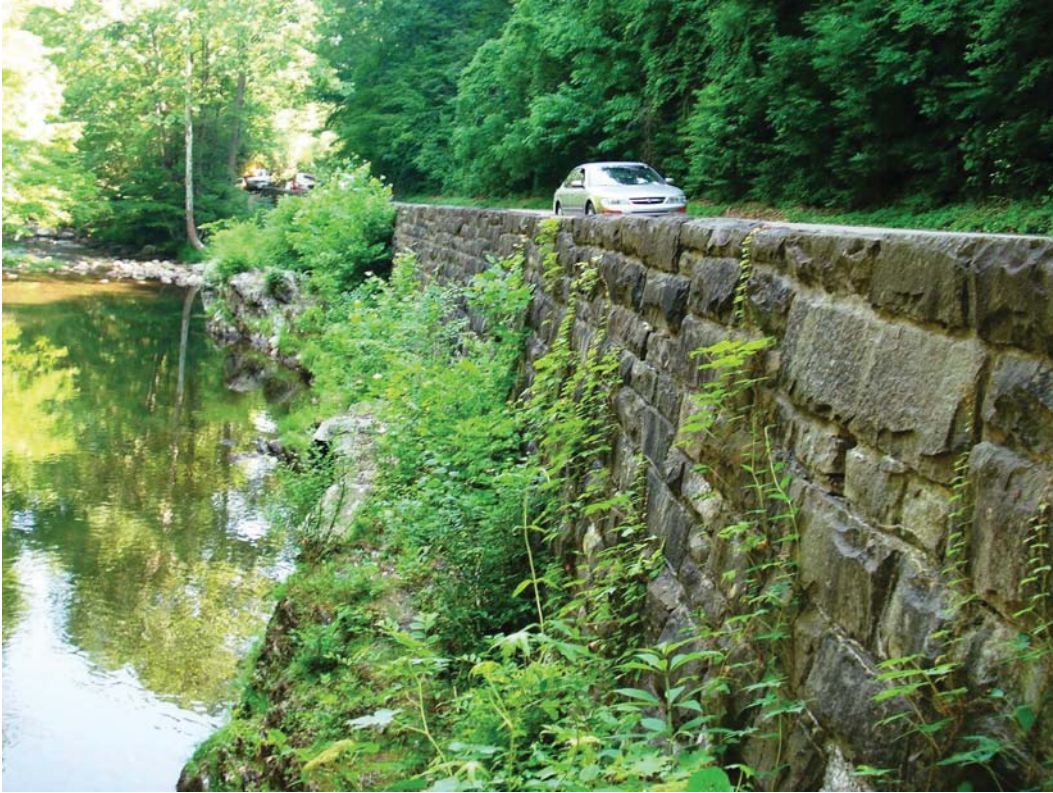
GRSM_0010N_0.537_R_1.jpg

Element (Weighting Factor)	Narrative	Condition Rating (0 - 10)
PERFORMANCE 8.00	Good to excellent	8
WALL FOUNDATION MATERIAL 8.00	founded on bedrock, no distress	9
MORTAR 8.00	Minor cracking and debonding	8
STONE MASONRY 8.00	No distress noted in stone	9
ROAD/SIDEWALK/SHOULDER 0.50	minor cracking	8
TRAFFIC BARRIER/FENCE 0.50	guardwall with/minor impact damage, degraded mortar at wall interface (about 40%)	8
CULVERT 0.50	18" concrete pipe through wall, no distress	9
DOWNSLOPE 0.50	bedrock to river, no distress	9
LATERAL SLOPE 0.50	No distress	9

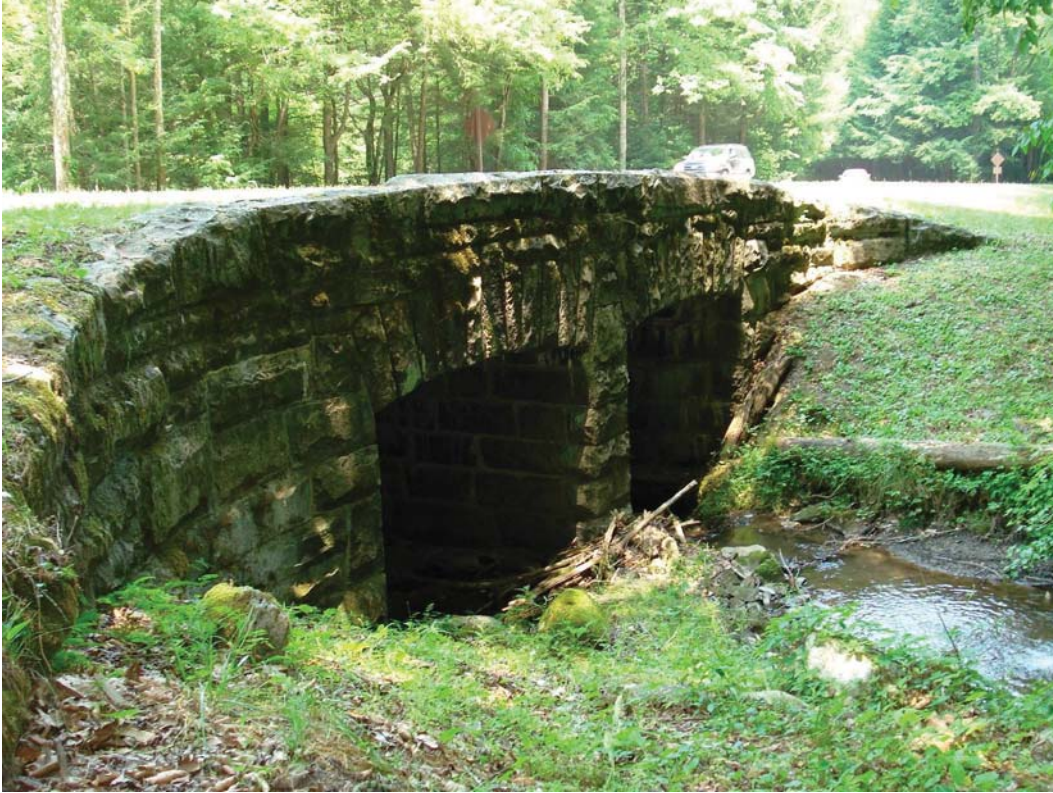
GRSM_0010N_1.129_L_1.jpg

Element (Weighting Factor)	Narrative	Condition Rating (0 - 10)
PERFORMANCE 8.00	As above	9
WALL FOUNDATION MATERIAL 8.00	Slightly undermined at wall start, concrete on bedrock.	8
MORTAR 8.00	Minor debonding in joints	9
STONE MASONRY 8.00	No distress, plumb	9
CULVERT 0.50	No distress	9
DOWNSLOPE 0.50	Stable creek bed. No distress	9
LATERAL SLOPE 0.50	No distress - stable road fill	9
ROAD/SIDEWALK/SHOULDER 0.50	No distress	9
WALL DRAINS 0.50	Non visible - no distress	9

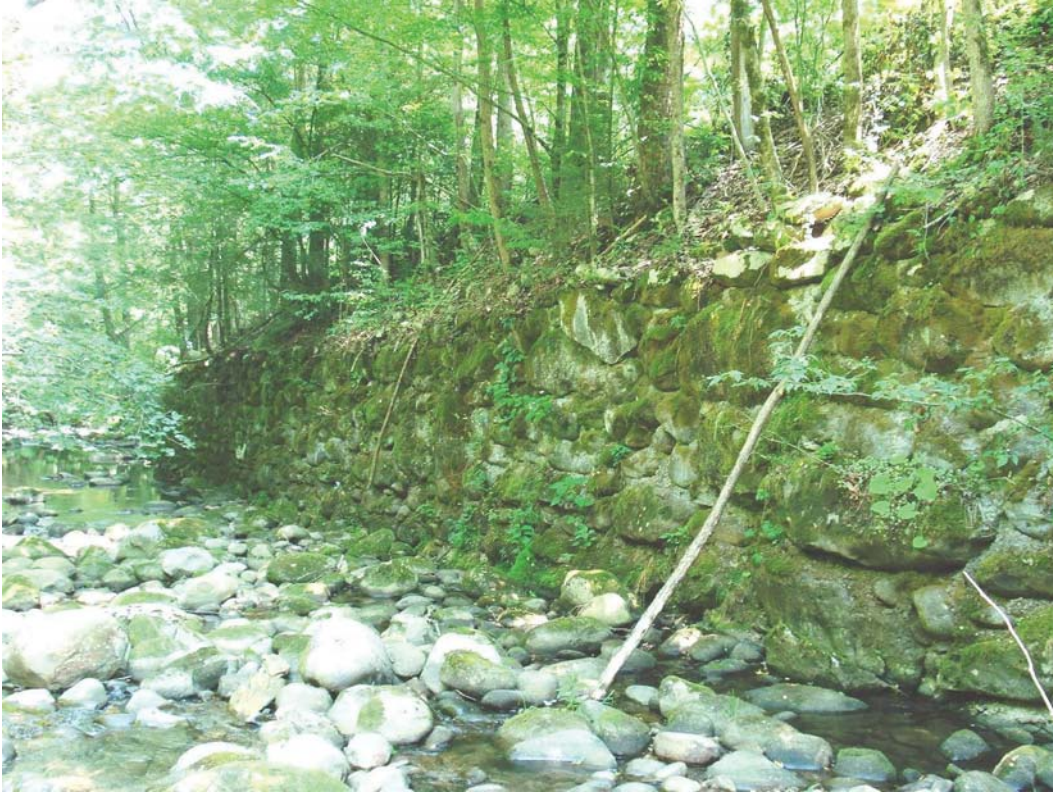
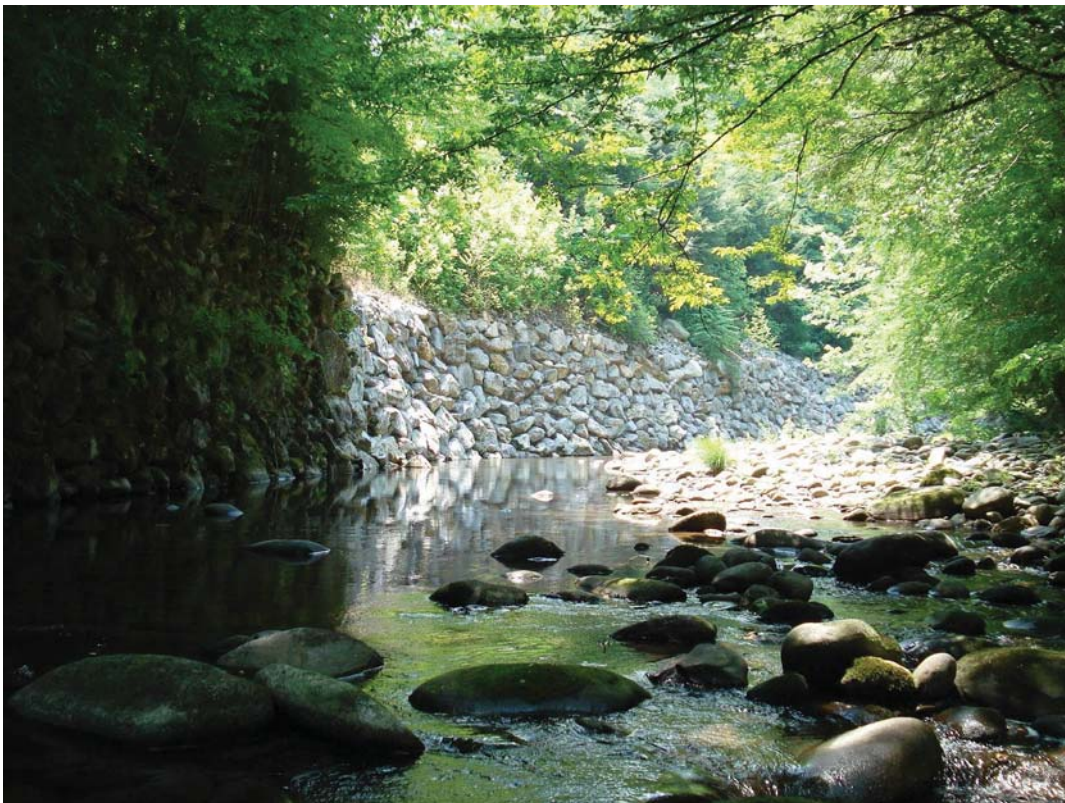
GRSM_0010N_1.148_R_1.jpg

Element (Weighting Factor)	Narrative	Condition Rating (0 - 10)
PERFORMANCE 8.00	As above	8
WALL FOUNDATION MATERIAL 8.00	Stable stream bed. No distress	8
MORTAR 8.00	Minimal cracking/debonding	9
STONE MASONRY 8.00	No distress	9
LATERAL SLOPE 0.50	Steep vegetated slope	8
WALL DRAINS 0.50	No distress	9
UPSLOPE 1.00	Steep, vegetated. Some raveling.	7

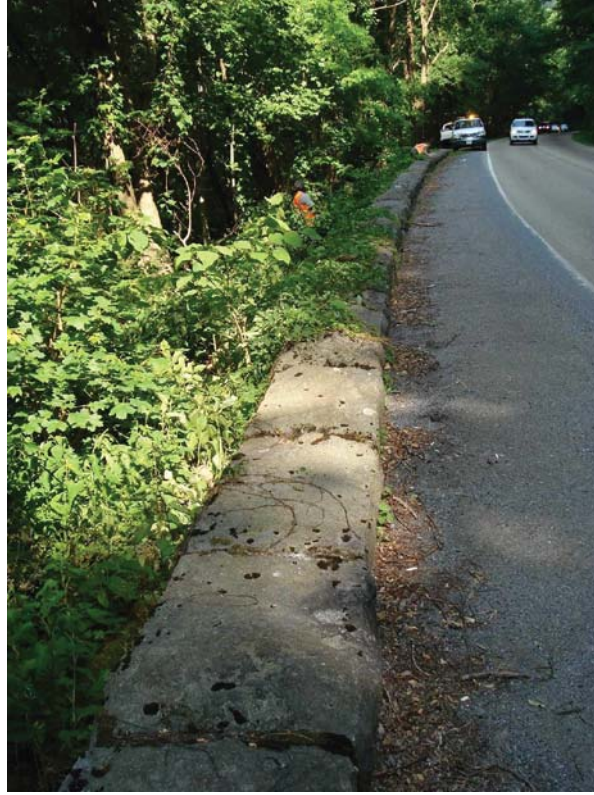
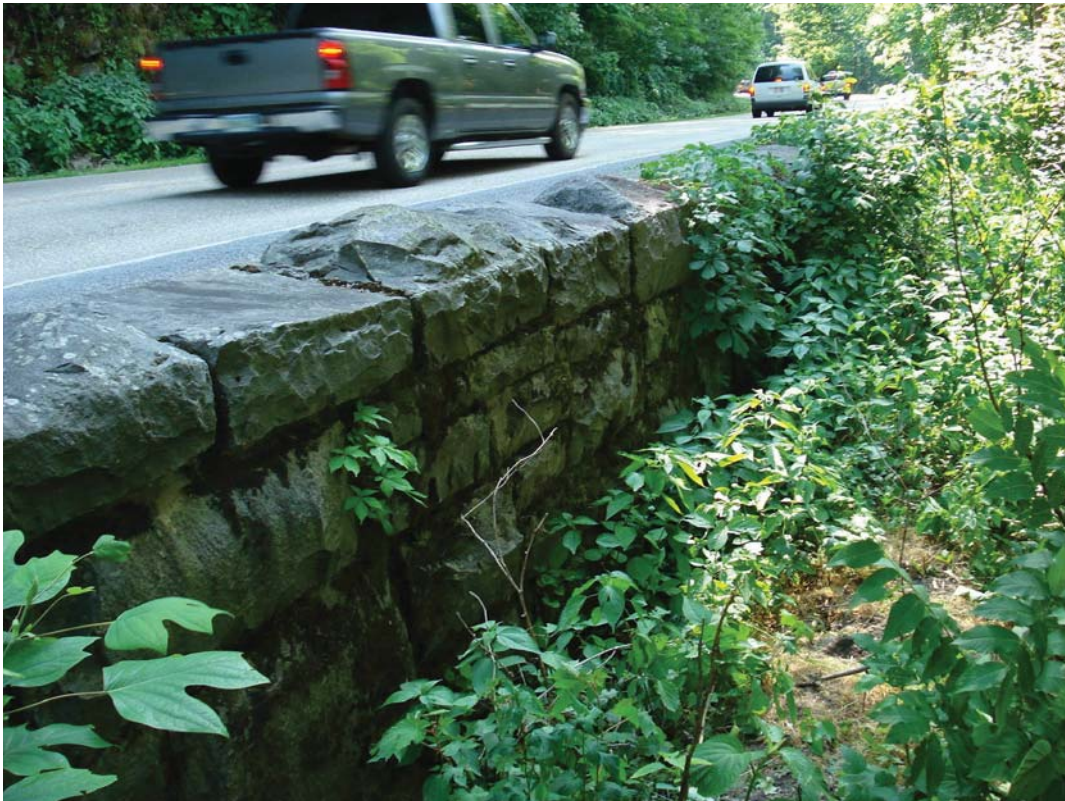
GRSM_0010N_5.960_L_1.jpg

Element (Weighting Factor)	Narrative	Condition Rating (0 - 10)
PERFORMANCE 8.00	North lateral slope may eventually impair long term performance	8
WALL FOUNDATION MATERIAL 8.00	Soil, no distress	9
MORTAR 8.00	Minor debonding at isolated locations	8
STONE MASONRY 8.00	No distress	9
DOWNSLOPE 0.50	Gentle slope for 20-30 ft, transitions to .75:1. No distress	8
WALL DRAINS 0.50	None evident, no distress	9
LATERAL SLOPE 1.00	Riprap at north end rotated out slightly, held up by trees	7

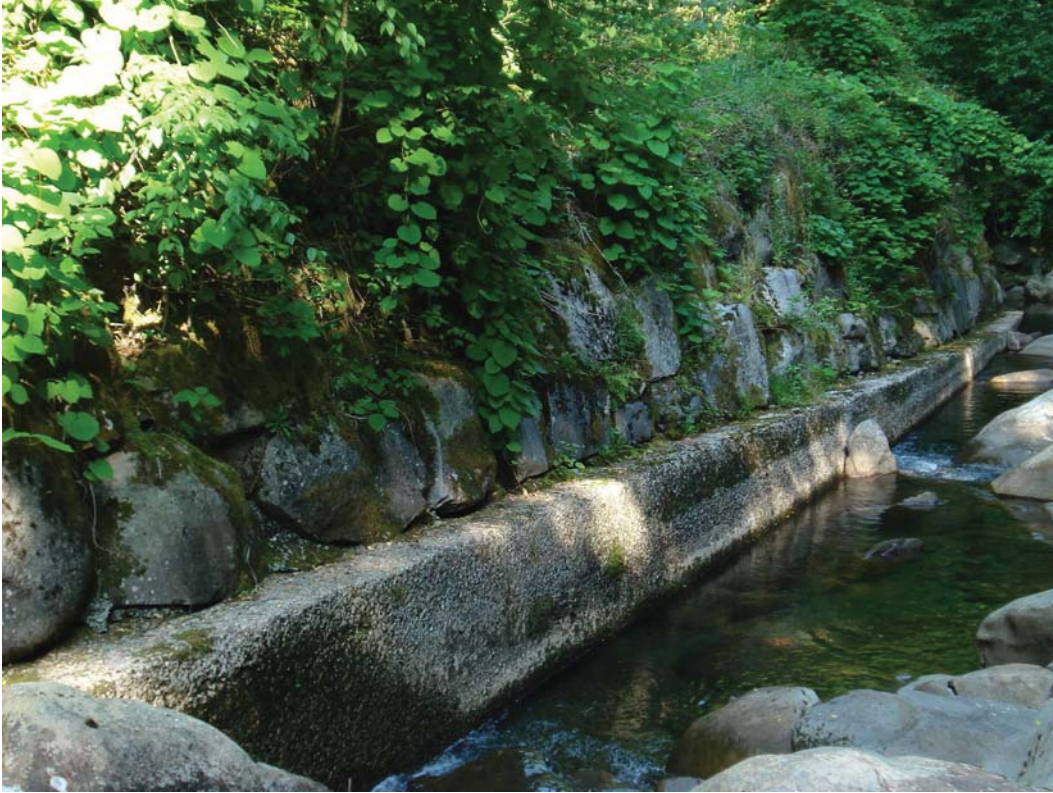
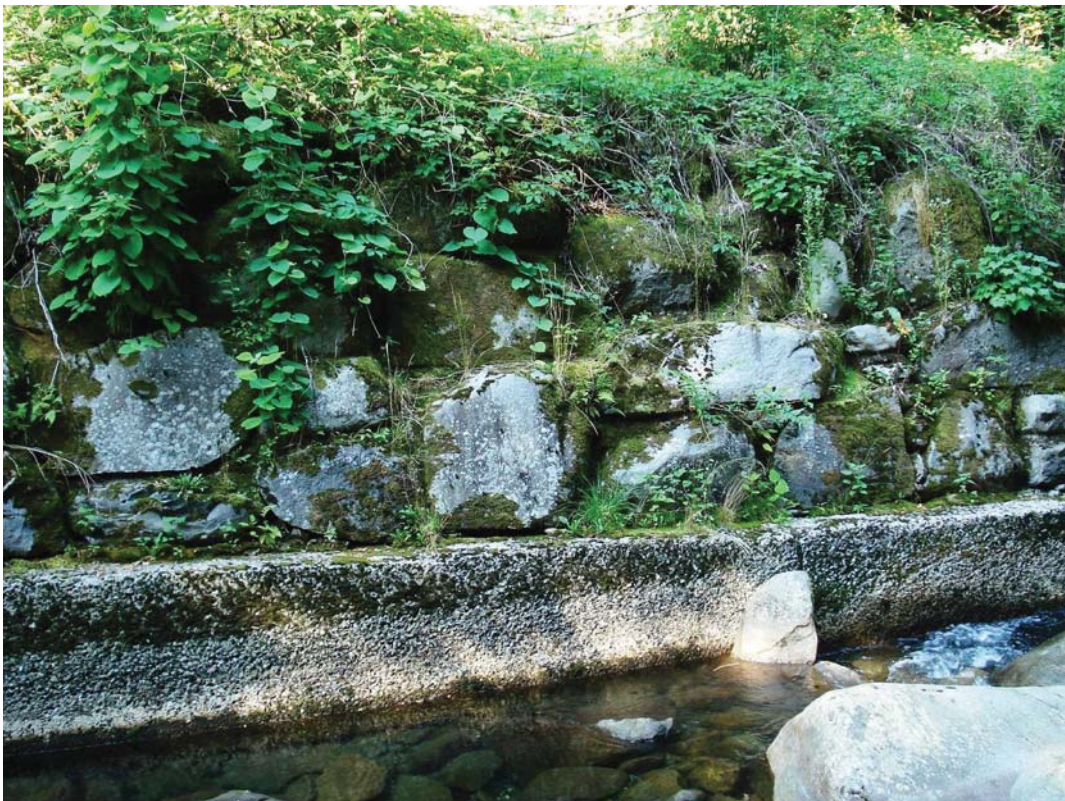
GRSM_0010N_6.205_L_1.jpg

Element (Weighting Factor)	Narrative	Condition Rating (0 - 10)
PERFORMANCE 8.00	As intended	9
WALL FOUNDATION MATERIAL 8.00	Cip concrete foundation on streambed material. No distress	9
MORTAR 8.00	Light weathering, minor spalling	8
STONE MASONRY 8.00	No distress	9
DOWNSLOPE 0.50	Streambed with/large boulders. No distress	9
LATERAL SLOPE 0.50	Riprap slope protection at ends, no distress	9
UPSLOPE 0.50	Heavily vegetated with/large boulders, no distress	9
WALL DRAINS 0.50	None observed, no distress	9

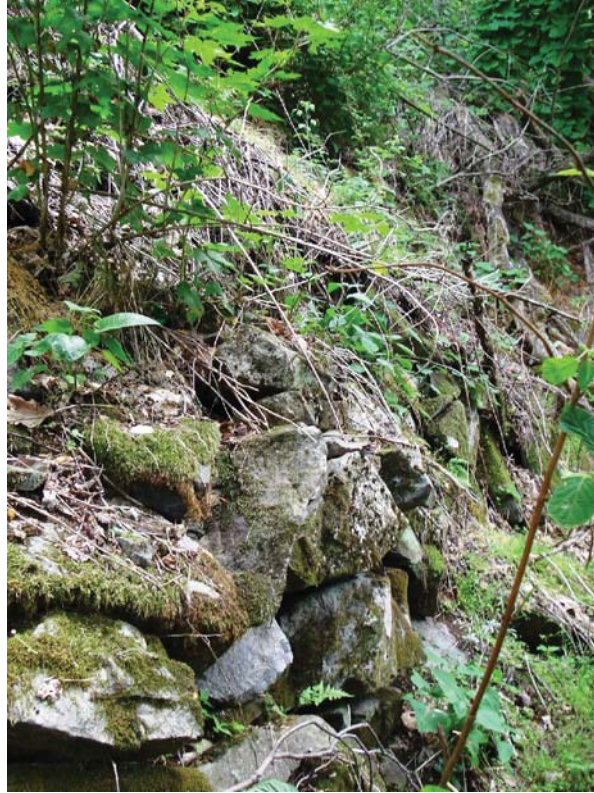
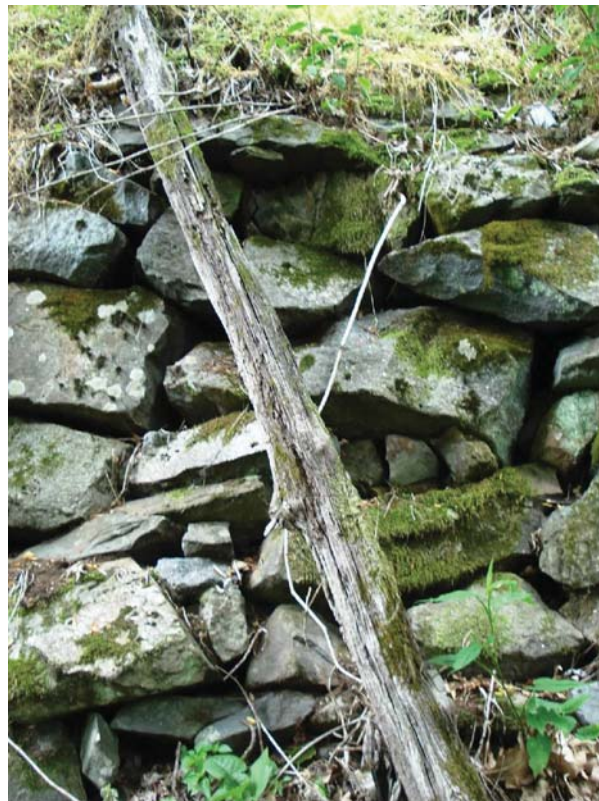
GRSM_0010N_7.130_R_1.jpg

Element (Weighting Factor)	Narrative	Condition Rating (0 - 10)
PERFORMANCE 8.00	Poor to critical, GD stones at base of wall have bulged out and have destabilized entire wall	4
WALL FOUNDATION MATERIAL 8.00	Founded on soil; no evidence that settlement of end causing wall movement	8
PLACED STONE 8.00	3' stacked rocks, rocks at base are bulging out causing separation of all rocks and settlement of roadway and wall	3
DOWNSLOPE 0.50	Moderate, angular rock fill, wooded, no observed distress	8
LATERAL SLOPE 0.50	Steep	8
ROAD/SIDEWALK/SHOULDER 1.00	Cracked and sagging within limits of wall	4
WALL DRAINS 0.50	Self draining, no obvious drainage-related issues	8
UPSLOPE 1.00	Grassy shoulder; shows some signs of deformation	6

Failure Consequence:	HIGH
Recommendation Narrative:	Rebuild Wall - Remove and Reset existing wall stones: remove and salvage 1650sf existing stone: No unit cost in guide - use \$50/sf. Rebuild dry stack wall w/salvaged material - \$50/sf, 1650sf x (50+50) = \$165000. Poor access - increase 30% - \$165,000x1.3.
Repair Cost:	\$232,500

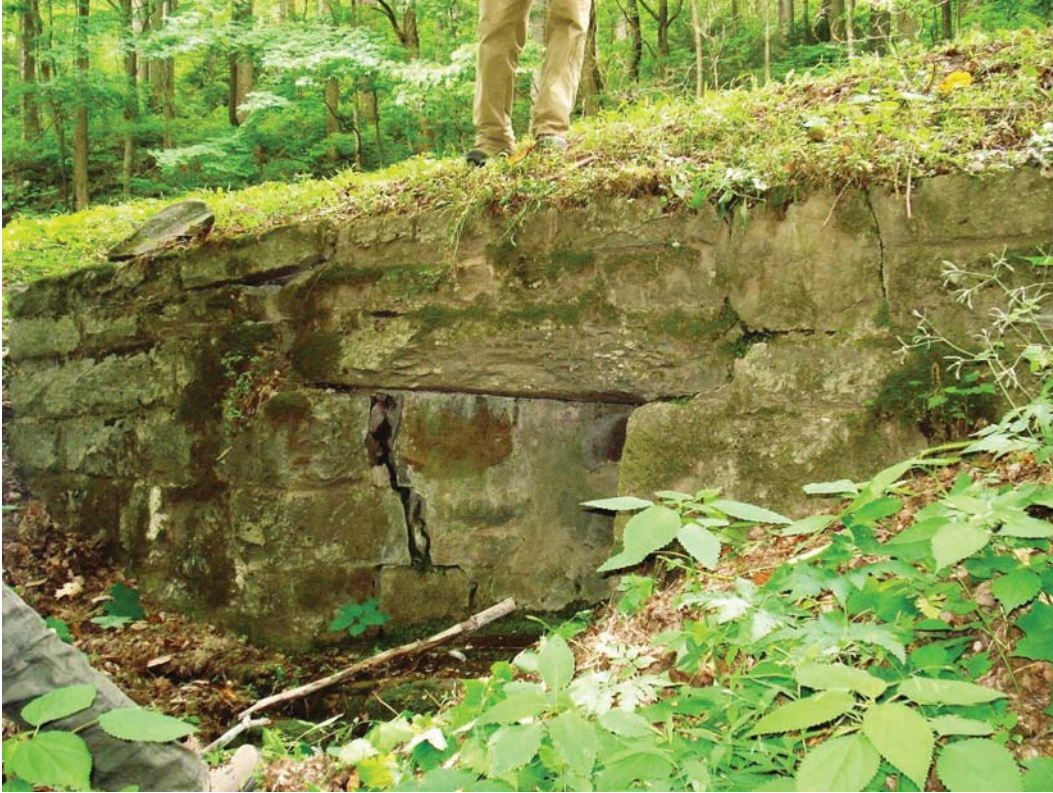
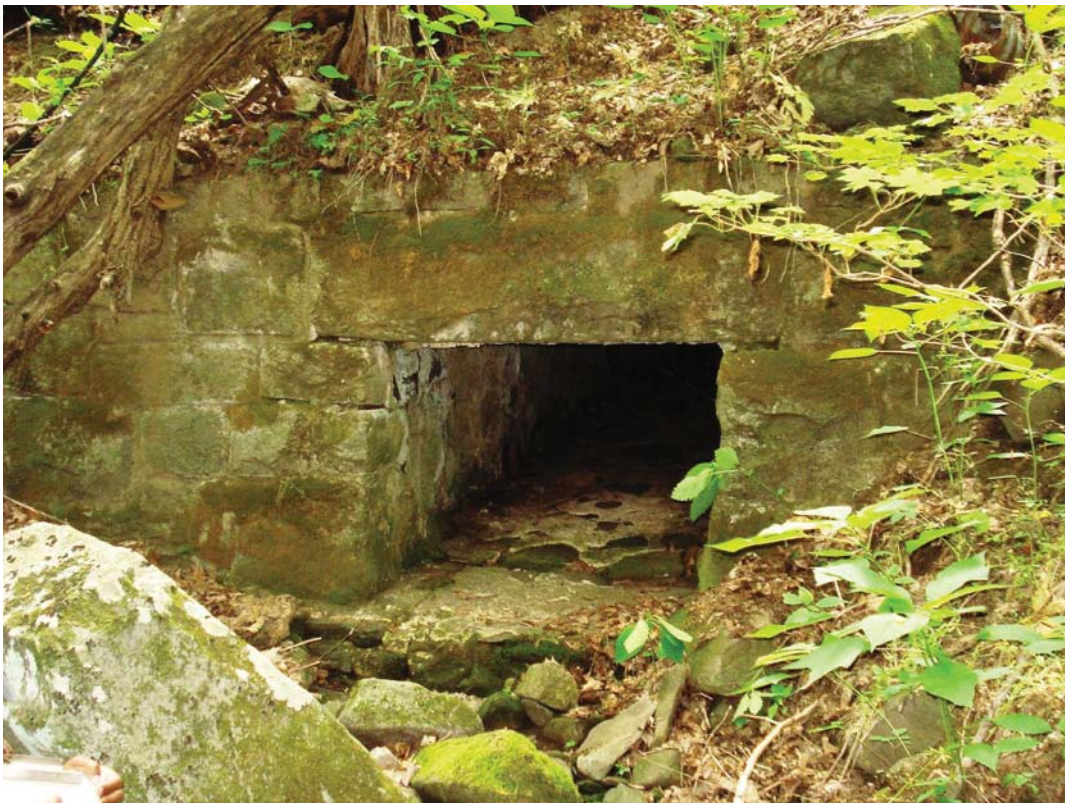
GRSM_0010N_7.741_R_1.jpg

Element (Weighting Factor)	Narrative	Condition Rating (0 - 10)
PERFORMANCE 8.00	Poor performance; segment damaged and requires repair	6
WALL FOUNDATION MATERIAL 8.00	Possible undermining at northern half; possible saturated foundation soil has settled	5
MORTAR 8.00	Generally in good condition, minor debonding; badly damaged down northern half	6
STONE MASONRY 8.00	Generally good condition; loose stones at damaged section	6
DOWNSLOPE 0.50	Riprap at culvert outlet, wooded, moderate slope, no distress	8
LATERAL SLOPE 0.50	No distress, no erosion	8
UPSLOPE 0.50	Grassy shoulder, no distress	8
WALL DRAINS 0.50	No observed internal drainage-related issues	8

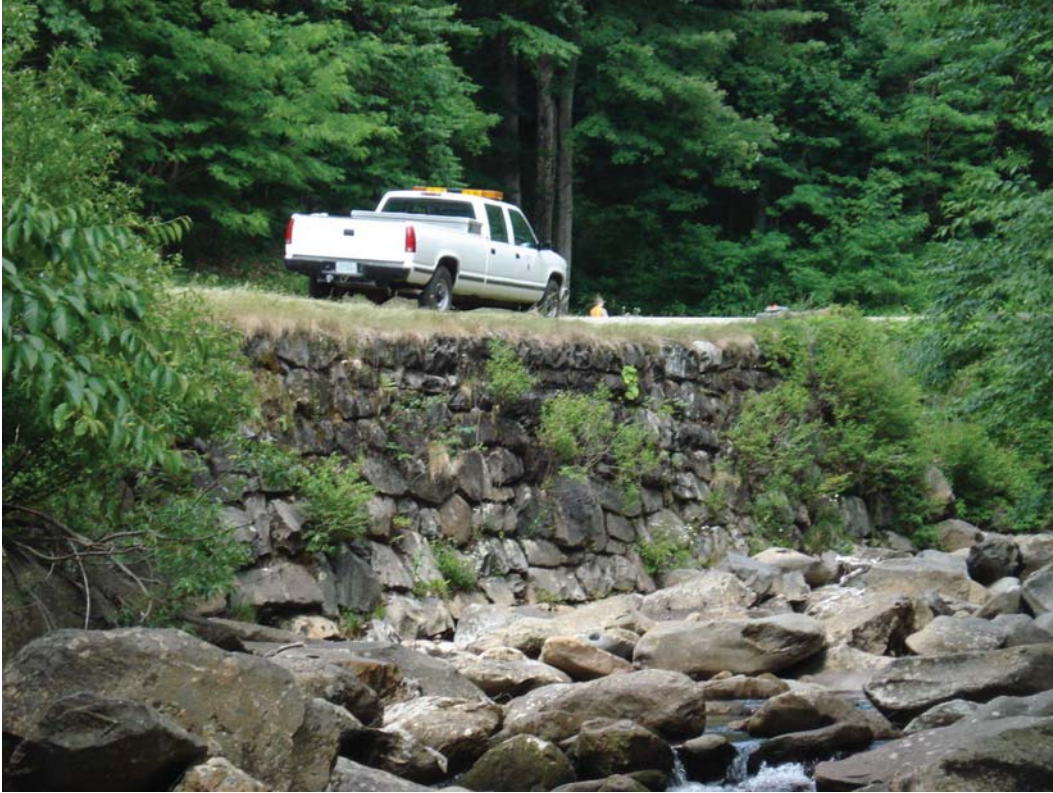
GRSM_0010N_9.447_R_1.jpg

Wall ID:	GRSM-0010N-9.447-R		
Route Name:	NEWFOUND GAP ROAD NORTH		
Inspection Date:	June 13, 2007	Approximate Year Built:	1938
*Wall Rating:	76	Maintenance Action:	No Action

Element (Weighting Factor)	Narrative	Condition Rating (0 - 10)
PERFORMANCE 8.00	Good	7
WALL FOUNDATION MATERIAL 8.00	Riverbed, possible stones missing	7
MORTAR 8.00	Some cracking, debonding	7
STONE MASONRY 8.00	Intact as new	9
LATERAL SLOPE 0.50	Steep, vegetated, large boulders	8
UPSLOPE 0.50	Flat grass covered	9
WALL DRAINS 0.50	No distress	9

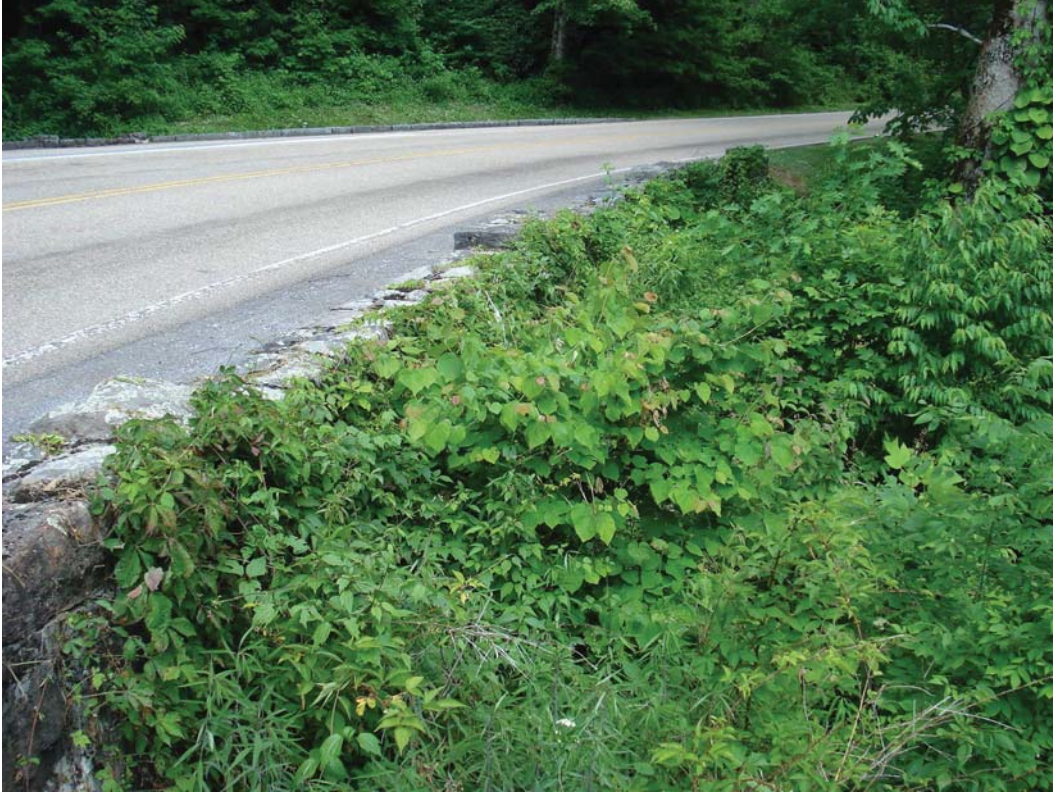
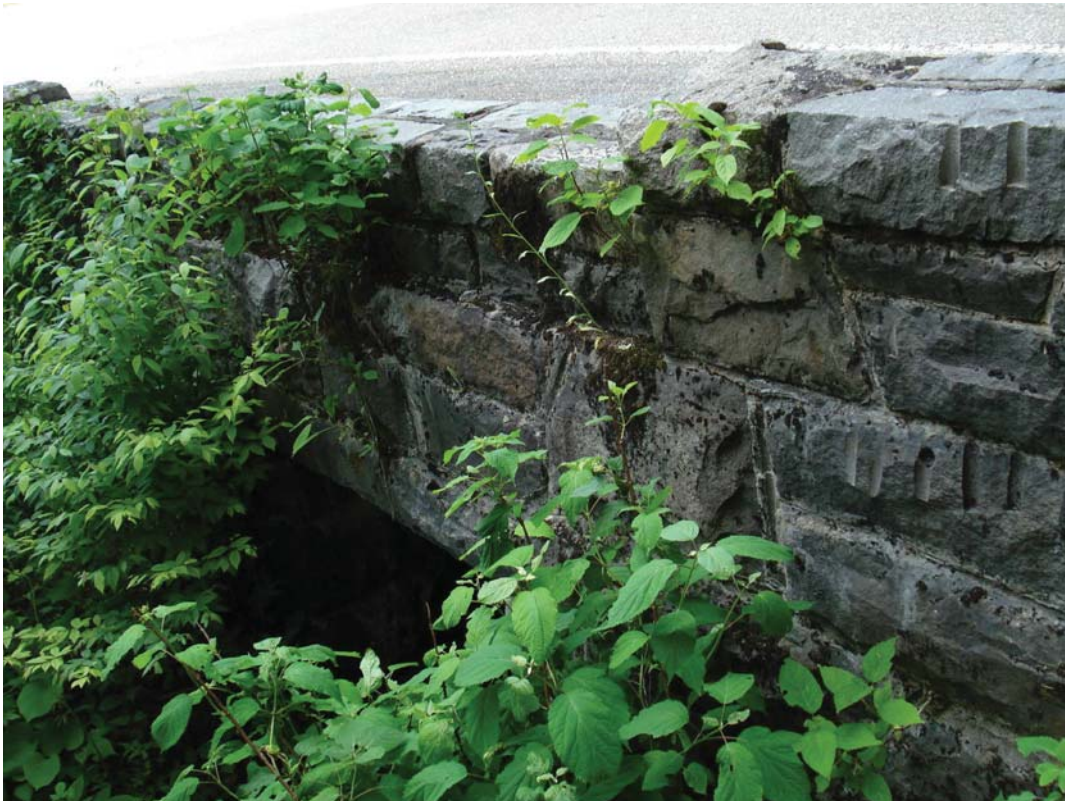
GRSM_0010N_9.473_R_1.jpg

Wall ID:	GRSM-0010N-9.473-R		
Route Name:	NEWFOUND GAP ROAD NORTH		
Inspection Date:	June 13, 2007	Approximate Year Built:	1938
*Wall Rating:	82	Maintenance Action:	No Action

Element (Weighting Factor)	Narrative	Condition Rating (0 - 10)
PERFORMANCE 8.00	Good to excellent	8
WALL FOUNDATION MATERIAL 8.00	Founded on soil, no settlement/rotation	8
STONE MASONRY 8.00	No distress	8
MORTAR 8.00	General weathering, no distress	9
DOWNSLOPE 0.50	Riprap erosion protection at culvert opening; no distress	8
LATERAL SLOPE 0.50	Vegetated	8
ROAD/SIDEWALK/SHOULDER 0.50	Asphalt pavement in good condition	8
VEGETATION 0.50	One large tree close to wall, does not affect wall	8
WALL DRAINS 0.50	No issues	9
