NPS Retaining Wall Inventory Program Great Smoky Mountains National Park

**Federal Lands Highway
Road Inventory Program**

Federal Highway Administration
Eastern Federal Lands Highway Division
Road Inventory Program (RIP)

Data Collection Date: April 2011
Report Date: November 2015

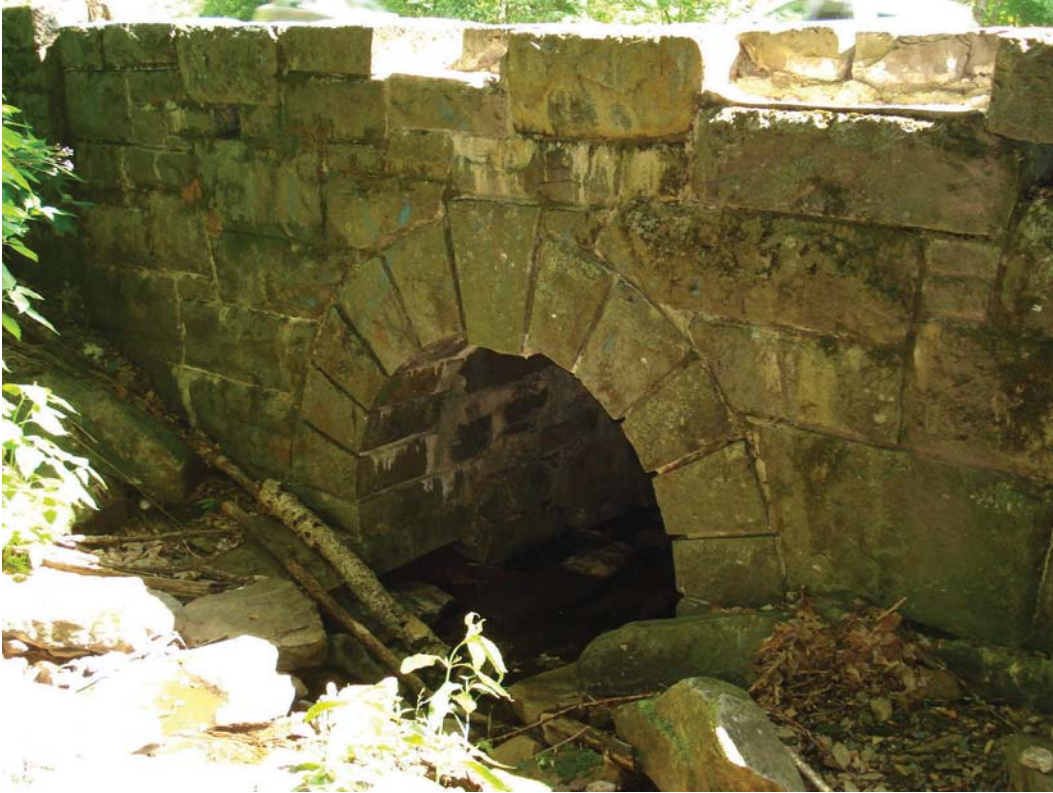
GRSM_0010N_9.494_L_1.jpg

Wall ID:	GRSM-0010N-9.494-L		
Route Name:	NEWFOUND GAP ROAD NORTH		
Inspection Date:	June 13, 2007	Approximate Year Built:	1938
*Wall Rating:	75	Maintenance Action:	Repair Elements

Wall Function:	Head Wall	Primary Wall Type:	Gravity - Mortared Stone
Surface Treatment:		Secondary Wall Type:	
Secondary Surface Treatment:		Architectural Facing:	
General Description:	Inlet, some stones missing from top of wall

Element (Weighting Factor)	Narrative	Condition Rating (0 - 10)
PERFORMANCE 8.00	Repair missing stone	7
WALL FOUNDATION MATERIAL 8.00	Firm soil	8
MORTAR 8.00	Some debonding	7
STONE MASONRY 8.00	Slight weathering	8
LATERAL SLOPE 0.50	Flat grassy slope	8
UPSLOPE 0.50	Forested, moderately steep, boulders	8
WALL DRAINS 0.50	No distress	9

Failure Consequence:	LOW
Recommendation Narrative:	Repoint 20% of face area: 2. x 140 = 28sf 28 x \$75/sf = \$2100. Replace stones: Salvage/re-use onsite material: 2 crew, 4hrs, 2 x \$55/hr x 4 = \$440. Repair undermine: Place 1 cy concrete: 1cy x \$1470/cy = \$1470.
Repair Cost:	\$4,010

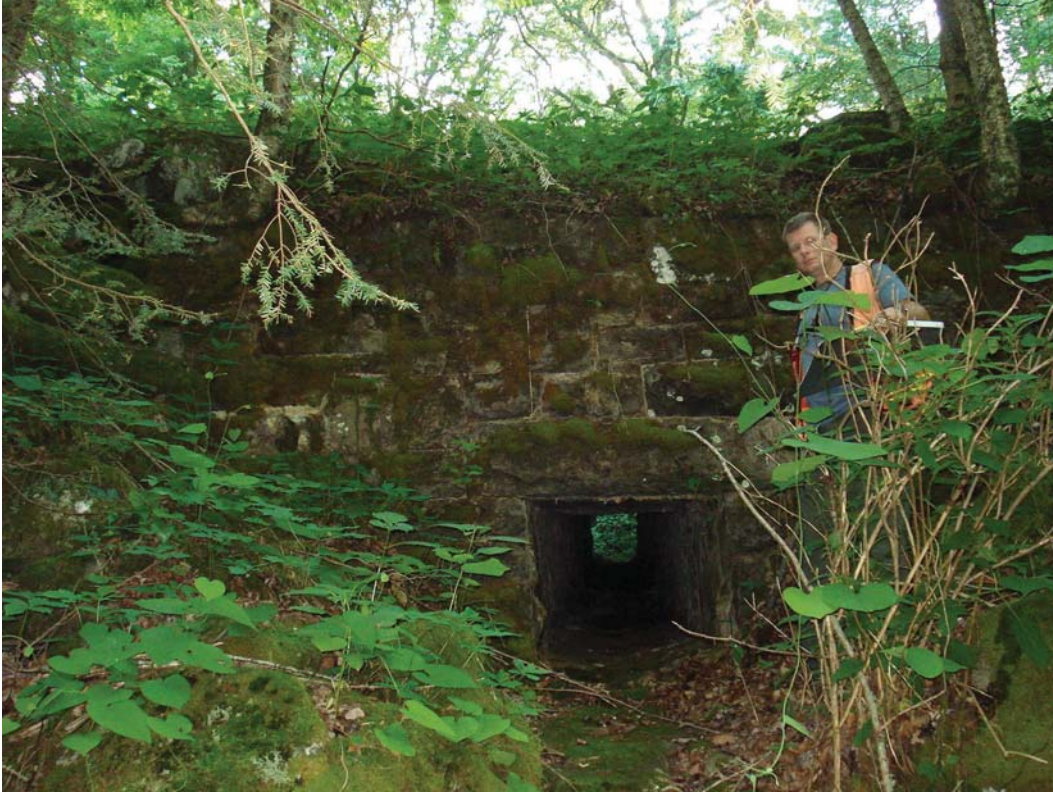
GRSM_0010N_9.580_R_1.jpg

Wall ID:	GRSM-0010N-9.580-R		
Route Name:	NEWFOUND GAP ROAD NORTH		
Inspection Date:	June 14, 2007	Approximate Year Built:	1938
*Wall Rating:	75	Maintenance Action:	Repair Elements

Element (Weighting Factor)	Narrative	Condition Rating (0 - 10)
PERFORMANCE 8.00	Performing as intended, requires mild repair	7
WALL FOUNDATION MATERIAL 8.00	No distress	8
MORTAR 8.00	Moderate condition signs of weeping and leaching, mild degradation mortar, some debonding, 1/8" cracks	6
STONE MASONRY 8.00	No distress	9
LATERAL SLOPE 0.50	No distress, dry stack stone wall	8
UPSLOPE 0.50	Moderately steep shoulder, soil and rock embankment, no distress	8
WALL DRAINS 1.00	Water appears to be seeping through wall face	6
DOWNSLOPE 1.00	Channeled, moderate erosion at culvert floor	7

Failure Consequence:	MODERATE
Recommendation Narrative:	Repoint 30% of wall face: .3 x 67sf = 20sf, 20sf x \$75/sf = \$1500. Replace stones and mortar at wall base/outlet(4' x 4' area): Use/salvage on-site stones, mortar incidental: 2 crew, 8 hrs: 2 x \$55 x 8 = \$880
Repair Cost:	\$2,380

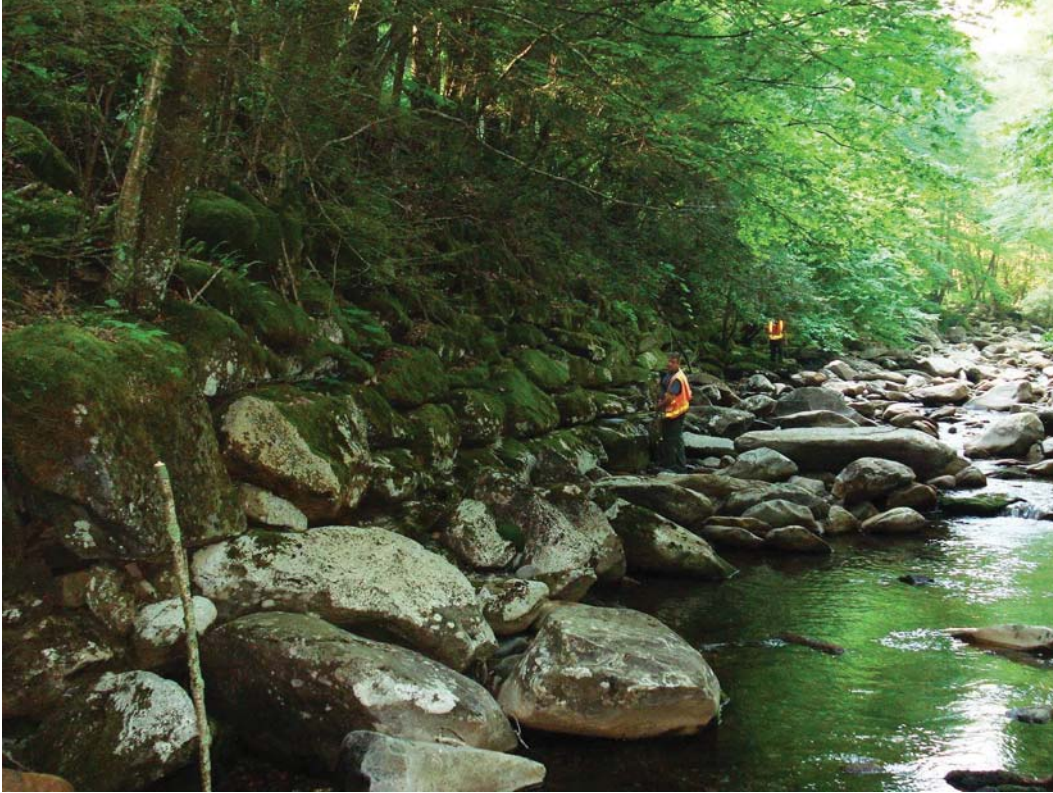
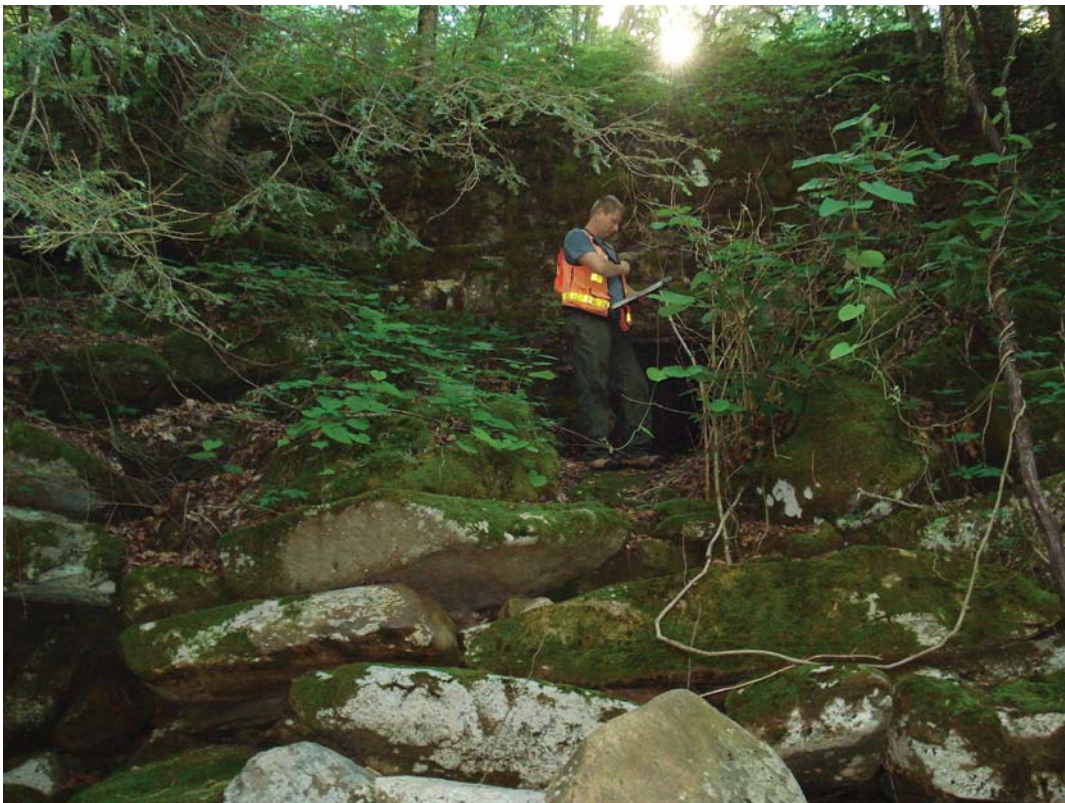
GRSM_0010N_9.600_R_1.jpg

Wall ID:	GRSM-0010N-9.600-R		
Route Name:	NEWFOUND GAP ROAD NORTH		
Inspection Date:	June 14, 2007	Approximate Year Built:	1938
*Wall Rating:	77	Maintenance Action:	No Action

Element (Weighting Factor)	Narrative	Condition Rating (0 - 10)
PERFORMANCE 8.00	Good, minor undermining and unraveling at HW location	8
WALL FOUNDATION MATERIAL 8.00	Founded on river bed material, no deformation	8
PLACED STONE 8.00	Large angular boulders, some loose near HW but don't affect stability	7
LATERAL SLOPE 0.50	No distress, keyed into lateral slope	8
WALL DRAINS 0.50	Wall is self draining, no distress	9
DOWNSLOPE 1.00	River + river bed, heavy river flow may be undermining wall at location of culvert, stones should be mortared	7

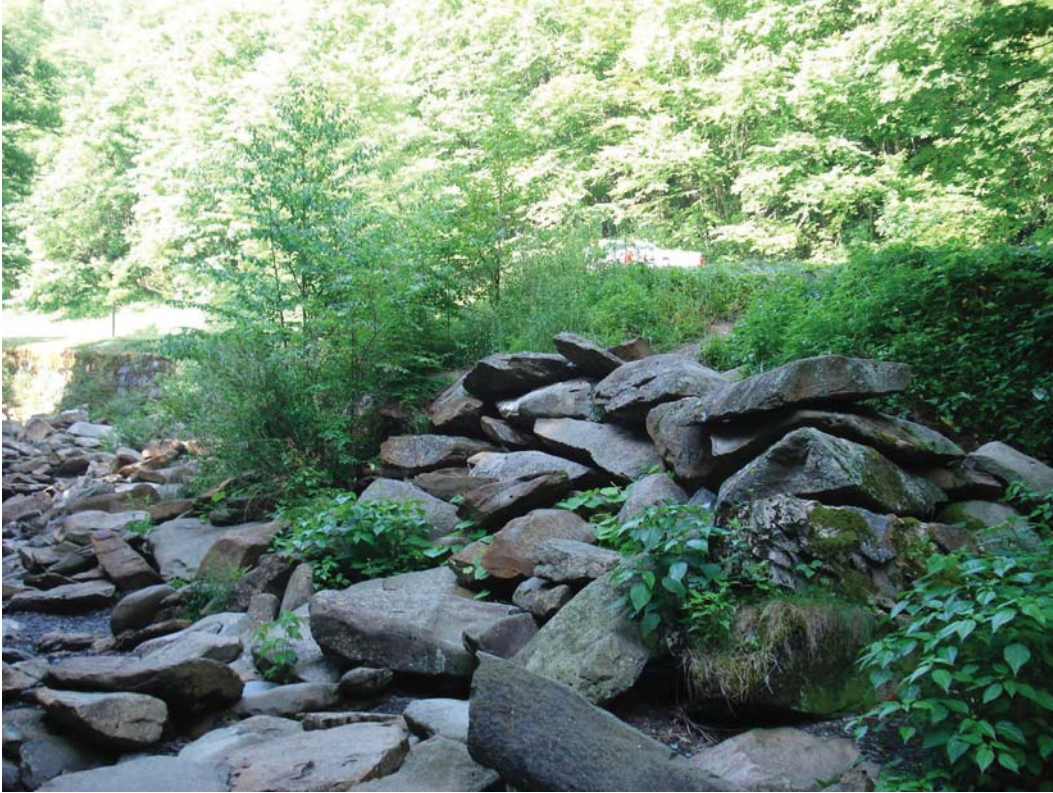
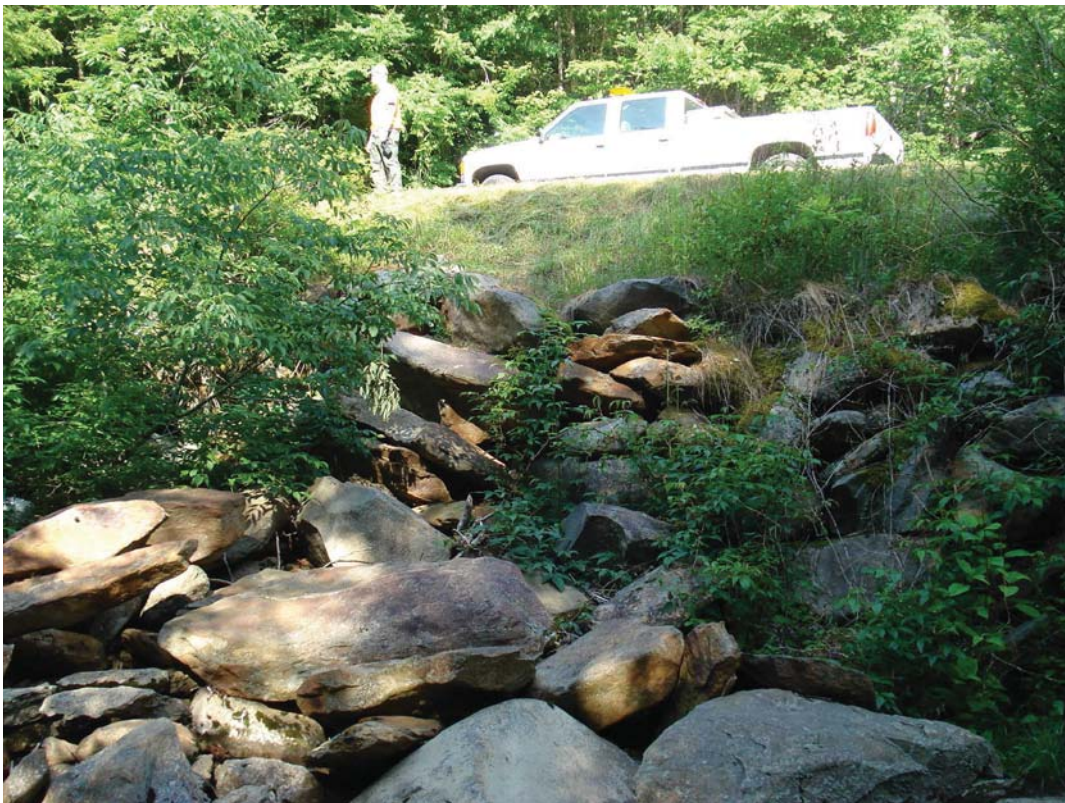
GRSM_0010N_9.790_L_1.jpg

Wall ID:	GRSM-0010N-9.790-L		
Route Name:	NEWFOUND GAP ROAD NORTH		
Inspection Date:	June 13, 2007	Approximate Year Built:	1938
*Wall Rating:	86	Maintenance Action:	Maintenance

Element (Weighting Factor)	Narrative	Condition Rating (0 - 10)
PERFORMANCE 8.00	Good	8
WALL FOUNDATION MATERIAL 8.00	Wall founded on blast rock and riverbed material, no erosion or distress	9
PLACED STONE 8.00	Stacked angular to sub-rounded boulders; rough-stacked; no distress	9
WALL DRAINS 0.50	Wall is self draining	9
LATERAL SLOPE 0.50	Terminates vertically at north end; keyed into GM wall south end	10
UPSLOPE 1.00	Void in slope at approx center of wall results from soil loss between large boulders	6

Failure Consequence:	MODERATE
Recommendation Narrative:	Place boulders and soil backfill: Use on-site material, 2 crew + backhoe for 6 hrs: 6hrs x (2(\$55) +\$150) = \$1560
Repair Cost:	\$1,560

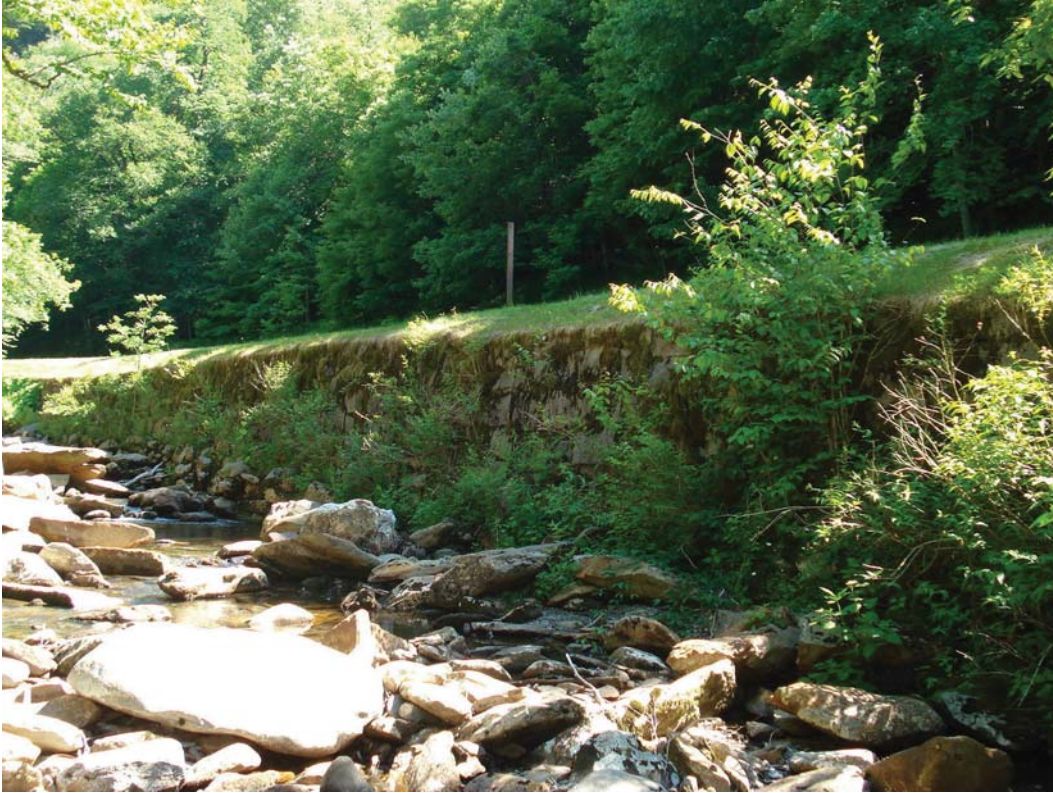
GRSM_0010N_9.798_L_1.jpg

Wall ID:	GRSM-0010N-9.798-L		
Route Name:	NEWFOUND GAP ROAD NORTH		
Inspection Date:	June 13, 2007	Approximate Year Built:	1938
*Wall Rating:	84	Maintenance Action:	No Action

Element (Weighting Factor)	Narrative	Condition Rating (0 - 10)
PERFORMANCE 8.00	Good	8
WALL FOUNDATION MATERIAL 8.00	PLACED STONE w/ concrete mortar, boulders 1'-6', mild undermining	8
MORTAR 8.00	Mild debonding	8
PLACED STONE 8.00	No distress	9
STONE MASONRY 8.00	No distress	9
CULVERT 0.50	1.5' culvert concrete pipe outlet, no distress	8
DOWNSLOPE 0.50	Riverbed, no distress (channel composed of cobbles and boulders)	8
LATERAL SLOPE 0.50	No distress, slope protection UW, native slope DW	8
WALL DRAINS 0.50	No distress	8

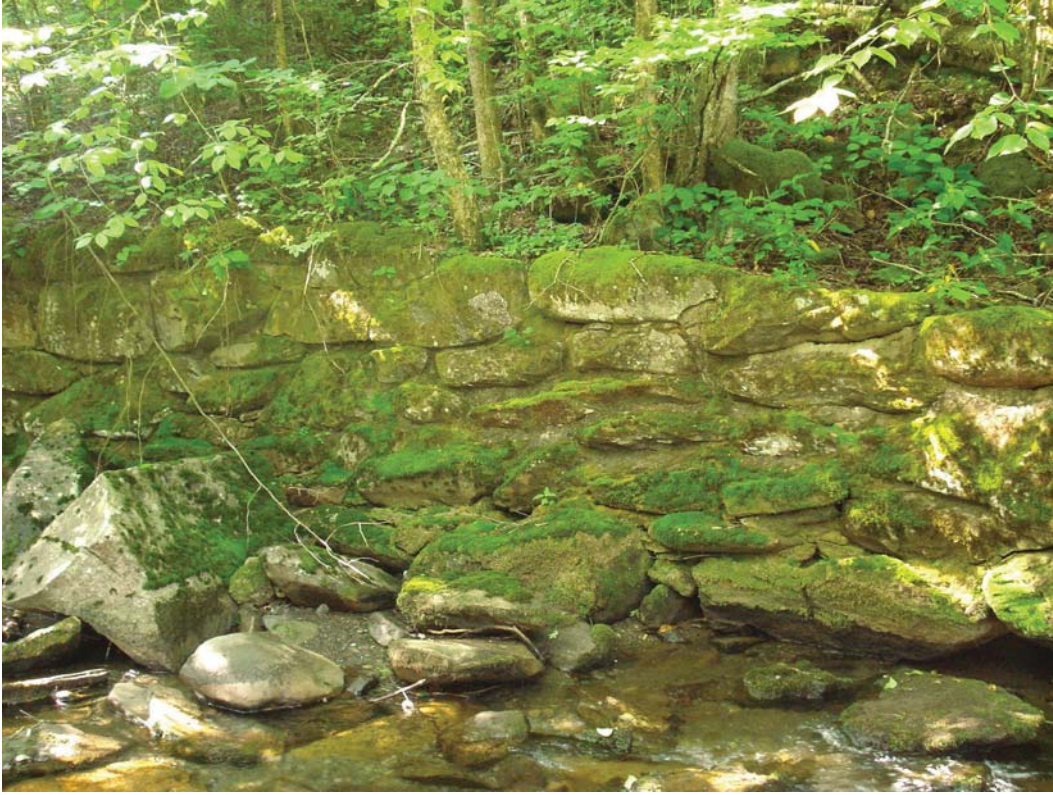
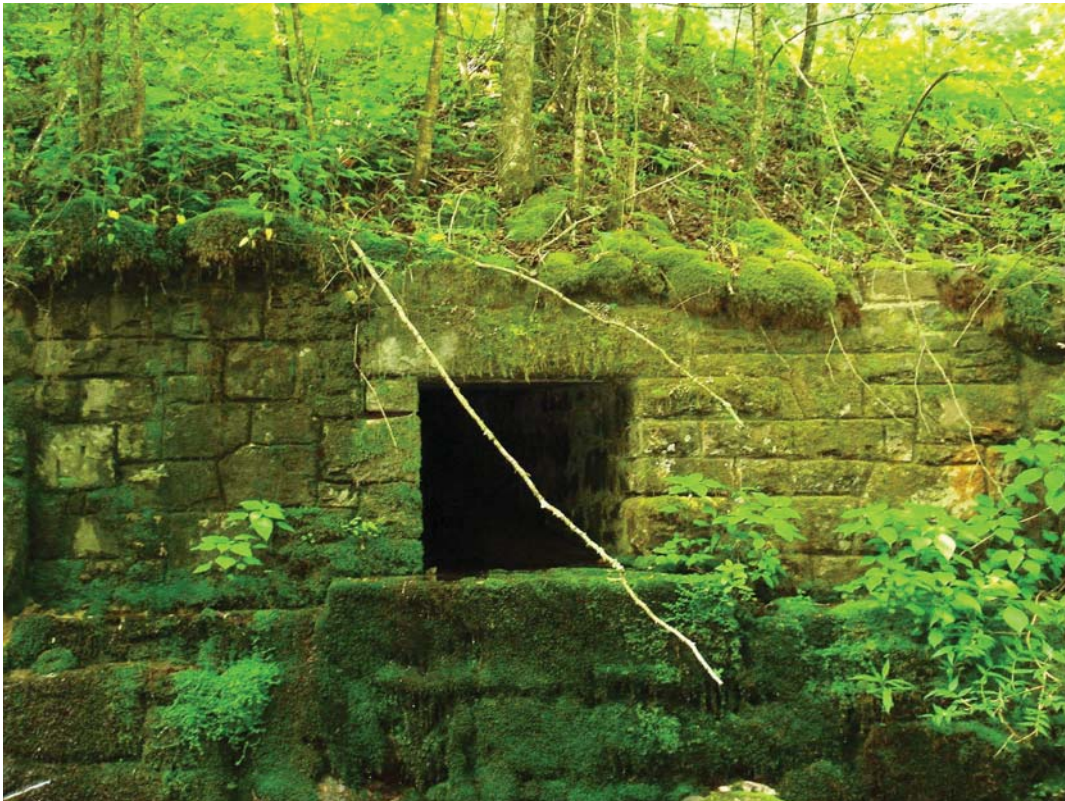
GRSM_0010N_9.982_L_1.jpg

Wall ID:	GRSM-0010N-9.982-L		
Route Name:	NEWFOUND GAP ROAD NORTH		
Inspection Date:	June 14, 2007	Approximate Year Built:	1938
*Wall Rating:	76	Maintenance Action:	No Action

Element (Weighting Factor)	Narrative	Condition Rating (0 - 10)
PERFORMANCE 8.00	Good, some small debonding and spalling mortar	8
WALL FOUNDATION MATERIAL 8.00	Founded on large boulders and riverbed material, no distress	8
MORTAR 8.00	General weathering, some debonding, some spalling	7
STONE MASONRY 8.00	Some blocks need to be remortared	7
UPSLOPE 0.50	Vegetated, 1:1, no distress	8
VEGETATION 0.50	Small trees on top of wall, no distress	8
WALL DRAINS 0.50	Occasional weep holes, no distress	8
CULVERT 0.50	No distress	9
LATERAL SLOPE 0.50	Keyed into slope at N end, no distress	9

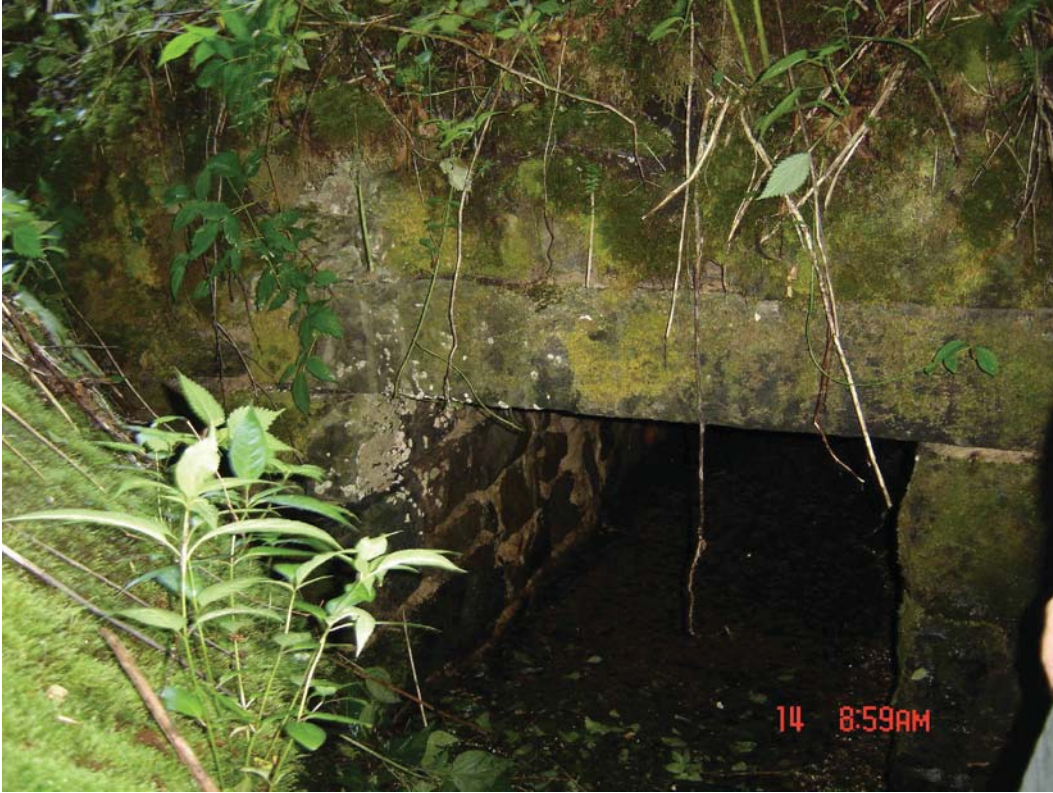
GRSM_0010N_9.996_R_1.jpg

Wall ID:	GRSM-0010N-9.996-R		
Route Name:	NEWFOUND GAP ROAD NORTH		
Inspection Date:	June 14, 2007	Approximate Year Built:	1938
*Wall Rating:	72	Maintenance Action:	Maintenance

Element (Weighting Factor)	Narrative	Condition Rating (0 - 10)
PERFORMANCE 8.00	Mortar distress threatens performance in the long term	6
WALL FOUNDATION MATERIAL 8.00	No distress	8
MORTAR 8.00	Very poor condition, completely degraded in some locations due to moisture, moss-covered	4
OTHER PRIMARY ELEMENT 8.00	Irregular riprap OK, mild erosion, no distress	8
PLACED STONE 8.00	No distress	8
STONE MASONRY 8.00	No distress	9
DOWNSLOPE 0.50	Channel poured slab, no distress	8
LATERAL SLOPE 0.50	Mild shifting of boulder at inlet, no hindering of function	8
OTHER SECONDARY ELEMENT 0.50	Riprap on top of wall, mild erosion	8

Failure Consequence:	MODERATE
Recommendation Narrative:	Repoint GM portion of wall face: 50sf x \$75/sf = \$3750. Difficult access (deep inlet), increase 25% - 3750 x 1.25 = 4687.5 Use \$4700
Repair Cost:	\$4,700

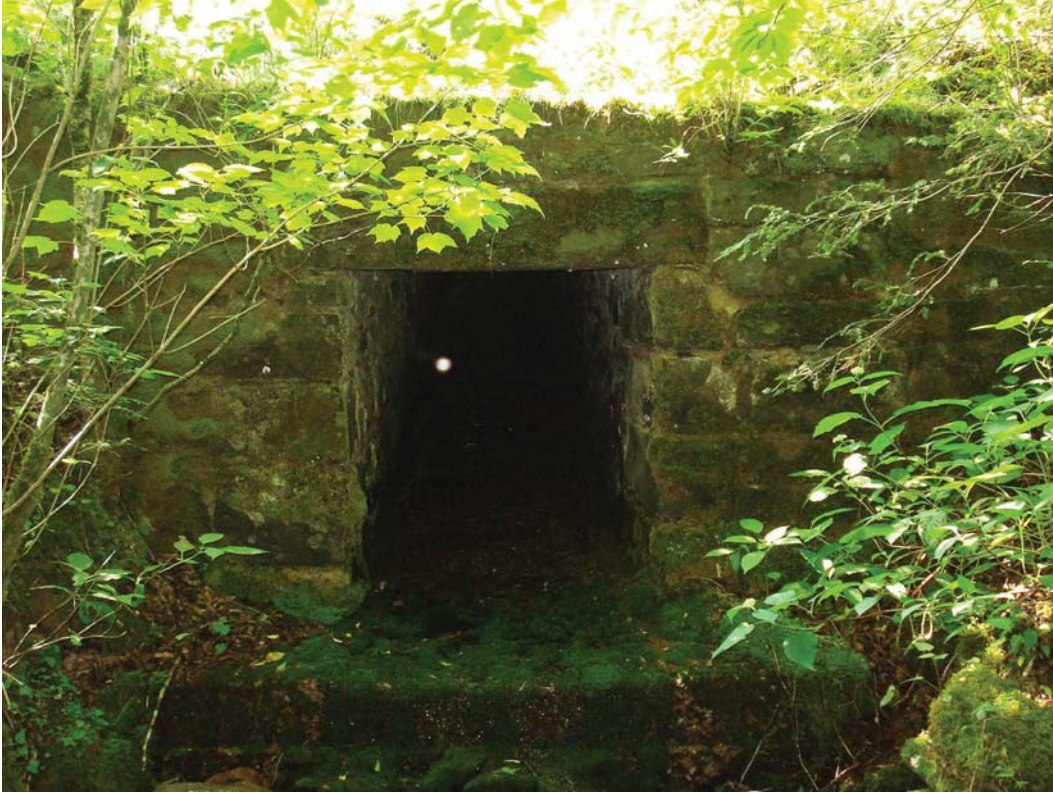
GRSM_0010N_10.099_L_1.jpg

Wall ID:	GRSM-0010N-10.099-L		
Route Name:	NEWFOUND GAP ROAD NORTH		
Inspection Date:	June 14, 2007	Approximate Year Built:	1938
*Wall Rating:	78	Maintenance Action:	No Action

Element (Weighting Factor)	Narrative	Condition Rating (0 - 10)
PERFORMANCE 8.00	Good	8
WALL FOUNDATION MATERIAL 8.00	Soil + rock	8
MORTAR 8.00	Fir condition	7
STONE MASONRY 8.00	No distress	8
DOWNSLOPE 0.50	Shallow creek bed	8
LATERAL SLOPE 0.50	Steep, forested, stable	8
ROAD/SIDEWALK/SHOULDER 0.50	Grass covered + riprap	8
WALL DRAINS 0.50	No distress	9

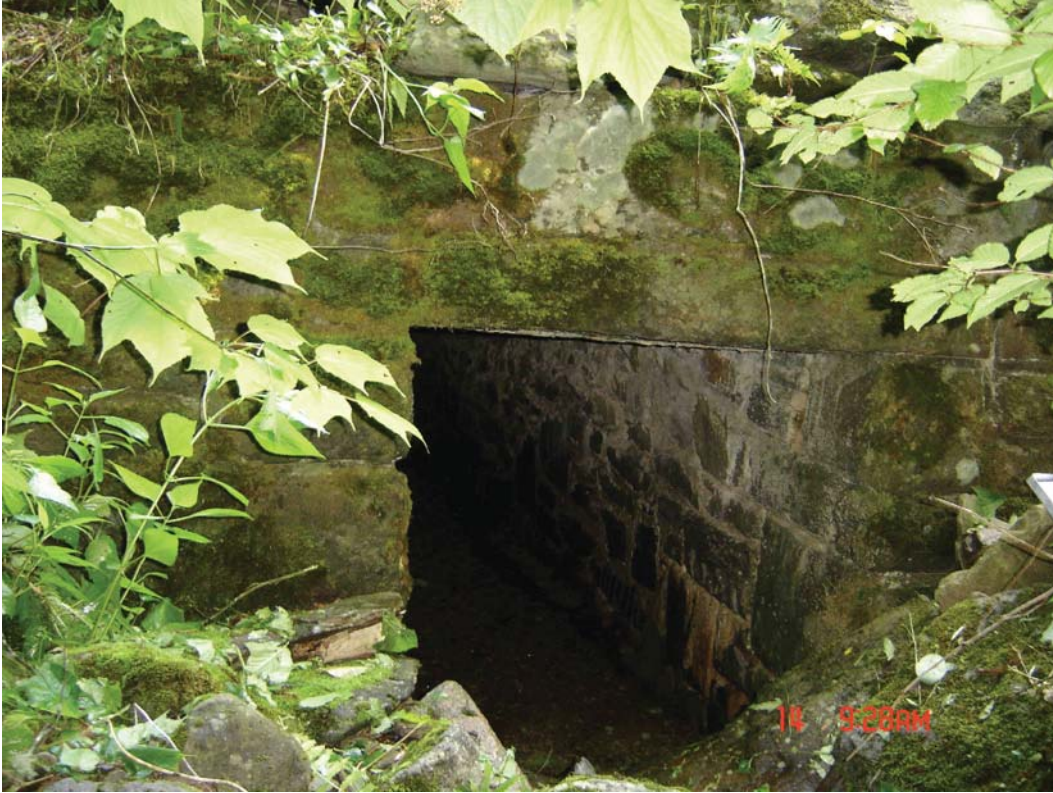
GRSM_0010N_10.100_R_1.jpg

Wall ID:	GRSM-0010N-10.100-R		
Route Name:	NEWFOUND GAP ROAD NORTH		
Inspection Date:	June 14, 2007	Approximate Year Built:	1938
*Wall Rating:	83	Maintenance Action:	No Action

Element (Weighting Factor)	Narrative	Condition Rating (0 - 10)
PERFORMANCE 8.00	Should be cleared of boulders, otherwise good	8
WALL FOUNDATION MATERIAL 8.00	Not visible, no distress	8
MORTAR 8.00	Mild debonding	8
OTHER PRIMARY ELEMENT 8.00	Riprap, no distress	8
PLACED STONE 8.00	No distress	9
STONE MASONRY 8.00	No distress	9
LATERAL SLOPE 0.50	Riprap, do distress	8
WALL DRAINS 0.50	No distress	8
UPSLOPE 0.50	Shoulder flat, no distress	9

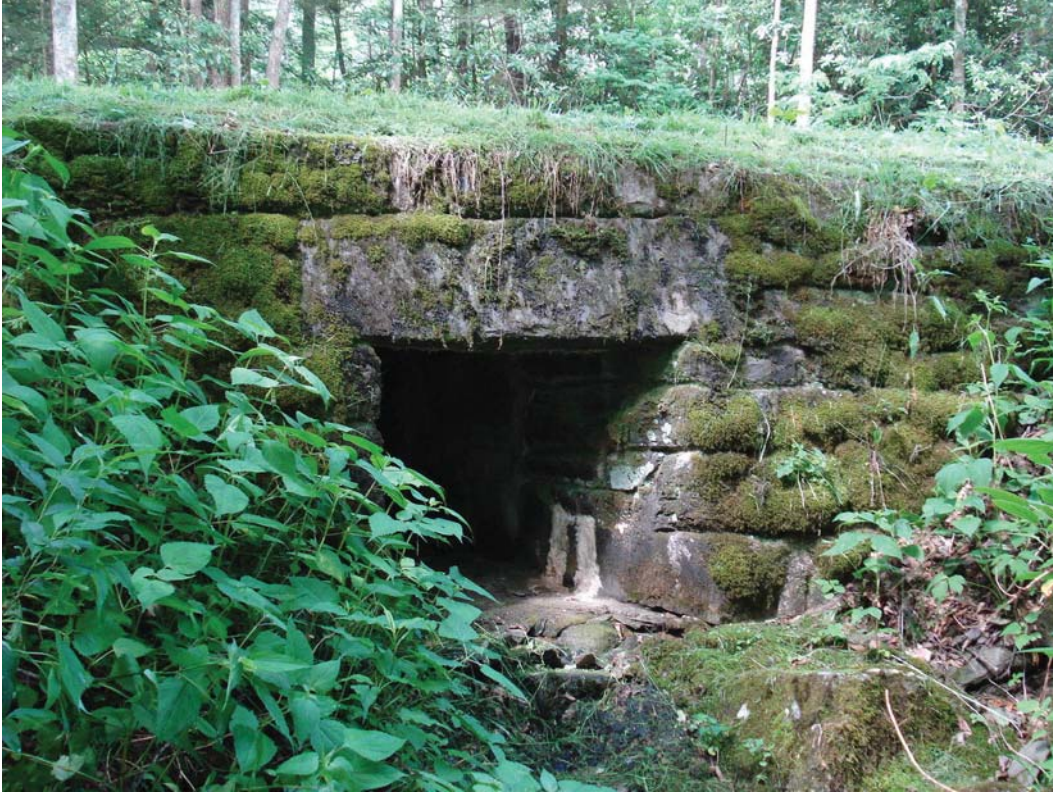
GRSM_0010N_10.587_L_1.jpg

Wall ID:	GRSM-0010N-10.587-L		
Route Name:	NEWFOUND GAP ROAD NORTH		
Inspection Date:	June 13, 2007	Approximate Year Built:	1938
*Wall Rating:	80	Maintenance Action:	No Action

Element (Weighting Factor)	Narrative	Condition Rating (0 - 10)
PERFORMANCE 8.00	Good	8
WALL FOUNDATION MATERIAL 8.00	Firm soil + rock	8
MORTAR 8.00	No distress	8
STONE MASONRY 8.00	No distress	8
CULVERT 0.50	No distress	8
DOWNSLOPE 0.50	Forested creek bed	8
LATERAL SLOPE 0.50	Grass to forested, flat to steep	8
ROAD/SIDEWALK/SHOULDER 0.50	No distress	9
WALL DRAINS 0.50	No distress	9

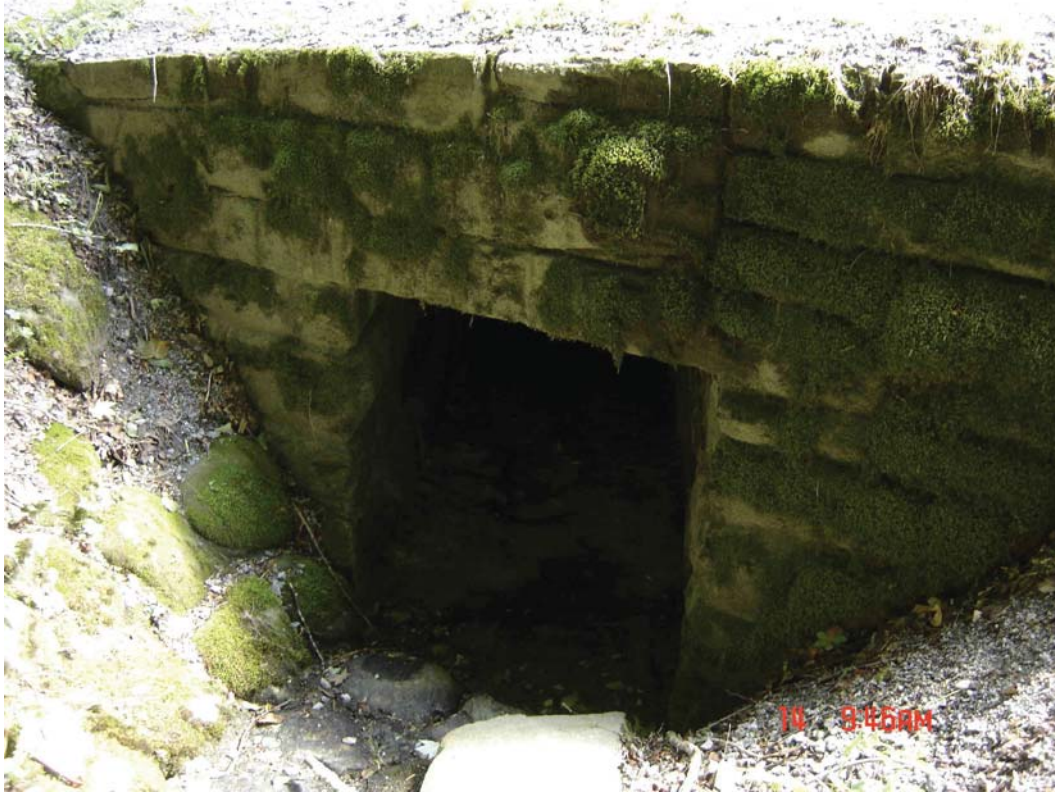
GRSM_0010N_10.589_R_1.jpg

Wall ID:	GRSM-0010N-10.589-R		
Route Name:	NEWFOUND GAP ROAD NORTH		
Inspection Date:	June 14, 2007	Approximate Year Built:	1938
*Wall Rating:	80	Maintenance Action:	Maintenance

Element (Weighting Factor)	Narrative	Condition Rating (0 - 10)
PERFORMANCE 8.00	Missing cap rock, otherwise good	7
WALL FOUNDATION MATERIAL 8.00	No distress	8
MORTAR 8.00	Mild debonding	8
STONE MASONRY 8.00	No distress, one missing block (on site)	9
DOWNSLOPE 0.50	No distress	8
LATERAL SLOPE 0.50	Rounded cobbles + small boulders w/ mortar	8
WALL DRAINS 0.50	No distress	8
UPSLOPE 0.50	Flat shoulder	9

Failure Consequence:	HIGH
Recommendation Narrative:	Replace and mortar missing stones: Salvage on-site material: 2 crew, 4 hrs - mortar incidental, 2 x 4 x \$55/hr = \$440 Use \$500 minimum
Repair Cost:	\$500

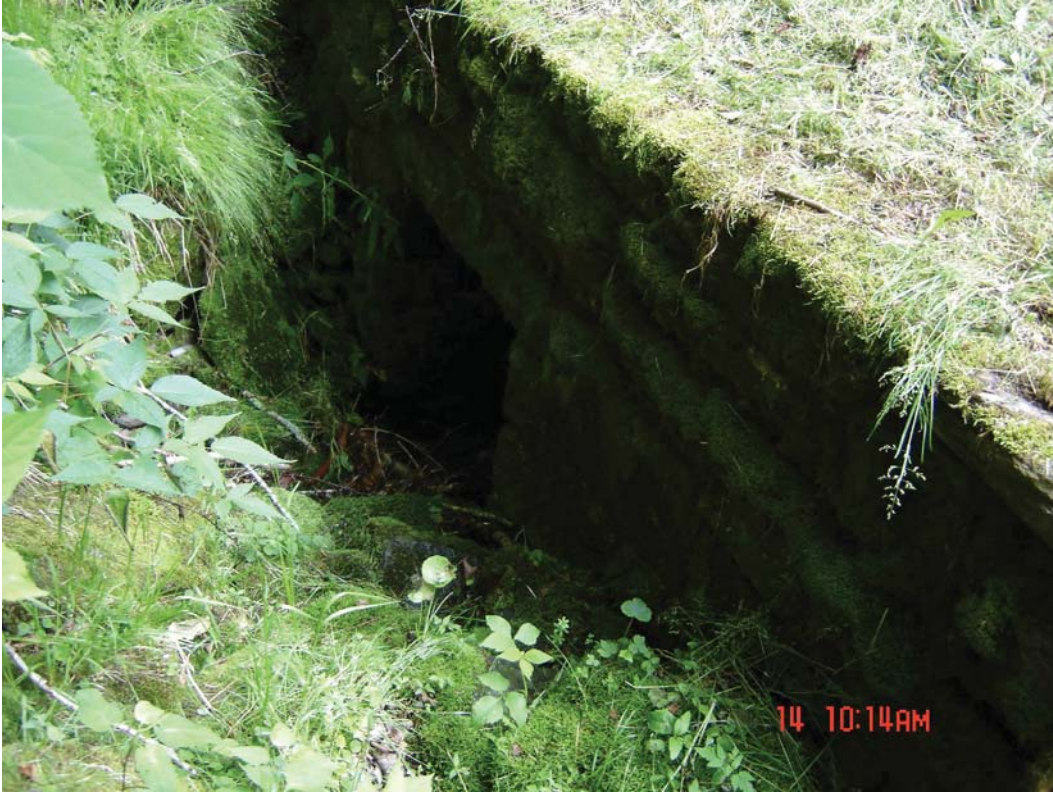
GRSM_0010N_10.760_R_1.jpg

Wall ID:	GRSM-0010N-10.760-R		
Route Name:	NEWFOUND GAP ROAD NORTH		
Inspection Date:	June 14, 2007	Approximate Year Built:	1938
*Wall Rating:	78	Maintenance Action:	Repair Elements

Element (Weighting Factor)	Narrative	Condition Rating (0 - 10)
PERFORMANCE 8.00	Slight undermining, otherwise good	7
WALL FOUNDATION MATERIAL 8.00	Rock + concrete, slightly undermined but still functional	7
MORTAR 8.00	Mild debonding	8
STONE MASONRY 8.00	No distress	9
LATERAL SLOPE 0.50	Riprap, no distress	8
WALL DRAINS 0.50	No distress	8
UPSLOPE 0.50	Flat shoulder	9
DOWNSLOPE 1.00	Slight erosion of concrete on channel, some rock clutter in bottom	7

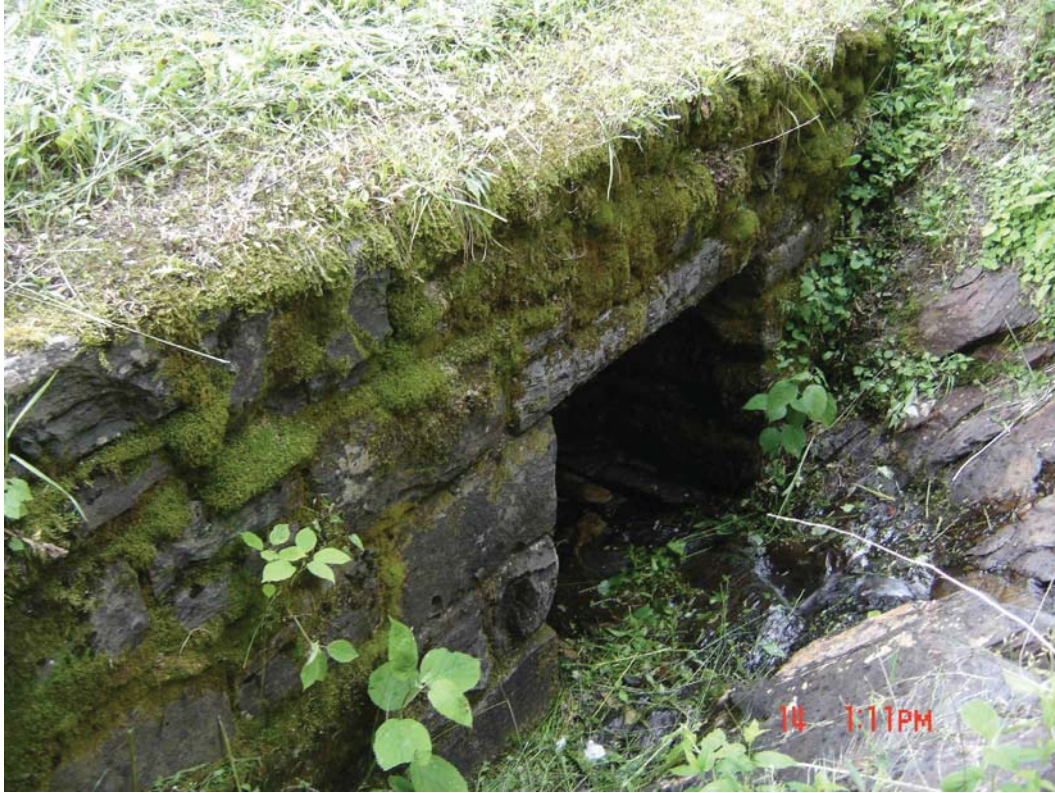
GRSM_0010N_12.305_L_1.jpg

Wall ID:	GRSM-0010N-12.305-L		
Route Name:	NEWFOUND GAP ROAD NORTH		
Inspection Date:	June 14, 2007	Approximate Year Built:	1938
*Wall Rating:	85	Maintenance Action:	No Action

Element (Weighting Factor)	Narrative	Condition Rating (0 - 10)
PERFORMANCE 8.00	Good	8
WALL FOUNDATION MATERIAL 8.00	Bedrock, no distress	9
MORTAR 8.00	Minor debonding	8
STONE MASONRY 8.00	No distress	9
WALL DRAINS 0.50	No distress	8
DOWNSLOPE 0.50	Channel bedrock, no distress	9
LATERAL SLOPE 0.50	Bedrock, no distress	9
UPSLOPE 0.50	Shoulder, no distress	9

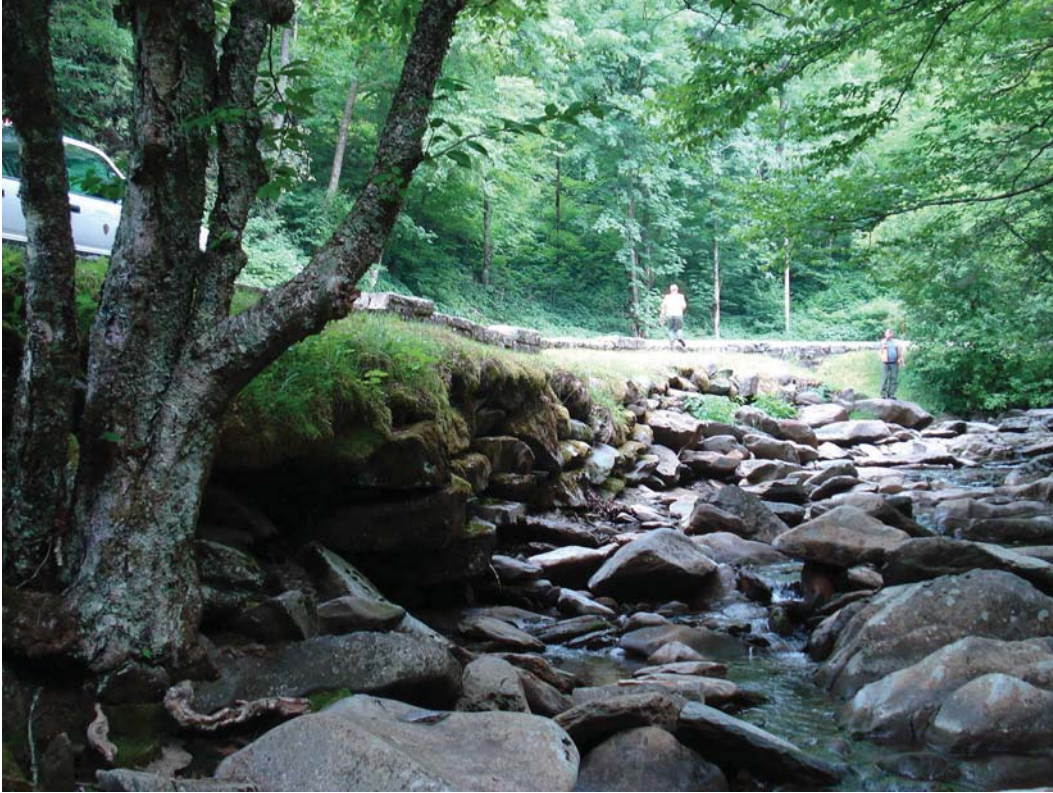
GRSM_0010N_12.404_R_1.jpg

Wall ID:	GRSM-0010N-12.404-R		
Route Name:	NEWFOUND GAP ROAD NORTH		
Inspection Date:	June 14, 2007	Approximate Year Built:	1938
*Wall Rating:	70	Maintenance Action:	Repair Elements

Element (Weighting Factor)	Narrative	Condition Rating (0 - 10)
PERFORMANCE 8.00	North end performance threatened by distress	6
WALL FOUNDATION MATERIAL 8.00	No distress due to foundation issues	9
PLACED STONE 8.00	Loose stone and undermining at north end	6
WALL DRAINS 0.50	Self draining, no distress	9
VEGETATION 1.00	Trees at north end causing wall distress	6
LATERAL SLOPE 1.00	Distress on northern end	7
ROAD/SIDEWALK/SHOULDER 1.00	Minor pavement cracking, some settlement in shoulder	7

Failure Consequence:	LOW
Recommendation Narrative:	Remove and reset north 30 ft of wall - Add chinking stones throughout: Removal: Backhoe hrs@\$150/hr = \$1200, 2 crew 8hrs@\$55/hr = \$880. Reset: 30ftx7ft = 210sf, 210 x \$50/sf = \$10,500. Chinking - Place chinking stones in small voids, 2 crew 8hrs@\$55/hr
Repair Cost:	\$13,460

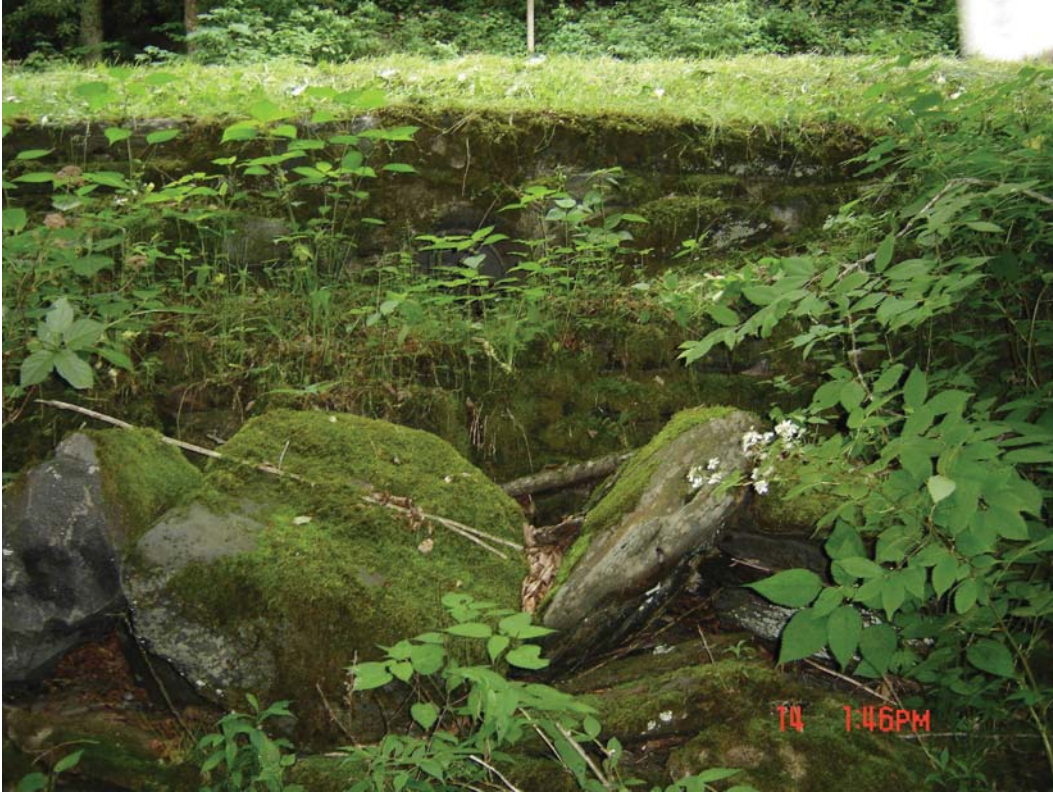
GRSM_0010N_12.556_R_1.jpg

Wall ID:	GRSM-0010N-12.556-R		
Route Name:	NEWFOUND GAP ROAD NORTH		
Inspection Date:	June 14, 2007	Approximate Year Built:	1938
*Wall Rating:	83	Maintenance Action:	No Action

Element (Weighting Factor)	Narrative	Condition Rating (0 - 10)
PERFORMANCE 8.00	As intended	8
WALL FOUNDATION MATERIAL 8.00	Not visible, likely cobbles and boulders, no visible foundation-related distress in wall	8
MORTAR 8.00	Mild debonding, moss-covered	8
STONE MASONRY 8.00	Quarried capstone, moss-covered, no distress	9
DOWNSLOPE 0.50	Channel edge, fortified with/riprap, no distress	9
LATERAL SLOPE 0.50	Boulder fill, mild raveling, vegetated, no distress	9
ROAD/SIDEWALK/SHOULDER 0.50	Grass shoulder, no distress	9
WALL DRAINS 0.50	None, no distress	9

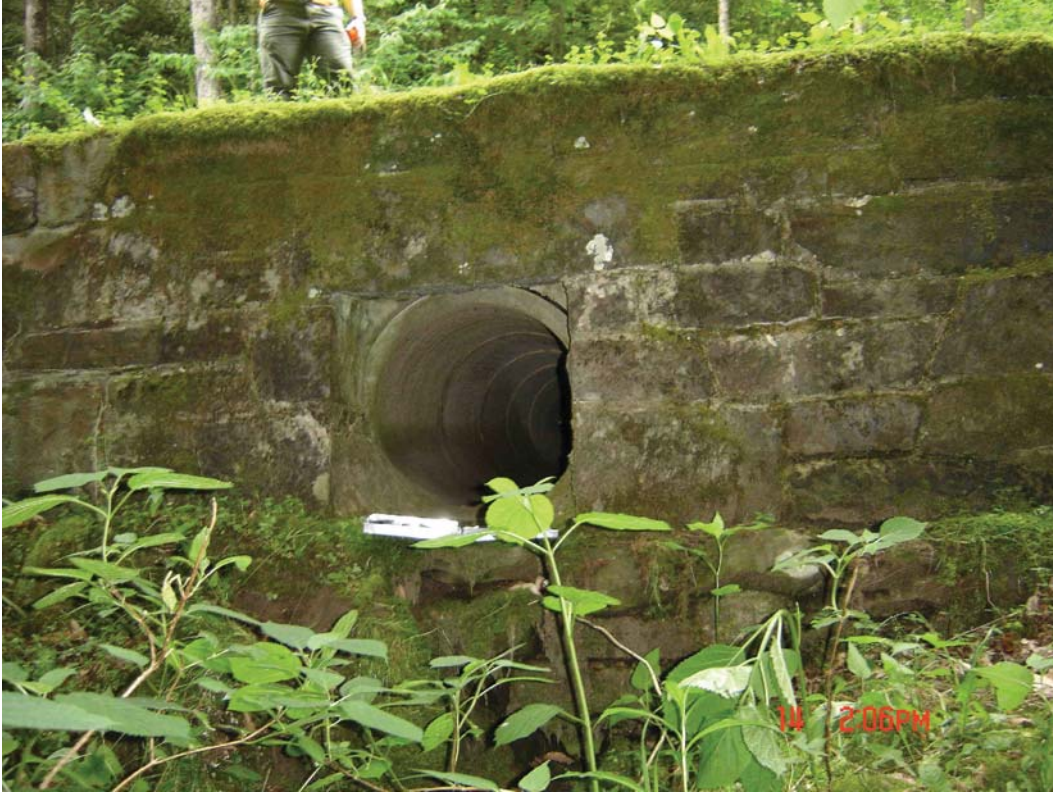
GRSM_0010N_12.615_R_1.jpg

Wall ID:	GRSM-0010N-12.615-R		
Route Name:	NEWFOUND GAP ROAD NORTH		
Inspection Date:	June 14, 2007	Approximate Year Built:	1938
*Wall Rating:	56	Maintenance Action:	Replace Wall

Element (Weighting Factor)	Narrative	Condition Rating (0 - 10)
PERFORMANCE 8.00	Drainage, mortar and foundation distress threaten short term performance	5
WALL FOUNDATION MATERIAL 8.00	Not visible but undermined by water flowing behind wall face	5
MORTAR 8.00	extensive debonding and weathering, mortar missing in some places	6
STONE MASONRY 8.00	Stones intact but wall displaced outward 1-2".	6
DOWNSLOPE 0.50	Riprap fill, no distress	9
CULVERT 1.00	Culvert disconnected from headwall, water flowing behind wall face	5
CURB/BERM/DITCH 1.00	Surface shoulder water infiltrating into fill	5
ROAD/SIDEWALK/SHOULDER 1.00	Grass-covered shoulder with/voids	5
WALL DRAINS 1.00	None, water flow behind wall face likely causing mortar and foundation distress	6

Failure Consequence:	HIGH
Recommendation Narrative:	Remove and replace headwall: Remove wall: 2 crew 12hrs@\$55/hr = \$1320, Backhoe 12hrs@\$150 = \$1800. Dump Truck (stone salvage and haul - later use) 4hrs@\$120/hr = \$480. Construct 50sf mortared stone headwall - FHWA contract cost includes new material.
Repair Cost:	\$11,600

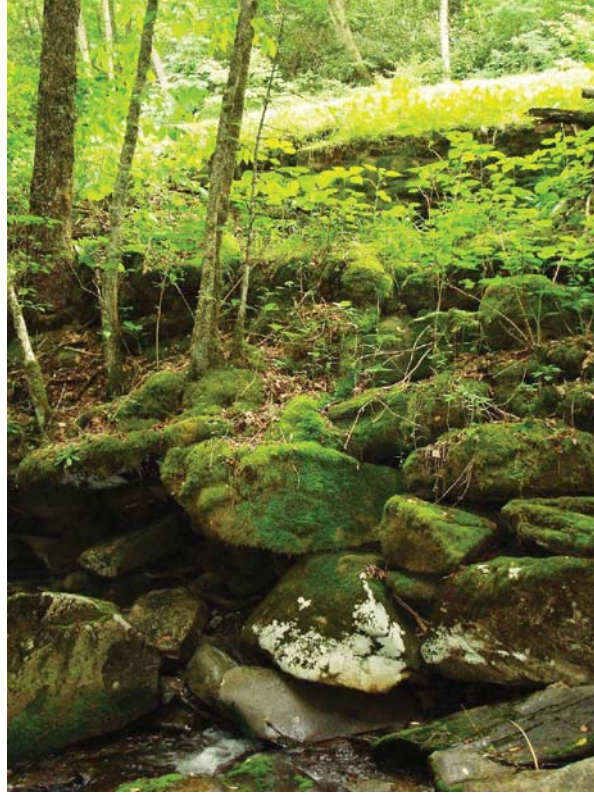
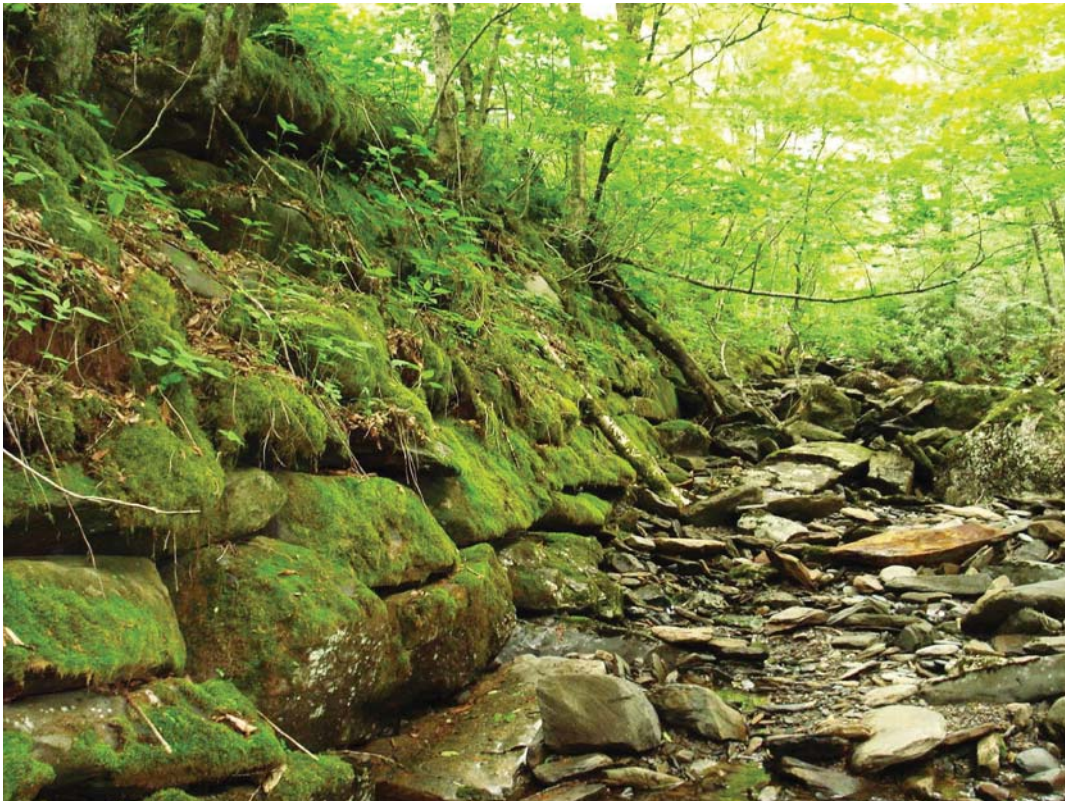
GRSM_0010N_12.660_R_1.jpg

Wall ID:	GRSM-0010N-12.660-R		
Route Name:	NEWFOUND GAP ROAD NORTH		
Inspection Date:	June 14, 2007	Approximate Year Built:	1938
*Wall Rating:	77	Maintenance Action:	Maintenance

Element (Weighting Factor)	Narrative	Condition Rating (0 - 10)
PERFORMANCE 8.00	Missing toe stones and vegetation threatening long term performance. No immediate threat to performance	7
WALL FOUNDATION MATERIAL 8.00	Large diameter boulders and bedrock, river bed. No distress	9
PLACED STONE 8.00	Isolated areas of missing stones near toe, approx 250sf	7
LATERAL SLOPE 0.50	Stable natural slope, no distress	9
UPSLOPE 0.50	Well vegetated slope with/tress, no distress	9
WALL DRAINS 0.50	self draining, no distress	9
VEGETATION 1.00	Numerous trees growing on top of wall. Roots may be displacing some face stones	7

Failure Consequence:	HIGH
Recommendation Narrative:	Replace missing toe stones - approx 250sf: 3 crew 12 hrs@\$55/hr = \$1980, Track hoe 12 hrs@\$225/hr = \$2700. Remove Selective Vegetation - Roots damaging wall: 2 crew 8hrs@\$55/hr = \$880
Repair Cost:	\$5,560

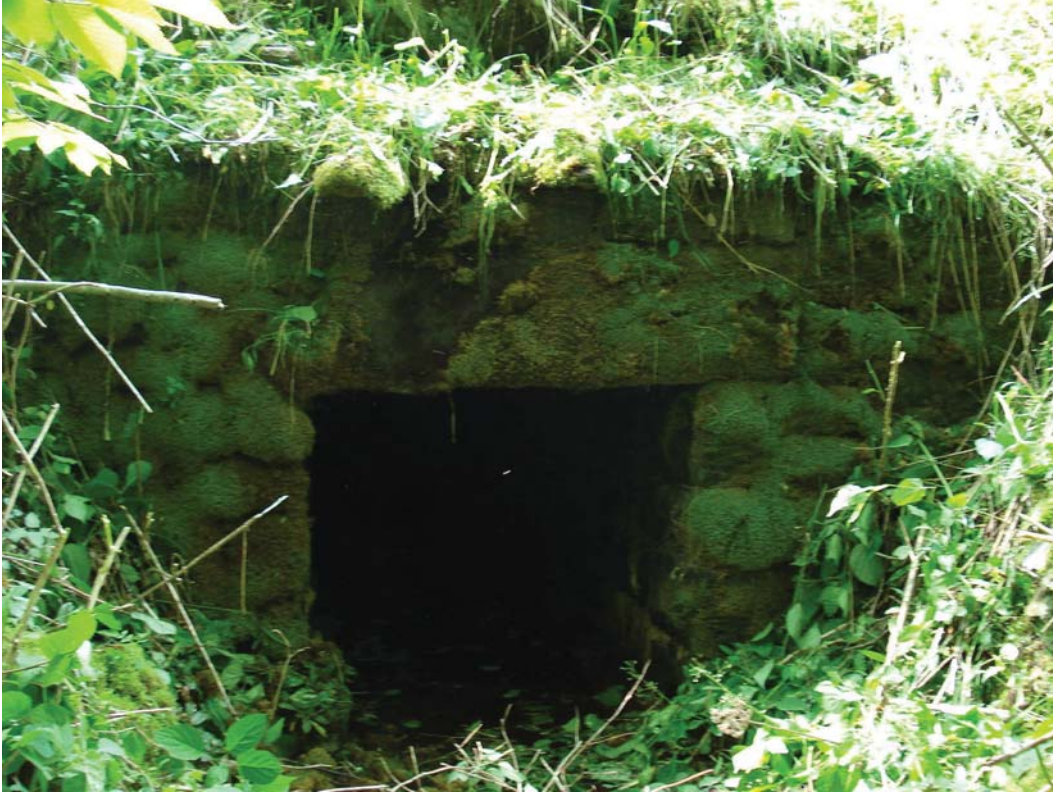
GRSM_0010N_12.746_L_1.jpg

Wall ID:	GRSM-0010N-12.746-L		
Route Name:	NEWFOUND GAP ROAD NORTH		
Inspection Date:	June 14, 2007	Approximate Year Built:	1938
*Wall Rating:	90	Maintenance Action:	No Action

Element (Weighting Factor)	Narrative	Condition Rating (0 - 10)
PERFORMANCE 8.00	As intended	9
WALL FOUNDATION MATERIAL 8.00	no distress	9
MORTAR 8.00	no distress	9
STONE MASONRY 8.00	no distress	9
DOWNSLOPE 0.50	riprap lined creek channel, no distress	9
LATERAL SLOPE 0.50	No distress	9
UPSLOPE 0.50	no distress	9
WALL DRAINS 0.50	none, no distress	9
