NPS Retaining Wall Inventory Program Great Smoky Mountains National Park

**Federal Lands Highway
Road Inventory Program**

Federal Highway Administration
Eastern Federal Lands Highway Division
Road Inventory Program (RIP)

Data Collection Date: April 2011
Report Date: November 2015

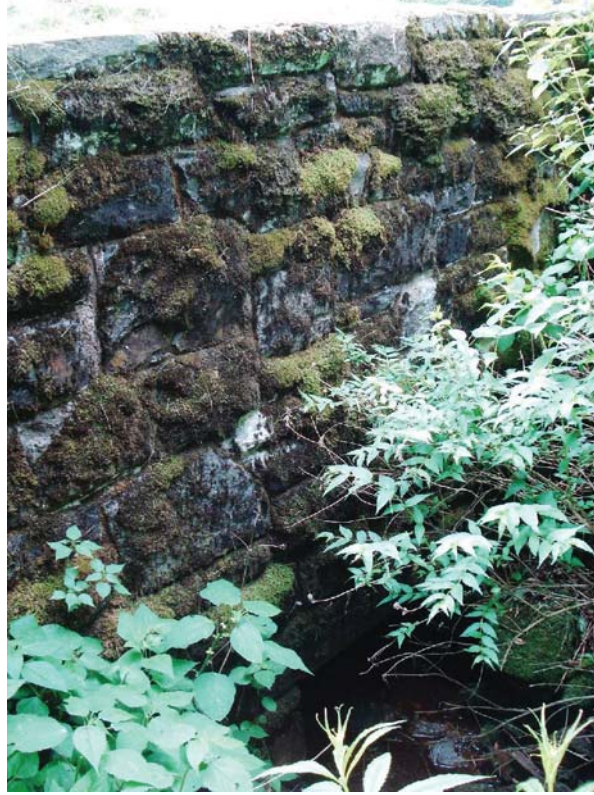
GRSM_0010N_12.746_R_1.jpg

Wall ID:	GRSM-0010N-12.746-R		
Route Name:	NEWFOUND GAP ROAD NORTH		
Inspection Date:	June 14, 2007	Approximate Year Built:	1938
*Wall Rating:	92	Maintenance Action:	No Action

Element (Weighting Factor)	Narrative	Condition Rating (0 - 10)
PERFORMANCE 8.00	As intended, good to excellent	9
WALL FOUNDATION MATERIAL 8.00	On bedrock, no distress	10
MORTAR 8.00	No distress	9
STONE MASONRY 8.00	no distress	9
LATERAL SLOPE 0.50	minor erosion on south end	8
DOWNSLOPE 0.50	bedrock in creek channel, no distress	9
ROAD/SIDEWALK/SHOULDER 0.50	Grassy shoulder, no distress	9
WALL DRAINS 0.50	none visible, no distress	9

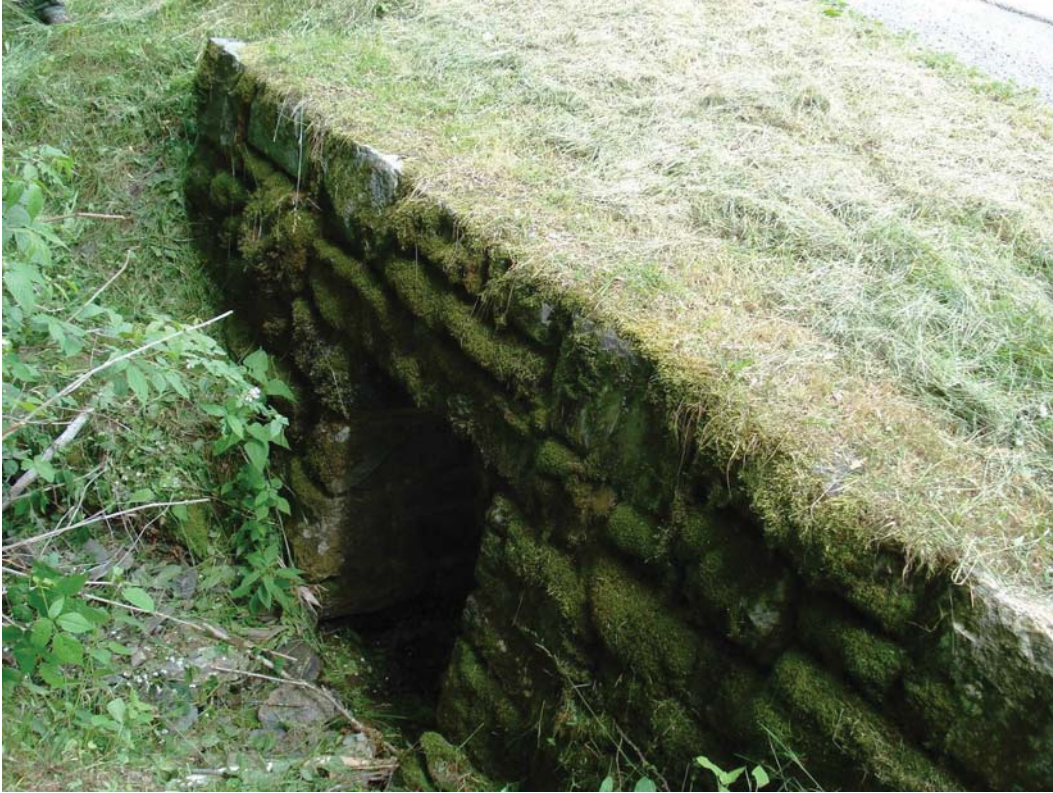
GRSM_0010N_12.793_L_1.jpg

Wall ID:	GRSM-0010N-12.793-L		
Route Name:	NEWFOUND GAP ROAD NORTH		
Inspection Date:	June 14, 2007	Approximate Year Built:	1938
*Wall Rating:	83	Maintenance Action:	No Action

Element (Weighting Factor)	Narrative	Condition Rating (0 - 10)
PERFORMANCE 8.00	Good, as intended	8
WALL FOUNDATION MATERIAL 8.00	Firm soil, no distress	9
MORTAR 8.00	some debonding, weathering, moss-covered	7
STONE MASONRY 8.00	moss-covered, as new	9
LATERAL SLOPE 0.50	shallow grass-covered embankment, no distress noted	9
ROAD/SIDEWALK/SHOULDER 0.50	shallow slope, grass covered, no distress noted	9
UPSLOPE 0.50	forested, no distress noted	9
WALL DRAINS 0.50	no distress	9

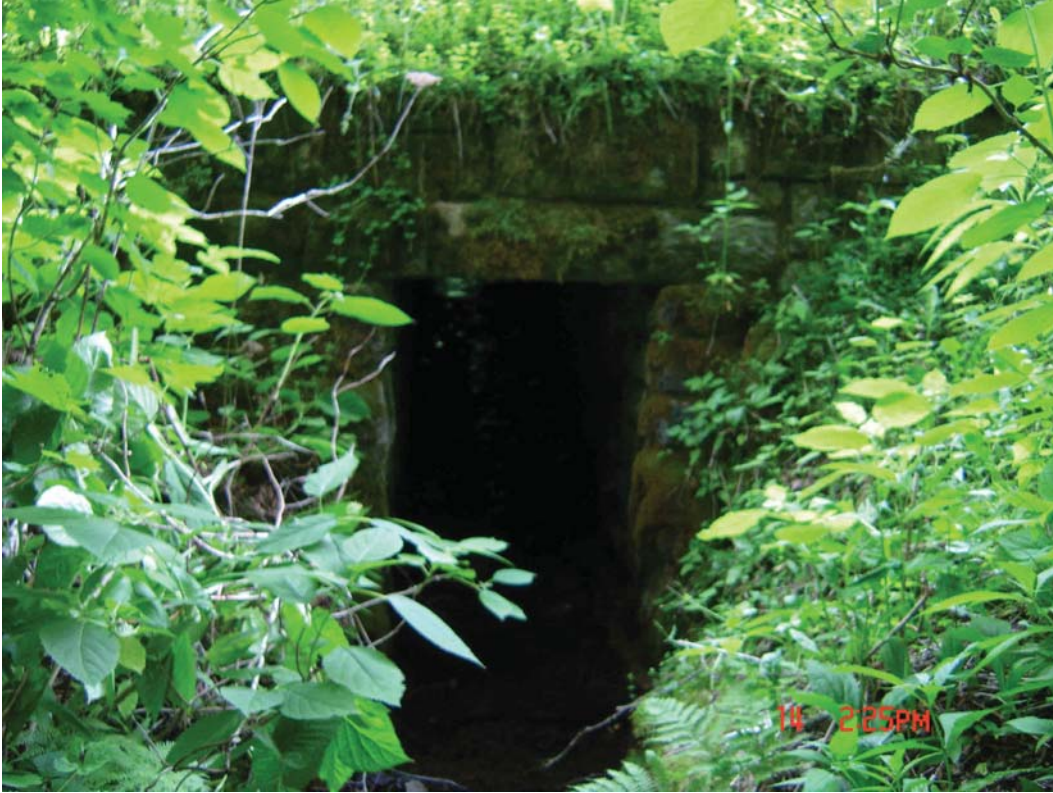
GRSM_0010N_12.798_R_1.jpg

Wall ID:	GRSM-0010N-12.798-R		
Route Name:	NEWFOUND GAP ROAD NORTH		
Inspection Date:	June 14, 2007	Approximate Year Built:	1938
*Wall Rating:	83	Maintenance Action:	No Action

Element (Weighting Factor)	Narrative	Condition Rating (0 - 10)
PERFORMANCE 8.00	As intended	8
WALL FOUNDATION MATERIAL 8.00	Rock and concrete. No distress noted	9
MORTAR 8.00	Moderate debonding and weathering, light cracking, moss covered	7
STONE MASONRY 8.00	No distress	9
LATERAL SLOPE 0.50	Rock and soil fill, mild raveling	8
DOWNSLOPE 0.50	Loose rock channel bottom, low gradient, no distress	9
ROAD/SIDEWALK/SHOULDER 0.50	Grassy shoulder, no distress	9
WALL DRAINS 0.50	None, no distress	9

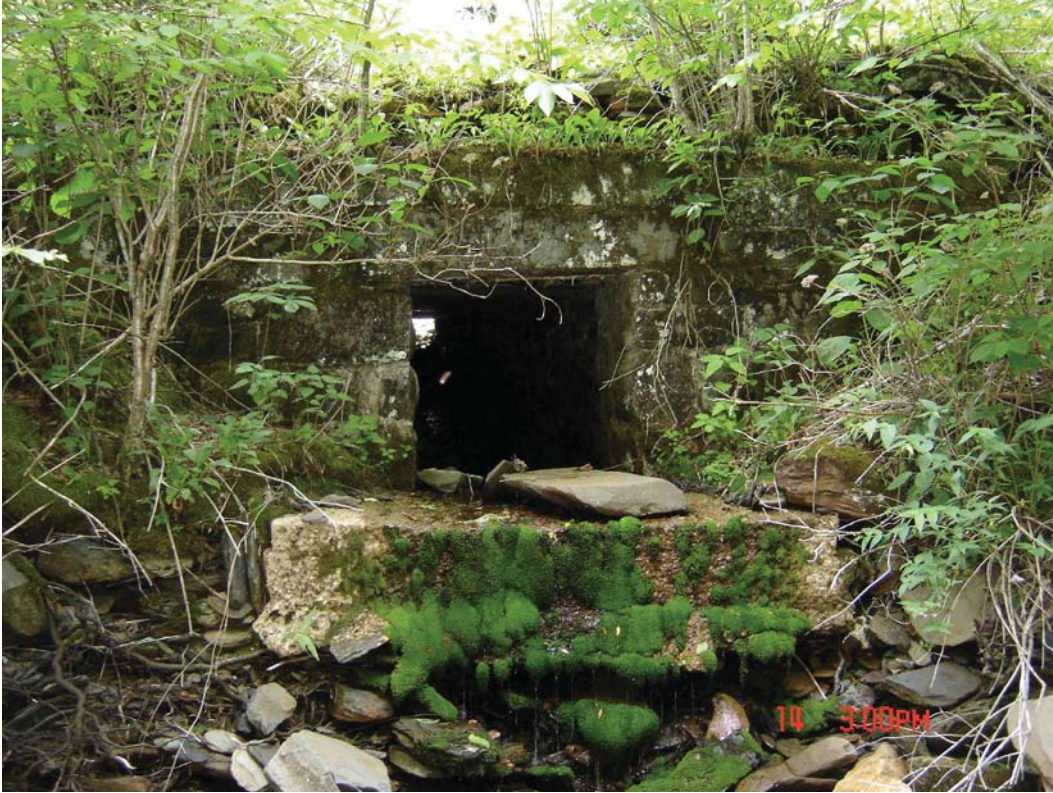
GRSM_0010N_12.865_R_1.jpg

Wall ID:	GRSM-0010N-12.865-R		
Route Name:	NEWFOUND GAP ROAD NORTH		
Inspection Date:	June 14, 2007	Approximate Year Built:	1938
*Wall Rating:	83	Maintenance Action:	No Action

Element (Weighting Factor)	Narrative	Condition Rating (0 - 10)
PERFORMANCE 8.00	As intended	8
WALL FOUNDATION MATERIAL 8.00	2' thick concrete slab (likely reinforced). No distress	9
MORTAR 8.00	Moderately weathered, some de-bonding, moss covered.	7
STONE MASONRY 8.00	No distress	9
DOWNSLOPE 0.50	Slight undermining, not currently effecting wall.	8
LATERAL SLOPE 0.50	Vegetated embankment, some scour at toe.	8
UPSLOPE 0.50	Rock slope, no distress	9
WALL DRAINS 0.50	None, no distress	9

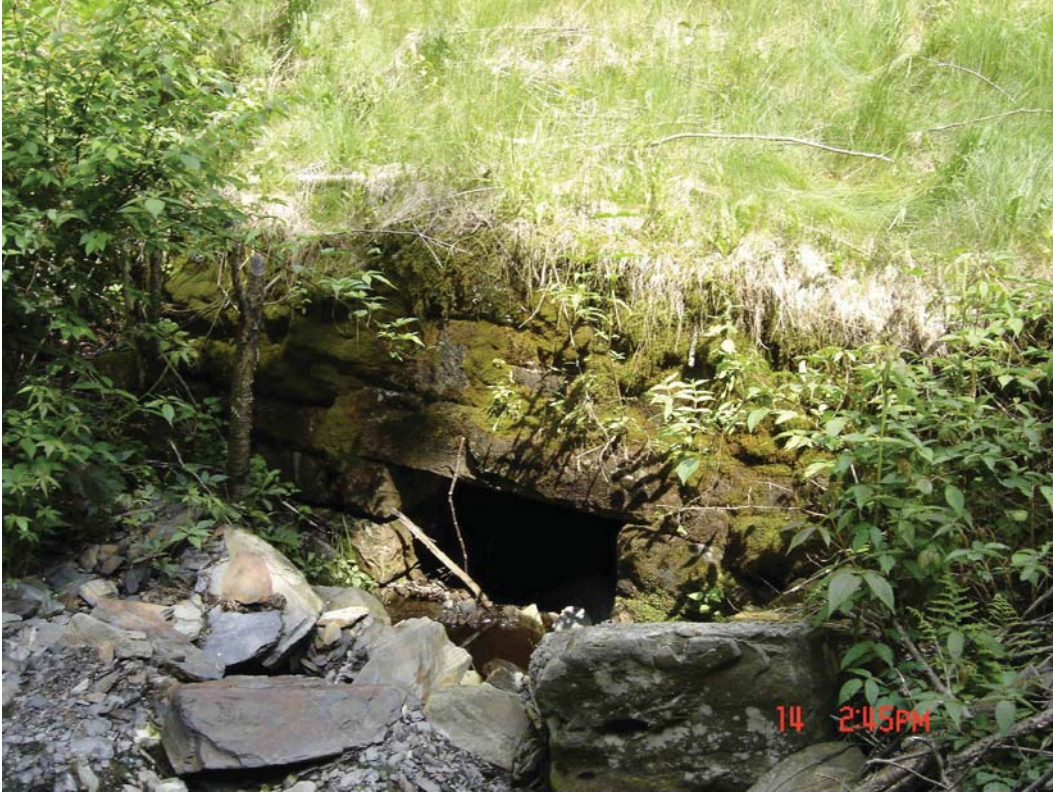
GRSM_0010N_12.867_L_1.jpg

Wall ID:	GRSM-0010N-12.867-L		
Route Name:	NEWFOUND GAP ROAD NORTH		
Inspection Date:	June 14, 2007	Approximate Year Built:	1938
*Wall Rating:	80	Maintenance Action:	Maintenance

Element (Weighting Factor)	Narrative	Condition Rating (0 - 10)
PERFORMANCE 8.00	Aggrading stream, mortar loss slightly impairing long term performance	7
WALL FOUNDATION MATERIAL 8.00	Likely founded on or near bedrock, no distress	9
MORTAR 8.00	Loss of mortar (3-4") on lower 10% of wall, moss covered	7
STONE MASONRY 8.00	No distress	9
LATERAL SLOPE 0.50	riprap over bedrock, no distress	9
UPSLOPE 0.50	Grassy rock fill shoulder, no distress	9
WALL DRAINS 0.50	none, no distress	9
DOWNSLOPE 1.00	Creek bed aggrading into culvert	7

Failure Consequence:	MODERATE
Recommendation Narrative:	Repoint headwall: lower 10% of 65sf = 6.5sf, use 20sf, 20sf x \$75/sf = \$1500. lean inlet debris: 2 crew 2hrs@\$55/hr = \$220
Repair Cost:	\$1,720

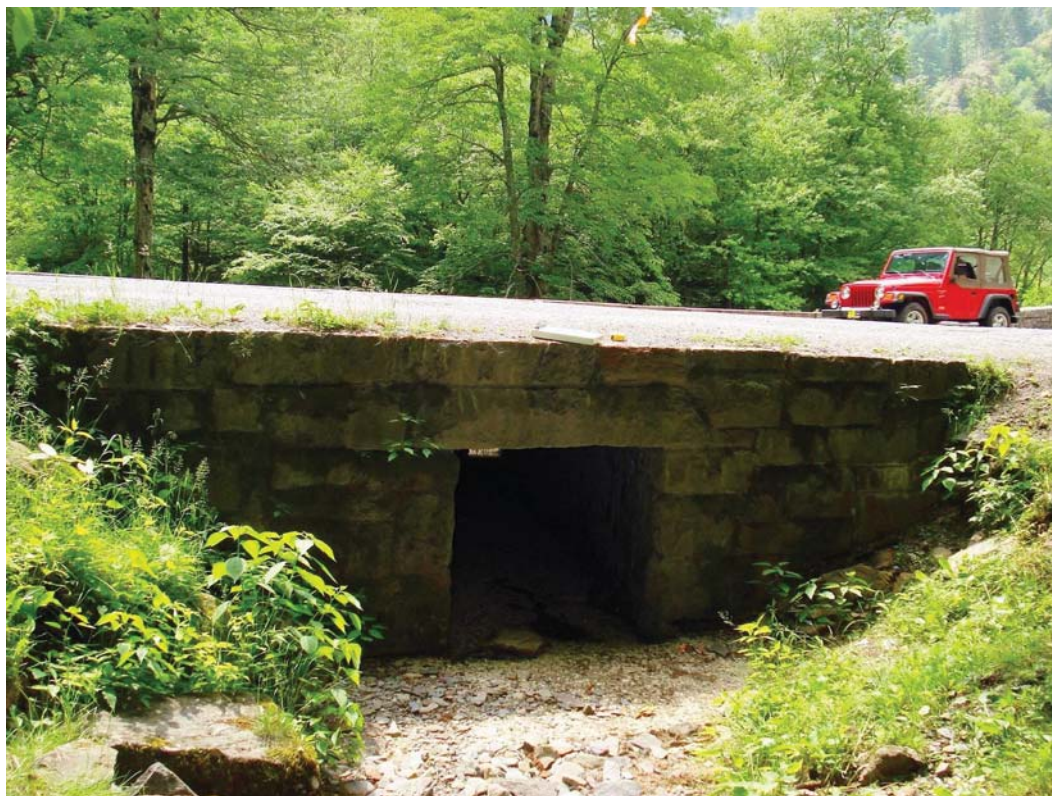
GRSM_0010N_13.080_L_1.jpg

Wall ID:	GRSM-0010N-13.080-L		
Route Name:	NEWFOUND GAP ROAD NORTH		
Inspection Date:	June 14, 2007	Approximate Year Built:	1938
*Wall Rating:	88	Maintenance Action:	No Action

Element (Weighting Factor)	Narrative	Condition Rating (0 - 10)
PERFORMANCE 8.00	Good to excellent	9
WALL FOUNDATION MATERIAL 8.00	no distress	9
MORTAR 8.00	Light weathering, minor debonding	8
STONE MASONRY 8.00	no distress	9
DOWNSLOPE 0.50	riprap lined dry creek bed, no distress	9
LATERAL SLOPE 0.50	no distress	9
ROAD/SIDEWALK/SHOULDER 0.50	No distress	9
WALL DRAINS 0.50	no distress	9

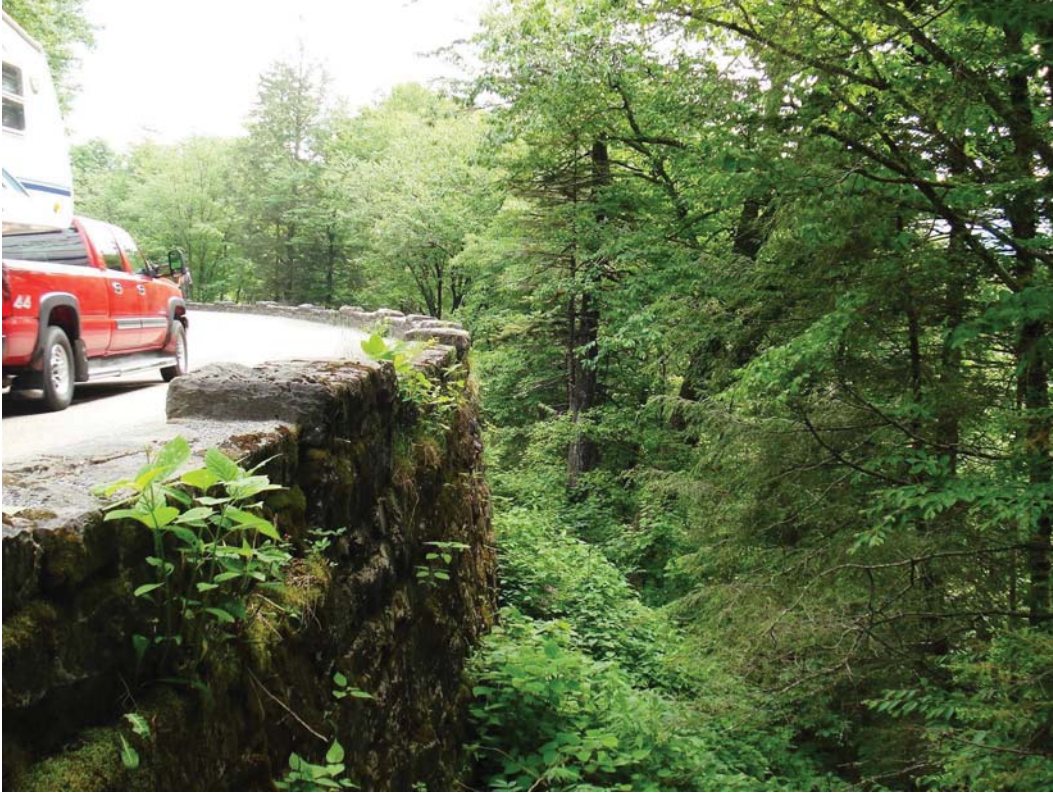
GRSM_0010N_13.244_R_1.jpg

Wall ID:	GRSM-0010N-13.244-R		
Route Name:	NEWFOUND GAP ROAD NORTH		
Inspection Date:	June 14, 2007	Approximate Year Built:	1938
*Wall Rating:	88	Maintenance Action:	No Action

Element (Weighting Factor)	Narrative	Condition Rating (0 - 10)
PERFORMANCE 8.00	Good to excellent	9
WALL FOUNDATION MATERIAL 8.00	no distress	9
MORTAR 8.00	minor isolated cracking	8
STONE MASONRY 8.00	No stone distress noted, mortar distress captured above	9
UPSLOPE 0.50	vegetated and wooded, moderate to steep slope, no distress	8
LATERAL SLOPE 0.50	no distress	9
ROAD/SIDEWALK/SHOULDER 0.50	no distress	9
WALL DRAINS 0.50	no distress	9

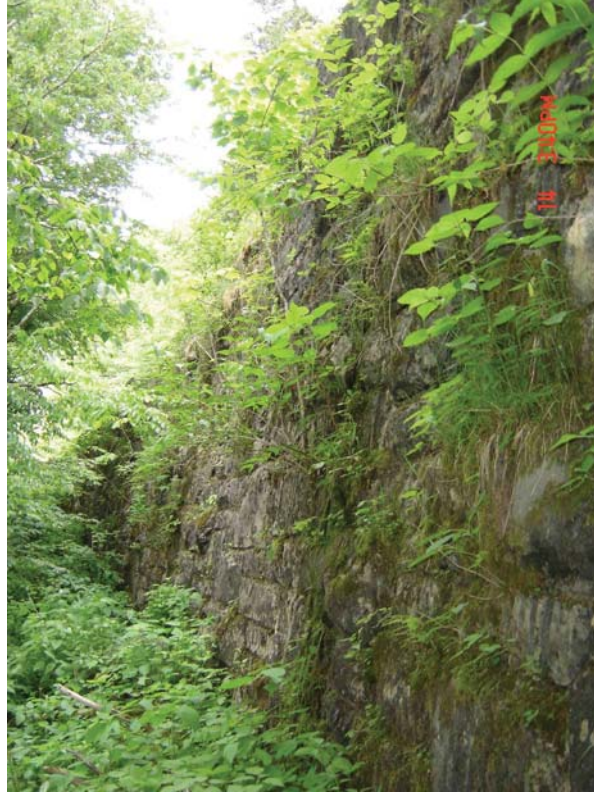
GRSM_0010N_13.316_R_1.jpg

Wall ID:	GRSM-0010N-13.316-R		
Route Name:	NEWFOUND GAP ROAD NORTH		
Inspection Date:	June 14, 2007	Approximate Year Built:	1938
*Wall Rating:	85	Maintenance Action:	No Action

Element (Weighting Factor)	Narrative	Condition Rating (0 - 10)
PERFORMANCE 8.00	Good, as intended	8
WALL FOUNDATION MATERIAL 8.00	firm soil, no distress	9
MORTAR 8.00	Light debonding, moss covered.	8
STONE MASONRY 8.00	no distress, moss covered	9
DOWNSLOPE 0.50	Appears stable, thick vegetation.	8
ROAD/SIDEWALK/SHOULDER 0.50	no wall distress. Some wheel path cracking.	9
WALL DRAINS 0.50	none, no distress	9
LATERAL SLOPE 1.00	Mild slope creep before beginning of wall. Guardwall leaning slightly. Appears to be old event.	7

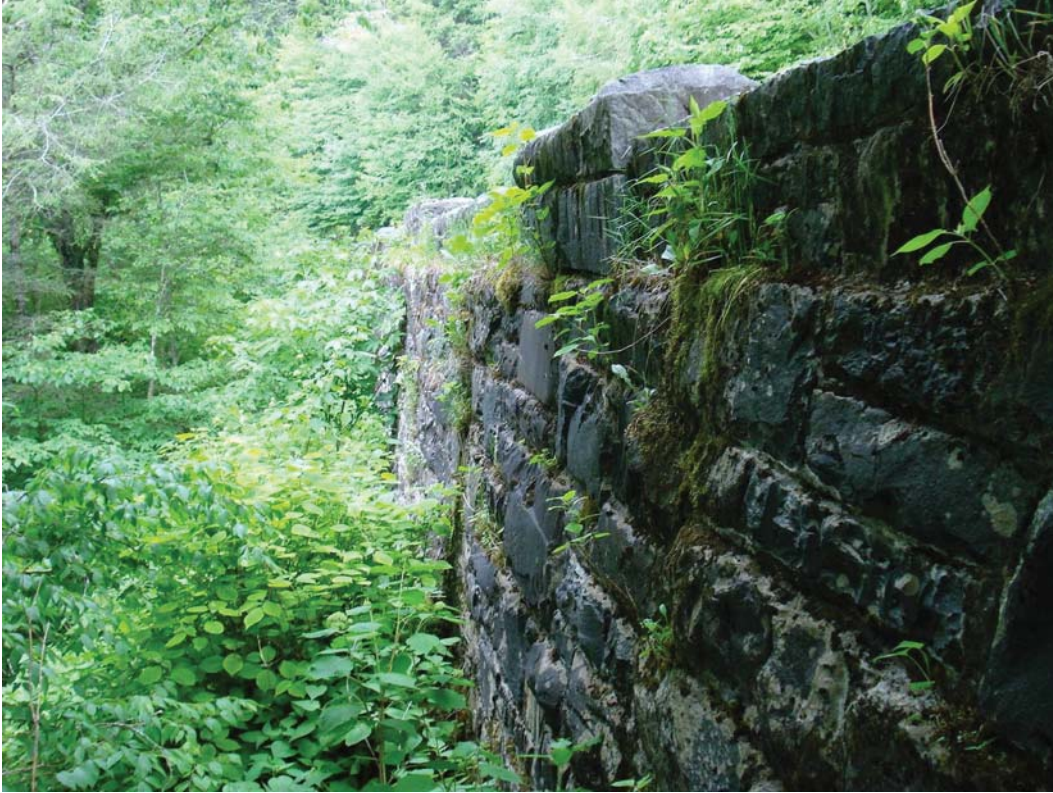
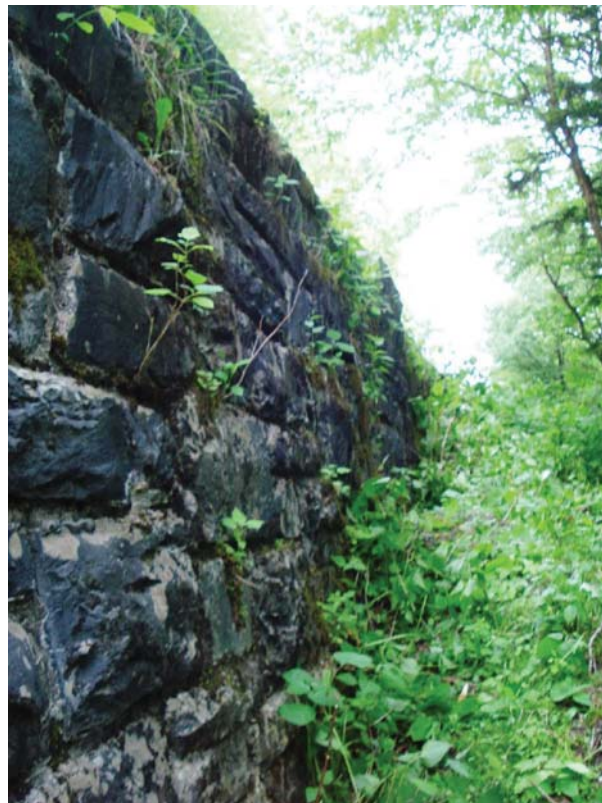
GRSM_0010N_13.356_R_1.jpg

Wall ID:	GRSM-0010N-13.356-R		
Route Name:	NEWFOUND GAP ROAD NORTH		
Inspection Date:	June 14, 2007	Approximate Year Built:	1938
*Wall Rating:	85	Maintenance Action:	No Action

Element (Weighting Factor)	Narrative	Condition Rating (0 - 10)
PERFORMANCE 8.00	Good to excellent	8
WALL FOUNDATION MATERIAL 8.00	no distress	9
MORTAR 8.00	Minor cracking	8
STONE MASONRY 8.00	no distress in stones	9
ROAD/SIDEWALK/SHOULDER 0.50	Minor cracking along outside pavement edge	8
DOWNSLOPE 0.50	heavily vegetated and wooded, moderate to steep, no distress	9
LATERAL SLOPE 0.50	no distress	9
WALL DRAINS 0.50	no distress	9

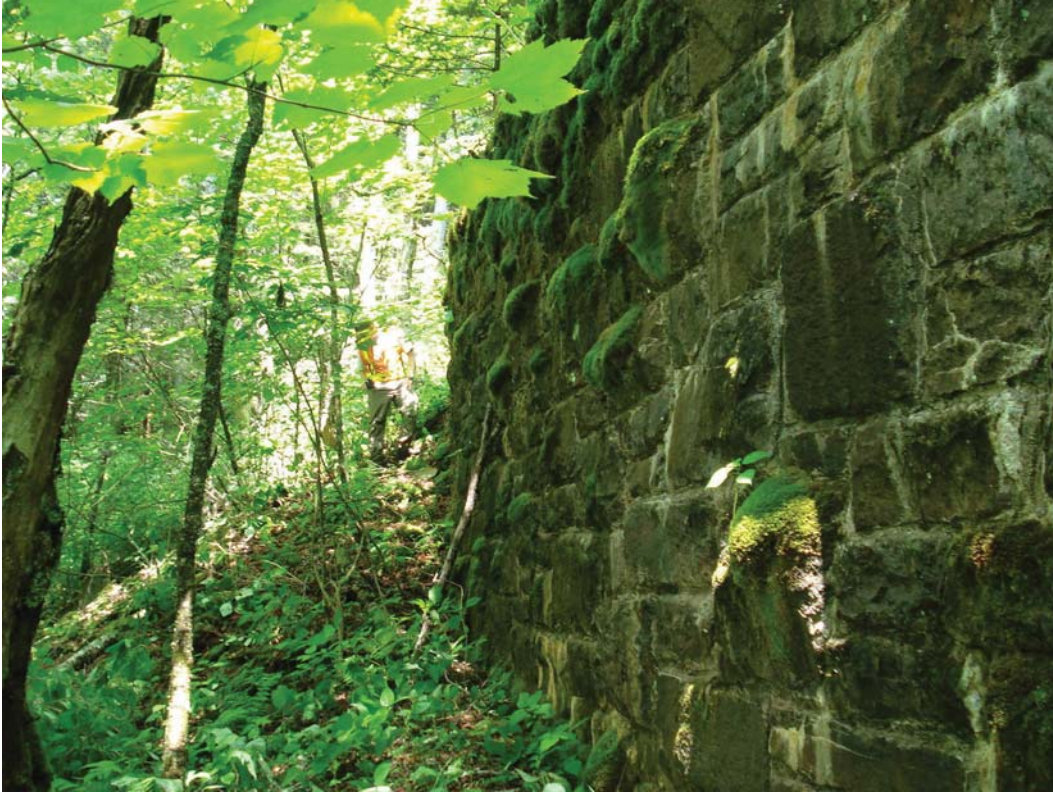
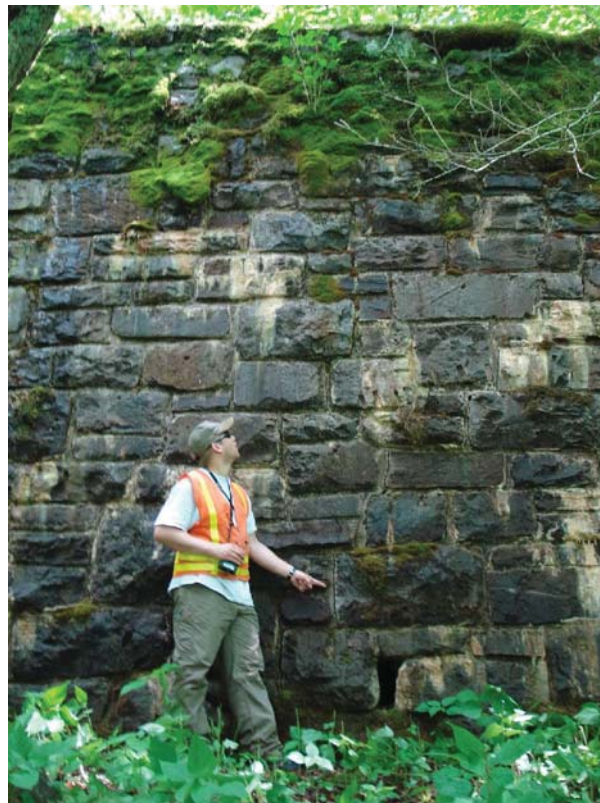
GRSM_0010N_14.917_R_1.jpg

Wall ID:	GRSM-0010N-14.917-R		
Route Name:	NEWFOUND GAP ROAD NORTH		
Inspection Date:	June 15, 2007	Approximate Year Built:	1938
*Wall Rating:	69	Maintenance Action:	Repair Elements

Wall Function:	Fill Wall	Primary Wall Type:	Gravity - Mortared Stone
Surface Treatment:		Secondary Wall Type:	
Secondary Surface Treatment:		Architectural Facing:	
General Description:	GM toe wall for steep slope supporting pullout area of high ADT roadway high consequence of failure

Element (Weighting Factor)	Narrative	Condition Rating (0 - 10)
PERFORMANCE 8.00	Fair. Localized cracking at top at approx. centerline of wall; bulging and tilting along top of wall	6
WALL FOUNDATION MATERIAL 8.00	No evidence of settlement or rotation about the base	9
MORTAR 8.00	Full length cracking through mortar at approx. centerline of wall; minor debonding and spalling of mortar	6
STONE MASONRY 8.00	1/4-in. cracks for full height of wall at approx. centerline; bulging and tilting of blocks along top of wall for approx. 50 ft.	6
DOWNSLOPE 0.50	Moderate vegetated and wooded slope; no evidence of distress	8
UPSLOPE 0.50	Steep vegetated and wooded slope with rip rap fill; no evidence of slope movement	8
VEGETATION 0.50	Several medium diameter trees within 3 ft of wall along base and top of wall; trees do not appear to be affecting wall performance	8
WALL DRAINS 0.50	Weep holes spaced approx. 10 ft c-c along base; all weep holes appear to be functioning properly; damage along top of wall may be drainage related	8

Failure Consequence:	HIGH
Recommendation Narrative:	Remove/reset stone masonry - 55.5 cuyd (\$3,195/cuyd) = \$177,500. Stone Masonry Repointing - 140 sqft (\$75/sqft) = \$10,500.
Repair Cost:	\$188,000

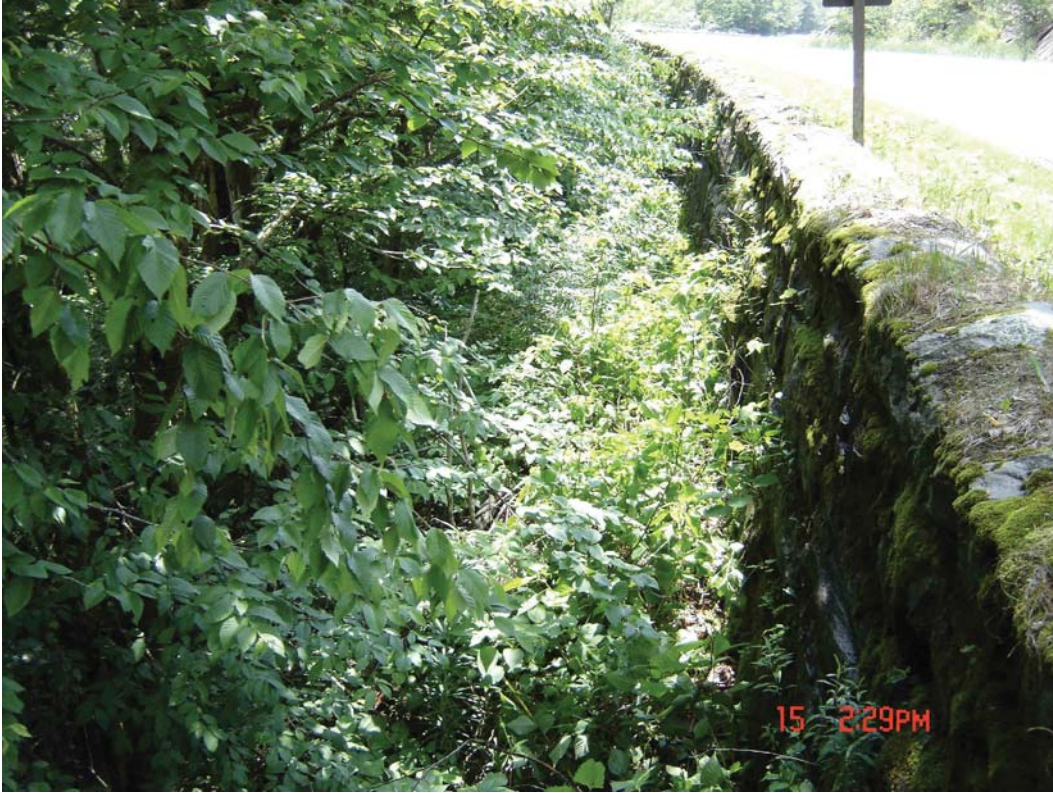
GRSM_0010S_15.056_R_1.jpg

Wall ID:	GRSM-0010S-15.056-R		
Route Name:	NEWFOUND GAP ROAD SOUTH		
Inspection Date:	June 15, 2007	Approximate Year Built:	1938
*Wall Rating:	83	Maintenance Action:	No Action

Wall Function:	Fill Wall	Primary Wall Type:	Gravity - Mortared Stone
Surface Treatment:		Secondary Wall Type:	
Secondary Surface Treatment:		Architectural Facing:	
General Description:	GM fill wall along southbound travel lane of high ADT roadway constructed atop moderate to steep forested slope high consequence of failure

Element (Weighting Factor)	Narrative	Condition Rating (0 - 10)
PERFORMANCE 8.00	Good to excellent performance	8
WALL FOUNDATION MATERIAL 8.00	No distress; no evidence of settlement or rotation	9
MORTAR 8.00	General age-related weathering	8
STONE MASONRY 8.00	Minor debonding	8
CULVERT 0.50	No distress; two 18-in. diameter pipe culverts along the base of wall	9
DOWNSLOPE 0.50	No distress; moderate to steep forested slope	9
LATERAL SLOPE 0.50	No distress	9
ROAD/SIDEWALK/SHOULDER 0.50	No distress to roadway or shoulder	9
WALL DRAINS 0.50	No distress	9

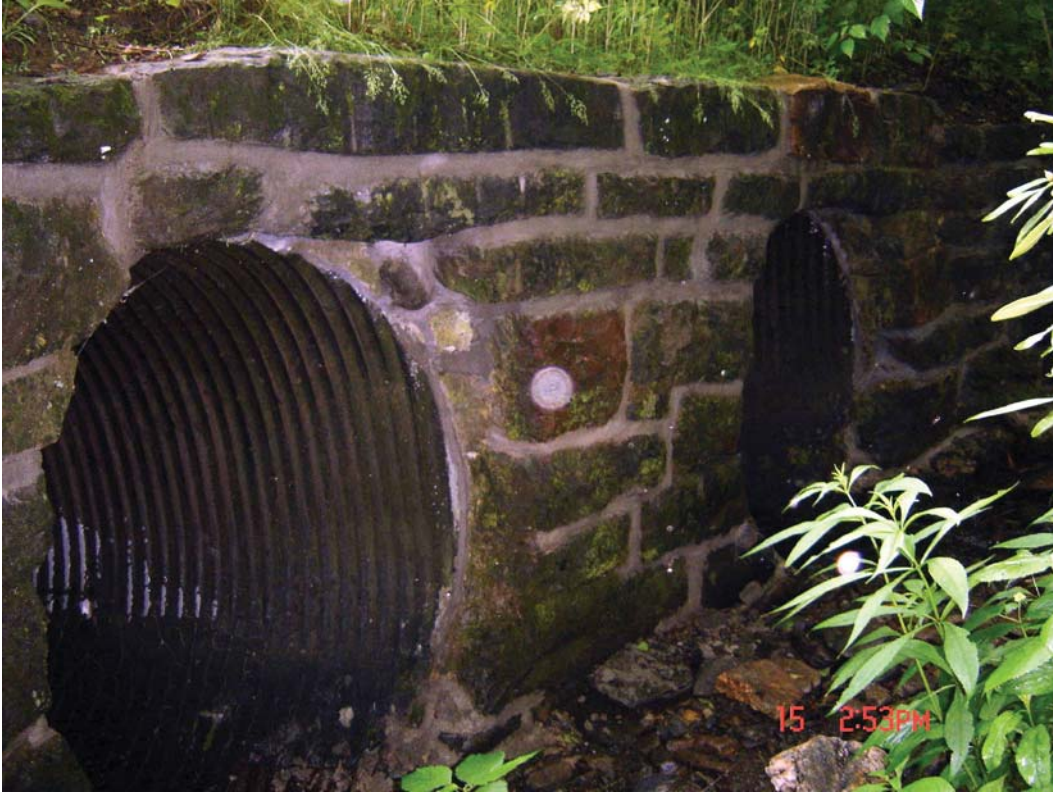
GRSM_0010S_20.035_L_1.jpg

Wall ID:	GRSM-0010S-20.035-L		
Route Name:	NEWFOUND GAP ROAD SOUTH		
Inspection Date:	June 15, 2007	Approximate Year Built:	1938
*Wall Rating:	88	Maintenance Action:	No Action

Element (Weighting Factor)	Narrative	Condition Rating (0 - 10)
PERFORMANCE 8.00	Good to excellent performance	8
WALL FOUNDATION MATERIAL 8.00	No distress; no evidence of settlement or rotation	9
MORTAR 8.00	No distress; recently repointed along approximately 70% of wall	9
STONE MASONRY 8.00	No distress	9
CULVERT 0.50	Two 60-in. diameter CMP culverts with a bitumen lining; minor degradation of the bitumen lining	8
DOWNSLOPE 0.50	No distress; creek bed	9
LATERAL SLOPE 0.50	No distress	9
WALL DRAINS 0.50	No evidence of drainage-related distress	9
ROAD/SIDEWALK/SHOULDER 0.50	No distress to roadway or shoulder	10

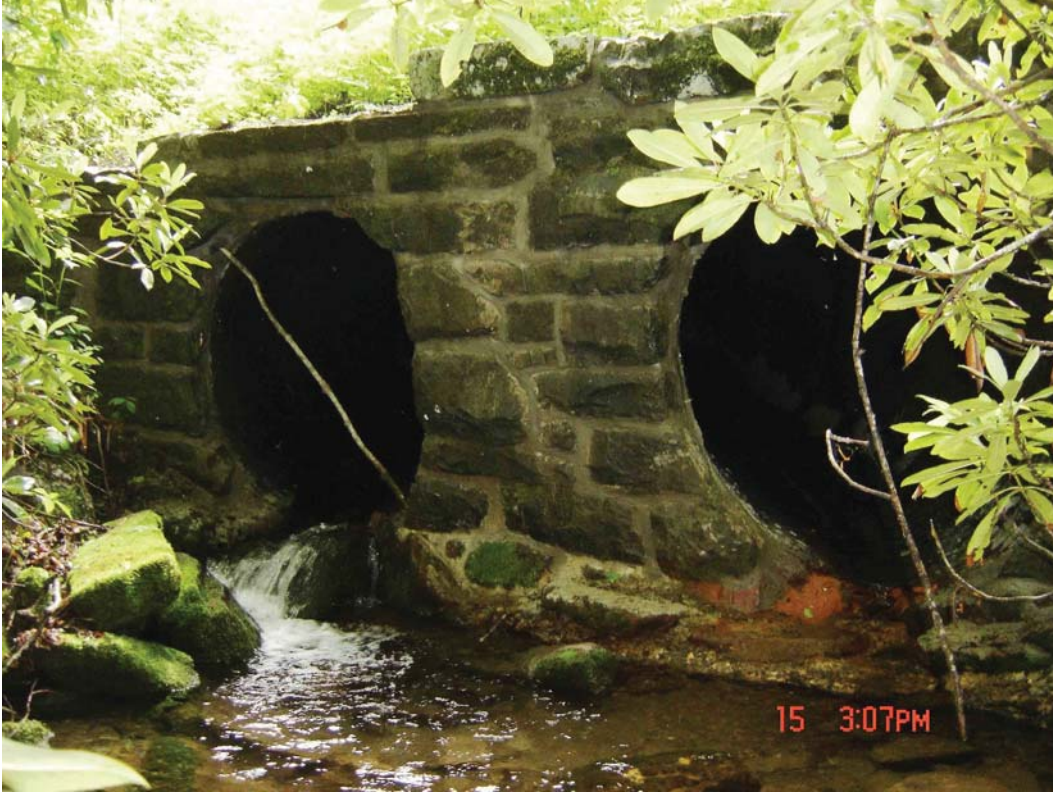
GRSM_0010S_20.045_R_1.jpg

Wall ID:	GRSM-0010S-20.045-R		
Route Name:	NEWFOUND GAP ROAD SOUTH		
Inspection Date:	June 15, 2007	Approximate Year Built:	1938
*Wall Rating:	88	Maintenance Action:	No Action

Wall Function:	Head Wall	Primary Wall Type:	Gravity - Mortared Stone
Surface Treatment:		Secondary Wall Type:	
Secondary Surface Treatment:		Architectural Facing:	
General Description:	GM outlet headwall for two 60 in diameter CMP culverts with bitumen lining along southbound travel lane of high ADT roadway moderate consequence of failure

Element (Weighting Factor)	Narrative	Condition Rating (0 - 10)
PERFORMANCE 8.00	Good performance overall; missing caprock should be replaced	8
WALL FOUNDATION MATERIAL 8.00	No distress; no evidence of settlement or rotation	9
MORTAR 8.00	No distress; recently repointed along approximately 70% of the wall	9
STONE MASONRY 8.00	Good condition overall; one missing caprock	9
CULVERT 0.50	Two 60-in. diameter CMP culverts with bitumen lining; minor degradation of lining	8
DOWNSLOPE 0.50	No distress; creek bed	9
LATERAL SLOPE 0.50	No distress	9
ROAD/SIDEWALK/SHOULDER 0.50	No distress to roadway or shoulder	9
UPSLOPE 0.50	No distress to vegetated fill embankment	9

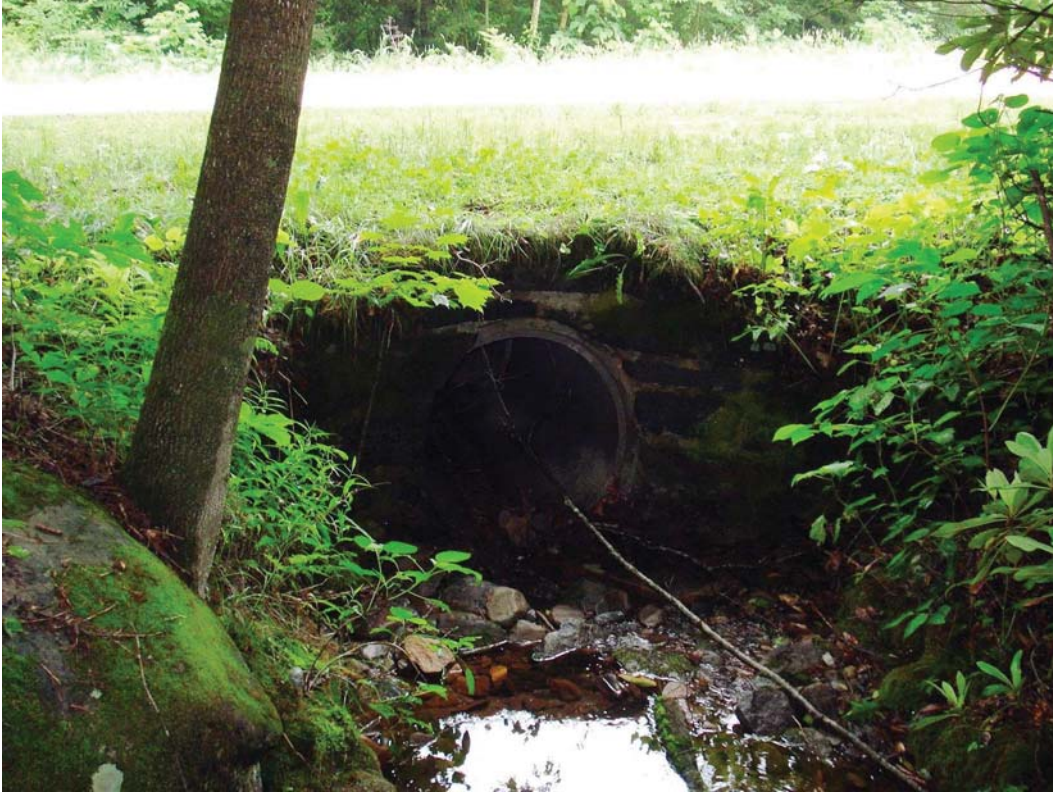
GRSM_0010S_20.057_L_1.jpg

Wall ID:	GRSM-0010S-20.057-L		
Route Name:	NEWFOUND GAP ROAD SOUTH		
Inspection Date:	June 15, 2007	Approximate Year Built:	1938
*Wall Rating:	81	Maintenance Action:	Maintenance

Wall Function:	Head Wall	Primary Wall Type:	Gravity - Mortared Stone
Surface Treatment:		Secondary Wall Type:	
Secondary Surface Treatment:		Architectural Facing:	
General Description:	GM outlet headwall for 36 in diameter concrete pipe culvert along northbound travel lane of high ADT roadway moderate consequence of failure

Element (Weighting Factor)	Narrative	Condition Rating (0 - 10)
PERFORMANCE 8.00	Good performance; general age-related weathering of wall material	8
WALL FOUNDATION MATERIAL 8.00	No distress; no evidence of settlement or rotation	9
STONE MASONRY 8.00	Moderate debonding around the culvert has created an annulus	7
MORTAR 8.00	General age-related weathering	8
CULVERT 0.50	No distress; 36-in diameter concrete culvert	9
LATERAL SLOPE 0.50	No distress	9
WALL DRAINS 0.50	No evidence of drainage-related distress	9
DOWNSLOPE 0.50	No distress; riprap lined creek bed	10
ROAD/SIDEWALK/SHOULDER 0.50	No distress to roadway or grassy shoulder	10

Failure Consequence:	MODERATE
Recommendation Narrative:	Stone Masonry Repointing - 10.49 sqft (\$75/sqft) = \$786.45
Repair Cost:	\$786

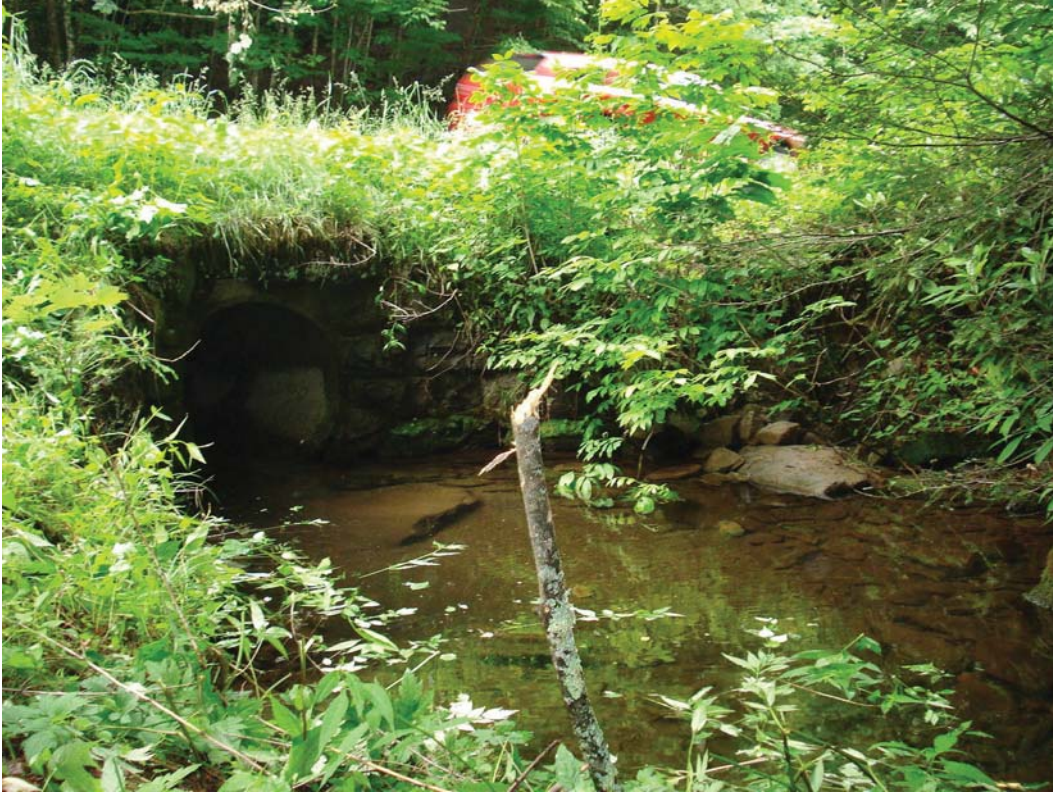
GRSM_0010S_20.057_R_1.jpg

Wall ID:	GRSM-0010S-20.057-R		
Route Name:	NEWFOUND GAP ROAD SOUTH		
Inspection Date:	June 15, 2007	Approximate Year Built:	1938
*Wall Rating:	75	Maintenance Action:	Maintenance

Wall Function:	Head Wall	Primary Wall Type:	Gravity - Mortared Stone
Surface Treatment:		Secondary Wall Type:	
Secondary Surface Treatment:		Architectural Facing:	
General Description:	GM outlet headwall for a 36 in diameter CMP culvert with a bitumen lining along southbound travel lane of high ADT roadway moderate consequence of failure

Element (Weighting Factor)	Narrative	Condition Rating (0 - 10)
PERFORMANCE 8.00	Good performance of wall; however, scour hole at outlet threatens stability of the wall	7
WALL FOUNDATION MATERIAL 8.00	Scour hole forming along base of wall causing undermining of the foundation; no evidence that wall has moved as result of undermining	8
STONE MASONRY 8.00	Moderate debonding along base of wall	7
MORTAR 8.00	General age-related weathering	8
ROAD/SIDEWALK/SHOULDER 0.50	No distress to roadway or vegetated shoulder	9
WALL DRAINS 0.50	No evidence of drainage-related distress	9
DOWNSLOPE 1.00	Large scour hole forming along base of wall an extending approximately 24 ft away from wall; pile of rocks downstream promoting negative flow	5
LATERAL SLOPE 1.00	Erosion of lateral slope due to poor downstream drainage	6

Failure Consequence:	MODERATE
Recommendation Narrative:	Clear stone piles from downstream - 4 labor hrs (\$55/hr) = \$220. Stone Masonry Repointing - 10.64 sqft (\$75/sqft) = \$797.96. Backfill Scour Hole w/ Placed Riprap, Class 1 - 23.11 cuyd (\$80/cuyd) = \$1,848.89
Repair Cost:	\$2,867

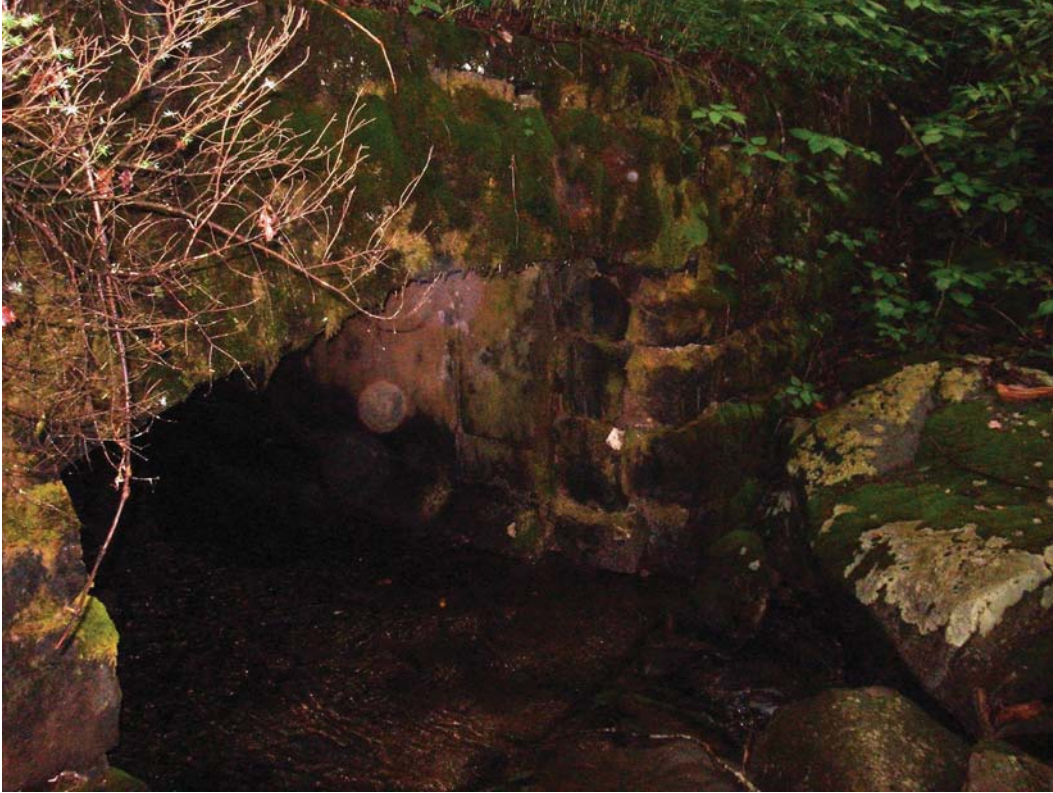
GRSM_0010S_20.258_R_1.jpg

Wall ID:	GRSM-0010S-20.258-R		
Route Name:	NEWFOUND GAP ROAD SOUTH		
Inspection Date:	June 15, 2007	Approximate Year Built:	1938
*Wall Rating:	68	Maintenance Action:	Repair Elements

Wall Function:	Head Wall	Primary Wall Type:	Gravity - Mortared Stone
Surface Treatment:		Secondary Wall Type:	
Secondary Surface Treatment:		Architectural Facing:	
General Description:	GM inlet headwall for 5 ft x 11 ft box culvert opening along southbound travel lane of high ADT roadway low consequence of failure

Element (Weighting Factor)	Narrative	Condition Rating (0 - 10)
PERFORMANCE 8.00	Good performance overall; moderate to severe degradation of mortar threatens the long-term performance of the wall	6
WALL FOUNDATION MATERIAL 8.00	No distress; no evidence of settlement or rotation	9
MORTAR 8.00	Severely degraded and spalling along approximately 50% of wall	4
STONE MASONRY 8.00	Degradation of mortar has caused moderate debonding	7
LATERAL SLOPE 0.50	No distress	9
WALL DRAINS 0.50	No evidence of drainage-related distress	9
CULVERT 0.50	No distress	10
DOWNSLOPE 0.50	Riprap lined stream channel	10
UPSLOPE 0.50	No distress; relatively level grassy shoulder	10

Failure Consequence:	LOW
Recommendation Narrative:	Stone Masonry Repointing - 185 sqft (\$75/sqft) = \$13,875
Repair Cost:	\$13,875

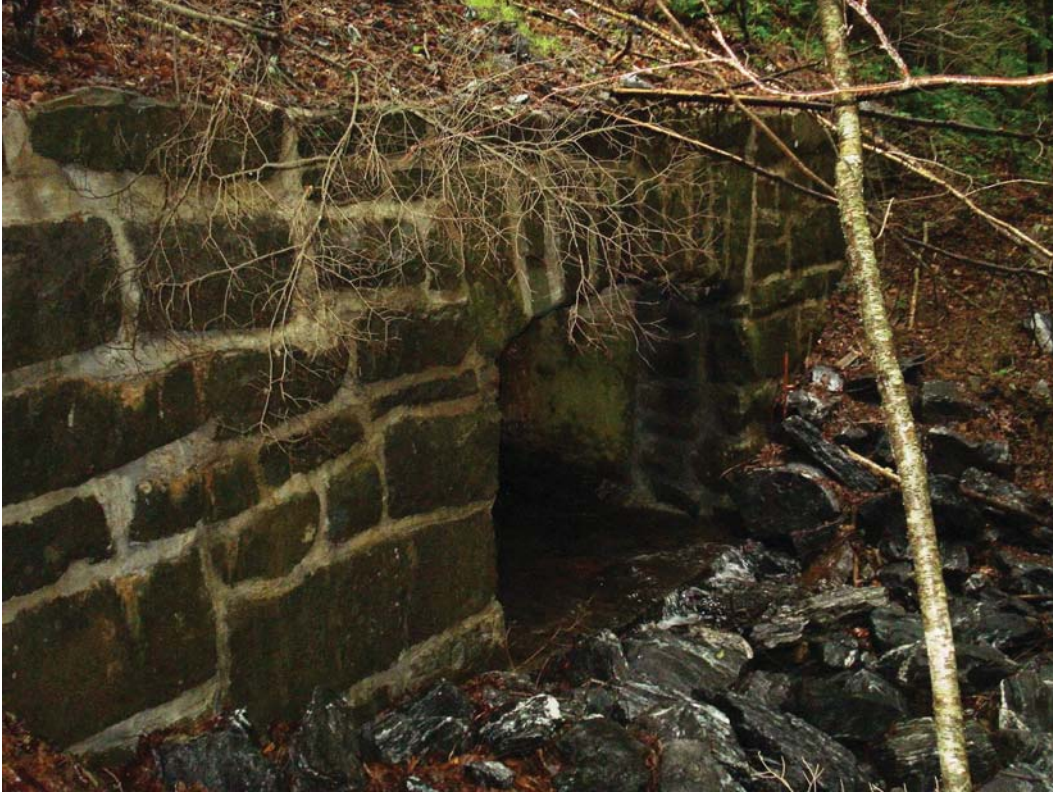
GRSM_0010S_20.260_L_1.jpg

Wall ID:	GRSM-0010S-20.260-L		
Route Name:	NEWFOUND GAP ROAD SOUTH		
Inspection Date:	June 15, 2007	Approximate Year Built:	1938
*Wall Rating:	95	Maintenance Action:	No Action

Wall Function:	Head Wall	Primary Wall Type:	Gravity - Mortared Stone
Surface Treatment:		Secondary Wall Type:	
Secondary Surface Treatment:		Architectural Facing:	
General Description:	GM outlet headwall constructed along northbound travel lane of high ADT roadway low consequence of failure

Element (Weighting Factor)	Narrative	Condition Rating (0 - 10)
PERFORMANCE 8.00	Good to excellent performance overall	9
WALL FOUNDATION MATERIAL 8.00	No distress; no evidence of settlement or rotation	9
MORTAR 8.00	Wall appears to have been recently repointed	10
STONE MASONRY 8.00	No distress	10
DOWNSLOPE 0.50	No distress; riprap lined channel extends away from wall	9
LATERAL SLOPE 0.50	No distress	9
WALL DRAINS 0.50	No evidence of drainage-related issues	9
CULVERT 0.50	No distress	10
ROAD/SIDEWALK/SHOULDER 0.50	No distress to roadway or relatively level grassy shoulder	10

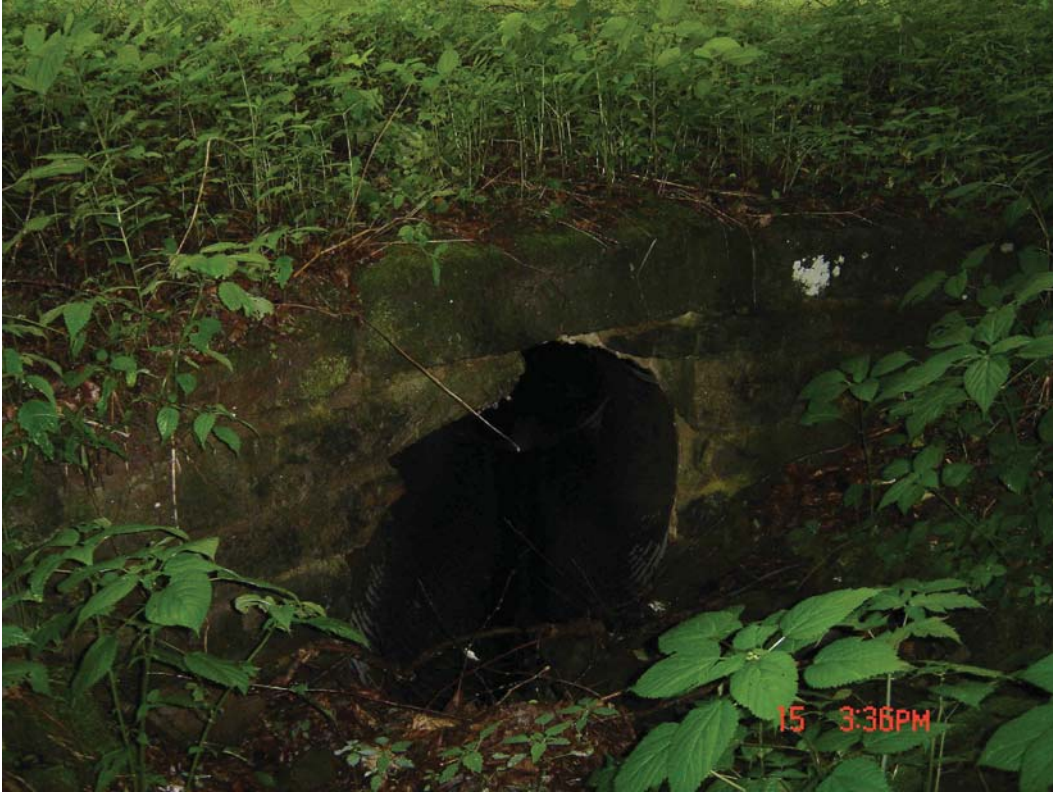
GRSM_0010S_20.388_R_1.jpg

Wall ID:	GRSM-0010S-20.388-R		
Route Name:	NEWFOUND GAP ROAD SOUTH		
Inspection Date:	June 15, 2007	Approximate Year Built:	1938
*Wall Rating:	83	Maintenance Action:	Maintenance

Wall Function:	Head Wall	Primary Wall Type:	Gravity - Mortared Stone
Surface Treatment:		Secondary Wall Type:	
Secondary Surface Treatment:		Architectural Facing:	
General Description:	GM inlet headwall for 40 in diameter CMP culvert with a bitumen lining along southbound travel lane of high ADT roadway moderate consequence of failure

Element (Weighting Factor)	Narrative	Condition Rating (0 - 10)
PERFORMANCE 8.00	Good overall performance; minor degradation of mortar	8
WALL FOUNDATION MATERIAL 8.00	No distress; no evidence of settlement or rotation	9
MORTAR 8.00	General age-related distress; minor spalling around the culvert opening	8
STONE MASONRY 8.00	Minor debonding	8
DOWNSLOPE 0.50	Creek bed; minor accumulation of debris at culvert inlet	8
VEGETATION 0.50	Several medium diameter trees within 3 ft of wall along base and top of wall; trees do not appear to be affecting wall performance	8
WALL DRAINS 0.50	No evidence of drainage related distress	8
CULVERT 0.50	No distress	9
LATERAL SLOPE 0.50	No distress	9

Failure Consequence:	MODERATE
Recommendation Narrative:	Stone Masonry Repointing - 1.13 sqft (\$75/sqft) = \$84.56. Clear Debris from Inlet - 8 labor hrs (\$55/hr) = \$220.
Repair Cost:	\$305

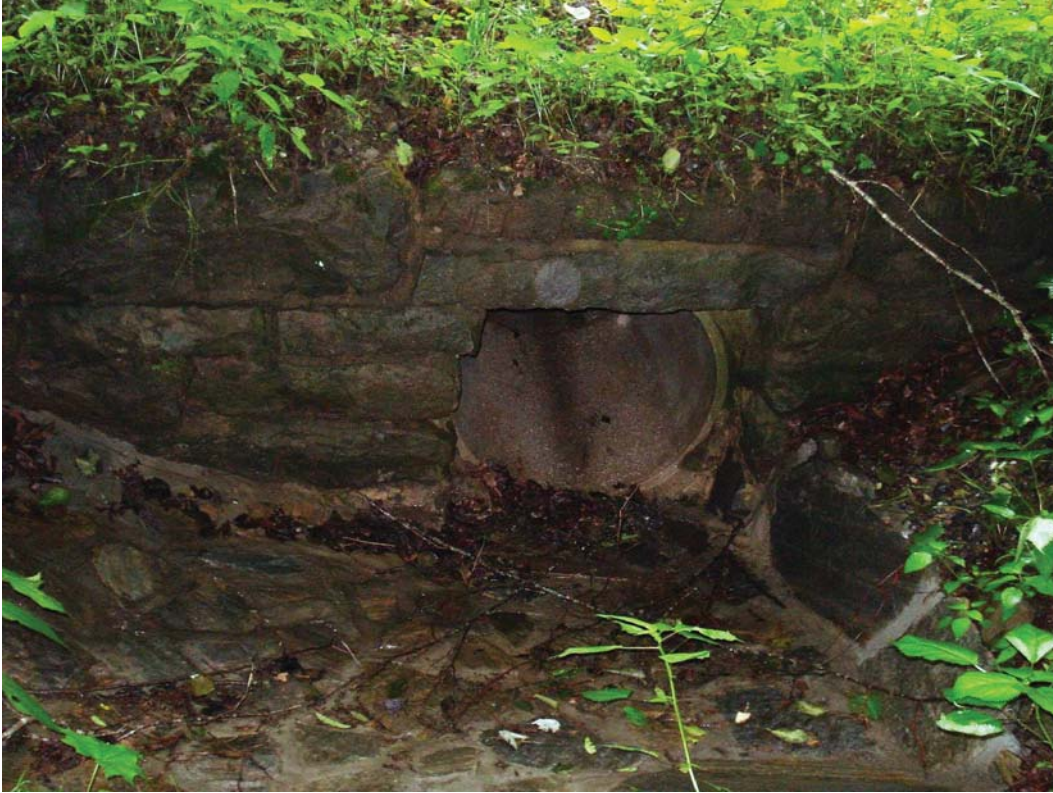
GRSM_0010S_20.832_R_1.jpg

Wall ID:	GRSM-0010S-20.832-R		
Route Name:	NEWFOUND GAP ROAD SOUTH		
Inspection Date:	June 15, 2007	Approximate Year Built:	1938
*Wall Rating:	91	Maintenance Action:	No Action

Wall Function:	Head Wall	Primary Wall Type:	Gravity - Mortared Stone
Surface Treatment:		Secondary Wall Type:	
Secondary Surface Treatment:		Architectural Facing:	
General Description:	GM inlet headwall for a 36 in diameter concrete culvert constructed along southbound travel lane of high ADT roadway moderate consequence of failure

Element (Weighting Factor)	Narrative	Condition Rating (0 - 10)
PERFORMANCE 8.00	Good to excellent performance	9
WALL FOUNDATION MATERIAL 8.00	No distress; no evidence of settlement or rotation	9
MORTAR 8.00	Wall appears to have been recently repointed	9
STONE MASONRY 8.00	No distress	9
ROAD/SIDEWALK/SHOULDER 0.50	No asphalt pavement with no distress; no distress to relatively level grassy shoulder	9
WALL DRAINS 0.50	No evidence of drainage-related distress	9
CULVERT 0.50	No distress	10
CURB/BERM/DITCH 0.50	No distress to relatively new GM ditch	10
DOWNSLOPE 0.50	No distress	10

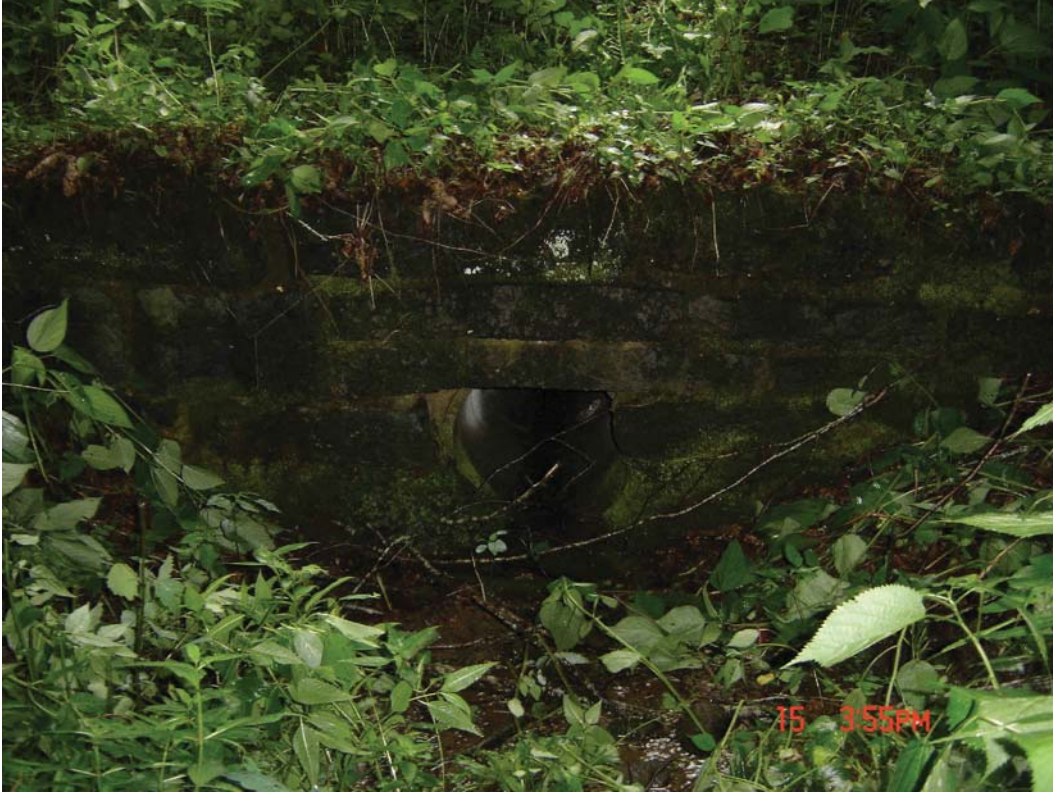
GRSM_0010S_20.988_R_1.jpg

Wall ID:	GRSM-0010S-20.988-R		
Route Name:	NEWFOUND GAP ROAD SOUTH		
Inspection Date:	June 15, 2007	Approximate Year Built:	1938
*Wall Rating:	85	Maintenance Action:	No Action

Wall Function:	Head Wall	Primary Wall Type:	Gravity - Mortared Stone
Surface Treatment:		Secondary Wall Type:	
Secondary Surface Treatment:		Architectural Facing:	
General Description:	GM inlet headwall for an 18 in diameter concrete pipe culvert along southbound travel lane of high ADT roadway moderate consequence of failure

Element (Weighting Factor)	Narrative	Condition Rating (0 - 10)
PERFORMANCE 8.00	Good performance	8
WALL FOUNDATION MATERIAL 8.00	No distress; no evidence of settlement or rotation	9
STONE MASONRY 8.00	Minor debonding	8
MORTAR 8.00	General age-related distress	9
CULVERT 0.50	18-in diameter concrete pipe culvert	8
DOWNSLOPE 0.50	No distress; moderately vegetated creek channel	8
LATERAL SLOPE 0.50	No distress	9
UPSLOPE 0.50	No distress to gently sloping vegetated slope	9
WALL DRAINS 0.50	No evidence of drainage-related issues	9
