NPS Retaining Wall Inventory Program Great Smoky Mountains National Park

**Federal Lands Highway
Road Inventory Program**

Federal Highway Administration
Eastern Federal Lands Highway Division
Road Inventory Program (RIP)

Data Collection Date: April 2011
Report Date: November 2015

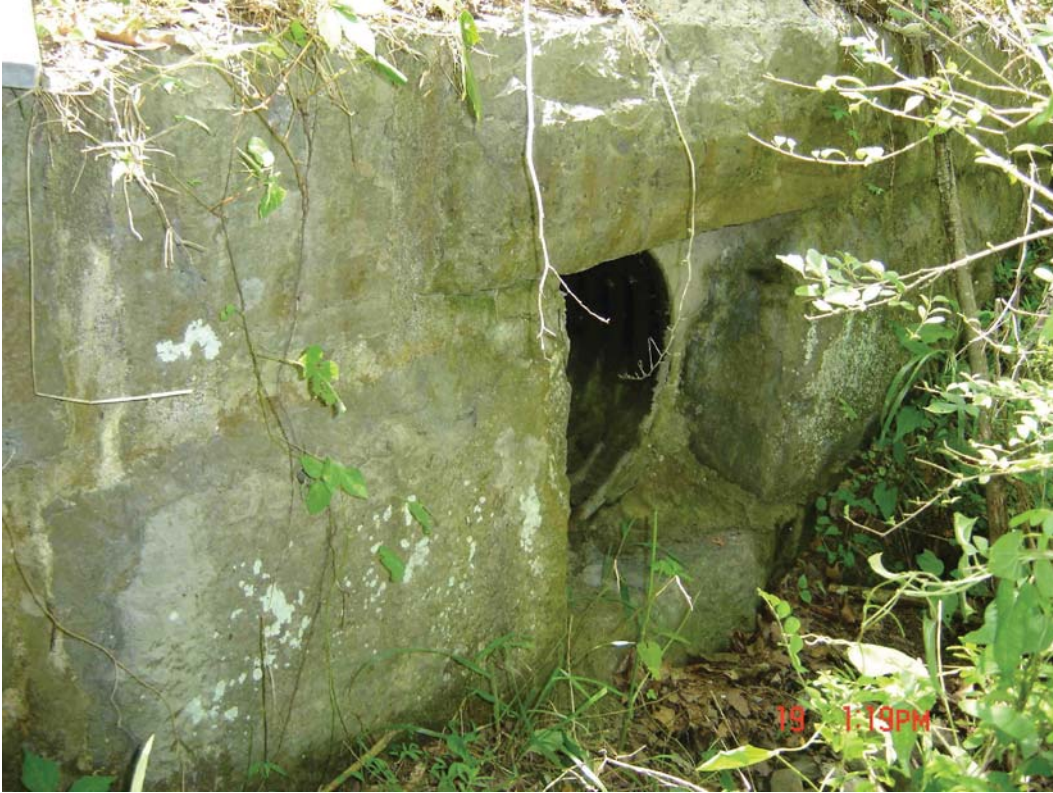
GRSM_0011S_0.460_L_1.jpg

Retaining Wall Condition Photos

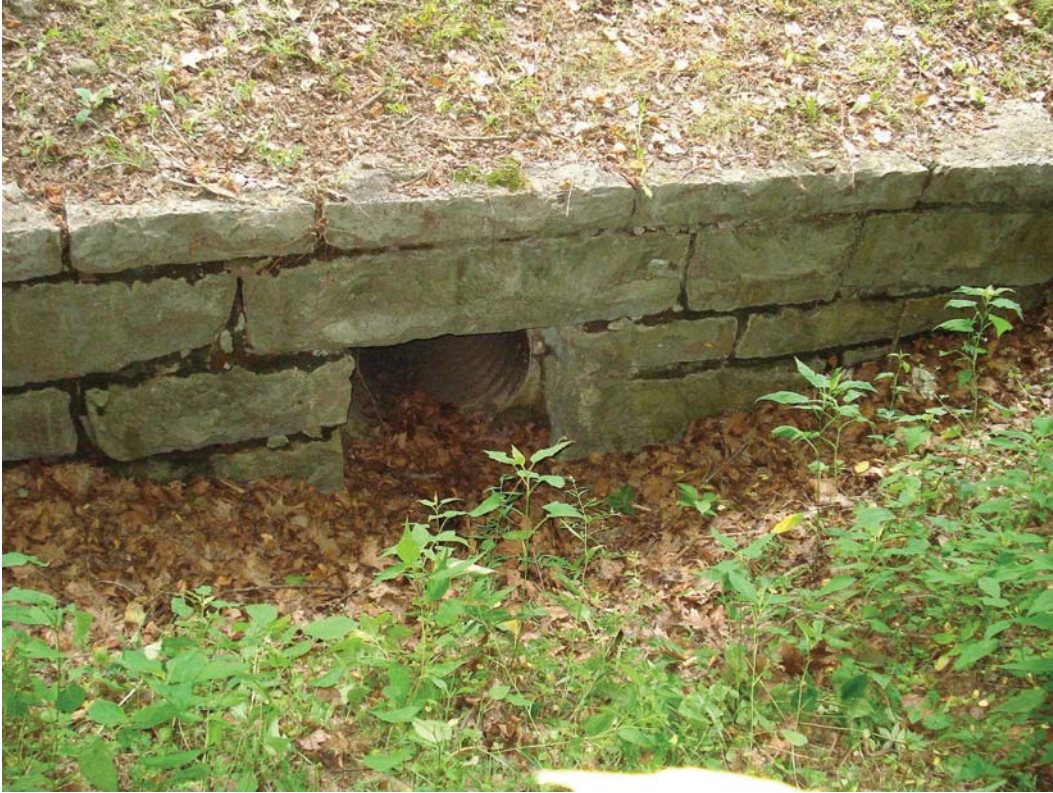
GRSM_0011S_0.610_R_1.jpg

Retaining Wall Condition Photos

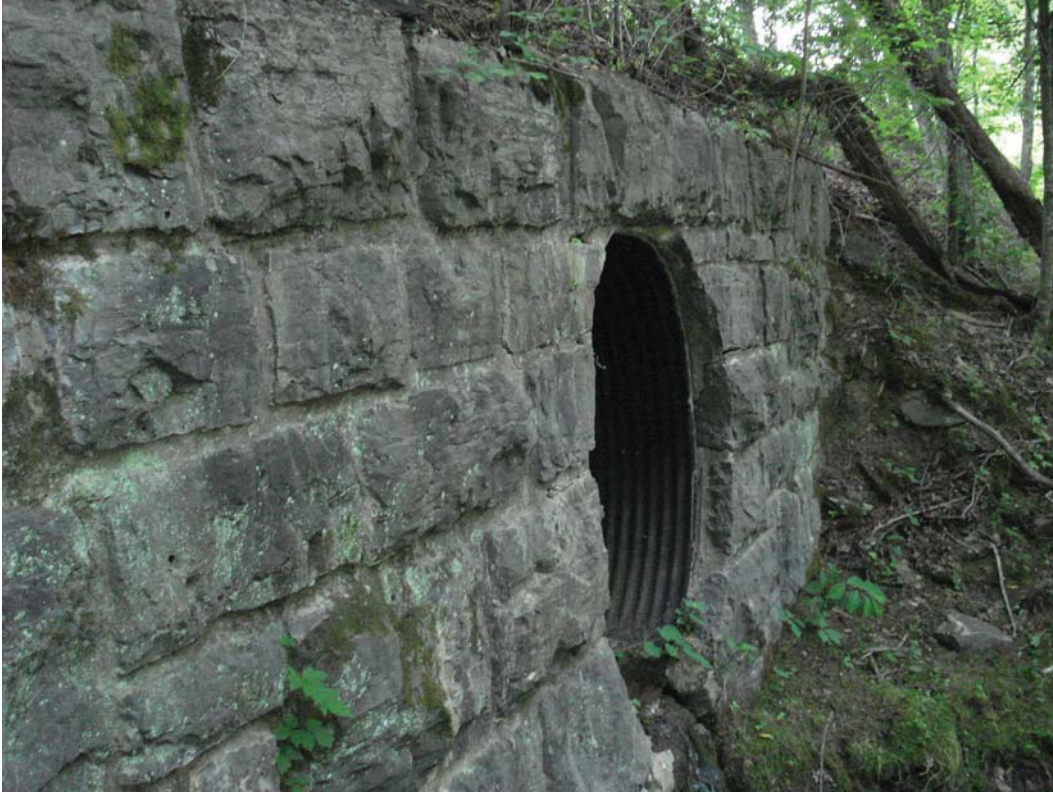
GRSM_0011S_0.905_L_1.jpg

Retaining Wall Condition Photos

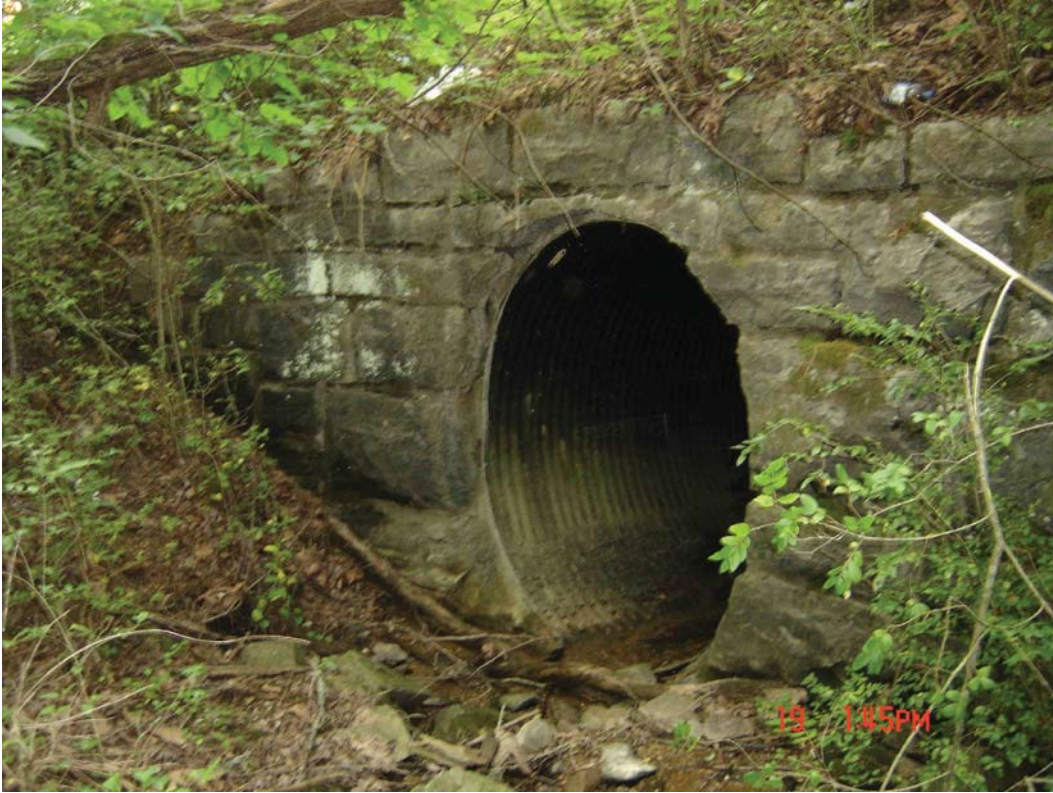
GRSM_0011S_0.905_R_1.jpg

Retaining Wall Condition Photos

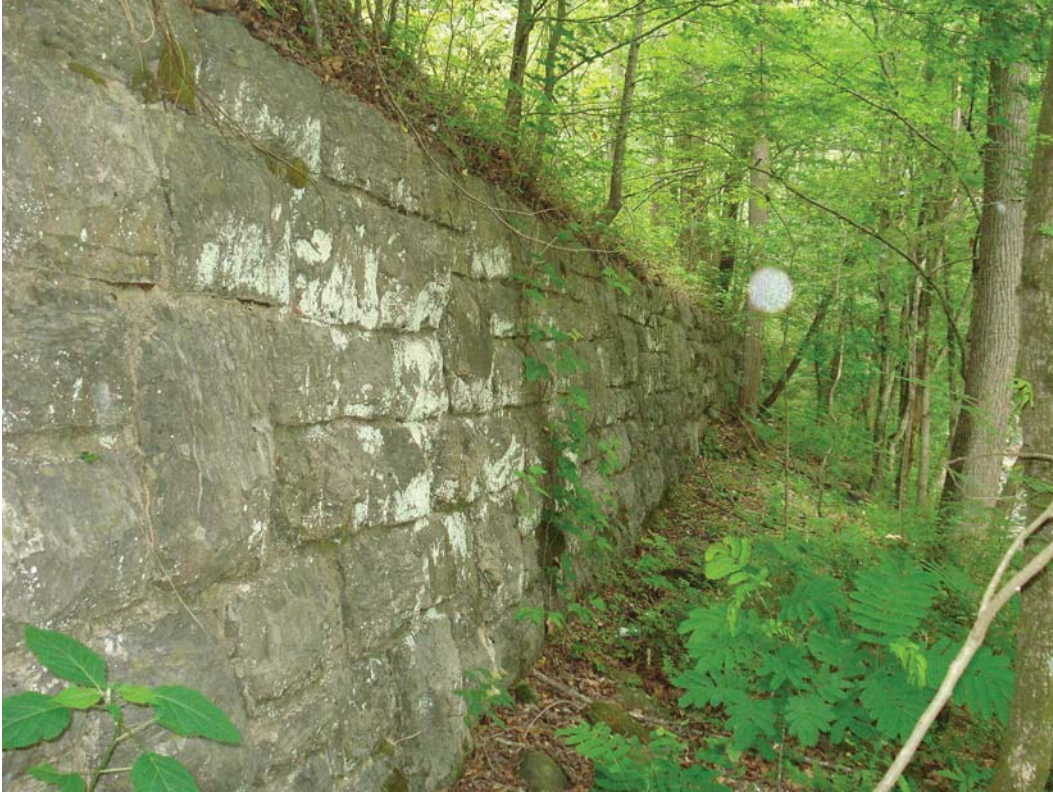
GRSM_0011S_1.190_L_1.jpg

Retaining Wall Condition Photos

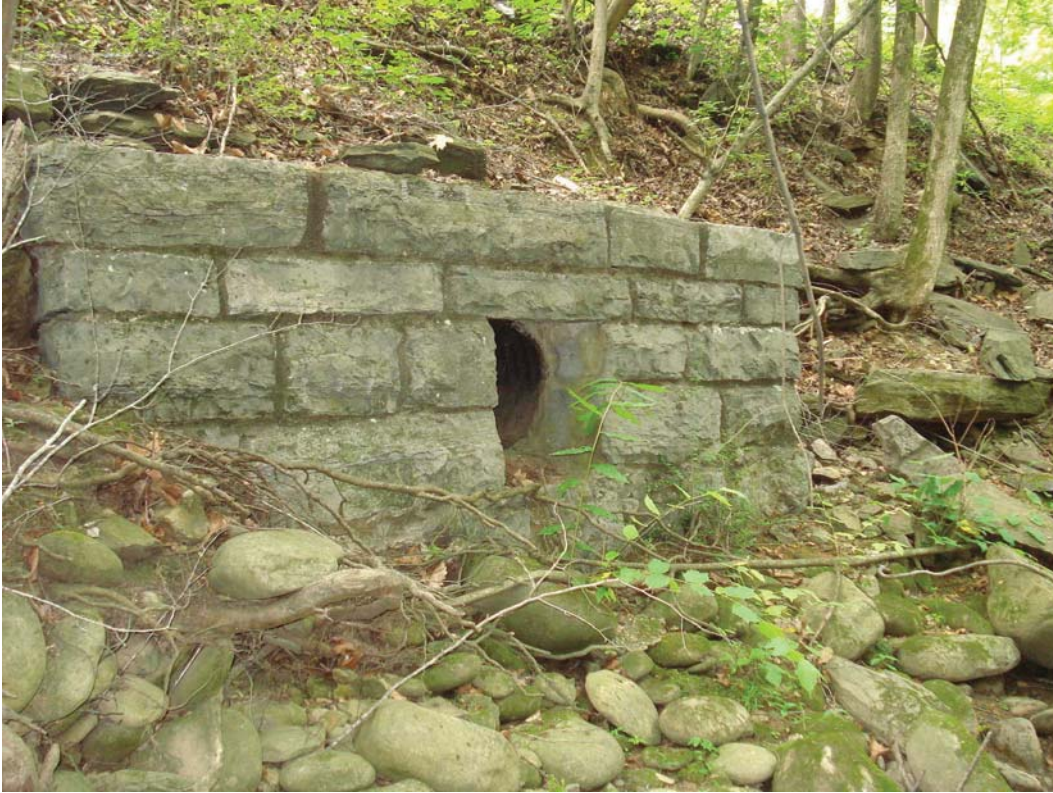
GRSM_0011S_1.362_L_1.jpg

Retaining Wall Condition Photos

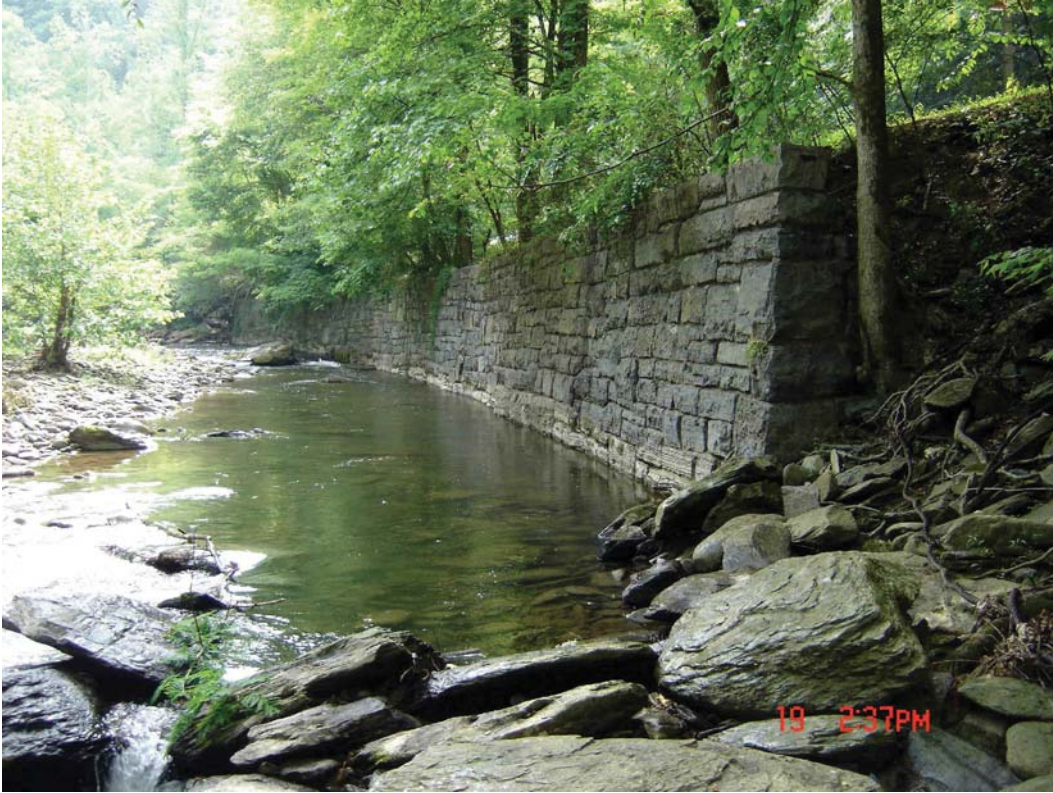
GRSM_0011S_1.416_L_1.jpg

Retaining Wall Condition Photos

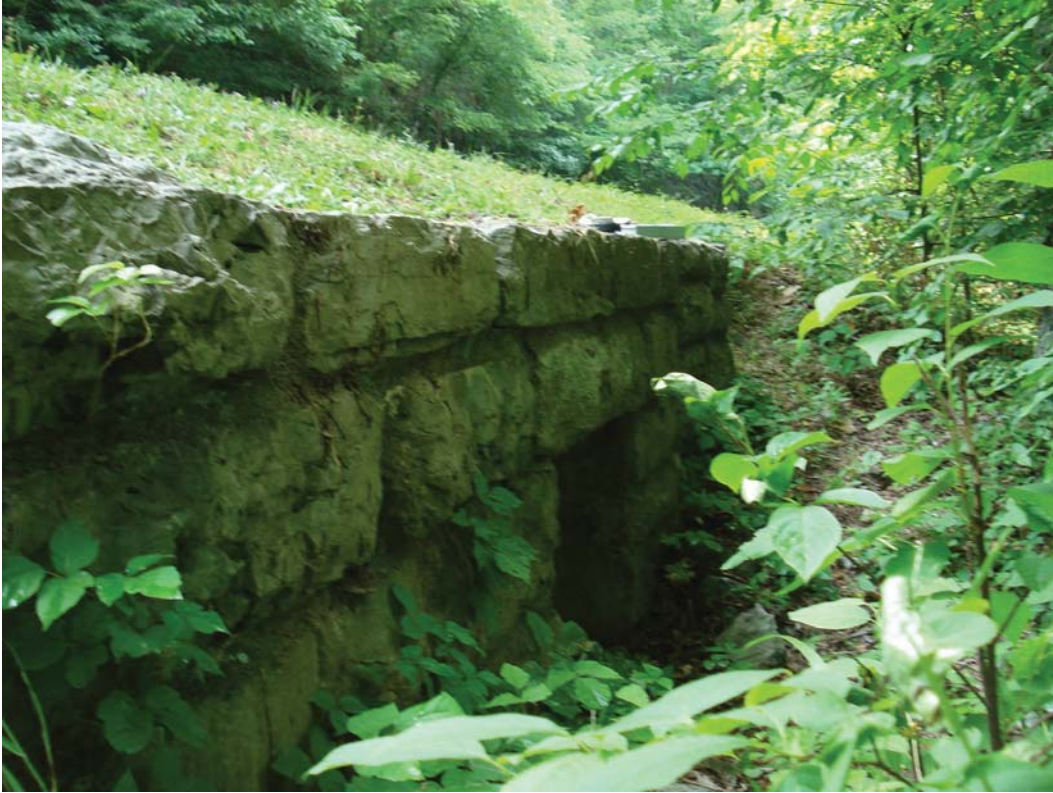
GRSM_0011S_1.580_L_1.jpg

Retaining Wall Condition Photos

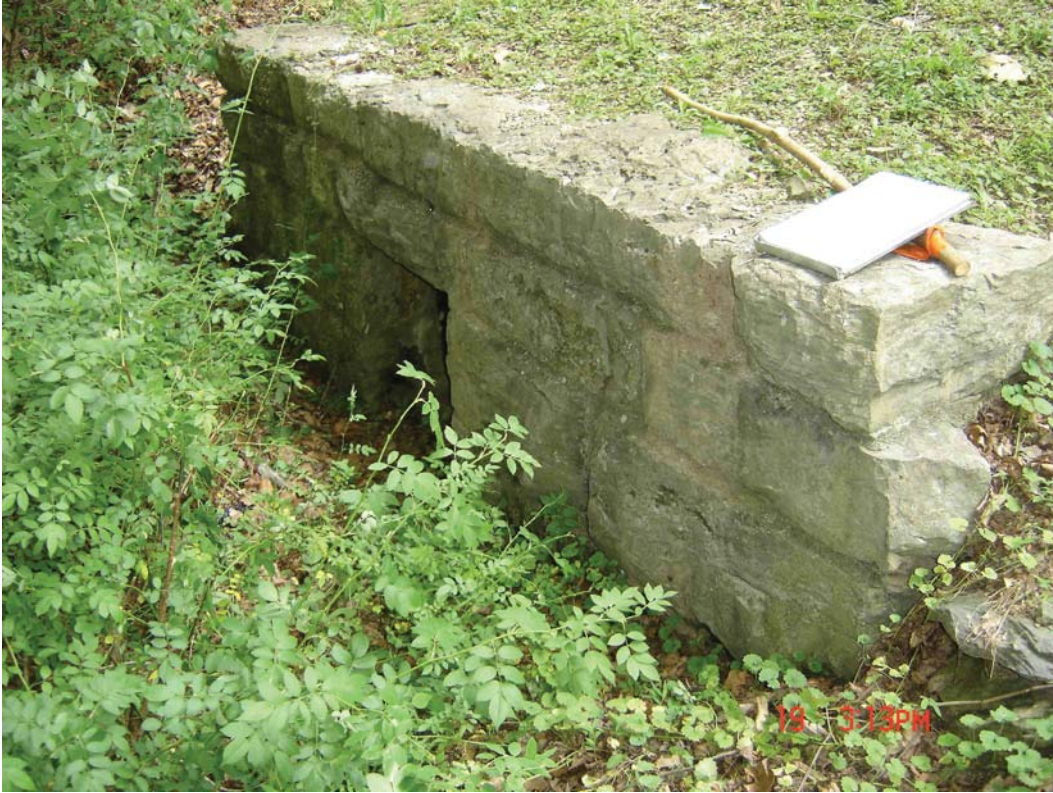
GRSM_0011S_1.682_L_1.jpg

Retaining Wall Condition Photos

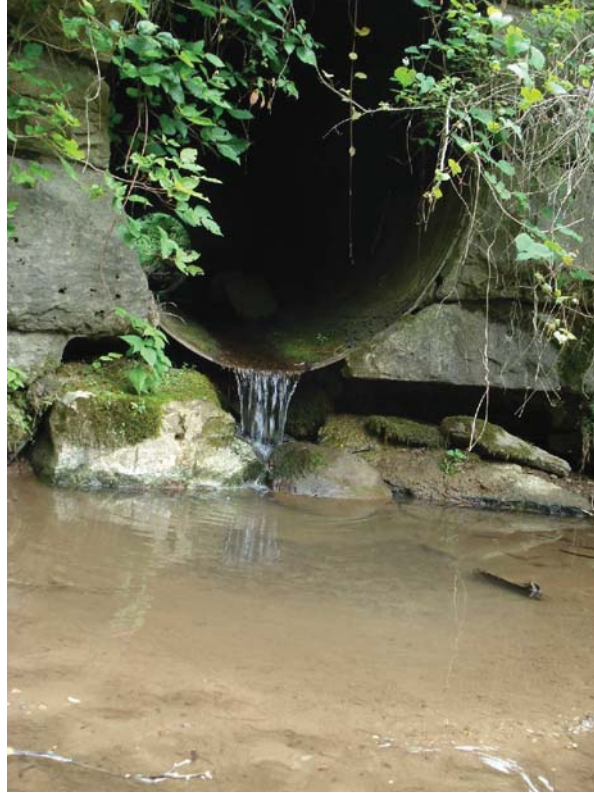
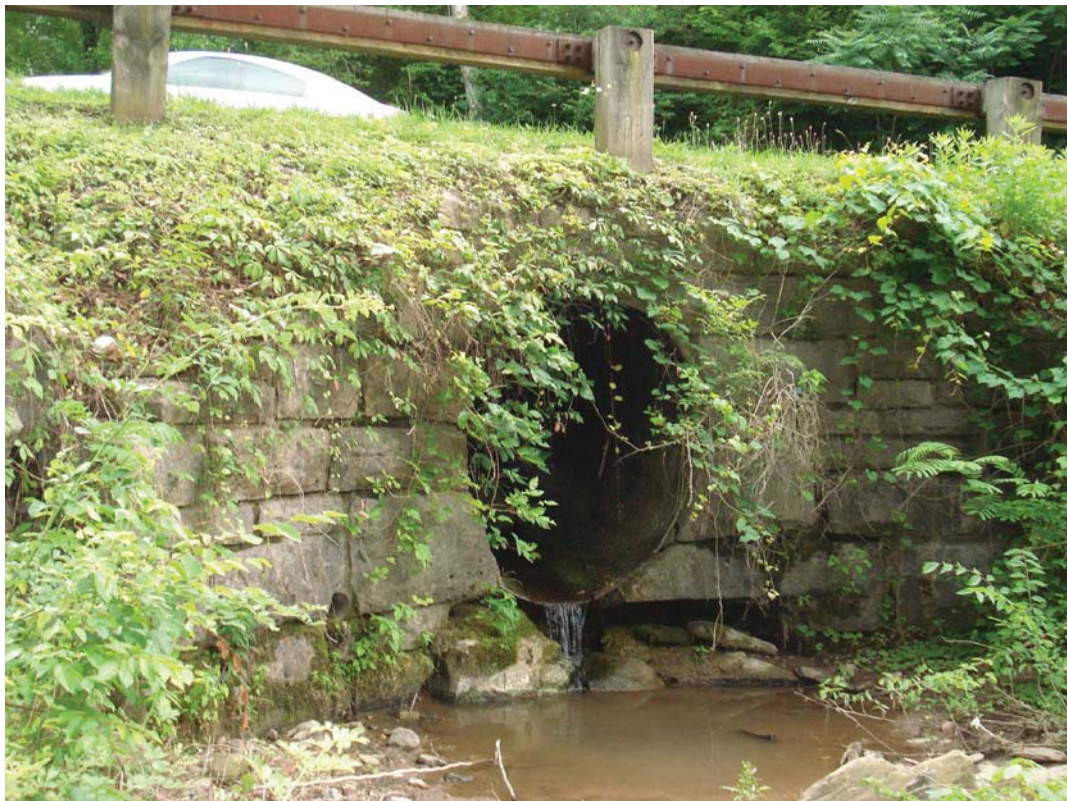
GRSM_0011S_1.852_L_1.jpg

Wall Function:	Head Wall	Primary Wall Type:	Gravity - Mortared Stone
Surface Treatment:		Secondary Wall Type:	
Secondary Surface Treatment:		Architectural Facing:	
General Description:	GM outlet headwall for a 70 in diameter bitumen lined CMP constructed along the eastern shoulder of a high ADT roadway and along the west bank of the West Prong Little Pigeon River high consequence of failure

TRAFFIC BARRIER/FENCE 0.50	No distress; steel backed timber guard rail	10
CULVERT 1.00	70-in. diameter CMP with a bitumen lining; major degradation of lining leading to minor to moderate rusting of pipe	7

Retaining Wall Condition Photos

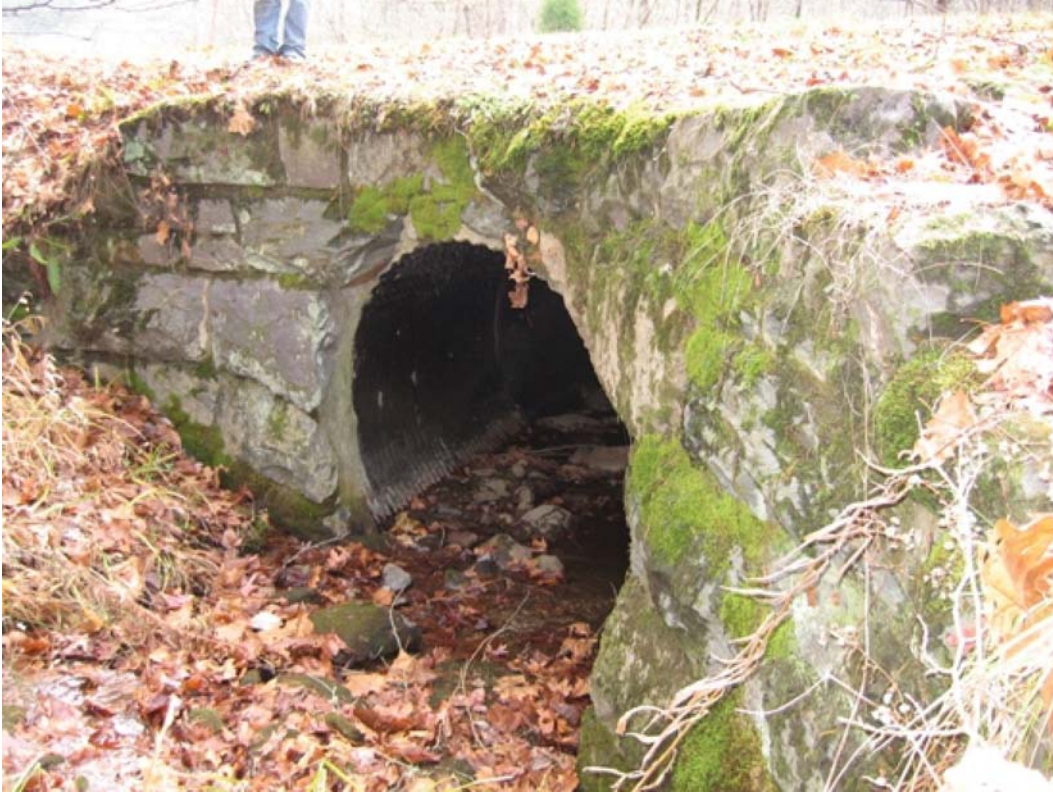
GRSM_0013ZZ_1.592_R_1.jpg

Wall ID:	GRSM-0013ZZ-1.592-R		
Route Name:	FIGHTING CREEK GAP ROAD AND SPUR		
Inspection Date:	November 27, 2007	Approximate Year Built:	1930
*Wall Rating:	82	Maintenance Action:	No Action

Element (Weighting Factor)	Narrative	Condition Rating (0 - 10)
PERFORMANCE 8.00	Good condition with moderate surface erosion on lateral slopes.	8
WALL FOUNDATION MATERIAL 8.00	Solid granular material in active alluvial stream channel, no signs of undermining or settlement.	9
MORTAR 8.00	Minor unbonding, minor cracking, performing as intended.	7
STONE MASONRY 8.00	Limestone cut blocks, 6-inches to 3-feet, moss covered, good performance.	9
CULVERT 0.50	5-foot CMP, minor to moderate corrosion, performing as intended.	8
UPSLOPE 0.50	Active alluvial stream channel, no signs of impact to wall.	8
ROAD/SIDEWALK/SHOULDER 0.50	Road has minor cracking, not associated with the wall. Shoulder is about 4H:1V grassy slope, good condition.	9
WALL DRAINS 0.50	None observed, not impacting wall function.	9
LATERAL SLOPE 1.00	Moderate surface erosion at steep slopes about 1.5H:1V, minor erosion at the end of the wall.	7

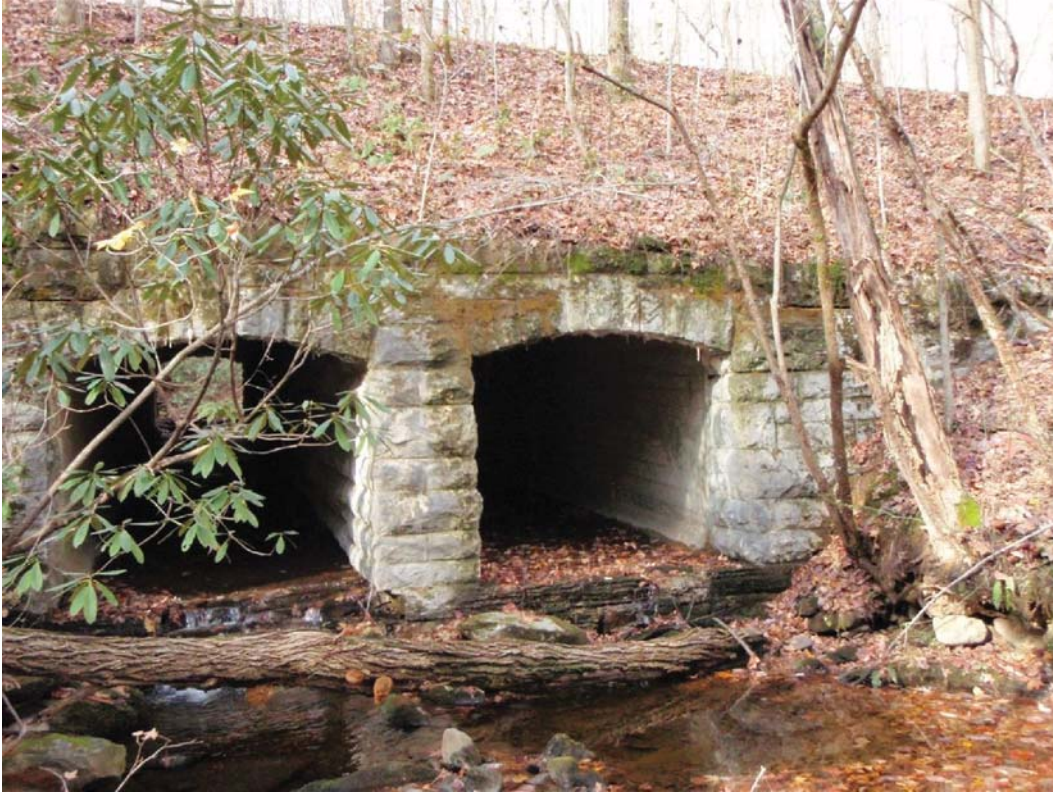
GRSM_0013ZZ_1.915_L_1.jpg

Wall ID:	GRSM-0013ZZ-1.915-L		
Route Name:	FIGHTING CREEK GAP ROAD AND SPUR		
Inspection Date:	November 27, 2007	Approximate Year Built:	1930
*Wall Rating:	90	Maintenance Action:	No Action

Element (Weighting Factor)	Narrative	Condition Rating (0 - 10)
PERFORMANCE 8.00	As designed.	9
WALL FOUNDATION MATERIAL 8.00	Firm soil.	9
MORTAR 8.00	Good conditions, no distress, some moss.	9
STONE MASONRY 8.00	Some moss, good condition.	9
DOWNSLOPE 0.50	Shallow, forested slope.	9
LATERAL SLOPE 0.50	Treed embankment fill slope appears stable.	9
ROAD/SIDEWALK/SHOULDER 0.50	Treed shoulder appears stable.	9
WALL DRAINS 0.50	No distress.	9

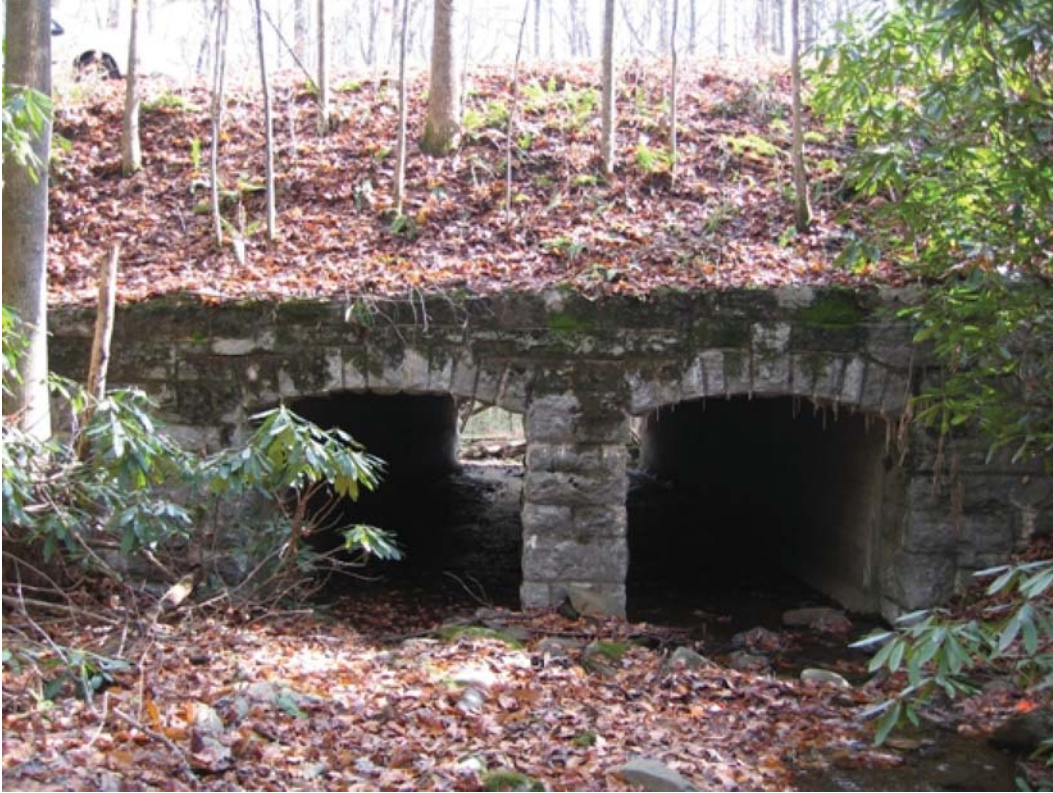
GRSM_0013ZZ_1.917_R_1.jpg

Wall ID:	GRSM-0013ZZ-1.917-R		
Route Name:	FIGHTING CREEK GAP ROAD AND SPUR		
Inspection Date:	November 27, 2007	Approximate Year Built:	1930
*Wall Rating:	87	Maintenance Action:	No Action

Element (Weighting Factor)	Narrative	Condition Rating (0 - 10)
PERFORMANCE 8.00	Good condition, performing as intended.	9
WALL FOUNDATION MATERIAL 8.00	Solid granular material, no signs of distress.	9
MORTAR 8.00	Minor unbonding, minor cracking and spalling.	8
STONE MASONRY 8.00	Limestone cut 1-foot by 2-foot blocks, hard, strong, moss covered, CaCO ₃ staining.	9
LATERAL SLOPE 0.50	About 1.5H:1V slope, well vegetated, minor surface erosion.	8
ROAD/SIDEWALK/SHOULDER 0.50	Road has minor cracking, not from wall. Shoulder has about 2H:1V slope down to top of headwall, grassy with trees.	8
CULVERT 0.50	Two CBC's, 8-feet wide by 7-feet high, minor corrosion, performing as intended.	9
UPSLOPE 0.50	Active alluvial channel with cobbles and boulders, not impacting wall.	9
WALL DRAINS 0.50	None observed, not impacting wall performance.	9

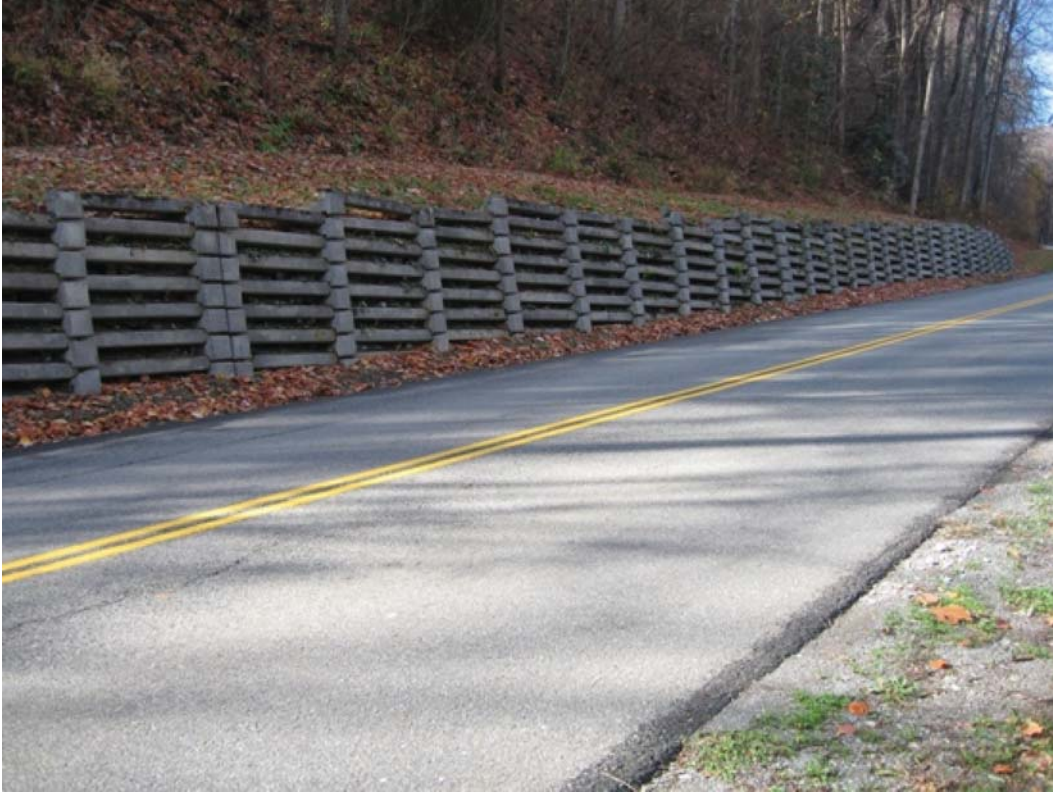
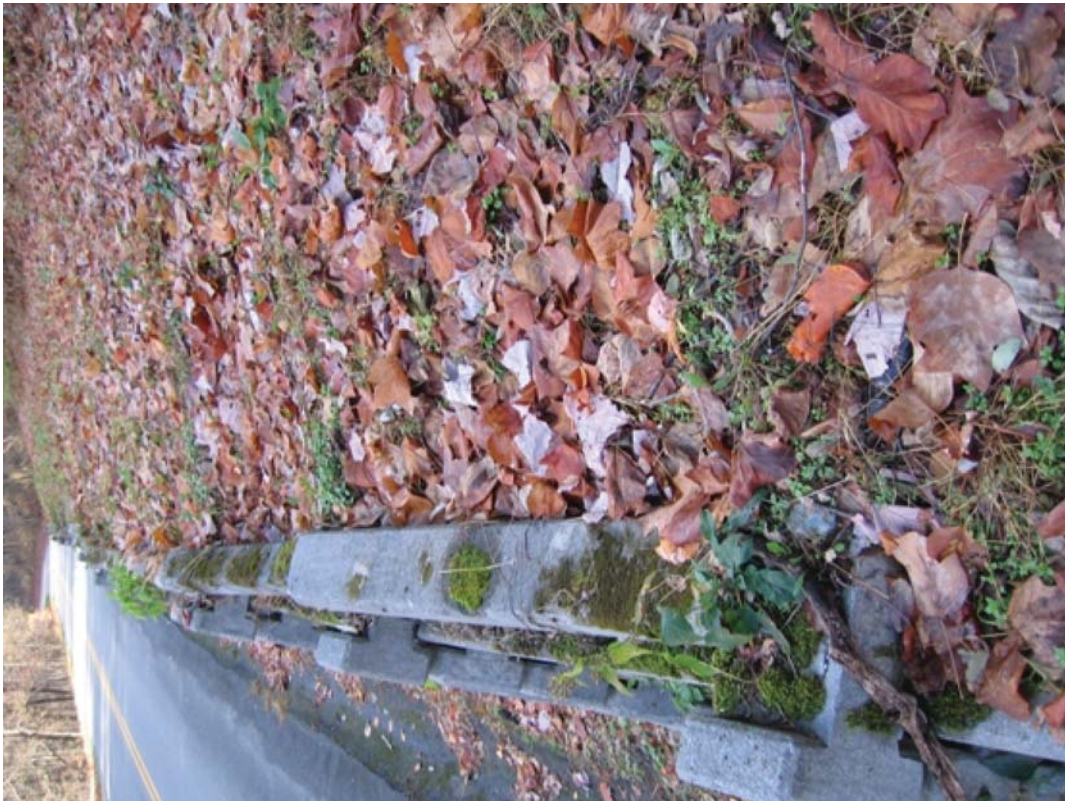
GRSM_0013ZZ_3.115_L_1.jpg

Wall ID:	GRSM-0013ZZ-3.115-L		
Route Name:	FIGHTING CREEK GAP ROAD AND SPUR		
Inspection Date:	November 27, 2007	Approximate Year Built:	1930
*Wall Rating:	74	Maintenance Action:	Maintenance

Element (Weighting Factor)	Narrative	Condition Rating (0 - 10)
PERFORMANCE 8.00	Fair to good condition with displaced top elements and erosion of backfill material, performing as intended.	7
WALL FOUNDATION MATERIAL 8.00	Solid granular material, embedment anticipated, good performance.	9
BIN OR CRIB 8.00	Concrete crib, moderate pitting throughout, top run displaced at several locations from settlement of rock backfill materials, at two isolated locations compression break at the top crib.	6
CURB/BERM/DITCH 0.50	Ditch paved in front of the wall, good slope, performing as intended.	9
LATERAL SLOPE 0.50	Tapers to ends of wall with no lateral slopes, no impact on wall.	9
ROAD/SIDEWALK/SHOULDER 0.50	Road has minor cracking not associated with wall.	9
VEGETATION 0.50	Minor vegetation at the face, helps stabilize the sandy backfill material.	9
WALL DRAINS 0.50	None observed, not impacting wall (rock backfill is free-draining).	9

Failure Consequence:	HIGH
Recommendation Narrative:	Add riprap at top of wall : 5'x150'x2' = 1,500 ft ³ = 56cyd x \$60/cyd (structure backfill - item #20803) = \$3,360. Markers at \$55/hr x 2 people x 2 hrs = \$220. Truck to haul material @ \$55/hr x 2 hrs = \$110. TOTAL = \$3,690
Repair Cost:	\$3,690

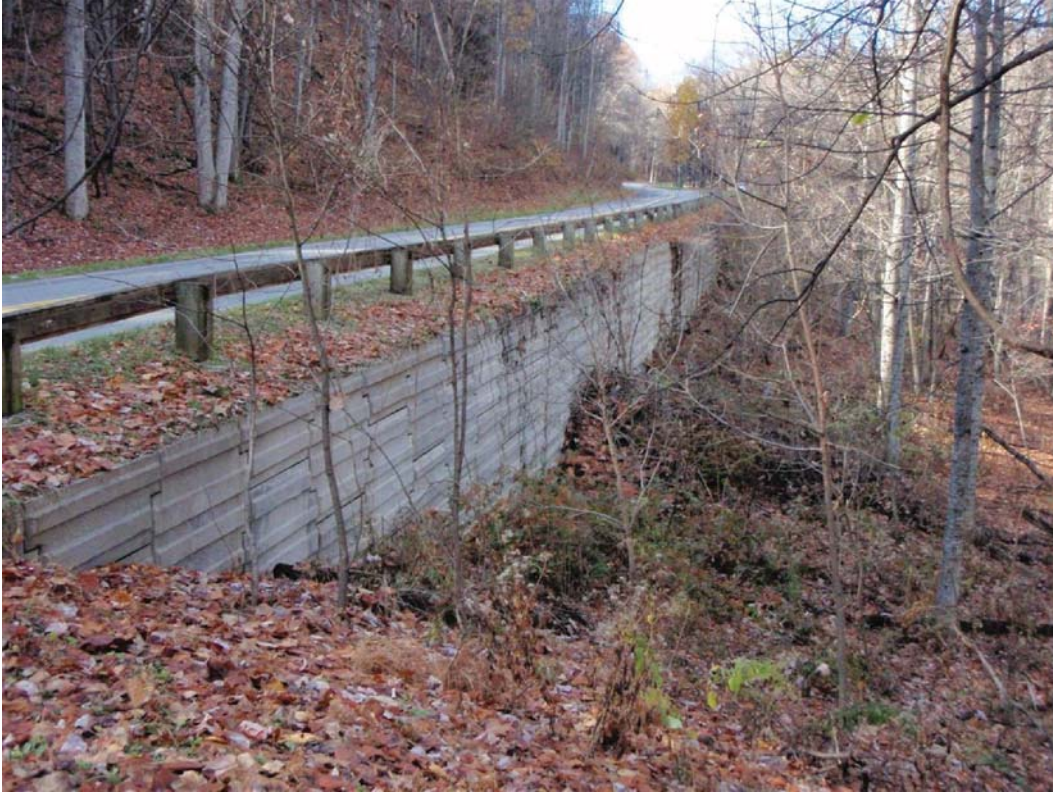
GRSM_0013ZZ_3.171_R_1.jpg

Wall ID:	GRSM-0013ZZ-3.171-R		
Route Name:	FIGHTING CREEK GAP ROAD AND SPUR		
Inspection Date:	November 27, 2007	Approximate Year Built:	1930
*Wall Rating:	90	Maintenance Action:	No Action

Element (Weighting Factor)	Narrative	Condition Rating (0 - 10)
PERFORMANCE 8.00	As designed.	9
WALL FOUNDATION MATERIAL 8.00	Firm soil.	9
CONCRETE 8.00	Facing concrete looks in good condition.	9
DOWNSLOPE 0.50	Steep forested slope, appears stable.	8
LATERAL SLOPE 0.50	Steep forested slope, appear stable.	8
WALL DRAINS 0.50	No distress.	9

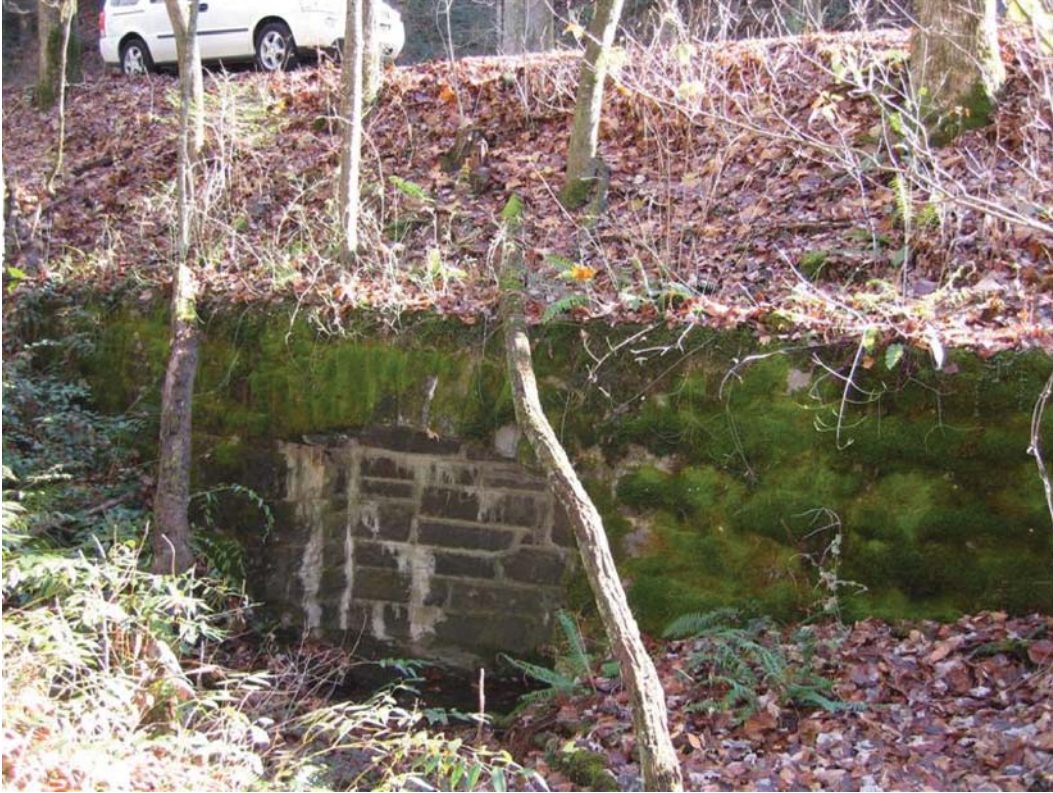
GRSM_0013ZZ_4.090_R_1.jpg

Wall ID:	GRSM-0013ZZ-4.090-R		
Route Name:	FIGHTING CREEK GAP ROAD AND SPUR		
Inspection Date:	November 27, 2007	Approximate Year Built:	1930
*Wall Rating:	80	Maintenance Action:	No Action

Element (Weighting Factor)	Narrative	Condition Rating (0 - 10)
PERFORMANCE 8.00	Good condition, covered with moss, but performing as intended.	8
WALL FOUNDATION MATERIAL 8.00	Solid granular material, alluvial stream channel, no signs of settlement or scour, good performance.	9
MORTAR 8.00	Minor unbonding in places, covered with moss throughout, minor cracking, performing as intended.	7
STONE MASONRY 8.00	Limestone cut stone (1'-3') blocks, strong, moss covered throughout, performing as intended.	8
CULVERT 0.50	8.5-foot wide by 6-foot high CBC (tapers to 6'x6' inside), moderate corrosion, CaCO3 stains, performing as intended.	8
LATERAL SLOPE 0.50	About 1.5H:1V steep slope with minor surface erosion, not impacting wall.	8
ROAD/SIDEWALK/SHOULDER 0.50	Road has no signs of distress. Shoulder is sloped at about 2H:1V, grassy with trees, good performance.	9
UPSLOPE 0.50	Active alluvial stream channel, sand and gravel, low slope angle about 3H:1V.	9

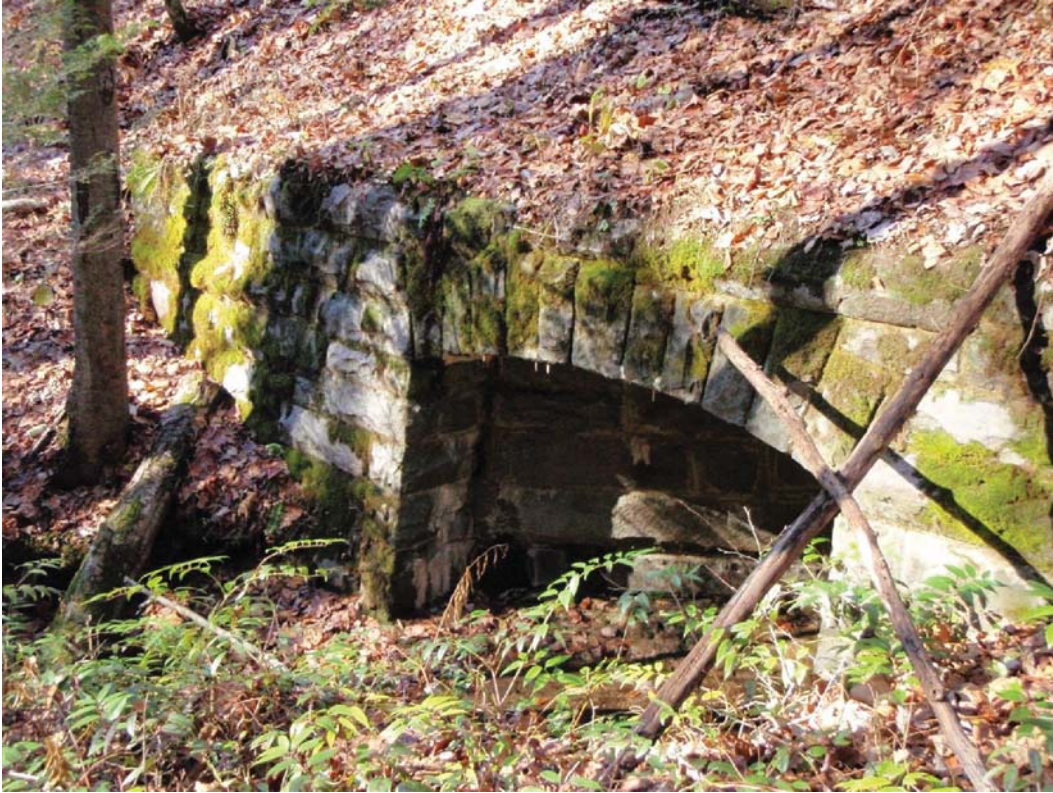
GRSM_0013ZZ_4.108_L_1.jpg

Wall ID:	GRSM-0013ZZ-4.108-L		
Route Name:	FIGHTING CREEK GAP ROAD AND SPUR		
Inspection Date:	November 27, 2007	Approximate Year Built:	1930
*Wall Rating:	82	Maintenance Action:	No Action

Element (Weighting Factor)	Narrative	Condition Rating (0 - 10)
PERFORMANCE 8.00	As required.	8
WALL FOUNDATION MATERIAL 8.00	Firm soil.	9
MORTAR 8.00	Mossy, no debonding or cracking observed	8
STONE MASONRY 8.00	Intact, competent, moss covered.	8
WALL DRAINS 0.50	No distress.	9
LATERAL SLOPE 1.00	Steep forested slope, some possible creep and little raveling.	7
ROAD/SIDEWALK/SHOULDER 1.00	Shoulder is steep, but forested, some possible creep with little raveling.	7

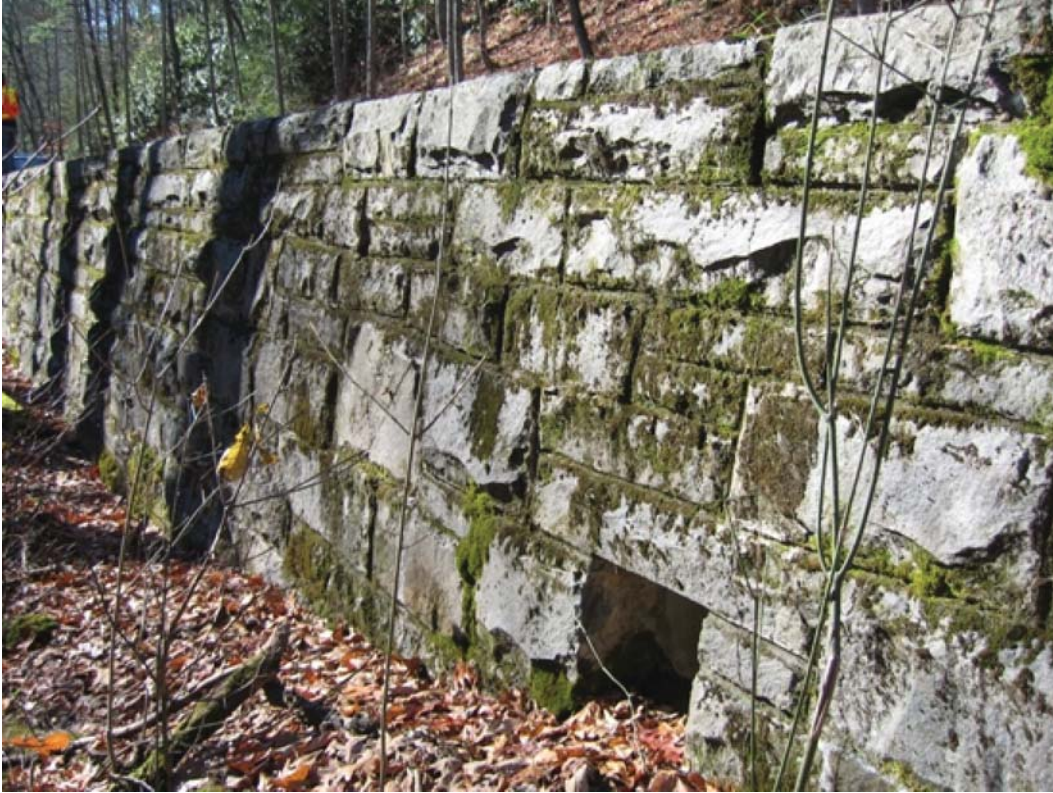
GRSM_0013ZZ_4.181_L_1.jpg

Wall ID:	GRSM-0013ZZ-4.181-L		
Route Name:	FIGHTING CREEK GAP ROAD AND SPUR		
Inspection Date:	November 27, 2007	Approximate Year Built:	1930
*Wall Rating:	85	Maintenance Action:	No Action

Element (Weighting Factor)	Narrative	Condition Rating (0 - 10)
PERFORMANCE 8.00	Good condition, performing as intended.	8
WALL FOUNDATION MATERIAL 8.00	Solid granular materials, no signs of distress.	9
MORTAR 8.00	Minor cracking and spalling, minor to moderate unbonding, moss covered.	8
STONE MASONRY 8.00	Limestone cut stone blocks 2-feet by 1-foot, strong, moss covered.	9
CULVERT 0.50	24-inch diameter concrete pipe, minor corrosion.	8
LATERAL SLOPE 0.50	Tapers to adjacent slopes at 1.5H:1V to 2H:1V slope, not impacting wall performance.	8
DOWNSLOPE 0.50	3-foot wide bench, 1.5H:1V slope down below, good condition.	9
ROAD/SIDEWALK/SHOULDER 0.50	Road has no signs of distress.	9
WALL DRAINS 0.50	None observed, not impacting wall performance.	9

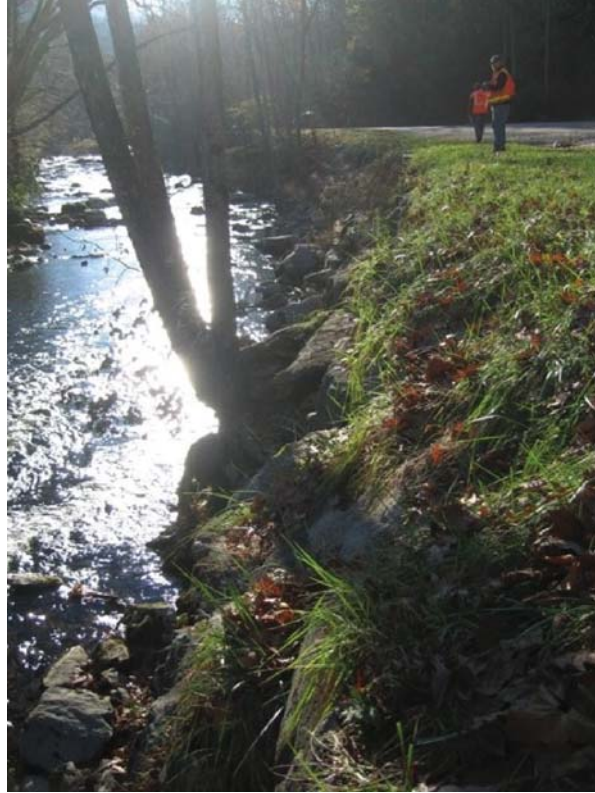
GRSM_0014_0.130_L_1.jpg

Wall ID:	GRSM-0014-0.130-L		
Route Name:	LITTLE RIVER GORGE ROAD		
Inspection Date:	November 27, 2007	Approximate Year Built:	1930
*Wall Rating:	76	Maintenance Action:	No Action

Element (Weighting Factor)	Narrative	Condition Rating (0 - 10)
PERFORMANCE 8.00	Good condition with occasional missing elements at the end of the wall.	8
WALL FOUNDATION MATERIAL 8.00	Solid granular boulders and gravel, active stream channel, scour potential, but no signs of movement.	8
MORTAR 8.00	Concrete mortar, minor cracking and spalling, occasional unbonding.	7
PLACED STONE 8.00	1-3' diameter limestone boulders, occasional loose at the top layer, functioning as intended.	8
WALL DRAINS 0.50	None observed, not impacting wall performance.	9
LATERAL SLOPE 1.00	At end of wall, missing stones from heavy erosion.	5
DOWNSLOPE 1.00	Active stream channel, minor scour, not impacting performance.	7
ROAD/SIDEWALK/SHOULDER 1.00	Wall is located at the edge of a paved shoulder, no signs of distress. Shoulder has about 6-8-foot wide grassy flat bench with occasional voids and soft spots.	7
VEGETATION 1.00	Occasional bushes and trees, pushing out the base of the wall, but stabilizing the top.	7

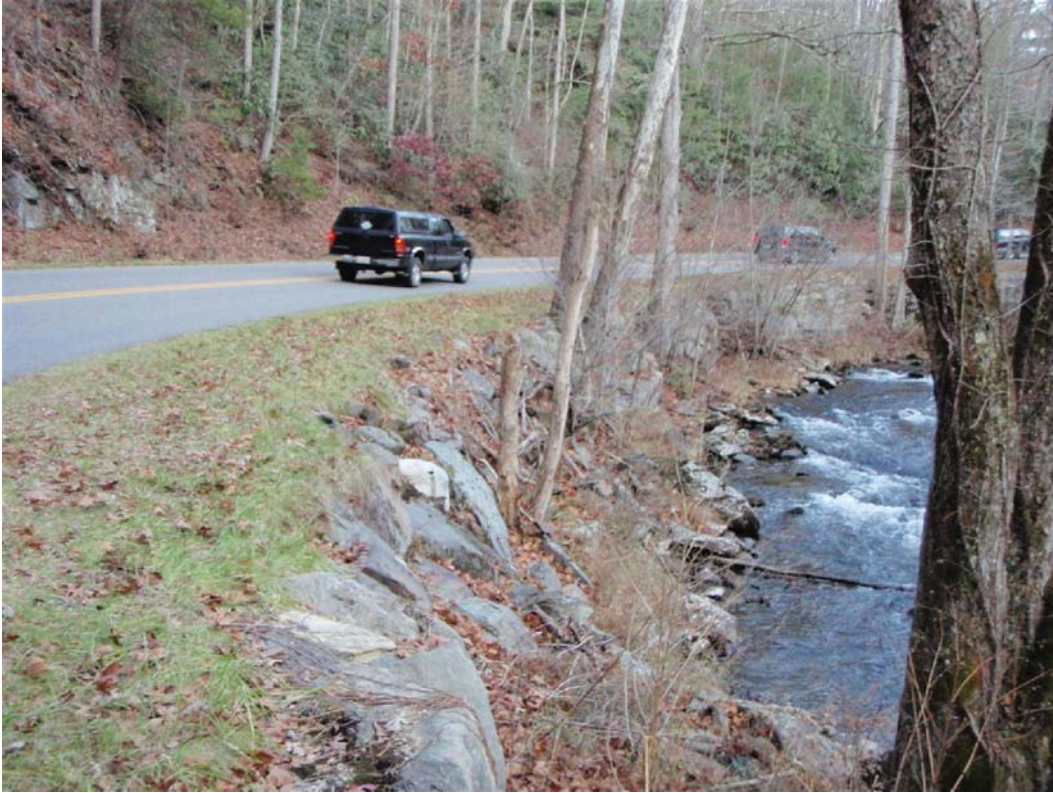
GRSM_0014_1.575_L_1.jpg

Wall ID:	GRSM-0014-1.575-L		
Route Name:	LITTLE RIVER GORGE ROAD		
Inspection Date:	November 27, 2007	Approximate Year Built:	1930
*Wall Rating:	90	Maintenance Action:	No Action

Element (Weighting Factor)	Narrative	Condition Rating (0 - 10)
PERFORMANCE 8.00	As required.	9
WALL FOUNDATION MATERIAL 8.00	Rocky granular fill (embankment fill) and bedrock.	9
MORTAR 8.00	Concrete mortar - appears to be a recent addition.	9
PLACED STONE 8.00	Intact, competent, no distress.	9
DOWNSLOPE 0.50	Stream, moderate scour potential.	8
LATERAL SLOPE 0.50	Rocky embankment fill, appears stable.	8
ROAD/SIDEWALK/SHOULDER 0.50	No distress.	9
WALL DRAINS 0.50	No distress.	9

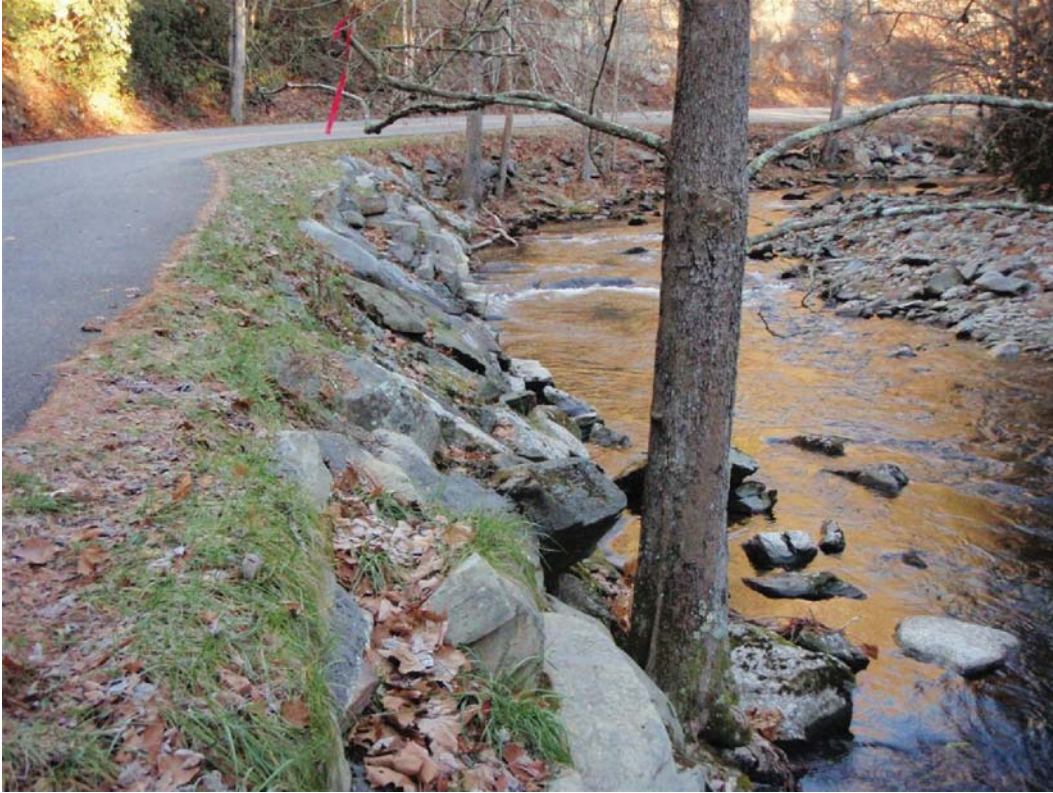
GRSM_0014_1.707_L_1.jpg

Wall ID:	GRSM-0014-1.707-L		
Route Name:	LITTLE RIVER GORGE ROAD		
Inspection Date:	November 28, 2007	Approximate Year Built:	Unknown
*Wall Rating:	90	Maintenance Action:	No Action

Element (Weighting Factor)	Narrative	Condition Rating (0 - 10)
PERFORMANCE 8.00	As required.	9
WALL FOUNDATION MATERIAL 8.00	Bedrock stream channel. No distress.	9
MORTAR 8.00	Concrete mortar. No distress observed.	9
PLACED STONE 8.00	Large irregular chunks of stone, generally 3 to 6 foot dimensions, sound/intact.	9
LATERAL SLOPE 0.50	Steep rocky embankment fill with some vegetation, appears stable.	9
ROAD/SIDEWALK/SHOULDER 0.50	No distress.	9
WALL DRAINS 0.50	No distress.	9
