NPS Retaining Wall Inventory Program Great Smoky Mountains National Park

**Federal Lands Highway
Road Inventory Program**

Federal Highway Administration
Eastern Federal Lands Highway Division
Road Inventory Program (RIP)

Data Collection Date: April 2011
Report Date: November 2015

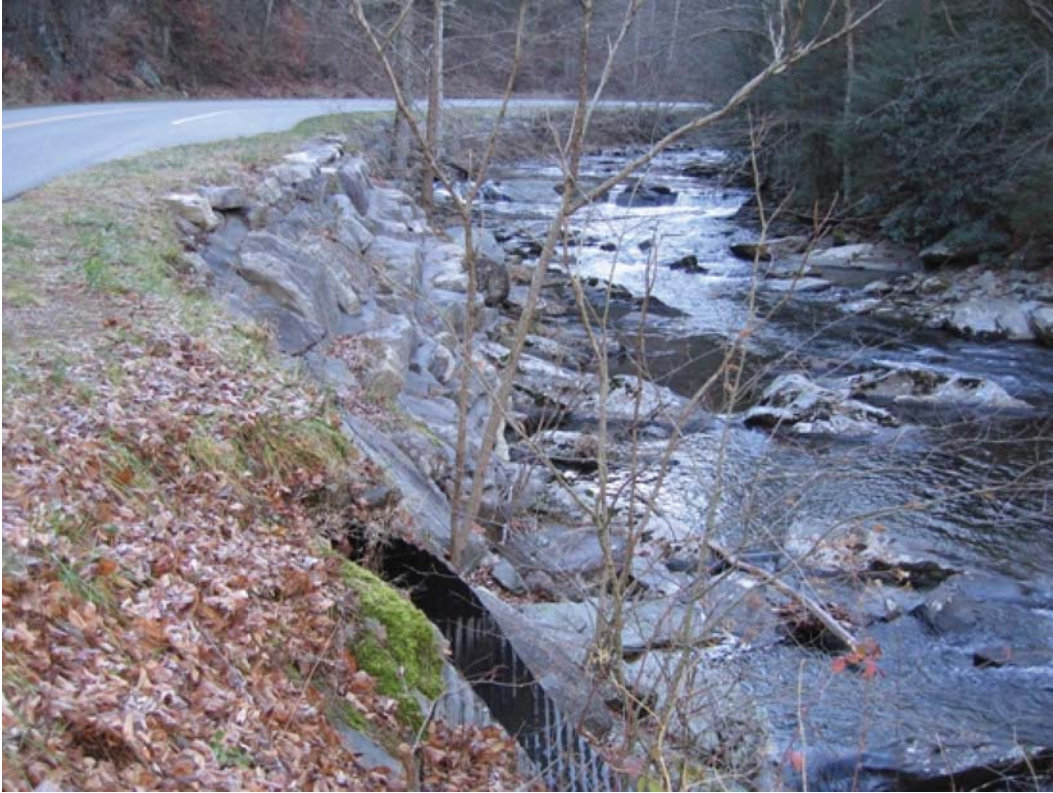
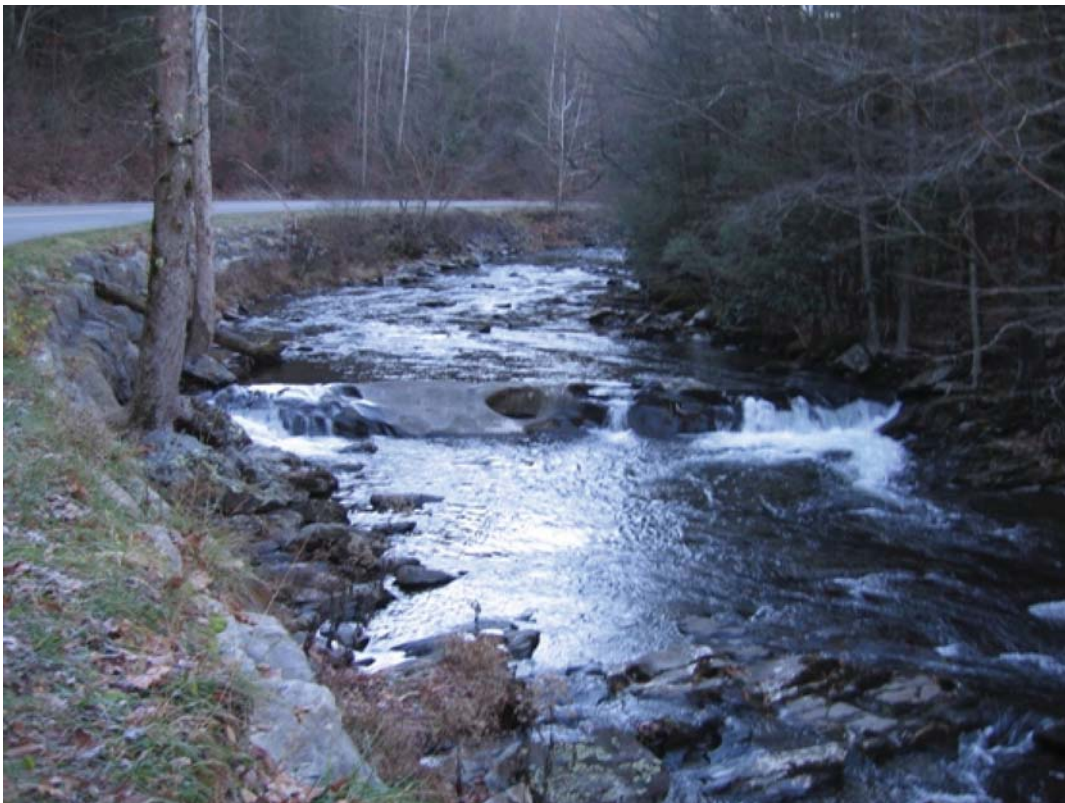
GRSM_0014_2.210_L_1.jpg

Wall ID:	GRSM-0014-2.210-L		
Route Name:	LITTLE RIVER GORGE ROAD		
Inspection Date:	November 28, 2007	Approximate Year Built:	1930
*Wall Rating:	70	Maintenance Action:	No Action

Element (Weighting Factor)	Narrative	Condition Rating (0 - 10)
PERFORMANCE 8.00	Fair condition, occasional missing element, but not impacting wall performance.	7
WALL FOUNDATION MATERIAL 8.00	Strong granular material in active stream channel, minor scour, performing as intended.	8
STONE MASONRY 8.00	Limestone 1-3' diameter rounded boulders, strong. At begin of wall, missing elements, but not impacting roadway (no repairs recommended), severe surface erosion.	6
MORTAR 8.00	Concrete mortar (shot application), occasional unbonded, minor cracking throughout, moss covered.	7
CULVERT 0.50	6-foot diameter CMP at end of wall, performing as intended.	9
WALL DRAINS 0.50	None observed, not impacting wall performance.	9
VEGETATION 1.00	Trees, brush, and grass, pushing out some boulders at isolated locations.	6
DOWNSLOPE 1.00	Active alluvial channel, minor scour and undermining.	7
LATERAL SLOPE 1.00	Steep slopes at begin and end of wall, about 1.5H:1V, minor surface erosion.	7

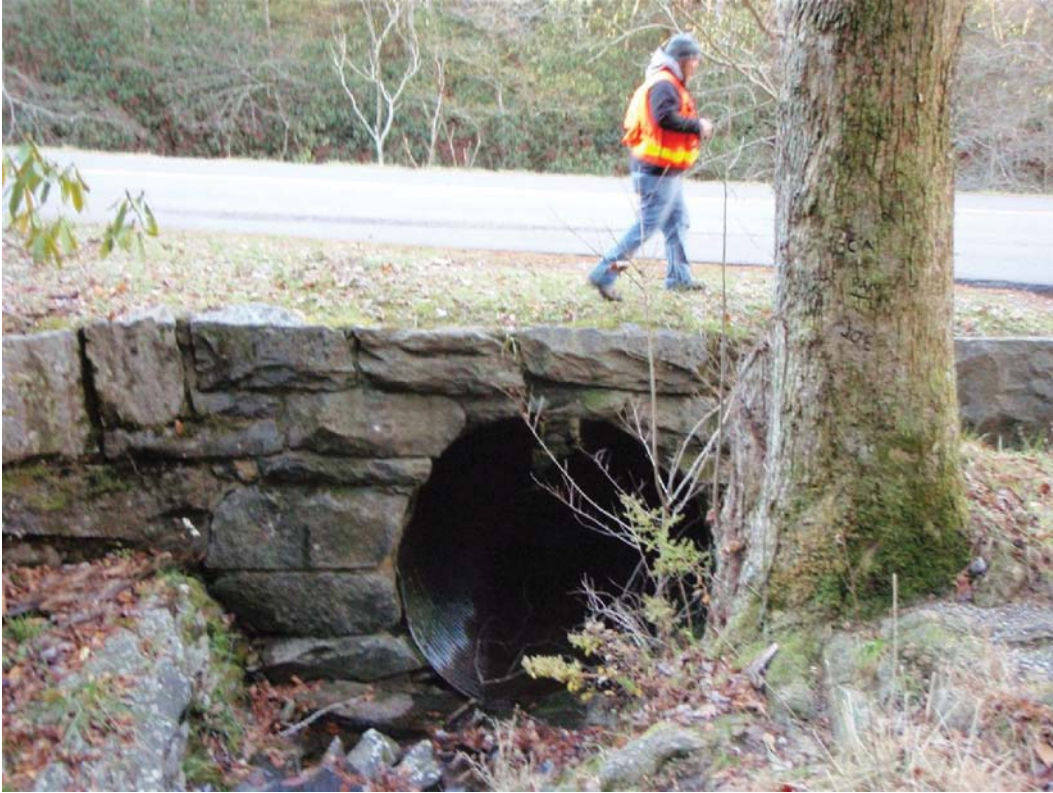
GRSM_0014_2.357_R_1.jpg

Wall ID:	GRSM-0014-2.357-R		
Route Name:	LITTLE RIVER GORGE ROAD		
Inspection Date:	November 28, 2007	Approximate Year Built:	1930
*Wall Rating:	80	Maintenance Action:	No Action

Element (Weighting Factor)	Narrative	Condition Rating (0 - 10)
PERFORMANCE 8.00	Good performance.	8
WALL FOUNDATION MATERIAL 8.00	Bedrock	9
MORTAR 8.00	Some debonding and weathering. One 1/8 to 1/4-inch crack left of culvert. Some small voids around culvert.	7
STONE MASONRY 8.00	Intact sound rock, slight surface weathering.	8
LATERAL SLOPE 0.50	Start - bedrock outcrop. End - slight erosion of embankment fill.	8
ROAD/SIDEWALK/SHOULDER 0.50	No distress.	9
UPSLOPE 0.50	Bedrock stream channel.	9
WALL DRAINS 0.50	No distress.	9
CULVERT 1.00	Some minor corrosion.	7

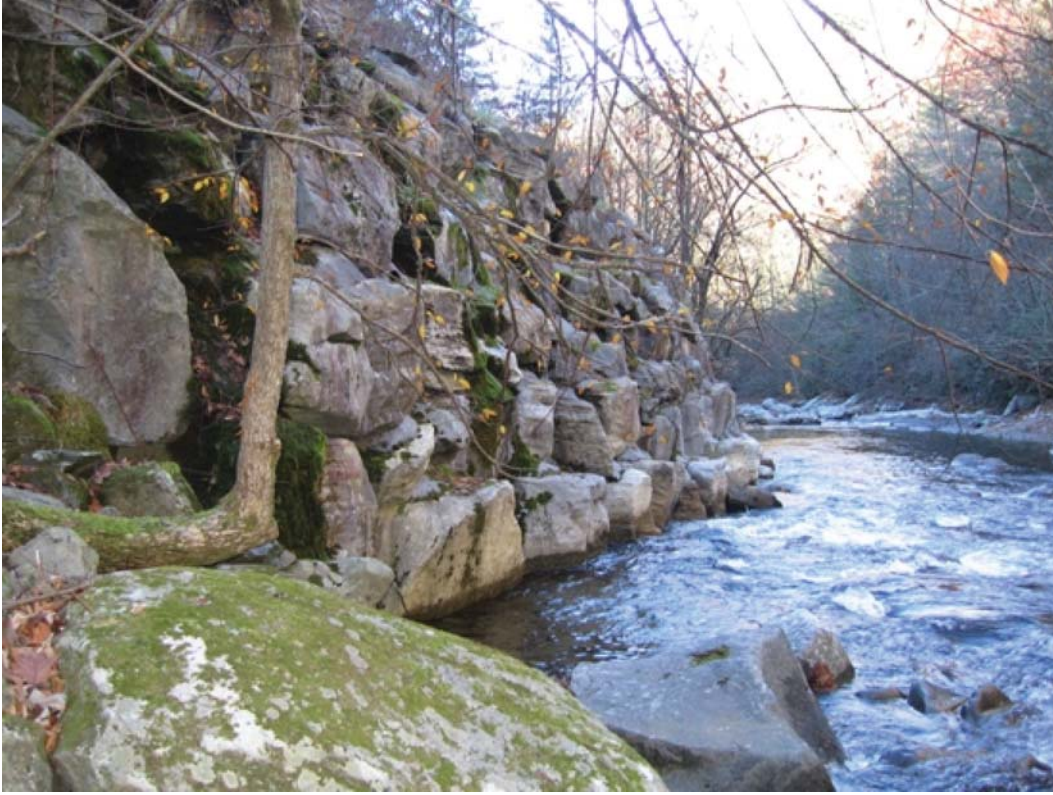
GRSM_0014_2.522_R_1.jpg

Wall ID:	GRSM-0014-2.522-R		
Route Name:	LITTLE RIVER GORGE ROAD		
Inspection Date:	November 28, 2007	Approximate Year Built:	1930
*Wall Rating:	82	Maintenance Action:	No Action

Element (Weighting Factor)	Narrative	Condition Rating (0 - 10)
PERFORMANCE 8.00	Good condition, performing as intended.	8
WALL FOUNDATION MATERIAL 8.00	Solid granular material and bedrock at active stream channel.	9
MORTAR 8.00	Concrete mortar, minor undermining and cracking, good condition overall.	8
STONE MASONRY 8.00	1-8-foot diameter limestone boulders, strong competent stone. Minor surface weathering, good condition.	8
DOWNSLOPE 0.50	Active stream channel, minor scour at base.	8
TRAFFIC BARRIER/FENCE 0.50	Guardrail at top of slope, no signs of distress.	9
WALL DRAINS 0.50	None observed, not impacting wall.	9
LATERAL SLOPE 1.00	About 1.5H:1V steep slope with trees and grass, minor surface erosion.	7
ROAD/SIDEWALK/SHOULDER 1.00	Road has minor longitudinal cracking parallel to wall. Shoulder is sloped about 1.5H:1V with trees and grass, moderate surface erosion.	7

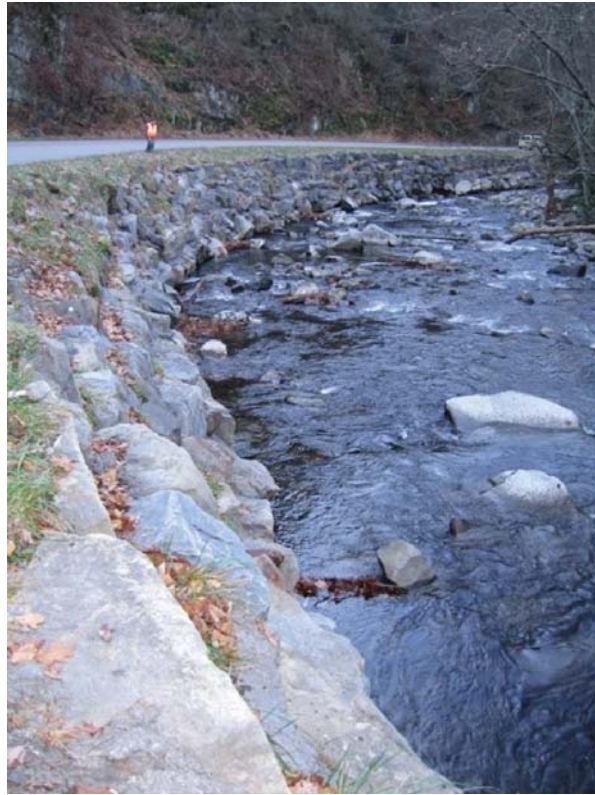
GRSM_0014_2.829_R_1.jpg

Wall ID:	GRSM-0014-2.829-R		
Route Name:	LITTLE RIVER GORGE ROAD		
Inspection Date:	November 28, 2007	Approximate Year Built:	1930
*Wall Rating:	65	Maintenance Action:	Maintenance
Wall Description			
Wall Function:	Fill Wall	Primary Wall Type:	Gravity - Mortared Stone
Surface Treatment:		Secondary Wall Type:	
Secondary Surface Treatment:		Architectural Facing:	
General Description:	Limestone boulder mortared fill wall adjacent to a stream.		
Wall Measurements			
Wall Length (ft.):	691	Face Area (sq.):	9674
Average Wall Height (ft.):	14	Face Angle (deg.):	60
Maximum Wall Height (ft.):	15	Vertical Offset (ft.):	0
Assessed Elements			
Element (Weighting Factor)	Narrative		Condition Rating (0 - 10)
PERFORMANCE 8.00	Fair to good conditions observed, but maintenance history indicates serious settlement issues with repairs 5-6 times, including pumping concrete at the back of the wall, needs further investigation.		7

WALL FOUNDATION MATERIAL 8.00	Solid granular material and bedrock at active stream channel, solid foundation. However, maintenance crew noted that this is a location that has been patched numerous times due to settlement issues.		3
MORTAR 8.00	Concrete mortar, minor unbonding, minor cracking, good condition.		8
STONE MASONRY 8.00	1-6-foot diameter limestone boulders, strong competent material. Minor surface weathering, epoxy rebar at bottom (dowelled into bedrock?) for stability.		8
WALL DRAINS 0.50	None observed, not impacting wall performance.		9
ROAD/SIDEWALK/SHOULDER 1.00	Road has minor longitudinal and transverse cracking. Shoulder is about 6-8 feet wide, flat, grassy, occasional voids at the top.		6
VEGETATION 1.00	Minor trees pushing out boulders.		6
DOWNSLOPE 1.00	Active stream channel, minor scour.		7
LATERAL SLOPE 1.00	Steep slopes at about 1.5H:1V, well vegetated, moss covered.		7
Repair Recommendations

Failure Consequence:	HIGH		
Recommendation Narrative:	Subsurface Investigation: Drill and sample with truck mounted rig @ back of wall in right land and left lane at 6 locations to determine extent of lateral settlement area. Assume \$3,000/day @ 3 days = \$9,000. Mob/Demob/Travel/Per Diem Crew = \$5,000. Traffic		
Repair Cost:	\$42,000

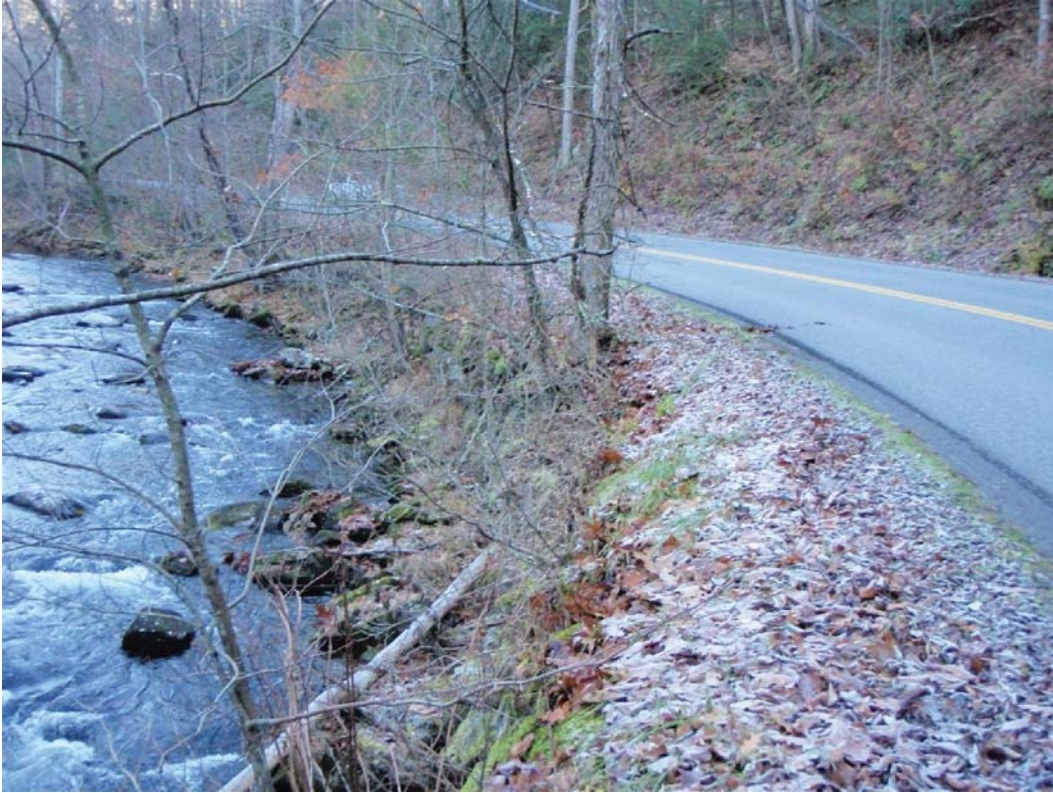
GRSM_0014_3.135_R_1.jpg

Wall ID:	GRSM-0014-3.135-R		
Route Name:	LITTLE RIVER GORGE ROAD		
Inspection Date:	November 28, 2007	Approximate Year Built:	1930
*Wall Rating:	87	Maintenance Action:	No Action

Element (Weighting Factor)	Narrative	Condition Rating (0 - 10)
PERFORMANCE 8.00	As required.	9
WALL FOUNDATION MATERIAL 8.00	Streambed boulders and bedrock. No undermining observed.	9
PLACED STONE 8.00	Moss covered appear intact. Some voids not affecting wall performance.	8
DOWNSLOPE 0.50	Streambed with moderate scour potential.	8
LATERAL SLOPE 0.50	Treed, rocky embankment fill and large boulder fill, appears stable.	9
ROAD/SIDEWALK/SHOULDER 0.50	No distress.	9
WALL DRAINS 0.50	No distress.	9

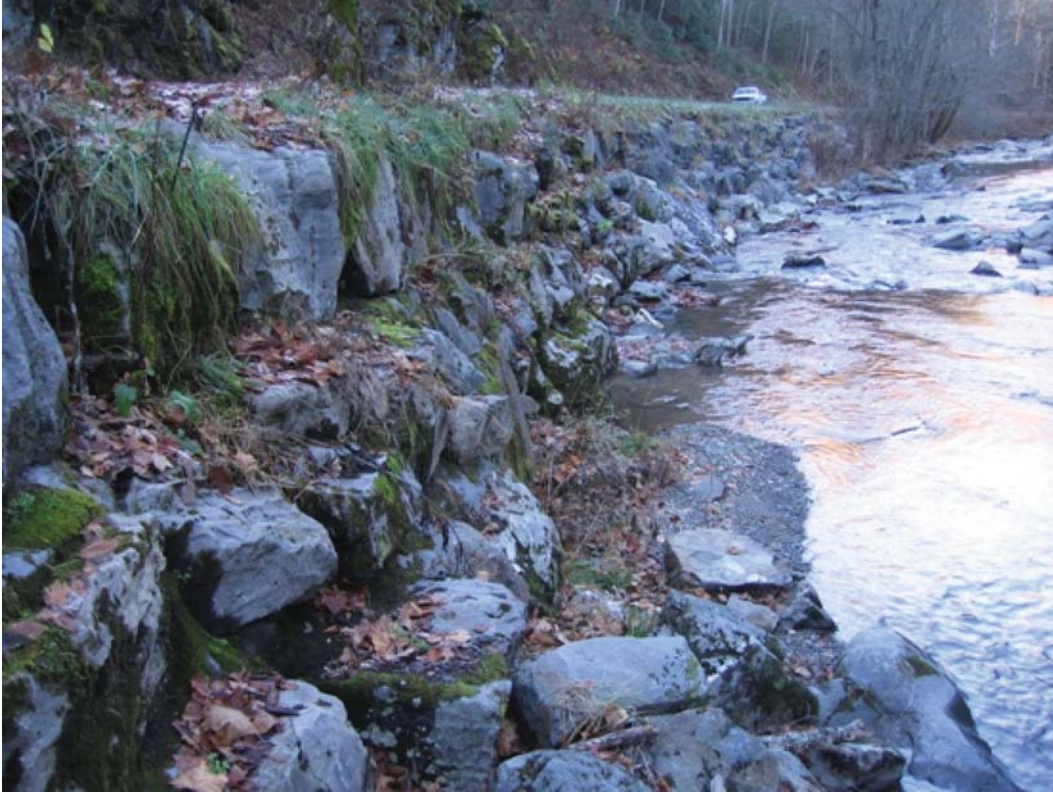
GRSM_0014_3.177_R_1.jpg

Wall ID:	GRSM-0014-3.177-R		
Route Name:	LITTLE RIVER GORGE ROAD		
Inspection Date:	November 28, 2007	Approximate Year Built:	1930
*Wall Rating:	82	Maintenance Action:	No Action

Element (Weighting Factor)	Narrative	Condition Rating (0 - 10)
PERFORMANCE 8.00	Good condition, performing as intended.	8
WALL FOUNDATION MATERIAL 8.00	Bedrock and solid granular material at the base in active stream channel, minor scour possible.	8
MORTAR 8.00	Concrete mortar, minor cracking, minor unbonding.	8
STONE MASONRY 8.00	1-8-foot diameter limestone boulders, slight weathering at the surface.	9
WALL DRAINS 0.50	None observed, not impacting wall performance.	9
DOWNSLOPE 1.00	Active stream channel, minor scour.	7
LATERAL SLOPE 1.00	About 1.5H:1V steep slope with trees, moderate surface erosion.	7
ROAD/SIDEWALK/SHOULDER 1.00	Road has minor cracks, not from the wall. Shoulder has about 6-foot wide grassy bench, minor soft spots.	7

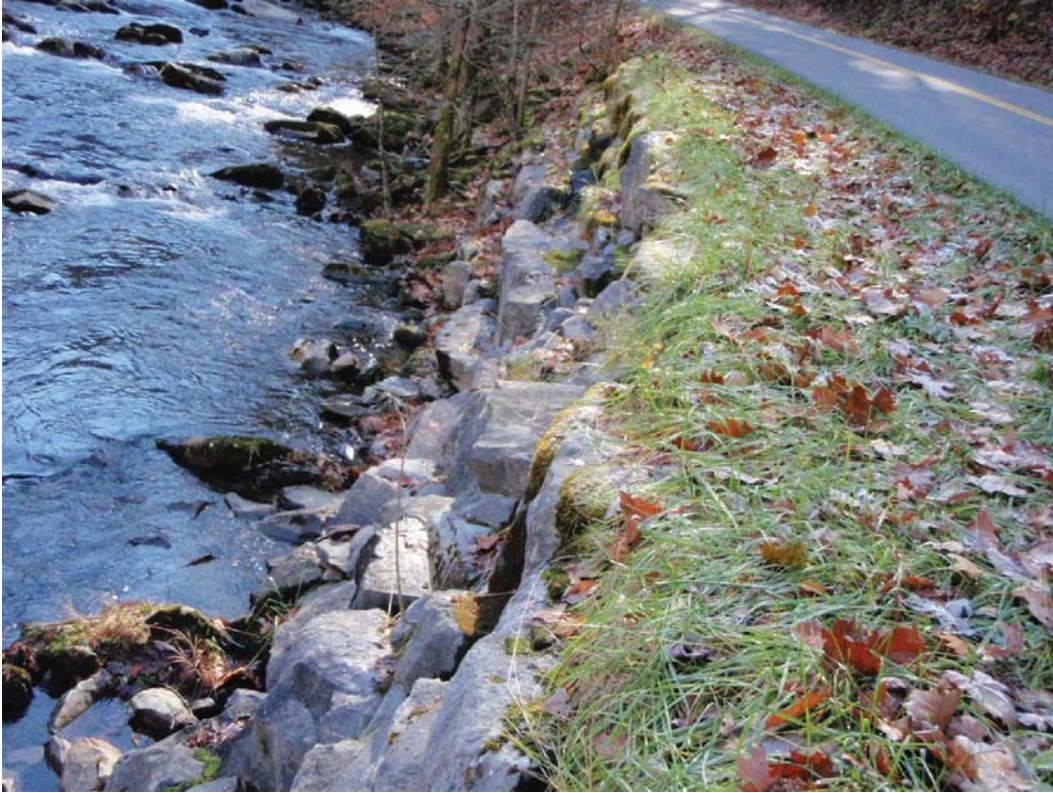
GRSM_0014_3.360_R_1.jpg

Wall ID:	GRSM-0014-3.360-R		
Route Name:	LITTLE RIVER GORGE ROAD		
Inspection Date:	November 28, 2007	Approximate Year Built:	1930
*Wall Rating:	90	Maintenance Action:	No Action

Element (Weighting Factor)	Narrative	Condition Rating (0 - 10)
PERFORMANCE 8.00	As required.	9
WALL FOUNDATION MATERIAL 8.00	Bedrock	9
MORTAR 8.00	No distress observed.	9
PLACED STONE 8.00	Large intact rock	9
DOWNSLOPE 0.50	Bedrock streambed, moderate scour potential.	8
LATERAL SLOPE 0.50	Treed rock embankment fill, appears stable.	9
ROAD/SIDEWALK/SHOULDER 0.50	No distress.	9
WALL DRAINS 0.50	No distress.	9

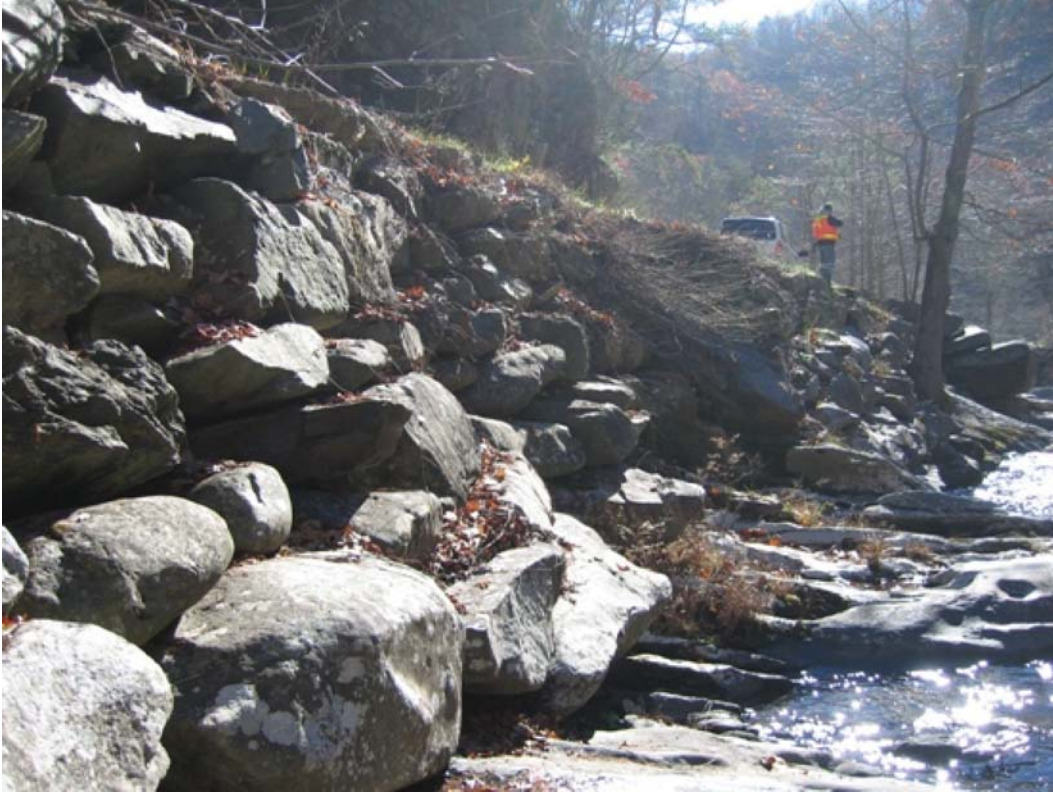
GRSM_0014_6.735_R_1.jpg

Wall ID:	GRSM-0014-6.735-R		
Route Name:	LITTLE RIVER GORGE ROAD		
Inspection Date:	November 28, 2007	Approximate Year Built:	1930
*Wall Rating:	79	Maintenance Action:	No Action

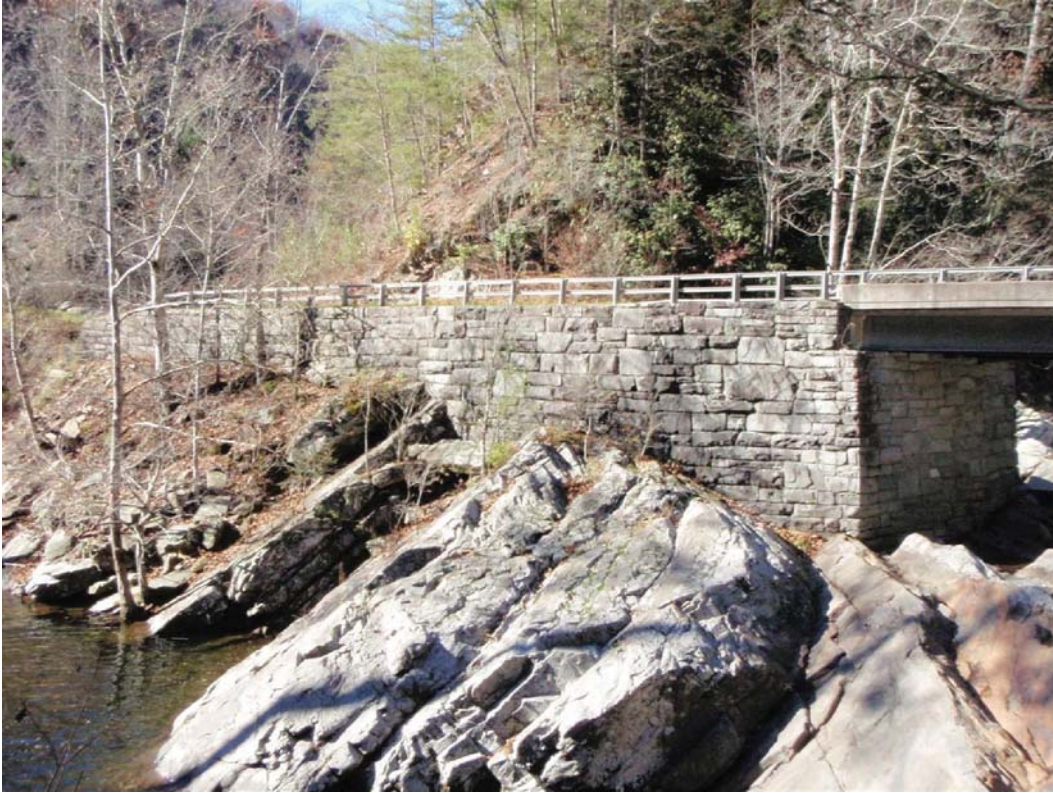
GRSM_0014_6.890_L_1.jpg

Wall ID:	GRSM-0014-6.890-L		
Route Name:	LITTLE RIVER GORGE ROAD		
Inspection Date:	November 28, 2007	Approximate Year Built:	1930
*Wall Rating:	88	Maintenance Action:	No Action

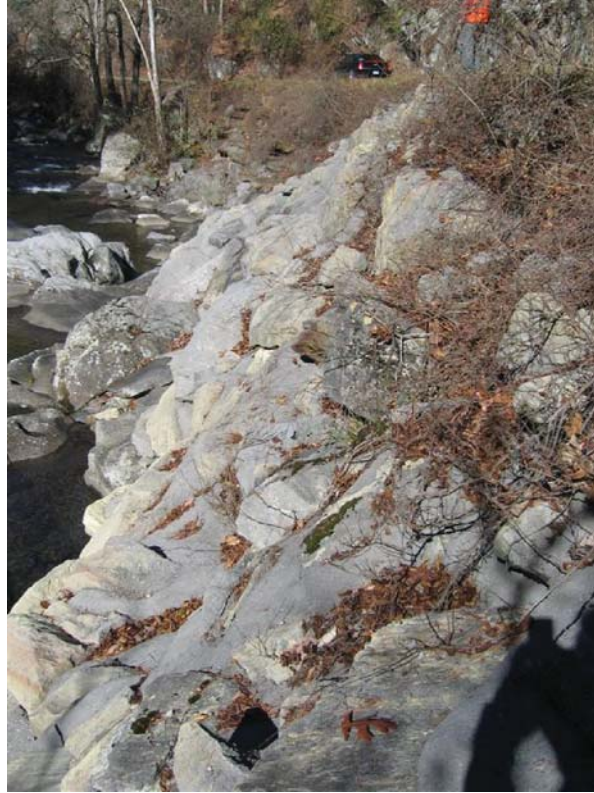
GRSM_0014_7.392_L_1.jpg

Wall ID:	GRSM-0014-7.392-L		
Route Name:	LITTLE RIVER GORGE ROAD		
Inspection Date:	November 28, 2007	Approximate Year Built:	1930
*Wall Rating:	71	Maintenance Action:	No Action

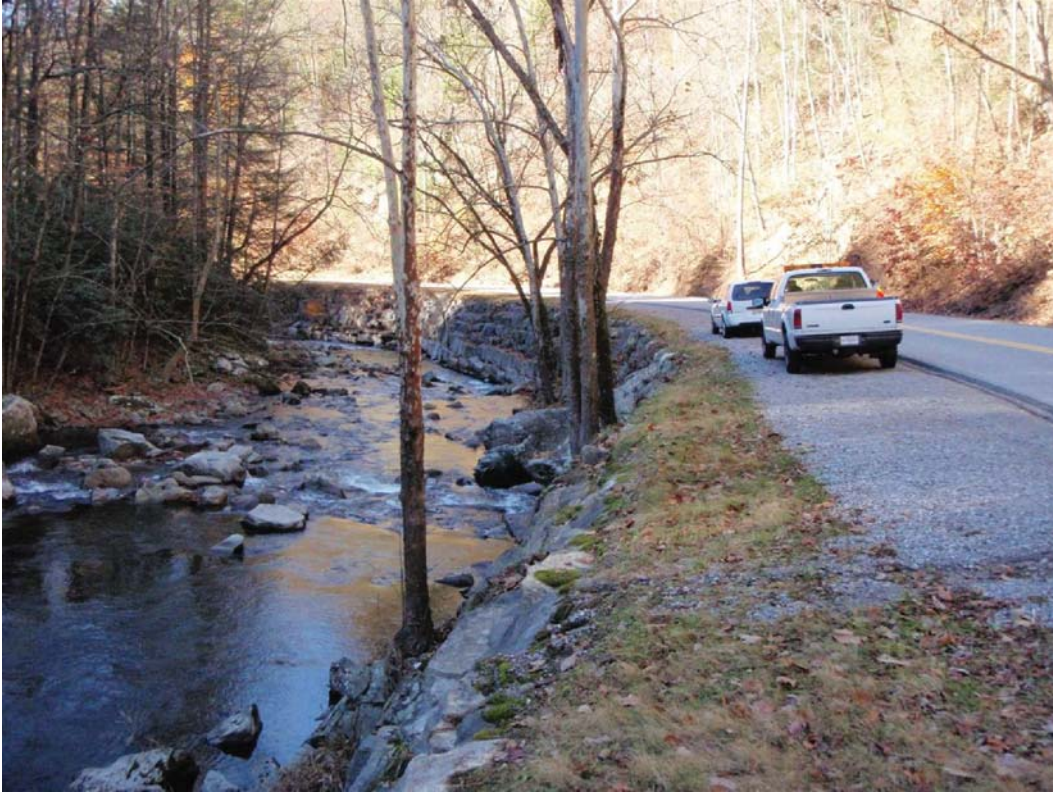
GRSM_0014_7.495_L_1.jpg

Wall ID:	GRSM-0014-7.495-L		
Route Name:	LITTLE RIVER GORGE ROAD		
Inspection Date:	November 28, 2007	Approximate Year Built:	1930
*Wall Rating:	82	Maintenance Action:	No Action

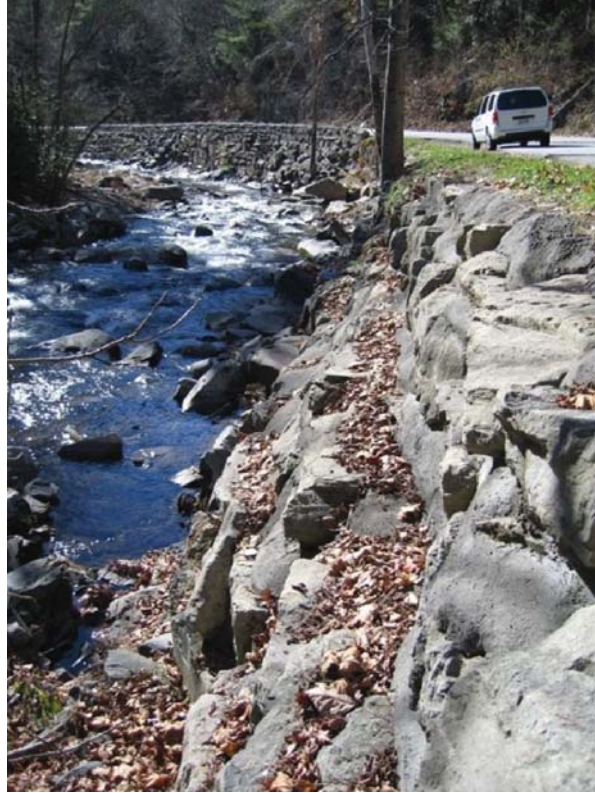
GRSM_0014_7.777_L_1.jpg

Wall ID:	GRSM-0014-7.777-L		
Route Name:	LITTLE RIVER GORGE ROAD		
Inspection Date:	November 28, 2007	Approximate Year Built:	1930
*Wall Rating:	84	Maintenance Action:	No Action

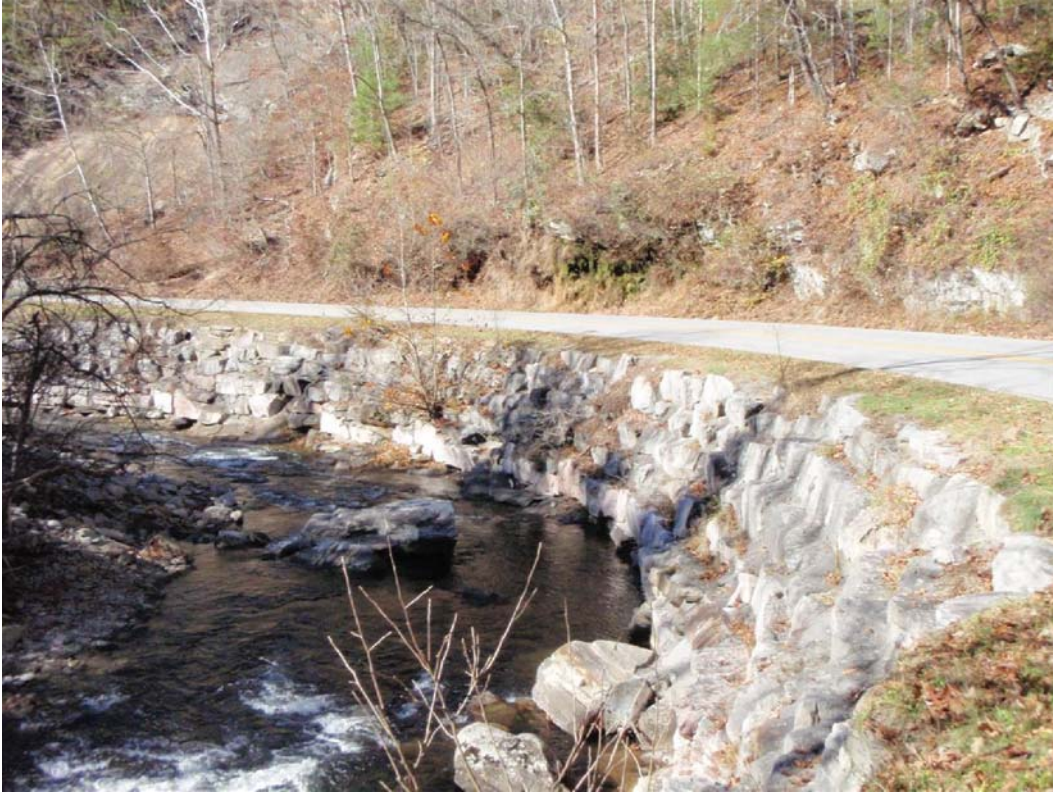
GRSM_0014_8.285_L_1.jpg

Wall ID:	GRSM-0014-8.285-L		
Route Name:	LITTLE RIVER GORGE ROAD		
Inspection Date:	November 28, 2007	Approximate Year Built:	1930
*Wall Rating:	89	Maintenance Action:	No Action

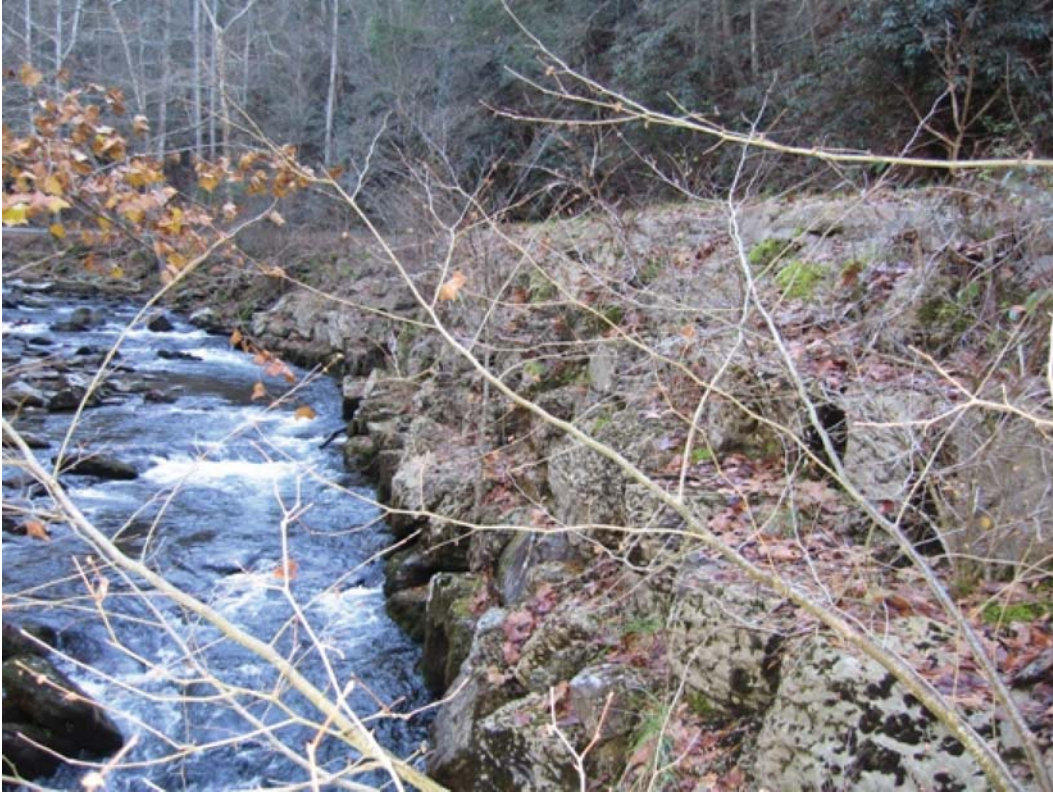
GRSM_0014_9.013_R_1.jpg

Wall ID:	GRSM-0014-9.013-R		
Route Name:	LITTLE RIVER GORGE ROAD		
Inspection Date:	November 28, 2007	Approximate Year Built:	1930
*Wall Rating:	77	Maintenance Action:	No Action

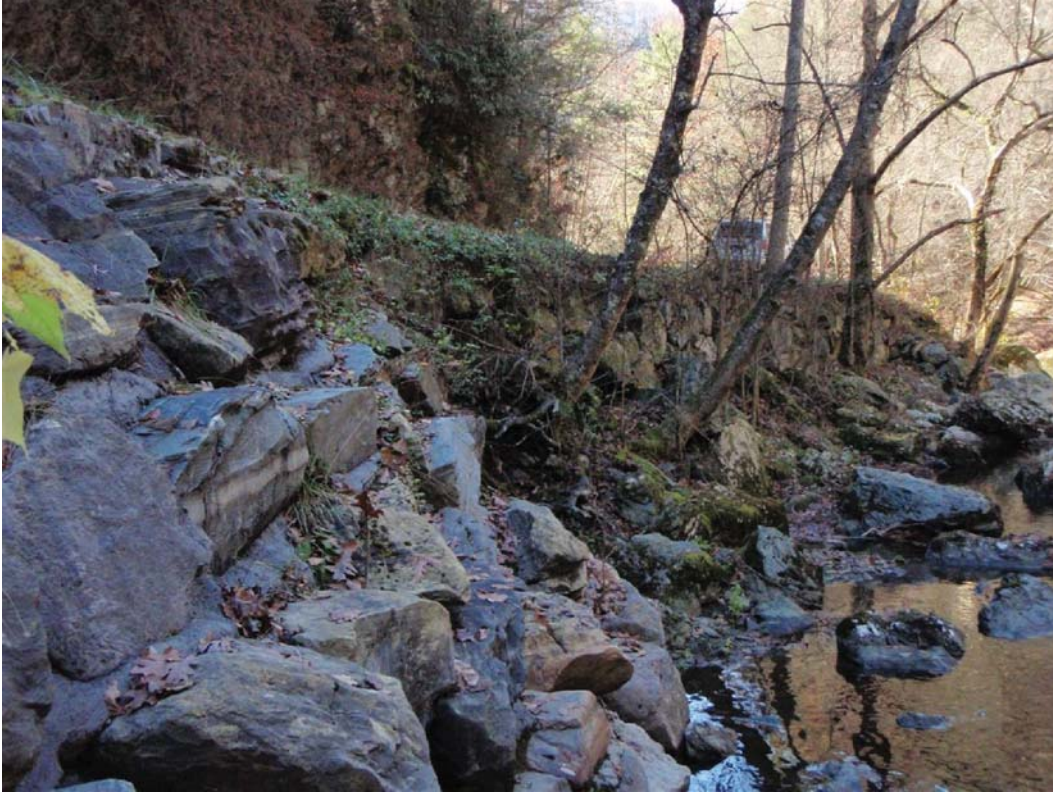
GRSM_0014_9.119_R_1.jpg

Wall ID:	GRSM-0014-9.119-R		
Route Name:	LITTLE RIVER GORGE ROAD		
Inspection Date:	November 28, 2007	Approximate Year Built:	1930
*Wall Rating:	80	Maintenance Action:	No Action

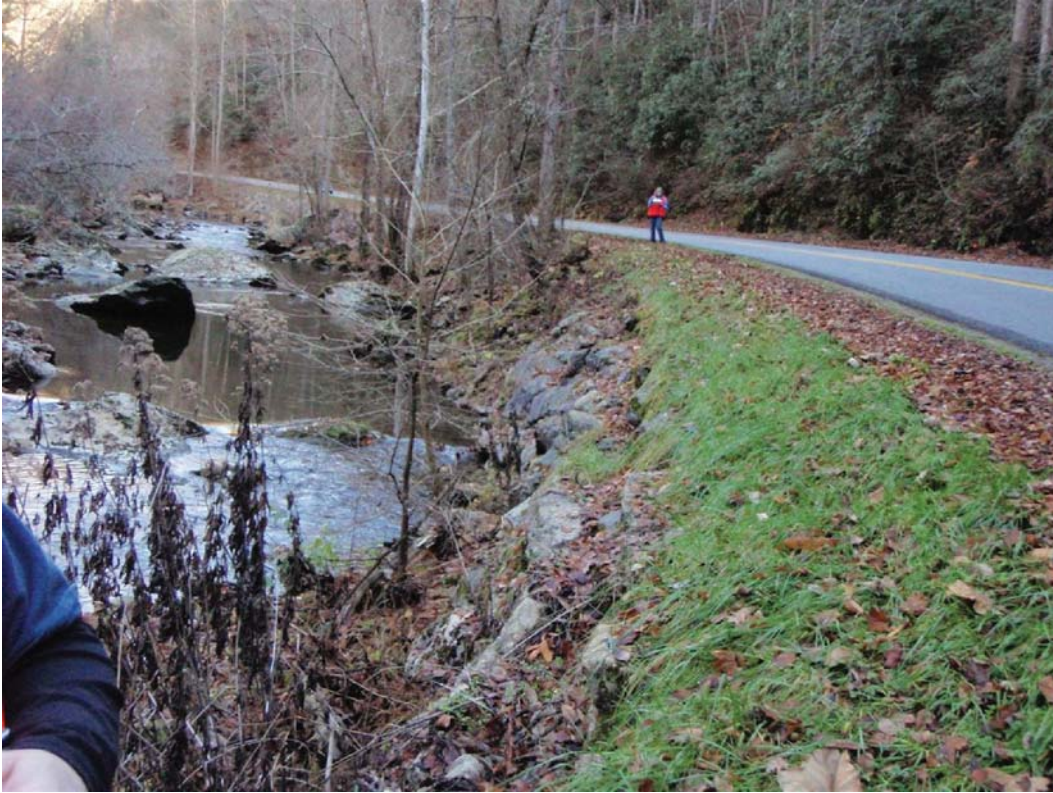
GRSM_0014_9.493_R_1.jpg

Wall ID:	GRSM-0014-9.493-R		
Route Name:	LITTLE RIVER GORGE ROAD		
Inspection Date:	November 28, 2007	Approximate Year Built:	1930
*Wall Rating:	80	Maintenance Action:	No Action

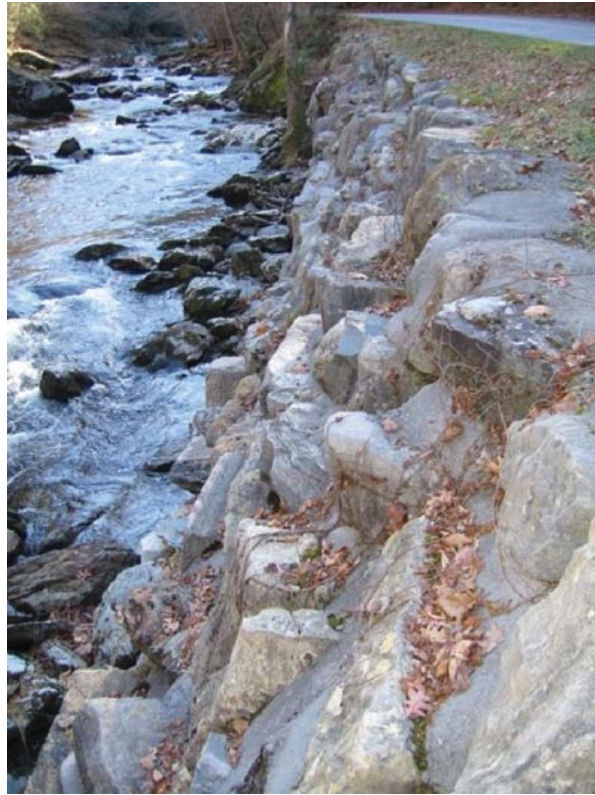
GRSM_0014_9.524_R_1.jpg

Wall ID:	GRSM-0014-9.524-R		
Route Name:	LITTLE RIVER GORGE ROAD		
Inspection Date:	November 28, 2007	Approximate Year Built:	1930
*Wall Rating:	85	Maintenance Action:	No Action

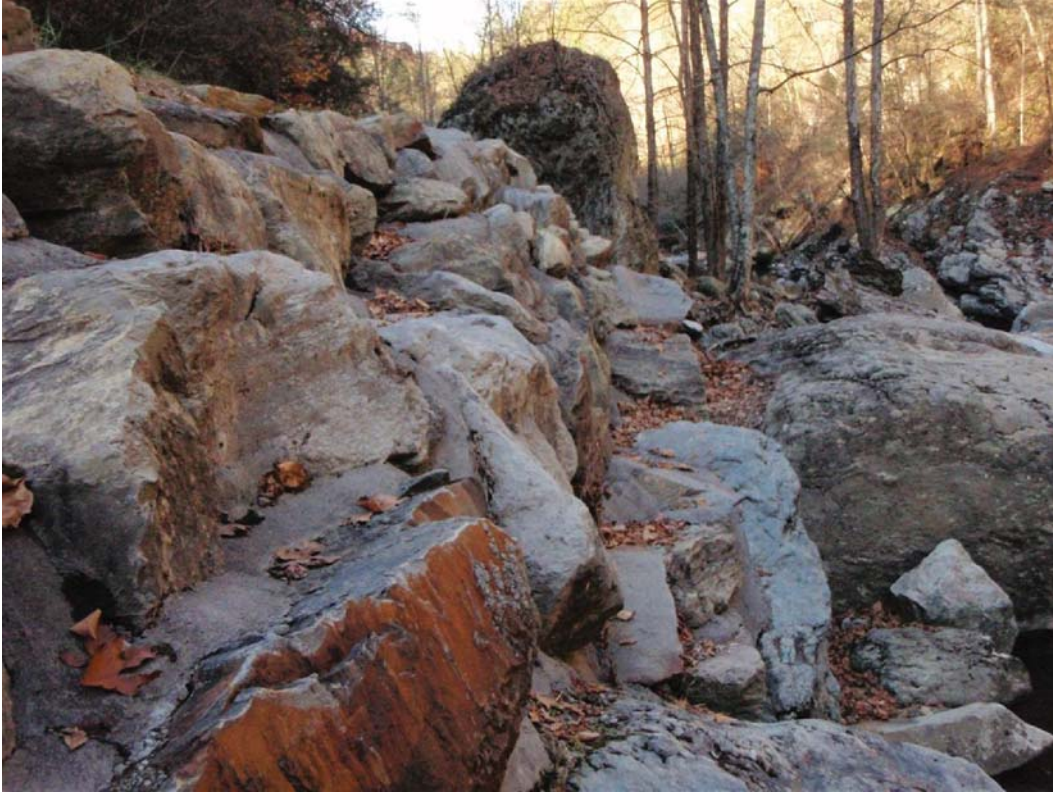
GRSM_0014_9.616_R_1.jpg

Wall ID:	GRSM-0014-9.616-R		
Route Name:	LITTLE RIVER GORGE ROAD		
Inspection Date:	December 10, 2007	Approximate Year Built:	1930
*Wall Rating:	88	Maintenance Action:	No Action

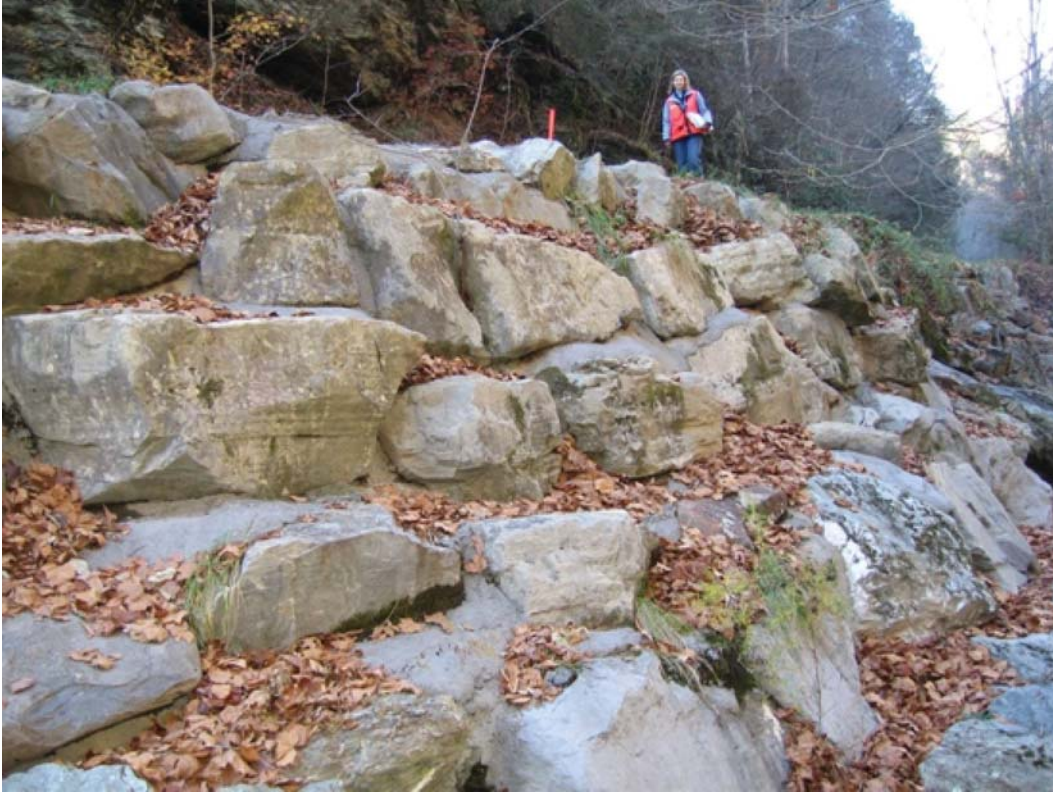
GRSM_0014_9.635_R_1.jpg

Wall ID:	GRSM-0014-9.635-R		
Route Name:	LITTLE RIVER GORGE ROAD		
Inspection Date:	November 28, 2007	Approximate Year Built:	1930
*Wall Rating:	85	Maintenance Action:	No Action

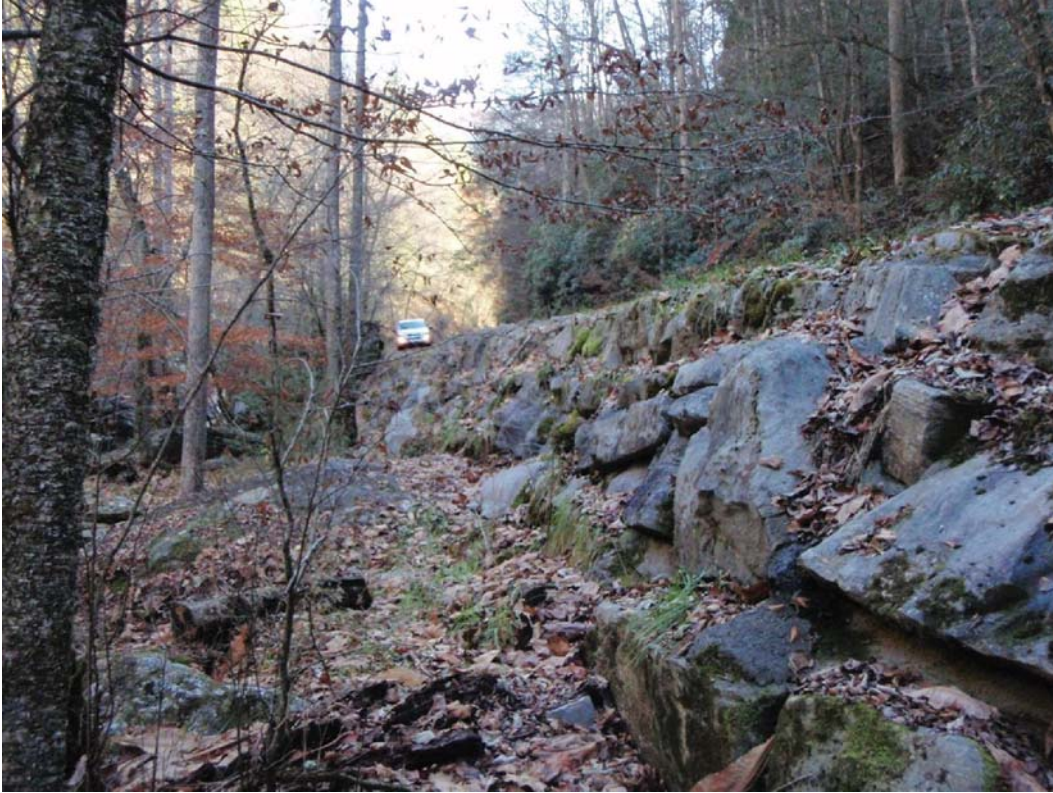
GRSM_0014_9.677_R_1.jpg

Wall ID:	GRSM-0014-9.677-R		
Route Name:	LITTLE RIVER GORGE ROAD		
Inspection Date:	November 28, 2007	Approximate Year Built:	1930
*Wall Rating:	85	Maintenance Action:	No Action

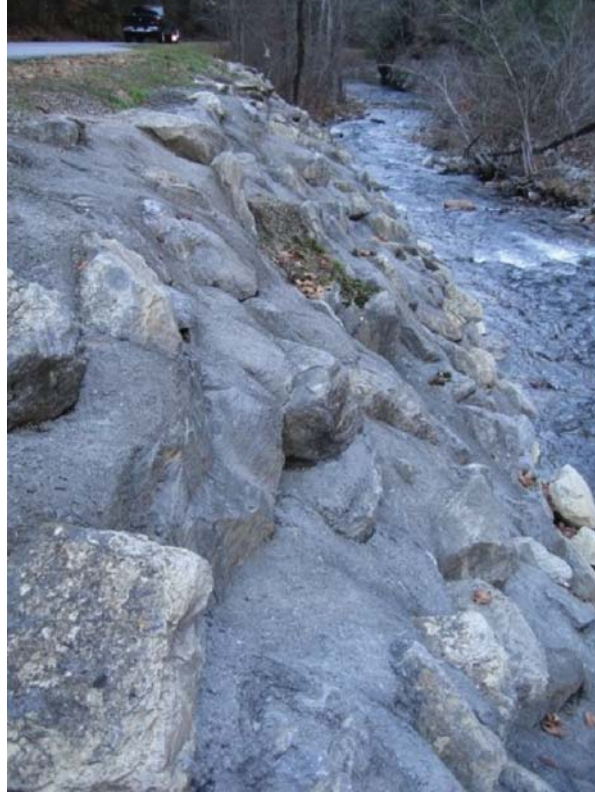
GRSM_0014_9.764_R_1.jpg

Wall ID:	GRSM-0014-9.764-R		
Route Name:	LITTLE RIVER GORGE ROAD		
Inspection Date:	November 28, 2007	Approximate Year Built:	1930
*Wall Rating:	85	Maintenance Action:	No Action

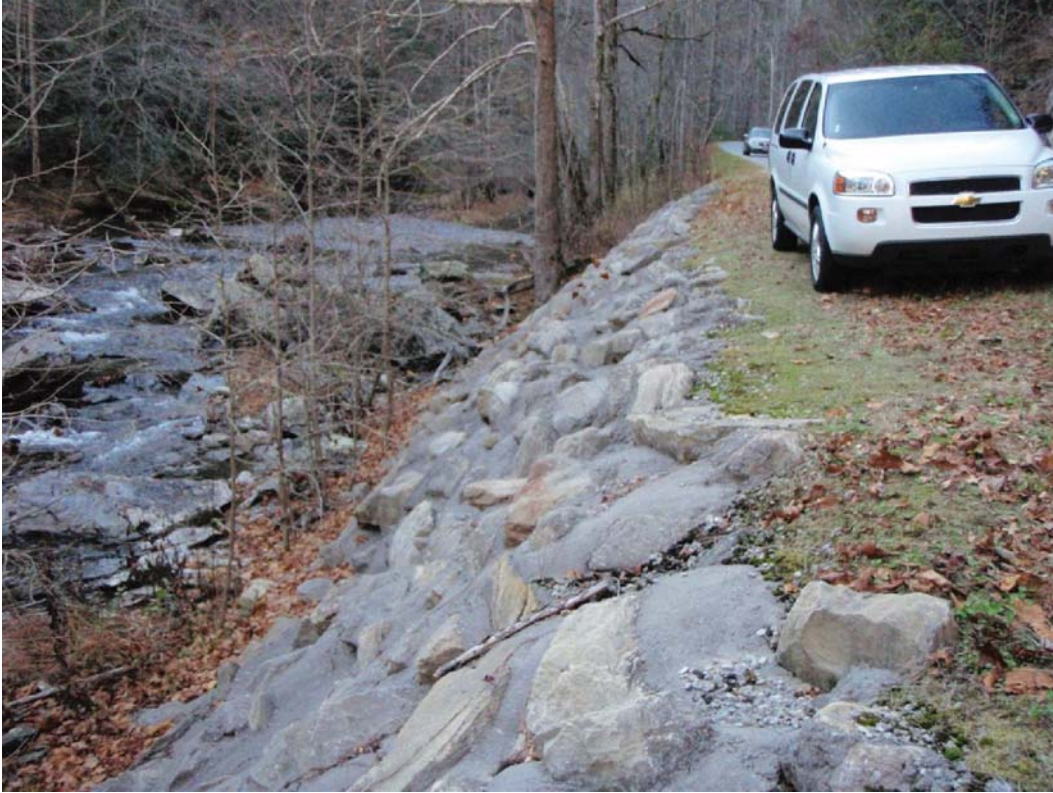
GRSM_0014_10.412_R_1.jpg

Wall ID:	GRSM-0014-10.412-R		
Route Name:	LITTLE RIVER GORGE ROAD		
Inspection Date:	November 28, 2007	Approximate Year Built:	1930
*Wall Rating:	90	Maintenance Action:	No Action

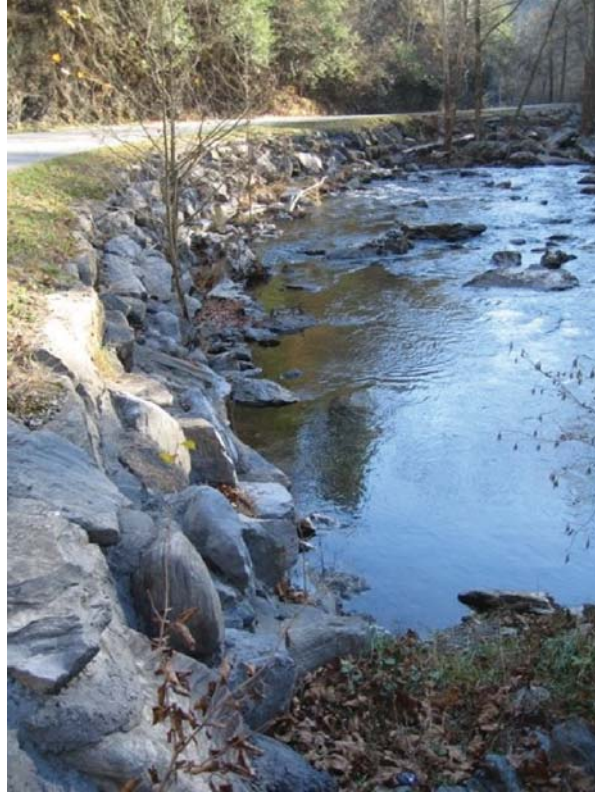
GRSM_0014_10.494_R_1.jpg

Wall ID:	GRSM-0014-10.494-R		
Route Name:	LITTLE RIVER GORGE ROAD		
Inspection Date:	November 28, 2007	Approximate Year Built:	1930
*Wall Rating:	82	Maintenance Action:	No Action

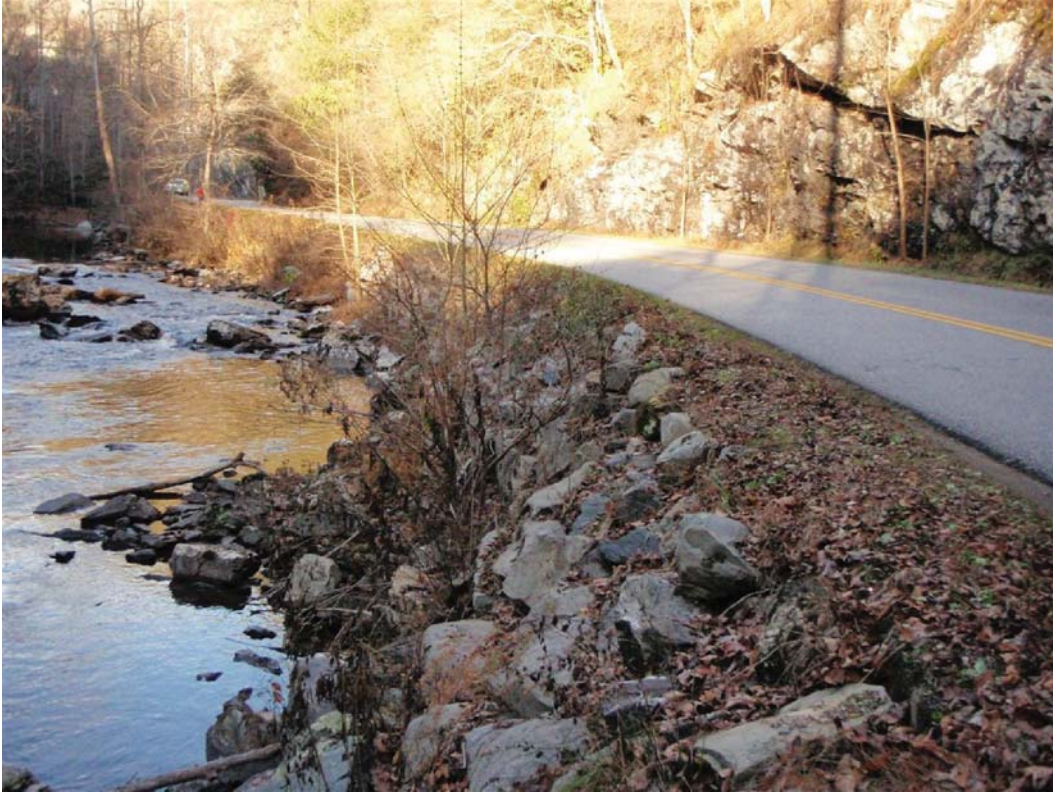
GRSM_0014_10.630_R_1.jpg

Wall ID:	GRSM-0014-10.630-R		
Route Name:	LITTLE RIVER GORGE ROAD		
Inspection Date:	November 28, 2007	Approximate Year Built:	1930
*Wall Rating:	85	Maintenance Action:	No Action

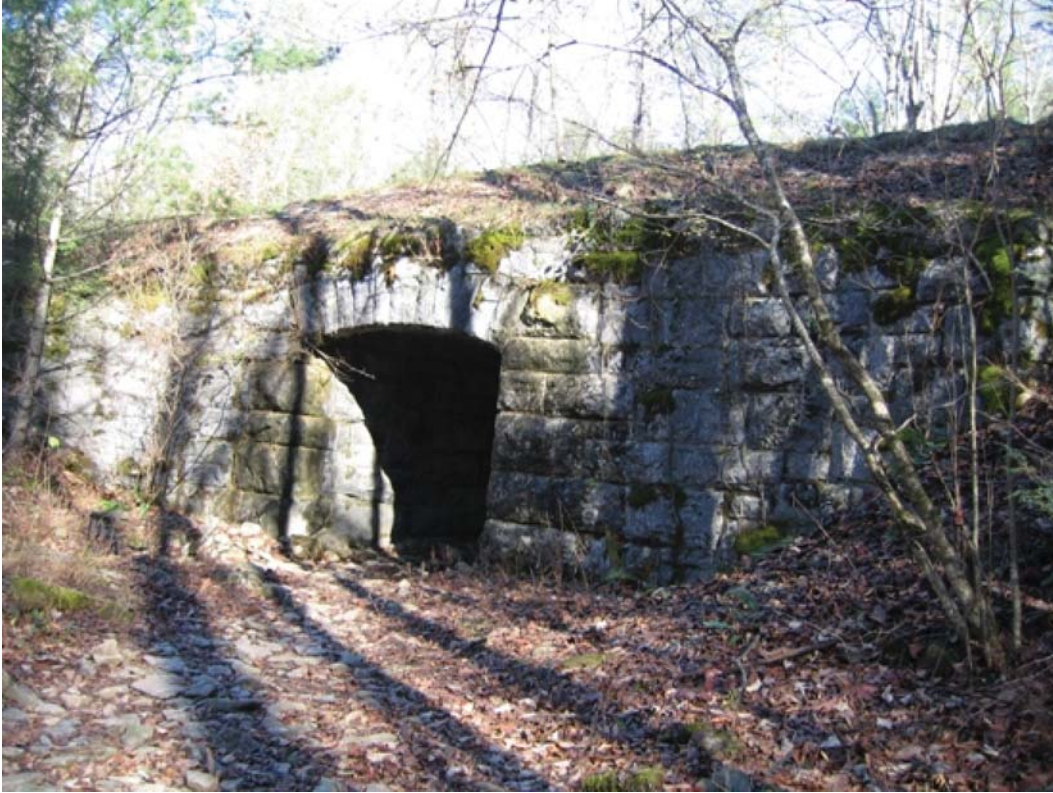
GRSM_0015_5.547_R_1.jpg

Element (Weighting Factor)	Narrative	Condition Rating (0 - 10)
PERFORMANCE 8.00	Good condition, performing as intended.	8
WALL FOUNDATION MATERIAL 8.00	Solid granular material, minor undermining, not impacting wall performance.	8
MORTAR 8.00	Concrete mortar, minor debonding, occasional minor cracking, moss cover.	8
STONE MASONRY 8.00	1-3 foot cut limestone blocks, strong, competent, moss cover, moderate surface weathering.	9
CULVERT 0.50	10' x10' CBC, animal crossing and trail crossing, old wood deck underneath, performing as intended.	9
ROAD/SIDEWALK/SHOULDER 0.50	Road has no signs of distress.	9
UPSLOPE 0.50	Granular stream material, relatively flat.	9
WALL DRAINS 0.50	None observed, not impacting wall performance.	9
LATERAL SLOPE 1.00	Steep slopes at 1.5H:1V, moderate surface erosion, minor riprap protection at end of wall.	6
