NPS Retaining Wall Inventory Program Great Smoky Mountains National Park

**Federal Lands Highway
Road Inventory Program**

Federal Highway Administration
Eastern Federal Lands Highway Division
Road Inventory Program (RIP)

Data Collection Date: April 2011
Report Date: November 2015

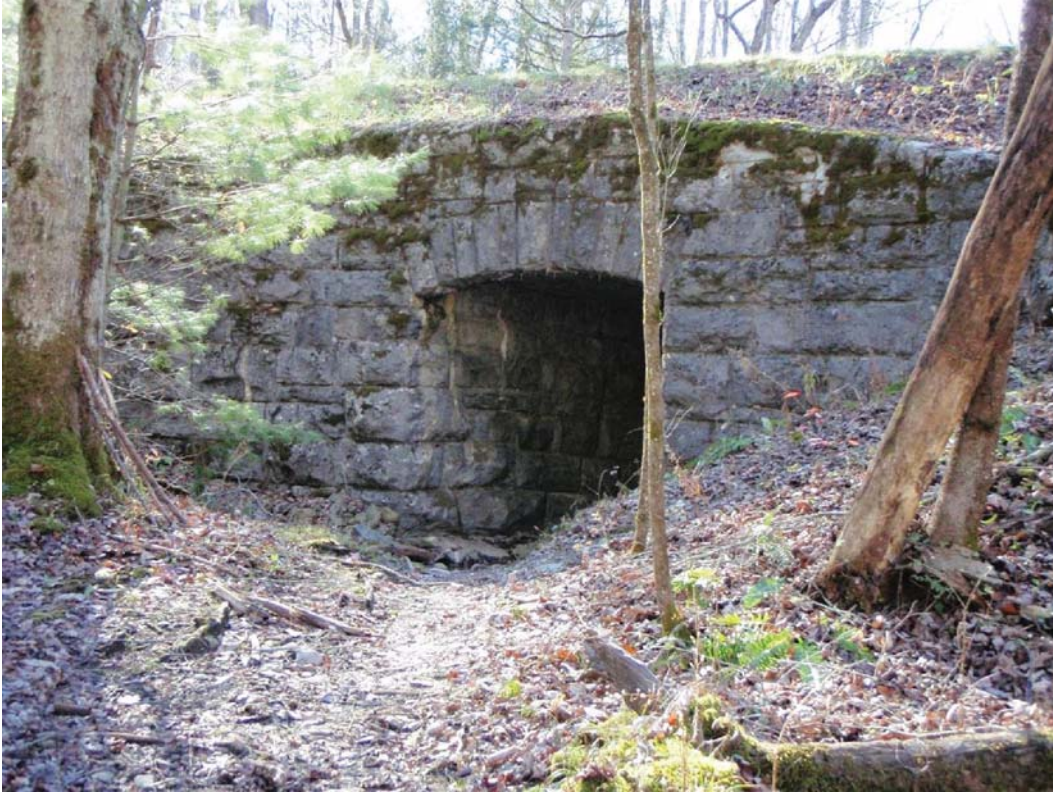
GRSM_0015_5.548_L_1.jpg

Element (Weighting Factor)	Narrative	Condition Rating (0 - 10)
PERFORMANCE 8.00	As required.	9
WALL FOUNDATION MATERIAL 8.00	Firm granular soil.	9
MORTAR 8.00	Efflorescence, otherwise no distress.	9
STONE MASONRY 8.00	No distress.	9
LATERAL SLOPE 0.50	Steep embankment fill with trees, minor raveling.	8
ROAD/SIDEWALK/SHOULDER 0.50	No distress.	9
UPSLOPE 0.50	Flat wooded area.	9
WALL DRAINS 0.50	No distress.	9

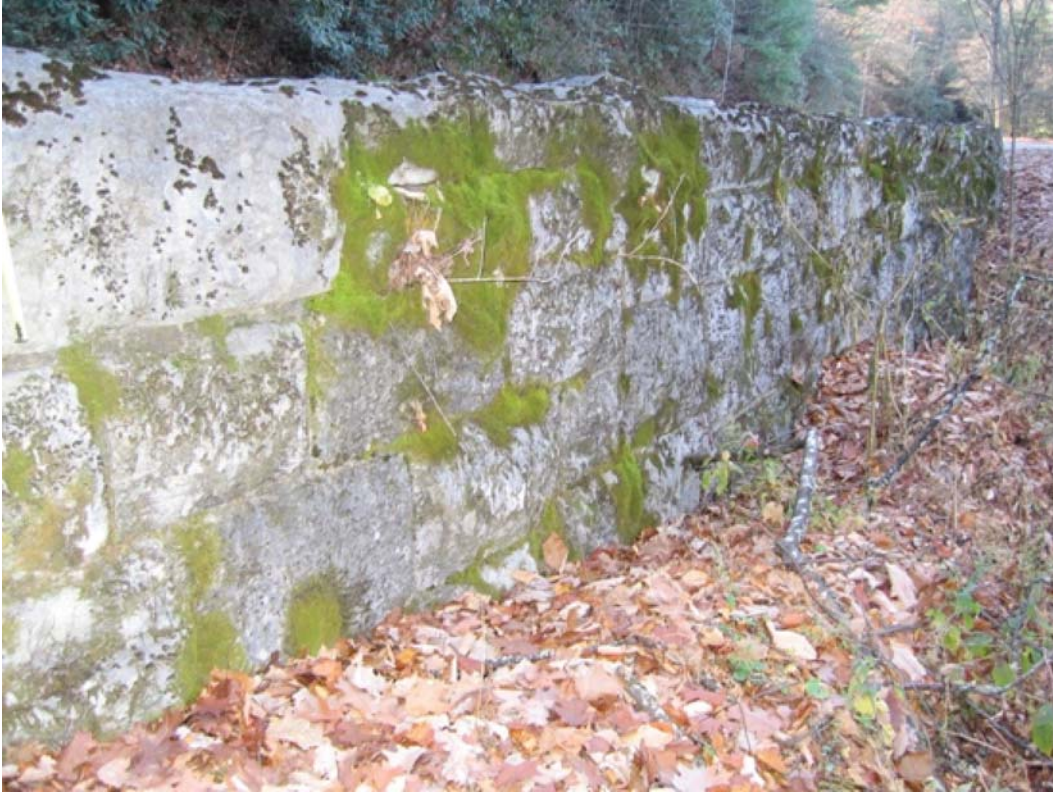
GRSM_0015_6.630_L_1.jpg

Element (Weighting Factor)	Narrative	Condition Rating (0 - 10)
PERFORMANCE 8.00	Good condition, performing as intended.	8
WALL FOUNDATION MATERIAL 8.00	Solid granular material, 3 wide benches, no signs of rotation or settlement.	9
MORTAR 8.00	Concrete mortar, minor cracks, minor debonding, moss cover.	8
STONE MASONRY 8.00	1-3 foot cut limestone blocks, strong, competent, moss cover, minor surface weathering.	8
ROAD/SIDEWALK/SHOULDER 0.50	Road has no signs of distress. Shoulder is 3-feet wide bench, grassy.	9
WALL DRAINS 0.50	None observed, not impacting wall performance.	9
LATERAL SLOPE 1.00	Headwall at begin of wall below and offset 10 feet, steep 1.5H:1V slopes with moderate to severe surface erosion.	6
DOWNSLOPE 1.00	3-foot wide bench with steep 1.5H:1V slopes below.	7

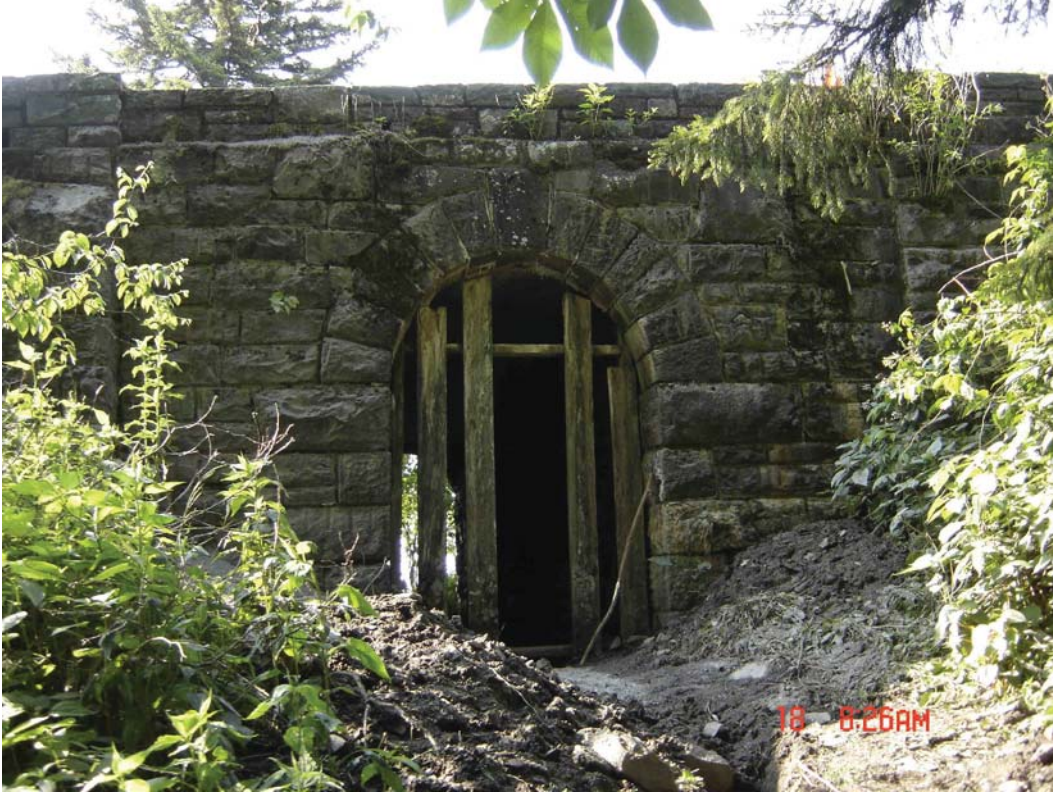
GRSM_0017_0.161_L_1.jpg

Element (Weighting Factor)	Narrative	Condition Rating (0 - 10)
PERFORMANCE 8.00	Maintenance required on mortar; otherwise good	7
WALL FOUNDATION MATERIAL 8.00	No distress	9
MORTAR 8.00	Moderate weathering and debonding; some efflorescence	7
STONE MASONRY 8.00	No distress	9
LATERAL SLOPE 0.50	Fill embankment, moderate slope, vegetated	8
DOWNSLOPE 0.50	Low gradient path/drainage	9
ROAD/SIDEWALK/SHOULDER 0.50	4' wide flat grass shoulder, no distress	9
WALL DRAINS 1.00	Evidence of seepage through mortar	7

Failure Consequence:	MODERATE
Recommendation Narrative:	Repoint 20% of wall face area: 0.2 x 312 = 62.4sf Use 65sf 65sf x \$75 = \$4875
Repair Cost:	\$4,875

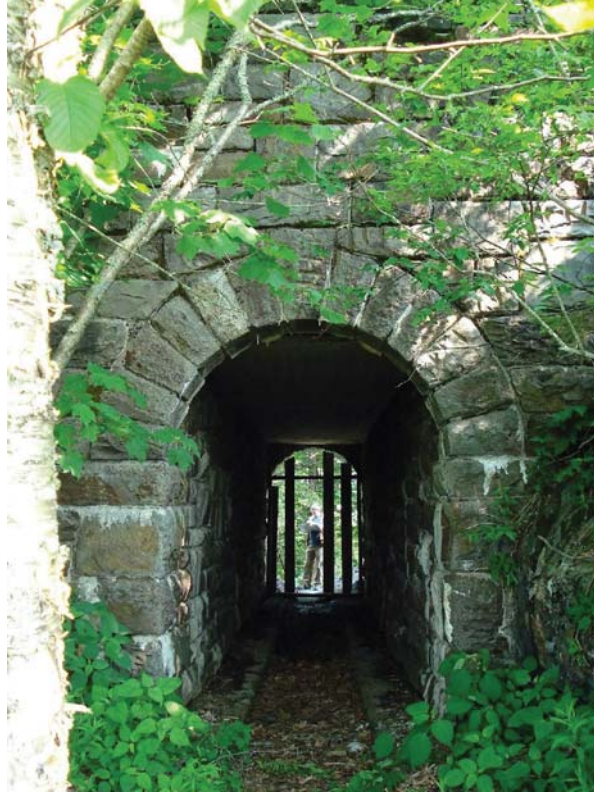
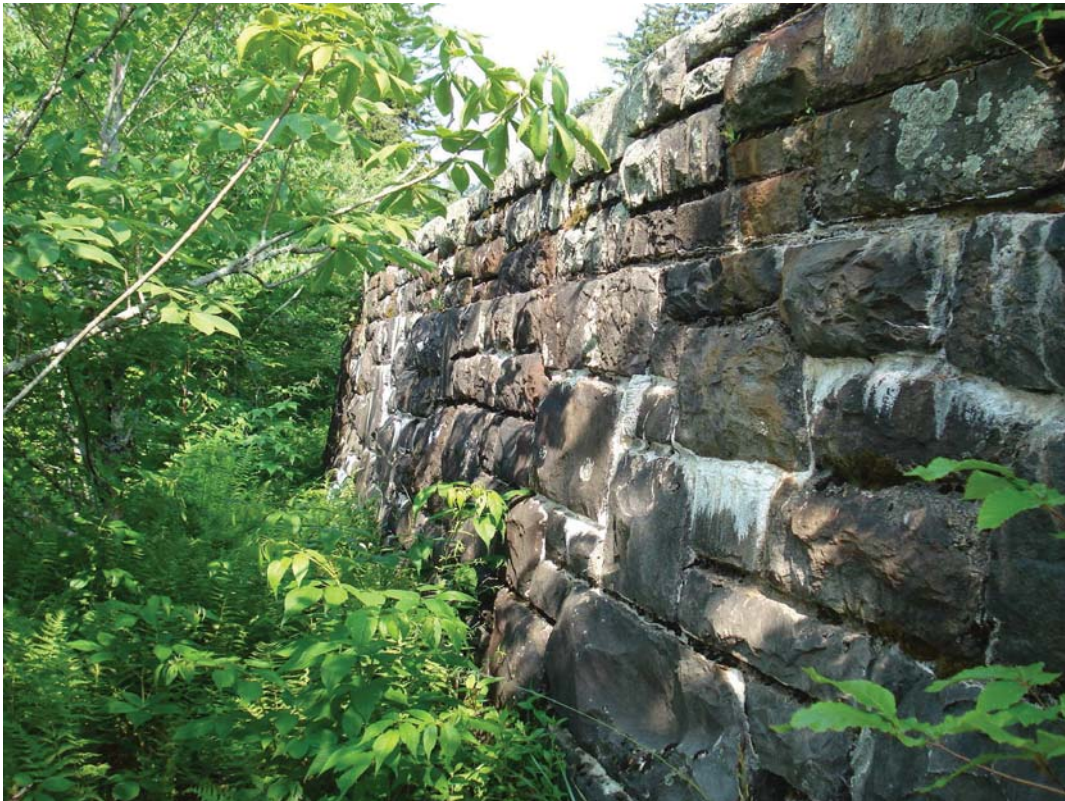
GRSM_0017_0.161_R_1.jpg

Element (Weighting Factor)	Narrative	Condition Rating (0 - 10)
PERFORMANCE 8.00	Good to excellent	9
WALL FOUNDATION MATERIAL 8.00	Founded on bedrock	9
MORTAR 8.00	Minor debonding/cracking	8
OTHER PRIMARY ELEMENT 8.00	Hiking path under roadway; minor cracking at top of box w/ exposed rebar	8
STONE MASONRY 8.00	Minor debonding	9
TRAFFIC BARRIER/FENCE 0.50	Guardwall has minor cracking/debonding	8
DOWNSLOPE 0.50	Steep slope, rocks, heavily vegetated; no distress	9
ROAD/SIDEWALK/SHOULDER 0.50	Pavement in good condition	9
WALL DRAINS 0.50	Weep holes evenly spaced along wall; appear functional	9

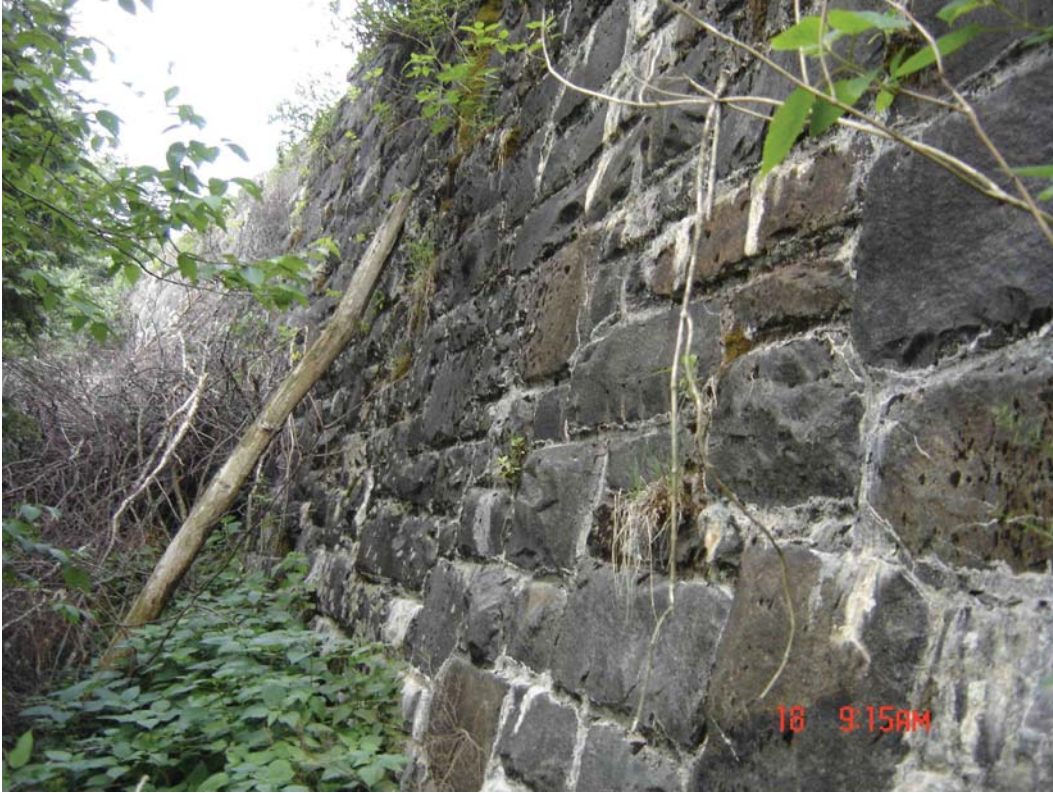
GRSM_0017_0.361_L_1.jpg

Element (Weighting Factor)	Narrative	Condition Rating (0 - 10)
PERFORMANCE 8.00	Good	8
WALL FOUNDATION MATERIAL 8.00	No distress	9
MORTAR 8.00	Mild debonding	8
STONE MASONRY 8.00	No distress	9
DOWNSLOPE 0.50	Steep, vegetated, large amount of slash brush piled at base of wall, coarse rock + soil fill	8
LATERAL SLOPE 0.50	Steep embankment fill, vegetated	8
CULVERT 0.50	No distress	9
ROAD/SIDEWALK/SHOULDER 0.50	5' grass shoulder; no distress	9
WALL DRAINS 0.50	Weep holes evenly spaced; no distress	9

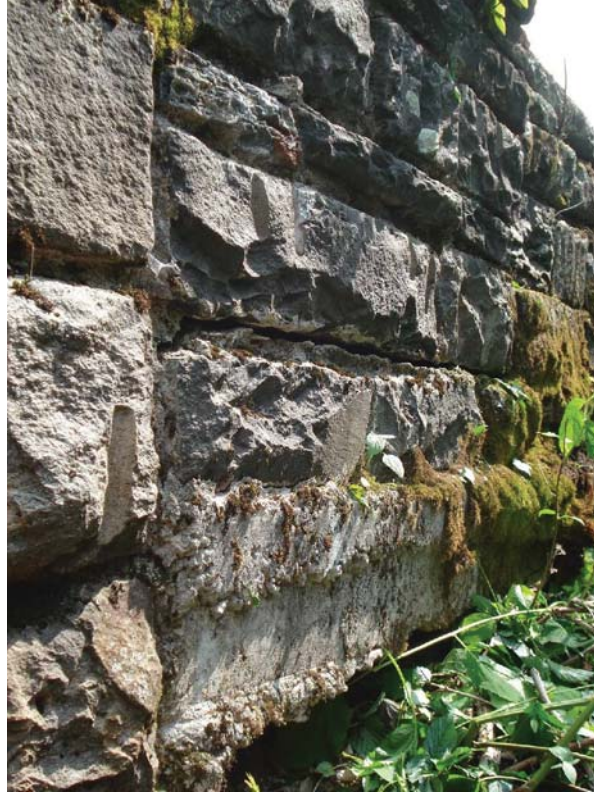
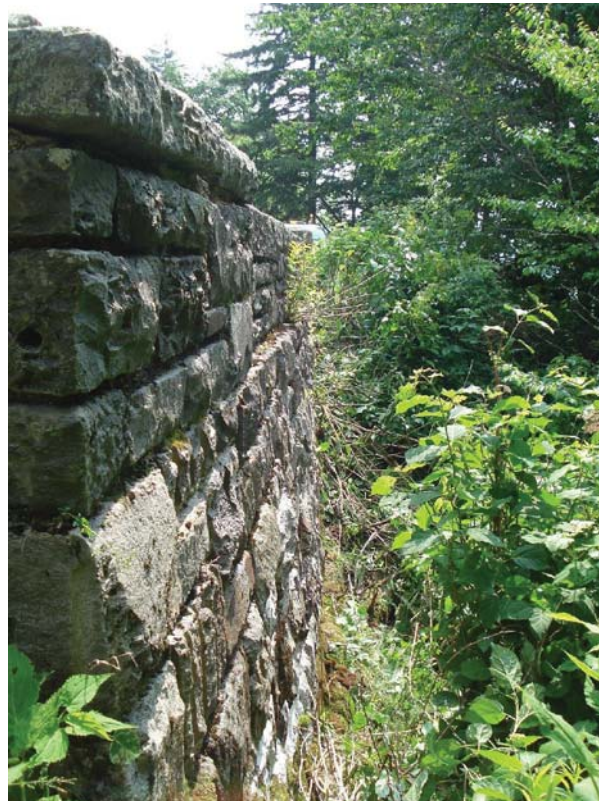
GRSM_0017_0.420_L_1.jpg

Element (Weighting Factor)	Narrative	Condition Rating (0 - 10)
PERFORMANCE 8.00	Undermining has caused wall distress and shoulder/guardwall settlement; overall fair condition	6
WALL FOUNDATION MATERIAL 8.00	Founded atop slope; undermining has caused separation of stones	6
MORTAR 8.00	Minor cracking/debonding; spalling at undermined location	8
STONE MASONRY 8.00	Separation at undermined area (.5"); otherwise good	8
DOWNSLOPE 0.50	Slash debris along base of wall; no distress	8
VEGETATION 0.50	Bushes at base of wall should be cut back	8
CULVERT 0.50	1.5' circular concrete culvert in good condition	9
LATERAL SLOPE 0.50	No distress	9
ROAD/SIDEWALK/SHOULDER 1.00	Small depression of shoulder at undermined spot	7

Failure Consequence:	MODERATE
Recommendation Narrative:	Repoint 15% of wall: .15 x 181sf = 27sf Use 30sf - 30sf x \$75 = \$2250. Repair undermine near wall end - 5'long x 1' high x 1' deep: Subexc 1' - place mortared stones in void. Ensure contact with wall: 2 crew 16 hrs - materials incidental: 2 x 16 x \$55 = \$
Repair Cost:	\$4,010

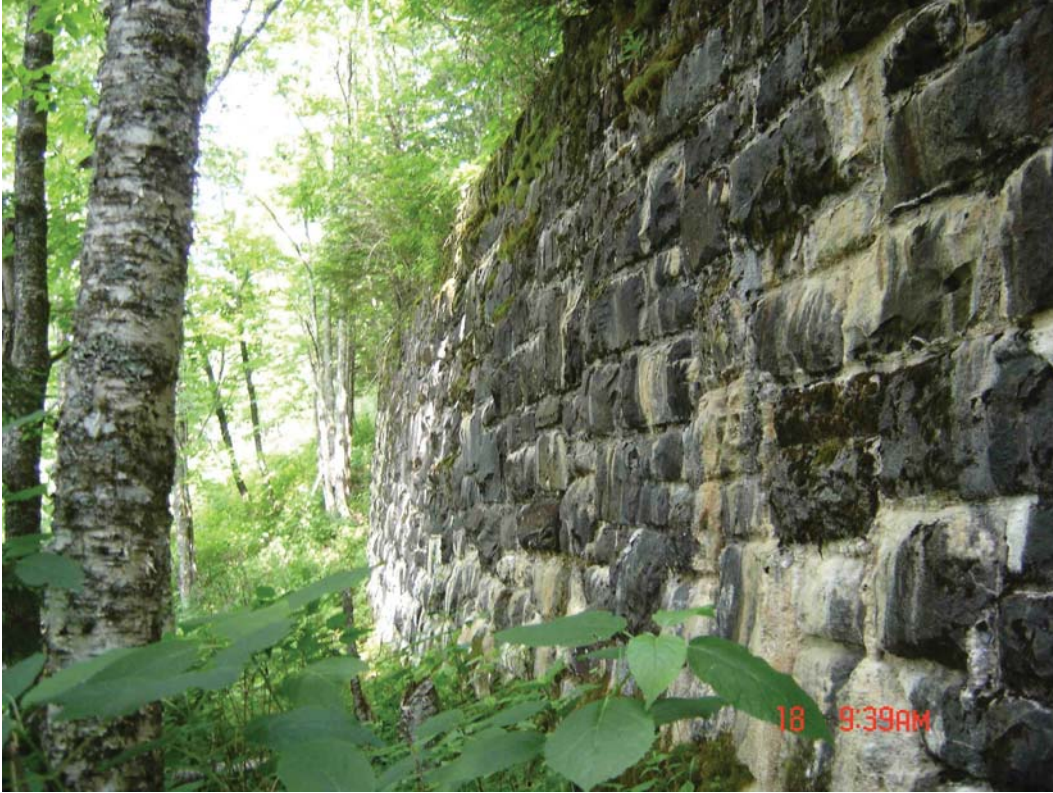
GRSM_0017_0.424_L_1.jpg

Element (Weighting Factor)	Narrative	Condition Rating (0 - 10)
PERFORMANCE 8.00	Weathering, otherwise good	7
WALL FOUNDATION MATERIAL 8.00	No distress	9
MORTAR 8.00	Mild debonding	7
STONE MASONRY 8.00	No distress	9
DOWNSLOPE 0.50	Moderate vegetated slight settlement at base of wall	8
LATERAL SLOPE 0.50	Steep vegetated, minor raveling	8
WALL DRAINS 0.50	No distress	9
UPSLOPE 1.00	Steep, coarse loose fill embankment, voids, minor raveling	7

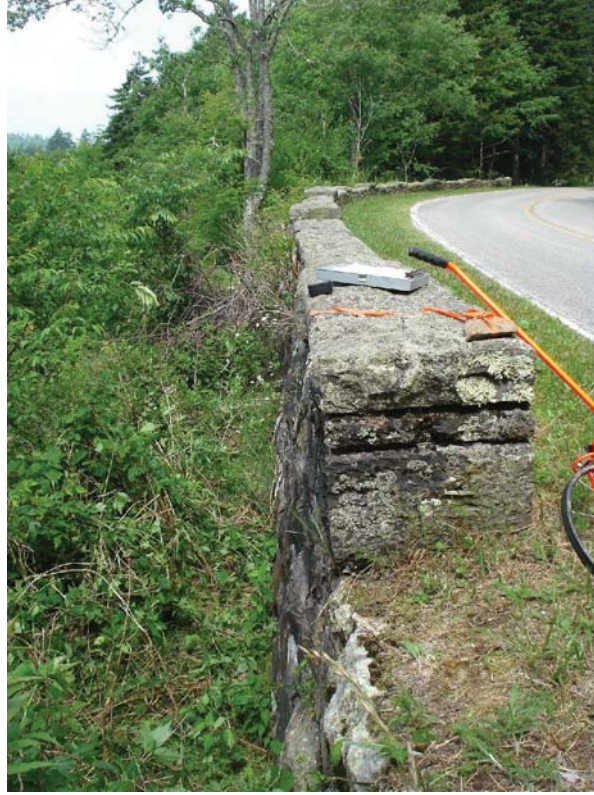
GRSM_0017_0.464_L_2.jpg

Element (Weighting Factor)	Narrative	Condition Rating (0 - 10)
PERFORMANCE 8.00	Minor undermining, several bushes too close to wall; otherwise good	8
WALL FOUNDATION MATERIAL 8.00	Minor undermining of foundation at several locations, founded on moderate to steep slope	8
MORTAR 8.00	General weathering	8
STONE MASONRY 8.00	Minor cracking/debonding	8
DOWNSLOPE 0.50	Highly vegetated slope, debris along wall may be causing slope creep away from wall	8
LATERAL SLOPE 0.50	Vegetated	8
VEGETATION 0.50	Bushes should be cut back 3' from wall	8
ROAD/SIDEWALK/SHOULDER 0.50	Pavement/roadway in excellent condition	9
WALL DRAINS 0.50	No distress	9

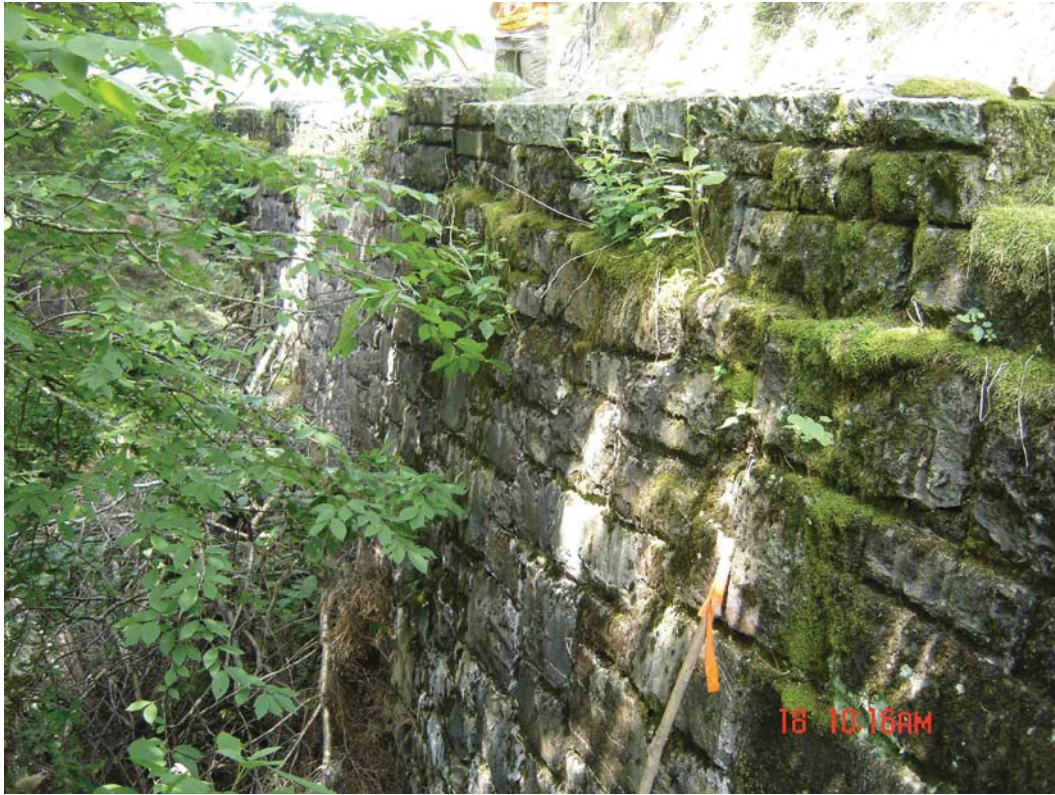
GRSM_0017_0.558_L_1.jpg

Element (Weighting Factor)	Narrative	Condition Rating (0 - 10)
PERFORMANCE 8.00	Good	8
WALL FOUNDATION MATERIAL 8.00	No distress	9
MORTAR 8.00	Mild debonding	8
STONE MASONRY 8.00	No distress	9
WALL DRAINS 0.50	No distress	8
CULVERT 0.50	Partially covered with slash; otherwise ok	9
ROAD/SIDEWALK/SHOULDER 0.50	No distress	9
DOWNSLOPE 1.00	Minor settling and raveling at base of wall, moderate to steep fill embankment	7
LATERAL SLOPE 1.00	~30' of roadway before start of wall is settling/cracking; downwall end ok	7

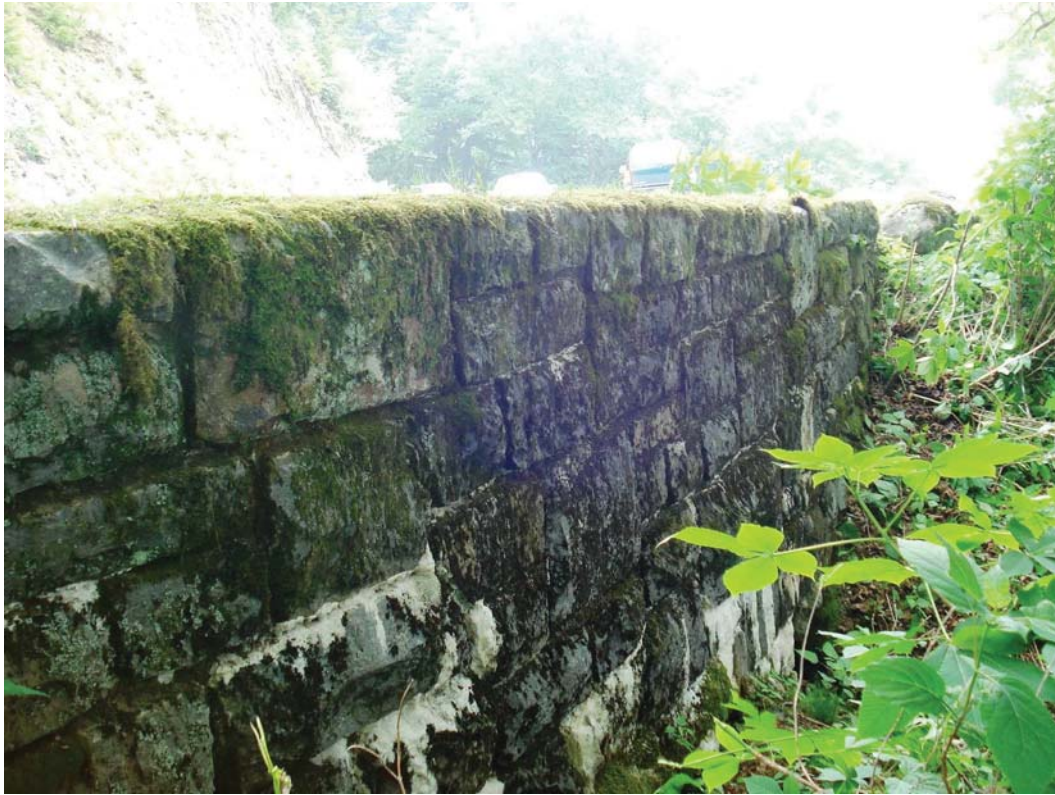
GRSM_0017_0.620_L_1.jpg

Element (Weighting Factor)	Narrative	Condition Rating (0 - 10)
PERFORMANCE 8.00	Good to excellent	9
WALL FOUNDATION MATERIAL 8.00	Minor localized undermining; otherwise no distress	9
MORTAR 8.00	General weathering	8
STONE MASONRY 8.00	Good to excellent	9
CULVERT 0.50	1.5' cmp culvert; no distress	9
DOWNSLOPE 0.50	Moderate to steep slope; no distress	9
LATERAL SLOPE 0.50	No distress	9
ROAD/SIDEWALK/SHOULDER 0.50	No distress	9
WALL DRAINS 0.50	No distress	9

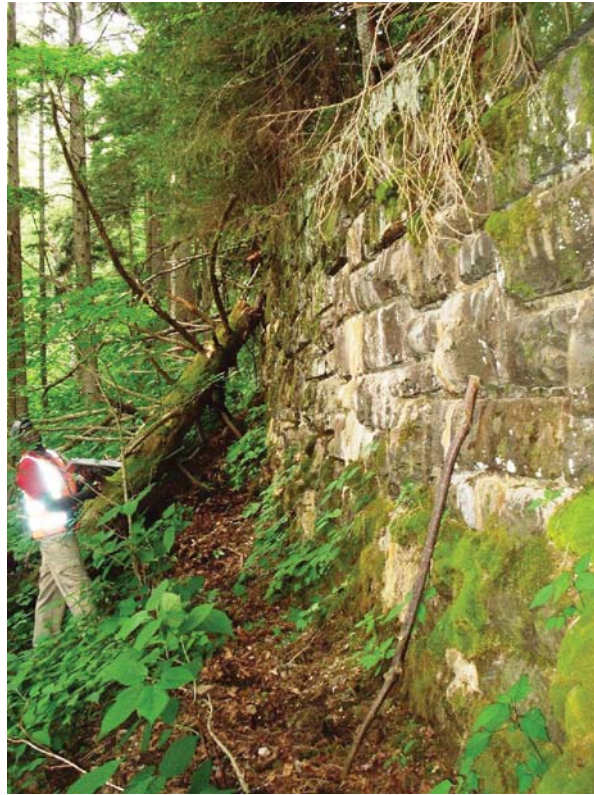
GRSM_0017_0.655_L_1.jpg

Element (Weighting Factor)	Narrative	Condition Rating (0 - 10)
PERFORMANCE 8.00	Minor spalling; otherwise good	8
WALL FOUNDATION MATERIAL 8.00	No distress	8
MORTAR 8.00	Age related weathering	7
STONE MASONRY 8.00	Minor cracking	8
DOWNSLOPE 0.50	Moderate slope, no distress	8
LATERAL SLOPE 0.50	No distress	8
VEGETATION 0.50	Several trees growing at top of wall (some big, some small)	8
WALL DRAINS 0.50	Occasional weep holes, no distress	8
UPSLOPE 0.50	No distress	9

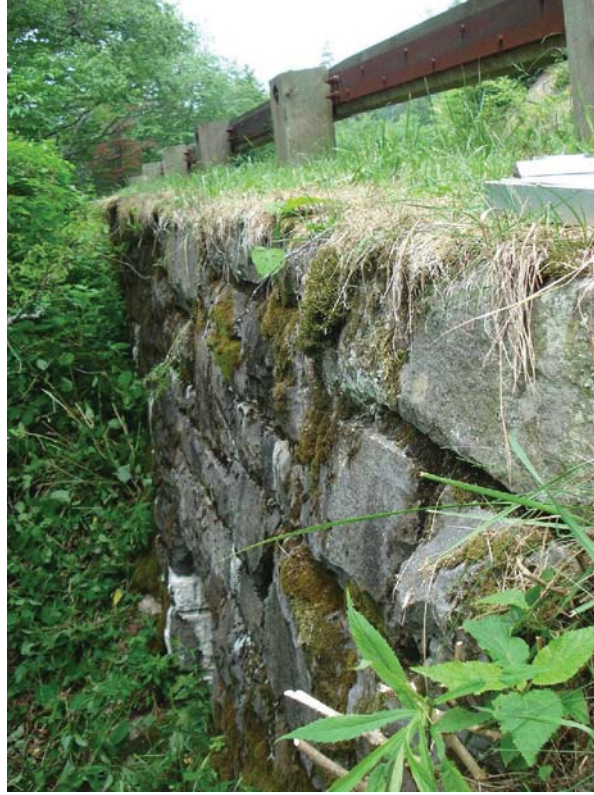
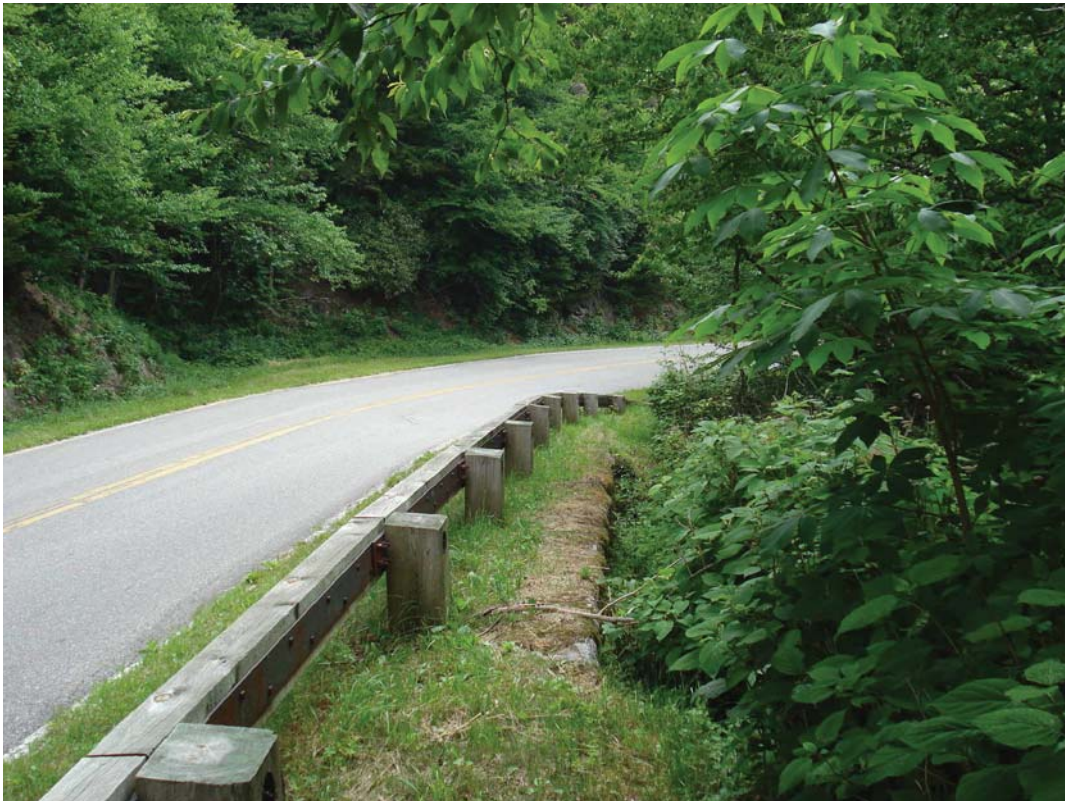
GRSM_0017_0.901_L_1.jpg

Element (Weighting Factor)	Narrative	Condition Rating (0 - 10)
PERFORMANCE 8.00	Good	8
WALL FOUNDATION MATERIAL 8.00	No distress	9
MORTAR 8.00	Mild degradation of mortar	8
STONE MASONRY 8.00	Minor debonding	8
CULVERT 0.50	Minor rusting, no distress	8
DOWNSLOPE 0.50	Mod/steep slope w/ riprap erosion protection at culvert opening	9
LATERAL SLOPE 0.50	No distress	9
ROAD/SIDEWALK/SHOULDER 0.50	Minor cracking in the pavement, no distress to shoulder	9
WALL DRAINS 0.50	No distress	9

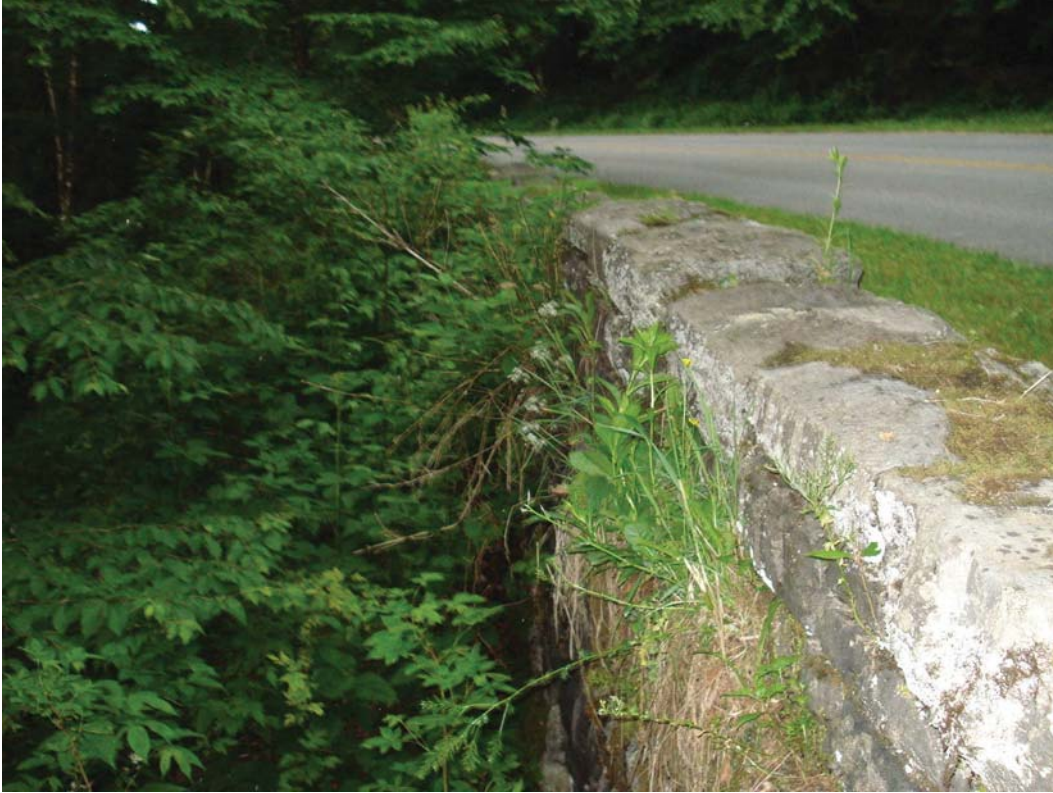
GRSM_0017_1.979_L_1.jpg

Element (Weighting Factor)	Narrative	Condition Rating (0 - 10)
PERFORMANCE 8.00	Good to excellent	8
WALL FOUNDATION MATERIAL 8.00	No distress	9
MORTAR 8.00	General weathering	8
STONE MASONRY 8.00	Minor debonding	8
WALL DRAINS 0.50	No distress	8
DOWNSLOPE 0.50	Moderate slope w/ heavy brush and tree cover, no distress	9
LATERAL SLOPE 0.50	No distress	9
VEGETATION 0.50	Heavy brush adjacent to wall	9

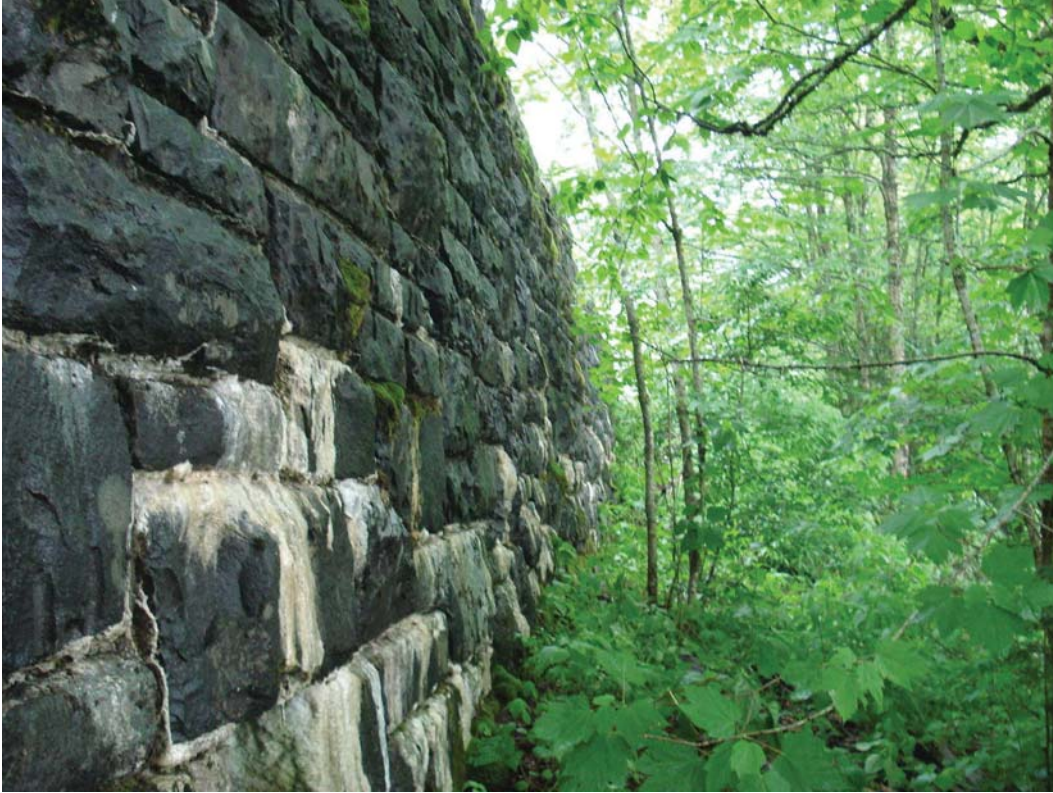
GRSM_0017_2.025_L_1.jpg

Element (Weighting Factor)	Narrative	Condition Rating (0 - 10)
PERFORMANCE 8.00	Good	8
WALL FOUNDATION MATERIAL 8.00	Firm soil and rock fill; some loose areas and slash debris	8
MORTAR 8.00	Weathering distress	8
STONE MASONRY 8.00	Minor spalling	8
DOWNSLOPE 0.50	Moderate to steep, minor erosion away from wall	8
LATERAL SLOPE 0.50	Moderate to steep slope, vegetated	8
ROAD/SIDEWALK/SHOULDER 0.50	Flat grass shoulder, no distress	9
WALL DRAINS 0.50	Weep hole present, no distress	9

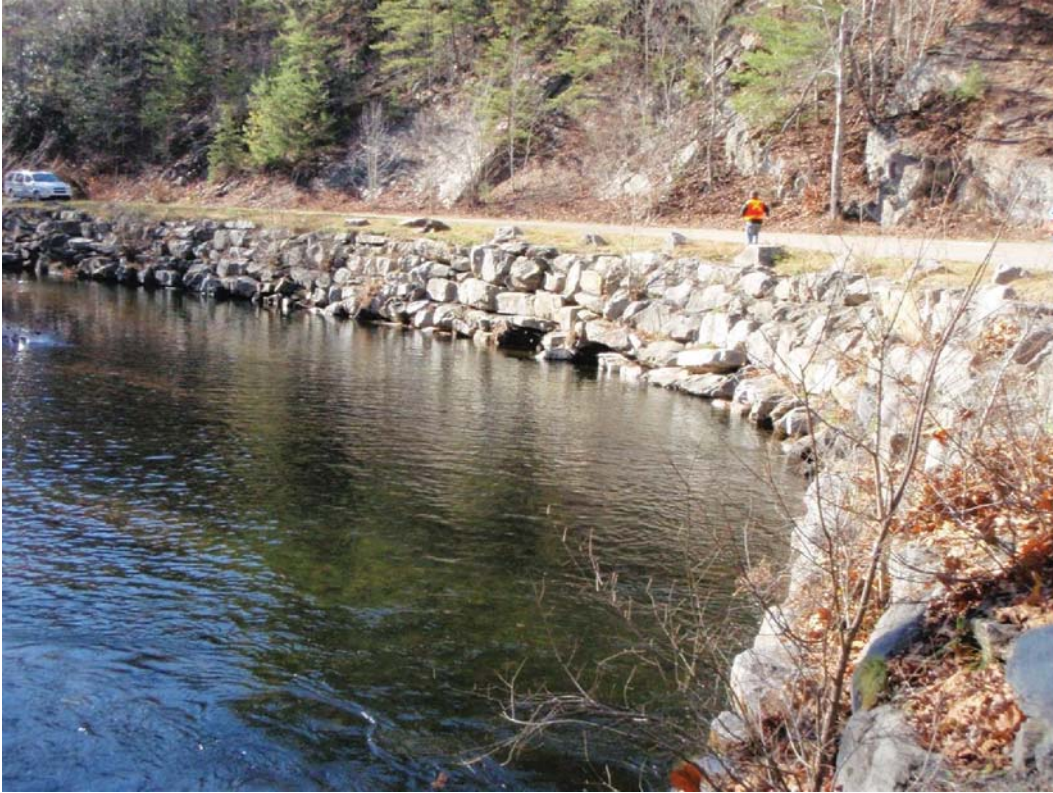
GRSM_0018_0.698_R_1.jpg

Element (Weighting Factor)	Narrative	Condition Rating (0 - 10)
PERFORMANCE 8.00	Fair to poor condition with failed section in the middle.	6
WALL FOUNDATION MATERIAL 8.00	Active stream channel material, slope about 1.5H:1V with minor to moderate scour at the base.	7
PLACED STONE 8.00	1-2 foot limestone boulders, moss covered throughout, minor voids throughout, 1 failed section at 71 feet from begin of wall. About 10'x10' section fell into stream, not impacting road yet, but eventually will encroach on roadway if not repaired.	4
LATERAL SLOPE 1.00	Washed out at the end of wall.	4
ROAD/SIDEWALK/SHOULDER 0.50	Road has minor cracking associated with failed section. Shoulder has about 2-feet wide flat bench with minor soft spots.	8
WALL DRAINS 0.50	None observed, not impacting wall.	8
DOWNSLOPE 1.00	Active stream channel with potential for undermining and scour.	6
VEGETATION 1.00	Grass and brush throughout with one large tree, both stabilize above and below slope.	7

Failure Consequence:	MODERATE
Recommendation Narrative:	Located about 71-feet from the begin of wall, a 10'x10' failed wall section needs to be replaced: Riprap Class 3 - place @ failed section 10'x10'x3' = 300 cft = 11 cyd @ \$220/cyd = \$2,444. Labor = 2 people x 4hrs x \$55/hr = \$440.
Repair Cost:	\$3,284

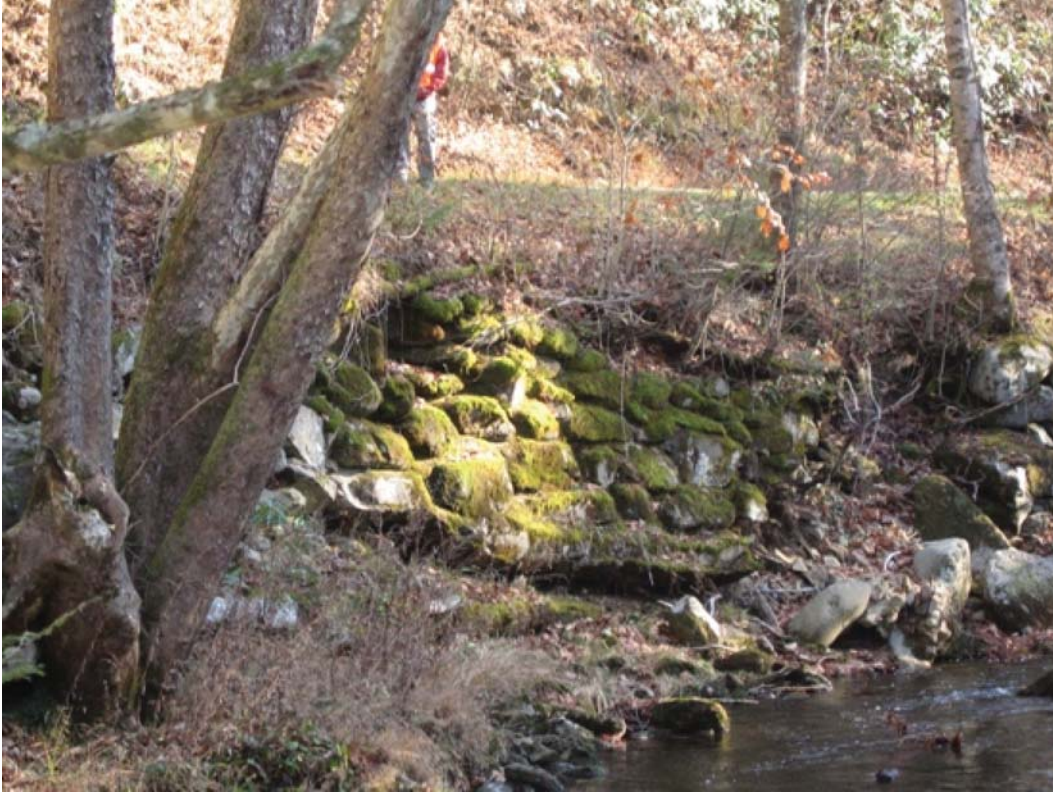
GRSM_0018_0.939_R_1.jpg

Element (Weighting Factor)	Narrative	Condition Rating (0 - 10)
PERFORMANCE 8.00	As required.	8
WALL FOUNDATION MATERIAL 8.00	Firm soil and embankment rock fill, slight undermining.	8
MORTAR 8.00	Extensive weathering and debonding	6
STONE MASONRY 8.00	Moss covered, some weathering.	8
DOWNSLOPE 0.50	Flat streambed cobbles.	8
ROAD/SIDEWALK/SHOULDER 0.50	No distress.	9
WALL DRAINS 0.50	No distress.	9
LATERAL SLOPE 1.00	Steep, some raveling, possible creep.	7

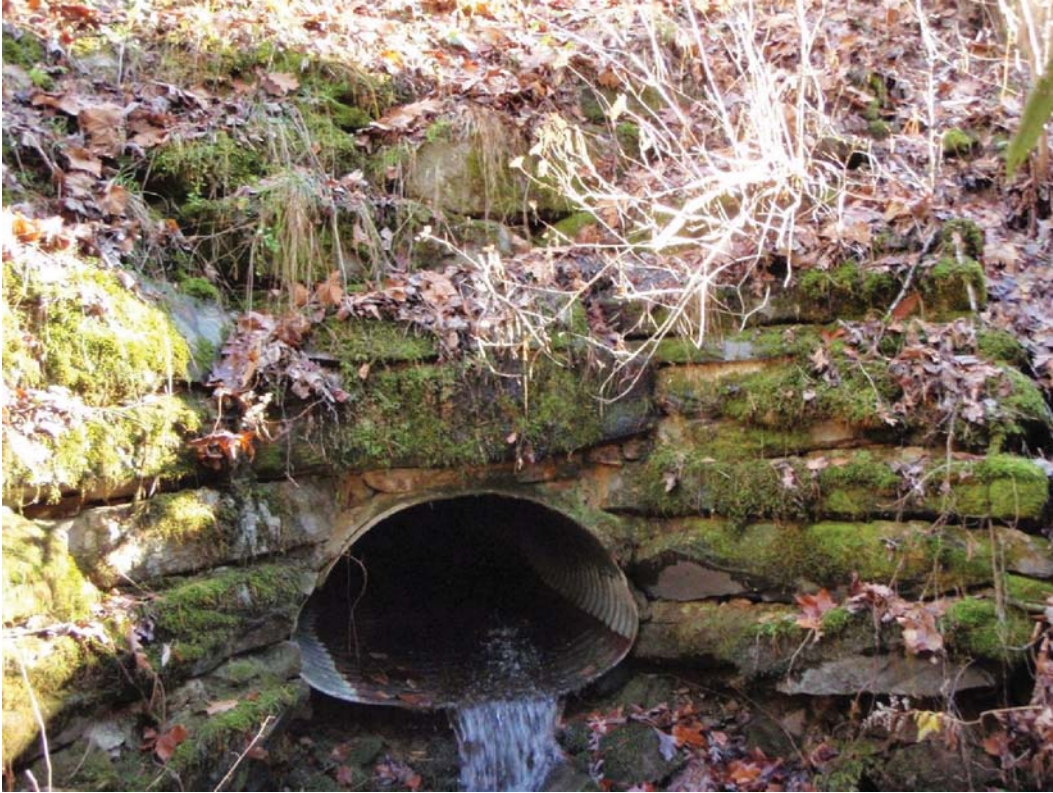
GRSM_0018_1.013_R_1.jpg

Element (Weighting Factor)	Narrative	Condition Rating (0 - 10)
PERFORMANCE 8.00	Fair to poor, 2 failed sections in shoulder not yet impacting roadway.	6
WALL FOUNDATION MATERIAL 8.00	Solid granular material in active stream channel, scour and undermining possible.	6
PLACED STONE 8.00	Limestone boulders (1-5-ft diameter) with occasional missing elements at 2 locations, failing in shoulder area, but not yet impacting roadway.	4
CULVERT 0.50	24-inch CMP at end of wall, performing as intended.	9
WALL DRAINS 0.50	None observed, not impacting wall performance.	9
DOWNSLOPE 1.00	Active stream channel, scour possible.	6
ROAD/SIDEWALK/SHOULDER 1.00	Road has slight cracking and depression above failed area. Shoulder is about 2-3 feet wide, occasional loose, soft ground, 2 local failed sections.	6
LATERAL SLOPE 1.00	1.5H:1V slope at begin and end of wall, moderate surface erosion.	7
VEGETATION 1.00	Trees and brush, both pushing out base of wall, but preventing erosion at the top of the wall.	7

Failure Consequence:	MODERATE
Recommendation Narrative:	Replace boulders at 2 failed shoulder locations: @ 30 feet from begin of wall = 15'widex10'htx3'deep = 450 ft ³ , @ 48 feet from begin of wall = 5'widex10'htx3'deep = 150 ft ³ , Total = 600 ft ³ = 22cyd. Riprap Class 6 @\$220/yd ³ = 22x220 = \$4,840
Repair Cost:	\$6,760

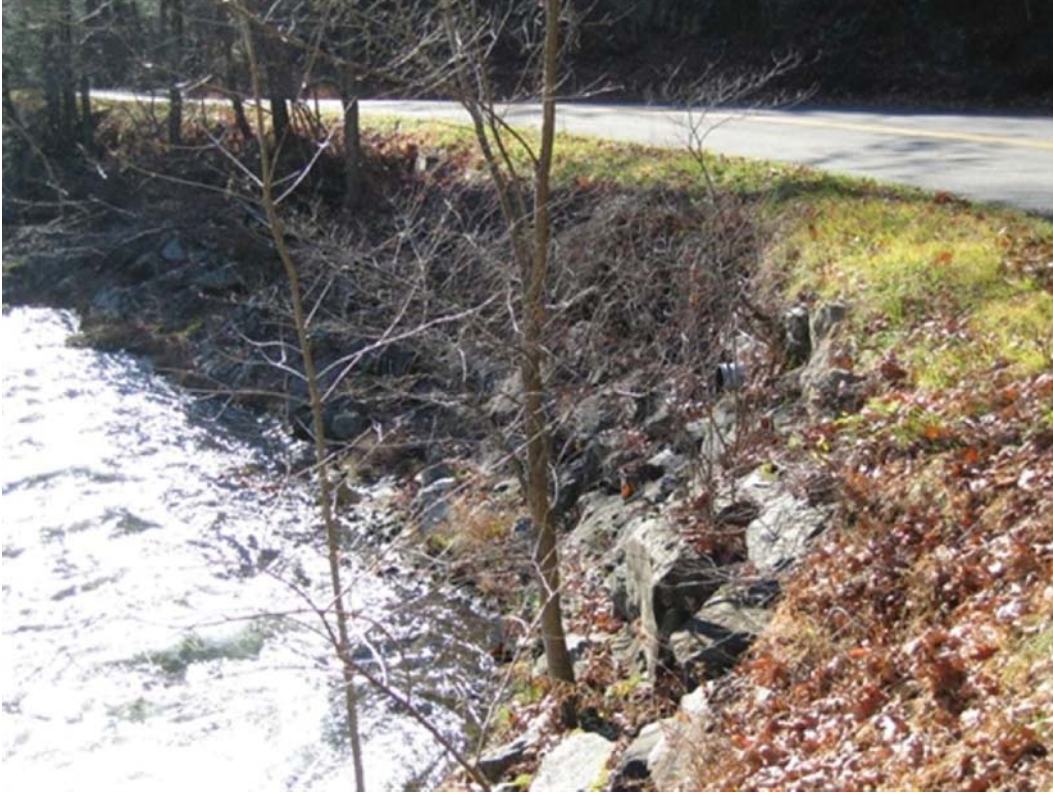
GRSM_0018_1.264_R_1.jpg

Element (Weighting Factor)	Narrative	Condition Rating (0 - 10)
PERFORMANCE 8.00	As required.	9
WALL FOUNDATION MATERIAL 8.00	Firm rock fill	9
PLACED STONE 8.00	Minor lichen growth, no distress.	9
DOWNSLOPE 0.50	Stream - low scour potential.	8
LATERAL SLOPE 0.50	Steep rocky embankment fill, possible creep.	8
ROAD/SIDEWALK/SHOULDER 0.50	Shallow grassy shoulder slope. Road has minor cracking not likely wall related.	9
WALL DRAINS 0.50	6-inch PVC pipe no distress.	9

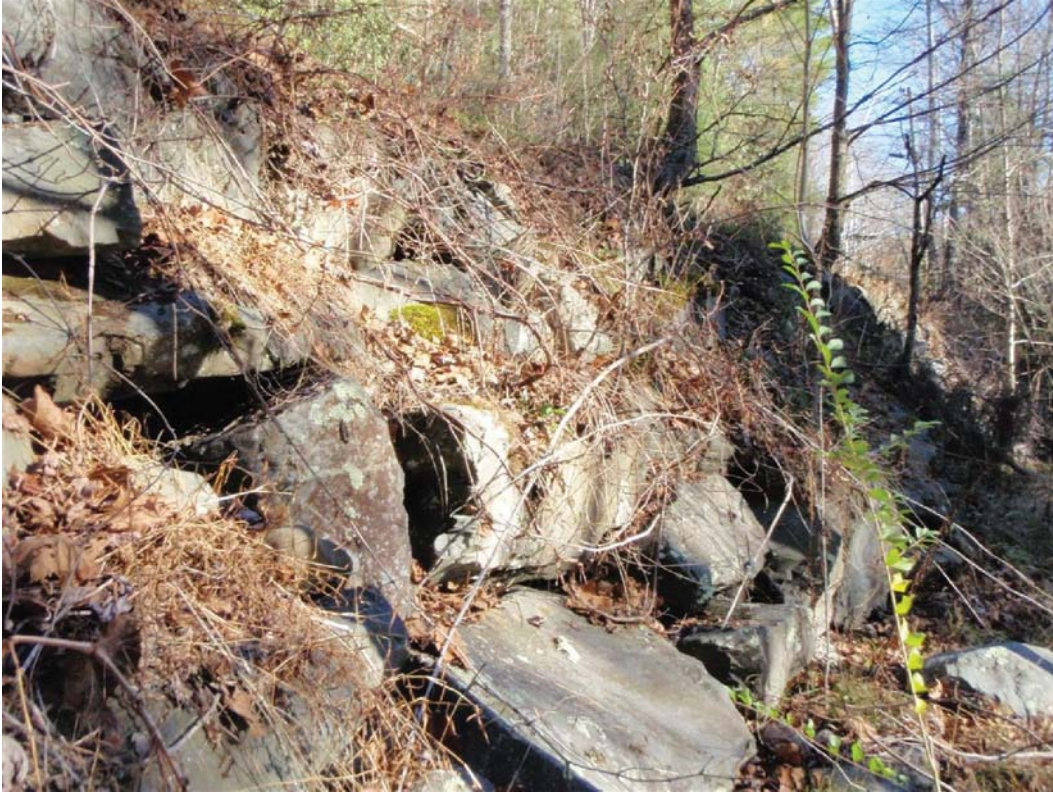
GRSM_0018_1.373_R_1.jpg

Element (Weighting Factor)	Narrative	Condition Rating (0 - 10)
PERFORMANCE 8.00	As required.	9
WALL FOUNDATION MATERIAL 8.00	Concreted. Streambed rock and bedrock.	9
MORTAR 8.00	Concrete mortar - no distress.	9
PLACED STONE 8.00	Slight weathering, otherwise no distress.	9
LATERAL SLOPE 0.50	Very steep rock fill embankment with some trees and slight raveling	8
ROAD/SIDEWALK/SHOULDER 0.50	No distress.	9
WALL DRAINS 0.50	No distress.	9

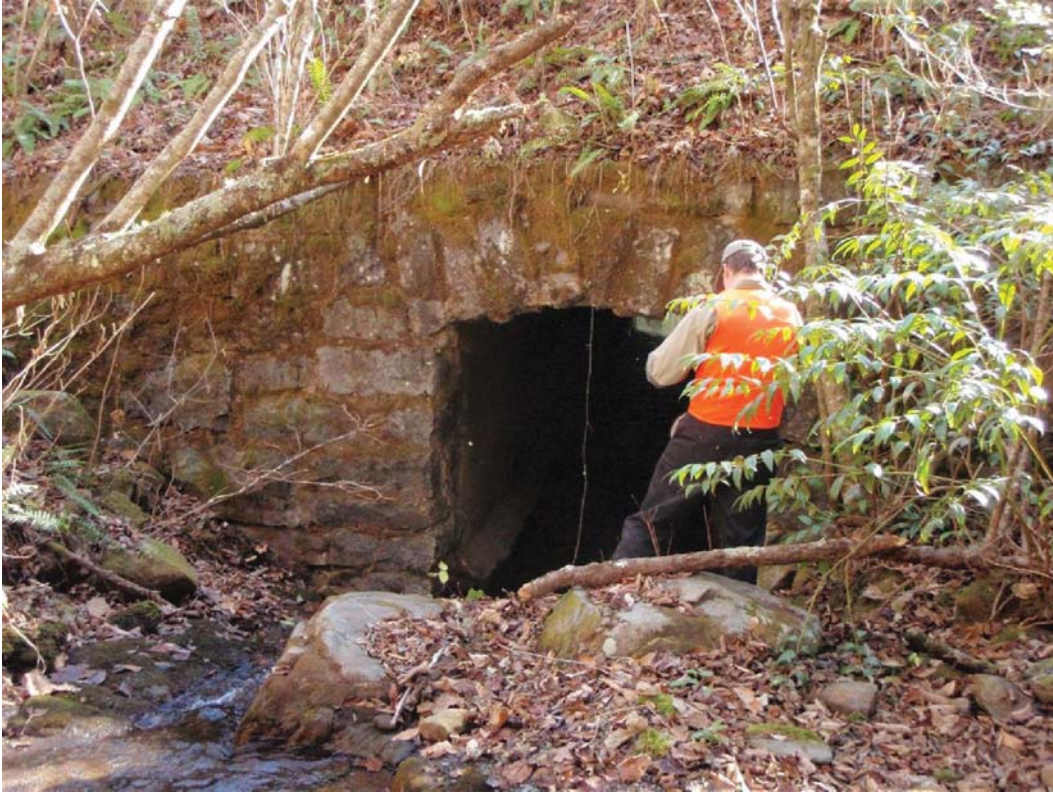
GRSM_0019_0.300_R_1.jpg

Element (Weighting Factor)	Narrative	Condition Rating (0 - 10)
PERFORMANCE 8.00	As intended	9
WALL FOUNDATION MATERIAL 8.00	Stable boulder/cobble/soil channel	9
MORTAR 8.00	Slight debonding (~15%, 1/2"max), moss	8
STONE MASONRY 8.00	No distress	9
LATERAL SLOPE 0.50	Stable embankment, 33 degrees, no distress	9
ROAD/SIDEWALK/SHOULDER 0.50	No distress	9
UPSLOPE 0.50	Stable embankment, 33 degrees, no distress	9
WALL DRAINS 0.50	No distress	9

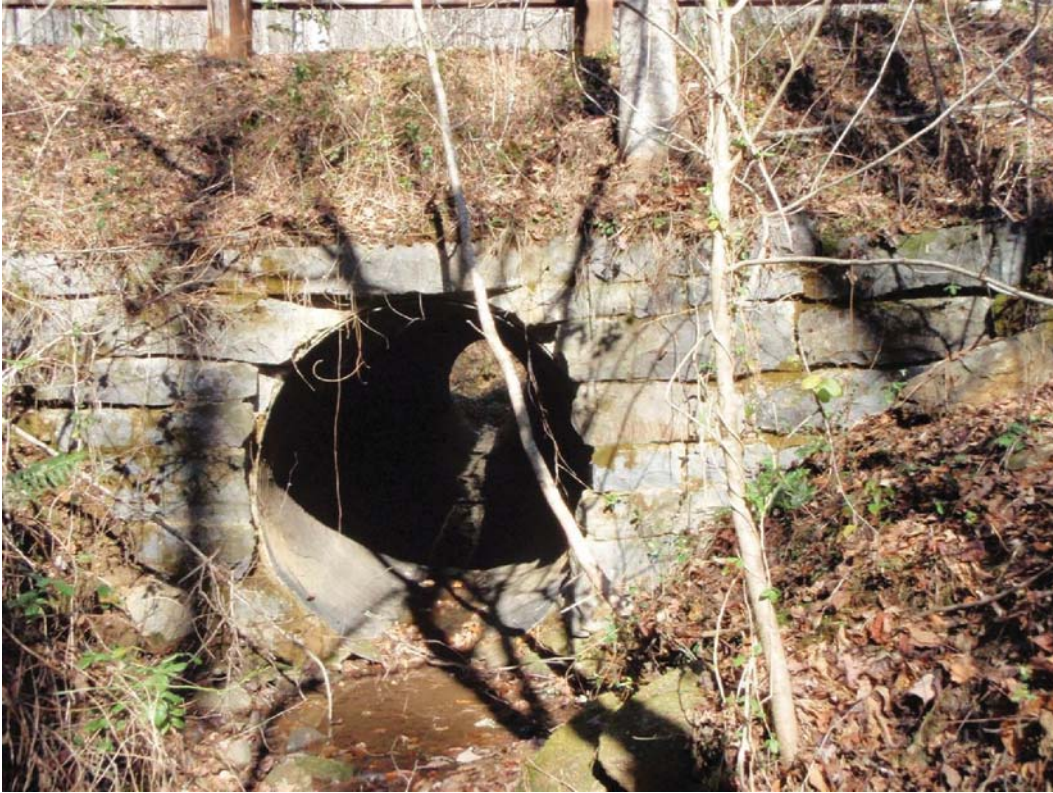
GRSM_0019_2.430_L_1.jpg

Element (Weighting Factor)	Narrative	Condition Rating (0 - 10)
PERFORMANCE 8.00	As intended	9
WALL FOUNDATION MATERIAL 8.00	Stable cobble channel	9
MORTAR 8.00	v.slight debond (>10%, 1/4" max). No other distress	9
PLACED STONE 8.00	No distress	9
LATERAL SLOPE 0.50	Stable embankment, 26 degrees, no distress	9
ROAD/SIDEWALK/SHOULDER 0.50	No distress	9
UPSLOPE 0.50	Stable embankment, 26 degrees, no distress	9
WALL DRAINS 0.50	No distress	9

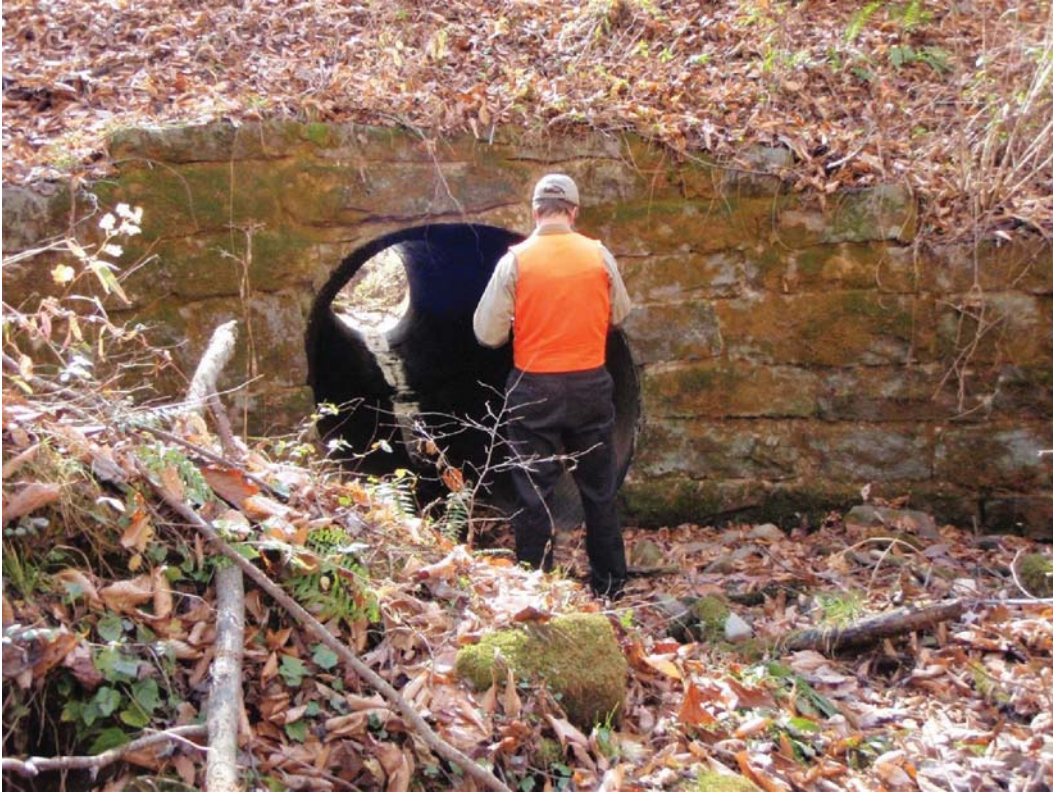
GRSM_0019_2.432_R_1.jpg

Element (Weighting Factor)	Narrative	Condition Rating (0 - 10)
PERFORMANCE 8.00	As intended	9
WALL FOUNDATION MATERIAL 8.00	Stable cobble channel, no distress	9
MORTAR 8.00	Slight debonding and some spalling (~15%, 1/4"max). No other distress	8
PLACED STONE 8.00	No distress	9
CULVERT 0.50	No distress	9
LATERAL SLOPE 0.50	Stable embankment, 24 degrees, no distress	9
ROAD/SIDEWALK/SHOULDER 0.50	No distress	9
UPSLOPE 0.50	Stable embankment, 24 degrees, no distress	9
WALL DRAINS 0.50	4" weep left side, no distress	9
