NPS Retaining Wall Inventory Program Great Smoky Mountains National Park

**Federal Lands Highway
Road Inventory Program**

Federal Highway Administration
Eastern Federal Lands Highway Division
Road Inventory Program (RIP)

Data Collection Date: April 2011
Report Date: November 2015

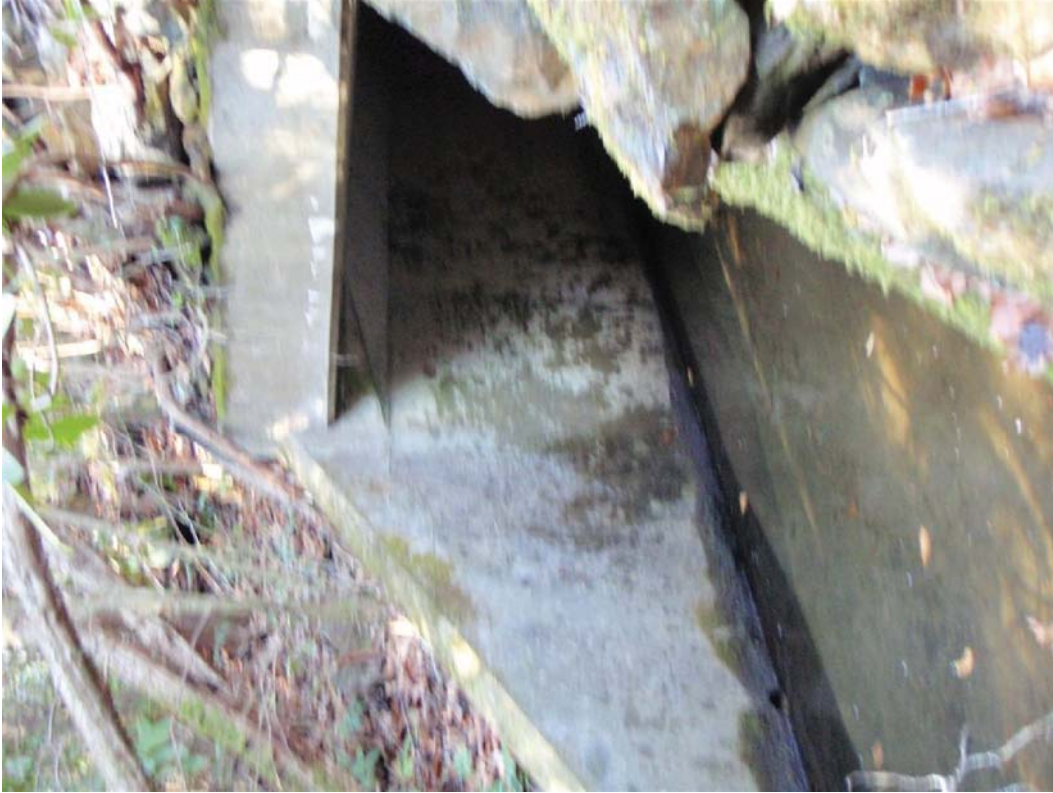
GRSM_0019_5.795_L_1.jpg

Element (Weighting Factor)	Narrative	Condition Rating (0 - 10)
PERFORMANCE 8.00	As intended	9
WALL FOUNDATION MATERIAL 8.00	Stable channel, no visible distress	9
CONCRETE 8.00	No distress	10
WALL DRAINS 0.50	Weep holes in box. No distress	9
LATERAL SLOPE 0.50	Stable rock embankment, 36 degrees, no distress	10
ROAD/SIDEWALK/SHOULDER 0.50	No distress	10
UPSLOPE 0.50	Stable rock embankment, 36 degrees, no distress	10

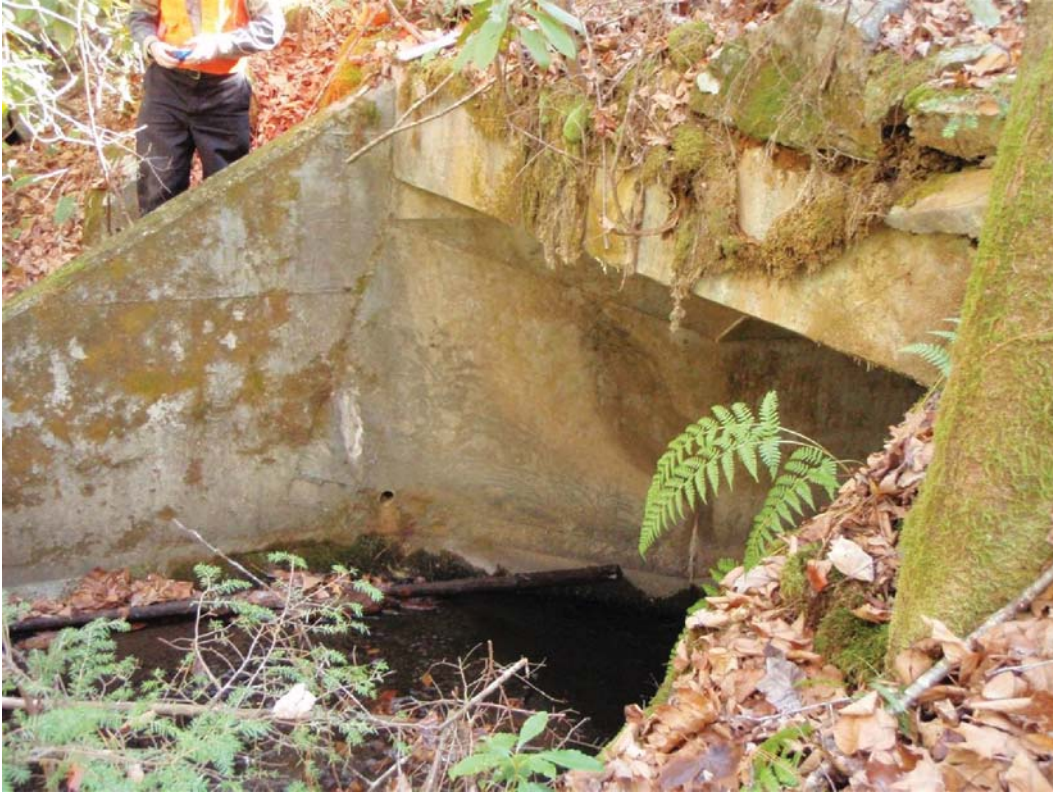
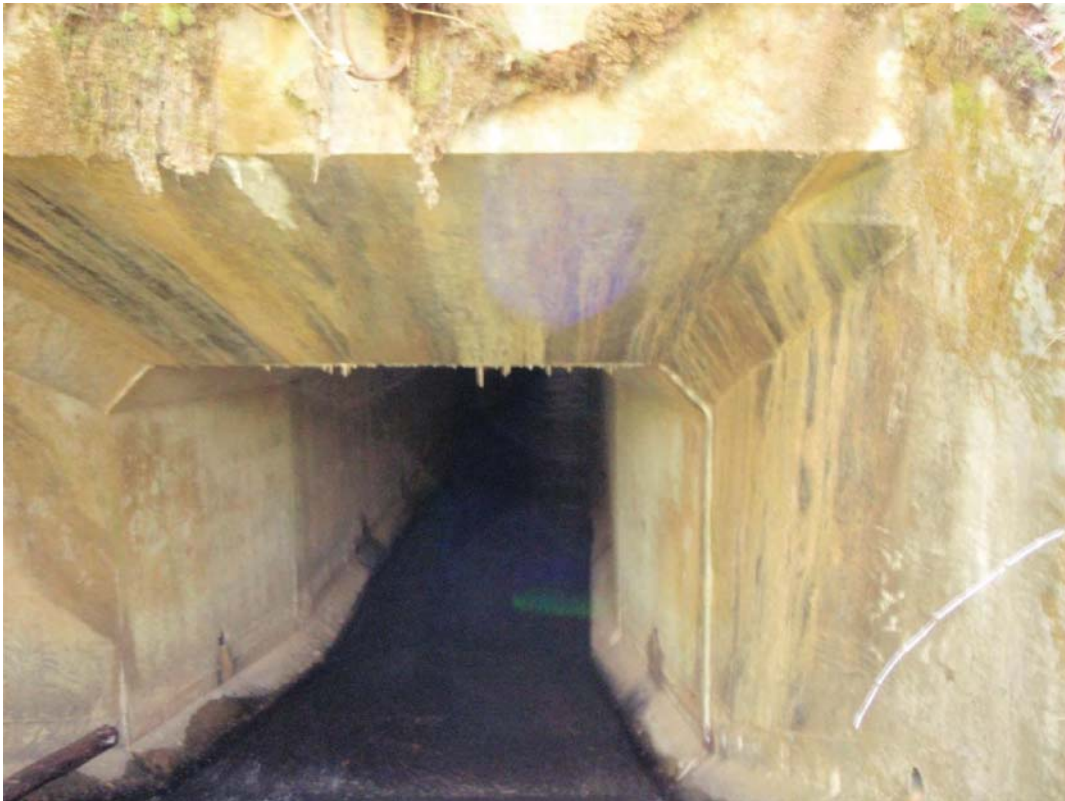
GRSM_0019_5.807_R_1.jpg

Element (Weighting Factor)	Narrative	Condition Rating (0 - 10)
PERFORMANCE 8.00	As intended	9
WALL FOUNDATION MATERIAL 8.00	concrete approach pad. No distress.	9
CONCRETE 8.00	minor damage on upper right corner (2'x1' piece broken off). No other distress.	9
LATERAL SLOPE 0.50	stable, well vegetated road embankment. No distress	9
UPSLOPE 0.50	Stable, well vegetated road embankment. No distress	9
WALL DRAINS 0.50	Weep holes in box culvert. No distress.	9
ROAD/SIDEWALK/SHOULDER 0.50	No distress	10

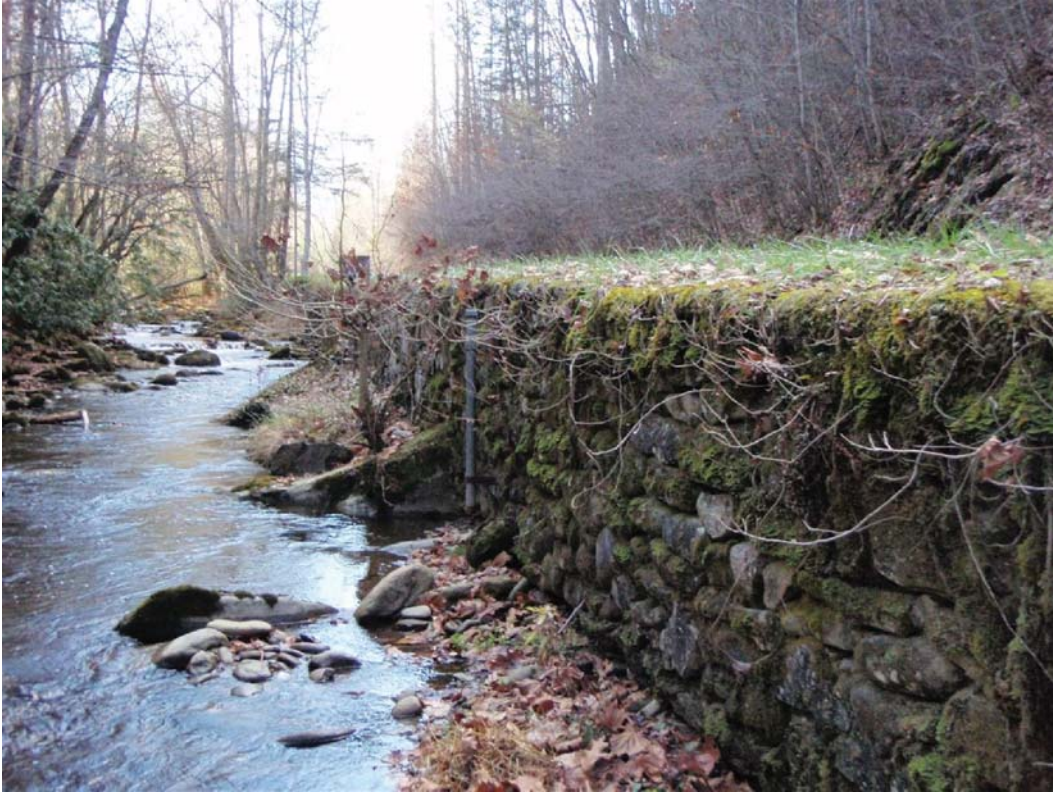
GRSM_0021_0.077_L_1.jpg

Element (Weighting Factor)	Narrative	Condition Rating (0 - 10)
PERFORMANCE 8.00	No roadway distress but mortar decay may threaten performance within a few years. Foundation void may threaten near term stability.	5
WALL FOUNDATION MATERIAL 8.00	Concrete footer undermined along river - 25'x3'x2'. Soil cobble material otherwise - no distress.	7
MORTAR 8.00	Badly weathered (1/2" grout loss) or missing over about 50% of joints	5
PLACED STONE 8.00	Rounded river stones 2.5ft minus. Wall tipped out 2-5 degrees past vertical along about 100ft of wall	6
DOWNSLOPE 0.50	River, stable channel	9
LATERAL SLOPE 0.50	Stable, well vegetated road embankment	9
ROAD/SIDEWALK/SHOULDER 0.50	No distress	9
WALL DRAINS 0.50	12"x15" cmp culvert through wall. Clear, bottom corroded slightly. Functional	9

Failure Consequence:	MODERATE
Recommendation Narrative:	Repoint wall 50% of wall face. 1773 sf x 0.5 x \$70/sf = \$62,055. Repair foundation void - place mortared stones in void 25'x3'x2'/27 x \$330/cy = \$1,830.
Repair Cost:	\$63,885

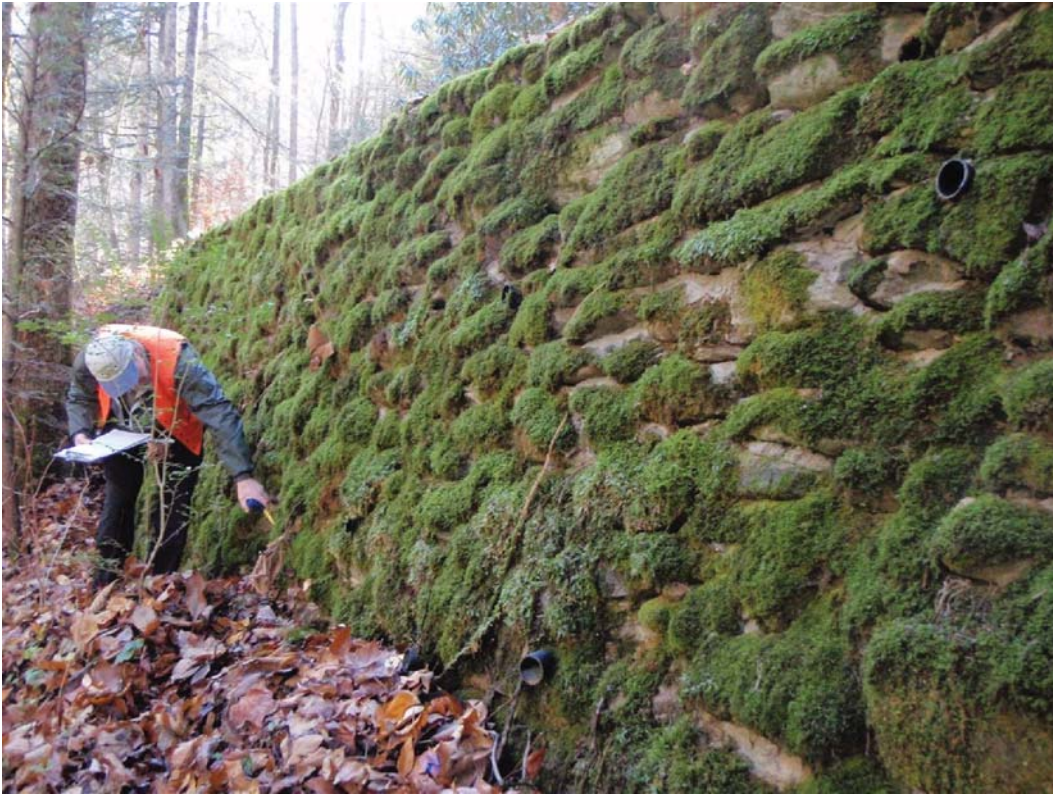
GRSM_0150_4.988_R_1.jpg

Wall ID:	GRSM-0150-4.988-R		
Route Name:	ROARING FORK MOTOR NATURE TRAIL		
Inspection Date:	December 03, 2007	Approximate Year Built:	1963
*Wall Rating:	87	Maintenance Action:	No Action

Wall Function:	Fill Wall	Primary Wall Type:	Gravity - Mortared Stone
Surface Treatment:		Secondary Wall Type:	
Secondary Surface Treatment:		Architectural Facing:	
General Description:	Mortared stone fill wall in good condition.

Element (Weighting Factor)	Narrative	Condition Rating (0 - 10)
PERFORMANCE 8.00	As intended	9
WALL FOUNDATION MATERIAL 8.00	Plumb, no distress. Sub-angular 1.5' munis	9
MORTAR 8.00	Voids/debonding 1/4-2", 30% of wall. Good interlock	8
DOWNSLOPE 0.50	30 degree stable soil, no distress.	9
LATERAL SLOPE 0.50	30 degree stable soil, no distress	9
ROAD/SIDEWALK/SHOULDER 0.50	No wall-related distress	9
WALL DRAINS 0.50	2" pvc weeps throughout, 18" cmp at base. No distress	9

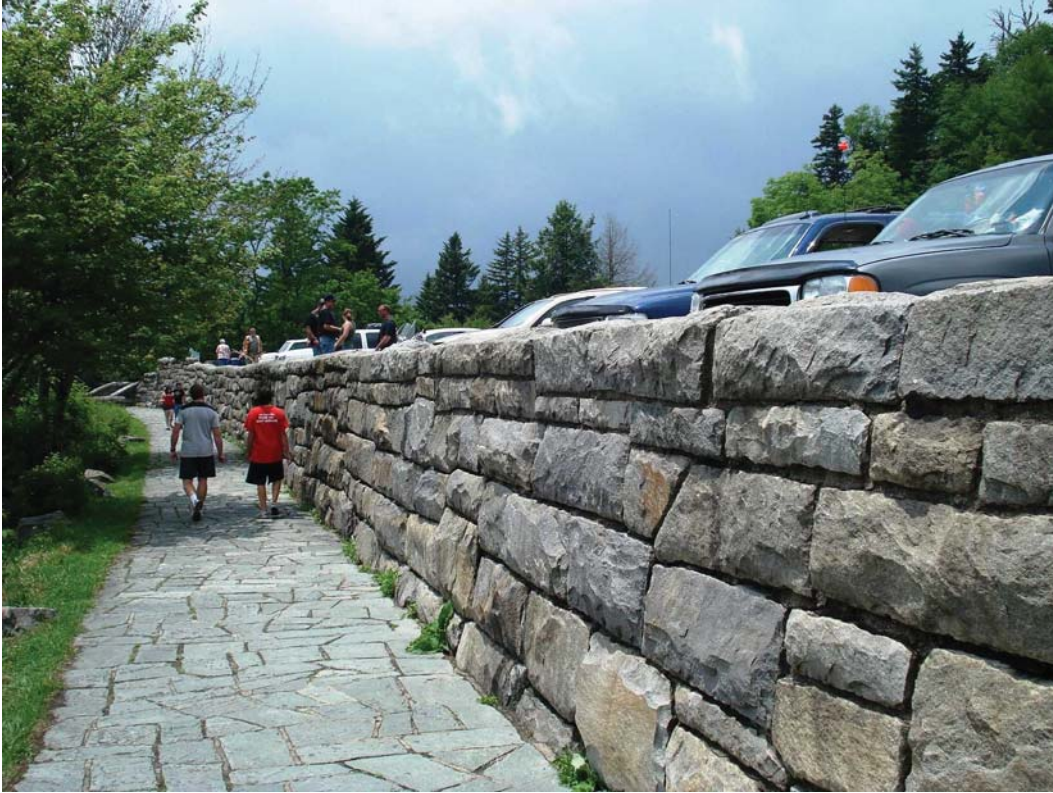
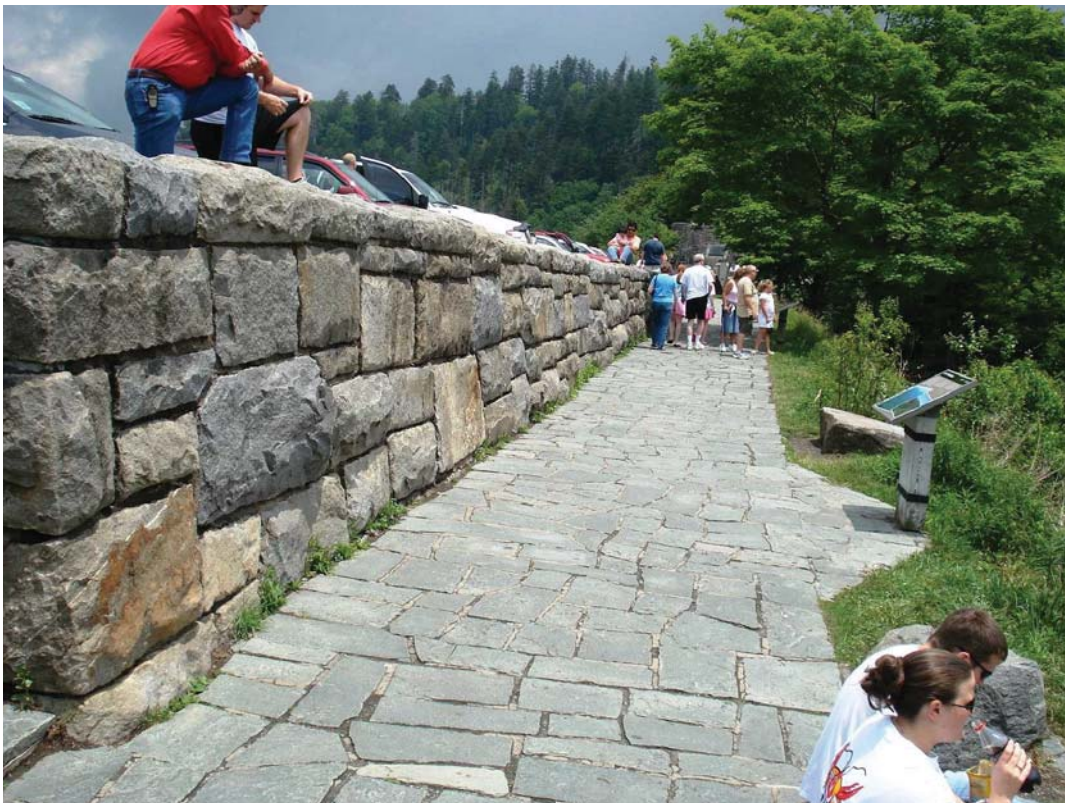
Wall ID:	GRSM-0955-0.000-P3		
Route Name:	NEWFOUND GAP PARKING AREA		
Inspection Date:	June 15, 2007	Approximate Year Built:	1952
*Wall Rating:	81	Maintenance Action:	No Action

GRSM_0955_0.000_P3_1.jpg

GRSM_0955_0.000_P3_2.jpg

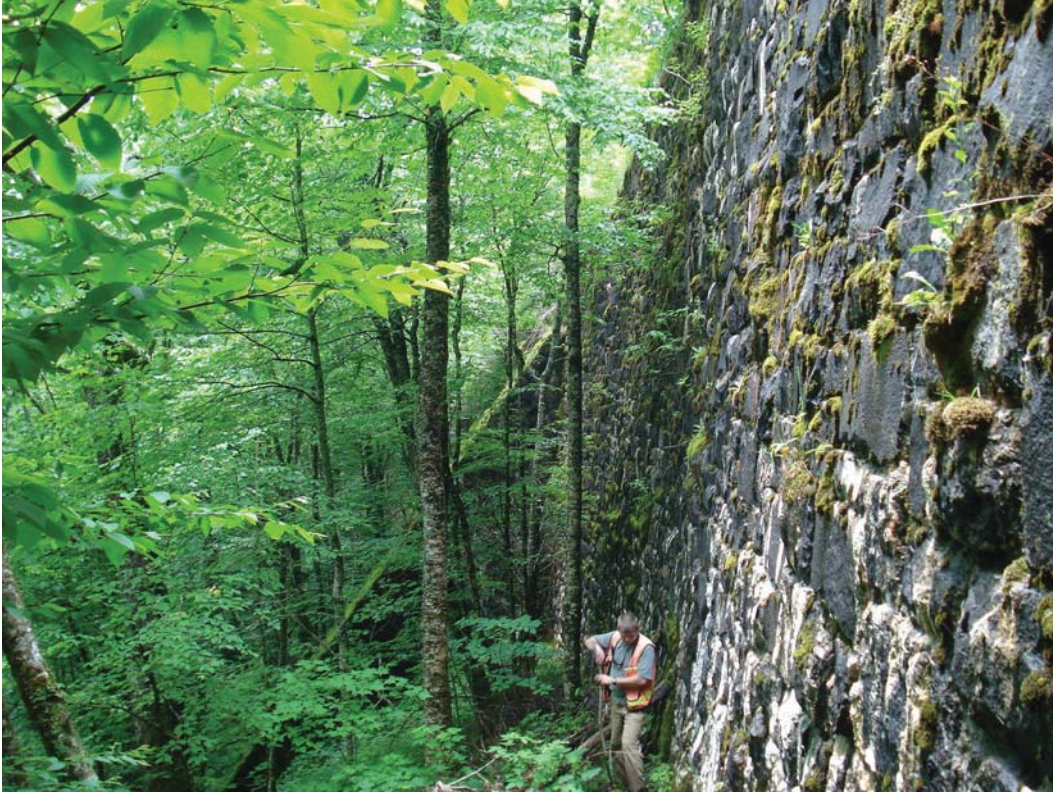
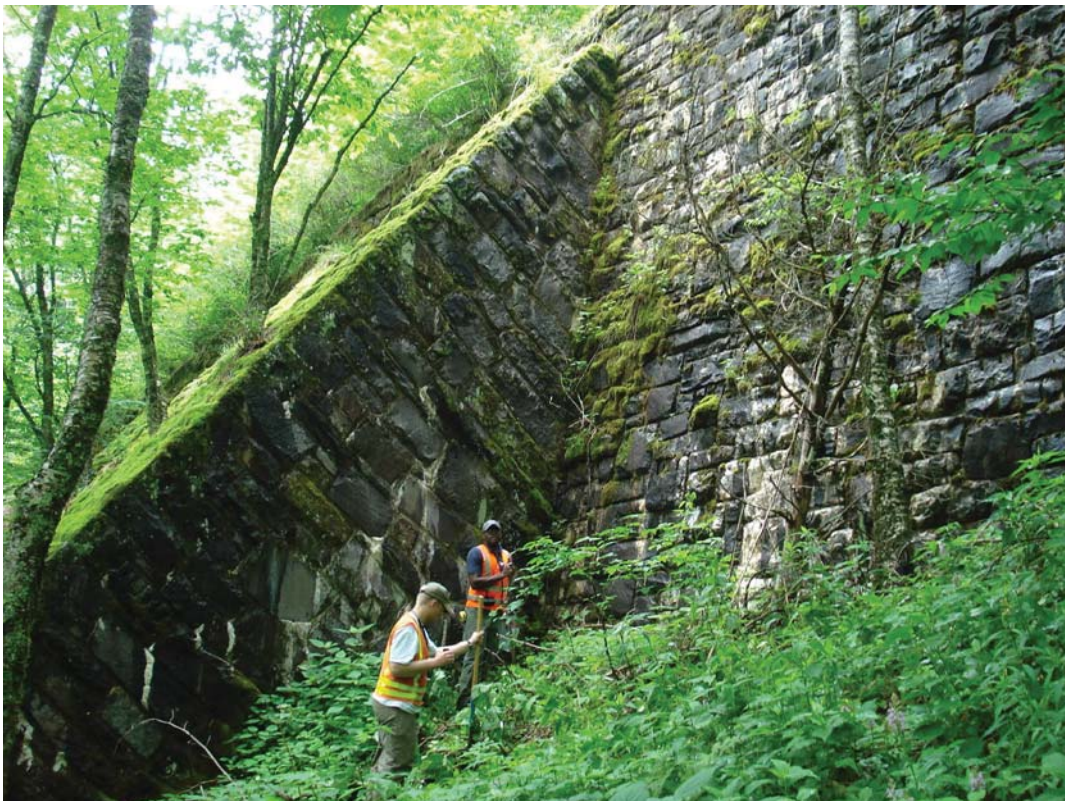
Wall ID:	GRSM-0955-0.000-P4		
Route Name:	NEWFOUND GAP PARKING AREA		
Inspection Date:	June 15, 2007	Approximate Year Built:	1952
*Wall Rating:	79	Maintenance Action:	No Action

GRSM_0955_0.000_P4_1.jpg

GRSM_0955_0.000_P4_2.jpg
