# SEQU

## WIP Report

### NPS Retaining Wall Inventory Program Sequoia National Park

**Data Collection Date: August 2007  
Report Date: December 2015**

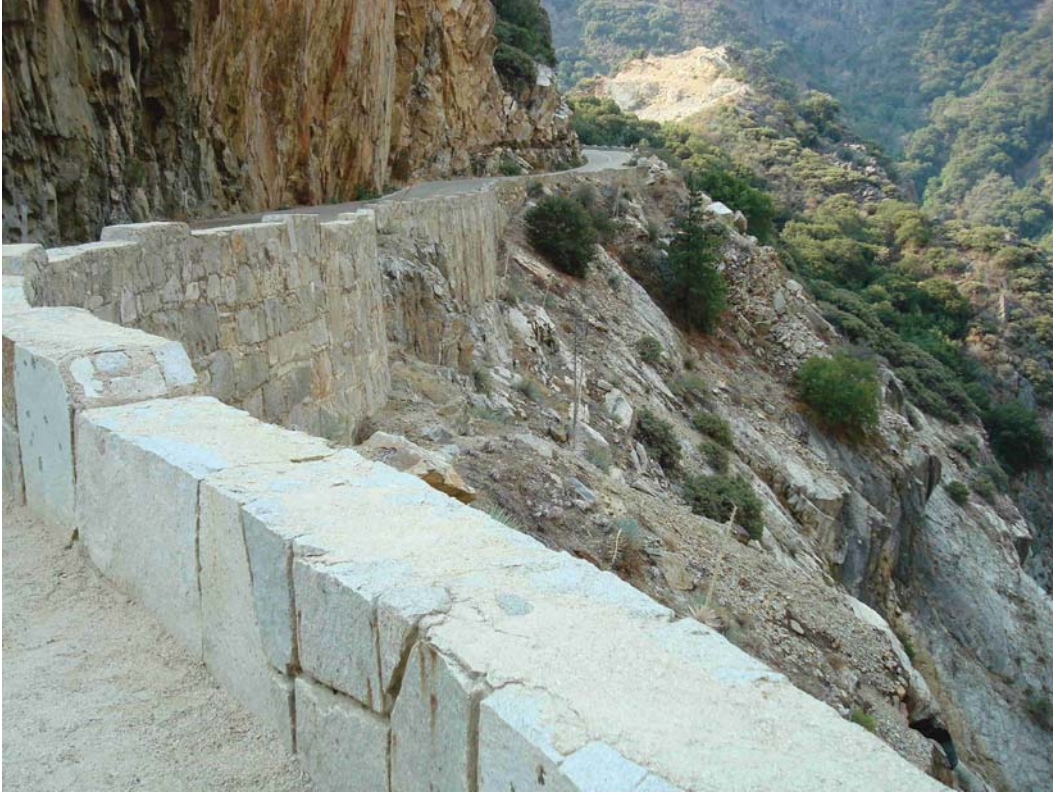
**SEQU\_0010\_0.550\_L\_1.jpg**

<b>Wall ID:</b>	SEQU-0010-0.559-L		
<b>Route Name:</b>	GENERALS HIGHWAY HISTORIC		
<b>Inspection Date:</b>	August 13, 2007	<b>Approximate Year Built:</b>	Unknown
<b>*Wall Rating:</b>	63	<b>Maintenance Action:</b>	Replace Elements

<b>Element (Weighting Factor)</b>	<b>Narrative</b>	<b>Condition Rating (0 - 10)</b>
PERFORMANCE 8.00	Bulging in 3 areas that may fail	6
WALL FOUNDATION MATERIAL 8.00	Compacted soil with stone paved ditches in front of wall. Sufficient to support wall	7
PLACED STONE 8.00	Stone are eroded with minor cracking. Generally, the wall is stable with bulging in 2-3 areas.	6
ROAD/SIDEWALK/SHOULDER 0.50	Good condition. No crack or distress attribute to wall movement.	8
VEGETATION 0.50	None affecting wall stability.	8
LATERAL SLOPE 1.00	Highly eroded on both sides. Possibly caused by ending all too short.	5
UPSLOPE 1.00	Loose soil, eroded with signs of movement.	5
WALL DRAINS 1.00	No drains are apparent. Signs of water flowing on wall surface.	6

<b>Failure Consequence:</b>	HIGH
<b>Recommendation Narrative:</b>	Rebuild bulging segment. Extending wall segment & matching stone schist - 200 ft <sup>2</sup> @ \$50/ft <sup>2</sup> = \$10,000. Traffic control (8 hrs) @ \$50/hr = \$4,000
<b>Repair Cost:</b>	\$14,000

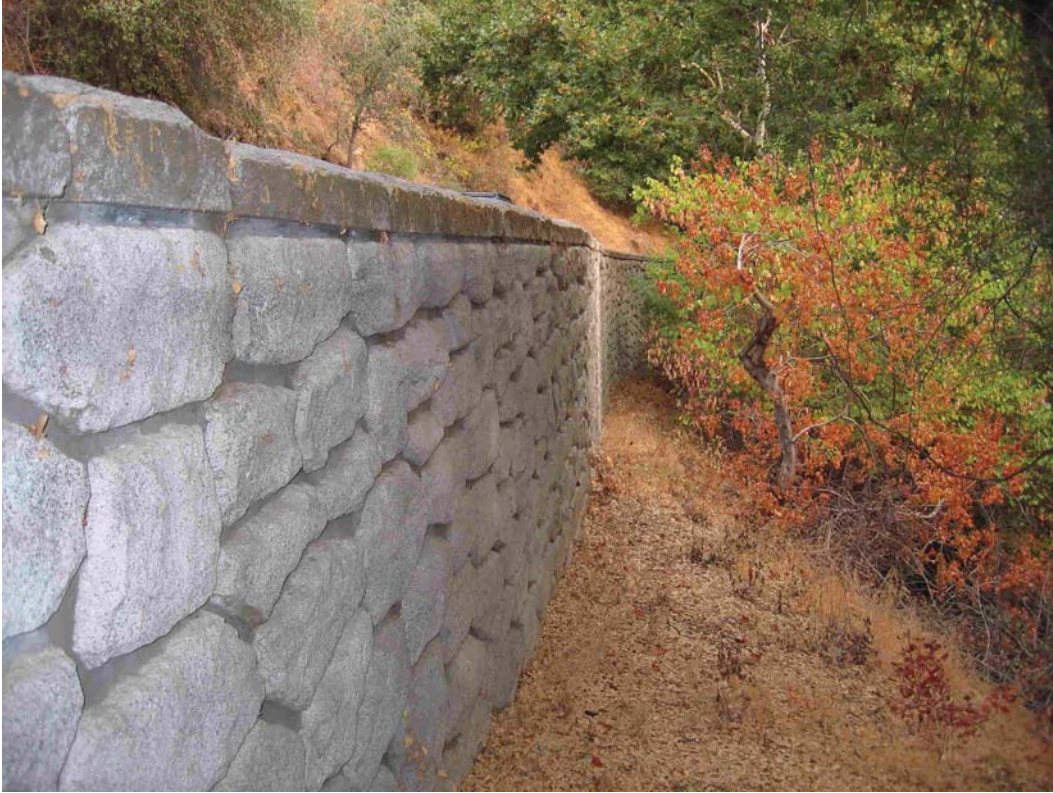
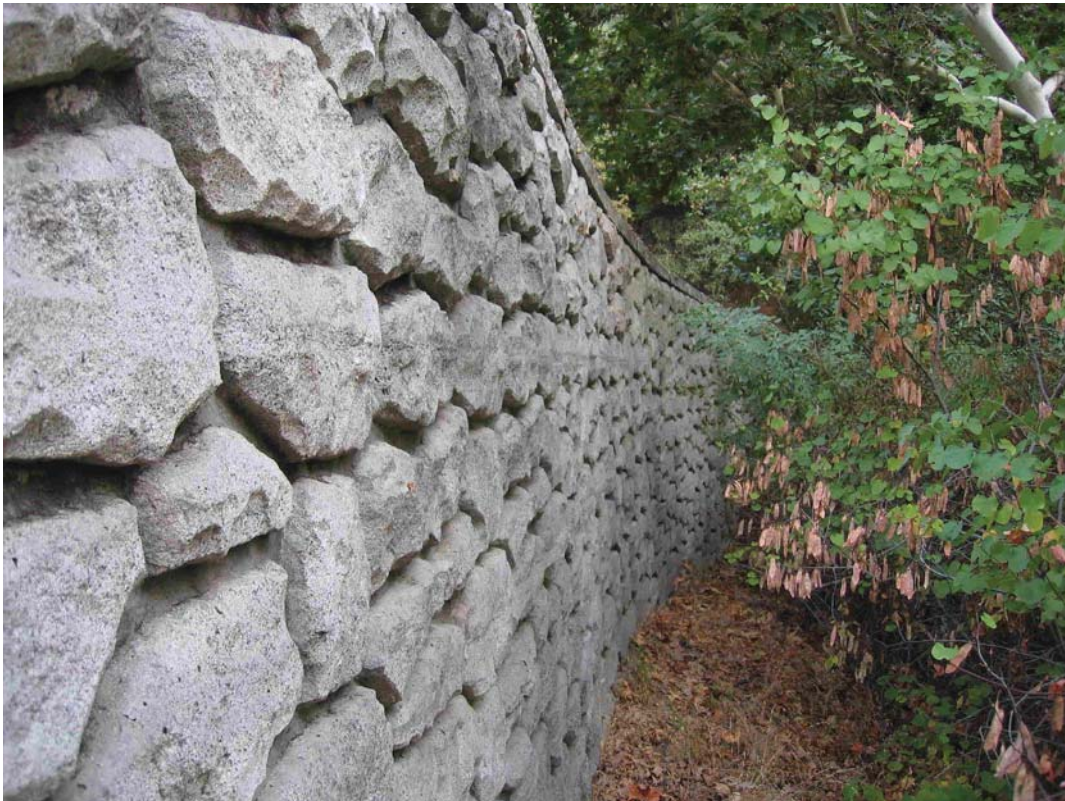
**SEQU\_0010\_1.332\_R\_1.jpg**

<b>Wall ID:</b>	SEQU-0010-1.332-R		
<b>Route Name:</b>	GENERALS HIGHWAY HISTORIC		
<b>Inspection Date:</b>	August 13, 2007	<b>Approximate Year Built:</b>	1995
<b>*Wall Rating:</b>	82	<b>Maintenance Action:</b>	No Action

<b>Wall Function:</b>	Fill Wall	<b>Primary Wall Type:</b>	Cantilever - Concrete
<b>Surface Treatment:</b>	Stain	<b>Secondary Wall Type:</b>	
<b>Secondary Surface Treatment:</b>		<b>Architectural Facing:</b>	Simulated Stone
<b>General Description:</b>	Cast in place concrete wall with form liner facing that replicate granite (like new wall).

<b>Element (Weighting Factor)</b>	<b>Narrative</b>	<b>Condition Rating (0 - 10)</b>
PERFORMANCE 8.00	Excellent condition. Performing as designed.	9
WALL FOUNDATION MATERIAL 8.00	Good condition. Loose soil at some areas 5 ft bench followed by 1.5H:1V slope. Sufficient to support wall. No signs of failure.	7
CONCRETE 8.00	Concrete with formliner. No signs of cracking, distress or fatigue. Excellent condition.	9
ARCHITECTURAL FACING 0.50	Formliner excellent condition. No cracking/spalling.	8
ROAD/SIDEWALK/SHOULDER 0.50	No cracking or signs of distress that is attributed to wall movement	8
TRAFFIC BARRIER/FENCE 0.50	Granite stone traffic and top faces. Outside face is formliner. Excellent condition.	8
VEGETATION 0.50	No vegetation affecting wall stability. Large trees on downslope	8
WALL DRAINS 0.50	Weepholes are installed in the bottom of wall	8
DOWNSLOPE 1.00	Steep varies between 1:5H:1V to 1H:1V soil with occasional boulders, large trees and bushes	7

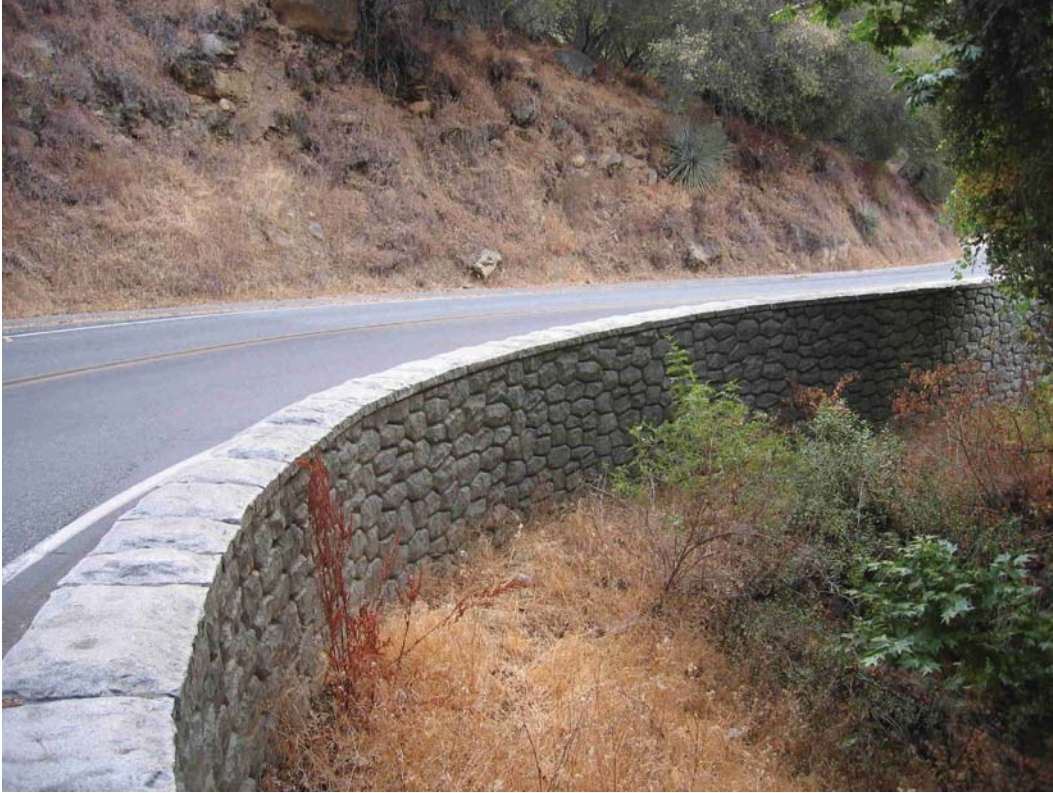
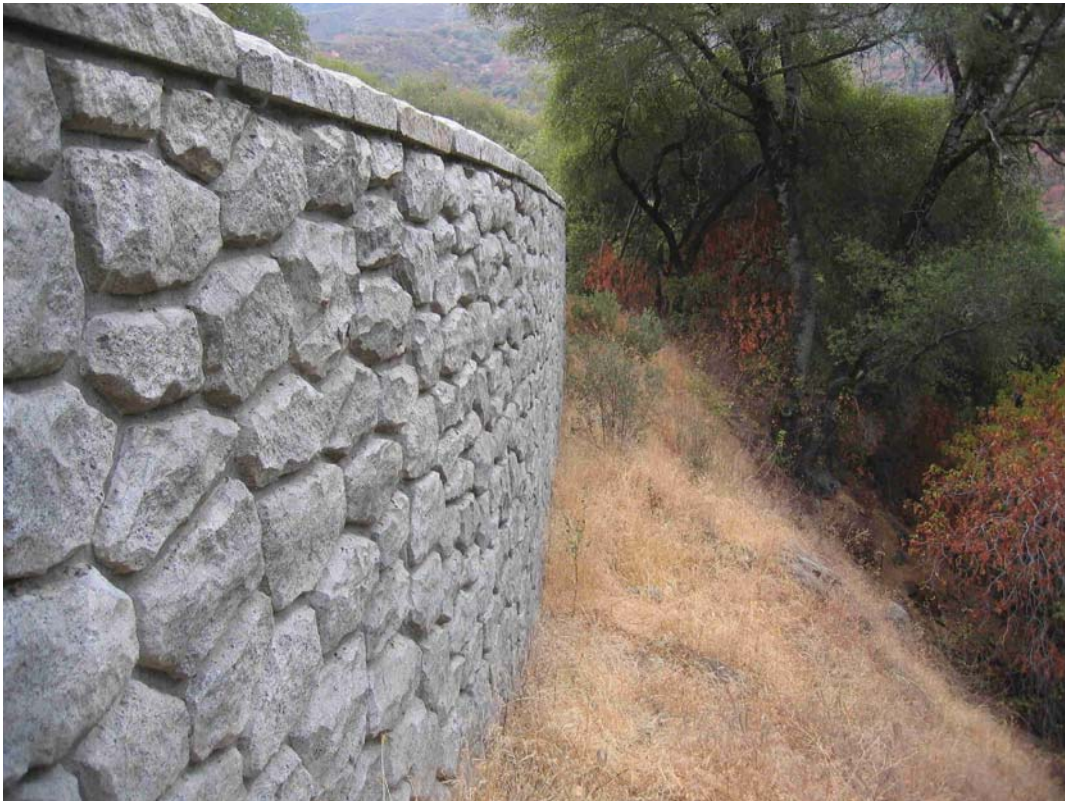
**SEQU\_0010\_1.374\_R\_1.jpg**

<b>Wall ID:</b>	SEQU-0010-1.374-R		
<b>Route Name:</b>	GENERALS HIGHWAY HISTORIC		
<b>Inspection Date:</b>	August 13, 2007	<b>Approximate Year Built:</b>	1997
<b>*Wall Rating:</b>	82	<b>Maintenance Action:</b>	No Action

<b>Wall Function:</b>	Fill Wall	<b>Primary Wall Type:</b>	Cantilever - Concrete
<b>Surface Treatment:</b>	Stain	<b>Secondary Wall Type:</b>	
<b>Secondary Surface Treatment:</b>		<b>Architectural Facing:</b>	Simulated Stone
<b>General Description:</b>	Cast in place concrete wall with form liner facing that replicate granite (like new wall).

<b>Element (Weighting Factor)</b>	<b>Narrative</b>	<b>Condition Rating (0 - 10)</b>
PERFORMANCE 8.00	Excellent condition. No cracking or global failure. (Like New)	9
WALL FOUNDATION MATERIAL 8.00	Good condition. Soil loose at some areas and steep (1:1) about 5 ft bench away from foundation.	7
CONCRETE 8.00	Concrete with formliner. No signs of cracking, distress or fatigue. Excellent condition.	9
ARCHITECTURAL FACING 0.50	Formliner is excellent condition	8
CULVERT 0.50	Culvert 24" CMP at beginning on wall. Good working condition	8
DOWNSLOPE 0.50	Steep varies between 1.5H:1V to 1H:1V soil with boulders and large trees	8
LATERAL SLOPE 0.50	Stable, good condition. Soil with boulders at 2H:1V connected to guardwall	8
ROAD/SIDEWALK/SHOULDER 0.50	No cracking or settlement in roadway adjacent to wall.	8
TRAFFIC BARRIER/FENCE 0.50	Granite stone traffic and top faces. Outside face is formliner. Excellent condition. No missing elements.	8

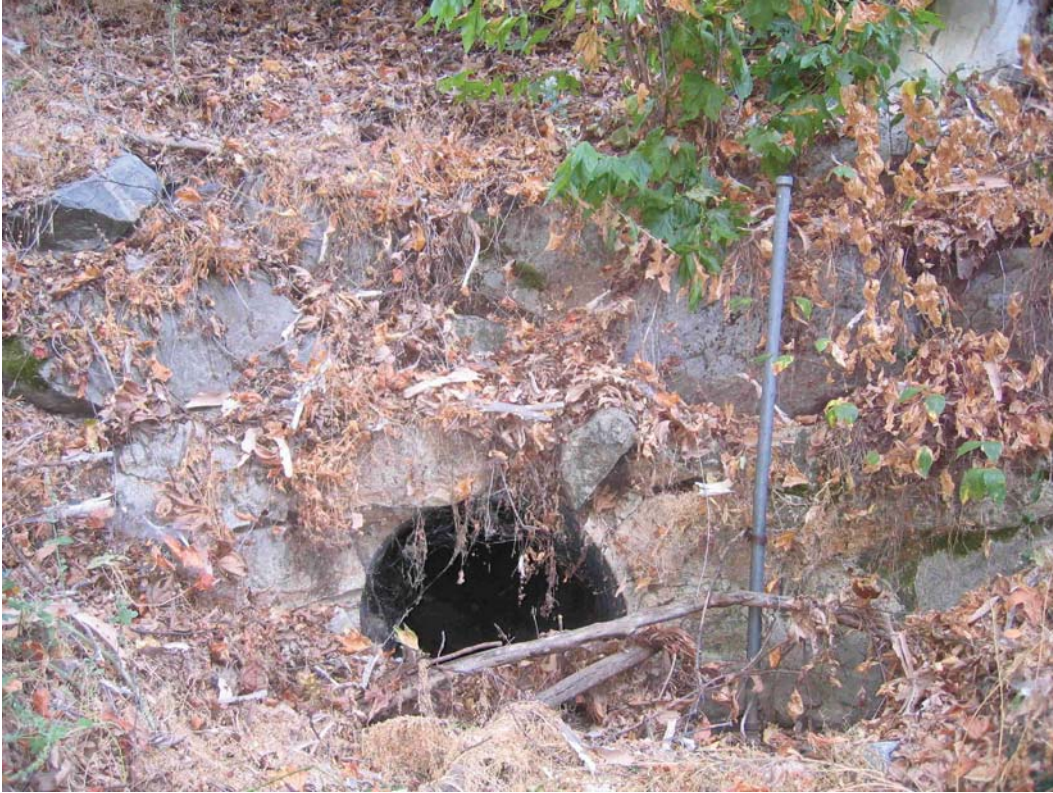
**SEQU\_0010\_1.378\_L\_1.jpg**

<b>Wall ID:</b>	SEQU-0010-1.378-L		
<b>Route Name:</b>	GENERALS HIGHWAY HISTORIC		
<b>Inspection Date:</b>	August 17, 2007	<b>Approximate Year Built:</b>	Unknown
<b>*Wall Rating:</b>	74	<b>Maintenance Action:</b>	No Action

<b>Element (Weighting Factor)</b>	<b>Narrative</b>	<b>Condition Rating (0 - 10)</b>
PERFORMANCE 8.00	Good performance. No global stability issues. Rocks are large but not lightly stacked.	7
WALL FOUNDATION MATERIAL 8.00	Boulders with compacted fill. Sufficient to support wall	8
PLACED STONE 8.00	Granite, Competent and strong. No weathering and cracking	8
VEGETATION 1.00	A large trees is growling over wall. Several bushes growing out of wall	5
UPSLOPE 1.00	Compact fill with vegetation and boulders with minor erosion. Large trees	6
DOWNSLOPE 1.00	Fill with boulders with minor erosion.	7
LATERAL SLOPE 1.00	Minor erosion and compacted fill with 1.5H <sup>1</sup> V slope.	7
WALL DRAINS 1.00	No drains were visible	7

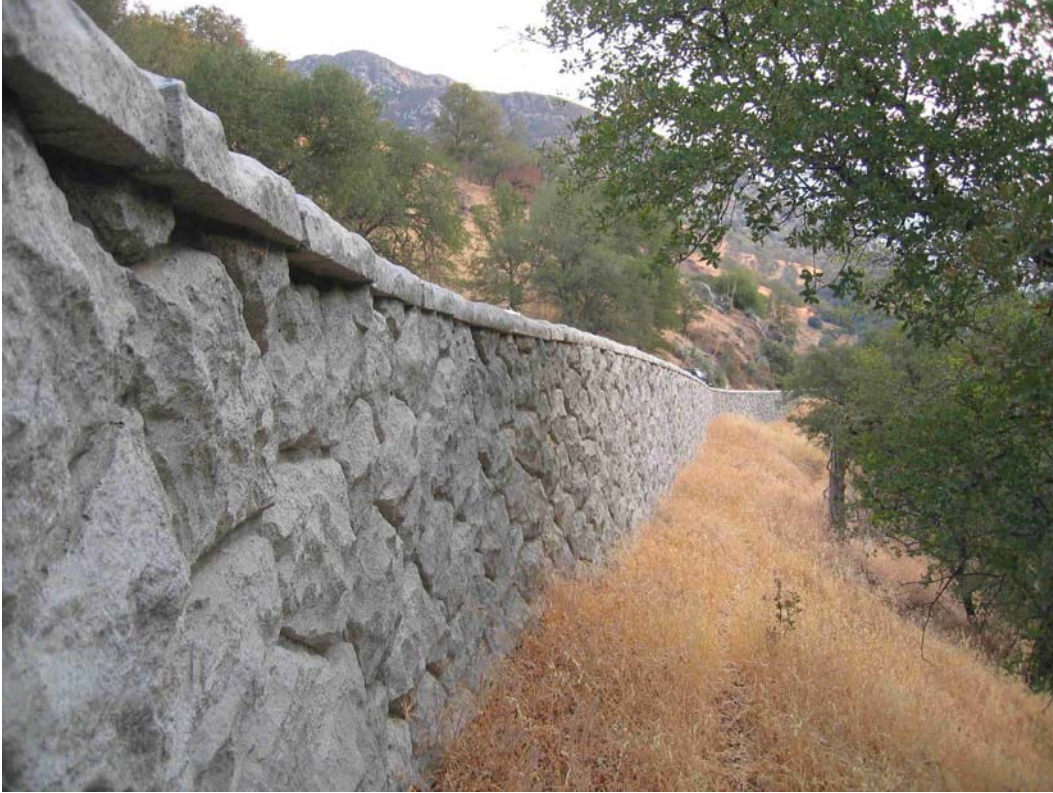
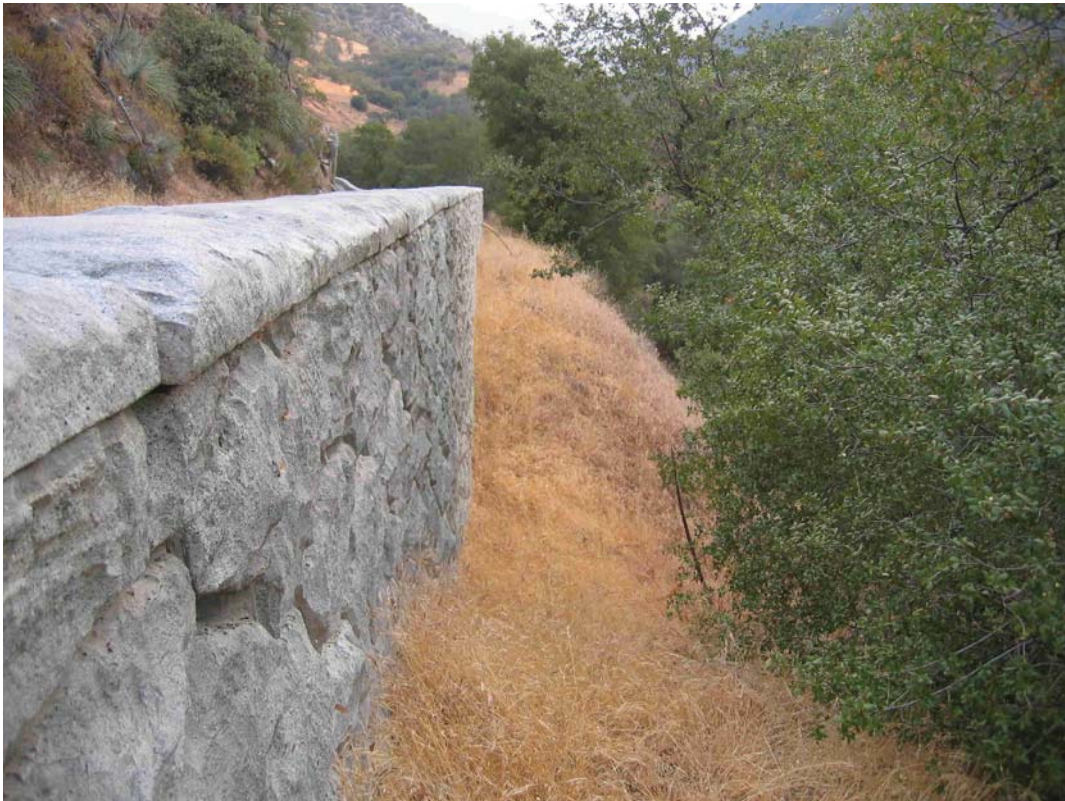
**SEQU\_0010\_1.487\_R\_1.jpg**

<b>Wall ID:</b>	SEQU-0010-1.487-R		
<b>Route Name:</b>	GENERALS HIGHWAY HISTORIC		
<b>Inspection Date:</b>	August 13, 2007	<b>Approximate Year Built:</b>	1997
<b>*Wall Rating:</b>	83	<b>Maintenance Action:</b>	No Action

<b>Wall Function:</b>	Fill Wall	<b>Primary Wall Type:</b>	Cantilever - Concrete
<b>Surface Treatment:</b>	Stain	<b>Secondary Wall Type:</b>	
<b>Secondary Surface Treatment:</b>		<b>Architectural Facing:</b>	Simulated Stone
<b>General Description:</b>	Cast in place concrete wall with form liner facing that replicate granite (like new wall).

<b>Element (Weighting Factor)</b>	<b>Narrative</b>	<b>Condition Rating (0 - 10)</b>
PERFORMANCE 8.00	Excellent working condition. No signs of global stability problems or settlement	9
WALL FOUNDATION MATERIAL 8.00	A bench of about 5 ft of soil with grass followed by 1H:1V slope of soil and boulder. Occasionally lose of foundation materials due to erosion. Specially by culverts.	7
CONCRETE 8.00	Concrete with formliner. No signs of cracking, distress or fatigue. Excellent condition.	9
ARCHITECTURAL FACING 0.50	Formliner. Excellent condition. No cracking is visible (Parapet)	8
LATERAL SLOPE 0.50	Steep soil slopes with boulders stable 1H:1V with some erosion.	8
TRAFFIC BARRIER/FENCE 0.50	Granite stone traffic and top faces. Outside face is formliner. Excellent condition.	8
WALL DRAINS 0.50	Some weep holes were observed near wall foundation. Functioning as designed	8
CULVERT 0.50	Several culverts (three) exist in the wall = 24" CMP - Good working condition	9

ROAD/SIDEWALK/SHOULDER 0.50	Excellent condition. No cracking or settlement are observed	9

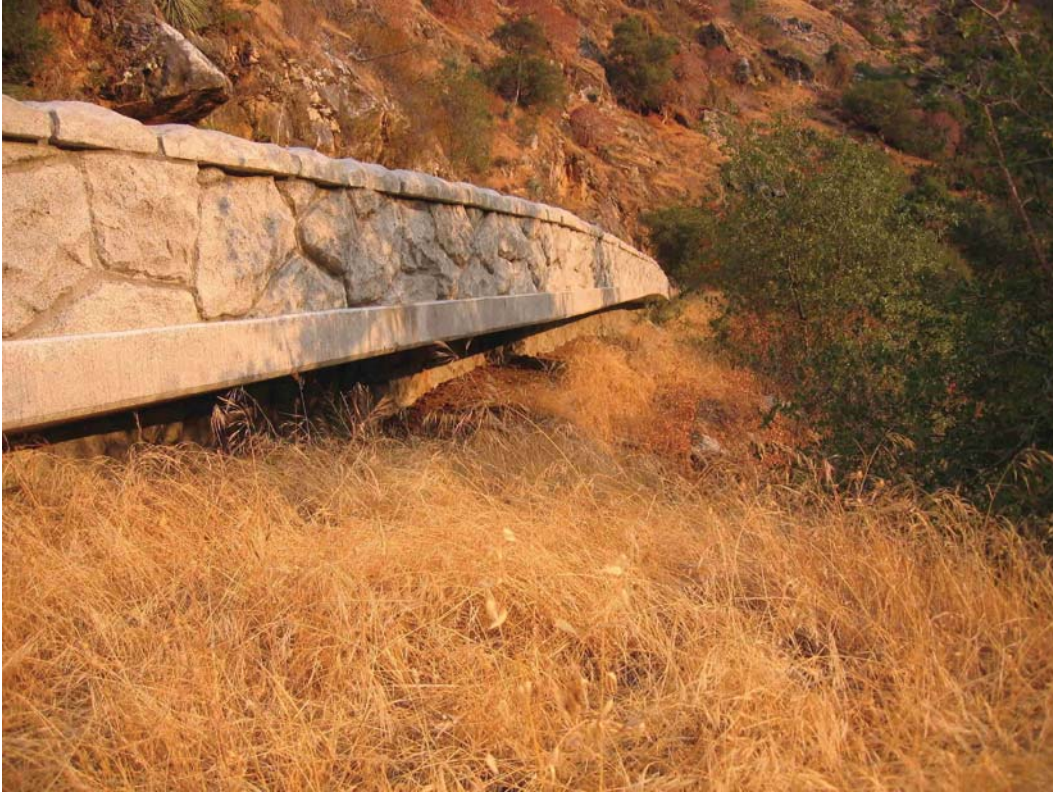
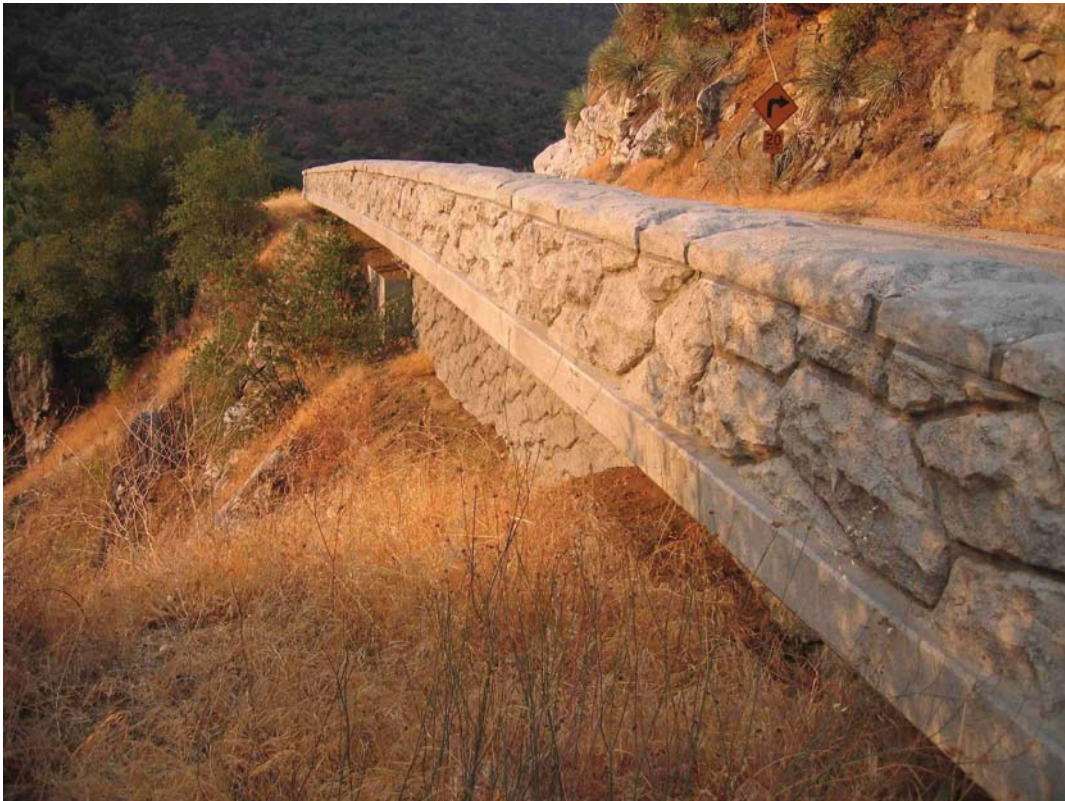
**SEQU\_0010\_1.703\_R\_1.jpg**

<b>Wall ID:</b>	SEQU-0010-1.703-R		
<b>Route Name:</b>	GENERALS HIGHWAY HISTORIC		
<b>Inspection Date:</b>	August 13, 2007	<b>Approximate Year Built:</b>	1997
<b>*Wall Rating:</b>	80	<b>Maintenance Action:</b>	No Action

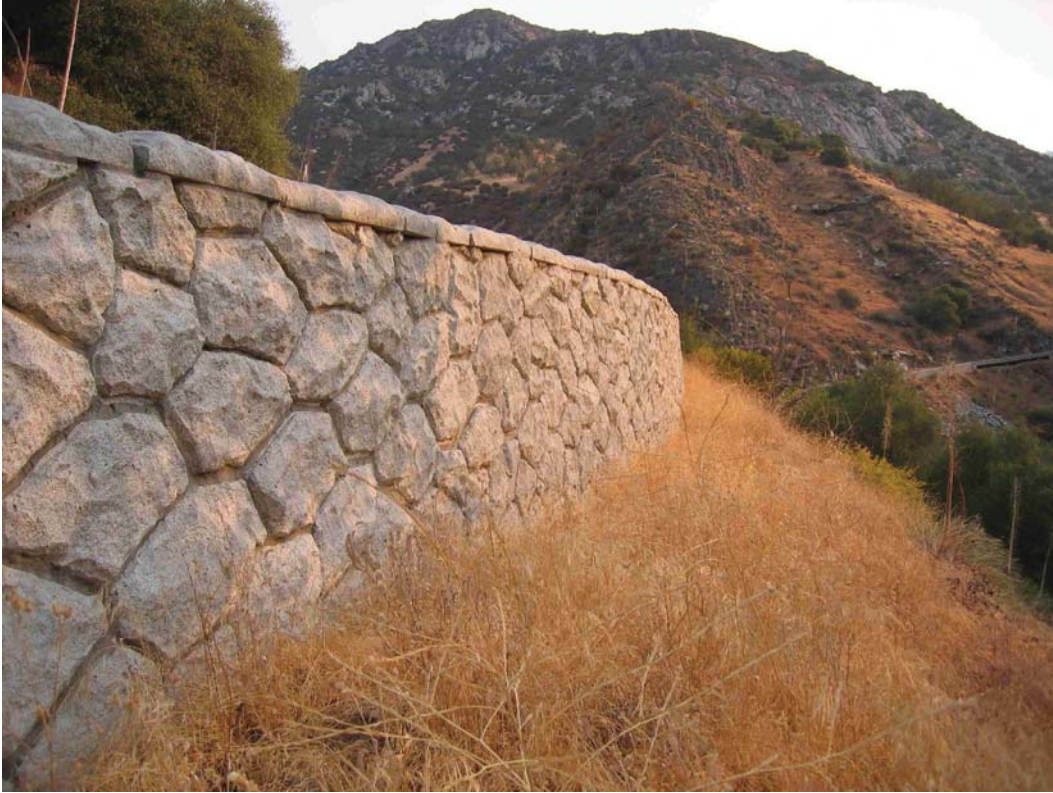
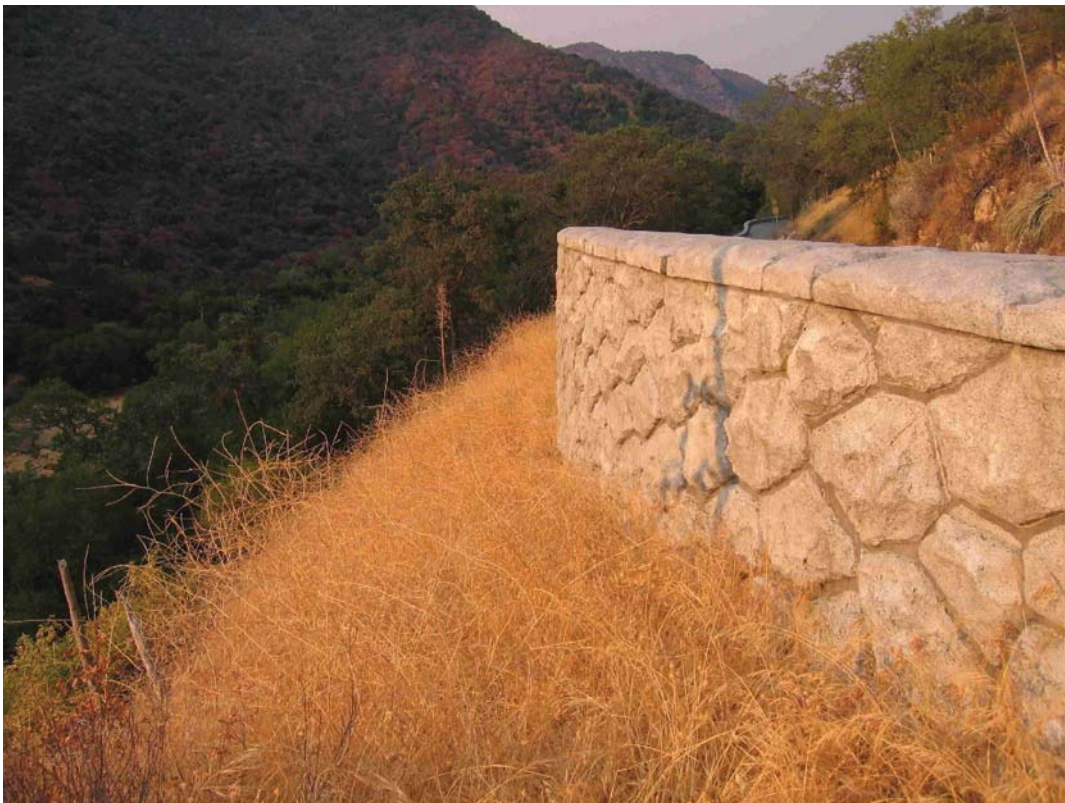
**SEQU\_0010\_1.739\_R\_1.jpg**

<b>Wall ID:</b>	SEQU-0010-1.739-R		
<b>Route Name:</b>	GENERALS HIGHWAY HISTORIC		
<b>Inspection Date:</b>	August 13, 2007	<b>Approximate Year Built:</b>	1997
<b>*Wall Rating:</b>	81	<b>Maintenance Action:</b>	No Action

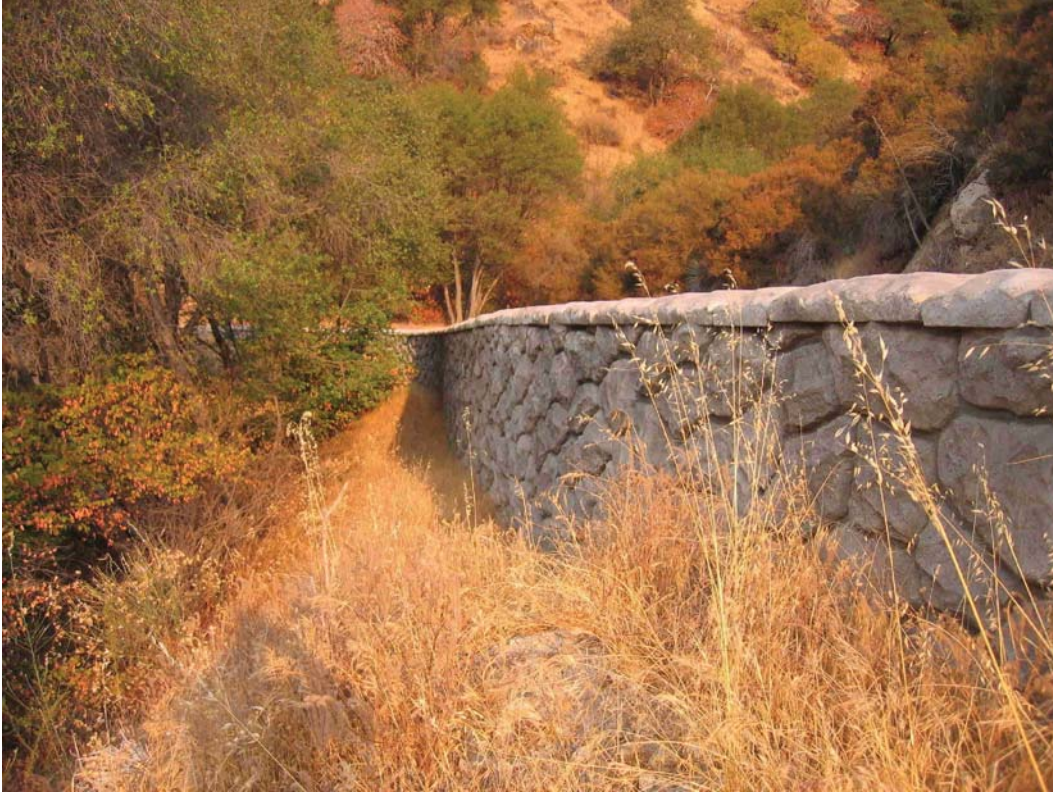
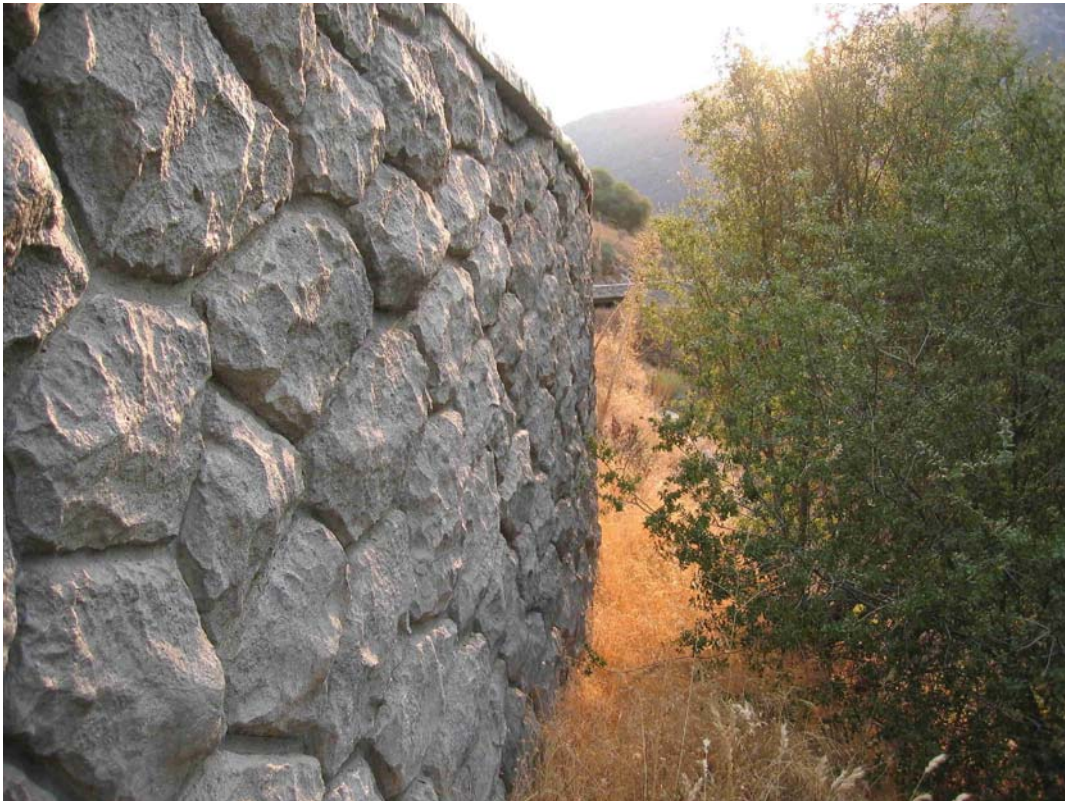
**SEQU\_0010\_1.857\_R\_1.jpg**

<b>Wall ID:</b>	SEQU-0010-1.857-R		
<b>Route Name:</b>	GENERALS HIGHWAY HISTORIC		
<b>Inspection Date:</b>	August 14, 2007	<b>Approximate Year Built:</b>	1997
<b>*Wall Rating:</b>	82	<b>Maintenance Action:</b>	Maintenance

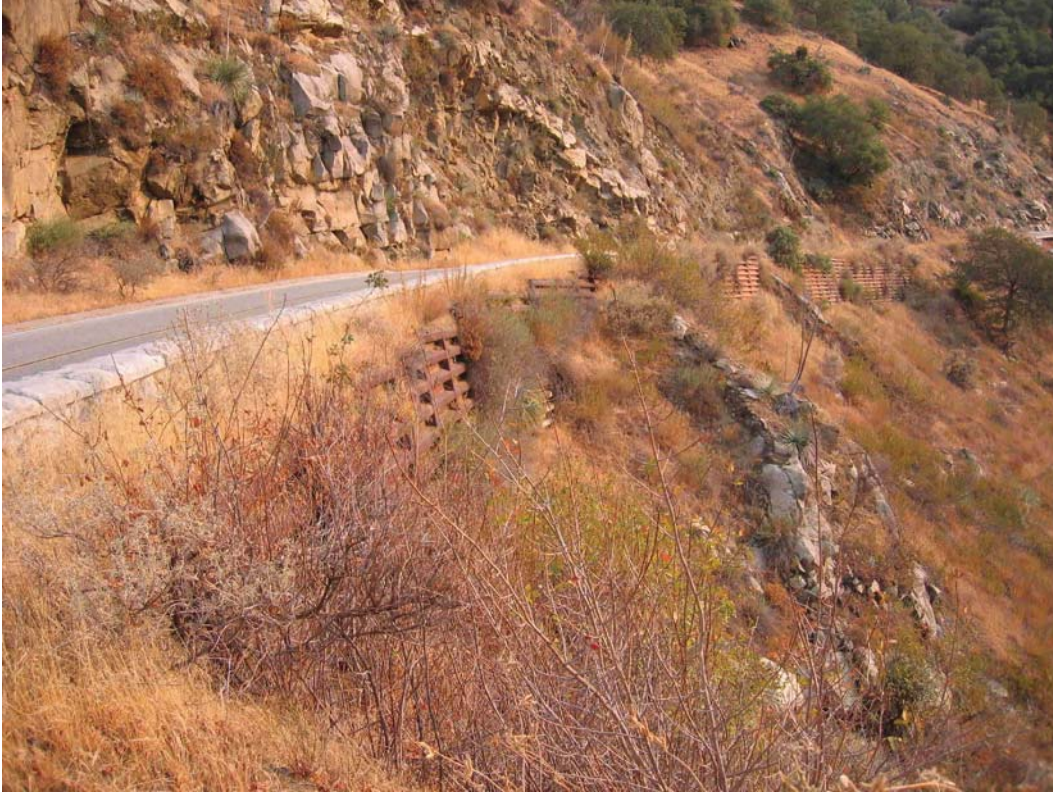
**SEQU\_0010\_2.170\_R\_1.jpg**

<b>Wall ID:</b>	SEQU-0010-2.170-R		
<b>Route Name:</b>	GENERALS HIGHWAY HISTORIC		
<b>Inspection Date:</b>	August 14, 2007	<b>Approximate Year Built:</b>	1970
<b>*Wall Rating:</b>	73	<b>Maintenance Action:</b>	No Action

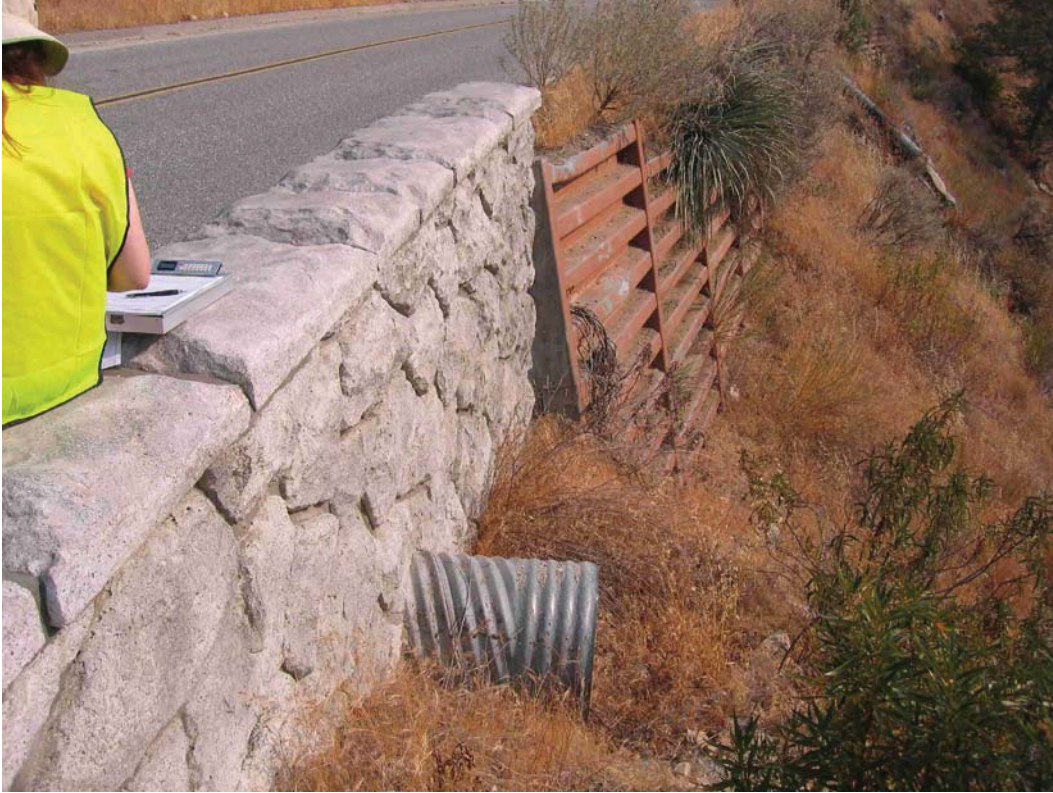
**SEQU\_0010\_2.199\_R\_1.jpg**

<b>Wall ID:</b>	SEQU-0010-2.199-R		
<b>Route Name:</b>	GENERALS HIGHWAY HISTORIC		
<b>Inspection Date:</b>	August 14, 2007	<b>Approximate Year Built:</b>	1997
<b>*Wall Rating:</b>	90	<b>Maintenance Action:</b>	No Action

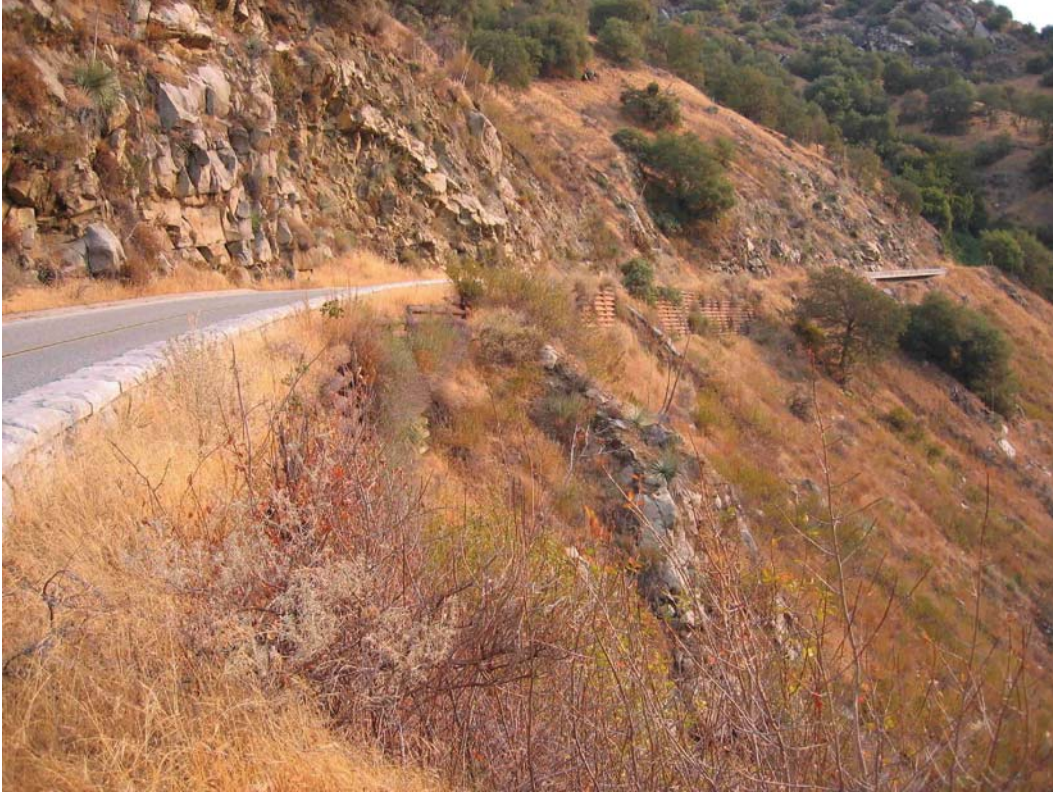
**SEQU\_0010\_2.205\_R\_1.jpg**

<b>Wall ID:</b>	SEQU-0010-2.205-R		
<b>Route Name:</b>	GENERALS HIGHWAY HISTORIC		
<b>Inspection Date:</b>	August 14, 2007	<b>Approximate Year Built:</b>	1970
<b>*Wall Rating:</b>	69	<b>Maintenance Action:</b>	No Action

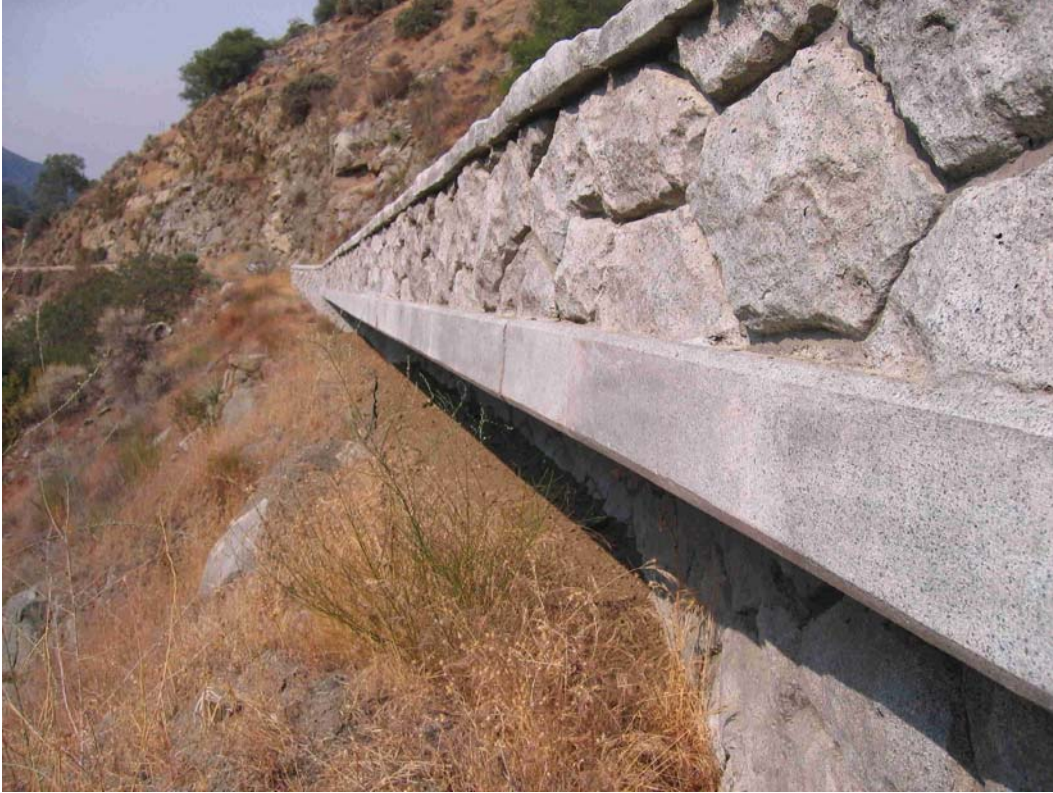
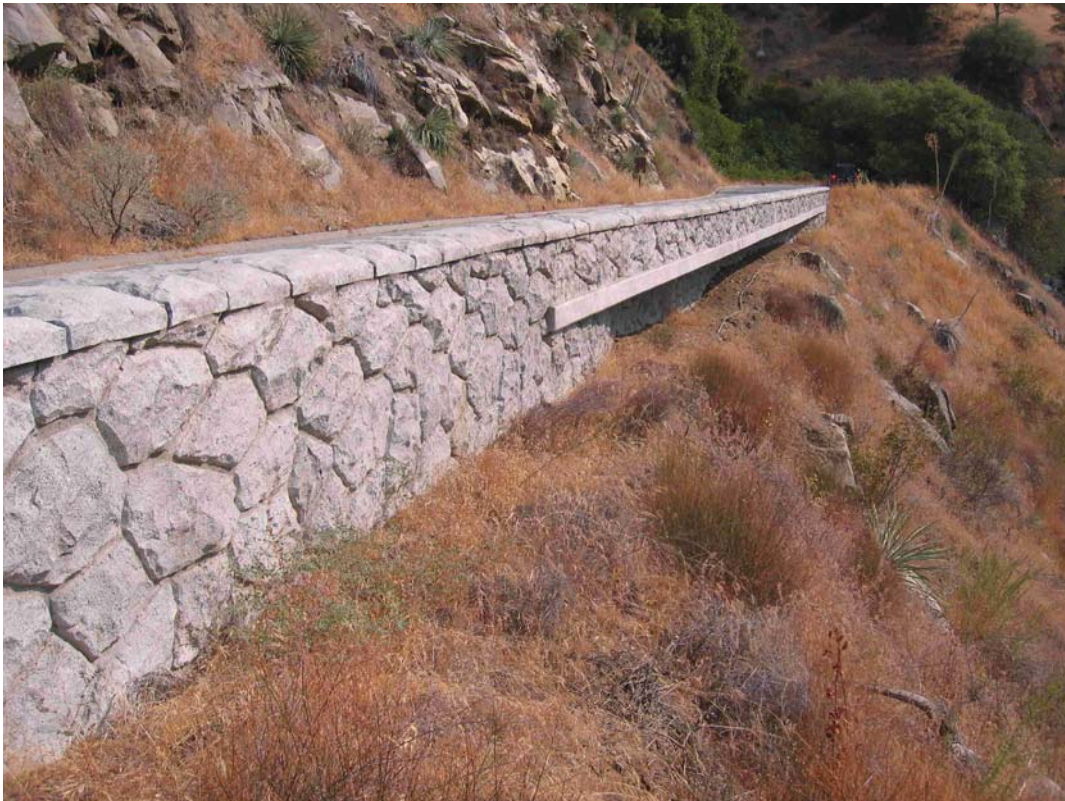
**SEQU\_0010\_2.277\_R\_1.jpg**

<b>Wall ID:</b>	SEQU-0010-2.277-R		
<b>Route Name:</b>	GENERALS HIGHWAY HISTORIC		
<b>Inspection Date:</b>	August 14, 2007	<b>Approximate Year Built:</b>	1997
<b>*Wall Rating:</b>	87	<b>Maintenance Action:</b>	No Action

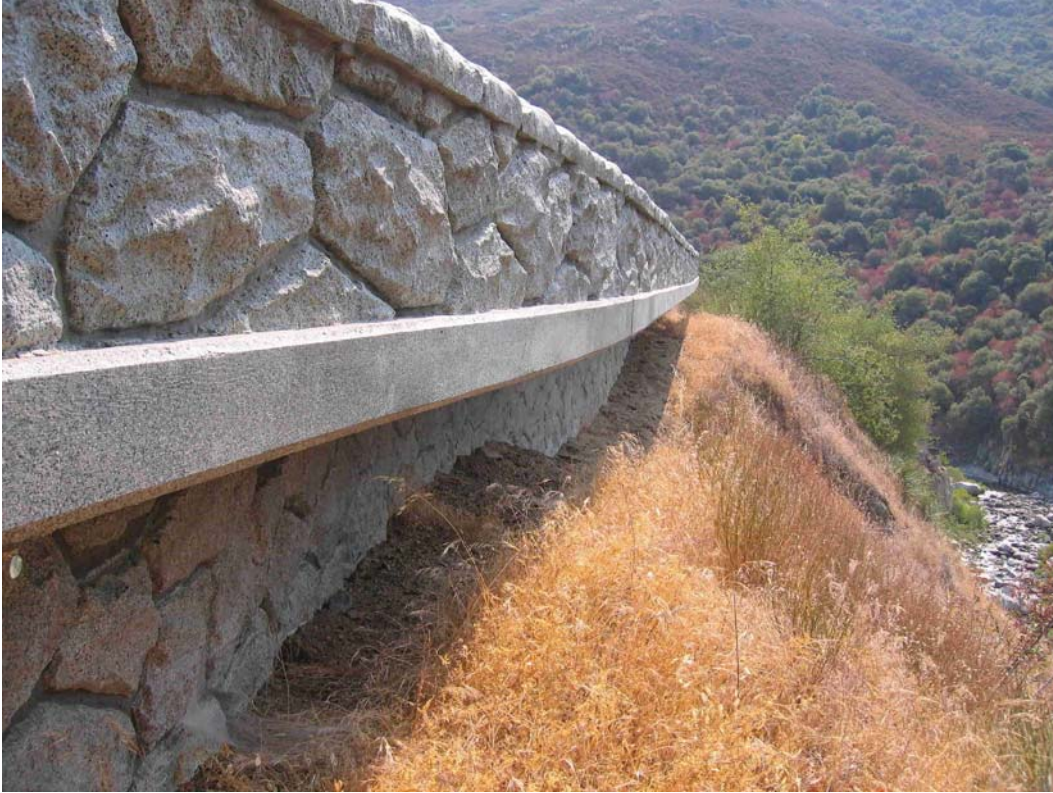
**SEQU\_0010\_2.369\_R\_1.jpg**

<b>Wall ID:</b>	SEQU-0010-2.369-R		
<b>Route Name:</b>	GENERALS HIGHWAY HISTORIC		
<b>Inspection Date:</b>	August 14, 2007	<b>Approximate Year Built:</b>	1997
<b>*Wall Rating:</b>	84	<b>Maintenance Action:</b>	No Action

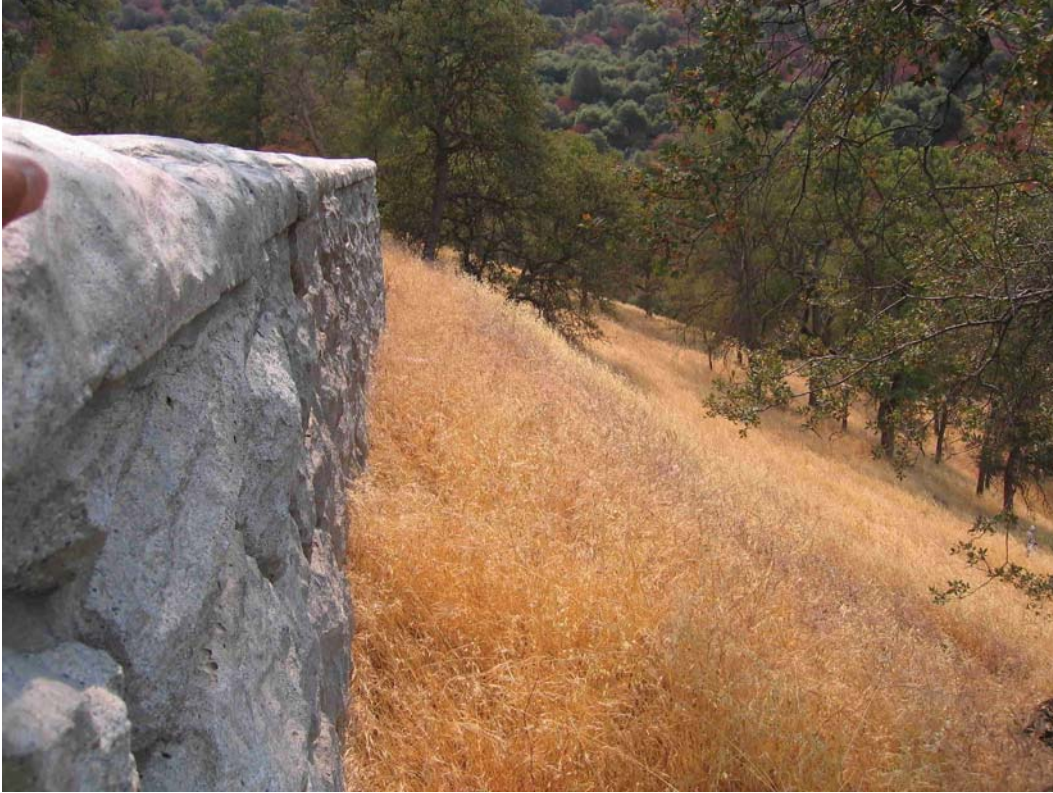
**SEQU\_0010\_2.482\_R\_1.jpg**

<b>Wall ID:</b>	SEQU-0010-2.482-R		
<b>Route Name:</b>	GENERALS HIGHWAY HISTORIC		
<b>Inspection Date:</b>	August 14, 2007	<b>Approximate Year Built:</b>	1997
<b>*Wall Rating:</b>	84	<b>Maintenance Action:</b>	No Action

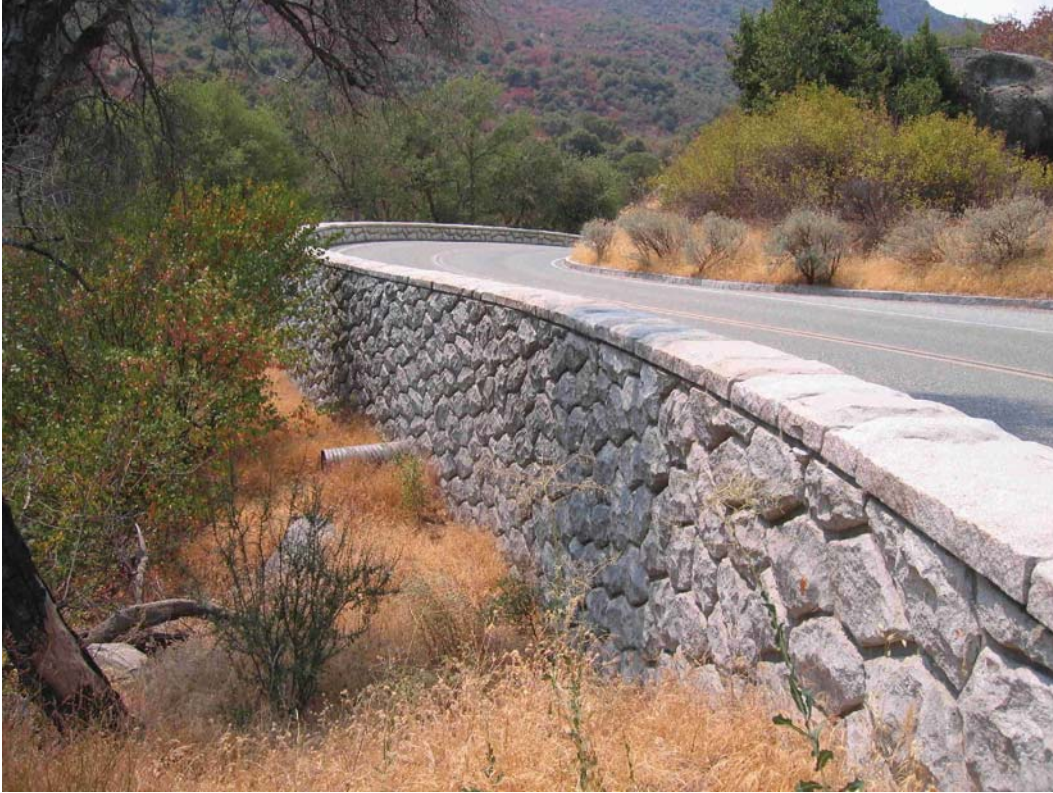
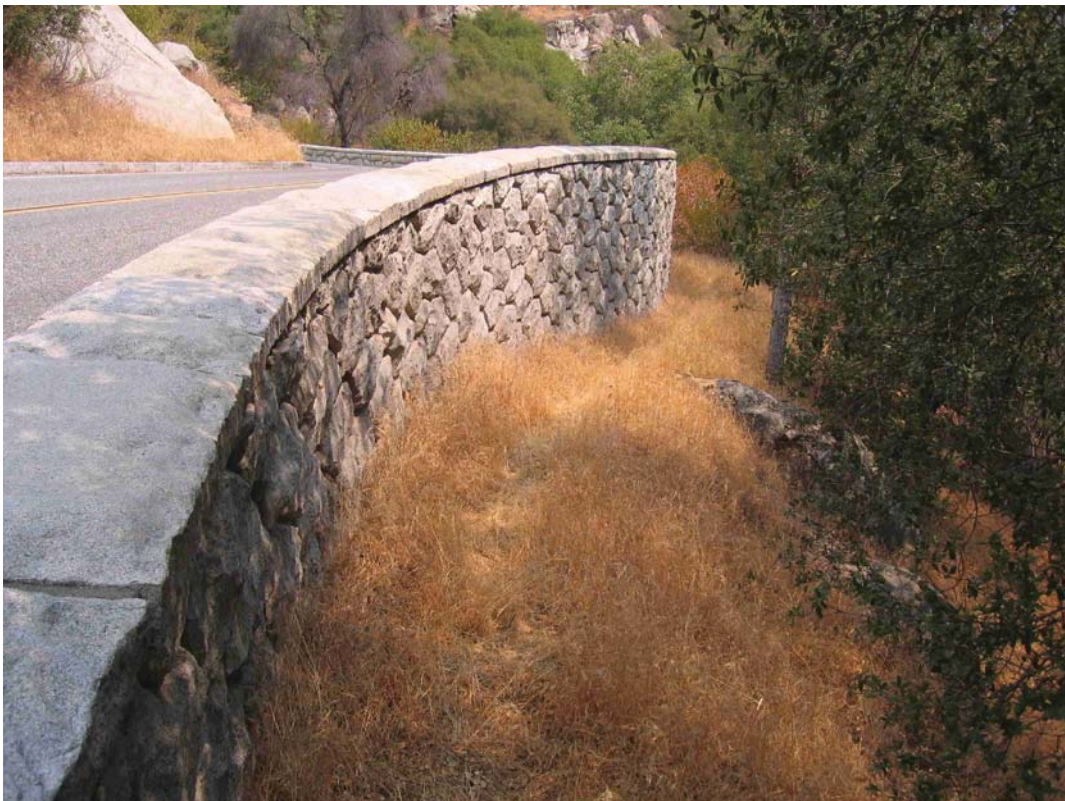
**SEQU\_0010\_2.633\_R\_1.jpg**

<b>Wall ID:</b>	SEQU-0010-2.633-R		
<b>Route Name:</b>	GENERALS HIGHWAY HISTORIC		
<b>Inspection Date:</b>	August 14, 2007	<b>Approximate Year Built:</b>	1997
<b>*Wall Rating:</b>	90	<b>Maintenance Action:</b>	No Action

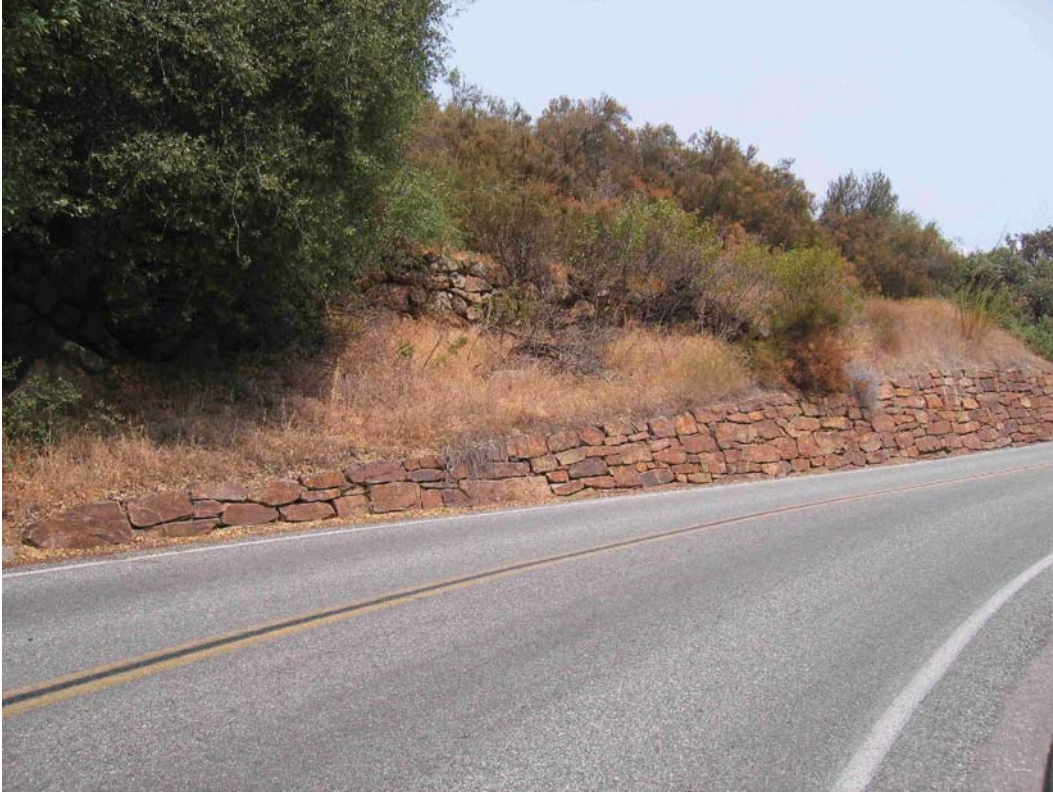
**SEQU\_0010\_3.105\_L\_1.jpg**

<b>Wall ID:</b>	SEQU-0010-3.105-L		
<b>Route Name:</b>	GENERALS HIGHWAY HISTORIC		
<b>Inspection Date:</b>	August 14, 2007	<b>Approximate Year Built:</b>	1997
<b>*Wall Rating:</b>	77	<b>Maintenance Action:</b>	No Action
