# SEQU

## WIP Report

### NPS Retaining Wall Inventory Program Sequoia National Park

**Data Collection Date: August 2007  
Report Date: December 2015**

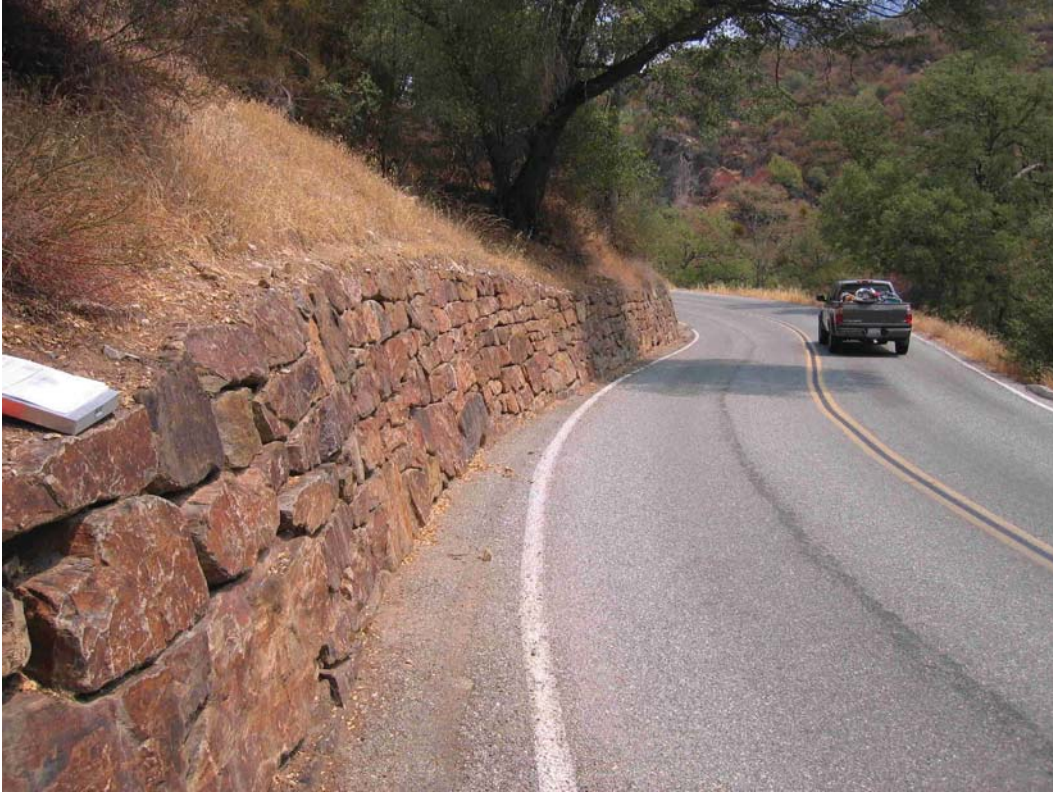
**SEQU\_0010\_3.410\_L\_1.jpg**

<b>Element (Weighting Factor)</b>	<b>Narrative</b>	<b>Condition Rating (0 - 10)</b>
PERFORMANCE 8.00	Performing as designed. No signs of global stability or settlement	8
WALL FOUNDATION MATERIAL 8.00	Paved. No cracks or settlement sufficient to support wall	8
PLACED STONE 8.00	Schist stones with slight weathering, few missing stones. Few voids in wall and some bulgin at the beginning of the wall	6
LATERAL SLOPE 0.50	Formed of large boulders in soil matrix. Stable, no erosion evident	8
WALL DRAINS 0.50	One wall drain in the center of wall	8
UPSLOPE 1.00	Sloughing and eroding of the soils are evident. Slope is at 1H:1V	7
VEGETATION 1.00	Large trees on upper slope. No vegetation on wall element	7

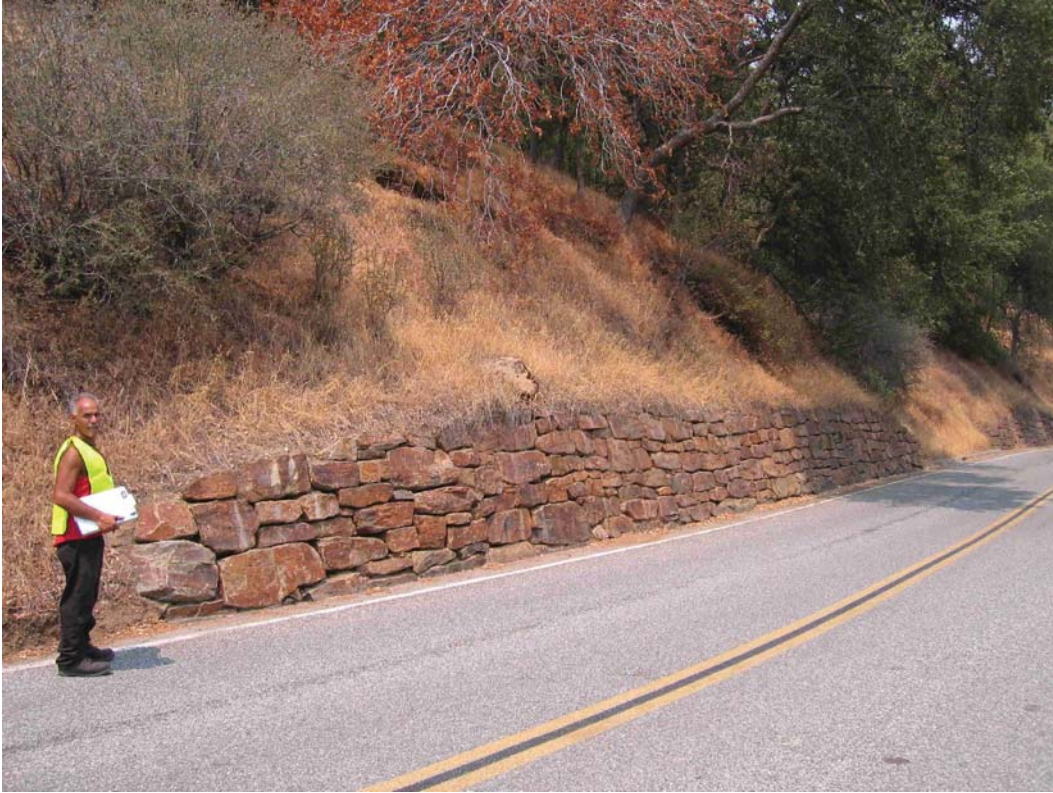
**SEQU\_0010\_3.475\_L\_1.jpg**

<b>Element (Weighting Factor)</b>	<b>Narrative</b>	<b>Condition Rating (0 - 10)</b>
PERFORMANCE 8.00	Performing as designed. No signs of global stability or settlement issues	8
WALL FOUNDATION MATERIAL 8.00	Paved. No cracks or settlement is visible and sufficient to support wall	8
PLACED STONE 8.00	Schist stone with slight weathering. No cracking. Few missing elements	8
VEGETATION 0.50	No vegetation affect wall stability	8
WALL DRAINS 0.50	Few wall drains are existing of bottom of wall. Clean and performing well	8
LATERAL SLOPE 1.00	Steep slope with signs of erosion. Soil with vegetation with 1H:1V	7
UPSLOPE 1.00	Sloughing and erosion is evident soil slope. Loose with trees and bushes. 1H:1V slope.	7

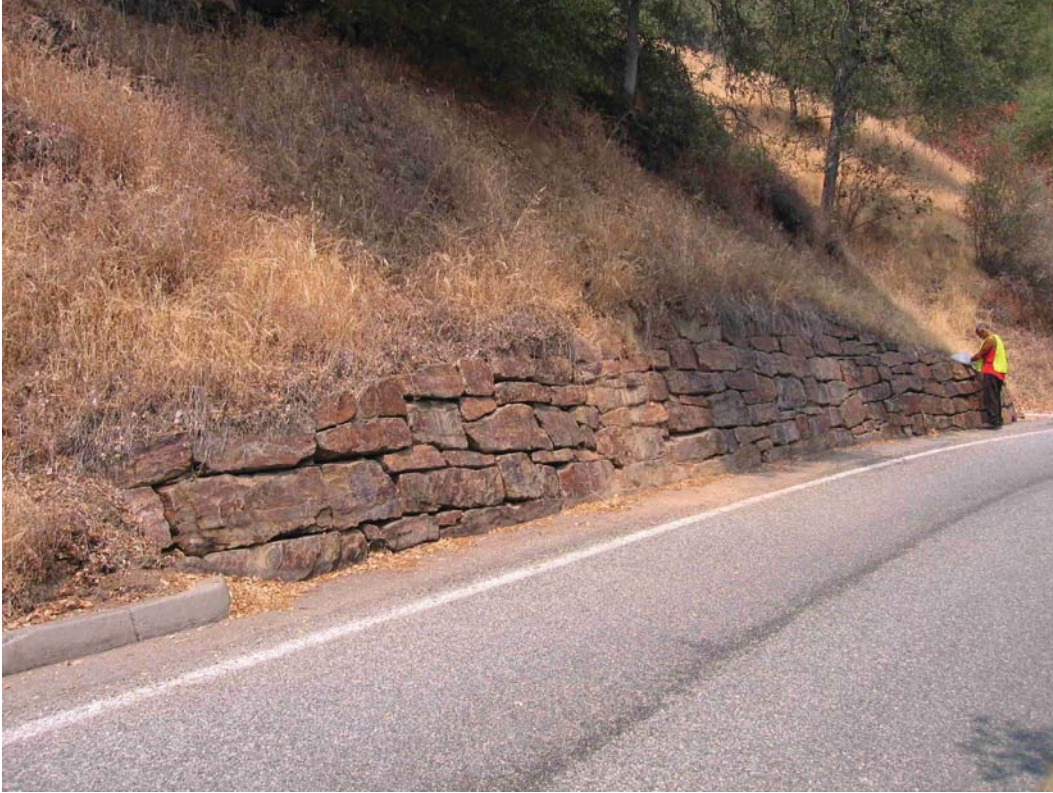
**SEQU\_0010\_3.499\_L\_1.jpg**

<b>Element (Weighting Factor)</b>	<b>Narrative</b>	<b>Condition Rating (0 - 10)</b>
PERFORMANCE 8.00	Performing as designed. No signs of global stability or settlement	8
WALL FOUNDATION MATERIAL 8.00	Paved. No cracking or settlement. Sufficient to support wall.	8
CONCRETE 8.00	Excellent condition. No cracking or distress	8
PLACED STONE 8.00	Schist stone with slightly weathering. No cracking or missing elements. Few voids	8
CULVERT 0.50	2- 48" CMP excellent condition	8
DOWNSLOPE 0.50	Boulders and stable	8
VEGETATION 0.50	No vegetation on wall face that effect wall stability	8
UPSLOPE 1.00	Erosion of soil. Very steep slope (1H:1V) with some trees.	6
LATERAL SLOPE 1.00	Sloughing and erosion of the soil. Steep slope at 1H:1V	7

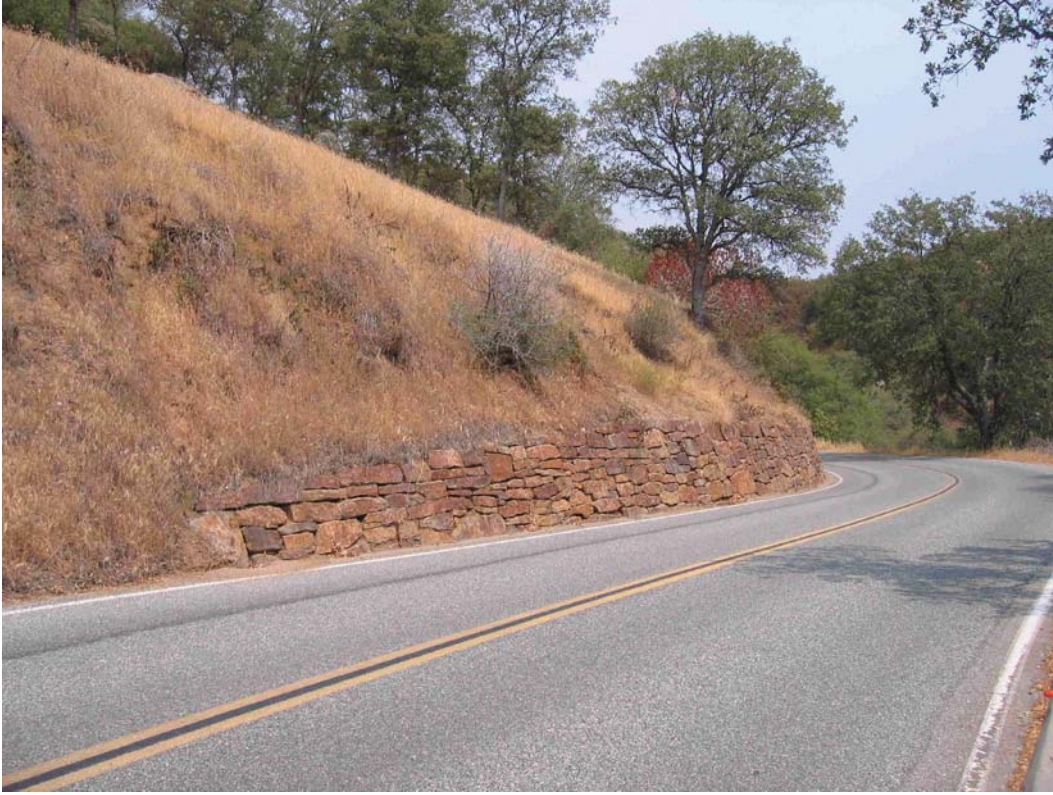
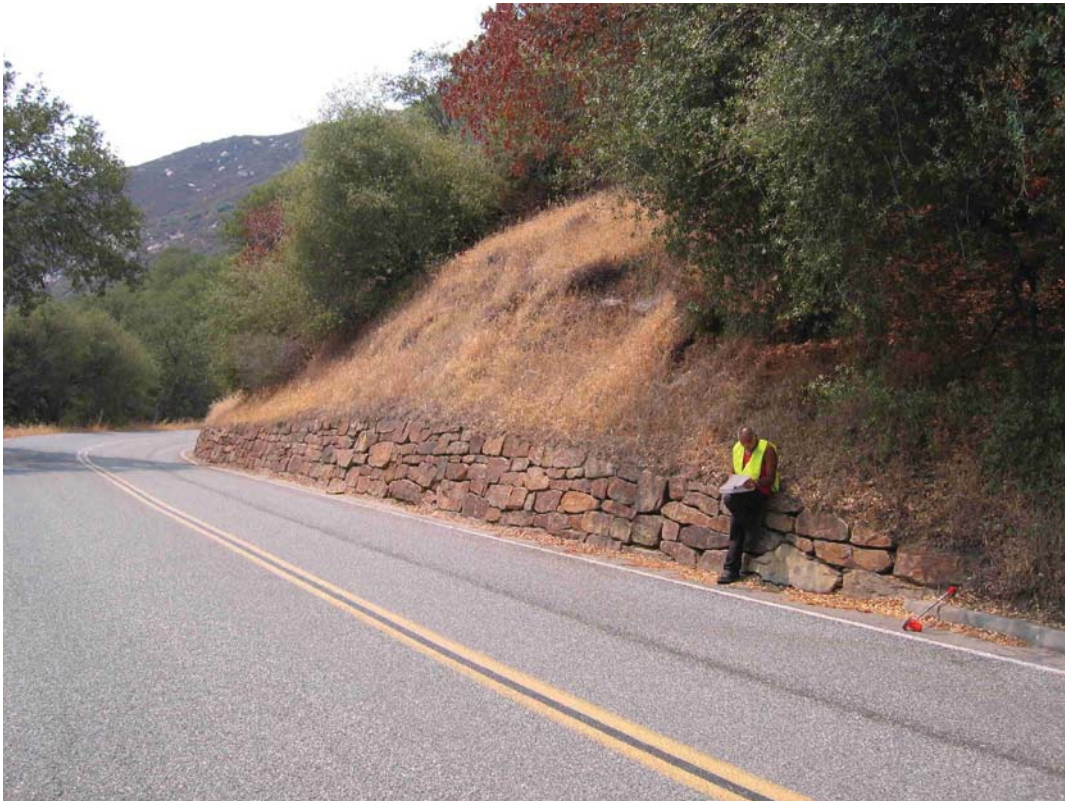
**SEQU\_0010\_3.525\_L\_1.jpg**

<b>Element (Weighting Factor)</b>	<b>Narrative</b>	<b>Condition Rating (0 - 10)</b>
PERFORMANCE 8.00	Performing as designed	8
WALL FOUNDATION MATERIAL 8.00	Paved. No cracking or settlement sufficient to support wall	8
PLACED STONE 8.00	Schist stone with slight weathering. No cracking, very few missing elements, very small area showed slight bulging	8
LATERAL SLOPE 0.50	Flat slopes. No sign of erosion and stable	8
VEGETATION 0.50	No vegetation effecting wall performance	8
WALL DRAINS 0.50	Wall drains exist in bottom of wall.	8
UPSLOPE 1.00	Sloughing and erosion are evident in the loose soils with few trees and bushes exist	7

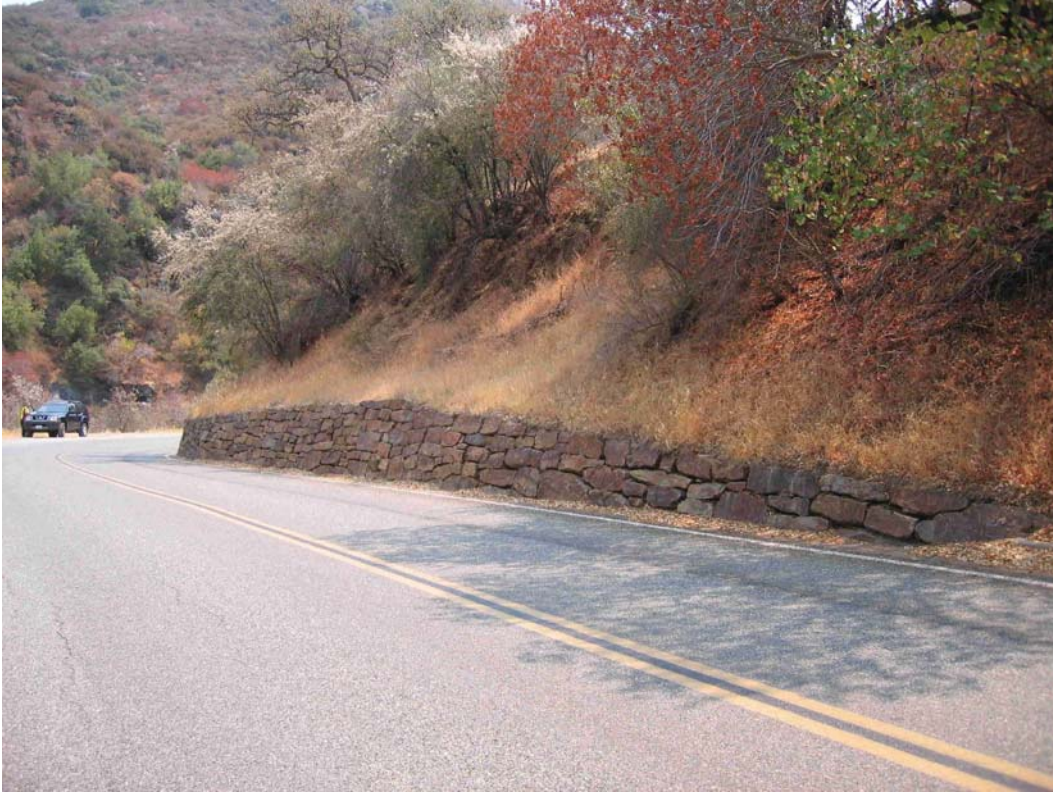
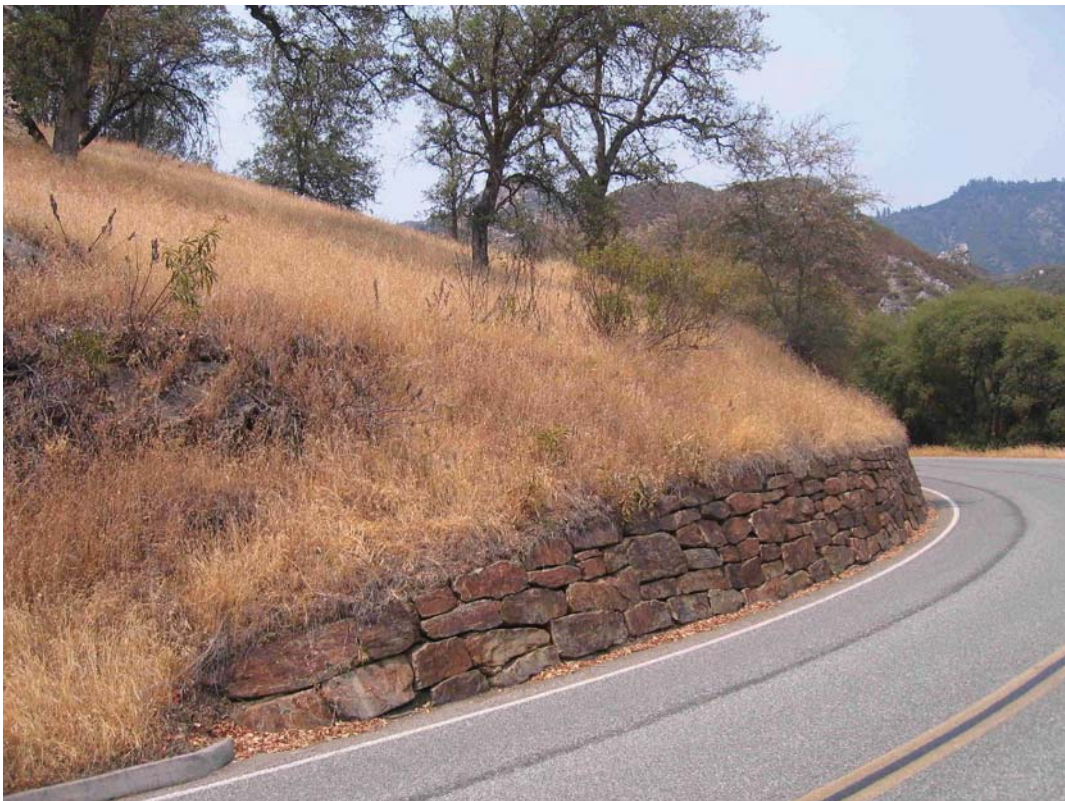
**SEQU\_0010\_3.612\_L\_1.jpg**

<b>Element (Weighting Factor)</b>	<b>Narrative</b>	<b>Condition Rating (0 - 10)</b>
PERFORMANCE 8.00	Performing as designed. No signs of global, stability, or settlement.	8
WALL FOUNDATION MATERIAL 8.00	Paved. No cracking or distress or settlement are visible, sufficient to support wall.	8
PLACED STONE 8.00	Schist stone with slight weathering. No cracking or missing elements	8
LATERAL SLOPE 0.50	2H:1V soil slope relatively stable.	8
VEGETATION 0.50	No vegetation effecting wall performance	8
WALL DRAINS 0.50	Wall drains were visible in wall. Performing well and clean.	8
UPSLOPE 1.00	2H:1V slope with some trees and bushes. Soil material loose at lines slight evidence of erosion.	7

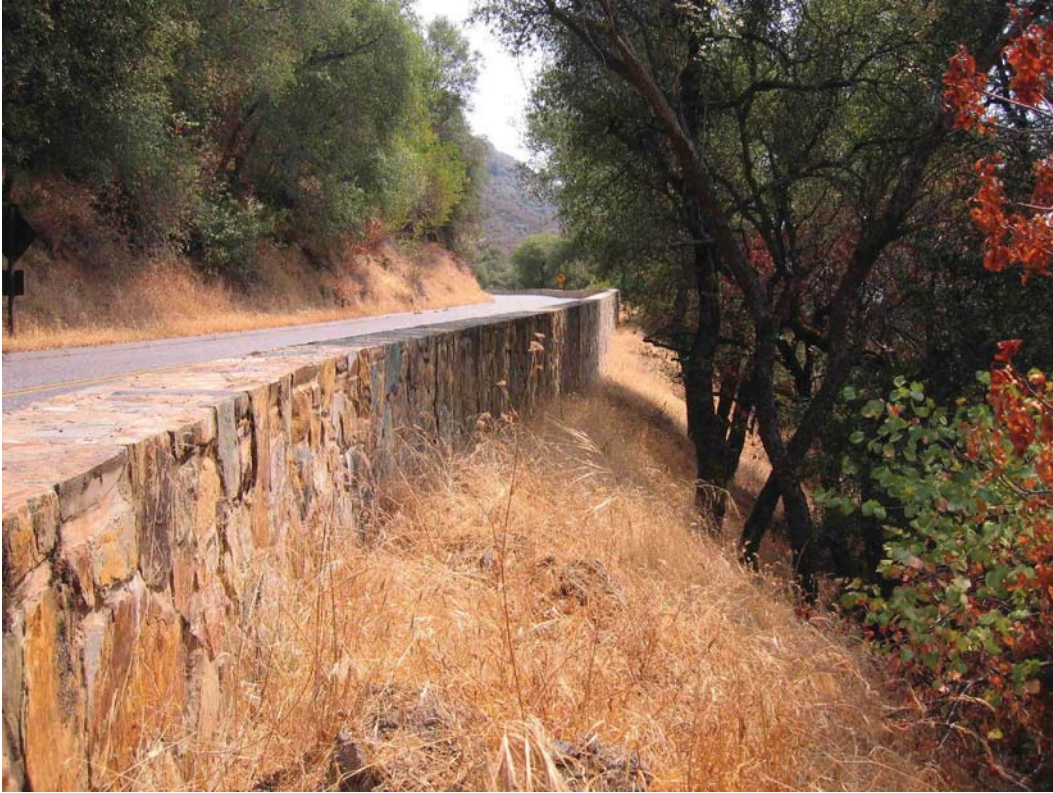
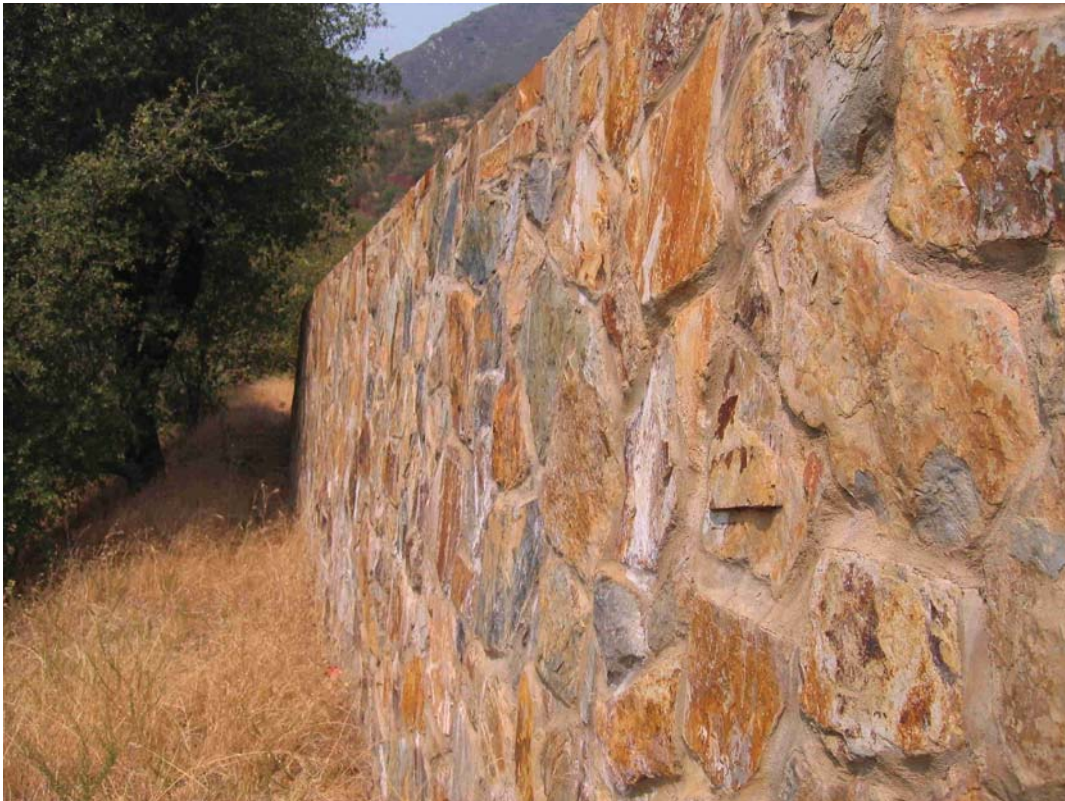
**SEQU\_0010\_4.139\_R\_1.jpg**

<b>Element (Weighting Factor)</b>	<b>Narrative</b>	<b>Condition Rating (0 - 10)</b>
PERFORMANCE 8.00	Excellent condition. Performing according to design. No signs of instability	9
WALL FOUNDATION MATERIAL 8.00	Loose soil with vegetation about 5 feet bench sufficient to support the wall	8
CONCRETE 8.00	Excellent condition. No cracking, fatigue or any type of failure.	9
ARCHITECTURAL FACING 0.50	Schist stone. Excellent condition	9
DOWNSLOPE 0.50	2H:1V soil with rocks. Stable, no signs of erosion	9
LATERAL SLOPE 0.50	One side was adjacent to MSE wall. The other side is soil with rock. Stable, no erosion	9
ROAD/SIDEWALK/SHOULDER 0.50	No cracking or distress caused by wall movement	9
TRAFFIC BARRIER/FENCE 0.50	Parapet with schist veneer on all sides. Excellent condition	9
VEGETATION 0.50	No vegetation on wall face or foundation that may effect wall stability	9

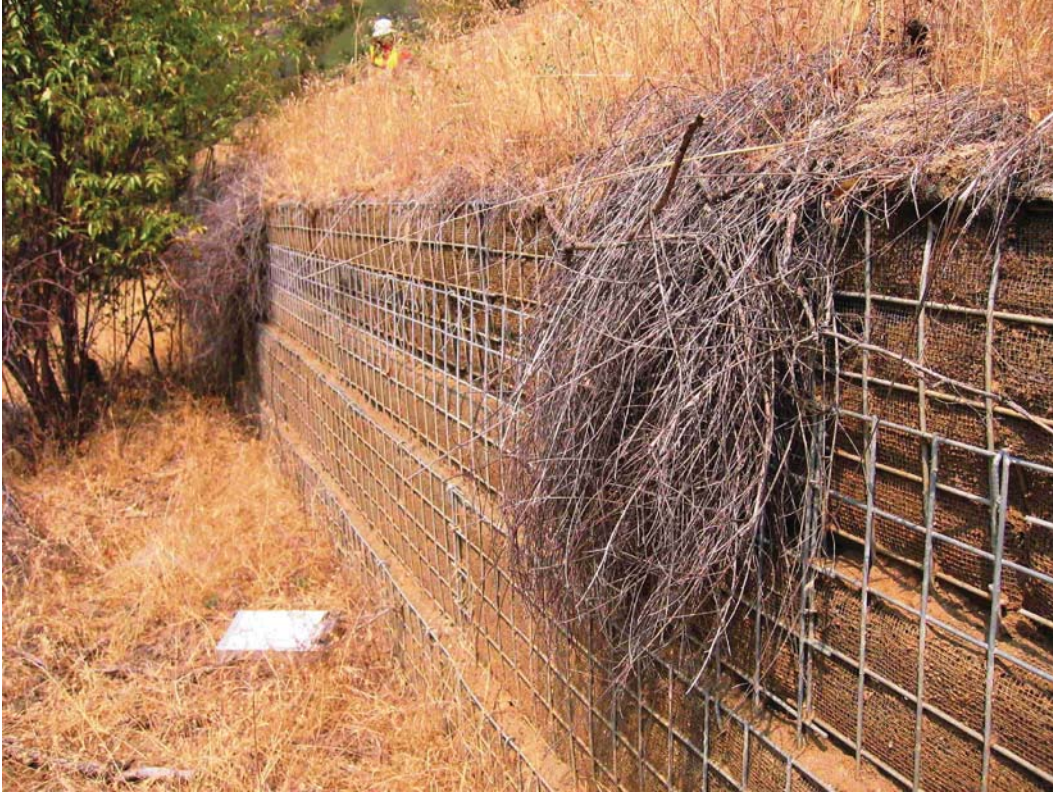
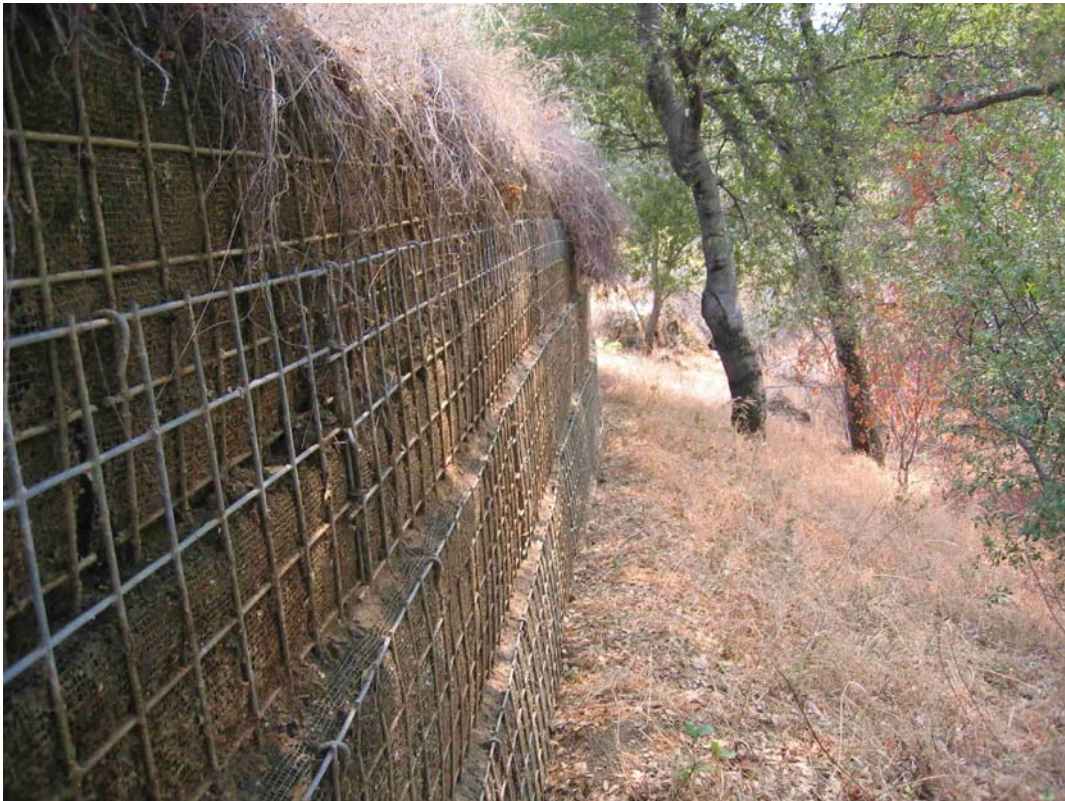
**SEQU\_0010\_4.200\_R\_1.jpg**

<b>Element (Weighting Factor)</b>	<b>Narrative</b>	<b>Condition Rating (0 - 10)</b>
PERFORMANCE 8.00	Performing as designed. No signs of major settlement or global instability	8
WALL FOUNDATION MATERIAL 8.00	Loose soils, minor erosion especially next to the culvert and slight undermining near the culvert.	7
WIRE/GEOSYNTHETIC FACING 8.00	The wire baskets are in excellent condition. No bulging or settlement are apparent. The face is vertical and baskets are intact	8
LATERAL SLOPE 0.50	One side is connected to cast in place. Other side is in good condition.	8
TRAFFIC BARRIER/FENCE 0.50	Guardwall with schist veneer on all sides. No cracks or distress. Excellent condition.	8
VEGETATION 0.50	Bushes are growing in wall face but not effecting all stability	8
DOWNSLOPE 1.00	Soil with vegetation. Slope is stable and 2H:1V.	7
ROAD/SIDEWALK/SHOULDER 1.00	Short crack near centerline due to slight wall settlement	7

<b>Failure Consequence:</b>	HIGH
<b>Recommendation Narrative:</b>	Unclassified fill material (5 yds) @ \$35/yd = \$175. Riprap, Class 4 (5 yds) @ \$130/yd = \$650. Labor (20 hrs) @ \$55/hr = \$1100. Backhoe (20 hrs) @ \$150/hr = \$3000.
<b>Repair Cost:</b>	\$4,925

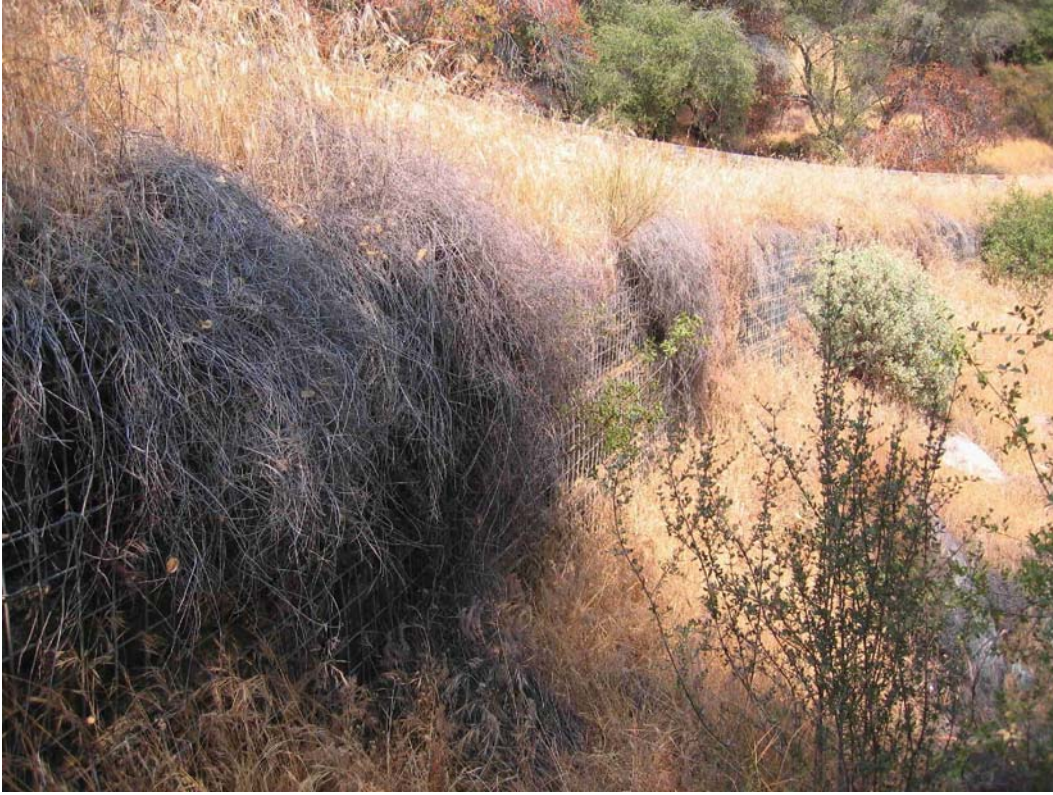
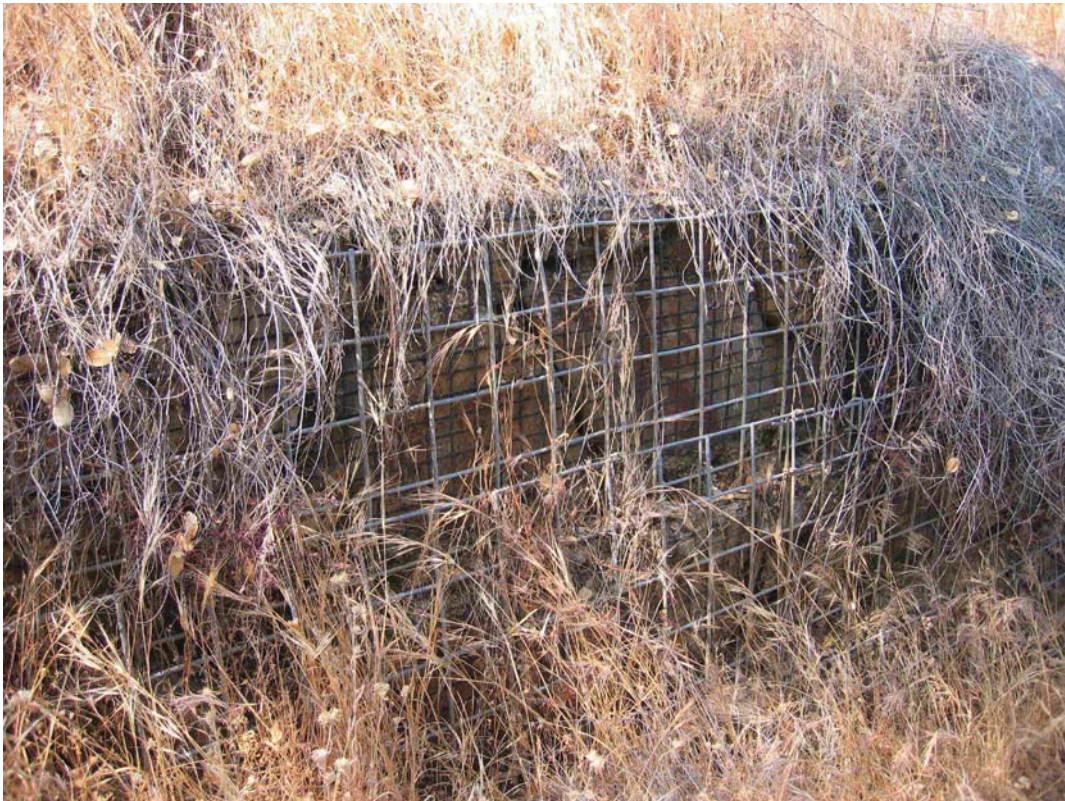
**SEQU\_0010\_4.532\_R\_1.jpg**

<b>Element (Weighting Factor)</b>	<b>Narrative</b>	<b>Condition Rating (0 - 10)</b>
PERFORMANCE 8.00	Performing very well. No signs of settlement or rotation.	8
WALL FOUNDATION MATERIAL 8.00	Soil with boulders and loose materials. No undermining or foundation problems sufficient to support wall steep 1V:1H.	8
WIRE/GEOSYNTHETIC FACING 8.00	Wires are in good condition. Slight signs of bulging and settlement. Not severe	8
CULVERT 0.50	One 24" CMP in the wall. Excellent condition.	8
TRAFFIC BARRIER/FENCE 0.50	Guardwall with schist facing on all sides. Stable and no cracking. Slightly weathering of schist.	8
VEGETATION 0.50	The wall face is purposely vegetated. No vegetation effect wall stability	8
WALL DRAINS 0.50	Wall drains were visible. Performing well and clean.	8
ROAD/SIDEWALK/SHOULDER 0.50	No cracking or distress	9
ARCHITECTURAL FACING 1.00	Schist stone was installed behind wire baskets as a facing. Not evaluated.	7

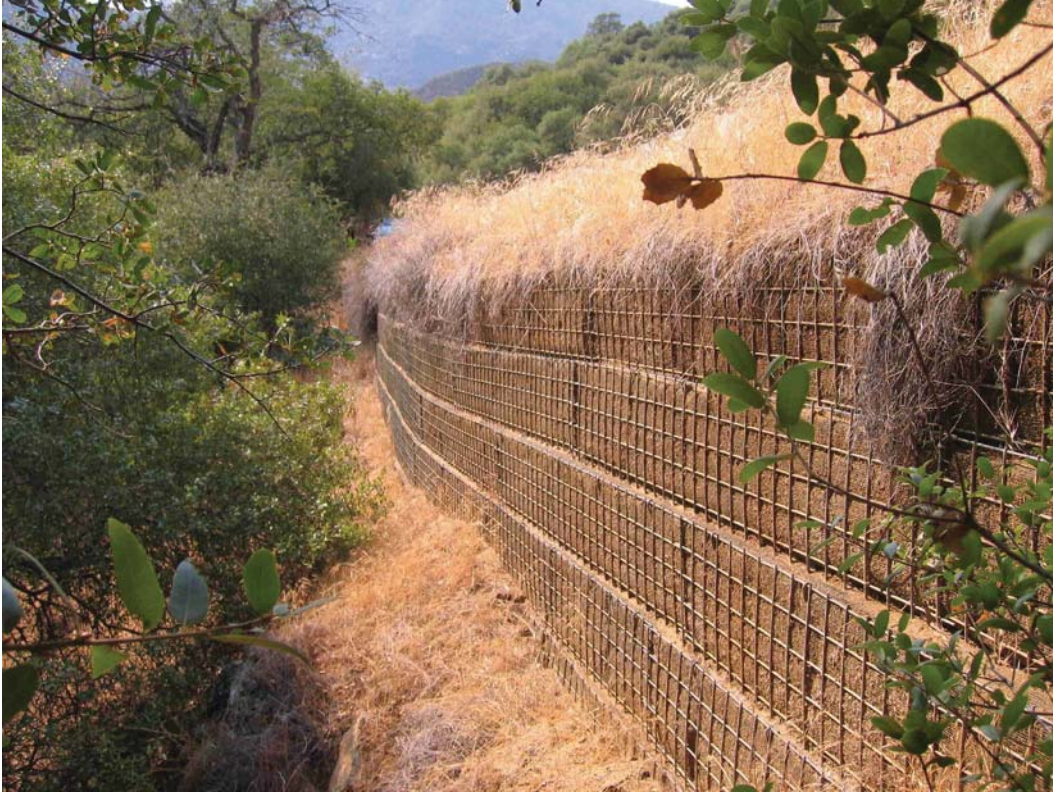
**SEQU\_0010\_4.581\_R\_1.jpg**

<b>Element (Weighting Factor)</b>	<b>Narrative</b>	<b>Condition Rating (0 - 10)</b>
PERFORMANCE 8.00	Excellent performance. No signs of bulging or global failure or settlement	8
WALL FOUNDATION MATERIAL 8.00	Soil with boulders, well vegetated bushes/trees sufficient to support wall	8
WIRE/GEOSYNTHETIC FACING 8.00	Wires are in excellent condition. No signs of rusting or bulging or settlement	8
LATERAL SLOPE 0.50	Stable. No signs of erosion or failure. 1.5H:1V with trees and bushes.	8
VEGETATION 0.50	None effecting wall stability	8
CULVERT 0.50	One 24" CMP below the wall foundation. Excellent condition.	9
ROAD/SIDEWALK/SHOULDER 0.50	No cracking or distress	9
TRAFFIC BARRIER/FENCE 0.50	Guardwall with schist veneer on all sides. No cracks or damage. Excellent condition	9
DOWNSLOPE 1.00	Steep stable 1.5H:1V slope. Soil with boulders with minor erosion.	7

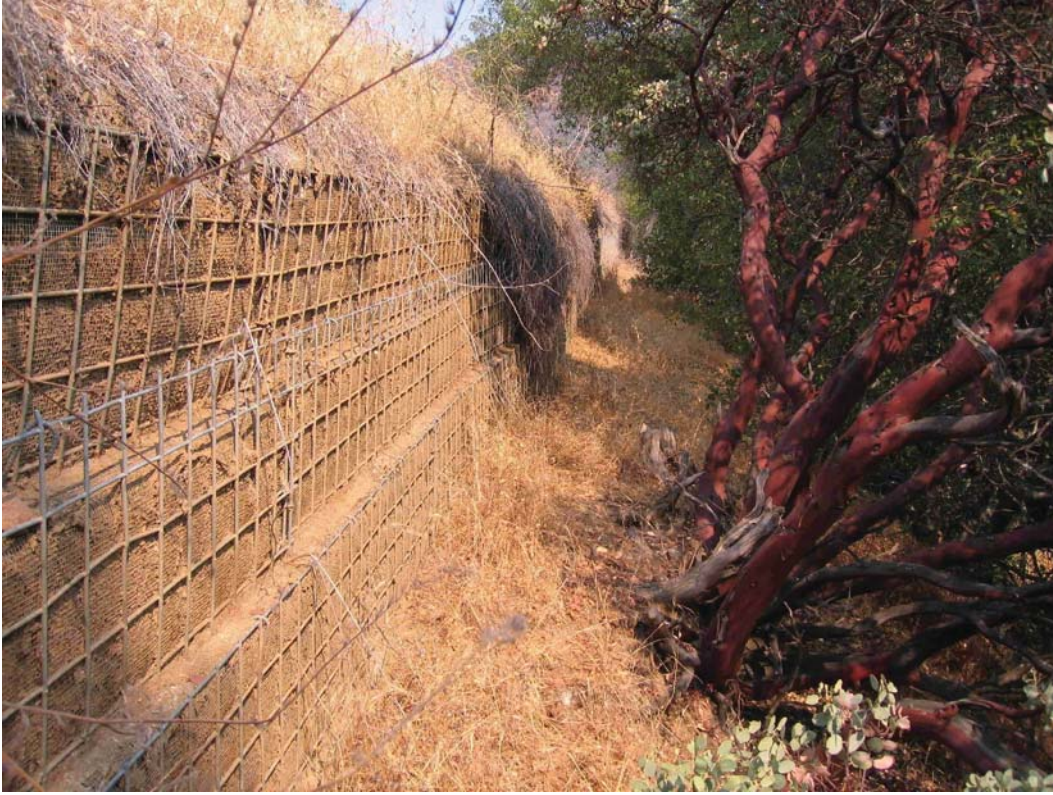
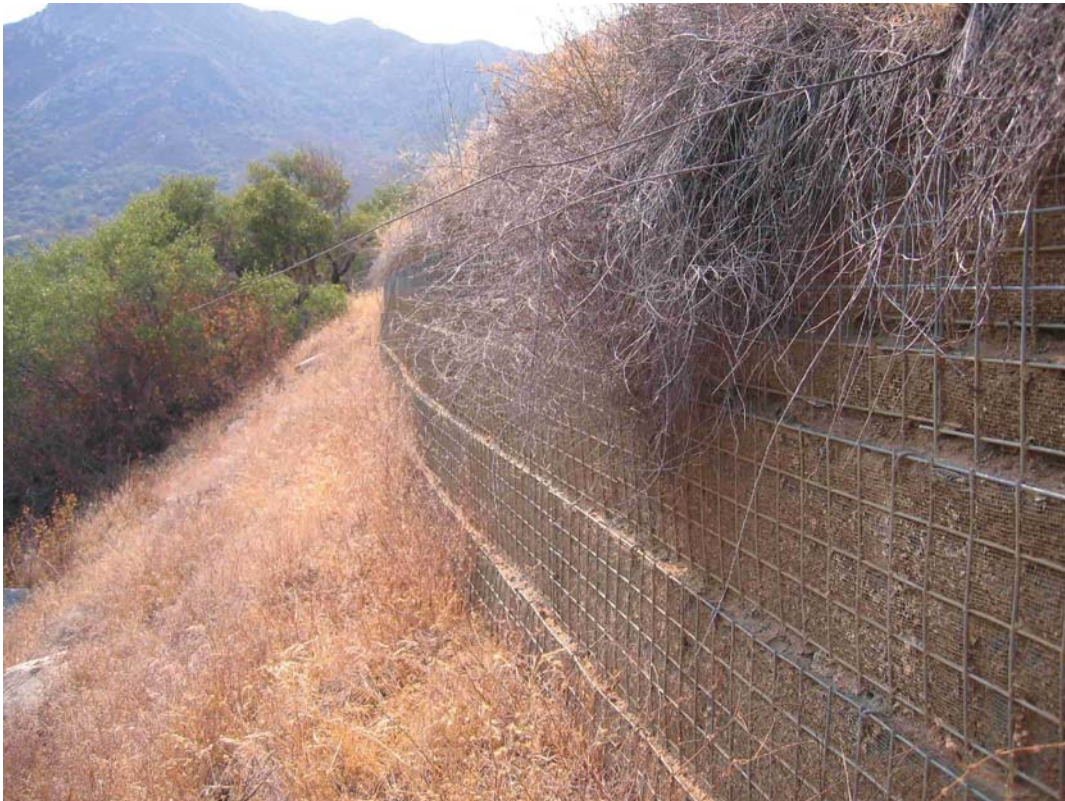
**SEQU\_0010\_4.618\_R\_1.jpg**

<b>Element (Weighting Factor)</b>	<b>Narrative</b>	<b>Condition Rating (0 - 10)</b>
PERFORMANCE 8.00	Excellent performance. No signs of settlement issues of global failures.	8
WALL FOUNDATION MATERIAL 8.00	Stable (1.5H:1V) slope with loose soil with boulders. No undermining or exposed bottom baskets.	8
WIRE/GEOSYNTHETIC FACING 8.00	Wire is in excellent condition. Minor signs of settlement and a damaged basket due to a rock fall at 160 ft from begin wall	7
LATERAL SLOPE 0.50	Good stable condition. Soil with boulders.	8
VEGETATION 0.50	Bushes are growing intentionally in the all. No effect on stability	8
WALL DRAINS 0.50	Drains were apparent, clean and functioning.	8
CULVERT 0.50	One 24" CMP in midwall. Excellent condition. Riprap with gabion baskets are also installed near culvert.	9
ROAD/SIDEWALK/SHOULDER 0.50	No crack or distress	9
TRAFFIC BARRIER/FENCE 0.50	Guardwall with schist facing all sides. No cracks or distress. Excellent condition	9

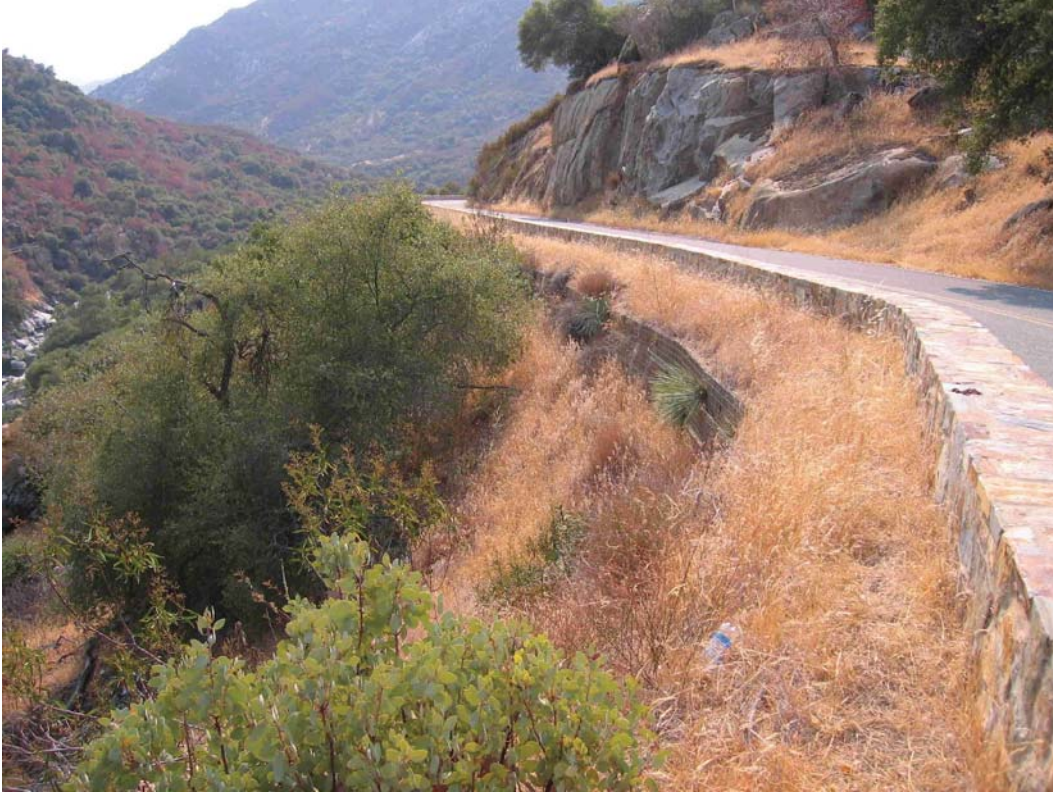
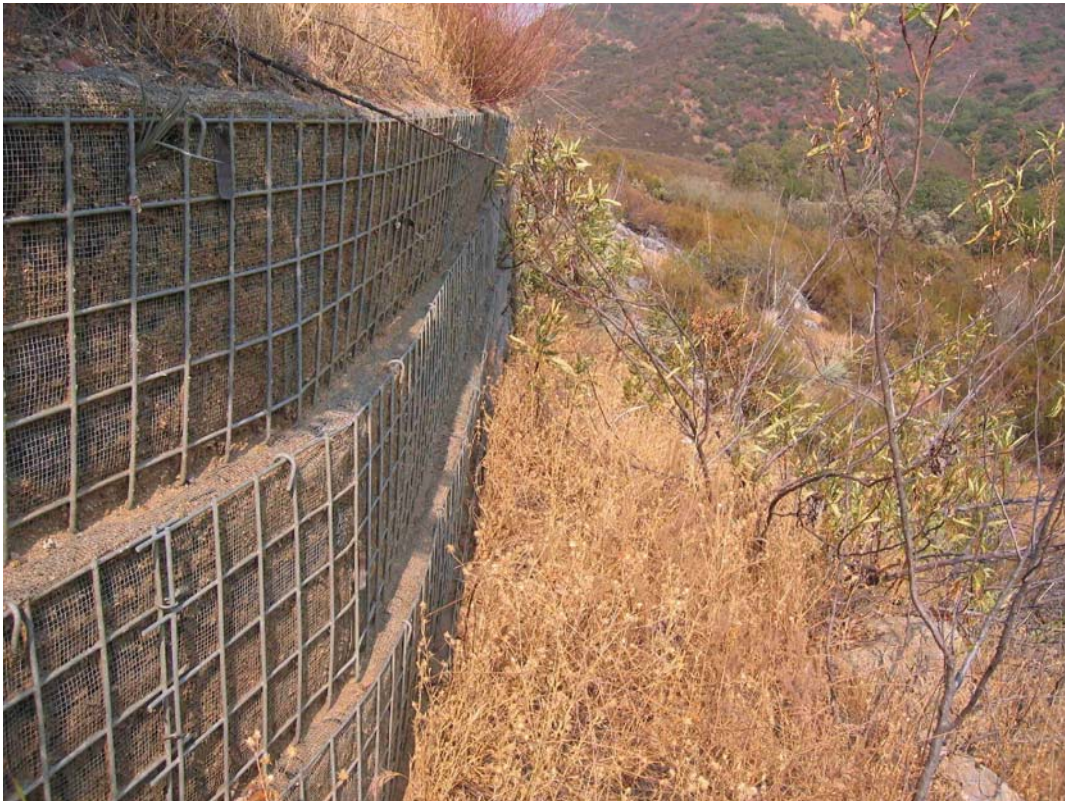
**SEQU\_0010\_4.770\_R\_1.jpg**

<b>Element (Weighting Factor)</b>	<b>Narrative</b>	<b>Condition Rating (0 - 10)</b>
PERFORMANCE 8.00	Excellent performance. No global failure issues or settlement issues.	8
WALL FOUNDATION MATERIAL 8.00	Loose soil material all bottom baskets are fully embedded. No undermining sufficient to support wall.	8
WIRE/GEOSYNTHETIC FACING 8.00	Wires are in good condition. Minor bulging in some baskets. Not severe or effecting wall. Minor settlement in some baskets.	7
LATERAL SLOPE 0.50	One side adjacent to guardwall and other side is bedrock.	8
WALL DRAINS 0.50	Wall drains are working and clean	8
ROAD/SIDEWALK/SHOULDER 0.50	No cracks or distress	9
TRAFFIC BARRIER/FENCE 0.50	Guardwall with schist veneer all faces. Excellent condition.	9
DOWNSLOPE 1.00	Very steep 0.75H:1V boulders with soil some erosion, bushes and trees.	7
VEGETATION 1.00	Vegetation intentionally growing in wall face. Not effecting stability.	7

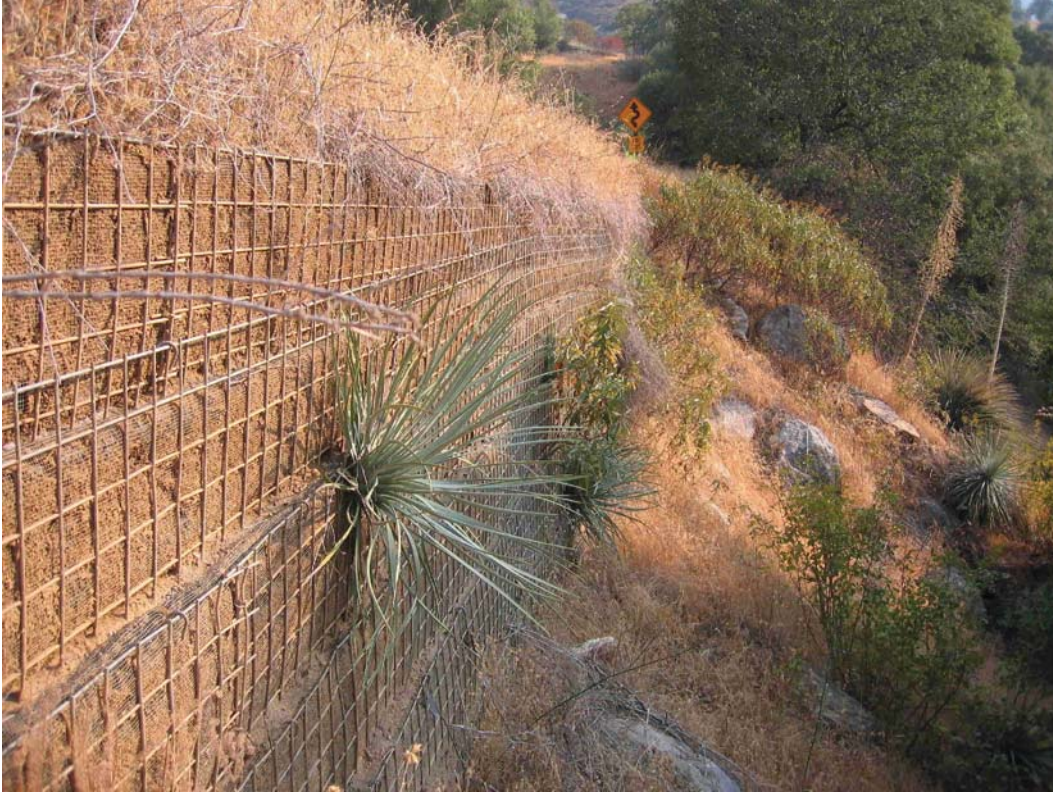
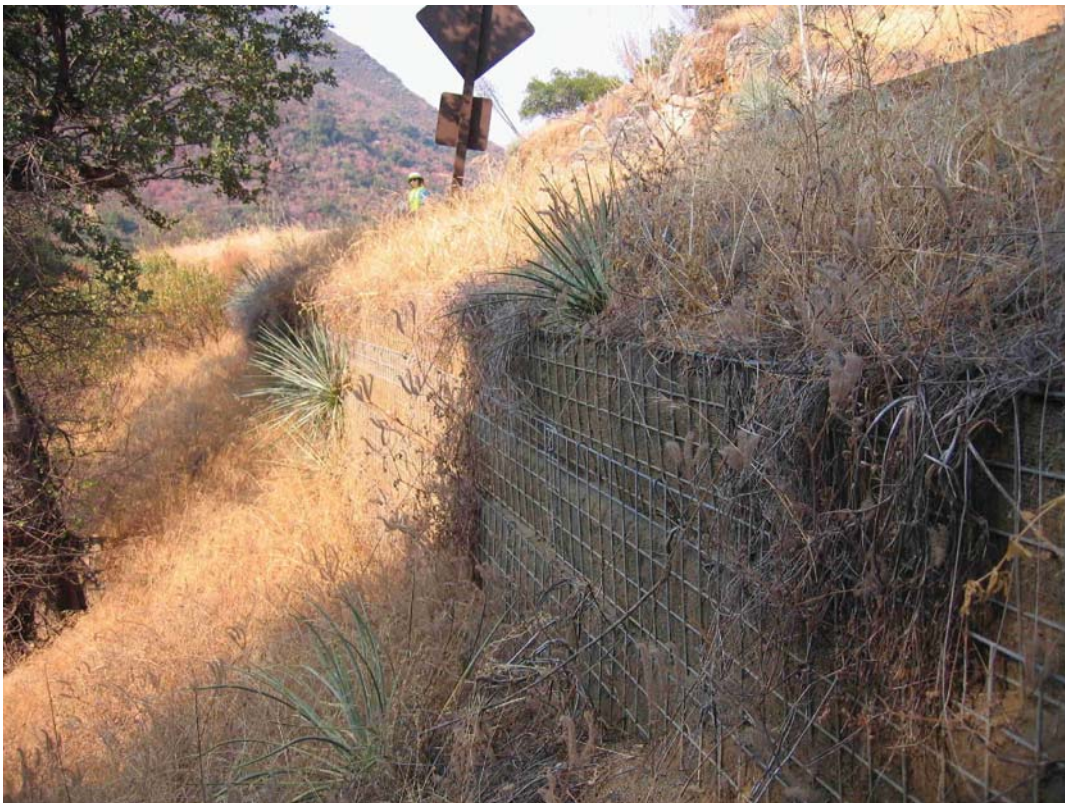
**SEQU\_0010\_4.900\_R\_1.jpg**

<b>Element (Weighting Factor)</b>	<b>Narrative</b>	<b>Condition Rating (0 - 10)</b>
PERFORMANCE 8.00	Performing as designed. No signs of major settlement or global failure.	8
WALL FOUNDATION MATERIAL 8.00	Loose soil, some erosion. Very steep 1H:1V of all base. All bottom baskets are buried sufficient to support wall.	7
WIRE/GEOSYNTHETIC FACING 8.00	Wire is in good condition. No corrosion, some settlement in the basket and minor bulging were observed. The baskets are generally intact.	7
ROAD/SIDEWALK/SHOULDER 0.50	No cracks or distress that may be caused by wall movement	8
TRAFFIC BARRIER/FENCE 0.50	Guardwall with schist stone veneer on all faces. No cracks or distress. Excellent condition.	8
DOWNSLOPE 1.00	0.75:1 steep slope. Boulders with soil, well vegetated with grass and trees. Some erosion exist.	7
LATERAL SLOPE 1.00	1H:1V boulders with soil and large trees. No signs of erosion or sloughing.	7

VEGETATION 1.00	Vegetation is growing intentionally on wall face. No effecting wall stability	7
WALL DRAINS 1.00	No wall drains were observed	7

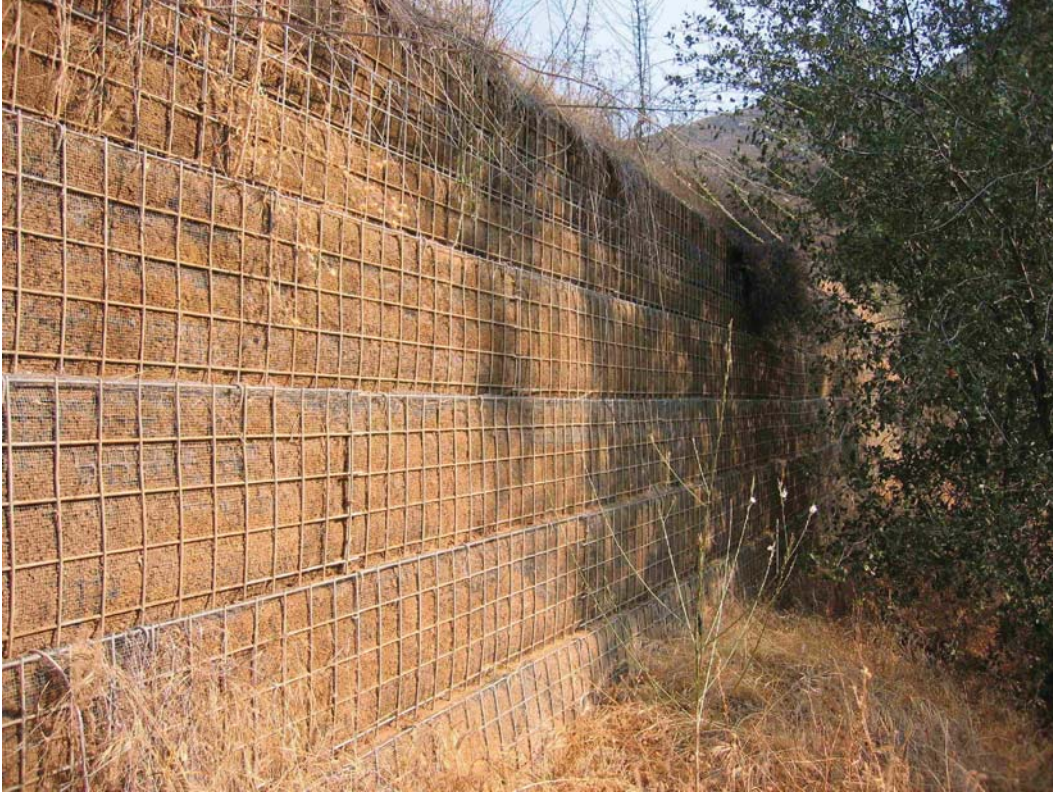
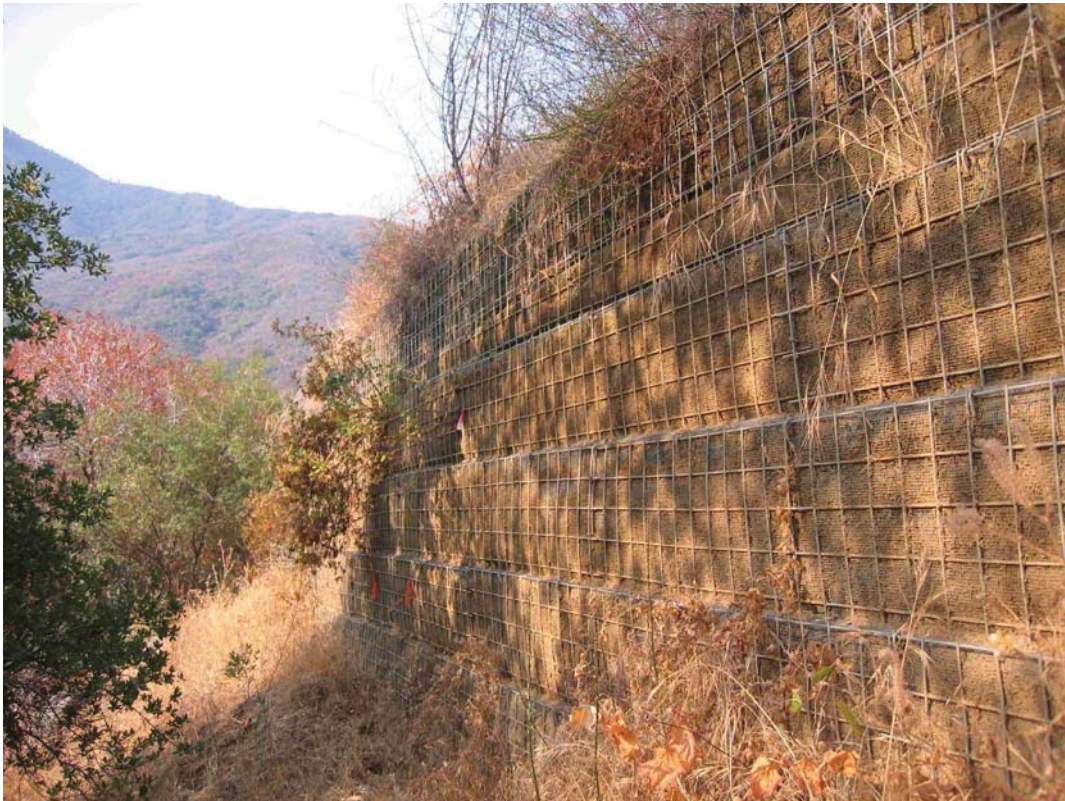
**SEQU\_0010\_5.010\_R\_1.jpg**

<b>Element (Weighting Factor)</b>	<b>Narrative</b>	<b>Condition Rating (0 - 10)</b>
PERFORMANCE 8.00	Good performance. Some signs of settlement but not affecting overall stability or performance.	7
WALL FOUNDATION MATERIAL 8.00	Soil with boulders with no bench (1H:1V). All bottom baskets are intact and embedded. Foundation is sufficient to support wall.	7
WIRE/GEOSYNTHETIC FACING 8.00	Wire is in good condition. Signs of settlement mainly in the top two baskets and specifically in the upper half of wall.	7
WALL DRAINS 0.50	Wall drains are clean and functioning.	8
ROAD/SIDEWALK/SHOULDER 1.00	The upper half of wall, the road is cracked due to wall settlement.	6
DOWNSLOPE 1.00	Very steep 0.75H:1V slope. Boulders with loose soil, well vegetated, minor erosion.	7
LATERAL SLOPE 1.00	Heavily vegetated with large bushes. 1H:1V slope but stable condition. Soil with boulders.	7
TRAFFIC BARRIER/FENCE 1.00	Guardwall with schist stone veneer on all sides. No cracks or distress.	7
