# SEQU

## WIP Report

### NPS Retaining Wall Inventory Program Sequoia National Park

**Data Collection Date: August 2007  
Report Date: December 2015**

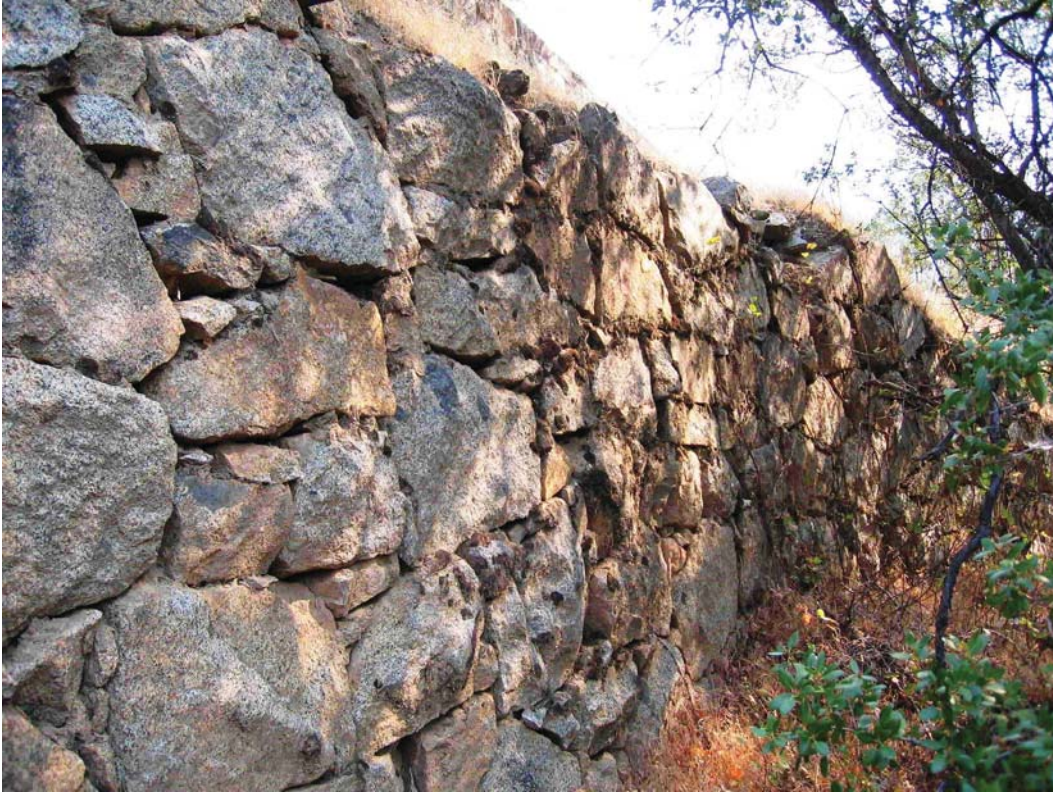
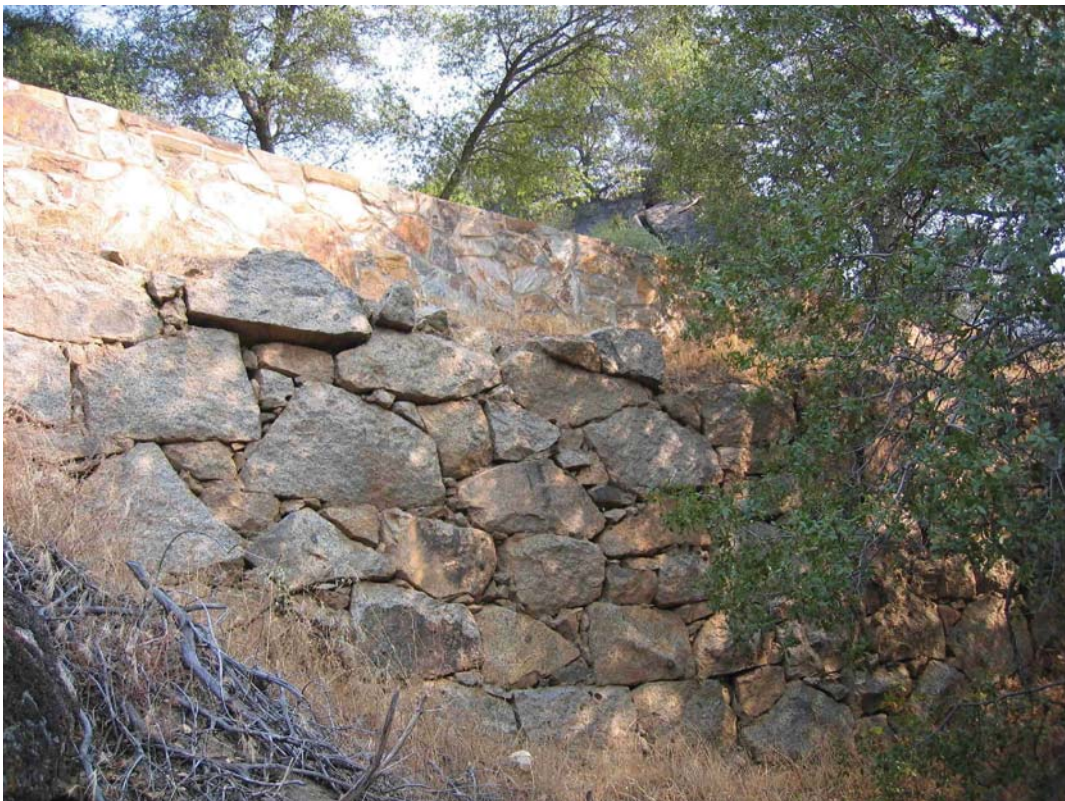
**SEQU\_0010\_5.484\_R\_1.jpg**

<b>Element (Weighting Factor)</b>	<b>Narrative</b>	<b>Condition Rating (0 - 10)</b>
PERFORMANCE 8.00	Good performance. No signs of rotating, settlement or global instability.	8
WALL FOUNDATION MATERIAL 8.00	Soil with boulders, loose, with minor erosion. No undermining or failure of foundation sufficient to support wall.	7
PLACED STONE 8.00	Rough cut large granite boulders. Some missing elements on the top row. Stones are strong and competent. No signs of weathering or cracking.	7
LATERAL SLOPE 0.50	Boulders/bedrock 1H:1V stable slope.	8
ROAD/SIDEWALK/SHOULDER 0.50	No cracks or distress	8
TRAFFIC BARRIER/FENCE 0.50	Guardwall with schist on all sides. No cracking or distress.	8
DOWNSLOPE 1.00	Soil with boulders 1H:1V slope. Loose materials, trees and bushes.	7
WALL DRAINS 1.00	No wall drains were visible.	7

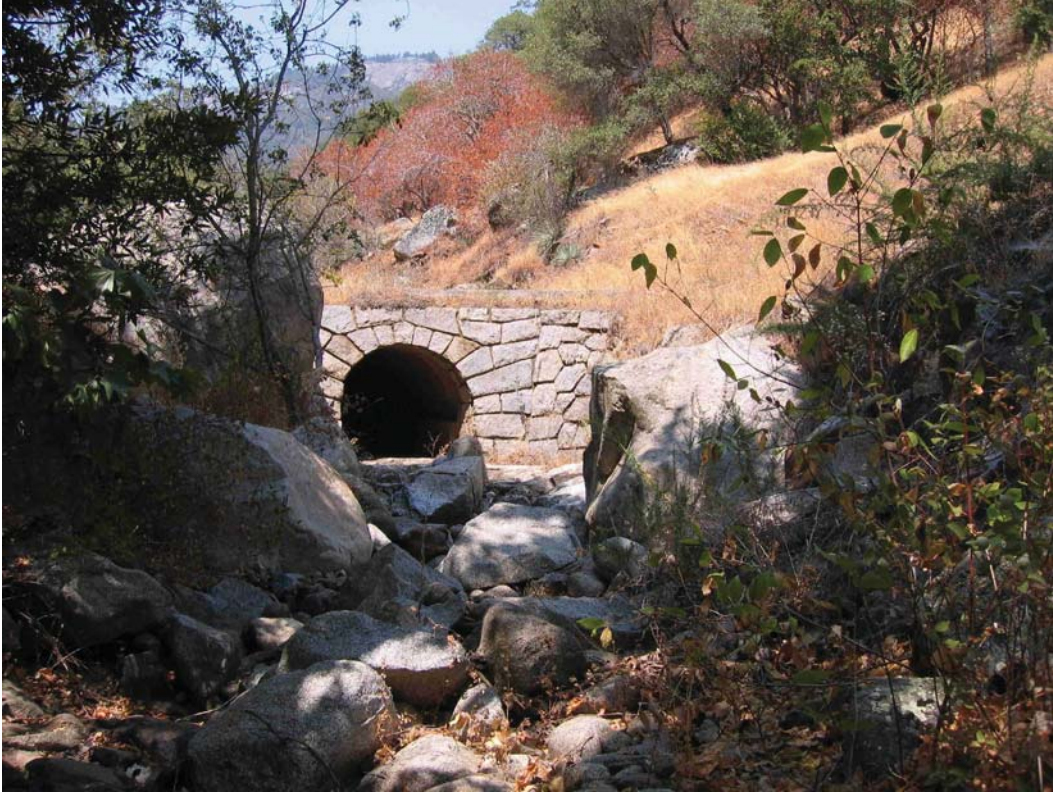
**SEQU\_0010\_6.623\_L\_1.jpg**

<b>Wall ID:</b>	SEQU-0010-6.623-L		
<b>Route Name:</b>	GENERALS HIGHWAY HISTORIC		
<b>Inspection Date:</b>	August 15, 2007	<b>Approximate Year Built:</b>	Unknown
<b>*Wall Rating:</b>	80	<b>Maintenance Action:</b>	No Action

<b>Element (Weighting Factor)</b>	<b>Narrative</b>	<b>Condition Rating (0 - 10)</b>
PERFORMANCE 8.00	Good performance. No global stability issues or settlement issues.	8
WALL FOUNDATION MATERIAL 8.00	Boulders, strong. No erosion.	8
MORTAR 8.00	Good condition. No cracking or shrinkage observed.	8
STONE MASONRY 8.00	Strong competent granite blocks. No missing elements. No weathering.	8
CULVERT 0.50	7 ft arch culvert with concrete footings.	8
DOWNSLOPE 0.50	Large boulders stable.	8
LATERAL SLOPE 0.50	Large boulders stable.	8
VEGETATION 0.50	No vegetation on wall face	8
WALL DRAINS 1.00	No wall drains were visible.	7

<b>Failure Consequence:</b>	HIGH
<b>Recommendation Narrative:</b>	None
<b>Repair Cost:</b>	\$0

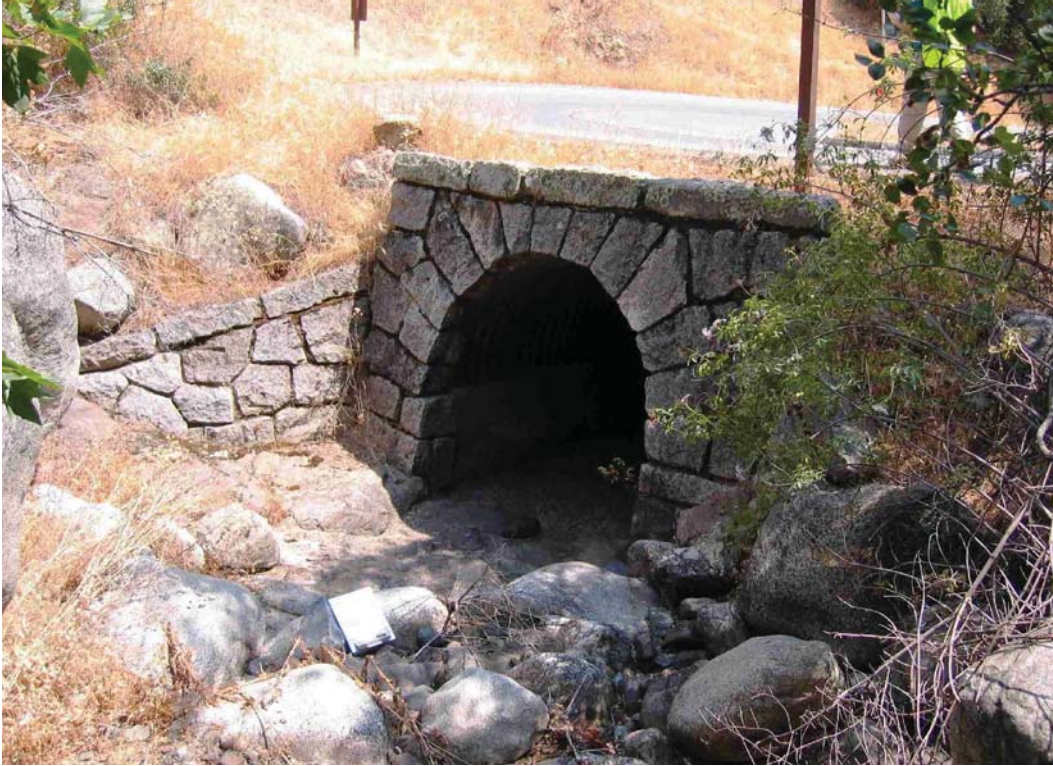
**SEQU\_0010\_6.626\_R\_1.jpg**

<b>Wall ID:</b>	SEQU-0010-6.626-R		
<b>Route Name:</b>	GENERALS HIGHWAY HISTORIC		
<b>Inspection Date:</b>	August 15, 2007	<b>Approximate Year Built:</b>	Unknown
<b>*Wall Rating:</b>	80	<b>Maintenance Action:</b>	No Action

<b>Element (Weighting Factor)</b>	<b>Narrative</b>	<b>Condition Rating (0 - 10)</b>
PERFORMANCE 8.00	Good performance.	8
WALL FOUNDATION MATERIAL 8.00	Large boulders, stable, no scouring.	8
MORTAR 8.00	Good condition with minor cracking.	8
STONE MASONRY 8.00	Strong granite blocks. No cracks or missing elements.	8
CULVERT 0.50	7 ft arch culvert.	8
ROAD/SIDEWALK/SHOULDER 0.50	No cracks or distress	8
VEGETATION 0.50	No vegetation on wall face.	8
DOWNSLOPE 0.50	Boulders and stable.	9
LATERAL SLOPE 0.50	Boulders and very large stable. No erosion.	9

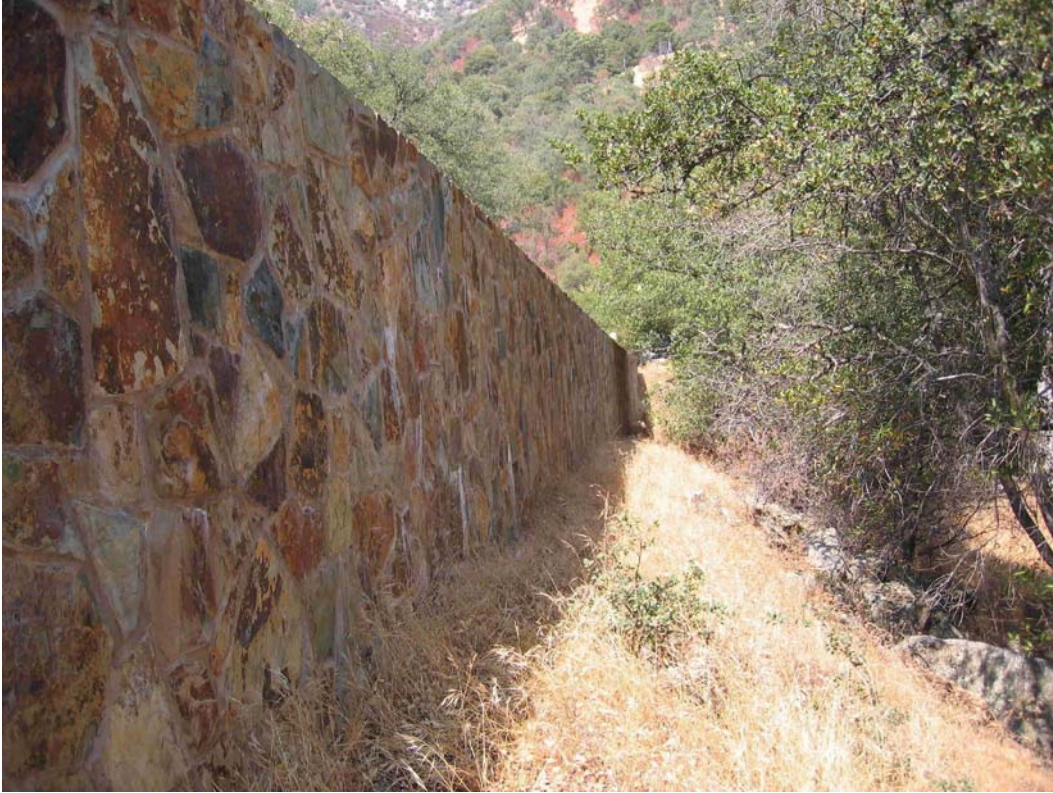
**SEQU\_0010\_6.704\_L\_1.jpg**

<b>Wall ID:</b>	SEQU-0010-6.704-L		
<b>Route Name:</b>	GENERALS HIGHWAY HISTORIC		
<b>Inspection Date:</b>	August 15, 2007	<b>Approximate Year Built:</b>	2001
<b>*Wall Rating:</b>	86	<b>Maintenance Action:</b>	No Action

<b>Element (Weighting Factor)</b>	<b>Narrative</b>	<b>Condition Rating (0 - 10)</b>
PERFORMANCE 8.00	Excellent performance. No signs or settlement and global instability.	8
WALL FOUNDATION MATERIAL 8.00	5 ft bench. Compacted soil and no signs of erosion or exposed footing. Excellent condition.	9
CONCRETE 8.00	Concrete covered with schist stone, no cracking is visible.	9
ARCHITECTURAL FACING 0.50	Schist stone with mortar, minor shrinkage cracks and slight weathering.	8
DOWNSLOPE 0.50	Soil with boulders relatively flat 4H:1V. No signs of erosion. Stable with bushes and trees.	8
LATERAL SLOPE 0.50	Soil with rock and stable minor erosion.	8
ROAD/SIDEWALK/SHOULDER 0.50	No cracks or distress caused by wall.	8
TRAFFIC BARRIER/FENCE 0.50	Parapet with schist on all sides. Excellent condition.	8
VEGETATION 0.50	No vegetation on wall face or affecting wall stability.	8

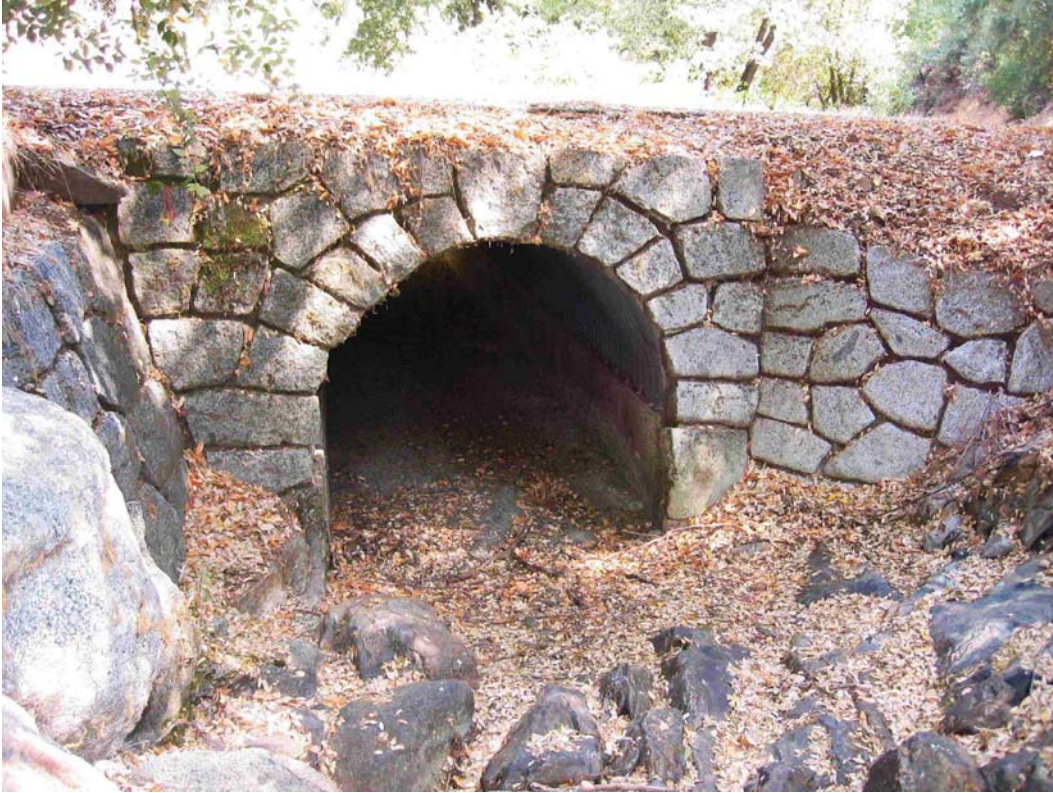
**SEQU\_0010\_6.995\_L\_1.jpg**

<b>Wall ID:</b>	SEQU-0010-6.995-L		
<b>Route Name:</b>	GENERALS HIGHWAY HISTORIC		
<b>Inspection Date:</b>	August 15, 2007	<b>Approximate Year Built:</b>	Unknown
<b>*Wall Rating:</b>	80	<b>Maintenance Action:</b>	No Action

<b>Element (Weighting Factor)</b>	<b>Narrative</b>	<b>Condition Rating (0 - 10)</b>
PERFORMANCE 8.00	Excellent performance. No settlements or global stability issues.	8
WALL FOUNDATION MATERIAL 8.00	Boulders with concrete. Stable but sufficient to support wall.	8
MORTAR 8.00	Mortar is in good condition. No signs of cracking or shrinkage.	8
STONE MASONRY 8.00	Competent and strong granite. No signs of weathering or cracking.	8
CULVERT 0.50	7 arched culvert over footings.	8
VEGETATION 0.50	No vegetation on wall face	8
DOWNSLOPE 0.50	Concrete and boulders.	9
LATERAL SLOPE 0.50	Bedrock and large boulders. No signs of erosion. Excellent condition.	9
UPSLOPE 0.50	Paved pullout	9

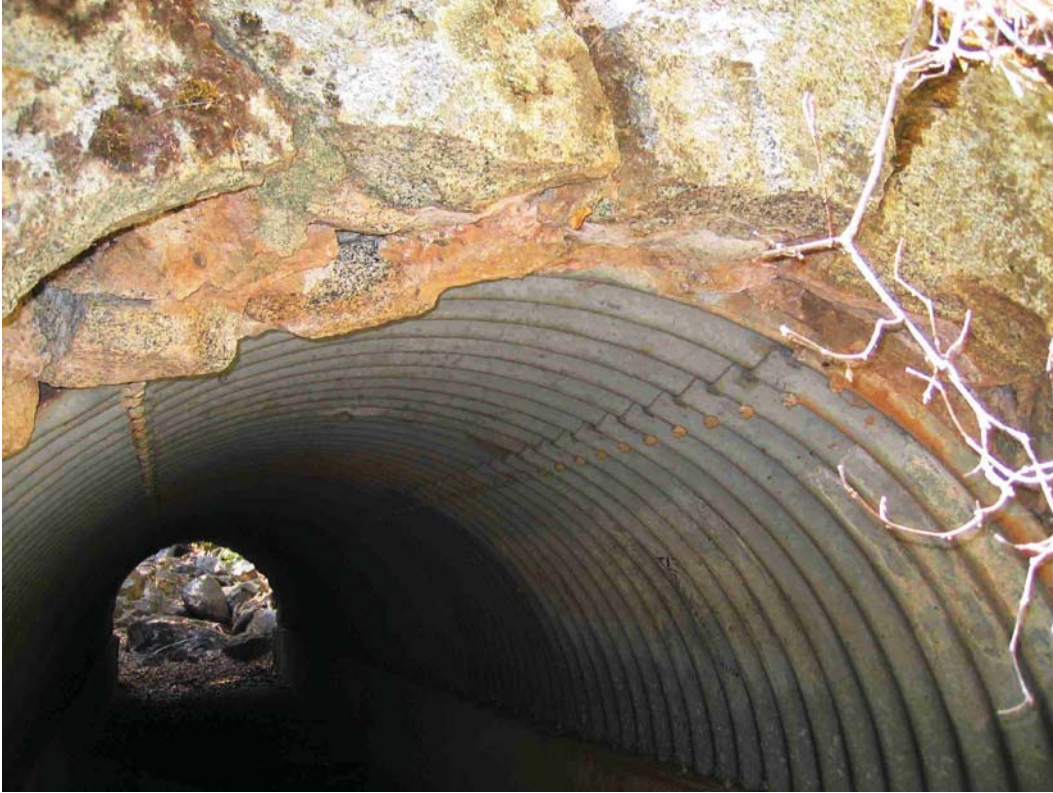
**SEQU\_0010\_6.996\_R\_1.jpg**

<b>Wall ID:</b>	SEQU-0010-6.996-R		
<b>Route Name:</b>	GENERALS HIGHWAY HISTORIC		
<b>Inspection Date:</b>	August 15, 2007	<b>Approximate Year Built:</b>	Unknown
<b>*Wall Rating:</b>	56	<b>Maintenance Action:</b>	Repair Elements

<b>Element (Weighting Factor)</b>	<b>Narrative</b>	<b>Condition Rating (0 - 10)</b>
PERFORMANCE 8.00	Good performance but foundation needs to fixed and reset stones.	6
WALL FOUNDATION MATERIAL 8.00	Foundation is undermined. If undermining continues to undercut, it will affect wall stability.	5
MORTAR 8.00	Missing mortar between stones.	5
STONE MASONRY 8.00	Good condition. No weathering or cracking. Missing elements.	6
DOWNSLOPE 1.00	Bedrock with large boulders and large trees and scouring.	6
LATERAL SLOPE 1.00	Bedrock with large boulders and large trees. Scouring underneath but no stability issues yet.	6
VEGETATION 1.00	No vegetation is on wall face or affecting wall performance.	7
WALL DRAINS 1.00	No wall drains are visible.	7

<b>Failure Consequence:</b>	HIGH
<b>Recommendation Narrative:</b>	Replace missing stonework and repair foundation. Place grouted riprap at foundation, 8 cubic yards @ \$330/cu.yd. = \$2,640. Replace masonry stone, 10 sq.ft. @ \$620/sq.ft = \$6,200. Misc. equipment time, 8 hours @ \$200/hr = \$1,600. Misc. Labor, 24 hours @ \$55
<b>Repair Cost:</b>	\$11,760

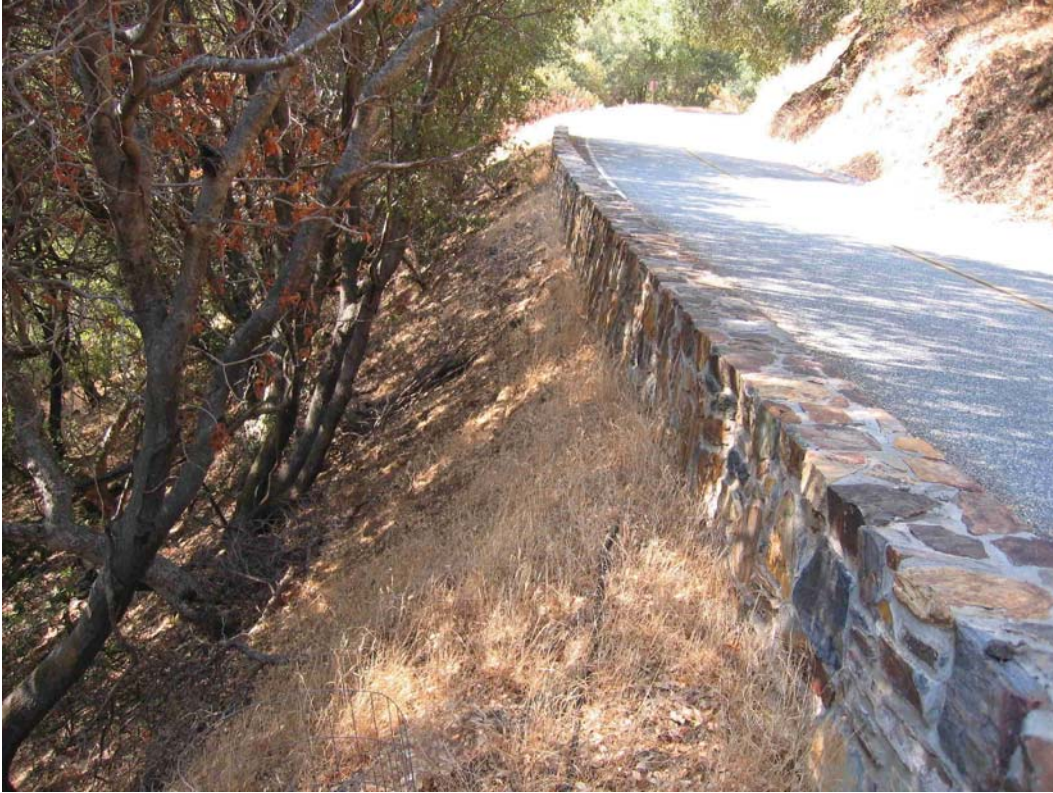
**SEQU\_0010\_7.315\_L\_1.jpg**

<b>Wall ID:</b>	SEQU-0010-7.315-L		
<b>Route Name:</b>	GENERALS HIGHWAY HISTORIC		
<b>Inspection Date:</b>	August 15, 2007	<b>Approximate Year Built:</b>	2001
<b>*Wall Rating:</b>	71	<b>Maintenance Action:</b>	No Action

<b>Element (Weighting Factor)</b>	<b>Narrative</b>	<b>Condition Rating (0 - 10)</b>
PERFORMANCE 8.00	Good performance based on roadway and guardwall performance.	7
WALL FOUNDATION MATERIAL 8.00	Wall is buried and not able to see. Soil and boulder covered wall face and toe.	7
WIRE/GEOSYNTHETIC FACING 8.00	Welded wire is buried and not able see. Soil and boulders covered wall face.	7
DOWNSLOPE 0.50	2H:1V slope with moderate vegetation with grass and bushes.	8
LATERAL SLOPE 0.50	Soil and boulders with minor erosion.	8
ROAD/SIDEWALK/SHOULDER 0.50	No settlement or cracking.	8
TRAFFIC BARRIER/FENCE 0.50	Schist guardwall (historic). Good condition.	8
WALL DRAINS 0.50	No drainage apparent.	8
VEGETATION 1.00	Wall buried. No large vegetation on buried wall.	6

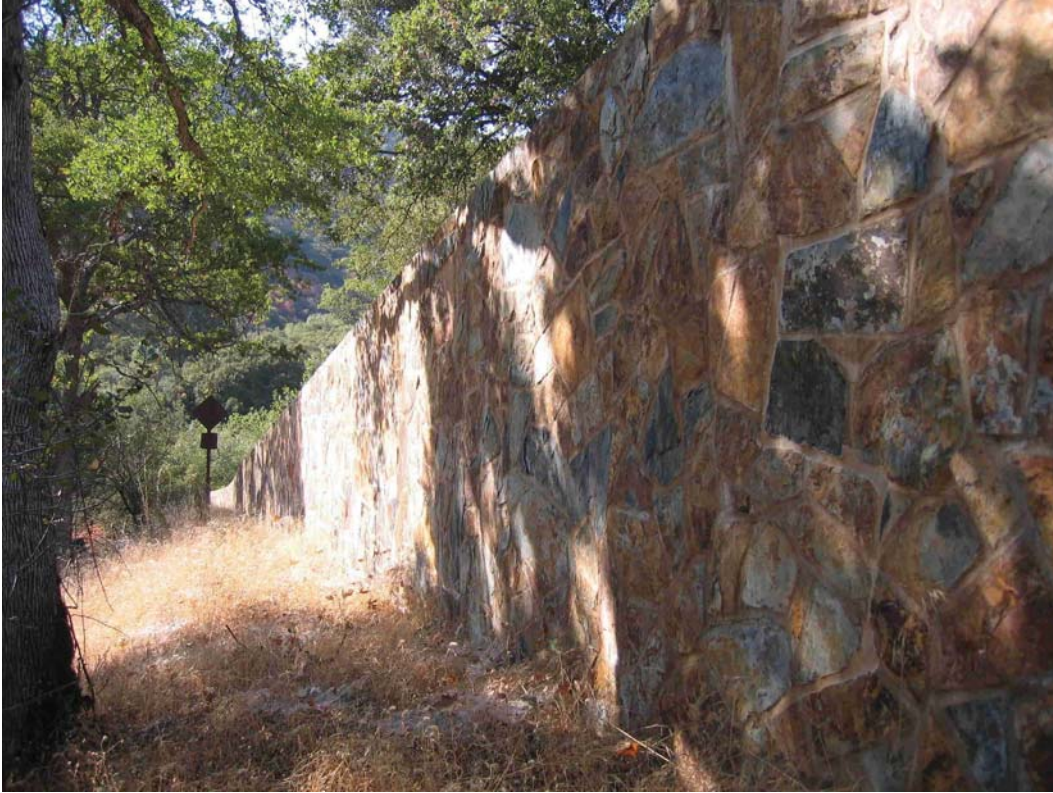
**SEQU\_0010\_7.857\_R\_1.jpg**

<b>Wall ID:</b>	SEQU-0010-7.857-R		
<b>Route Name:</b>	GENERALS HIGHWAY HISTORIC		
<b>Inspection Date:</b>	August 15, 2007	<b>Approximate Year Built:</b>	2001
<b>*Wall Rating:</b>	89	<b>Maintenance Action:</b>	No Action

<b>Element (Weighting Factor)</b>	<b>Narrative</b>	<b>Condition Rating (0 - 10)</b>
PERFORMANCE 8.00	Excellent performance. No signs of settlement or global instability.	9
WALL FOUNDATION MATERIAL 8.00	5 ft compacted soil bench. No signs of erosion or loose of material.	9
CONCRETE 8.00	Concrete covered with schist stone. No cracking is visible	9
ARCHITECTURAL FACING 0.50	Schist stone with mortar. Minor mortar shrinkage and slight weathering in stone. Good condition.	8
DOWNSLOPE 0.50	Soil with boulders. Slope 1.5H:1V with minor erosion.	8
ROAD/SIDEWALK/SHOULDER 0.50	No cracks or distress caused by wall.	8
TRAFFIC BARRIER/FENCE 0.50	Parapet with schist stone veneer on all sides. Excellent condition.	8
VEGETATION 0.50	No vegetation on wall face.	8
LATERAL SLOPE 0.50	Bedrock on both sides. Very stable.	9

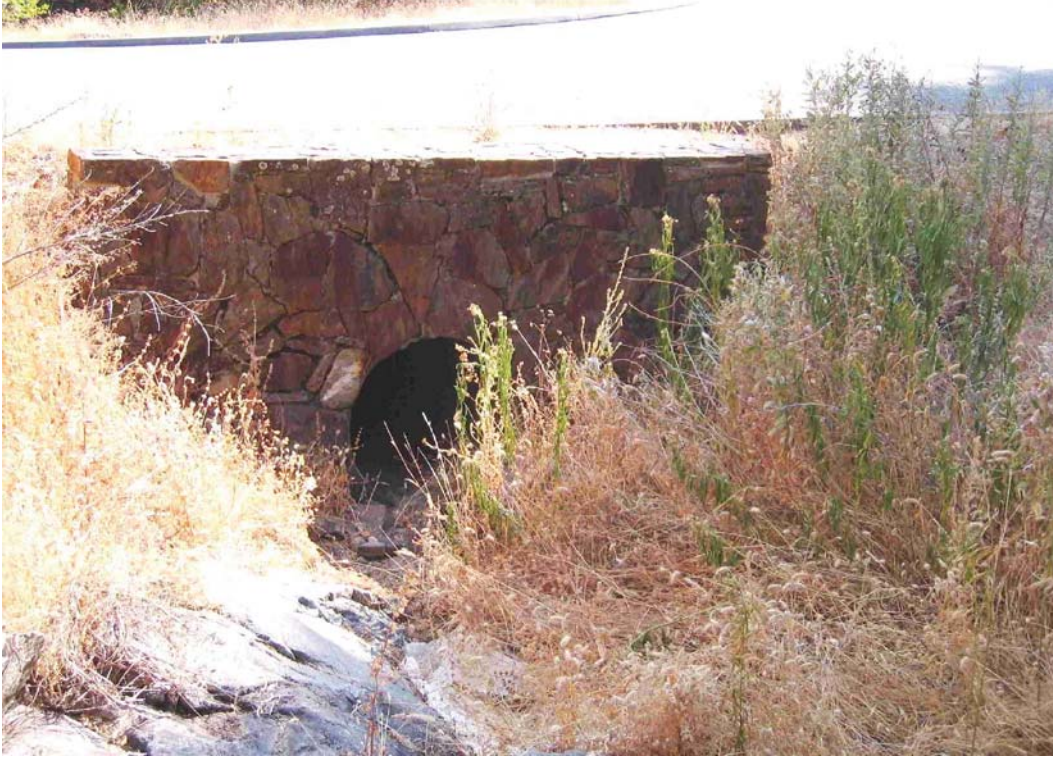
**SEQU\_0010\_8.041\_R\_1.jpg**

<b>Wall ID:</b>	SEQU-0010-8.041-R		
<b>Route Name:</b>	GENERALS HIGHWAY HISTORIC		
<b>Inspection Date:</b>	August 15, 2007	<b>Approximate Year Built:</b>	Unknown
<b>*Wall Rating:</b>	80	<b>Maintenance Action:</b>	No Action

<b>Element (Weighting Factor)</b>	<b>Narrative</b>	<b>Condition Rating (0 - 10)</b>
PERFORMANCE 8.00	Good performance.	8
WALL FOUNDATION MATERIAL 8.00	Bedrock, competent and strong (granite) sufficient to support wall.	8
MORTAR 8.00	Good condition. Minor shrinkage and no cracking.	8
STONE MASONRY 8.00	Stones are slightly weathered but intact and no missing elements.	8
CULVERT 0.50	One 24" CMP. Good condition with some rust on the bottom of culvert.	8
LATERAL SLOPE 0.50	Soil over bedrock with minor erosion.	8
VEGETATION 0.50	No vegetation on wall face	8
UPSLOPE 0.50	Bedrock competent strong granite	9
WALL DRAINS 1.00	No wall drain is visible	7

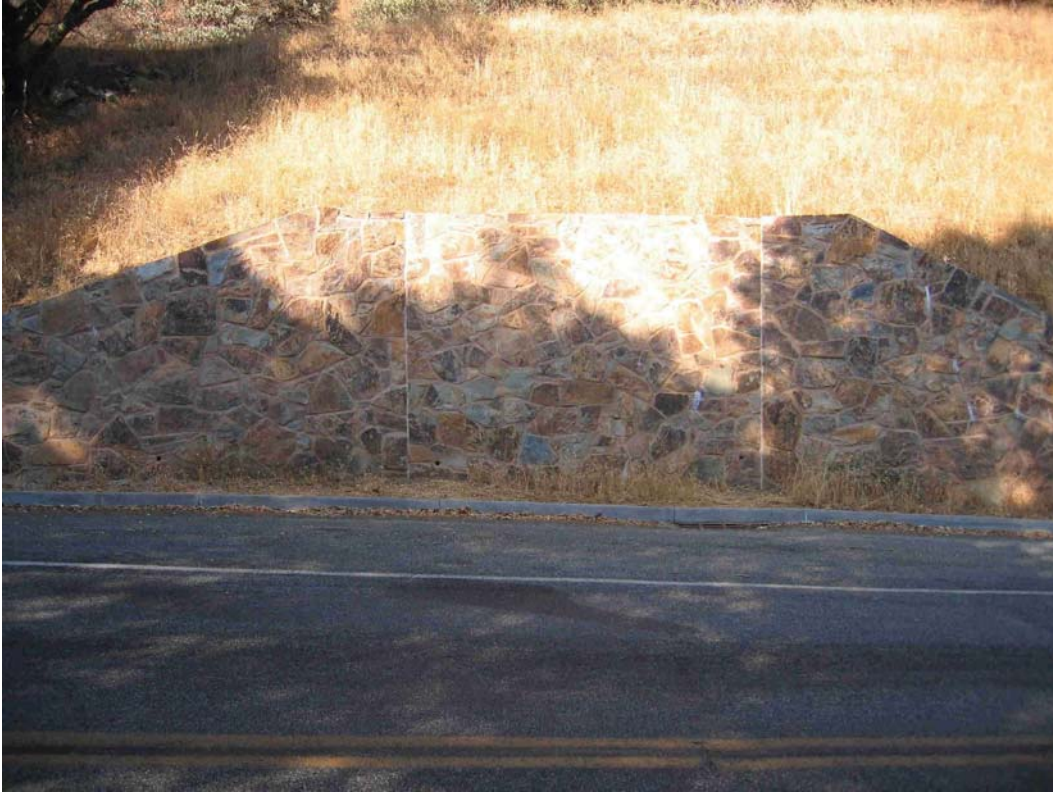
**SEQU\_0010\_8.154\_R\_1.jpg**

<b>Wall ID:</b>	SEQU-0010-8.154-R		
<b>Route Name:</b>	GENERALS HIGHWAY HISTORIC		
<b>Inspection Date:</b>	August 15, 2007	<b>Approximate Year Built:</b>	2004
<b>*Wall Rating:</b>	88	<b>Maintenance Action:</b>	No Action

<b>Element (Weighting Factor)</b>	<b>Narrative</b>	<b>Condition Rating (0 - 10)</b>
PERFORMANCE 8.00	Excellent performance. No signs of settlement or global instability.	9
WALL FOUNDATION MATERIAL 8.00	Curb backfill. Loose soil and moderate vegetation. Flat bench - 5 ft. No signs of distress.	9
CONCRETE 8.00	Concrete covered with schist stone. No cracking is visible.	9
ARCHITECTURAL FACING 0.50	Schist stone veneer. White stains in mortars. Facing constructed in 2007.	8
ROAD/SIDEWALK/SHOULDER 0.50	No signs of cracking.	9
VEGETATION 0.50	No vegetation on wall face.	9
WALL DRAINS 0.50	Weep holes are visible, clean and functioning.	9
LATERAL SLOPE 1.00	Loose soil with minor erosion.	7
UPSLOPE 1.00	Signs of minor erosion. Loose soil 1.5H:1V to 1H:1V slope well vegetation.	7

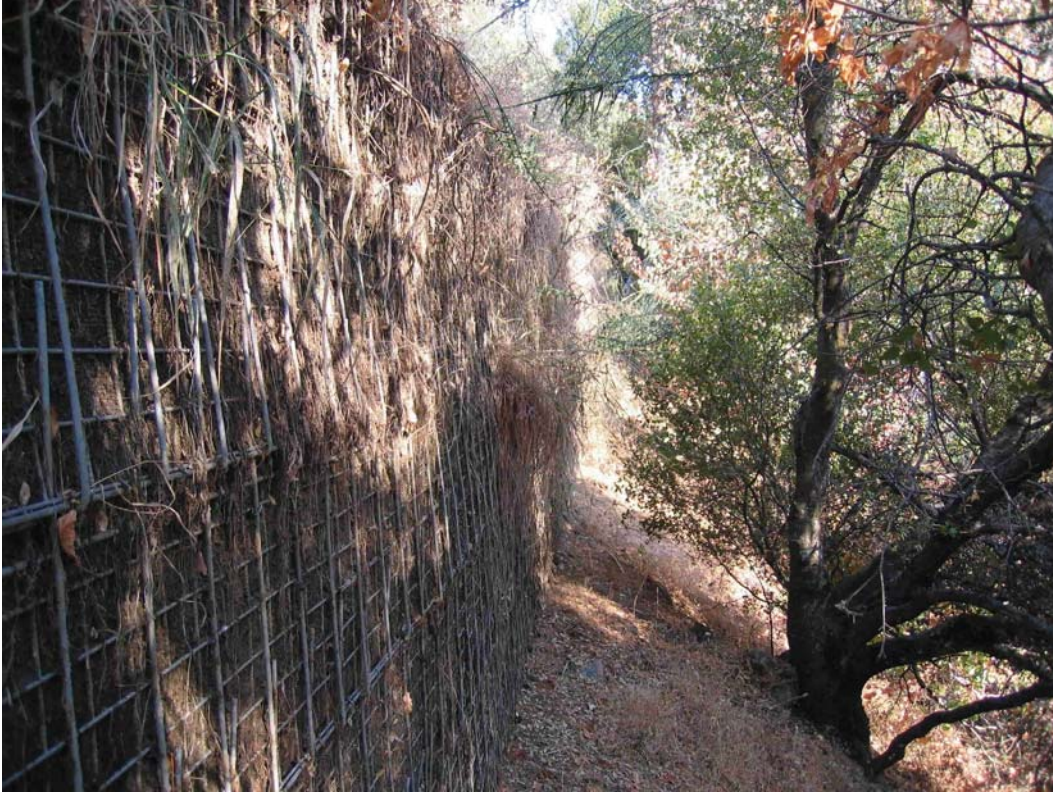
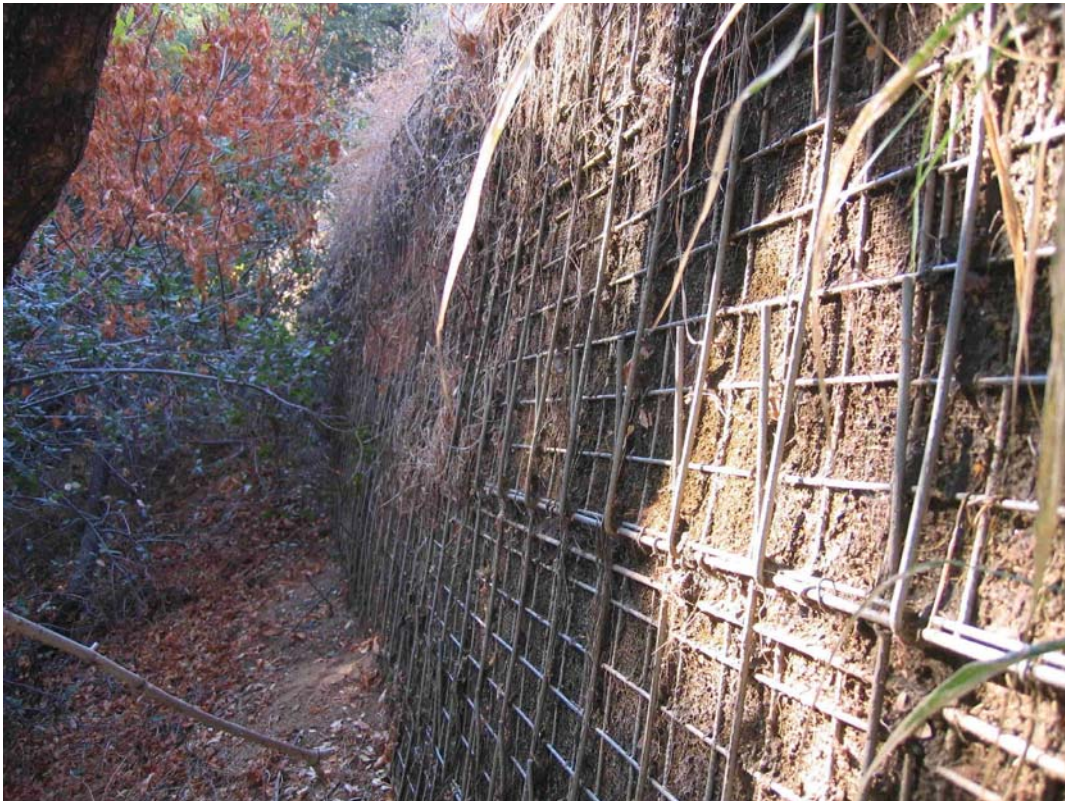
**SEQU\_0010\_8.380\_R\_1.jpg**

<b>Wall ID:</b>	SEQU-0010-8.380-R		
<b>Route Name:</b>	GENERALS HIGHWAY HISTORIC		
<b>Inspection Date:</b>	August 15, 2007	<b>Approximate Year Built:</b>	2001
<b>*Wall Rating:</b>	79	<b>Maintenance Action:</b>	No Action

<b>Element (Weighting Factor)</b>	<b>Narrative</b>	<b>Condition Rating (0 - 10)</b>
PERFORMANCE 8.00	Good performance. No signs of settlement, rotation, or global instability.	8
WALL FOUNDATION MATERIAL 8.00	Loose soil at steep angle 1H:1V thru 1.5H:1V. All bottom baskets are buried and no foundation problems exist. Sufficient to support wall.	8
WIRE/GEOSYNTHETIC FACING 8.00	Wire are in good condition. Baskets are straining and not bowed. Minor settlement in baskets, generally in very good condition and good batter.	8
LATERAL SLOPE 0.50	Bedrock, strong competent stable.	8
ROAD/SIDEWALK/SHOULDER 0.50	No cracks or distress	8
VEGETATION 0.50	Vegetation in intentionally growing in wall. No effect on stability.	9
DOWNSLOPE 1.00	Loose soil steep 1H:1V with boulders.	7
TRAFFIC BARRIER/FENCE 1.00	Guardwall with schist on all sides. Minor weathering in schist materials and shrinkage in mortar.	7
WALL DRAINS 1.00	No wall drains were visible.	7

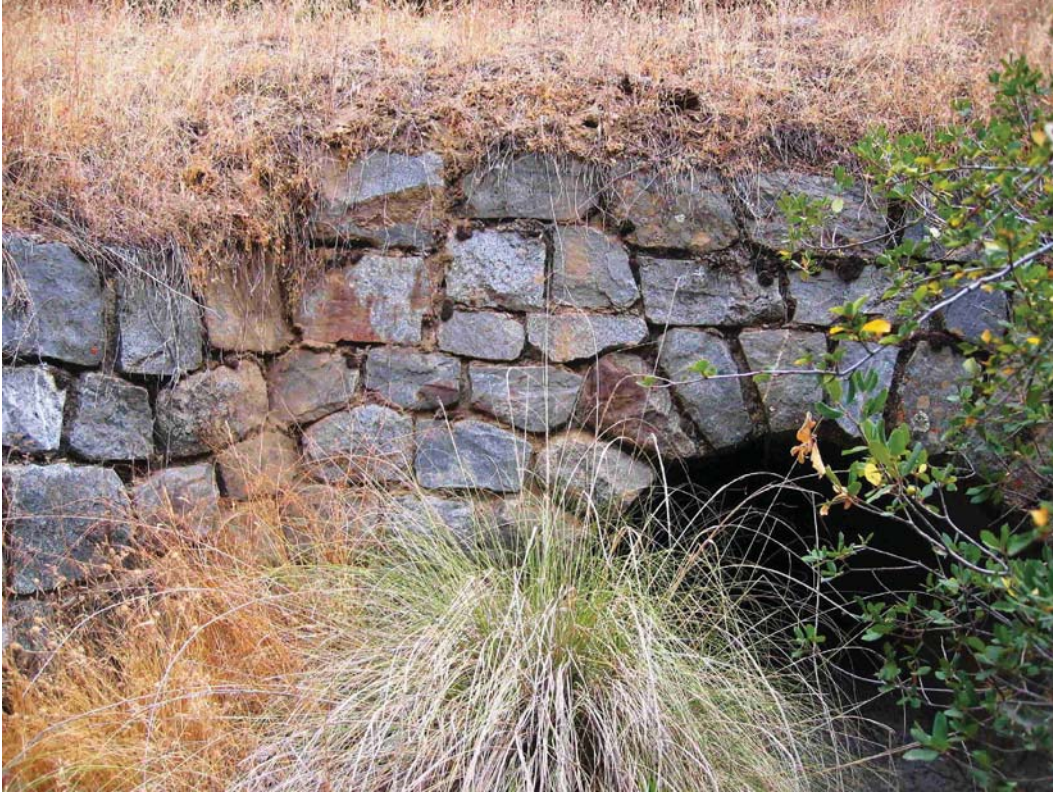
**SEQU\_0010\_8.820\_R\_1.jpg**

<b>Wall ID:</b>	SEQU-0010-8.820-R		
<b>Route Name:</b>	GENERALS HIGHWAY HISTORIC		
<b>Inspection Date:</b>	August 16, 2007	<b>Approximate Year Built:</b>	Unknown
<b>*Wall Rating:</b>	82	<b>Maintenance Action:</b>	No Action

<b>Element (Weighting Factor)</b>	<b>Narrative</b>	<b>Condition Rating (0 - 10)</b>
PERFORMANCE 8.00	Good performance.	8
WALL FOUNDATION MATERIAL 8.00	Granite, strong competent, bedrock.	9
MORTAR 8.00	Good condition. Minor cracking.	8
STONE MASONRY 8.00	Strong, competent, granite cut stone. No signs of weathering or cracking. No missing elements.	8
LATERAL SLOPE 0.50	Compacted soil. No signs or erosion, vegetated with grass. Stable flat slope begin of wall. 1.5H:1V slope on the end of wall.	8
UPSLOPE 0.50	Loose soil with grass flat 6H:1V.	8
DOWNSLOPE 0.50	Granite bedrock, strong, intact.	9
CULVERT 1.00	5 ft arch culvert on footings. Good condition.	7
VEGETATION 1.00	No vegetation in wall face that affected stability.	7

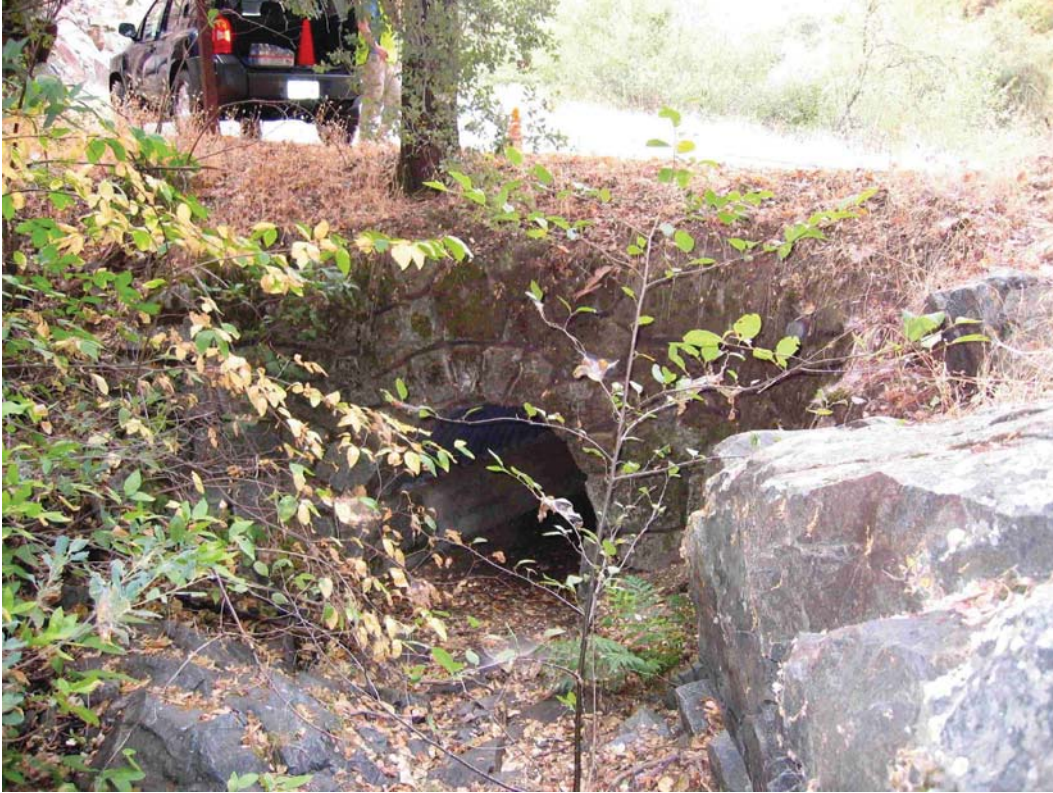
**SEQU\_0010\_8.823\_L\_1.jpg**

<b>Wall ID:</b>	SEQU-0010-8.823-L		
<b>Route Name:</b>	GENERALS HIGHWAY HISTORIC		
<b>Inspection Date:</b>	August 16, 2007	<b>Approximate Year Built:</b>	Unknown
<b>*Wall Rating:</b>	79	<b>Maintenance Action:</b>	No Action

<b>Element (Weighting Factor)</b>	<b>Narrative</b>	<b>Condition Rating (0 - 10)</b>
PERFORMANCE 8.00	Good performance.	8
WALL FOUNDATION MATERIAL 8.00	Bedrock, granite, strong, competent.	8
MORTAR 8.00	No cracks or shrinkage. Good condition.	8
STONE MASONRY 8.00	Strong, competent, granite. No weathering or cracking. No missing elements.	8
DOWNSLOPE 0.50	Granite, competent, bedrock.	8
LATERAL SLOPE 0.50	Bedrock, very strong granite.	8
CULVERT 1.00	5 ft arch culvert on footing. Good condition.	7
UPSLOPE 1.00	Loose soil. 2H:1V slope with grass.	7
WALL DRAINS 1.00	No wall drains are visible.	7

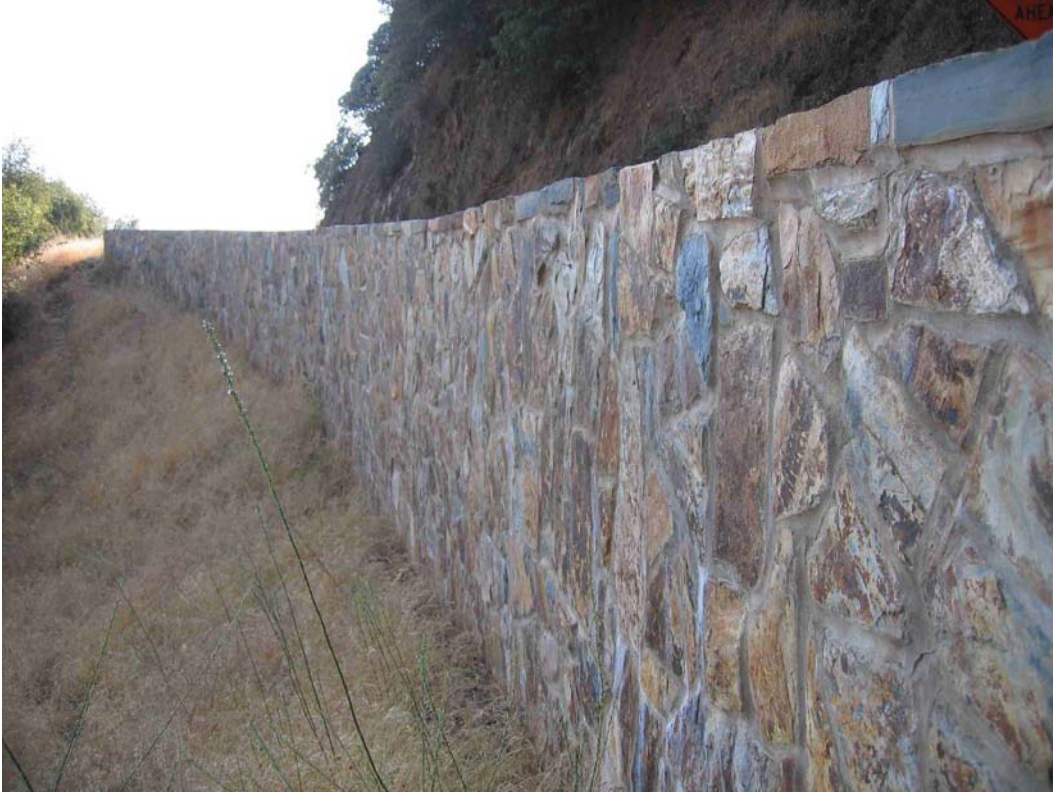
**SEQU\_0010\_9.496\_L\_1.jpg**

<b>Wall ID:</b>	SEQU-0010-9.496-L		
<b>Route Name:</b>	GENERALS HIGHWAY HISTORIC		
<b>Inspection Date:</b>	August 15, 2007	<b>Approximate Year Built:</b>	2001
<b>*Wall Rating:</b>	83	<b>Maintenance Action:</b>	No Action

<b>Element (Weighting Factor)</b>	<b>Narrative</b>	<b>Condition Rating (0 - 10)</b>
PERFORMANCE 8.00	Excellent performance. Performing as intended.	9
WALL FOUNDATION MATERIAL 8.00	Compacted soil. No undermining of wall foundation. Steep slope 1H:1V. Some erosion.	7
CONCRETE 8.00	Concrete is faced with real schist stone and mortar.	9
TRAFFIC BARRIER/FENCE 0.50	Concrete parapet with real schist stone on all sides. Excellent condition. Minor weathering and minor mortar cracking.	8
WALL DRAINS 0.50	Weep holes are visible and functioning.	8
ARCHITECTURAL FACING 0.50	Schist stone veneer and mortar. No signs ore shrinkage or cracking of the mortar. No cracking of the stone veneer and minor weathering of schist.	9
ROAD/SIDEWALK/SHOULDER 0.50	No cracks or distress.	9
VEGETATION 0.50	No vegetation on wall face affecting wall stability.	9
DOWNSLOPE 1.00	Very steep 1H:1V with loose soil, grass and large trees.	7

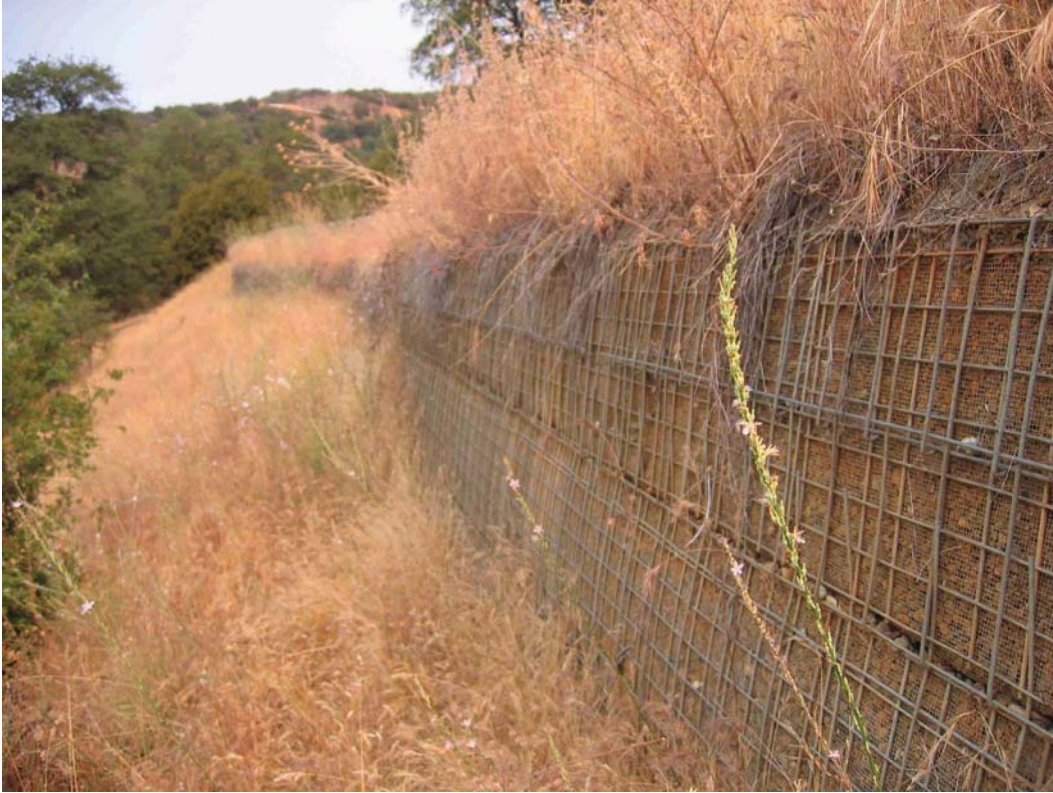
**SEQU\_0010\_9.536\_L\_1.jpg**

<b>Wall ID:</b>	SEQU-0010-9.536-L		
<b>Route Name:</b>	GENERALS HIGHWAY HISTORIC		
<b>Inspection Date:</b>	August 16, 2007	<b>Approximate Year Built:</b>	2001
<b>*Wall Rating:</b>	76	<b>Maintenance Action:</b>	No Action

<b>Element (Weighting Factor)</b>	<b>Narrative</b>	<b>Condition Rating (0 - 10)</b>
PERFORMANCE 8.00	Good performance. No signs of settlement or rotation.	8
WALL FOUNDATION MATERIAL 8.00	Steep 2H:1V slope. All bottom baskets are buried. Compacted soil and sufficient to support wall.	7
WIRE/GEOSYNTHETIC FACING 8.00	Welded wires/baskets are in good condition. No signs of settlement or rotation.	8
ROAD/SIDEWALK/SHOULDER 0.50	No cracks or distress caused by wall	8
TRAFFIC BARRIER/FENCE 0.50	Schist stone veneer guardwall. No cracking and some weathering to schist stone. Good condition.	8
VEGETATION 0.50	Vegetation is intentionally growing on wall face.	8
DOWNSLOPE 1.00	Very steep 1H:1V with grass. Some eroded areas that may affect foundation stability in the near future.	7
LATERAL SLOPE 1.00	Compacted soils with grass and trees.	7
WALL DRAINS 1.00	No wall drains were visible.	7

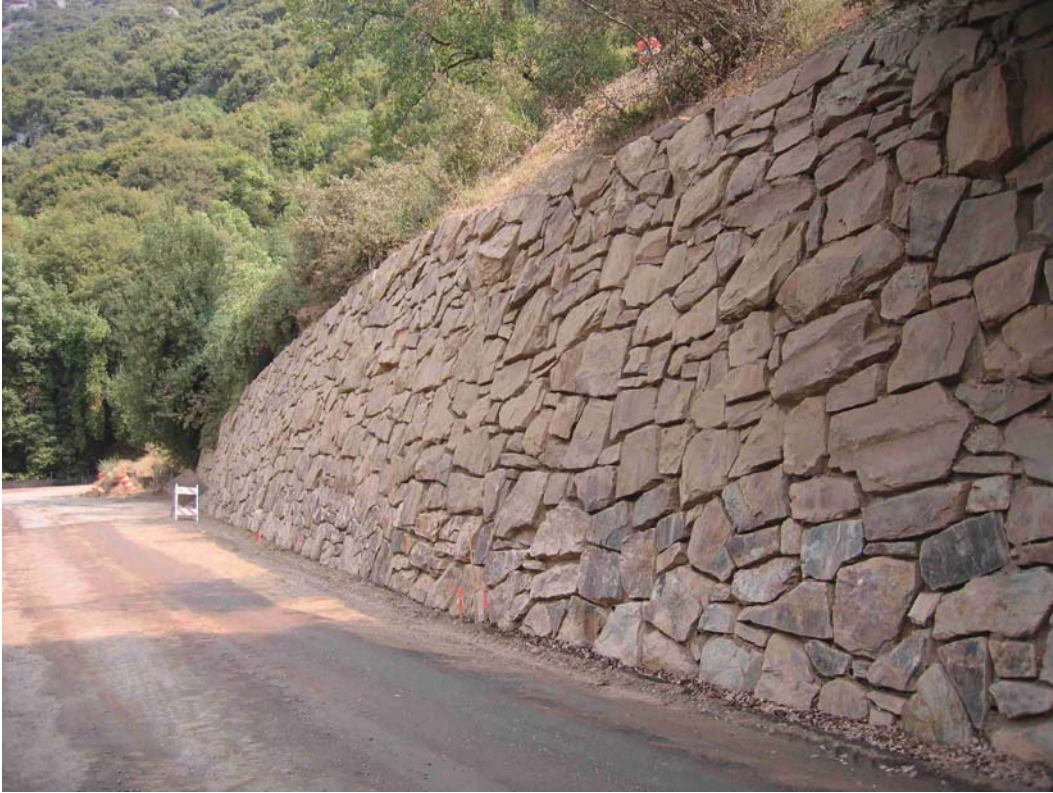
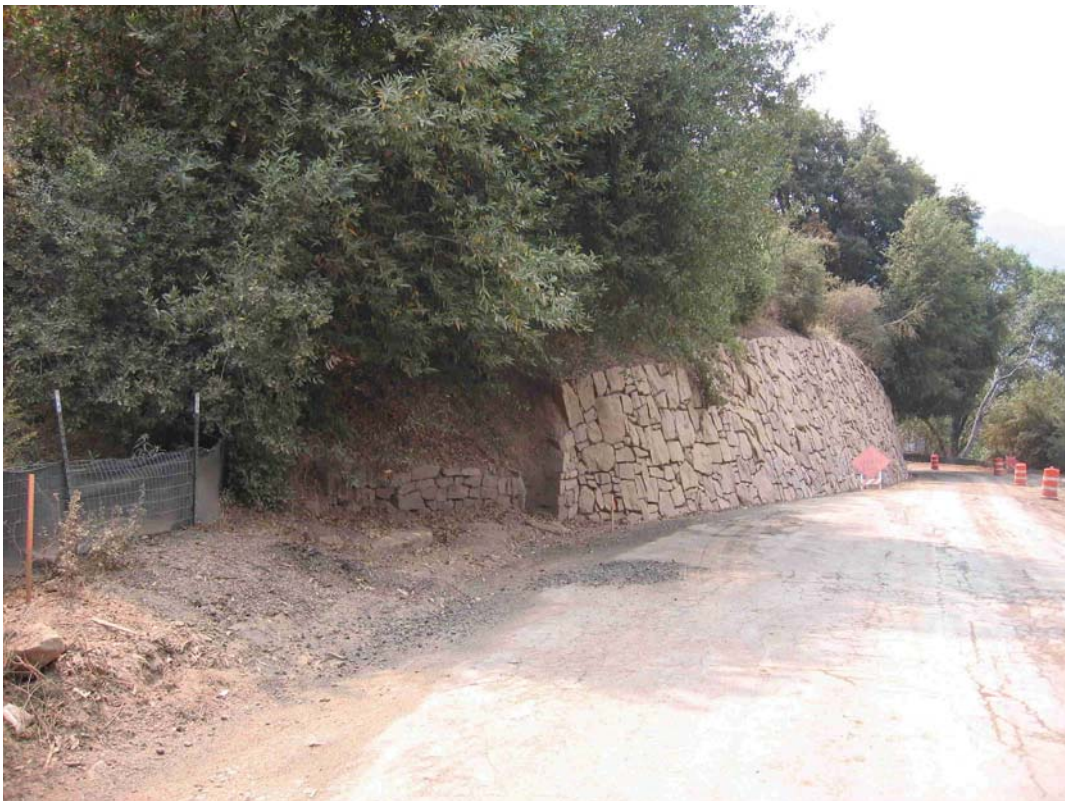
**SEQU\_0010\_10.146\_R\_1.jpg**

<b>Wall ID:</b>	SEQU-0010-10.146-R		
<b>Route Name:</b>	GENERALS HIGHWAY HISTORIC		
<b>Inspection Date:</b>	August 16, 2007	<b>Approximate Year Built:</b>	2007
<b>*Wall Rating:</b>	95	<b>Maintenance Action:</b>	No Action

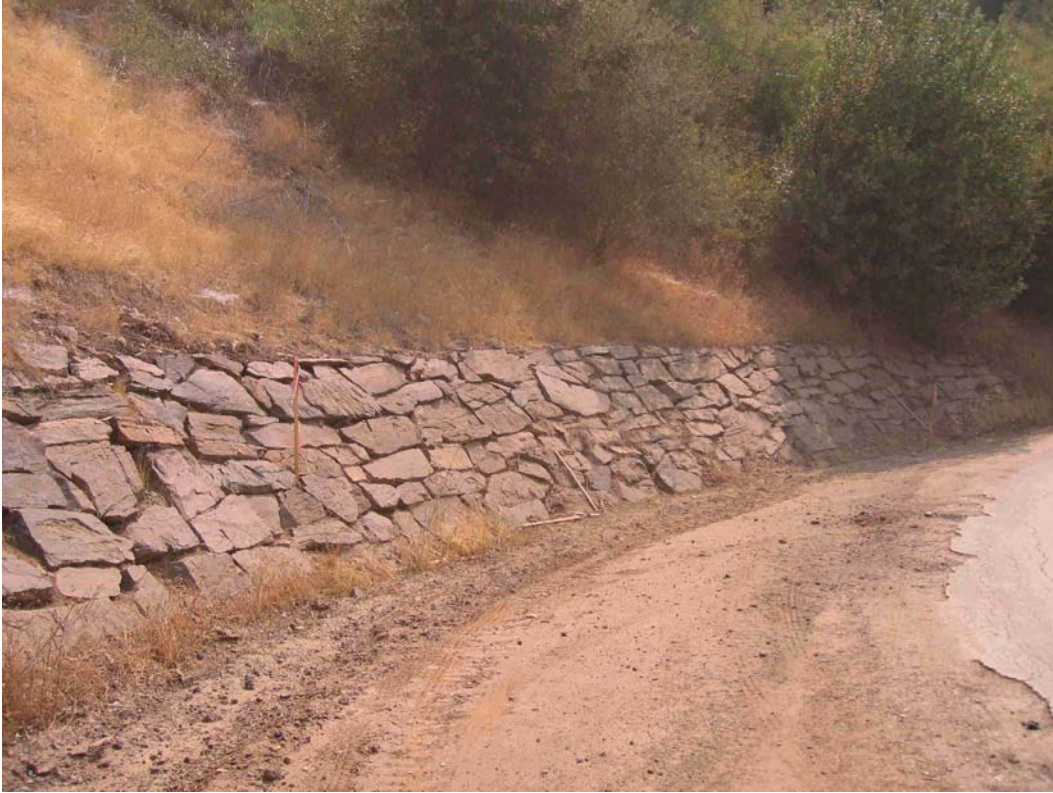
**SEQU\_0010\_10.266\_L\_1.jpg**

<b>Wall ID:</b>	SEQU-0010-10.266-L		
<b>Route Name:</b>	GENERALS HIGHWAY HISTORIC		
<b>Inspection Date:</b>	August 16, 2007	<b>Approximate Year Built:</b>	Unknown
<b>*Wall Rating:</b>	80	<b>Maintenance Action:</b>	No Action

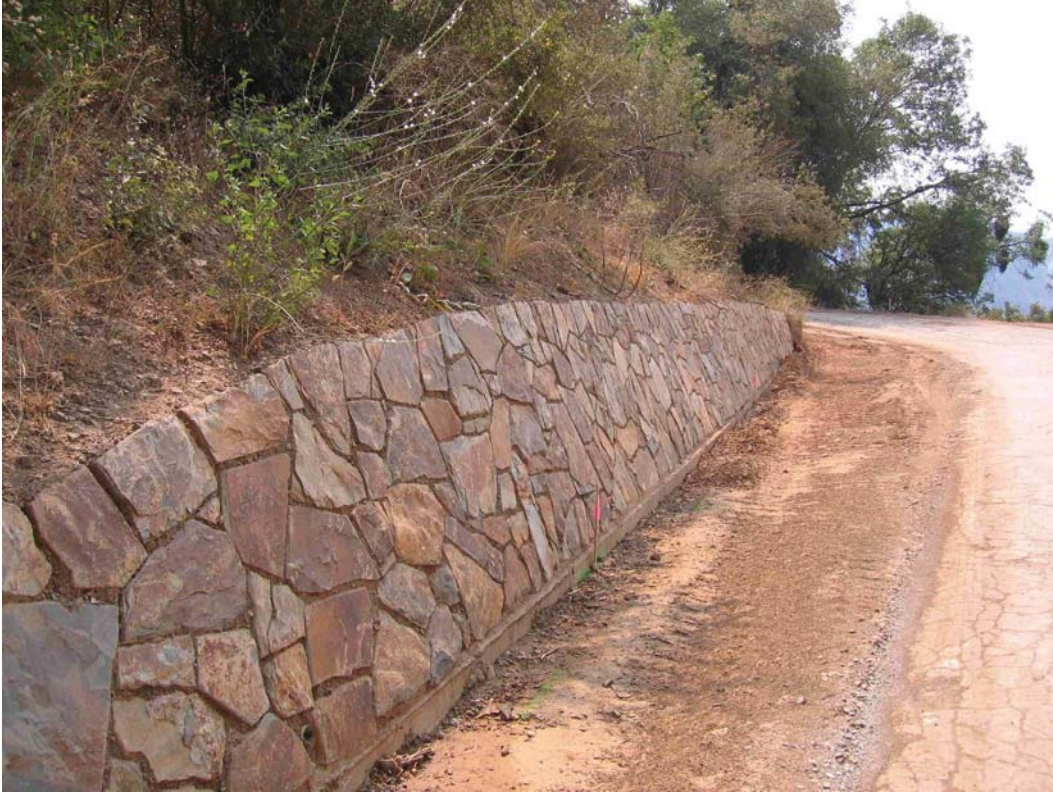
**SEQU\_0010\_10.292\_L\_1.jpg**

<b>Wall ID:</b>	SEQU-0010-10.292-L		
<b>Route Name:</b>	GENERALS HIGHWAY HISTORIC		
<b>Inspection Date:</b>	August 16, 2007	<b>Approximate Year Built:</b>	2007
<b>*Wall Rating:</b>	94	<b>Maintenance Action:</b>	No Action
